**Report: 2017 Annual Geotechnical Inspection**

February 2018

# 2017 Annual Geotechnical Inspection Meadowbank Gold Mine, Nunavut

**Report Number:** 1784282-1574-RPT-Rev0

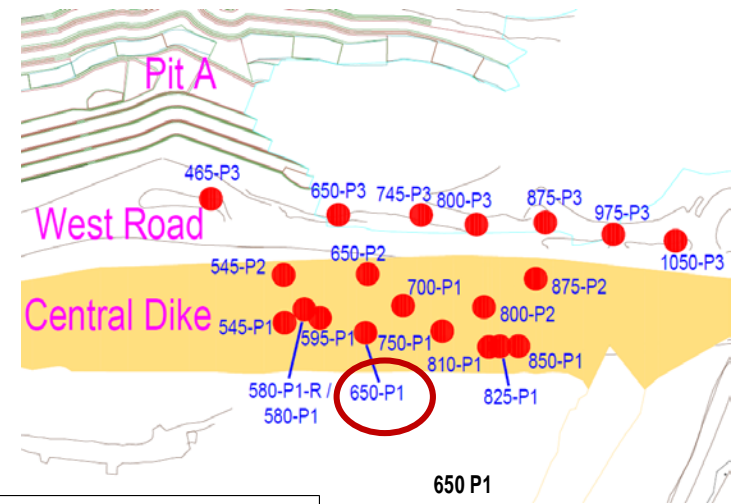
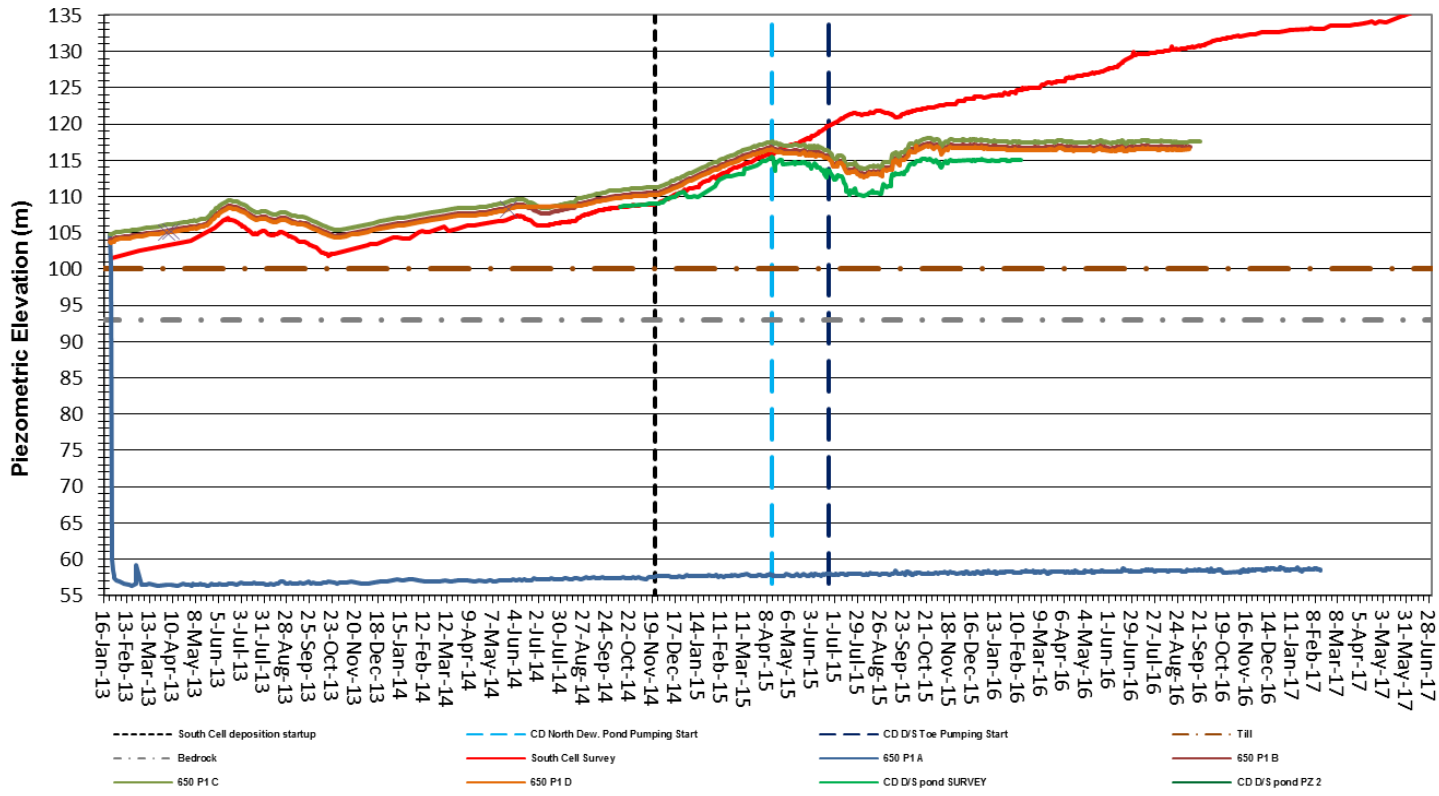
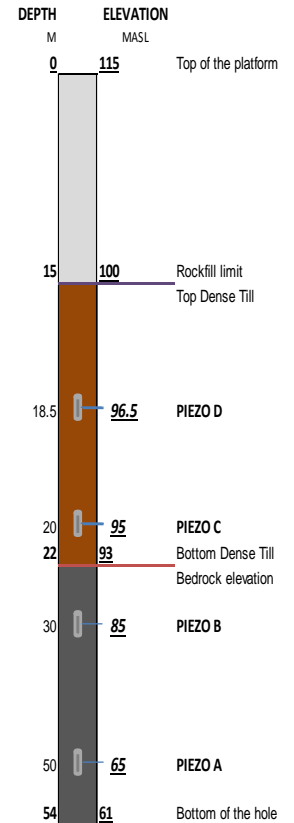
# 650-P1

- ➔ Piezometer reading not functional since February 2017
- ➔ Piezo A was in suction and piezo B to D were following D/S pond regime with readings around 117m.

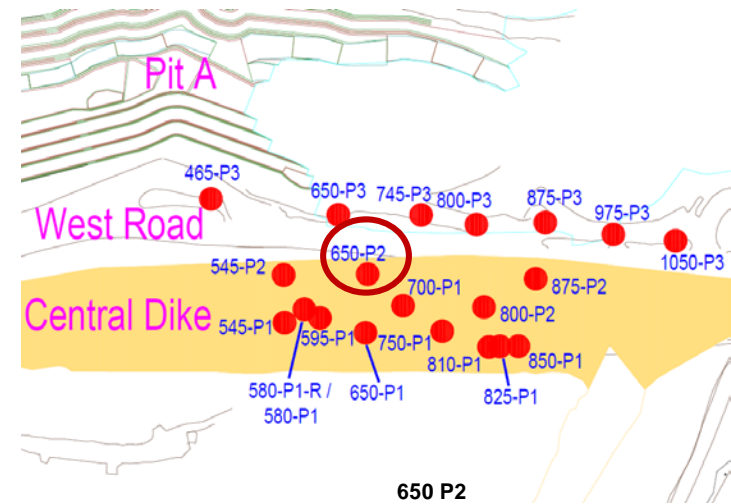
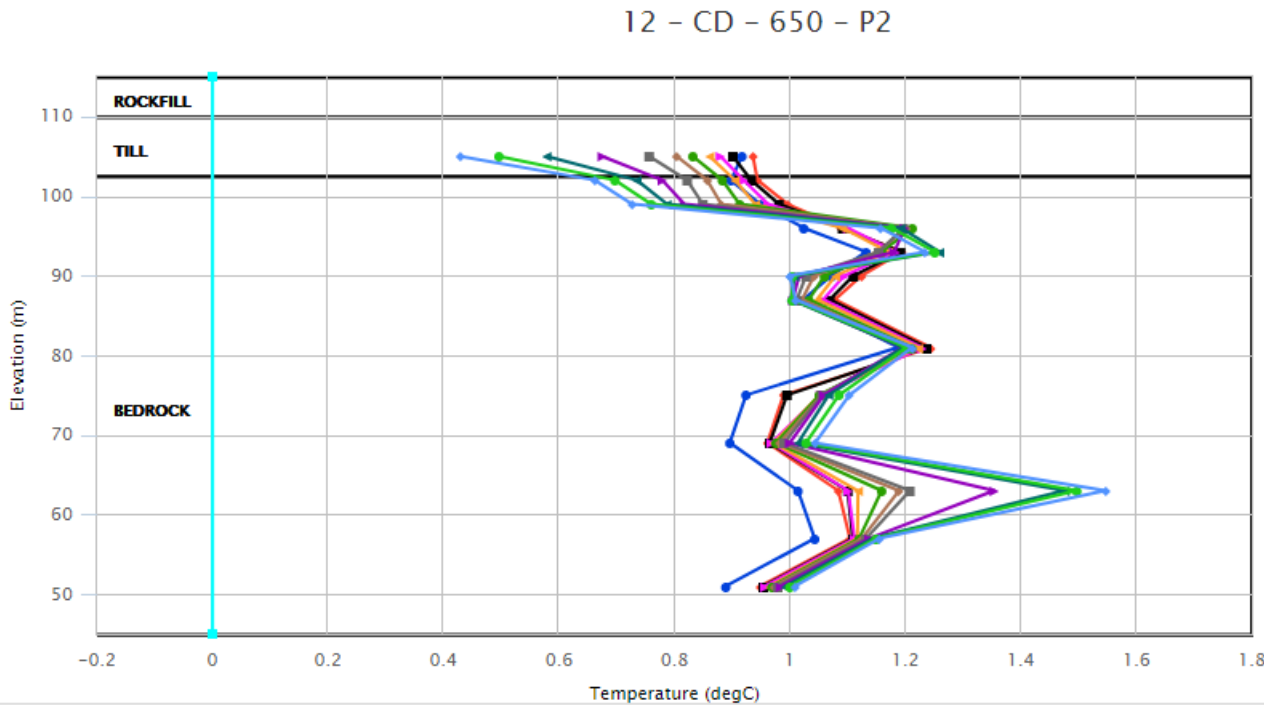
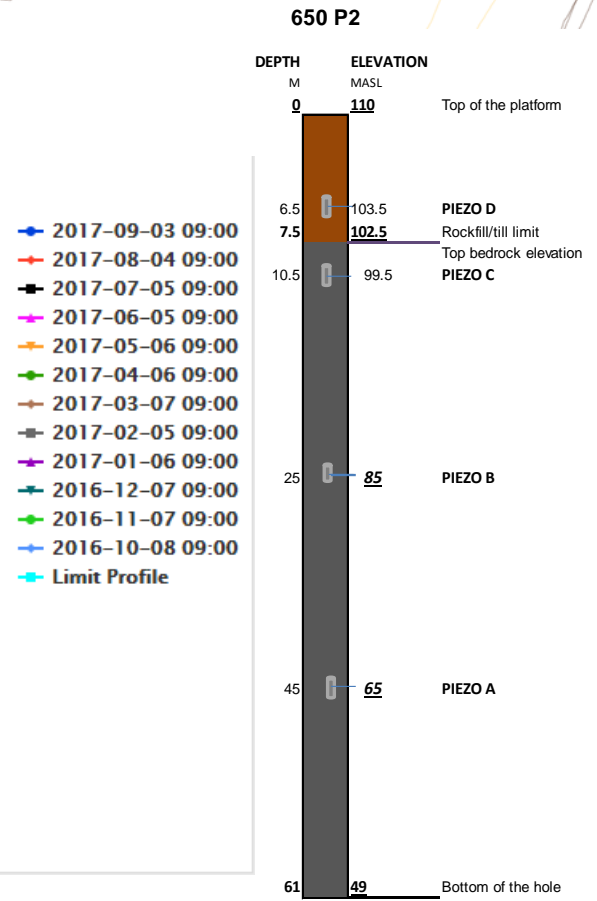
# THERMISTOR 650-P2

➔ Cooling trend observed below El. 80 similar to 2016 readings.

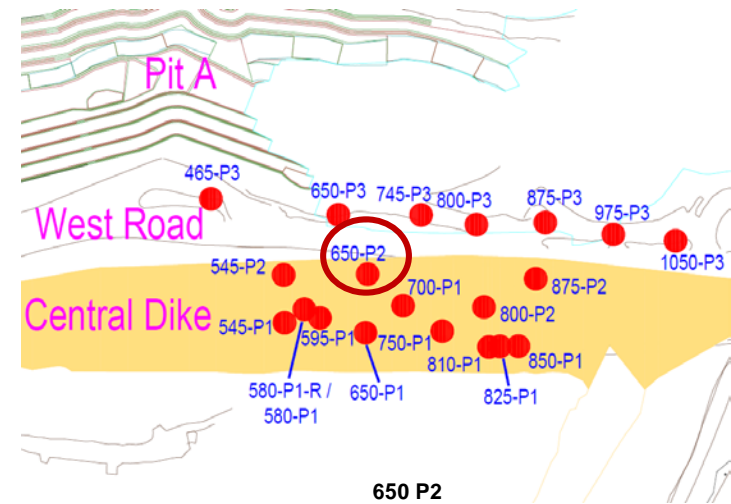
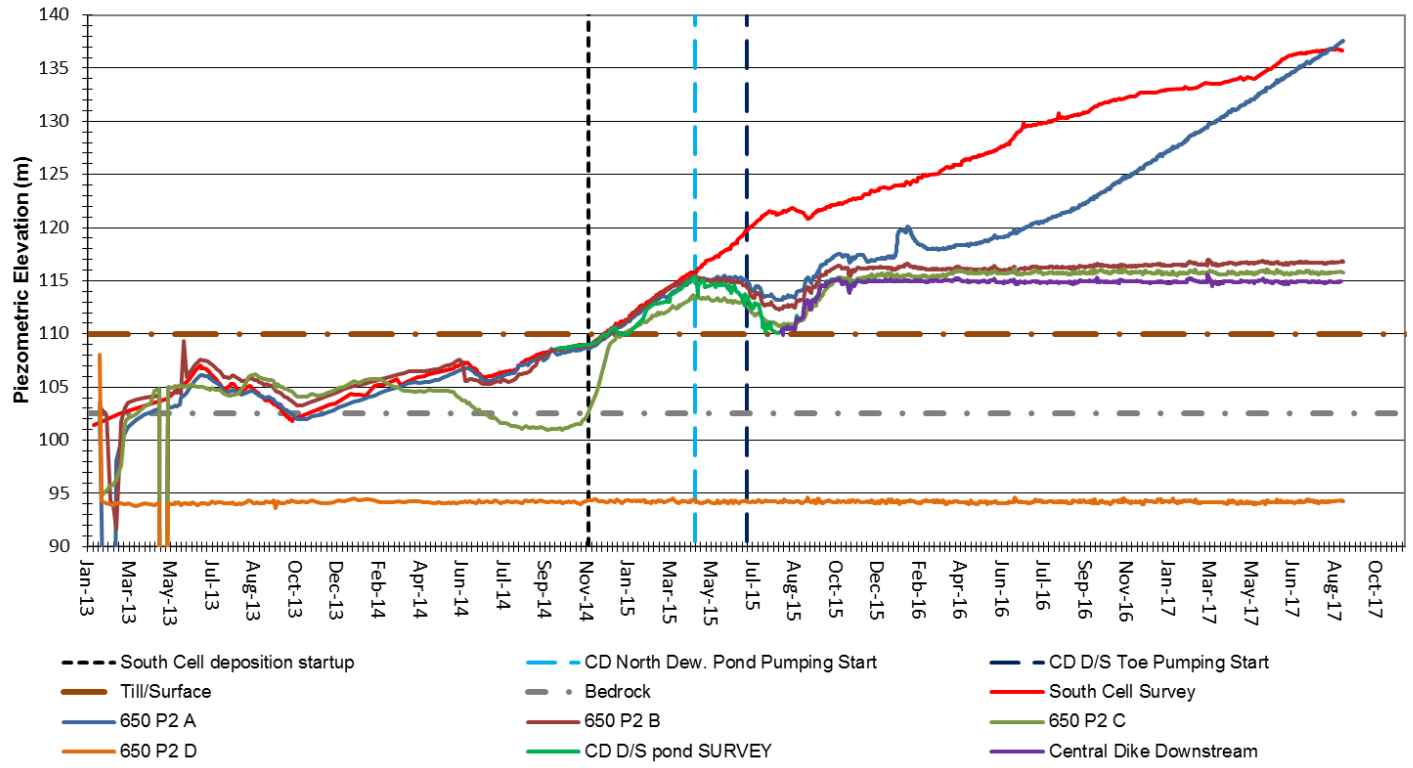
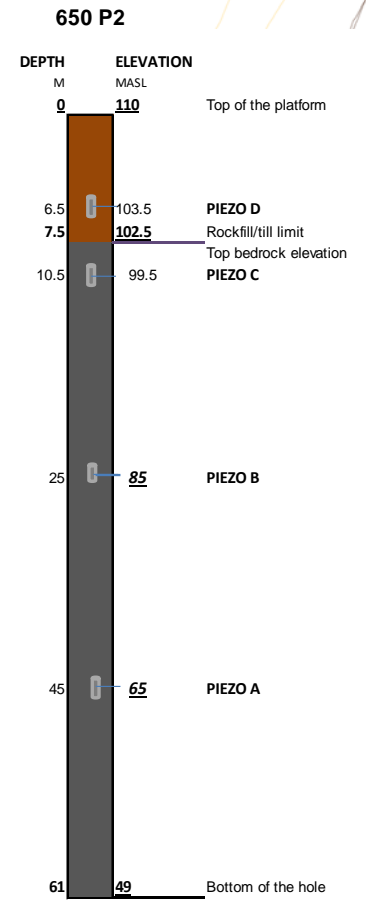
# PIEZOMETER 650-P2

- Piezometer A in bedrock continue its rise and is now over the elevation of the South Cell
- Piezo B-C are following the piezometric regime of the D/S pond
- Piezo D is in suction

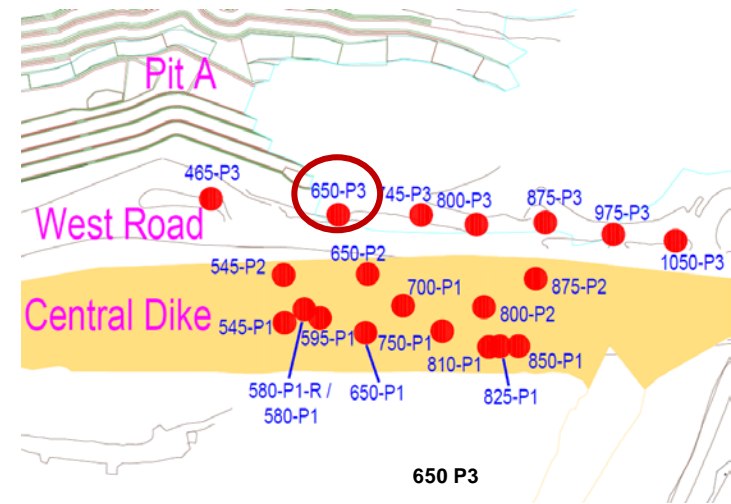
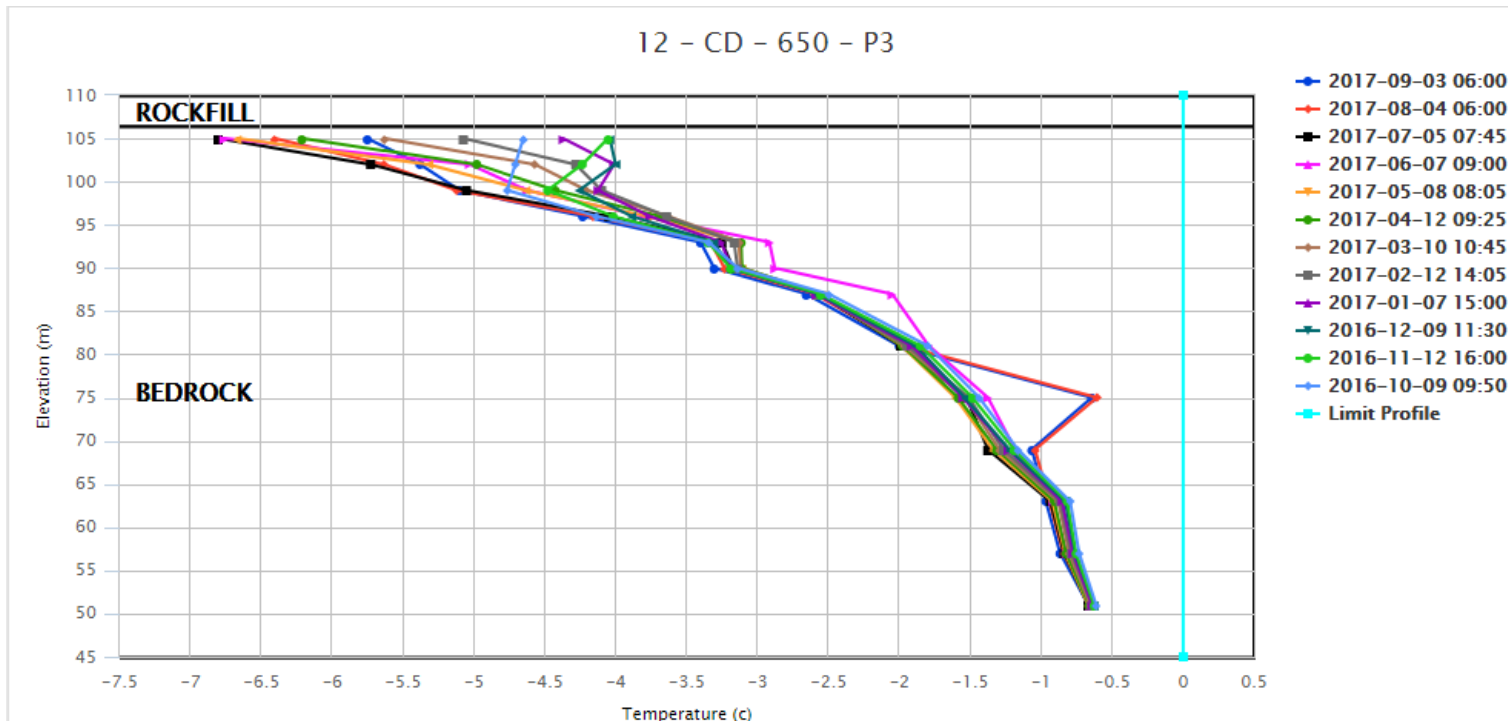
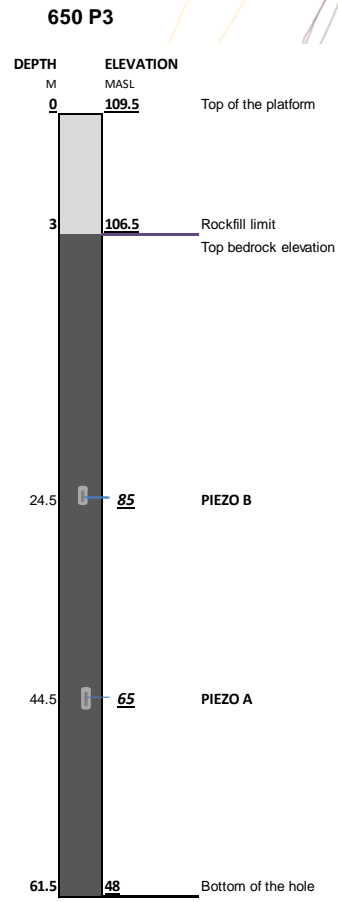
# THERMISTOR 650-P3

- Bedrock Below 0° C at 650-P3
- Temperature spike at El. 75 m is related to capacitance effect on this specific bead.

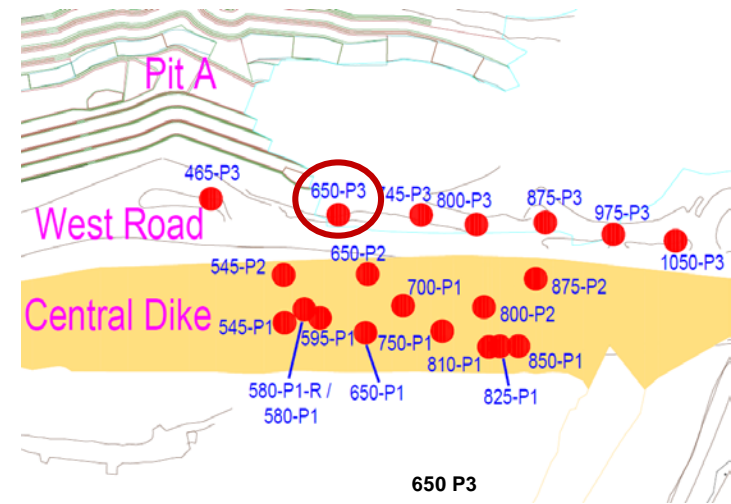
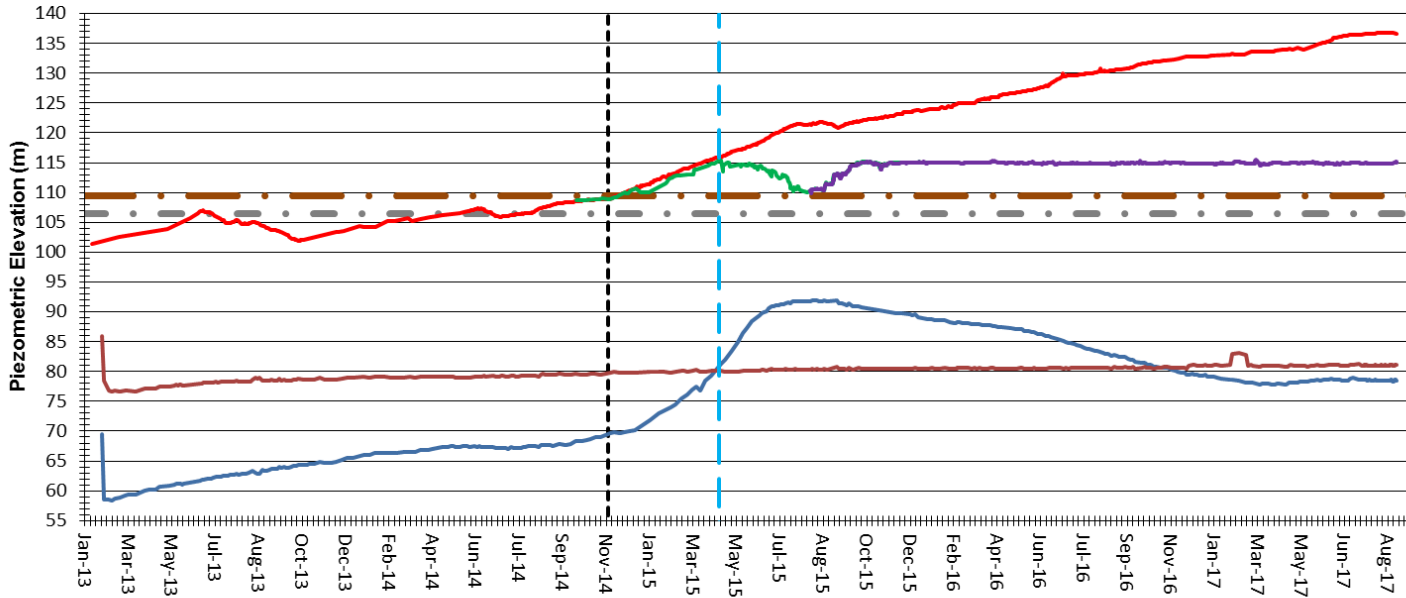
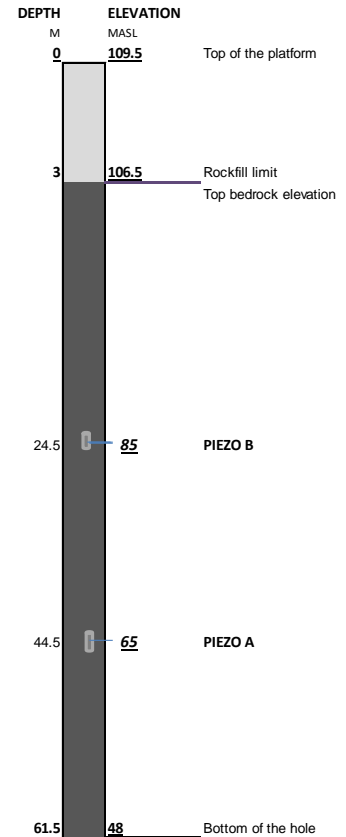
# PIEZOMETERS 650-P3

Frozen Piezometers

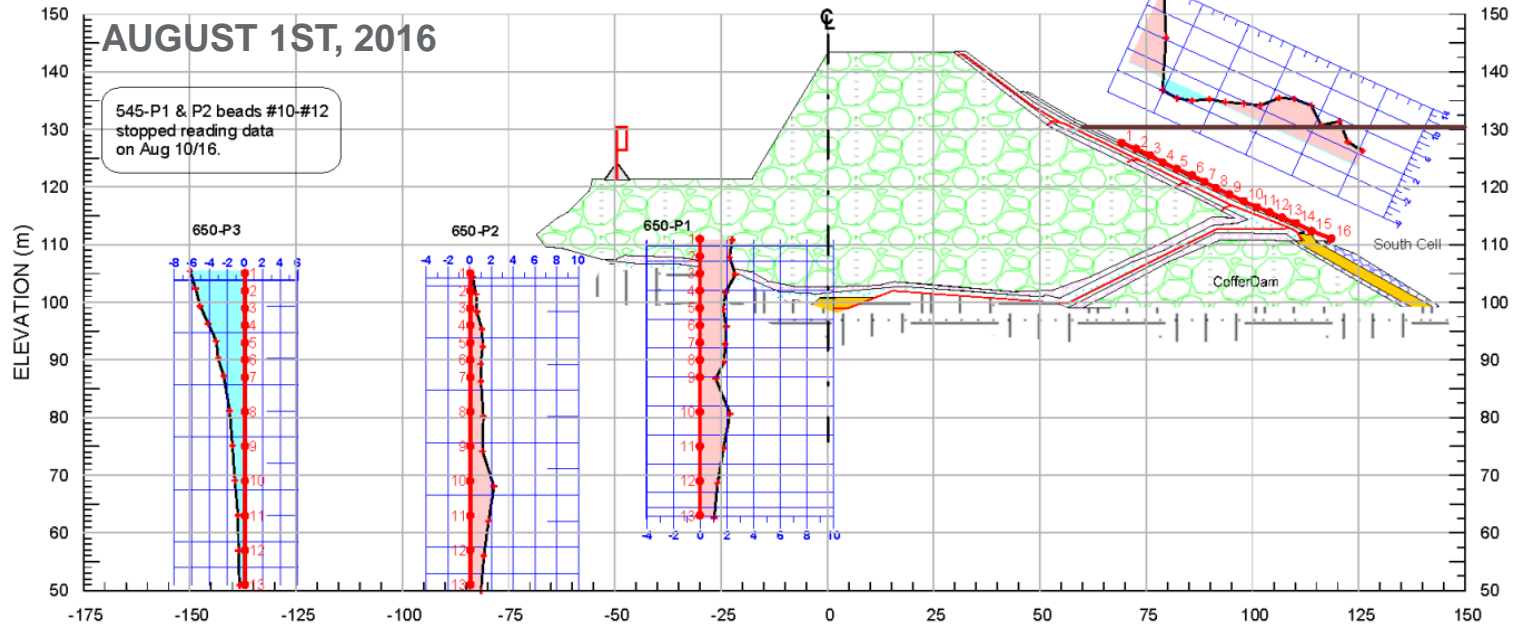
### AUGUST 1ST, 2016

545-P1 & P2 beads #10-#12 stopped reading data on Aug 10/16.

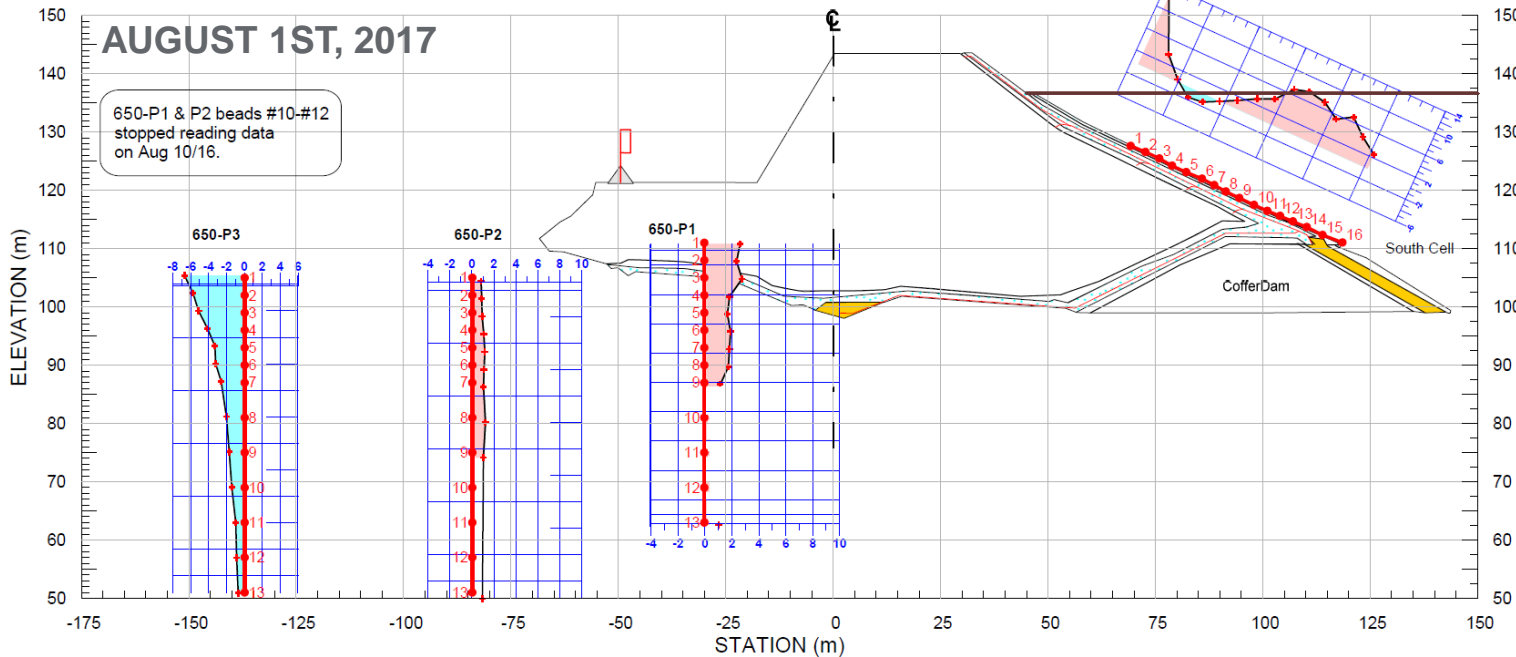
## Central Dike Section 0+650

650-P1 & P2 beads #10-#12 stopped reading data on Aug 10/16.

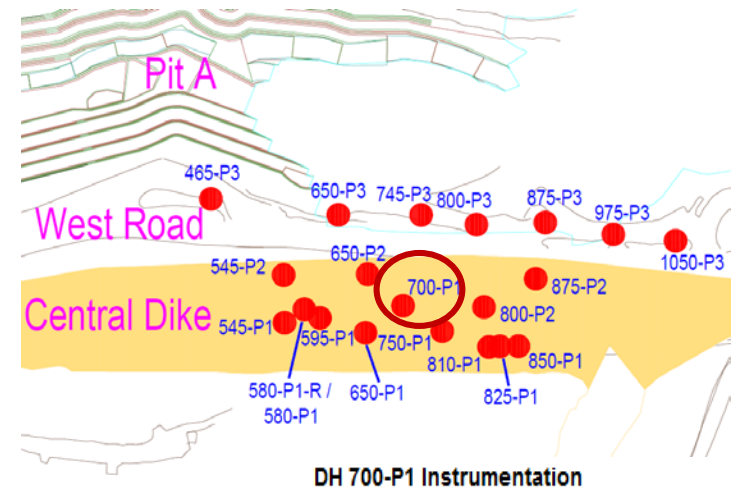
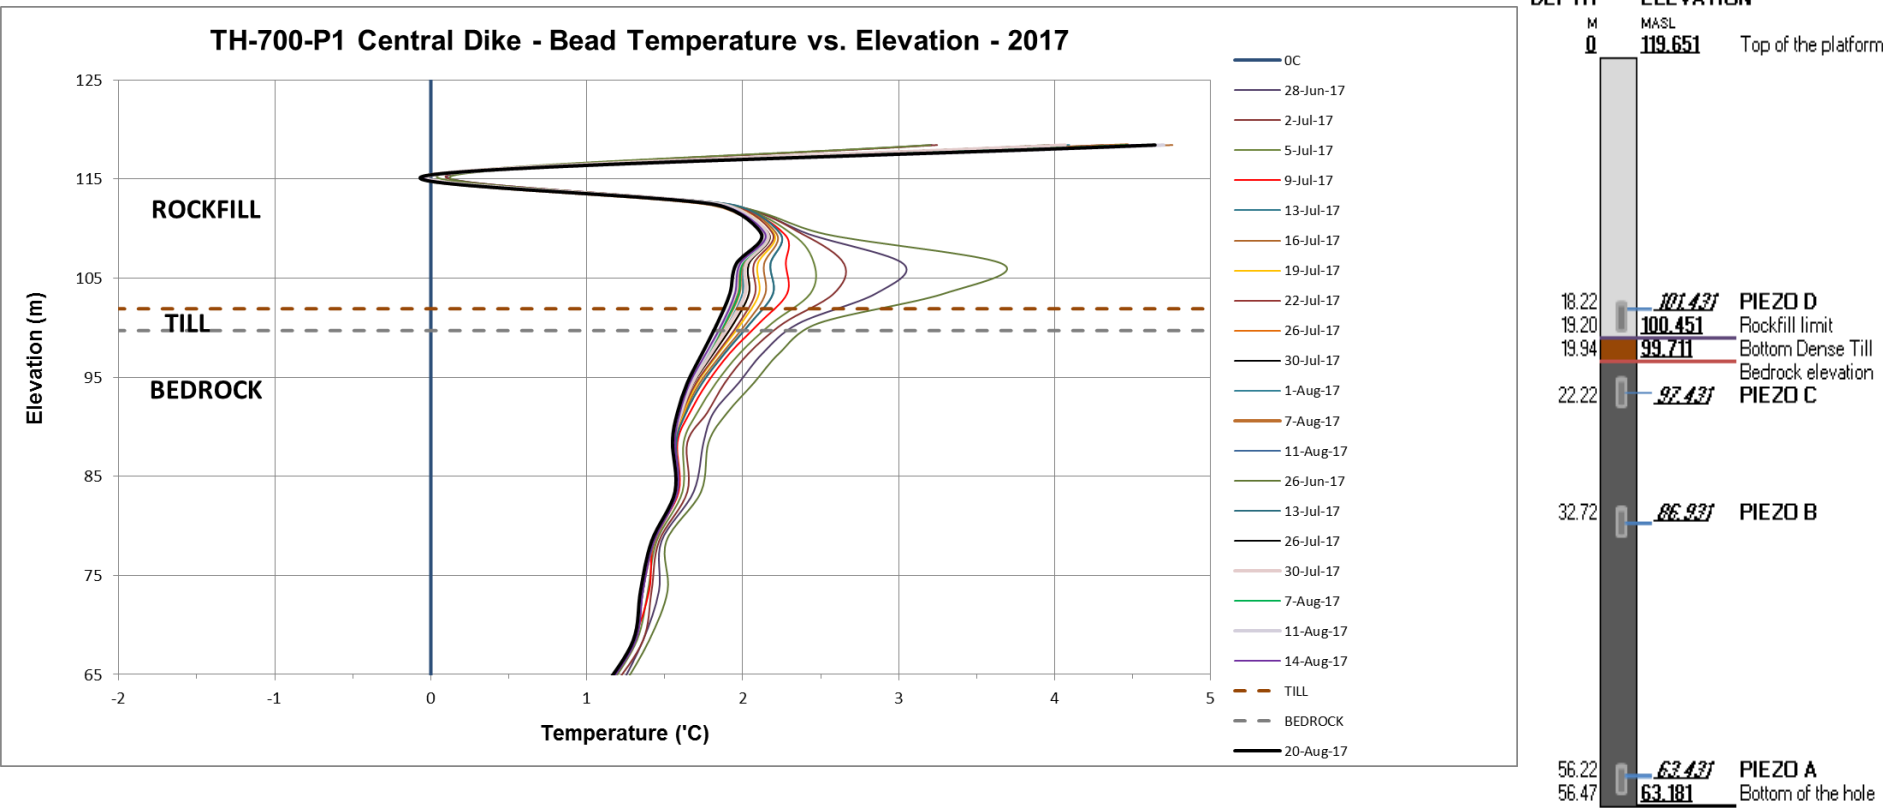
# THERMISTOR 700-P1

- New instrument installed in 2017
- Stabilisation of temperature ongoing
- Till and bedrock temperature readings above 0° C

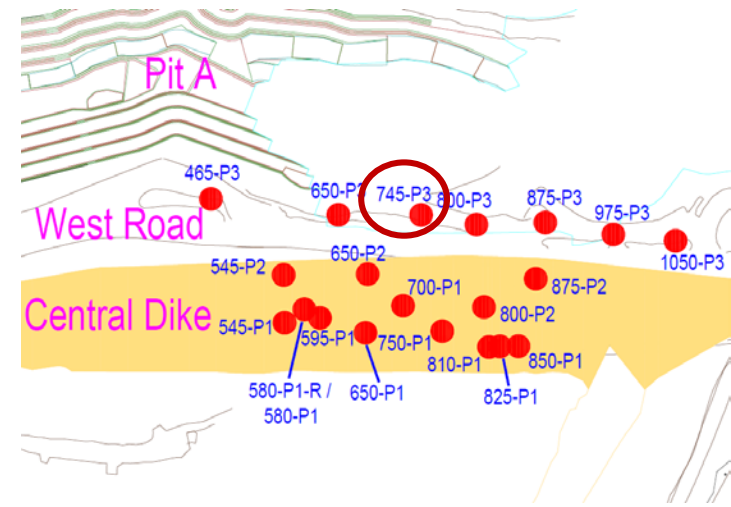
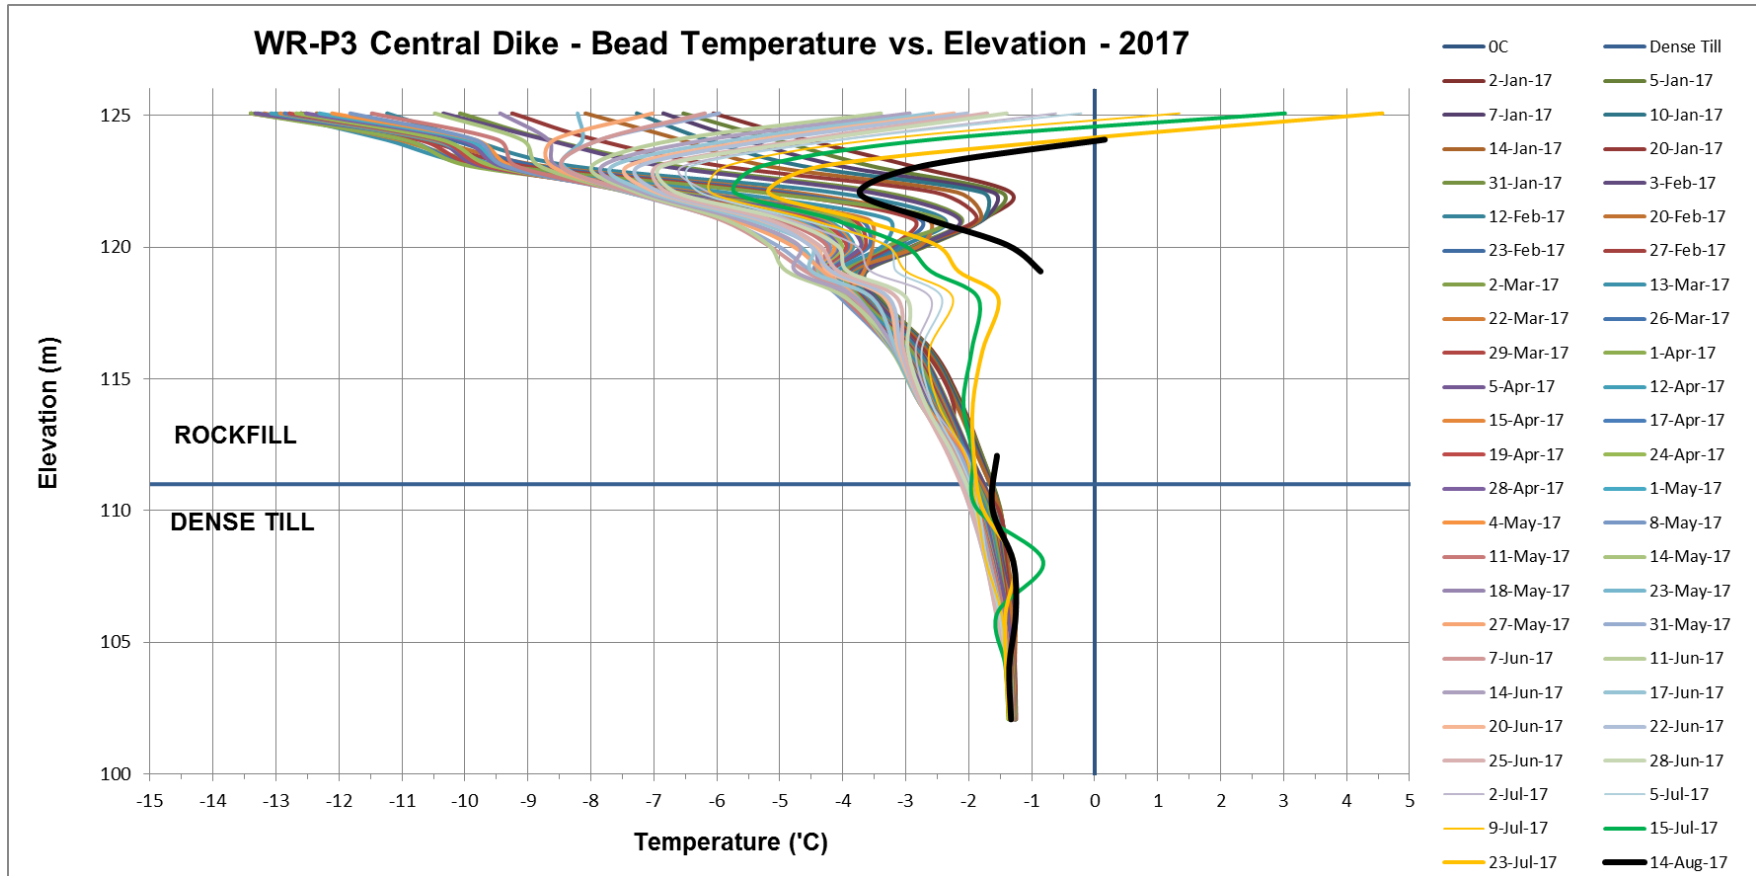
# THERMISTOR 745-P3

- Thermistor installed to monitor freeze back of the West Road. This thermistor do not reach bedrock
- Rockfill and till below 0° C at 745-P3
- Frozen limit of the northern section of the P3 line

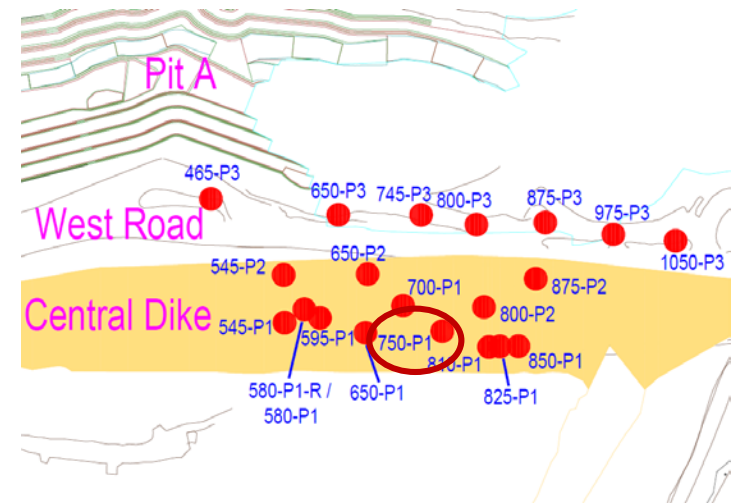
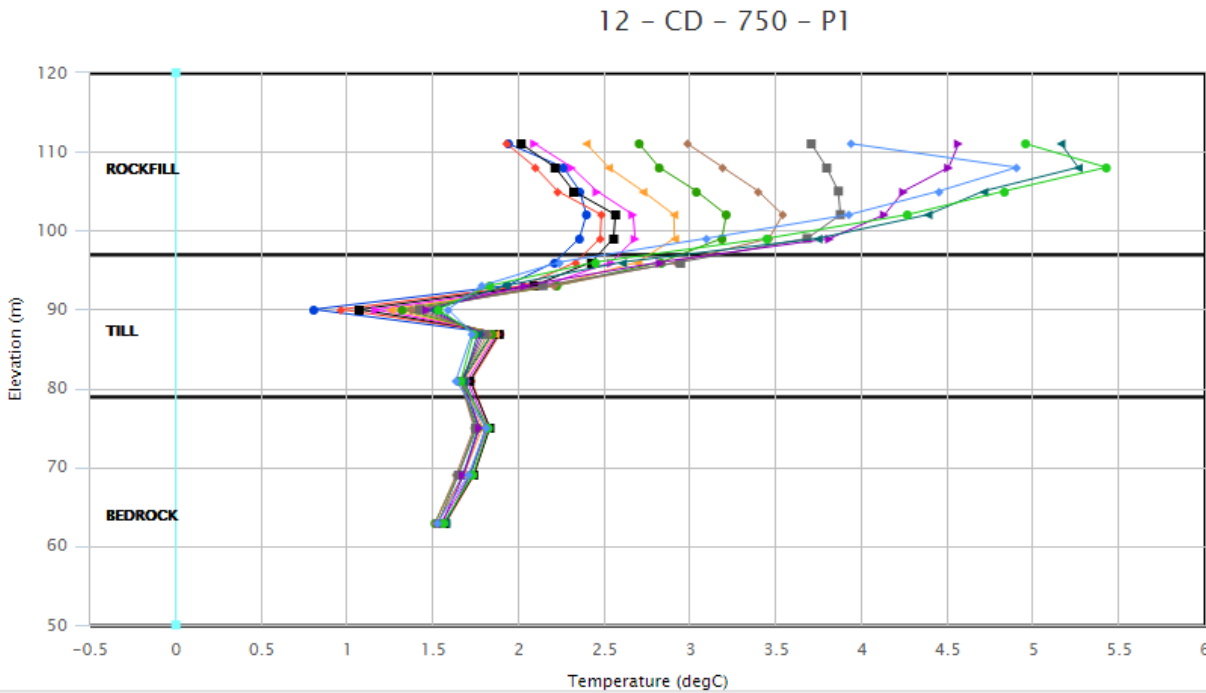
# THERMISTOR 750-P1

➔ Cooling trend in till layer. The bead located at elevation 90m is in average 1°C cooler than in 2016.

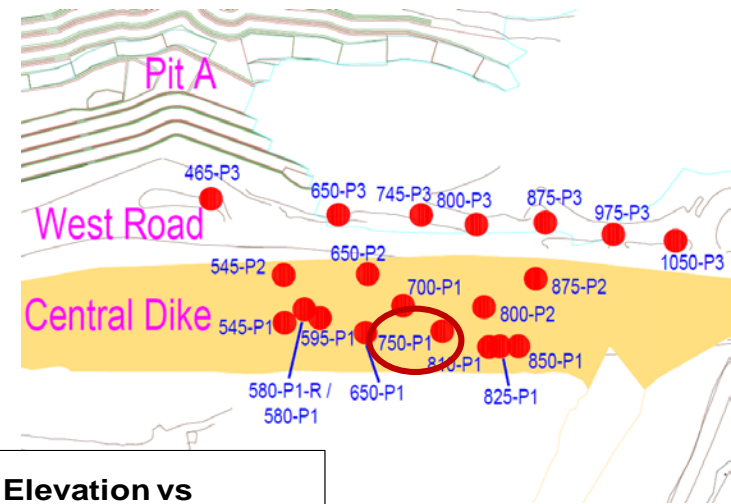
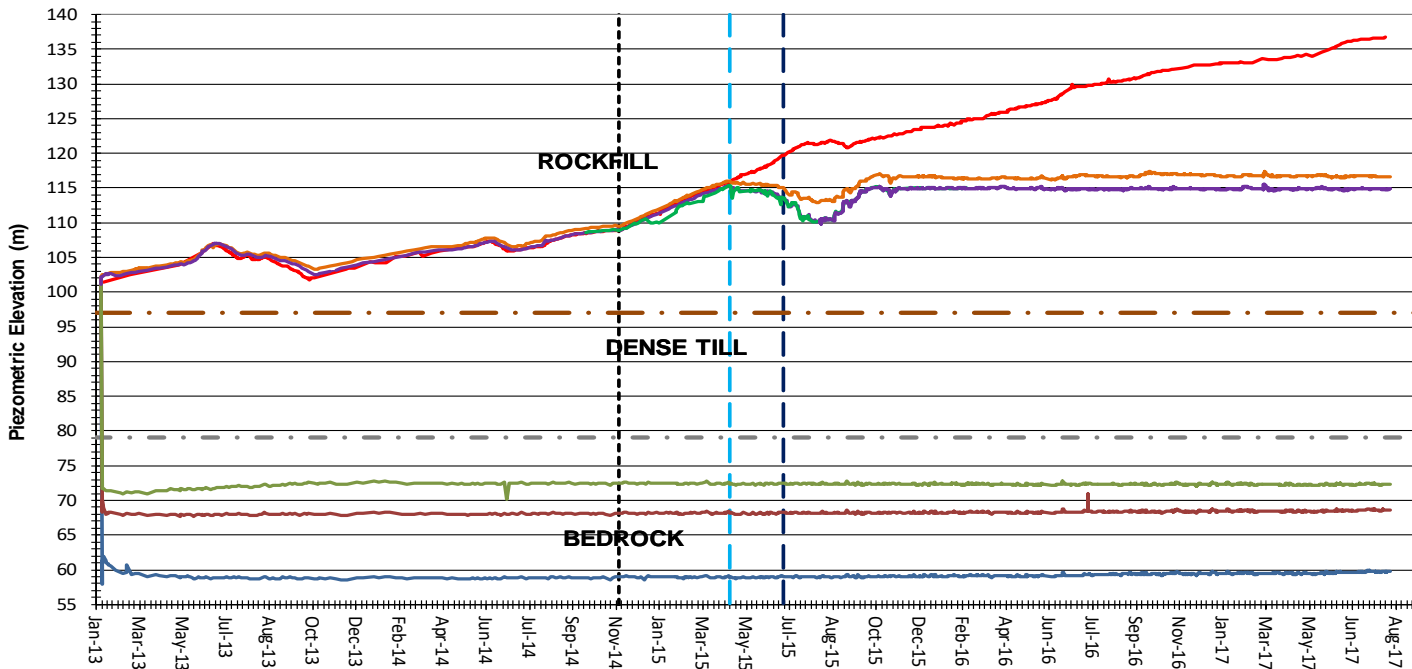
# PIEZOMETER 750-P1

- ➔ Piezo A, B and C are in suction
- ➔ Piezo D is have a direct reaction to any variation in elevation observe in the D/S pond.

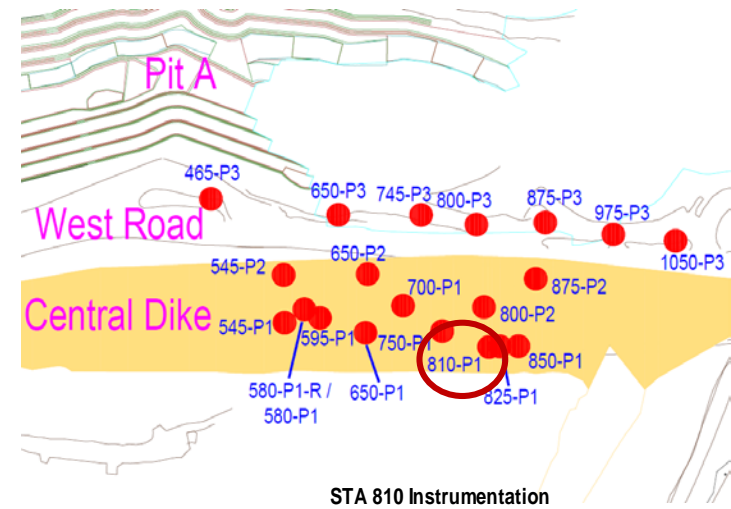
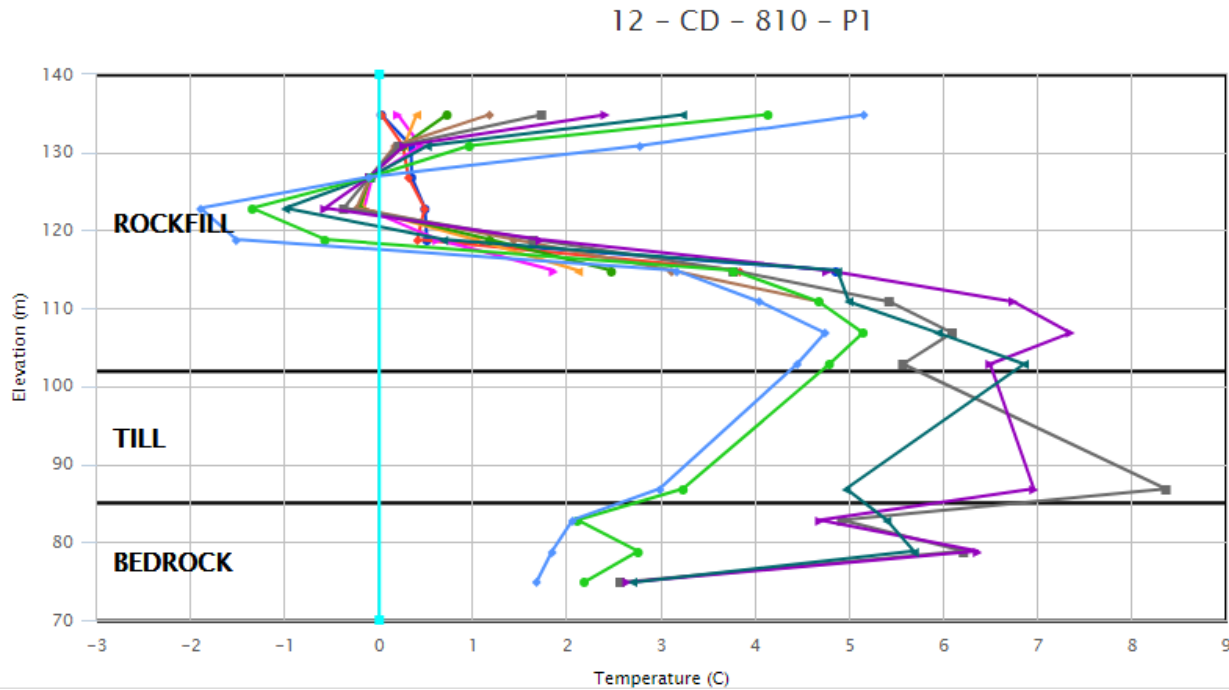
# THERMISTOR 810-P1

- Bead below El. 114.84 m stop working in February 2017
- Higher temperature observed in this hole (might be the instrument progressively failing)

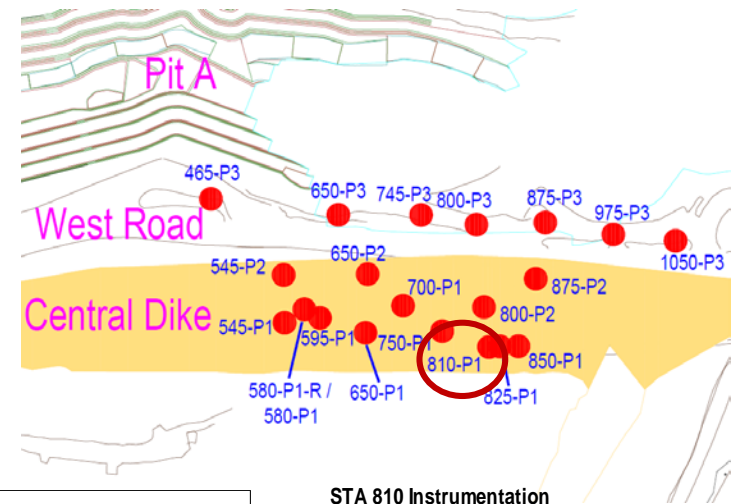
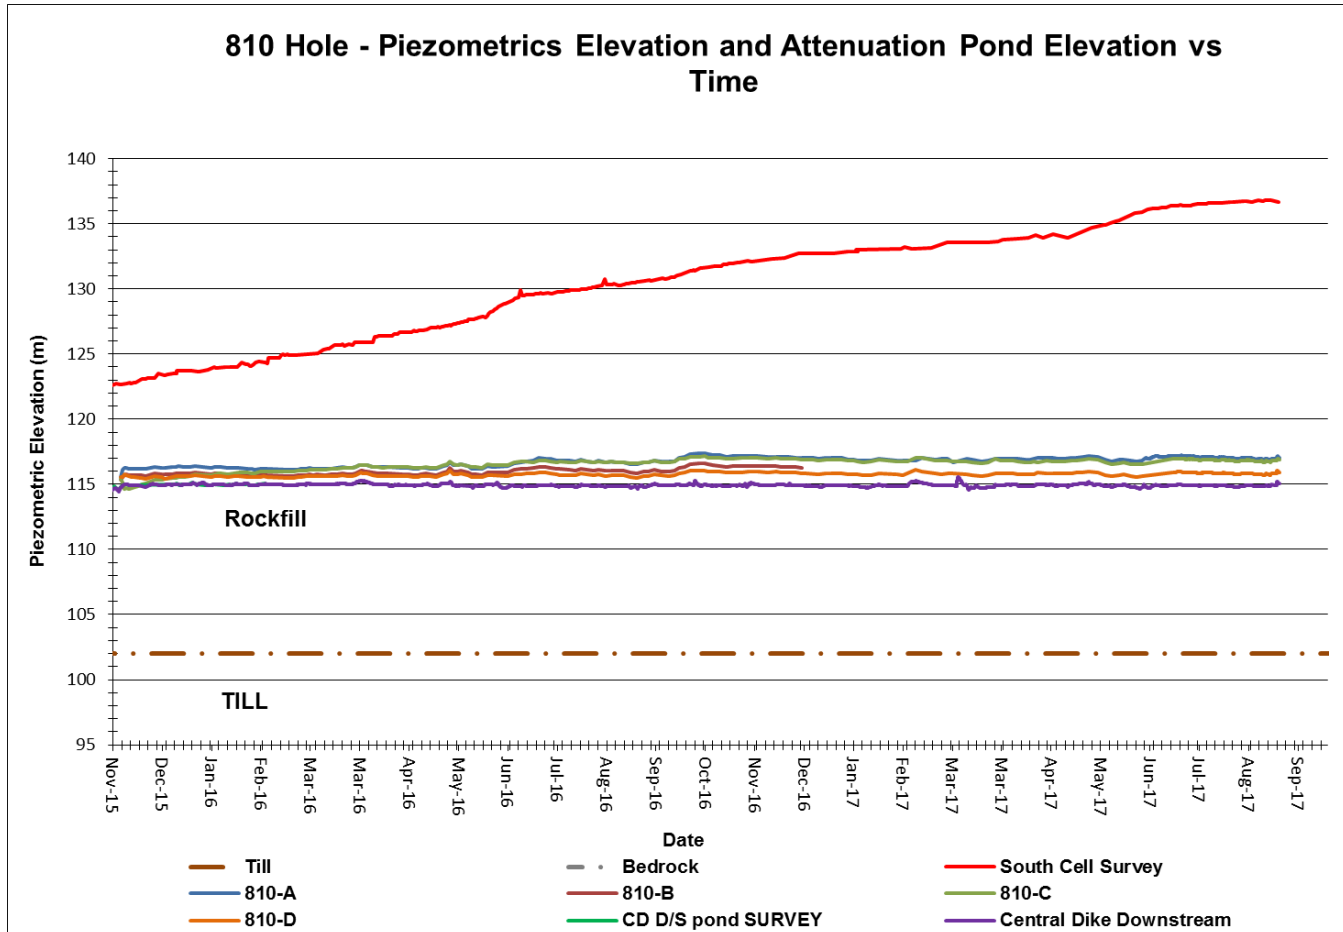
# PIEZOMETER 810-P1

- ➔ Piezo B stop working in January 2017
- ➔ Piezo A, C & D are following the elevation change of the D/S pond

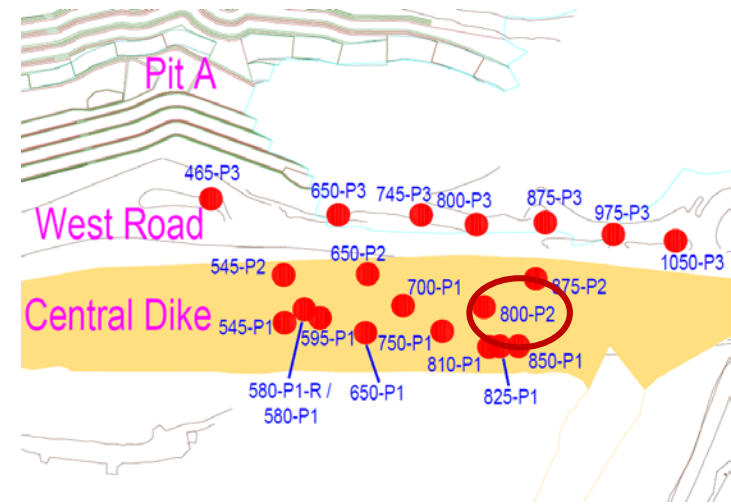
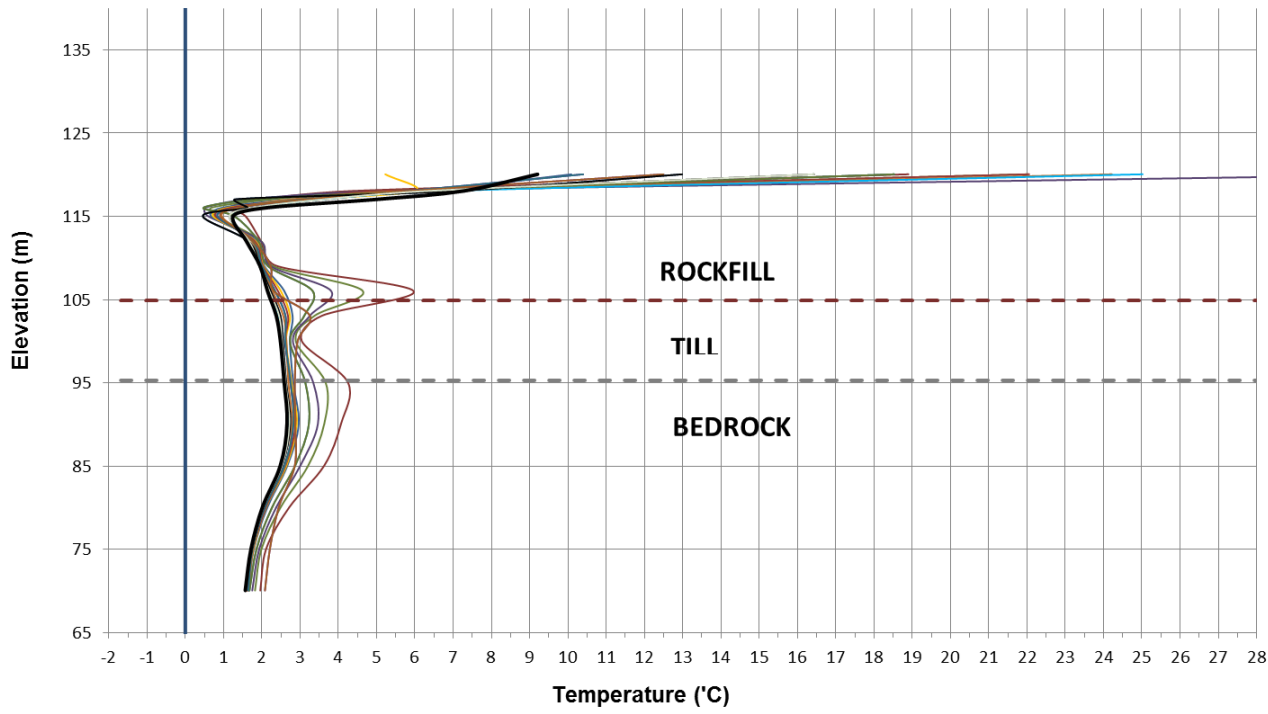
# THERMISTOR 800-P2

- New instrument installed in 2017
- Stabilisation of temperature ongoing
- Temperature above 0 °C

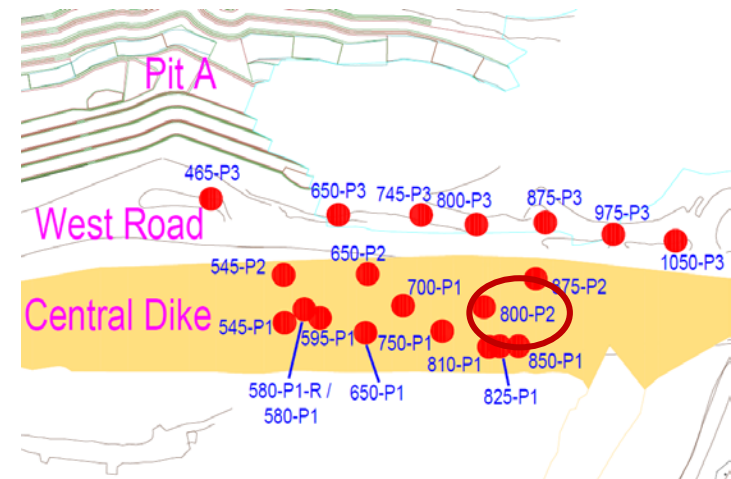
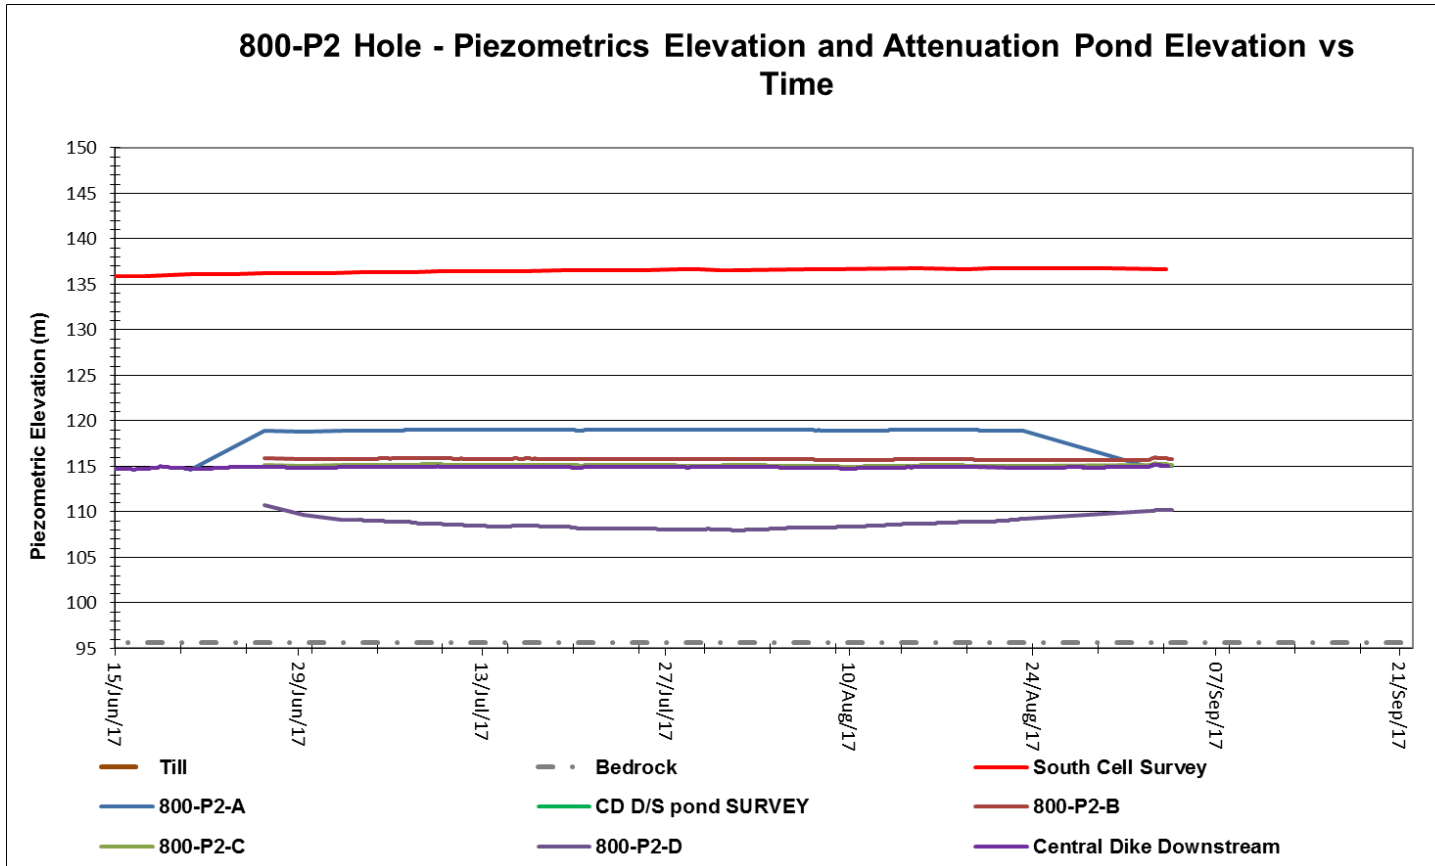
# PIEZOMETER 800-P2

- New instrument installed in 2017
- Stabilisation ongoing
- Piezo A,B and C are showing pressure readings similar to the elevation of the D/S pond.
