**Report: 2017 Annual Geotechnical Inspection**

February 2018

# 2017 Annual Geotechnical Inspection Meadowbank Gold Mine, Nunavut

**Report Number:** 1784282-1574-RPT-Rev0

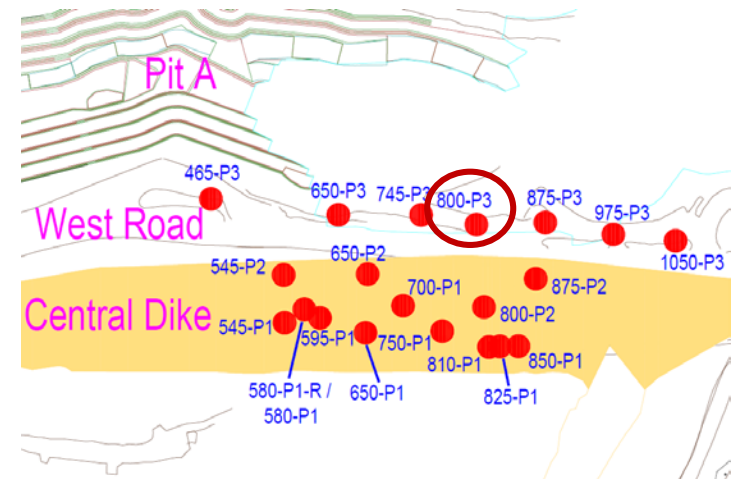
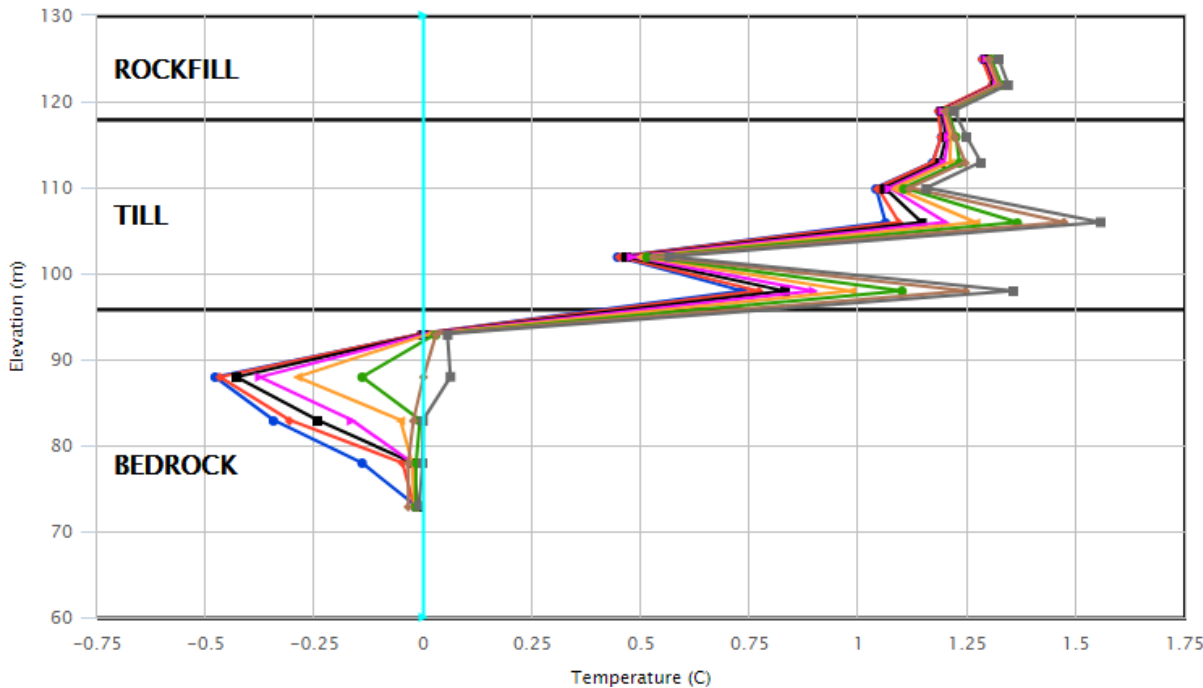
# THERMISTOR 800-P3

- New instrument installed in 2017
- Stabilisation in progress
- Temperature under 0° C below El. 93 m

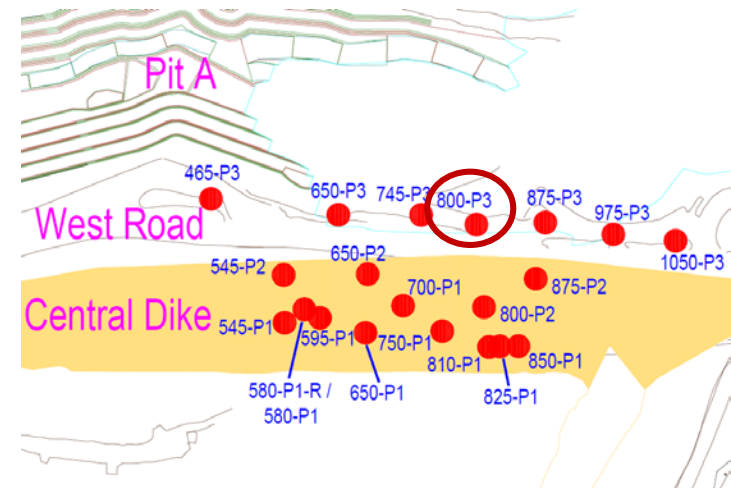
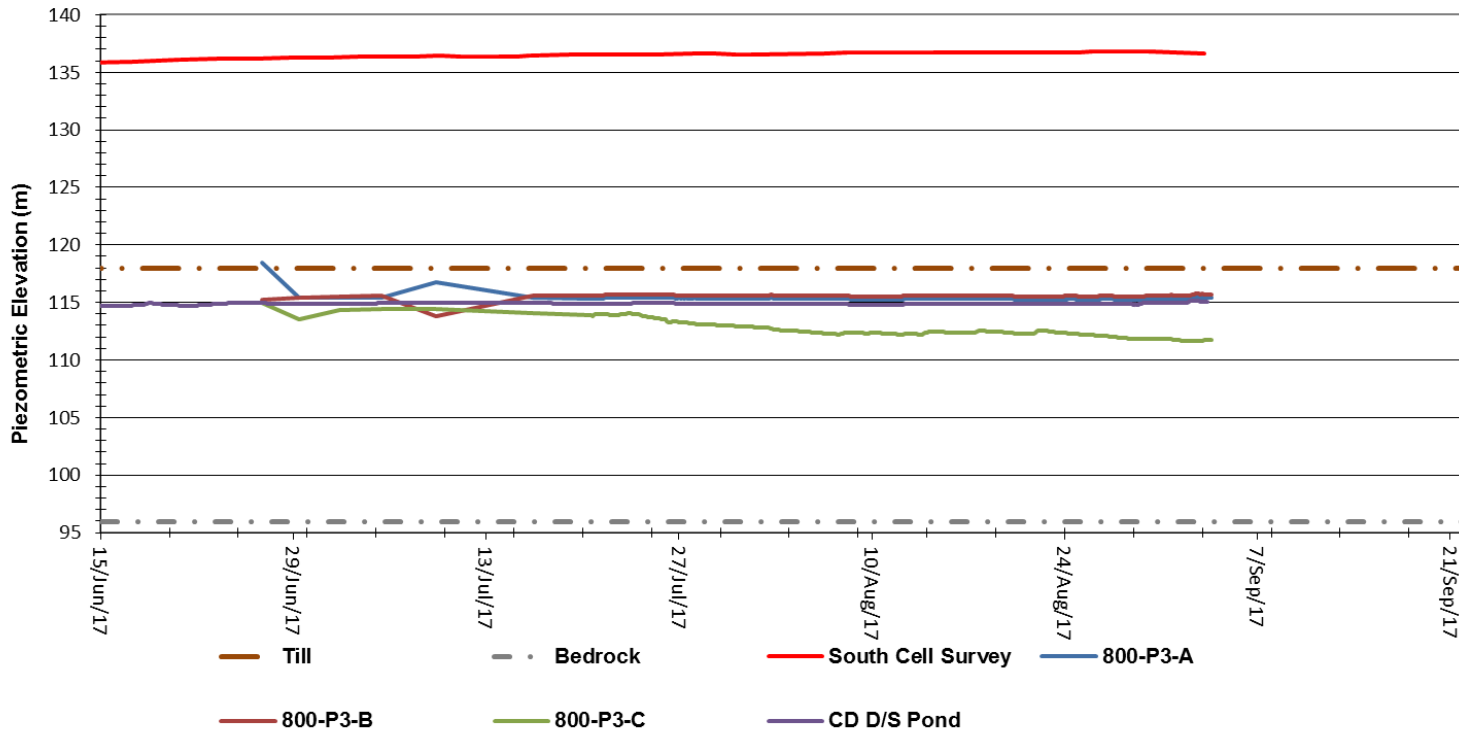
# PIEZOMETERS 800-P3

- New instrument installed in 2017
- Stabilization in progress
- Piezo A & B readings are similar to the D/S pond elevation readings
- Piezo C readings is slowly decreasing

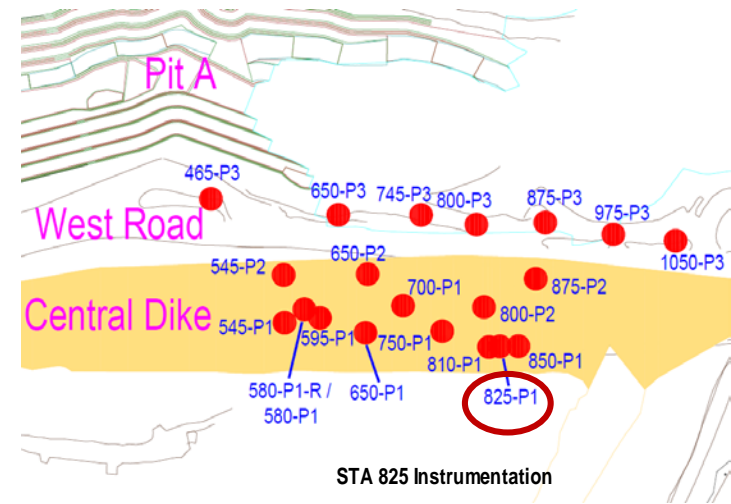
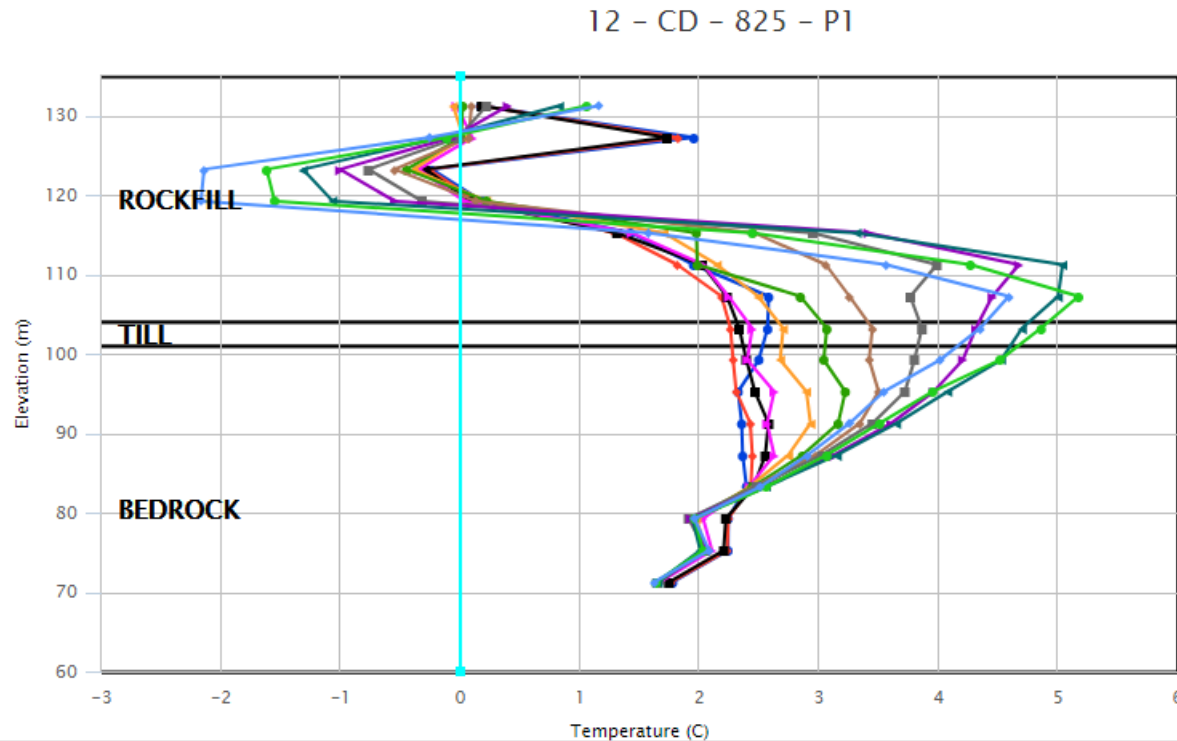
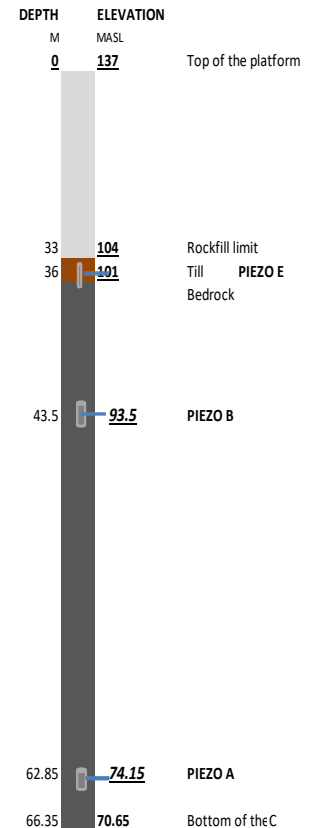
# THERMISTOR 825-P1

- Temperature variation over the year inside the bedrock/till units is higher than in the previous year:
- 2016: [1.5, 3.2]
- 2017: [1.6, 4.5]
- Generally warmer readings recorded over the last year.

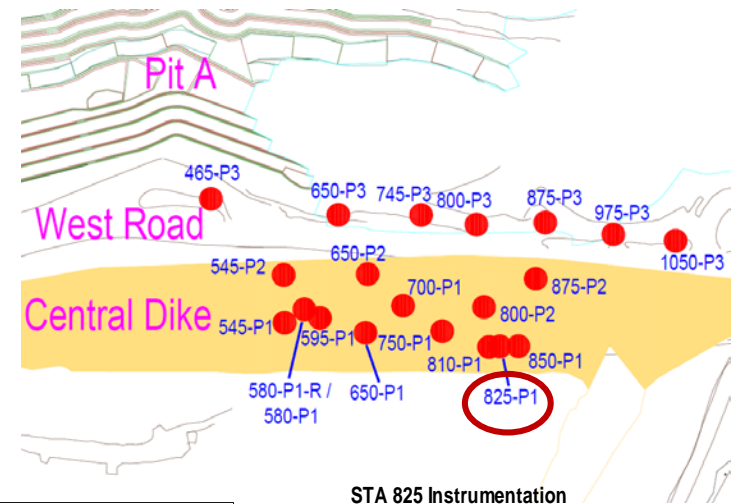
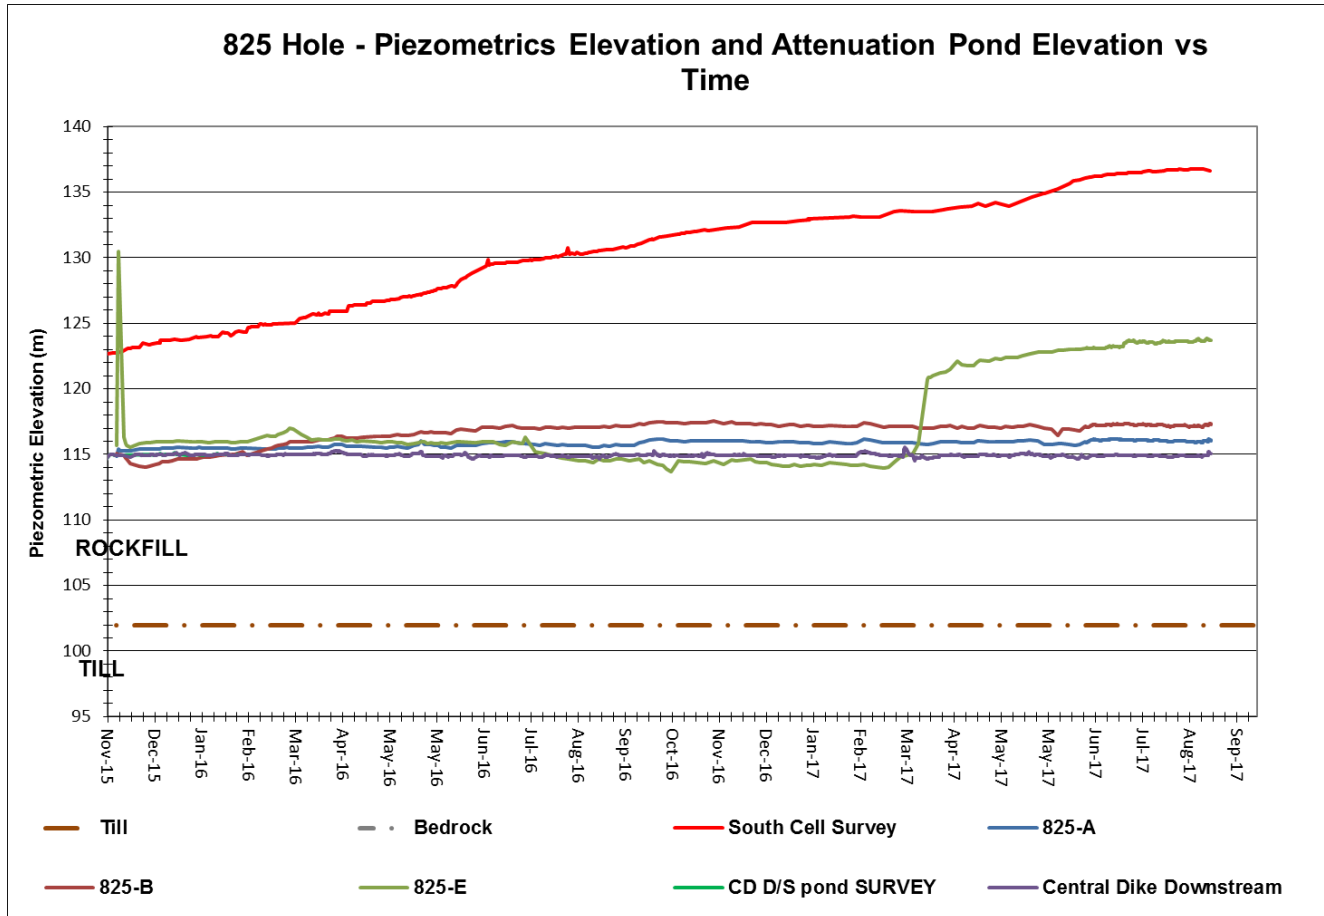
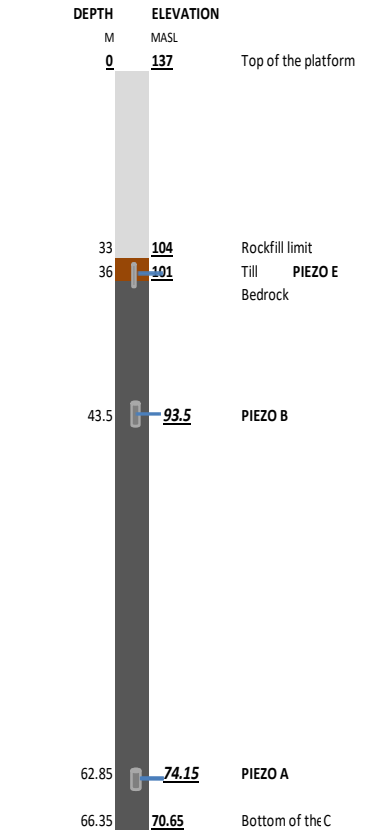
# PIEZOMETER 825-P1

- Increased in piezometric elevation of Piezo E since April 2017. Seem to be connected now with South Cell.
- Piezo A and B showing readings similar to the D/S pond and are reacting directly with elevation change.

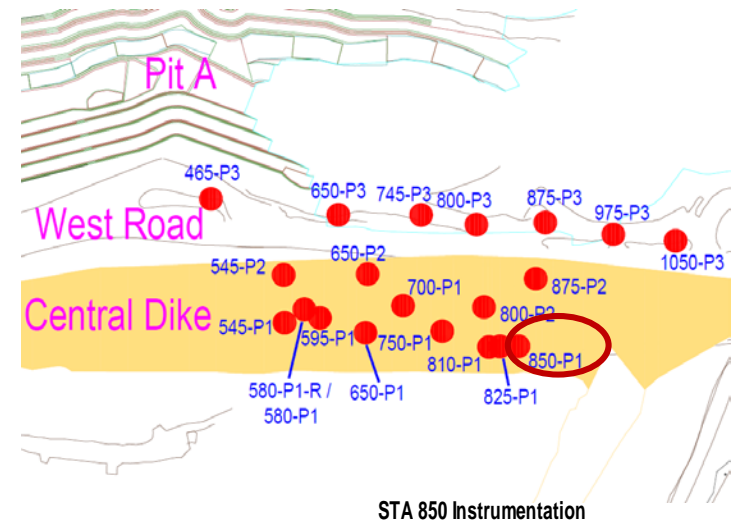
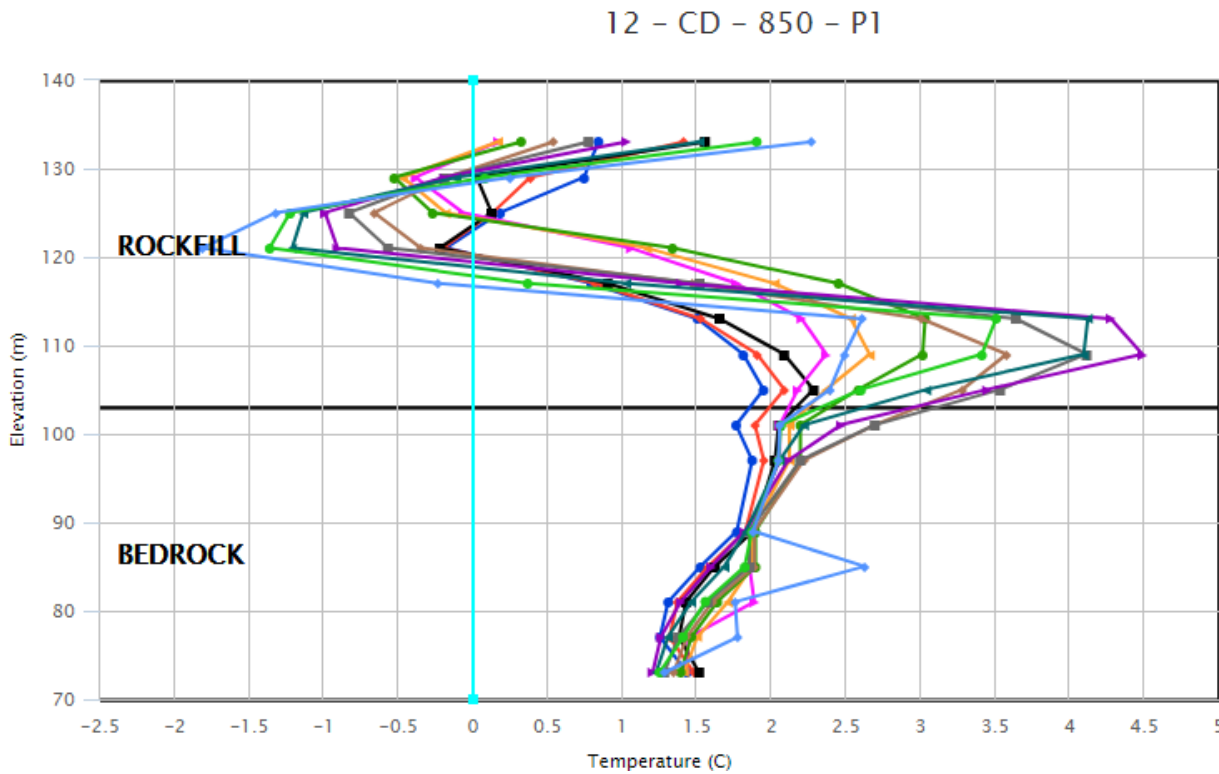
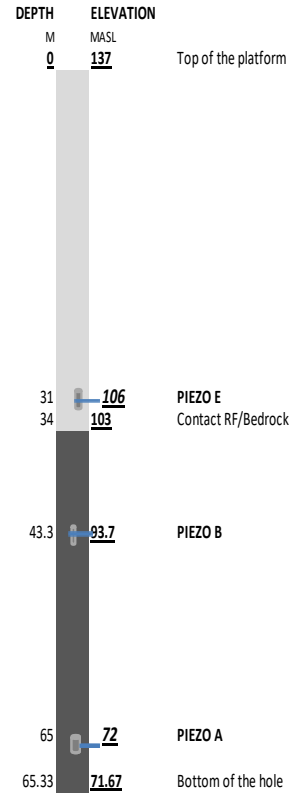
# THERMISTOR 850-P1

- Temperature above 0° C in bedrock at 850-P1
- Similar profile than in 2016

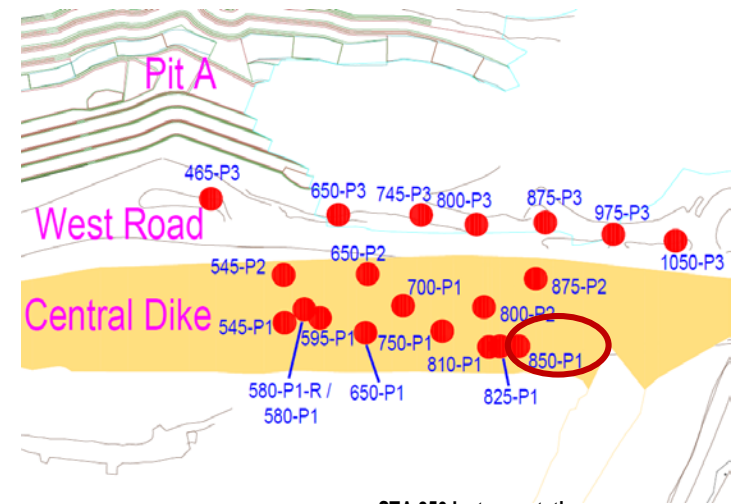
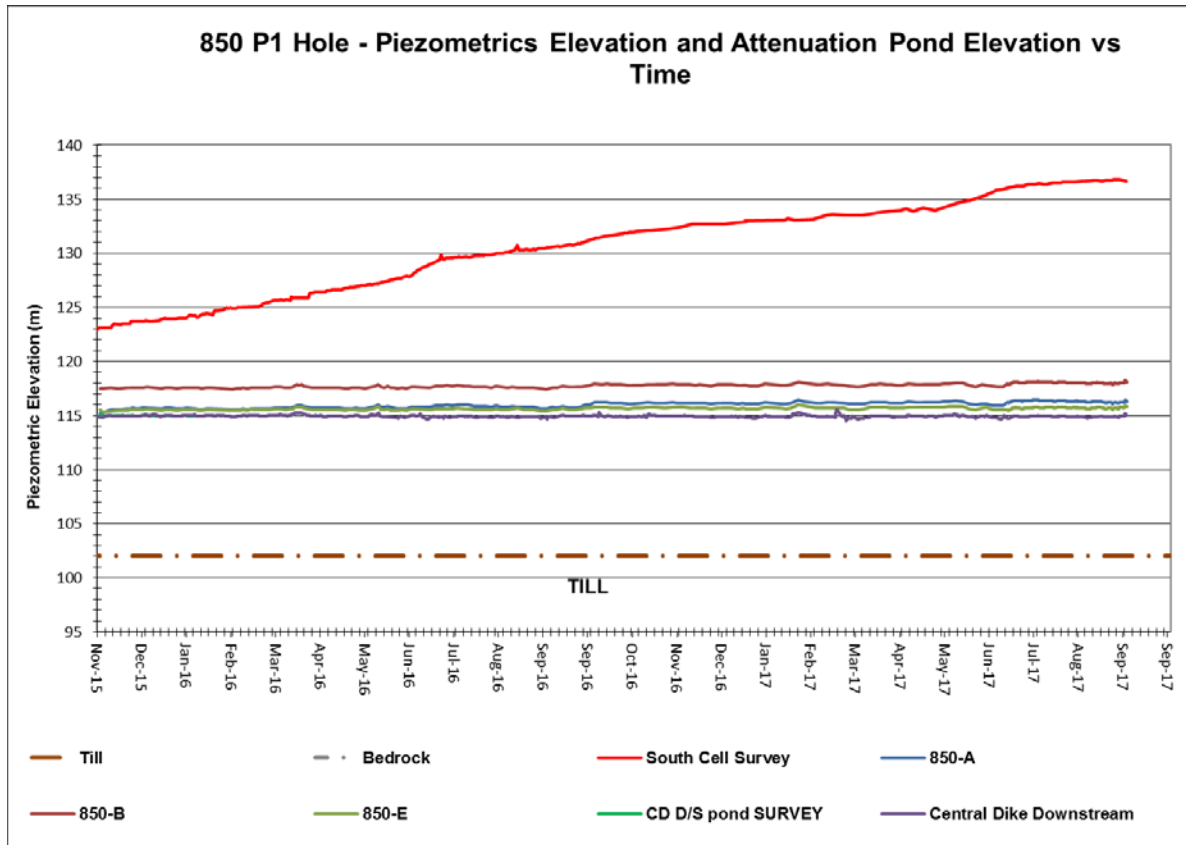
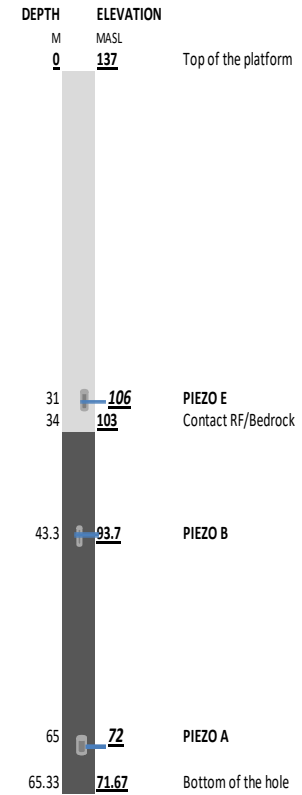
# PIEZOMETER 850-P1

- All piezometer are following the trend of the D/S pond regime
- However piezo B is one of the highest in the piezometer readings that have stable reading (117.5m)

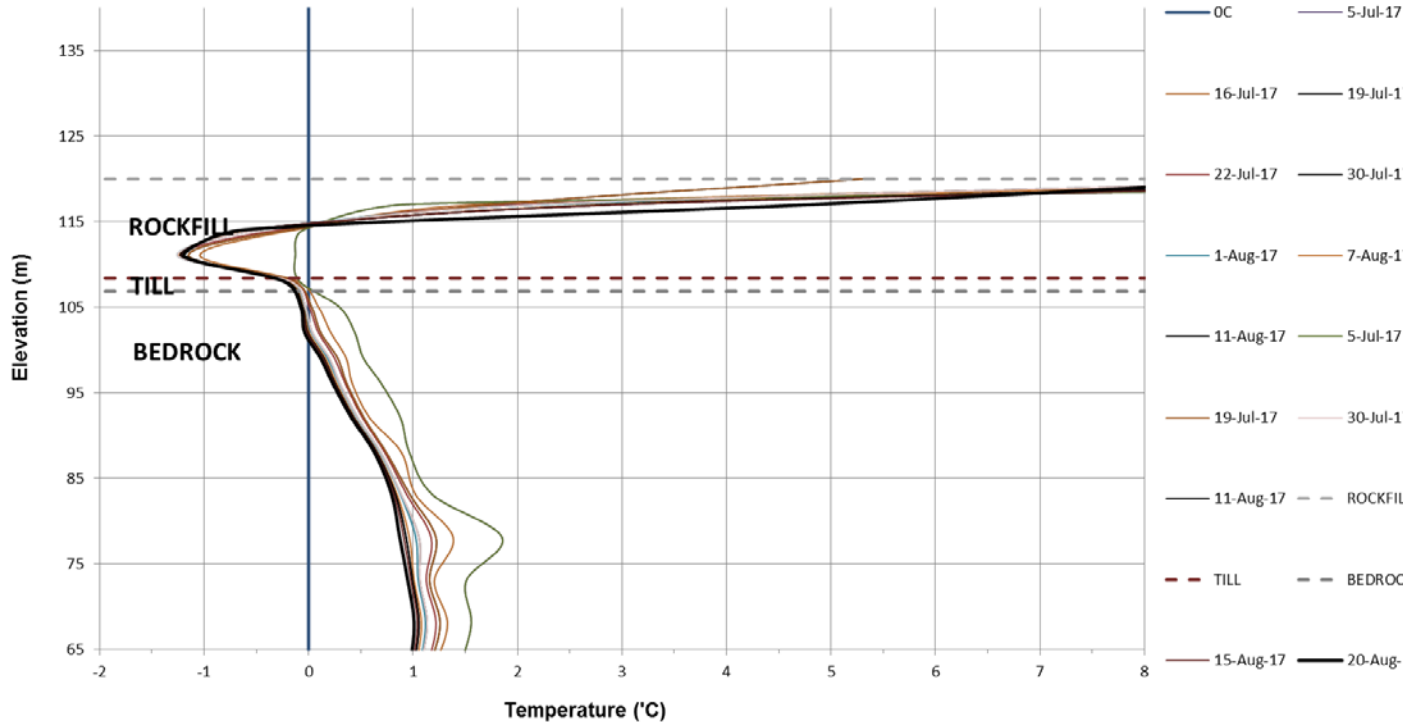
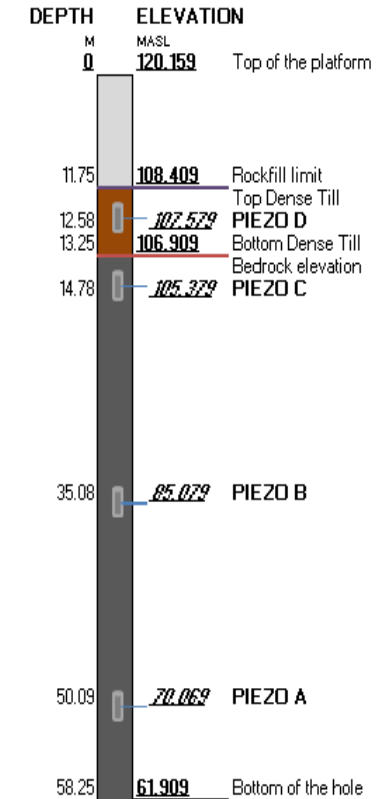
# THERMISTOR 875-P2

- New thermistor installed in 2017
- Stabilisation of temperature ongoing
- Bedrock temperature above 0° C

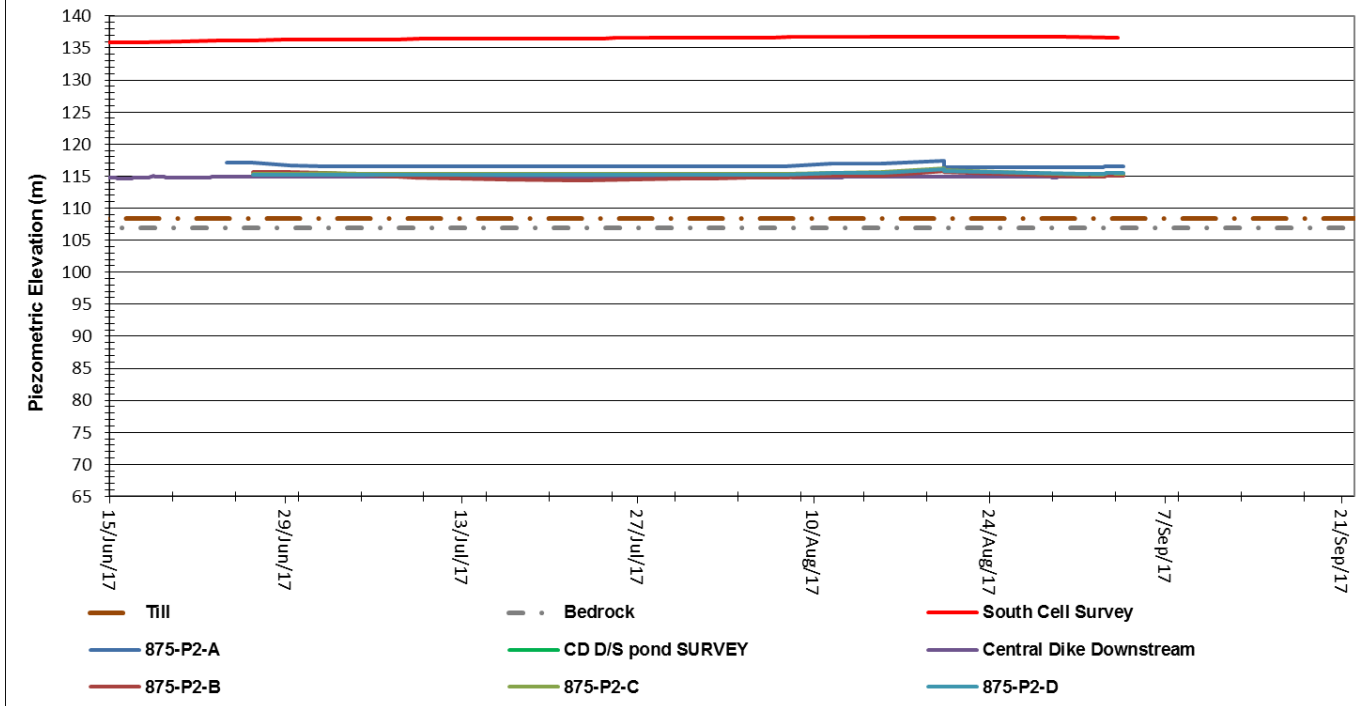
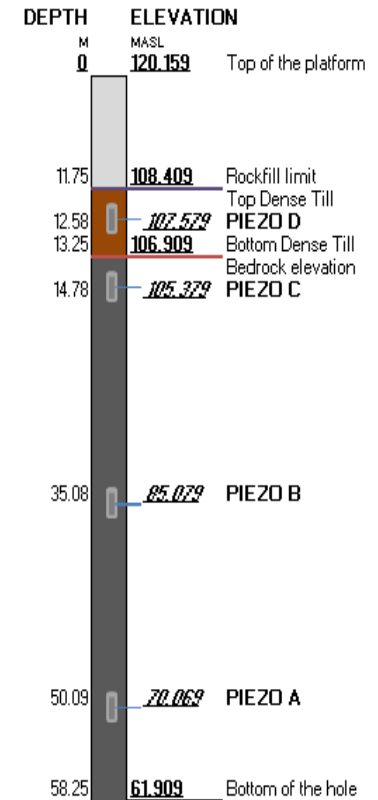
# PIEZOMETER 875-P2

- All piezometer are following the trend of the D/S pond regime
- Small glitch in the data was observed when automatization of the system was completed

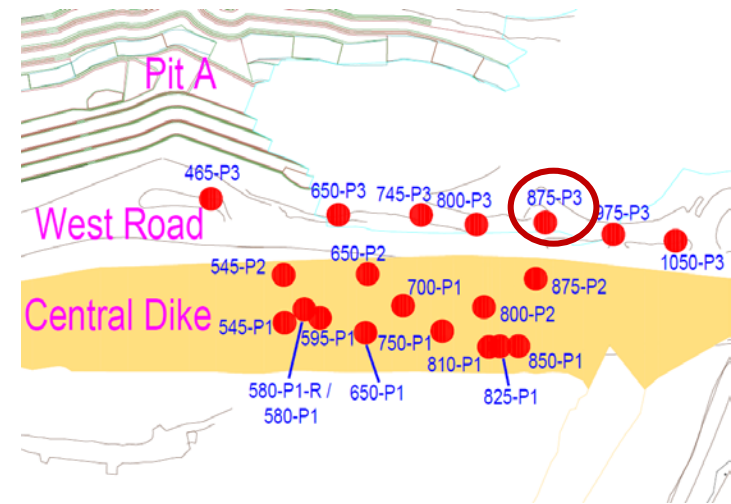
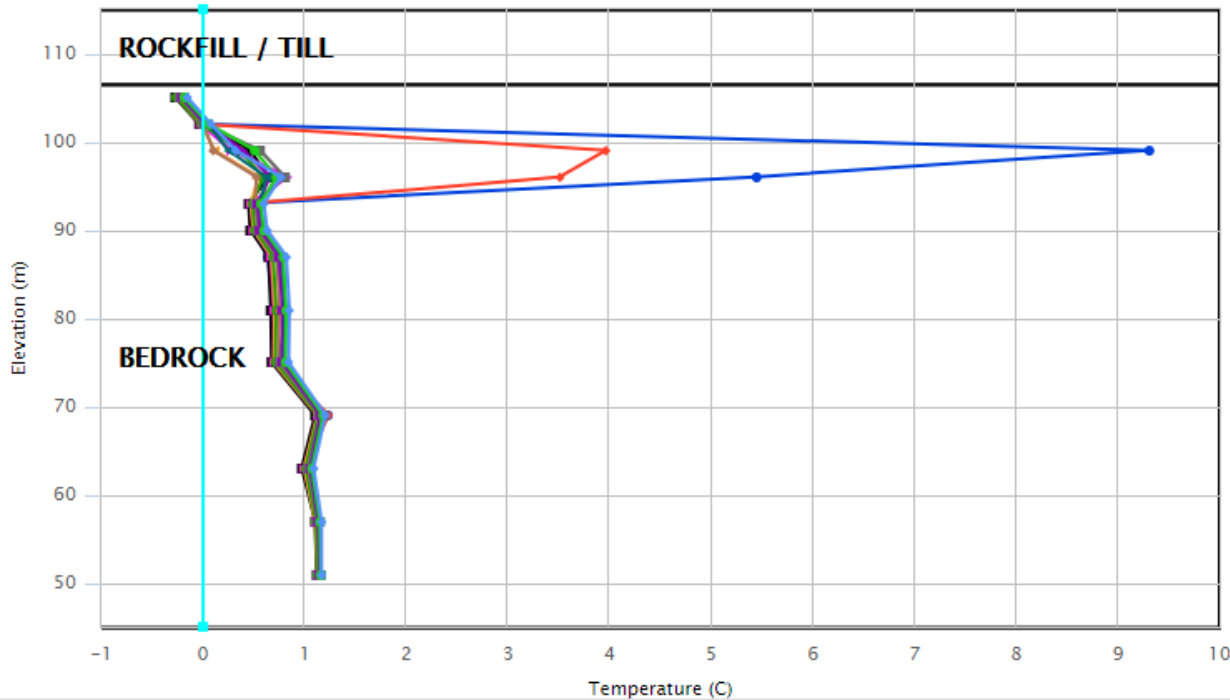
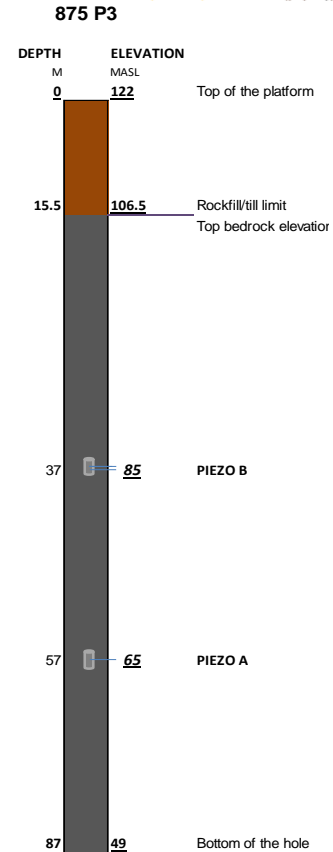
# THERMISTOR 875-P3

- Temperature above 0° C in bedrock at 875-P3
- Temperature spike at El.96 m and 99 m are related to capacitance effect.

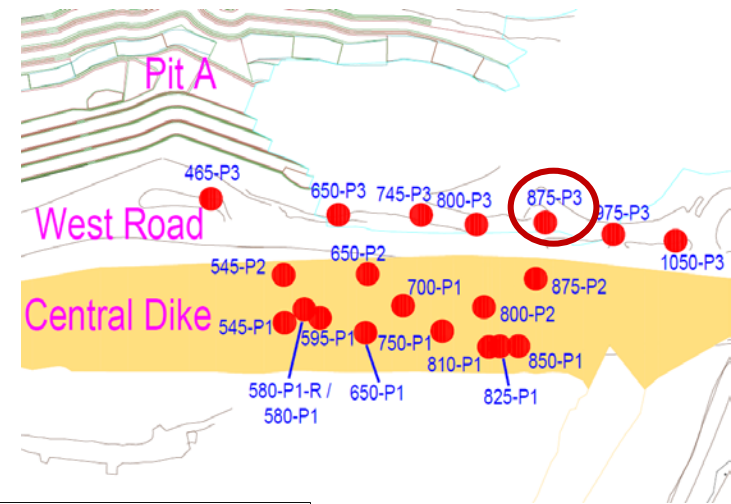
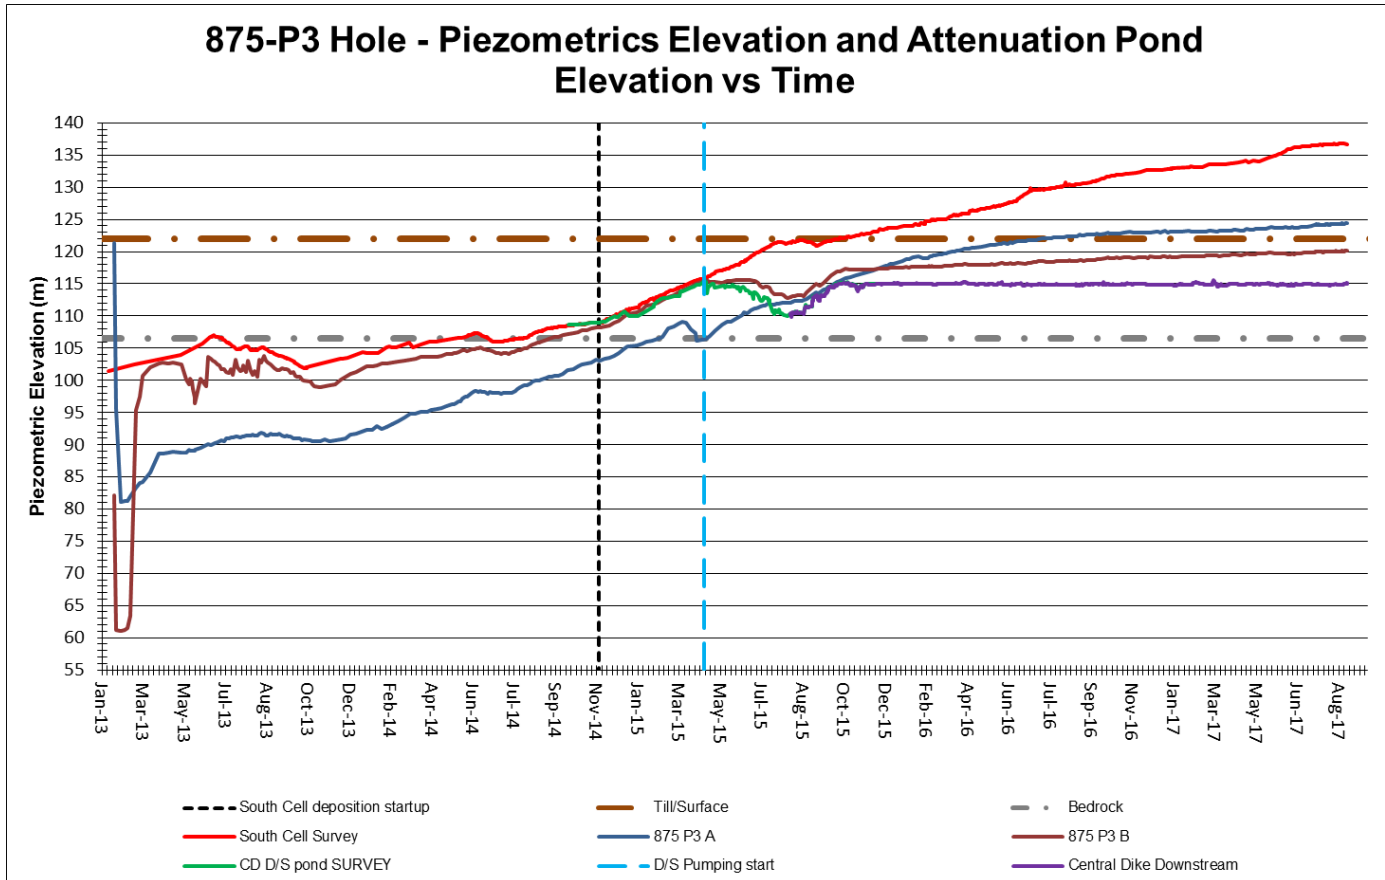
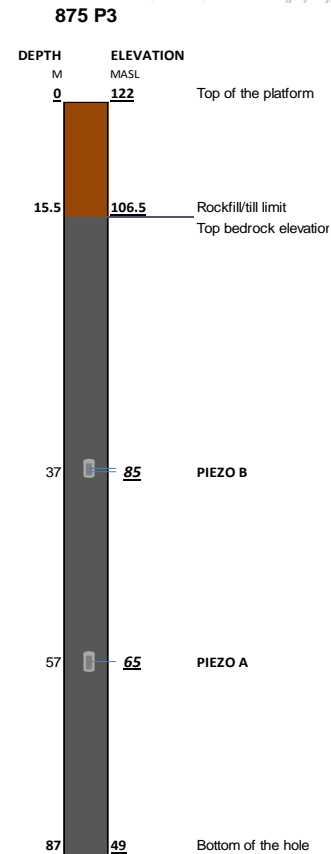
# PIEZOMETER 875-P3

➔ Piezometer at 875-P3 are in bedrock and are impacted by increase in South Cell head

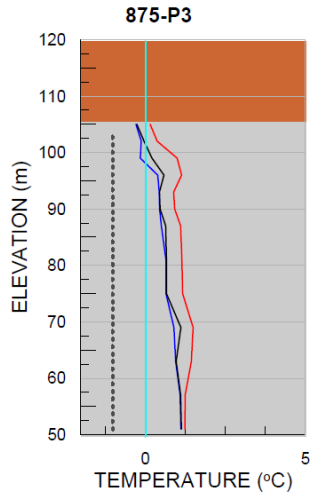
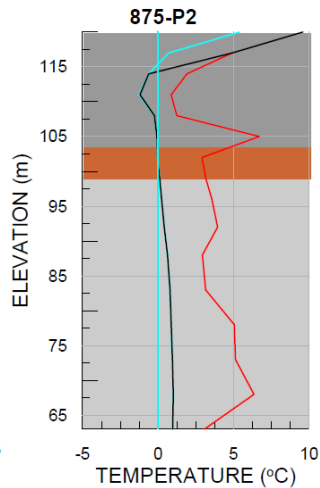
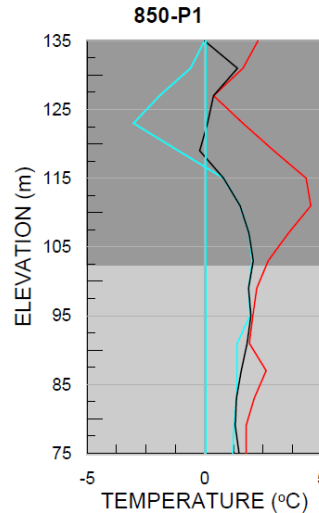
## THERMISTOR READINGS AUGUST 2016-2017

2017 graph are showing the good representation of the bedrock/till/rockfill units

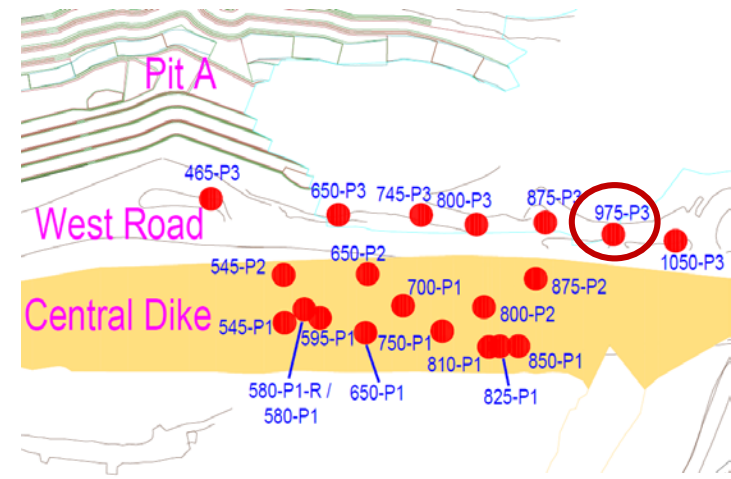
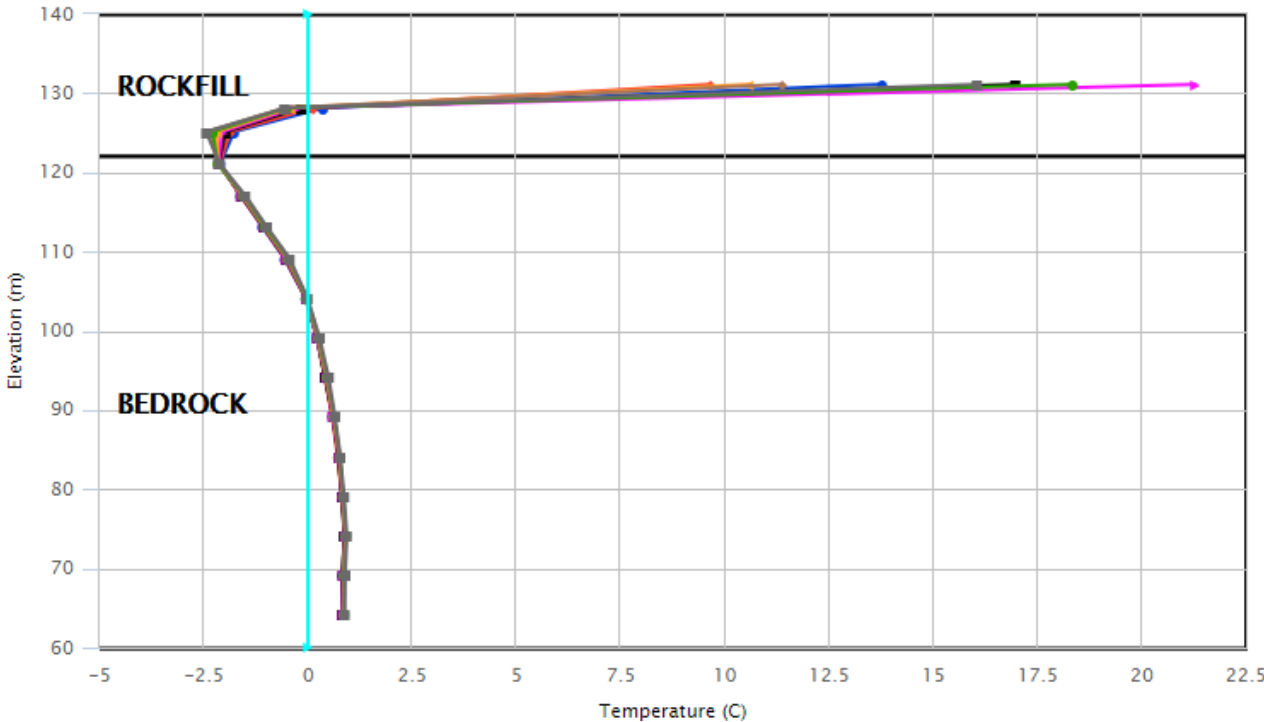
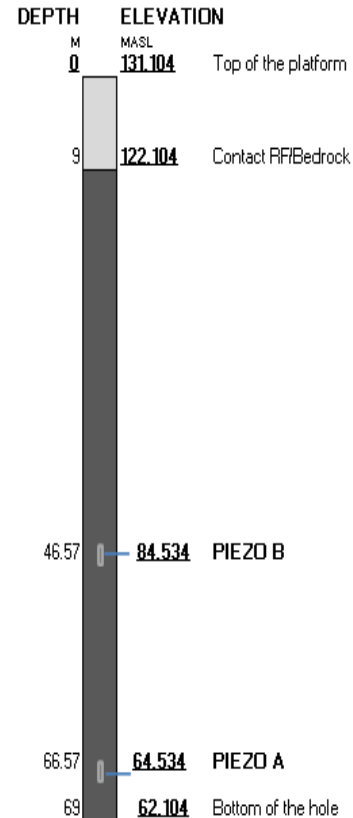
# THERMISTOR 975-P3

- New instrument installed in 2017
- Stabilization of the thermistor mostly done
- Temperature above 0° C in bedrock below El. 105 m

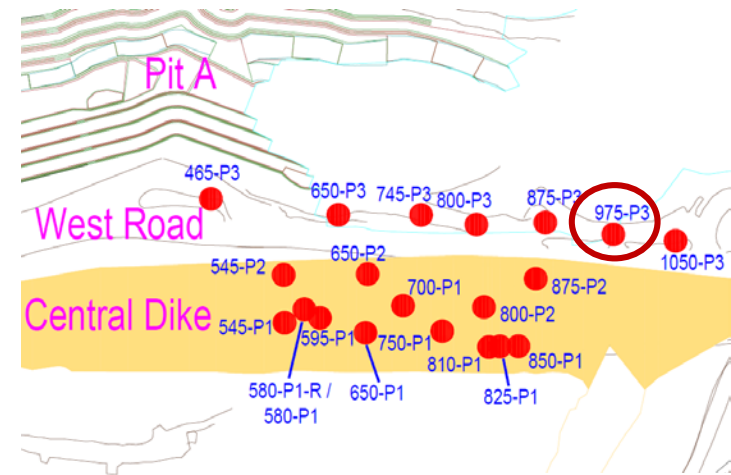
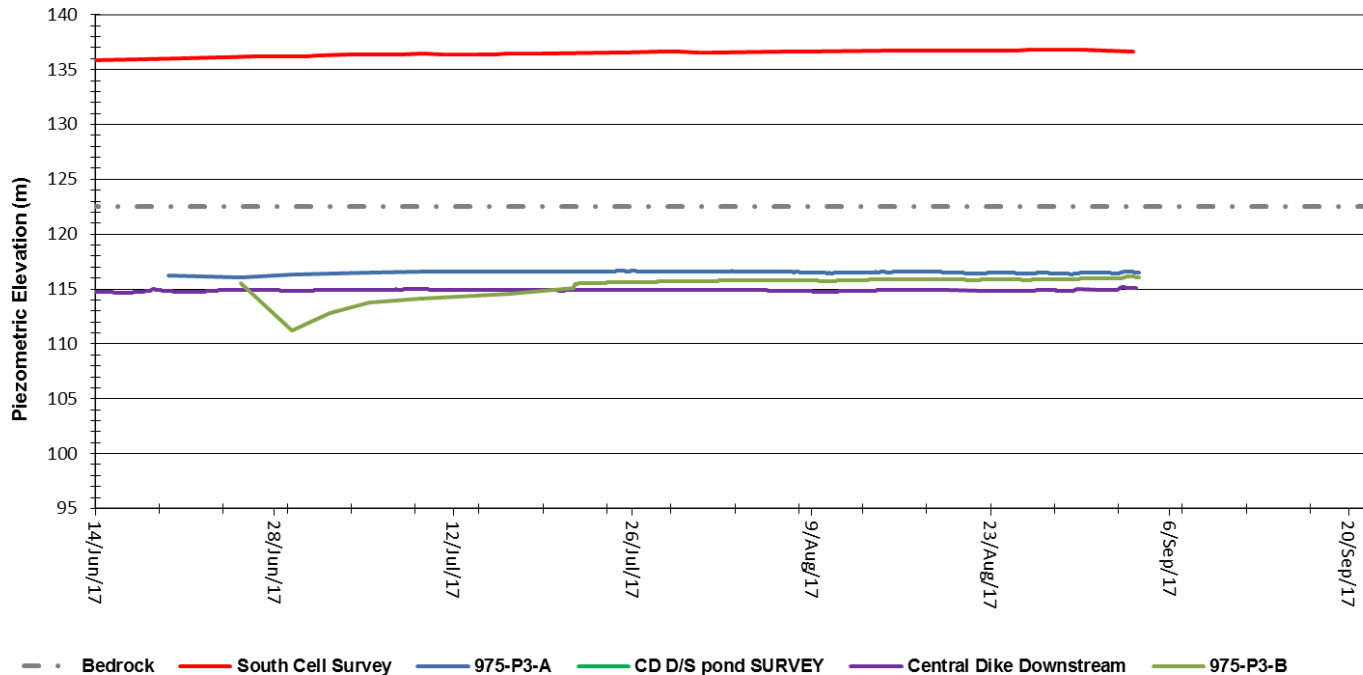
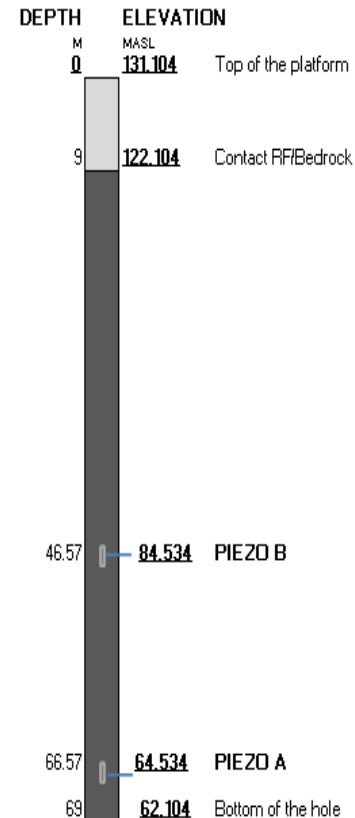
# PIEZOMETER 975-P3

- New instrument installed in 2017
- All piezometer are following the trend of the D/S pond regime

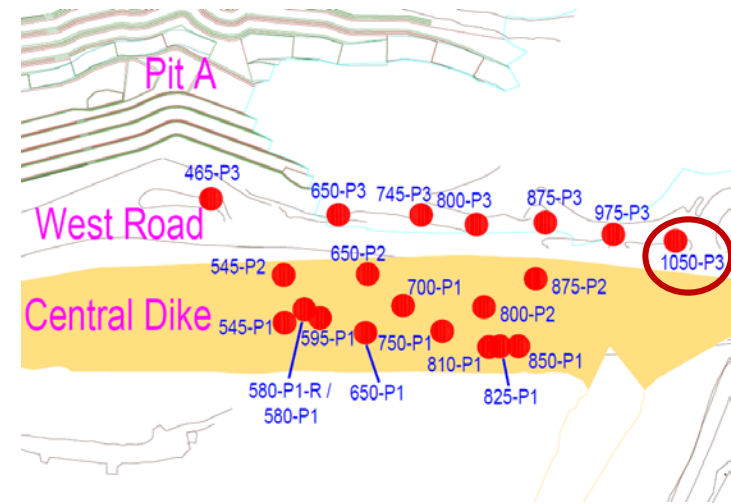
# THERMISTOR 1050-P3

➔ Temperature at 0° C in bedrock

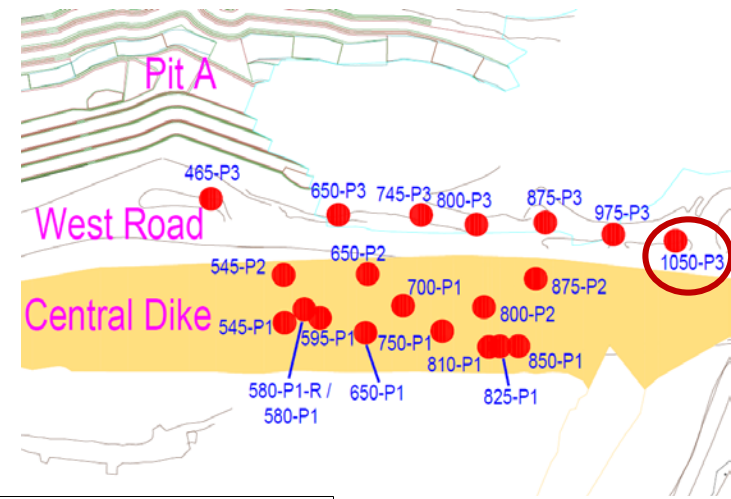
# PIEZOMETER 1050-P3

- ➔ Piezometers temperature just below the freezing point
- ➔ Piezometers are following the trend of the D/S pond elevation.

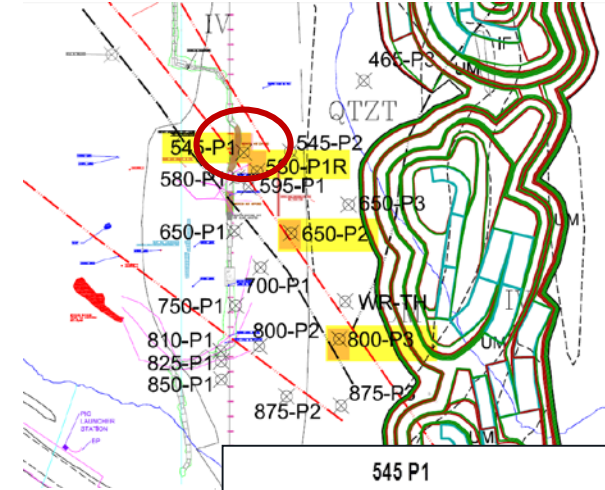
# THERMISTOR 545-P1

- 545-P1 thermistor is showing the same temperature profile than last year. Warmer peak observed at elevation 70m since the installation.
- Temperature in the bedrock/till unit is in between 1.1 and 1.75° C.

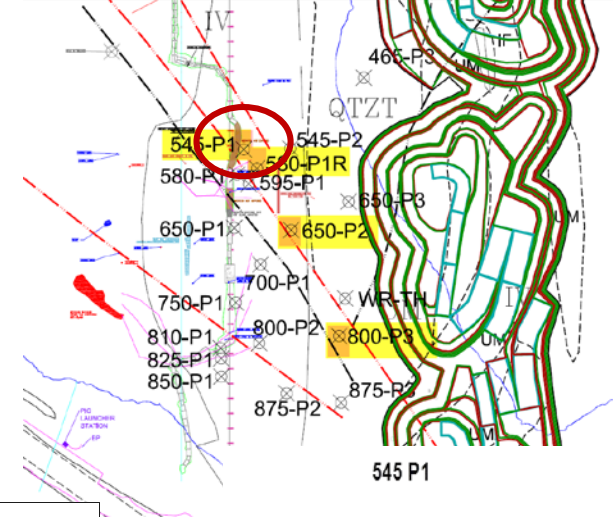
# PIEZOMETER 545-P1

- Piezometer D still constant, no change since August 2015
- Piezometer A is recording suction since its installation
- Identification of the piezo on the field is confusing. Interpretation of the readings must be done with precaution.

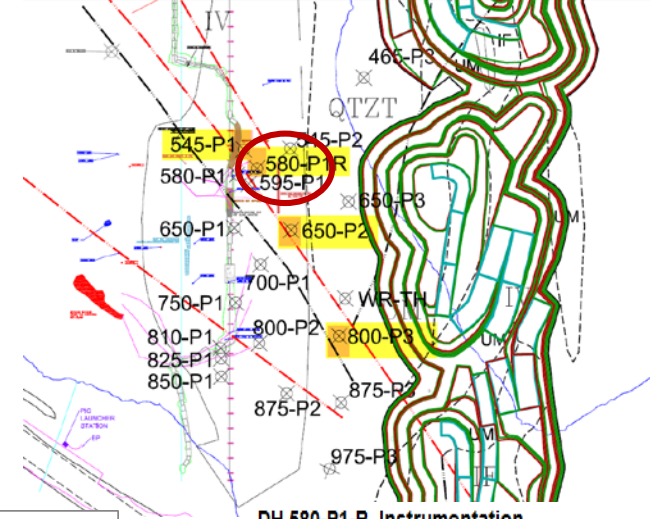
# THERMISTOR 580-P1R

- Stabilisation in progress
- Temperature readings above 0°C
- Similar temperature readings range than 580-P1

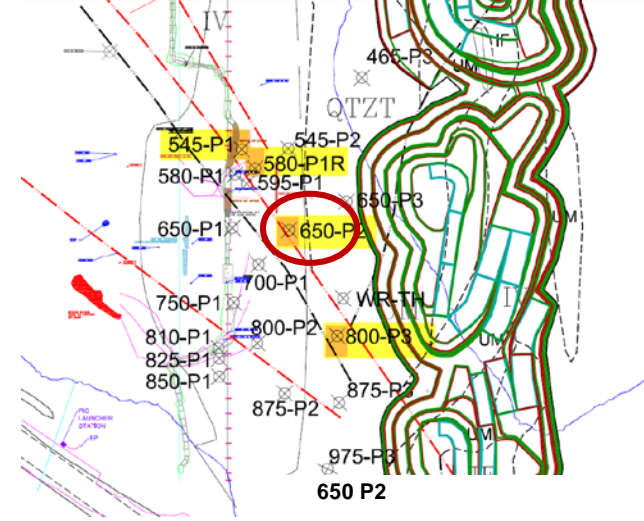
# THERMISTOR 650-P2

➔ Cooling trend observed below El. 80 similar to 2016 readings.

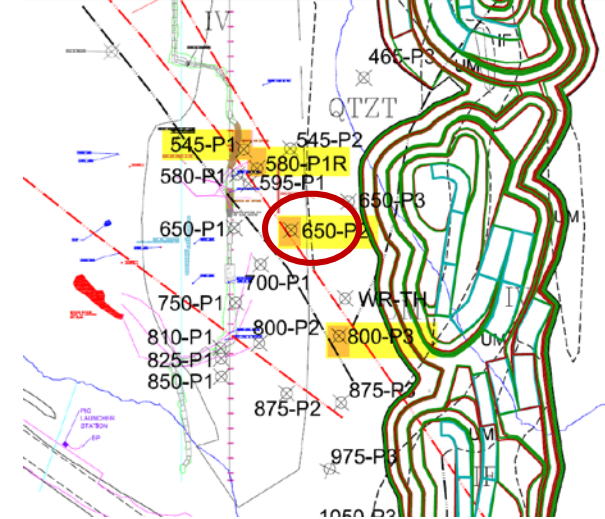
# PIEZOMETER 650-P2

- Piezometer A in bedrock continue its rise and is now over the elevation of the South Cell
- Piezo B-C are following the piezometric regime of the D/S pond
- Piezo D is in suction

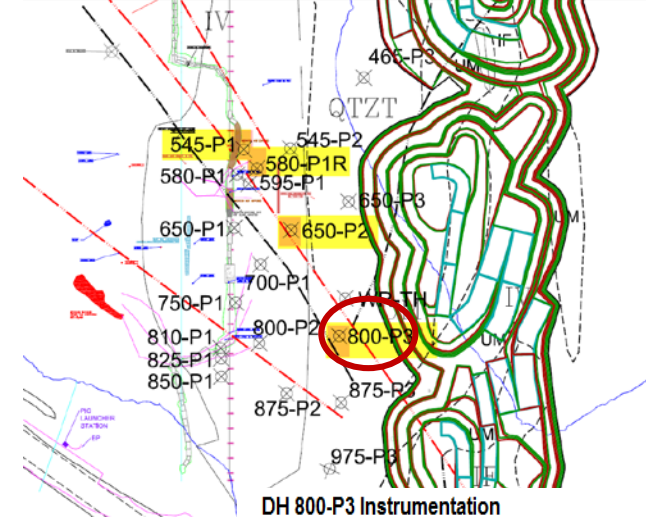
# THERMISTOR 800-P3

- New instrument installed in 2017
- Stabilisation in progress
- Temperature under 0° C below El. 93 m

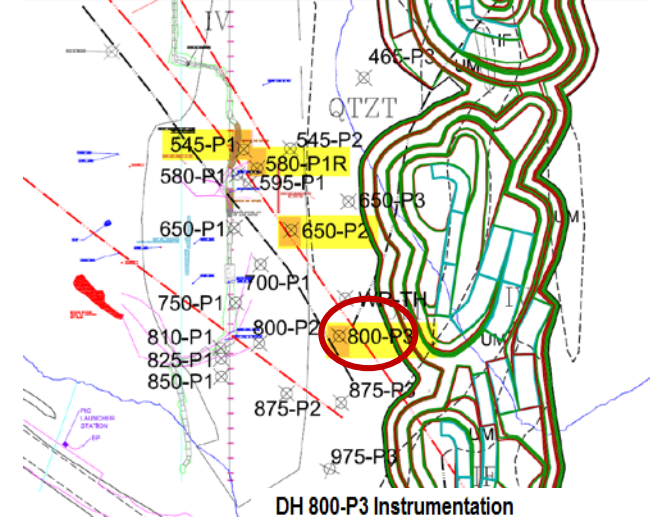
# PIEZOMETERS 800-P3

- New instrument installed in 2017
- Stabilization in progress
- Piezo A & B readings are similar to the D/S pond elevation readings
- Piezo C readings is slowly decreasing

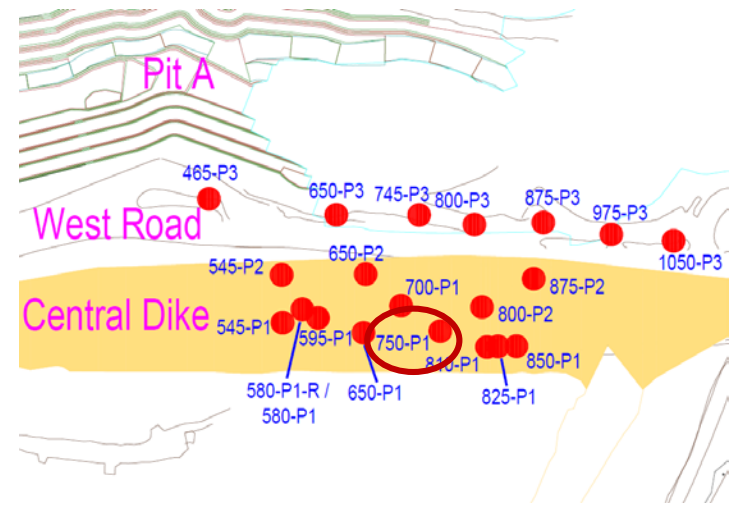
# THERMISTOR 750-P1

➔ Cooling trend in till layer. The bead located at elevation 90m is in average 1°C cooler than in 2016.
