**Report: 2017 Annual Geotechnical Inspection**

February 2018

# 2017 Annual Geotechnical Inspection Meadowbank Gold Mine, Nunavut

**Report Number:** 1784282-1574-RPT-Rev0

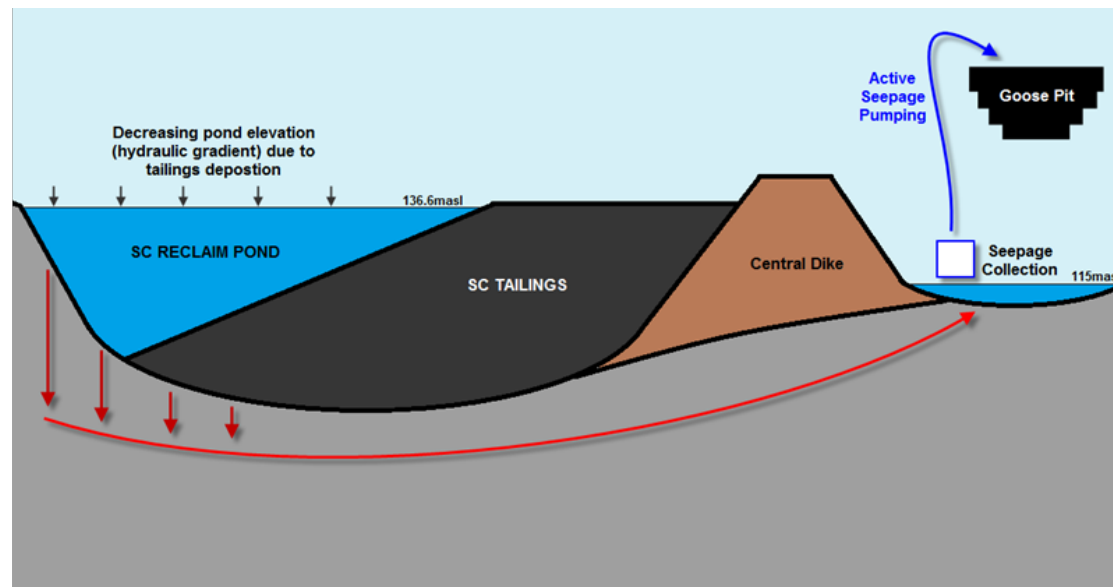
## Modified D/S Pond Setup

- Addition of a line from D/S Pond to Goose pit
- Water is transferred while keeping D/S Pond at El. 115 m
- Transfer 350 000 m<sup>3</sup> of water is initiated

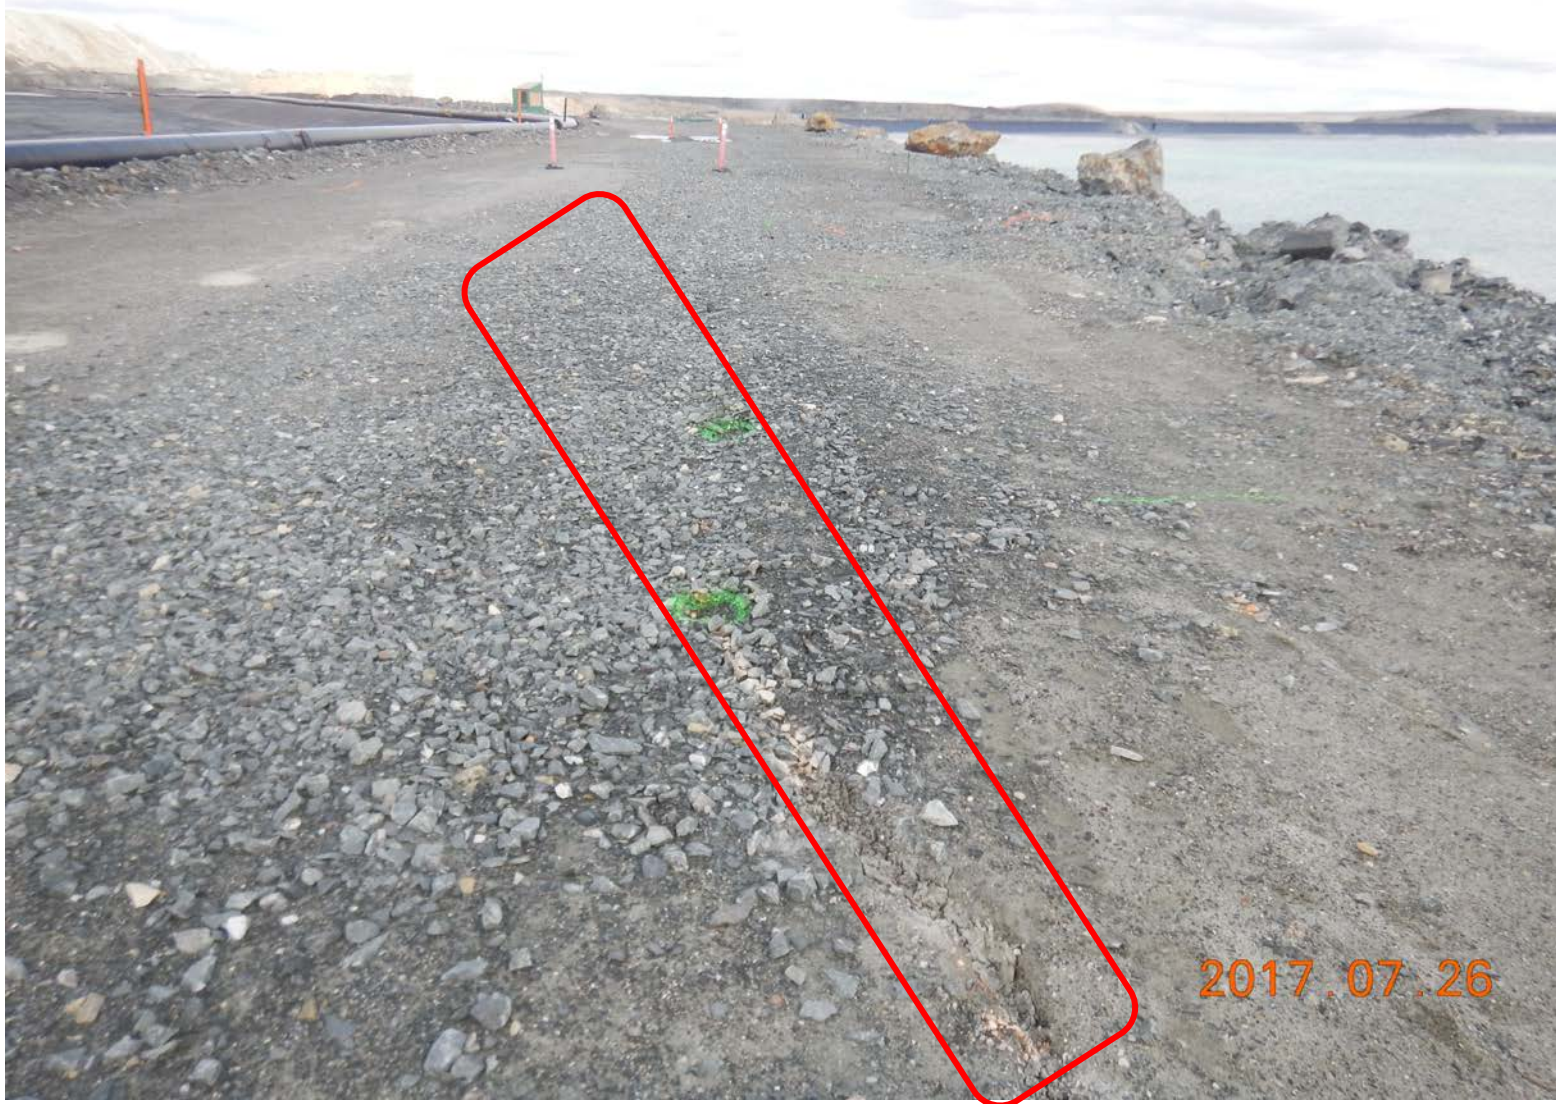
# 2016 CRACKS FILLED WITH BENTONITE

**May 25** - Filling the 2016 cracks with bentonite (from 10+500 to 10+750)

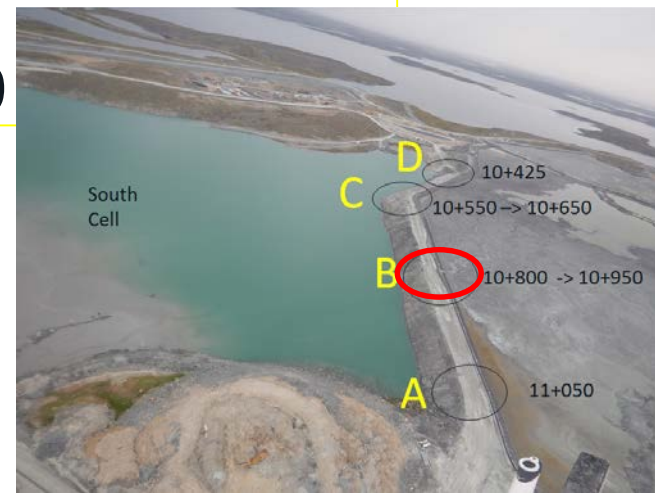
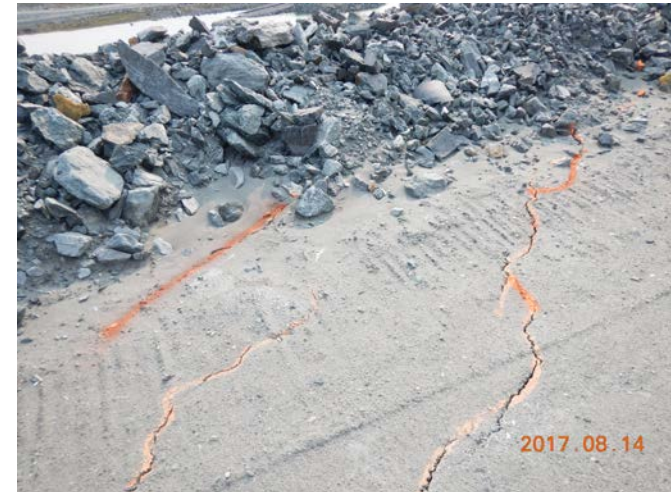
# AREA OF MOVEMENT-10+800 TO 10+950

**July 5** - Observation of settlement of 70cm deep and cracks from 10+840 and 10+925

- ➔ Observed initially on July 5th 2017
- ➔ Depression present in previous year but deeper and larger amplitude this year
- ➔ Cracks were not present before

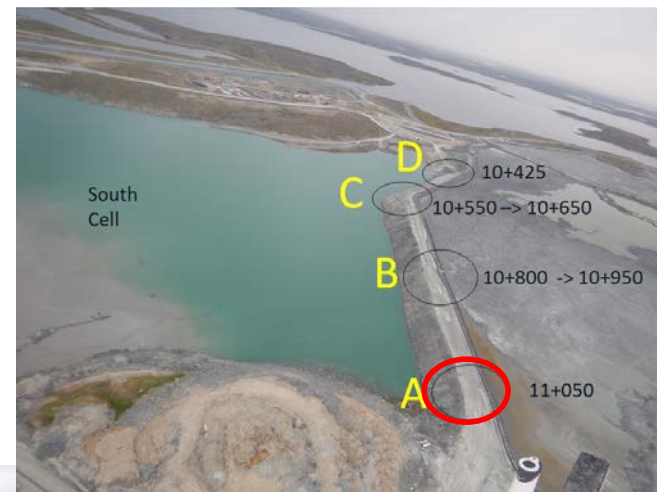
# PICTURE OF MOVEMENT – 11+050

**July 15** - Observation of new cracks at 10+425 and 11+050 (corresponding to limit of South Cell water)

- Observed initially on July 15th 2017
- Appeared when water reached the toe in the area
- Crack width relatively small (<1cm)
- Cracks did not progressed

- The new cracks found at 10+425 and 11+050 happened when the South Cell water elevation reached the toe of the structure in these areas, same process as last year.
  - The observed cracks in those zones are smaller in amplitude compared to last year observation from 10+500 to 10+750
- The instrumentation data still shows movement but in a stabilizing trend since freshet as confirmed by the visual inspection. Creep is expected to continue to be visible until the crest of the structure freezes.
- Tailings in the North Cell are frozen for 18m.
- The structure is still in yellow tarp level and the situation is considered moving towards stability.
- Monitoring of the prisms will continue on a reduced frequency.
- Frequent visual inspection of the structure are planned for freshet 2018.
- New cracks will be filled with bentonite before temperature falls below 0°C.

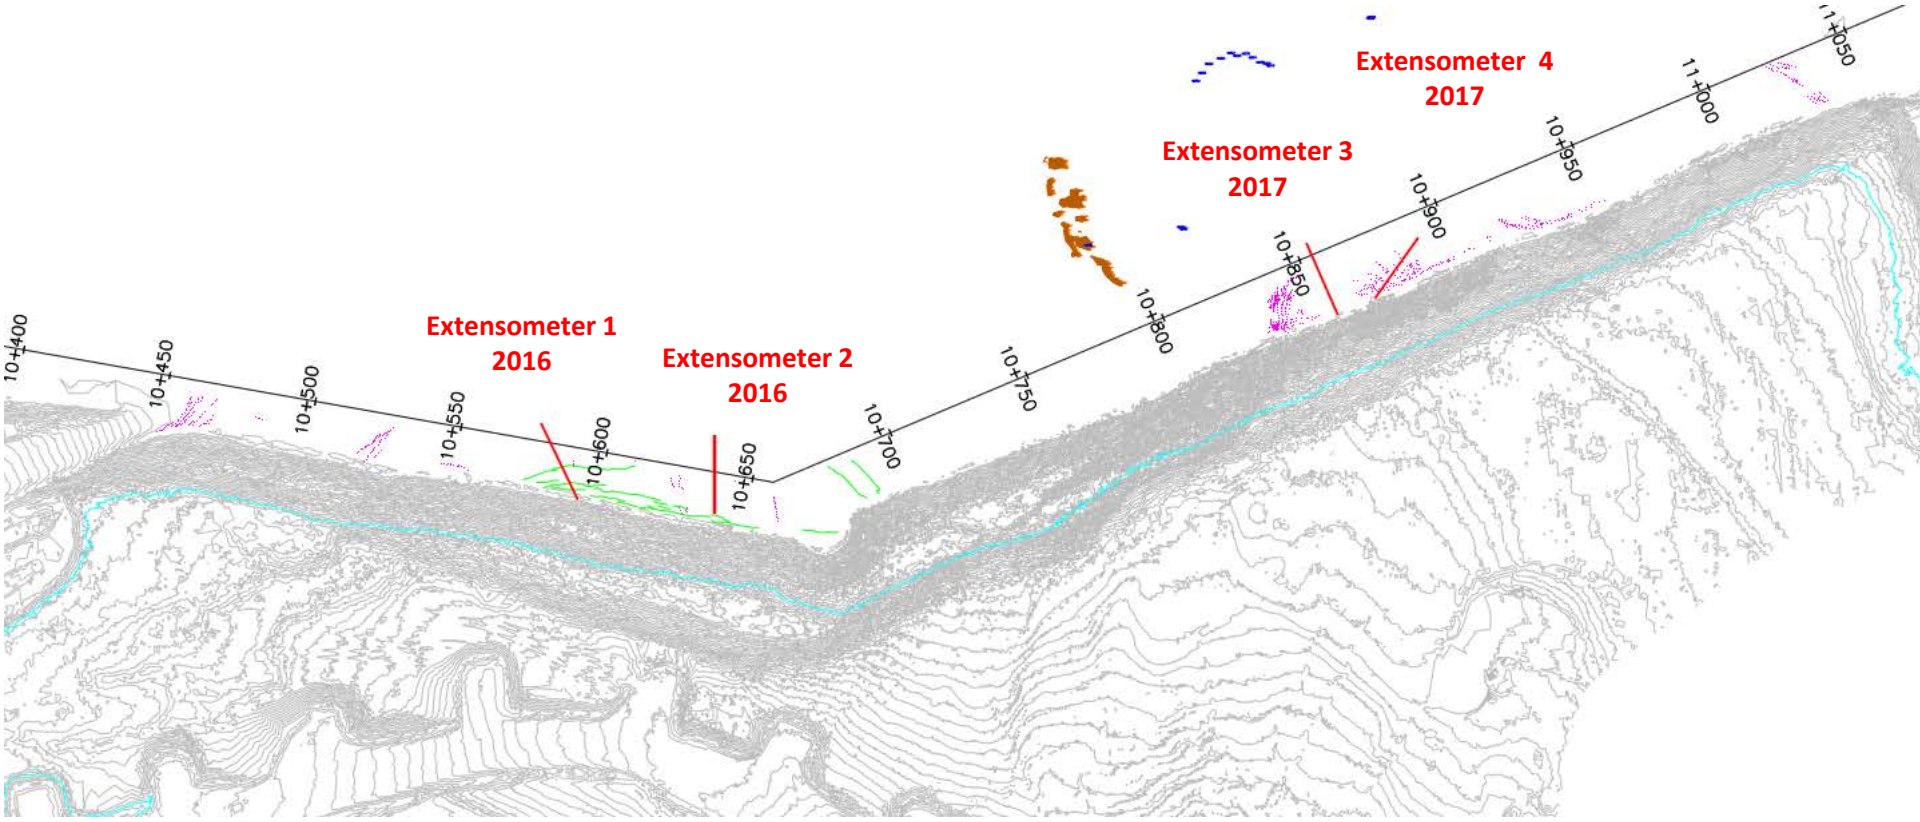
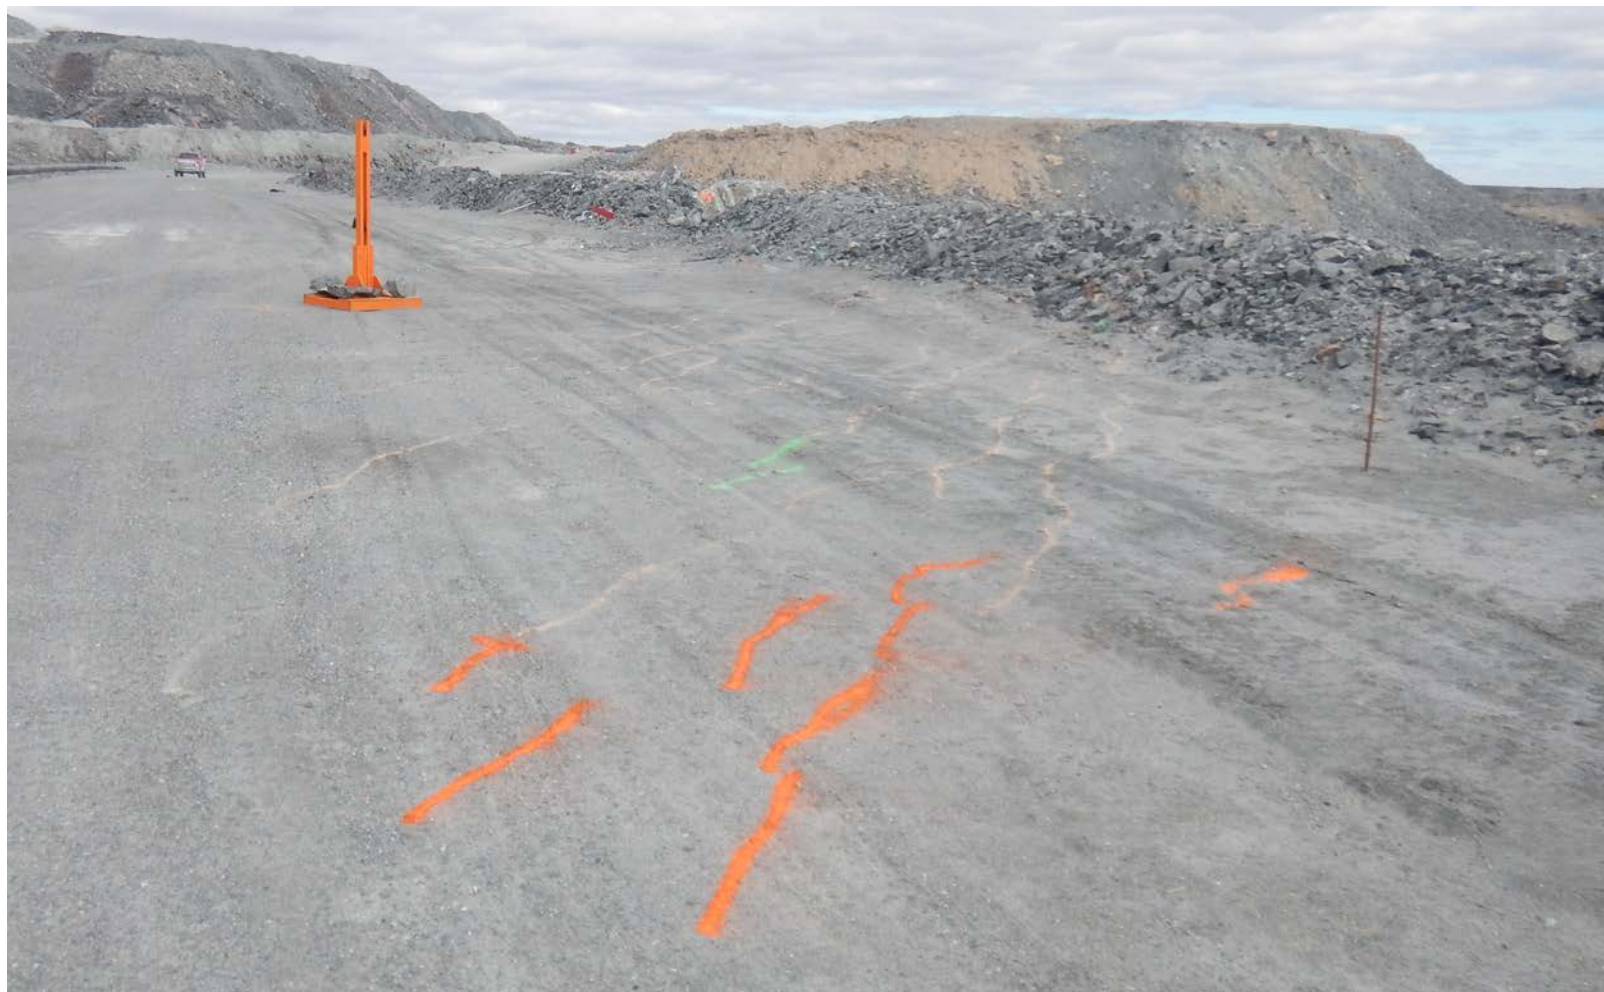
# HOMEMADE EXTENSOMETERS (4X)

➤ No movements were recorded on any of the 4 extensometers installed in 2017

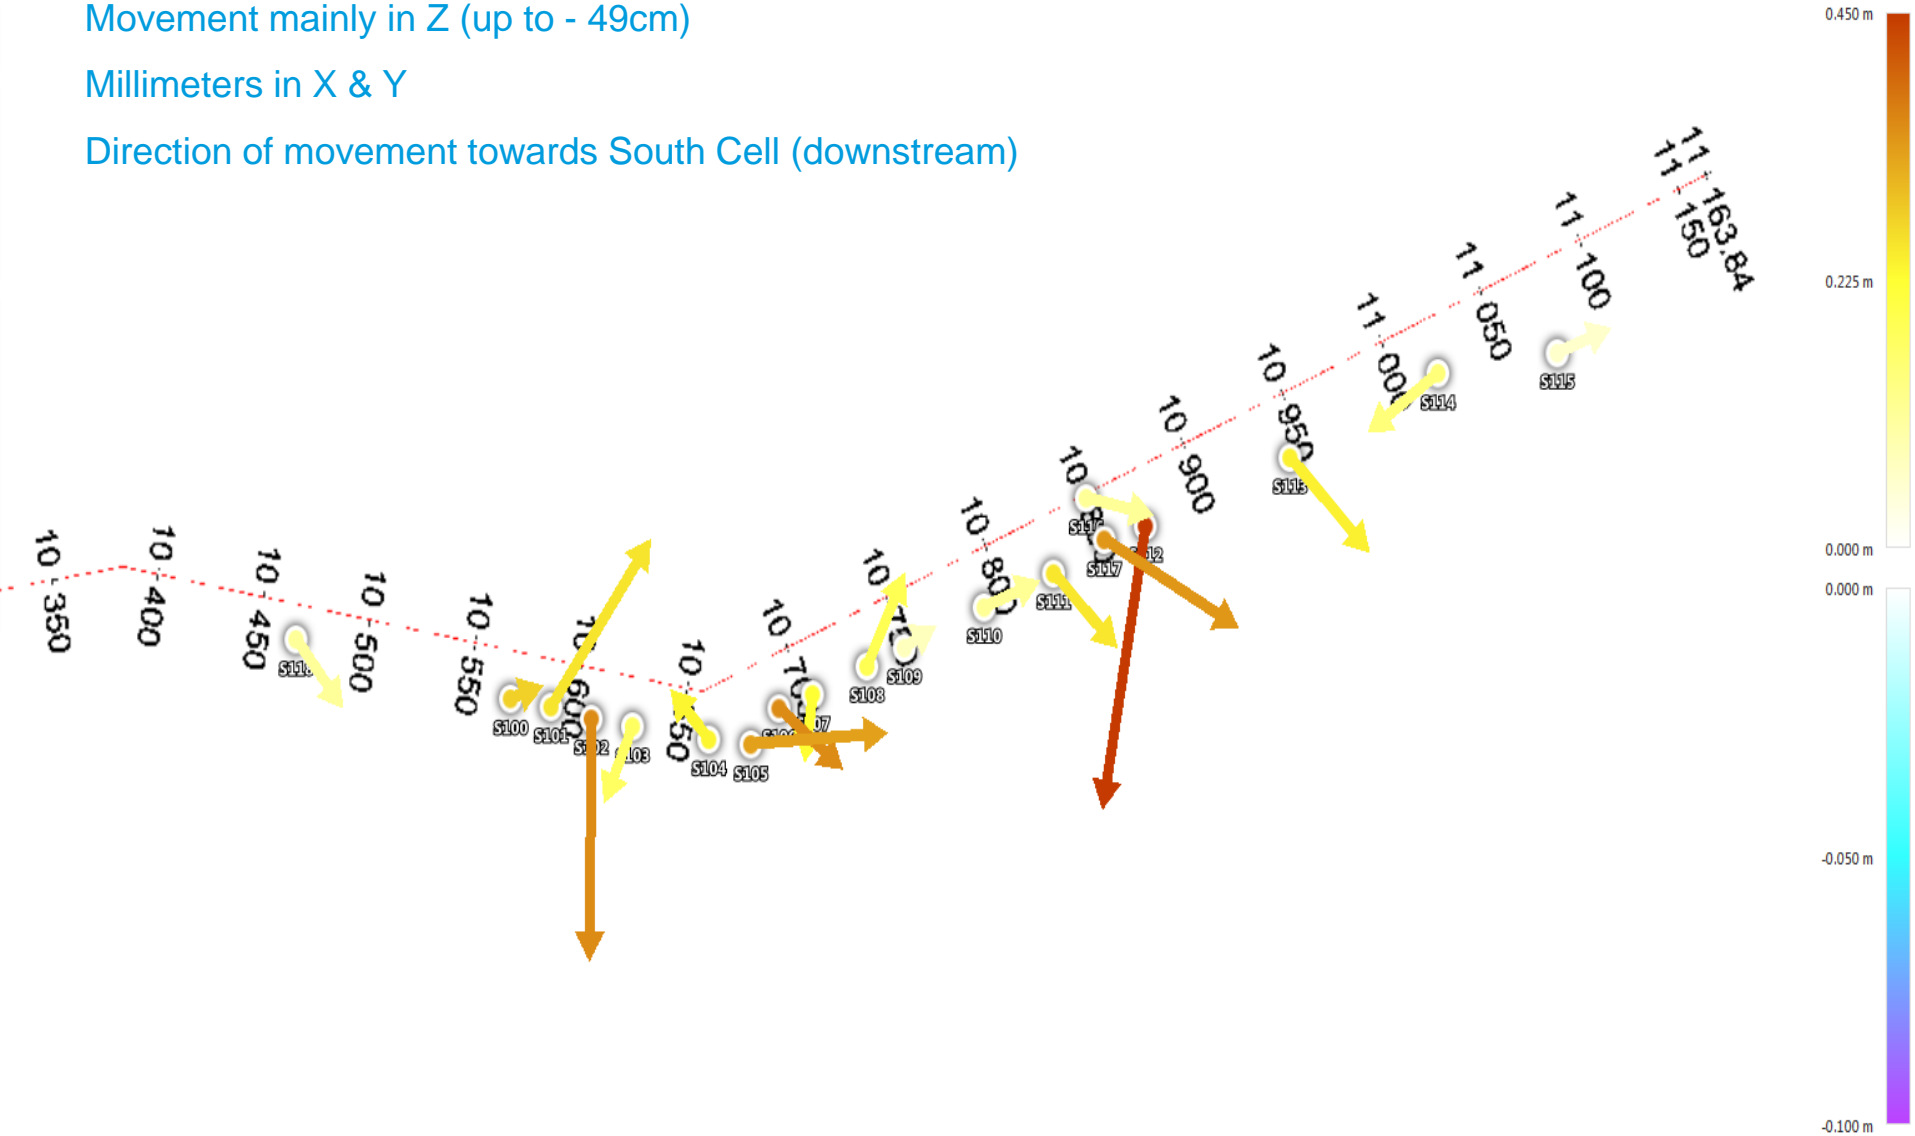
# PRISMS

Direction of movement towards South Cell (downstream)

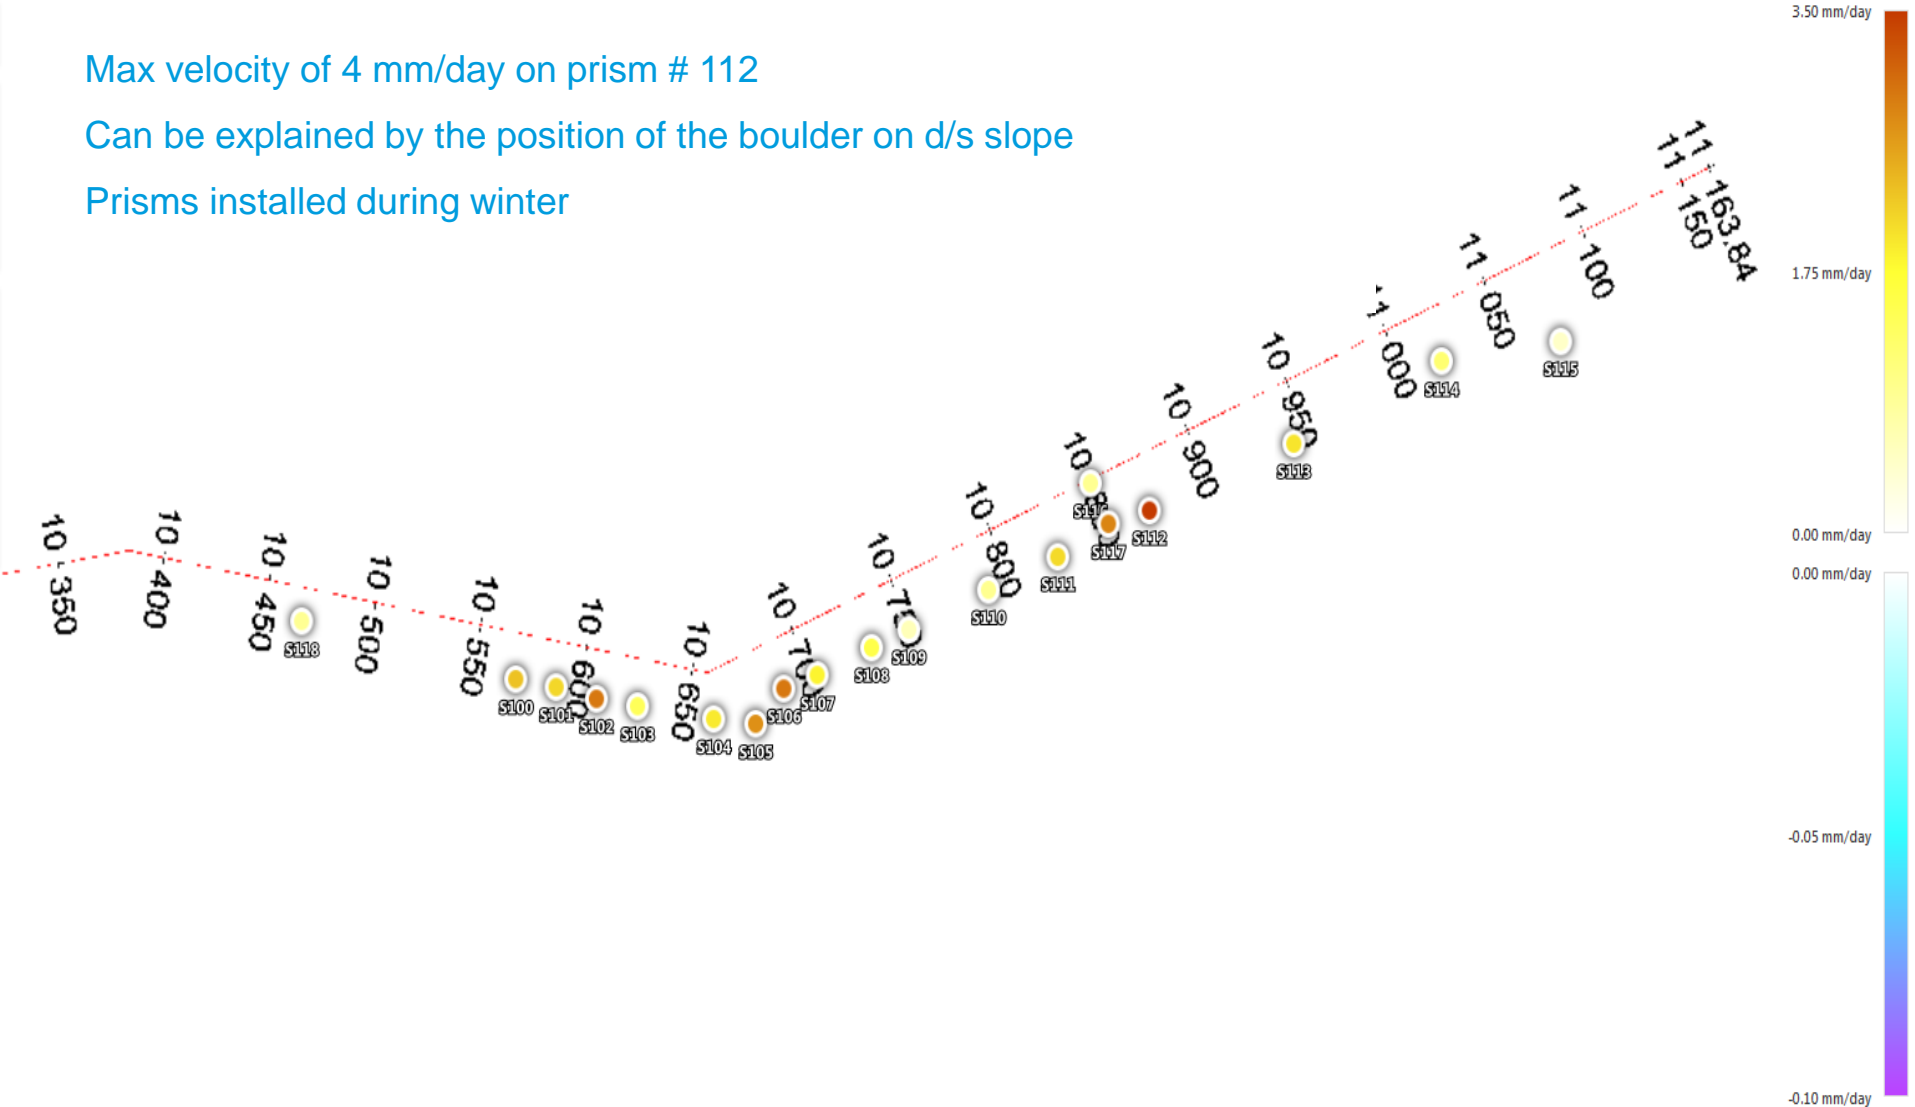
# PRISMS

Can be explained by the position of the boulder on d/s slope

Prisms installed during winter

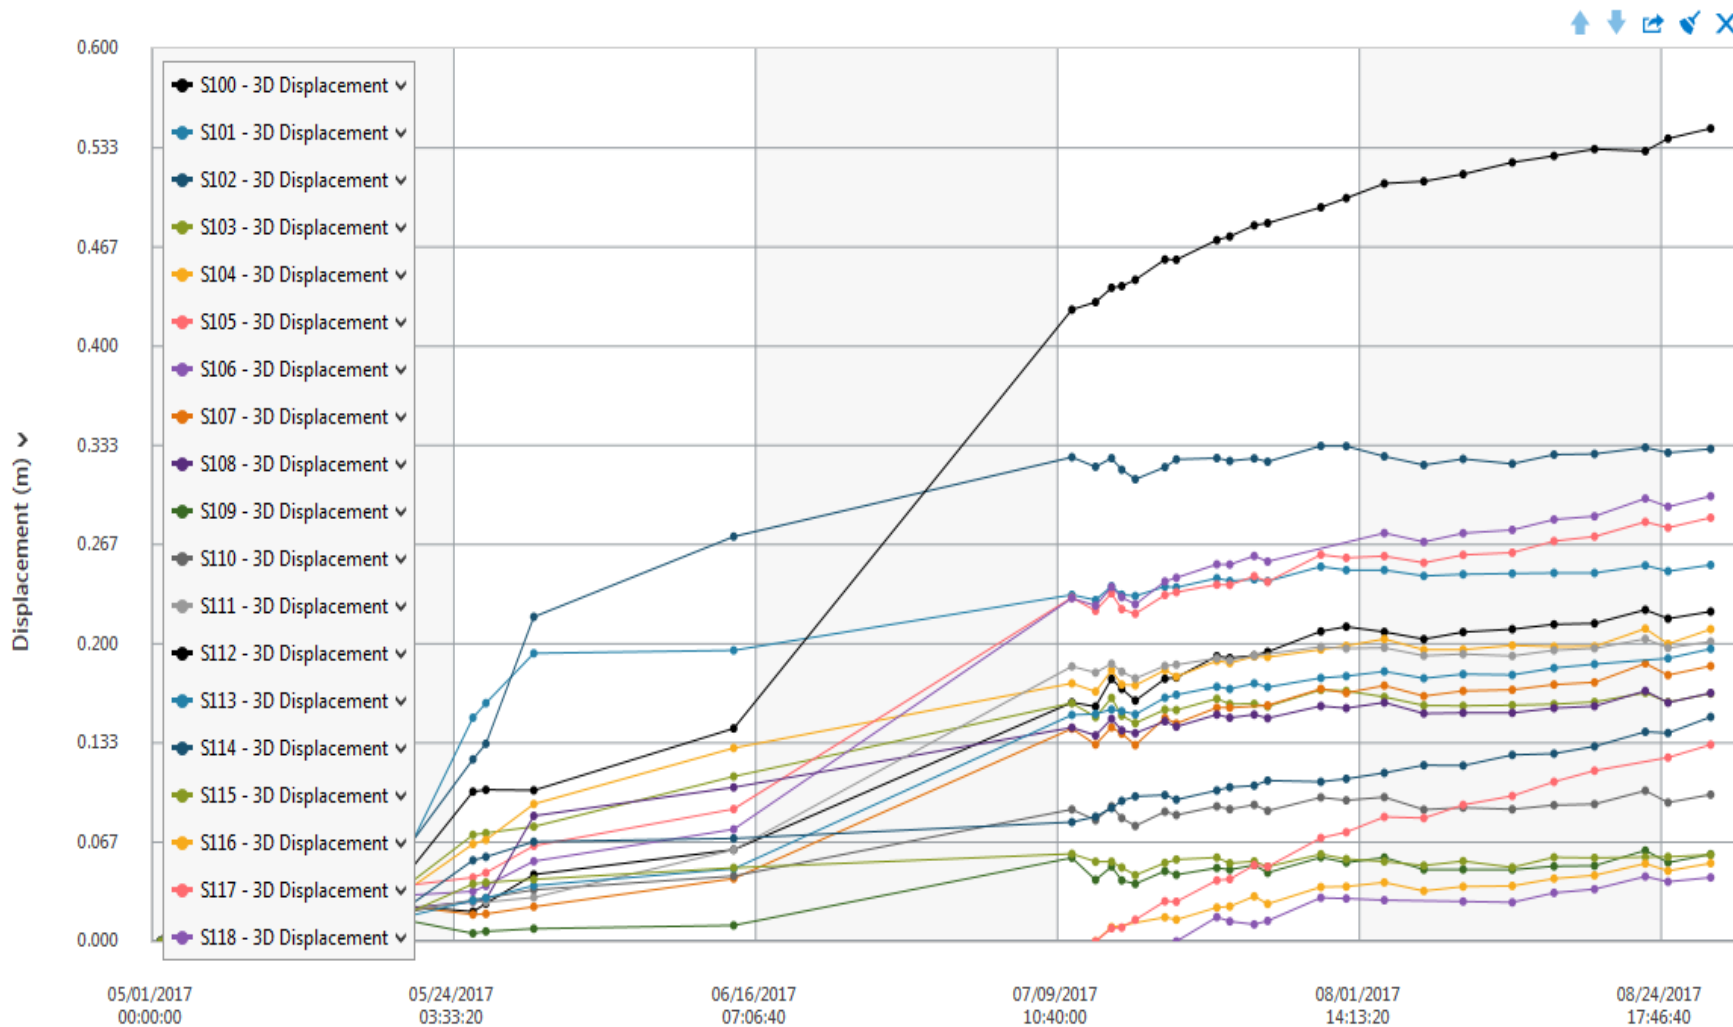
## Cumulative Displacement (3D) since May 2017

Max movement of 55cm

Most of the movement happened at freshet

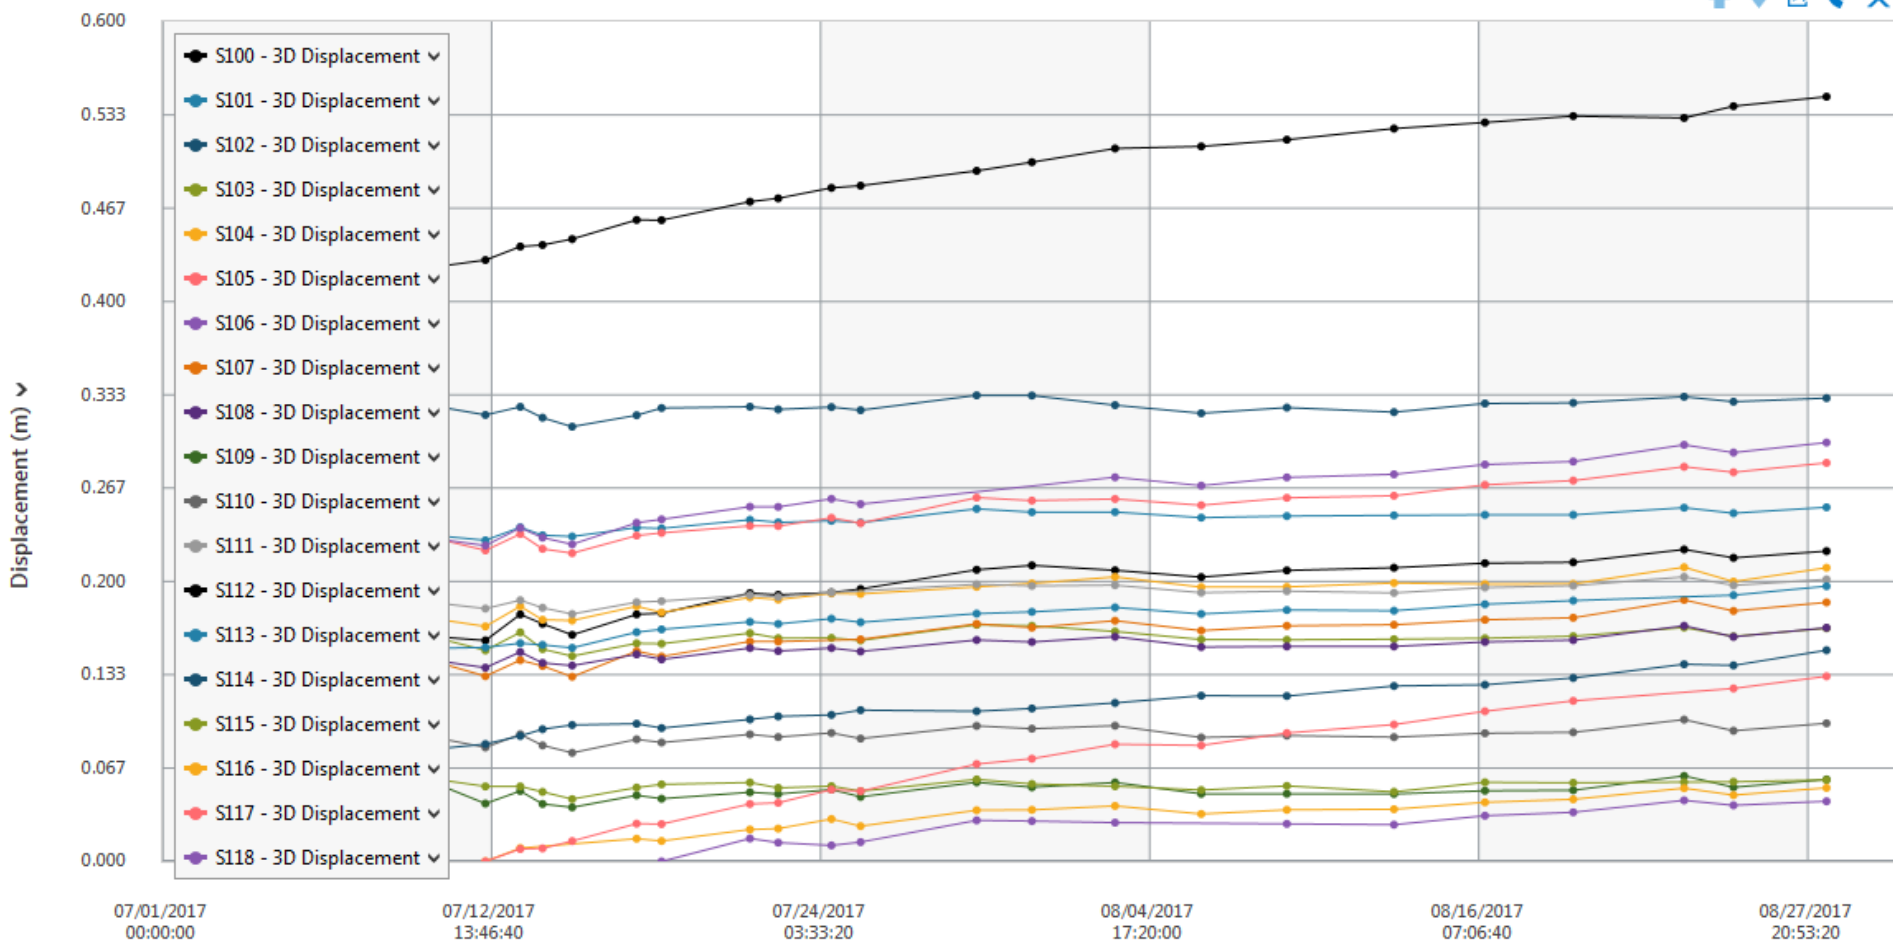
## Cumulative displacement (3D) since freshet

Still displacement but lower amplitude than considering thawing period

Max movement for the post-freshet period is ~5-6 cm

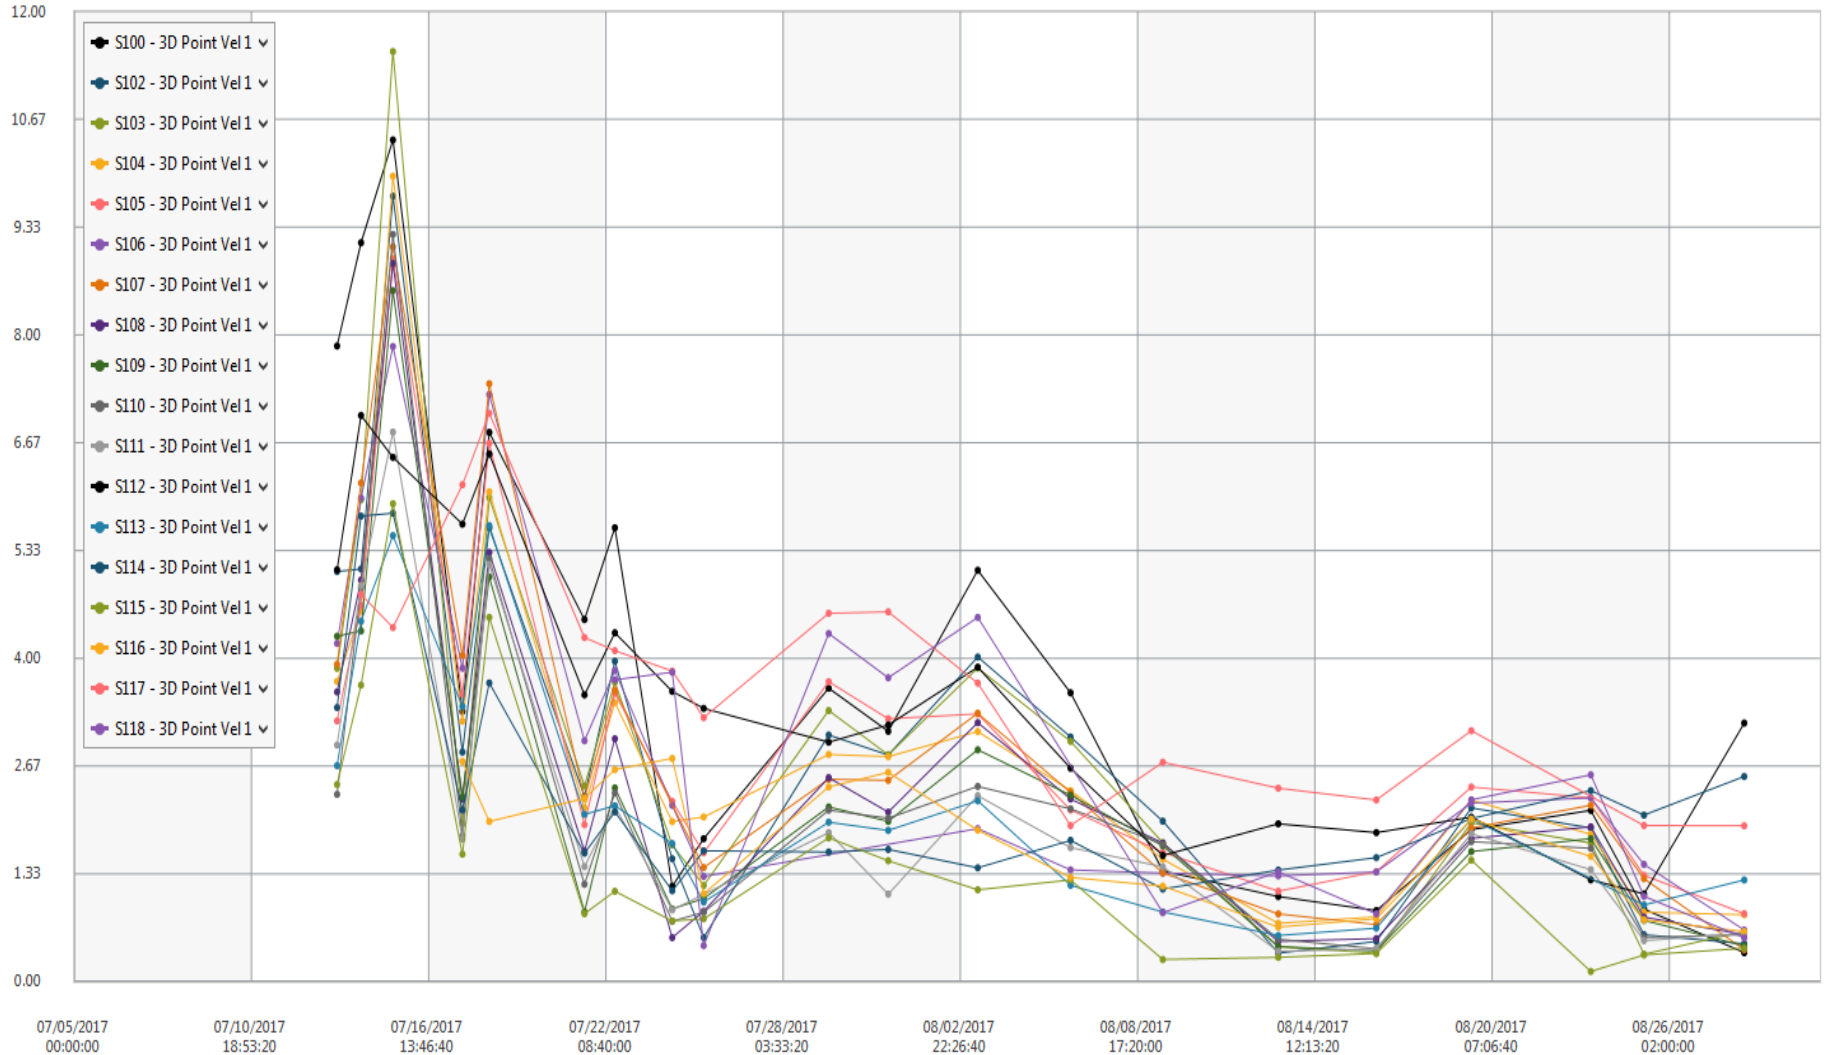
## 3D velocity since freshet

Decreasing velocity from average 5mm/day to 1.5mm/day

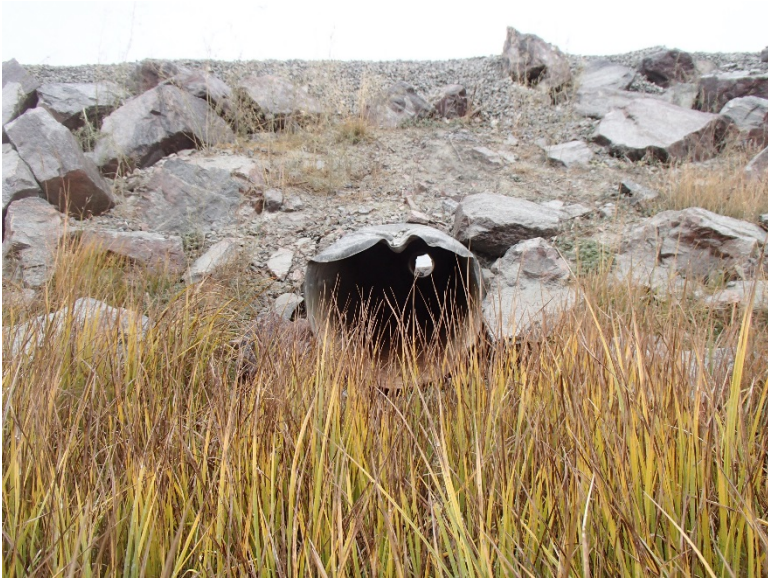
*Photograph D1-1: PRC1 km 0+430*

**Description:** View of culvert inlet, in good condition no sign of obstruction.

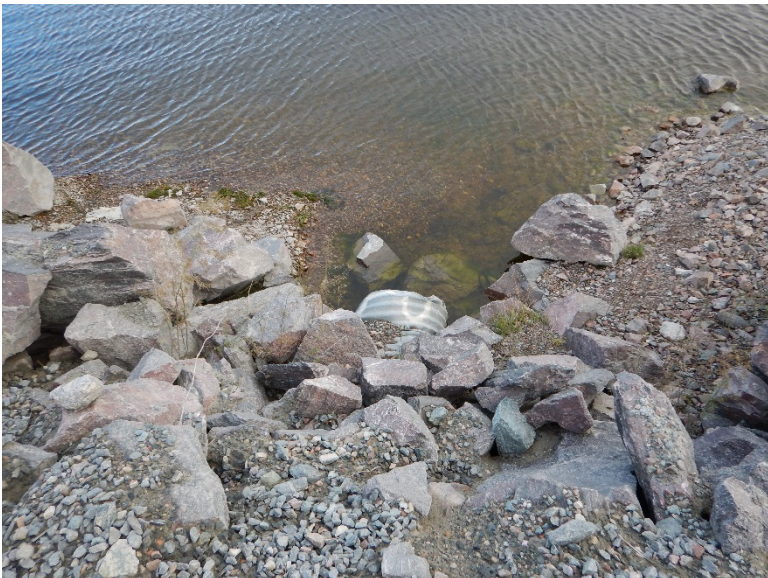
*Photograph D1-2: PRC1 km 0+430*

**Description:** View of culvert outlet. The outlet is slightly damaged and obstructed. The culvert is still functional and in overall good condition.

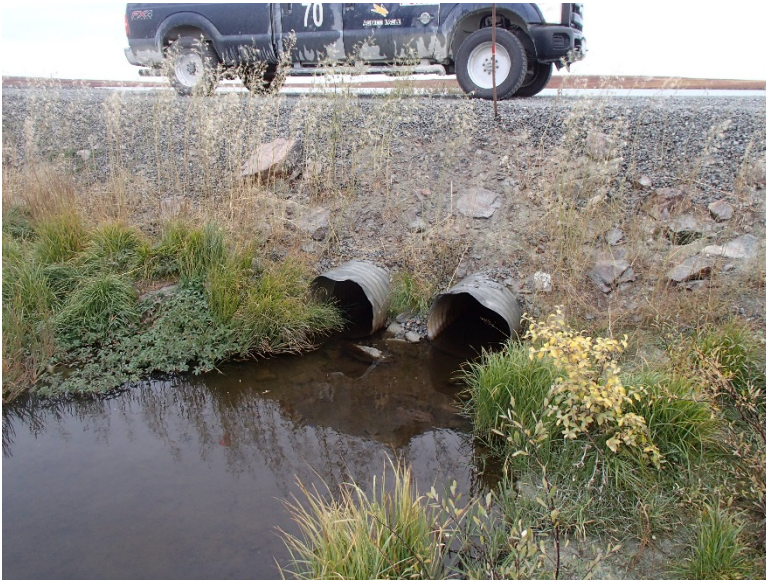
*Photograph D1-3: PRC2 km 0+470*

**Description:** View of culverts inlet. In good condition.

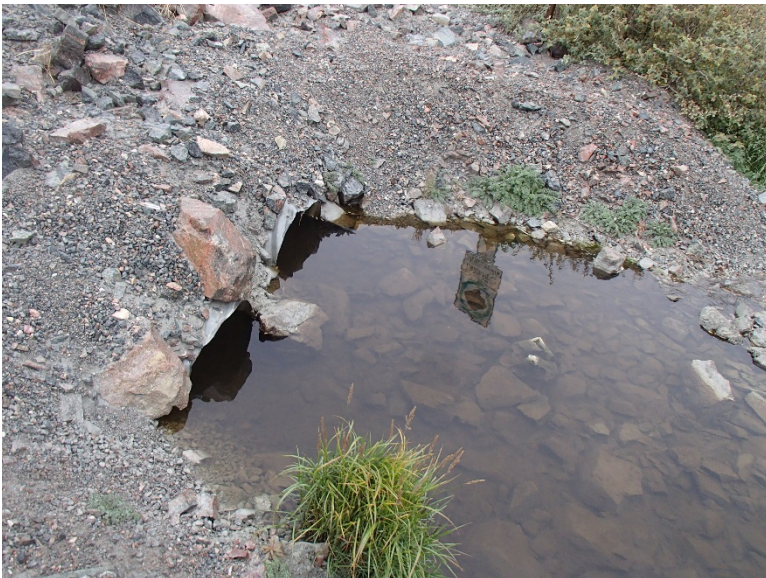
*Photograph D1-4: PRC2 km 0+470*

**Description:** View of culverts outlet. In good condition.

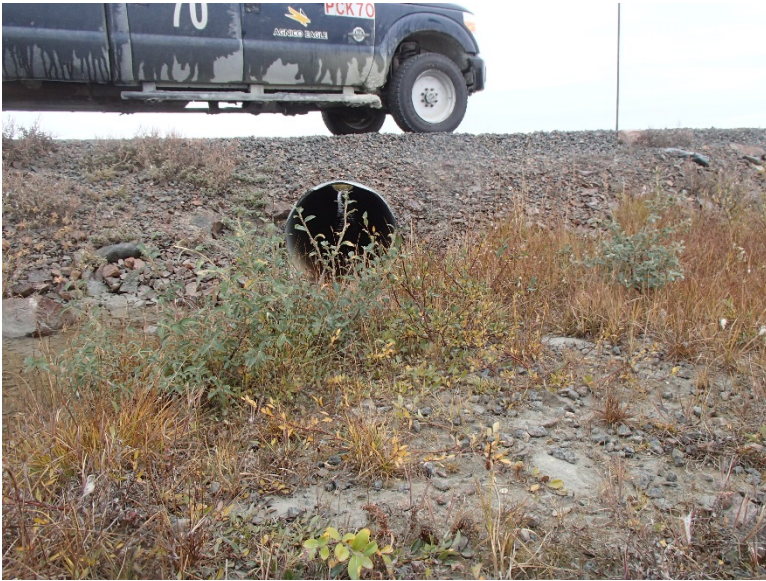
*Photograph D1-5: PRC3 km 1+380*

**Description:** View of culvert inlet. In good condition.

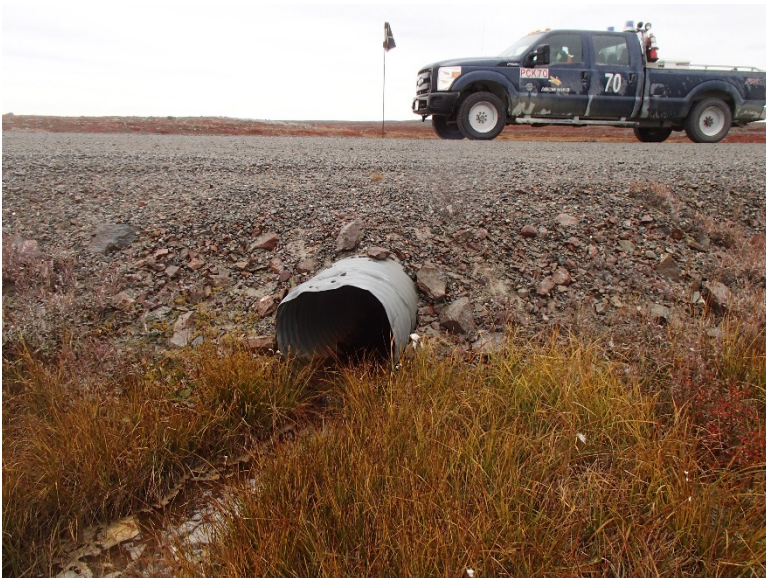
*Photograph D1-6: PRC3 km 1+380*

**Description:** View of culvert outlet. In good condition.

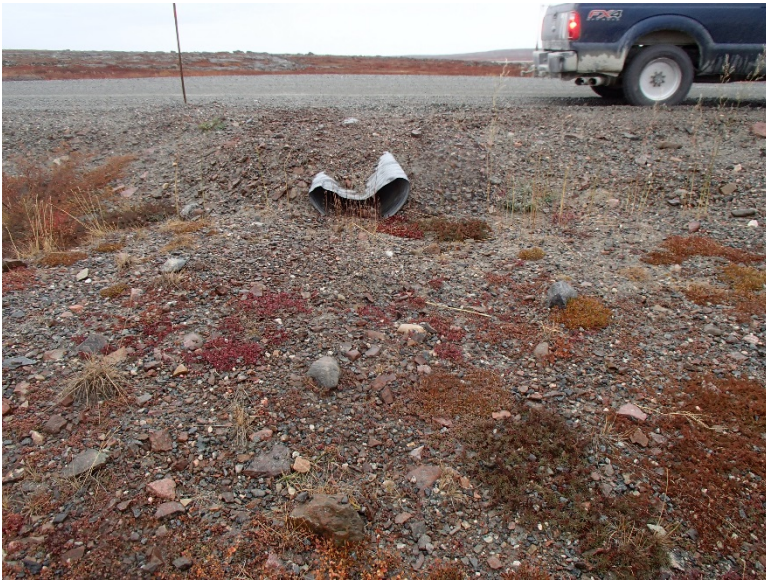
*Photograph D1-7: R-00A km 2+550*

**Description:** View of culvert inlet. The inlet is partially collapsed. No sign of flow.

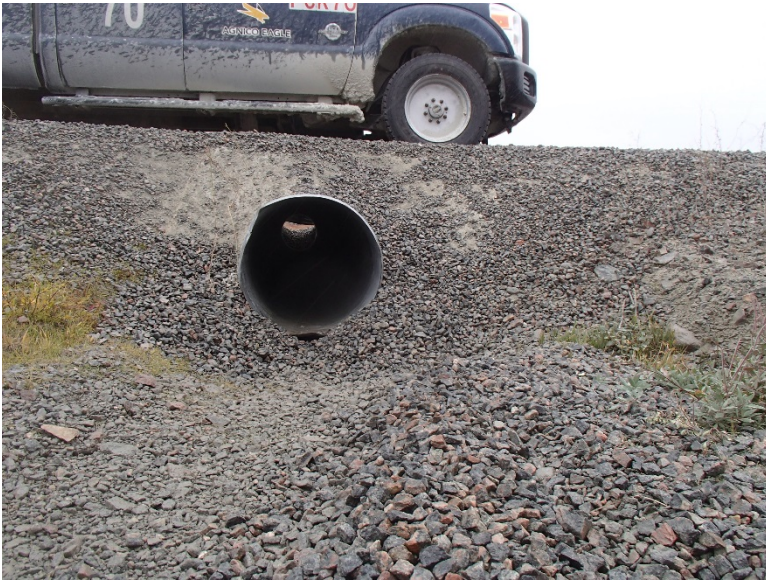
*Photograph D1-9: unnamed km 5+700*

**Description:** View of the culvert inlet. Good condition, inlet is short in length as the road rolling surface is at the edge of the inlet.

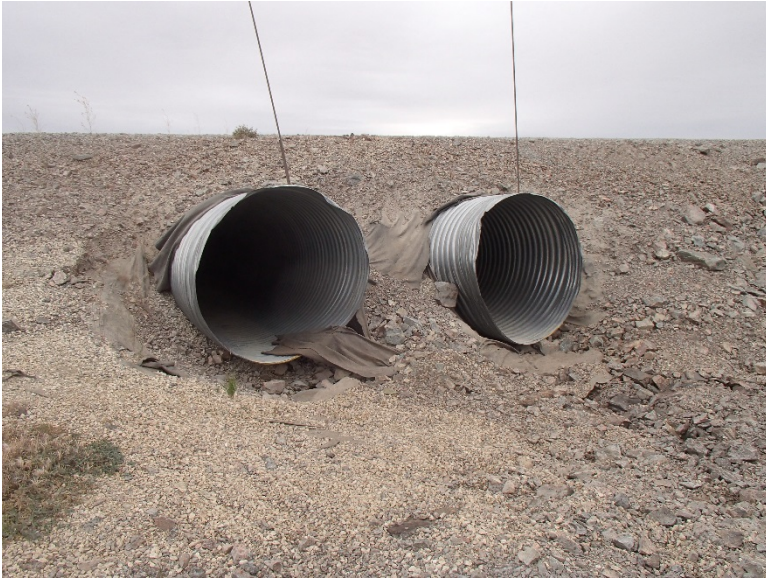
*Photograph D1-11: PC-17A km 8+830*

8+830	PC-17A		Sign of erosion beneath the inlet and flow of water occurring beneath the culvert. The 1800 CSP were installed too high. While conditions are not perfect, they have proven stable over the past years. No sign of degradation from last year on both the inlet and outlet sides.
8+850	PC-17	2x1200 mm CSP	In good condition
9+952	PC-1	1x600 mm CSP	In good condition
10+580	R-03	1x600 mm CSP	In good condition
12+050	R-04	1x1200 mm CSP	In good condition
12+745	PC-13	1x600 mm CSP	In good condition
13+250	Quarry 2		Slope remediation in progress.
13+405	PC-2	1x600 mm CSP	In good condition
13+685	PC-3	1x600 mm CSP	In good condition
13+950	unnamed	1x600 mm CSP	In good condition
14+910	PC-4	1x600 mm CSP	In good condition

**Description:** View of the culverts inlet. No sign of degradation since last year.

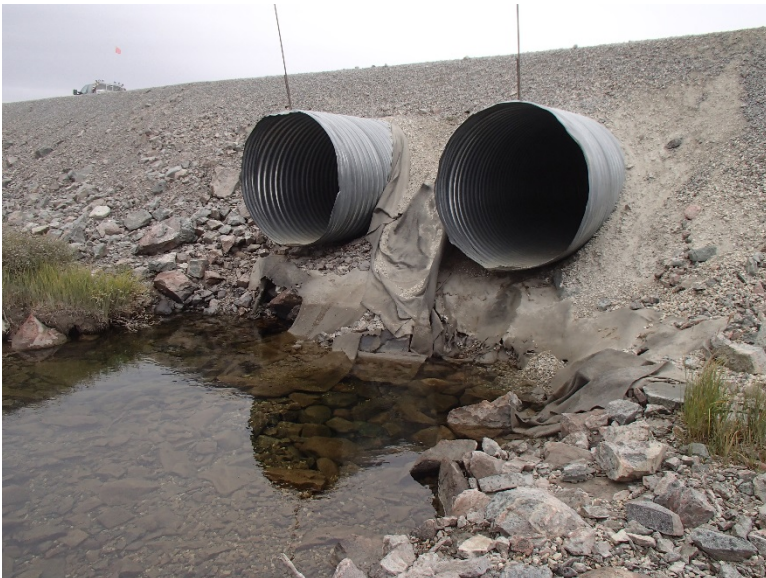
*Photograph D1-12: PC-17A km 8+830*

**Description:** View of the culverts outlet. No sign of degradation since last year.

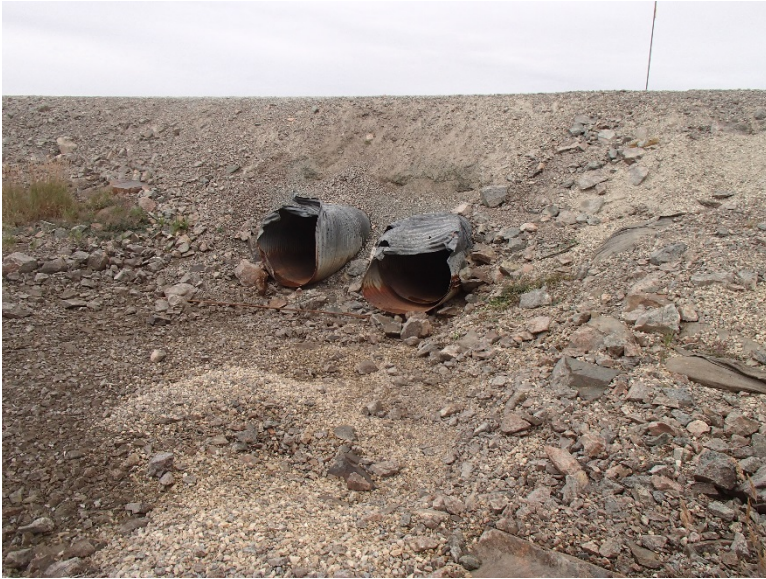
*Photograph D1-13: PC-17 km 8+850*

**Description:** View of the culverts inlet. Good condition.

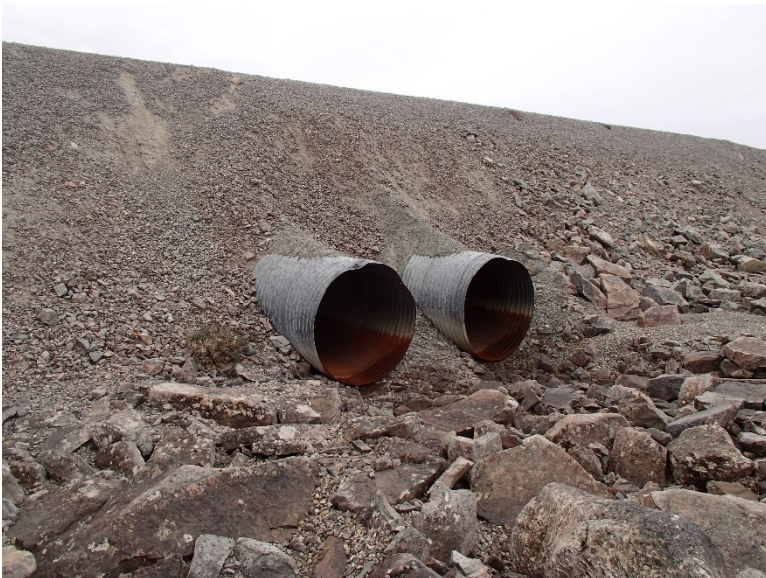
*Photograph D1-14: PC-17 km 8+850*

**Description:** View of the culverts outlet (right side of the picture). Good condition.
