**Report: 2017 Annual Geotechnical Inspection**

February 2018

# 2017 Annual Geotechnical Inspection Meadowbank Gold Mine, Nunavut

**Report Number:** 1784282-1574-RPT-Rev0

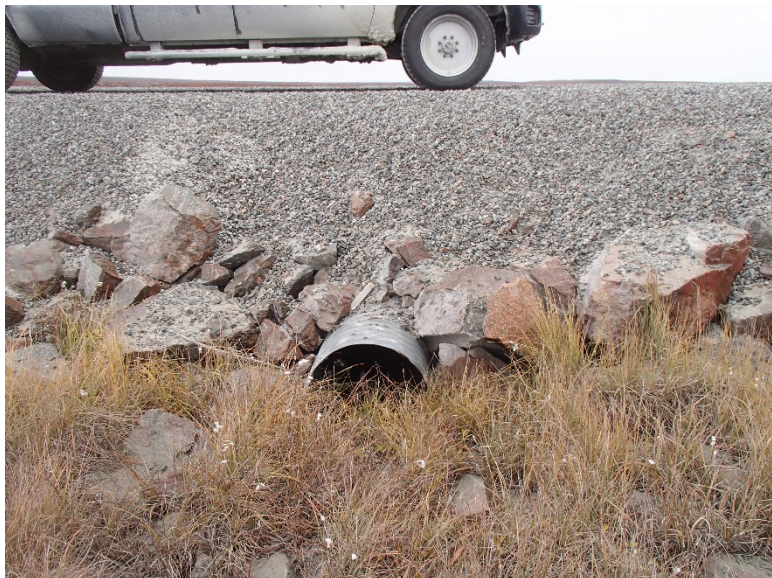
*Photograph D1-15: PC-1 km 9+952*

**Description:** View of the culvert inlet. In good condition.

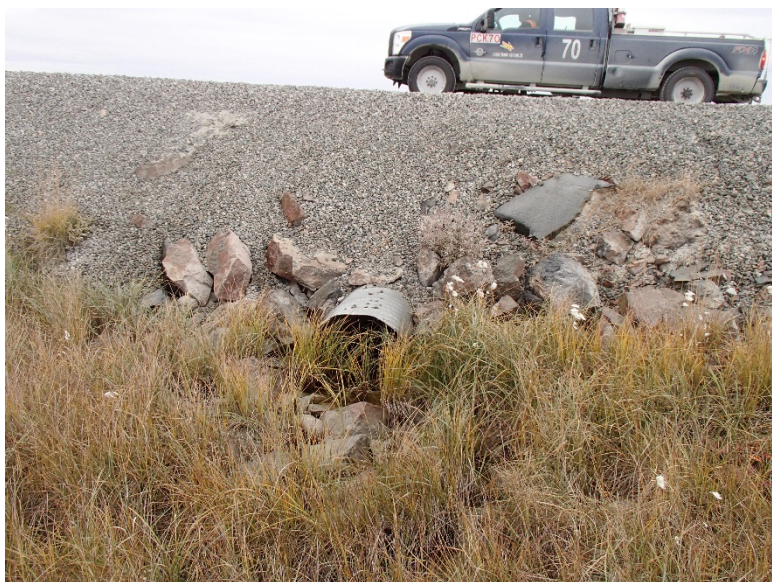
*Photograph D1-16: PC-1 km 9+952*

**Description:** View of the culvert outlet. In good condition.

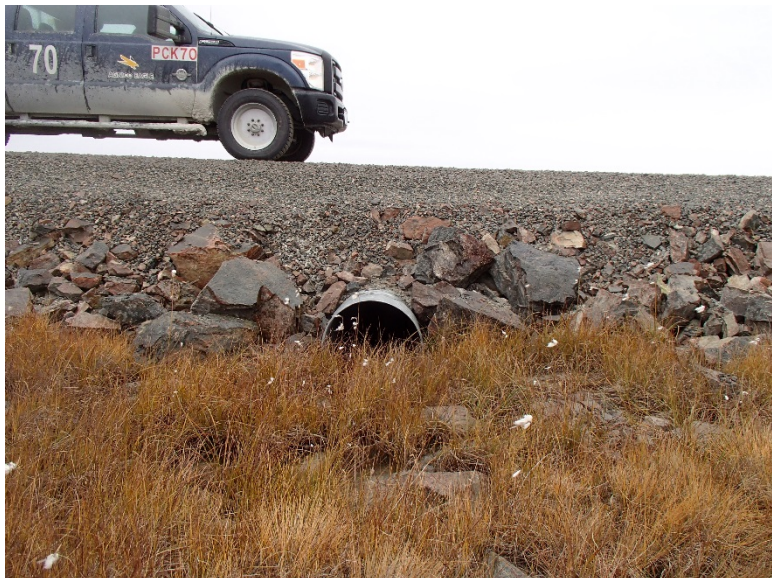
*Photograph D1-17: R-03 km 10+580*

**Description:** View of the culvert inlet. In good condition.

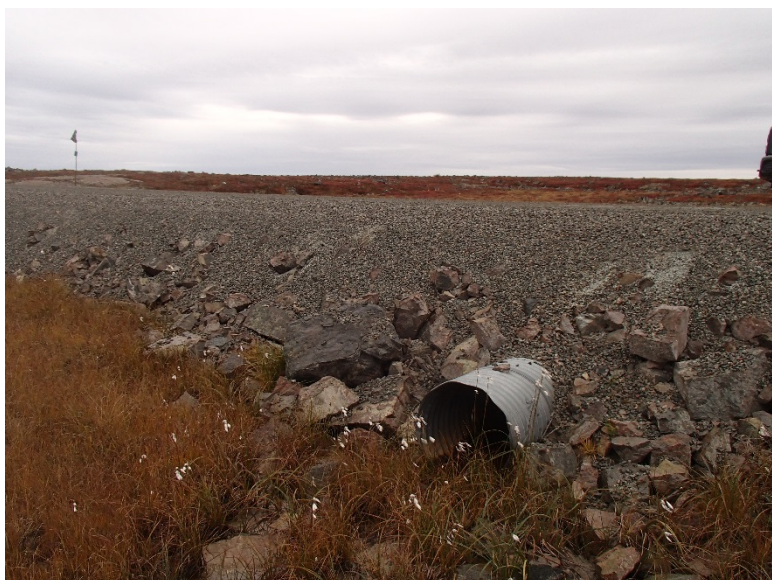
*Photograph D1-18: R-03 km 10+580*

**Description:** View of the culvert outlet. In good condition.

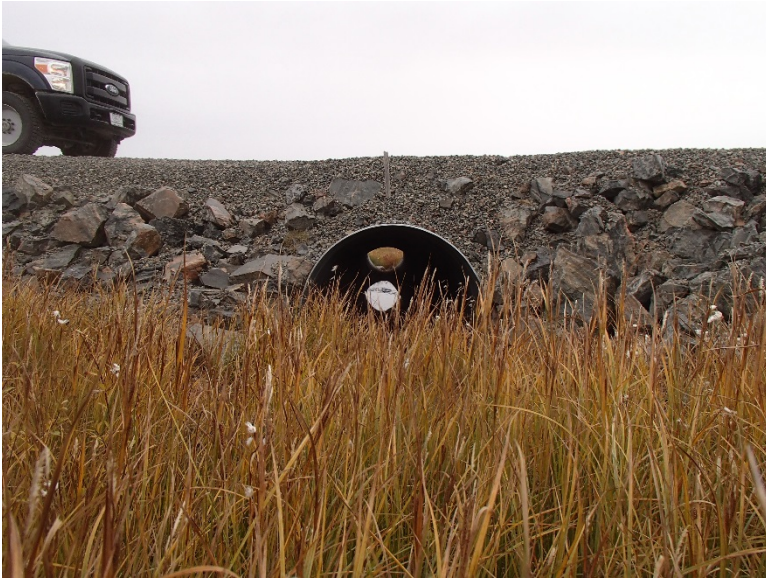
*Photograph D1-19: R-04 km 12+050*

**Description:** View of the culvert inlet. In good condition.

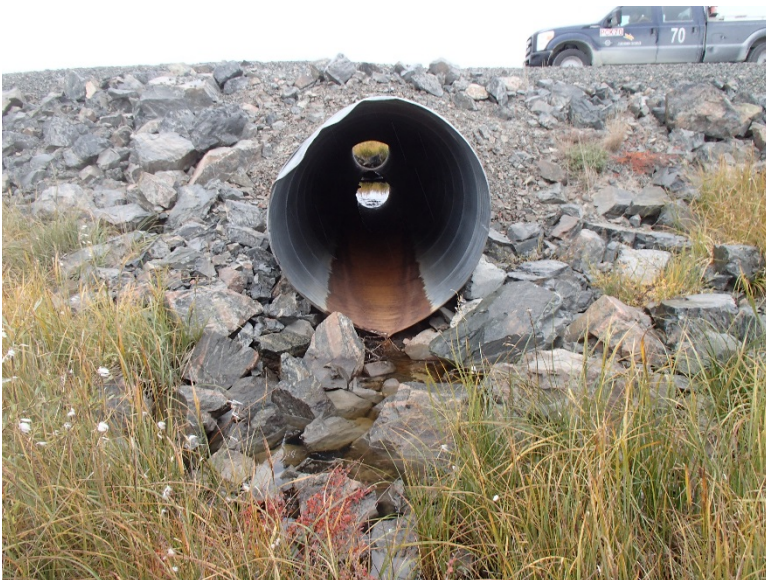
*Photograph D1-20: R-04 km 12+050*

**Description:** View of the culvert outlet. In good condition.

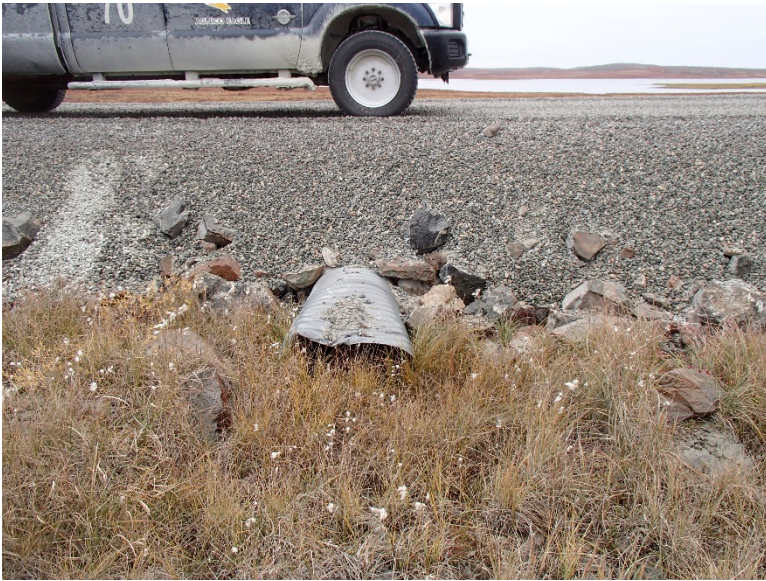
*Photograph D1-21: PC-13 km 12+745*

**Description:** View of the culvert inlet. In good condition.

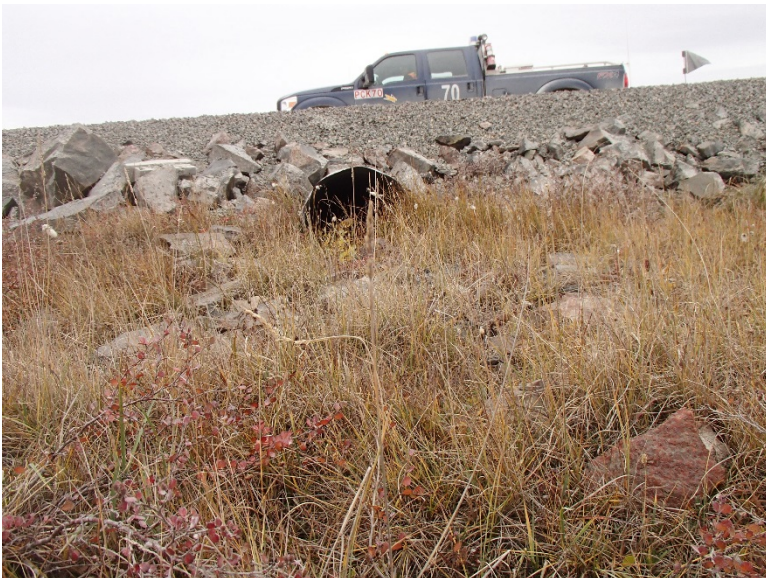
*Photograph D1-22: PC-13 km 12+745*

**Description:** View of the culvert outlet. In good condition.

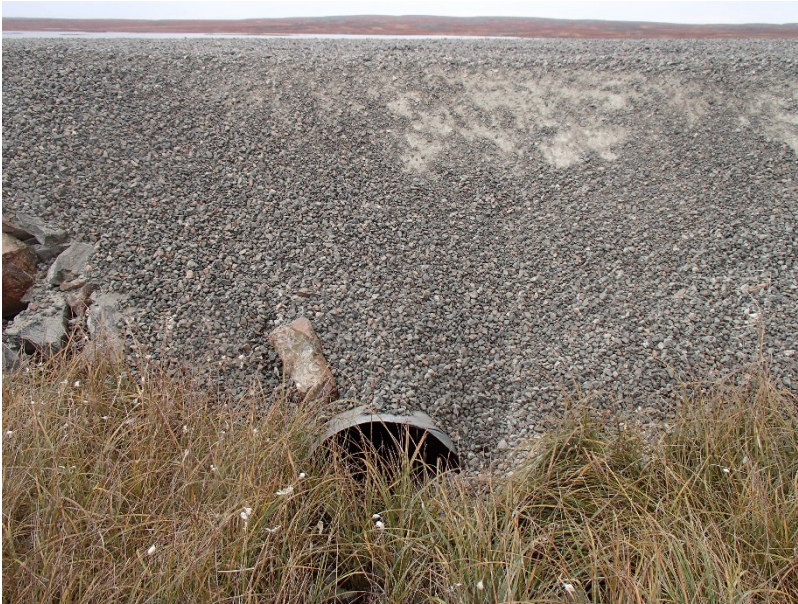
*Photograph D1-25: PC-3 km 13+685*

**Description:** View of the culvert inlet. In good condition.

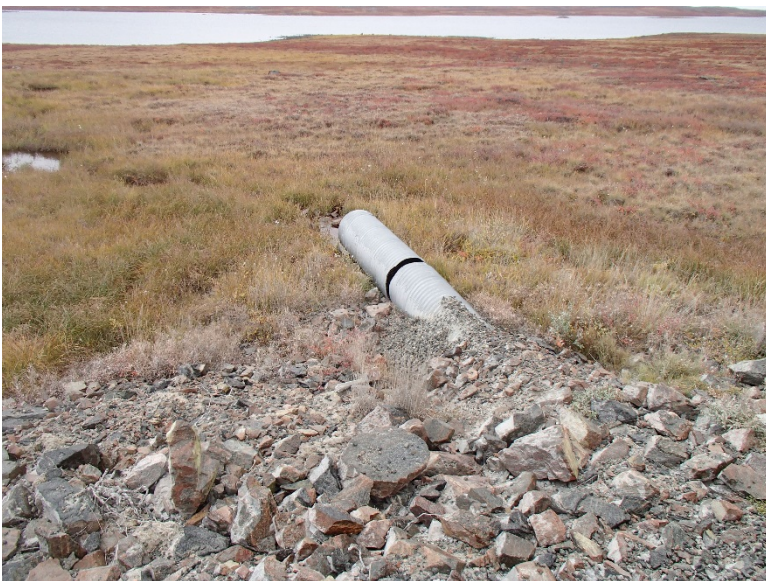
*Photograph D1-26: PC-3 km 13+685*

**Description:** View of the culvert outlet. In good condition.

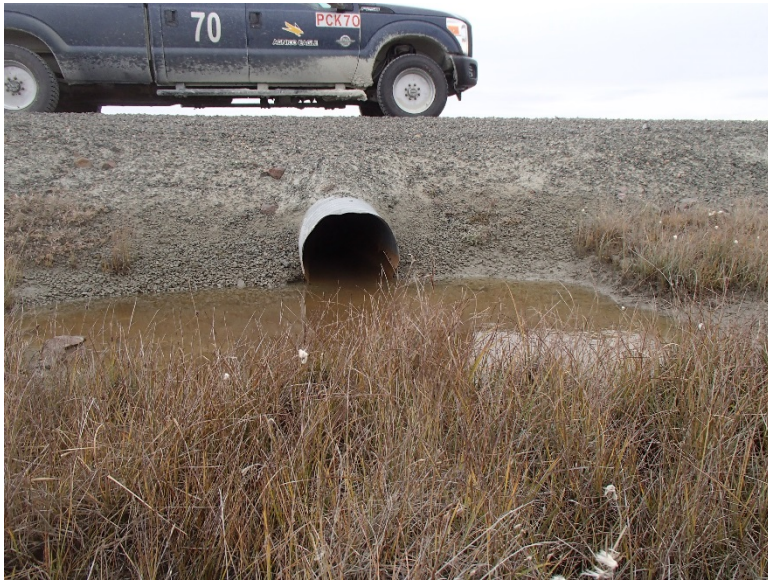
*Photograph D1-27: unnamed km 13+950*

**Description:** View of the culvert inlet. In good condition.

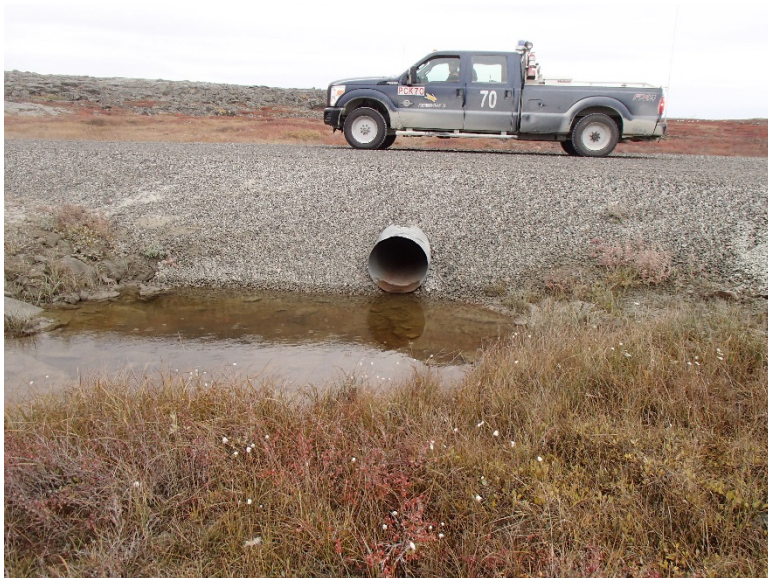
*Photograph D1-28: unnamed km 13+950*

**Description:** View of the culvert outlet. The outlet is in good condition.

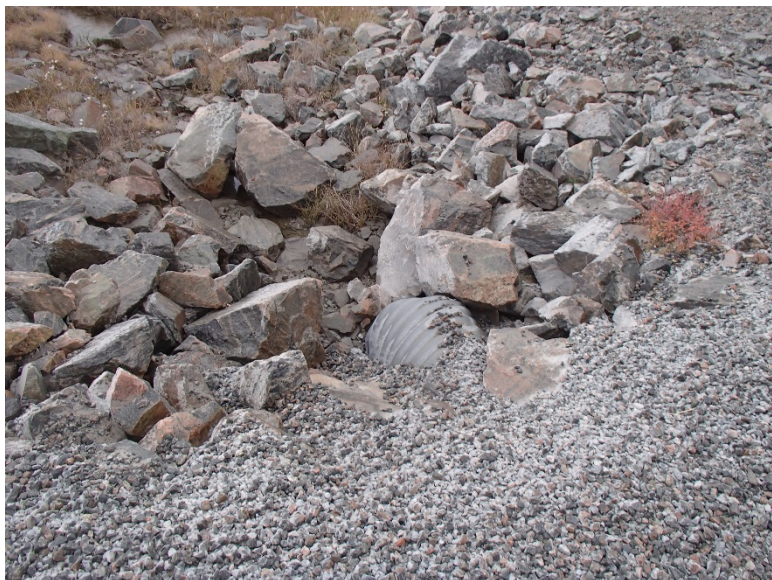
*Photograph D1-30: PC-4 km 14+910*

**Description:** View of the culvert outlet. In good condition. Large boulders around the outlet.

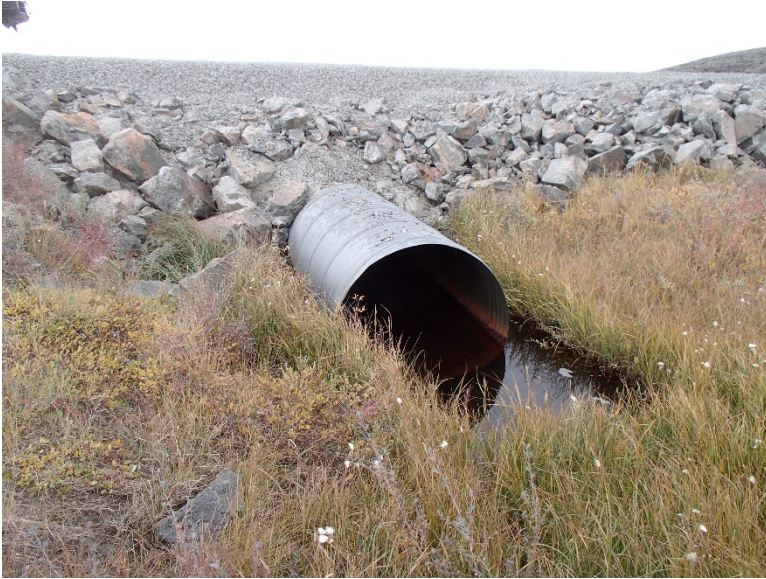
*Photograph D1-31: R-05A km 15+745*

**Description:** View of the culvert inlet. In good condition.

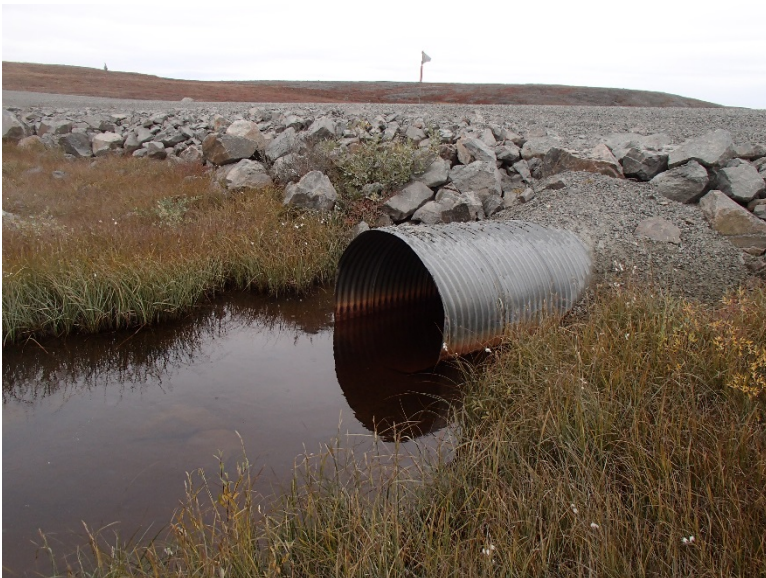
*Photograph D1-32: R-05A km 15+745*

**Description:** View of the culvert outlet. In good condition.

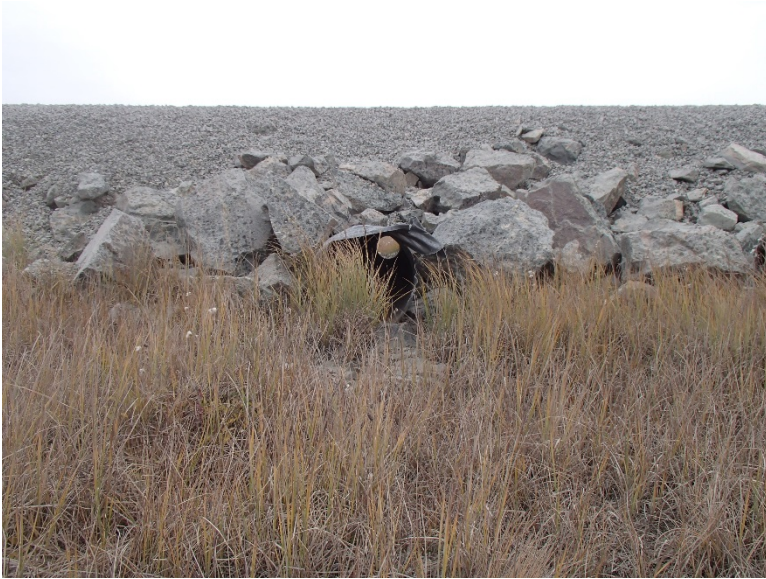
*Photograph D1-33: PC-5 km 18+280*

**Description:** View of the culvert inlet. In good condition.

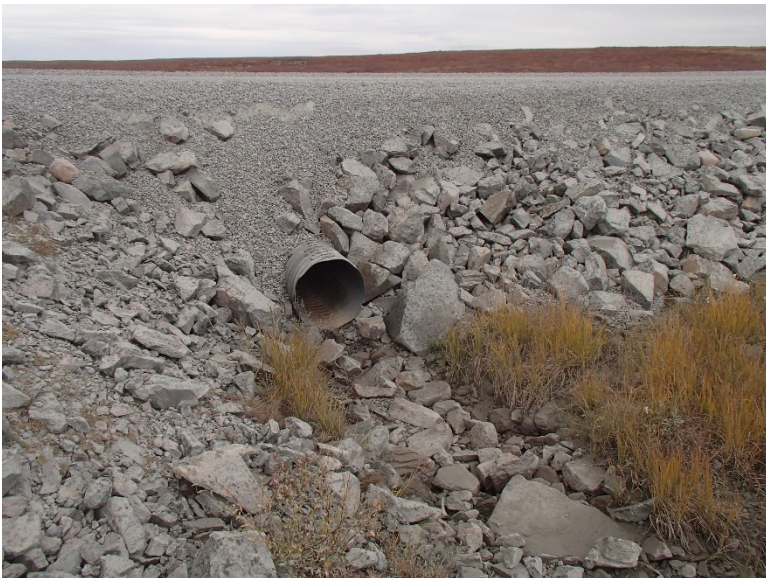
*Photograph D1-34: PC-5 km 18+280*

**Description:** View of the culvert outlet. In good condition.

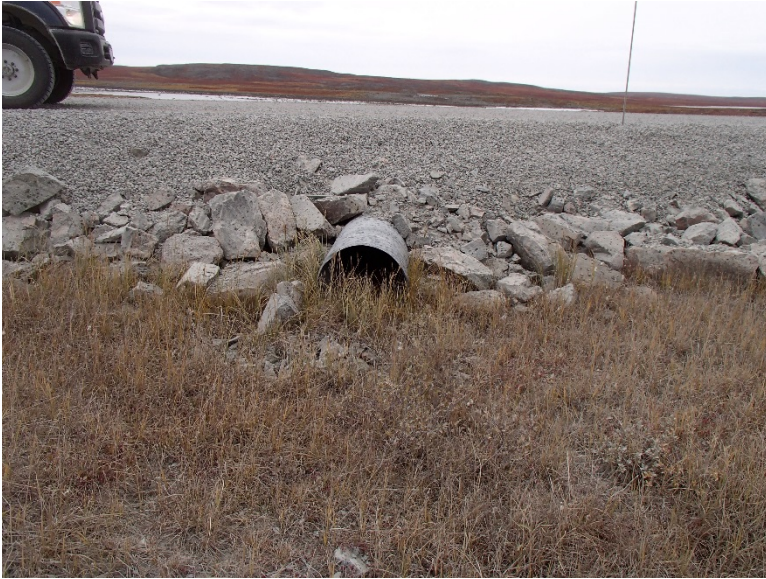
*Photograph D1-35: PC-6 km 18+900*

**Description:** View of culvert inlet. In good condition.

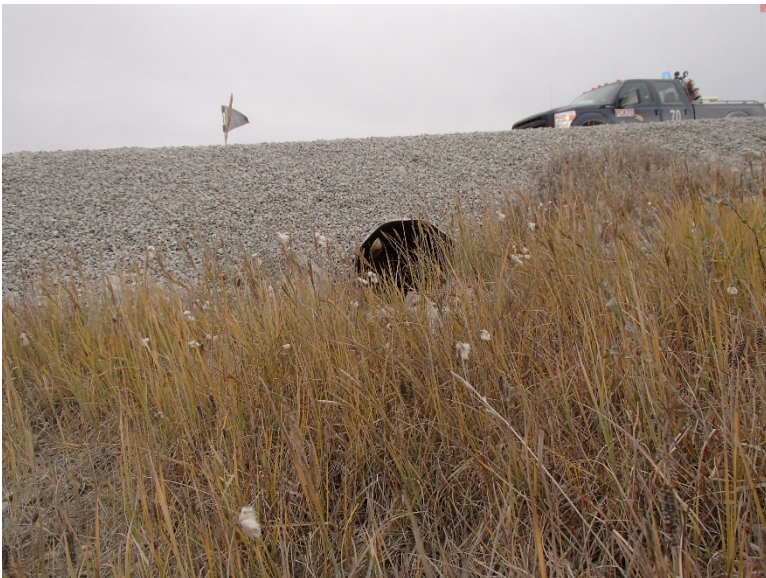
*Photograph D1-36: PC-6 km 18+900*

**Description:** View of culvert outlet. In good condition.

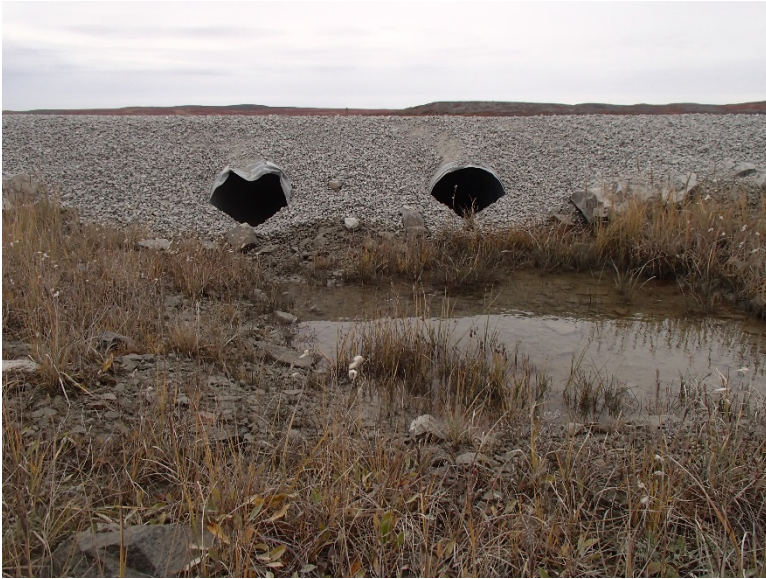
*Photograph D1-37: PC-7A km 20+240*

**Description:** View of culverts inlet. In general good condition.

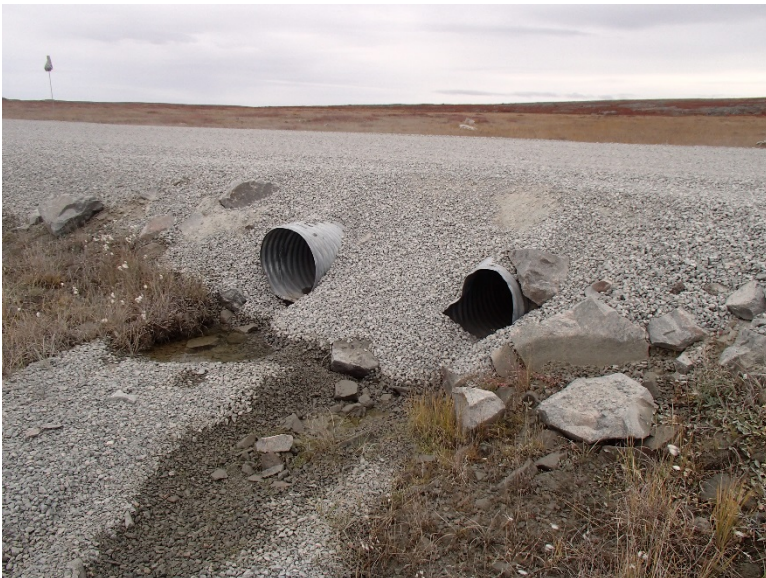
*Photograph D1-38: PC-7A km 20+240*

**Description:** View of culverts outlet. In good general condition.

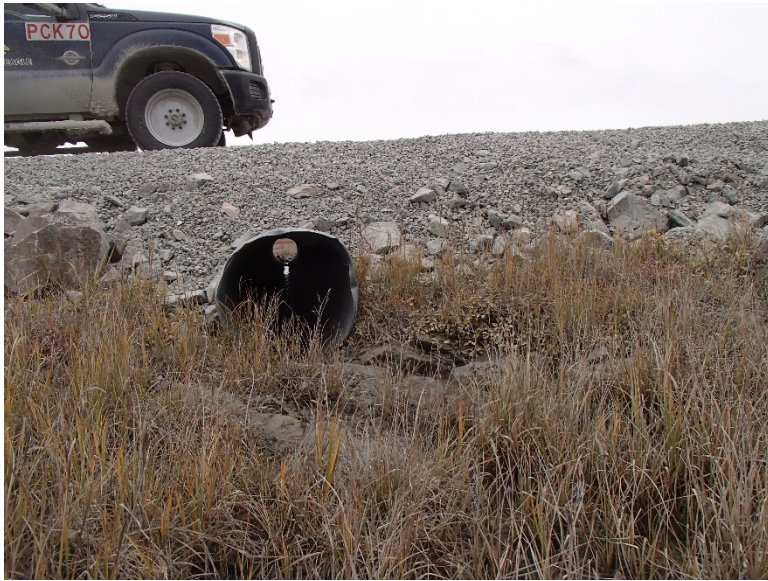
*Photograph D1-39: PC-7 km 20+250*

**Description:** View of the culvert inlet. In good condition.

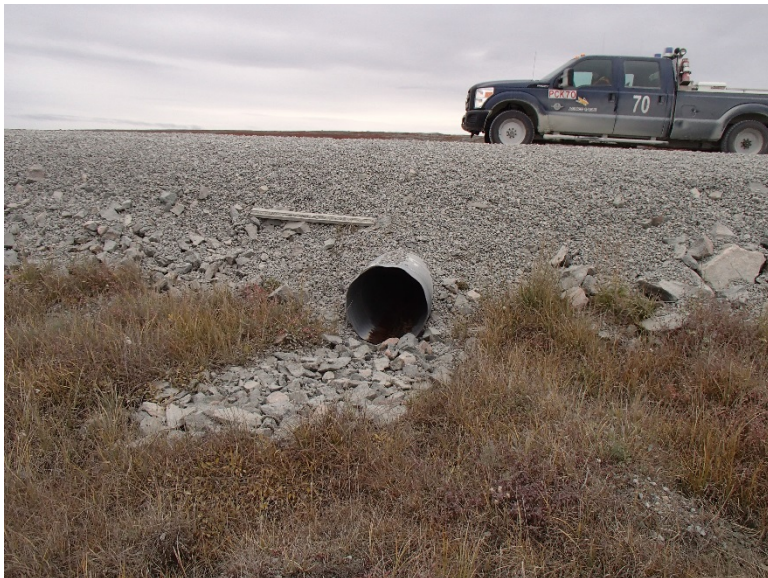
*Photograph D1-40: PC-7 km 20+250*

**Description:** View of the culvert outlet. In good condition.

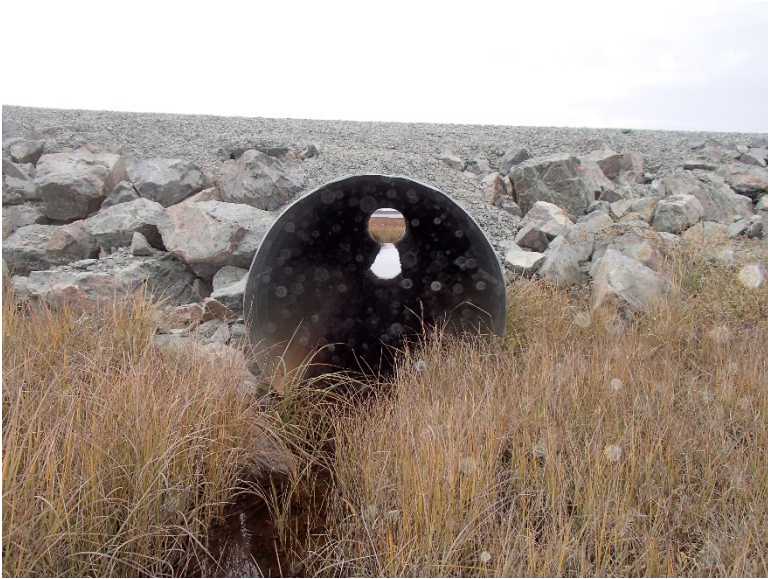
*Photograph D1-41: R-07 km 25+900*

**Description:** View of the culvert inlet. In good condition.

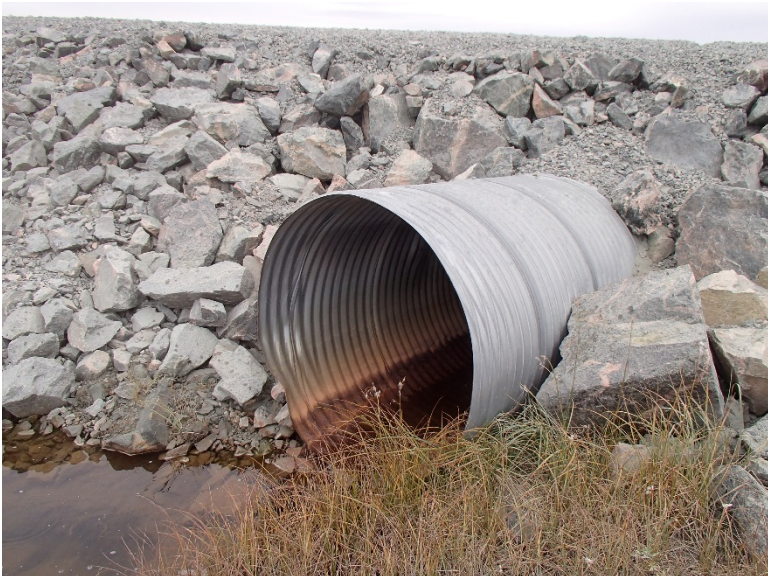
*Photograph D1-42: R-07 km 25+900*

**Description:** View of the culvert outlet. In good condition.

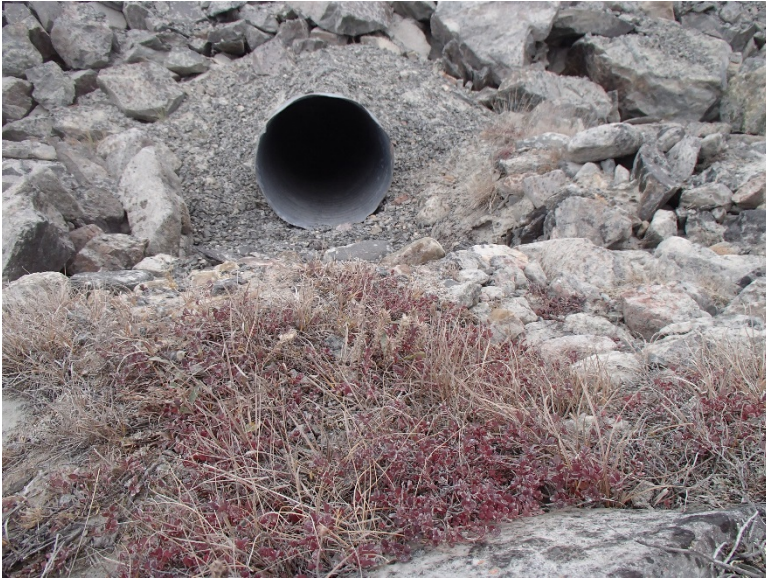
*Photograph D1-45: PC-9 km 35+690*

**Description:** View of the culvert inlet. In good condition.

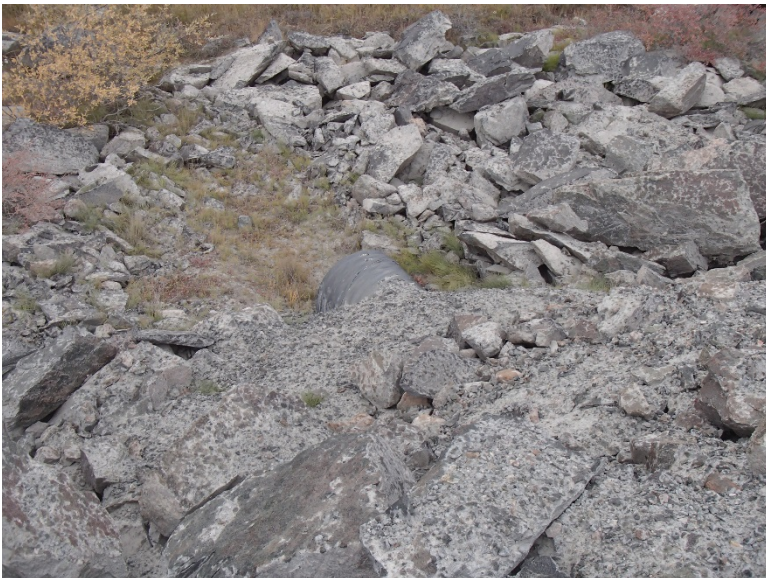
*Photograph D1-46: PC-9 km 35+690*

**Description:** View of the culvert outlet. In good condition.

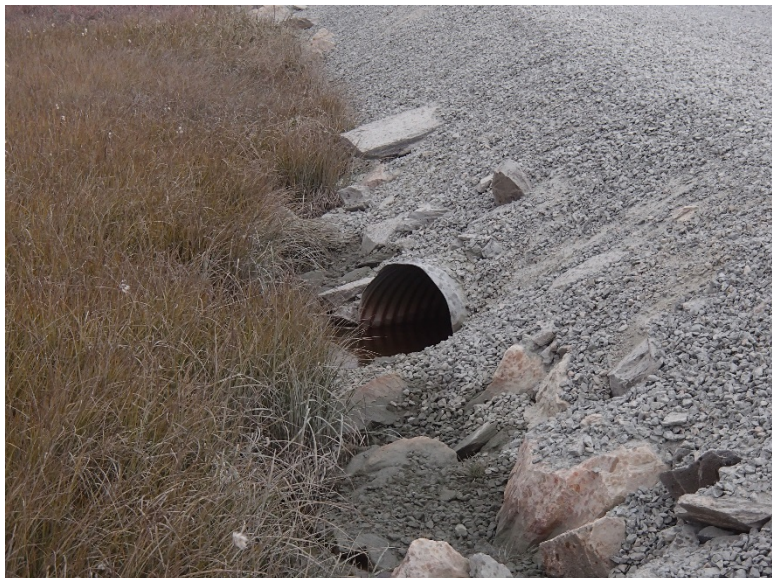
*Photograph D1-47: PC-10 km 36+865*

**Description:** View of the culvert inlet. In good condition.

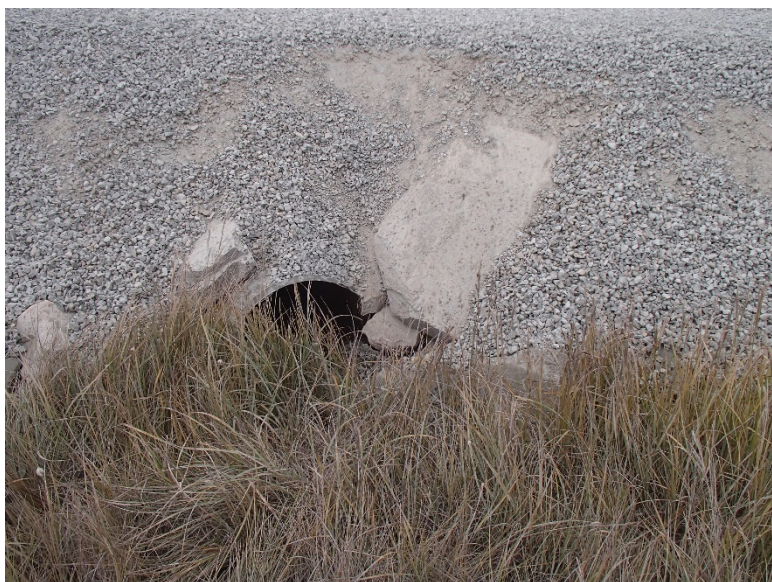
*Photograph D1-48: PC-10 km 36+865*

35+690	PC-9	1x600 mm CSP	In good condition.
36+470	Quarry 6		Slope remediation in progress. The remaining rock walls are clean and stable.
36+865	PC-10	1x600 mm CSP	In good condition. The outlet is partially buried.
39+552	PC-11	1x600 mm CSP	In good condition, but almost submerged by water. The inlet is too high and water is flowing underneath it.
39+800	Quarry 7		The quarry walls are in unstable condition. Scaling is recommended before resuming activities.
41+300	PC-12	1x600 mm CSP	In good condition, almost submerged.
42+950	Quarry 8		Crushing activities occurred in 2017.
44+600	Quarry 9		Presence of unstable loose rocks and boulders along the

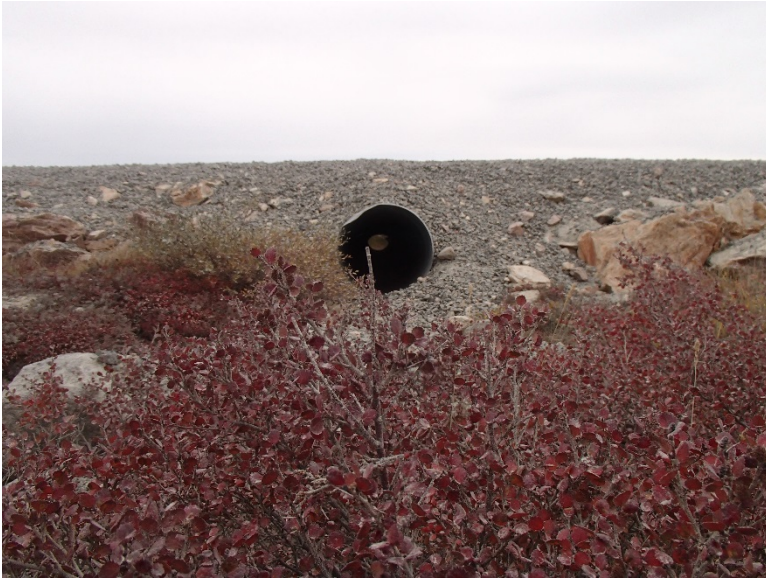
*Photograph D1-49: PC-11 km 39+552*

**Description:** View of the culvert inlet. The inlet is too high and water is flowing underneath.

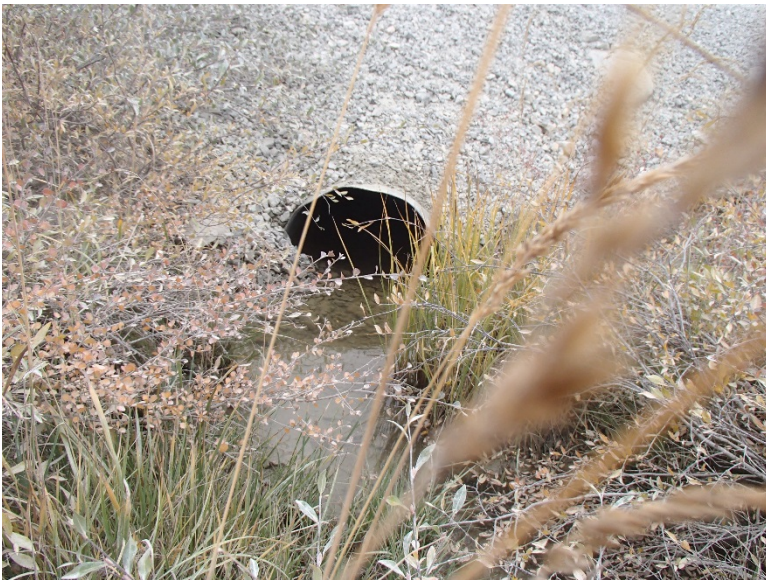
*Photograph D1-50: PC-11 km 39+552*

**Description:** View of the culvert outlet. In good condition, almost submerged.

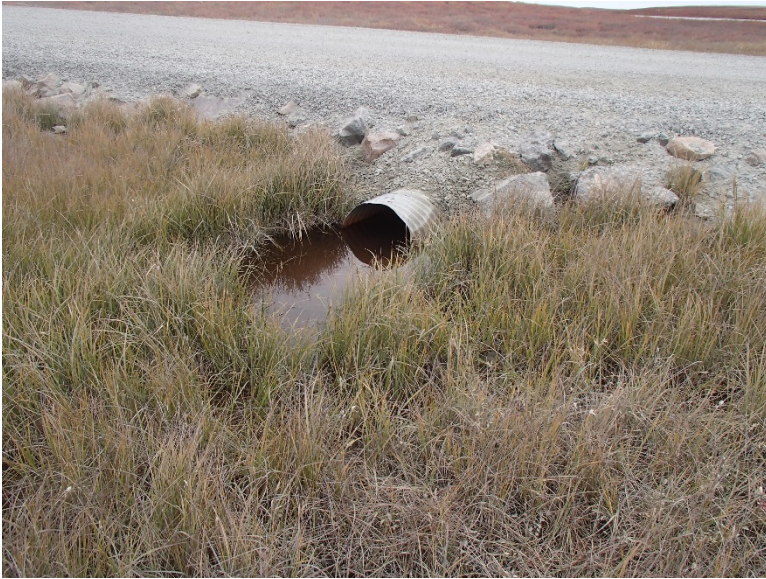
*Photograph D1-51: PC-12 km 41+300*

**Description:** View of the culvert inlet. In good condition, almost submerged.

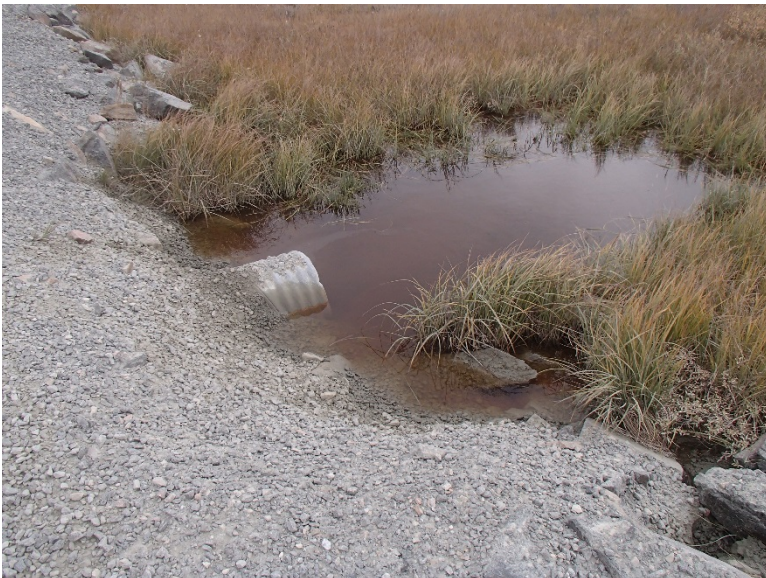
*Photograph D1-52: PC-12 km 41+300*

**Description:** View of the culvert outlet. In good condition, almost submerged.

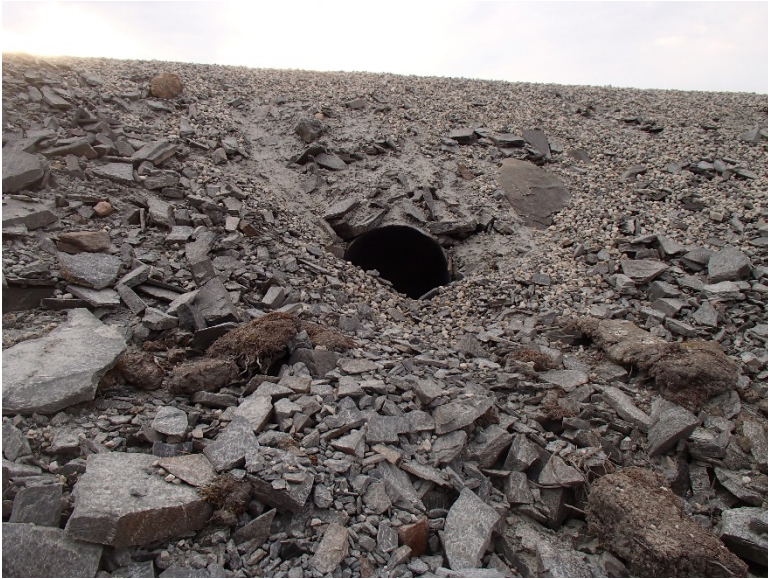
*Photograph D1-53: PC-16 km 41+300*

**Description:** View of the culvert inlet. In good condition. Outlet is buried (no photo) and must be cleaned.

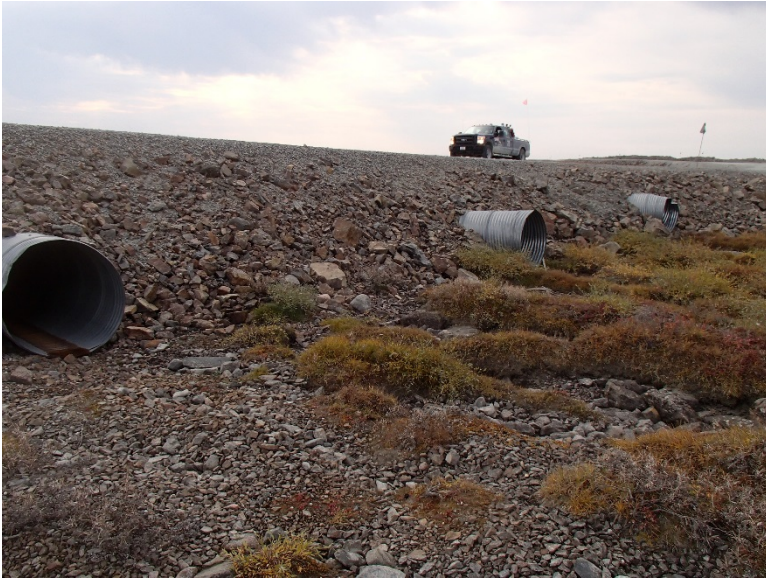
*Photograph D1-55: R-14 km 67+840*

**Description:** View of the outlet culverts. The middle and northern culverts show small signs of erosion at the outlet and these culverts are collapsed inside (hole in the middle). Expected to continue performing well.

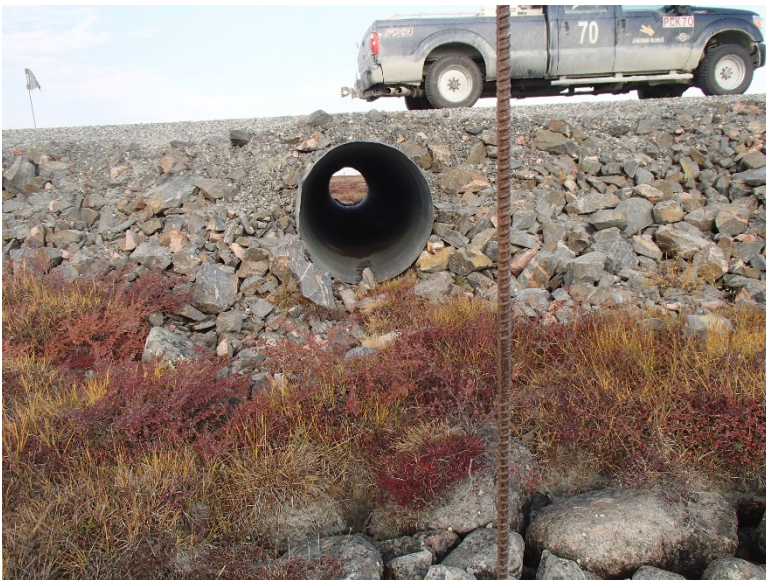
*Photograph D1-56: R-17 km 77+440*

**Description:** View of the culvert inlet. In good condition.

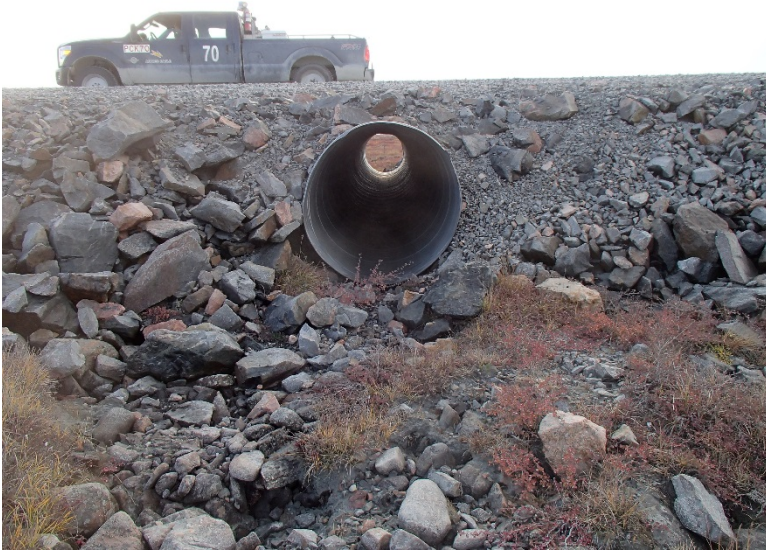
*Photograph D1-57: R-17 km 77+440*

**Description:** View of the culvert outlet. In good condition.

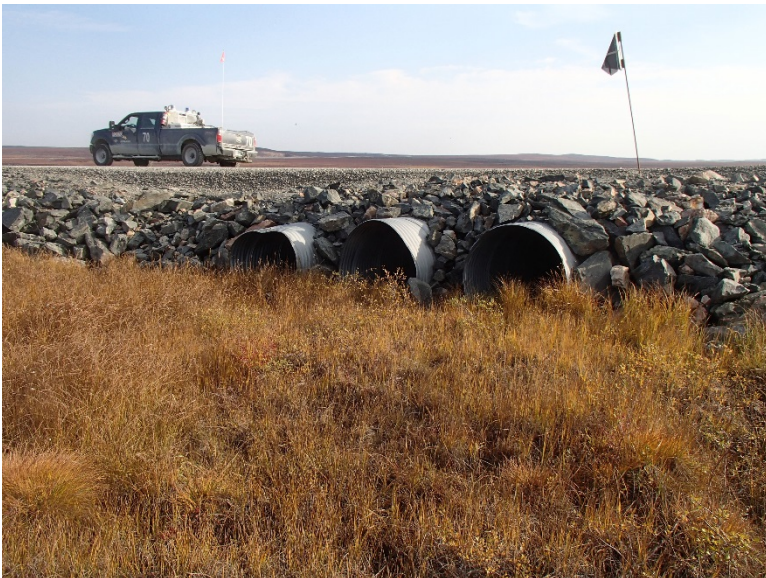
*Photograph D1-58: R-18A km 80+950*

**Description:** View of the culverts inlet. In good condition. The southern culvert inlet is partially buried.

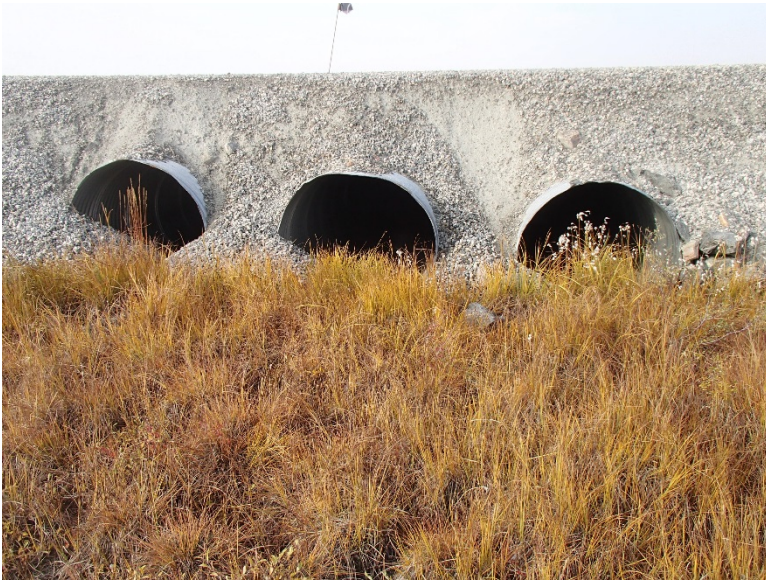
*Photograph D1-59: R-18A km 80+950*

**Description:** View of the culverts outlet. In good condition.

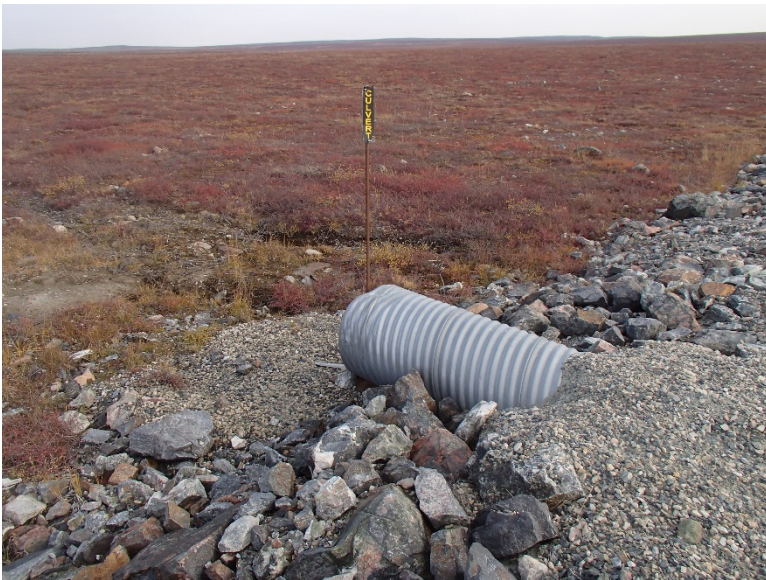
*Photograph D1-60: R-18B km 80+950*

**Description:** View of the culverts inlet. In good condition, installed above the ground surface.

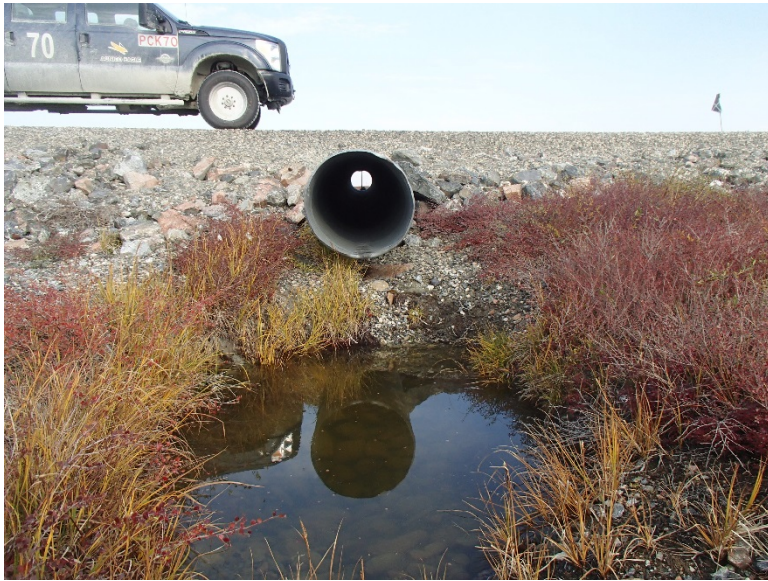
*Photograph D1-61: R-18B km 80+950*

**Description:** View of the culverts outlet. In good condition, installed above the ground surface.

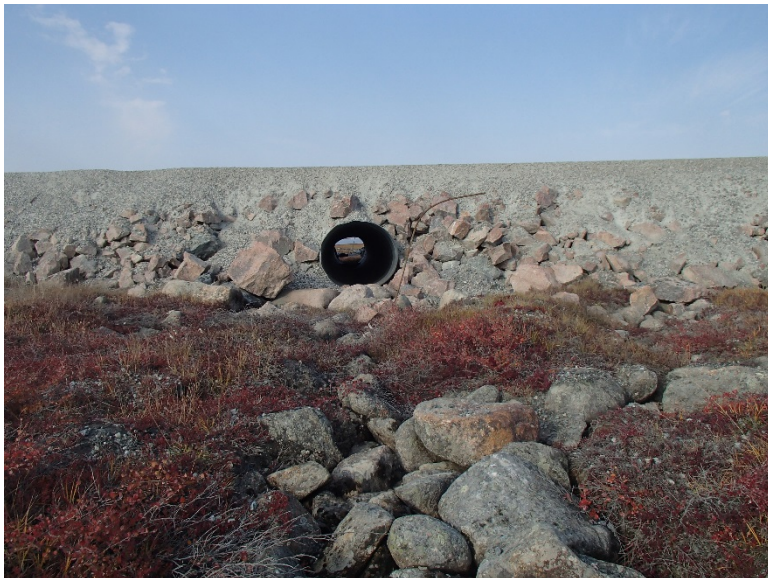
*Photograph D1-62: R-20 km 85+490*

**Description:** View of the culvert inlet. The middle of the culvert is slightly collapsed. The inlet is installed above the ground surface and water flows beneath the culvert. The culvert is in stable condition.

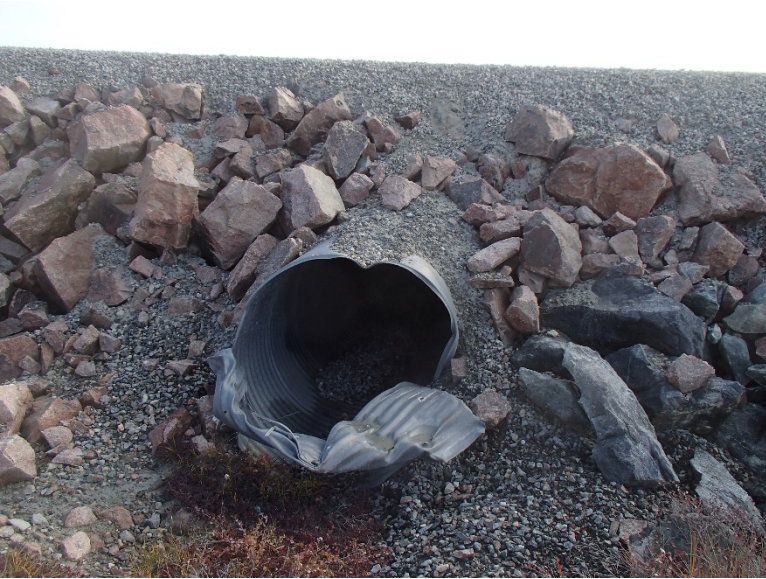
*Photograph D1-63: R-20 km 85+490*

**Description:** View of the culvert outlet. Outlet is a little bit twisted. The middle of the culvert is slightly collapsed. Water flows beneath the culvert. The culvert is in stable condition.

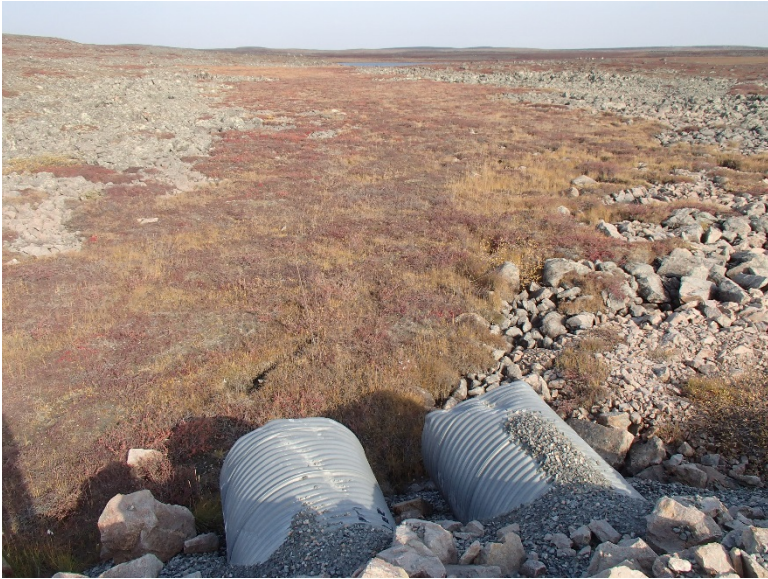
*Photograph D1-65: R-21 km 87+300*

**Description:** View of the culverts outlet. Both culverts are slightly collapsed in the middle. In stable condition, but should have been installed lower to avoid erosion issue.

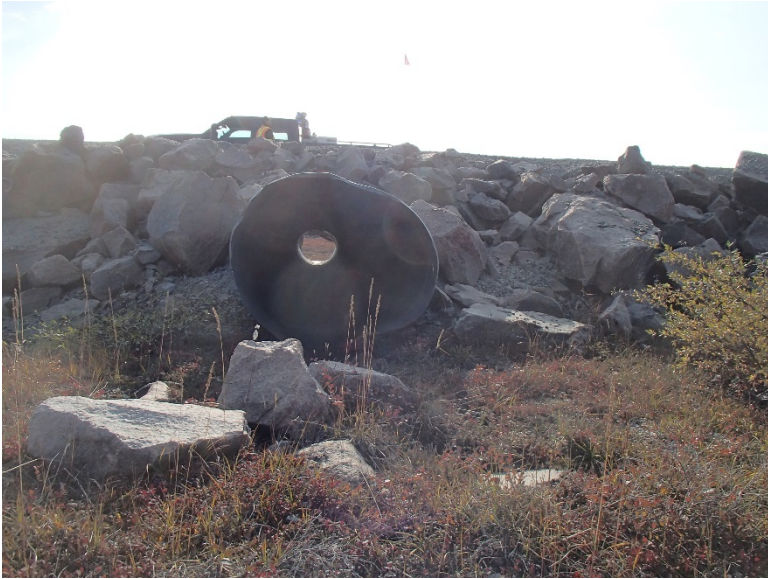
*Photograph D1-67: R-23 km 93+600*

**Description:** View of the culvert outlet. The culvert is installed too high and there is a low flow of water through the road rockfill. In good condition.

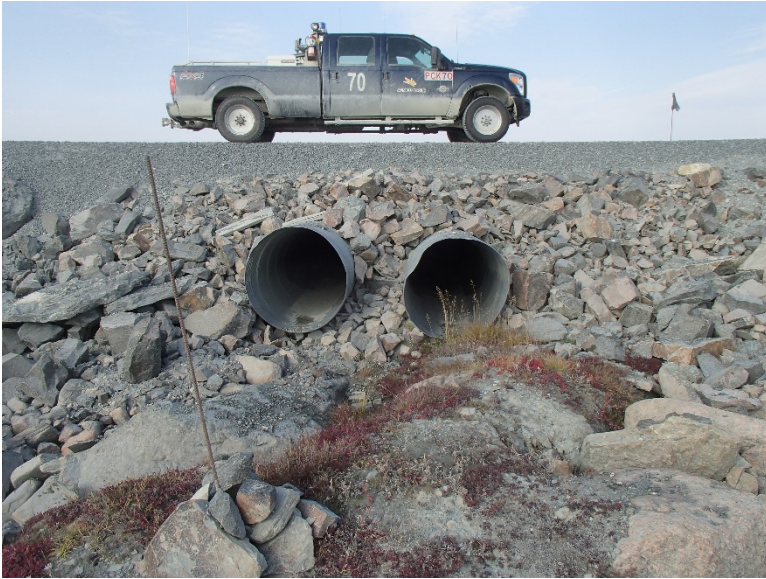
*Photograph D1-69: R-24 km 98+100*

**Description:** View of the culverts outlet. Both outlets are installed too high. The outlet of the southern culvert (left) shows signs of erosion. Both culverts show deformation in the upper part.

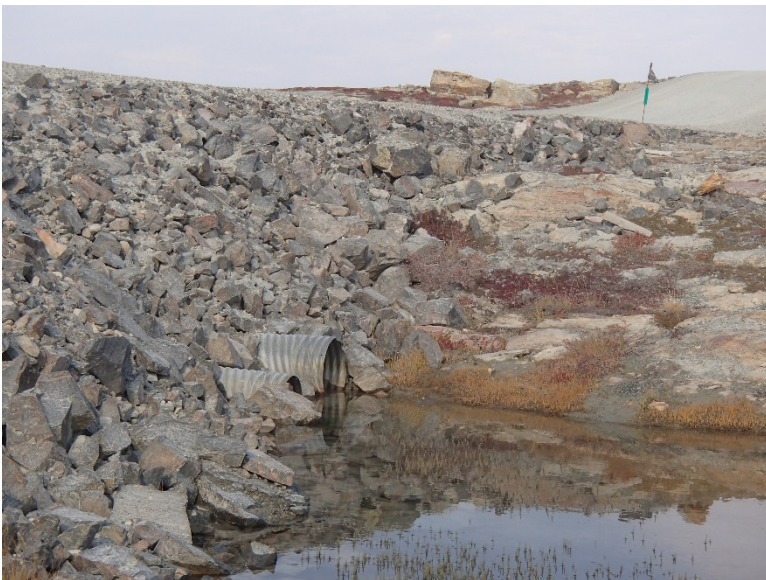
*Photograph D1-70: R-25 km 101+950*

**Description:** View of the culverts inlet. In good condition.

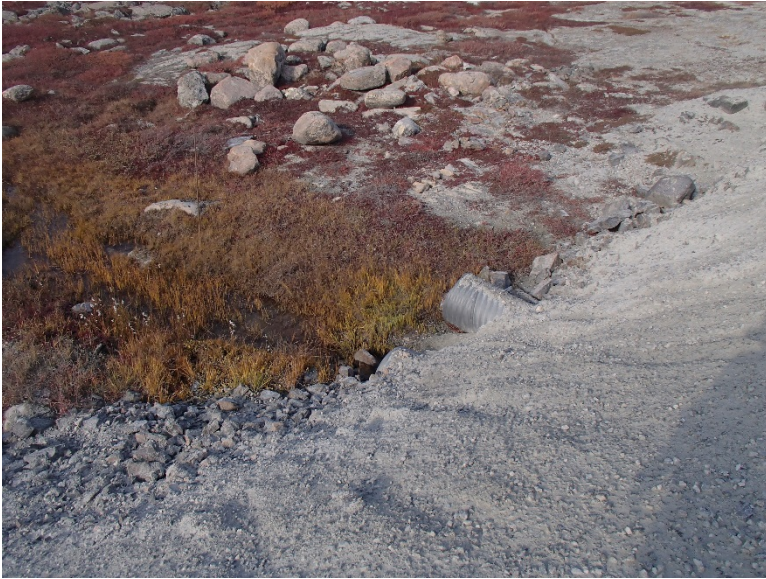
*Photograph D1-71: R-25 km 101+950*

**Description:** View of the culverts outlet. In good condition.
