**Report: 2017 Annual Geotechnical Inspection**

February 2018

# 2017 Annual Geotechnical Inspection Meadowbank Gold Mine, Nunavut

**Report Number:** 1784282-1574-RPT-Rev0

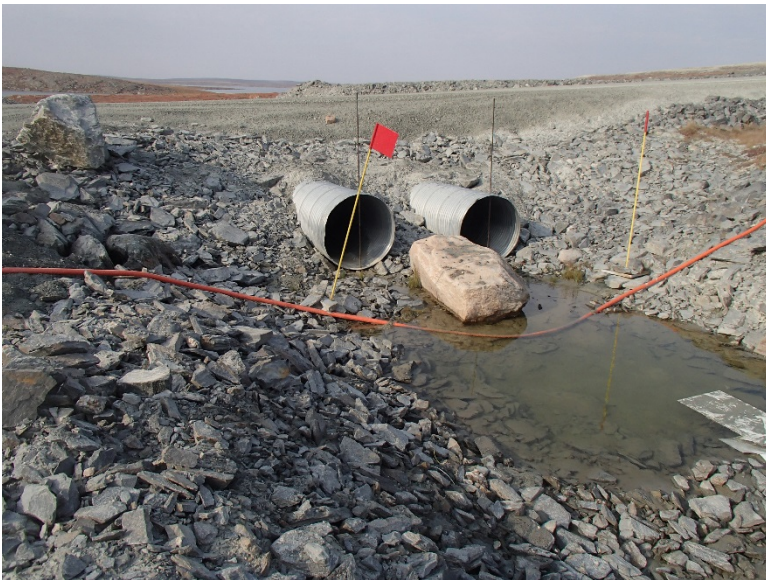
*Photograph D1-72: R-26 km 104+400*

**Description:** View of the culverts outlet. In good condition.

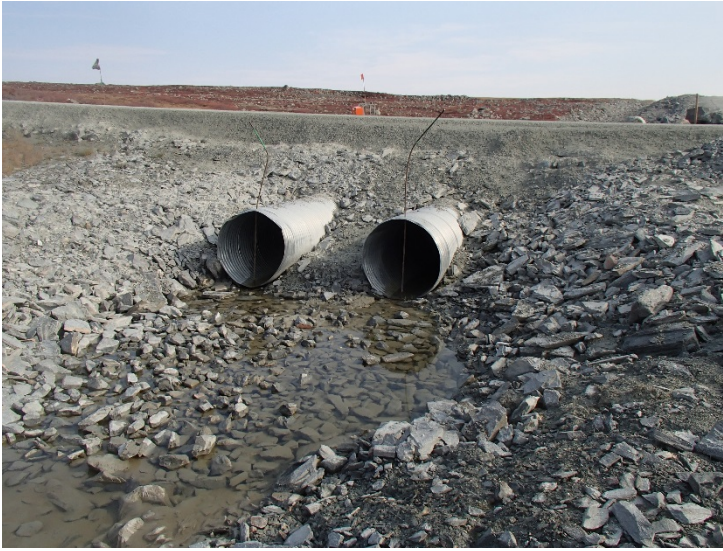
*Photograph D1-73: R-26 km 104+400*

**Description:** View of the culverts inlet. In good condition. In good condition.

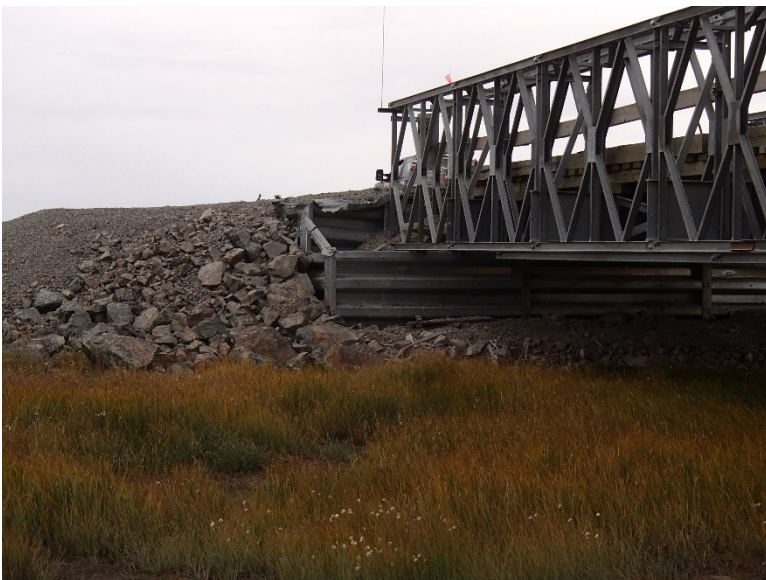
*Photograph D2-6 Bridges 2 – R05 km 17+600*

**Description:** Looking at the south abutment from downstream. Minor damage to the bin wall.

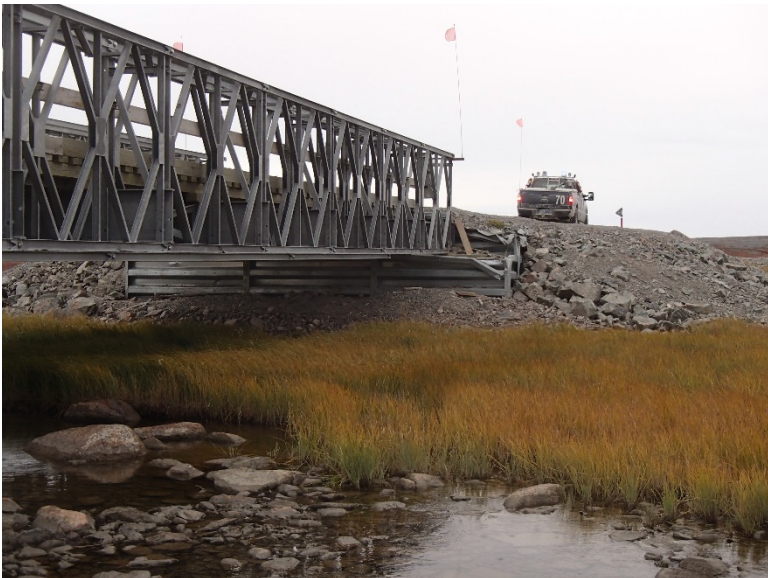
*Photograph D2-8 Bridges 2 – R05 km 17+600*

**Description:** Looking at the south abutment from upstream. Minor damage to the bin wall.

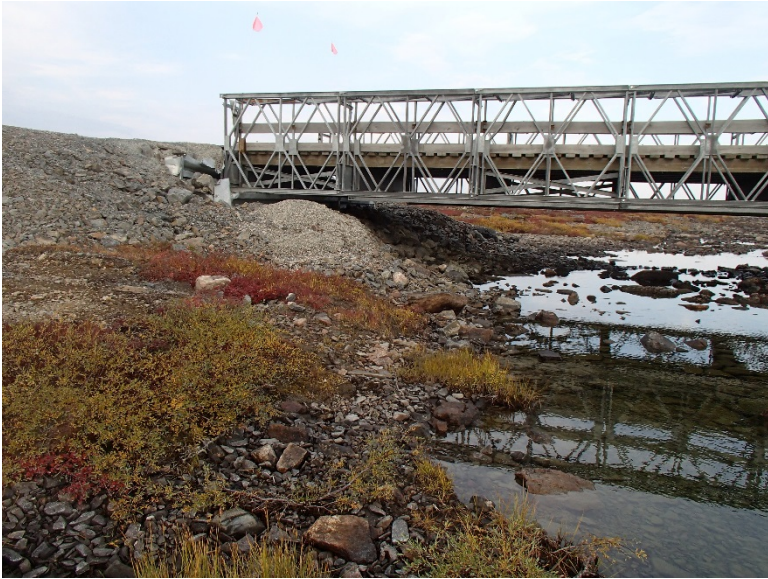
*Photograph D2-19 Bridges 6 – R15 km 69+200*

**Description:** Looking at the south abutment from downstream. Damage to the bin wall likely caused during snow removal activities. Bridge is tipping toward the west side on the abutment.

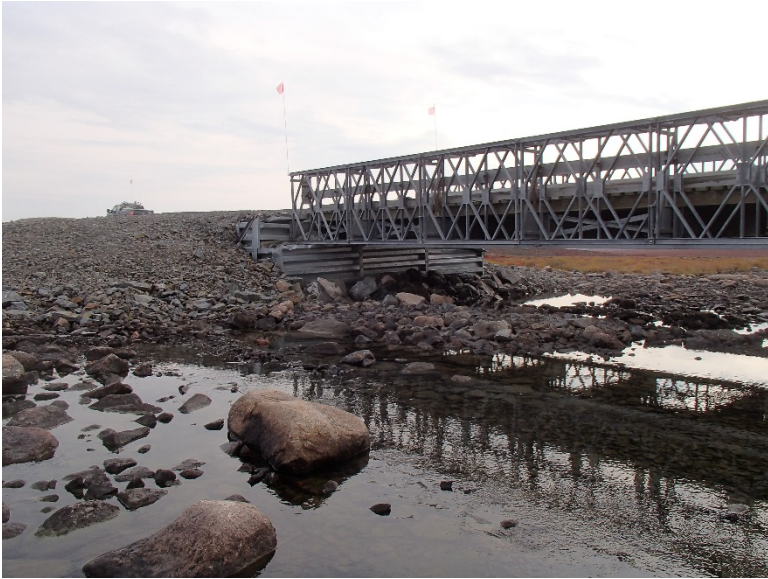
*Photograph D2-21 Bridges 6 – R15 km 69+200*

**Description:** Looking at the north abutment from upstream. Damage to the bin wall likely caused during snow removal activities. Bridge is tipping toward the west side on the abutment.

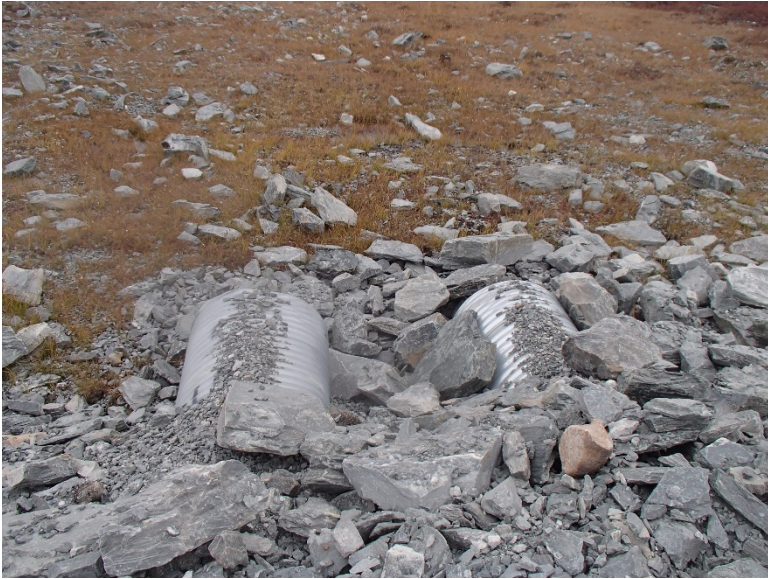
*Photograph E1-1: Culvert #39 km 9+193*

**Description:** View of culvert inlet, damaged in the middle.

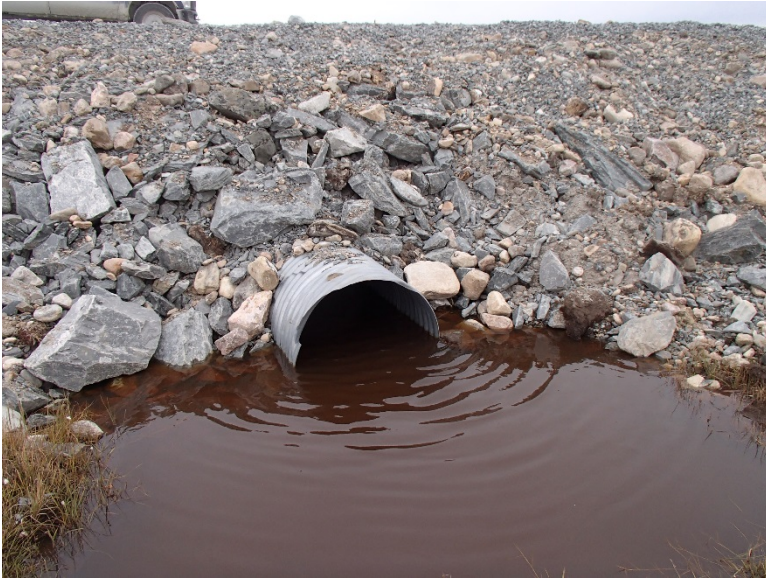
*Photograph E1-3: Culvert #60 km 12+775*

**Description:** View of culvert outlet, in good condition.

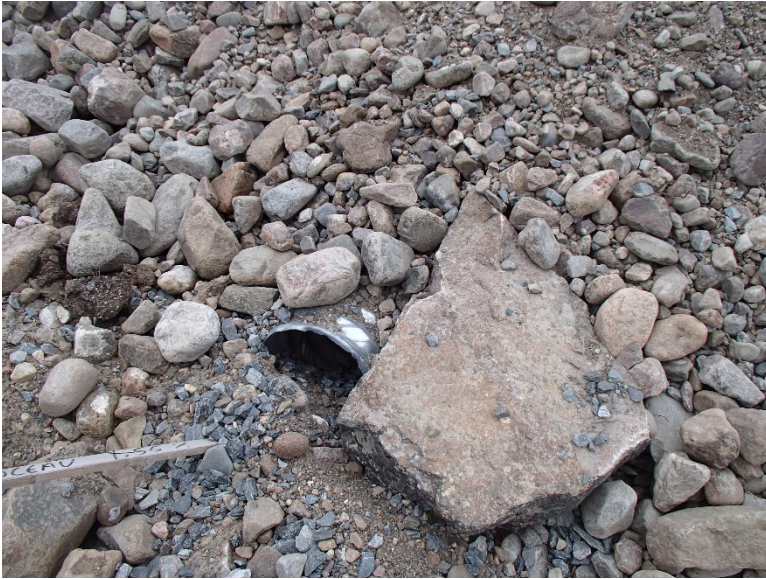
*Photograph E1-5: Culvert #115 km 26+865*

**Description:** View of culvert outlet, partially buried.

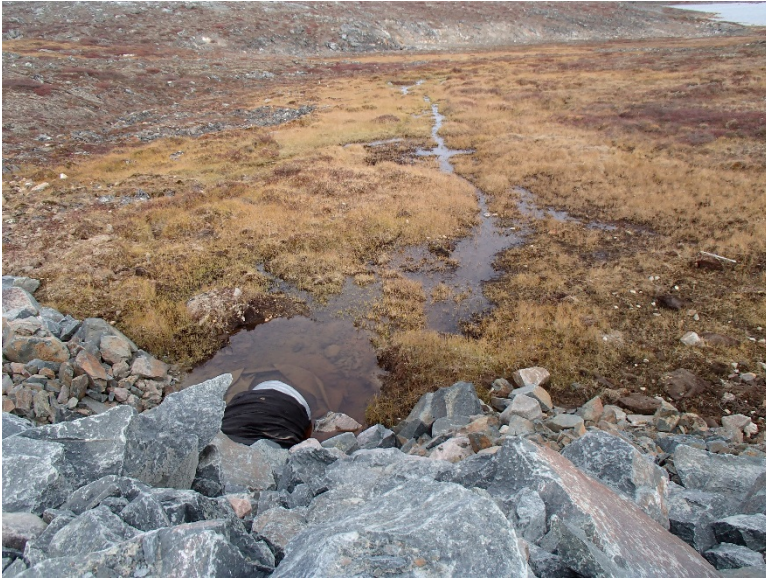
*Photograph E1-7: Culvert #167 km 41+843*

**Description:** View of culvert outlet, in good condition.

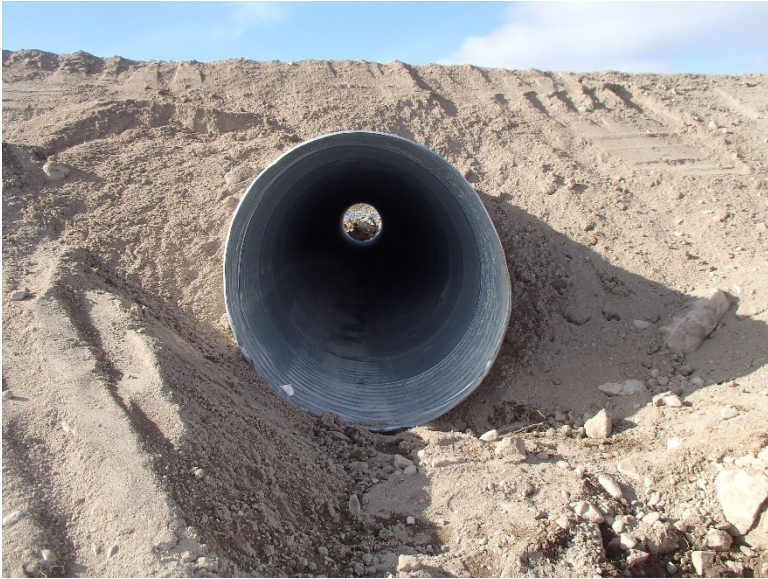
*Photograph E1-9: Culvert #278 km 61+870*

**Description:** View of culvert inlet, below ground surface, in good condition.

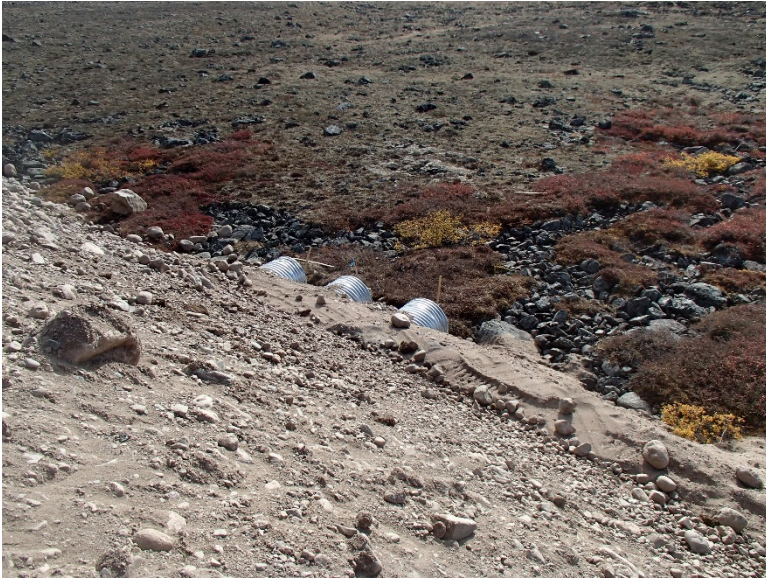
*Photograph E1-11: Culvert #284 km 63+070*

**Description:** View of culvert outlet, the 2 northern culverts are damaged.

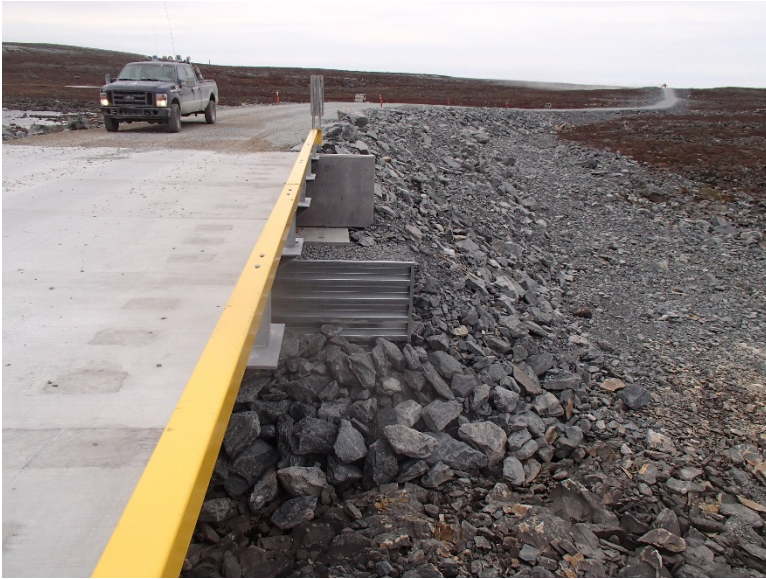
*Photograph E2-1 Bridges 1 – km 3+400*

**Description:** Looking at the north abutment from downstream.

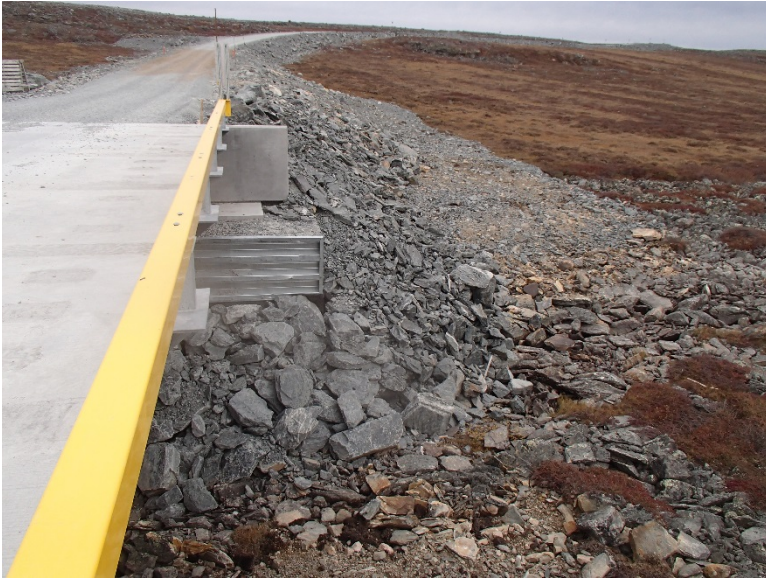
*Photograph E2-3 Bridges 1 – km 3+400*

**Description:** Looking at the south abutment from downstream.

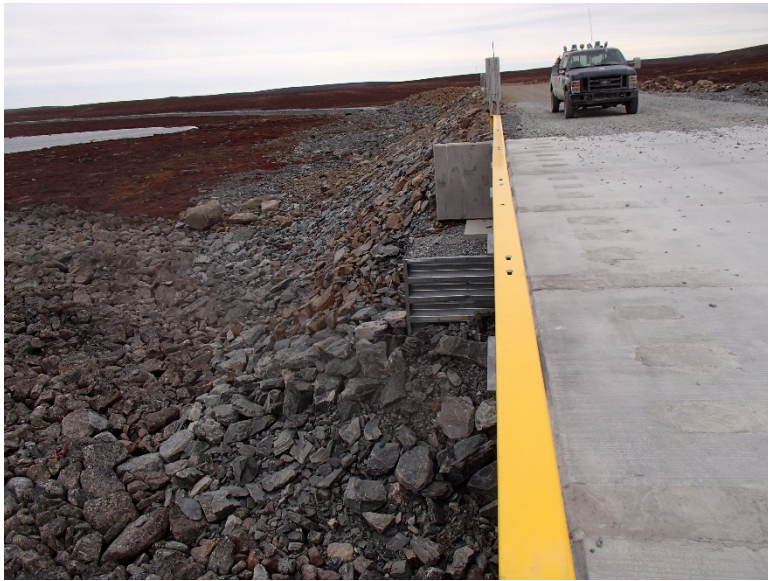
*Photograph E2-5 Bridges 2 – km 10+700*

**Description:** Looking at the north abutment from upstream.

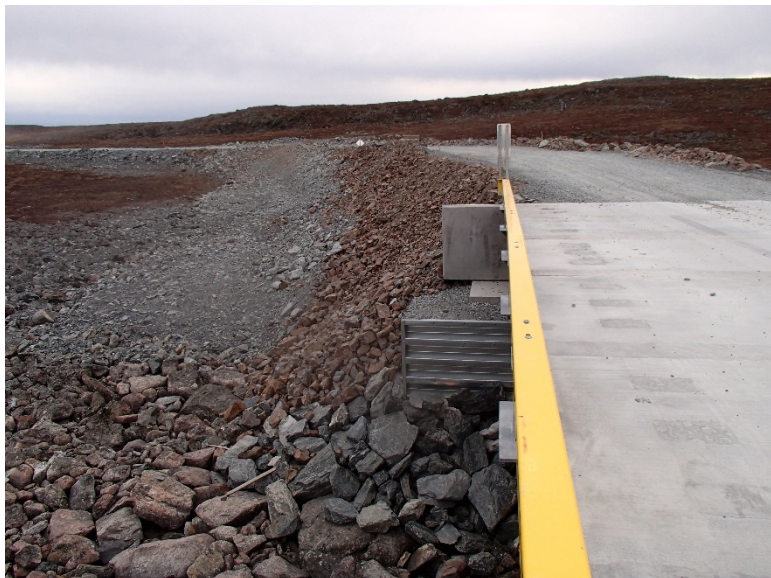
*Photograph E2-7 Bridges 2 – km 10+700*

**Description:** Looking at the south abutment from upstream.

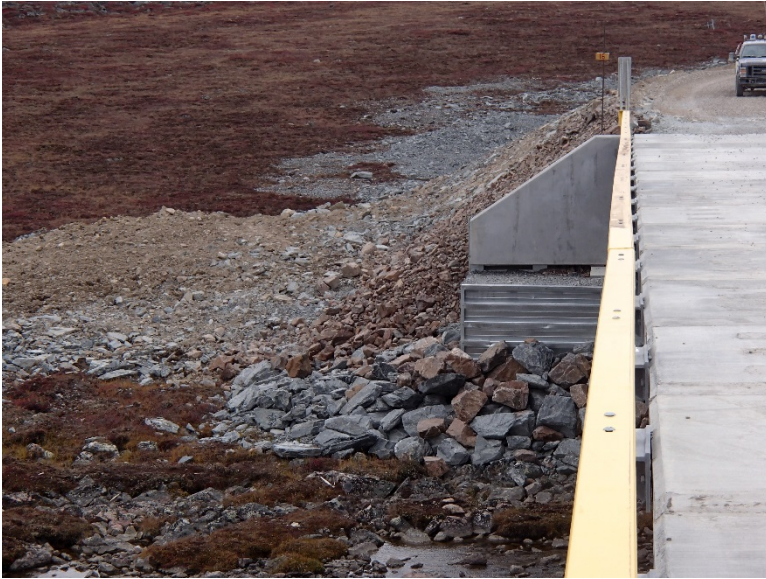
*Photograph E2-9 Bridges 3 – km 16+000*

**Description:** Looking at the north abutment from upstream.

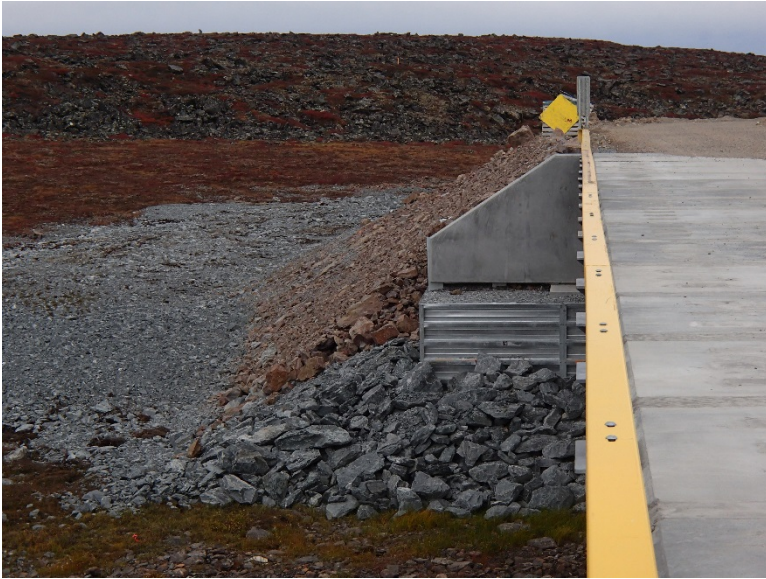
*Photograph E2-11 Bridges 3 – km 16+000*

**Description:** Looking at the south abutment from upstream.

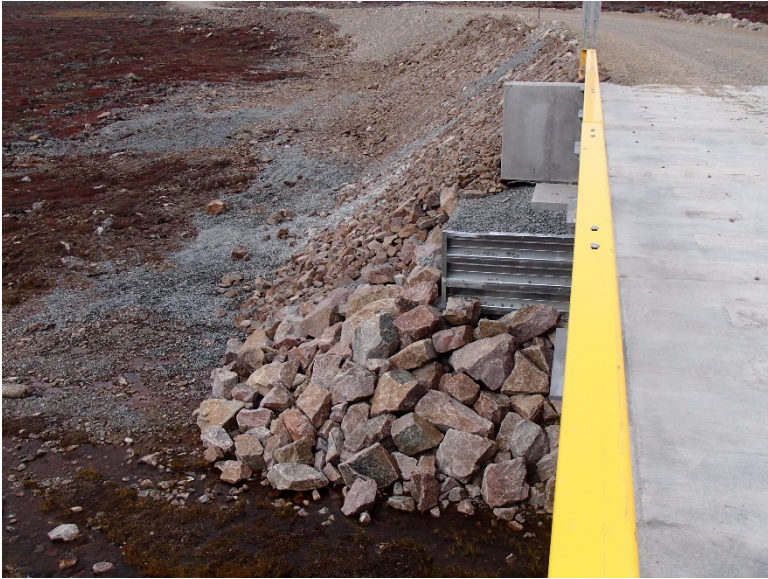
*Photograph E2-13 Bridges 4 – km 20+000*

**Description:** Looking at the north abutment from upstream.

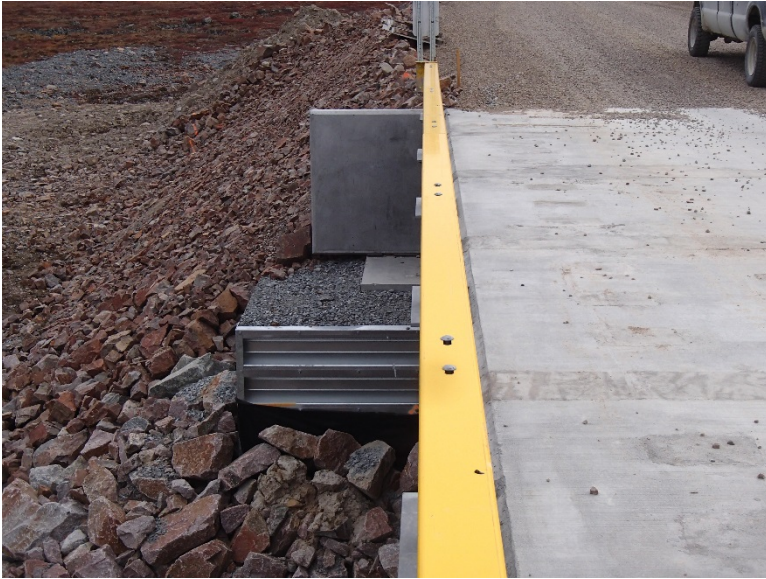
*Photograph E2-15 Bridges 4 – km 20+000*

**Description:** Looking at the south abutment from upstream.

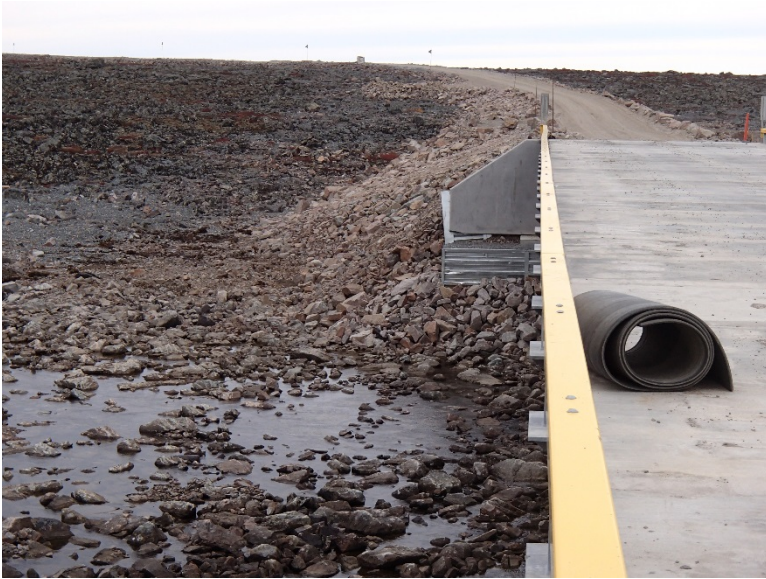
*Photograph E2-17 Bridges 5 – km 23+900*

**Description:** Looking at the north abutment from upstream.

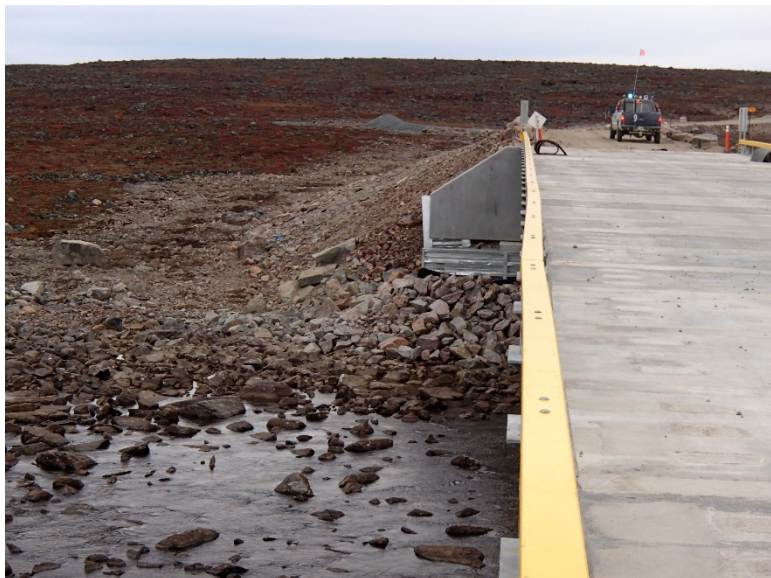
*Photograph E2-19 Bridges 5 – km 23+900*

**Description:** Looking at the south abutment from upstream.

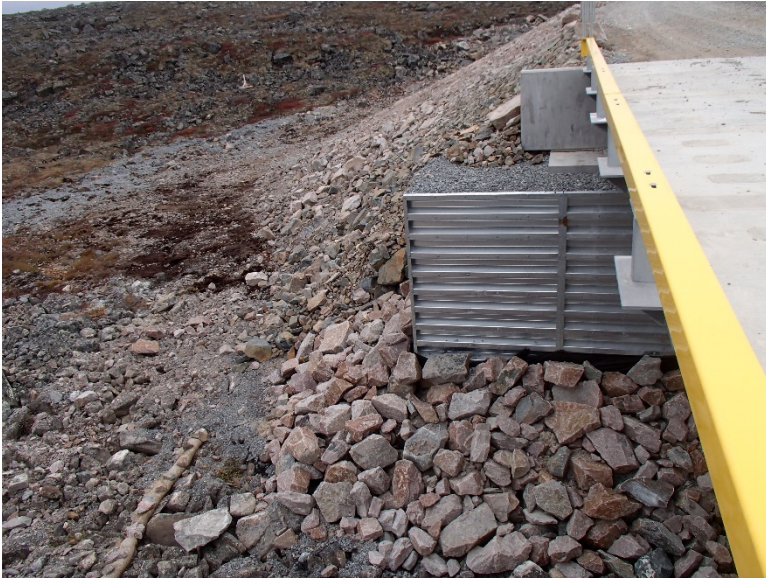
*Photograph E2-21 Bridges 6 – km 26+100*

**Description:** Looking at the north abutment from upstream.

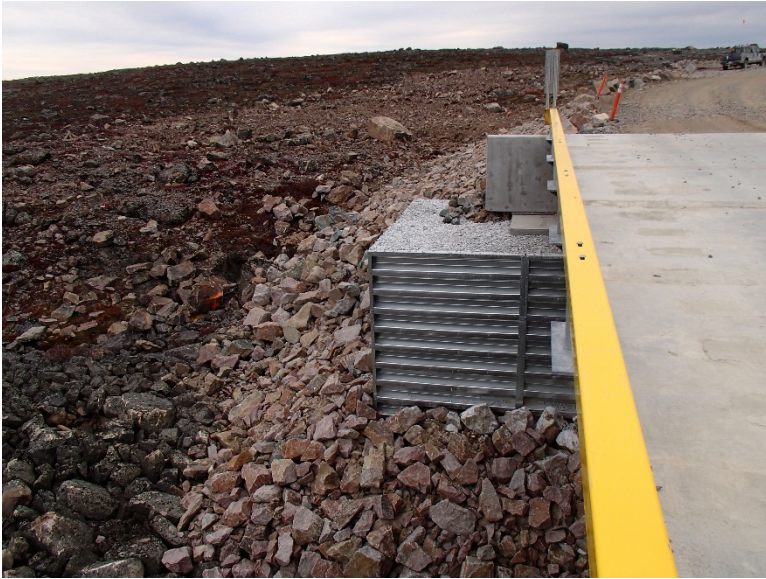
*Photograph E2-23 Bridges 6 – km 26+100*

**Description:** Looking at the south abutment from upstream.

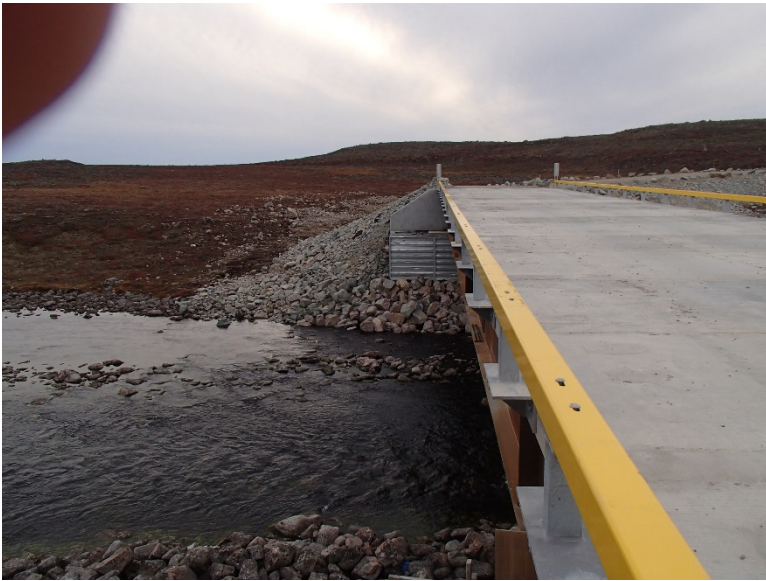
*Photograph E2-25 Bridges 7 – km 32+300*

**Description:** Looking at the north abutment from upstream.

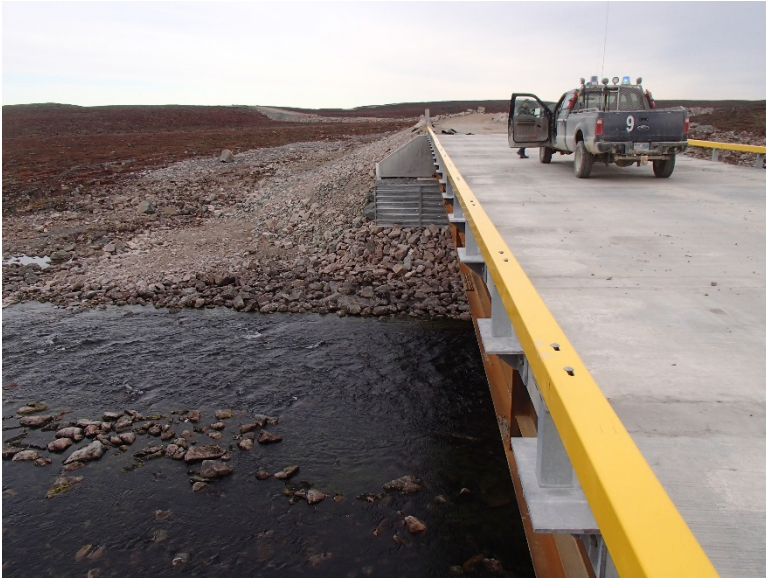
*Photograph E2-27 Bridges 7 – km 32+300*

**Description:** Looking at the south abutment from upstream.

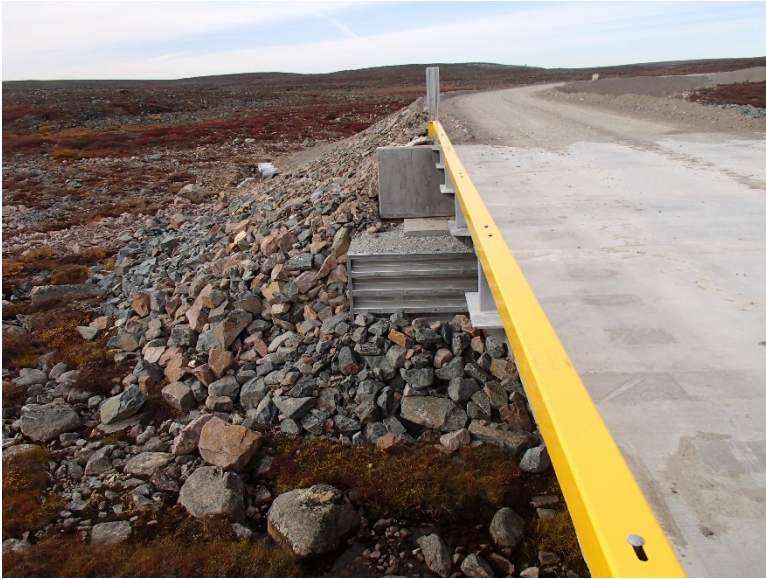
*Photograph E2-29 Bridges 8 – km 43+500*

**Description:** Looking at the north abutment from upstream.

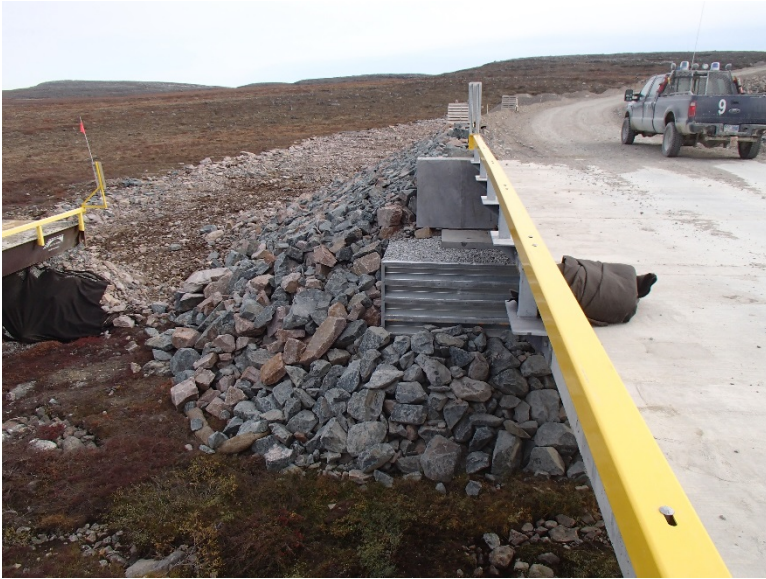
*Photograph E2-31 Bridges 8 – km 43+500*

**Description:** Looking at the south abutment from upstream.

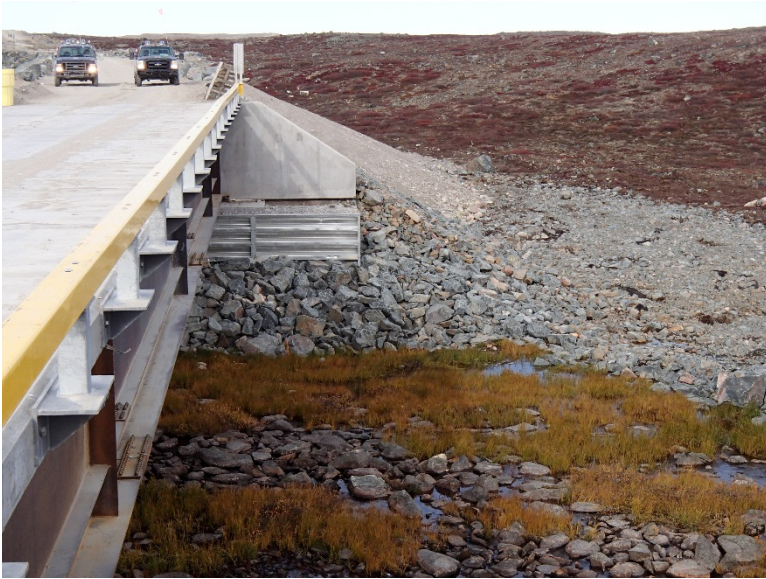
*Photograph E2-33 Bridges 9 – km 44+800*

**Description:** Looking at the north abutment from upstream.

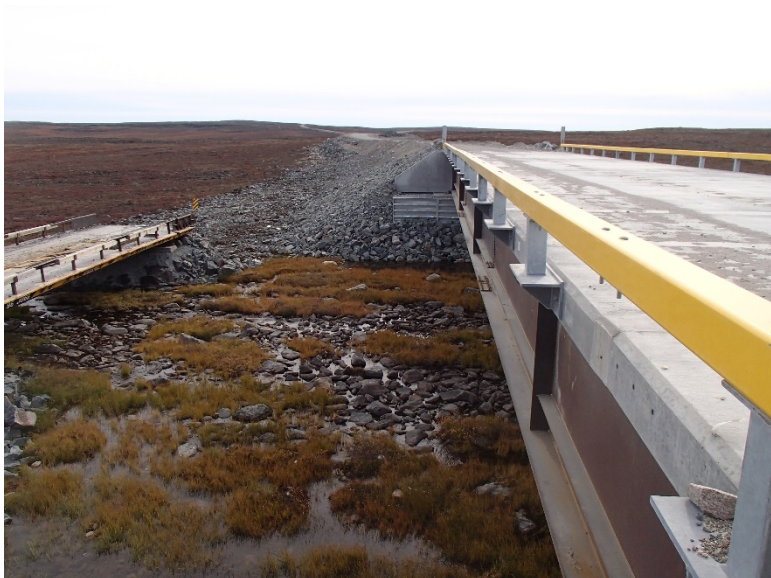
*Photograph E2-35 Bridges 9 – km 44+800*

**Description:** Looking at the south abutment from upstream.

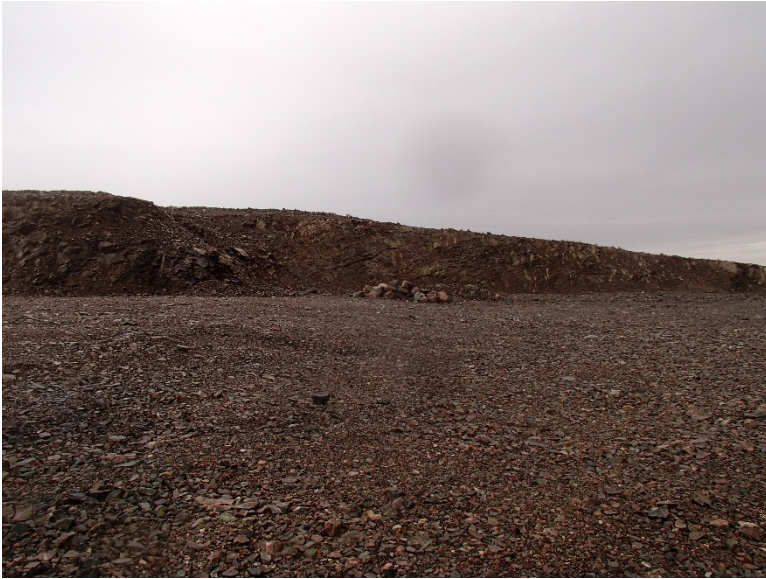
*Photograph F1-1: Quarry 1 – km 5+200*

**Description:** View of south walls.

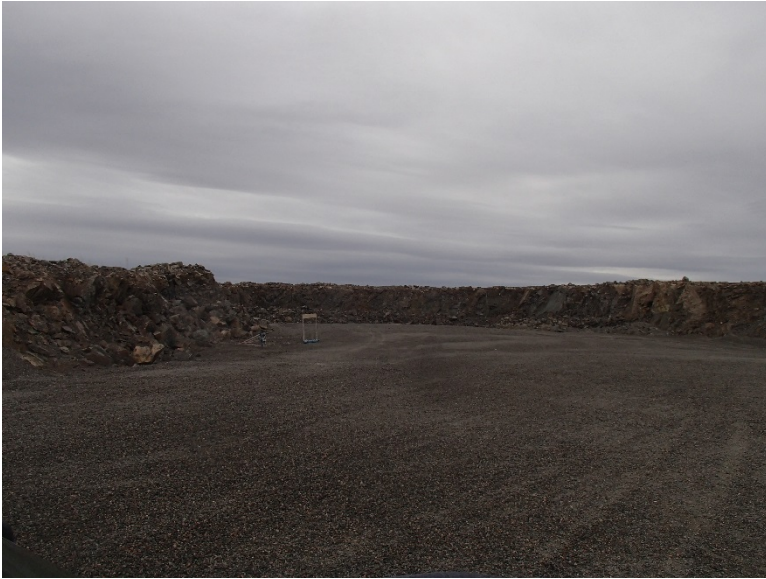
*Photograph F1-3: Quarry 2 – km 13+250*

**Description:** View of north and west walls.

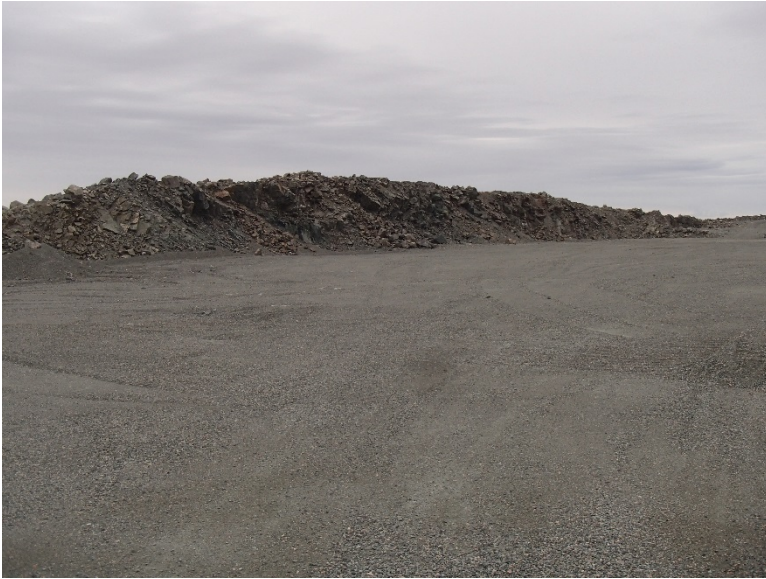
*Photograph F1-5: Quarry 3 – km 23+700*

**Description:** View of east wall.

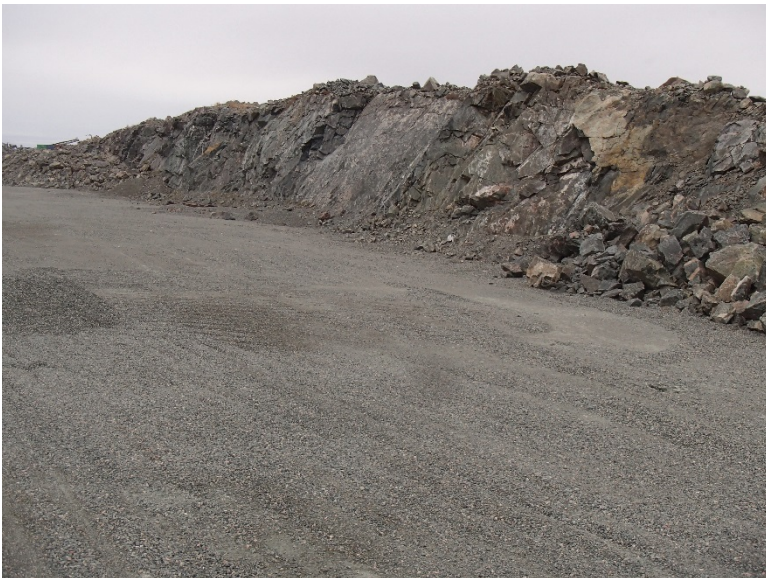
*Photograph F1-6: Quarry 3 – km 23+700*

**Description:** View of west wall. Presence of loose rock along steep wall.

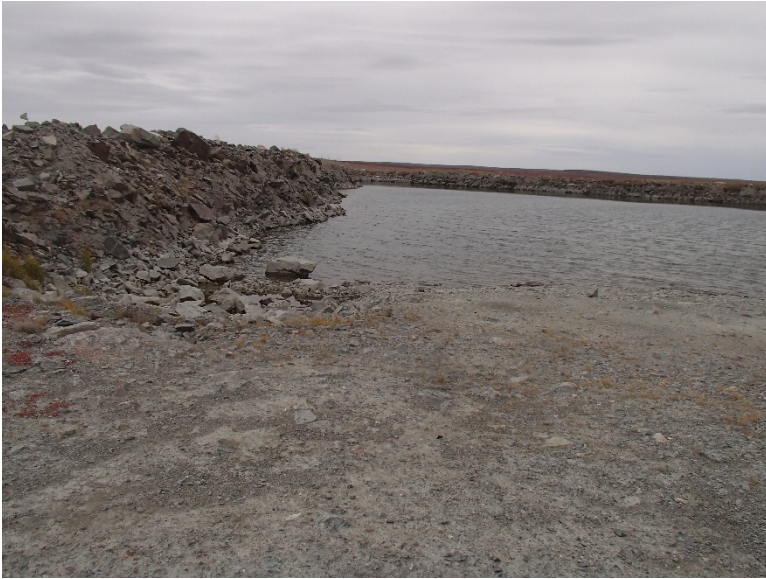
*Photograph F1-7: Quarry 4 – km 31+300*

**Description:** View of the east and south walls of Quarry 4. The quarry is flooded.

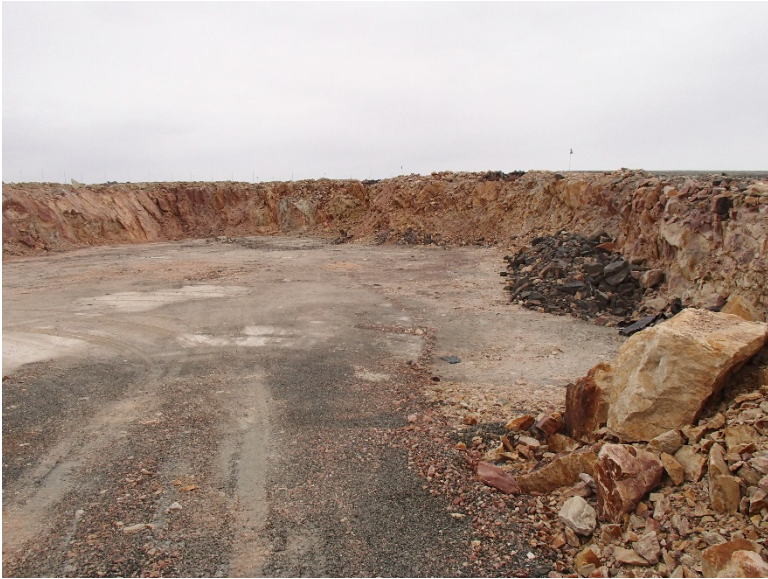
*Photograph F1-9: Quarry 5 – km 34+650*

**Description:** View of north and east walls.

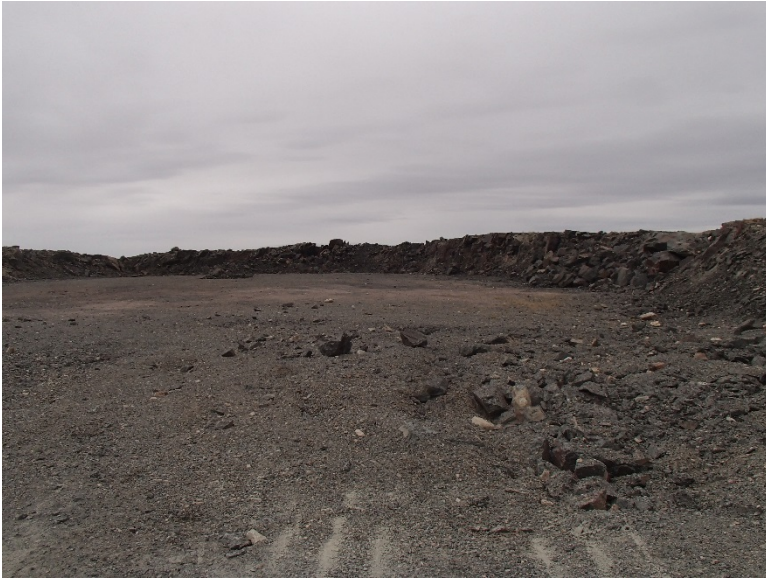
*Photograph F1-11: Quarry 6 – km 36+470*

**Description:** View of south and west walls.

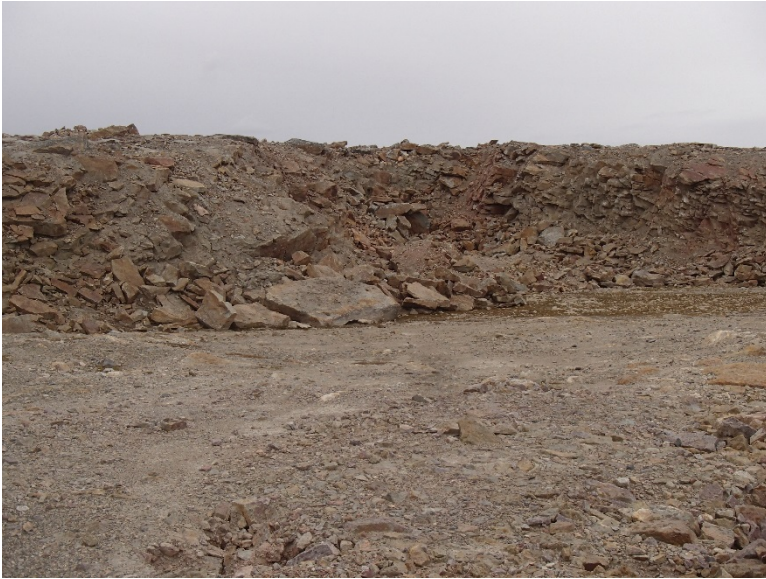
*Photograph F1-13: Quarry 7 – km 39+800*

**Description:** View of west wall. Presence of loose blocks.

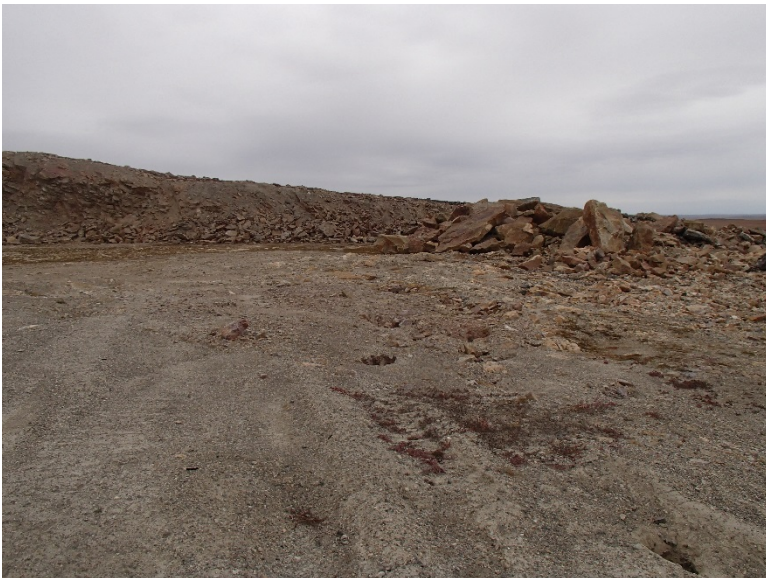
*Photograph F1-14: Quarry 7 – km 39+800*

**Description:** View of north wall. Loose blocks were removed.

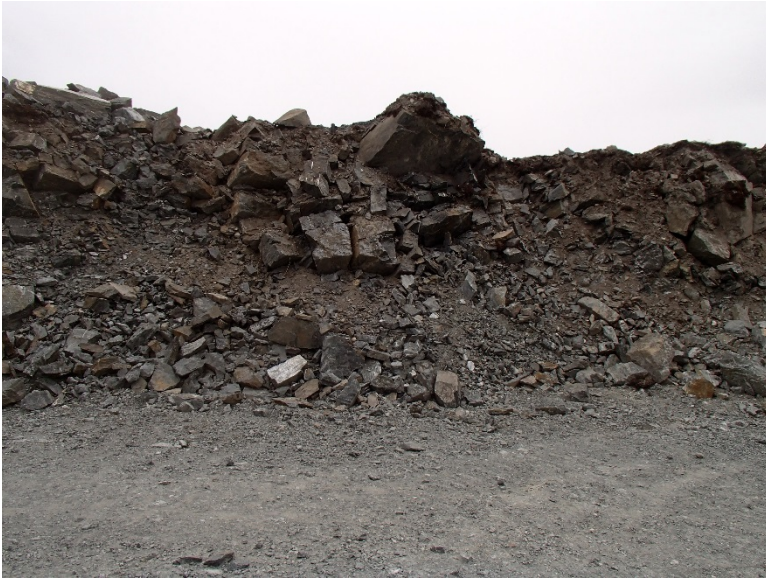
*Photograph F1-15: Quarry 8 – km 42+950*

**Description:** View of south wall. Presence of loose blocks.

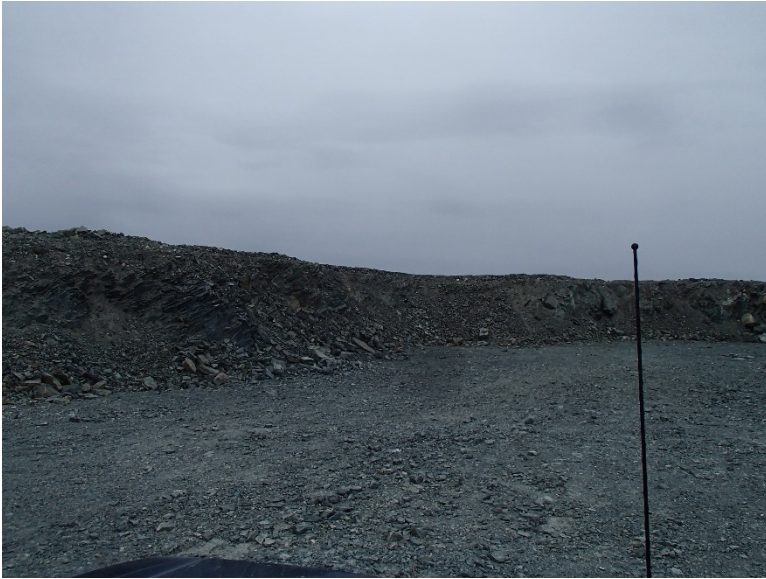
*Photograph F1-17: Quarry 9 – km 44+600*

**Description:** View of west and south walls. Presence of loose blocks at the base of the wall.

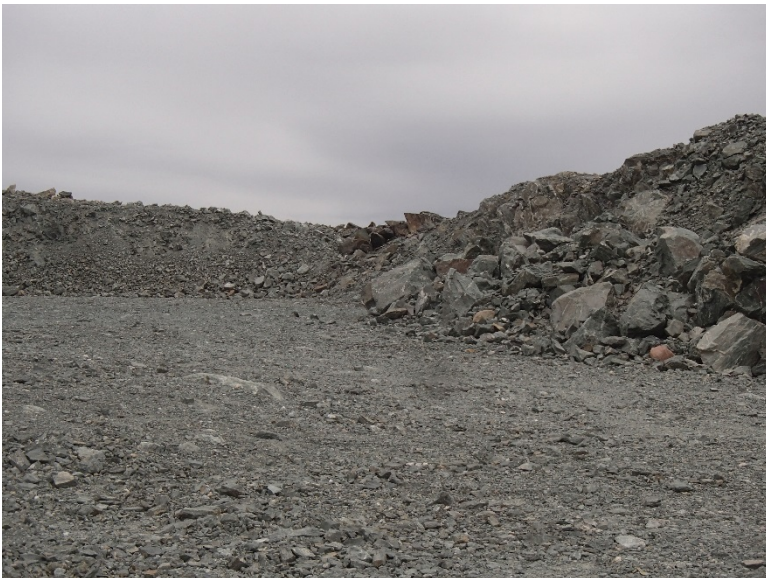
*Photograph F1-18: Quarry 9 – km 44+600*

**Description:** View of north and east walls. View of a pile of loose material.

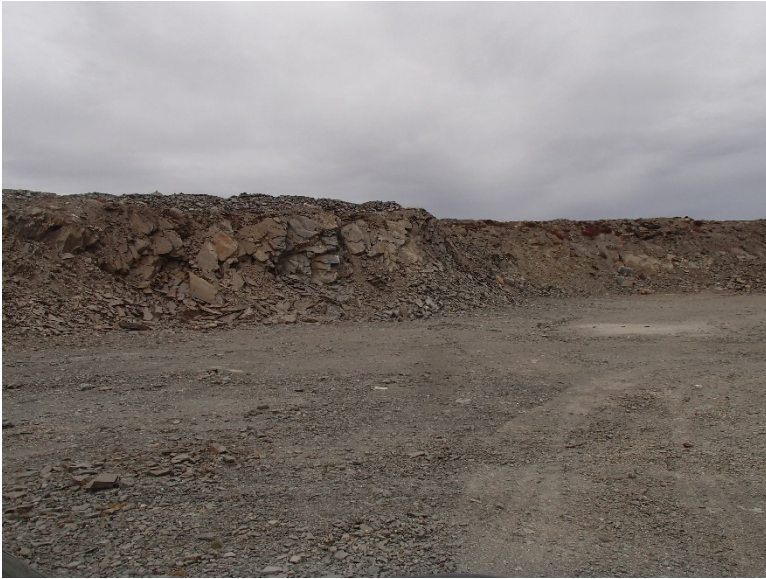
*Photograph F1-19: Quarry 10 – km 48+900*

**Description:** View of the west wall. Presence of unstable blocks.

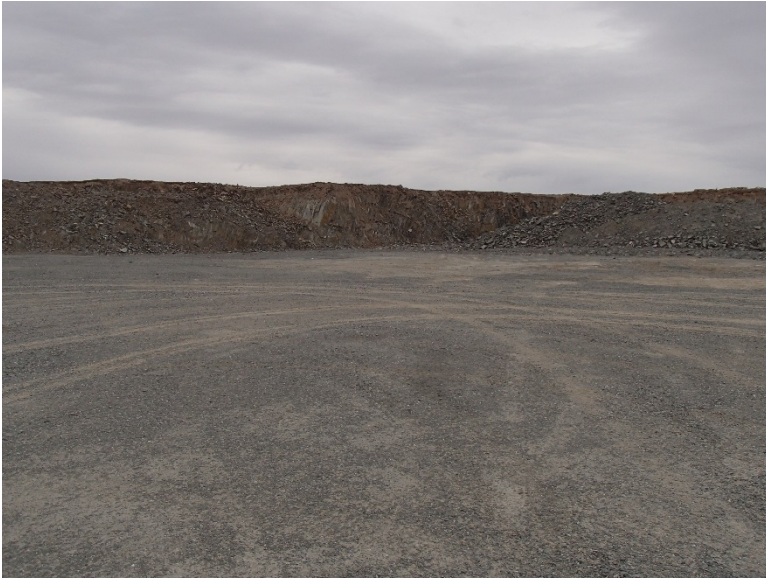
*Photograph F1-21: Quarry 11 – km 53+500*

**Description:** Overview of Quarry 11 looking at the west and north walls.

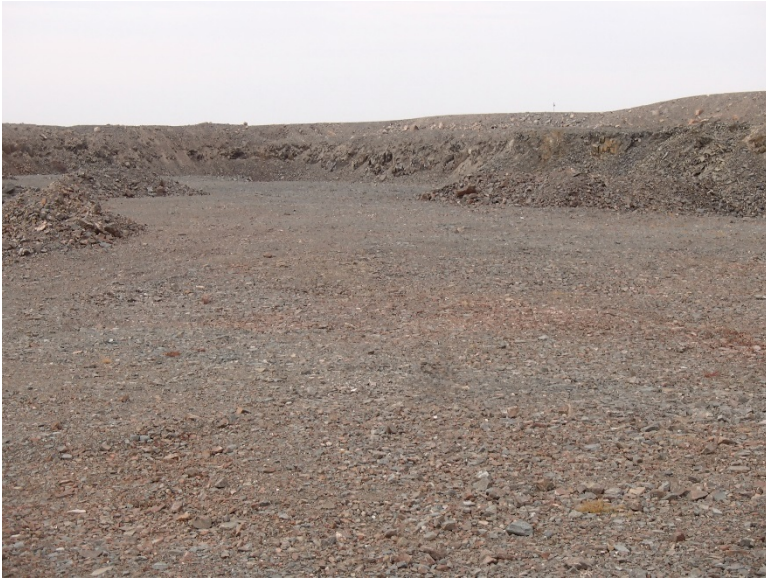
*Photograph F1-23: Quarry 12 – km 58+300*

**Description:** View of the south and east walls.

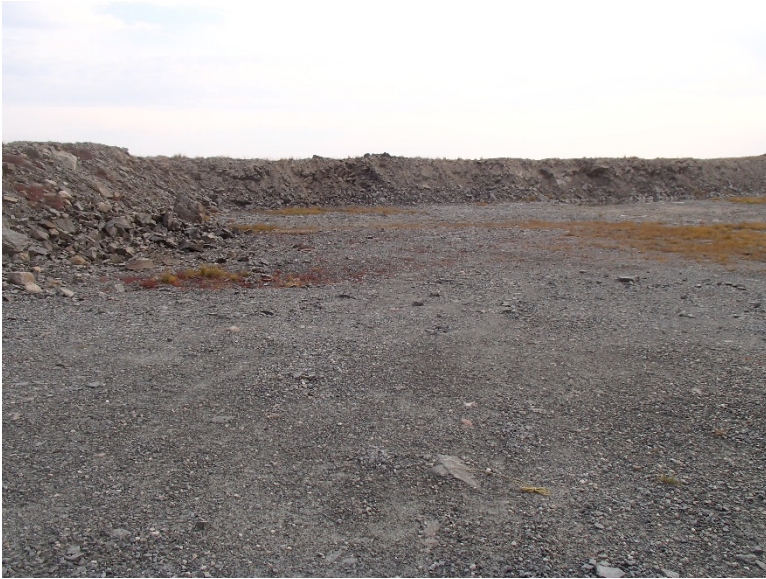
*Photograph F1-25: Quarry 13 – km 62+350*

**Description:** View of the west and north walls.

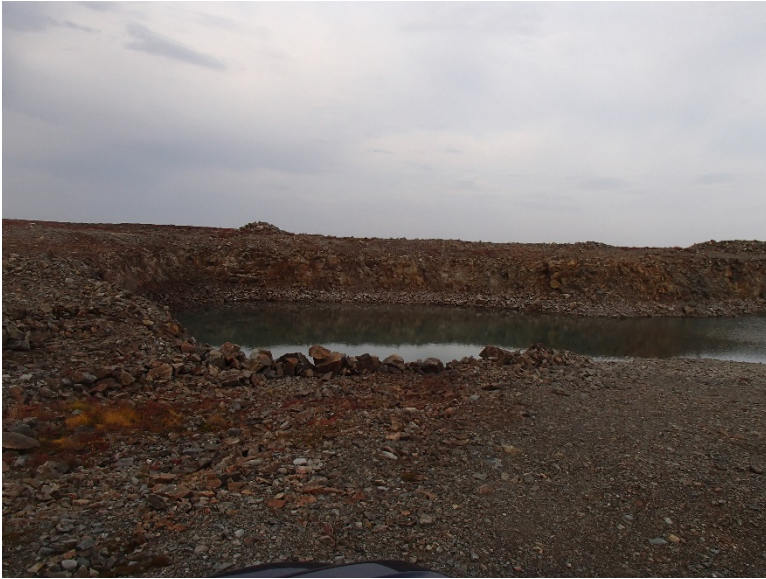
*Photograph F1-27: Quarry 14 – km 65+700*

**Description:** View of west and south walls. Quarry flooded.

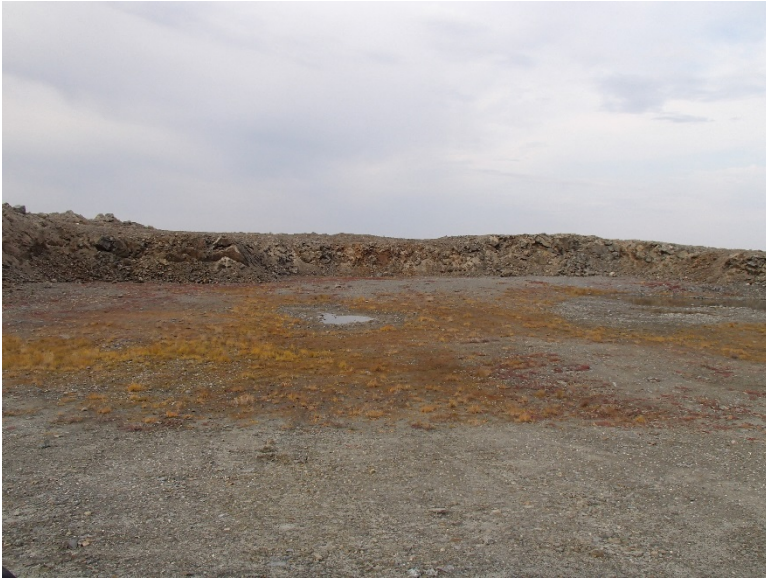
*Photograph F1-29: Quarry 15 – km 67+600*

**Description:** View of the south and west walls.

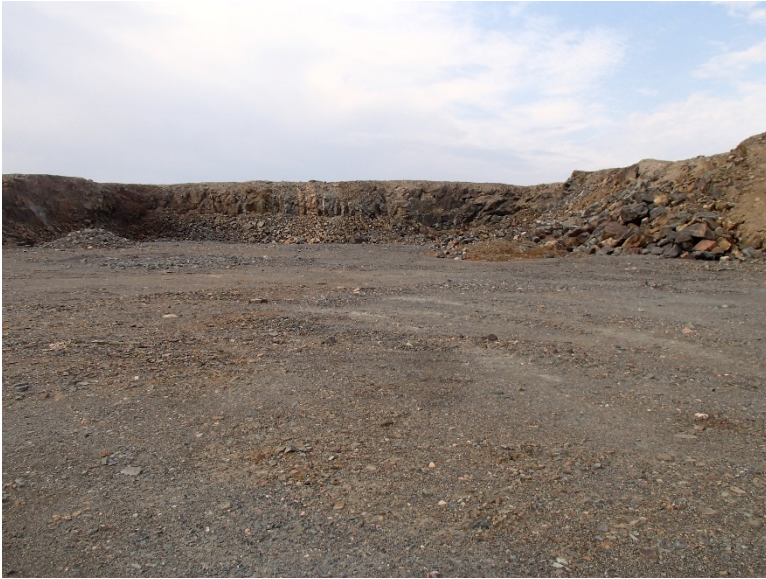
*Photograph F1-31: Quarry 16 – km 70+400*

**Description:** View of the south and west walls. Presence of loose rocks on steep wall.
