**Report: 2017 Annual Geotechnical Inspection**

February 2018

# 2017 Annual Geotechnical Inspection Meadowbank Gold Mine, Nunavut

**Report Number:** 1784282-1574-RPT-Rev0

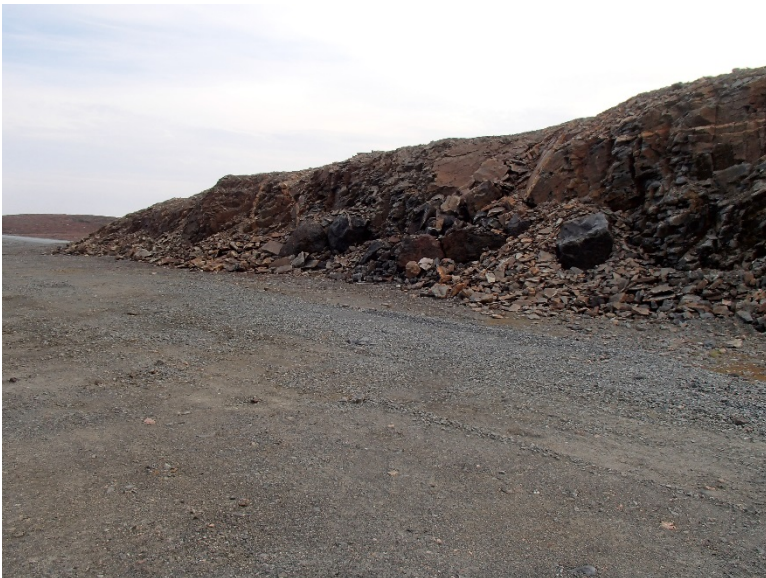
*Photograph F1-32: Quarry 16 – km 70+400*

**Description:** View of the east wall. Presence of loose rocks on steep wall.

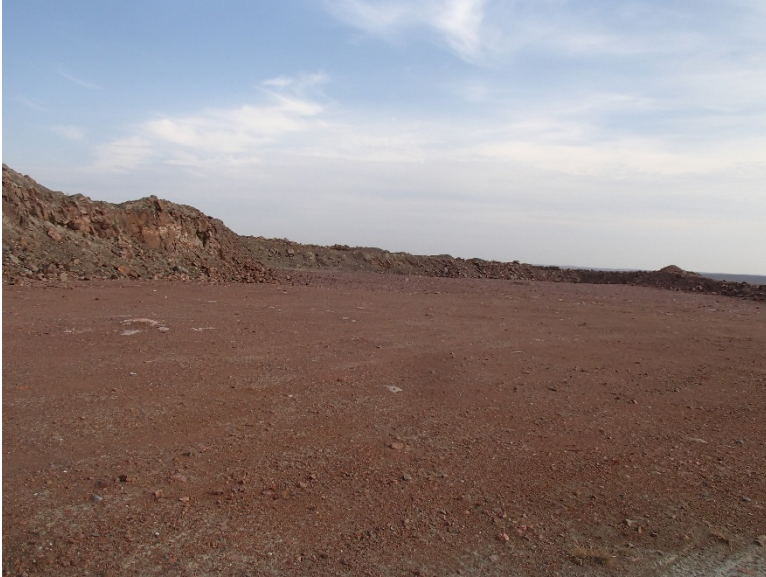
*Photograph F1-33: Quarry 17 – km 72+800*

**Description:** Looking at the north and west walls.

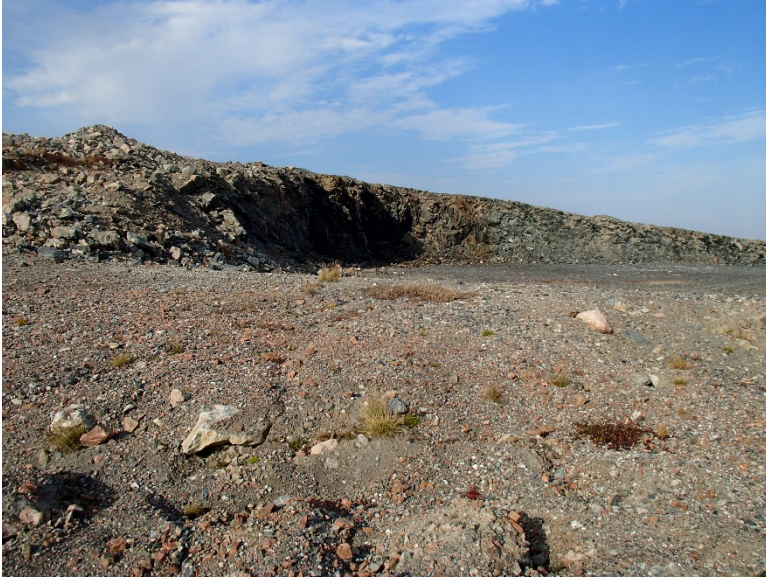
*Photograph F1-35: Quarry 18 – km 80+200*

**Description:** View of the south wall.

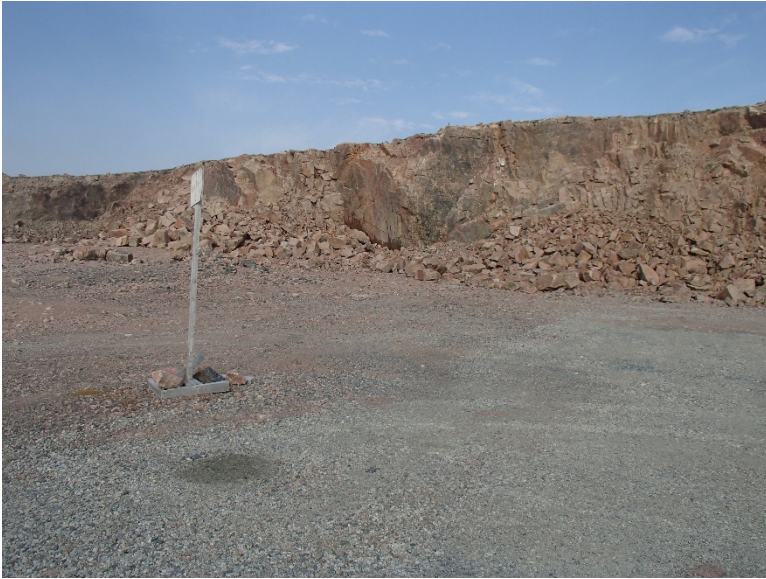
*Photograph F1-37: Quarry 19 – km 84+300*

**Description:** Looking at the north and west walls.

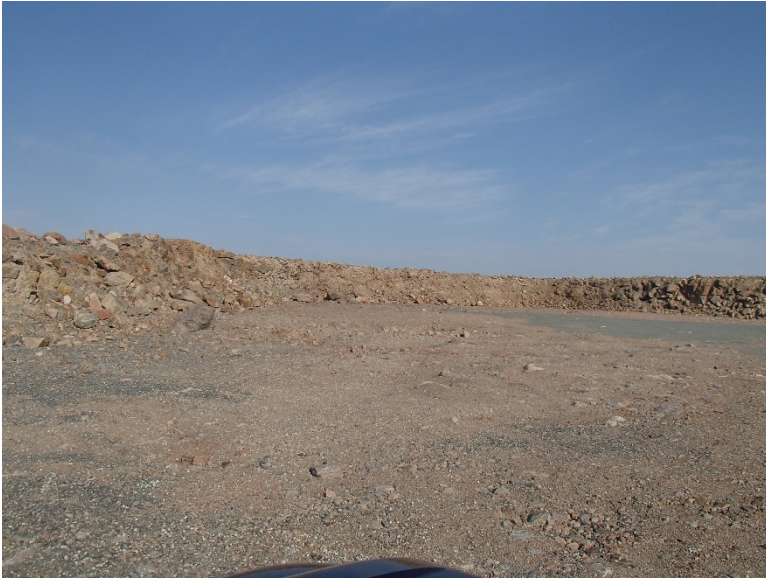
*Photograph F1-39: Quarry 20 – km 89+550*

**Description:** Looking at the north and west walls.

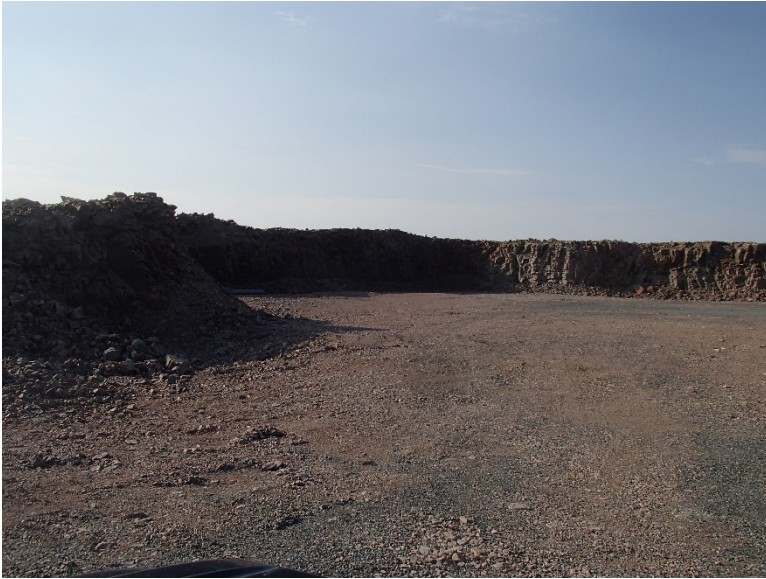
*Photograph F1-41: Quarry 21 – km 93+400*

**Description:** Looking at the south and east walls.

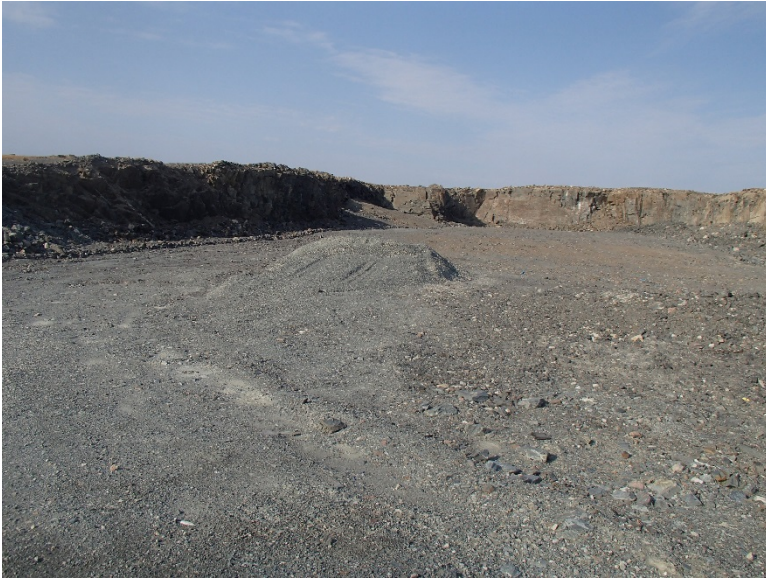
*Photograph F1-43: Quarry 22 – km 99+200*

**Description:** View of the south and west walls.

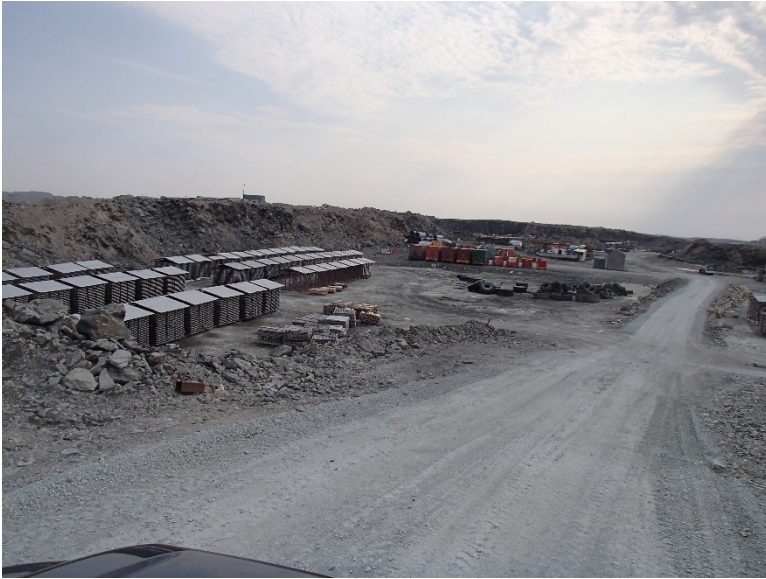
*Photograph F1-45: Quarry 23 (Airstrip Quarry)*

**Description:** Looking at the north wall.

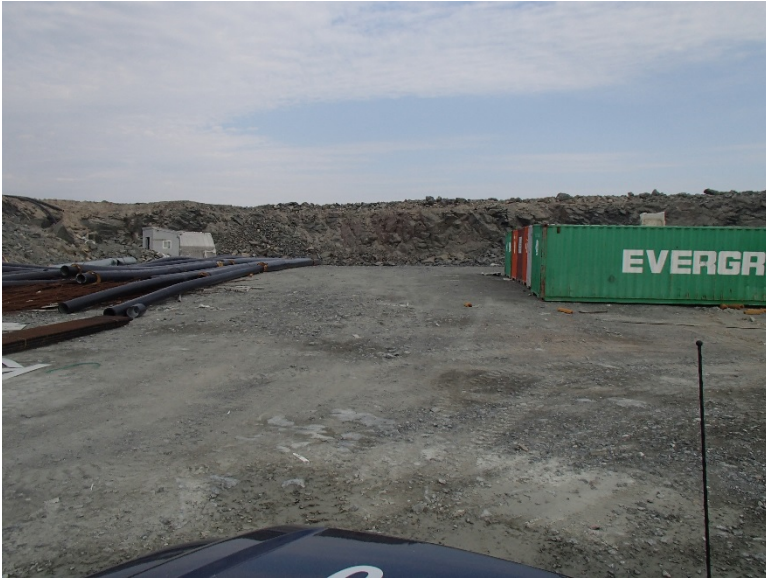
*Photograph F1-47: Quarry 23 (Airstrip Quarry)*

**Description:** Looking at the north wall. Presence of loose rocks along steep wall.

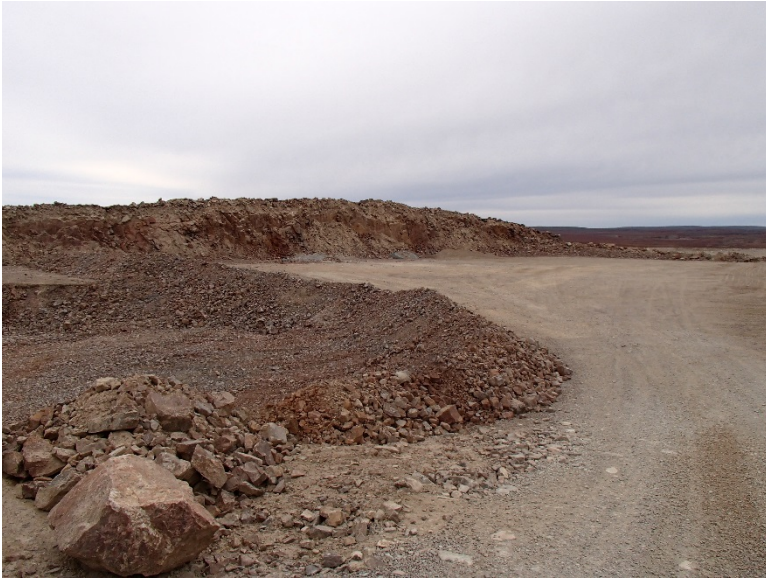
*Photograph F2-1 Eskers and Quarries 1 – km 15+000*

**Description:** View of esker #1. Loose rock is present on the steep wall.

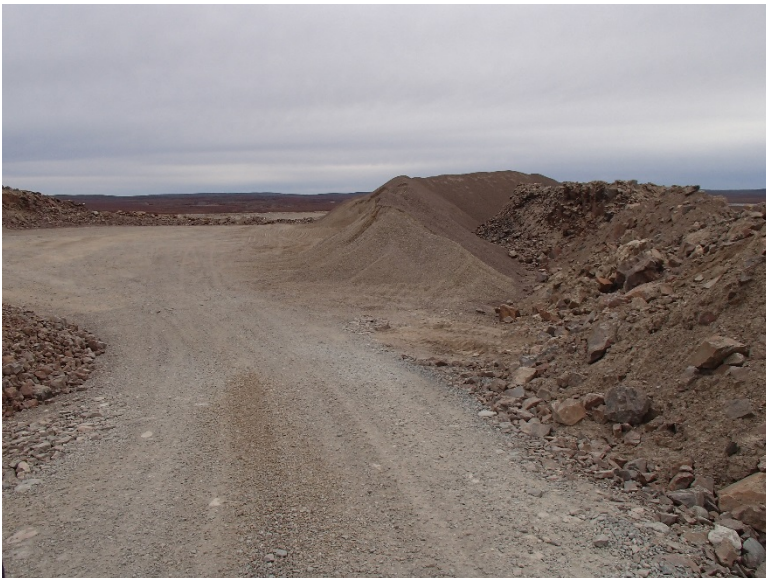
*Photograph F2-2 Eskers and Quarries 1 – km 15+000*

**Description:** View of esker #1. Loose rock is present on the steep wall.

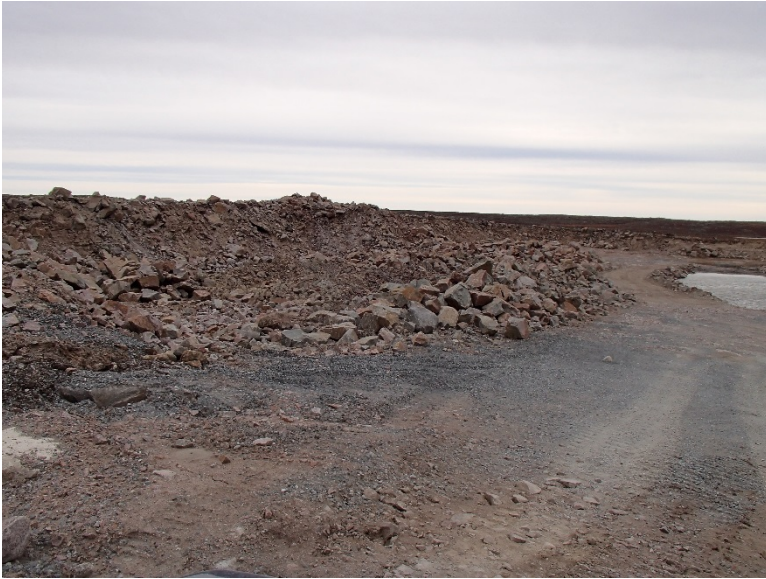
*Photograph F2-3 Eskers and Quarries 2 – km 25+000*

**Description:** View of esker #2. General good condition but some steep walls and loose rocks.

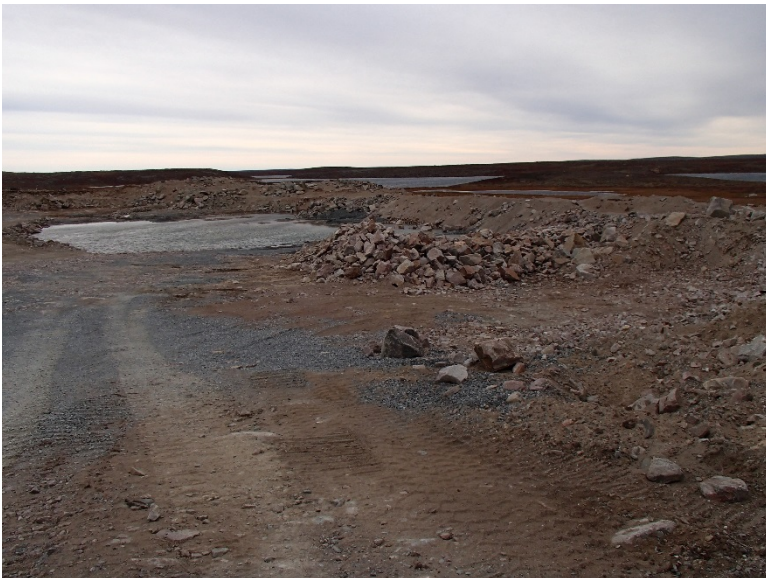
*Photograph F2-4 Eskers and Quarries 2 – km 25+000*

**Description:** View of esker #2. General good condition but some steep walls and loose rocks.

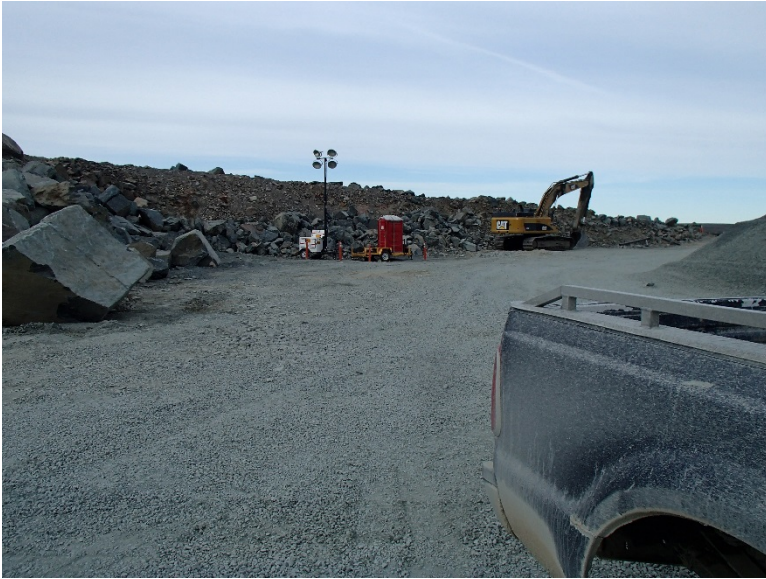
*Photograph F2-5 Eskers and Quarries 3 – km 35+000*

**Description:** View of the rock quarry at km 35. Unstable walls subject to rockfalls.

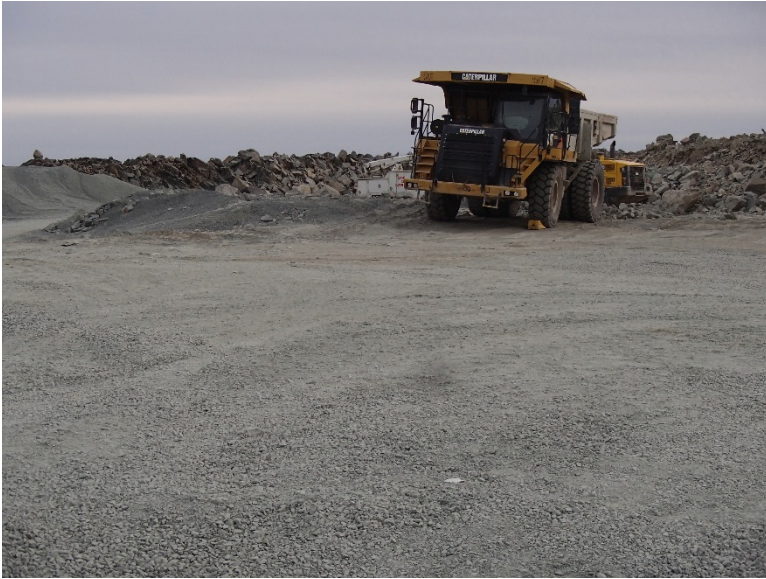
*Photograph F2-7 Eskers and Quarries 3 – km 35+000*

**Description:** View of the rock quarry at km 35. Unstable walls subject to rockfalls.

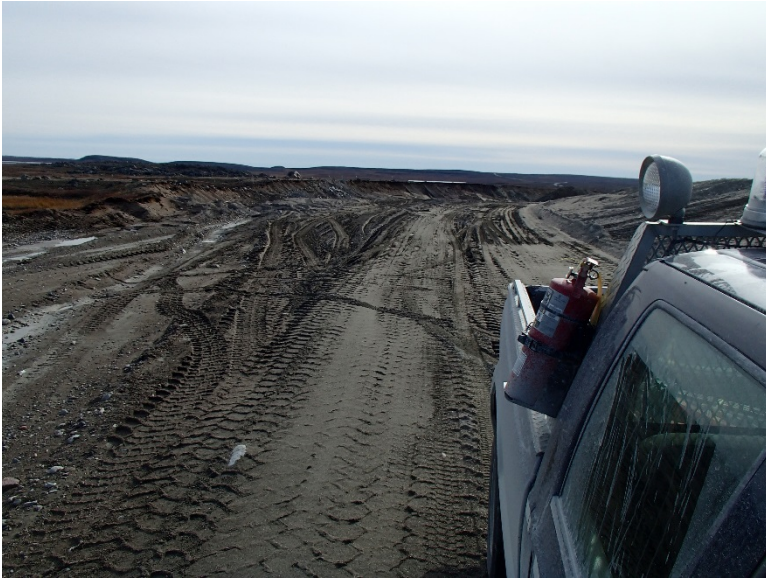
*Photograph F2-9 Eskers and Quarries 4 – km 46+000*

**Description:** View of esker #3. The 2-m high steep soil slopes are unstable.

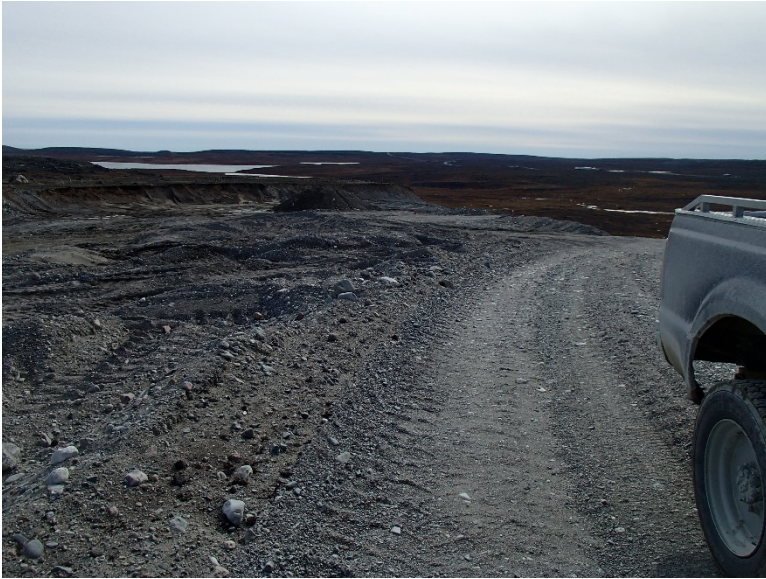
*Photograph F2-11 Eskers and Quarries 4 – km 46+000*

**Description:** View of esker #3. The 2-m high steep soil slopes are unstable.

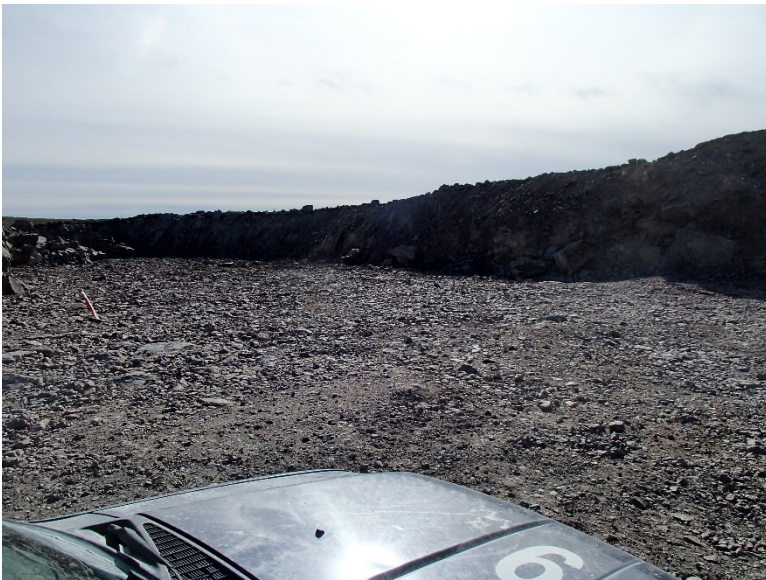
*Photograph F2-12 Eskers and Quarries 5 – km 52+000*

**Description:** View of the rock quarry at km 52. In good conditions with loose blocks on the north wall.

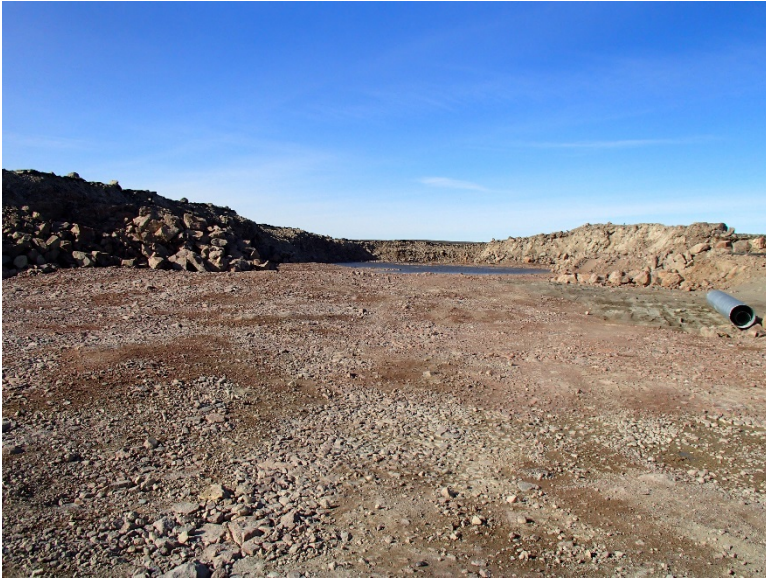
*Photograph F2-13 Eskers and Quarries 5 – km 52+000*

**Description:** View of the rock quarry at km 52. In good conditions with loose blocks on the north wall.

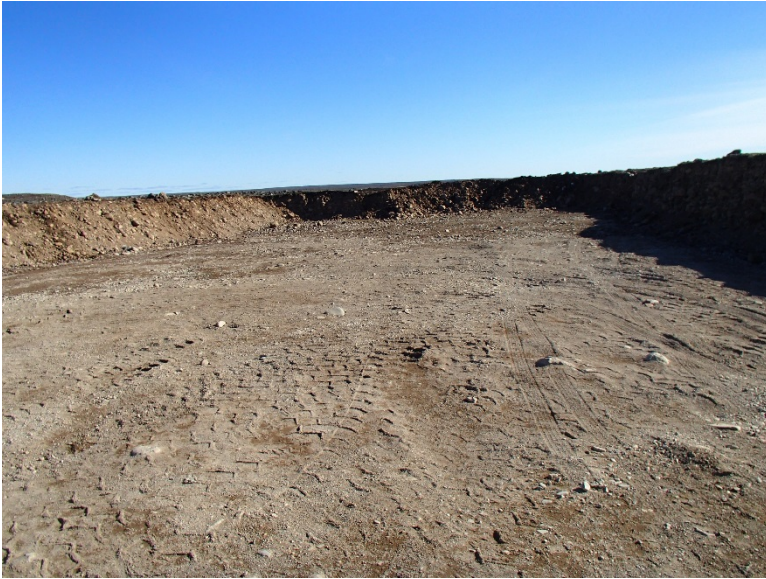
*Photograph F2-15 Eskers and Quarries 6 – km 62+000*

**Description:** View of esker #6C (north borrow pit). The 2-m high steep soil slopes are unstable.

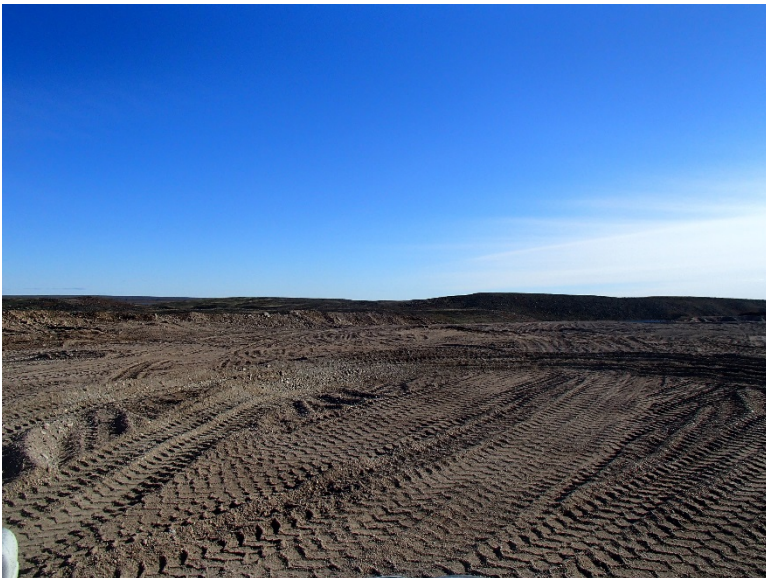
*Photograph F2-16 Eskers and Quarries 6 – km 62+000*

**Description:** View of esker #6B. In good condition.

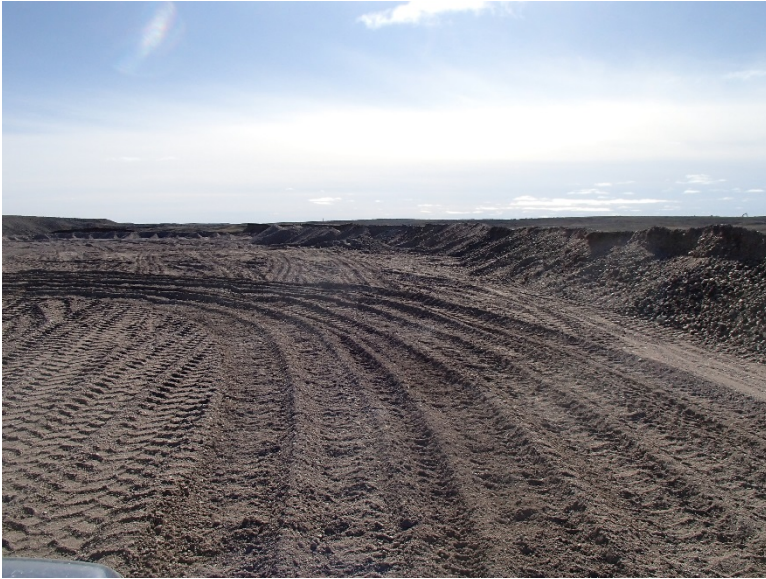
*Photograph F2-17 Eskers and Quarries 6 – km 62+000*

**Description:** View of eskers #6A and #6D. In good condition.

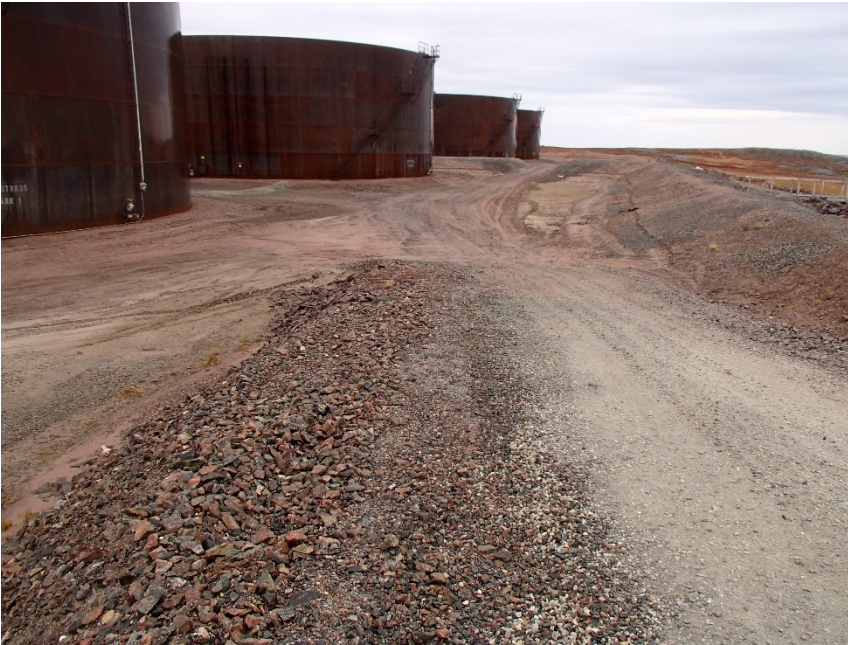
*Photograph G1-1 Baker Lake Tank Farm*

**Description:** From the south side of Tank 1, looking southeast at Tanks 1, 2, 3, and 4. Presence of water ponding.

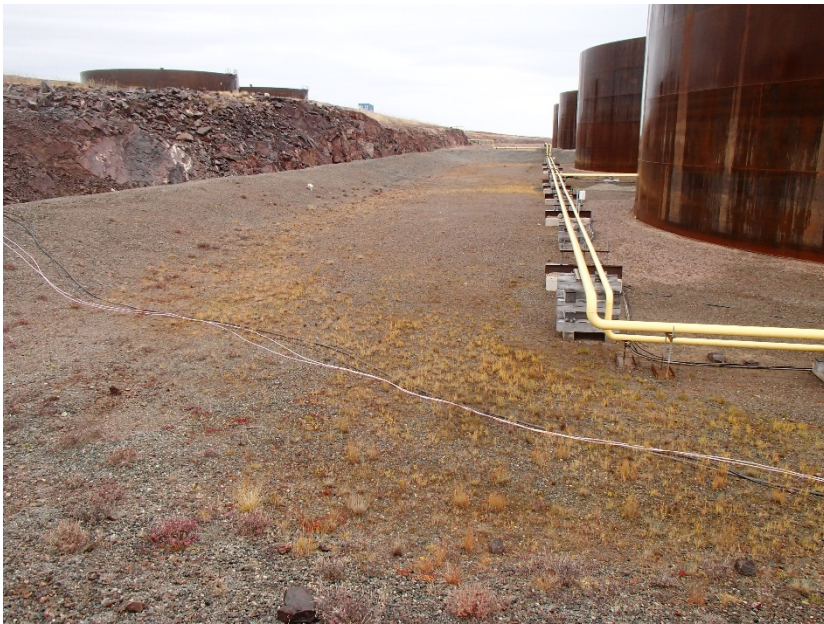
*Photograph G1-3 Baker Lake Tank Farm*

**Description:** From the north side of Tank 1, looking southeast at Tanks 1, 2, 3, and 4.

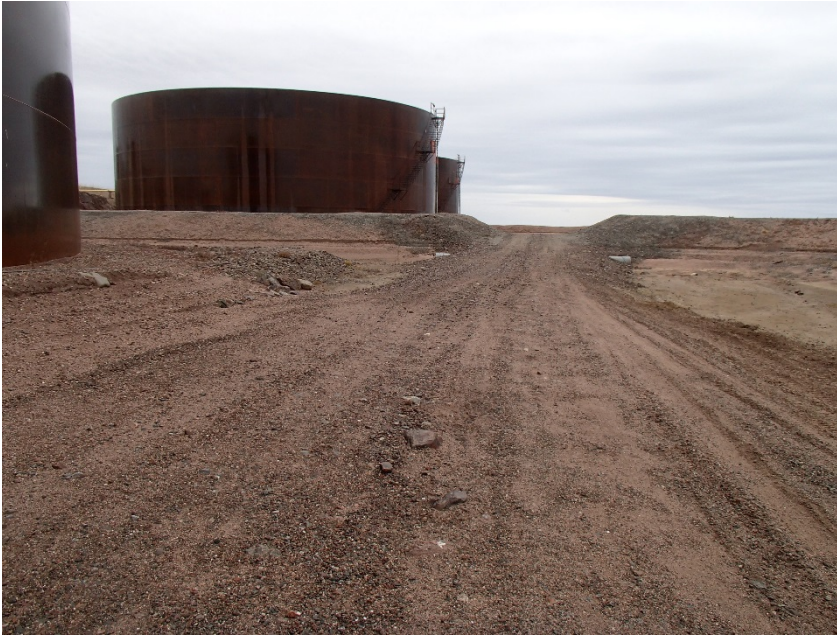
*Photograph G1-5 Baker Lake Tank Farm*

**Description:** Looking northeast toward the south side of Tanks 2 and 3.

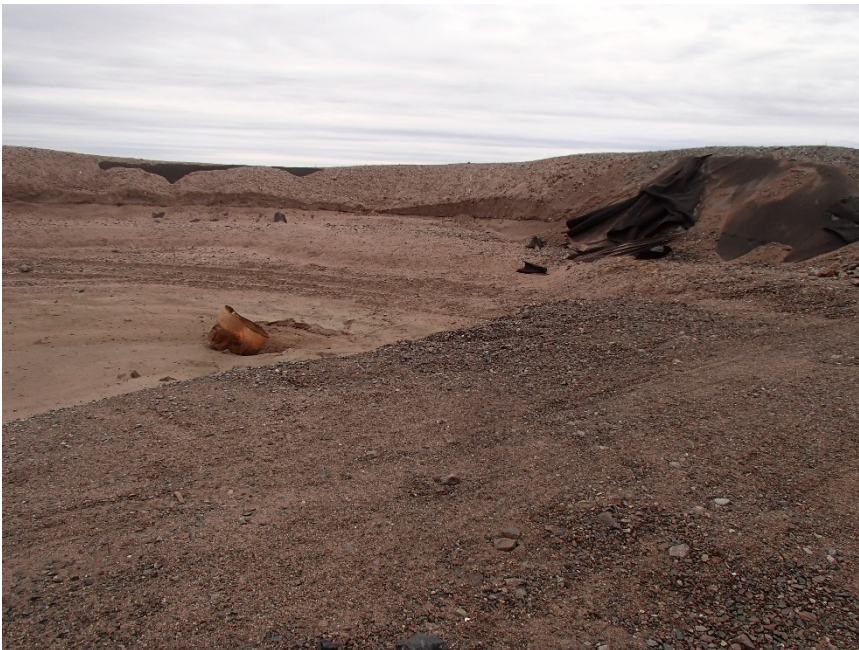
*Photograph G1-6 Baker Lake Tank Farm*

**Description:** Looking south. The geomembrane between the south side of tank 2 and 3 is damaged.

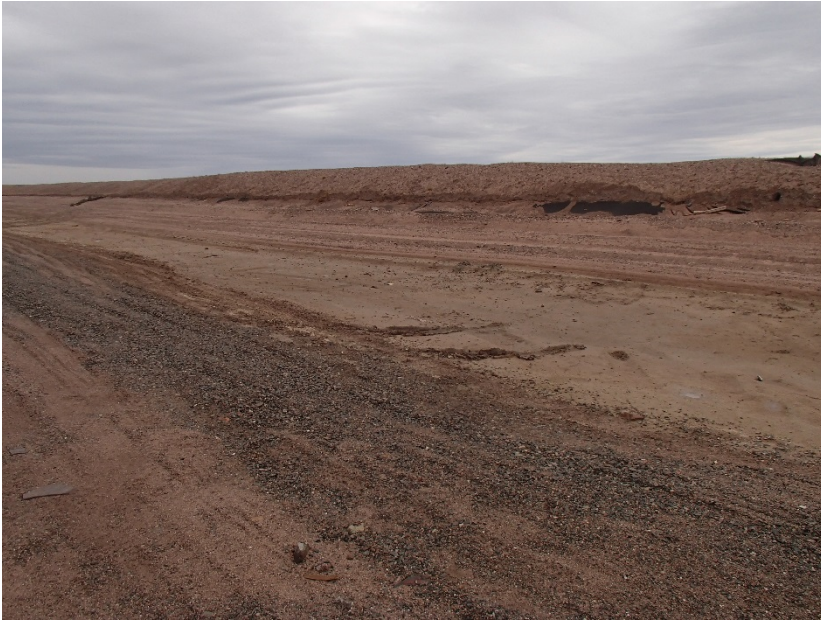
*Photograph G1-7 Baker Lake Tank Farm*

**Description:** From the southwestern corner of Tank 3 looking southeast. View of exposed LLDPE.

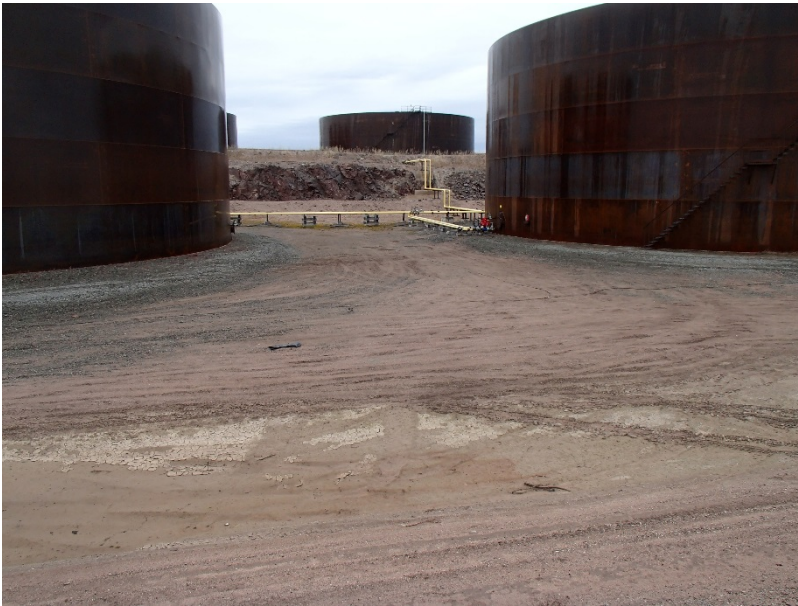
*Photograph G1-9 Baker Lake Tank Farm*

**Description:** From the south portion of the site looking north at the south side of Tank 3, 4 and 5.

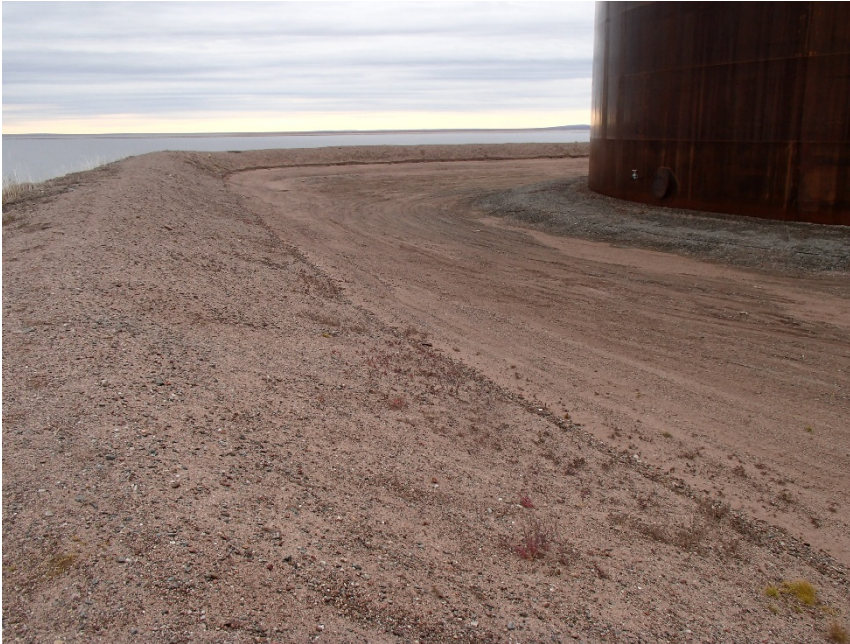
*Photograph G1-11 Baker Lake Tank Farm*

**Description:** From the northeastern corner of Tank 4 looking southwest toward Tank 4.

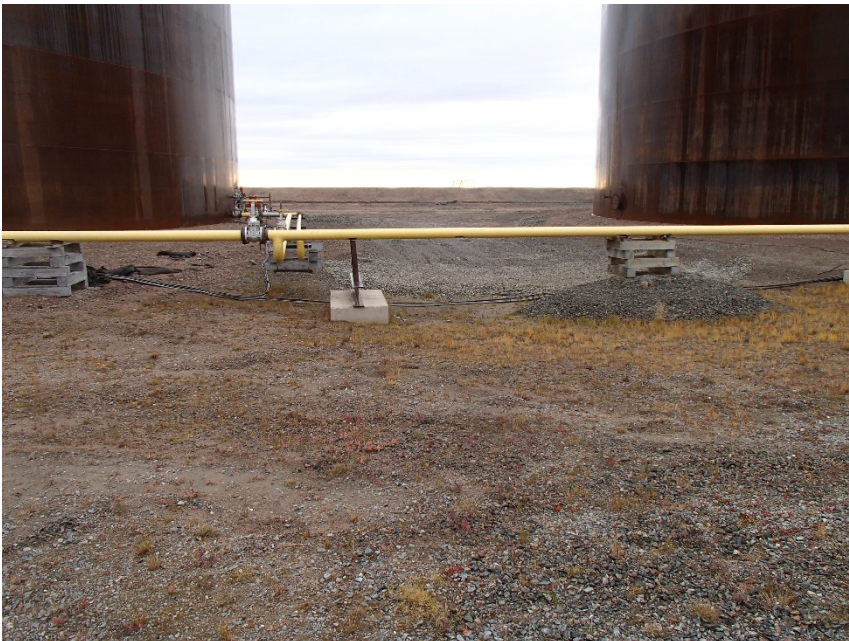
*Photograph G1-14 Baker Lake Tank Farm*

**Description:** From the northern corner of Tank 2 looking west towards the northeastern side of Tank 1.

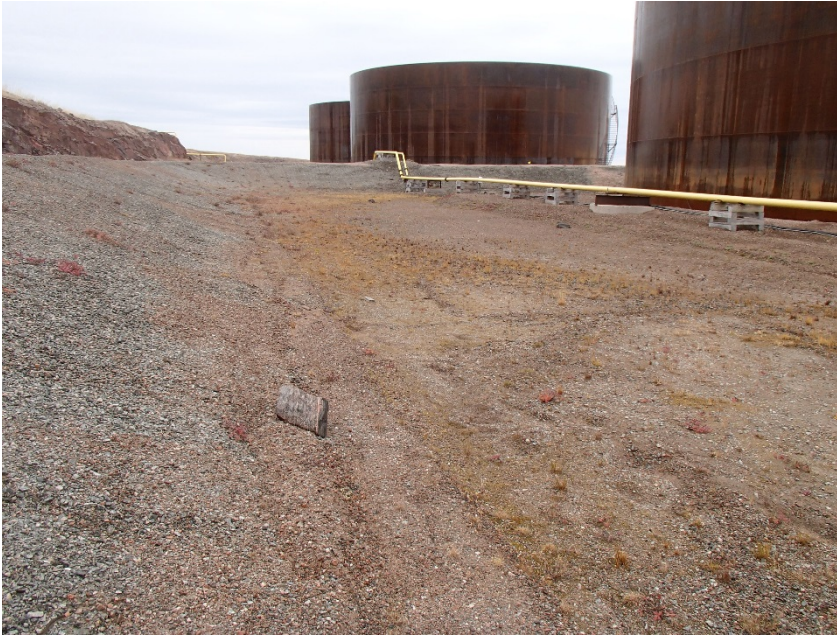
*Photograph G1-15 Baker Lake Tank Farm*

**Description:** From the northern corner of Tank 2 looking southeast towards the northeastern side of Tank 1.

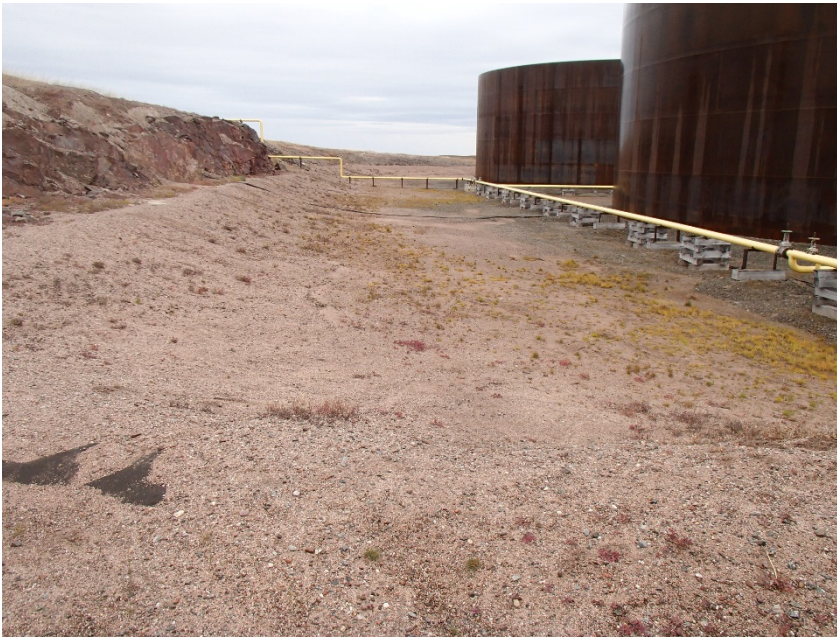
*Photograph G1-17 Baker Lake Tank Farm*

**Description:** From the northwestern corner of Tank 3 looking southeast towards the northeastern side of Tanks 3 and 4.

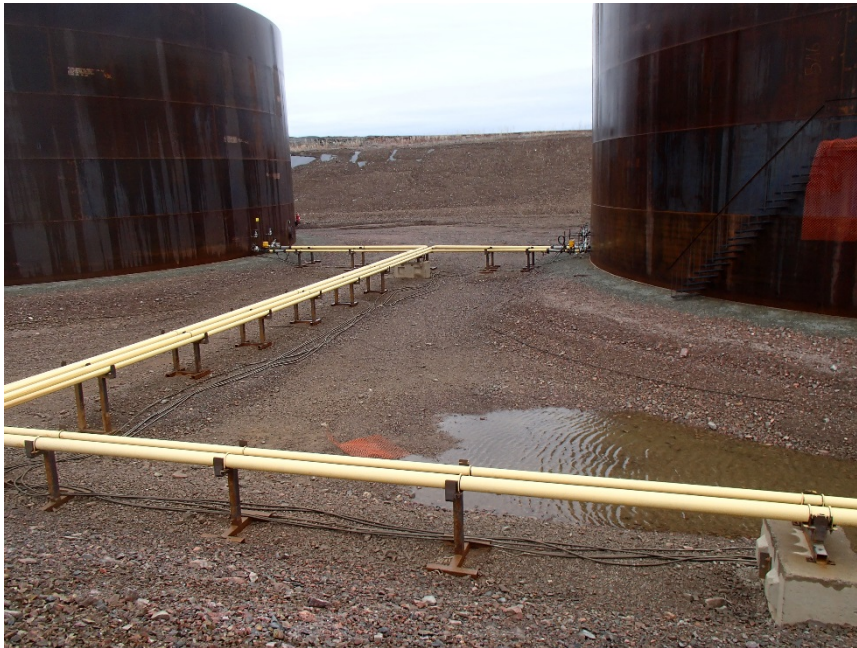
*Photograph G1-19 Baker Lake Tank Farm*

**Description:** Looking north between Tanks 5 and 6. Presence of water ponding.

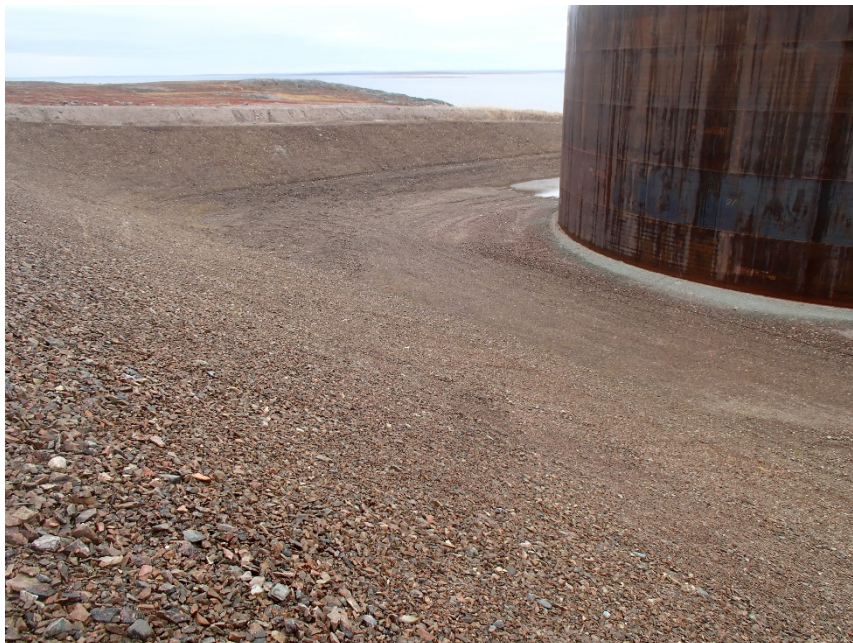
*Photograph G1-21 Baker Lake Tank Farm*

**Description:** Looking southeast at the northeastern side of Tank 6. Presence of water ponding.

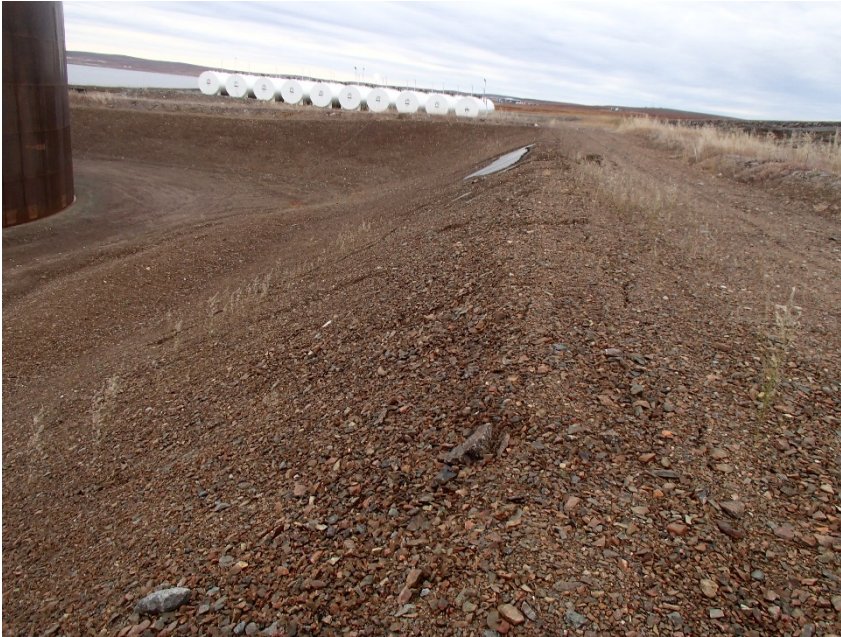
*Photograph G1-23 Baker Lake Tank Farm*

**Description:** Looking west at the northeastern side of Tank 5.

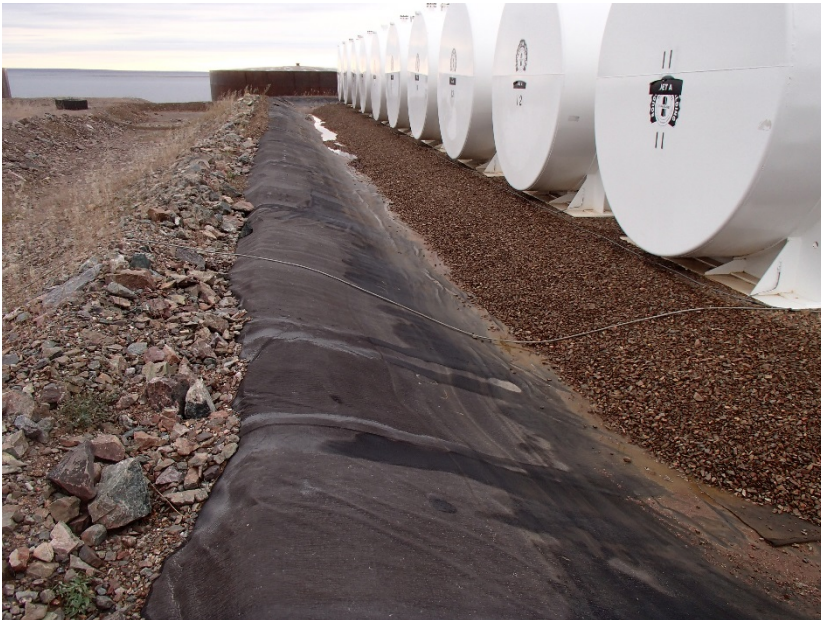
*Photograph G1-25 Baker Lake Tank Farm*

**Description:** From the northeastern corner of the Jet A fuel tanks looking south. Presence of exposed geomembrane.

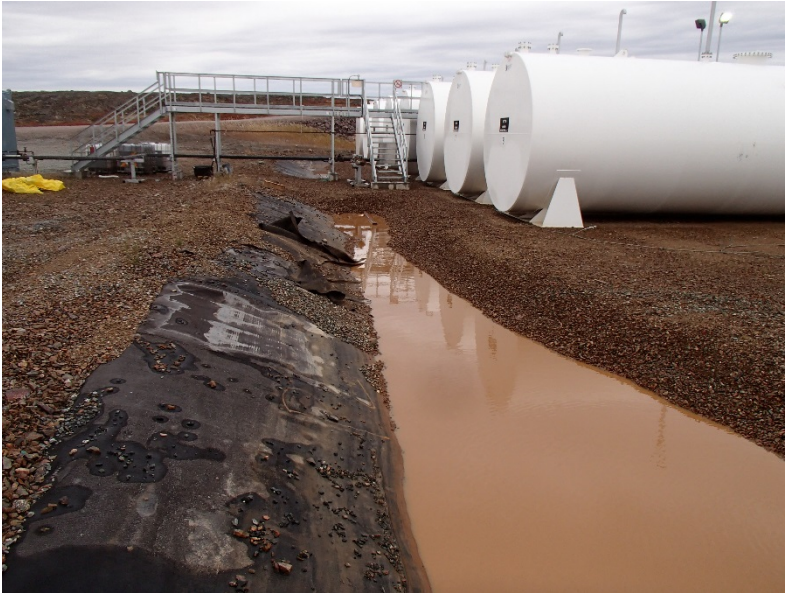
*Photograph G1-27 Baker Lake Tank Farm*

**Description:** From the southwestern corner of the Jet A fuel tanks looking east. Presence of exposed geomembrane and water ponding.

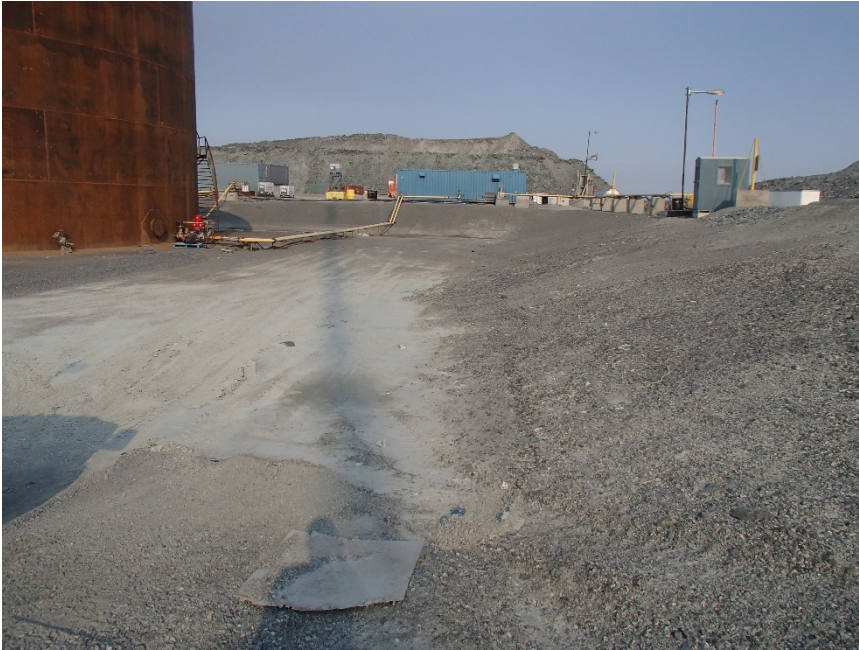
*Photograph G2-1 Meadowbank Tank Farm*

**Description:** From the western corner, looking east at the tank.

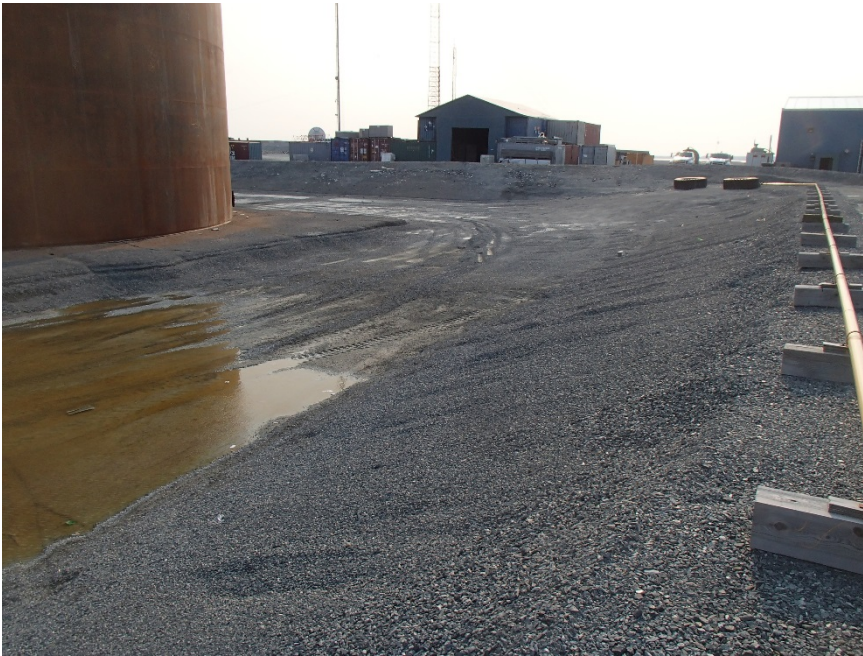
*Photograph G2-3 Meadowbank Tank Farm*

**Description:** From the eastern side, looking northwest.

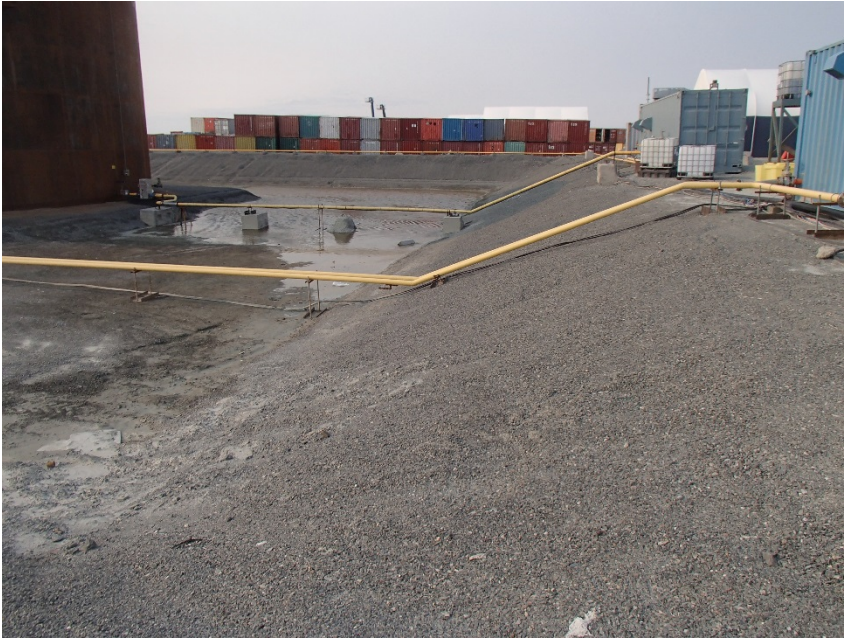
*Photograph G2-5 Meadowbank Tank Farm*

**Description:** Looking northeast from the southern corner. Accumulation of water in the eastern corner.

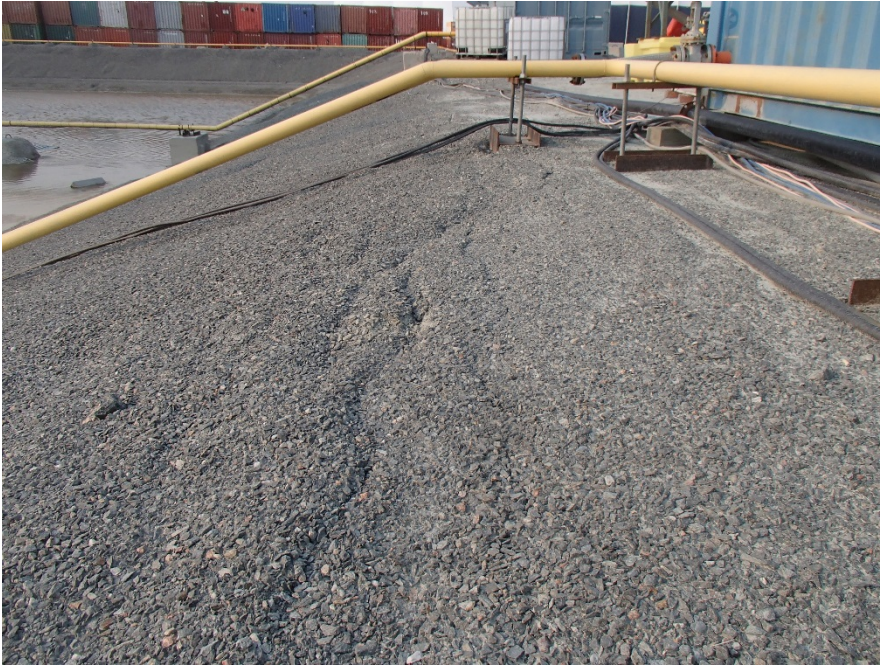
*Photograph G2-7 Meadowbank Tank Farm*

**Description:** From the southern corner: presence of small tension cracks on the crest (about 3 m long).

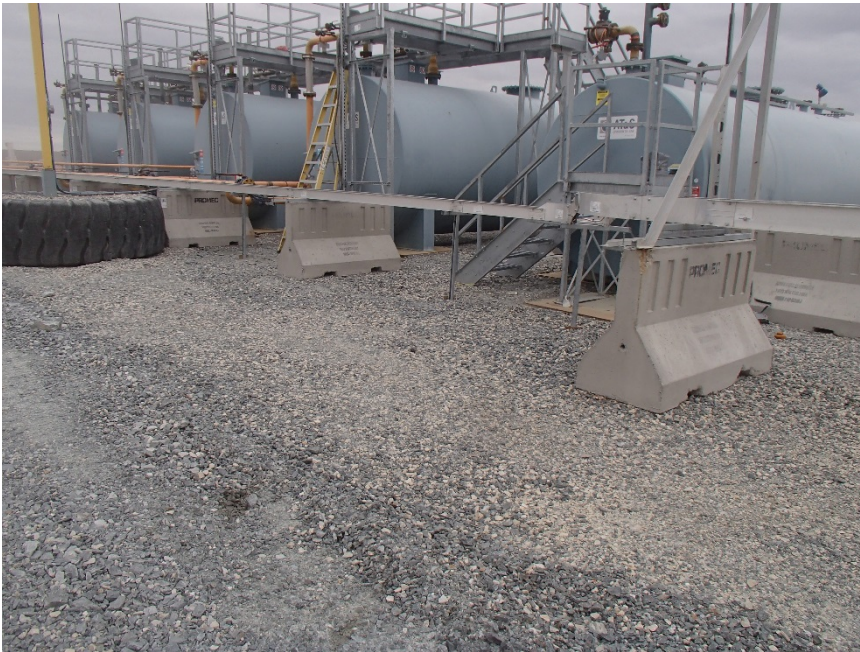
*Photograph G3-1 Vault Tank Farm*

**Description:** From the southeast corner of the Tanks looking northwest toward the Vault Tank Farm.

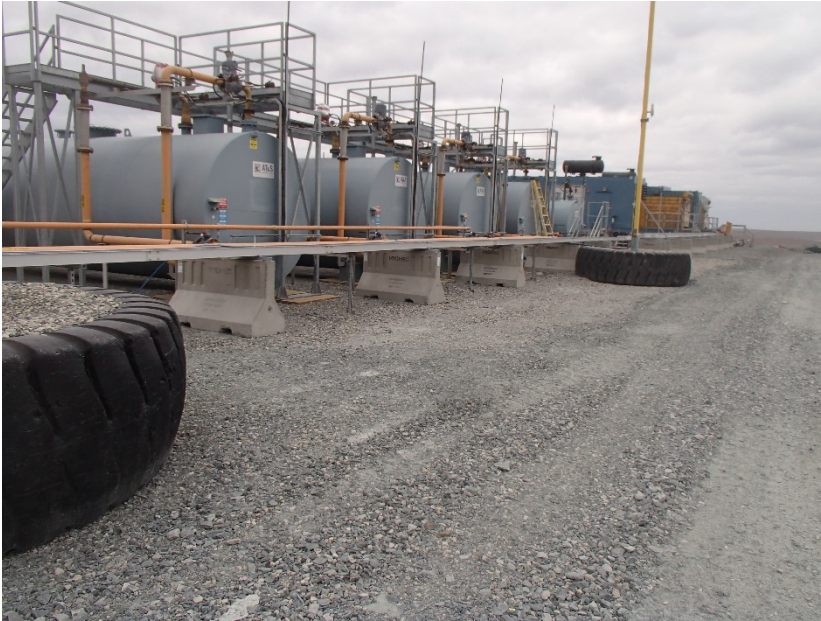
*Photograph G3-3 Vault Tank Farm*

**Description:** From the southwest corner of the Tanks Looking northeast toward the Vault Tank Farm.

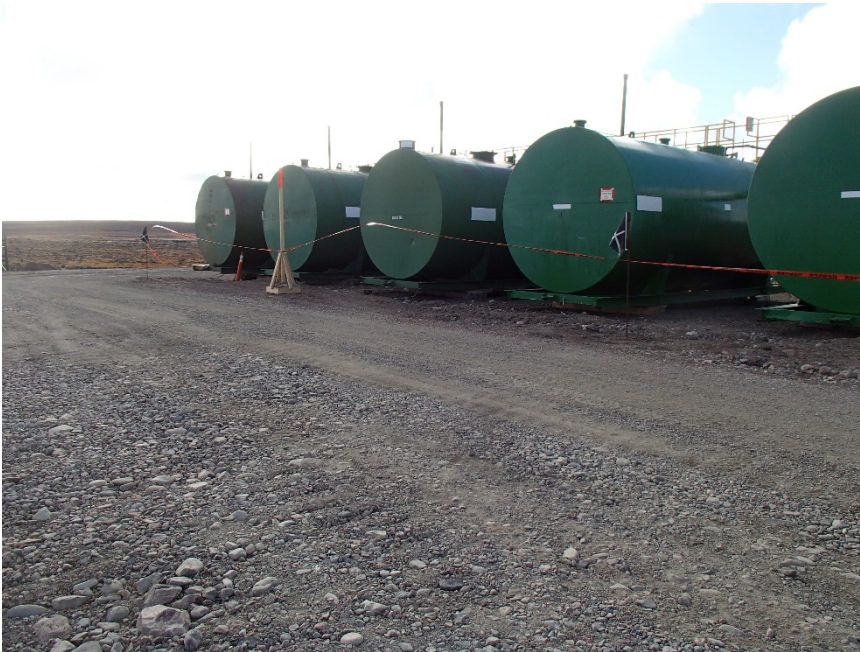
*Photograph G4-1 Amaruq Tank Farm*

**Description:** From the northeast side of the Tanks looking south toward the Amaruq Tank Farm.
