**Report: 2017 Annual Geotechnical Inspection**

February 2018

# 2017 Annual Geotechnical Inspection Meadowbank Gold Mine, Nunavut

**Report Number:** 1784282-1574-RPT-Rev0

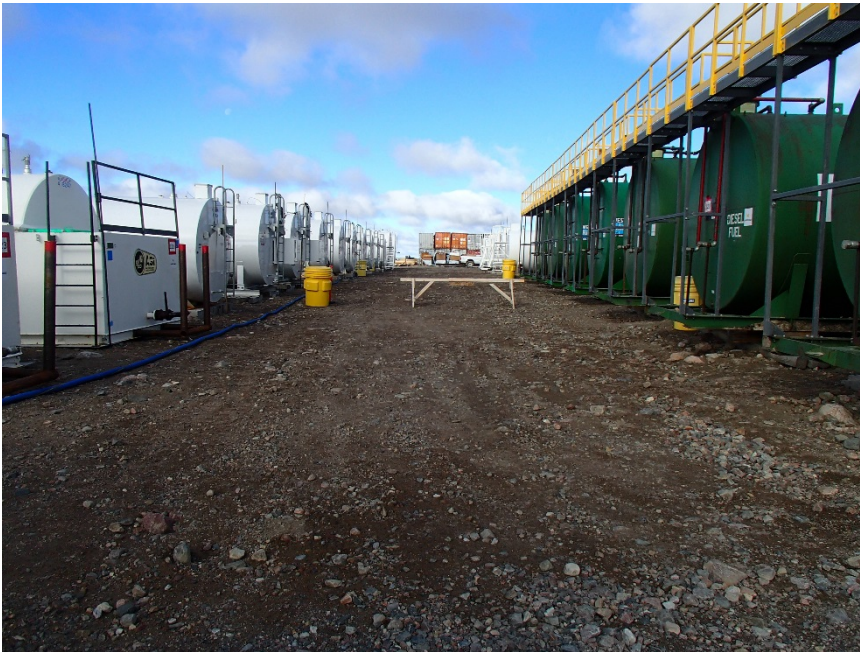
*Photograph G4-3 Amaruq Tank Farm*

**Description:** From the southeast side of the Tanks looking northwest toward the Amaruq Tank Farm.

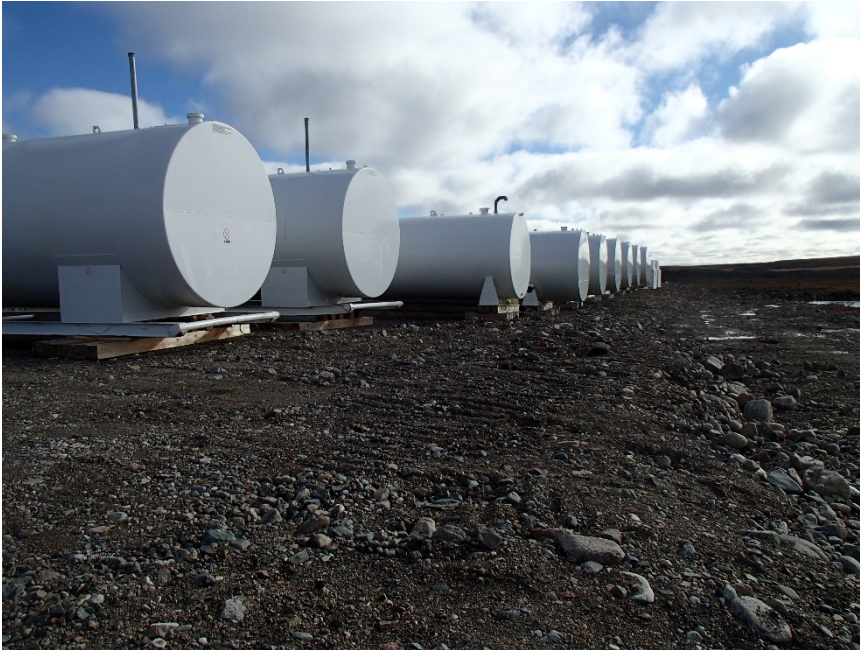
*Photograph G4-5 Amaruq Tank Farm*

**Description:** From the northwest corner of the Tanks looking southeast toward the Amaruq Tank Farm.

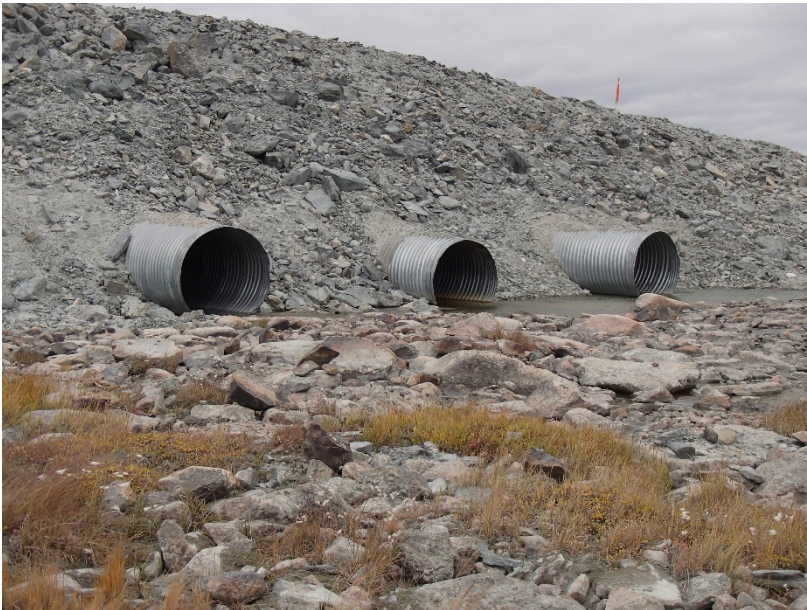
*Photograph H1-1 Vault Road Culverts*

**Description:** Looking at the outlet of the three culverts located on Vault Road at 640964E/7217466N. All of them are deformed in the middle.

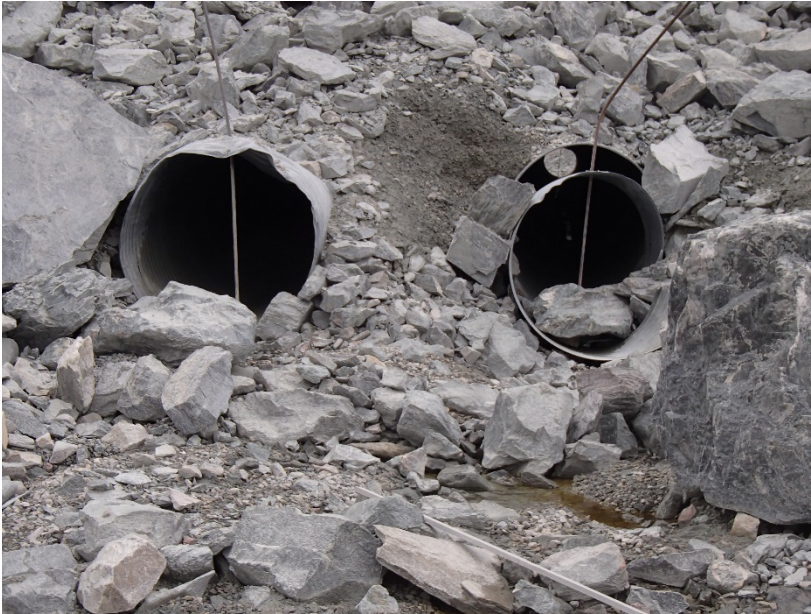
*Photograph H1-5 Vault Road Culverts*

**Description:** Culvert on the NP1 side at 639 214 E / 7 216 189 N on Vault Road. Culvert broken and partially obstructed.

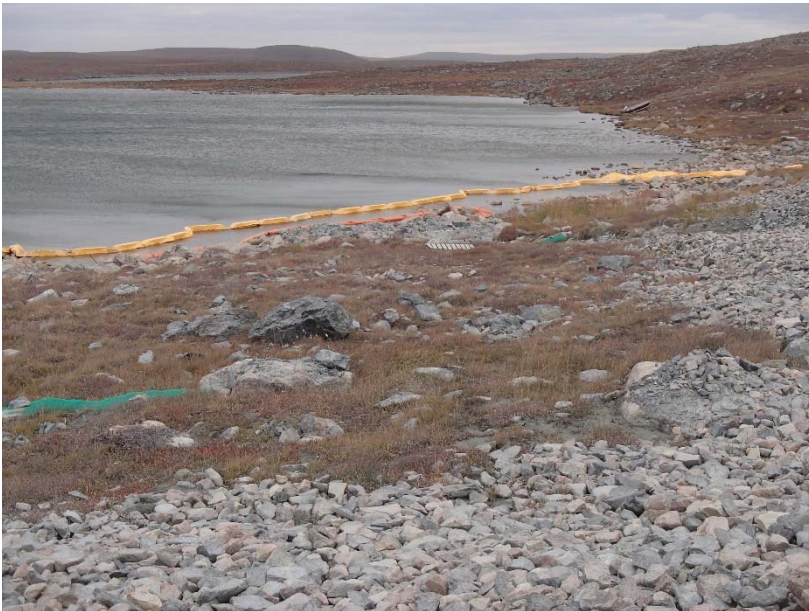
*Photograph H2-1 Diversion Ditch and its Sediment and Erosion Protection Structure*

**Description:** Looking south toward Lake NP1 at the sediment and erosion protection structure. Presence of 2 silt curtains and 3 wooden barrier.

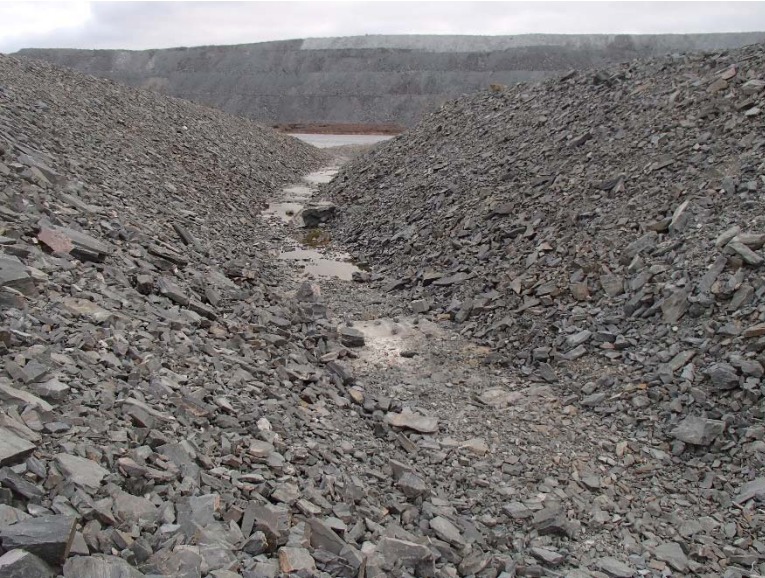
*Photograph H2-3 Diversion Ditch and its Sediment and Erosion Protection Structure*

**Description:** From the eastern diversion ditch looking south toward Lake NP2.

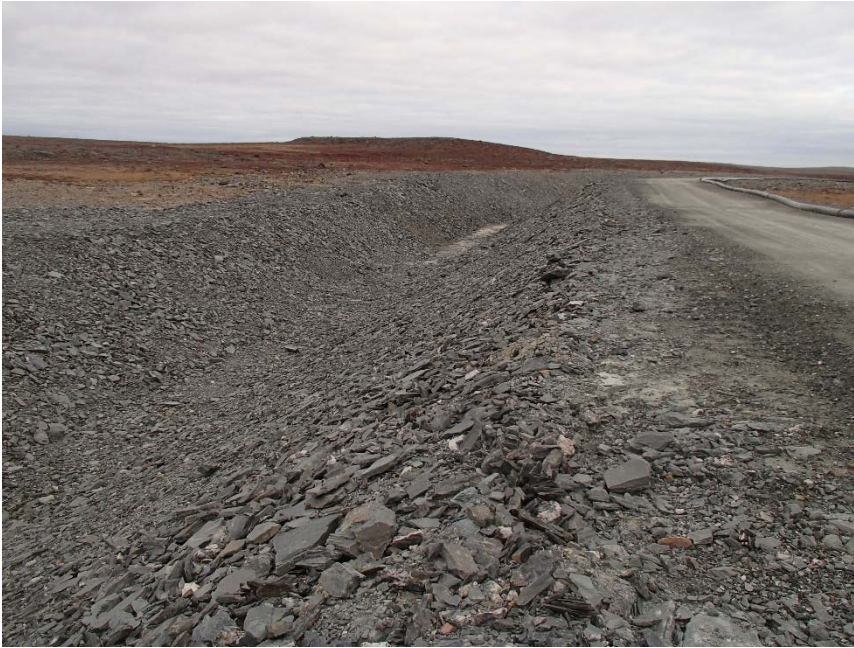
*Photograph H2-5 Diversion Ditch and its Sediment and Erosion Protection Structure*

**Description:** From the eastern diversion ditch, looking east.

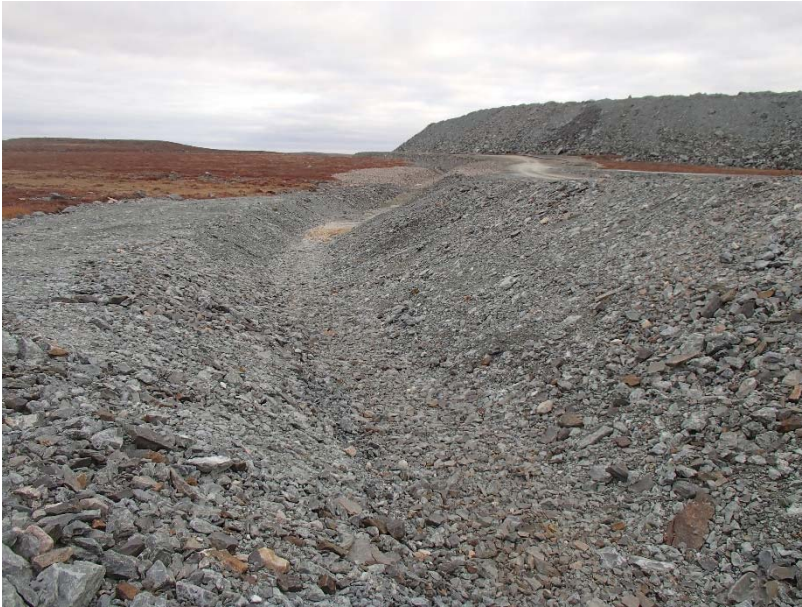
*Photograph H2-7 Diversion Ditch and its Sediment and Erosion Protection Structure*

**Description:** From the northern diversion ditch looking southeast.

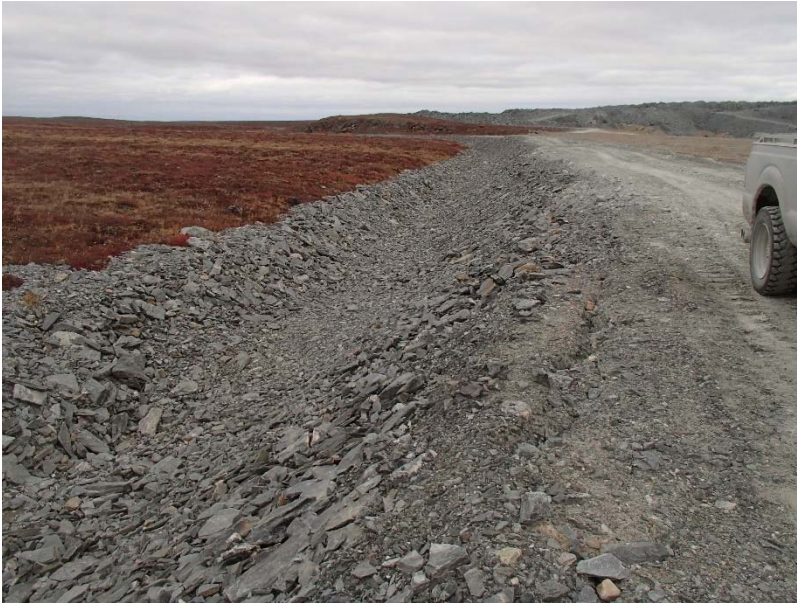
*Photograph H2-9 Diversion Ditch and its Sediment and Erosion Protection Structure*

**Description:** From the northern diversion ditch looking east.

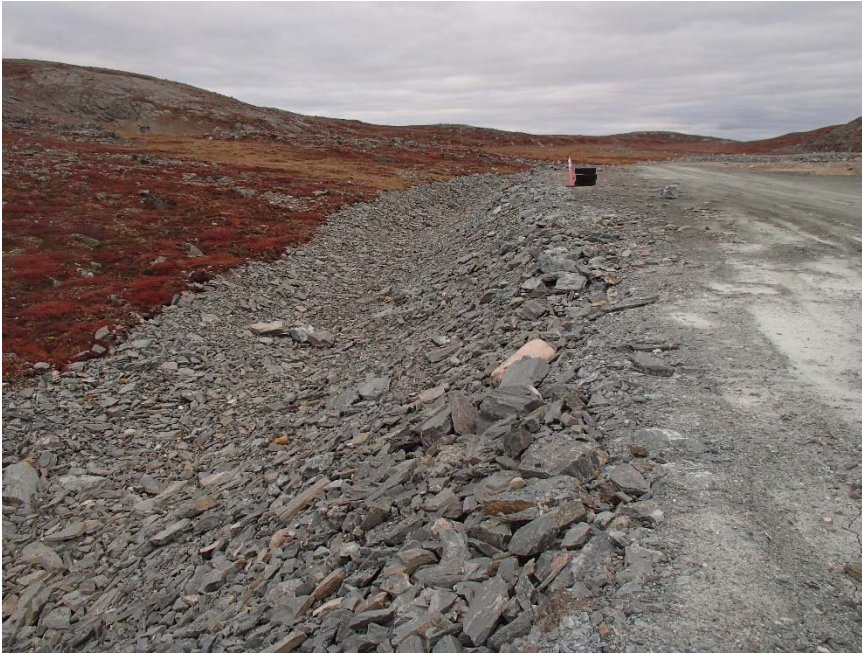
*Photograph H2-11 Diversion Ditch and its Sediment and Erosion Protection Structure*

**Description:** From 637281E/7216790N, looking north. View of the western diversion ditch.

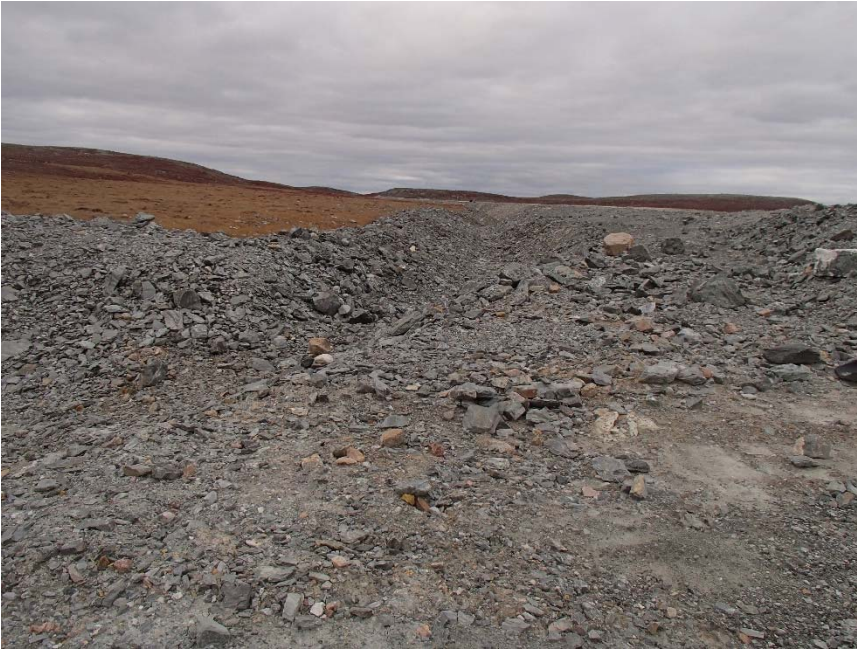
*Photograph H2-13 Diversion Ditch and its Sediment and Erosion Protection Structure*

**Description:** From 637251E/7216171N, looking north at the western diversion ditch.

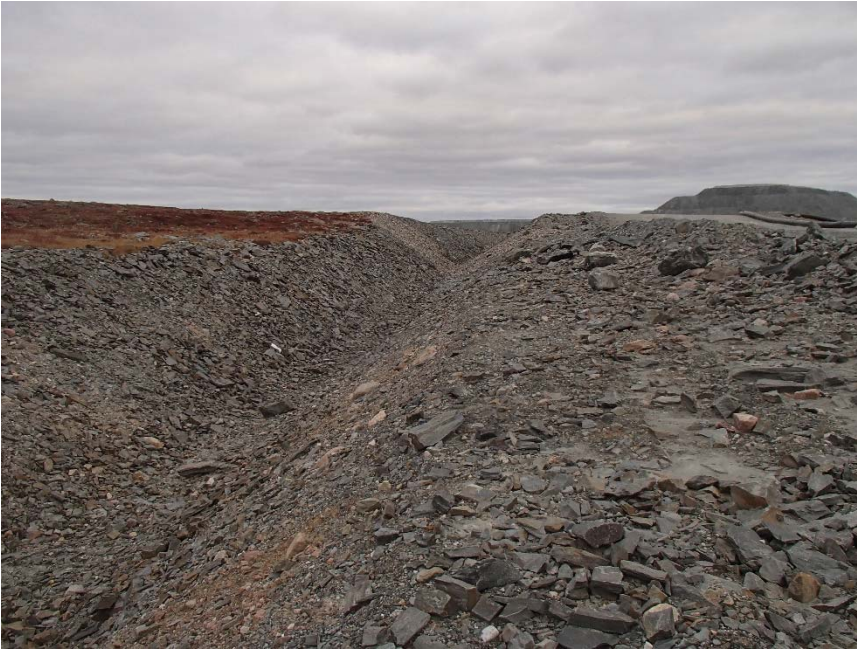
*Photograph H2-15 Diversion Ditch and its Sediment and Erosion Protection Structure*

**Description:** From 637074E/7216157N, looking east at the western diversion ditch.

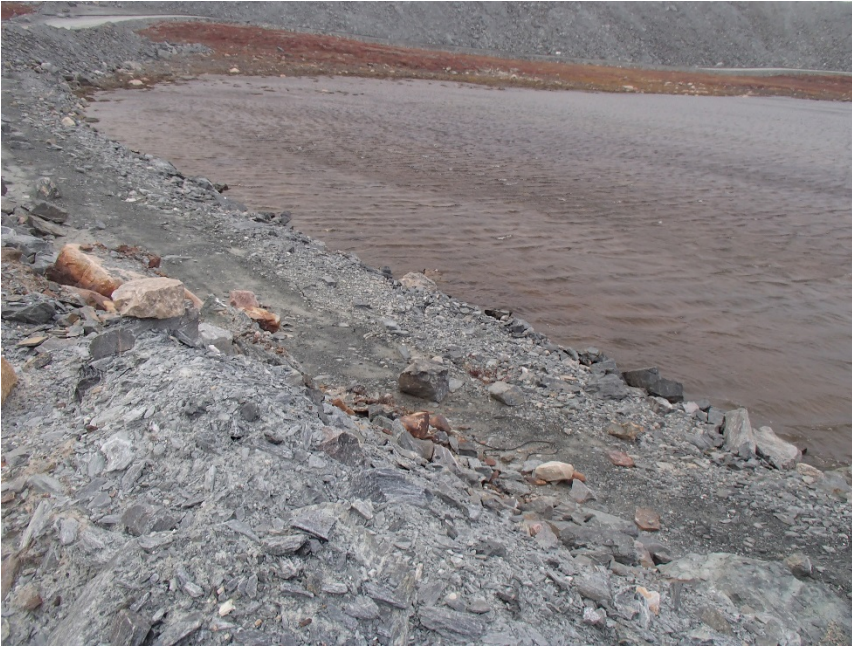
*Photograph H3-1 RSF Till Plug*

**Description:** From the south side of NP2 Lake (north of the diversion ditch) looking west at the RSF till plug.

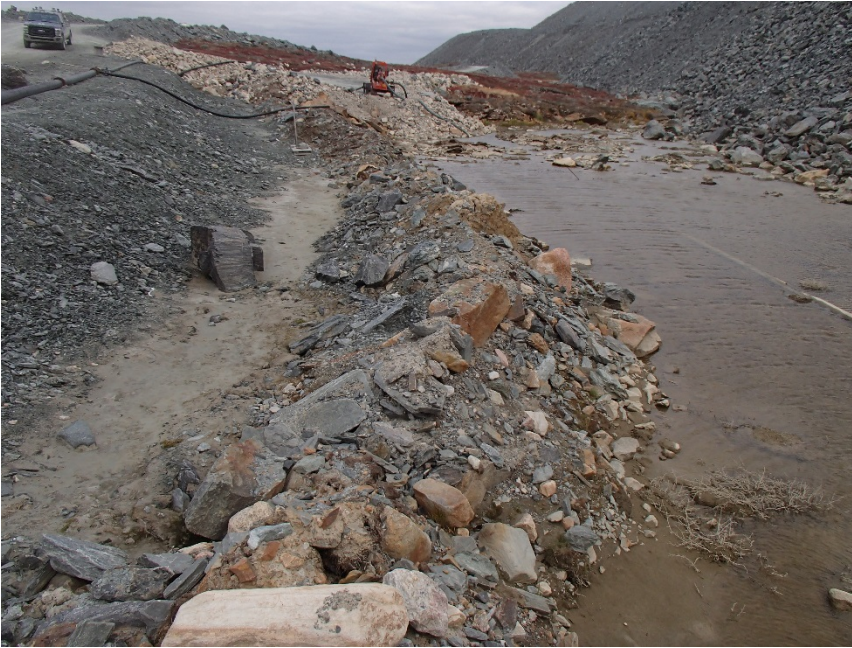
*Photograph H3-3 RSF Till Plug*

**Description:** From the south side of NP2 Lake (south of the diversion ditch) looking southeast at the RSF till plug.

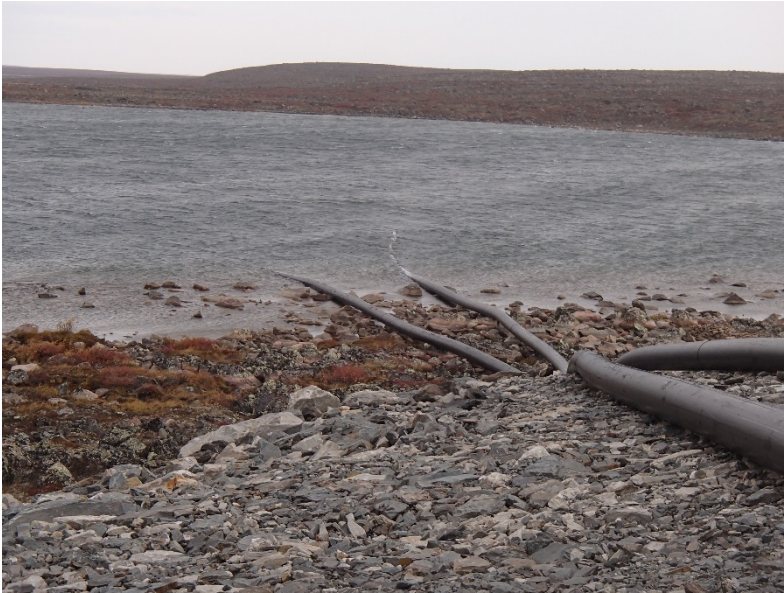
*Photograph H4-1 Diffusers – Vault Diffuser*

**Description:** Looking at the Diffuser at Vault. In good condition.

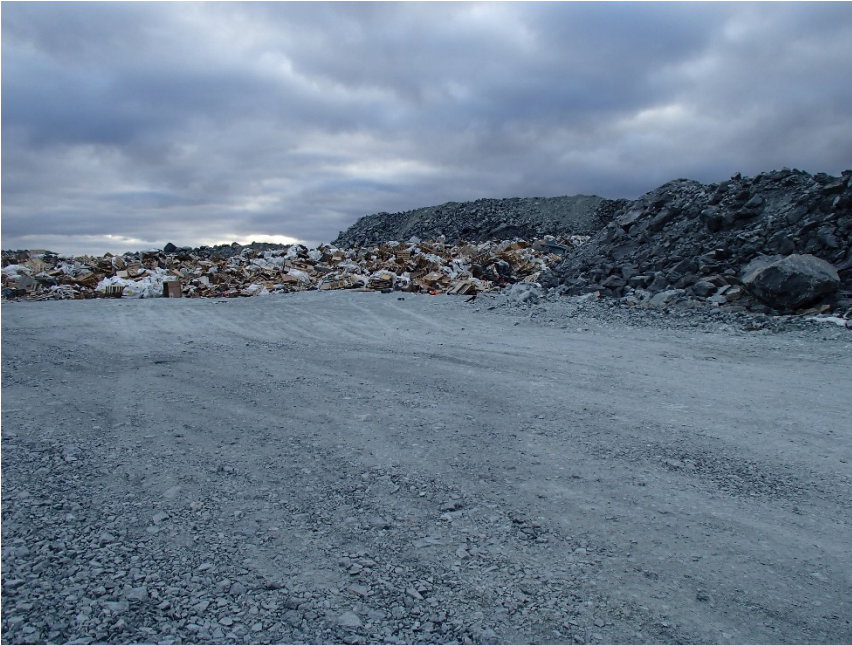
*Photograph H5-1 Landfill*

**Description:** From 638857E/7215767N, looking north at the landfill.

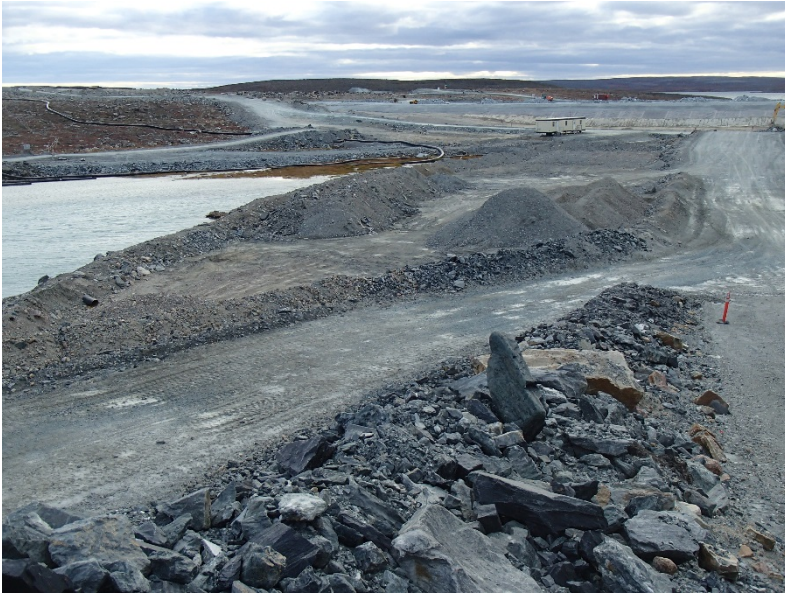
*Photograph H6-1 Contaminated Soil Storage and Bioremediation Landfarm Facility*

**Description:** Looking southwest at the Contaminated Soil Storage and Bioremediation Landfarm Facility located within the South Cell of the TSF.

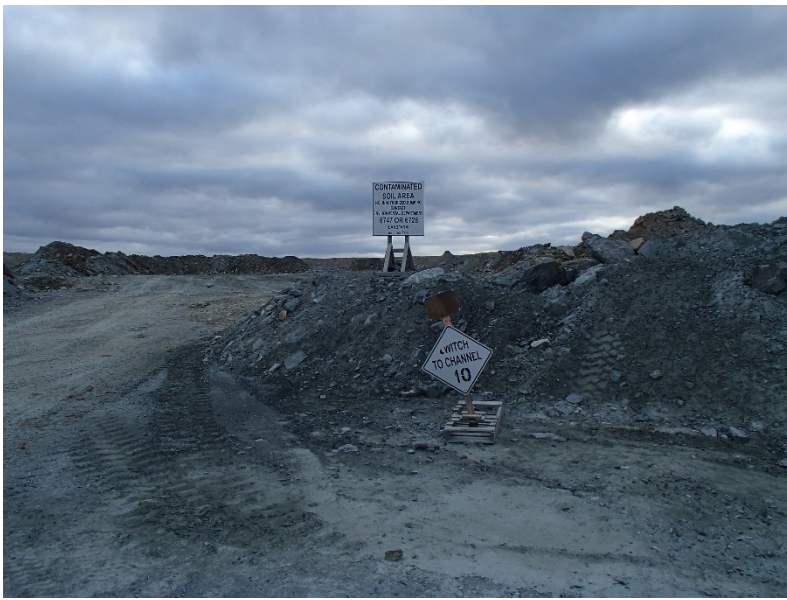
*Photograph H6-3 Contaminated Soil Storage and Bioremediation Landfarm Facility*

**Description:** From the northeast extremity of the South Cell, looking northwest at the new Contaminated Soil Storage and Bioremediation Landfarm Facility located within the South Cell of the TSF, north of Central Dike.

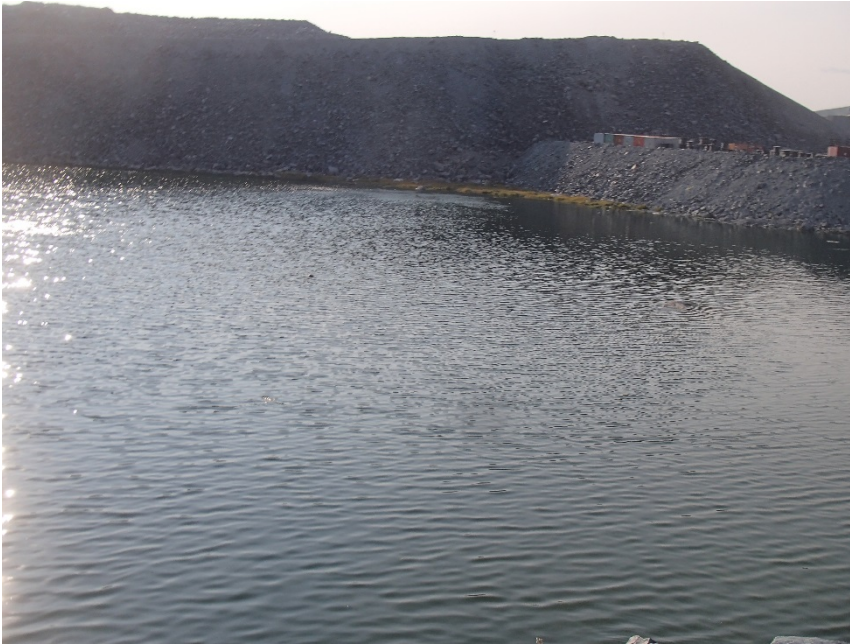
*Photograph H7-1 Stormwater Pond*

**Description:** From the northern side of the pond, looking west at Stormwater Pond and crusher ramp.

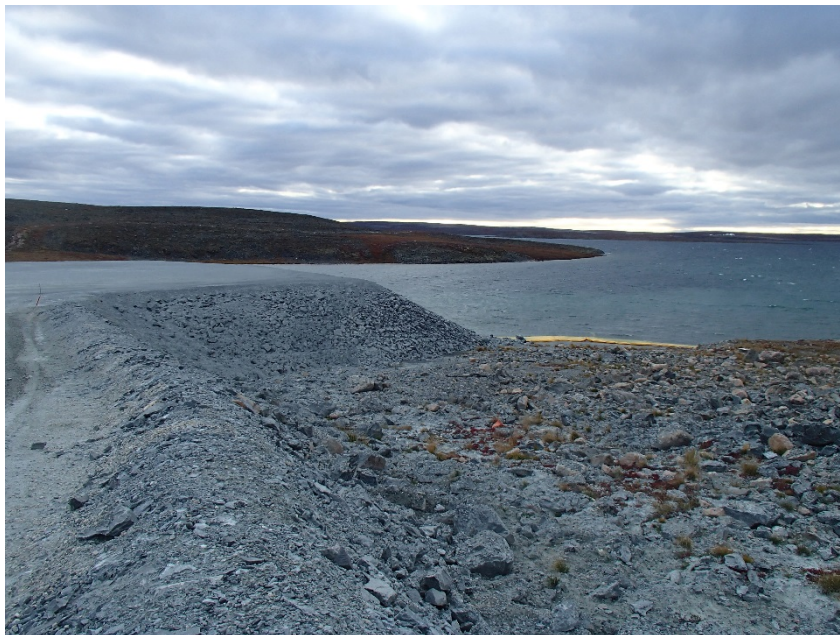
*Photograph H8-1 Airstrip*

**Description:** Looking west at the extremity of the airstrip located within Third Portage Lake.

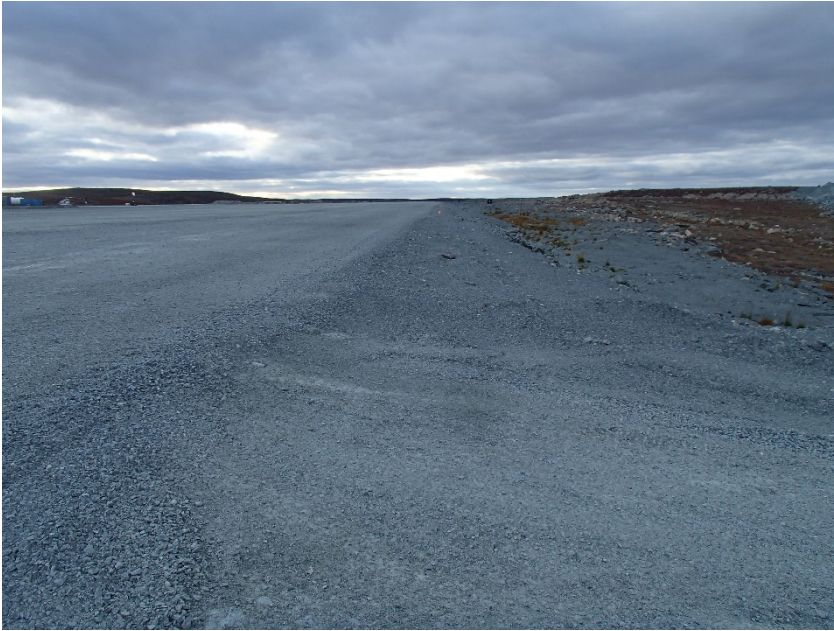
*Photograph H8-3 Airstrip*

**Description:** From the northeast side of the airstrip looking northwest.

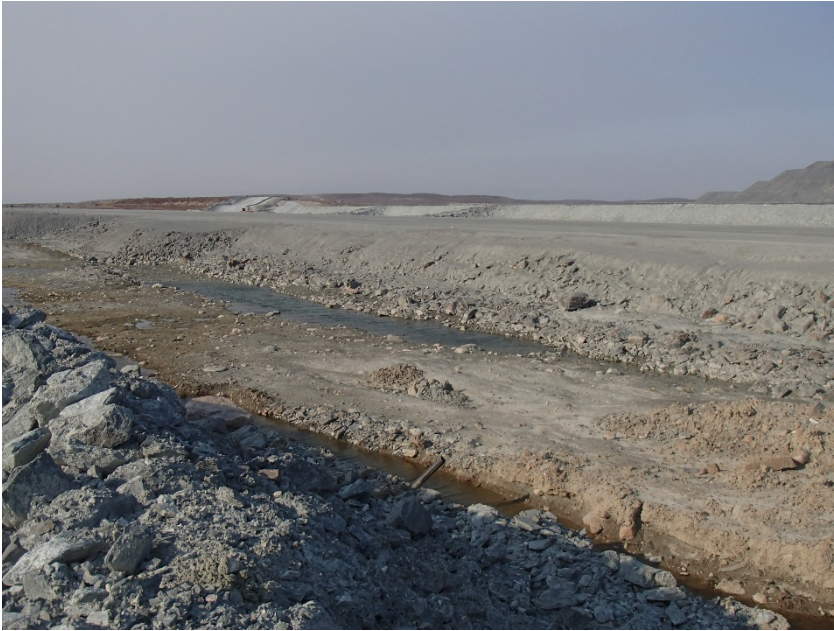
*Photograph H8-5 Airstrip*

**Description:** From the southeast side of the airstrip looking northwest.
