Report: 2016 Annual Geotechnical Inspection

2016 Annual Geotechnical Inspection Meadowbank Gold Mine, Nunavut

Agnico-Eagle Mines Limited
Meadowbank Division
PO Box 540
Baker Lake, Nunavut X0C 0A0

Report Number: Doc 1549 1662181 Rev0

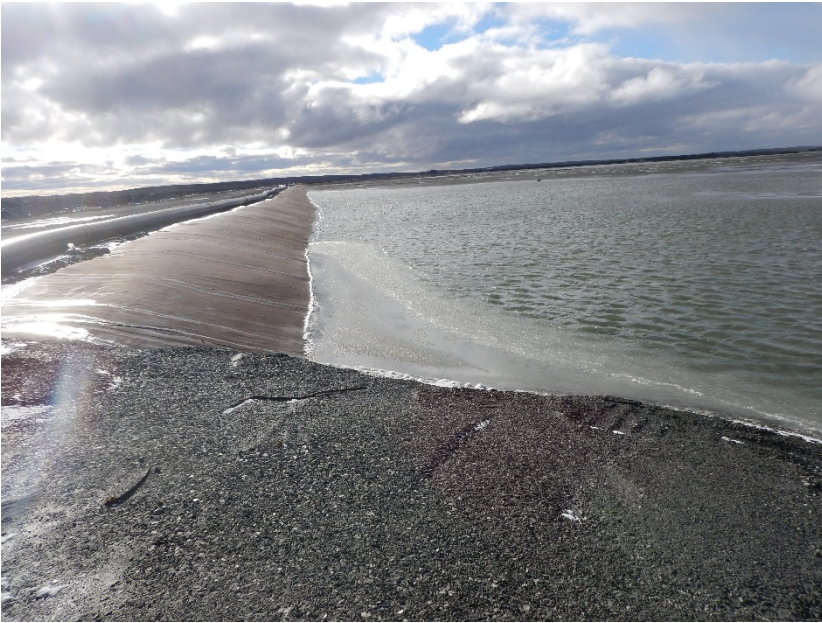
Photograph B4-1 Stormwater Dike

- Shallow water (30 cm deep) was observed ponding against a portion of Stormwater Dike in the North Cell. This small accumulation of water against the dike is not considered a problem.

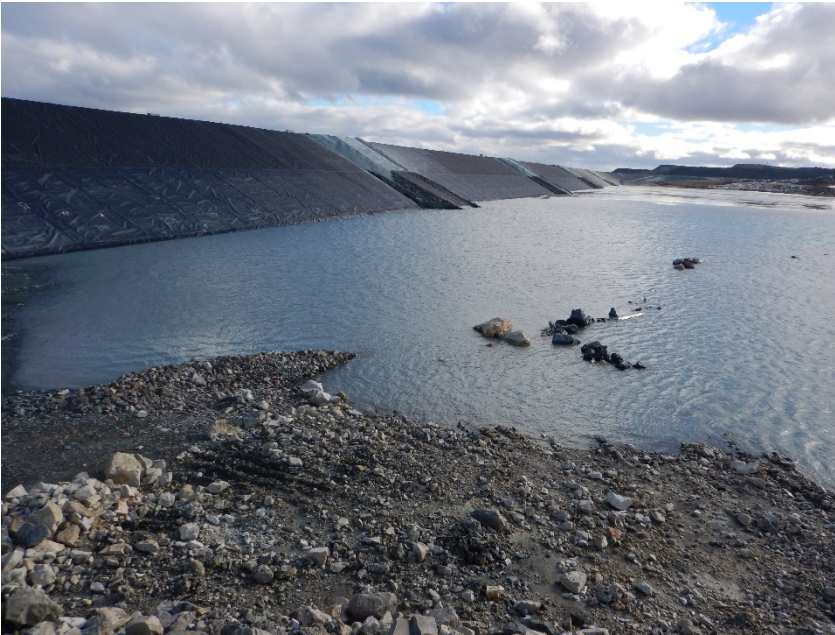
Photograph B7-1 Central Dike

Description: From the north of Central Dike within the South Cell looking south. View of the upstream slope of Central Dike. There is water ponding directly against the north section of the structure.

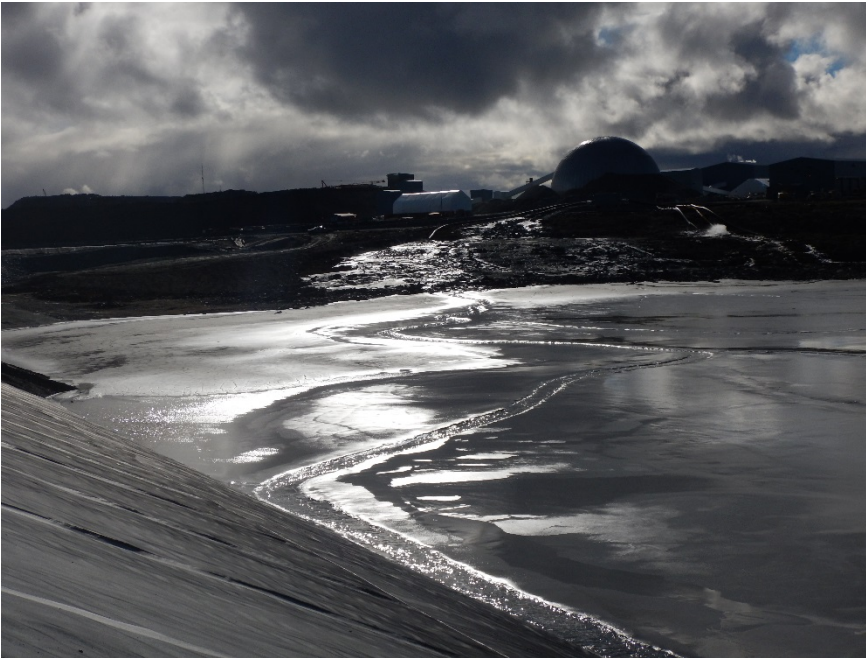
Photograph B7-3 Central Dike

Description: From approximately Sta. 0+700 looking southwest at the upstream slope. Adequate tailings beach against the south section of the structure.

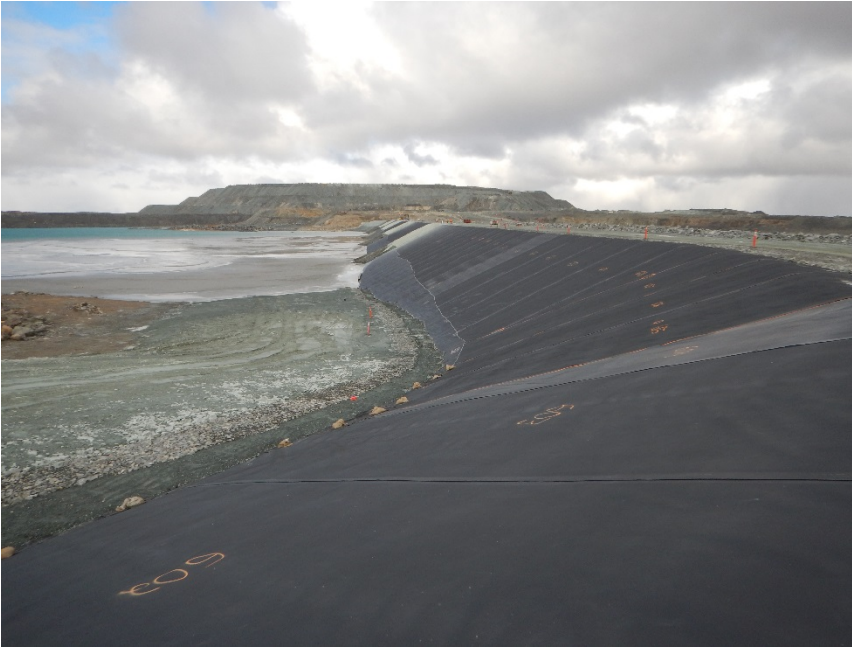
Photograph B7-5 Central Dike

Description: From approximately Sta. 0+920 looking northwest at the upstream slope.

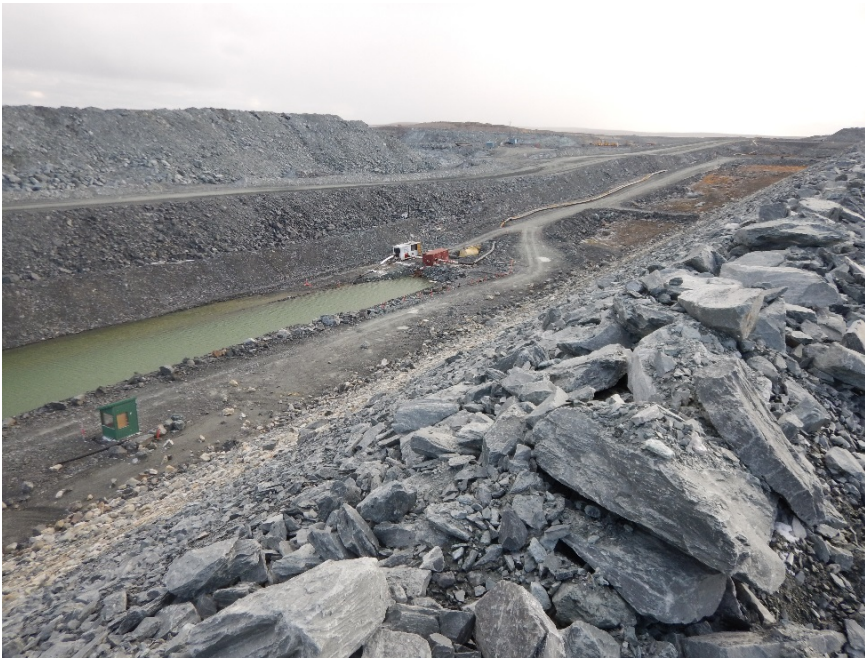
Photograph B7-7 Central Dike

- Seepage from the South Cell is ponding on the downstream side of Central Dike. At the time of the inspection, the water was clear and an average flow of approximately 550 m³/hr was pumped back to the South Cell to maintain the downstream pond at El. 115 m. AEM is working closely with the MDRB and the dike designer (Golder) to determine the seepage pathway and to establish measures to keep the situation under control. Golder recommends: 1) maintaining a tailings beach against Central Dike, 2) controlling the hydraulic gradient by proper management of the South Cell water pond and dike downstream toe pond, 3) closely monitoring the water quality; and 4) inspecting the structure for changing conditions.

Description: From approximately Sta. 0+720 looking southeast at the downstream slope and toe. View of the downstream pond and pumping system.

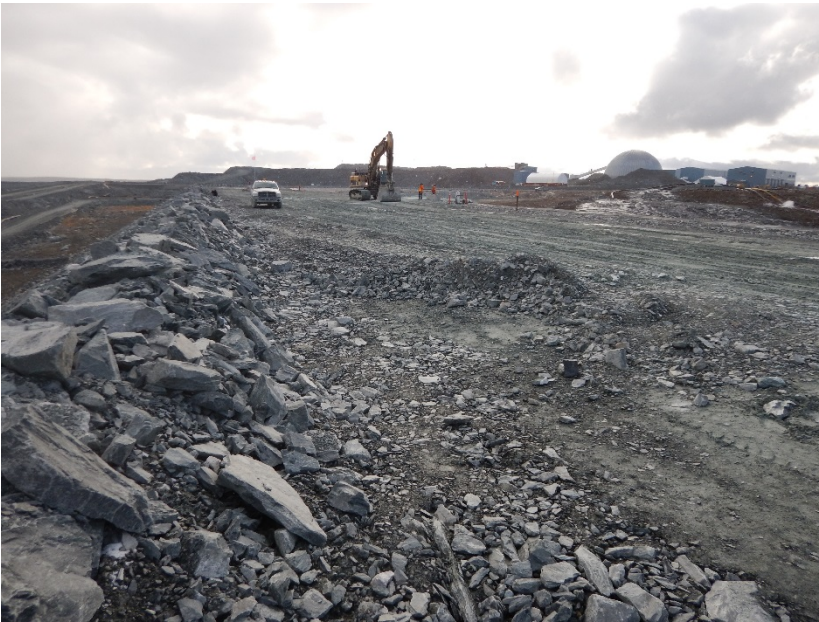
Photograph B7-9 Central Dike

Description: From approximately Sta. 0+720 looking south at the crest.

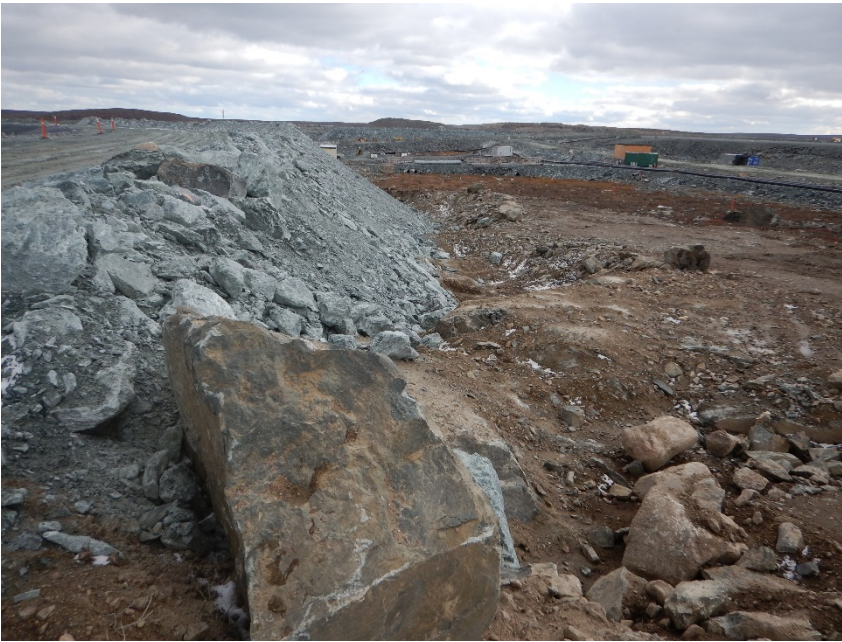
Photograph B7-11 Saddle Dam 5

Description: From 40+620 downstream, looking southeast at the downstream toe area.

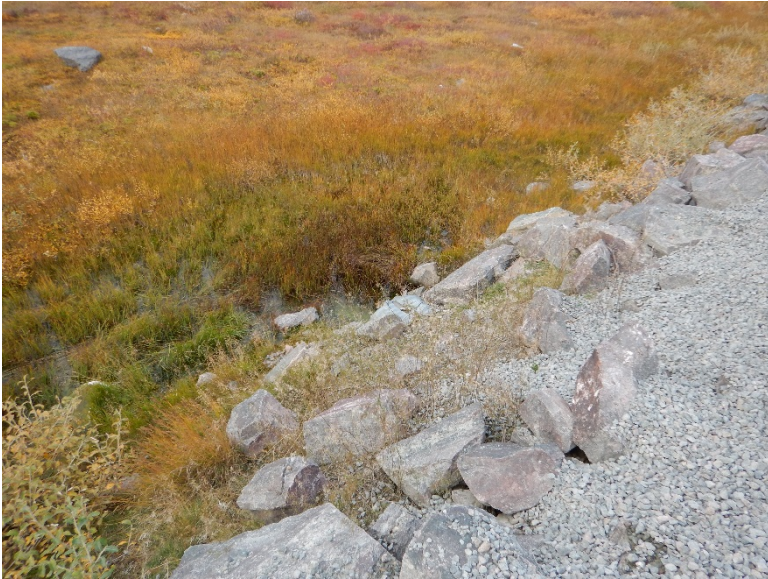
Photograph D1-1: PRC1 km 0+430

Description: View of culvert inlet, in good condition no sign of obstruction.

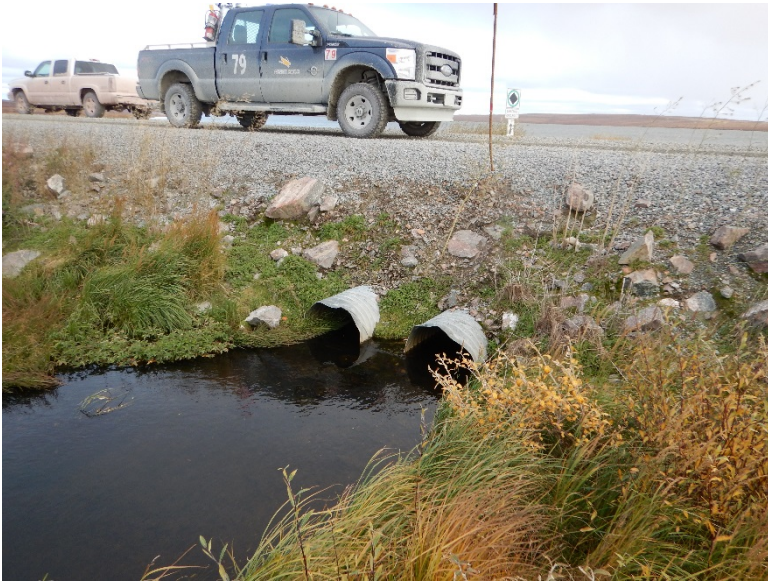
Photograph D1-3: PRC2 km 0+470

Description: View of culverts inlet. In good condition.

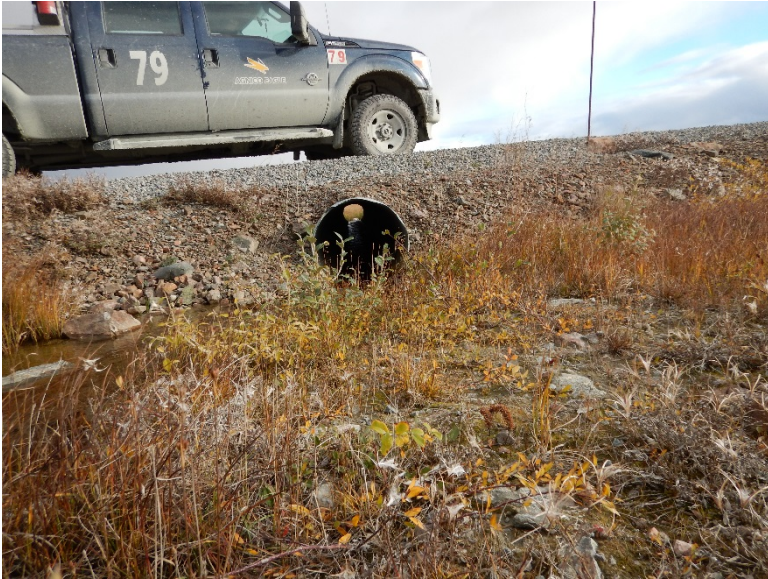
Photograph D1-5: PRC3 km 1+380

Description: View of culvert inlet. In good condition.

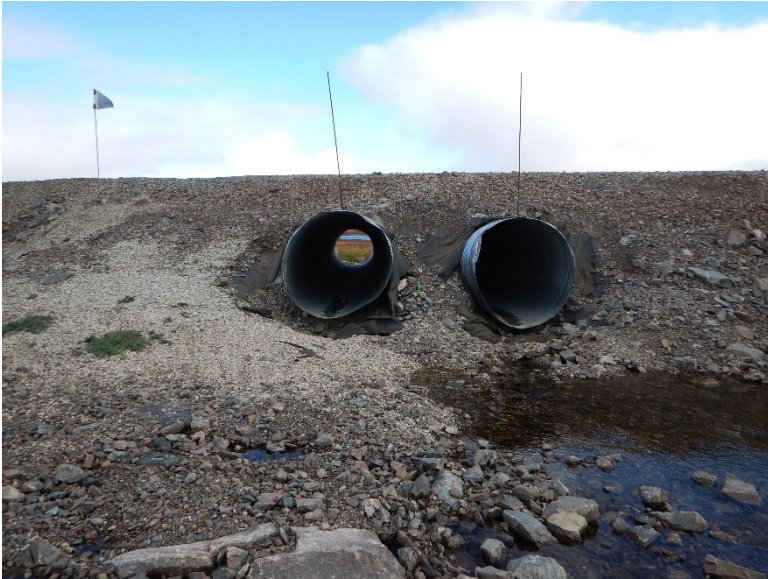
Photograph D1-13: PC-17A km 8+830

Description: View of the culverts inlet. Sign of erosion and flow of water beneath the inlet.

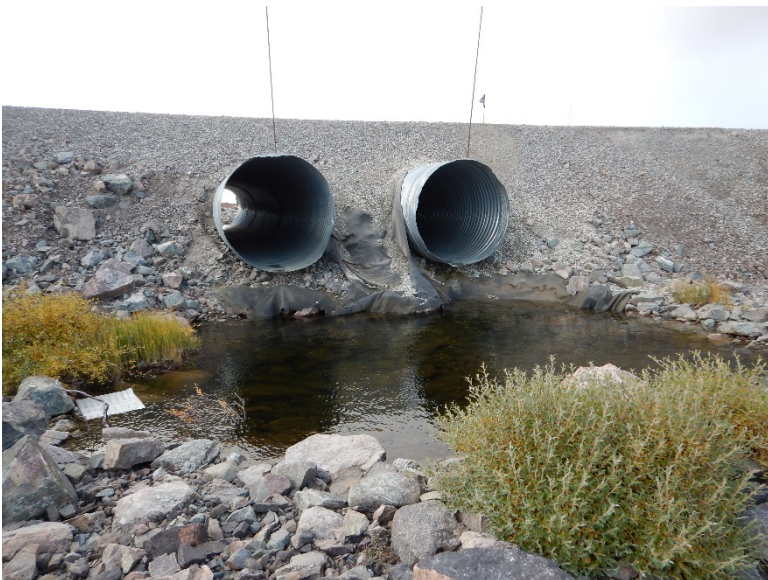
Photograph D1-14: PC-17A km 8+830

Description: View of the culverts outlet (left side of the picture). The culverts were installed too high. Sign of erosion, flow of water beneath the culverts and deterioration.

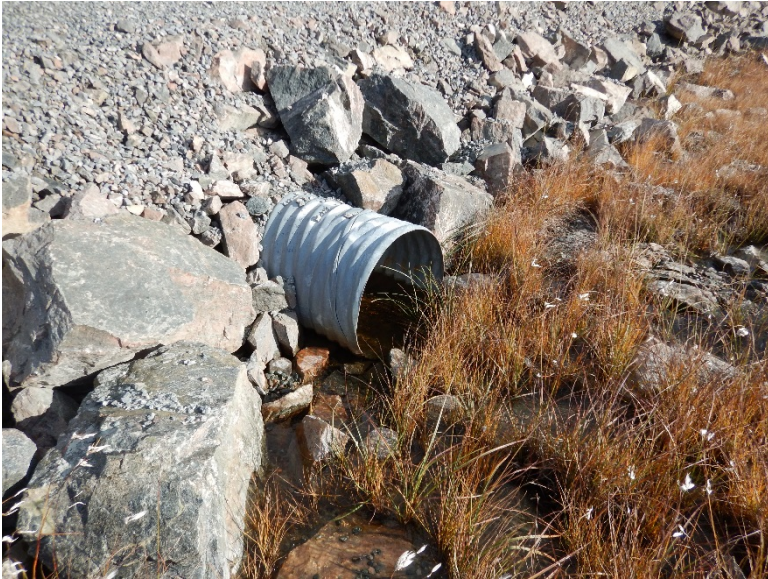
Photograph D1-19: R-03 km 10+580

Description: View of the culvert inlet. In good condition.

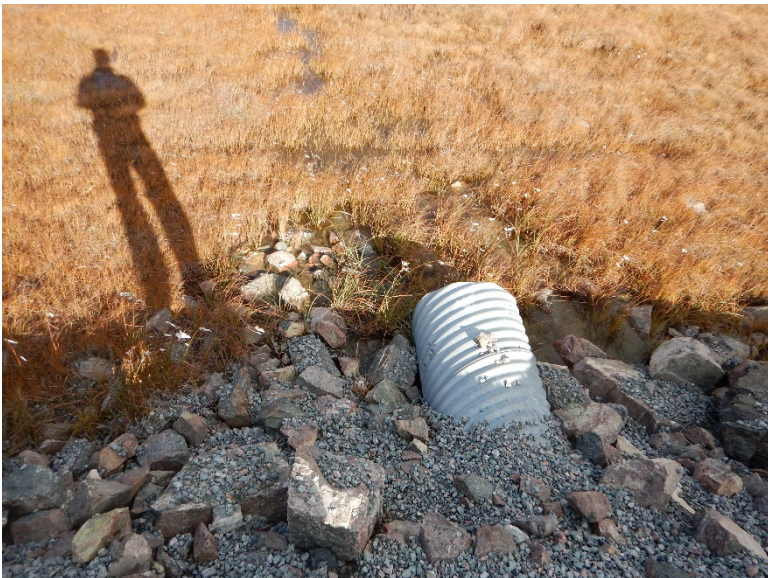
Photograph D1-20: R-03 km 10+580

Description: View of the culvert outlet. In good condition.

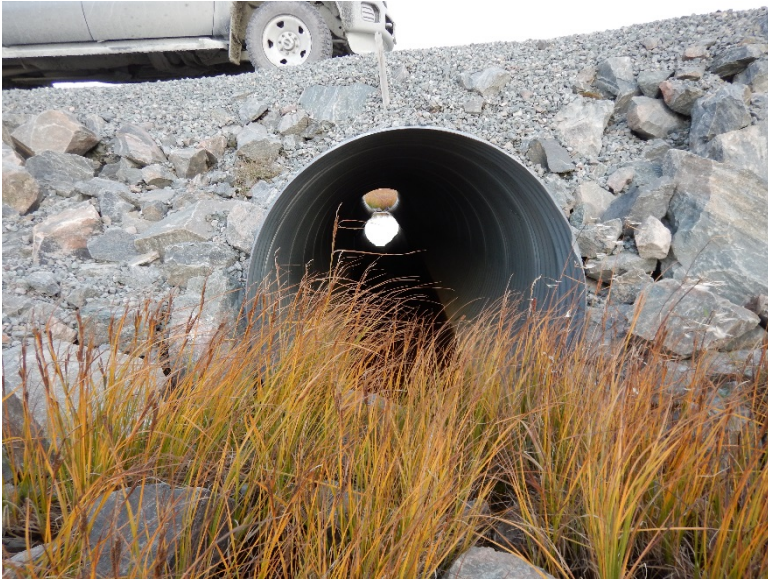
Photograph D1-21: R-04 km 12+050

Description: View of the culvert inlet. In good condition.

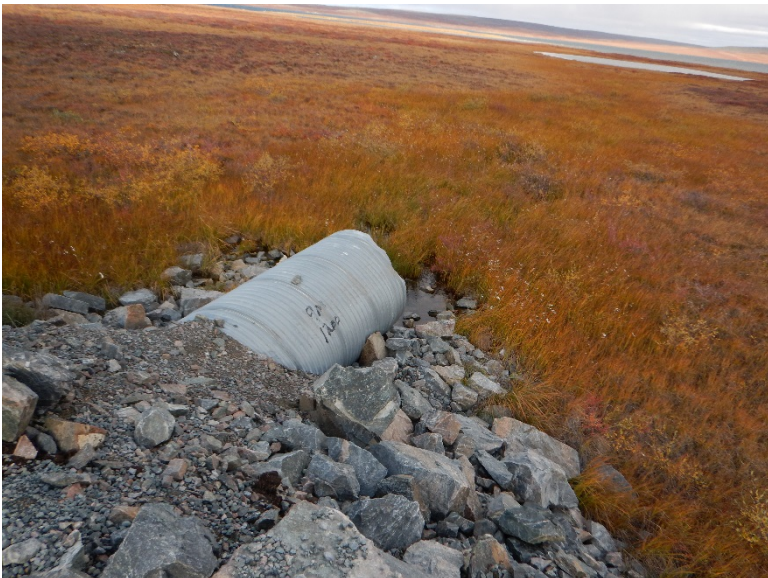
Photograph D1-22: R-04 km 12+050

Description: View of the culvert outlet. In good condition.

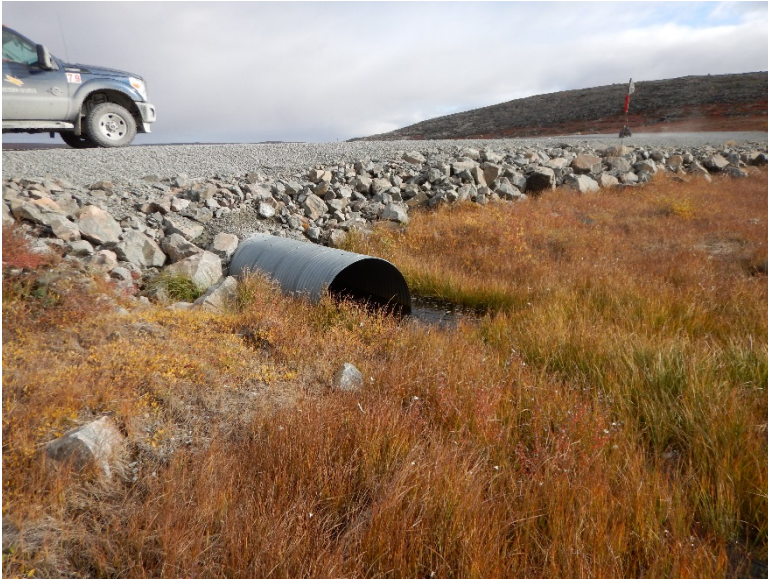
Photograph D1-33: R-05A km 15+745

Description: View of the culvert inlet. In good condition.

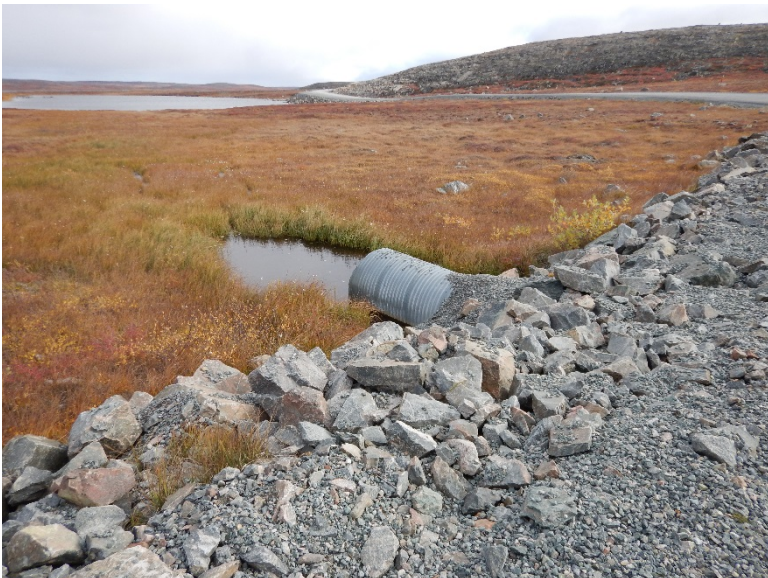
Photograph D1-34: R-05A km 15+745

Description: View of the culvert outlet. In good condition.

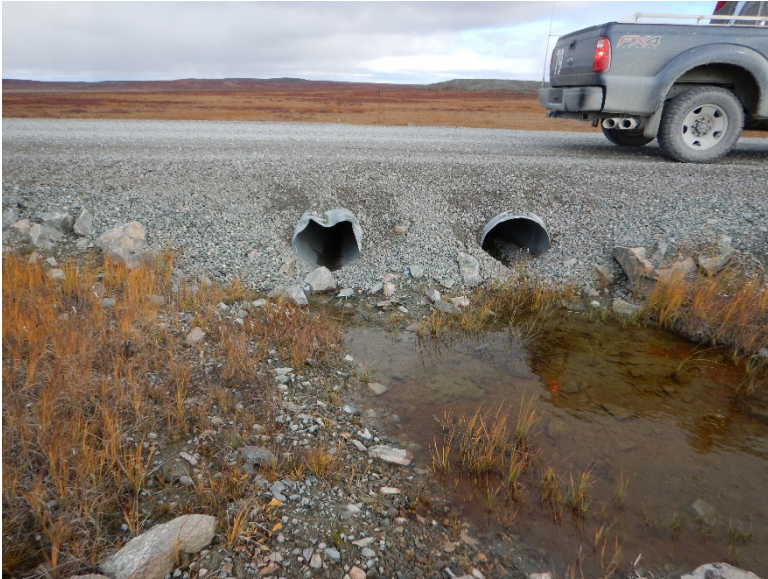
Photograph D1-39: PC-7A km 20+240

Description: View of culverts inlet. Inlet of southern culvert partially obstructed.

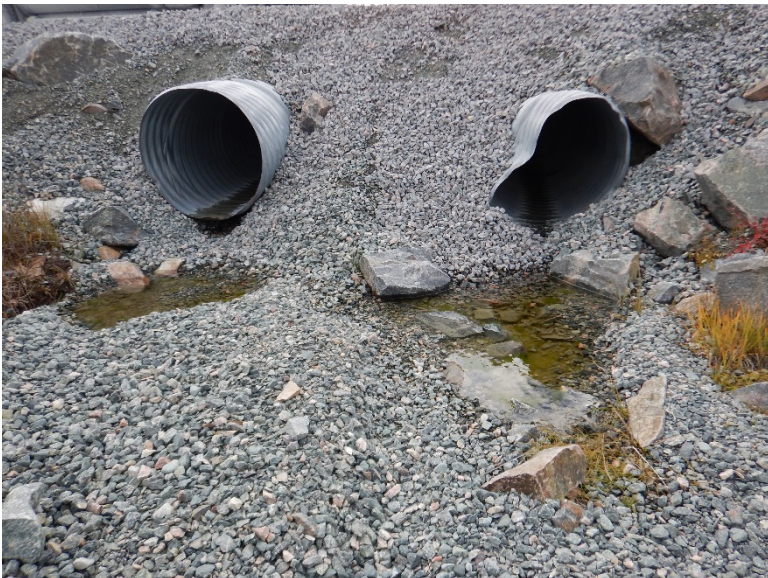
Photograph D1-40: PC-7A km 20+240

Description: View of culverts outlet. Outlet of northern culvert damaged.

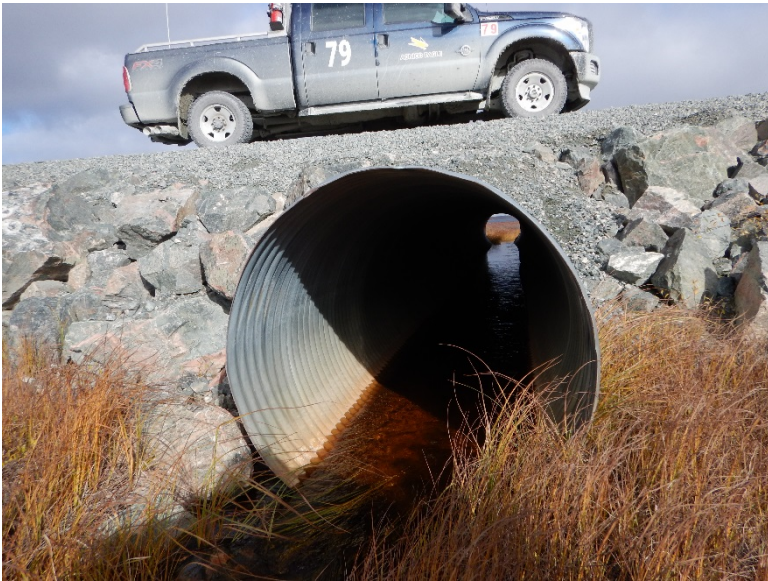
Photograph D1-43: R-07 km 25+900

Description: View of the culvert inlet. In good condition.

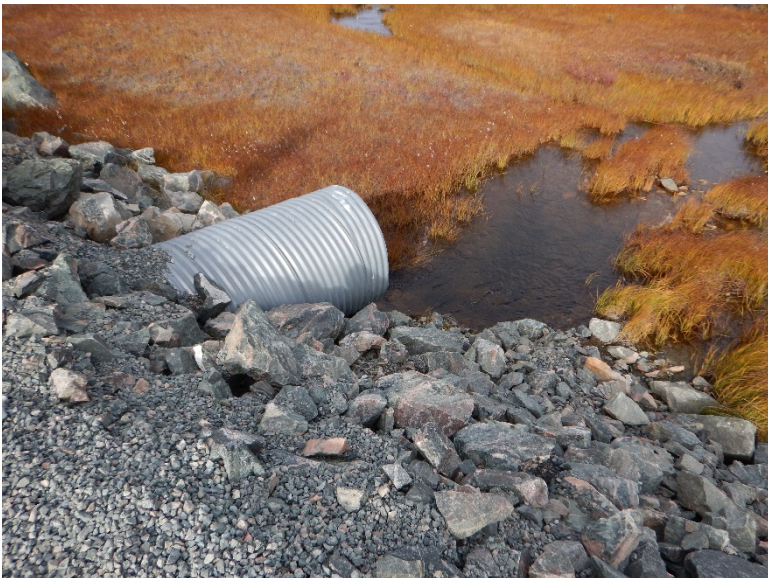
Photograph D1-44: R-07 km 25+900

Description: View of the culvert outlet. In good condition.

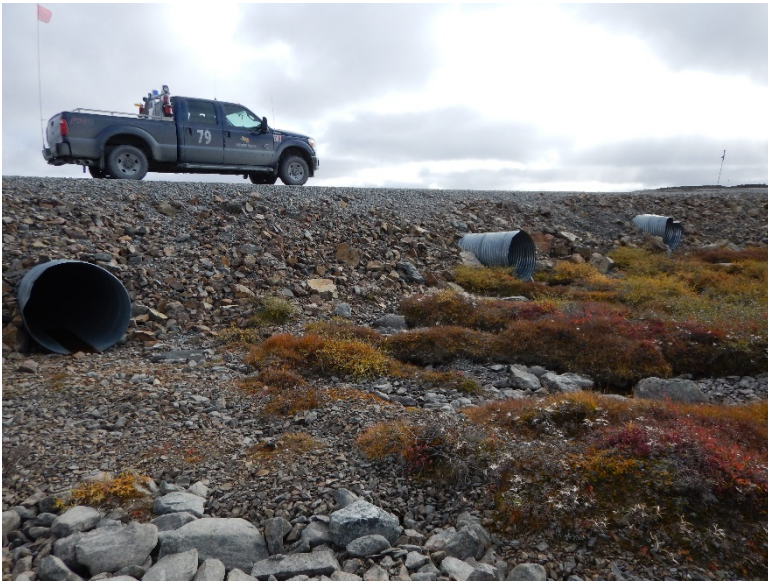
Photograph D1-55: R-14 km 67+840

Description: View of the inlet culverts. Middle and northern culverts are collapsed inside (hole in the middle). Expected to continue performing well.

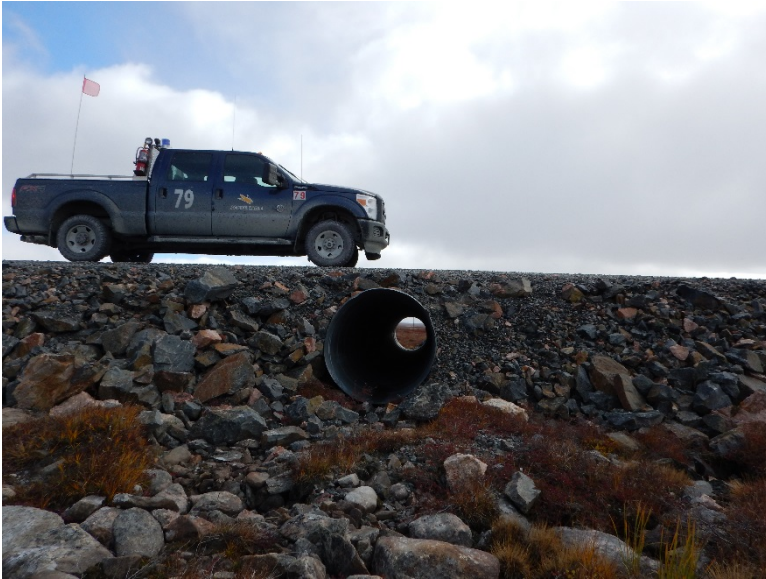
Photograph D1-57: R-17 km 77+440

Description: View of the culvert inlet. In good condition.

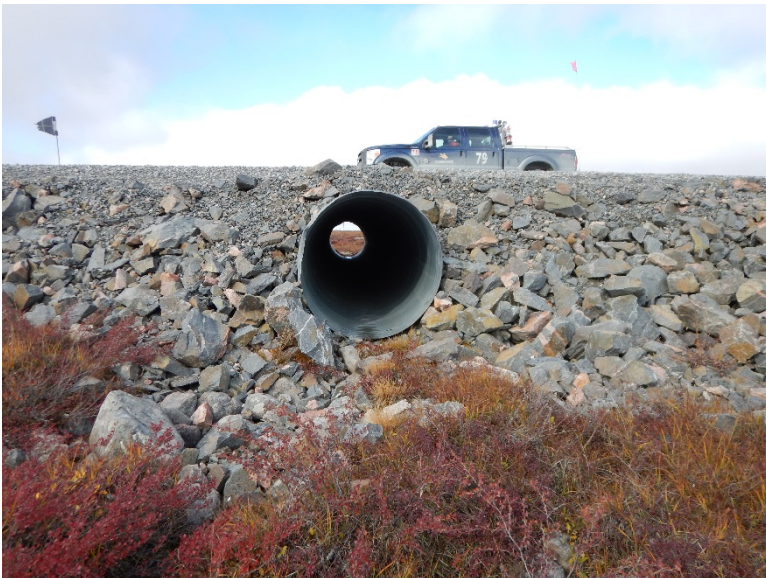
Photograph D1-58: R-17 km 77+440

Description: View of the culvert outlet. In good condition.

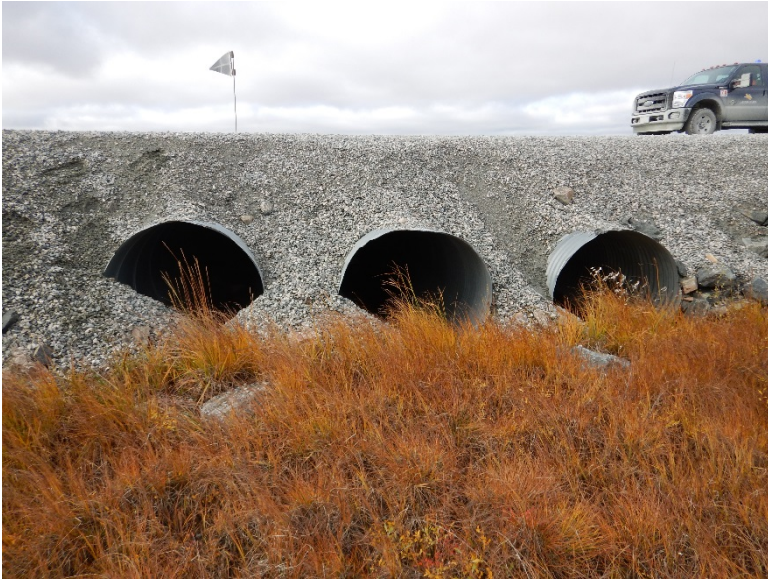
Photograph D1-59: R-18A km 80+950

Description: View of the culverts inlet. In good condition. The southern culvert inlet is partially buried.

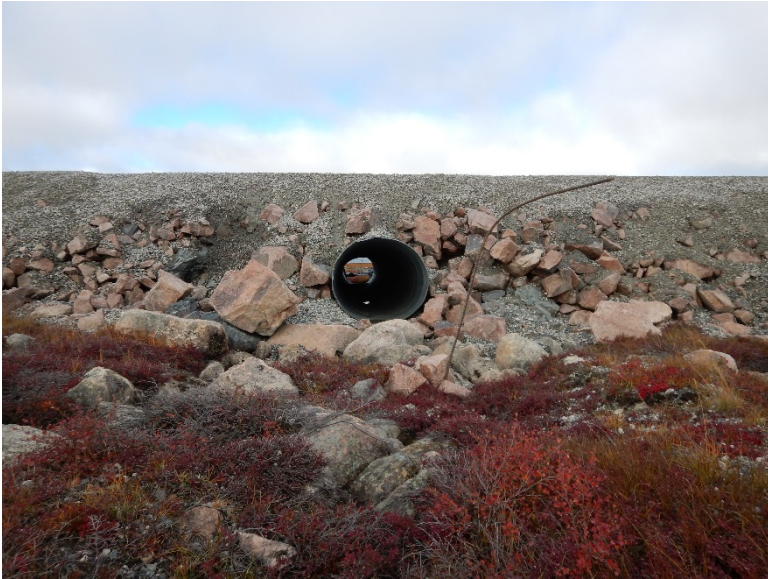
Photograph D1-63: R-20 km 85+490

Description: View of the culvert inlet. The middle of the culvert is slightly collapsed. The inlet is installed above the ground surface and water flows beneath the culvert. The culvert is in stable condition.

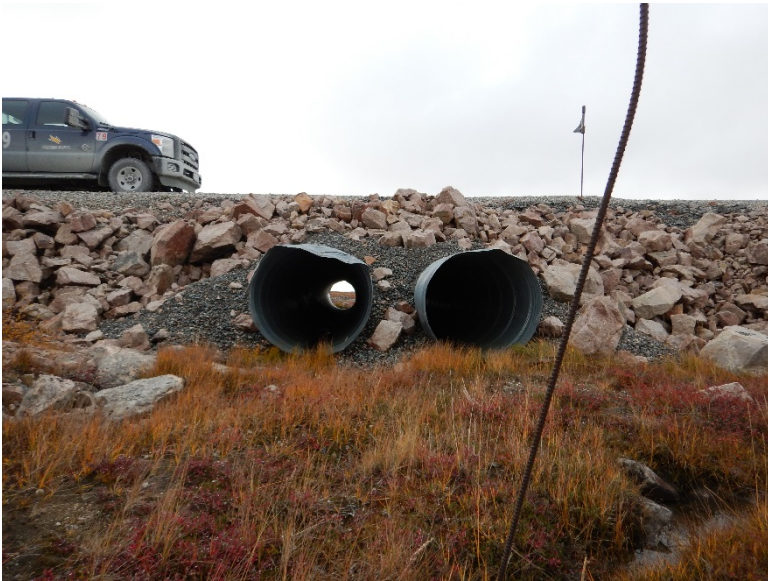
Photograph D1-65: R-21 km 87+300

Description: View of the culverts inlet. Both culverts are slightly collapsed in the middle. In stable condition, but should have been installed lower to avoid erosion issue.

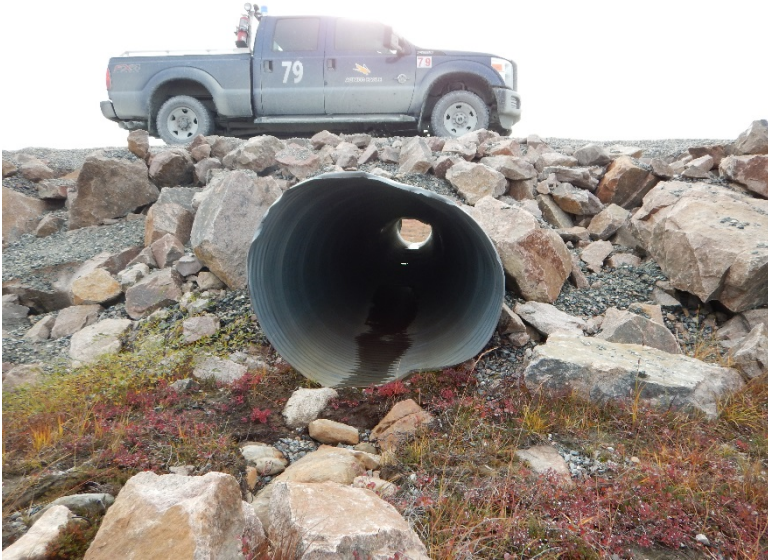
Photograph D1-67: R-23 km 93+600

Description: View of the culvert inlet. The culvert is installed too high and there is a low flow of water through the road rockfill. In good condition.

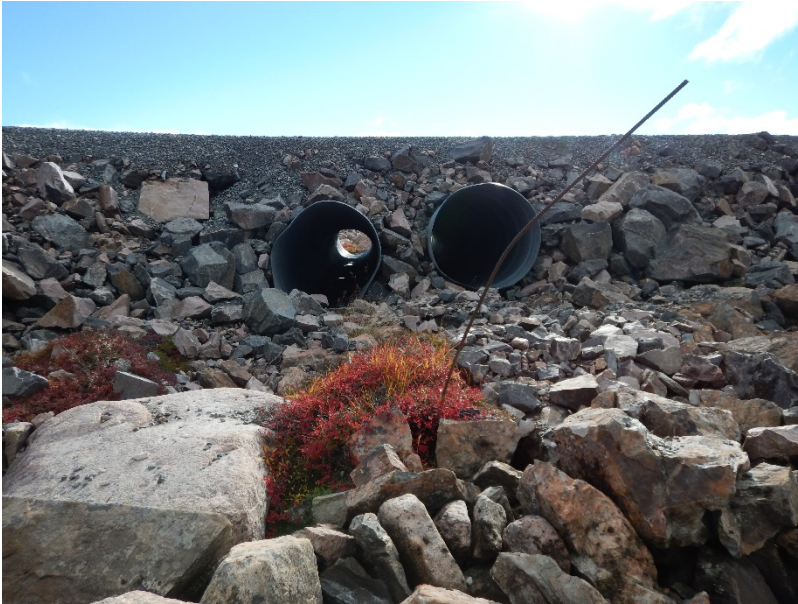
Photograph D1-69: R-24 km 98+100

Description: View of the culverts inlet. South inlet is installed too high. Both culverts show deformation in the upper part.

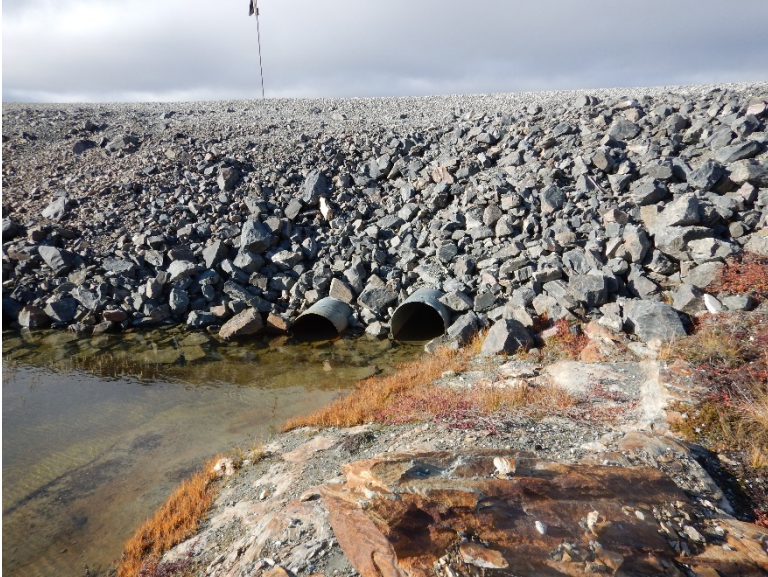
Photograph D1-71: R-25 km 101+950

Description: View of the culverts inlet. In good condition.

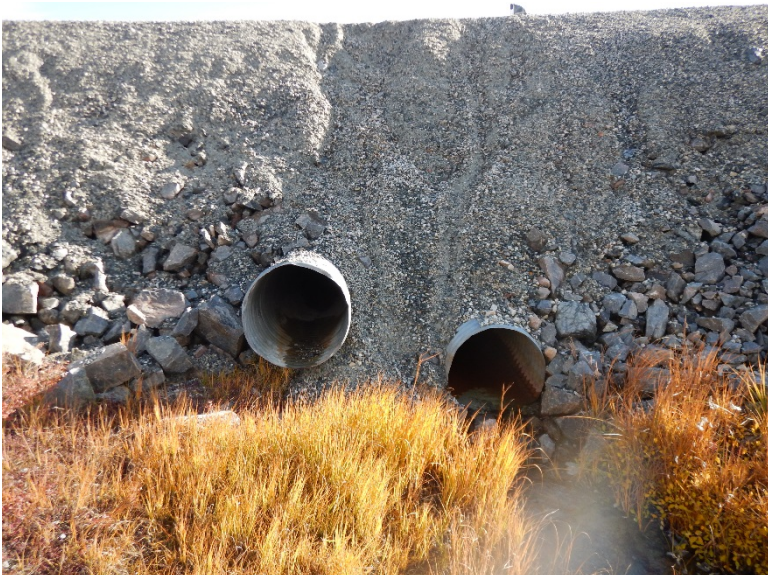
Photograph D1-72: R-25 km 101+950

Description: View of the culverts outlet. In good condition.

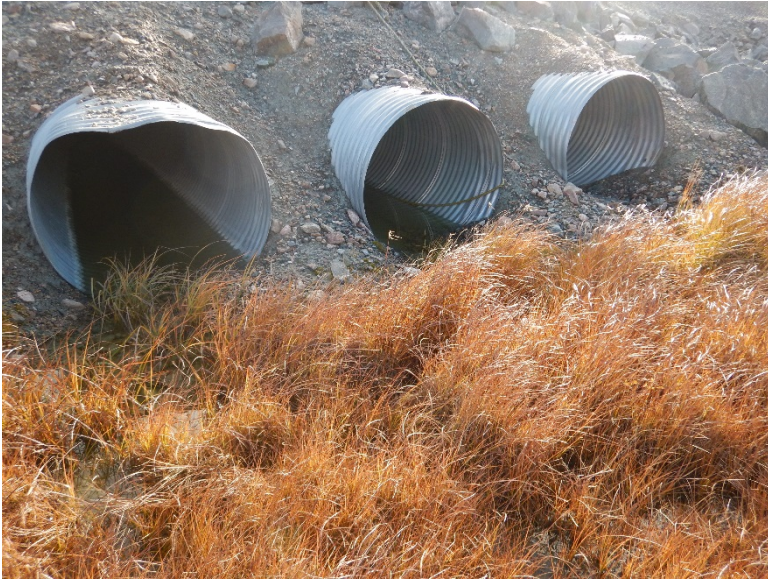
Photograph D1-73: R-26 km 104+400

Description: View of the culverts outlet. In good condition.

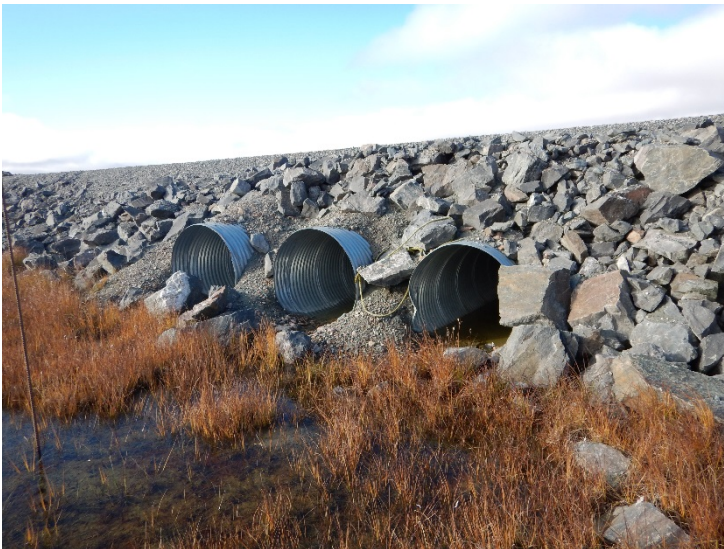
Photograph D1-74: R-26 km 104+400

Description: View of the culverts inlet. In good condition. Presence of a 0.4 m boulder in front of the west inlet. In good condition.

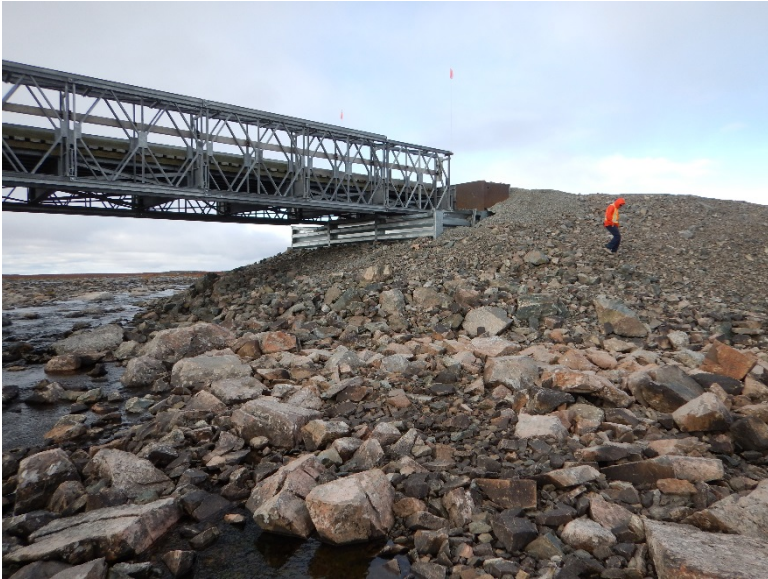
Photograph D2-1 Bridges 1 – R02 km 8+750

Description: Looking at the north abutment from downstream.

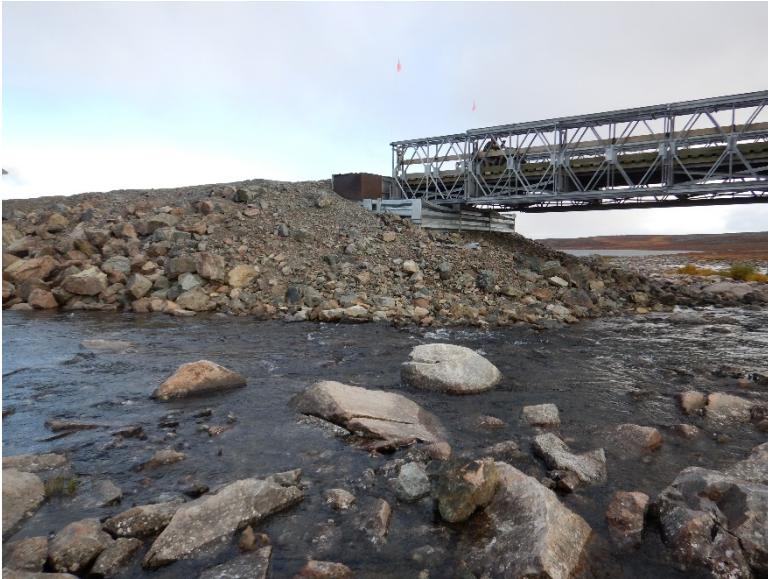
Photograph D2-3 Bridges 1 – R02 km 8+750

Description: Looking at the north abutment from upstream.

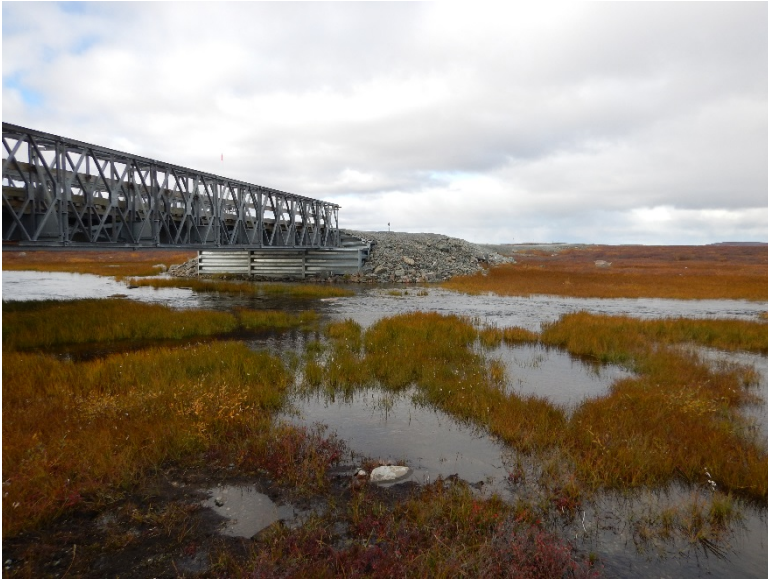
Photograph D2-5 Bridges 2 – R05 km 17+600

Description: Looking at the north abutment from downstream.

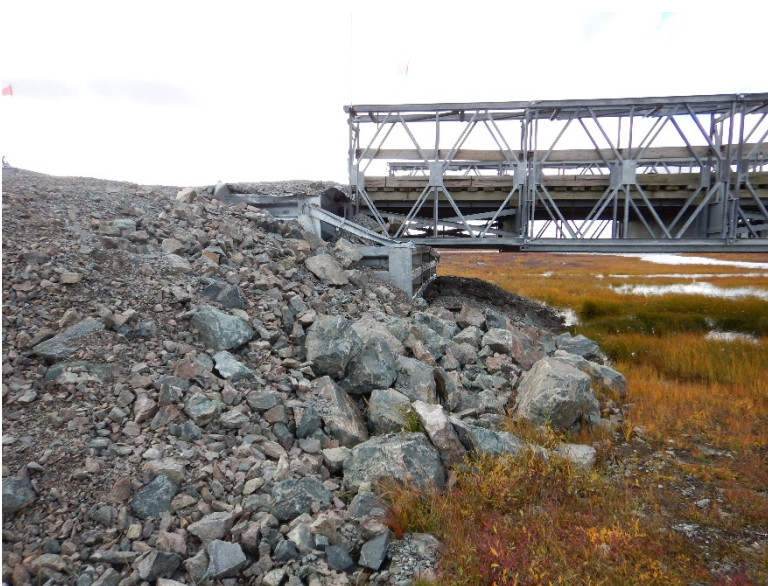
Photograph D2-6 Bridges 2 – R05 km 17+600

Description: Looking at the south abutment from downstream. Minor damage to the bin wall.

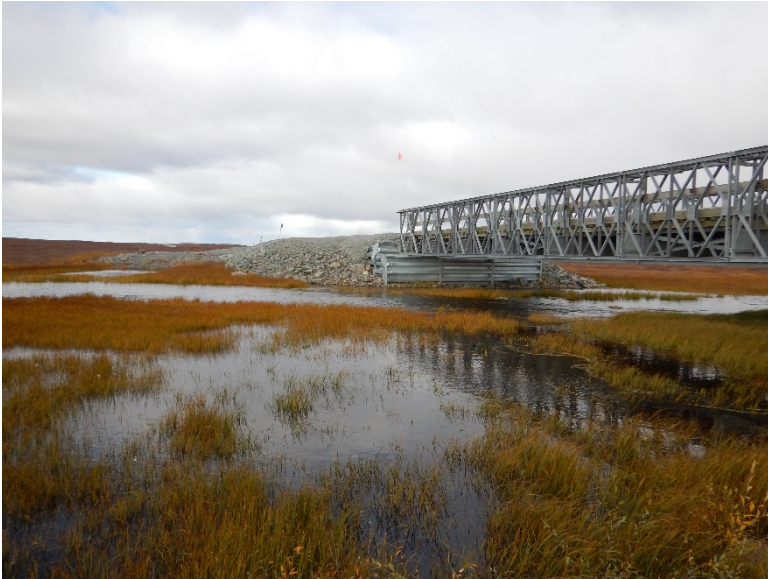
Photograph D2-7 Bridges 2 – R05 km 17+600

Description: Looking at the north abutment from upstream.

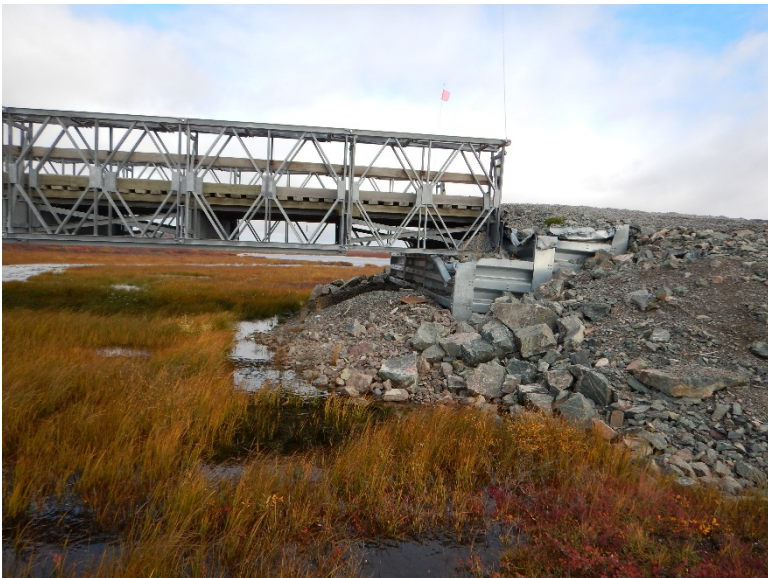
Photograph D2-8 Bridges 2 – R05 km 17+600

Description: Looking at the south abutment from upstream. Minor damage to the bin wall.

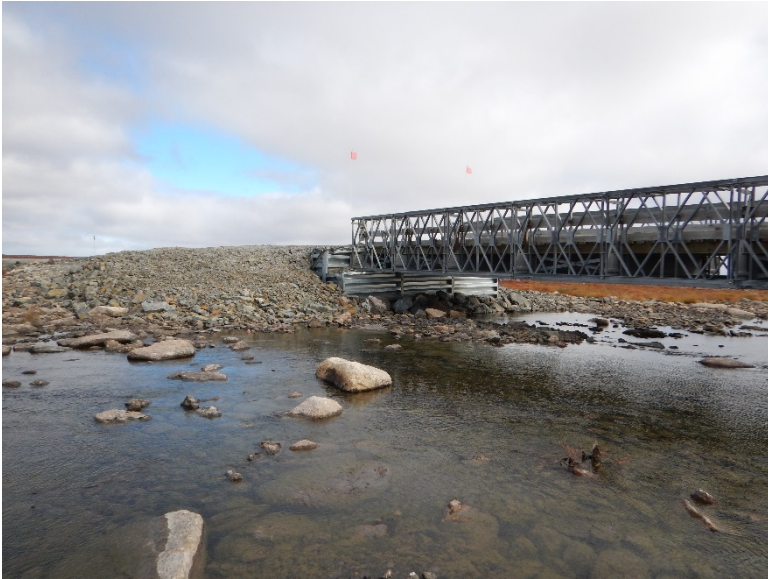
Photograph D2-17 Bridges 6 – R15 km 69+200

Description: Looking at the north abutment from upstream. Damage to the bin wall likely caused during snow removal activities. Bridge is tipping toward the west side on the abutment.

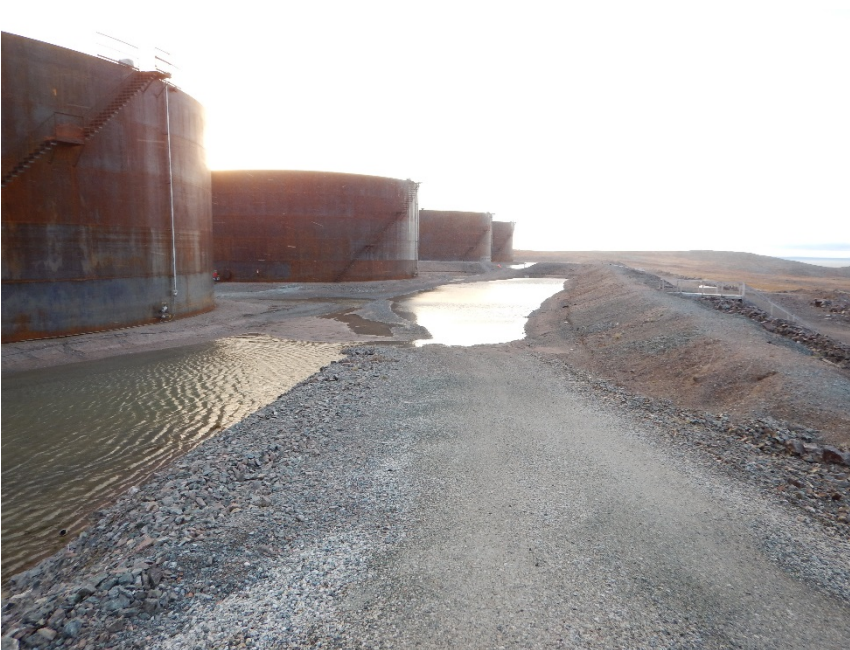
Photograph F1-1 Baker Lake Tank Farm

Description: From the south side of Tank 1, looking southeast at Tanks 1, 2, 3, and 4. Presence of water ponding.

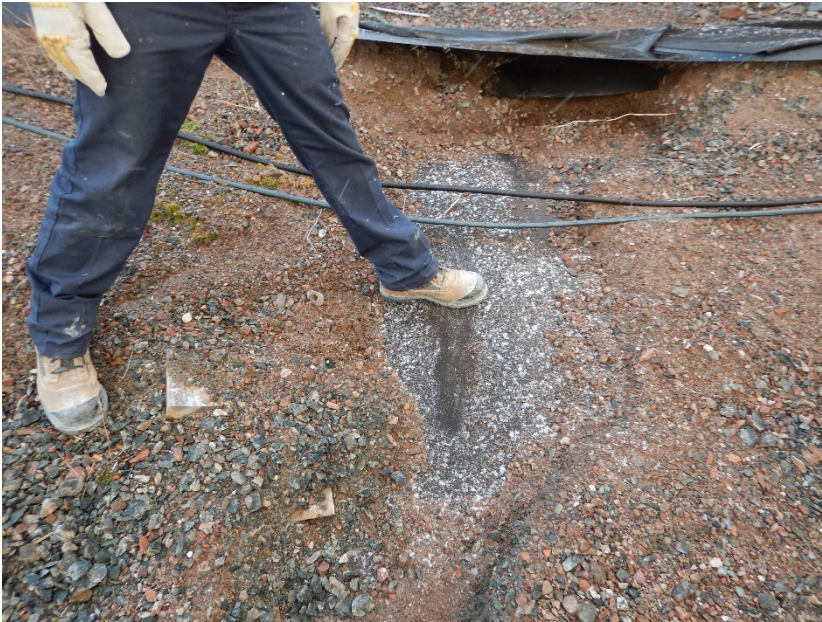
Photograph F1-3 Baker Lake Tank Farm

Description: Exposed area of geomembrane on the northwest side of Tank 1. Textile in place.

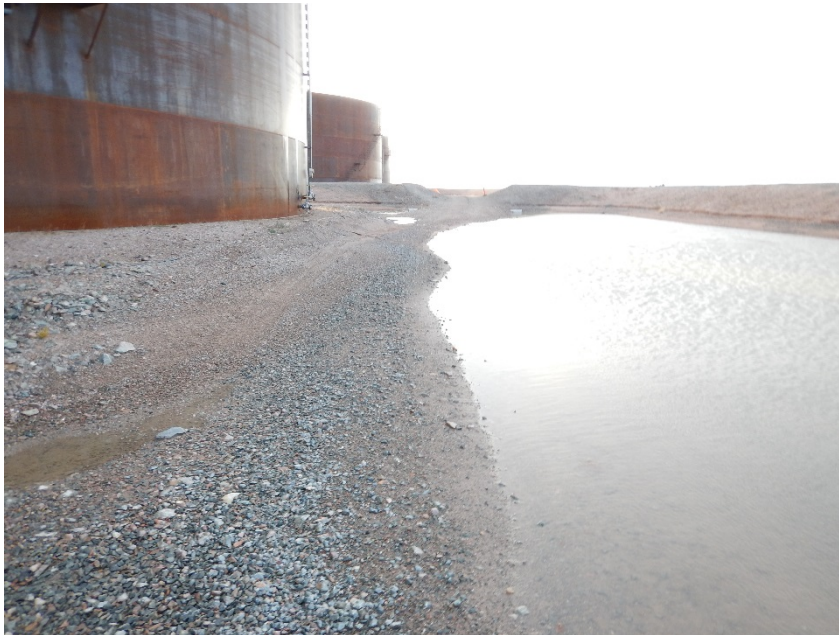
Photograph F1-5 Baker Lake Tank Farm

Description: Looking northeast toward the south side of Tanks 2 and 3. Presence of water ponding.

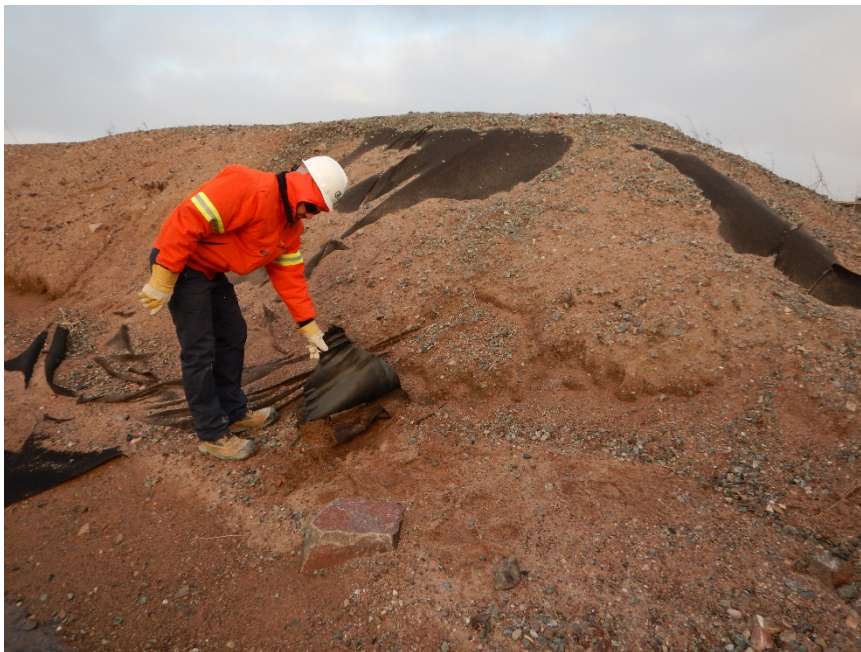
Photograph F1-6 Baker Lake Tank Farm

Description: The geomembrane between the south side of tank 2 and 3 is damaged.
