Report: 2016 Annual Geotechnical Inspection

2016 Annual Geotechnical Inspection Meadowbank Gold Mine, Nunavut

Agnico-Eagle Mines Limited
Meadowbank Division
PO Box 540
Baker Lake, Nunavut X0C 0A0

Report Number: Doc 1549 1662181 Rev0

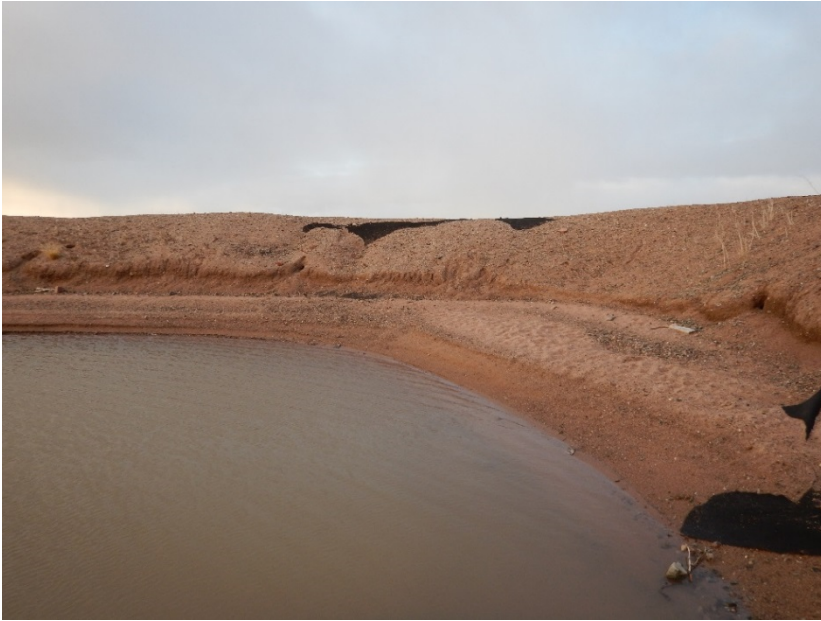
Photograph F1-7 Baker Lake Tank Farm

Description: From the southwestern corner of Tank 3 looking southwest. Presence of water ponding. View of exposed LLDPE.

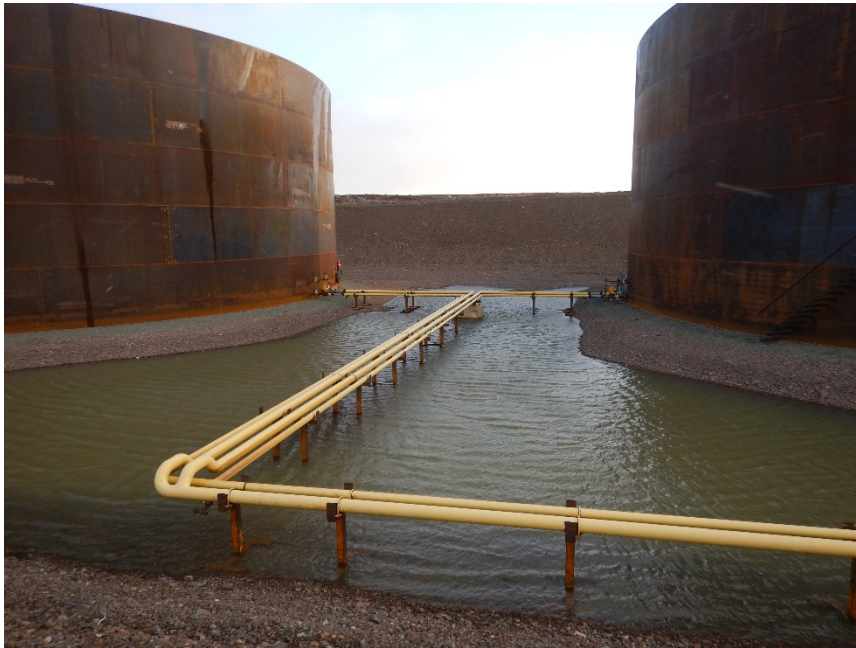
Photograph F1-17 Baker Lake Tank Farm

Description: Looking north between Tanks 5 and 6. Presence of water ponding.

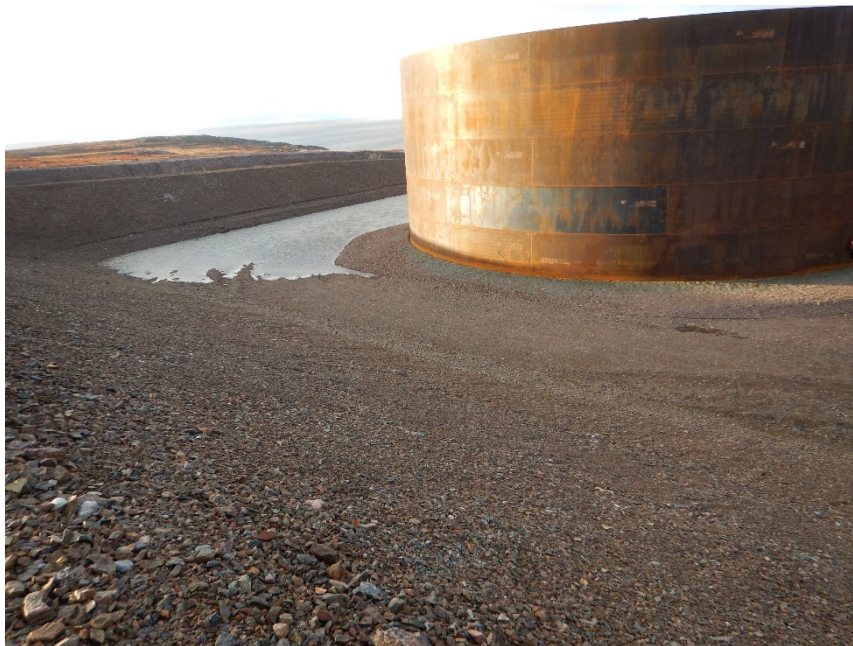
Photograph F1-19 Baker Lake Tank Farm

Description: Looking southeast at the northeastern side of Tank 6. Presence of water ponding.

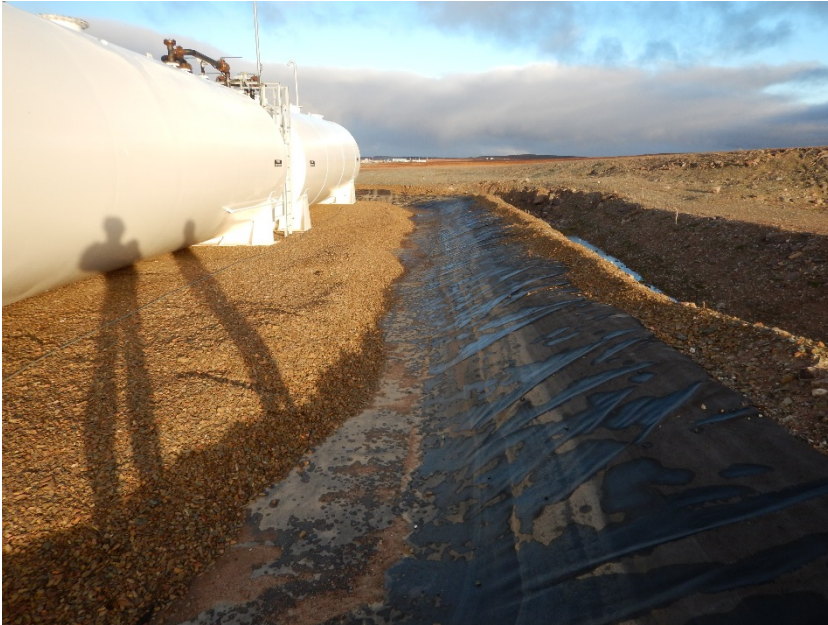
Photograph F1-23 Baker Lake Tank Farm

Description: From the northeastern corner of the Jet A fuel tanks looking west. Presence of exposed geomembrane.

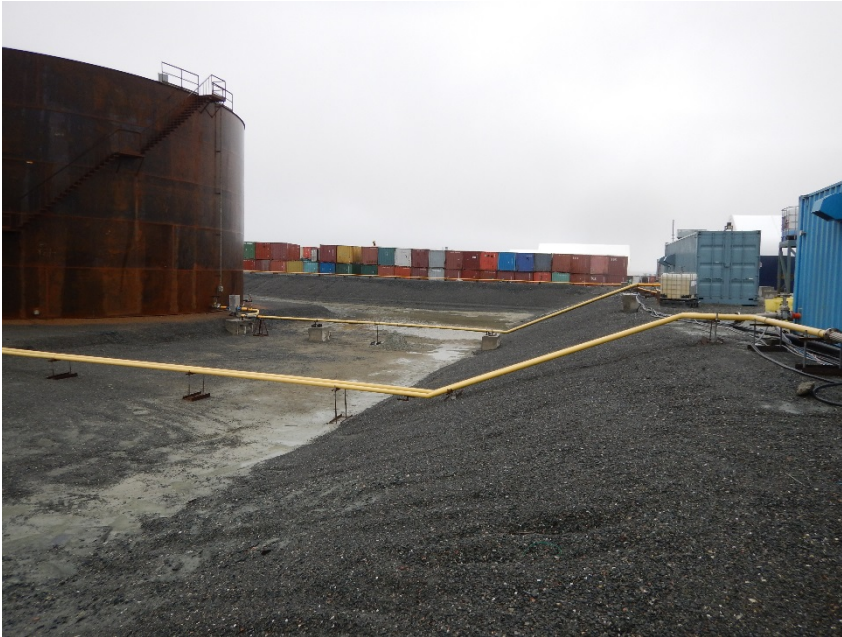
Photograph F2-5 Meadowbank Tank Farm

Description: Looking northeast from the southern corner. Accumulation of water in the eastern corner.

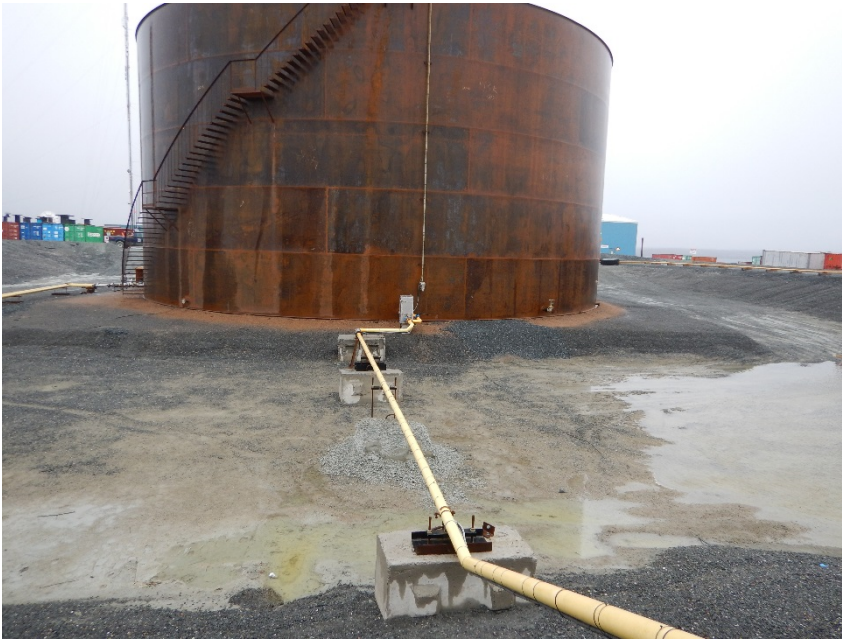
Photograph F2-7 Meadowbank Tank Farm

Description: Looking northwest from the northeastern side. Accumulation of water on the east side.

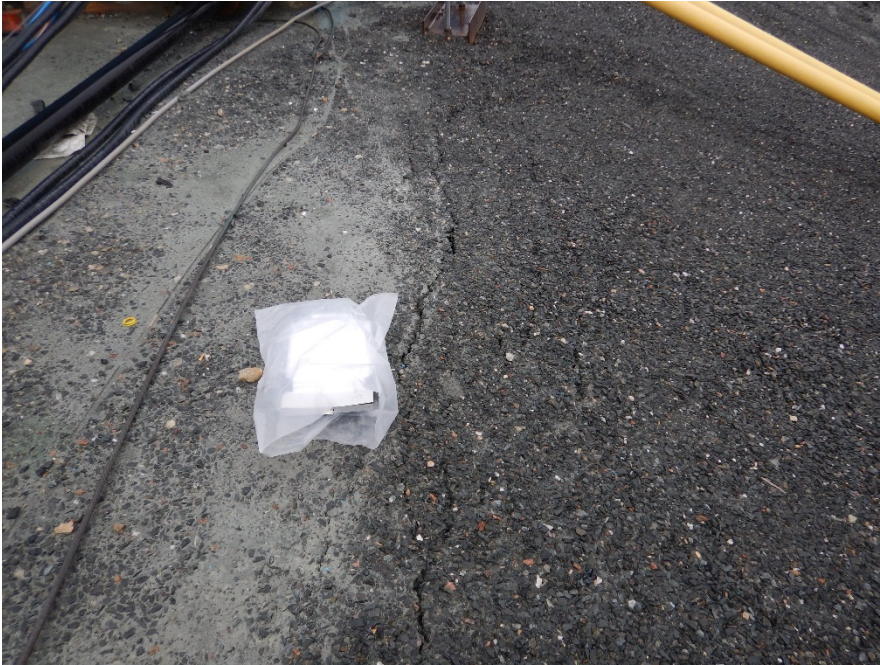
Photograph F2-9 Meadowbank Tank Farm

Description: From the southern corner: presence of small tension cracks on the crest (about 3 m long).

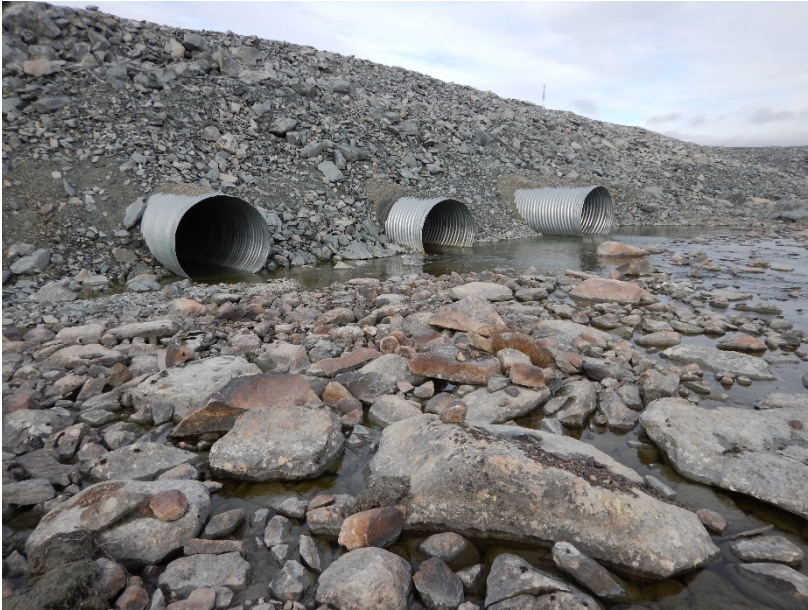
Photograph G1-1 Vault Road Culverts

Description: Looking at the outlet of the three culverts located on Vault Road at 640964E/7217466N. All of them are deformed in the middle.

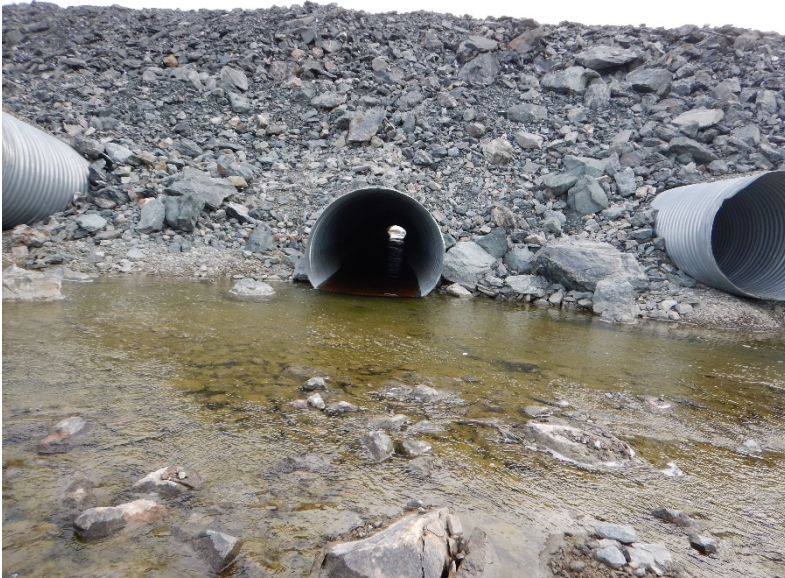
Photograph G1-3 Vault Road Culverts

Description: From the inlet side of the three culverts located on Vault Road at 640964E/7217466N. Looking inside the central culvert. The culvert is slightly deformed on top in the middle.

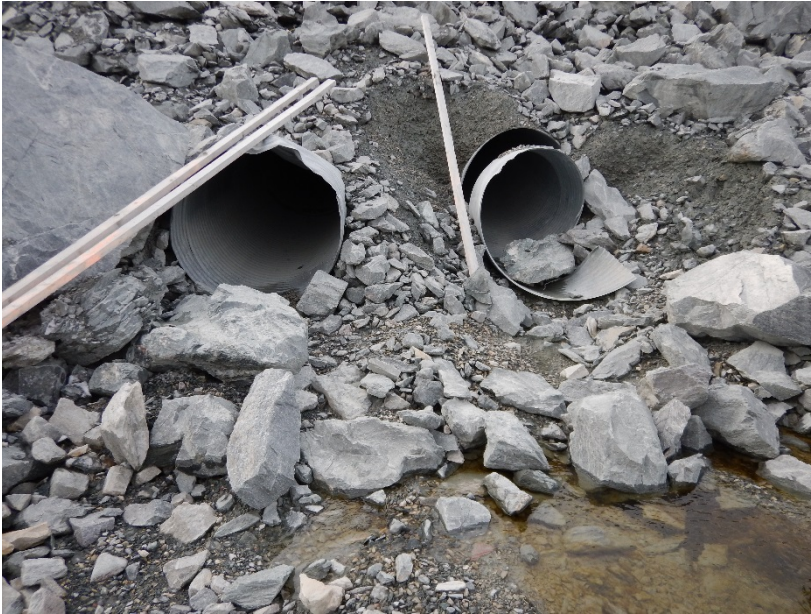
Photograph G1-5 Vault Road Culverts

Description: Culvert on the NP1 side at 639 214 E / 7 216 189 N on Vault Road. Culvert broken and partially obstructed.

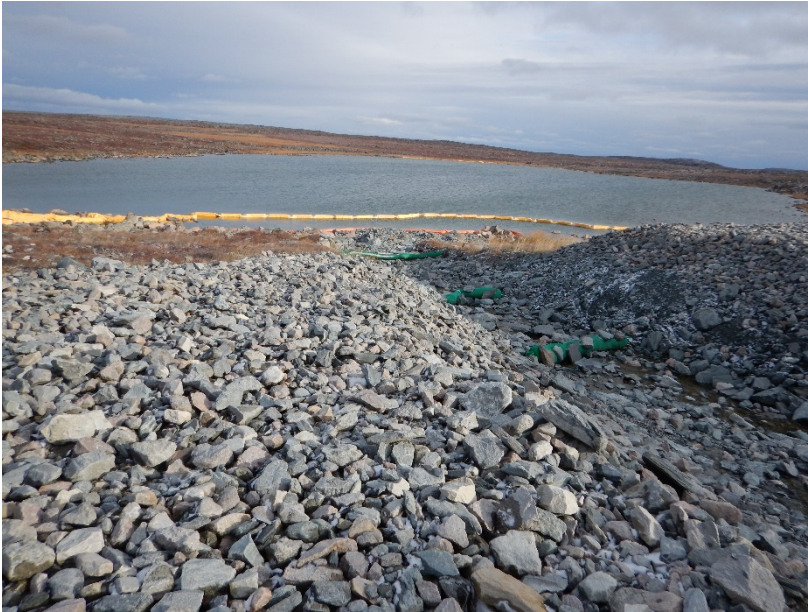
Photograph G2-1 Diversion Ditch and its Sediment and Erosion Protection Structure

Description: Looking south toward Lake NP1 at the sediment and erosion protection structure. Presence of 2 silt curtains and 3 wooden barrier.

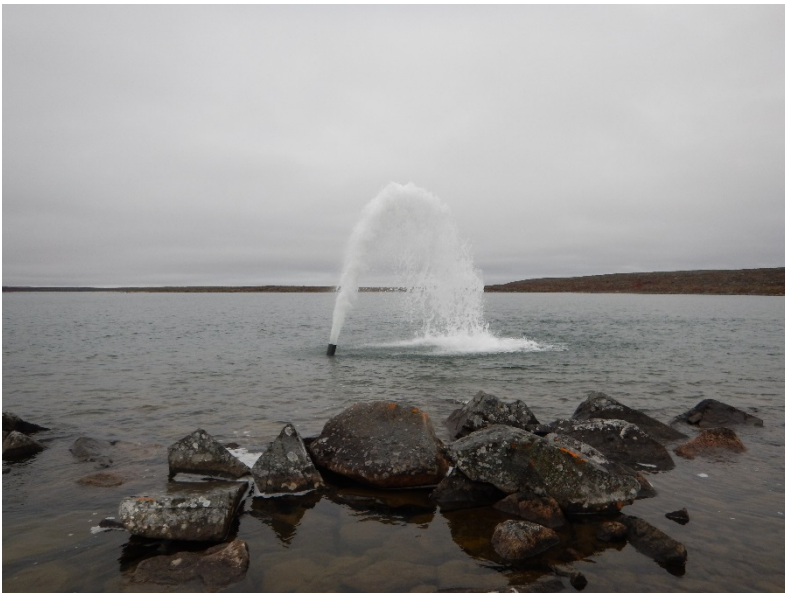
Photograph G4-2 Diffusers – Wally Lake Diffuser

Description: Looking at the Wally Lake Diffuser. The pipe is not anchored at the bottom of the lake.

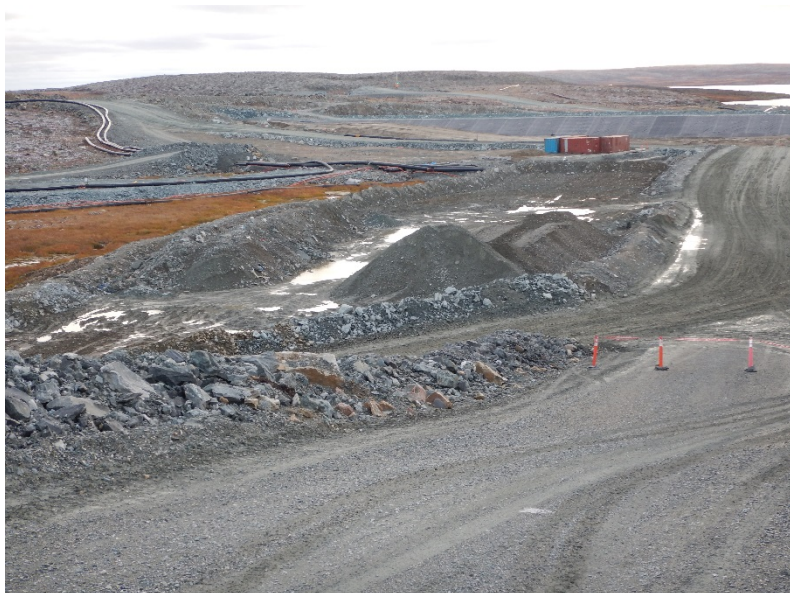
Photograph G6-1 Contaminated Soil Storage and Bioremediation Landfarm Facility

Description: Looking southwest at the Contaminated Soil Storage and Bioremediation Landfarm Facility located within the South Cell of the TSF.

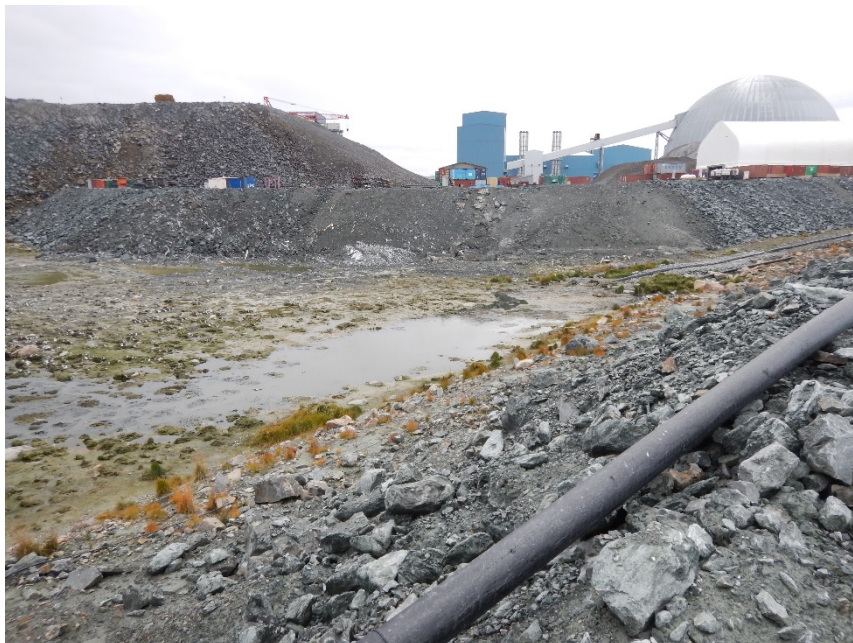
Photograph G7-1 Stormwater Pond

Description: From the northern side of the pond, looking west at Stormwater Pond and crusher ramp.
