### **Annual Review of Portage and Goose Pit Slope Performance**

# 2016 ANNUAL PIT SLOPE PERFORMANCE REVIEW MEADOWBANK MINE, NUNAVUT

DECEMBER 21, 2016

ISSUED FOR USE  
704-ENG. EARC03050-01

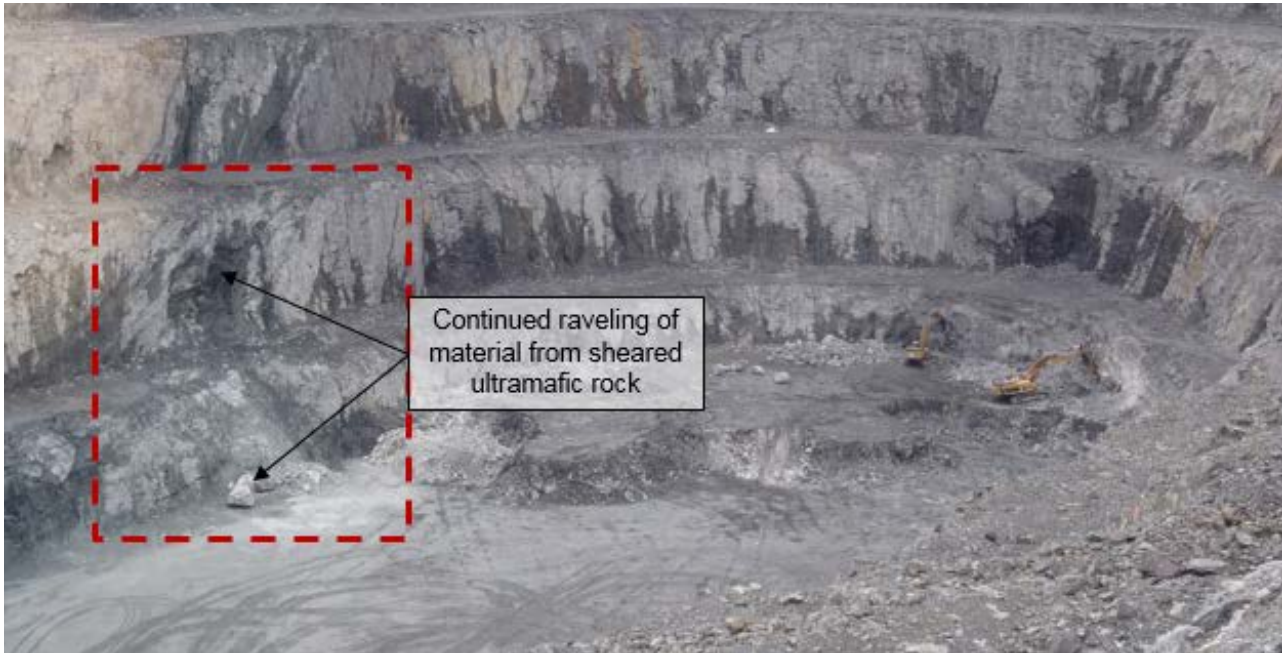
An area of instability of the lower west wall observed during the 2014 inspection continues to ravel, and some new material has accumulated at the toe of the slope (shown in Photograph 4-3, Photograph 4-4, and Photograph 4-5). A hard toe in iron formation remains at the base of the slope, undercutting out-dipping planes. Poor quality and strongly sheared ultramafic rock between quartzite and iron formation continues to ravel. More ultramafic rock has been exposed along the lowermost bench because of mining down of the pushback area. This has resulted in loss of catchment locally.

Photograph 4-4: Pit A lower west wall raveling

These are bench scale occurrences and not indicative of larger scale instability, hence can be managed through mucking as necessary. However, due to the poor quality of the ultramafic rock a bumper berm should be

constructed at the toe of the slope beneath the ultramafic rock to restrict runout of any additional material that might ravel from this area, and to restrict access by personnel or equipment in this area.

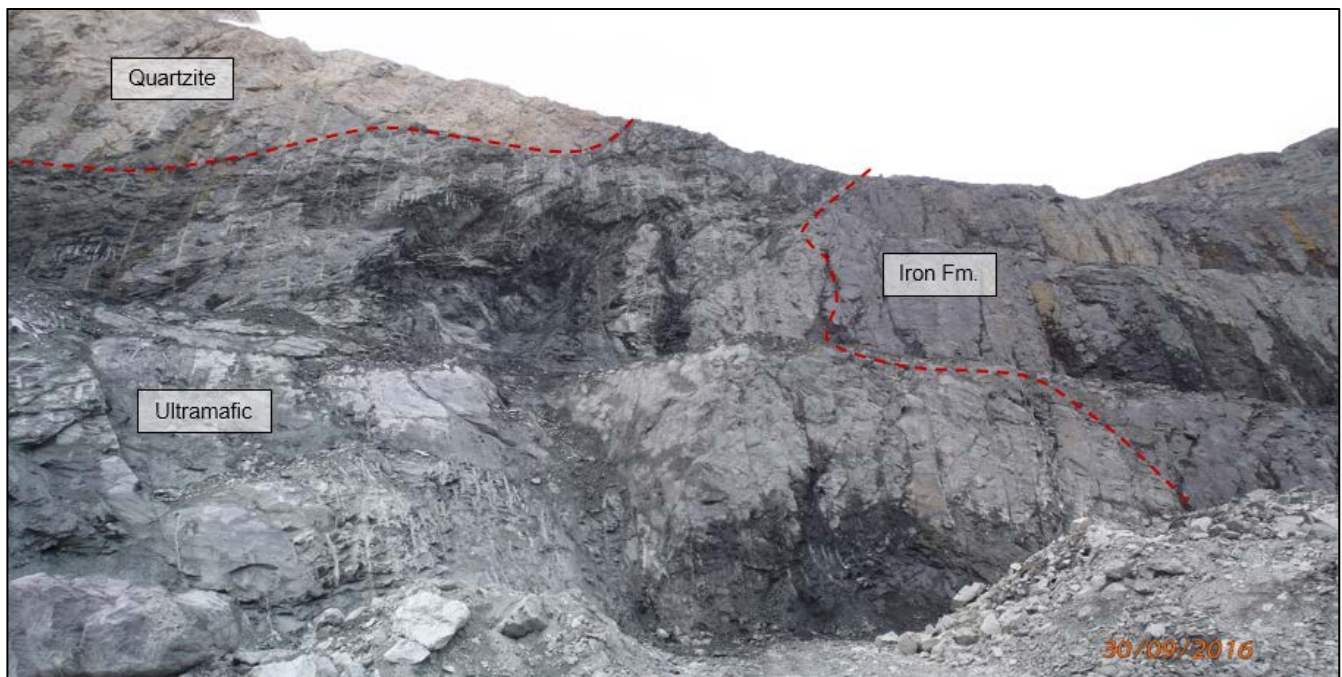
Photograph 4-5: Pit A west wall lower bench exposing poor quality sheared ultramafic rock

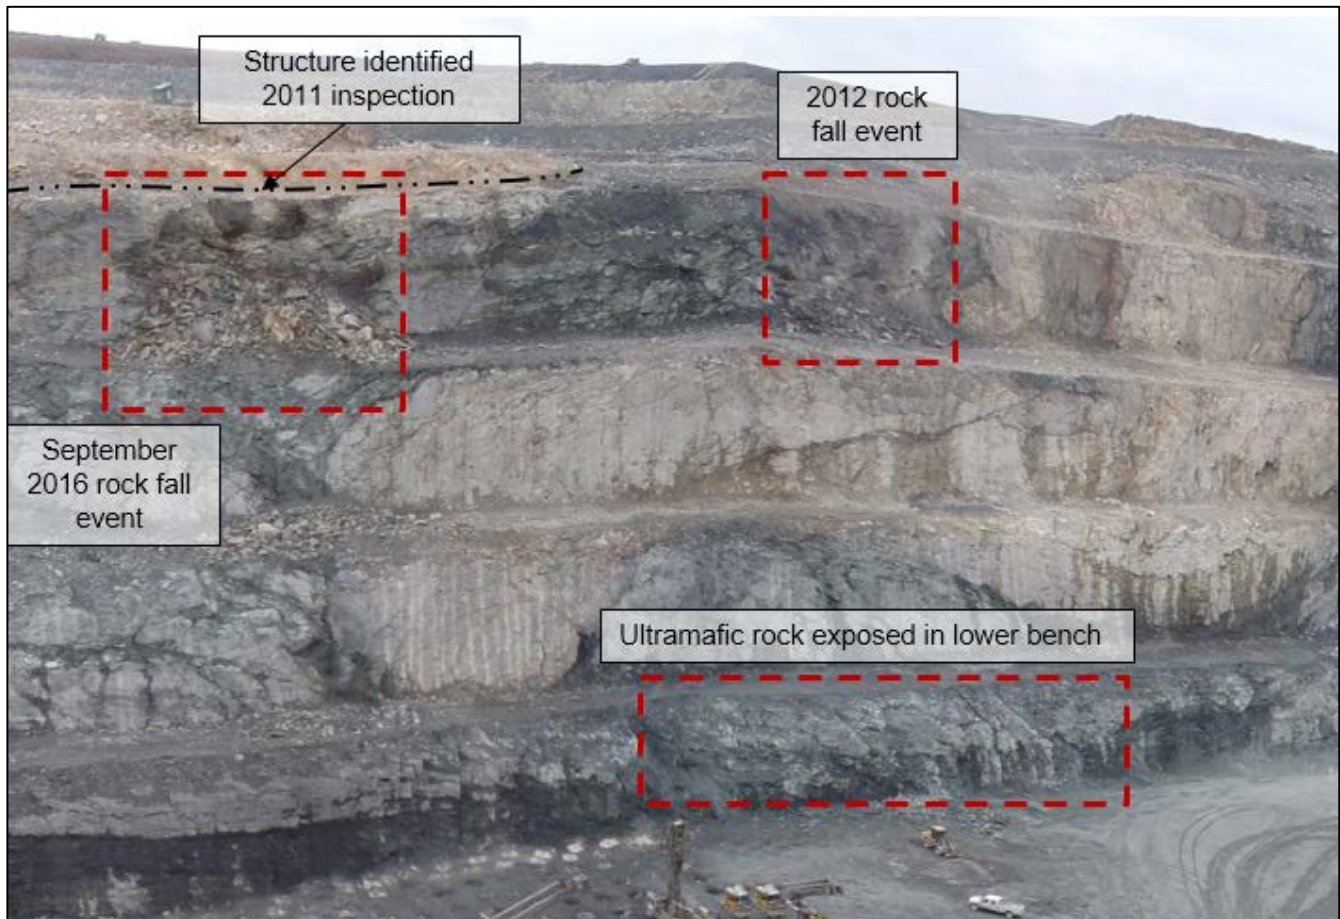
A rock fall event from 2012 along the west wall of Pit A continues to be monitored. The location is shown on the following photograph. The geological structure and rock mass quality that contributed to the 2012 rock fall event has also contributed to the rock fall event in September 2016.

Photograph 4-7: Pit A 5109 bench instability 2012 and 2016

The 2012 bench-scale instability is a result of complex folding and shearing of the stratigraphy in this area. Contributing to the raveling of material is a structure behind the wall dipping at a relatively steep angle to the west. This provides a back-release surface to allow toppling and raveling of the poor-quality rock. Previously the ramp access to Pit A traversed beneath this area and the area was monitored on an on-going basis with restricted access to the area through the use of berms to prevent bench access.

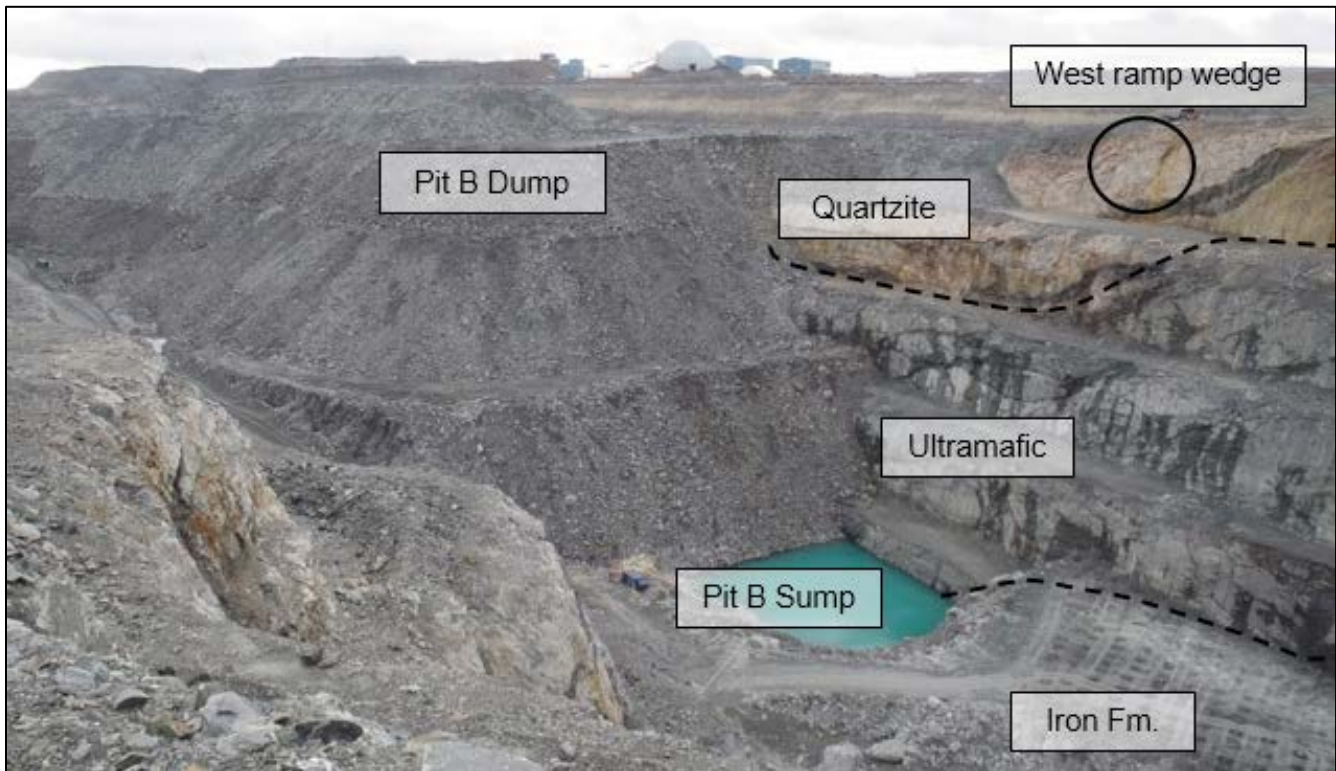
The remaining portion of west wall of Pit B that has not been backfilled with waste rock continues to perform adequately. Quartzite is exposed in the upper benches overlying ultramafic rock, and iron formation. There is no access to the west wall of the pit, and access to the base of the pit is gained by the east ramp which also provides access to Pit A.

Photograph 4-17: Pit B west wall performance (2016)

There is no evidence of large-scale instability for the west wall of Pit B.

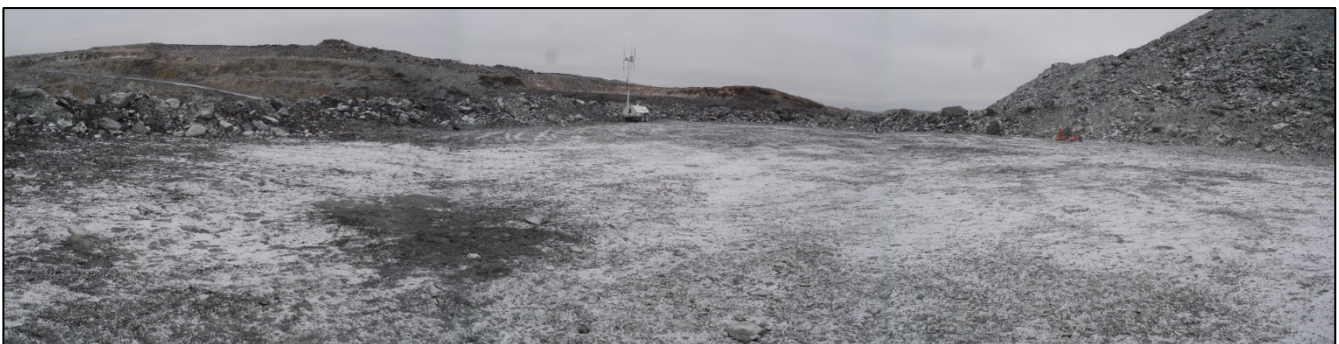
Photograph 4-19: Pit B dump platform (2016)

The crest of the dump was traversed, and no evidence of tension cracks or settlement were observed: no bulging of the dump toe or dump face was observed.

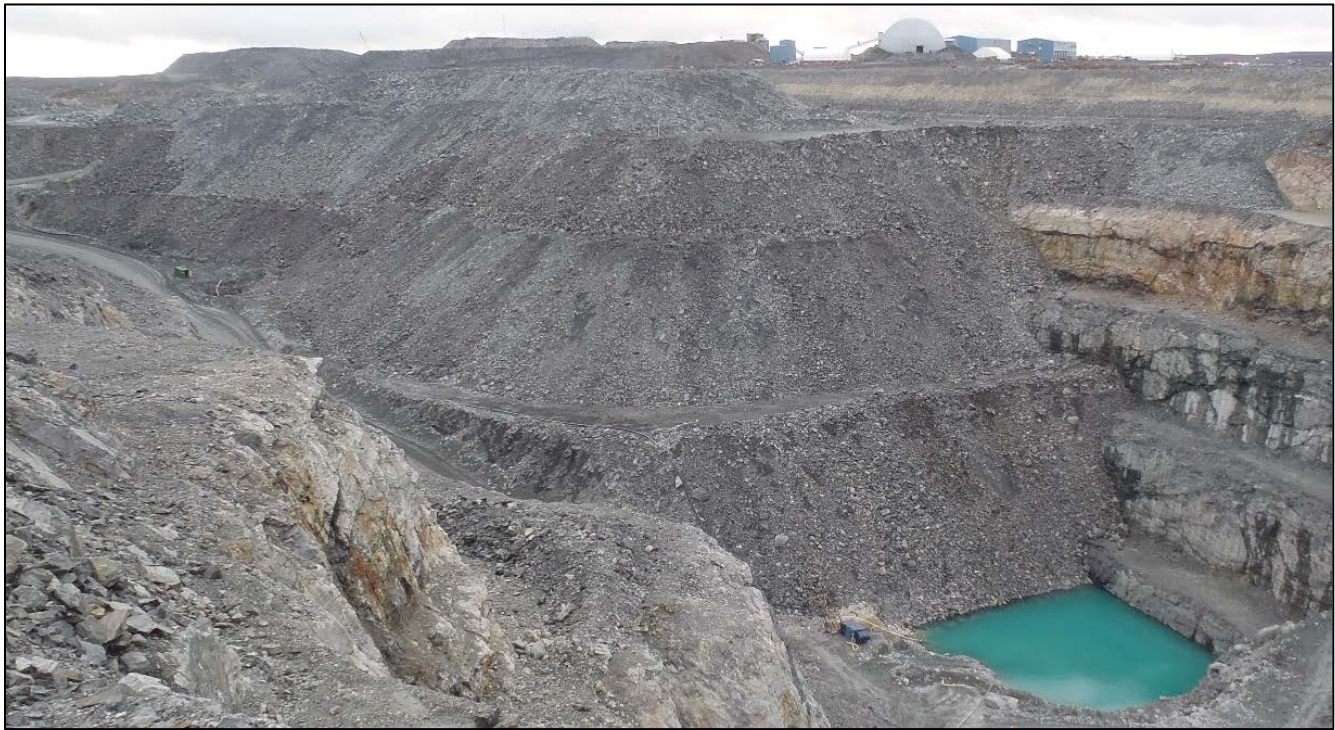
*Photograph 4-20: Pit B Dump looking southwest (2016)*

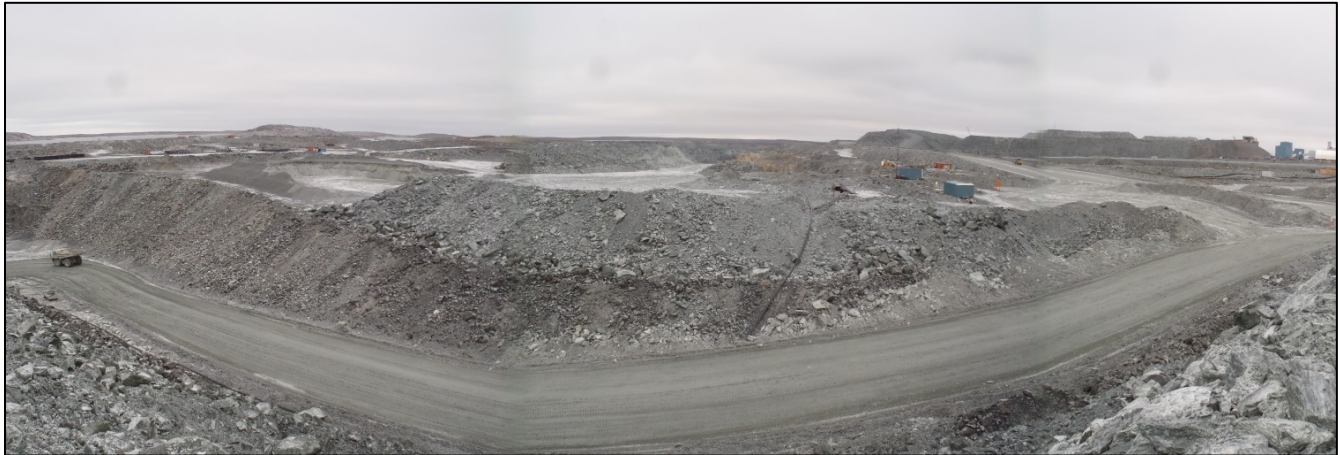
Photograph 5-1: Pit C waste rock dumps looking south (2016)

The west and east pit walls of Pit C are buttressed by waste rock and no longer present any geotechnical hazard. The main dump platform for Pit C is used for storing stockpiles of stemming material. The Pit C dump is performing adequately. There were no tension cracks observed in the crest area, and no bulging of the face or toe areas was noted at the time of the inspection.

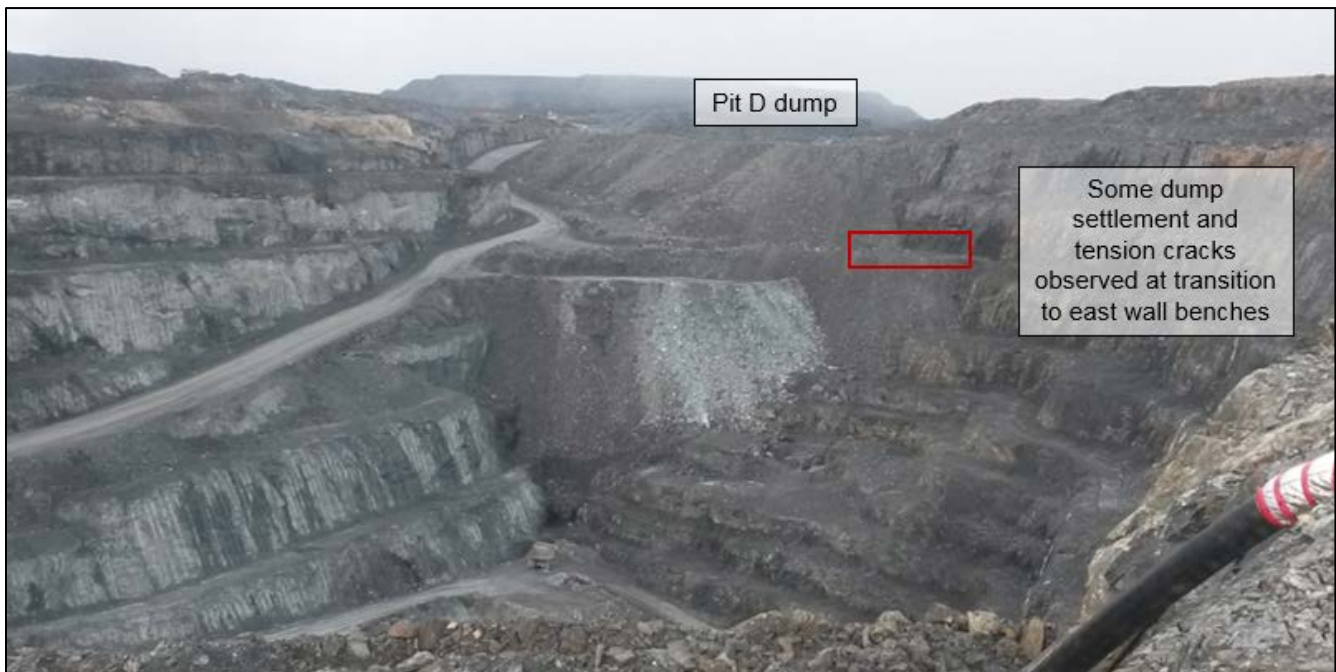
Since the 2015 inspection, the toe of the Pit D dump has advanced further south with the development of two additional dump platforms in the transition from Pit D/Pit E. These are shown in Photograph 5-2.

Photograph 5-2: Pit D dump, viewing north from crest of Pit E3 (2016)

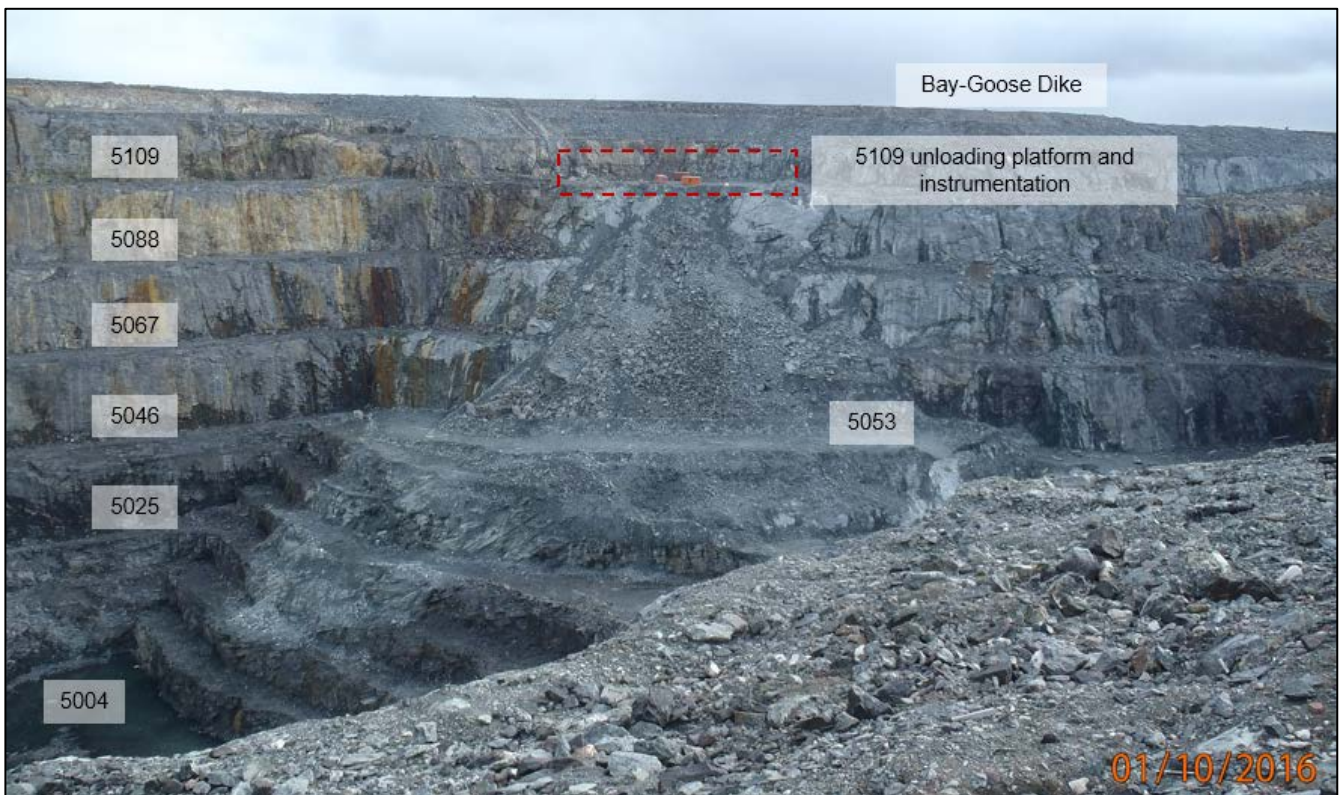
Photograph 6-3: Pit E3 south wall (2016)

The potential for the failure to extend back to the dewatering dike and affect the integrity of the dike has been investigated. The engineering geology model and stability analyses indicate that failure behind the crest will be limited to the depth of the ultramafic contact with the iron formation, and will not extend back to the dewatering dike.

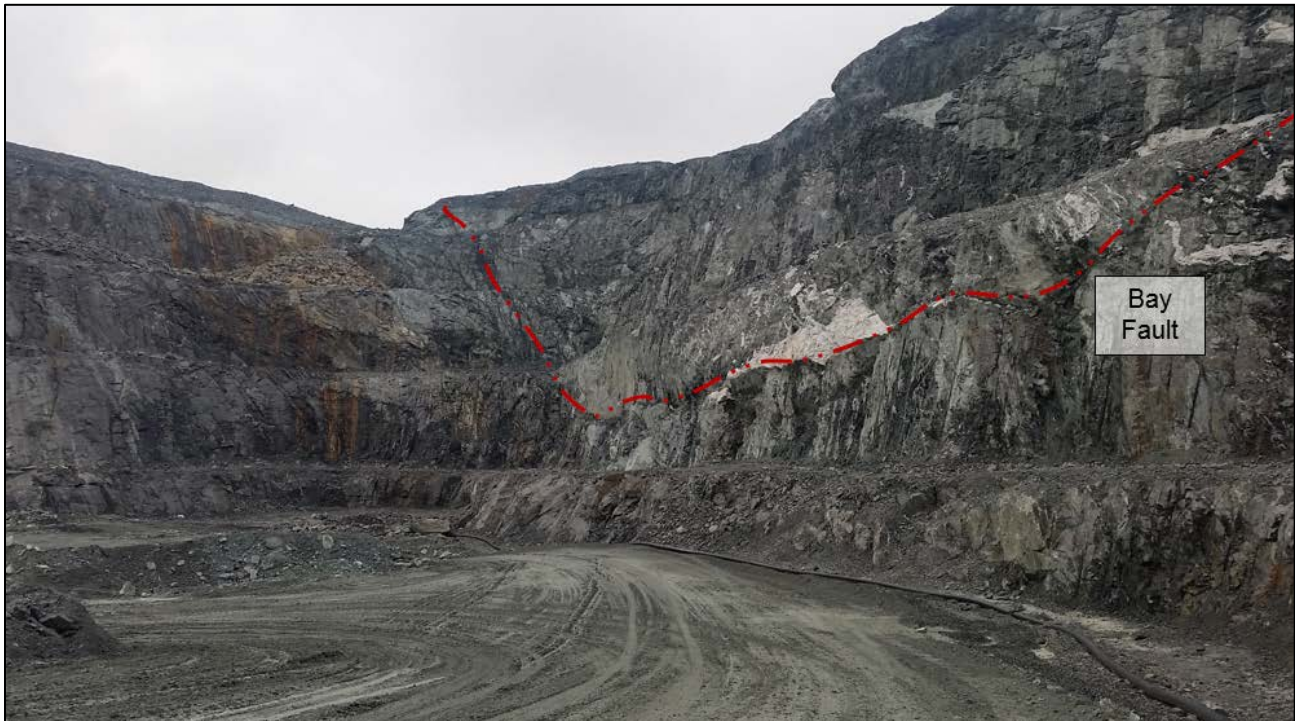
This instability is exacerbated by the presence of shear zones and the Bay Fault within the ultramafic rock, which are inclined steeply into the west wall. The area of the overhang has been cleaned well, as has the bench beneath it. As this area of the pit continues to be mined down, continuing raveling of ultramafic rock can be expected. However, this material is expected to collect on the catch benches.

On the lowest bench, stratigraphy may be re-oriented due to folding adjacent to the fault, resulting in some out-dipping planes. This re-orientation of stratigraphy is visible in the south wall.

Photograph 6-6: South end of Pit E3 west wall lower benches (2016)

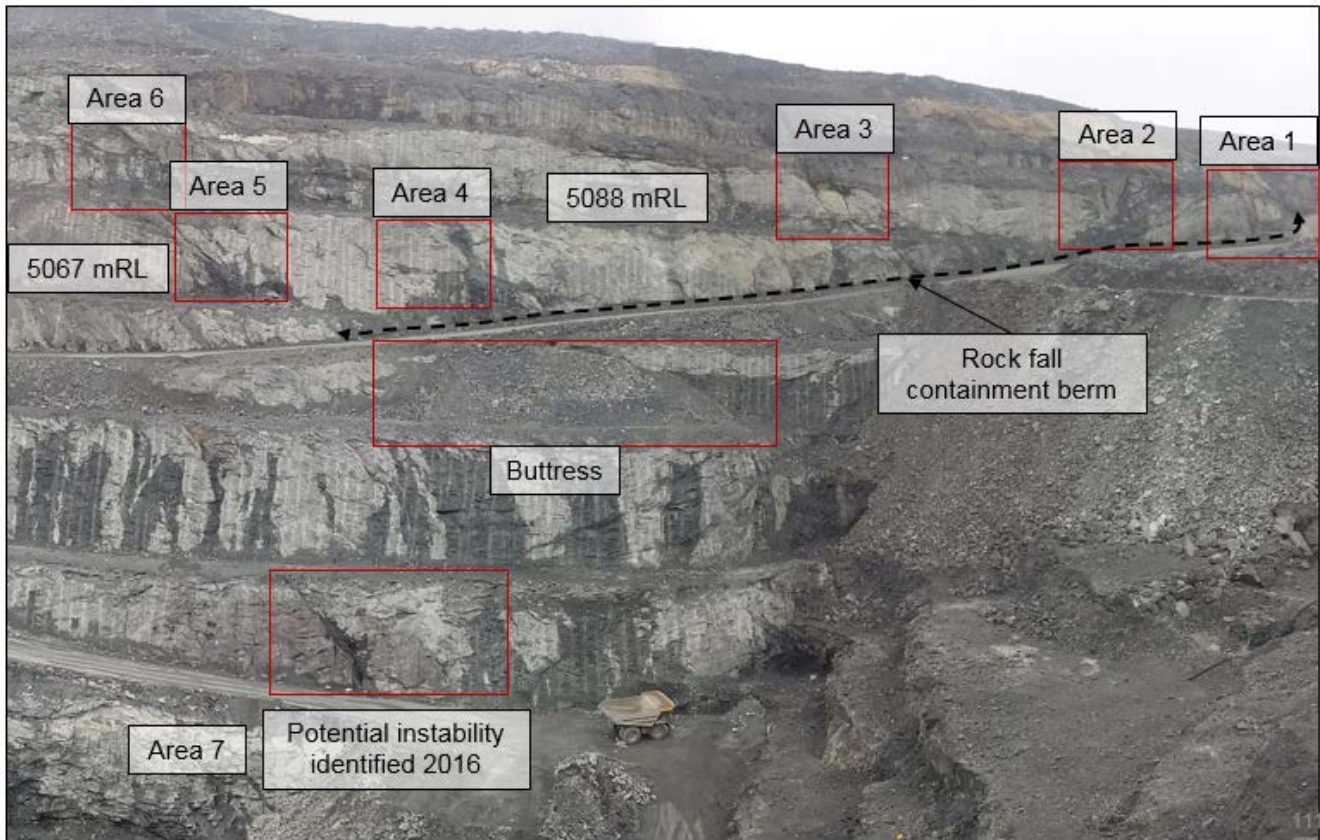
The Pit E3 ramp is situated on the west wall of the pit, and descends to the south into the pit. Six areas of potential instability identified during the 2015 inspection were visited in 2016, and are shown below. A seventh potential area of instability was identified during the 2016 inspection. These are shown in the following photograph.

Photograph 6-7: Pit E3 west wall ramp areas of potential instability (2016)

The rock fall containment berm constructed along the west edge of the ramp continues to provide adequate catchment for rock falls that have occurred along the west wall above the ramp. As the ramp descends south along the west wall into the base of Pit E3, it becomes single lane to accommodate the width of the containment berm adjacent to the bench. A buttress constructed down slope of the ramp provides additional support to the ramp.

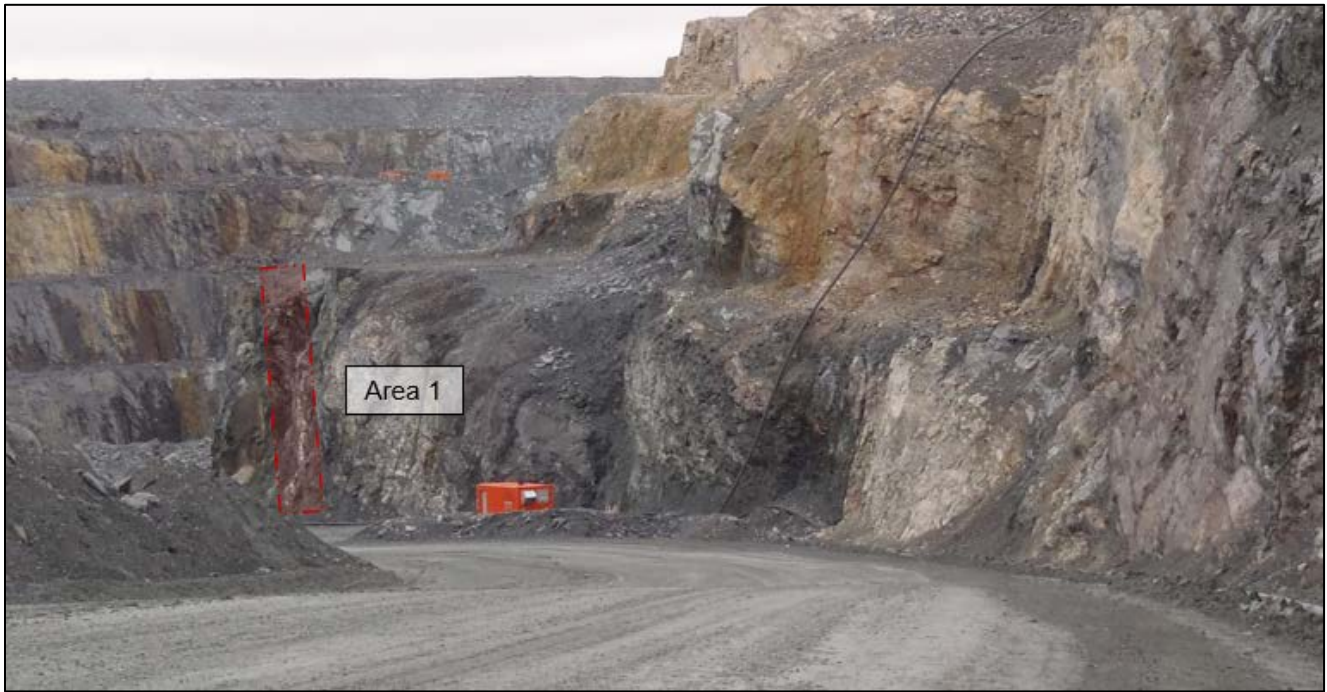
The ramp passes beneath an area of wall that was problematic during the 2014 site visit (Area 1 and Area 2). The area of wall is associated with a fault zone – possibly the Bay Fault or a splay off that fault trend - trending through this area of the pit. This fault, or shear, is several metres wide, and steeply dipping to the west.

Photograph 6-8: Pit E3 Ramp Area 1 above ramp - Bay Fault or splay (2016)

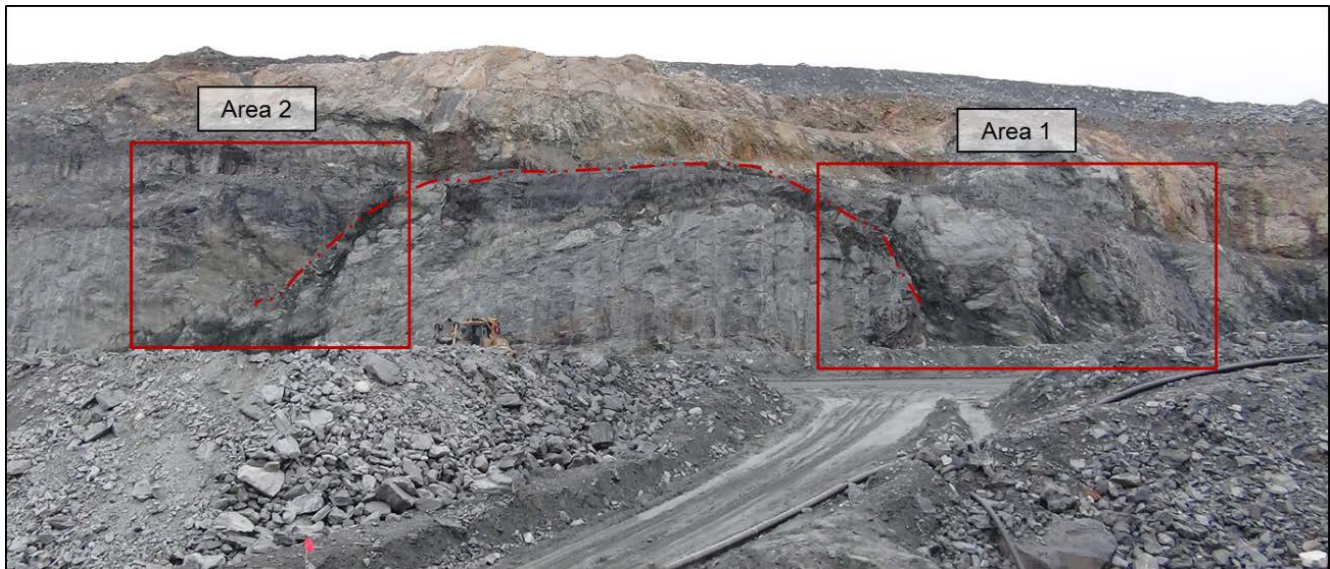
Photograph 6-9: Pit E3 Ramp Areas 1 and 2 - Bay Fault or splay (from 2015 inspection)

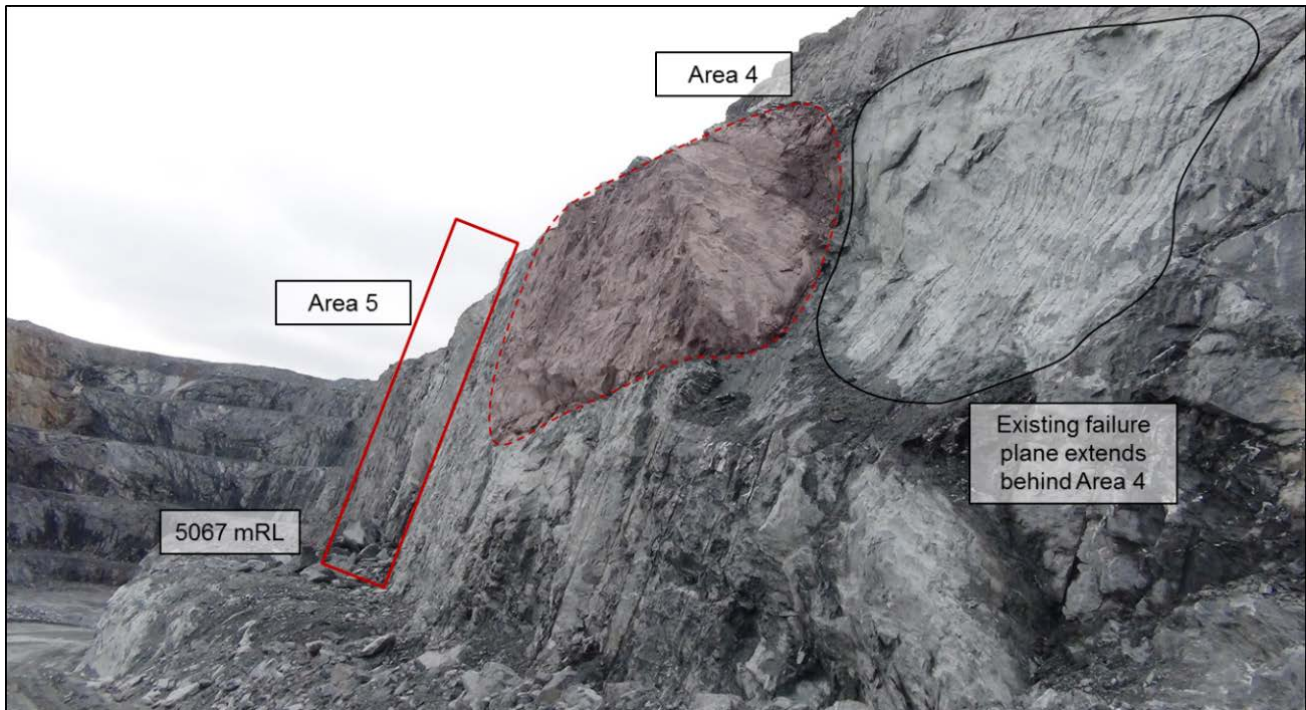
Photograph 6-12: Pit E3 Ramp Areas 4 and 5 viewed from the ramp (from 2015 inspection)

No new material was observed to have failed on to the 5067 bench since the 2015 inspection. However, it is possible that some opening of the plane behind the Area 4 block has occurred; this block should continue to be monitored as part of the regular site geotechnical inspections.

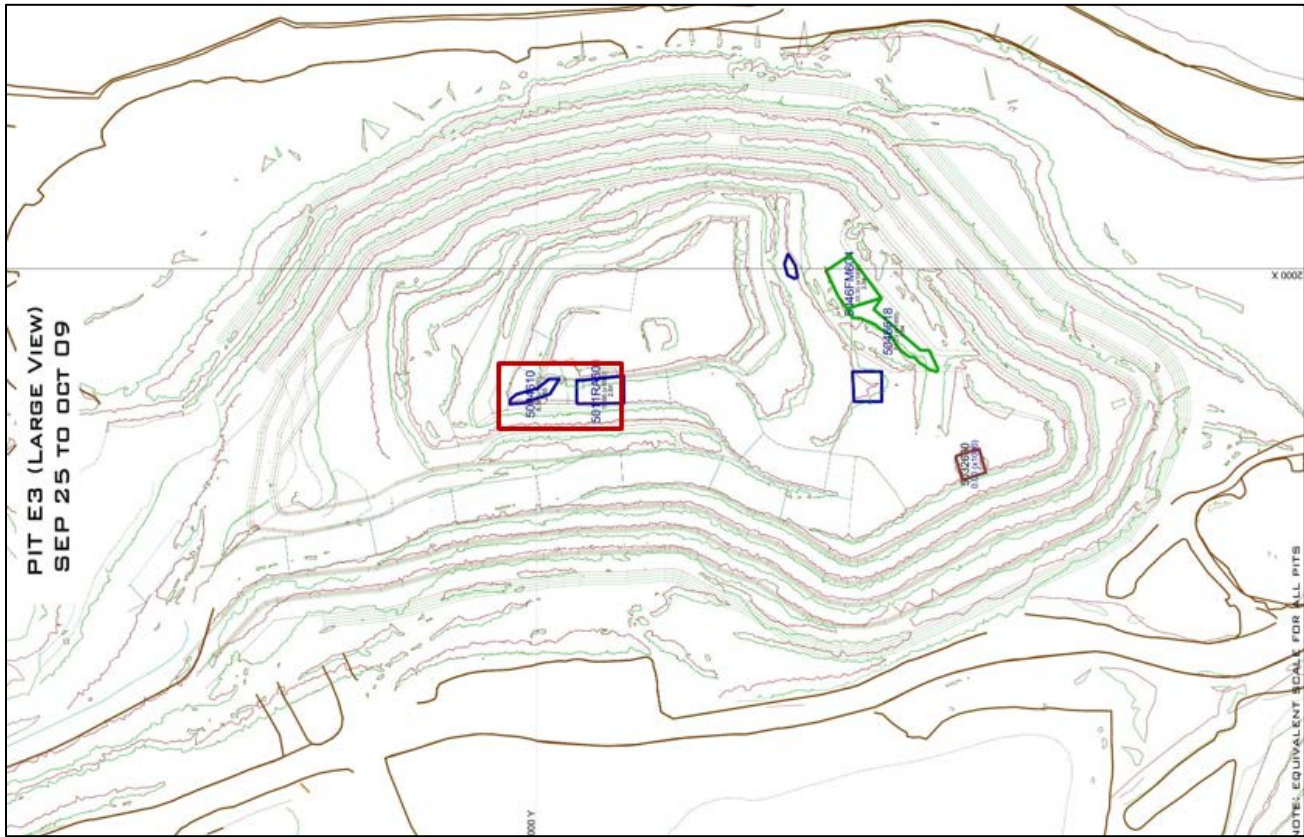
A seventh area of potential instability was identified during the 2016 inspection. The area is at the base of the ramp, on the north side of the pit, and near the contact between iron formation and ultramafic rock. The location is shown on the following figure.

Figure 6-2: Area 7 instability at base of Pit E3 ramp

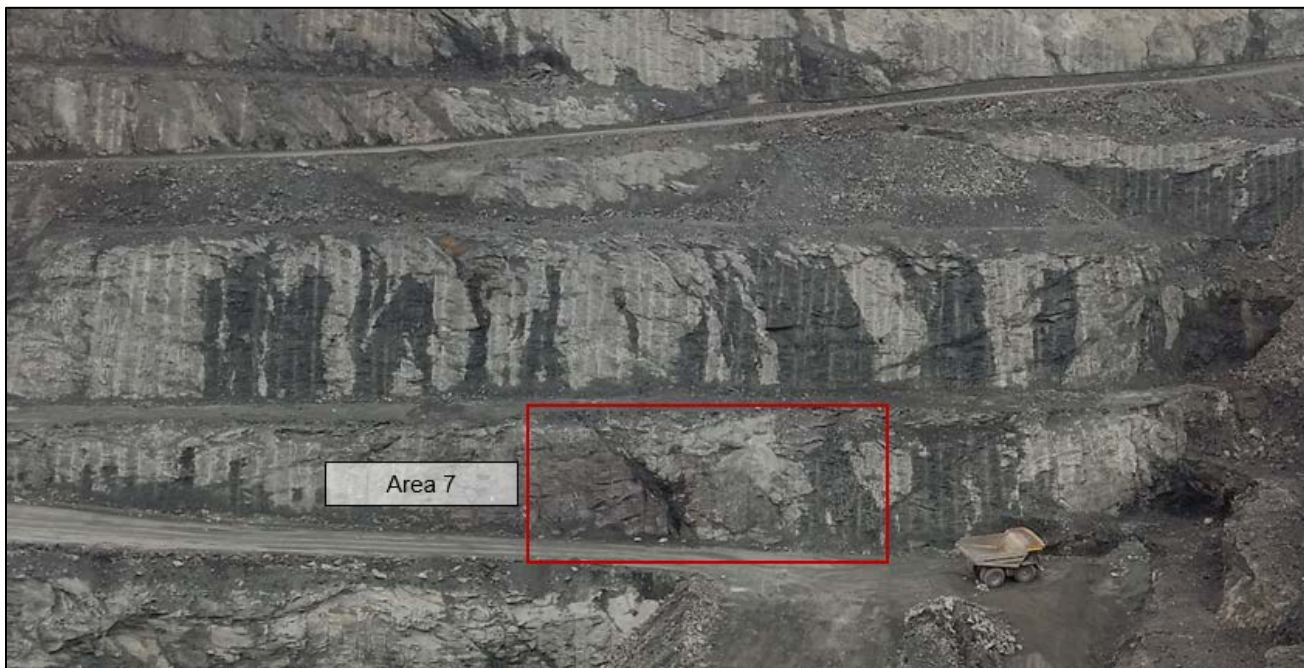
Figure 6-3: Area 7 instability (2016)

The potential instability is characterized by strongly sheared ultramafic rock in contact with iron formation, with associated shear planes dipping out of the bench face. Some of the sheared planes are open. The geometry is to

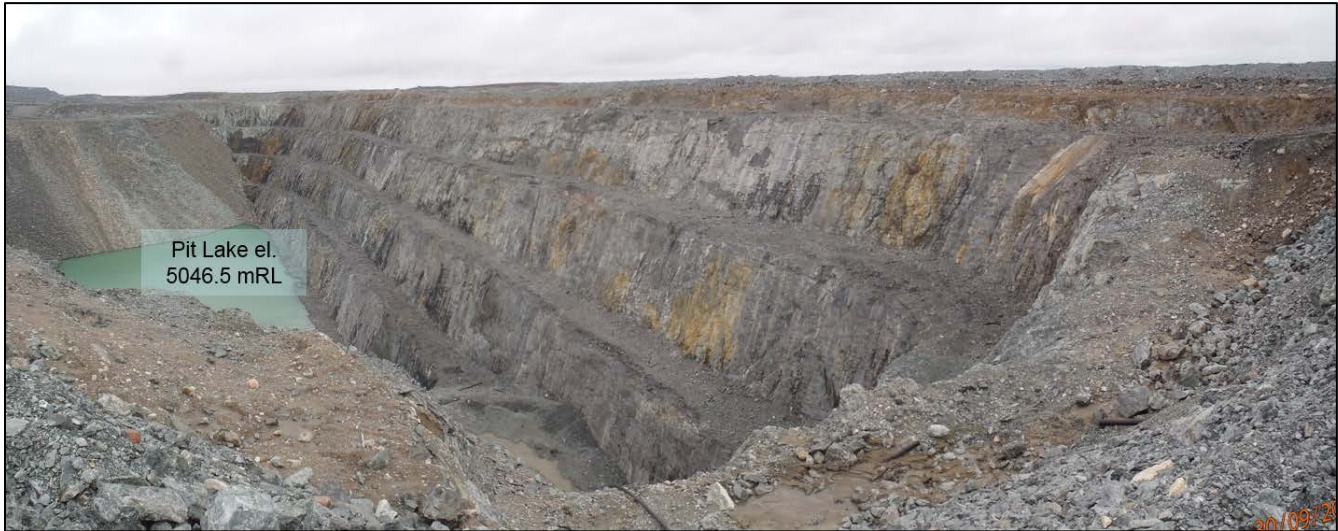
The east wall of the Goose Pit was excavated predominantly in intermediate volcanic rock and iron formation. The stratigraphy is inclined steeply at a consistent angle to the west. Steep bench faces were achieved with the use of careful pre-shear blasting. There has been very little loss of catchment, and very little accumulation of material on the benches.

*Photograph 7-1: Goose Pit east wall performance looking north (2016)*

The east wall continues to perform satisfactorily and there are no immediate geotechnical concerns.

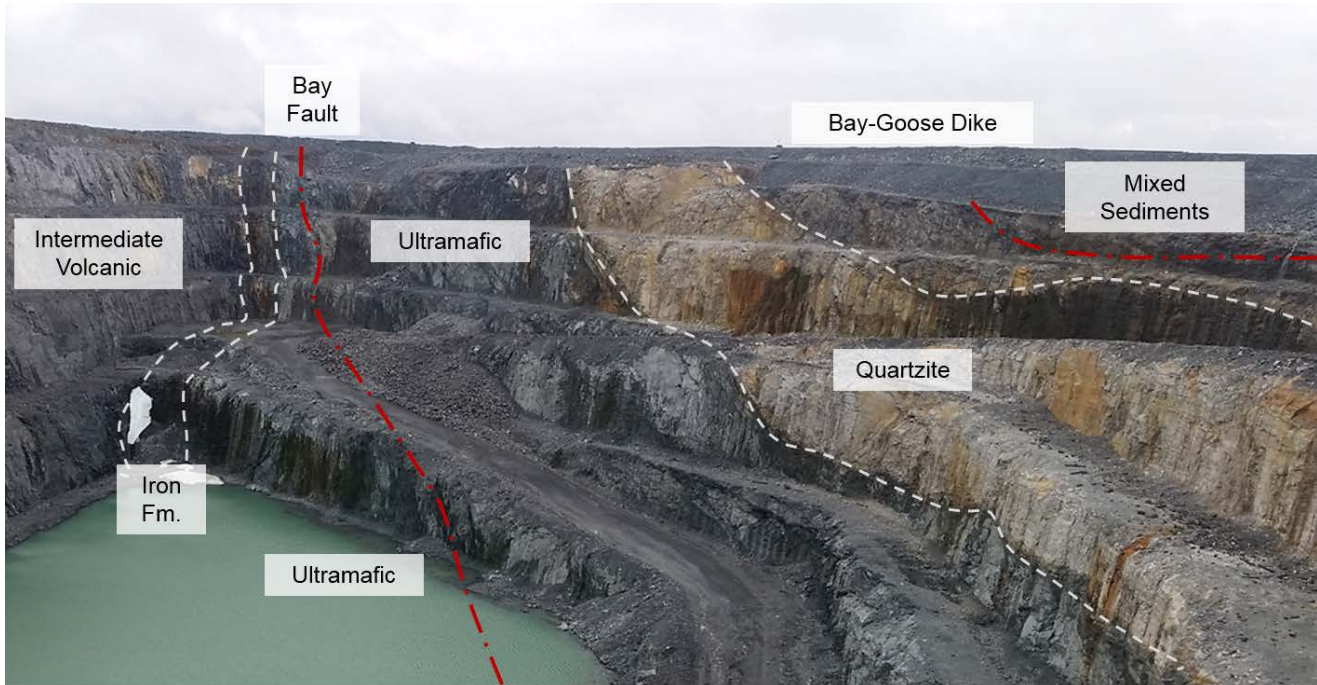
The south wall of the Goose pit is comprised of iron formation and intermediate volcanic rock in the east, transitioning through a sequence of ultramafic rock, quartzite, and iron formation. The most prominent structural feature is the Bay Fault which intersects the south wall of the pit, within the ultramafic rock. The various lithological units are shown in the following photograph.

Photograph 7-2: Goose Pit south wall performance (September 2016)

The performance of the bench overall south wall continues to be satisfactory. There is no evidence of instability; no accumulations of material on the benches since 2015 are observed. There are no significant geotechnical concerns for the Goose Pit south wall.

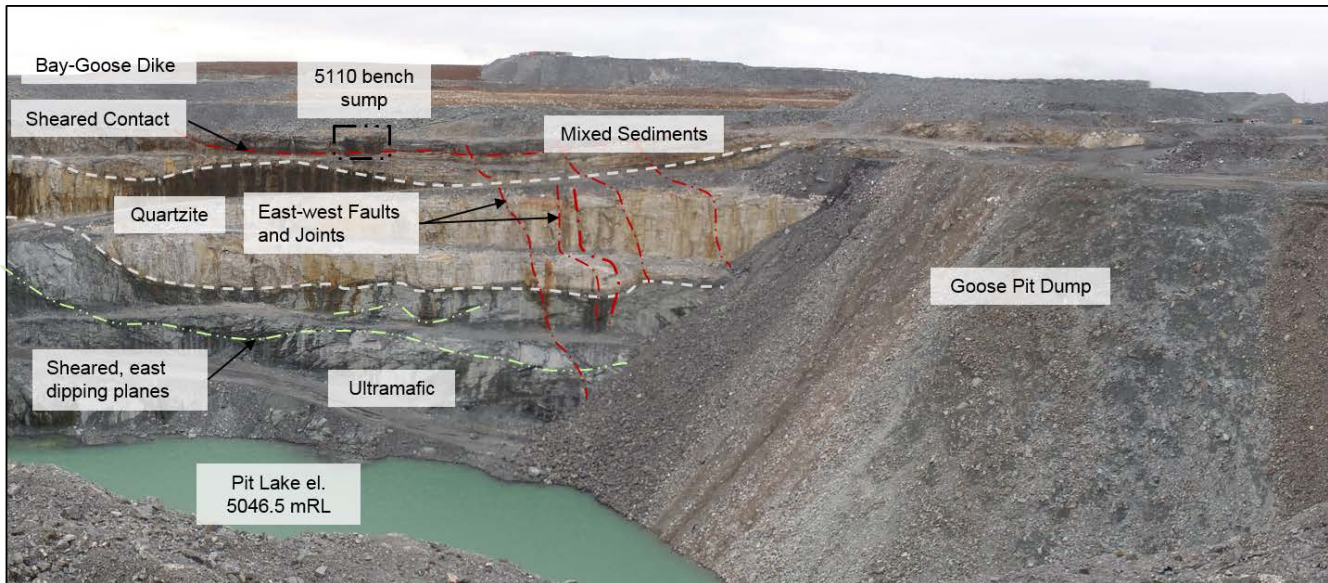
Much of the west wall of the pit is now covered by a waste rock dump which conceals or partially conceals many of the instabilities noted during previous inspections, and now acts to buttress those instabilities.

Photograph 7-3: Goose Pit west wall performance (September 2016)

There are no significant geotechnical concerns noted with the performance of the west pit wall of the Goose Pit, and no evidence of large scale (overall slope) instability for the west wall of the closed pit.

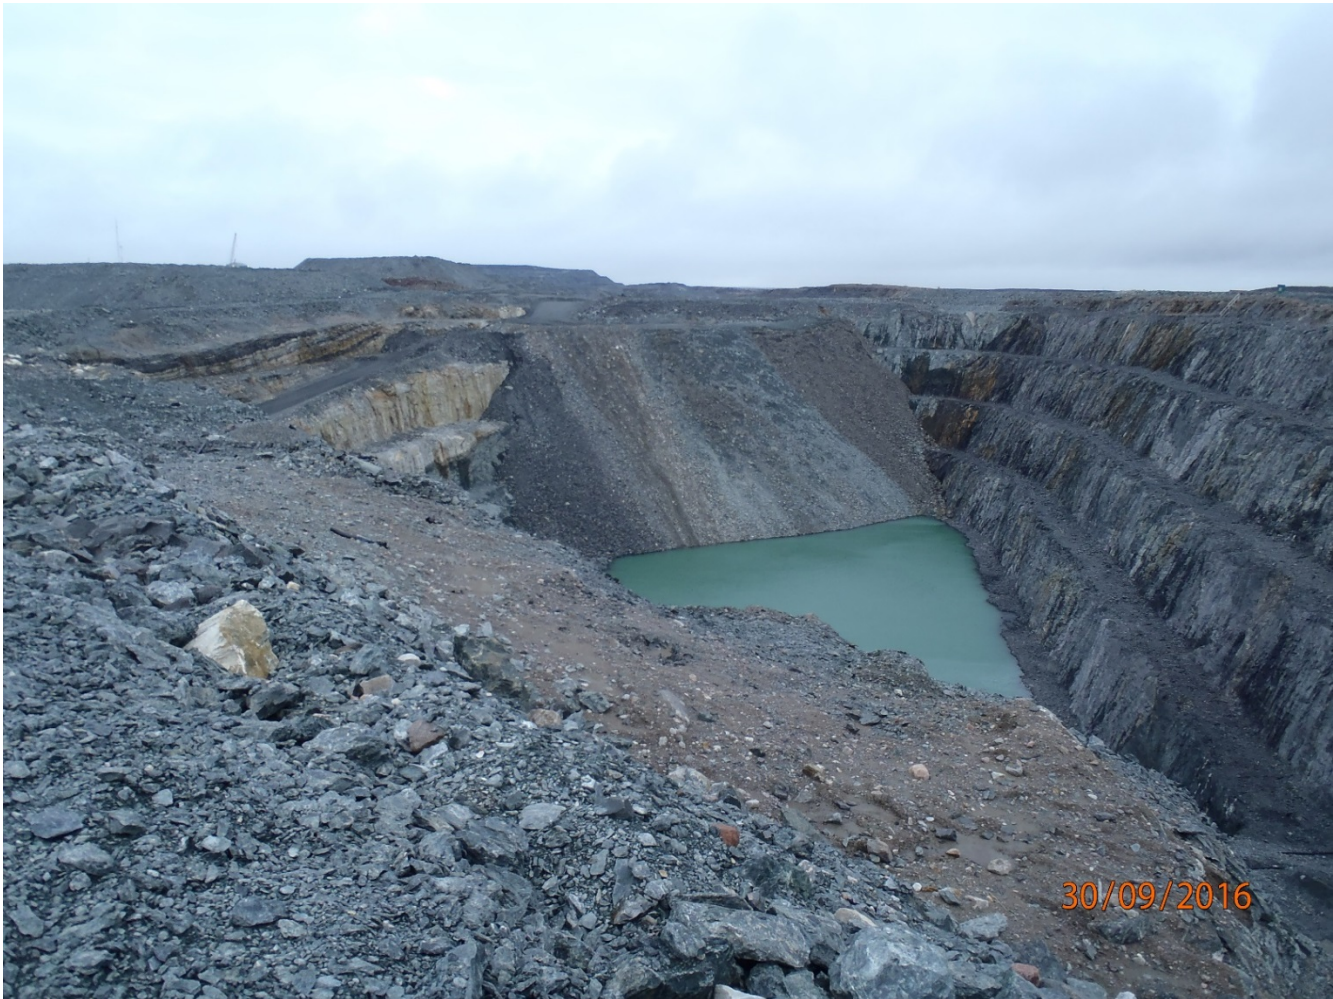
The Goose Pit has been used as a short-haul waste rock dump. Waste rock has been dumped from the crest area and ramp entry at the northwest end of the pit. The dump platform is currently at elevation 5120 mRL; the dump toe extends into the pit lake, and across the pit floor to the east wall, at the north end of the pit. Currently, there is no active dumping.

*Photograph 7-4: Goose Pit waste rock dump (September 2016)*

A no-entry berm has been constructed to prevent vehicles and personnel from accessing the dump platform.

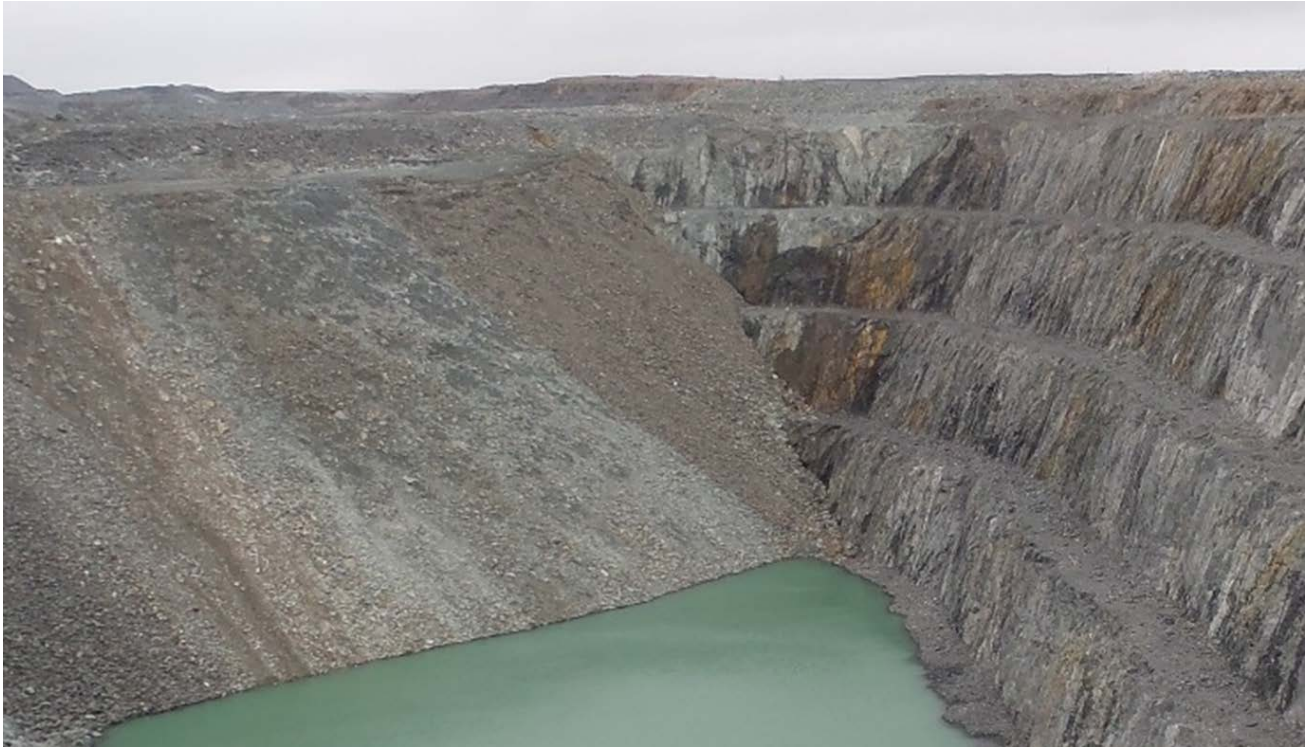
intersecting the wall, and the seepage face is at approximately the same elevation as observed during the 2015 inspection.

*Photograph 7-7: Goose Pit north end wall (September 2016)*

There are no significant geotechnical concerns noted, and no evidence of large scale (overall slope) instability for the north end-wall of the closed pit.
