### **Annual Review of Portage and Goose Pit Slope Performance**

# 2016 ANNUAL PIT SLOPE PERFORMANCE REVIEW MEADOWBANK MINE, NUNAVUT

DECEMBER 21, 2016

ISSUED FOR USE  
704-ENG. EARC03050-01

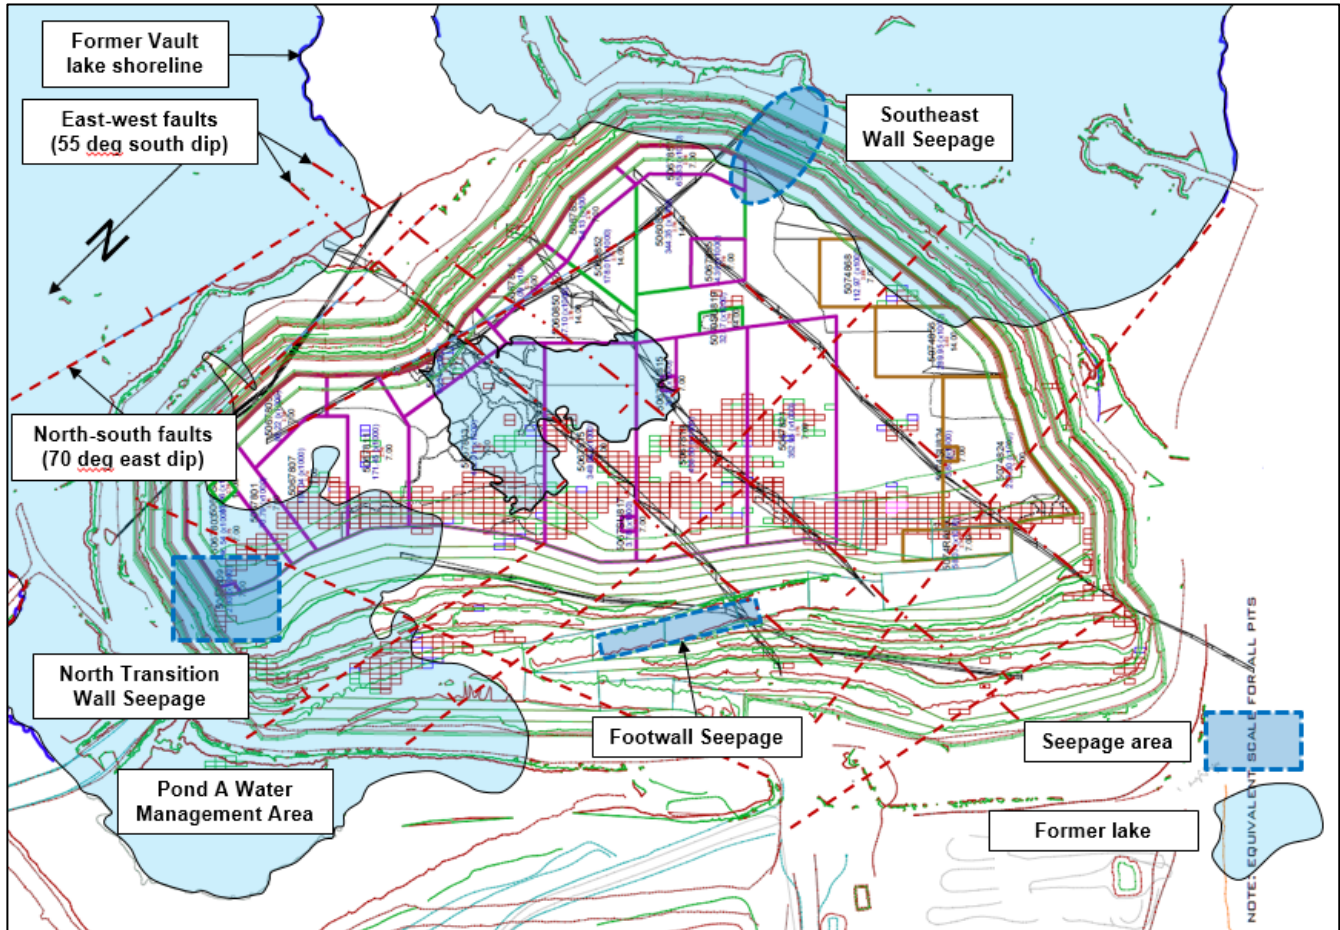
The locations for water inflows and seepage noted during the 2016 inspection remain the same as for the 2015 inspection. There are three main areas of the pit where water inflow or seepage are noted. These are shown on the figure below. These are generally related to the dewatering of Vault Lake, to the current lake level, and to release of water stored in the talik beneath the former lakes. These are discussed in relevant sections below.

Figure 8-3: Vault Pit seepage and pit inflow locations

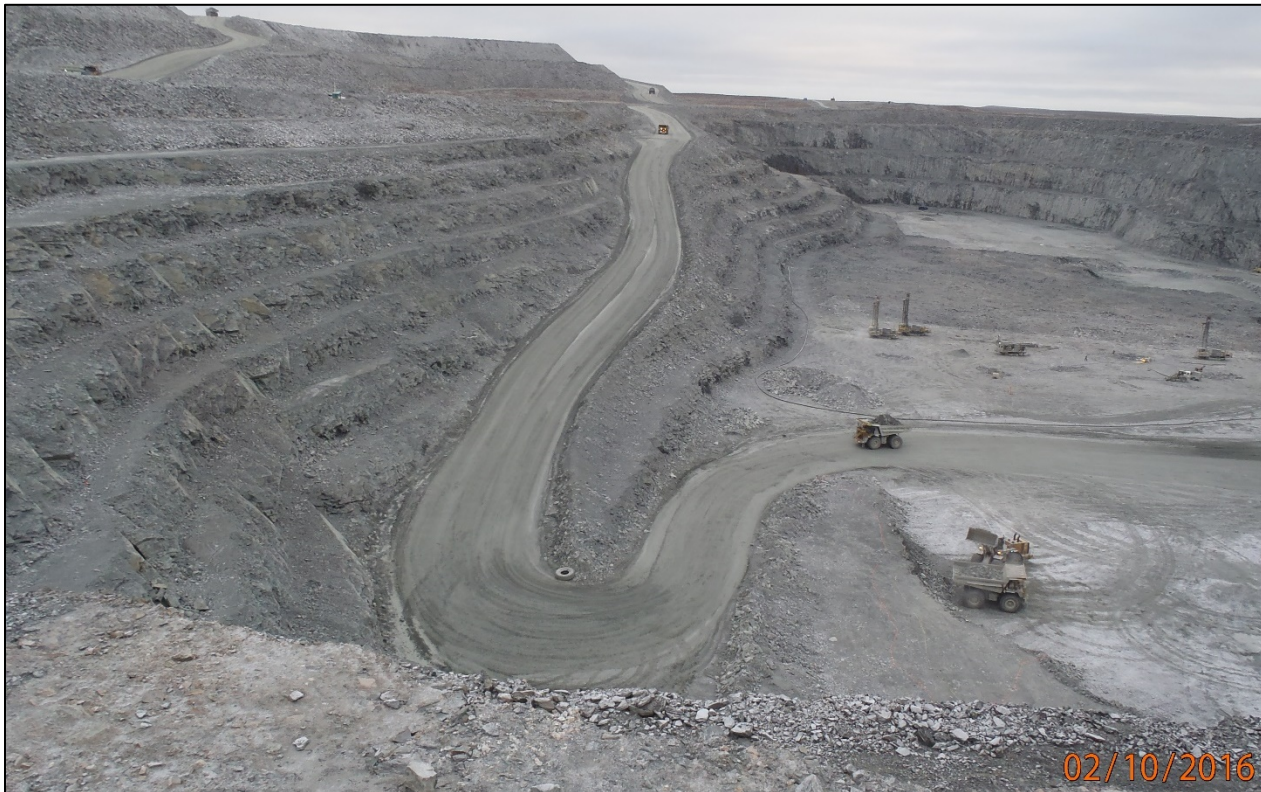
The west wall (grid west) of the Vault is being mined as a series of single-benches (7m high) to create a footwall slope. The deposit dips at relatively shallow angles to the east (grid east), parallel to the foliation and stratigraphy. The average inclination is 22 degrees, but ranges from as shallow as 10 degrees to as steep as 40 degrees. Bench faces are not pre-sheared but are bulk blasted at steep angles, and generally break back, or are scaled back, to the orientation of the foliation. Consequently, there are some benches with considerable loss of catchment. This was anticipated during the design process, and benches were restricted to single-height to minimize failure volumes and allow for this catchment loss. Within the West Wall Design Sector, average back break was estimated in the optimization study to be 1.3 m, with maximum back break of approximately 3 m (Golder, 2013b). Observations of current performance are consistent with the predicted back break distances.

Photograph 8-1: Vault pit grid west footwall slope, south end of pit, looking north

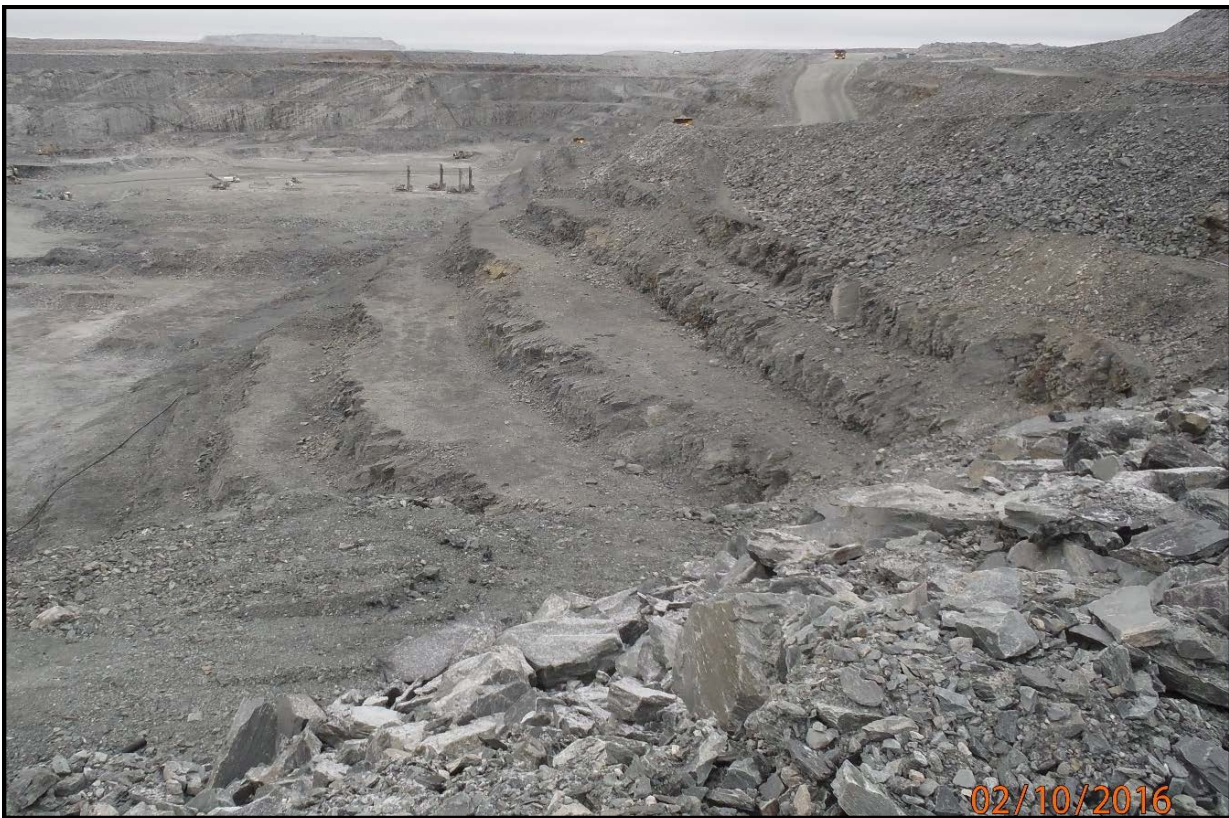
Photograph 8-2: Vault Pit grid west footwall slope, north end of pit looking south

The inter-ramp slope angle is shallow at 33 degrees, and so the likelihood of larger scale multiple bench failures of significant volume is low.

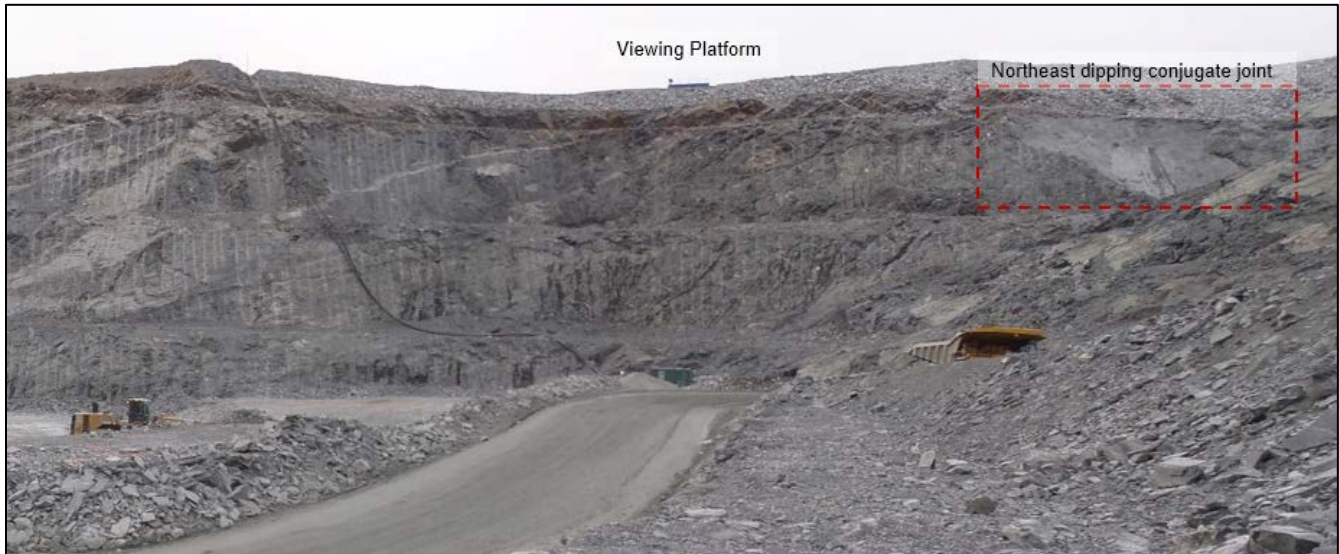
The southwest wall (grid south) intersects the stratigraphy and foliation perpendicular to their trend. The gently dipping structure can be seen clearly in the wall, as shown in the following photographs. A continuous northeast dipping joint is visible at the southwest transition from the grid west wall to the grid south wall. This joint set was recognized during feasibility level design studies and described as a very widely spaced feature. This is consistent with few observations of this set in the active pit walls.

Photograph 8-5: Vault Pit grid south wall transition

The walls in the west to southwest transition area are performing well, with half barrels clearly visible in the final walls. There is very little deviation noted for the blast holes.

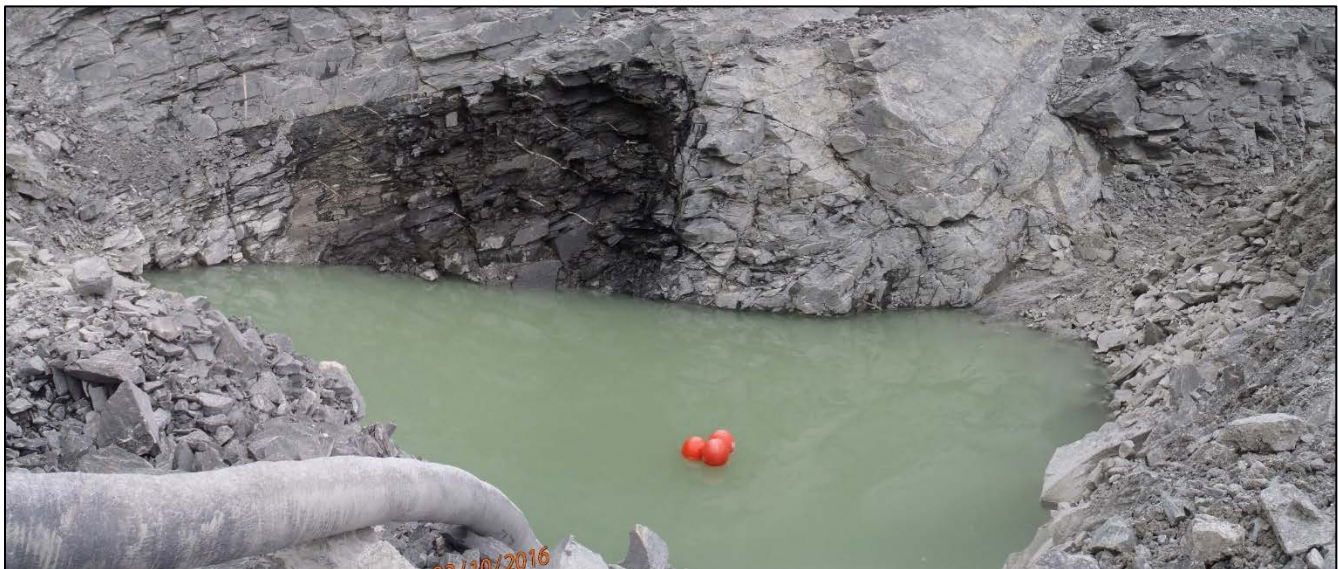
A small sump is in the southwest corner of the pit and manages water in this area.

Photograph 8-6: Sump at southwest corner of Vault pit

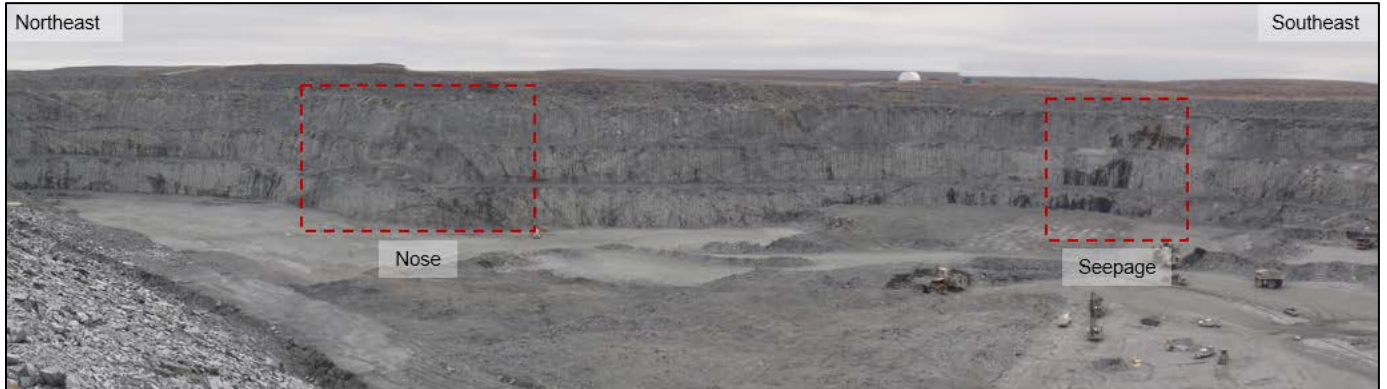
The southeast to northeast highwall (grid east) is being mined down from the final crest position. The wall is performing satisfactorily.

Photograph 8-7: Panaromic of highwall

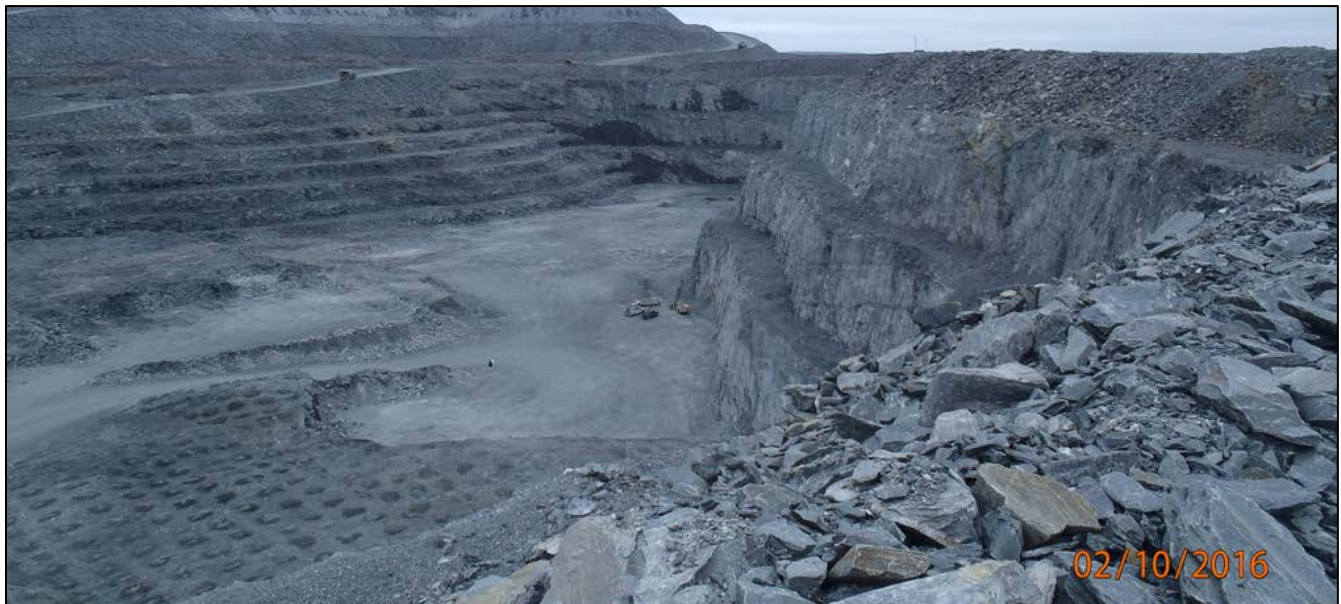
The final wall benches are being mined using pre-shear blasting methods, and are being excavated to 75-degree bench face angles. Half barrels from the blast holes are clearly visible in the walls and there is very little deviation in the borehole traces. The benches are cleaned well, and there is no indication of significant raveling and no significant build-up of material on the benches. Catch bench widths are designed to 10.5 m. There is some over break of bench crests due to blasting but this is not significant. In general, the toe of the thermal capping material is 5 m to 10 m back from the pit crest.

Photograph 8-8: Typical bench crests along highwall

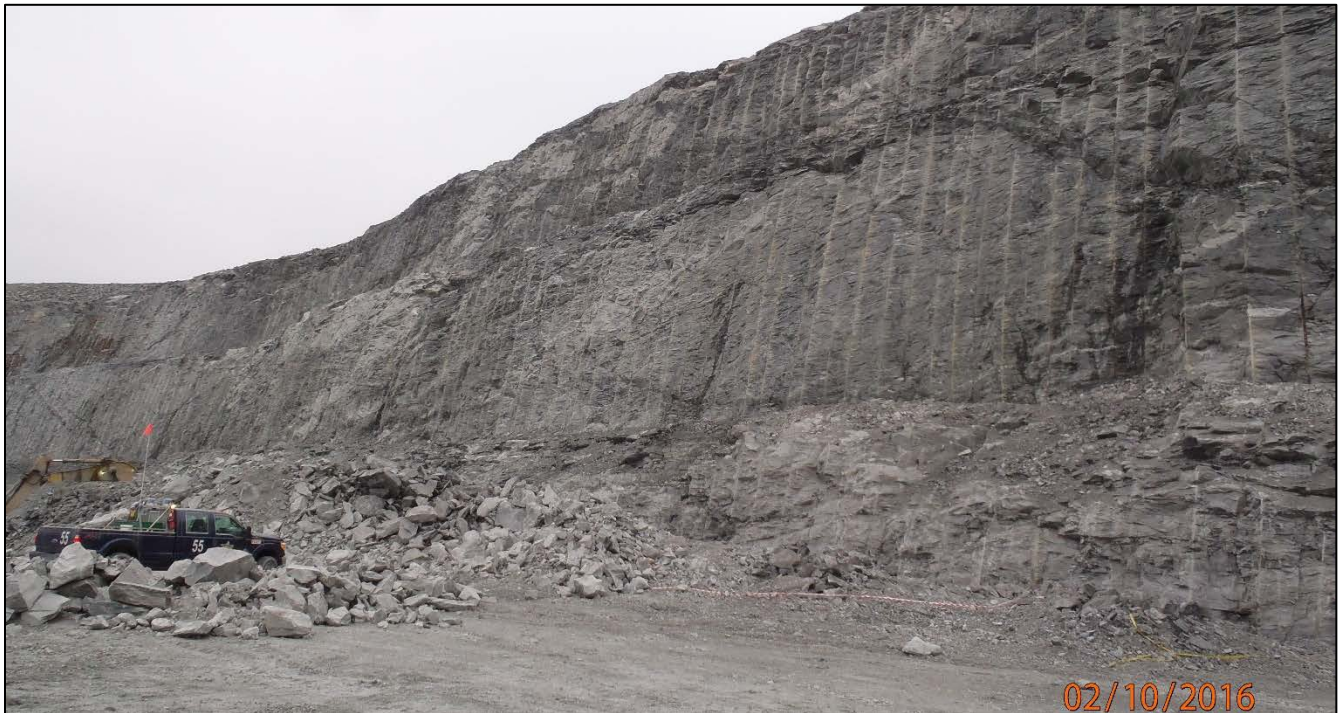
Photograph 8-9: Bench performance and visible half barrels on highwall

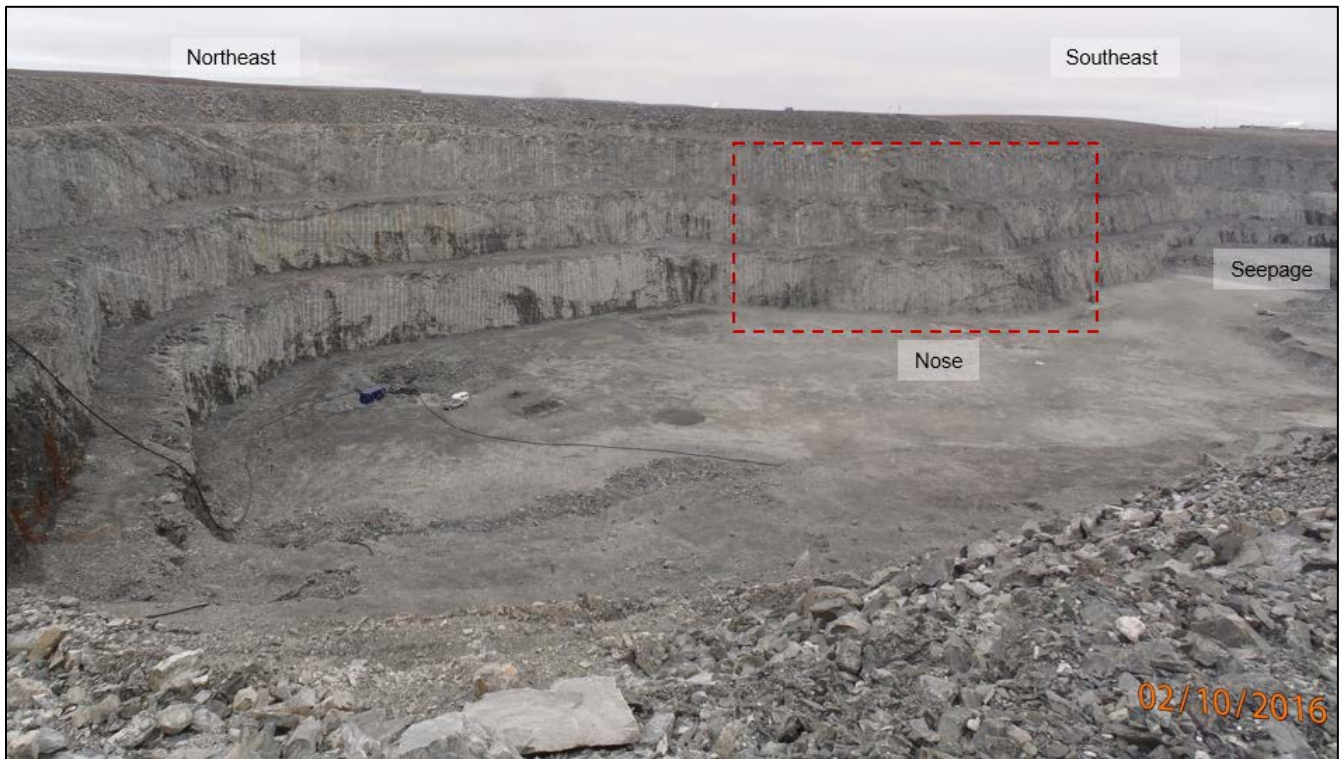
Photograph 8-11: Nose area of highwall

A series of widely spaced faults and open continuous joints dip into the nose area at high angles. The orientation of these structures could conceivably result in flexural toppling type failure mechanisms; however the competency of the intermediate volcanic rock at the Vault deposit, and the wide spacing of these features suggests these types of mechanisms are unlikely to develop.

There are no significant bench-scale geotechnical concerns noted for the nose area, and no evidence of large scale (overall slope) instability.

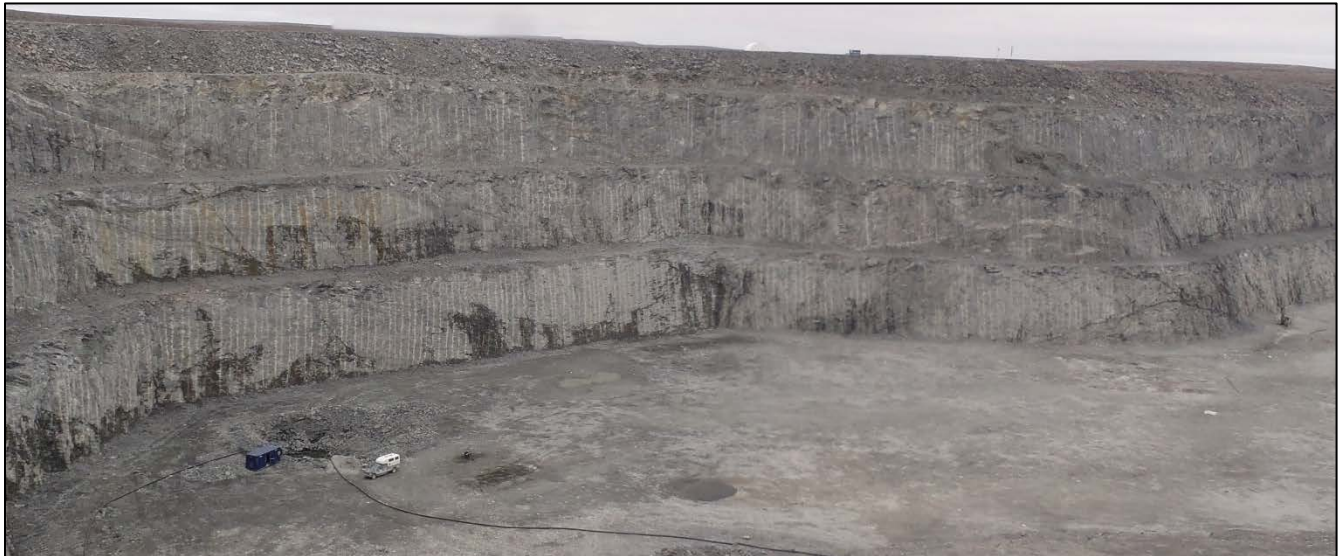
The benches of the northeast end of the highwall are performing adequately. The final bench faces show clearly visible half barrels of the pre-shear holes, and there is very little deviation. There is some over break of bench crests from blasting but this does not significantly decrease the catch bench widths. A small sump is excavated adjacent to the wall to manage water. The wall is generally dry, but with some minor localized areas of seepage from existing fractures.

*Photograph 8-13: Performance of northeast section of highwall*

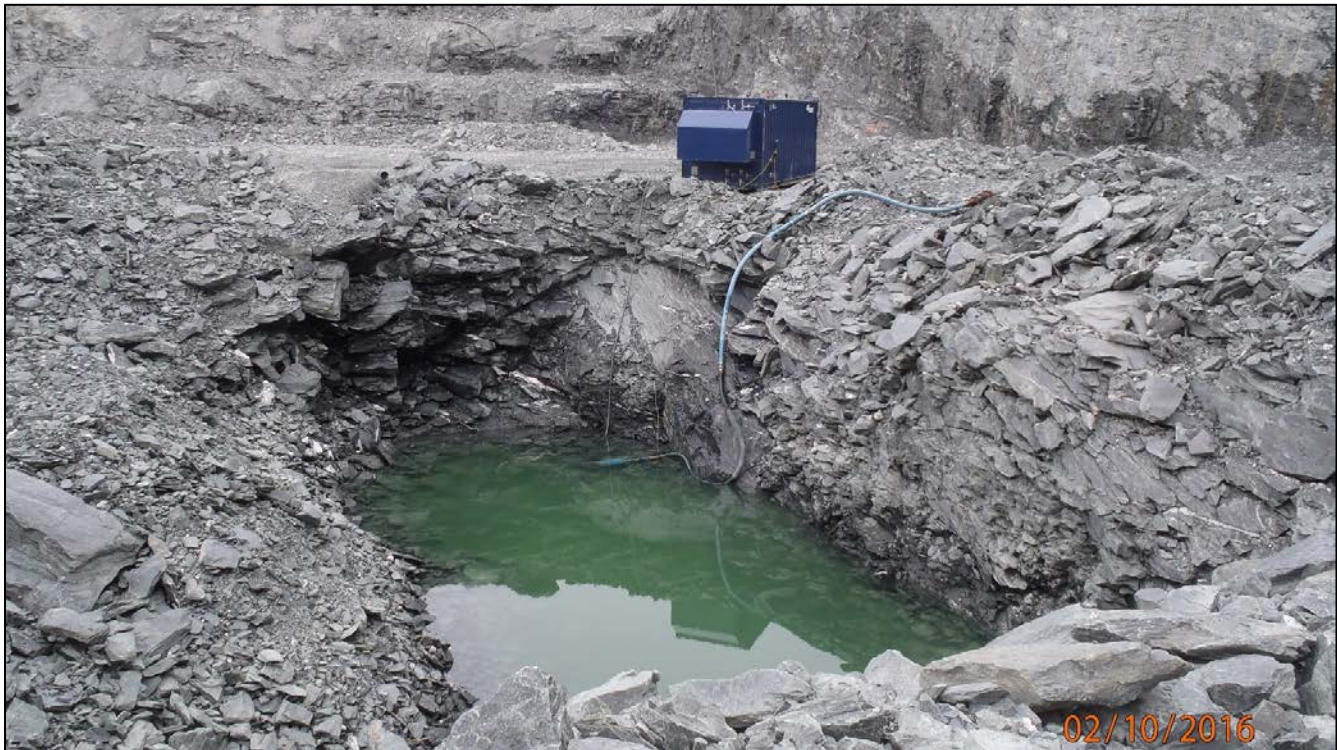
Photograph 8-14: Sump in northeast floor

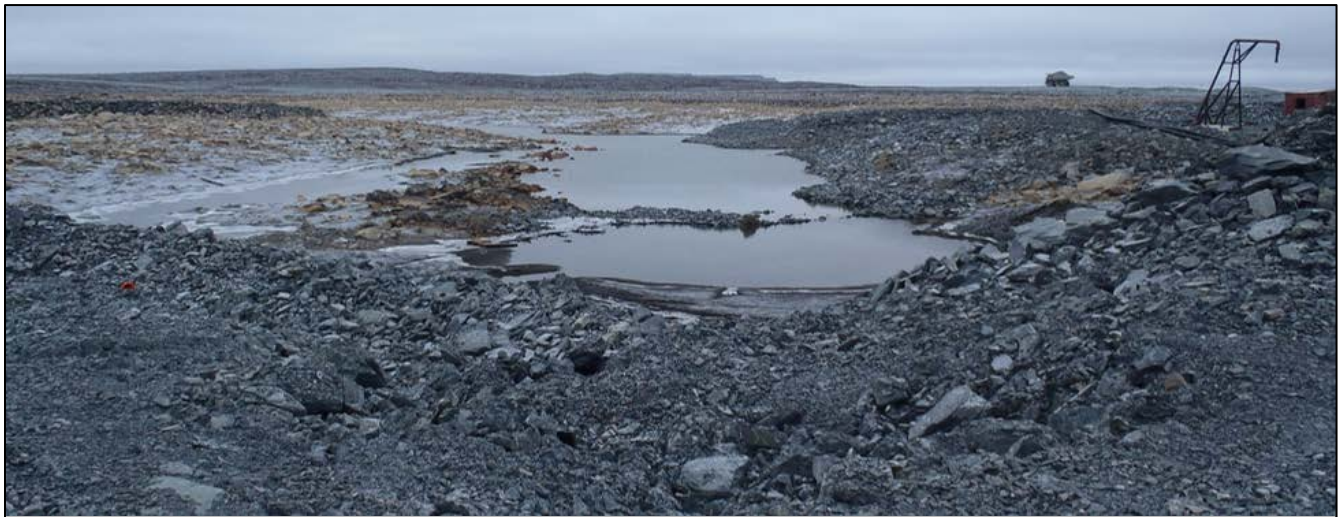
*Photograph 8-18: Vault lake level at time of site visit*

Some seepage through the rock and in to the pit should be expected but it is anticipated this will continue to diminish over time. An ice curtain may form in this area during winter, and this may contribute to local raveling of material from the wall during spring freshet.

- Continue to manage the level of Vault Lake below the bedrock/till contact elevation to restrict any flow through the ring road or overburden materials.
- Continue to monitor the ring road as part of regular site geotechnical inspections for any further settlement or development of tension cracks.
- Continue visual monitoring of the inflows on the pit wall as part of regular site geotechnical inspections.
- Monitor potential local raveling of material from the wall during spring freshet.

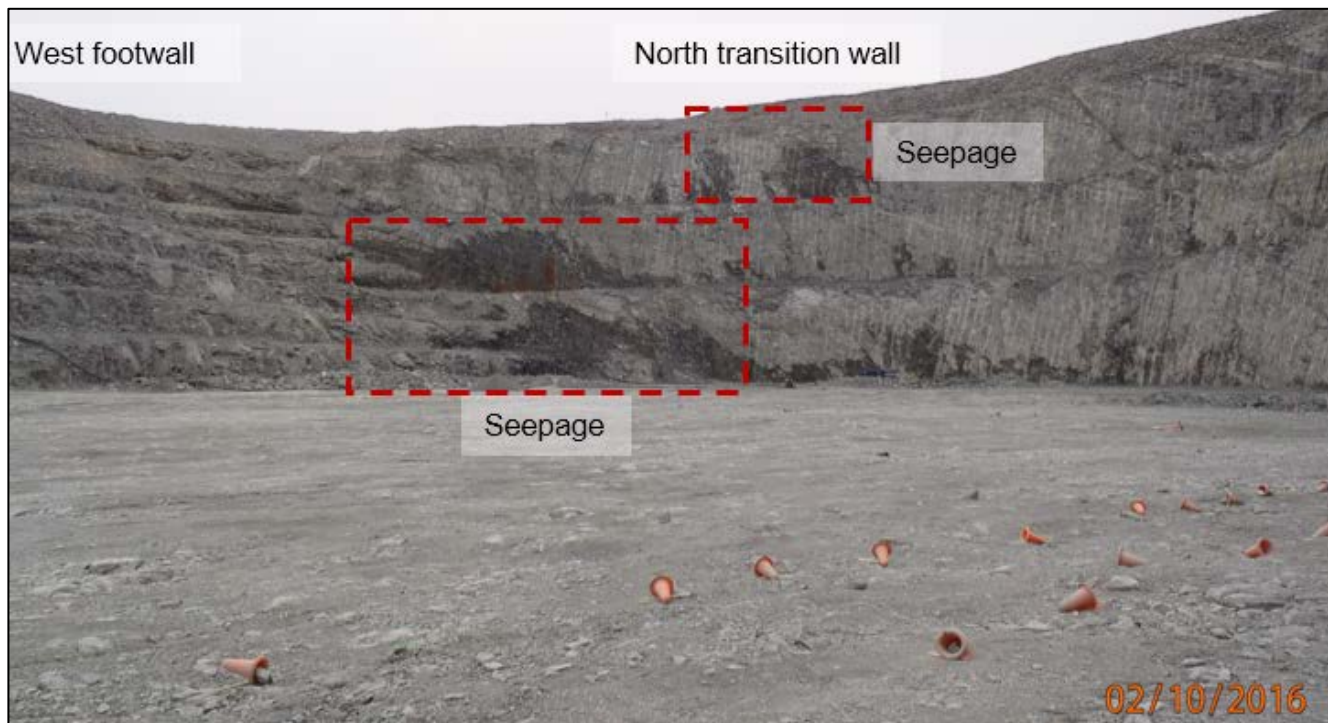
The Vault north wall (grid north) transitions from the highwall wall to the footwall. The north wall benches are performing satisfactorily although some crest loss is noted. There is seepage from the north wall through west footwall. There is a sump near the base of the wall at the northwest corner used to manage the seepage.

Photograph 8-19: Vault Pit north transition wall

The local crest loss along the north transition wall is related to the change of wall orientation relative to the southeast dipping foliation, and its intersection with steeply northeast dipping joint planes. The joint planes provide a release surface for block sliding along the foliation.

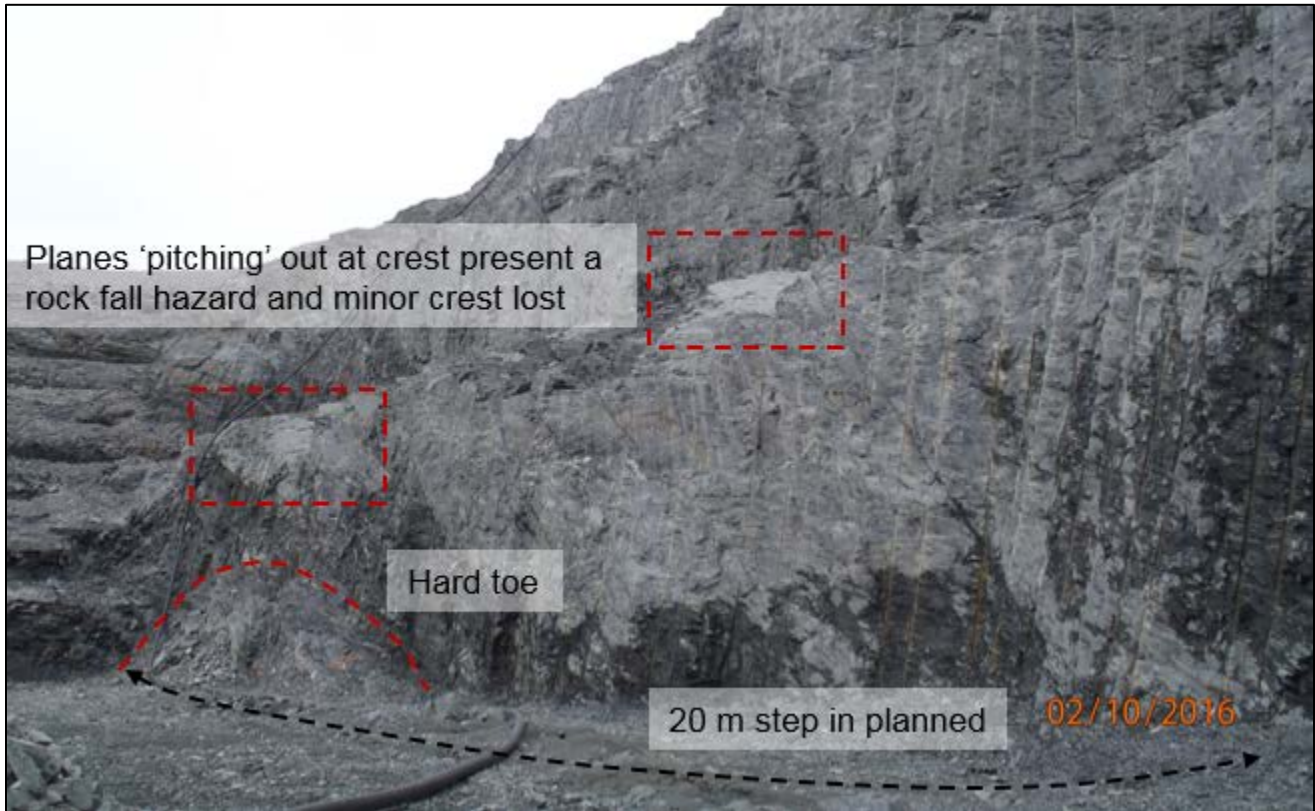
Photograph 8-21: North wall transition

The crest loss and block instability along the north wall was discussed with AEM during the site inspection, and it was recommended that a bumper berm be placed along the toe of the north wall to retain any material raveling from the benches, and to prevent equipment and personnel from approaching this area. The hard toe at the northwest corner will remain in place as there is a 20 m step-in catch bench planned at this level.

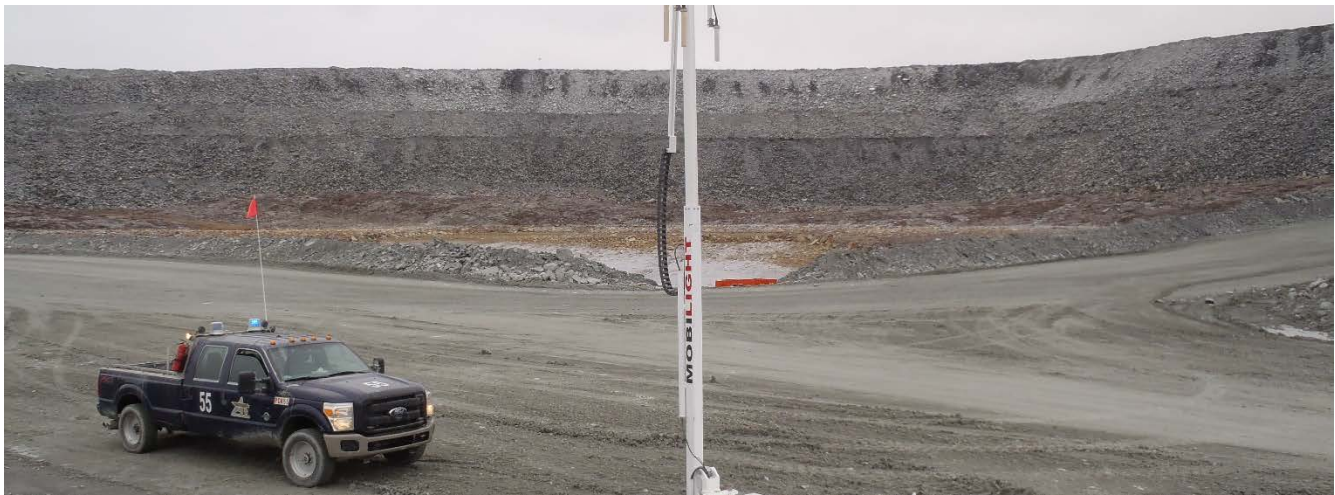
The northwest end of the pit is developed in the former lake bed of the dewatered Vault Lake. Furthermore, a water management pond – Pond A – is located to the north of the haul road which separates Pond A from the seepage area. Pond A is shown in the following photograph.

*Photograph 8-23: Vault Pit Pond A water management pond*

The seepage source is likely the release of water stored in the talik beneath Vault Lake. Flows are low and are not likely to result in the formation of significant ice.
