### **Annual Review of Portage and Goose Pit Slope Performance**

# 2017 ANNUAL PIT SLOPE PERFORMANCE REVIEW MEADOWBANK MINE, NUNAVUT

DECEMBER 22, 2017

An annual site visit to inspect the performance of the pit walls of the open pits at Agnico Eagle Mines Ltd.'s (AEM) Meadowbank Mine was carried out by Tetra Tech Canada Inc. (Tetra Tech) during the period 25 September 2017 to 28 September 2017. A detailed summary of recommendations is presented in Section 9.

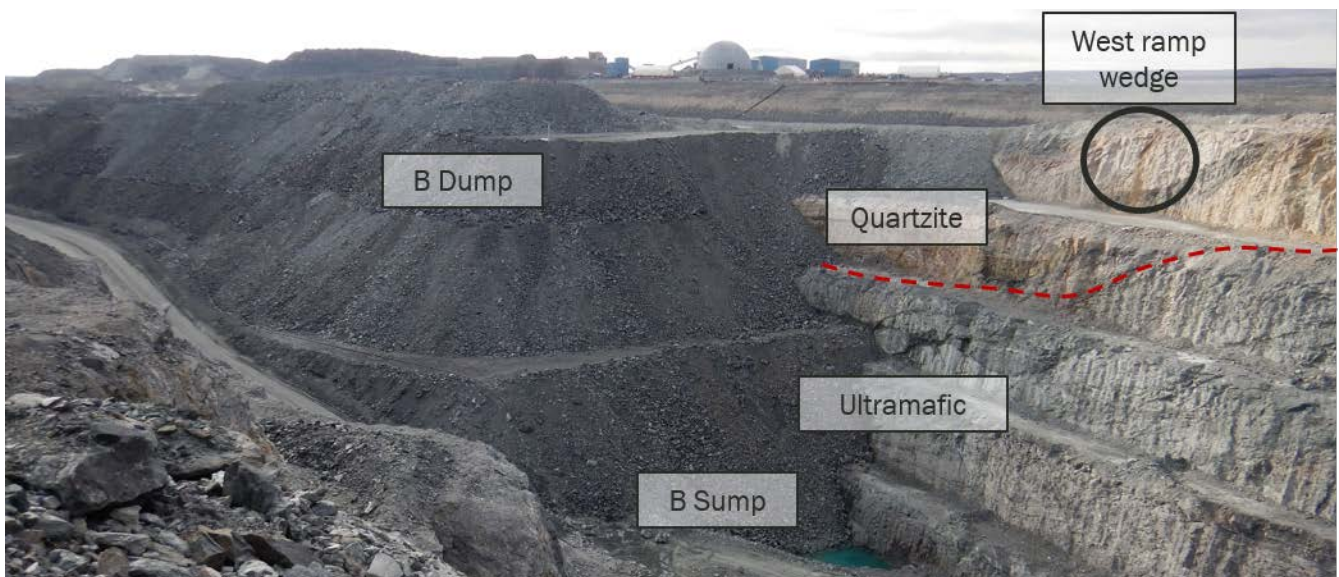
*Photograph 4-13: Pit B west wall performance (2017)*

There is no evidence of large-scale instability for the west wall of Pit B.

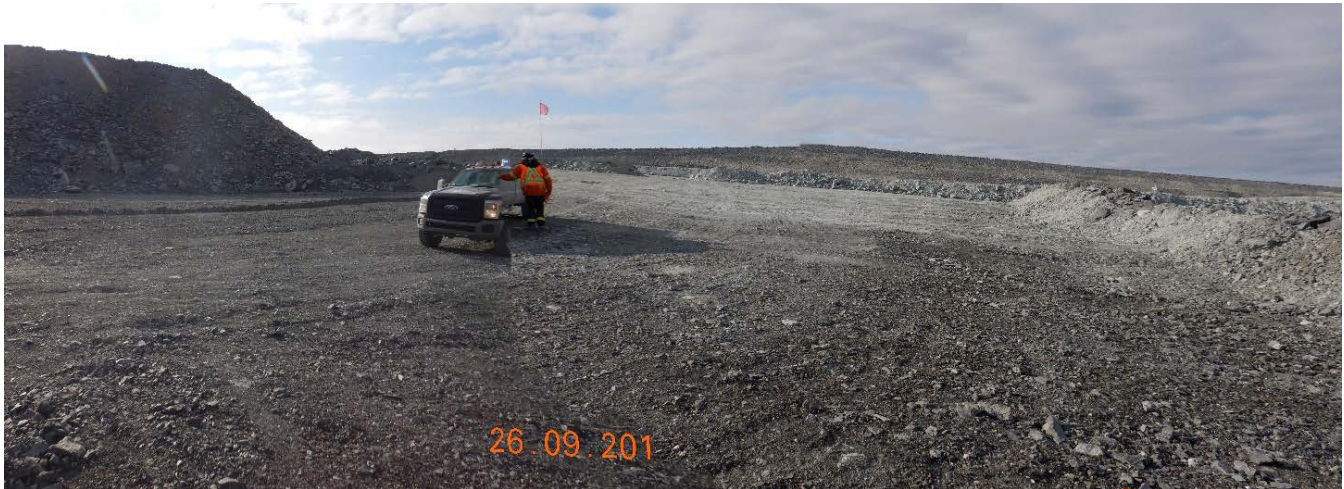
*Photograph 4-15: Pit B dump platform (2017)*

The crest of the dump was traversed, and no evidence of tension cracks or settlement were observed: furthermore, no bulging of the dump toe or dump face was observed.

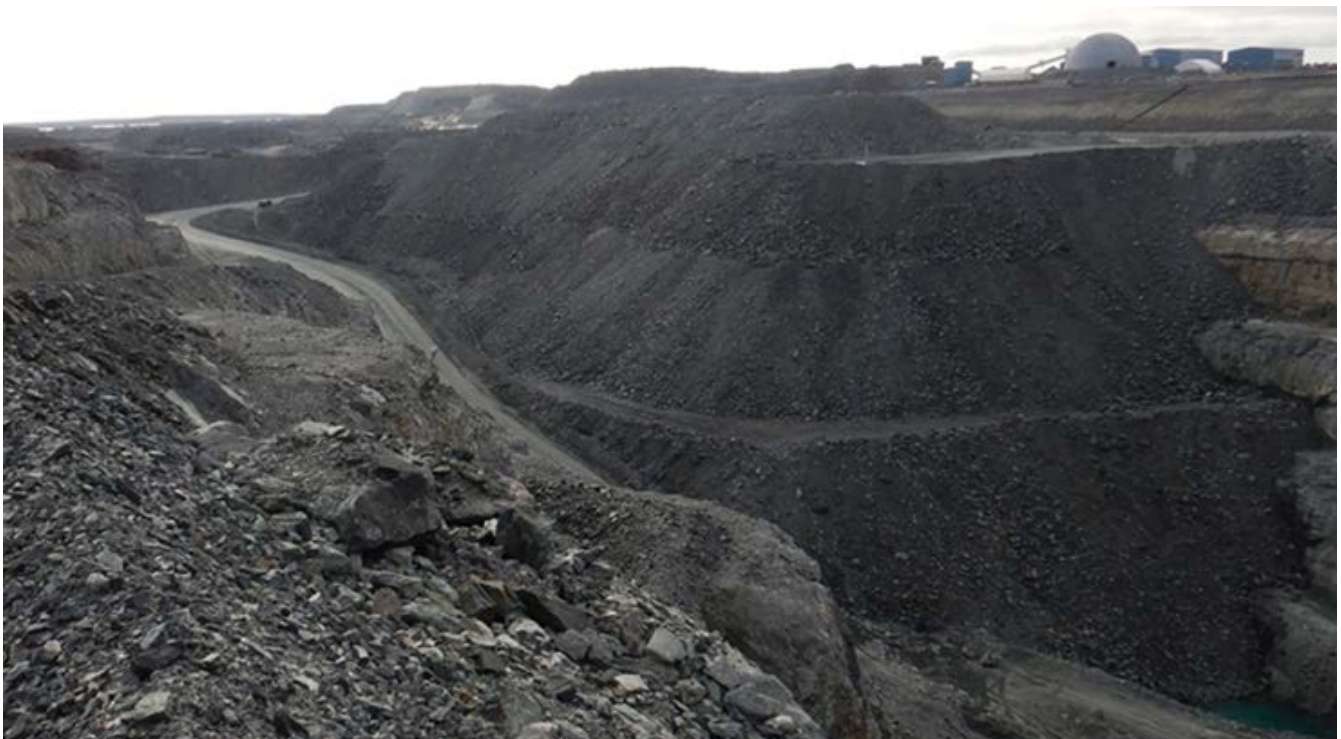
*Photograph 4-16: Pit B dump looking southwest (2017)*

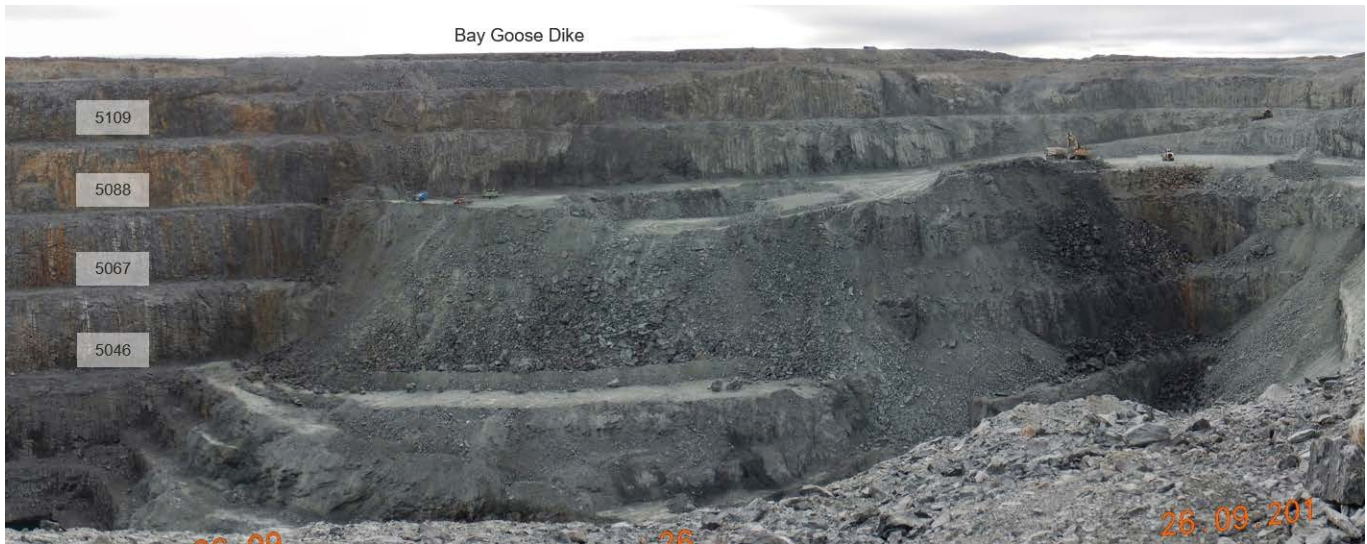
The following photograph shows the south wall at the time of the site visit. The wall has been mined down from the 5109 mRL platform in 2016, to approximately the 5088 mRL platform.

*Photograph 6-4: Pit E south wall (2017)*

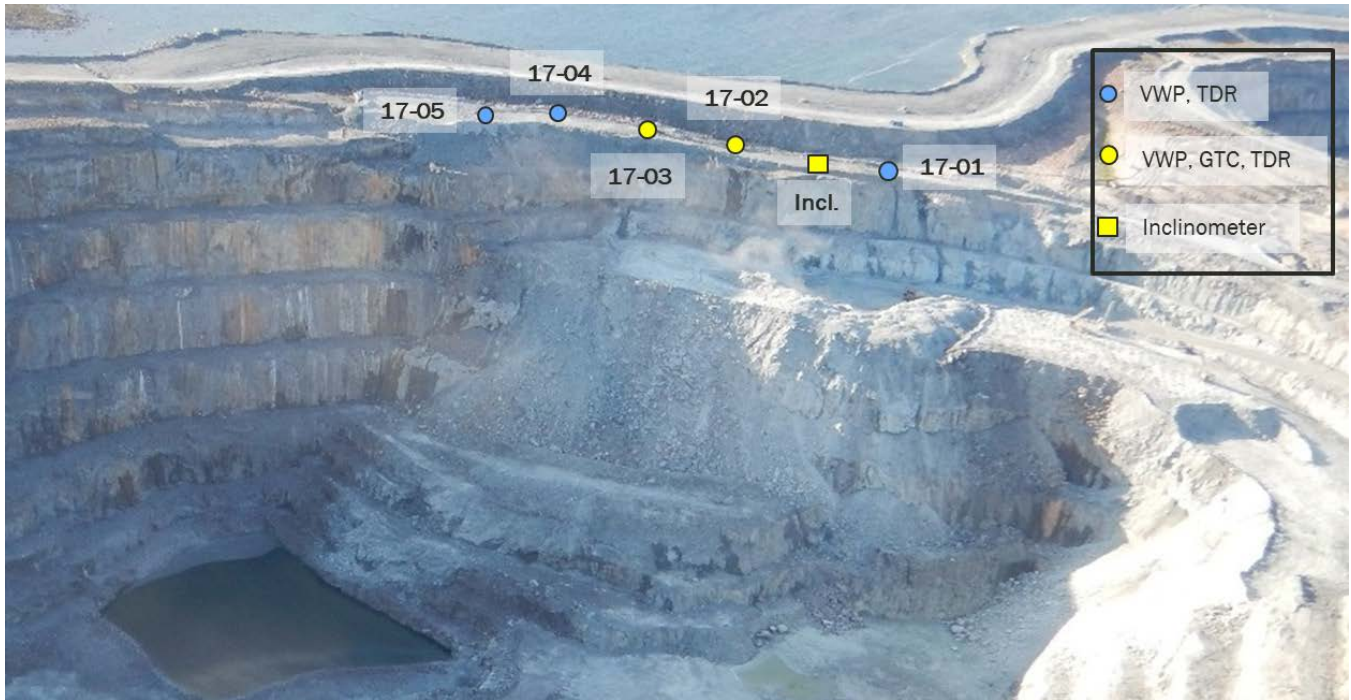
**Photograph 6-10: Pit E south wall instrumentation locations**

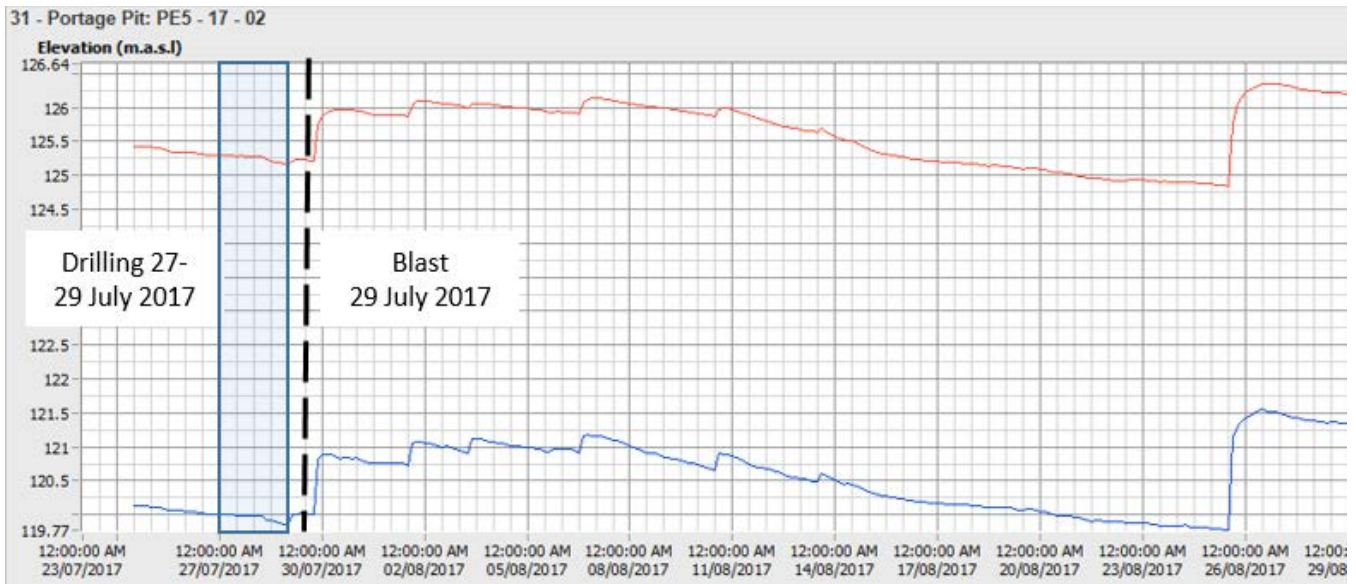
A review of the other instrument records do not show the response to drilling, but do show a response to the blast. The responses to the blast are very similar for piezometers in 17-02 and 17-04, as well as from an existing installation P3E-14. The response involved a 1 to 2 metre rapid (almost instantaneous) rise in pressure head. This was followed by a series of perturbations over a period of 3 to 4 weeks at which time the pre-blast levels were reached. A similar response occurred around 25 August 2017 but was not investigated further.

Figure 6-3: Instrument PE-17-02 piezometer response to blast

The responses in the piezometers are considered to be consistent with the current conceptual hydrogeological and engineering geological model which includes a central structural zone extending through the south wall of the pit (through the former failed wall), and is hydraulically connected to Third Portage Lake. The rapid and large drop in pressure in the one piezometer nest, followed by relatively rapid recovery, is suggestive of a hydraulic connection between the location of that piezometer, and the drilled blast pattern at the toe of the slope, while the rapid and smaller increase in pressure in the other piezometers, followed by a slower recovery, is suggestive of other lower conductivity zones.

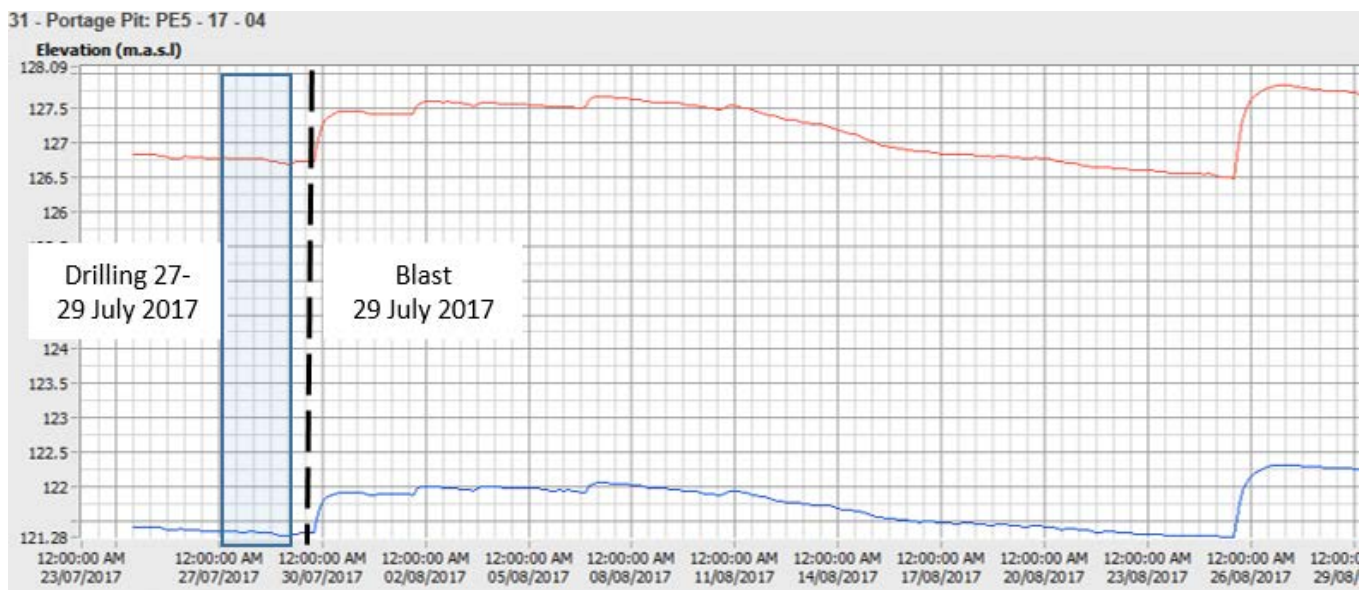
Figure 6-4: Instrument PE-17-04 piezometer response to blast

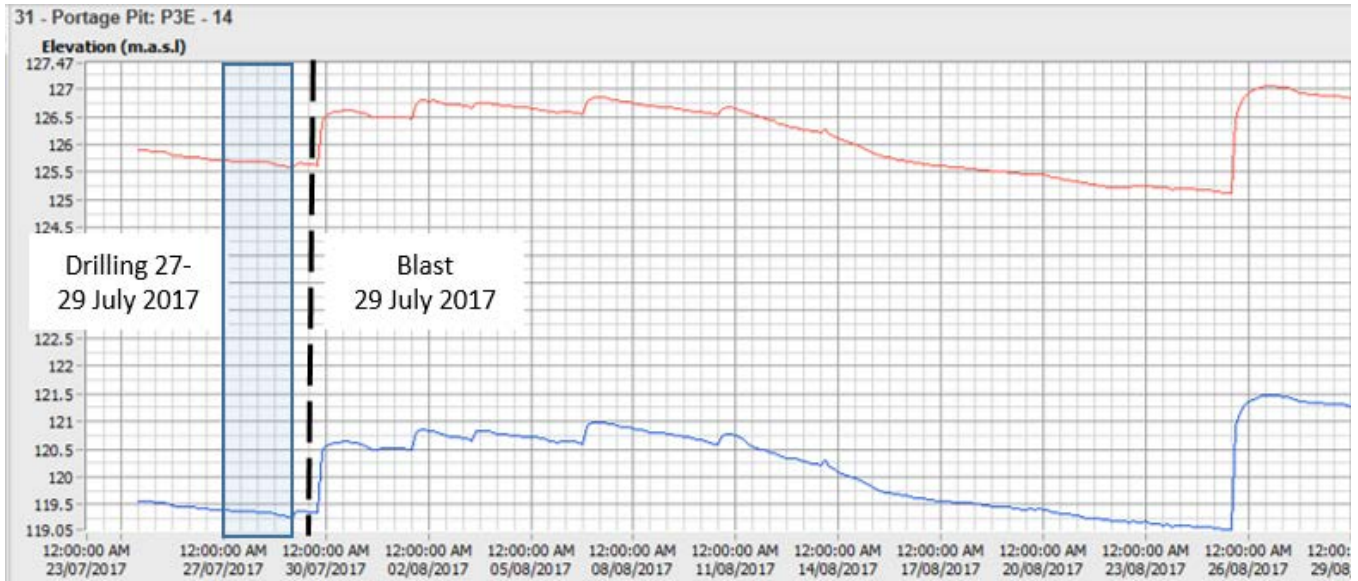
**Figure 6-5: Instrument PE3-14 piezometer response to blast**

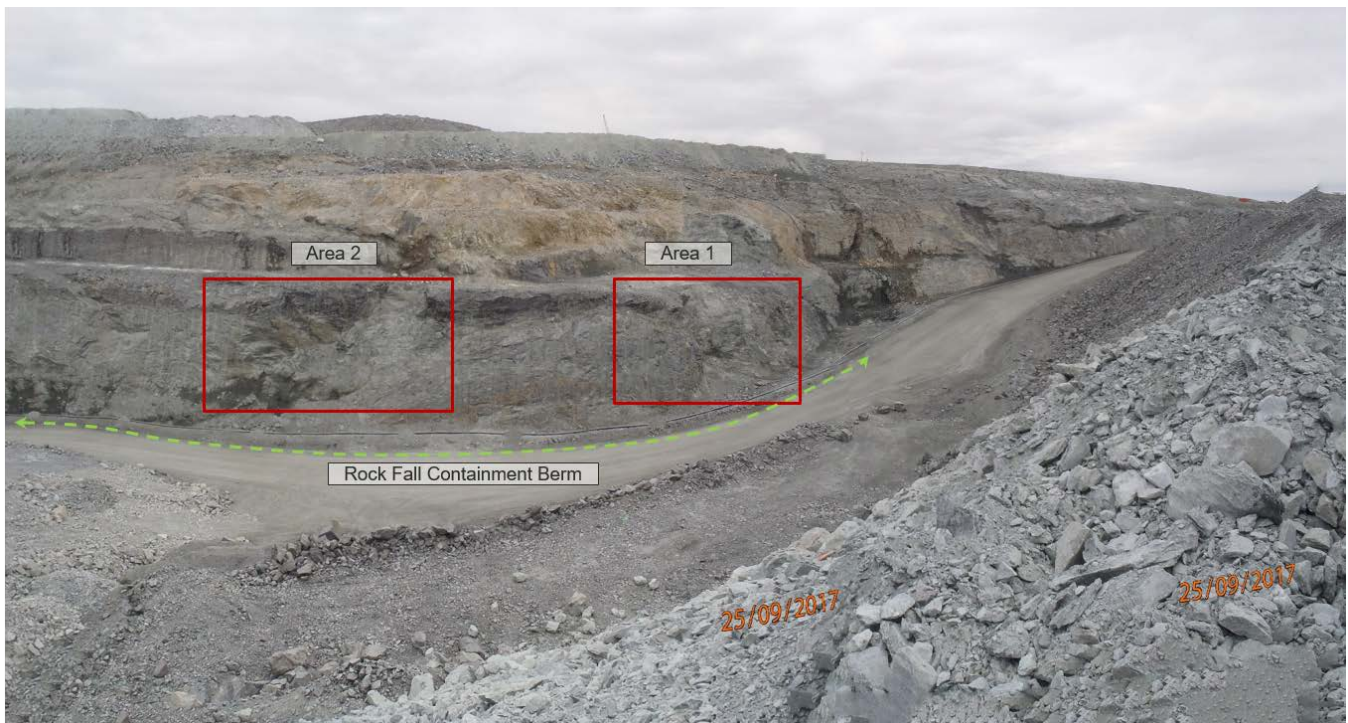
*Photograph 6-13: Pit E west wall ramp areas of potential instability (2017)*

The rock fall containment berm constructed along the west edge of the ramp continues to provide adequate catchment for rock falls that have occurred along the west wall above the ramp.

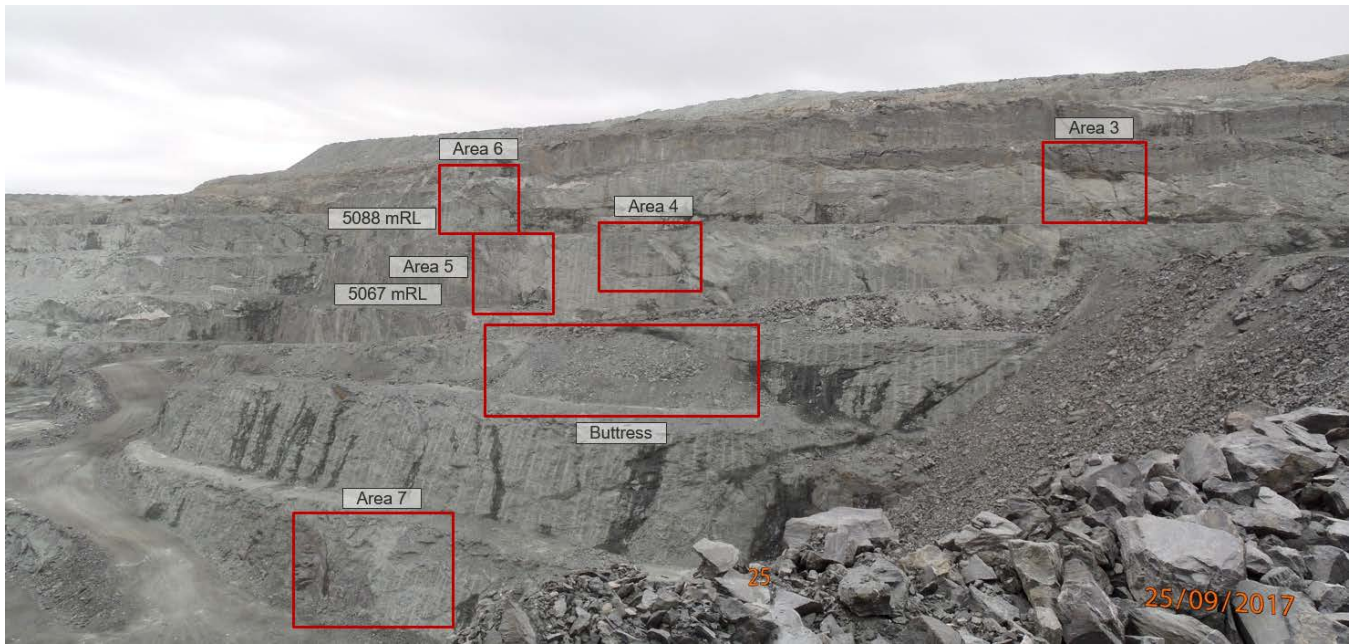
**Photograph 6-14: Pit E west wall ramp areas of potential instability (2017)**

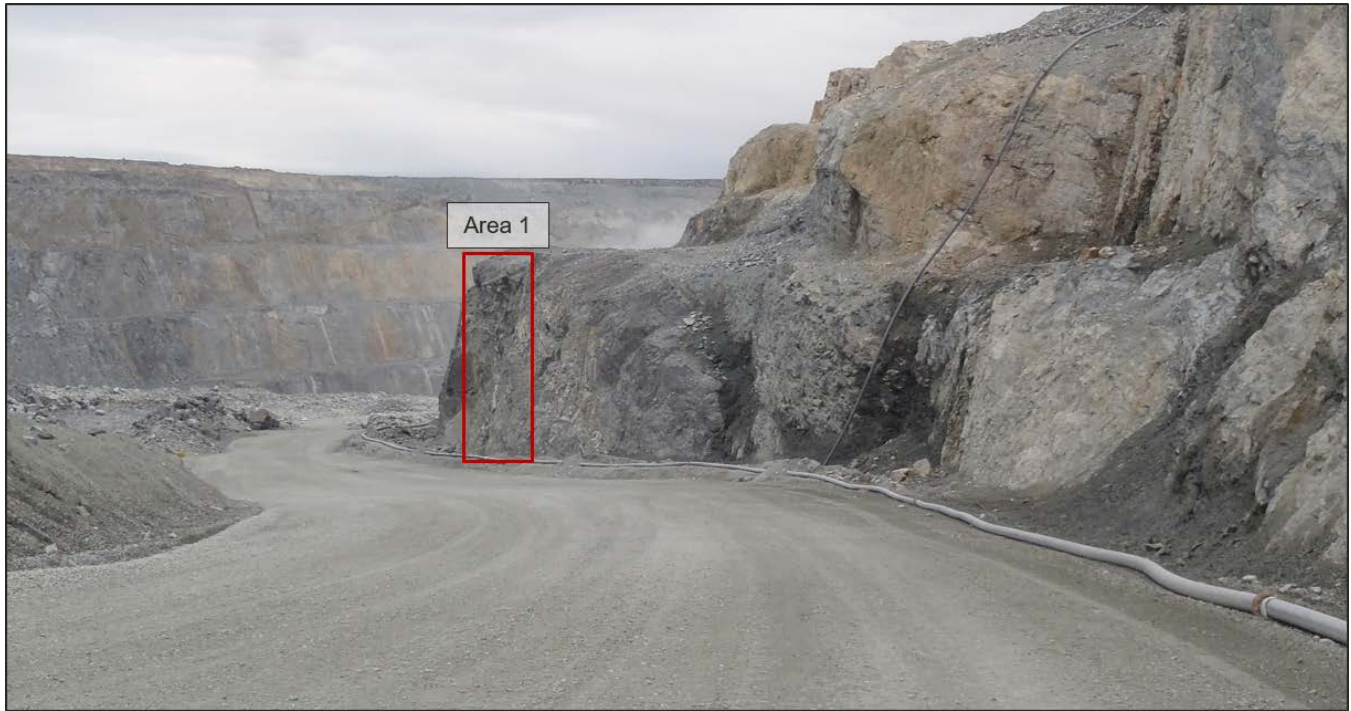
The ramp passes beneath an area of wall that was experienced several rock falls in 2014 (Area 1 and Area 2). The area of wall is associated with a fault zone – possibly the Bay Fault or a splay off that fault trend - trending along the west wall of the pit. This fault, or shear, is several metres wide, and steeply inclined to the west.

**Photograph 6-15: Pit E Ramp Area 1 above ramp - Bay Fault or splay (2017)**

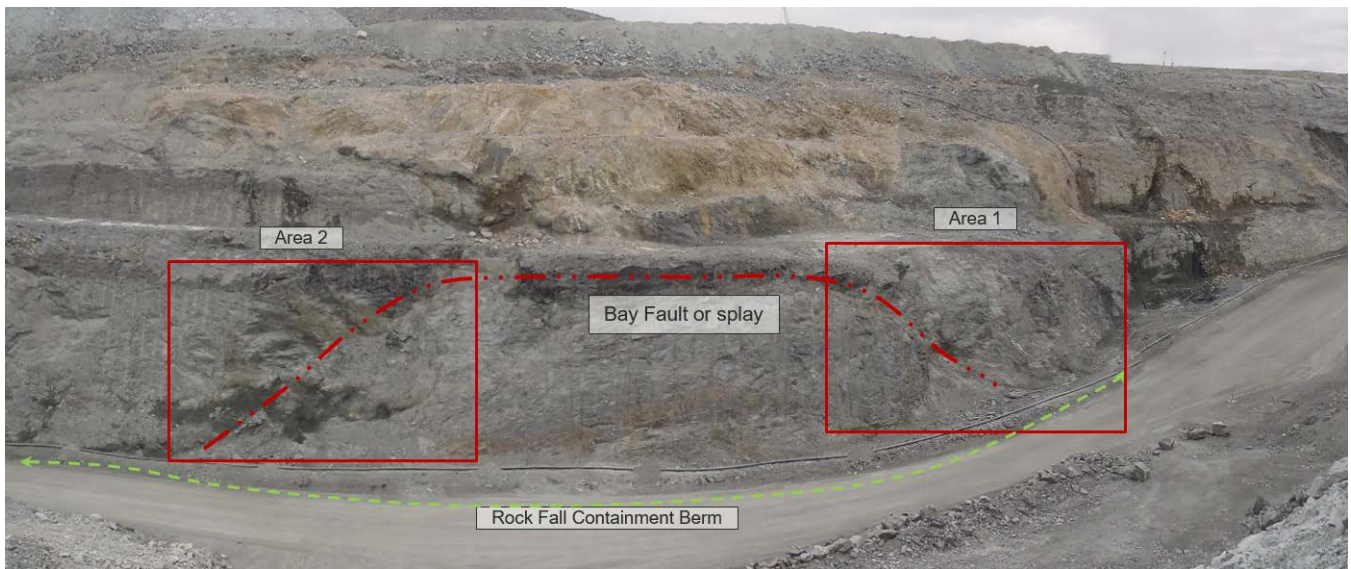
**Photograph 6-16: Pit E ramp Areas 1 and 2 -Bay Fault or splay (2017). Note final bench height is 21 m**

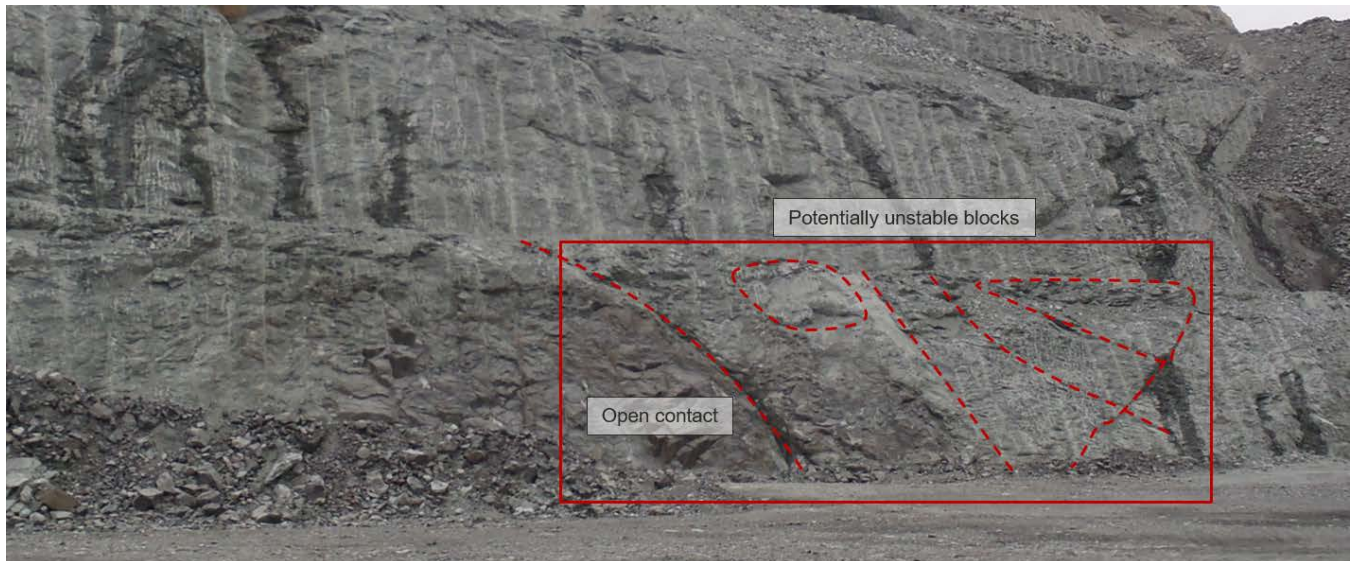
**Photograph 6-20: Pit E ramp Area 7 at bottom of ramp**

The potential instability is characterized by strongly sheared ultramafic rock in contact with iron formation, with associated shear planes dipping out of the bench face. Some of the sheared planes are open and appear to form potential wedge and planar mechanisms. The geometry is to some degree similar to the instability that was encountered adjacent to the ramp in the Goose Pit in 2014. A safety berm should be constructed along this section of ramp to prevent personnel and equipment from stopping beneath this area. The area should continue to be monitored as part of regular site geotechnical inspections.

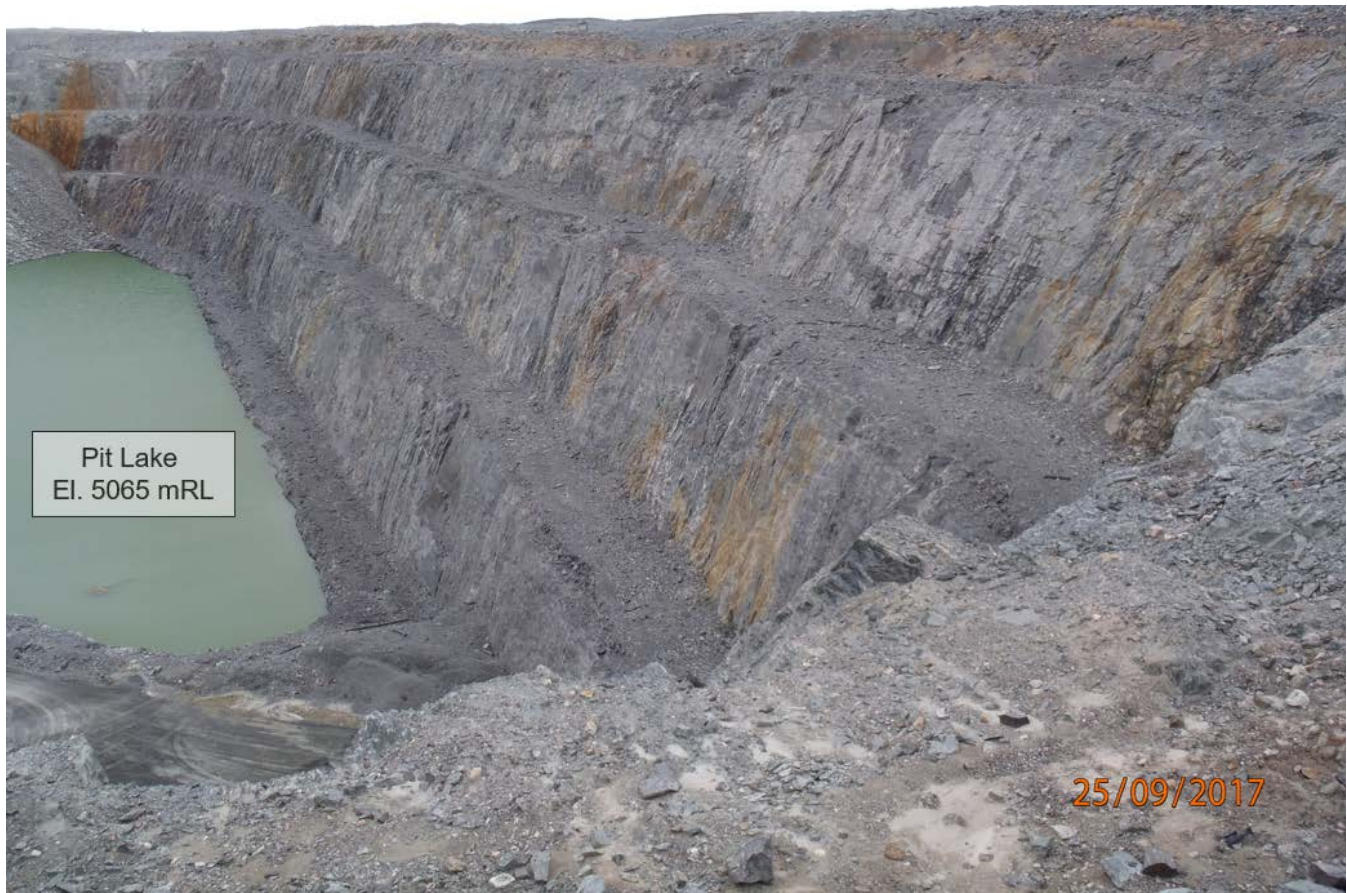
*Photograph 7-1: Goose Pit east wall looking north (2017)*

The east wall continues to perform satisfactorily and there are no immediate geotechnical concerns.

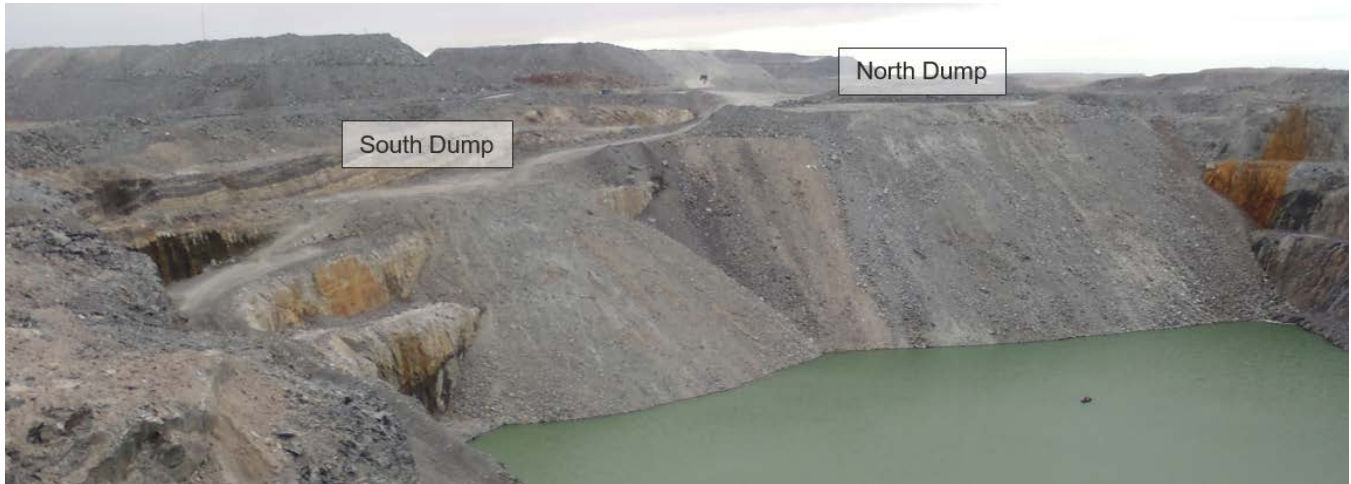
**Photograph 7-4: Goose Pit waste rock dumps (2017)**

Several large tension cracks were noted during the 2015 inspection of the North Dump platform, between 10 m and 20 m back from the dump crest. The tension cracks are curvilinear and extend the full width of the dump platform. It was noted during the 2015 inspection that approximately 30 cm of vertical displacement across the cracks and lateral separation (opening) had occurred. During the 2016 inspection, it was observed that the vertical displacement across the cracks has increased due to dump crest settlement. Additional tension cracks were also observed at that time.

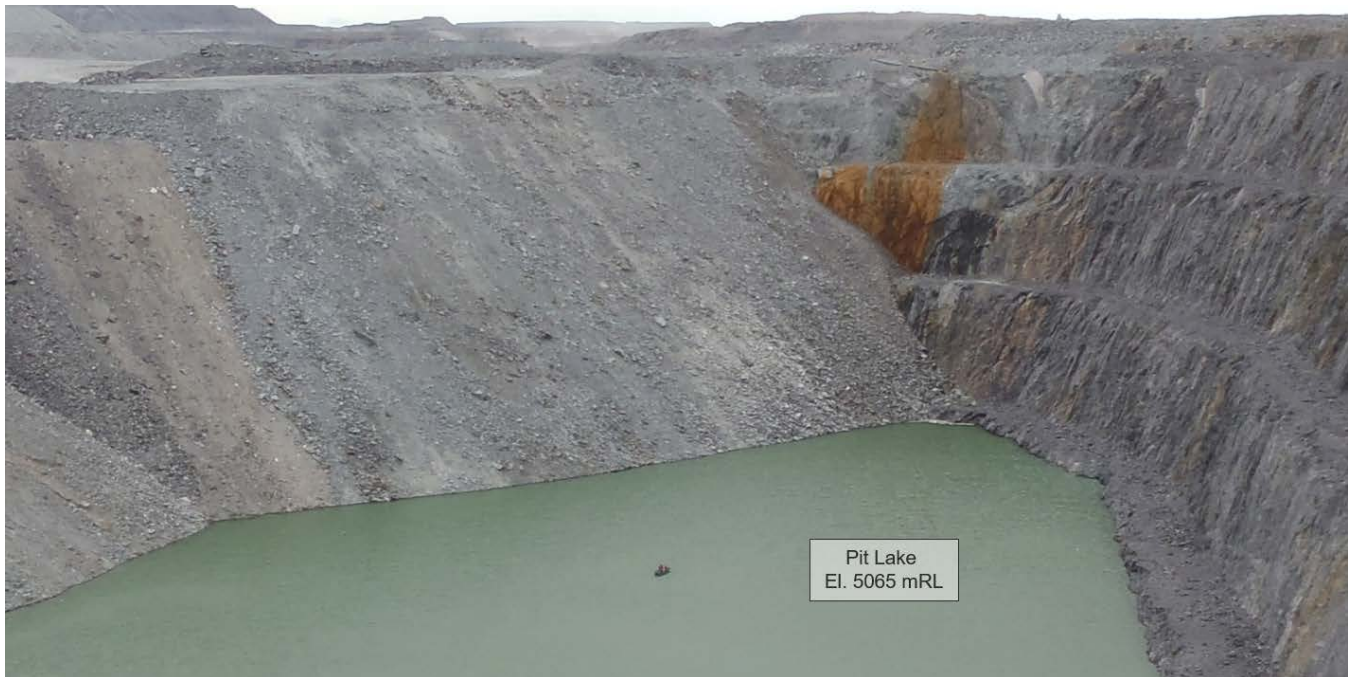
*Photograph 7-5: Goose Pit northwest through northeast wall (north end wall 2017)*

The northwest through northeast walls of the pit are almost entirely covered by the North Dump. As such many of the previous areas of instability are covered and no longer present any significant hazard. Seepage is still noted on the north end-wall in association with the main structural features intersecting the wall, and the seepage face is

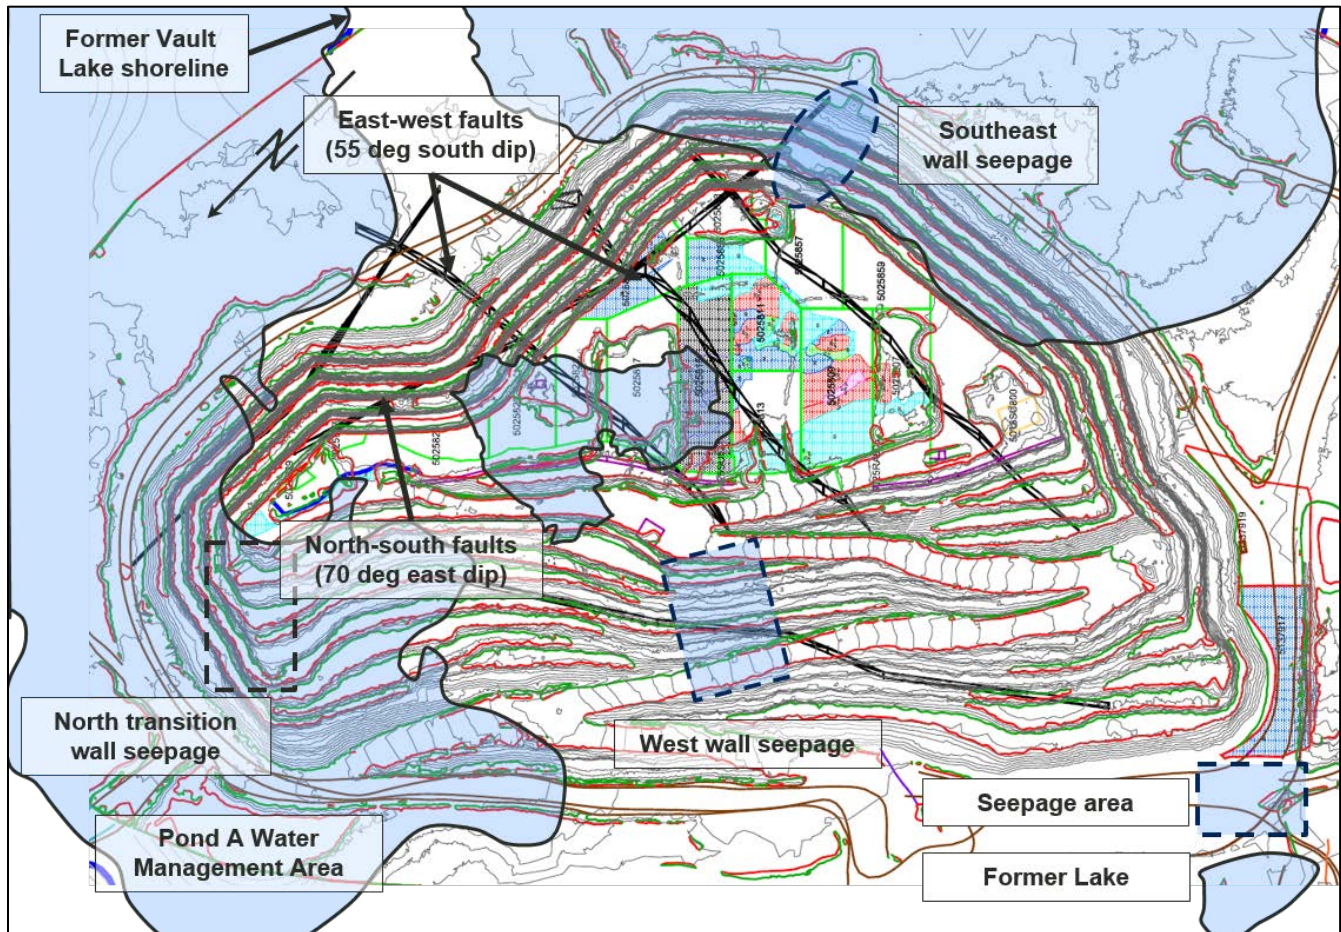
The locations for water inflows and seepage noted during the 2017 inspection remain the same as for previous inspections. There are three main areas of the pit where water inflow or seepage are noted. These are shown on the figure below and discussed in relevant sections. These are generally related to the dewatering of Vault Lake, and to release of water stored in the talik beneath the former lakes.

Figure 8-2: Vault Pit water inflow and seepage (2017)

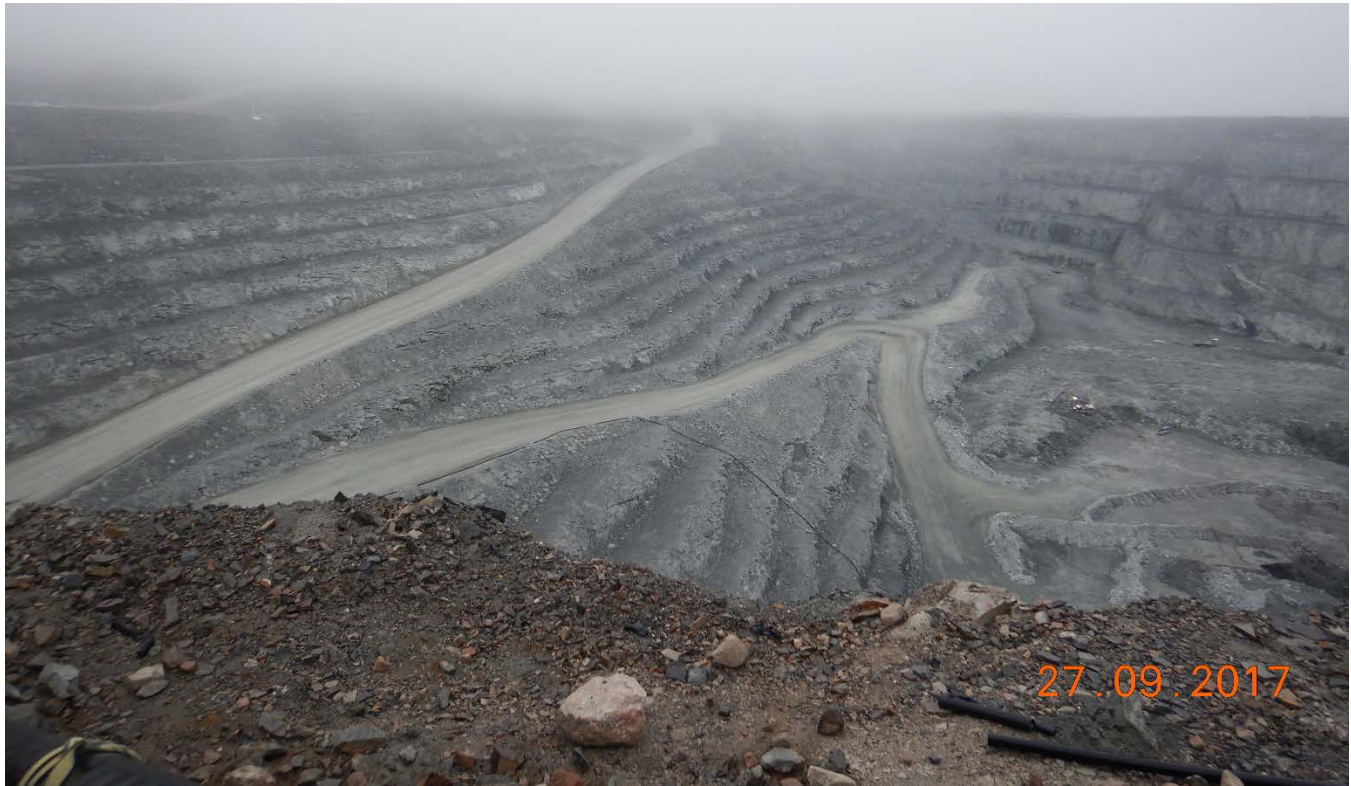
Within the West Wall Design Sector, average back break was estimated to be 1.3 m, with maximum back break of approximately 3 m (Golder, 2013b). Recent estimates of back break distances by AEM show the range in average back break to be from about 1.4 m to 3.7 m for this slope, averaging about 2.4 m which is slightly higher than the predicted back break.

*Photograph 8-1: Vault Pit west wall looking north (2017)*

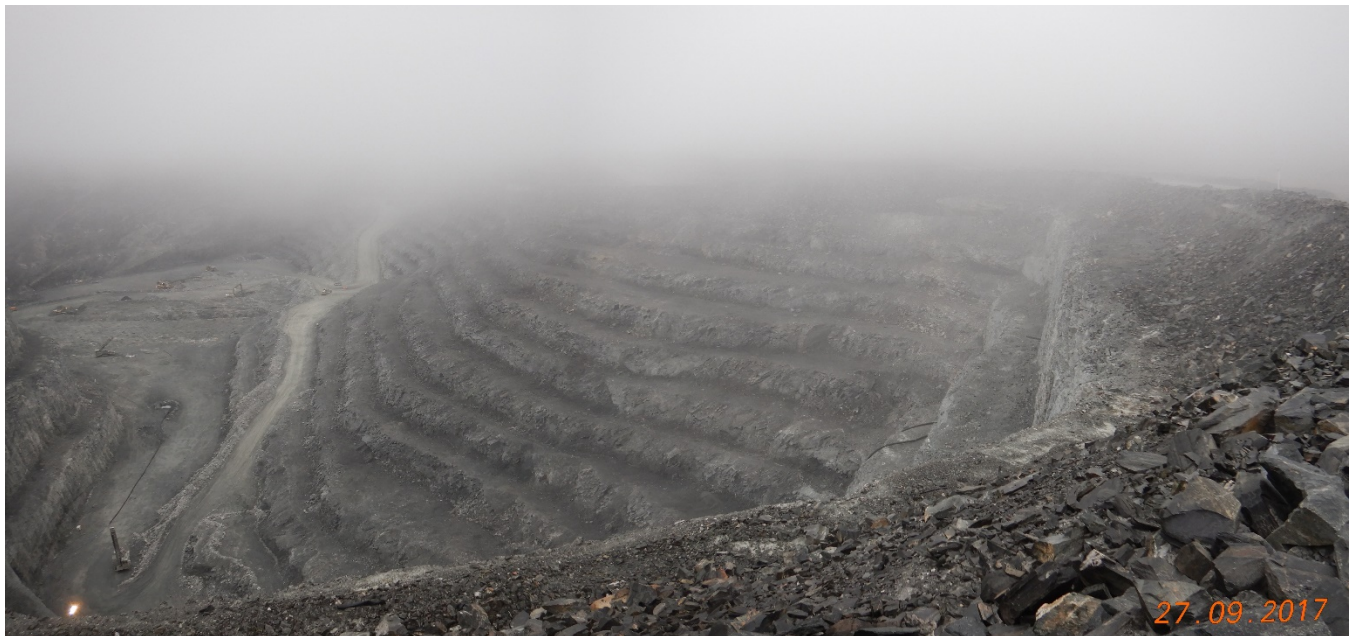
*Photograph 8-2: Vault Pit west wall looking south (2017)*

There are no significant geotechnical concerns noted, and no evidence of large scale (overall slope) instability for the footwall slope.

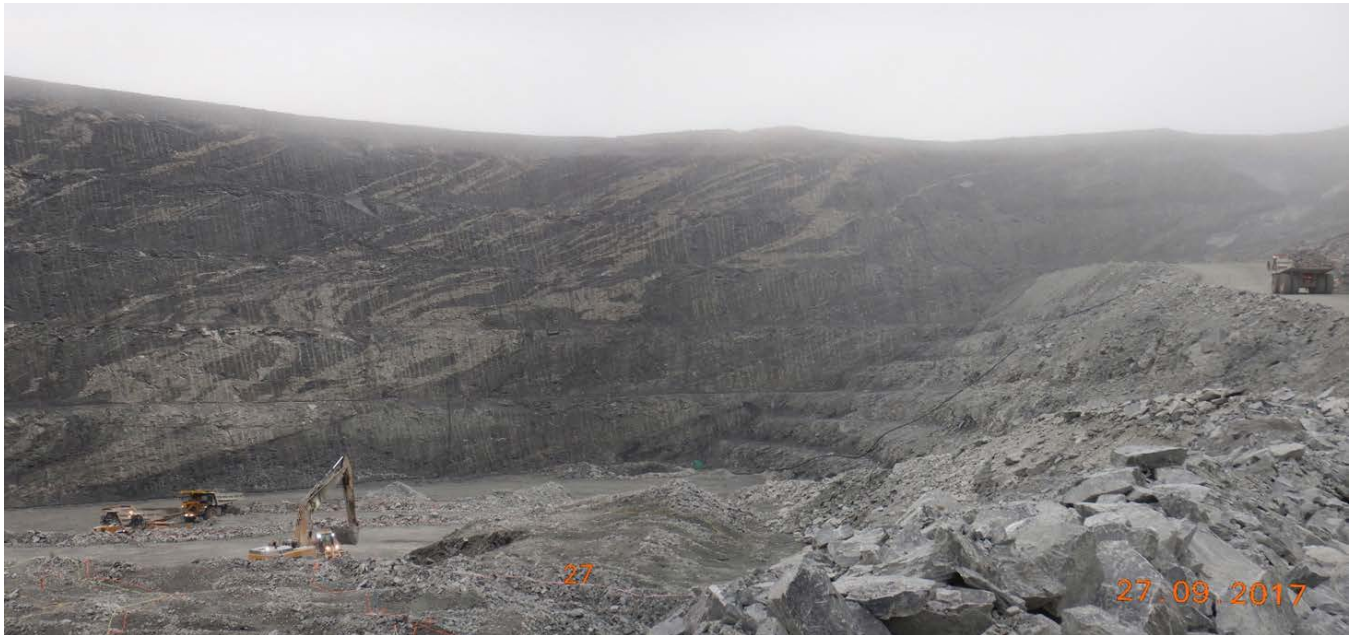
**Photograph 8-4: Vault Pit grid south wall (2017)**

The southwest wall (grid south) intersects the stratigraphy and foliation perpendicular to their trend. The gently east dipping structure can be seen clearly in the wall. The overall wall continues to perform well, with little accumulation of material noted on the benches. The half barrel traces from pre-shear blasting are clearly visible on the wall, even from a distance. There is very little deviation noted for the blast holes.

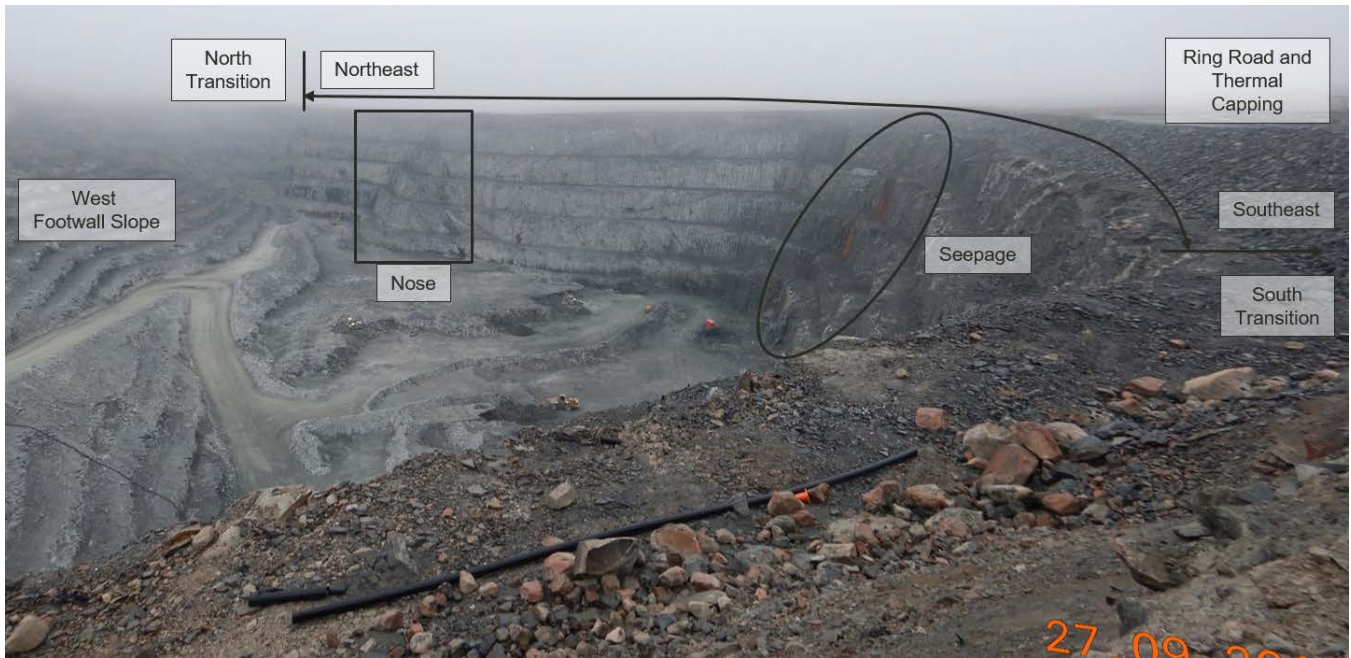
**Photograph 8-7: Vault Pit east highwall (2017)**

The southeast to northeast highwall (grid east wall) is being mined down from its final crest position. The wall is performing satisfactorily.

The final benches are being mined using pre-shear blasting methods, and are being excavated to 75-degree bench face angles. Half barrels from the blast holes are clearly visible in the walls and there is very little deviation in the borehole traces. The benches are cleaned well, and there is no indication of significant raveling and no significant accumulation of material on the benches. There is some over break of bench crests due to blasting but this is not significant. In general, the toe of the thermal capping material is greater than 2 m back from the pit crest.

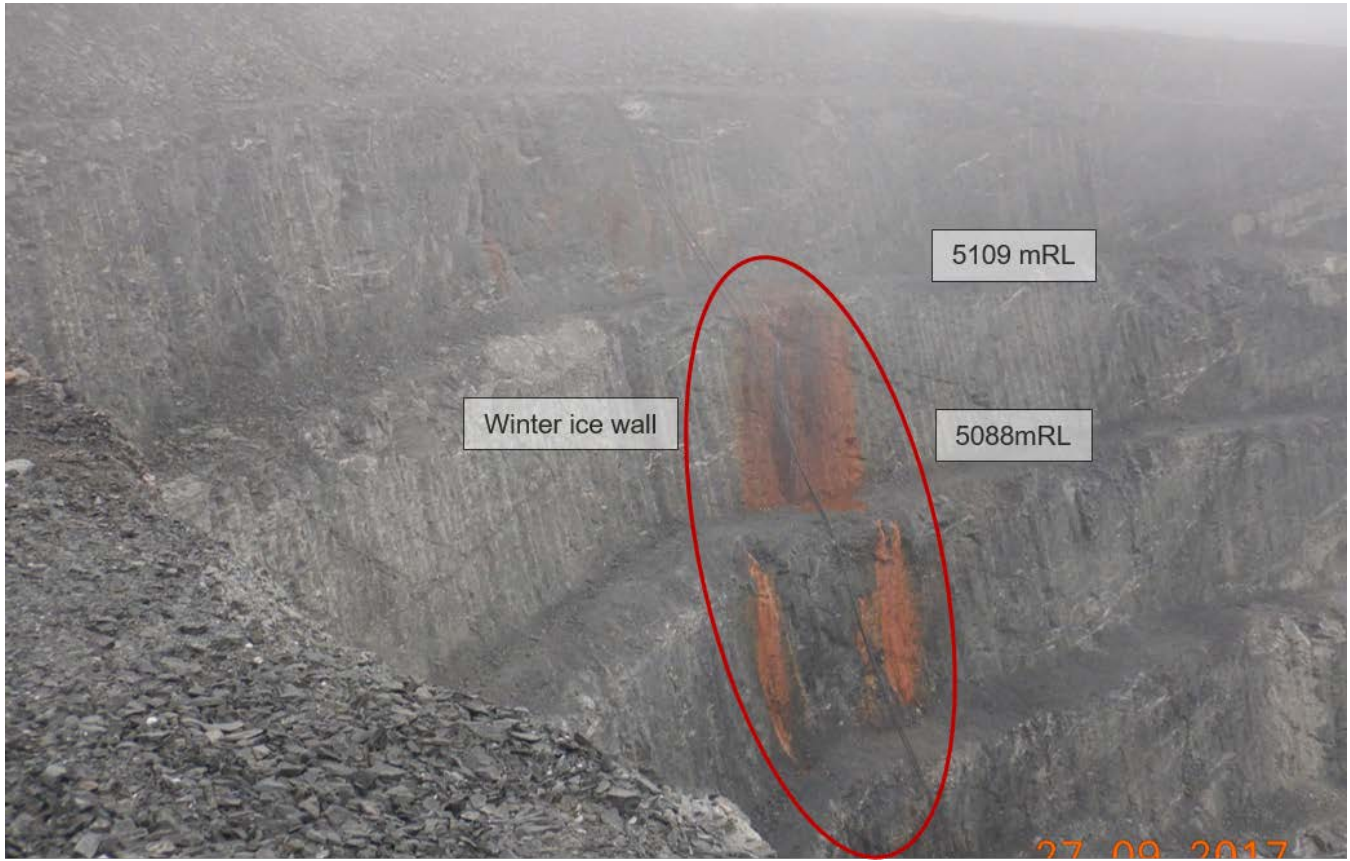
*Photograph 8-10: Vault Pit seepage from southeast pit wall 5109 bench (2017)*

The water inflows to the pit from the southeast wall have been most problematic during winter, when a large ice wall is formed. AEM have investigated the ice wall further, contracting an external consultant (Vertika) to provide advice on possible management options (Vertika, 2017).

While the ground remains unfrozen, seepage through the rock towards the pit will continue and an ice curtain will continue to form in this area during winter. In winter this will present operational hazards due to potential ice falls.

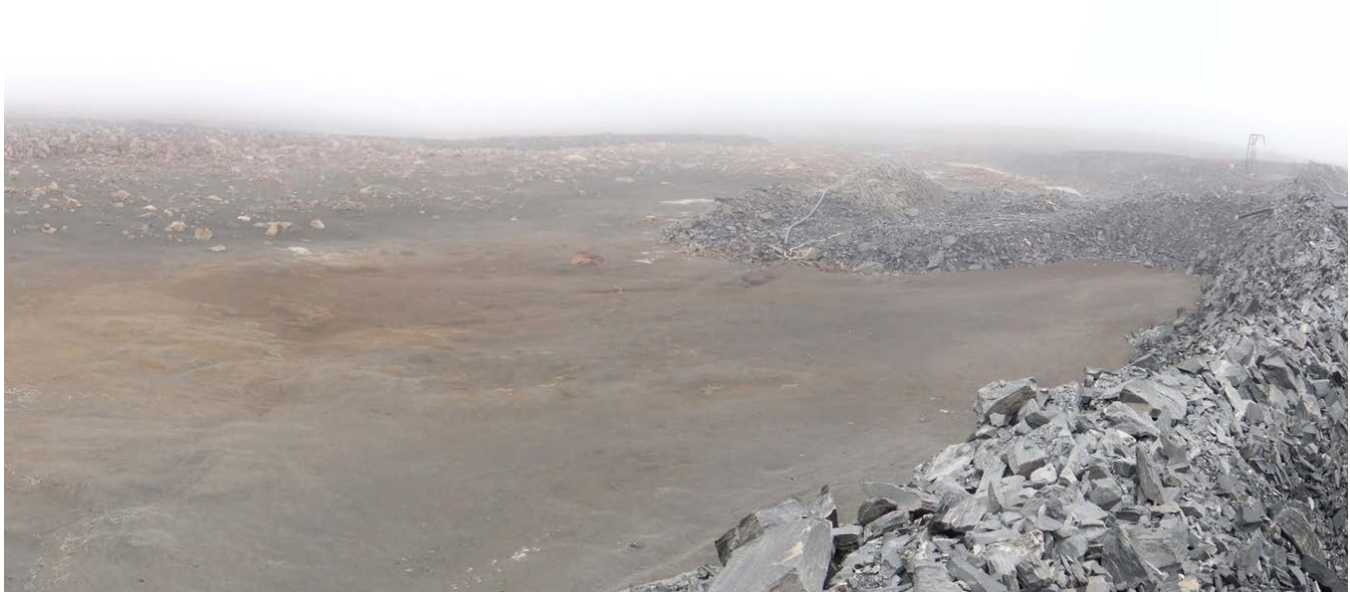
*Photograph 8-11: Vault Pit Pond D water level at time of site visit (2017) – essentially dry*

AEM manage the water elevation in Pond D (former Vault Lake) at a low level to assist in lowering water levels behind the wall. Based on data provided by AEM, the pond elevation is being managed between approximately 5130 mRL (dry), and 5134 mRL.
