### **Annual Review of Portage and Goose Pit Slope Performance**

# 2017 ANNUAL PIT SLOPE PERFORMANCE REVIEW MEADOWBANK MINE, NUNAVUT

DECEMBER 22, 2017

An annual site visit to inspect the performance of the pit walls of the open pits at Agnico Eagle Mines Ltd.'s (AEM) Meadowbank Mine was carried out by Tetra Tech Canada Inc. (Tetra Tech) during the period 25 September 2017 to 28 September 2017. A detailed summary of recommendations is presented in Section 9.

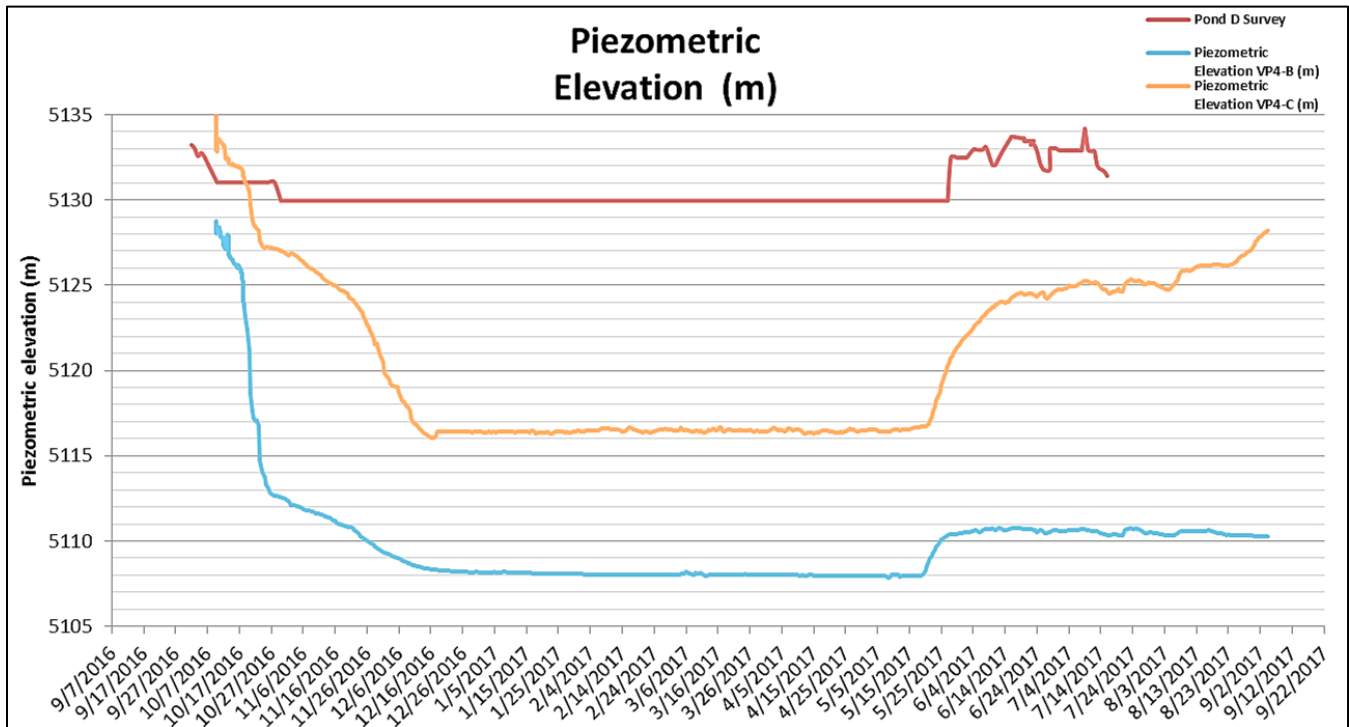
**Figure 8-3: Response of VP4 to change in Pond D elevation (Ref. Appendix C)**

Instrument VP4 is located behind the seepage area, and consists of a thermistor cable and 3 nested vibrating wire piezometers. A review of the data, plotted against the elevation of Pond D, shows the response in piezometers VP4-C (el. 5116 mRL) and VP4-B (el. 5095 mRL) and suggests that when Pond D is drained, VP4-C is close to dry conditions, and VP4-B has significantly dropped. When water begins to accumulate in Pond D there is an immediate response from both piezometers.

It is possible that over time the talik will drain out provided that Pond D continues to be managed with a water level as low as possible, or even dry. The piezometers installed behind the wall should continue to be monitored to determine changes in piezometric head with time, and the thermistors should be monitored to determine the rate at which freeze back of the ground is developing.

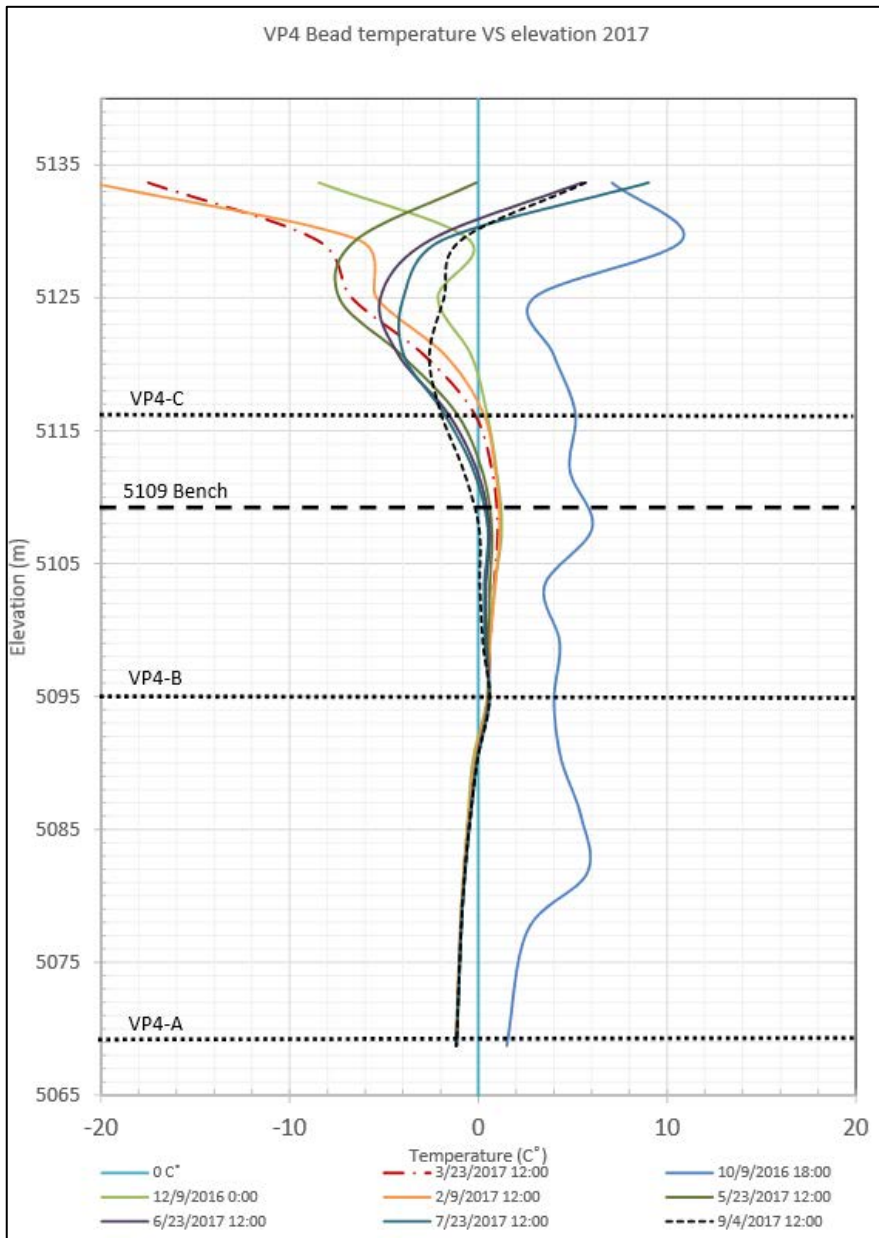
**Figure 8-4: Vault Pit VP4 thermal profile**

A review of the thermistor data from instrument VP4 also provides useful information as shown in Figure 8-4. Selected data shortly following the installation of the thermistor in October and December 2016 are provided as a baseline reference only. The thermal profile suggests that freeze back of the seepage zone is in progress, but temperatures are still marginally above zero degrees C in the region that seepage is noted from the wall (as of September 2017), and so ice wall formation can be expected again this year.

VP4 is installed behind the area of the ice wall. As with VP2, VP3 displays a typical permafrost 'trumpet' curve. The curve shows that the upper portion of the wall, to an elevation of approximately 5109 mRL, is within permafrost. Between 5109 mRL and 5090 mRL, temperatures are marginally above zero degrees C in the region that seepage

is noted from the wall and where the winter ice wall takes form. The thermistor profile suggests that a cooling trend is underway, and that eventually the wall will freeze back fully.

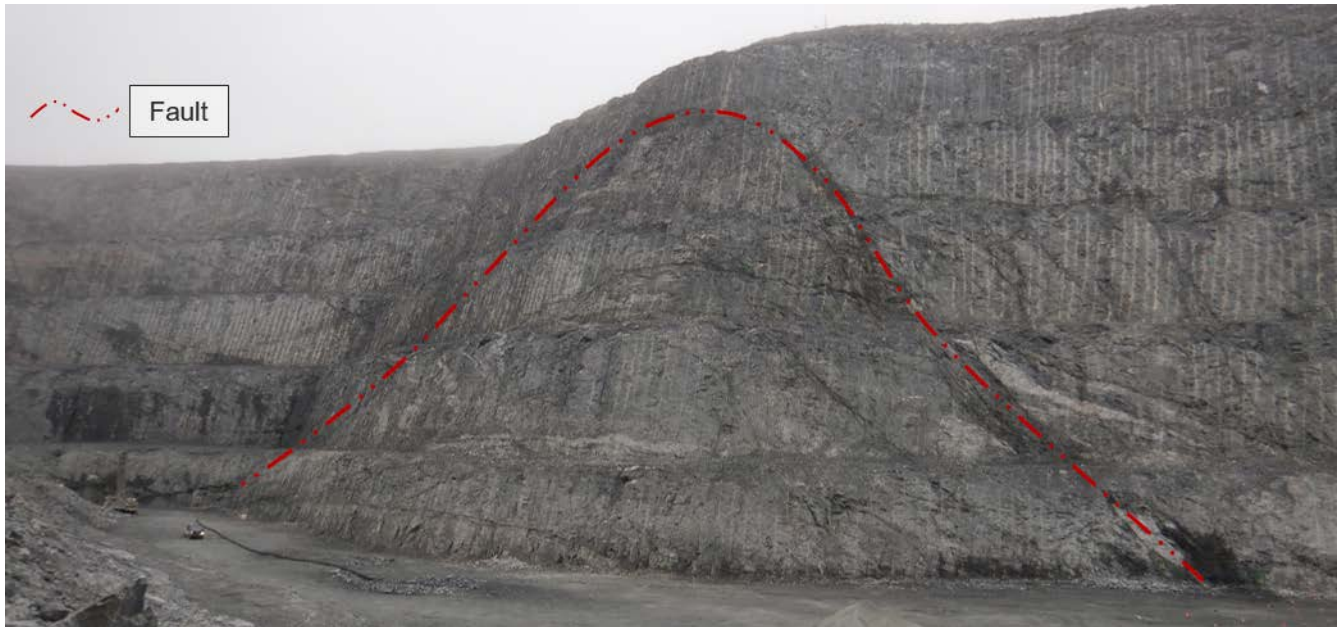
*Photograph 8-13: Vault Pit east highwall nose, fault, and widely spaced open joints*

A minor change in wall orientation results in the formation of a ‘nose’ in the highwall near the northeast end of the wall. This sector of the wall has been developed within permafrost, and there are no apparent seepage faces on the wall.

A series of widely spaced faults and open continuous joints dip into the nose area at steep angles. The orientation of these structures could conceivably result in the development of toppling type failure mechanisms; the competency of the intermediate volcanic rock at the Vault deposit, and the wide spacing of these features suggests toppling is unlikely to develop. However, as mining continues, this area should be carefully monitored for the presence of any outward dipping features that could potentially act as a base plane for large block sliding. There is currently one prism installed in this area; additional prisms should be installed. At the time of the site visit this area of the wall was performing satisfactorily.

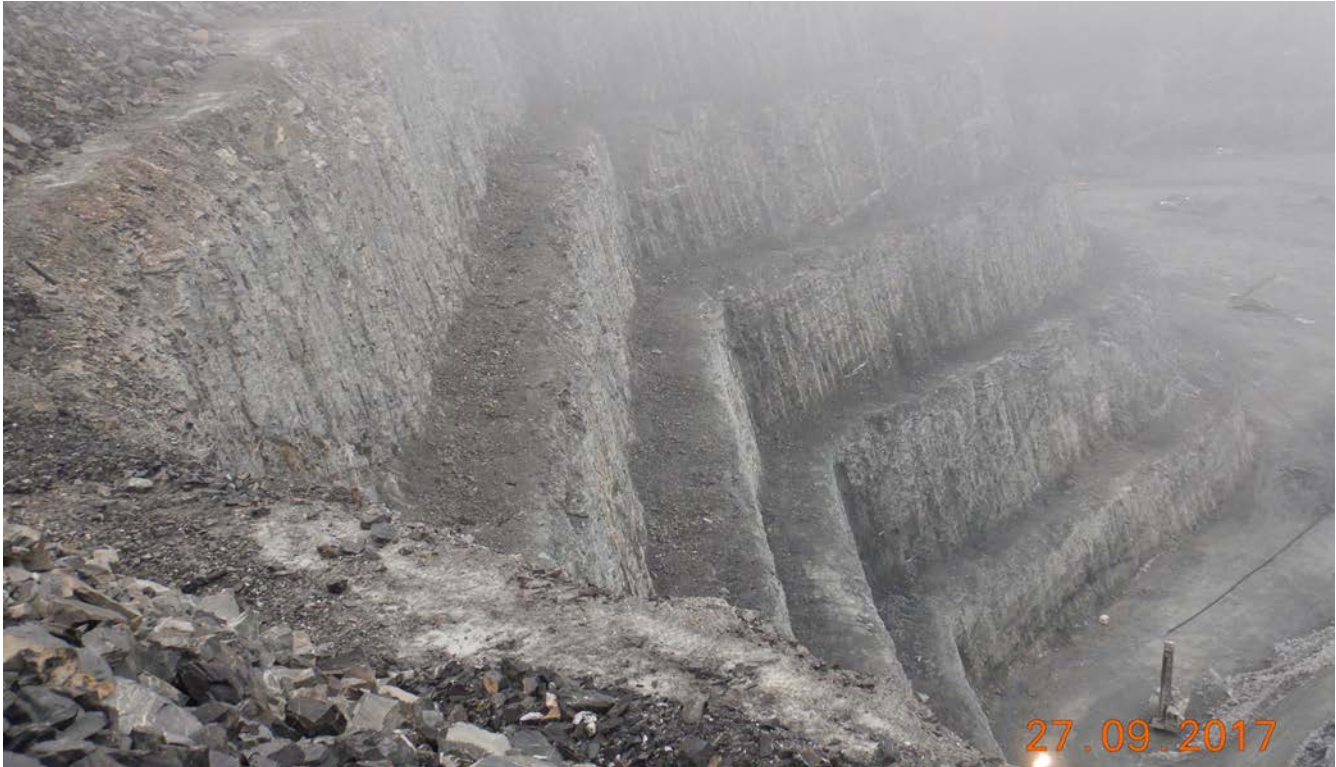
*Photograph 8-14: Vault Pit northeast wall bench performance (2017)*

The benches of the northeast end of the highwall are performing adequately. The final bench faces show clearly visible half barrels of the pre-shear holes, and there is very little deviation. There is minor over break of bench crests from blasting. A small sump is excavated adjacent to the wall to manage water. The wall is generally dry, but with some minor localized areas of seepage from existing fractures.

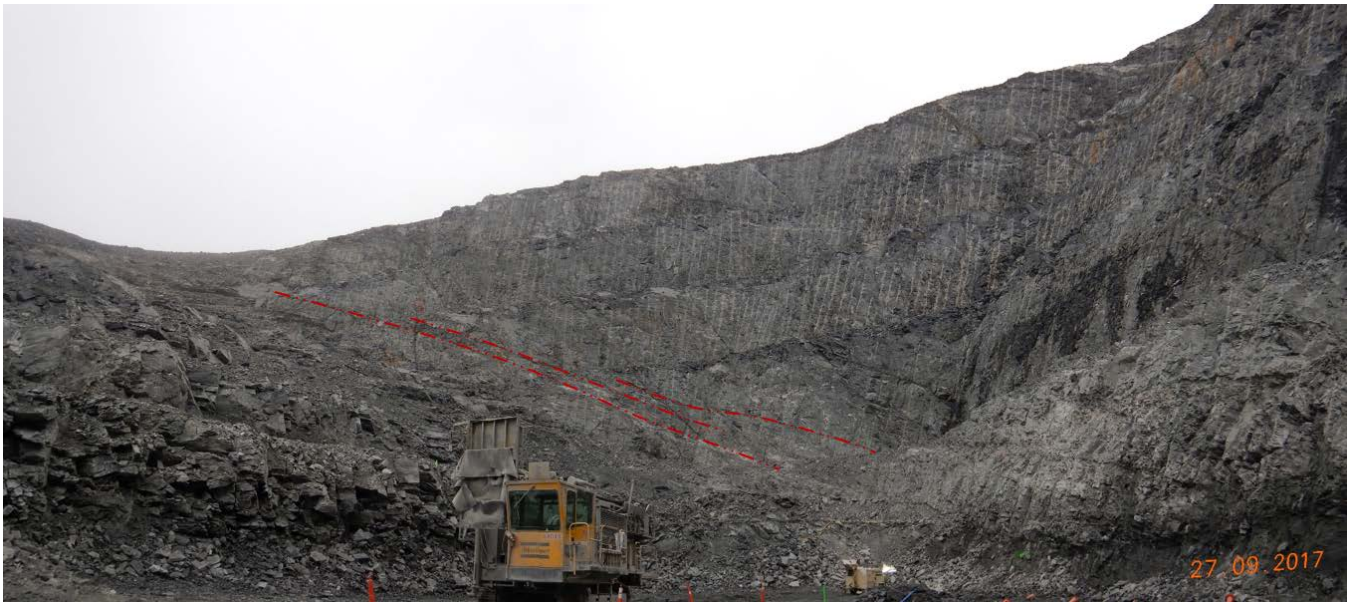
**Photograph 8-15: Vault Pit east dipping shear planes in north wall, intersecting northeast wall (2017)**

A series of shear planes, parallel to stratigraphy, are visible in the north transition wall. These are inclined towards grid east at the same orientation as the stratigraphy, at around 30 degrees. The shear planes intersect the lowermost bench of the grid east wall at the northeast end of the pit.

- Continue to reinforce use of good pre-shear blasting practices to minimize wall damage.
- Continue to encourage good wall scaling practices and not over-excavating past dig lines.
- Continue visual monitoring and recording of observations as part of regular site geotechnical inspections.

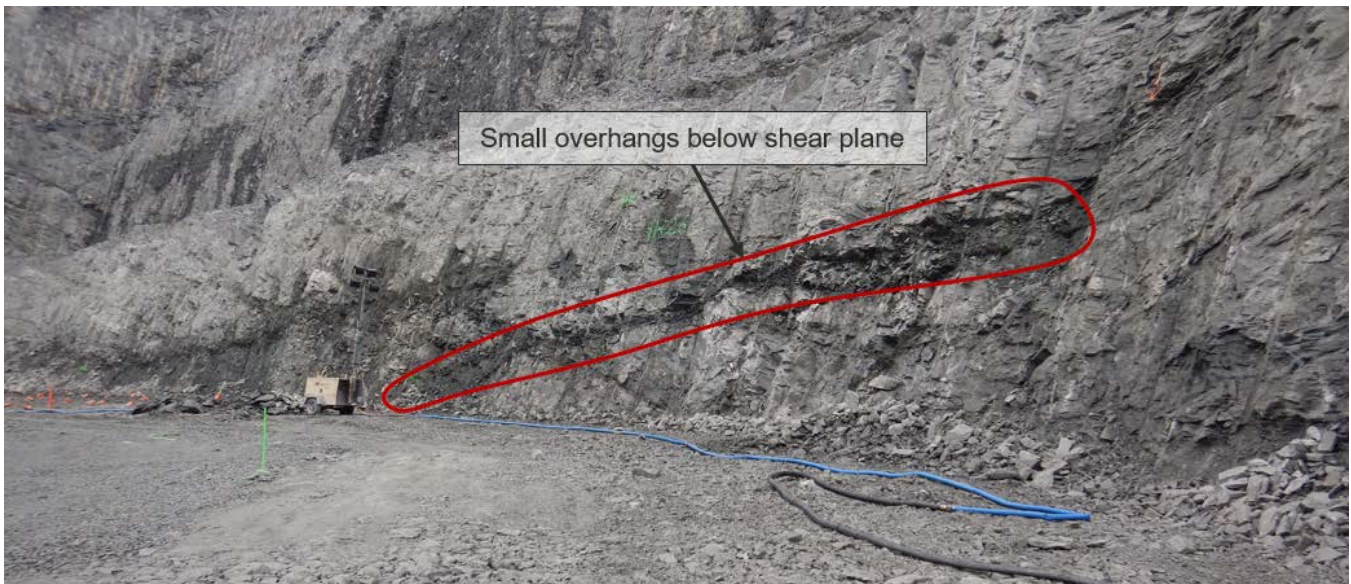
The intersection of the shear planes with the wall result in the potential for the development of overhangs if the rock is damaged during blasting, and bench faces are over excavated as a result. An example of the possibility of overhangs developing is shown in the following photograph.

**Photograph 8-16: Vault Pit shear planes intersecting east wall showing minor overhang development**

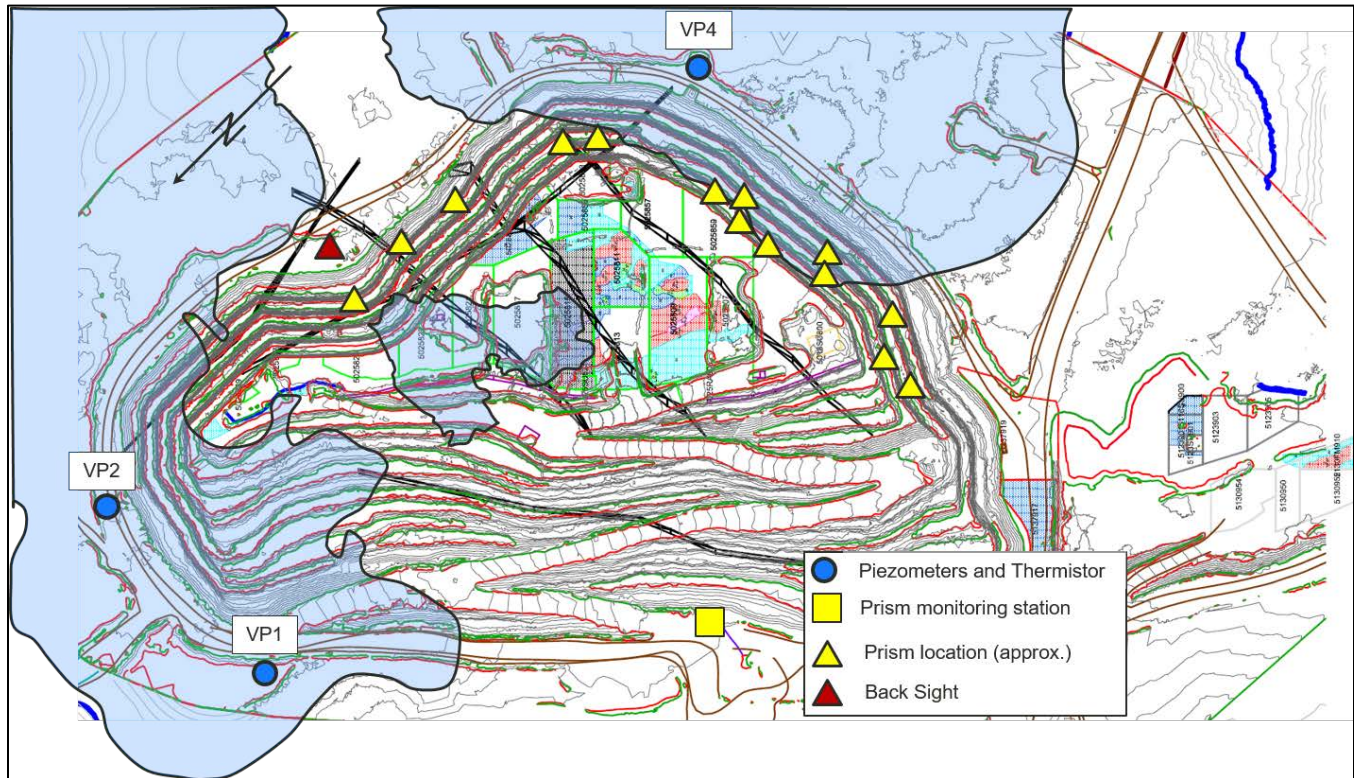
**Figure 8-5: Vault Pit instrumentation plan**

In addition to monitoring thermal and hydrogeological conditions in specific areas, AEM are installing prisms on final bench faces as the pit is deepened. The approximate locations for the instrumentation at the Vault Pit at the time of the site visit is shown in Figure 8-6. The available instrumentation data are presented in Appendix C.

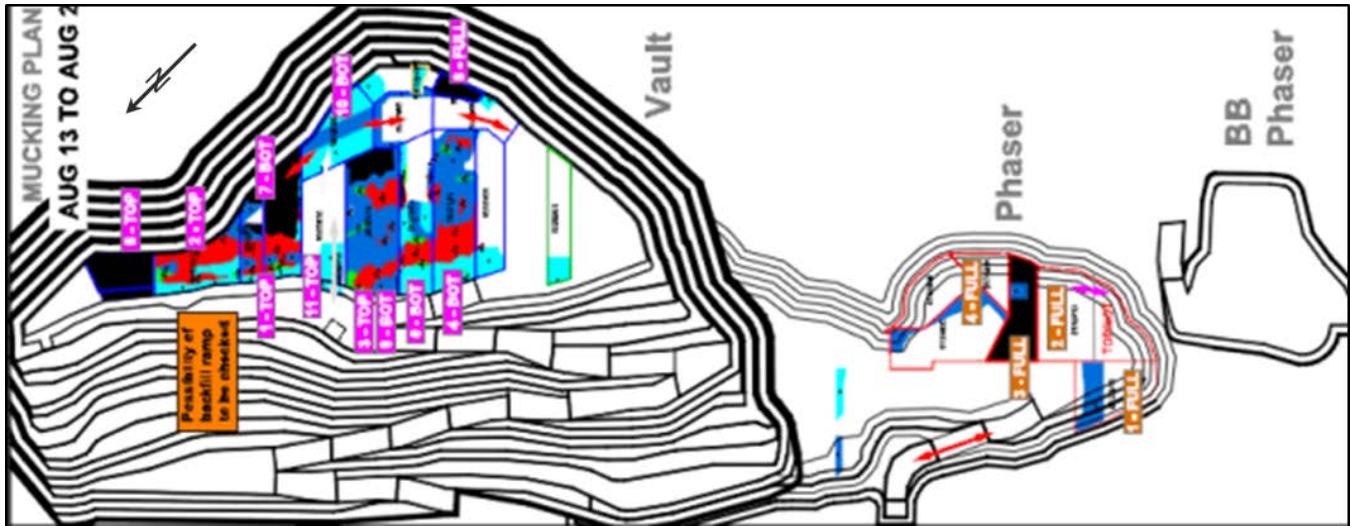
**Figure 8-6: Pushback of Vault South Pit Wall to Phaser and BB Phaser Pits**

The planned depth of the Phaser Pit will be in the range of 40 to 50 m (2 to 3 benches), not including the overburden at the crest of the pit which is estimated to be in the range of 20 to 25 m deep, based on cross sections provided by AEM. The west wall (footwall) of the pit will be in permafrost; a portion of the east wall of the pit may be within talik beneath the former Phaser Lake, which reached a maximum depth of about 3 m. Consequently, the talik beneath the lake is not expected to be significant, although some water inflow to the pit of talik water should be expected. It is anticipated this water will be managed using appropriately located sumps and pumps, as is done for the Vault Pit. The pit will be mined over a period of approximately 1 year, from Q3 2017 to Q3 2018. Ice build-up on the walls may occur during winter and may result in increased raveling.

BB Phaser Pit will be approximately 40 to 50 m south of the Phaser Pit. The pit will be excavated entirely within the lakeshore outline of the dewatered Phaser Lake. Based on available lake bathymetry the depth of Phaser Lake underlying BB Phaser Pit footprint is on the order of 1 to 2 m. Consequently, this portion of the lake will have frozen to lake bottom annually, and so the development of a deep talik beneath the lake is not expected. Nevertheless, some inflow to the pit of talik water should be expected. Ice build-up on the walls may occur during winter and may result in increased raveling. It is anticipated this water will be managed using appropriately located sumps and pumps, as is done for the Vault Pit. The planned depth of mining of the BB Phaser Pit will be in the range of 30 to 40 m, not including overburden at the crest of the pit which may be up to 25 to 30 m deep, based on cross sections provided by AEM. The pit will be mined over a period of approximately 1 year, from Q1 2018 to Q1 2019.

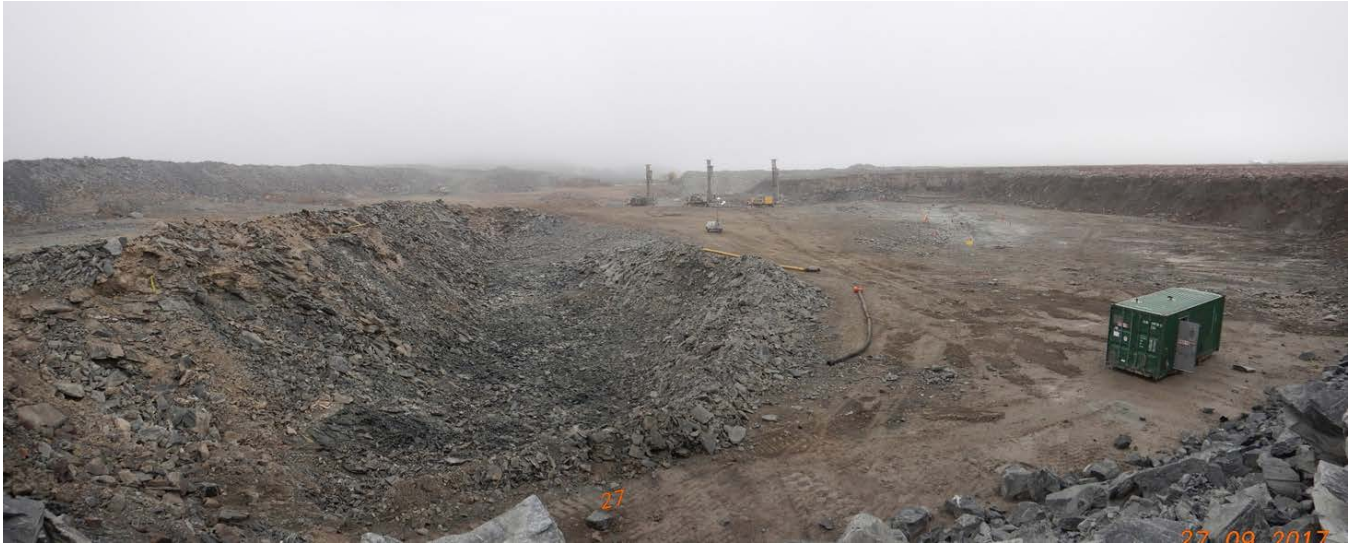
*Photograph 8-18: Phaser Pit stripping (September 2017)*

At the time of the site visit there was very little rock exposure to be seen; stripping of the overburden materials was in progress, and some initial blasting had been completed. Approximately 5 to 7 m of overburden, frost shattered and blast damaged bedrock visible.

- Continue visual monitoring and recording of observations as part of regular site geotechnical inspections.
- Continue mapping to confirm the orientation of stratigraphy and other important structures.

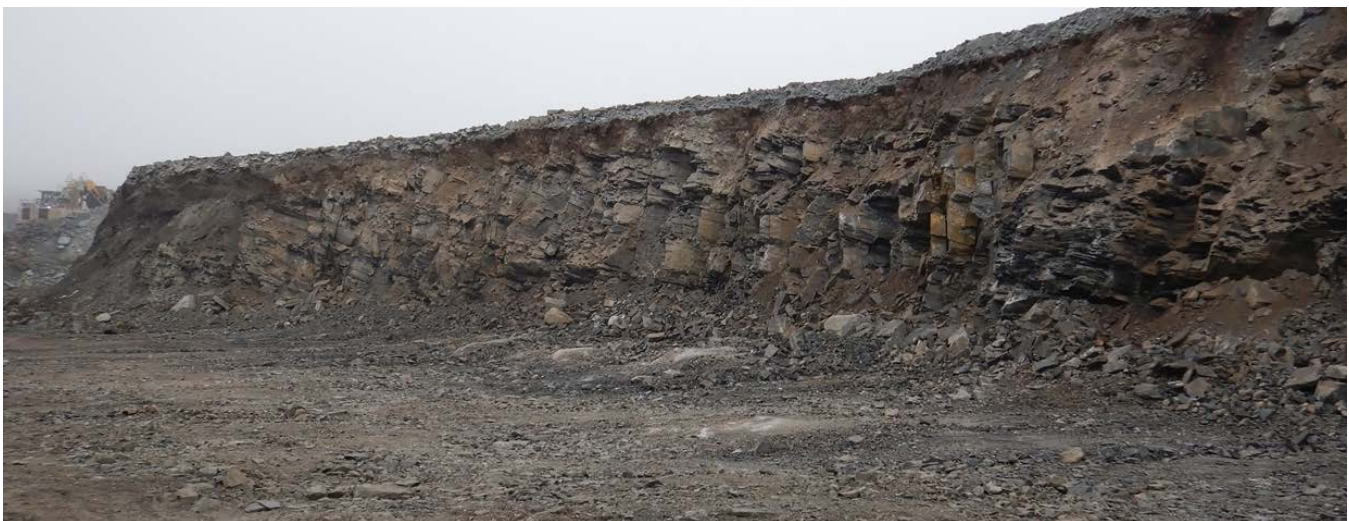
*Photograph 8-19: Phaser Pit east dipping stratigraphy (2017)*

Although rock exposure was limited, and damaged by blasting and near surface weathering, the general orientation of the stratigraphy could be seen inclined to the east at a shallow angle, similar to the main Vault deposit stratigraphy.

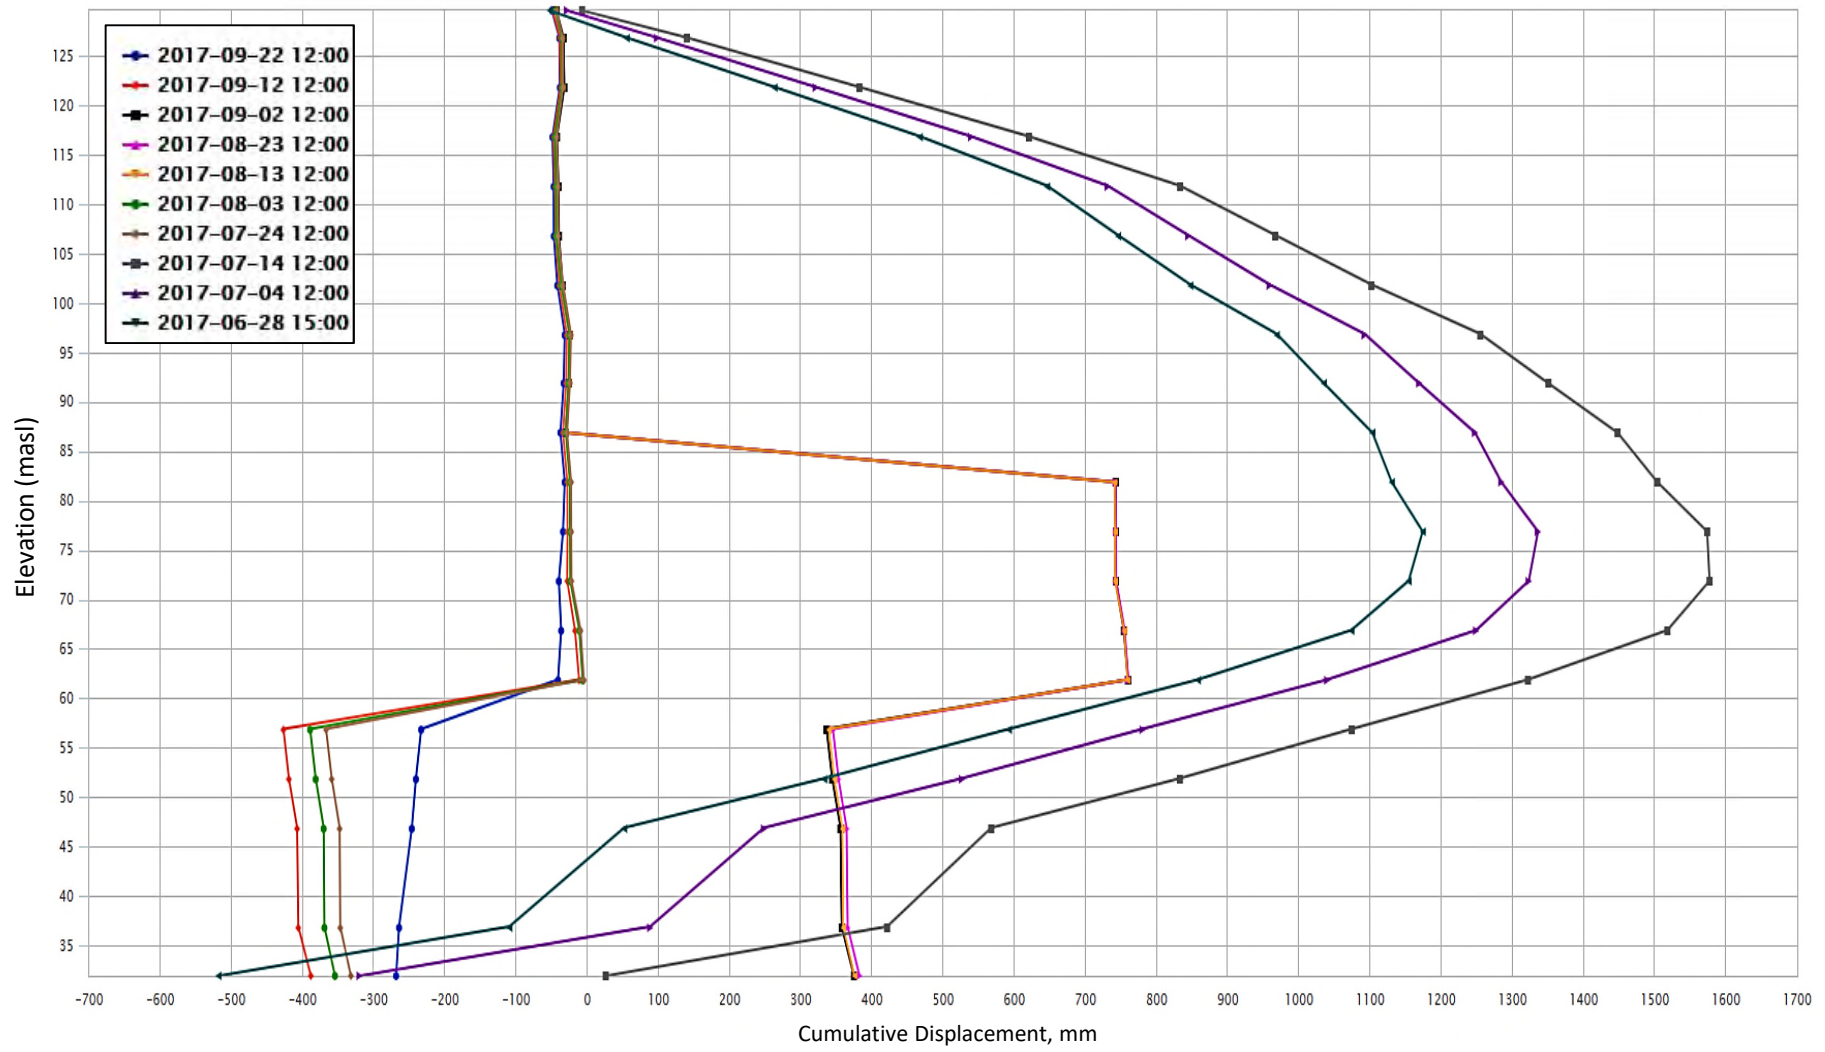
**Figure A-15**

**NOTE: INCLINOMETER DATA ARE UNRELIABLE. FOLLOWING MAY 1 2017 DUE TO A MALFUNCTIONING THERMISTOR AT SENSOR 16. AGNICO ARE WORKING WITH THE SUPPLIER TO RESOLVE.**

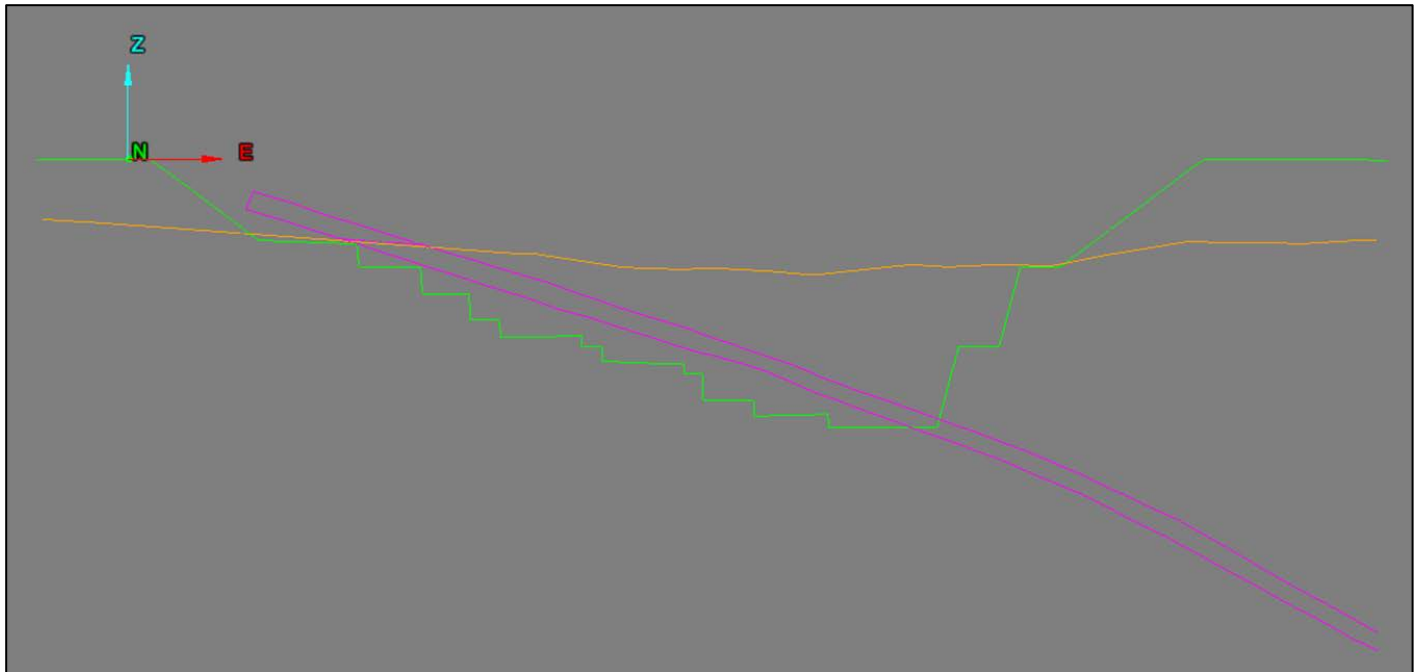
Figure 5: Cross Section through Phaser Pit (Source: Agnico Eagle Mines 2017)

Mining of Phaser Pit commenced in 2017. The planned depth of the Phaser Pit will be in the range of 40 to 50 m (2 to 3 benches), not including the overburden at the crest of the pit which is estimated to be in the range of 20 to 25 m deep, based on cross sections provided by Agnico. The west wall (footwall) of the pit will be in permafrost; a portion of the east wall of the pit may be within talik beneath the former Phaser Lake, which reached a maximum depth of about 3 m. Consequently, the talik beneath the lake is not expected to be significant, although some water inflow to the pit of talik water should be expected. It is anticipated this water will be managed using appropriately located sumps and pumps, as is done for the Vault Pit. The pit will be mined over a period of approximately 1 year, from Q3 2017 to Q3 2018. Ice build-up on the walls may occur during winter and may result in increased raveling.

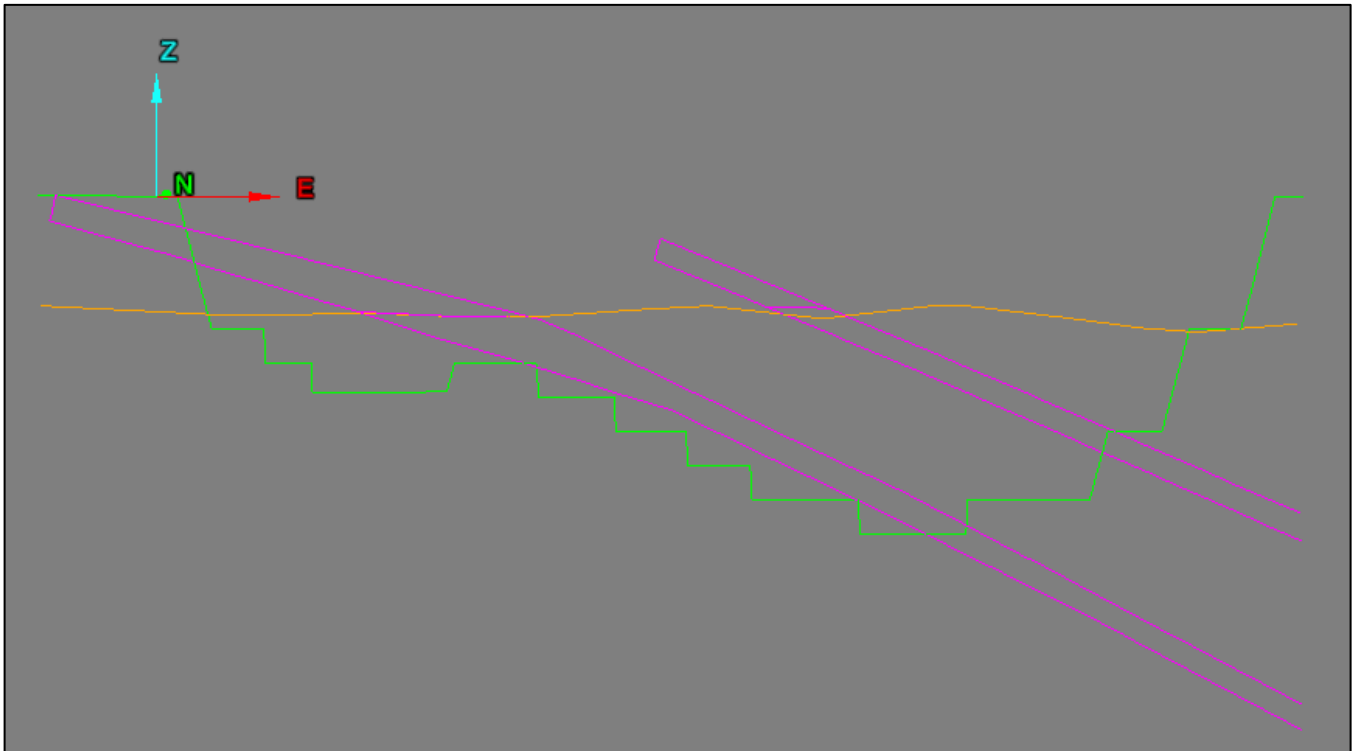
**Figure 6: Cross Section through BB Phaser Pit (note, overburden slopes as shown are incorrect, and will sloped back appropriately) (Source: Agnico Eagle Mines 2017)**

Consequently, this portion of the lake will have frozen to lake bottom annually, and so the development of a deep talik beneath the lake is expected to be limited. Nevertheless, some inflow to the pit of talik water should be expected. Ice build-up on the walls may occur during winter and may result in increased raveling. It is anticipated this water will be managed using appropriately located sumps and pumps, as is done for the Vault Pit. The planned depth of mining of the BB Phaser Pit will be in the range of 30 to 40 m, not including overburden at the crest of the pit which may be up to 25 to 30 m deep, based on cross sections provided by Agnico. The pit will be mined over a period of approximately 1 year, from Q1 2018 to Q1 2019.

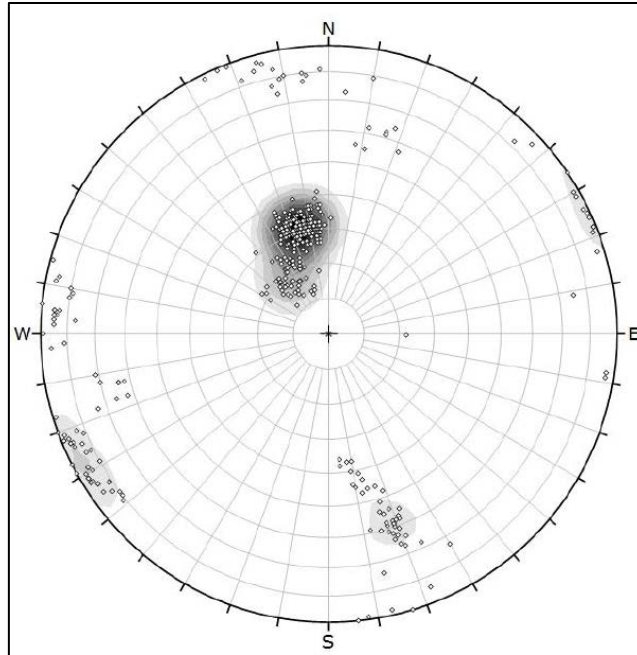
**Figure 8: Vault Pit Main Structural Orientations from LiDAR Scan of Vault Quarry East Wall (Agnico 2013)**

The main structures mapped from the Vault Quarry East Wall using the I-Site software are consistent with the general structural model for the presence of the systematic south-southeast dipping foliation, north-northwest dipping orthogonal joint set, and northwest-southeast trending conjugate joint set.

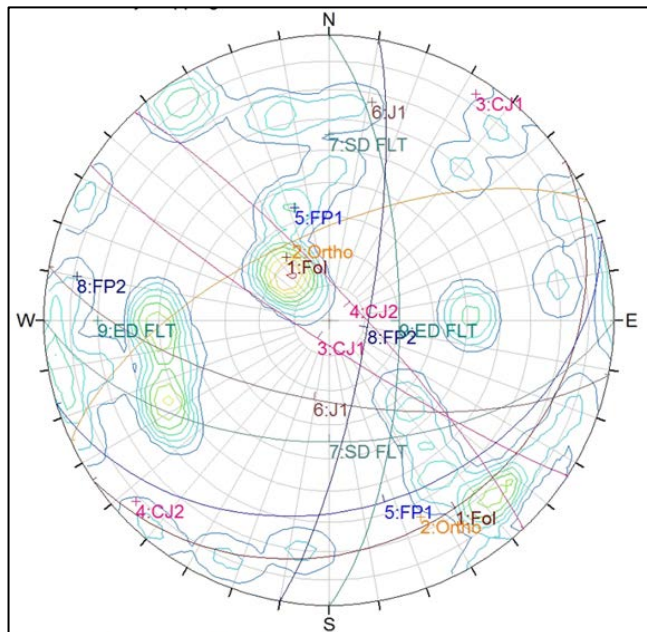
**Figure 9: Vault Pit Main Structural Orientations from In-Pit Mapping (Golder 2014)**

The results of the in-pit mapping show that the general orientations of the main systematic features are consistent with the orientations used for the development of the slope design criteria for the Vault Pit in 2003, and the optimized slope design criteria in 2013.

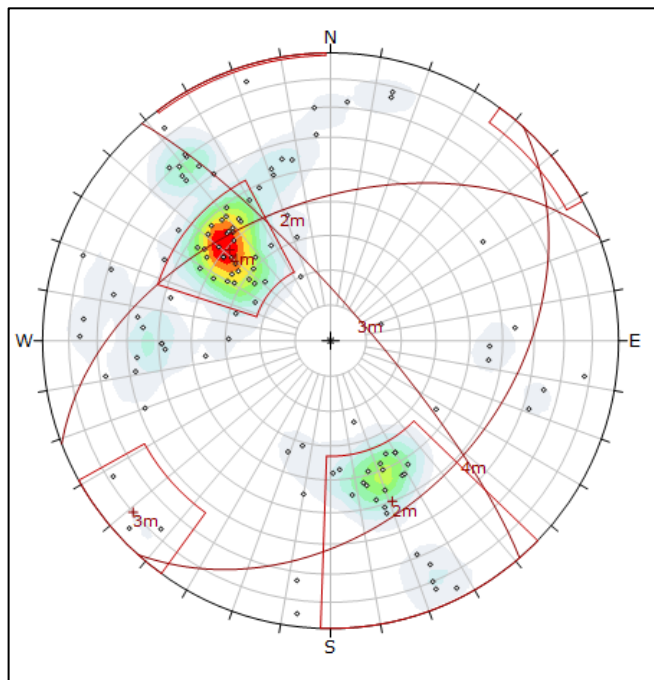
**Figure 10: Phaser Pit Main Structural Orientations from LiDAR (Agnico 2017)**

The results of the interpreted LiDAR scan show that the general orientations of the main systematic features (south-southeast dipping foliation, northwest dipping orthogonal set, and northeast-southwest trending conjugate set) are consistent with the orientations used for the development of the Vault Pit slope design criteria in 2004, and the optimized slope design criteria in 2013. The orientations are also generally consistent with the subsequent and confirmatory mapping efforts in 2013 and 2014. Therefore, it is a reasonable assumption that the main structural orientations influencing the design and actual mining of the main Vault Pit are applicable to the Phaser and BB Phaser Pit push back.
