Appendix F1

GN Spill Report

Please find the following information as a follow up to the Spill report submitted January 2nd, 2016 by Agnico Eagle Meadowbank division. This detailed report is submitted to the Inspector in compliance with the conditions under the Nunavut Water Board License 2AM-MEA1525, Part H, Item 8b.

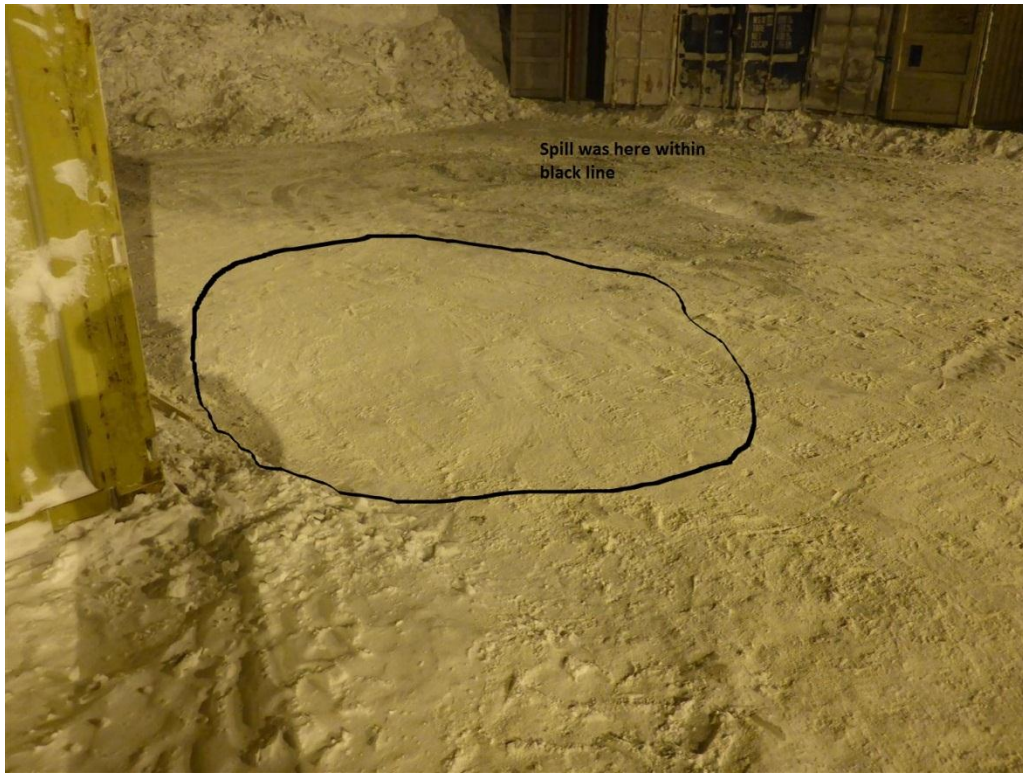
Photo 1 – Area where the lime was spilled on the ground, immediately after clean up (January 1st, 2016)

The powdered lime was picked up from the ground immediately after the spill with a skid steer bucket and hand shovels. The spilled lime was disposed at the mill in the tailings area. Photos 1 and 2 show the area after the lime was cleaned up from the ground, respectively on January 1st and January 3rd, 2016.

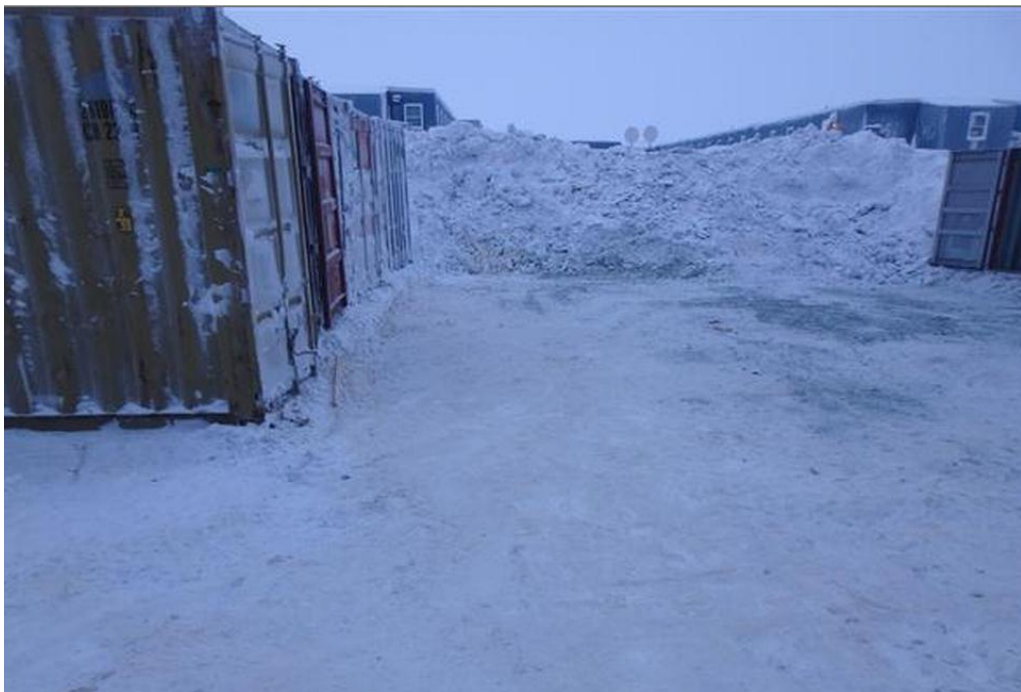
Photo 2 – Area where the lime was spilled on the ground, after clean up (January 3rd, 2016)

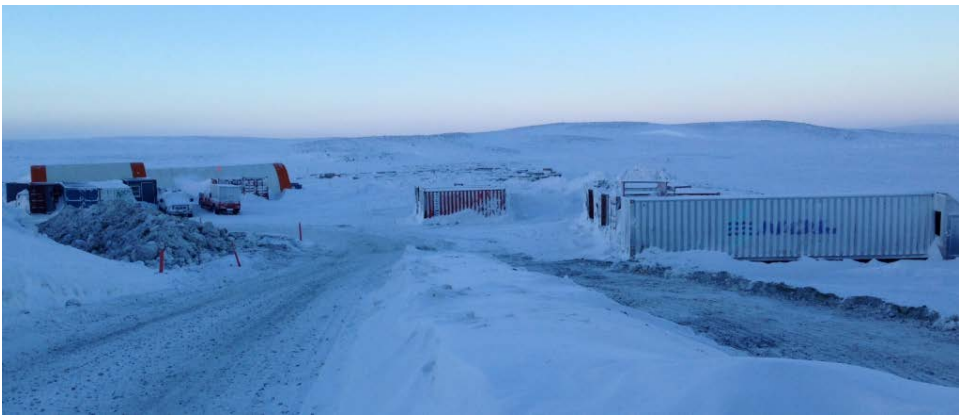
Photo 5 - Remaining water/grease/snow (frozen material) in pile to be disposed in tailings (January 9th, 2016)

The final scrape up of the area was completed on January 7th and 8th 2016. Remaining water/grease/snow (frozen material) was put in pile in the berms and will be disposed in the tailings area. Photos 1 to 5 show the sequence of events.

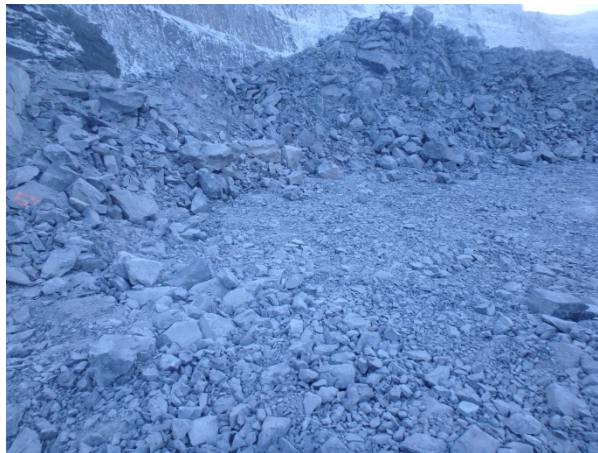
On January 23rd 2016, the main hydraulic hose on backhoe #8, working in Pit E3, failed and caused hydraulic oil to be spilled on the ground. The quantity of hydraulic oil spilled was 300 liters, and the area of contamination was 30 m² after the equipment was moved for clean-up. The spill was contained on location the hose was repaired.

Hydraulic hose on backhoe #08 failed while working in Pit E3 mainly due to cold weather conditions.

The area was cleaned and contaminated soil was collected and brought to the Meadowbank landfarm. An estimated volume of 20 m³ of contaminated material was excavated and transported to the landfarm.

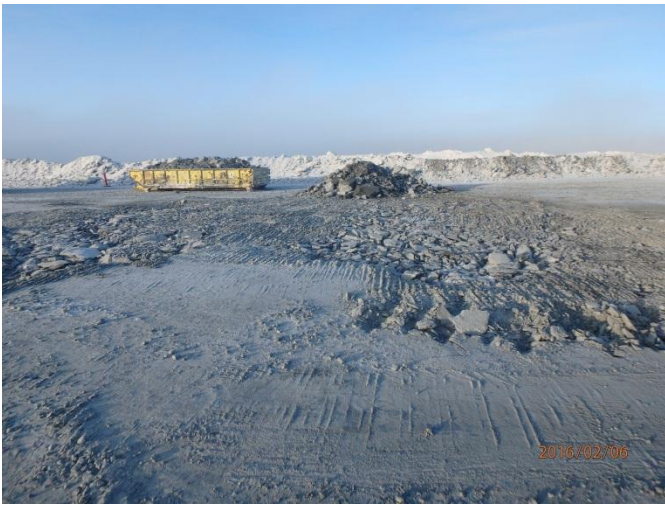
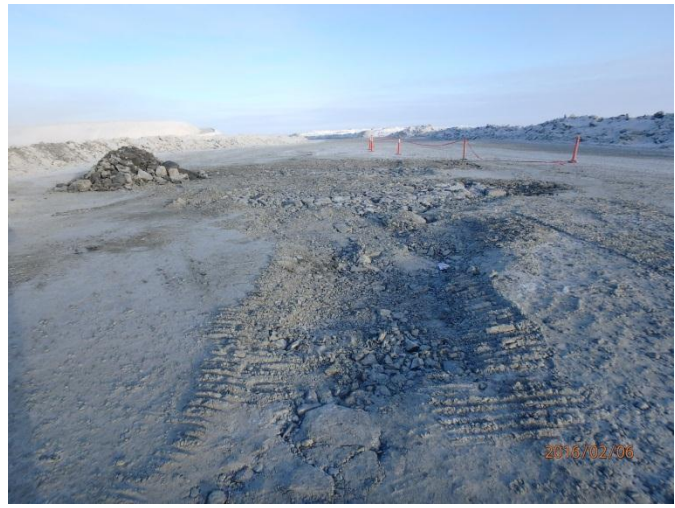
On February 4th, Backhoe 11 was on the Sleipner and being pulled by HTR 31. The Sleipner caught on the road, it flipped over and punctured the fuel tank and at the same time ruptured a hydraulic hose.

The leak from the fuel tank was plugged with wood pieces and secondary containment was also put under the Backhoe. Once the equipment moved out of the way, the area was cleaned using a shovel and contaminated soil was collected and brought to the Meadowbank Landfarm. An estimated volume of 30 m³ of contaminated material was collected.

A formal training program for the use of Sleipner will be developed and all operators will have to receive the training. The procedure for the use of Sleipners will be modified to ensure appropriate operations and communications are being done.

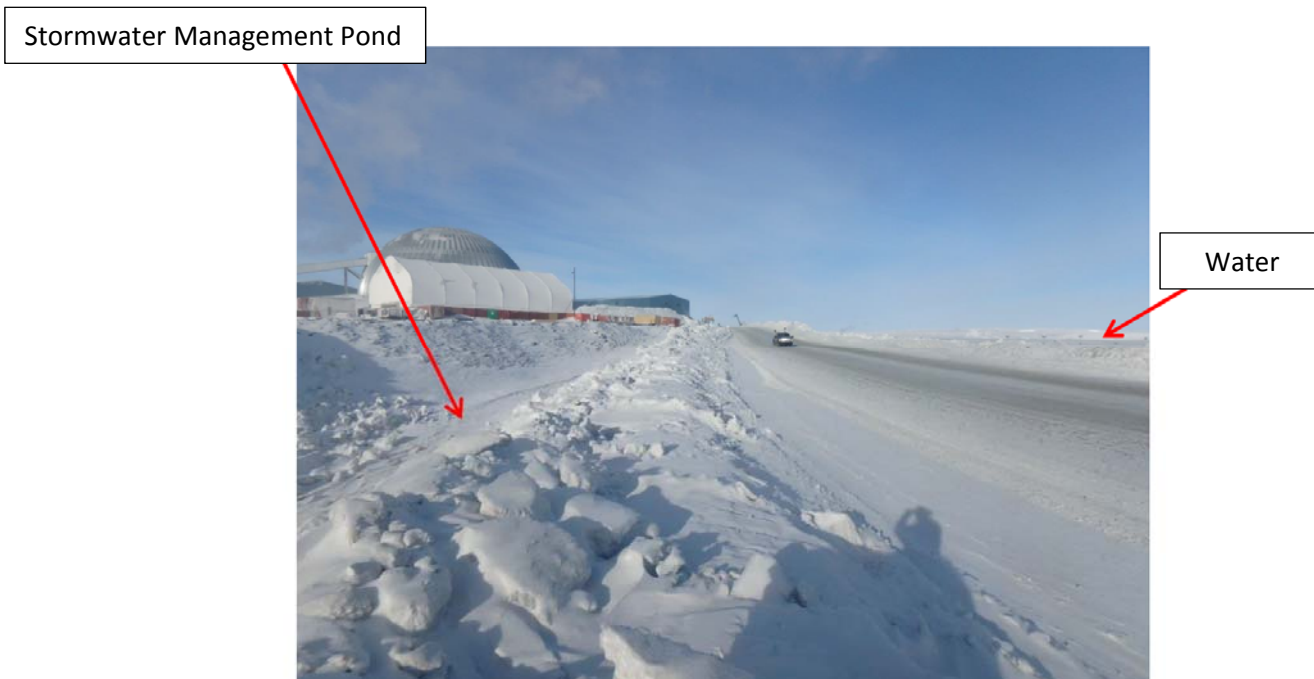
On March 12th, 2016, a fitting on the sewage line bringing treated sewage to the Stormwater Management Pond broke and resulted in sewage being discharge upstream of its usual location. Although the product was still being discharge within the Stormwater pond area, a portion of the sewage went underneath the road and was contained in a section facing north between the airstrip and the road.

The fitting on the line broke because external pressure was being added to the pipe by snow being pushed over from the iron pad towards the discharge line. The sewage was thus discharge closer to the road. This created a change in the path of the flow, resulting in water being observed on the north side.

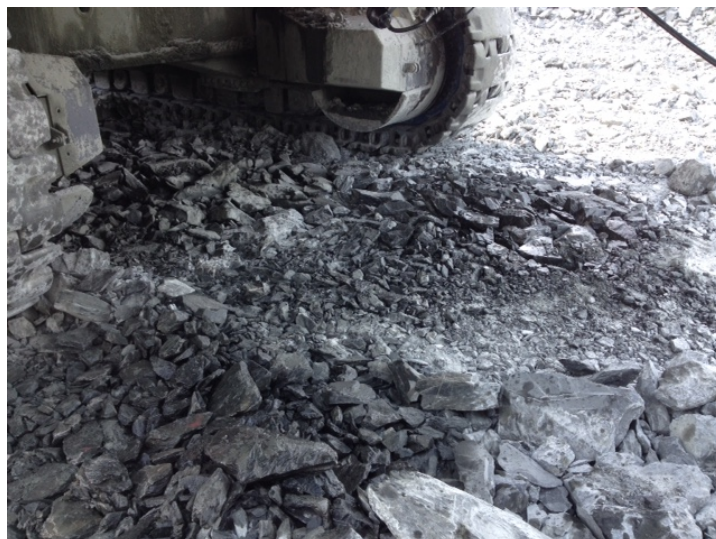
Mechanical failure as the hydraulic pump burst.

The machine was turned off and the spill contained with absorbent pads. The contaminated pads were sent to the HAZMAT area and the contaminated soil excavated and disposed at the landfarm. An estimated volume of 8m³ of contaminated material was collected.

Meeting with Mine and Maintenance department to evaluate the root cause of the spill. Modifications were made in the preventive maintenance log and planning to address specific inspections of hoses on equipment. A visual inspection was already being done on equipment, but a specific item related to hose inspections is now included to PM's executed on those type machinery. The item "Inspect all hydraulic hoses for leaks or potential failures" was added to the planning module and is now part of all hydraulic systems maintenance.

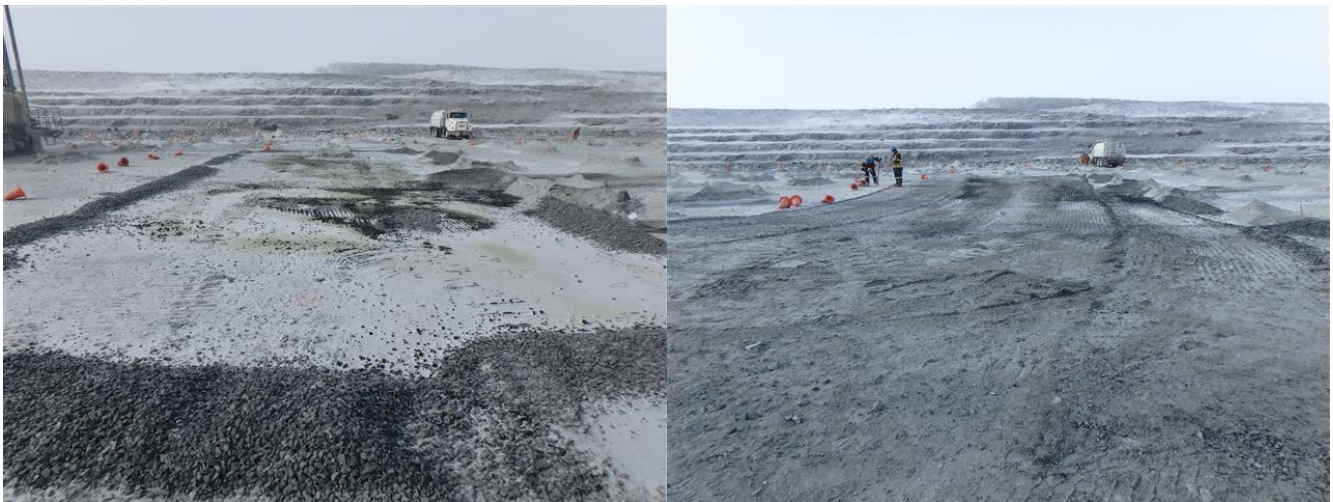
Area before clean-up

Area after clean-up

The area was then cleaned with a loader. Caution had to be taken since the area is located in the vicinity of a blast pattern.

Contaminated material was brought to the Landfarm and absorbent pads were properly disposed of.

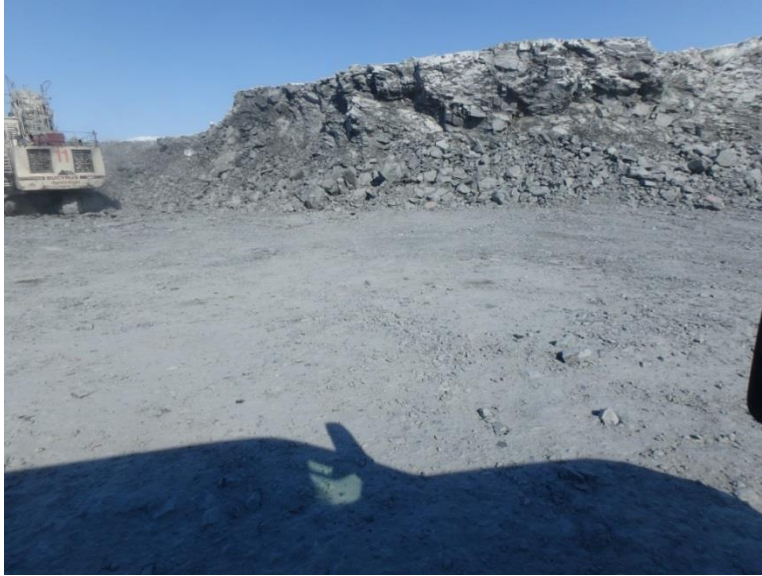
Area after clean-up

The spill was contained in the area and absorbent pad were also laid out underneath the backhoe. The area was then cleaned with a loader. Contaminated material was brought to the Landfarm and absorbent pads were properly disposed of.

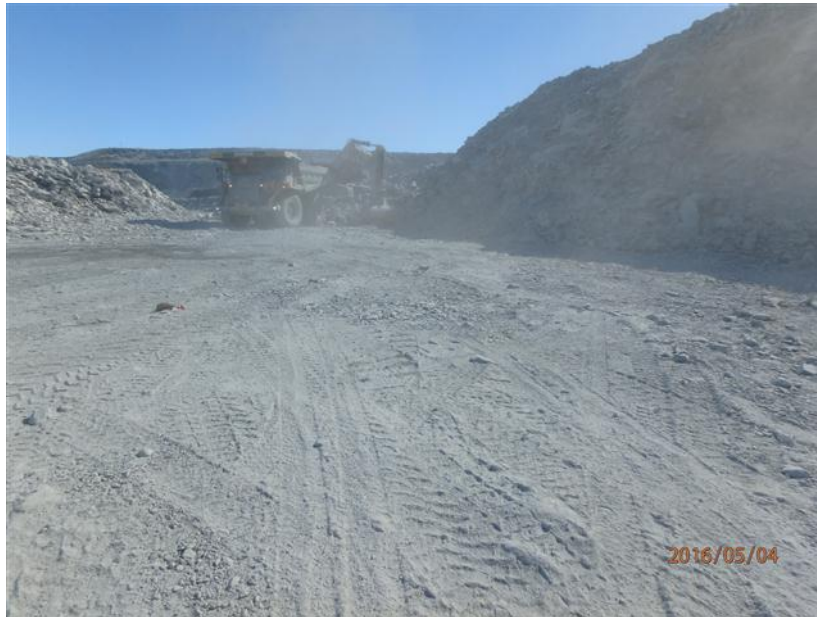
Area after clean-up

The spill on the ground was picked up immediately, backhoe gathered contaminated material onto a spot than was picked up using a 980 loader and brought to the yellow roll-off bin. Once placed in yellow roll-off bin, Site Services were contacted to empty the bin at the landfarm

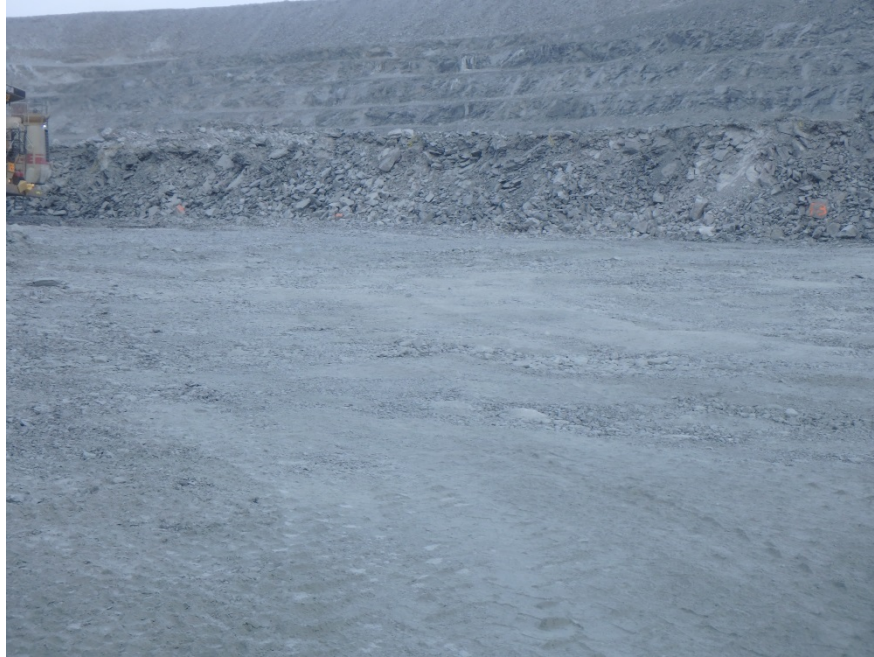
The cylinders on site are inspected regularly for possible defects and wear. Hours are also tracked for them and they are changed systematically after thresholds are met. For the specific event on the cylinder of backhoe 10, after inspections, there were no visible signs that could have foretold the failure.

The backhoe was repaired and removed from the location as soon as possible; the area was then cleaned with a loader.

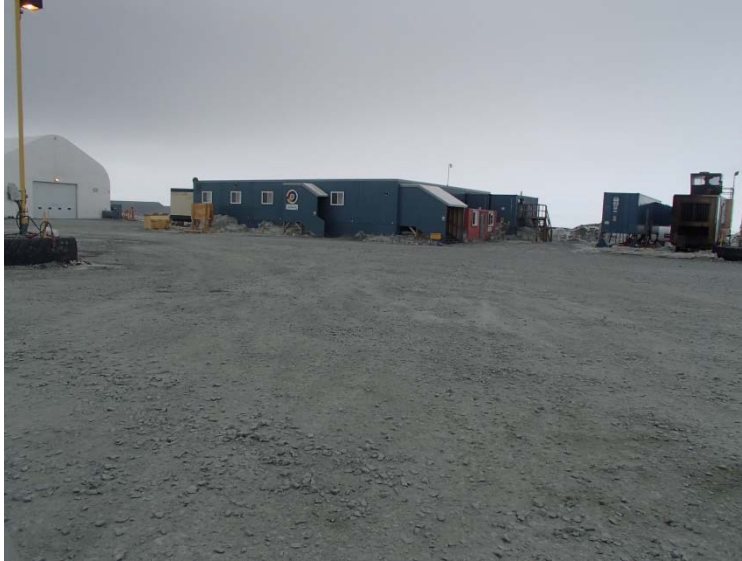
The pump that failed was just newly installed on the haul truck. Once it was removed from the equipment it was inspected to assess for any defects. Visual inspections could not indicate any issues. A new pump was installed in the haul truck, it worked without any problems.

The haul truck was stopped immediately. A secondary container was put in place to catch the falling hydraulic oil and absorbent pads were laid out on the ground. When the truck was repaired and could be moved, the contaminated soil was collected with a loader.

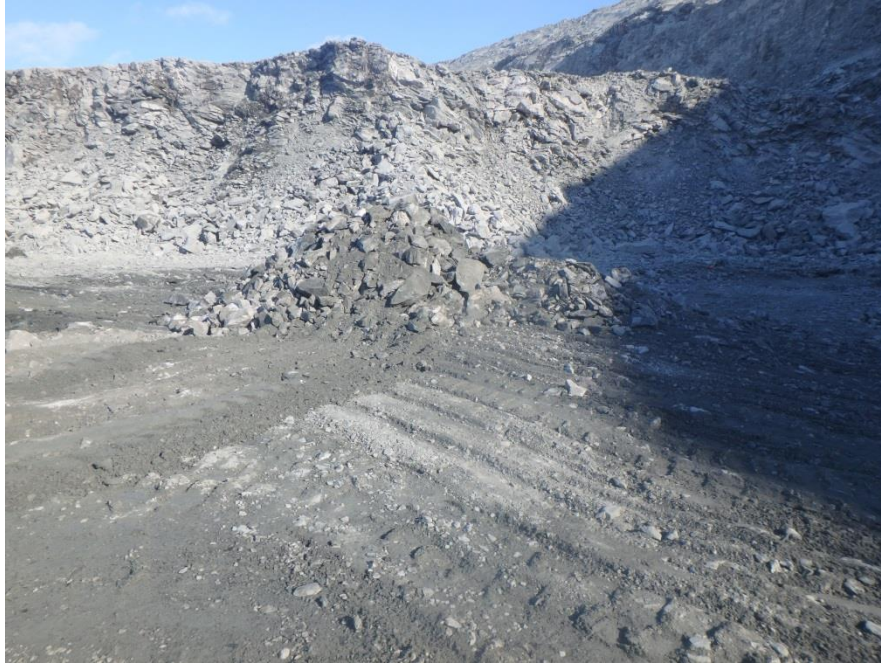
The defective bolt was changed on the clamps. A visual inspection was done on the other clamp bolts on the backhoe and nothing particular was found. The failed bolt was also checked for stress signs. Nothing out of the ordinary was noted. The bolt type and brand was also found to be the same as usually used on Caterpillar equipment.

The backhoe was stopped immediately. Once the machinery could be moved safely, contaminated material was collected and brought to the landfarm area.

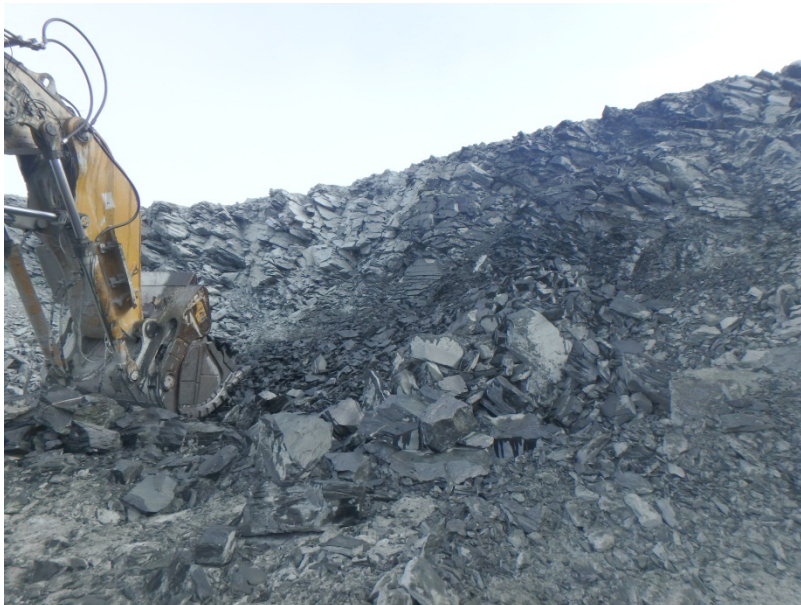
On May 19th, 2016, a main hydraulic hose broke on backhoe #10 causing hydraulic oil to be spilled on the ground and pit wall

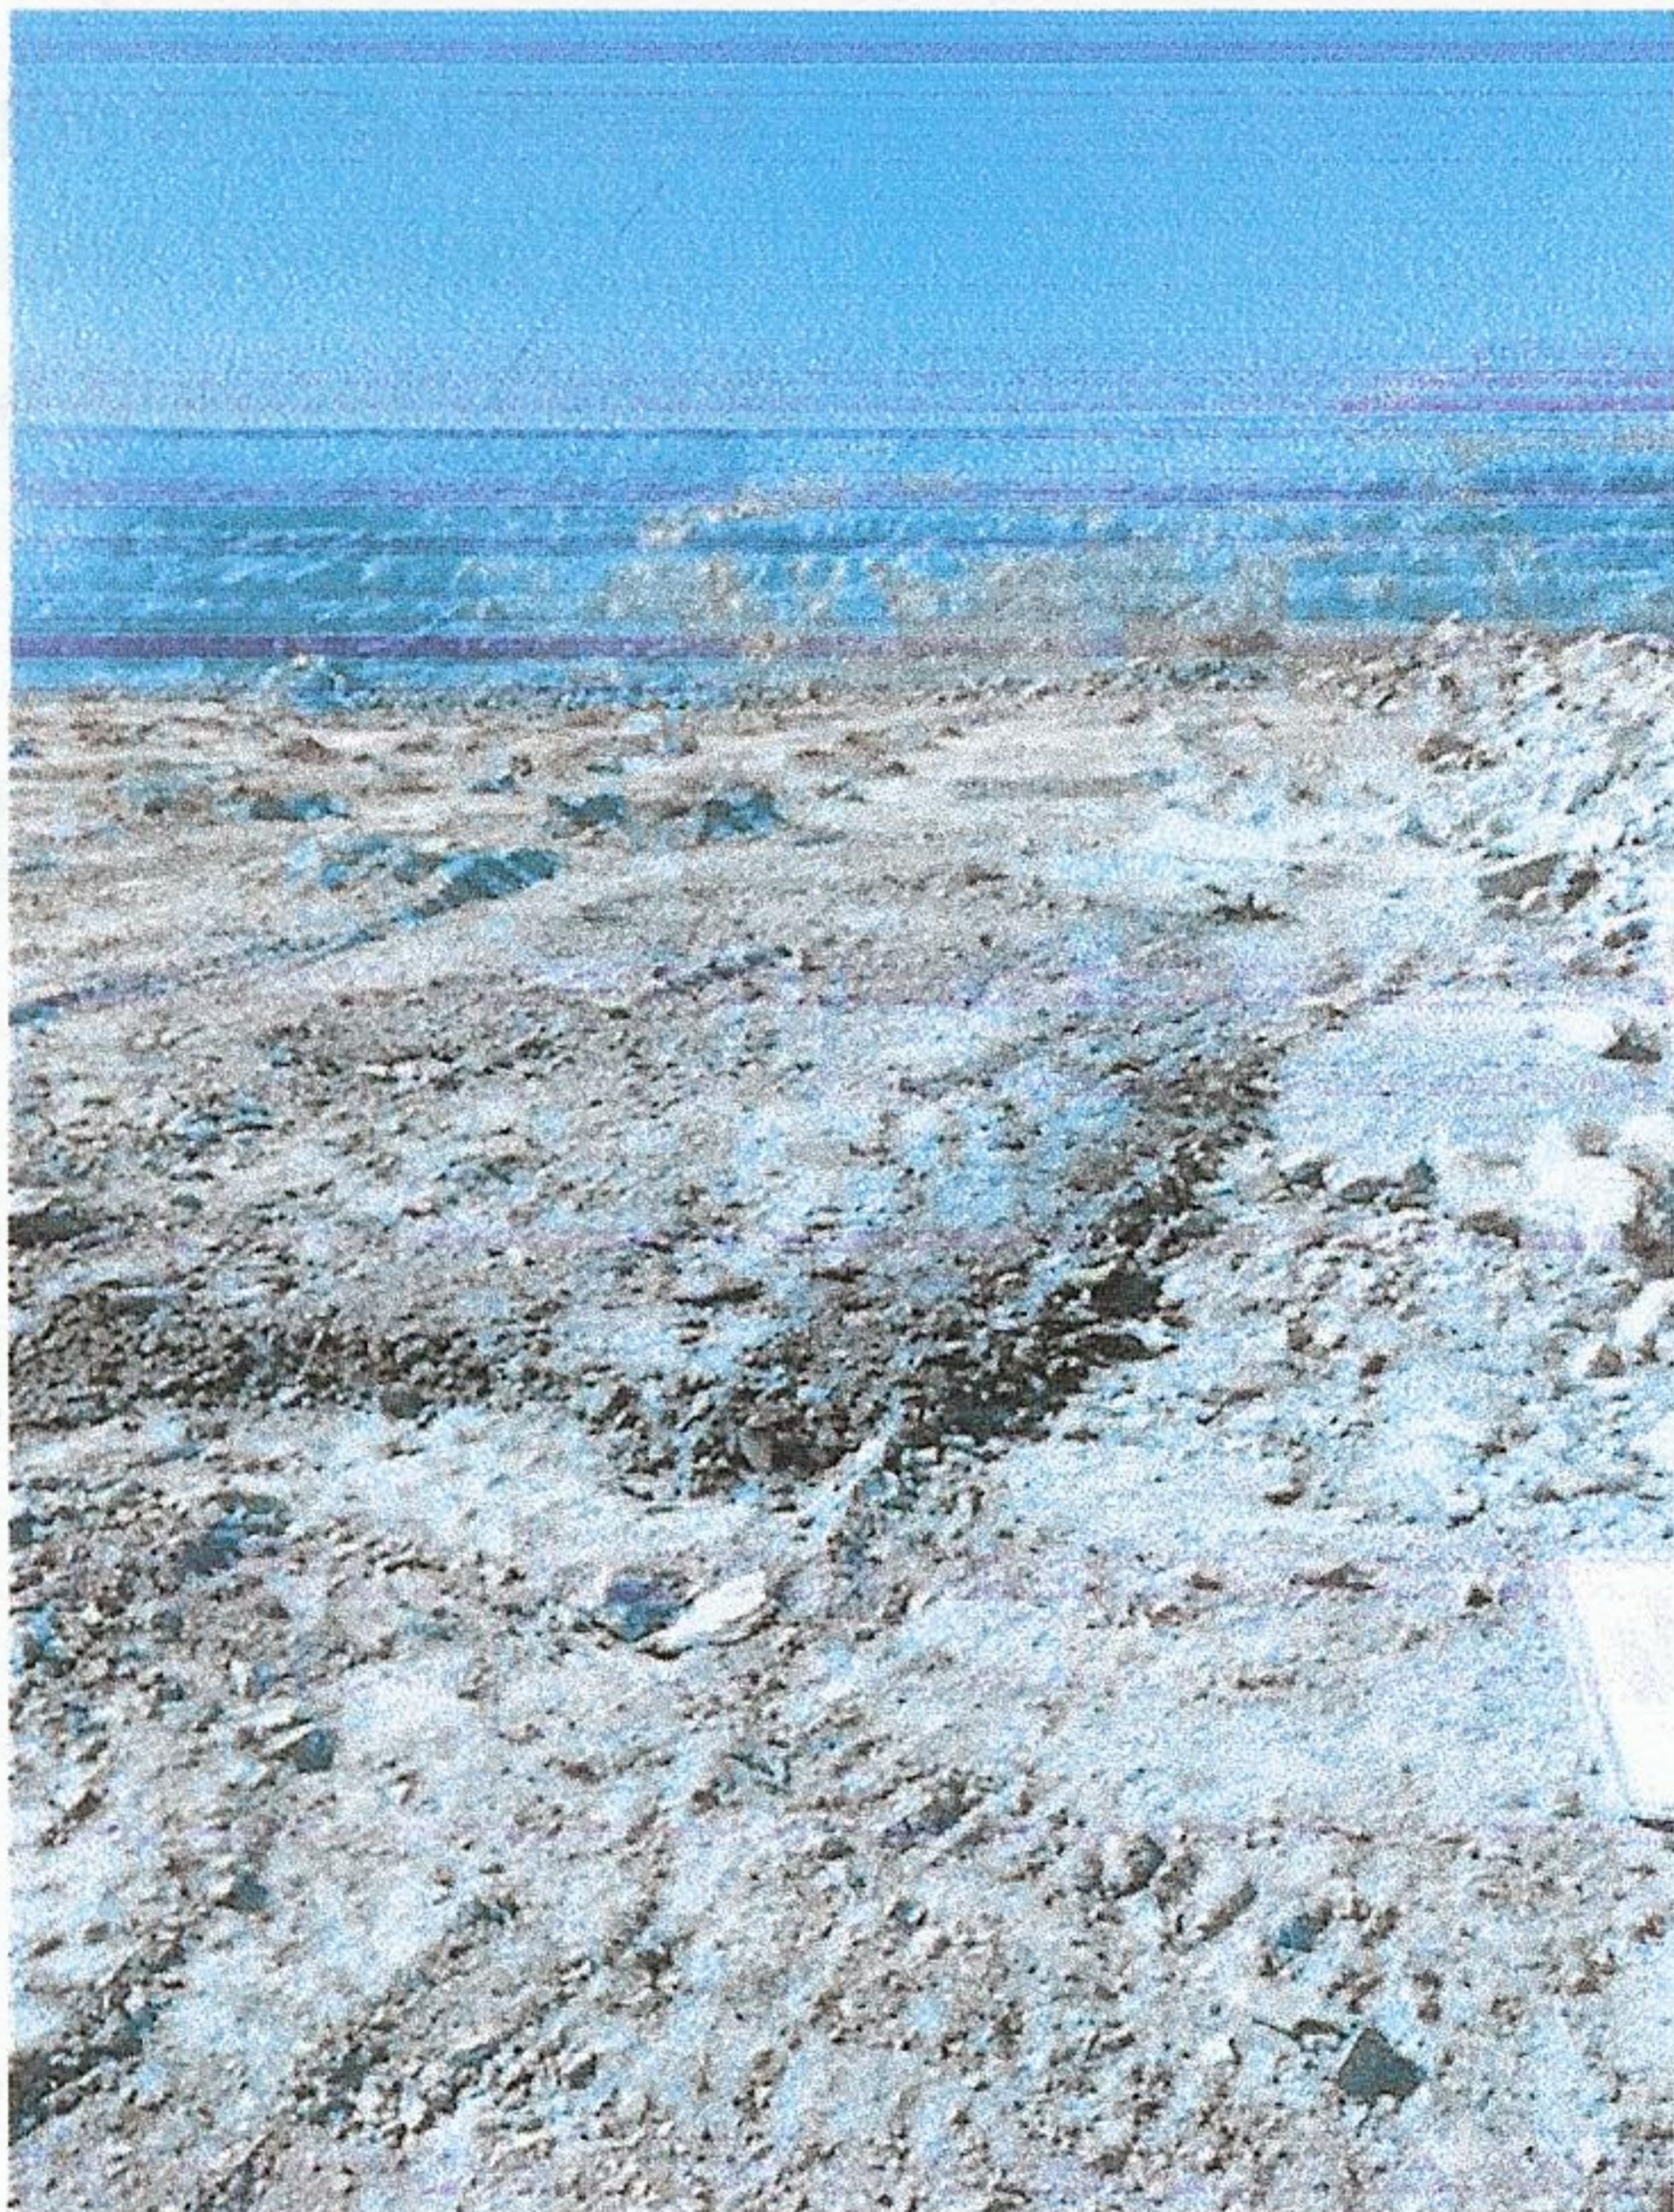
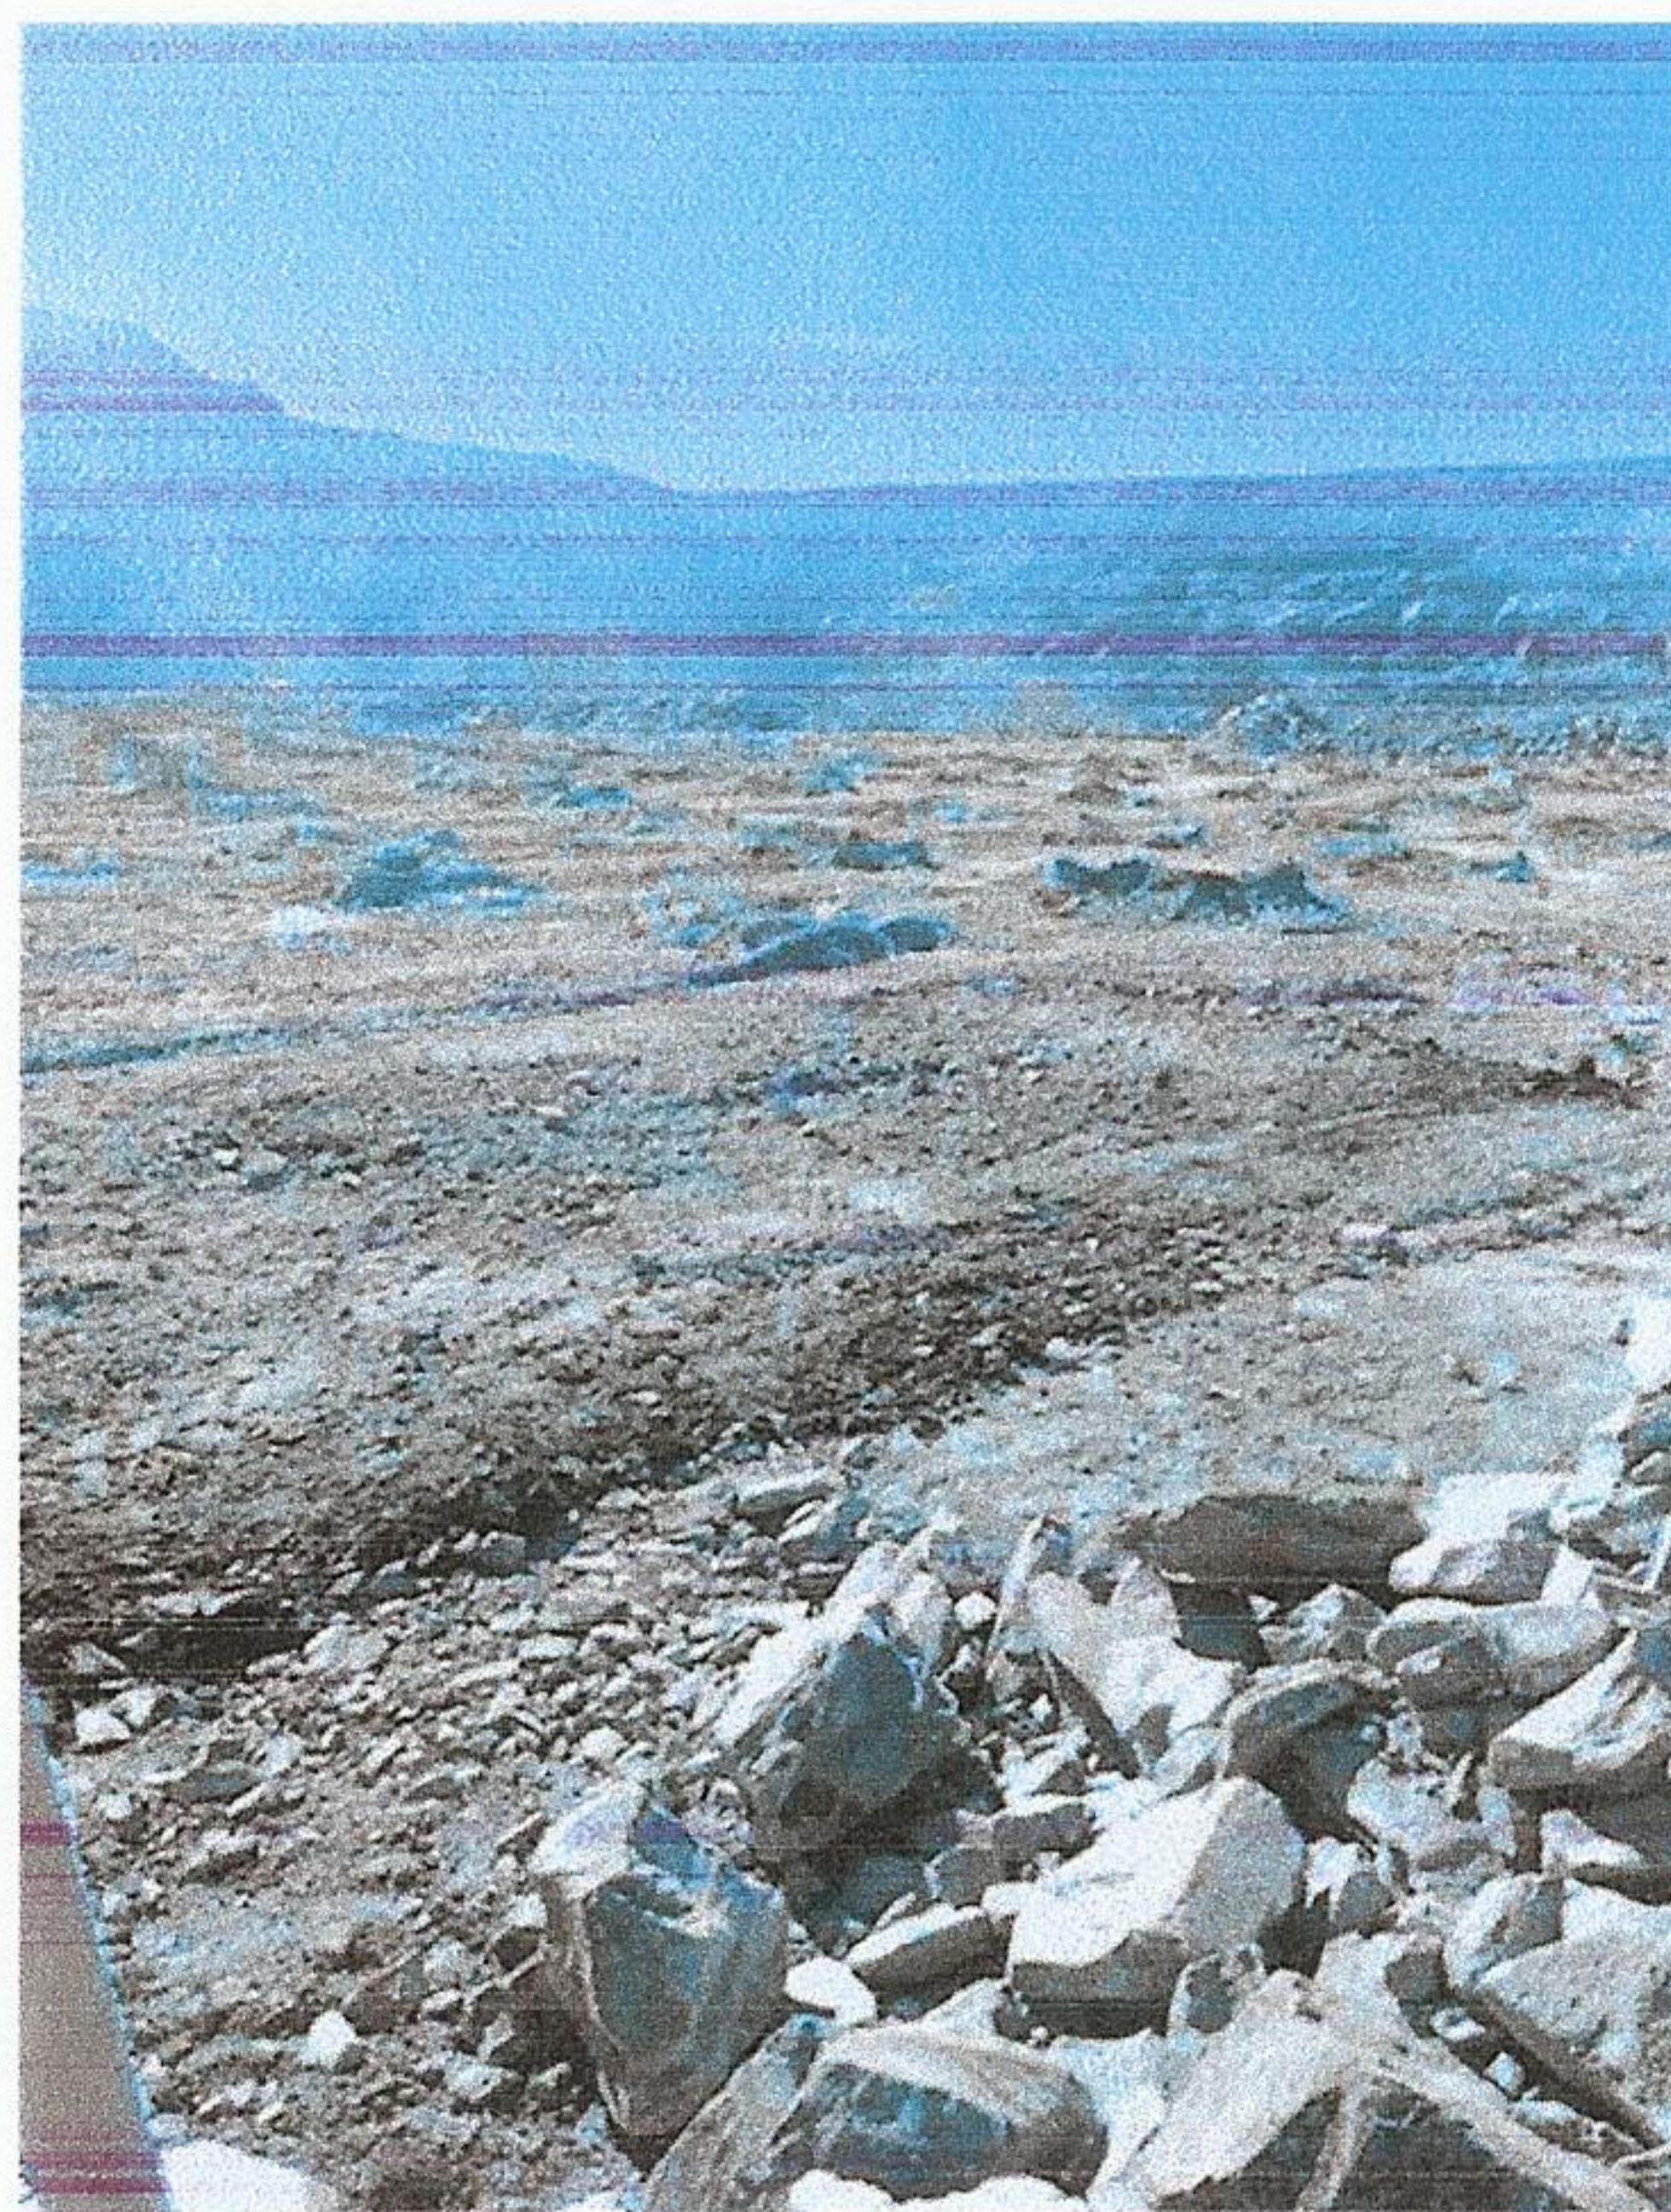
Mechanical failure as the hydraulic hose ruptured on the drill

Operator of the drill stopped the equipment immediately to prevent further contamination. Absorbent pads were placed on the ground and a plastic 2ndary containment under the leak. Once the leak was repaired, absorbent pads were picked up and disposed of appropriately and oil collected in the 2ndary containment was placed in a sealed drum and brought to the HAZMAT area to be disposed of appropriately.

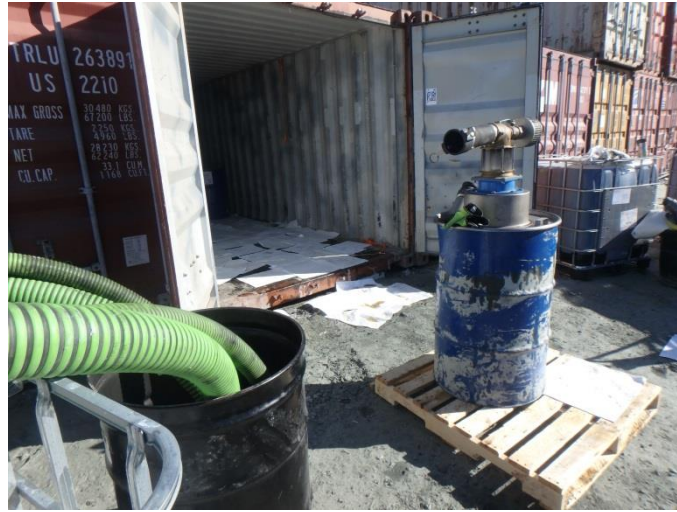
After investigation, it was determined that the operator did not follow standard practices. When removing totes from the back of a container, when visibility is less, a spotter should be used to ensure forks are properly placed before lifting and that product being lifted is stable. The worker was reminded of work procedures, as well as warehouse crew made aware of importance of following procedures.

Spill was contained inside the container at first but leaked outside from the back side. A vacuum pump was used to collect oil left inside and absorbent pads were laid out to contain spill.

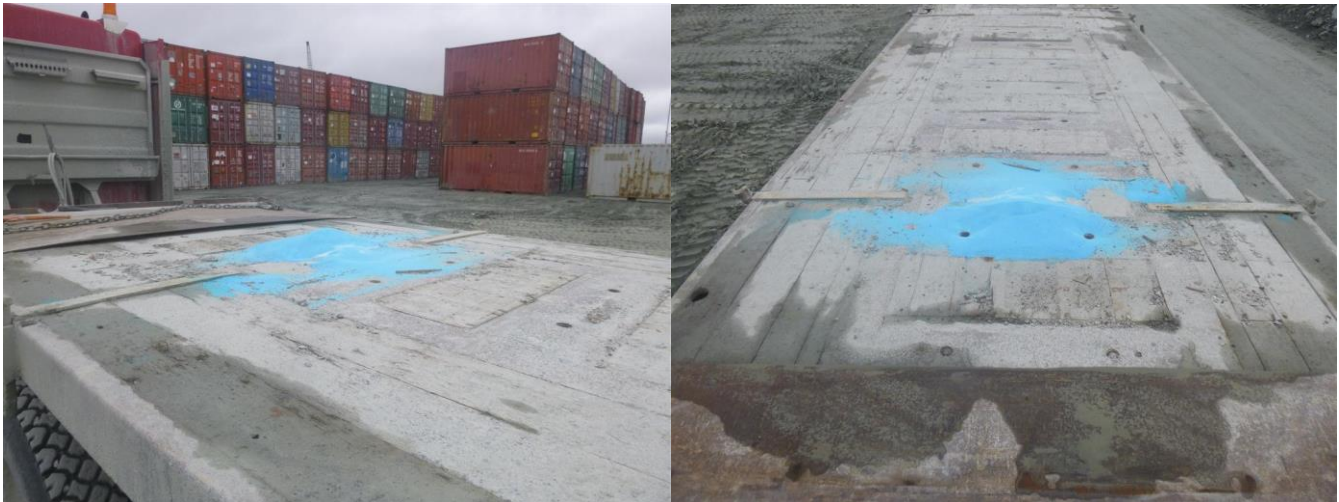
In the process of lifting a c-can in the transit area, product was noticed spilling from the bottom of the container. The operator immediately stopped work. Upon inspection product was identified as bulk bags of powdered copper sulfate.

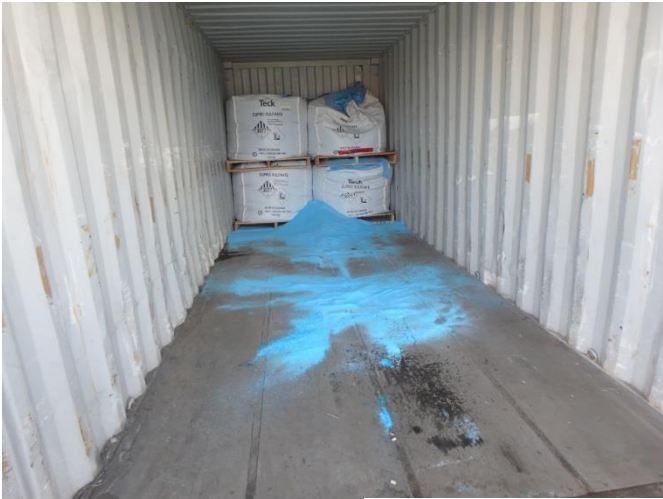
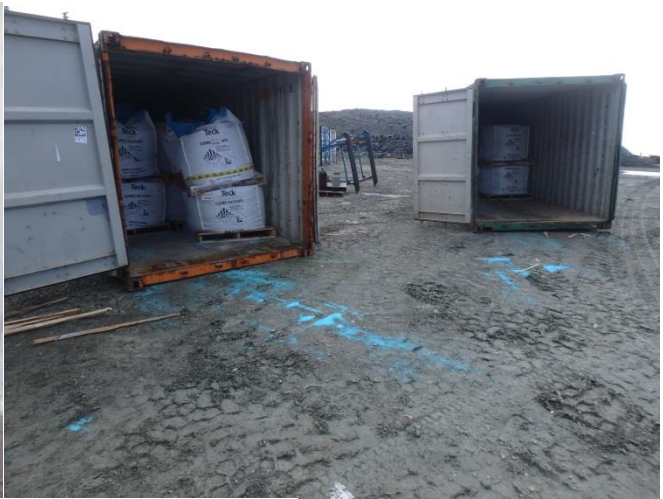
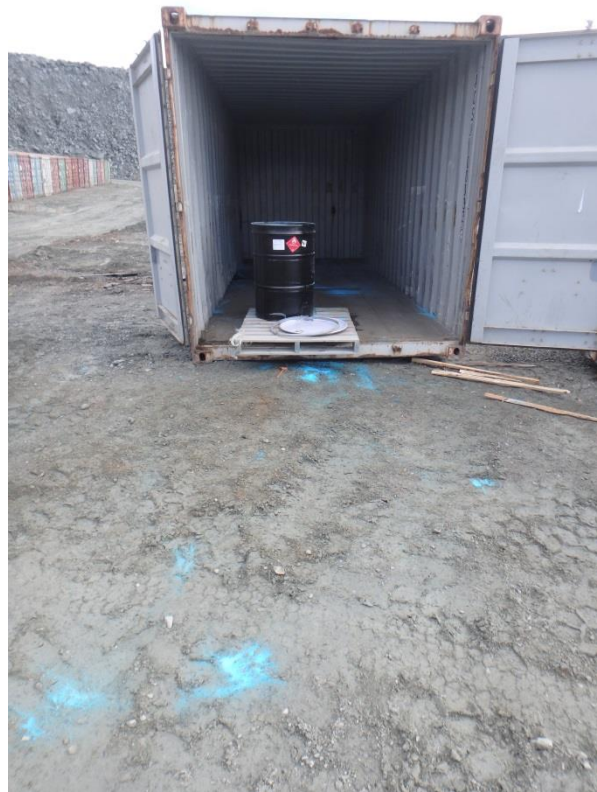
After investigation, it was determined that a bag inside the container appeared to be ripped during transportation. C-cans are inspected upon charging before transportation and also upon arrival and this practice enabled proper actions to be taken.

The bulk bags were removed one by one and placed in an empty container brought on location. The majority of product was left inside the c-can and collected and placed in an empty drum.
