Appendix F1

GN Spill Report

Please find the following information as a follow up to the Spill report submitted January 2nd, 2016 by Agnico Eagle Meadowbank division. This detailed report is submitted to the Inspector in compliance with the conditions under the Nunavut Water Board License 2AM-MEA1525, Part H, Item 8b.

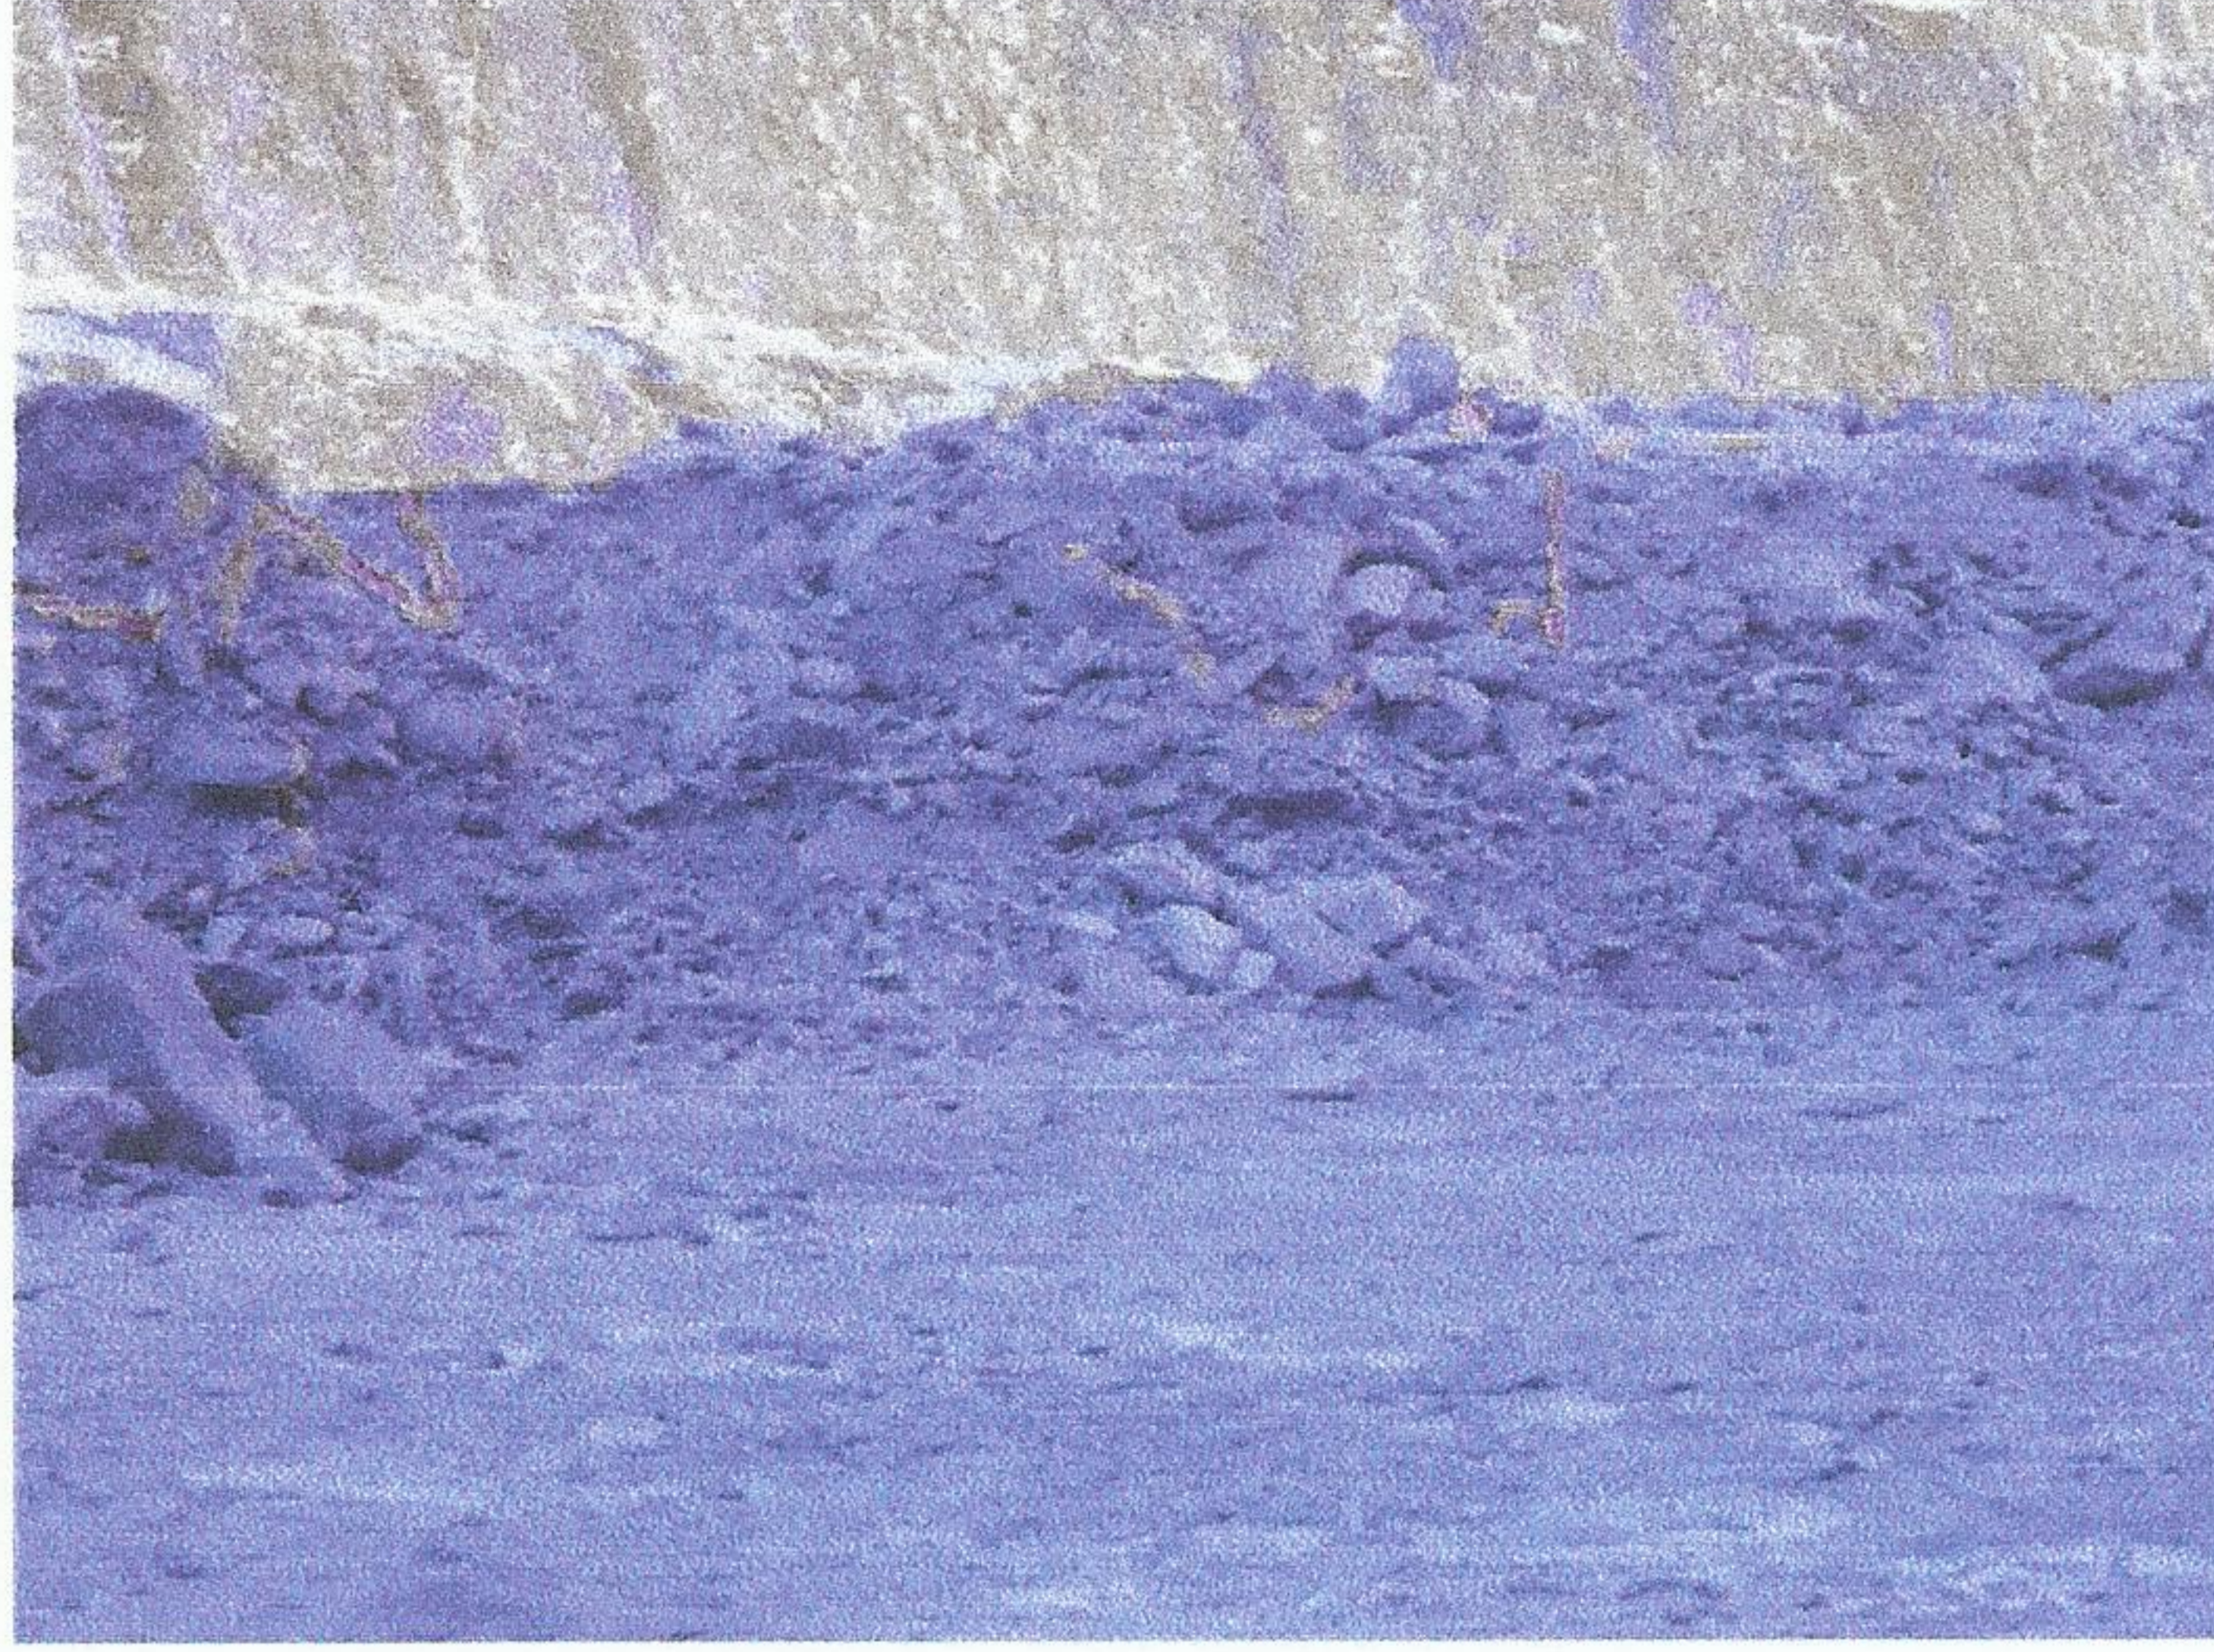
During operations in Pit A, a hydraulic hose failed on the Swing arm of the Back hoe while loading a haul truck. Operator of the equipment stopped the engine right away to prevent further spilling on to the ground. The operator contacted his supervisor immediately to have the equipment repaired.

Operator of the equipment called his supervisor immediately upon shutting off his equipment to be repaired. Once the repairs were completed, contaminated area was cleaned up using a 980 loader and material was placed in a yellow roll-off bin to be brought to the Land farm.

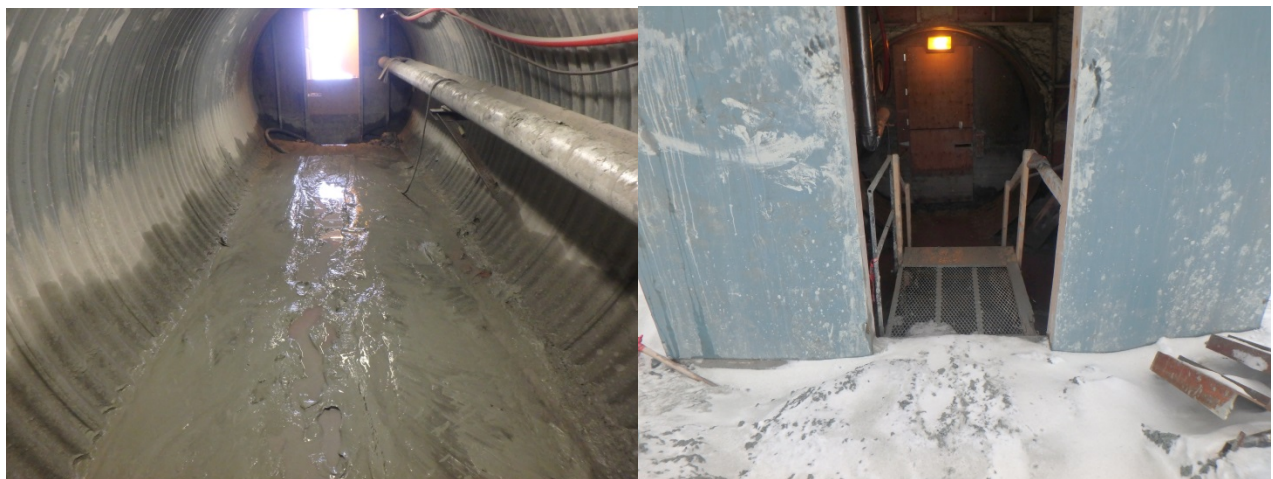
During routine inspections, an operator noticed glycol leaking from a pipe in the emergency underground access tunnel from the crusher to the dome area. Quickly the valve of the system was closed to prevent more spillage. A volume of 12 000 liters was estimated to have leaked inside the enclosure.

Upon further inspection, an end cap was found to have a hole causing glycol to leak from the line

The glycol within the tunnel was immediately collected and pumped into empty totes. The contaminated product was stored in the totes within our Hazmat storage area to be shipped with our annual hazardous waste disposal shipment.

The failed end cap piece was replaced and the glycol system was inspected for any more issues or signs of defect. The system is also connected to an alarm panel for quick intervention.

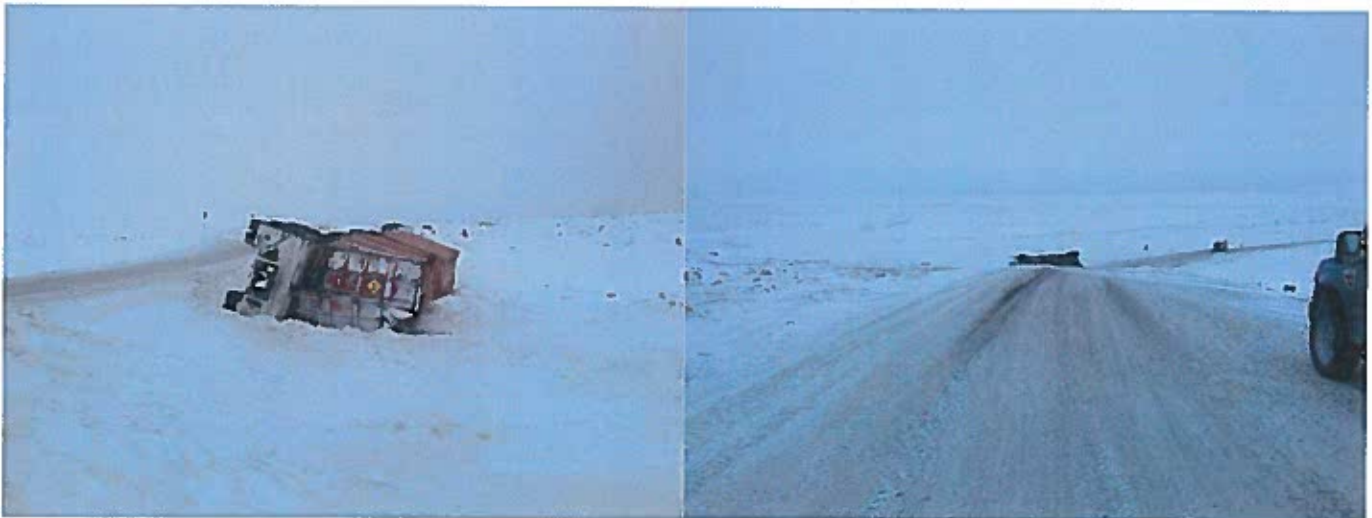
Hauling containers from the Baker Lake laydown area to the Meadowbank site, the tractor slid and rolled over off the side of the road at km 102. The operator was uninjured and was taken out of the equipment. Diesel fuel was spilling from the truck tanks. The containers, filled with Ammonium Nitrate 1000 kg bags, were damaged in the incident and some product leaked outside by an opening.

Upon investigation (see report in appendix), it was found that the truck spun out on the hill and then slid backwards into the ditch landing on its right side. The truck ahead of the one involved in the accident had to stop when climbing the hill because it was lacking traction. This forced the tractor to stop at the bottom of the hill to wait for the other tractor to be pulled uphill. The hill was then graded for added traction before the impacted tractor attempted to climb the hill. Since it started from a dead stop at the bottom of the hill then tried to climb uphill, it also lost traction. The driver tried to brake on location but kept sliding backwards.

It was found upon visual inspection of the tractor-trailer that the brake stroke on all axles equipped with maxi chambers was showing stroke in excess of 2 inches (measured at the scene), meaning that they were not properly adjusted and prevented the tractor and trailer from having proper braking power. All hauling equipment was then stopped by Agnico Eagle management until proper reports were given by Arctic Fuel Services to the fact that all equipment was meeting requirements.

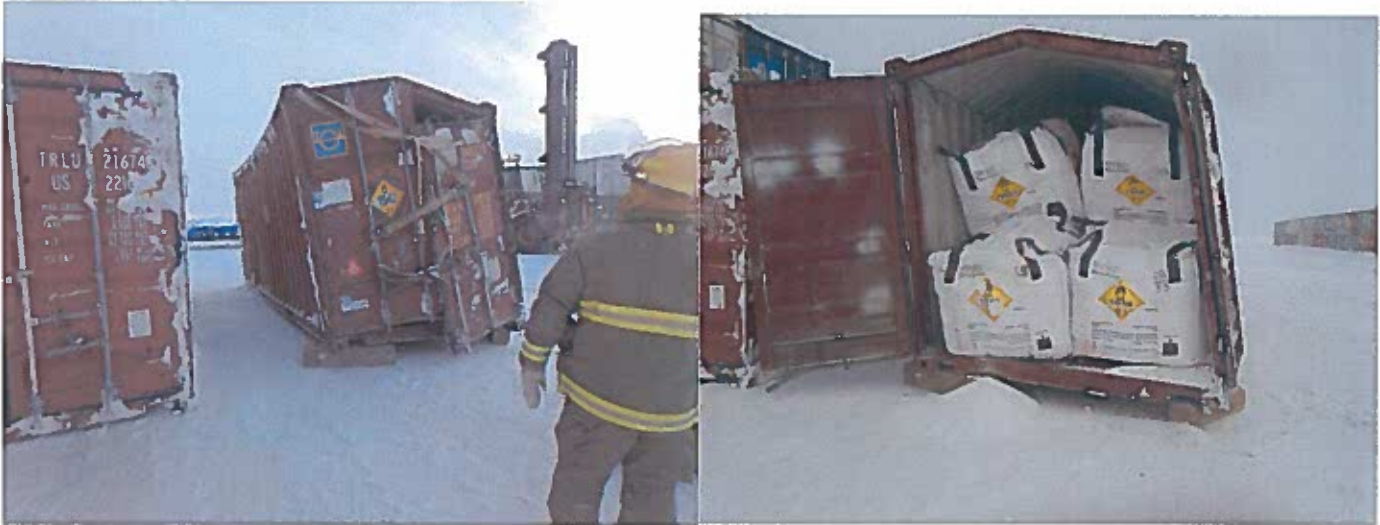
The recovered damaged containers were brought to the Emulsion plant for assessment and disposal of unusable product. Of the 2 recovered c-cans, only one had damaged bags. A total of 500 kg of product was recovered from the area, including product that spilled on the ground during handling and product that was contained within. This contaminated ammonium nitrate product, being unusable, was disposed by spreading on a loaded blast pattern. The remaining undamaged tote bags were transferred to other containers and will be used in normal emulsion processes.

A complete investigation was done on site and issues were found with the tractor-trailer condition (appendix). A meeting was then held between Arctic Fuel services, the contractor responsible for the hauling on the AWAR for Agnico Eagle. Root causes identified were: improper inspection of trucks and overall inadequate maintenance being performed on them (meeting minutes in appendix). Corrective measures were discussed and agreed upon, including proper pre-op inspections, possible disciplinary measures when items are not met and random audits being performed by the Meadowbank maintenance department on Arctic Fuel equipment float.

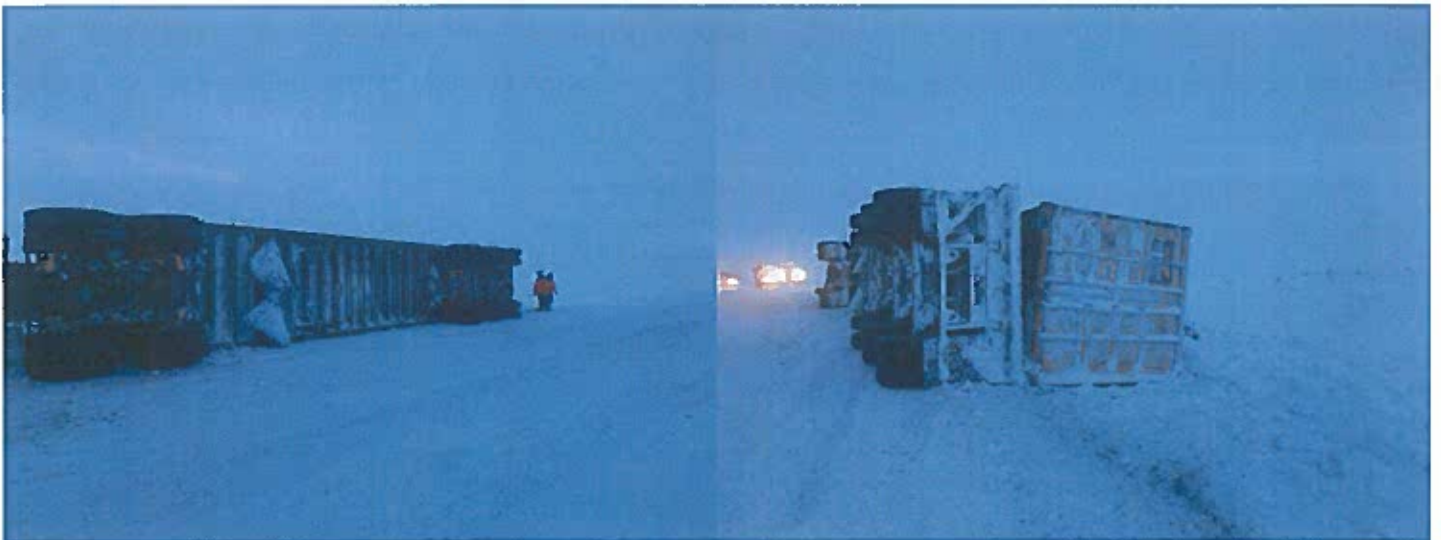
Upon investigation (see report in appendix), it was found that the first axle on the trailer had a major structural failure on the right side. It was only supporting the load on that side by the two rear axles. After a straightaway coming into the turn, the trailer suspension could not compensate and caused the equipment to roll to its side.

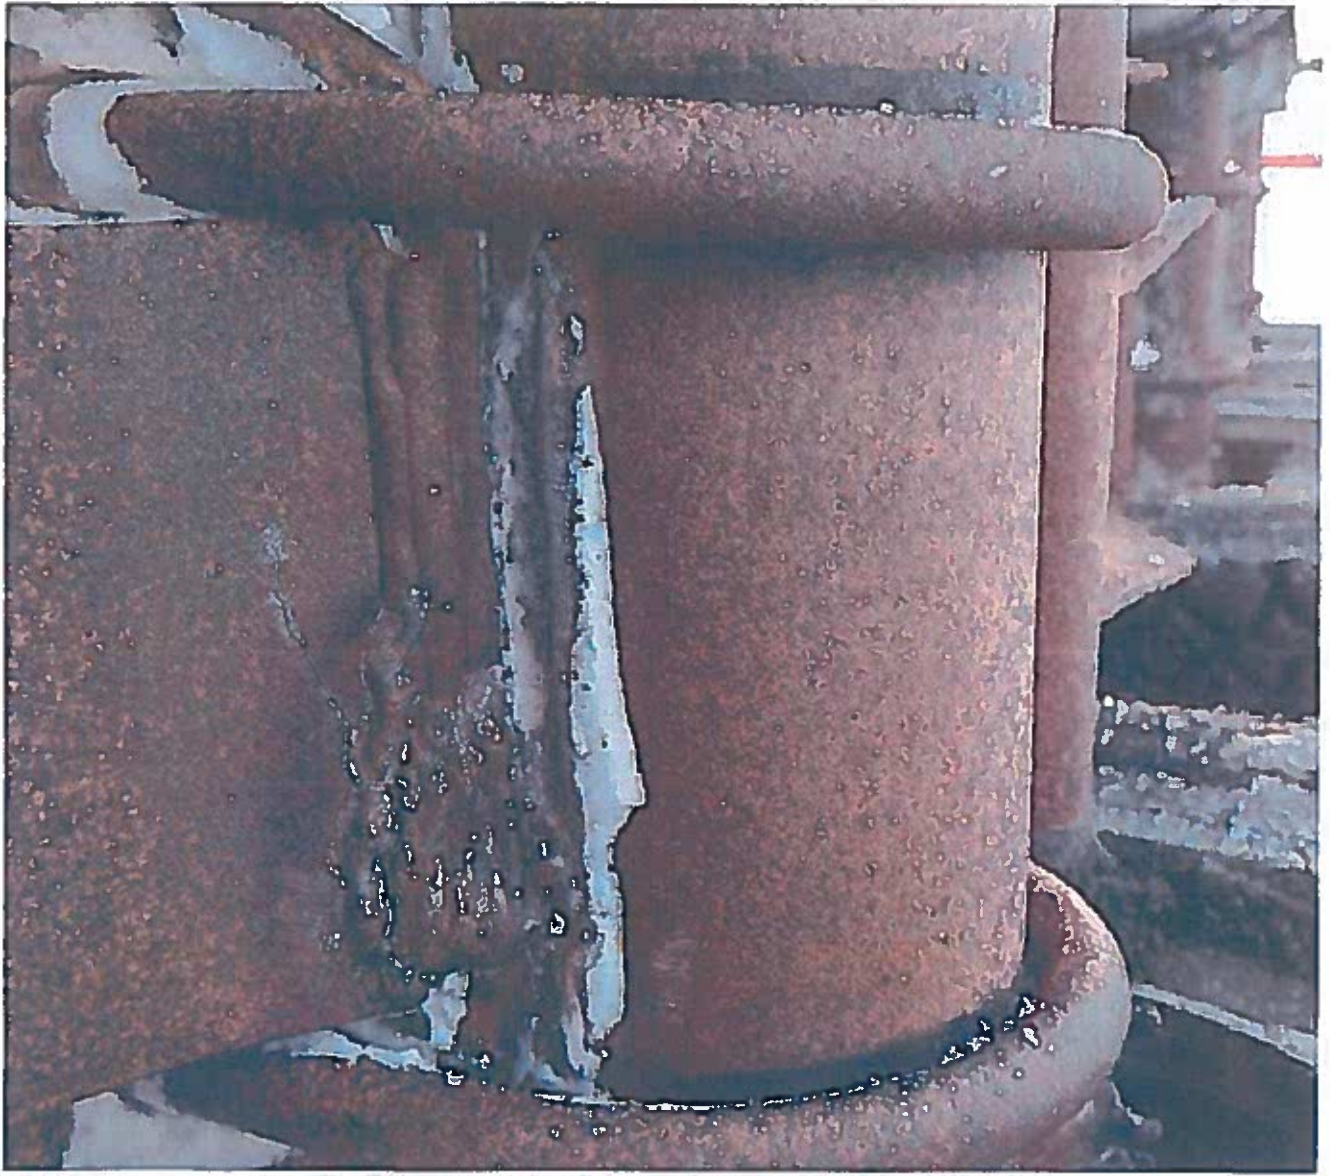
suspension arm
broke off at black
✓
