## **Appendix F1**

### **GN Spill Report**

## January 28<sup>th</sup>, 2017 LOA 12 oil spill

Please find the following information as a follow up to the Spill report submitted January 29th, 2017 by Agnico Eagle Meadowbank division. This detailed report is submitted to the Inspector in compliance with the conditions under the Nunavut Water Board License 2AM-MEA1525, Part H, Item 8c.

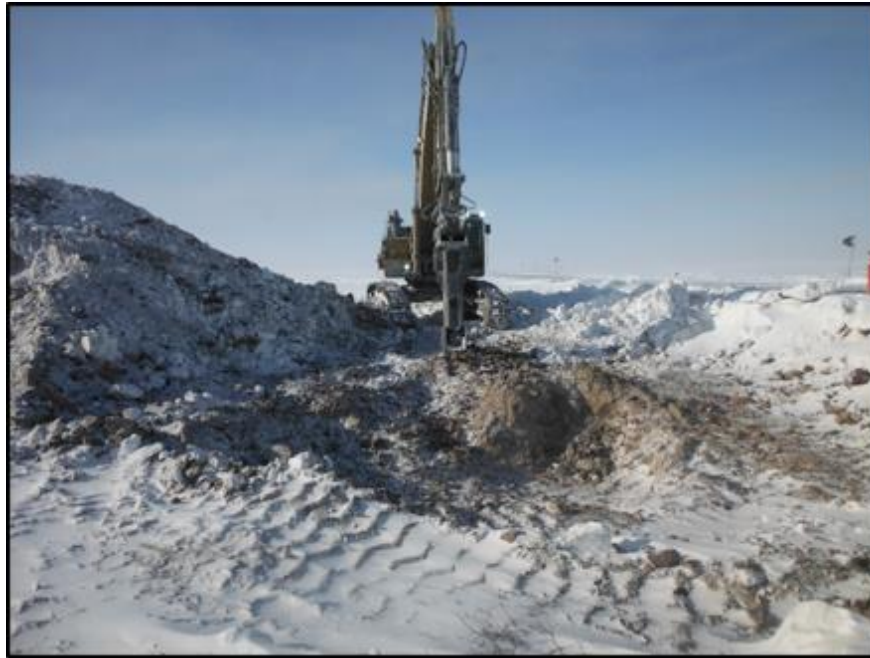
April 21: Using the hammer to remove material.

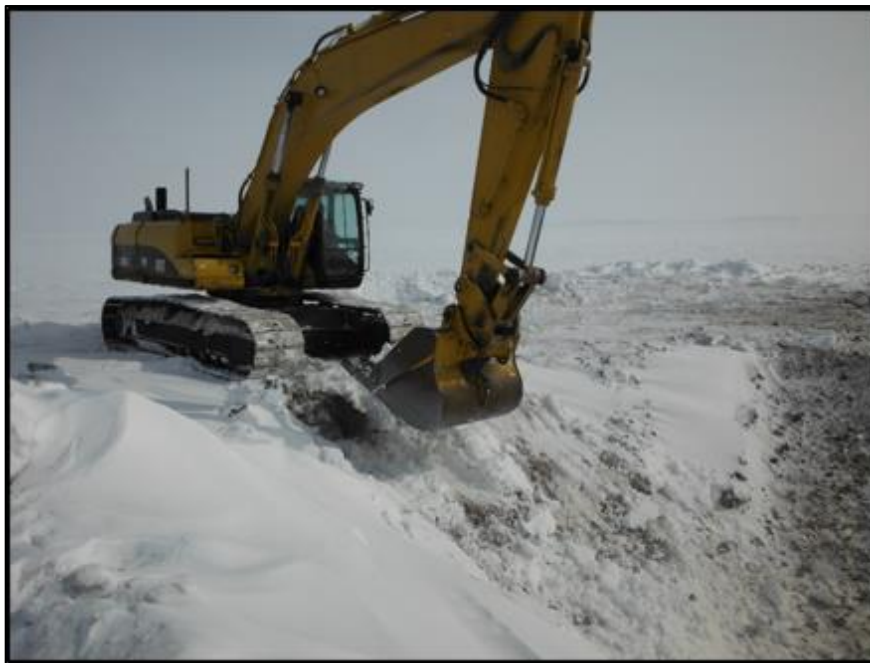
April 21: Removing snow from excavation for confirmatory sampling.

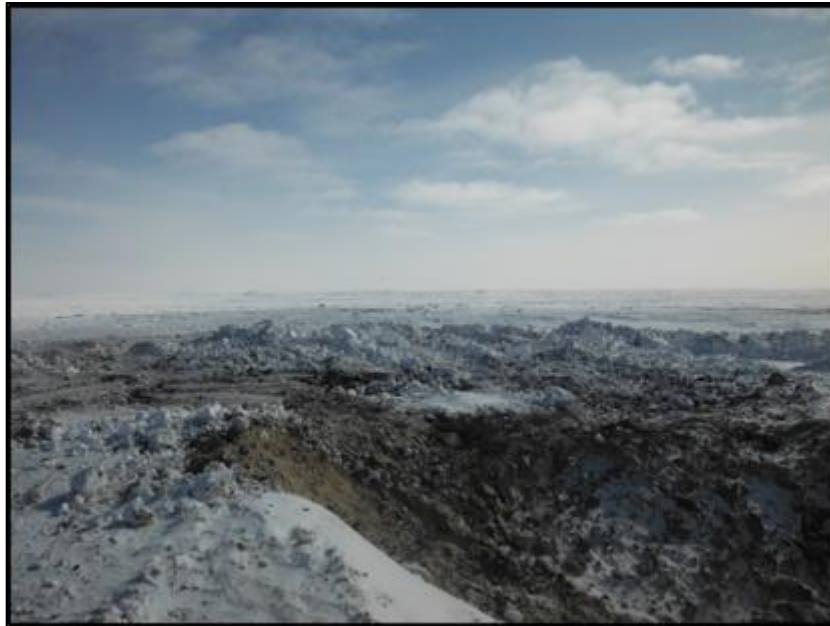
April 22: Stockpile removed from location.

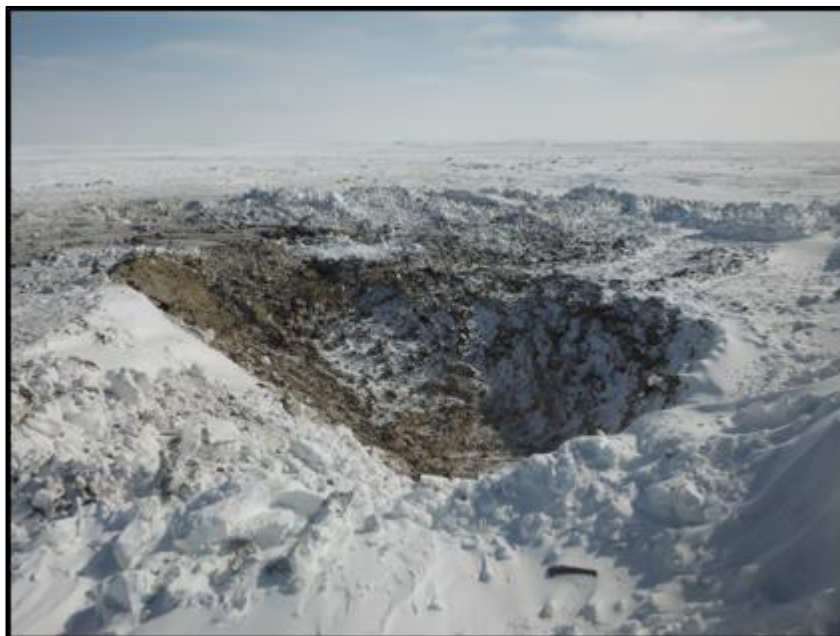
April 22: Final excavation boundary.

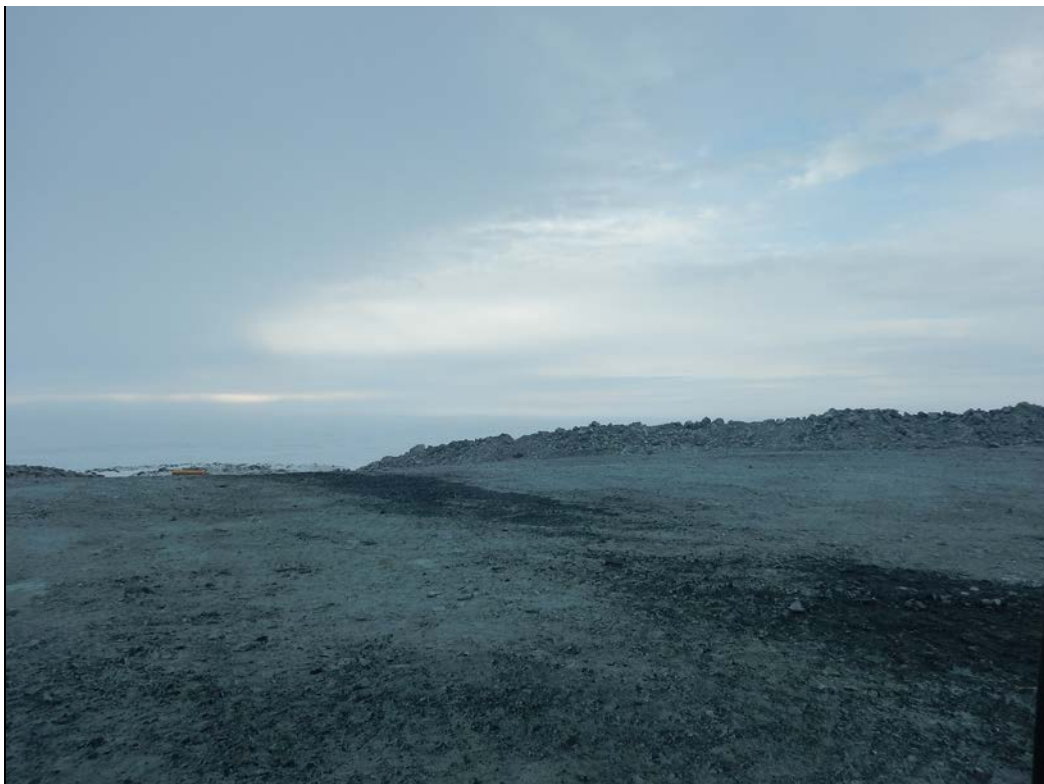
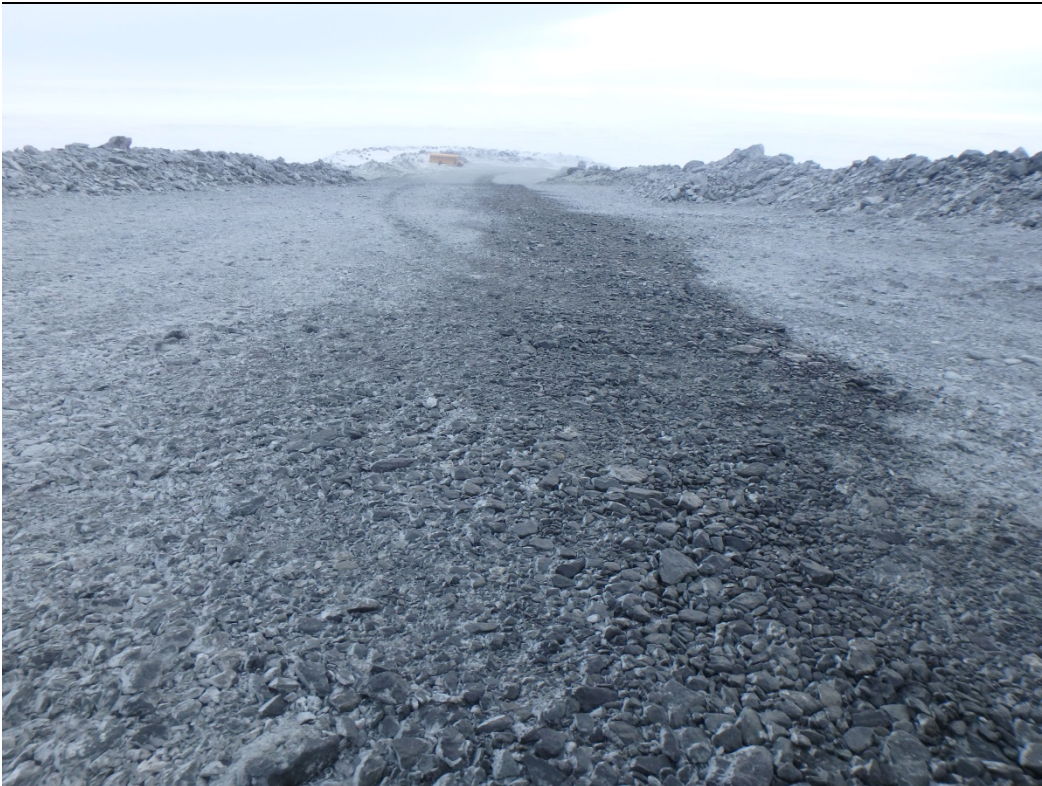
During operations at Portage pit waste dump, a hose failure on haul truck 06 occurred creating a spill

The spill was caused by a hose failure on the hauling unit.

As part of the preventive maintenance program done on site, the hydraulic system including hoses and fittings are inspected. Pre-operations checks including routine visual inspection of the hydraulic system is also performed.

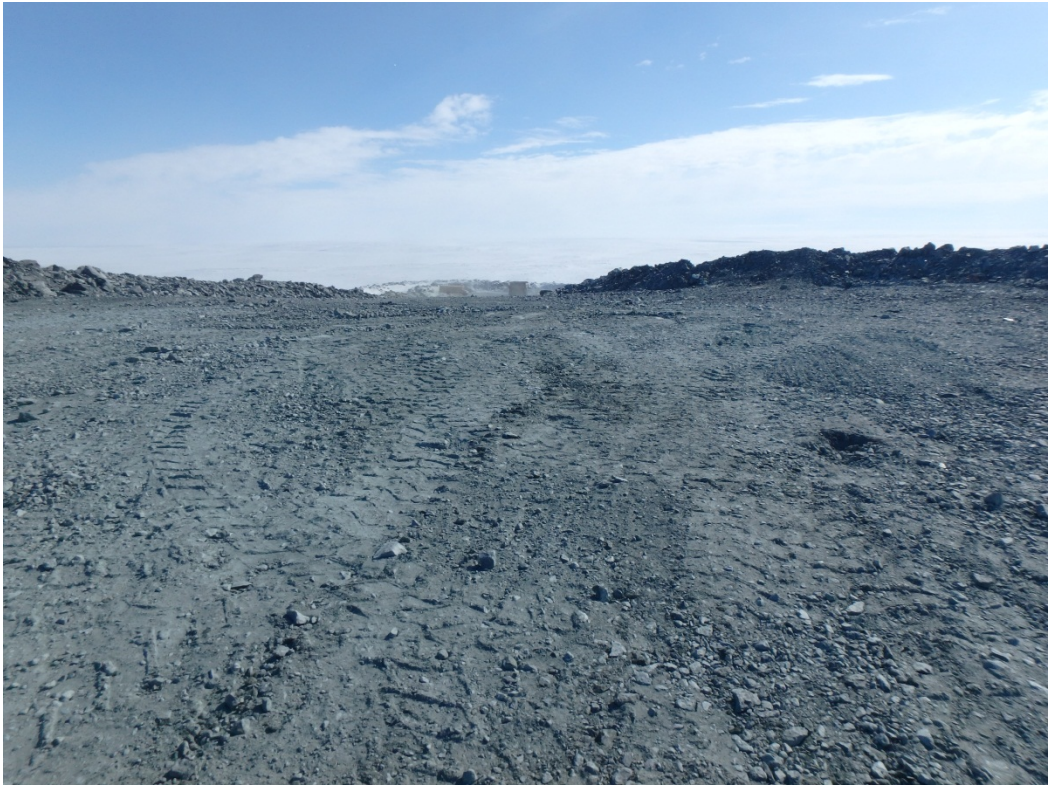
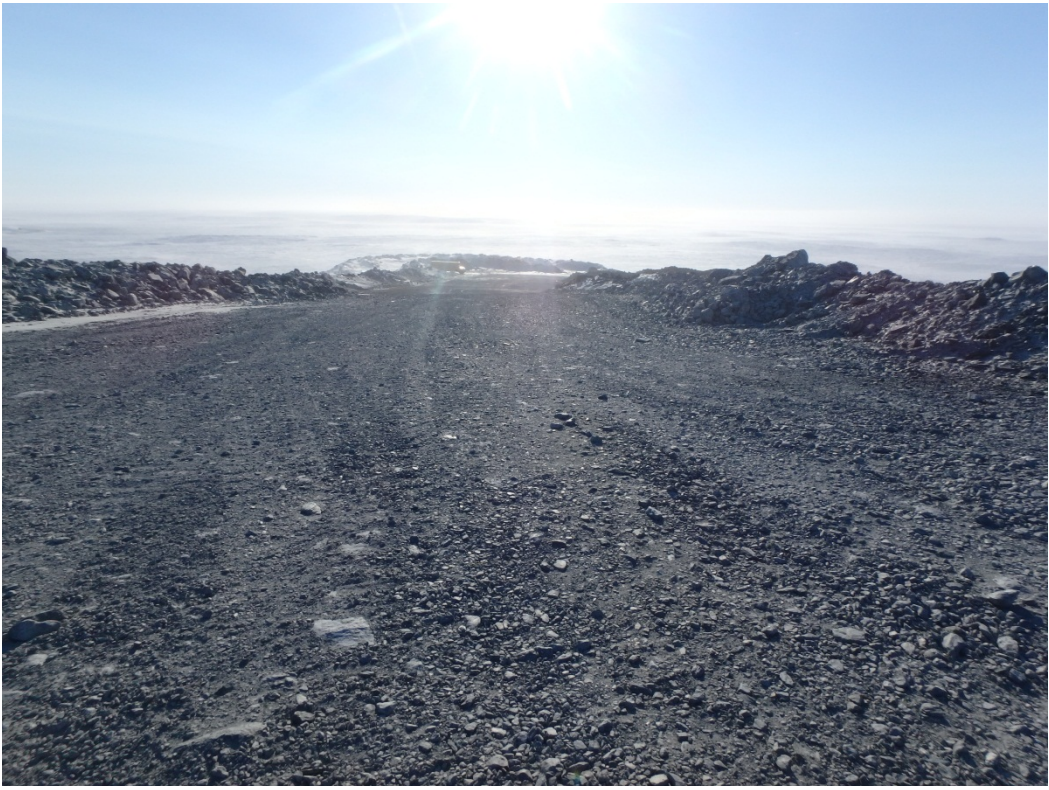
When the operator realized oil was spilling, he stopped the engine and called his supervisor. A grader was used to gather the contaminated soil and a loader collected the material and disposed it at the landfarm

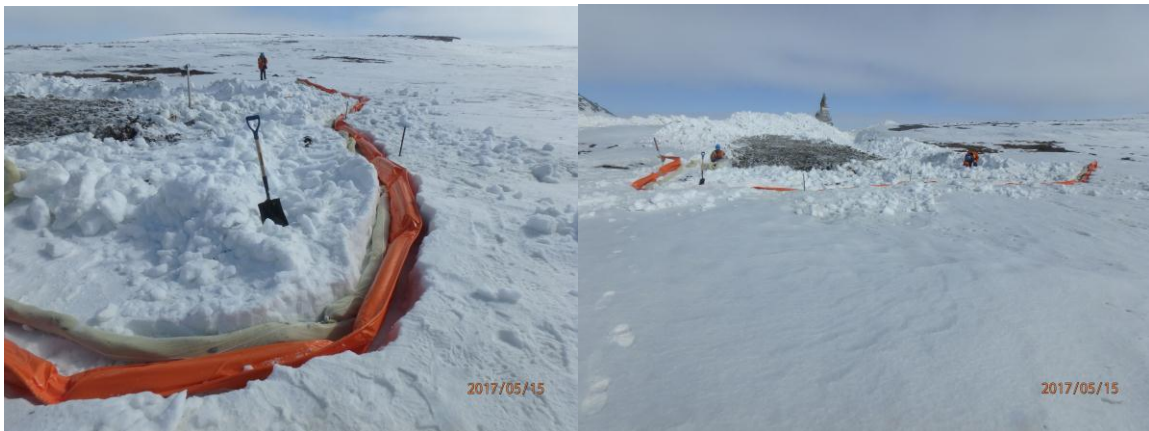
The equipment was repaired on location and the area was scrapped clean. Contaminated snow and material was removed and was disposed at the Landfarm area. Further assessments were done in the spill area and downward towards NP2 Lake shore for any signs of impacts within the waterbody. No evidence was found in the receiving lake. As precautionary measure, maritime barriers and recovery booms were installed on ice. The containment was inspected daily afterward for any signs of contaminants.

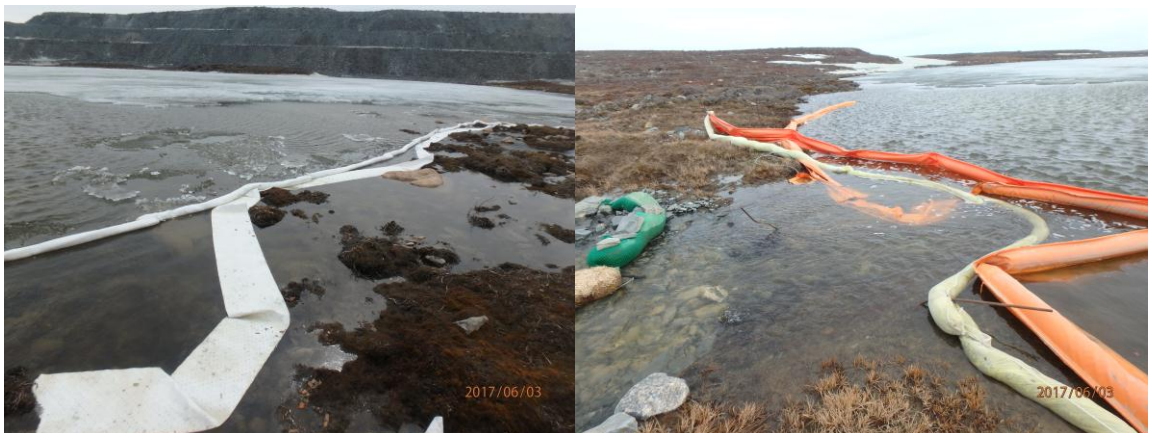
Upon ice melt, barriers were readjusted and sorbent boom replaced.

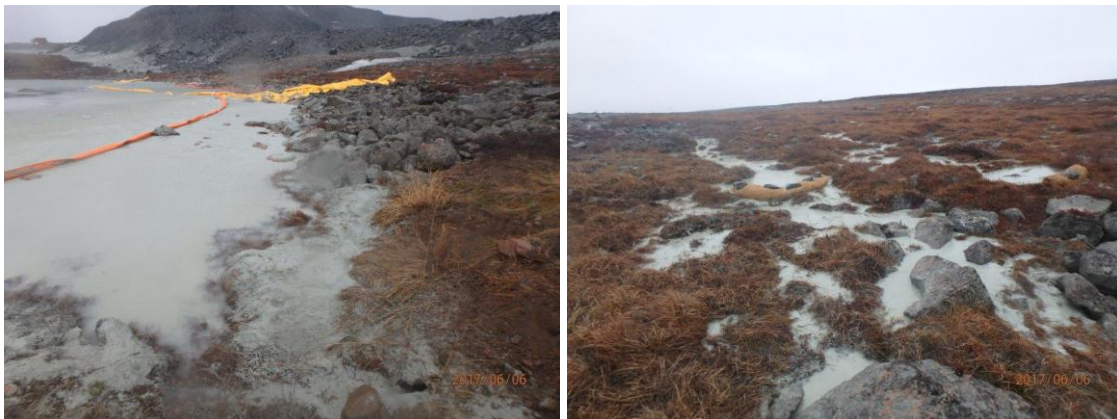
Photo 1: NP1 Lake Visual observation of the TSS exceedance, taken on June 6<sup>th</sup>.

On June 6<sup>th</sup> early morning inspection, visual evidence was noted within the banks and shore of NP1 lake of colored water flowing downstream to the lake (see Photo 1, below). Samples were collected for TSS analysis. One set of samples was brought to the internal laboratory at the Meadowbank site and a second set shipped to an external laboratory. Although not accredited, the Meadowbank lab is used for quick assessment since results are readily available and provided within a short timeframe. Being in a remote site, the sample shipped to the external lab requires shipping and logistic delays. Results are shown in table 1.

Mud was observed on location (North side), mud that was under previously present snowbanks and thus was not visible on previous inspections. The great amount of precipitation received on site from the night of the 5<sup>th</sup> to the 6<sup>th</sup> and ongoing for 24 hours increased greatly runoff and snowmelt and created flow outside of usual runoff locations.

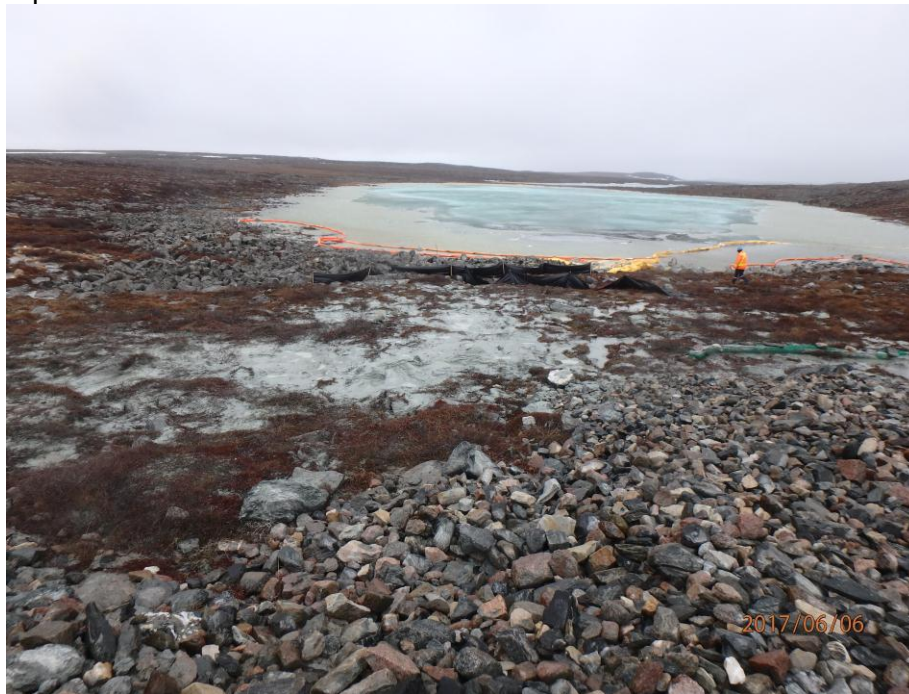
Photo 2: Mitigation measures

As a precautionary measure, additional barriers were placed on the north lake banks limiting TSS arrival speed in the lake on June 6<sup>th</sup> (Photo 2). It is important to note that barriers were already in place within NP1 Lake, as presented on the picture below. Silt fences and additional wood chip logs were installed on the upstream flows to prevent more sediments from entering water. As well, all remaining snow was removed from the road side up and downhill of the areas.

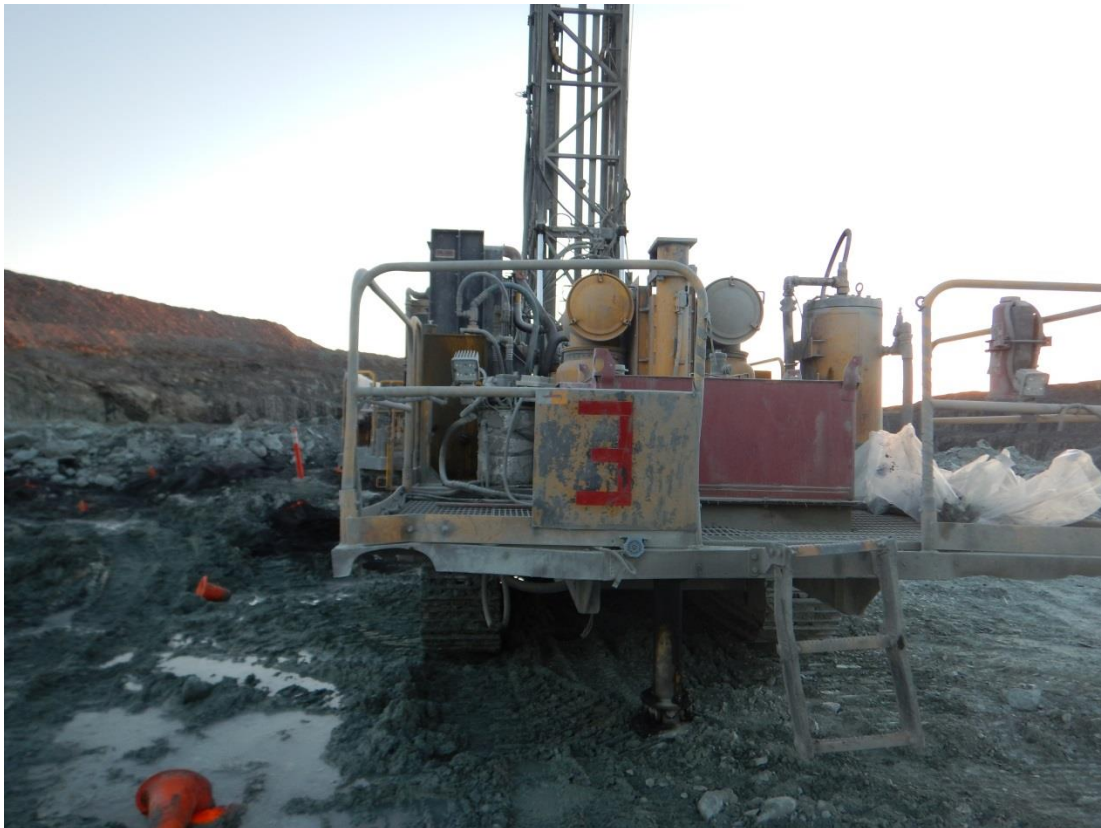
The spill was caused by a failure of an o-ring cause by wear on a hose of the hydraulic system of the drill.

The hydraulic system including hoses and fittings on drilling equipment are inspected as part of the preventive maintenance program done on site. Pre-operation checks also include visual inspection of the hydraulic system.

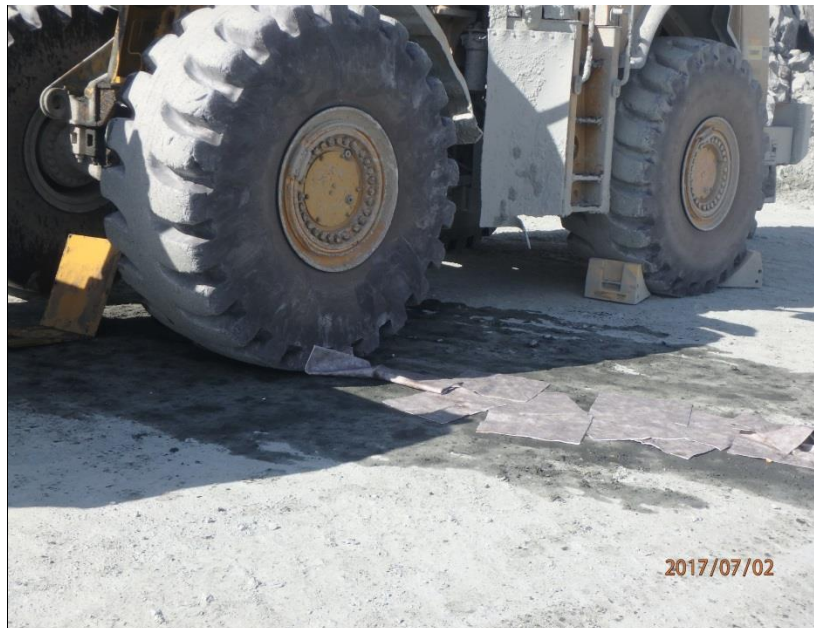
The spill was caused by a hose failure on the hydraulic system of the loading equipment.

The hydraulic system including hoses and fittings on drilling equipment are inspected as part of the preventive maintenance program done on site. The specific PM inspection is also done on loading equipment in relation to the hydraulic system. Pre-operation checks also include visual inspection of the hydraulic system.

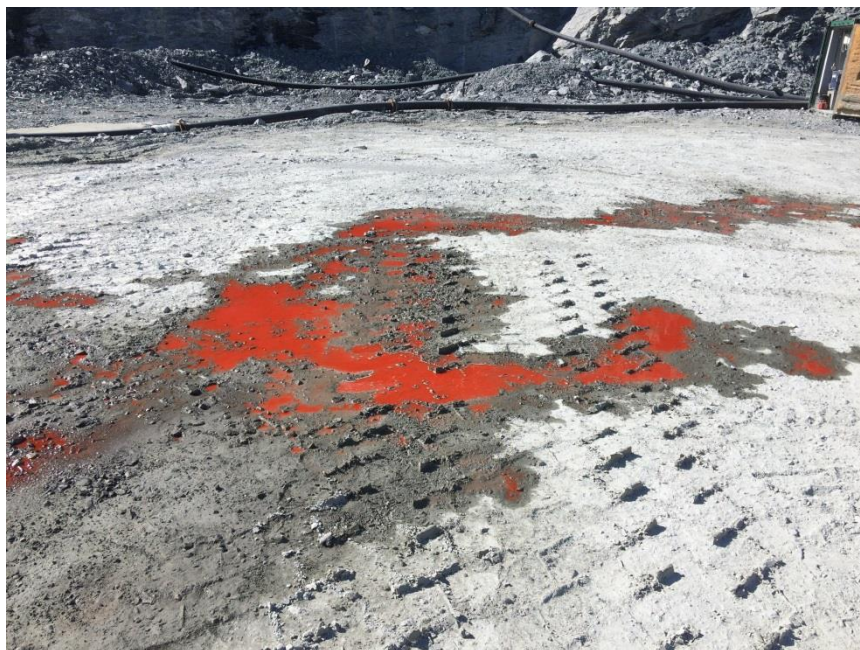
The spill was caused by a failure of a turbo fitting on the cooling system of the hauling equipment.

The equipment is visually inspected for leaks as part of the pre-operational check. Regular preventive maintenance is also done on hauling equipment on site, including inspection on the cooling system parts and fittings.

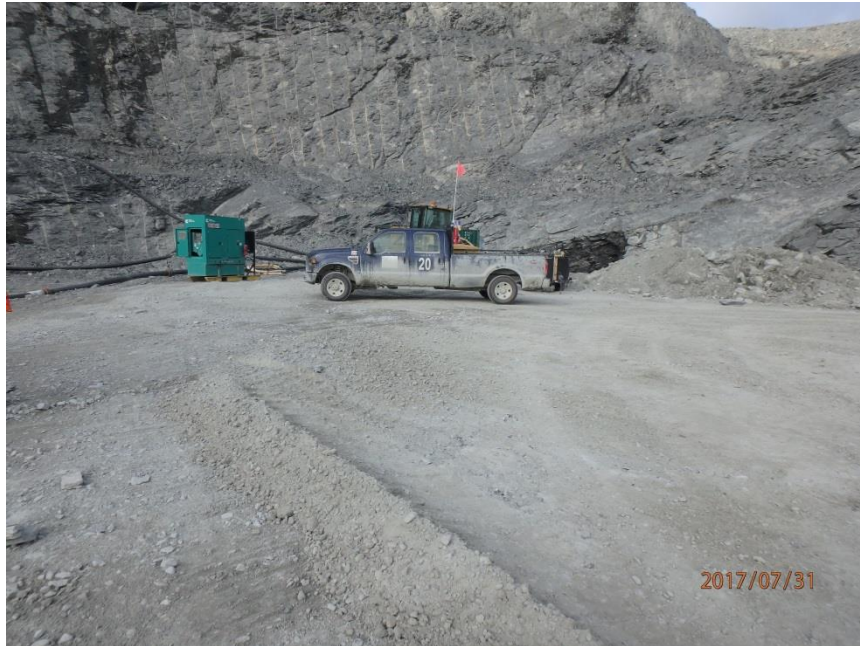
Once the haul truck was safely moved out, the area was scrapped clean and the contaminated material was brought to the Tailings Storage Facility (TSF).

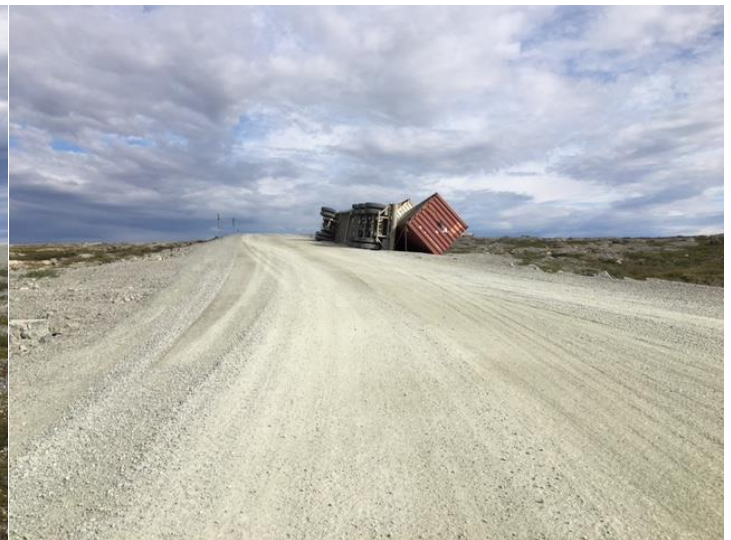
Tractor and trailer off-road

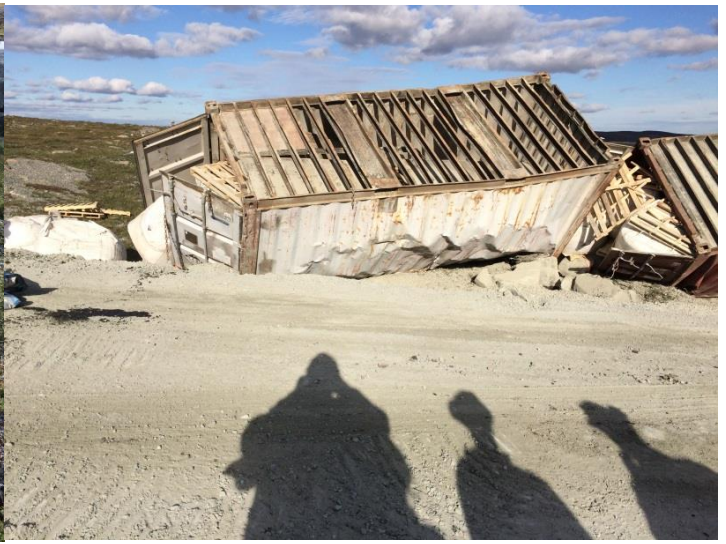
Berm and chemical booms

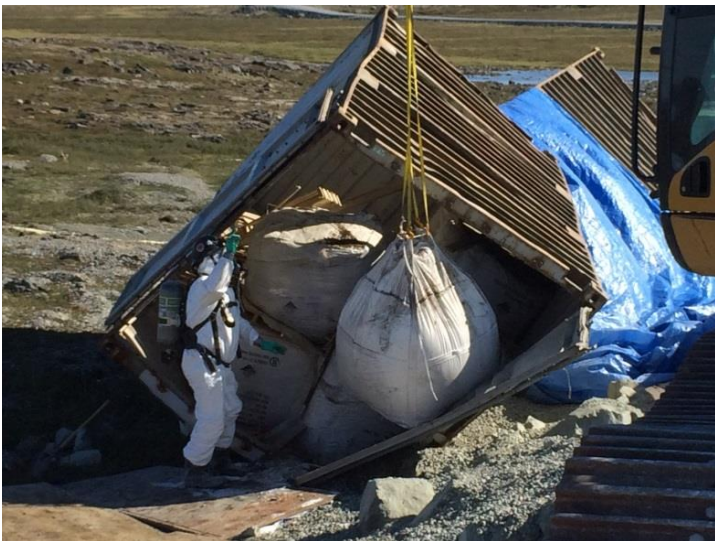
Bags outside the sea can

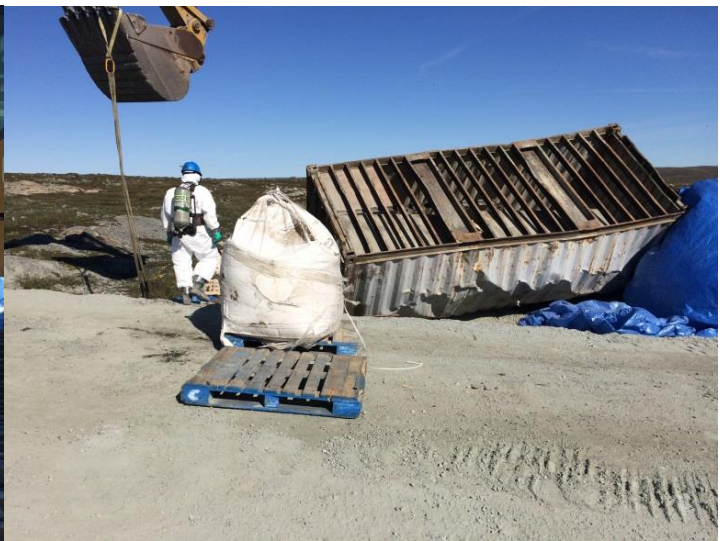
Bags recovery

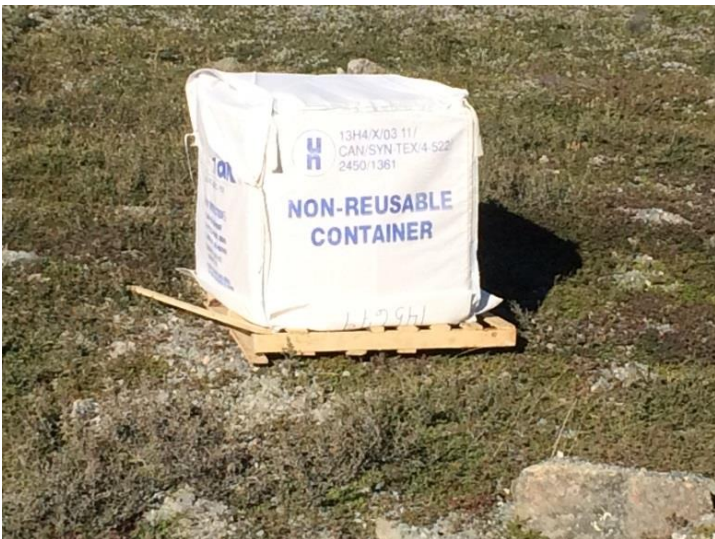
Bags recovery (2)

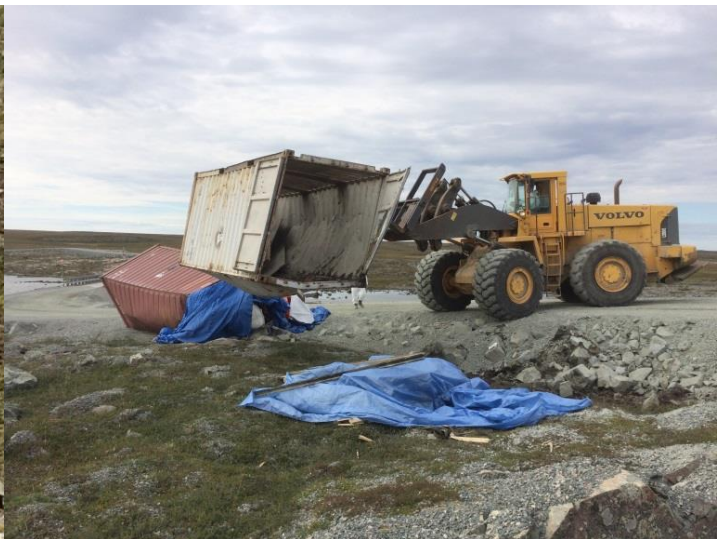
Products transferred in a quatrex

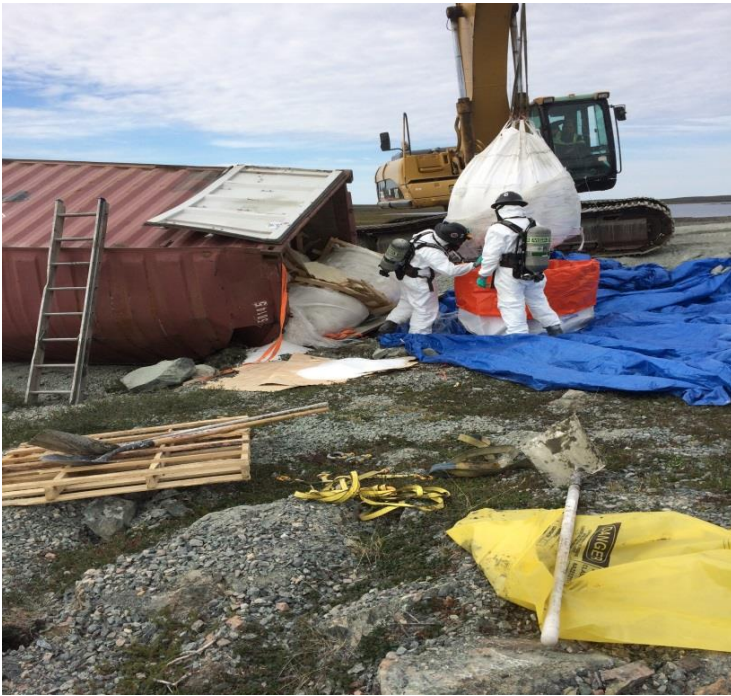
Empty sea can

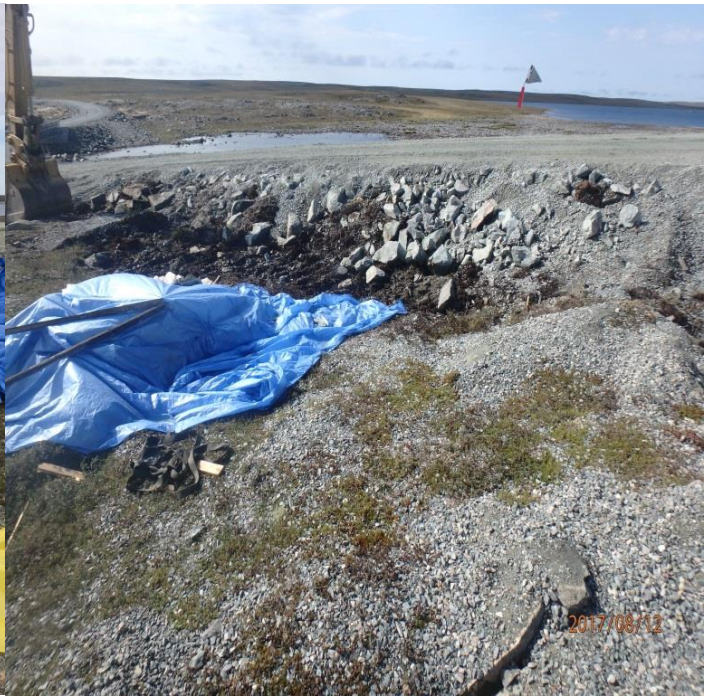
Bags recovery

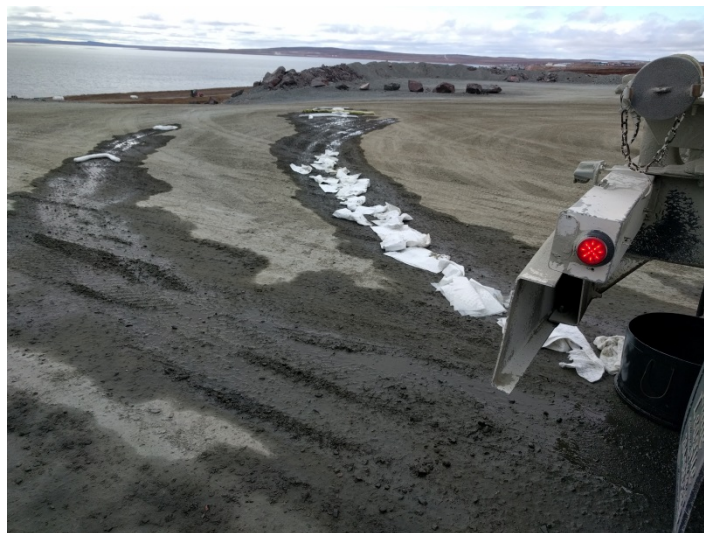
An AFS worker was filling up at Baker Lake when the operator saw that the tanker was overflowing. As soon as the worker realized that, he stopped the filling, starts to put absorbent pads and called his supervisor. A new flow meter was installed at the fuel station and the numbers showed by the meter were erroneous causing the operator to underestimate the amount of fuel in the tanker. The area where the spill occurred is lined. An investigation was completed and the corrective measures can be seen below. Upon the investigation, the quantity spilled was evaluated at a 1000L according to the flow and the time of the spill.

The incident occurred when the tanker overflow tank got overfilled. The wrong number on the flow meter caused the operator to underestimate the quantity and the preventive system in case of overflow didn't work as planned.

- Install a window in the fuel farm sea-can so the driver has a better view of his truck and the surrounding when he reaches inside to look at the meter.
- Improving our commissioning procedures for extra precaution when we test new equipments
- Re-design our spill control system connected to the overflow of the tanker.

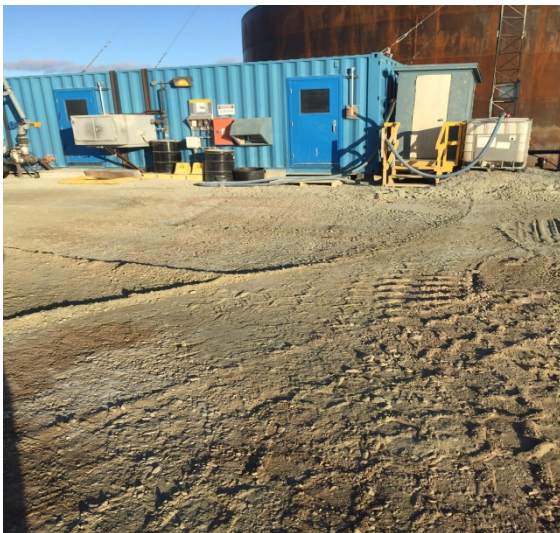
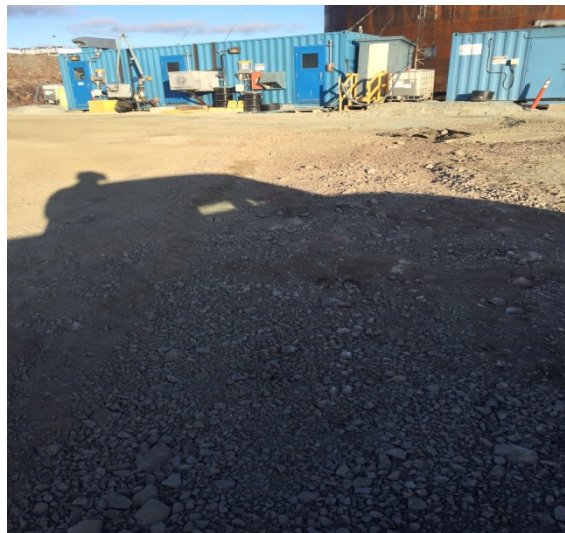
All the contaminated soil was scrapped and brought to the Meadowbank landfarm (about 22 m3). An investigation is under way to determine what went wrong with the new flow meter as well as the overflow preventive system.

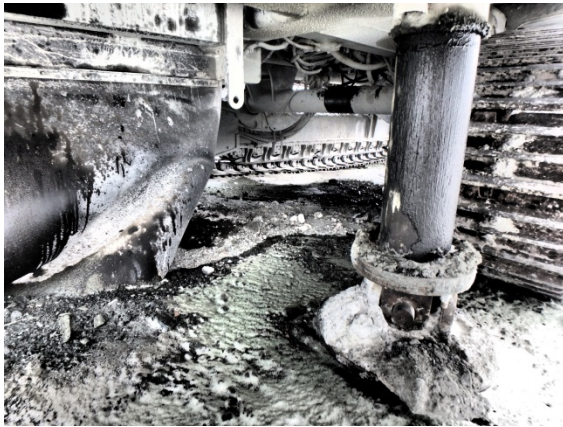
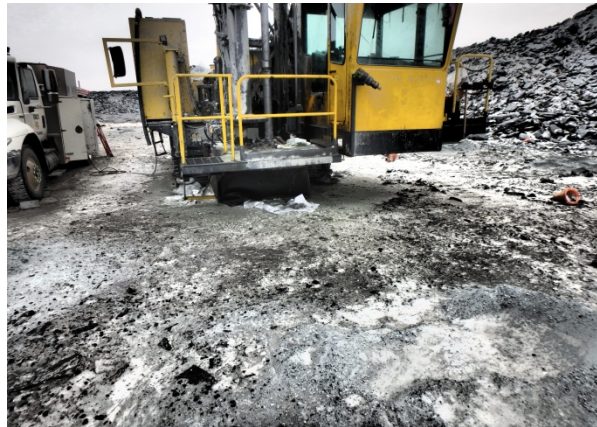
During the operation the drill head creep down and the hammer started percussing. At that time the hammer damaged hydraulic hose on the deck.

A hydraulic hose rupture was caused damage by the hammer movement on the hose.

Hydraulic hoses were changed and the pump was repaired. Everything was inspected and no other leaks were observed once inspection was completed.

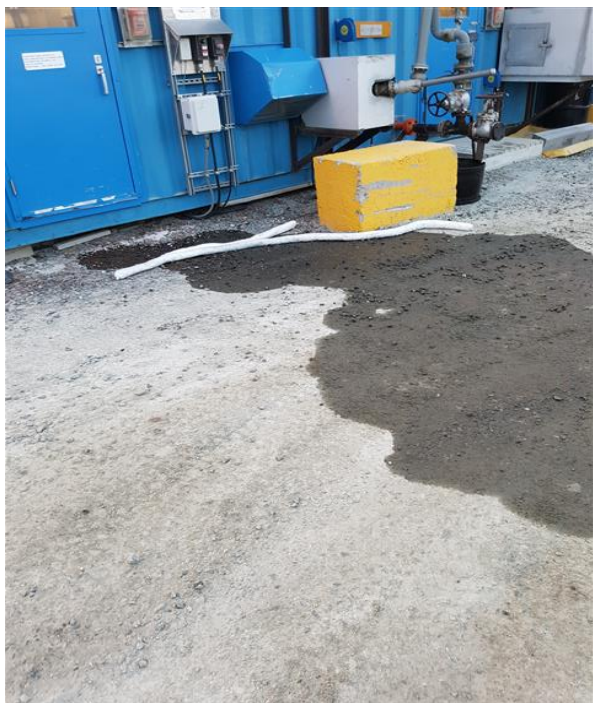
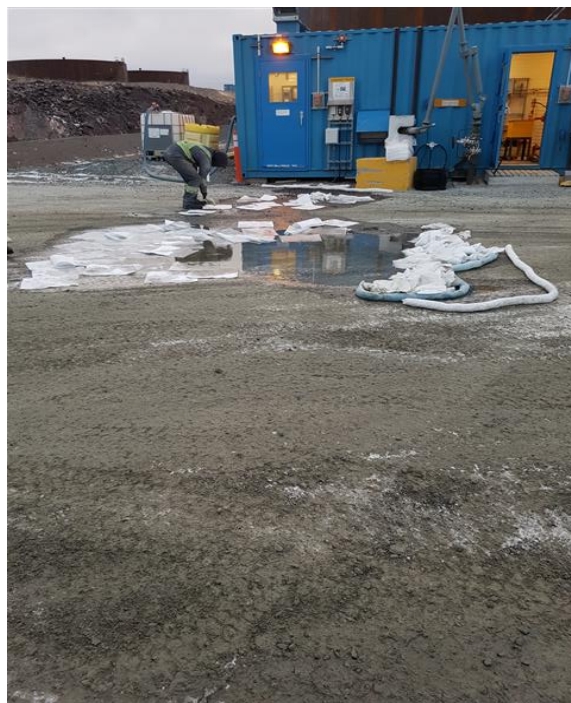
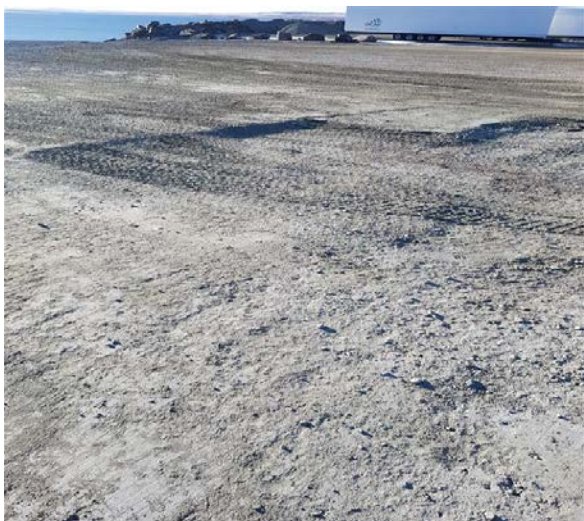
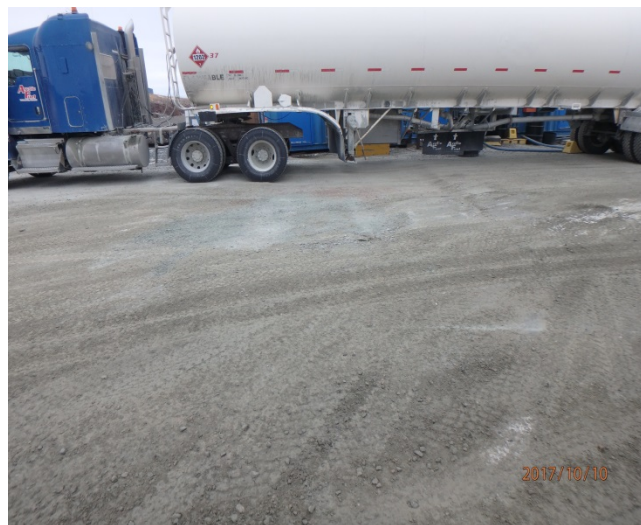
The incident occurred when the truck tank got overfill. Human error and a poor communication between the workers are the main causes for this spill.

The pump was stopped and the operator placed the absorbents pads on the spill to contain it. They have called a loader to scrape the contaminated soil.

All the contaminated soil was scrapped and brought to the Meadowbank landfarm (about 3 m<sup>3</sup>). A meeting was held with the contractor. They reviewed the procedure and some modifications will be done.

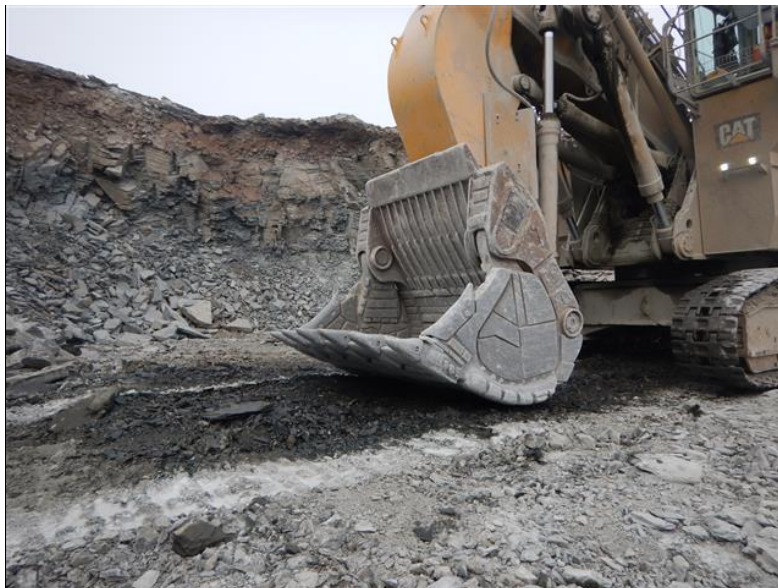
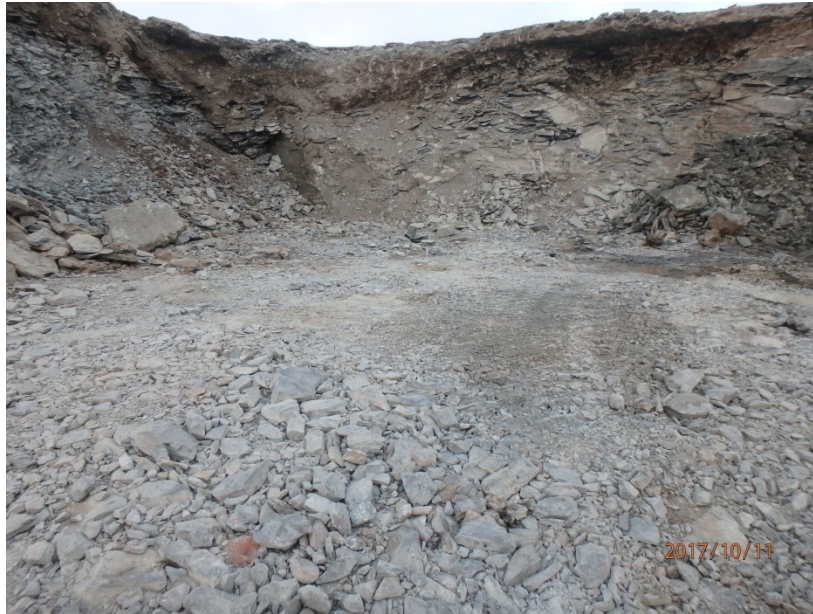
During operations, at Phaser pit, the operator of backhoe 13, noticed a leak of oil. He stopped immediately the engine.

The spill was caused by hose failure on the loading unit.

The equipment engine was stopped immediately. The operator called mechanic department for the repair. A loader unit cleaned the surface affected and the contaminated material have been removed and brought to the landfarm area

The hoses and fittings are inspected as part of the preventive maintenance program done on site. Routine visual inspection of the hydraulic system is also performed during pre-operations checks.

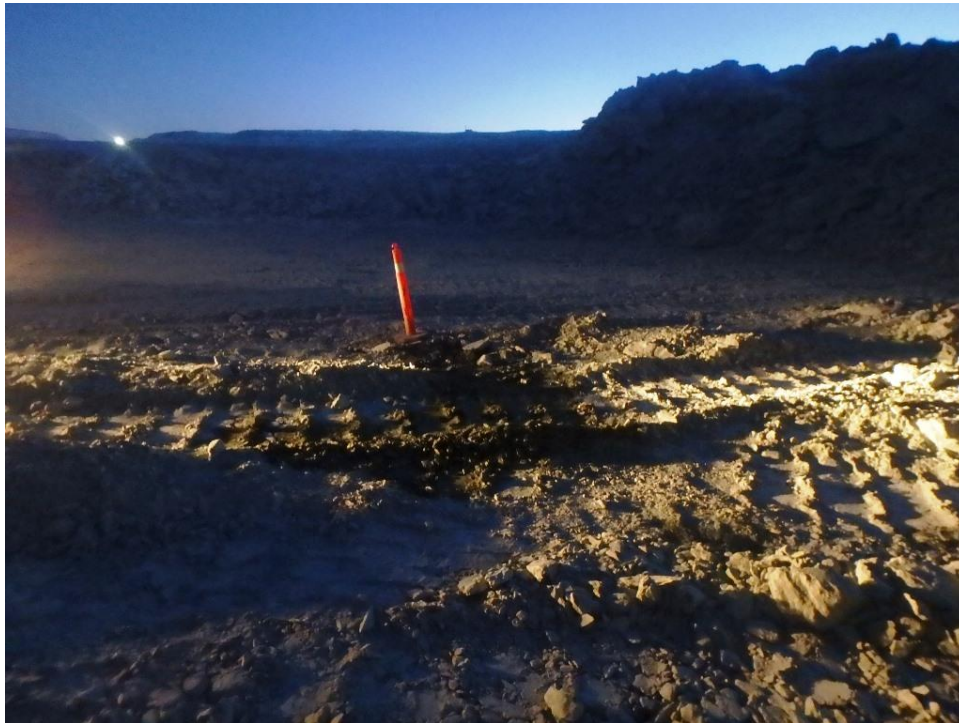
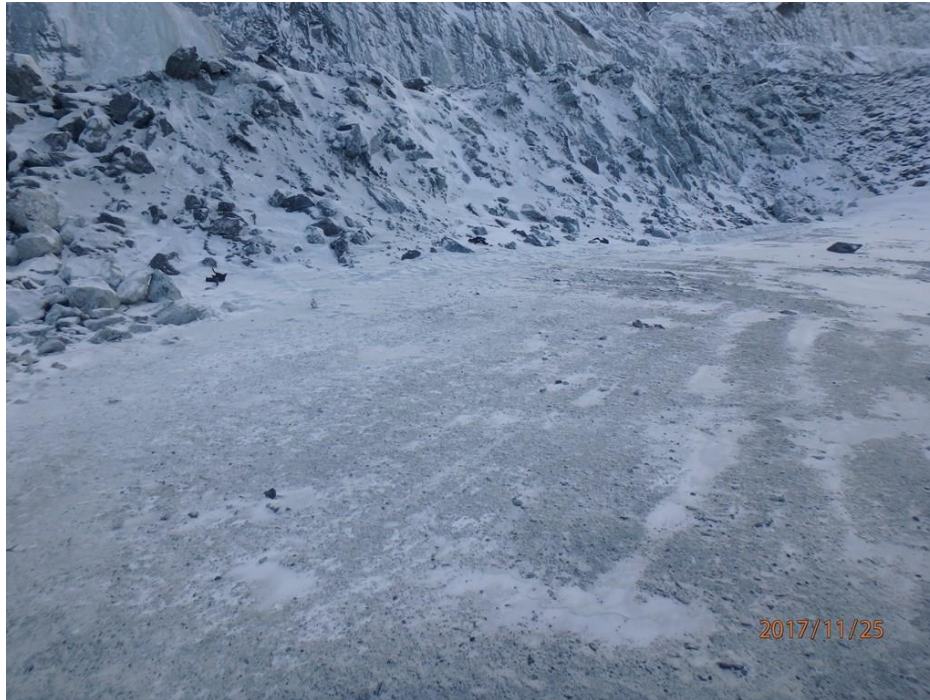
The spill was caused by freeze on the release system on the nozzle of the distributing hose of the fuel truck, during refilling operations.

The ground was scrapped clean and all contaminated material was brought to the Landfarm.

Fuel nozzle is checked prior to starting refilling procedures, but can become frozen during operations with cold diesel fuel and operating conditions. A reminder was done concerning forecasting potential freeze on equipment by adapting practices and testing state of equipment.

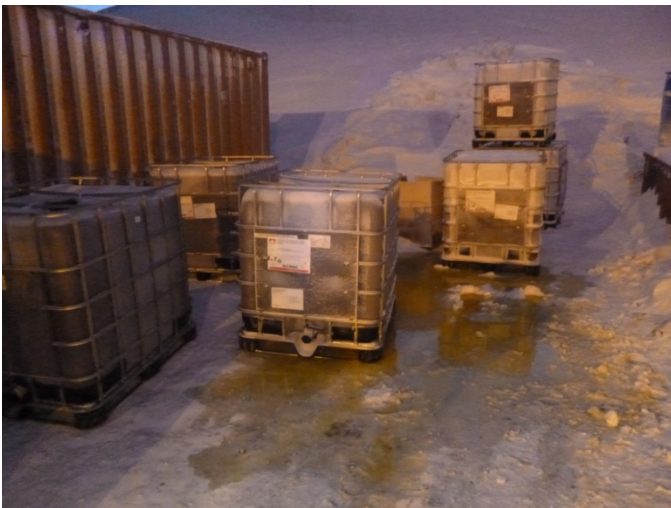
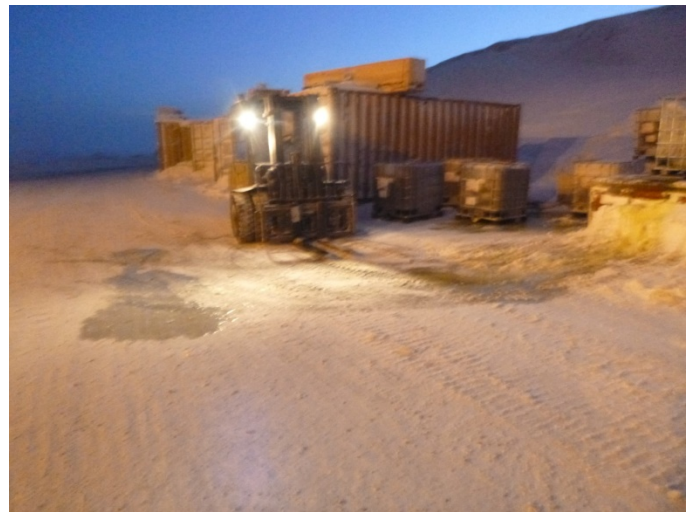
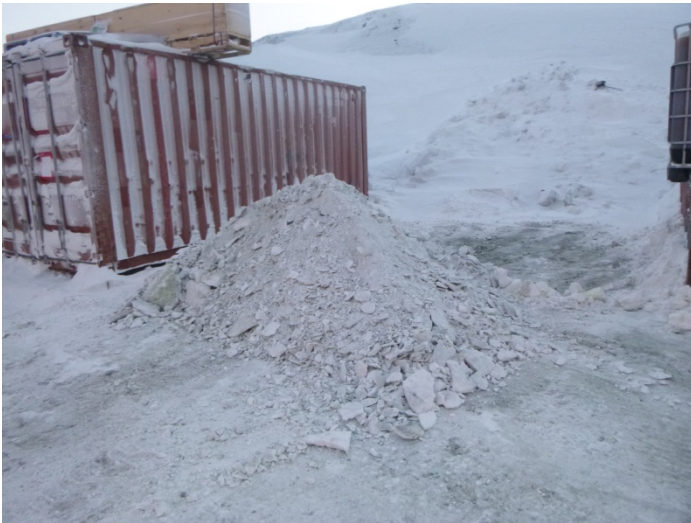
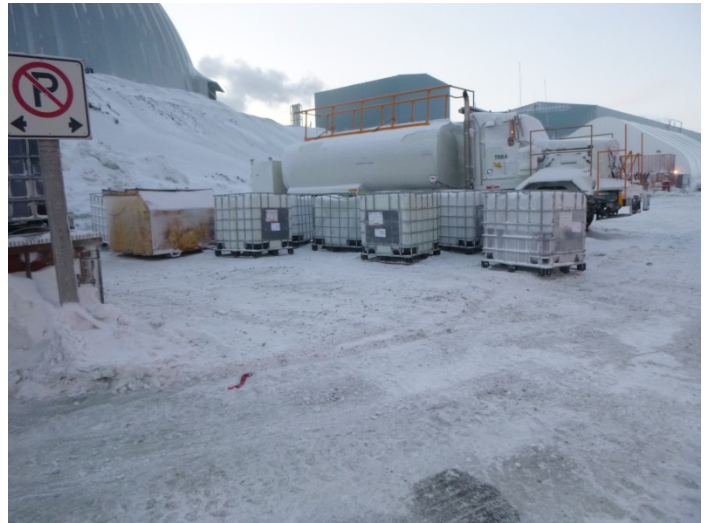
While trying to bring a tote from the oil pad to the maintenance shop, the operator punctured the bottom of the tote with the forklift fork and the oil spilled on the ground.

When he saw the oil coming from the tote, the operator put the tote on the secondary containment. All the contaminated material (snow) was collected and disposed in the tailing.

A reminder was given to the operator to ensure that operation is safe when we handling tote. The operator must be confident that the forks are on the right place.
