## **Appendix F1**

### **GN Spill Report**

## January 28<sup>th</sup>, 2017 LOA 12 oil spill

Please find the following information as a follow up to the Spill report submitted January 29th, 2017 by Agnico Eagle Meadowbank division. This detailed report is submitted to the Inspector in compliance with the conditions under the Nunavut Water Board License 2AM-MEA1525, Part H, Item 8c.

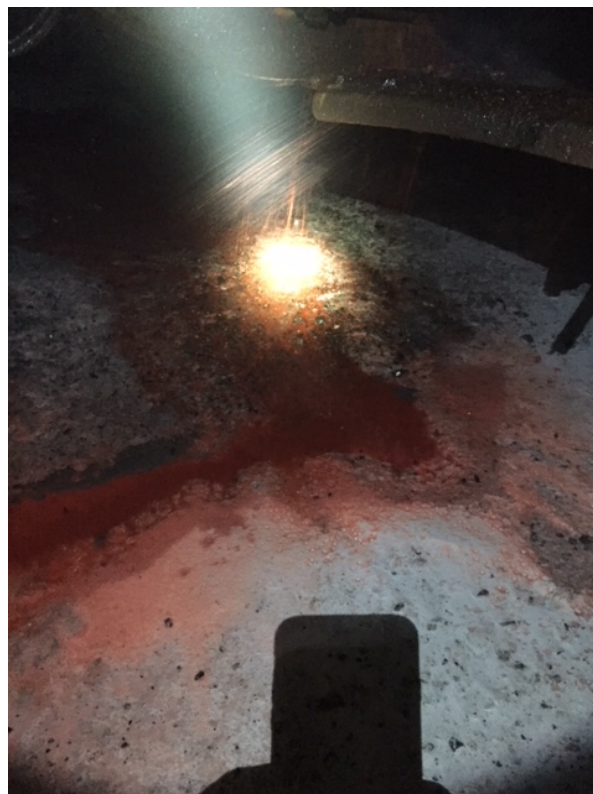
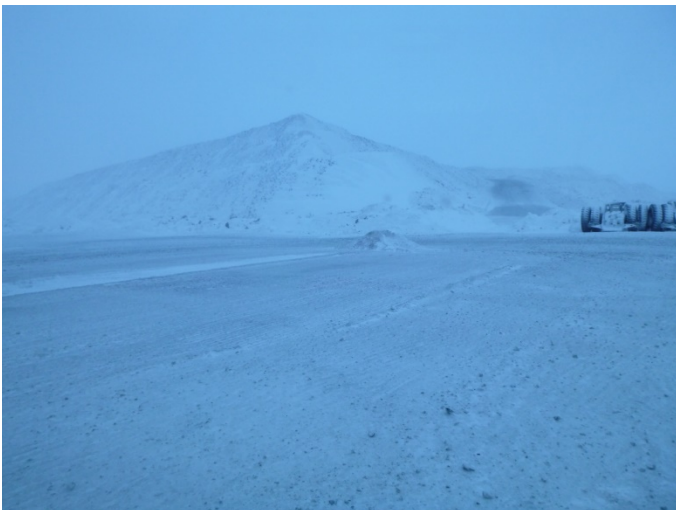
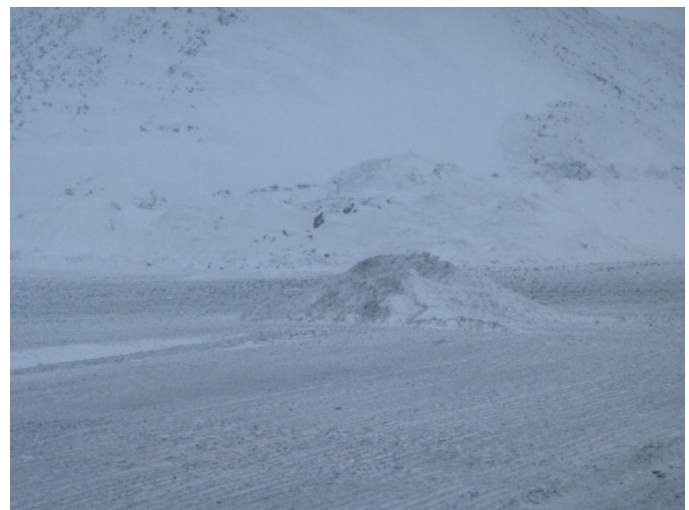
A truck driver following another haul truck saw a leak coming from this truck in front of him. He called the driver to let him know that he have a problem with his equipment.

As soon as his co-worker advice the driver that he have a leak coming from his haul truck, the operator stopped the engine and he called a mechanic to fix the problem. All the contaminated snow has been collected and disposed in the tailing.

We have already a preventive maintenance program for all of our equipment. The hoses and fitting check are included in this maintenance. Pre-operational checks including a visual inspection are also done at the beginning of each shift.

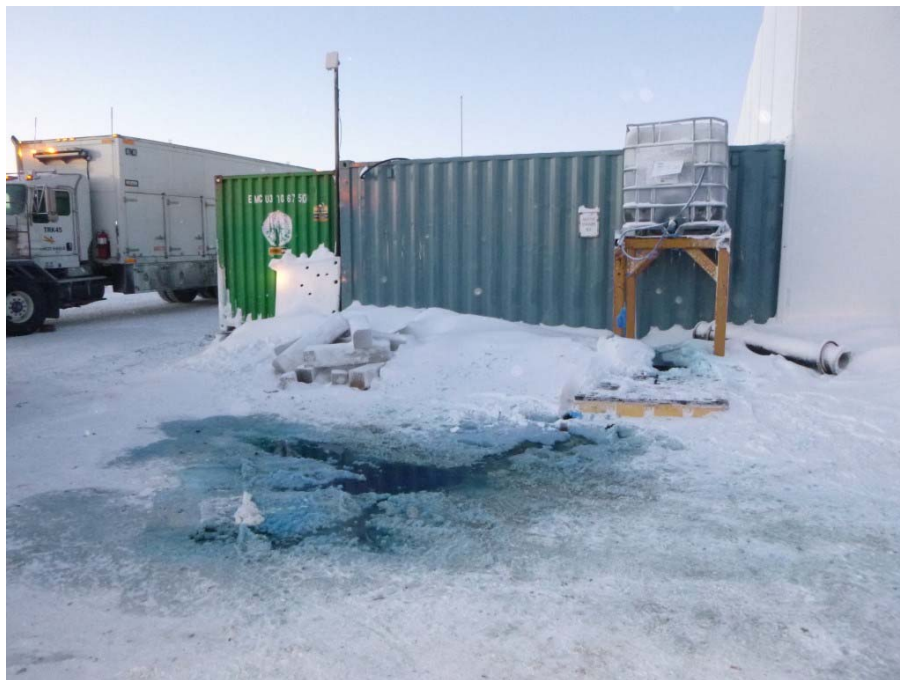
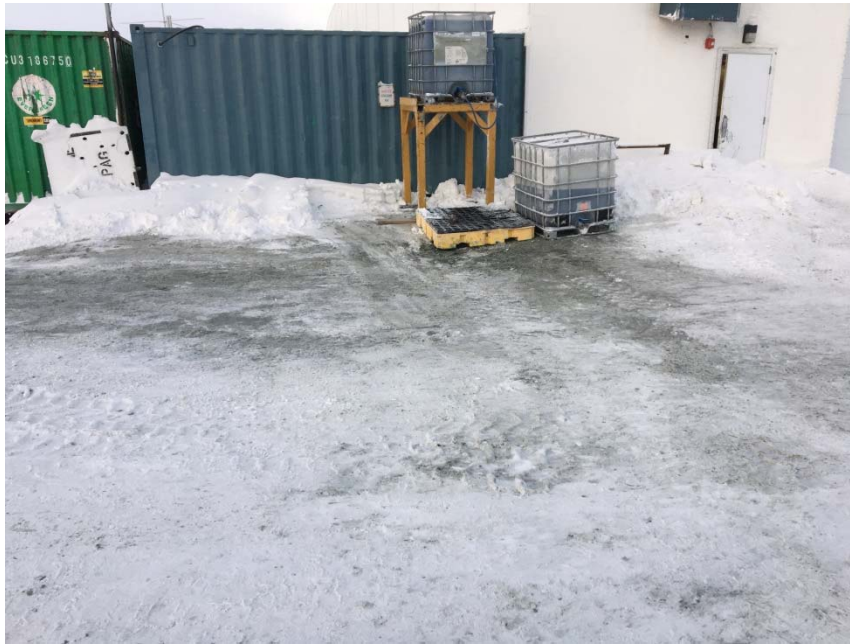
The spill was caused by the broken valve on the distribution line. With extreme cold conditions on site, the plastic valve broke during handling.

The remainder of the liquid left in the damaged tote was transferred to another container and all contaminated material/snow on the ground was collected and brought to the Tailings Storage Facility.

The entire area was scrapped clean and the refilling system was cleared of snow to ensure proper usage of the dispenser. Crews were reminded that the system has to be use with caution and extra precautionary measures to be taken during extreme cold temperature to prevent damage to sensitive parts.
