### **2017 South Cell Internal Structure As-built Report**

**SOUTH CELL INTERNAL STRUCTURE AS-BUILT REPORT**

**AGNICO-EAGLE MINES LIMITED  
MEADOWBANK GOLD PROJECT**

**DECEMBER 31, 2017**

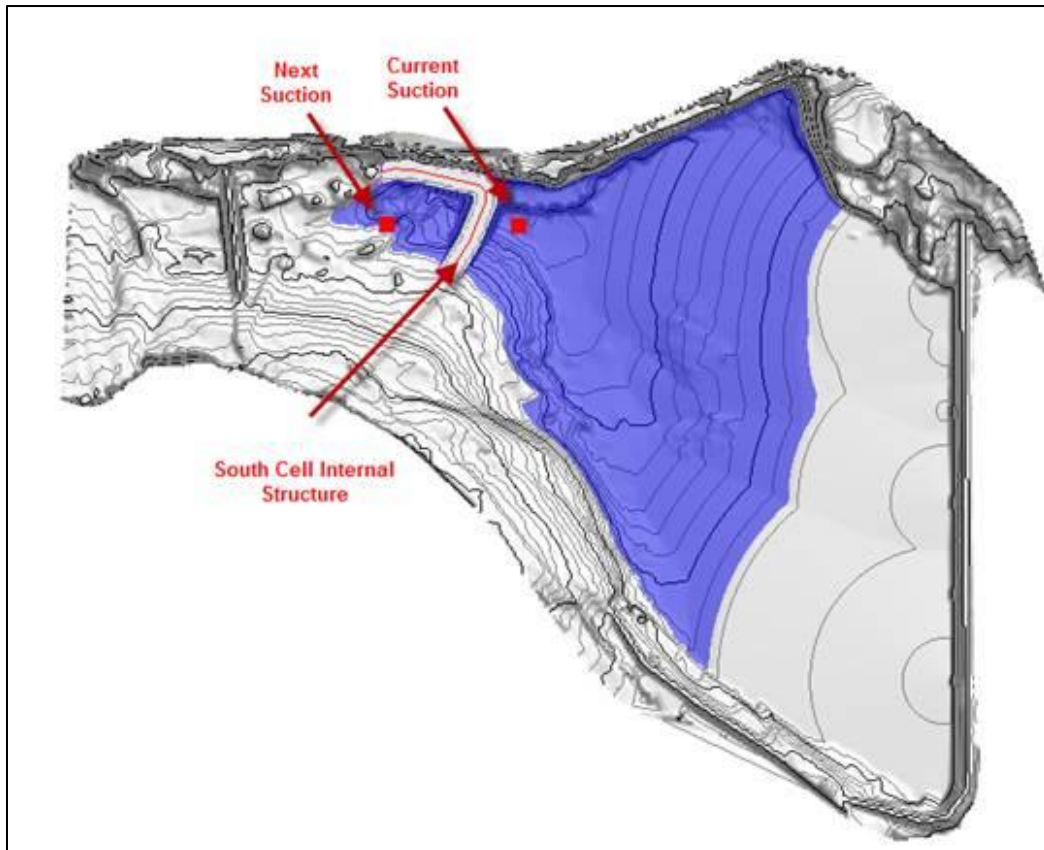
**Figure 1:** The proposed South Cell Internal Structure with the current and next reclaim pump suction locations.

During the August 2017 deposition plan update, the Meadowbank Engineering team identified a risk of slurry channelling over the frozen tailings beach during the winter of 2018. This could result in the sub-aqueous slurry beach reaching the reclaim suction, causing reclaim water quality issues at the mill. This would cause an increase in freshwater usage and overall pond volume putting in jeopardy the water freeboard limit. To mitigate this risk, the construction of a permeable rockfill internal structure in front of the reclaim area has been evaluated to block migration of the tailings toward the reclaim pump (Figure 1).

Prior to building the internal structure the current reclaim pump suction will be moved to a new location within the area that will be separated from the rest of the South Cell by the internal structure (Figure 1). No constraints are foreseen for the tailings deposition and reclaim water pumping during and after the construction of this structure.

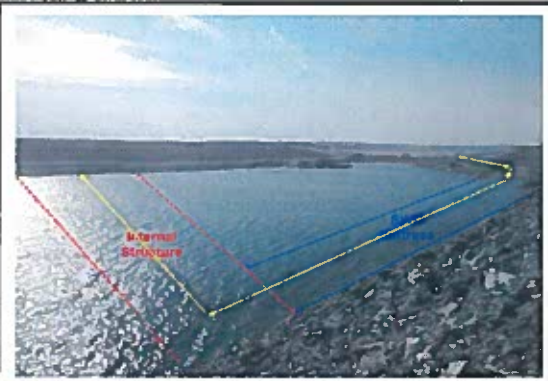
**General Observations:**  
Ice starts to be hard, Danger need to break the ice  
 \_\_\_\_\_  
 \_\_\_\_\_  
 \_\_\_\_\_  
 \_\_\_\_\_

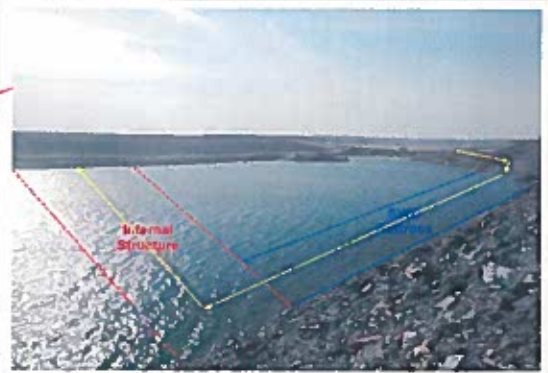
Y  N   
 Comment / Observation: \_\_\_\_\_  
 Any movement present on the slope? (Loose rocks, bulging, etc.) Location: loose rocks on the slope  
 Description: \_\_\_\_\_

Not a lot of trucks in the morning. Deeper area can explain the short advance and the lack of trucks.

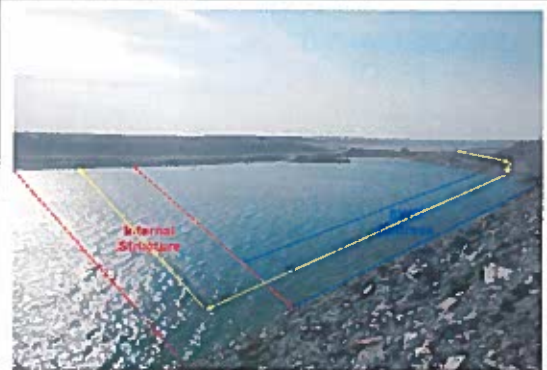
Any movement present on the slope? (Loose rocks, bulging, etc.)	Y <input type="checkbox"/> N <input checked="" type="checkbox"/> Comment / Observation: _____ Location: _____ Description: <u>The slope is made of loose rocks.</u>
---	--

The structure is in good condition, the floor is good and always on grade.

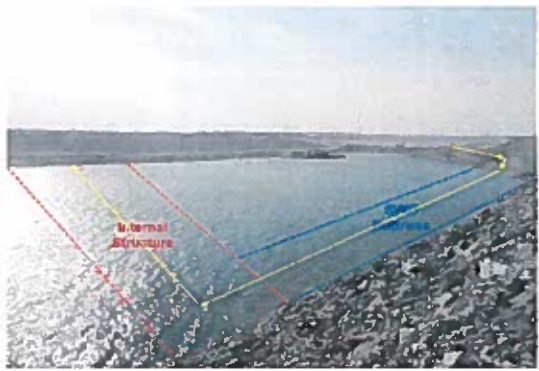
General Observations:  
Material gradually sloughing down the edge slope of internal structure. Advised operator to maintain higher beam and dump trucks further away from the edge

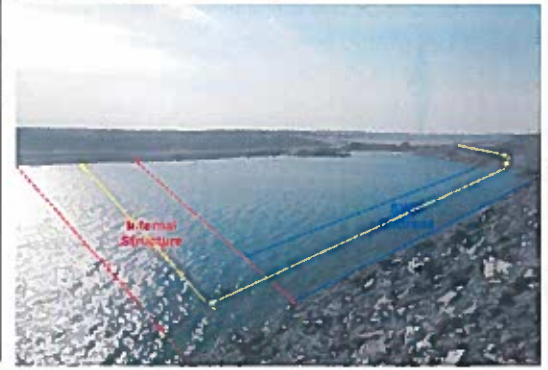
Ice is forming around the dumping area.  
The area is dusty. The dust come from the tailing above the working place.

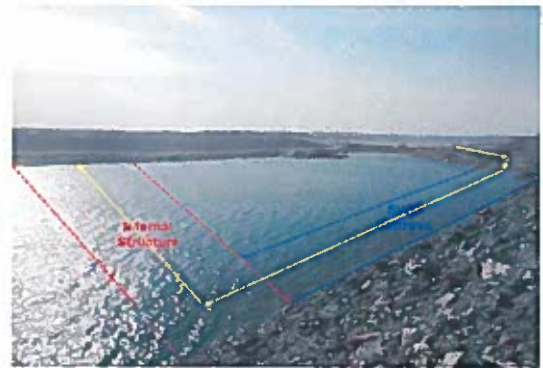
The structure seems to be very large.  
Dusty from the tailings above.

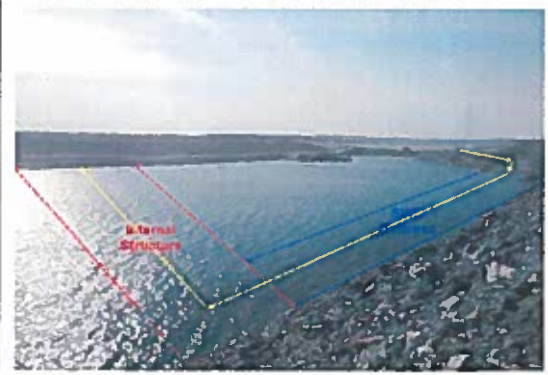
The project was completed  
Water was pouring through the structure toward the end. They put another load on it to cover.
