APPENDIX 6 2023 ANNUAL GEOTECHNICAL INSPECTION REPORT

2023 Annual Geotechnical Inspection Meliadine Gold Mine, Nunavut, Canada

PRESENTED TO
Agnico Eagle Mines Limited

JANUARY 31, 2024
ISSUED FOR USE
FILE: 704-ENG.EARC03140-33
AGNICO EAGLE DOCUMENT NUMBER: 65-600-230-TCR-001

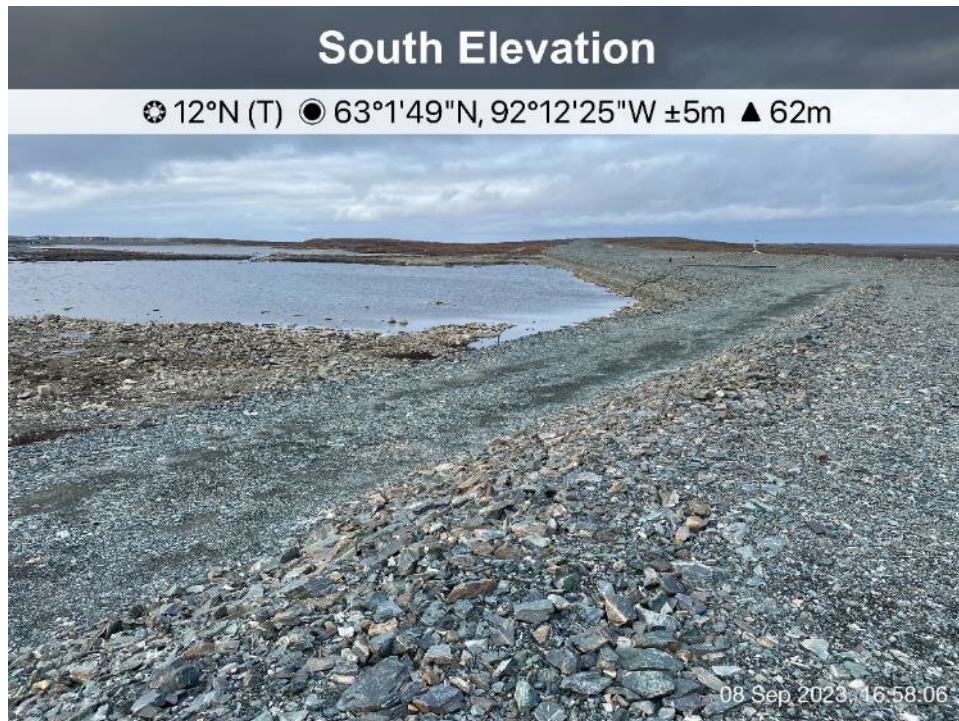
D-CP1 - Photo 1: Dike D-CP1: Upstream face - some wave erosion evident from 2019/2020 high water level event, no change from previous years.

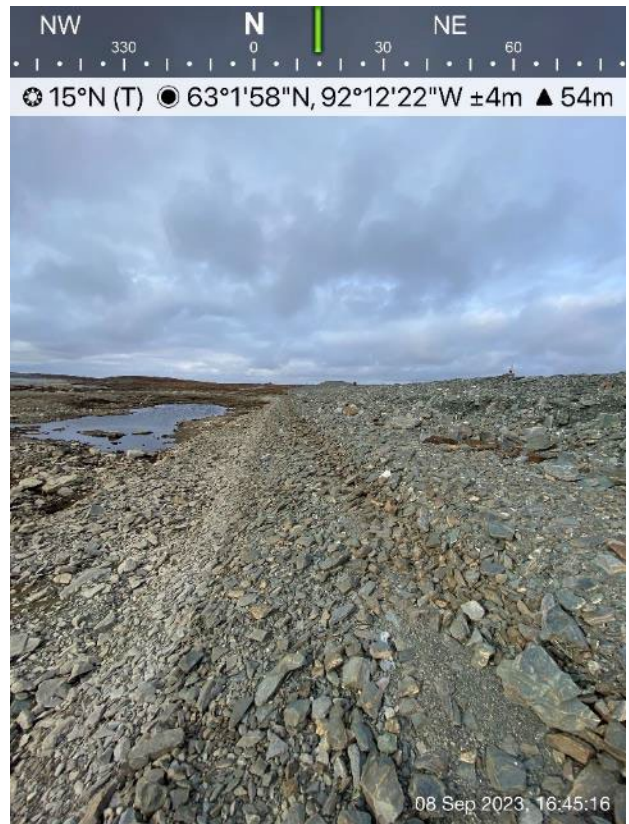
D-CP1 - Photo 2: Dike D-CP1: Upstream face - some wave erosion evident from 2019/2020 high water level event, no change from previous years.

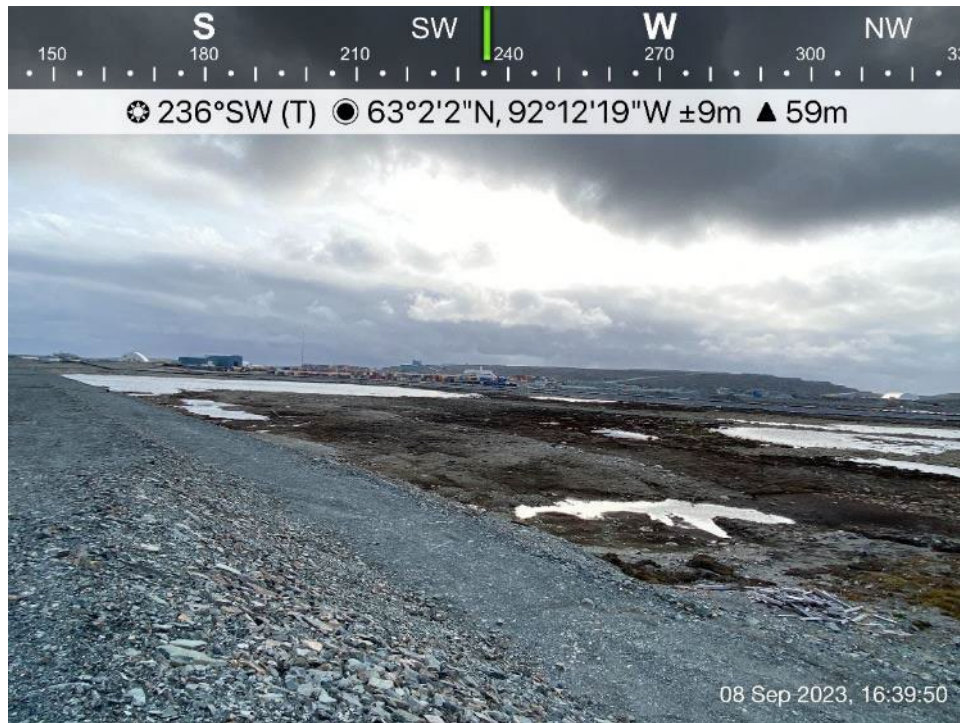
D-CP1 - Photo 3: CP1: Upstream view of CP1 - water level well managed.

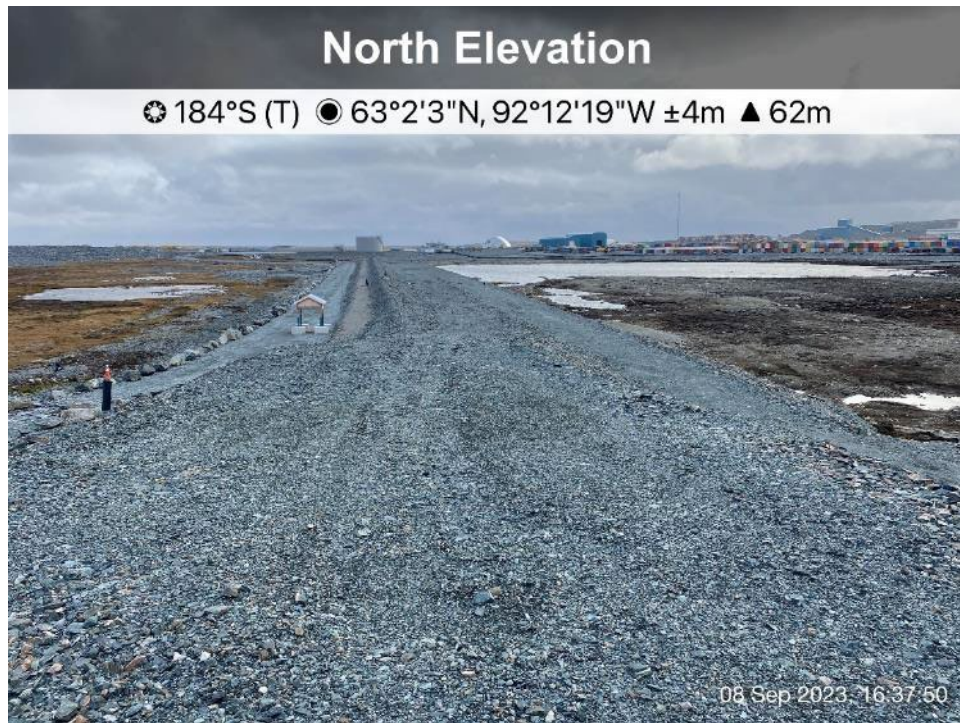
D-CP1 - Photo 4: Dike D-CP1: Dike crest view - downstream on left, upstream on right.

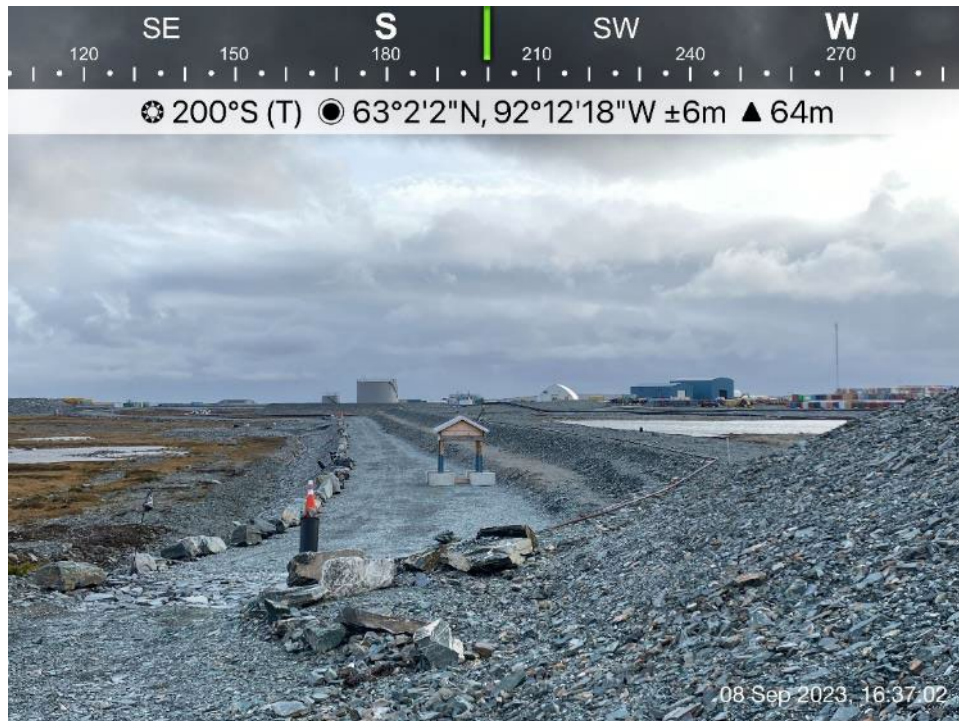
D-CP1 - Photo 7: Dike D-CP1: Dike downstream toe berm view.

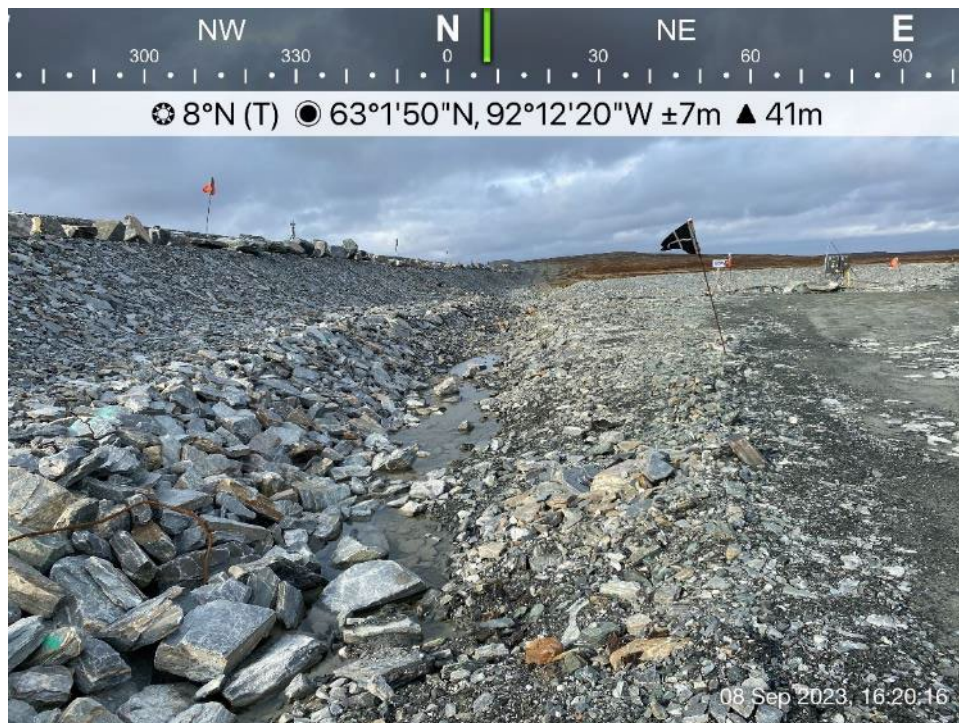
D-CP1 - Photo 8: Dike D-CP1: Dike downstream runoff/seepage collection south channel.

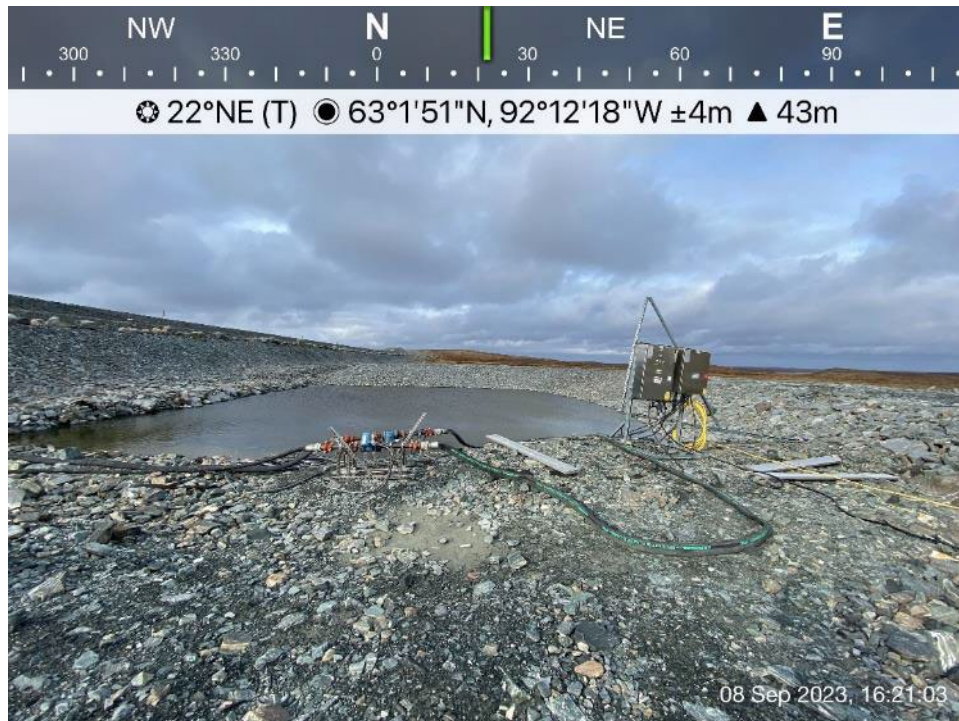
D-CP1 - Photo 9: Dike D-CP1: Dike downstream collection sump.

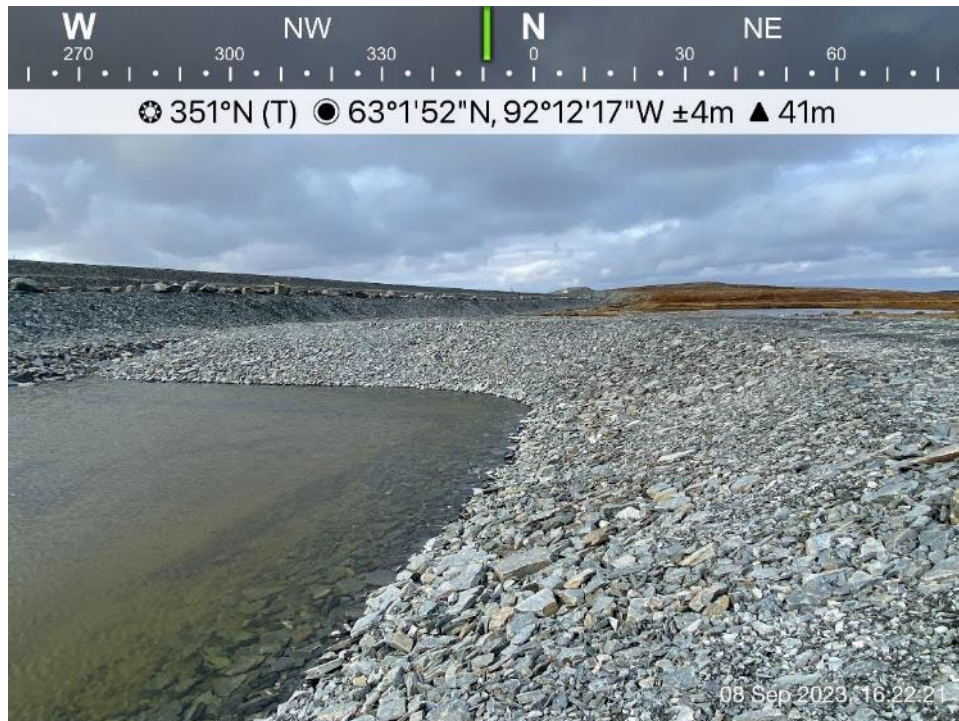
D-CP1 - Photo 10: Dike D-CP1: Dike downstream sump - rockfill berm.

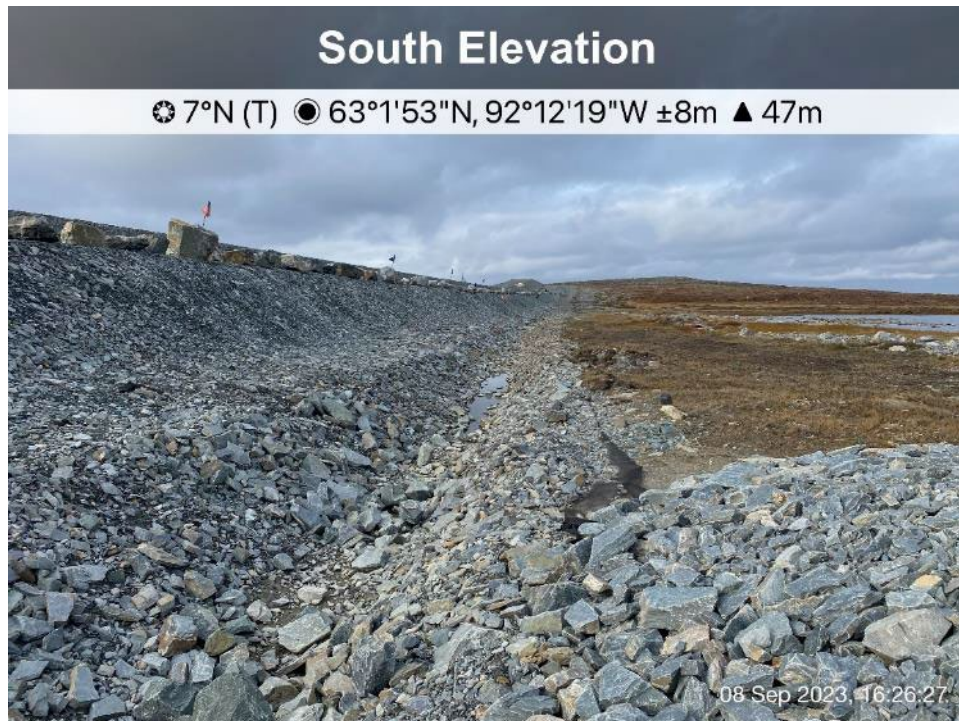
D-CP1 - Photo 11: Dike D-CP1: Dike downstream runoff/seepage collection north channel.

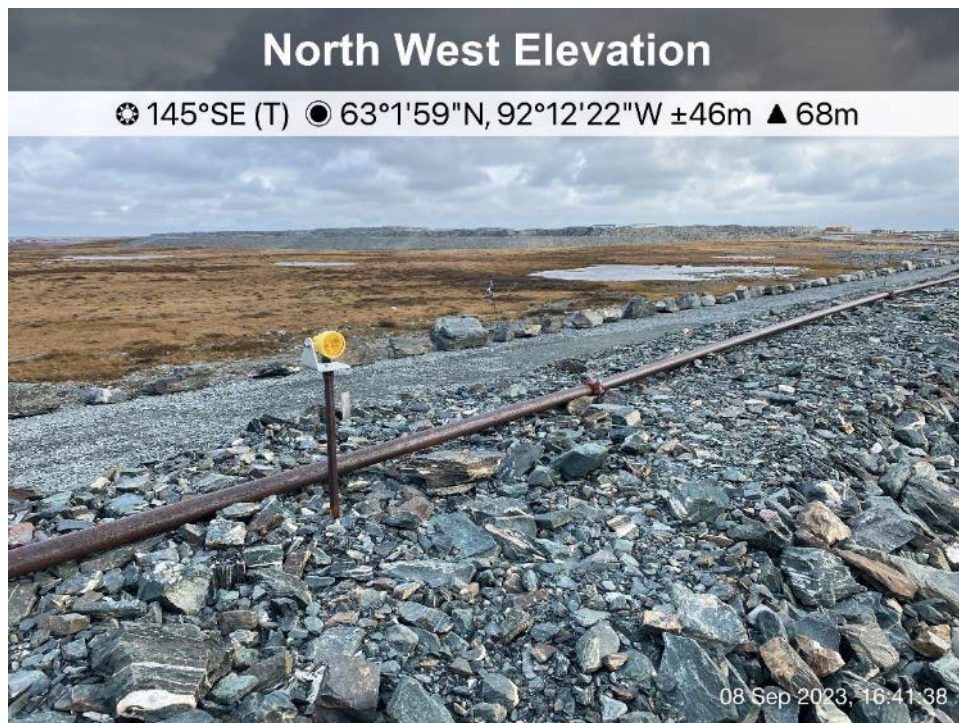
D-CP1 - Photo 14: Dike D-CP1: Dike survey control point.

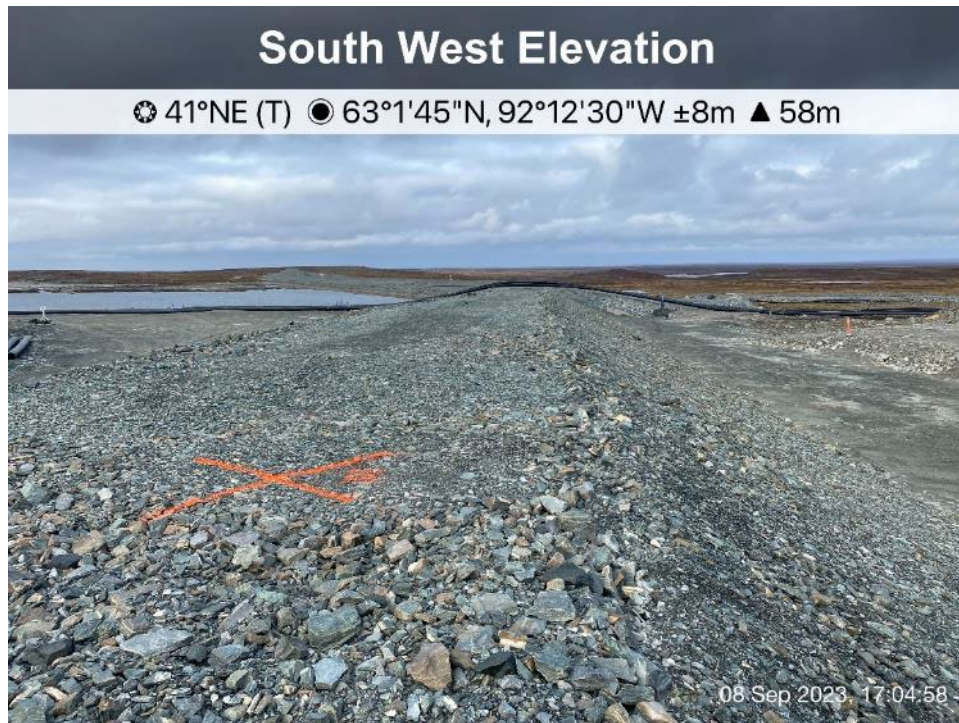
D-CP1 - Photo 15: Dike D-CP1: Pipelines crossing at Station 1+250 of Dike D-CP1.

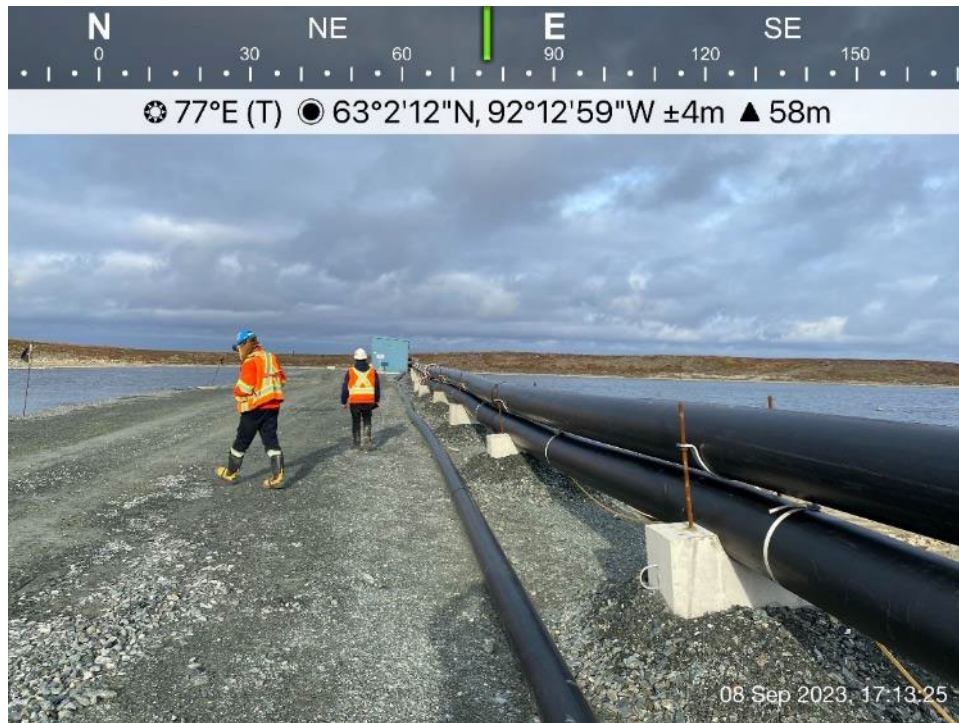
D-CP1 - Photo 17: Dike D-CP1: Pipelines on Jetty 1.

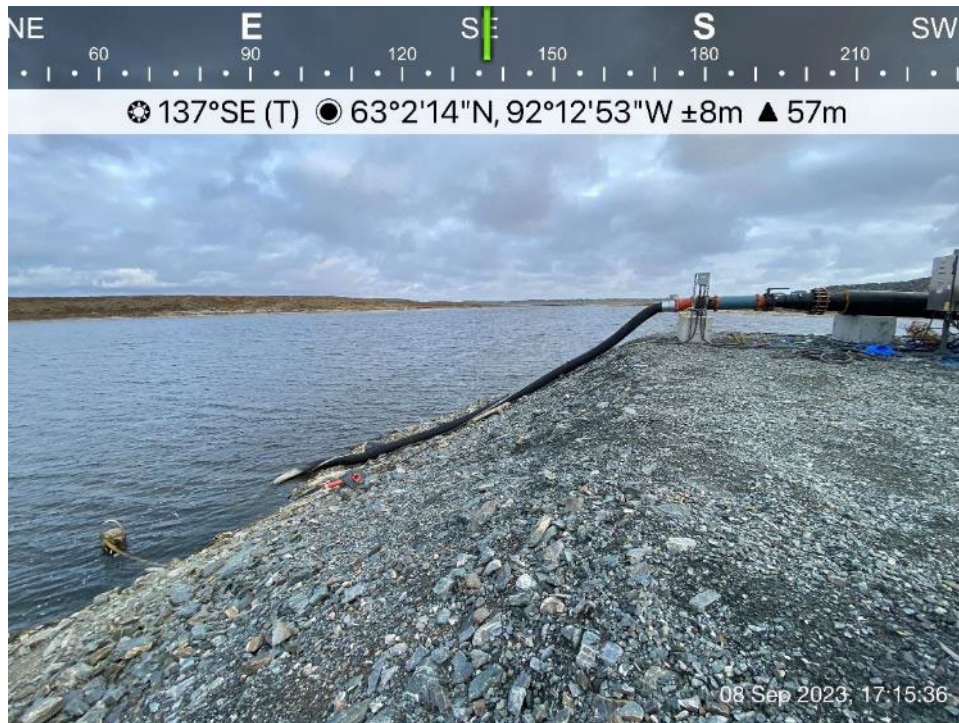
- Jetty 1 was in good condition except for erosion on the southeast corner of the slope. The erosion coincides with historic high-water levels, as shown in Photo 18. The erosion is like that observed in previous years. The fines are being washed out leaving the coarse material. The erosion is undercutting the fill up to 0.3 m in the southeast corner and may result in a slump of the surface fill in the area. The pump house is well back from the area; however, the cables in the area should be pulled back from the slope crest. Except for slope erosion, no other permafrost degradation was observed during the 2023 annual geotechnical inspection.

D-CP1 - Photo 18: Dike D-CP1: Jetty 1 water intake - minor erosion, no change from previous years.

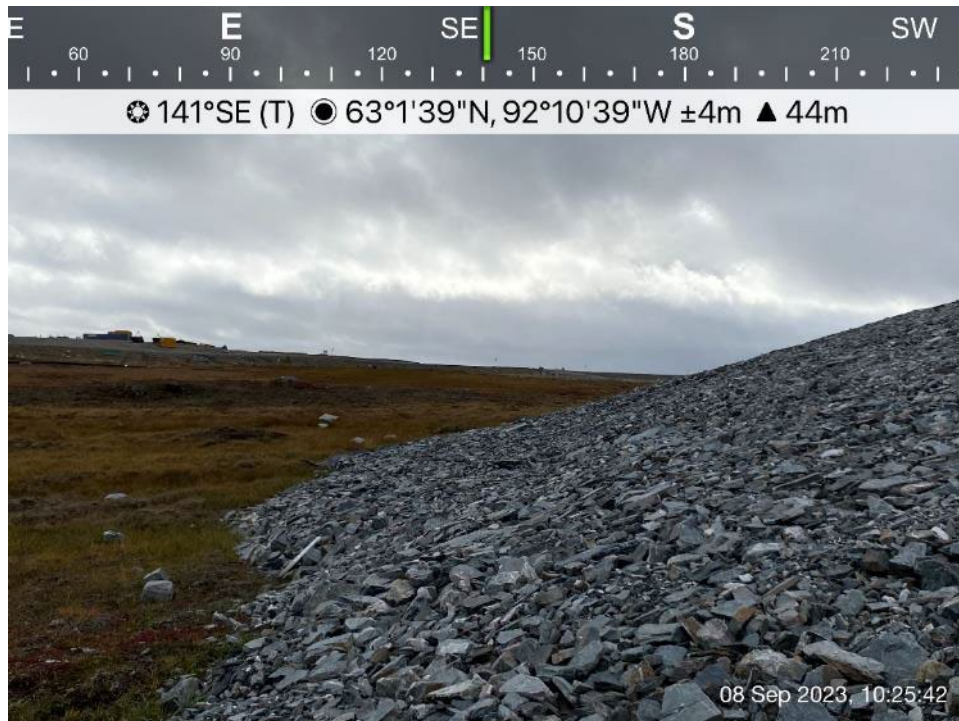
CP2 Thermal Berm - Photo 6: CP2 Thermal Berm - downstream slide slope.

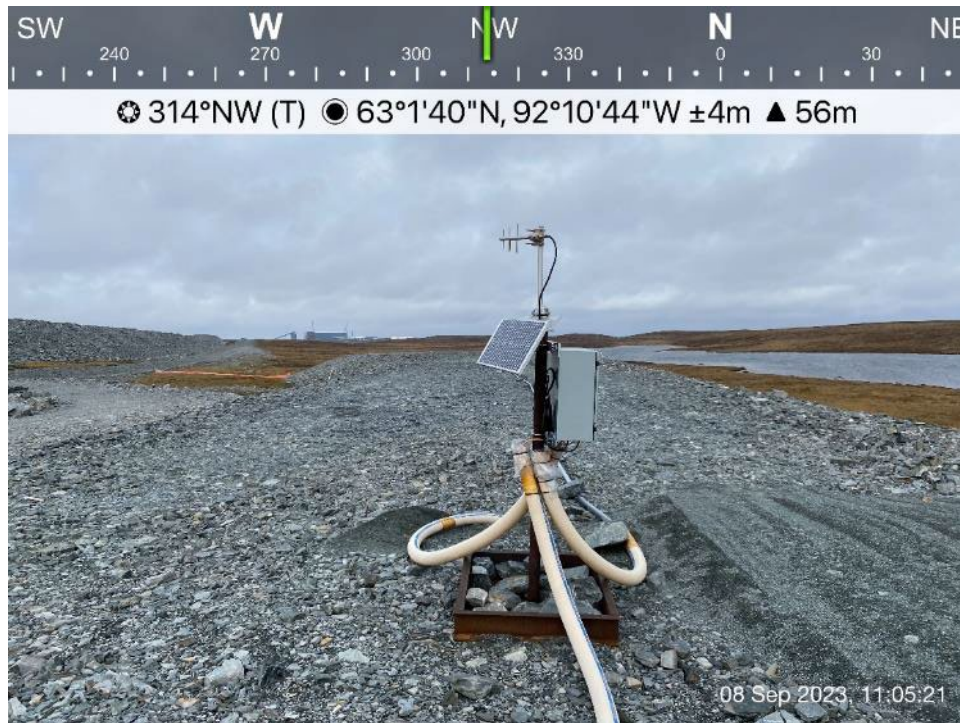
CP2 Thermal Berm - Photo 17: CP2 Thermal Berm - GTC data collection system.

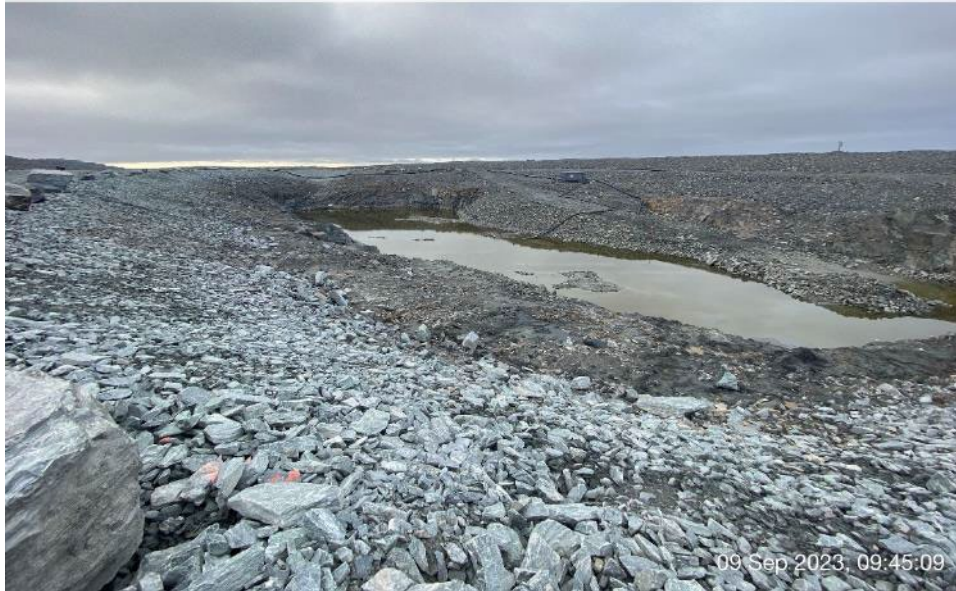
CP3 - Photo 1: CP3 - Small amount of water stored in CP3, bedrock slopes with fractured rock, no stability concern.

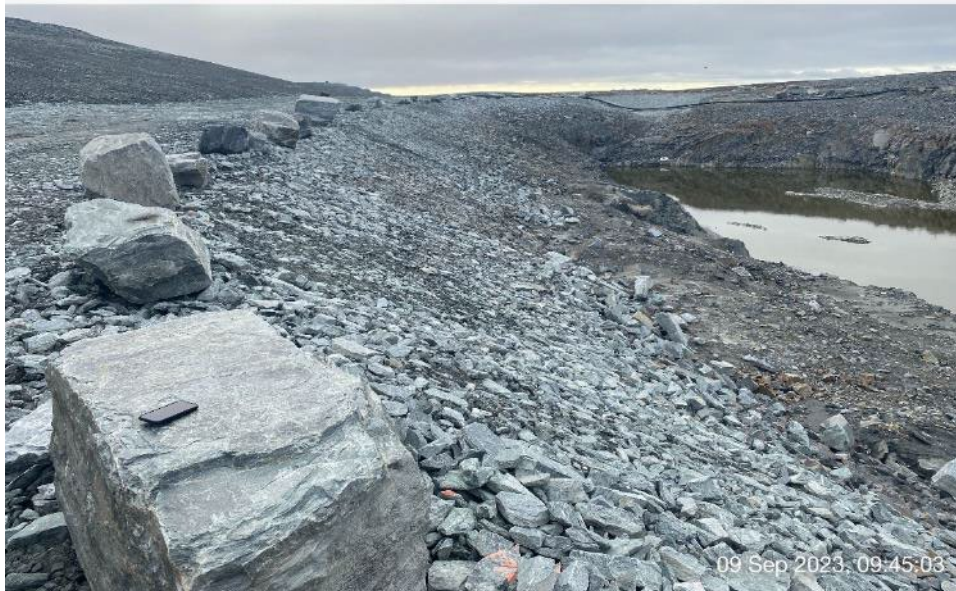
CP3 - Photo 2: CP3- waste rock cover placed between TSF toe and CP3 as thermal protection.

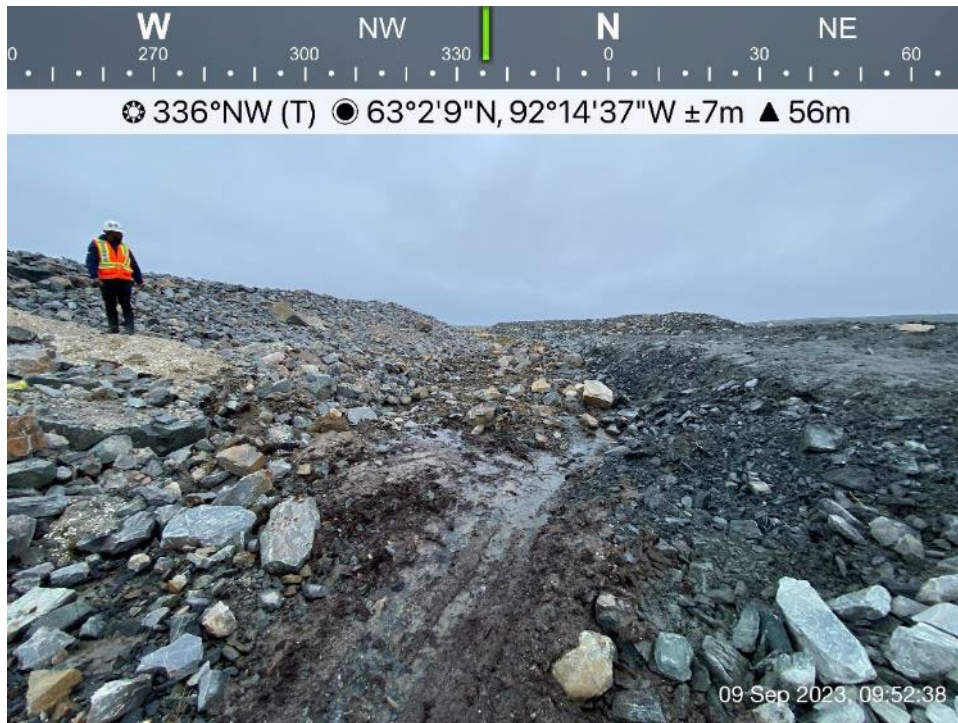
CP3 - Photo 4: CP3 - little water flow from snow stockpile melting to CP3.

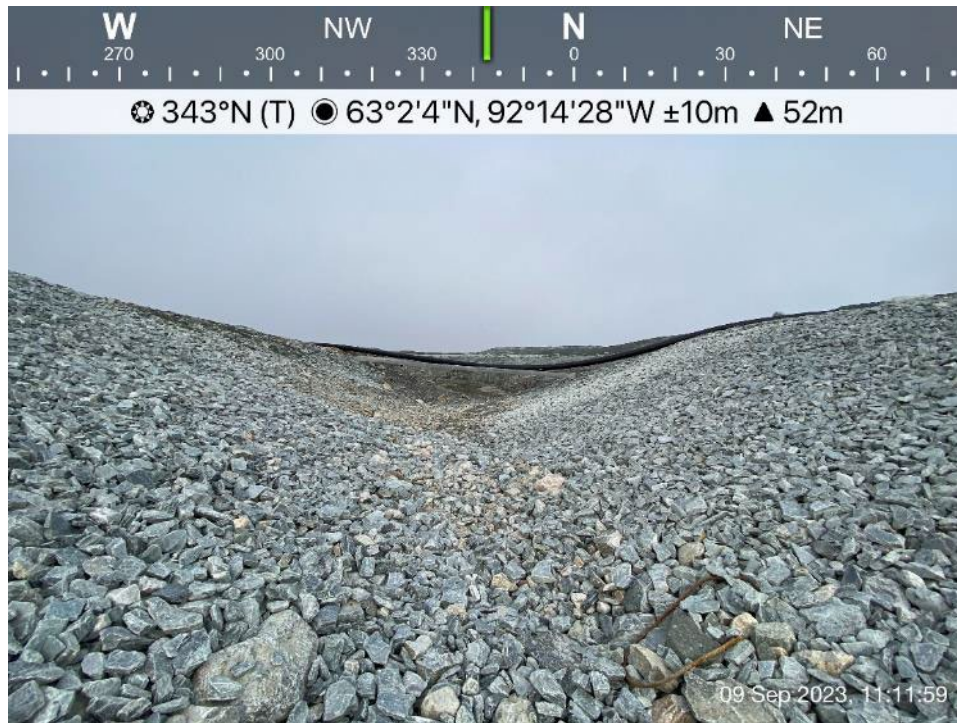
Channel 3 - Photo 6: Channel 3 - Channel 3 northwest end, entering CP3.

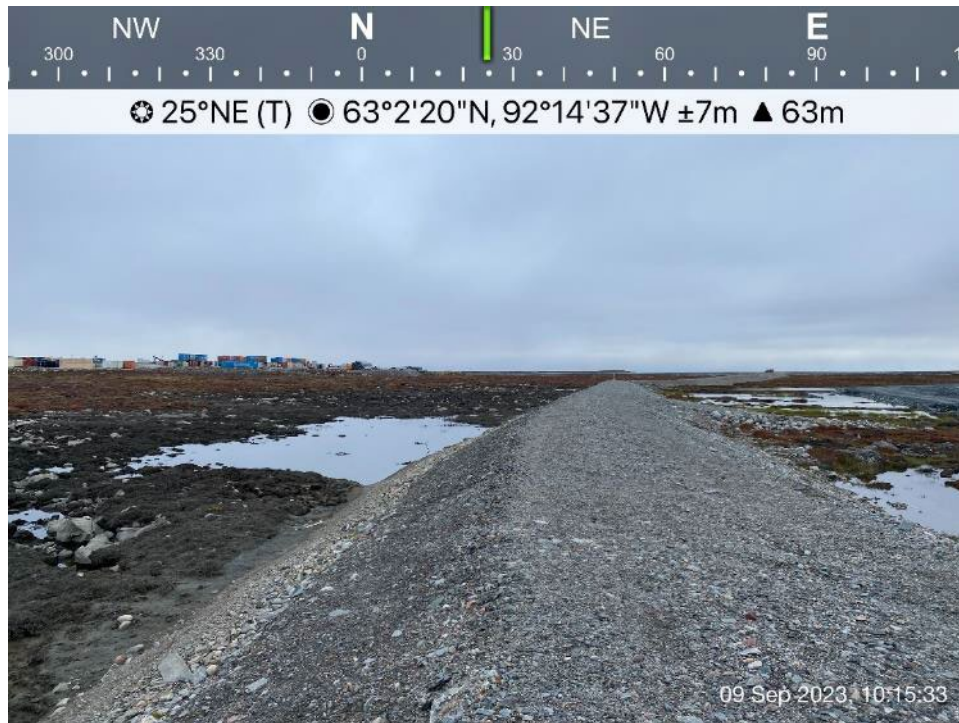
Berm 2 - Photo 14: Berm 2 - north section, ponded water on both sides.

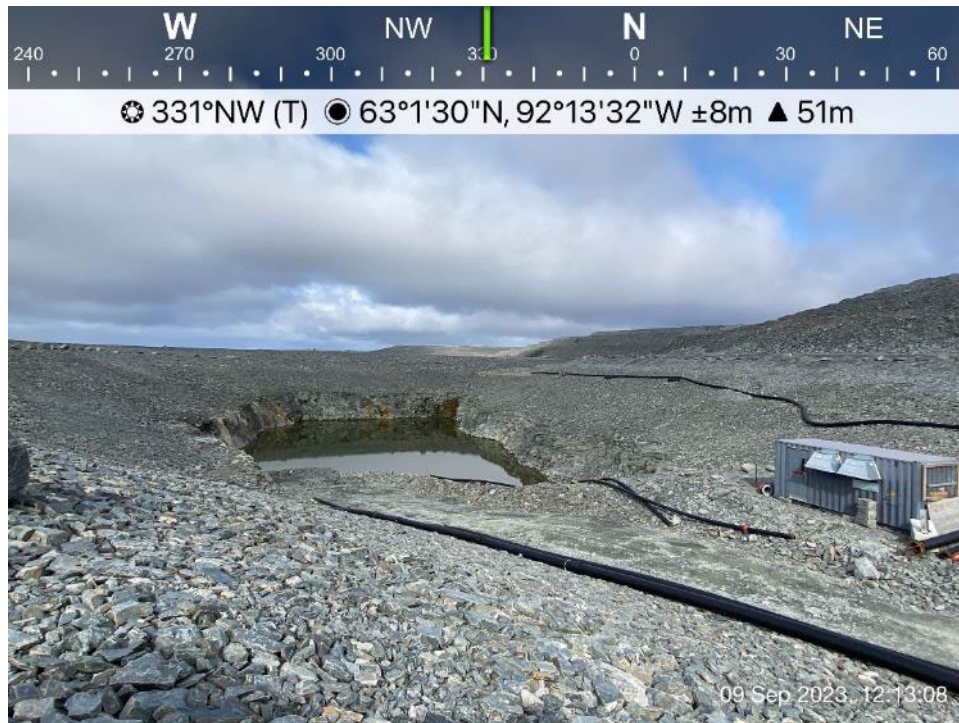
CP4 - Photo 1: CP4 - Looking northwest, CP4 in the background.

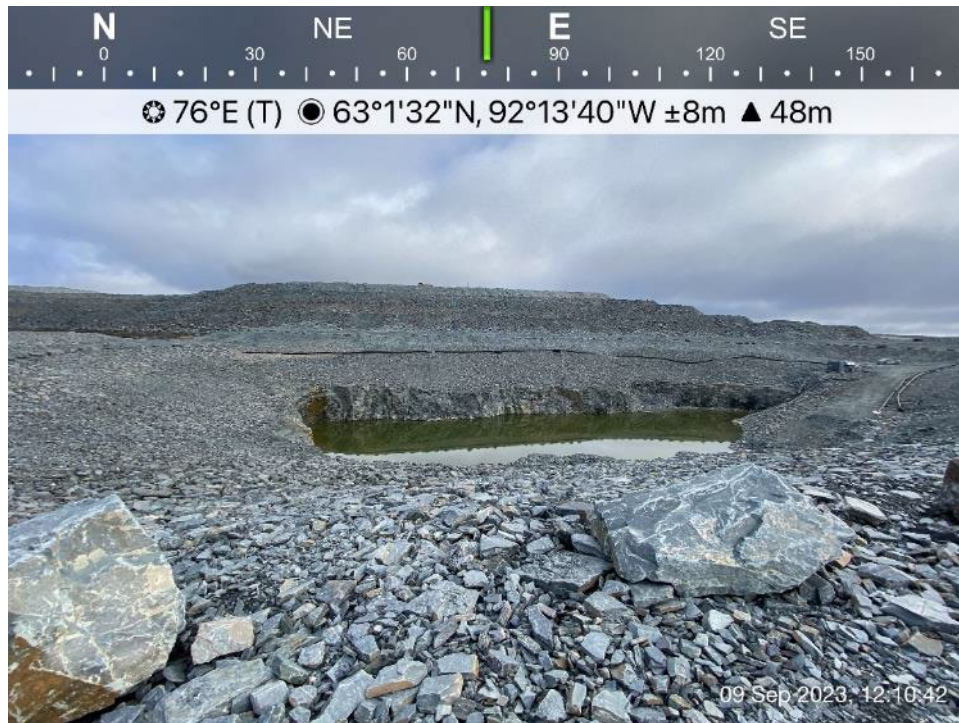
CP4 - Photo 2: CP4 - Looking east, WRSF1 in the background.

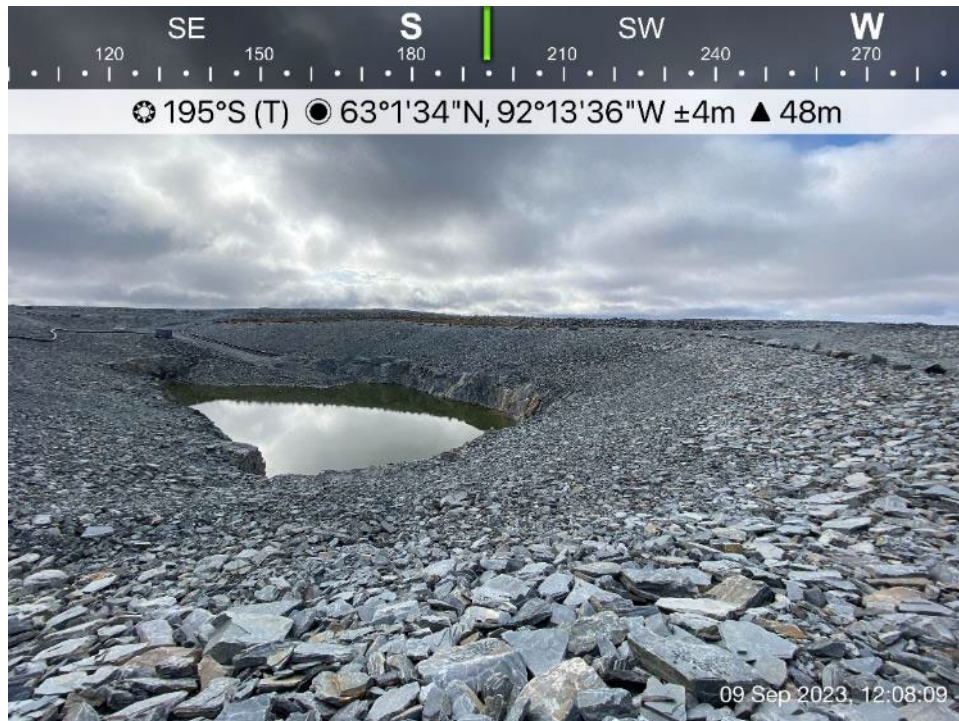
CP4 - Photo 3: CP4 - Looking south, CP4 in the background.

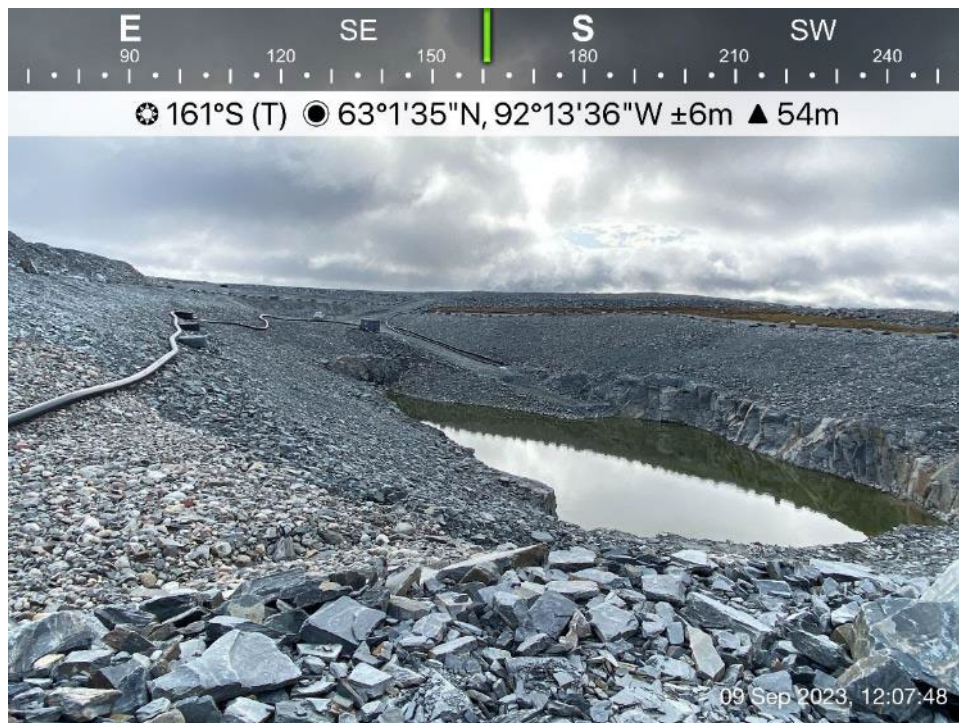
CP4 - Photo 4: CP4 - West and East slopes.

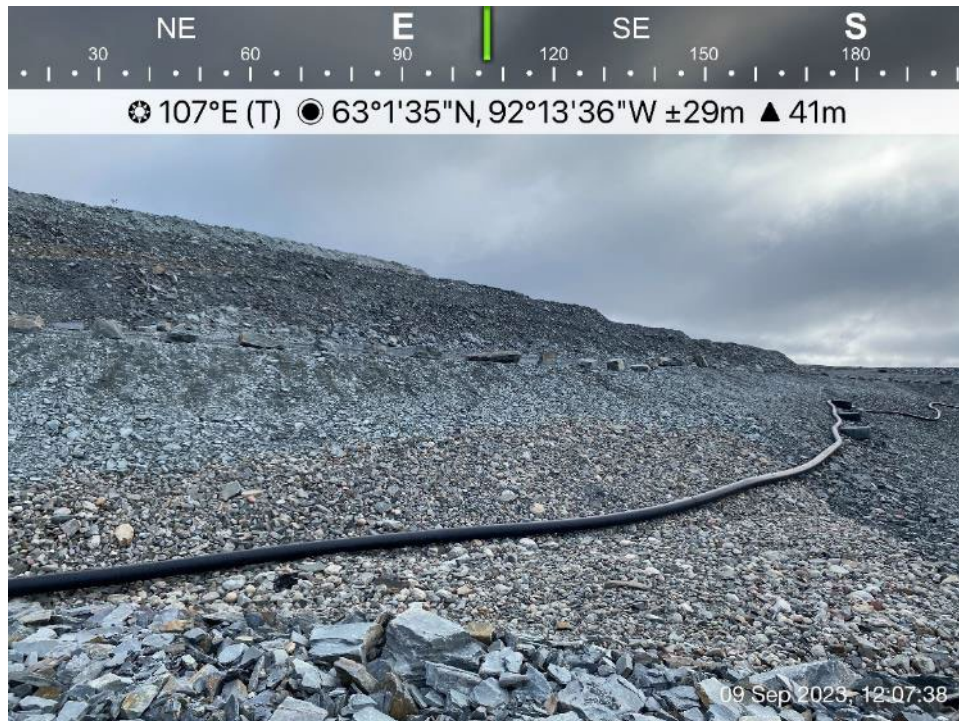
CP4 - Photo 5: CP4 - East slopes, additional rockfill material placed between CP4 and WRSF1.

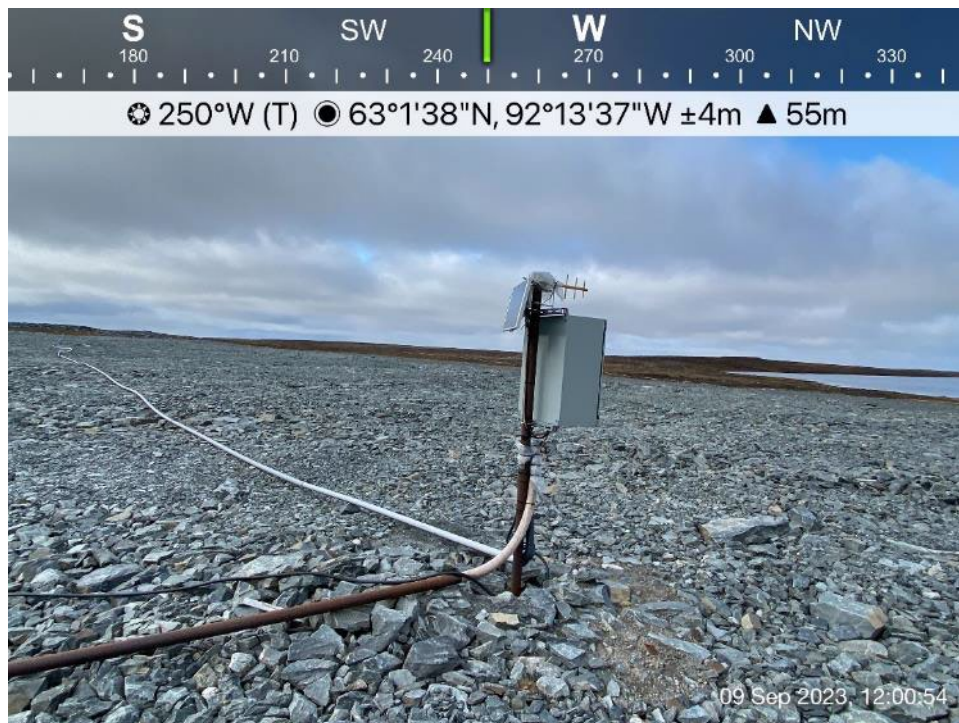
CP4 Thermal Berm - Photo 6: CP4 Thermal Berm - Looking west, GTCs data collection system.

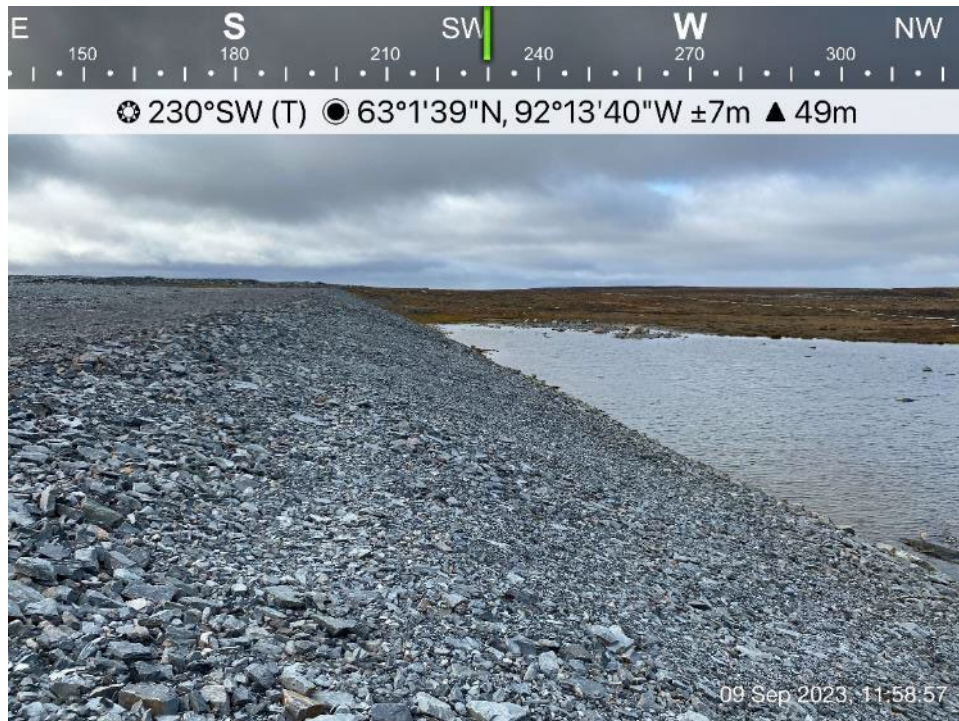
CP4 Thermal Berm - Photo 8: CP4 Thermal Berm - Looking southwest, downstream side slope.

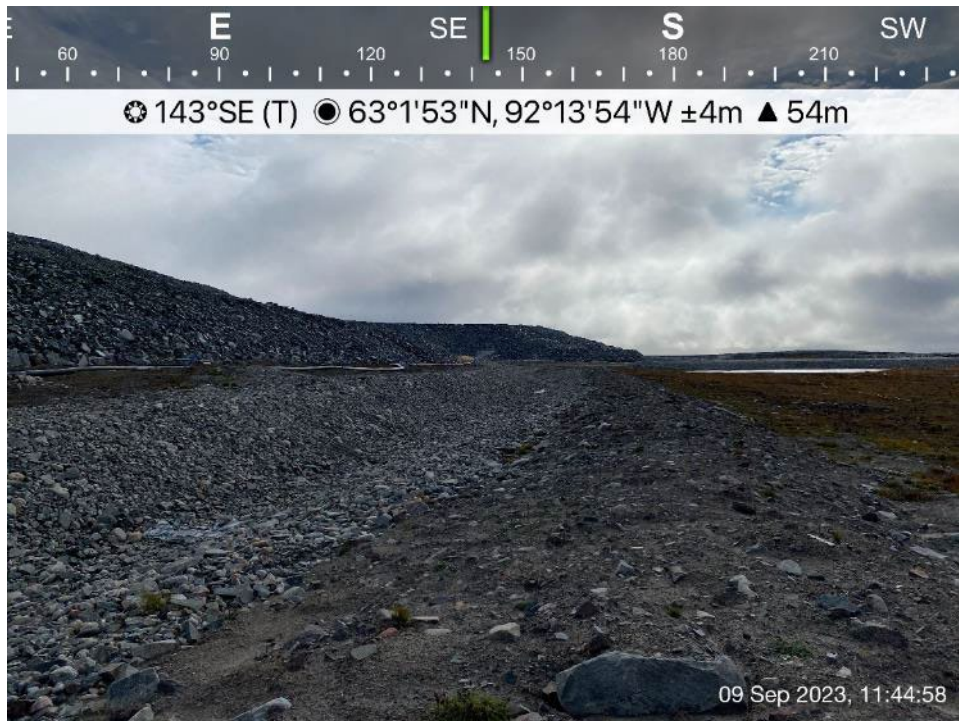
Channel 4 - Photo 10: Channel 4 - Looking southeast, WRSF1 in the background.

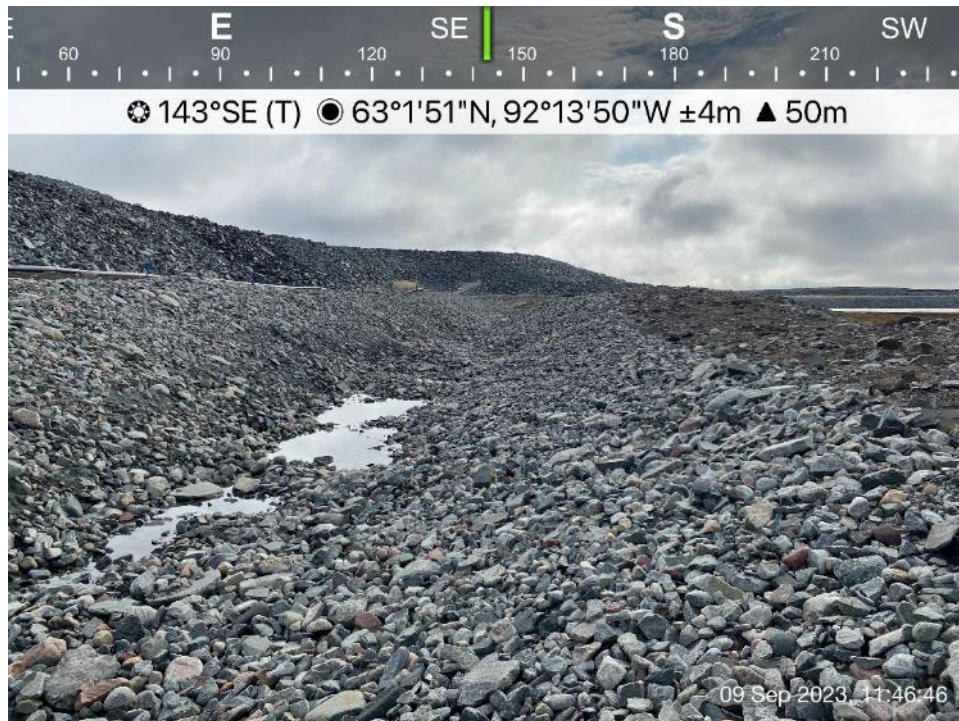
Channel 4 - Photo 11: Channel 4 - Settlement in base of channel resulting in minor ponding.

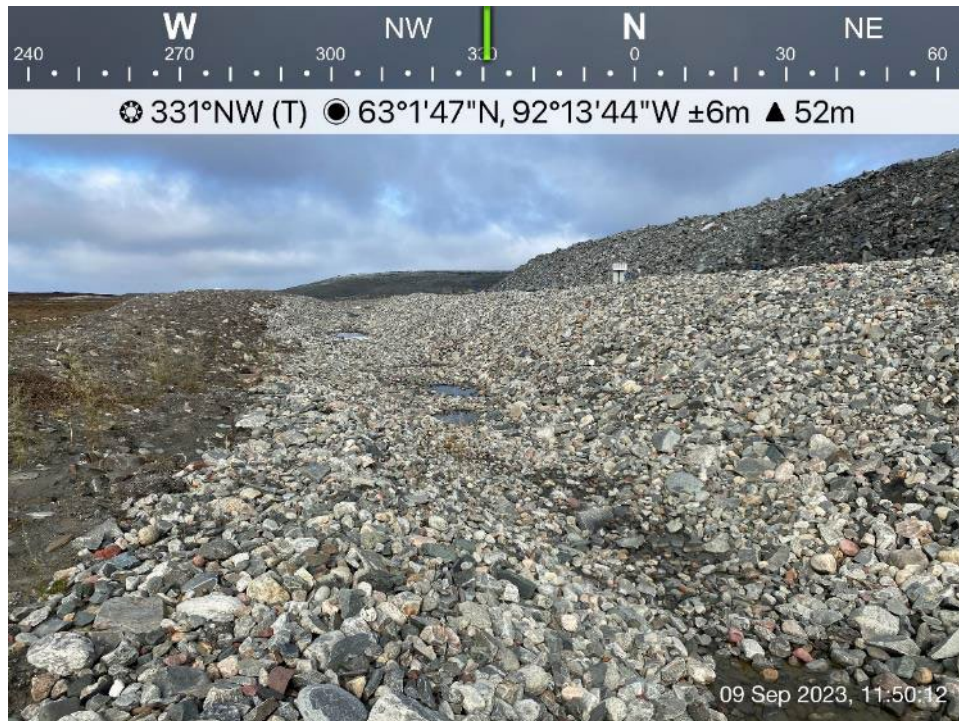
Channel 4 - Photo 12: Channel 4 - Settlement in base of channel resulting in minor ponding, subsidence in downstream slope of channel.

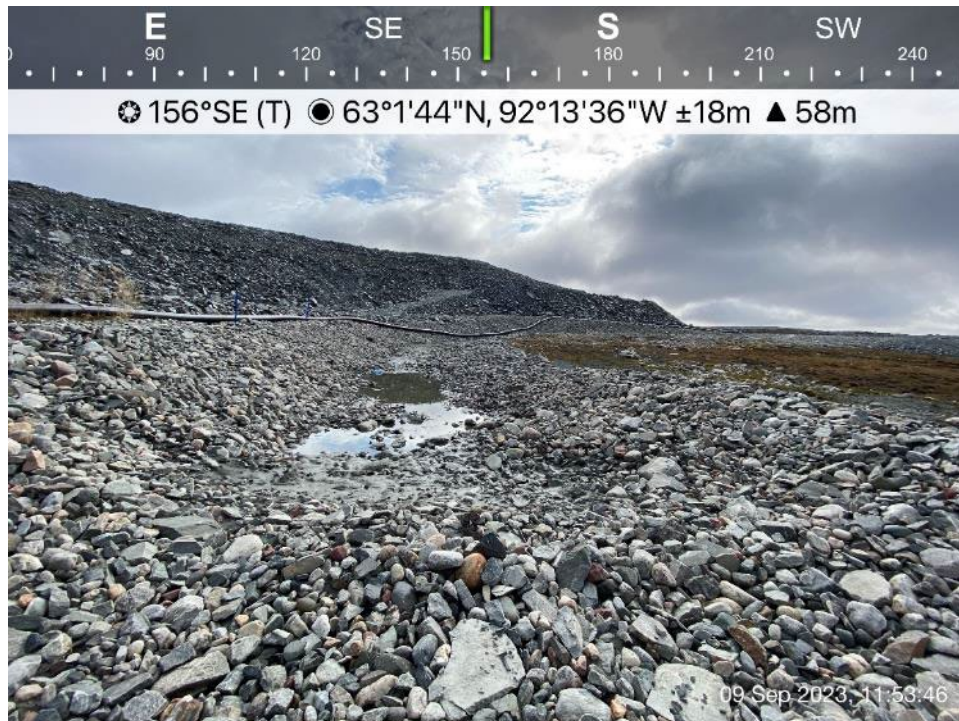
Channel 4 - Photo 13: Channel 4 - Settlement in base of channel resulting in minor ponding.

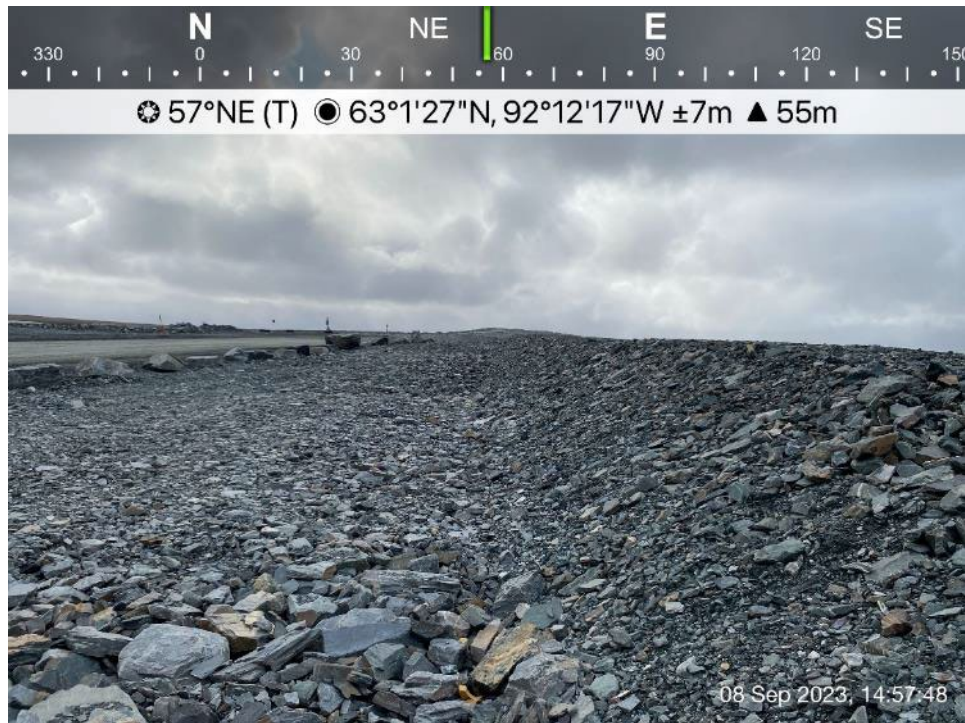
CP5 - Photo 1: Dike D-CP5 - Looking northeast, dike downstream side slope.
