APPENDIX 6 2023 ANNUAL GEOTECHNICAL INSPECTION REPORT

2023 Annual Geotechnical Inspection Meliadine Gold Mine, Nunavut, Canada

PRESENTED TO
Agnico Eagle Mines Limited

JANUARY 31, 2024
ISSUED FOR USE
FILE: 704-ENG.EARC03140-33
AGNICO EAGLE DOCUMENT NUMBER: 65-600-230-TCR-001

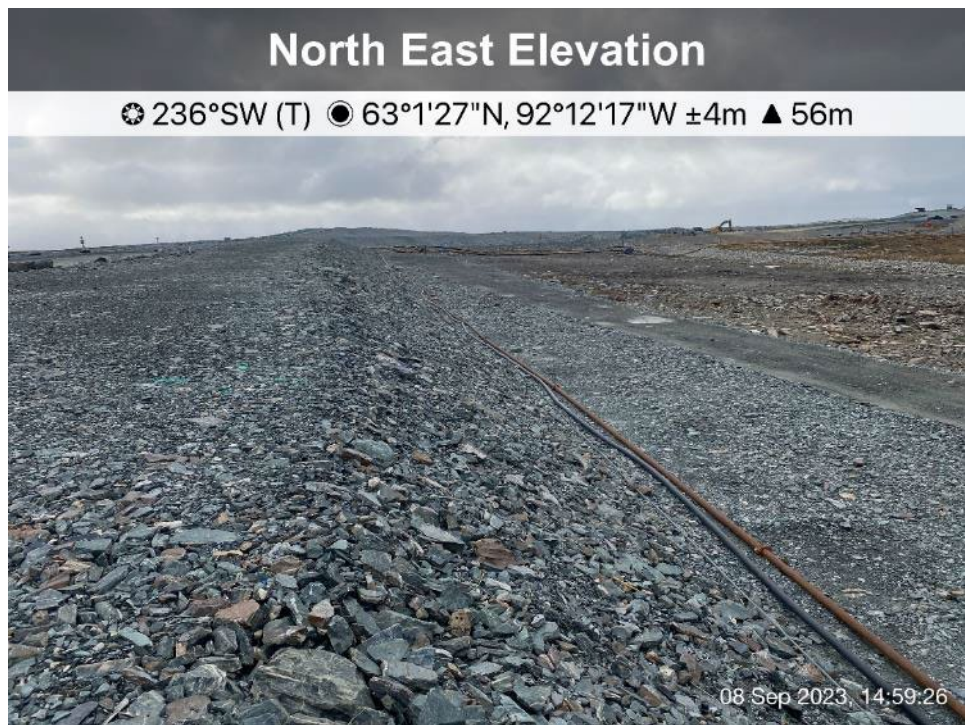
CP5 - Photo 2: Dike D-CP5 - Looking southwest, dike upstream side slope.

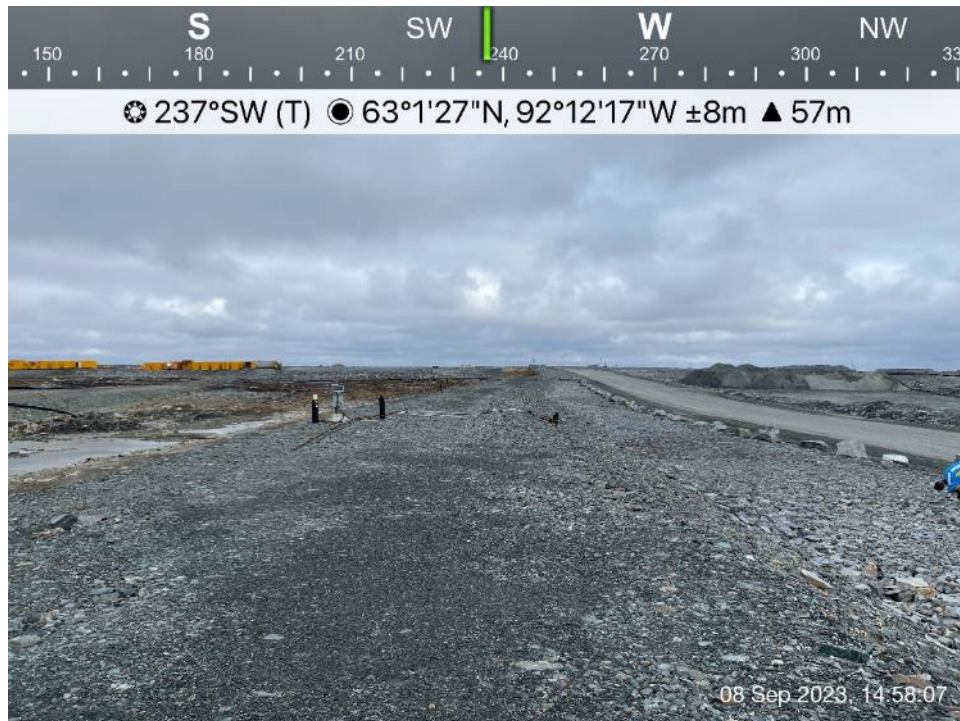
CP5 - Photo 3: Dike D-CP5 - looking southwest, dike downstream side slope and crest.

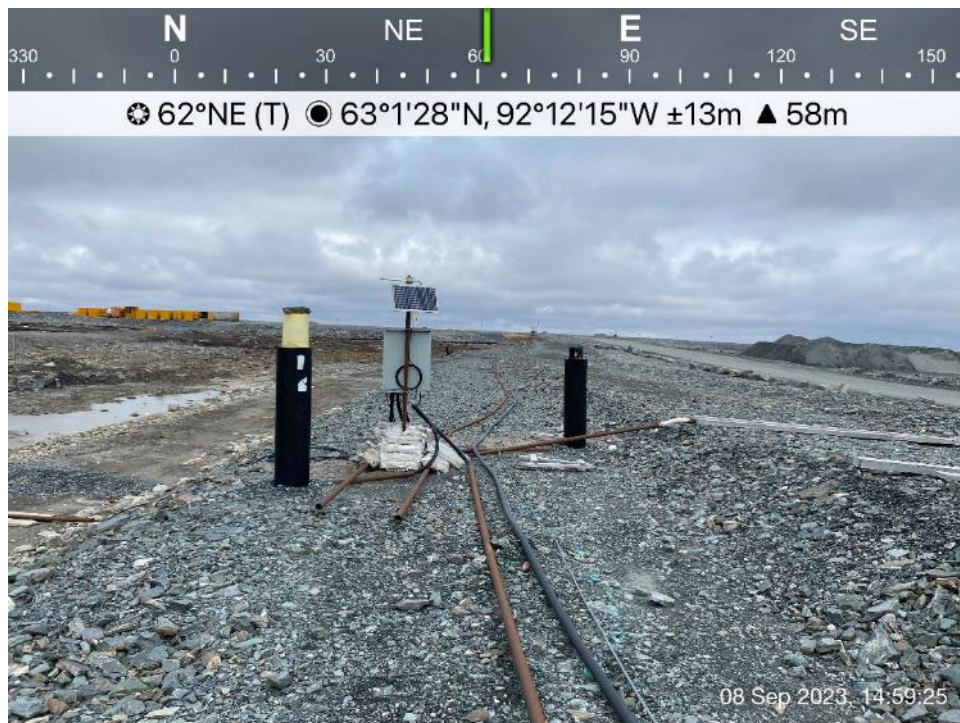
CP5 - Photo 4: Dike D-CP5 - Looking northeast, GTC housing and data collection system.

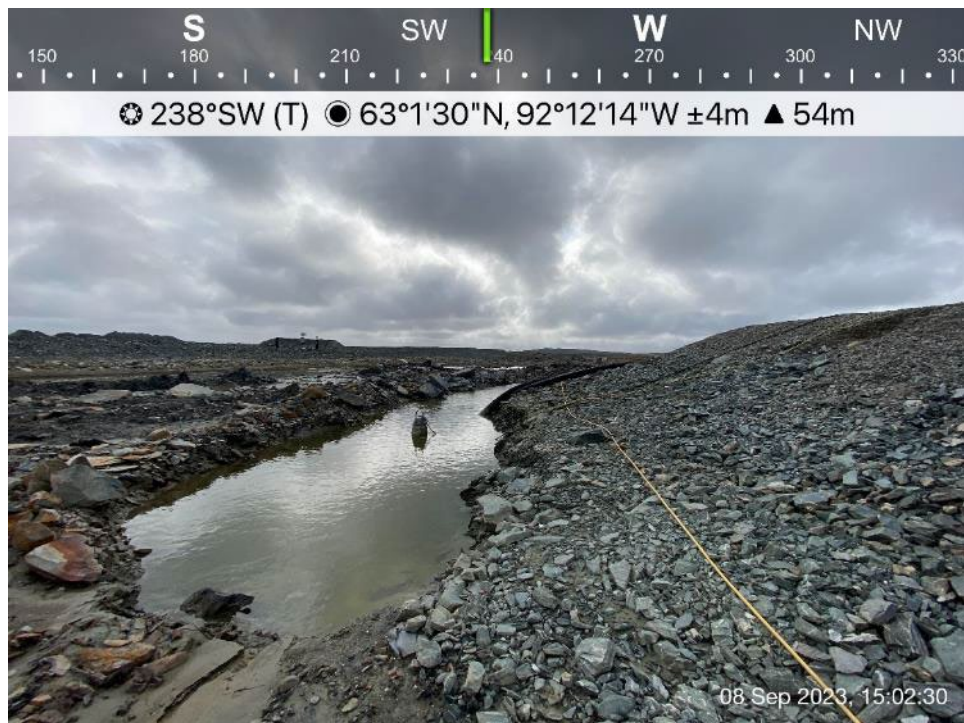
CP5 - Photo 6: CP5- Jetty and ditch around jetty, trash pump in the ditch to pump water out of CP5.

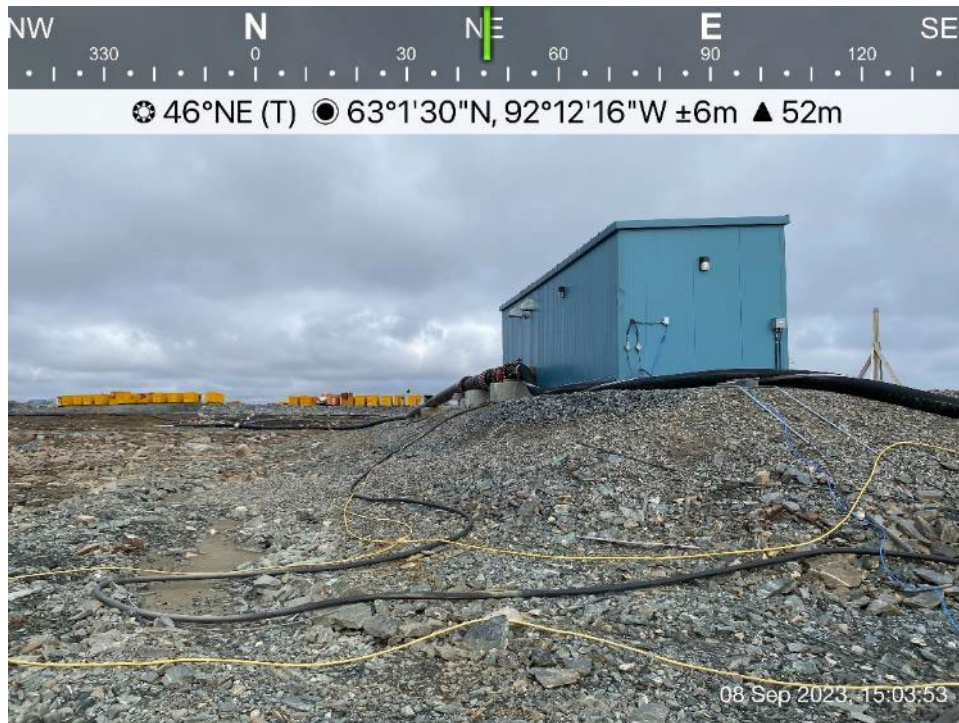
CP5 - Photo 7: CP5 - Jetty and pumping house.

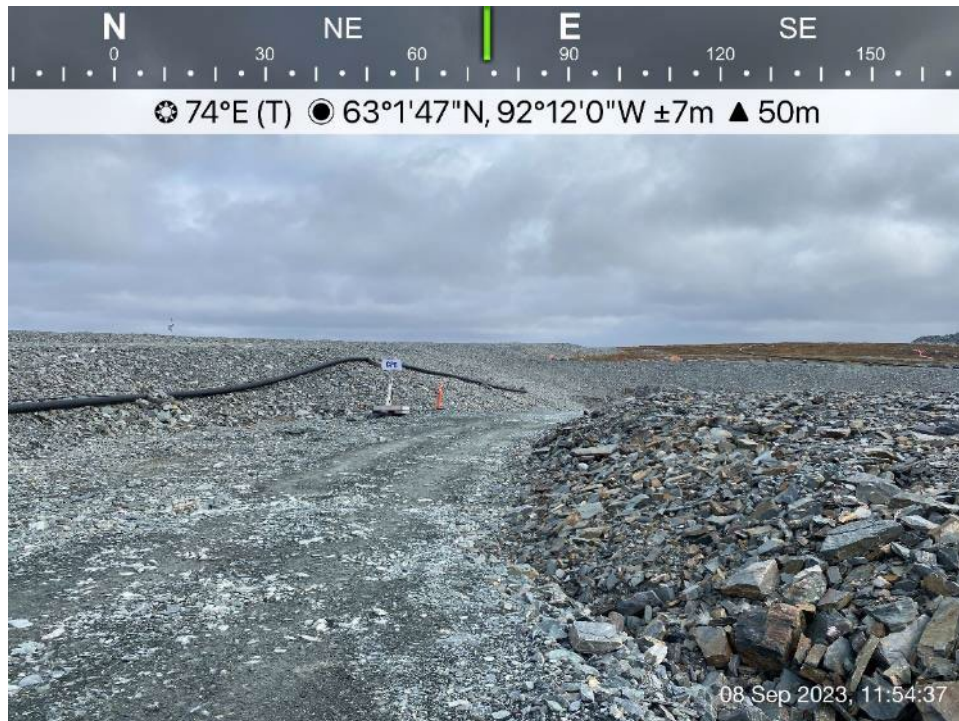
CP6 - Photo 1: CP6 - Looking east, ramp entering CP6.

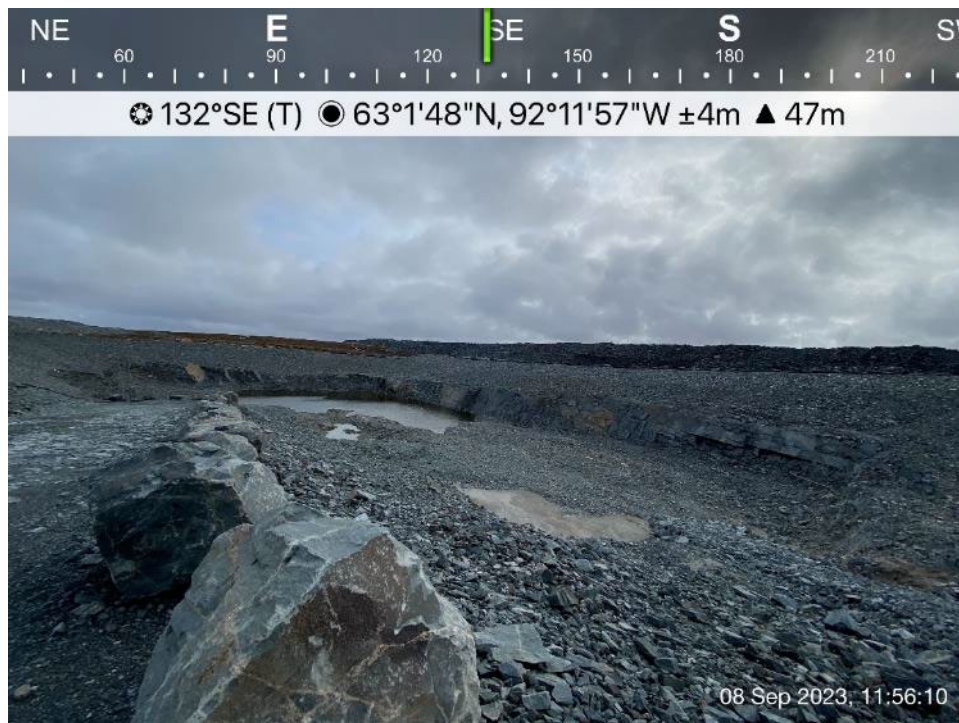
CP6 - Photo 2: CP6 - Overview of CP6, looking southeast.

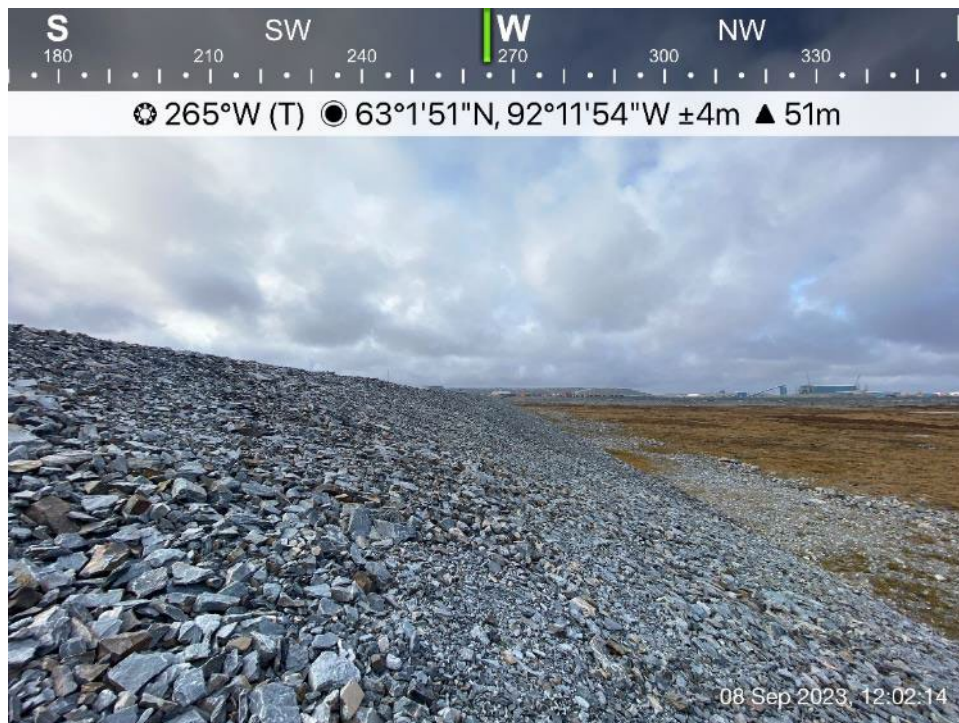
CP6 - Photo 6: CP6 Thermal Berm, looking west, upstream slope.

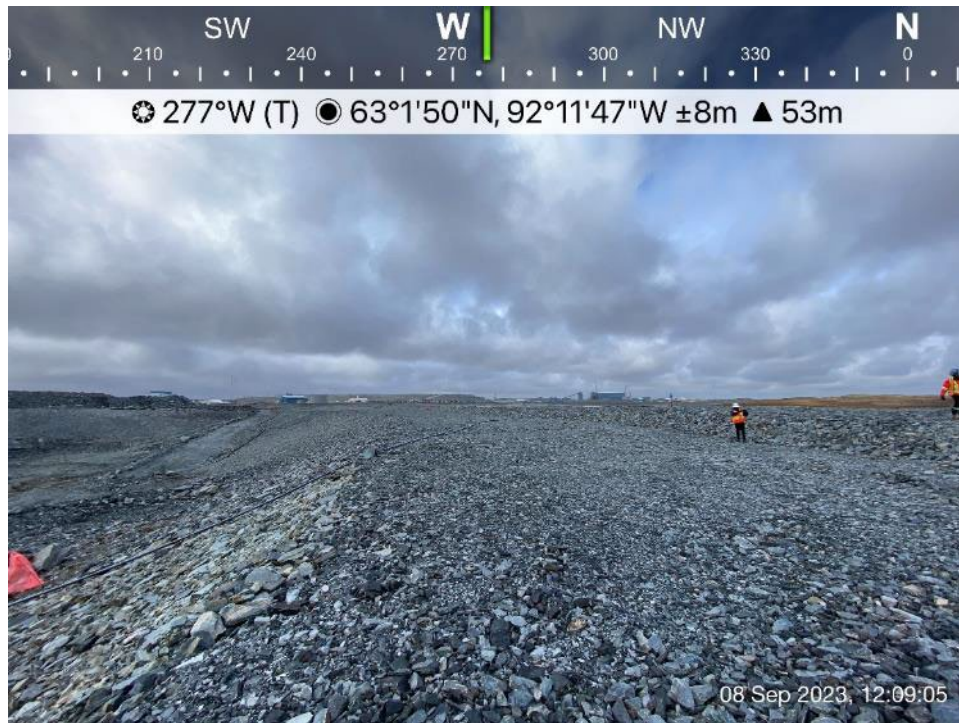
CP6 - Photo 8: CP6 Thermal Berm, looking west, berm crest and upstream slope, CP6 on the left.

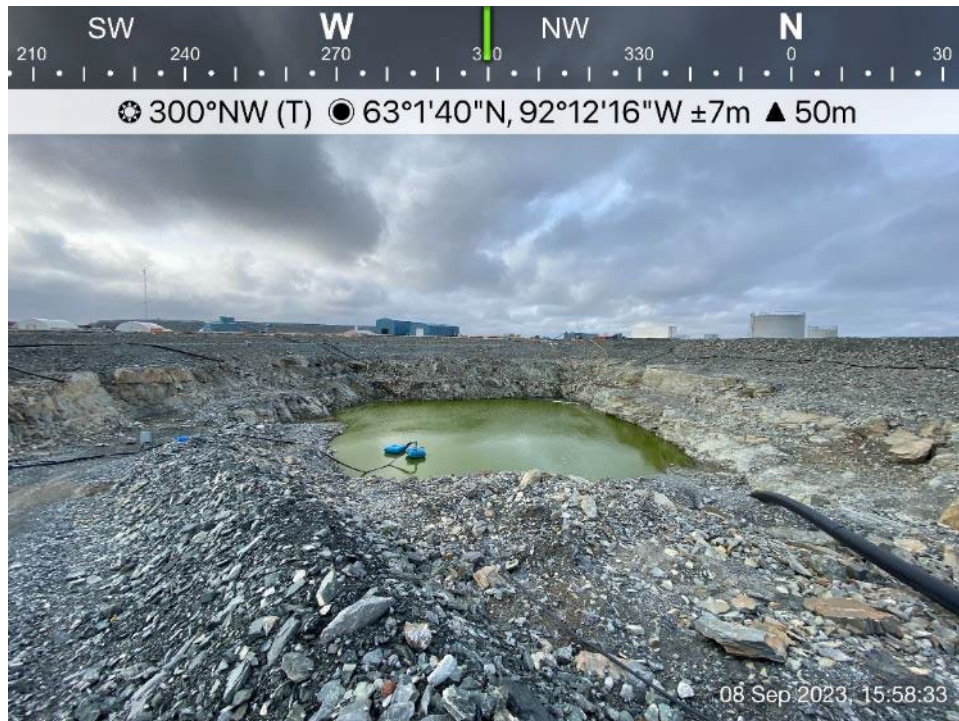
SP1 - Photo 1: SP1 Saline Pond - Looking west, overview of SP1, pond in bedrock, ROM covered overburden slopes.

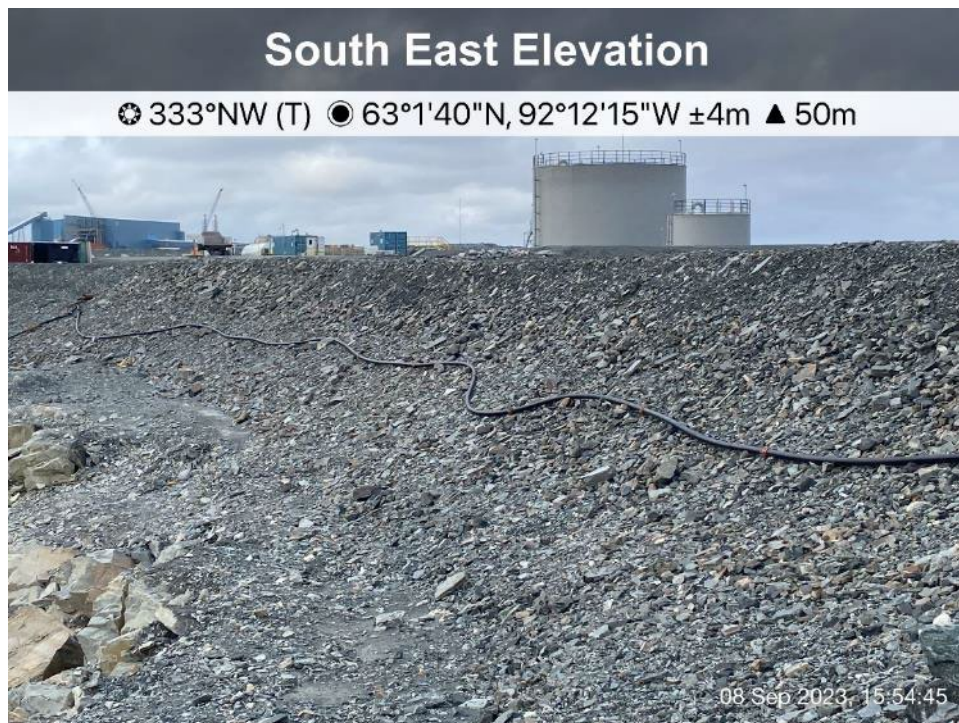
SP1 - Photo 2: SP1 Saline Pond - Perimeter berm side slope.

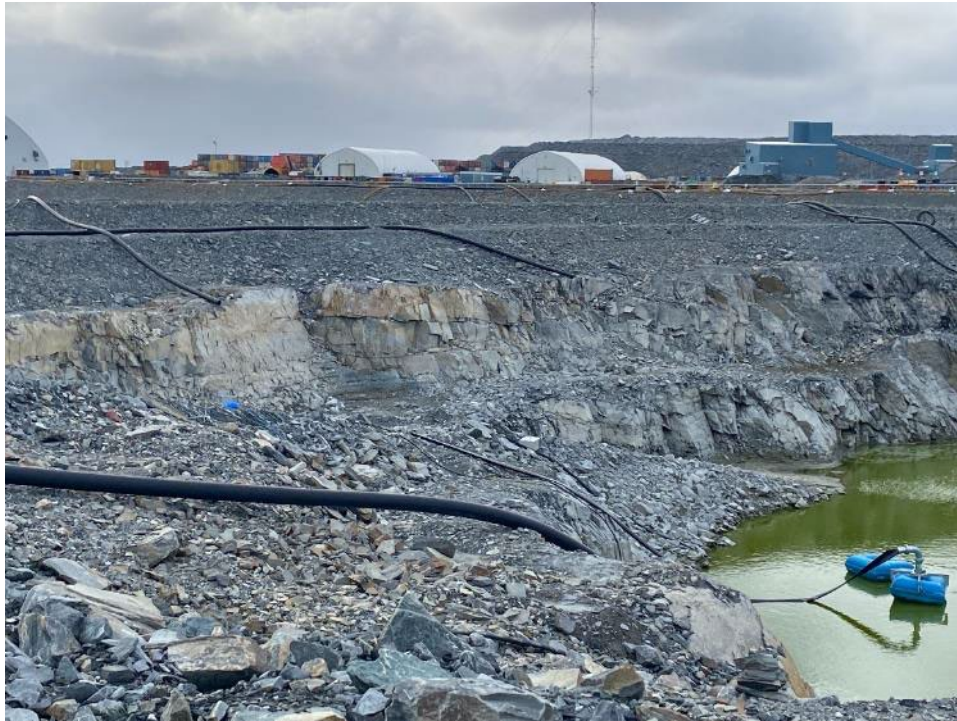
SP1 - Photo 3: SP1 Saline Pond - Perimeter berm side slope and bedrock side wall.

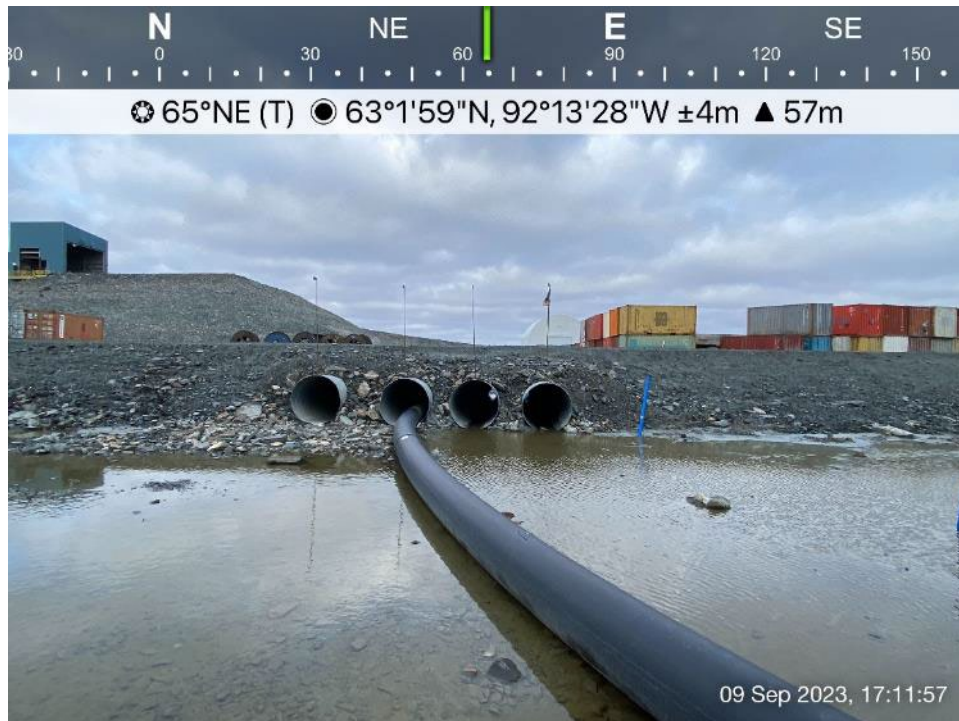
Channel 1 - Photo 1: Channel 1 - Upper reach, culverts divert water from Lake H13 to Channel 1.

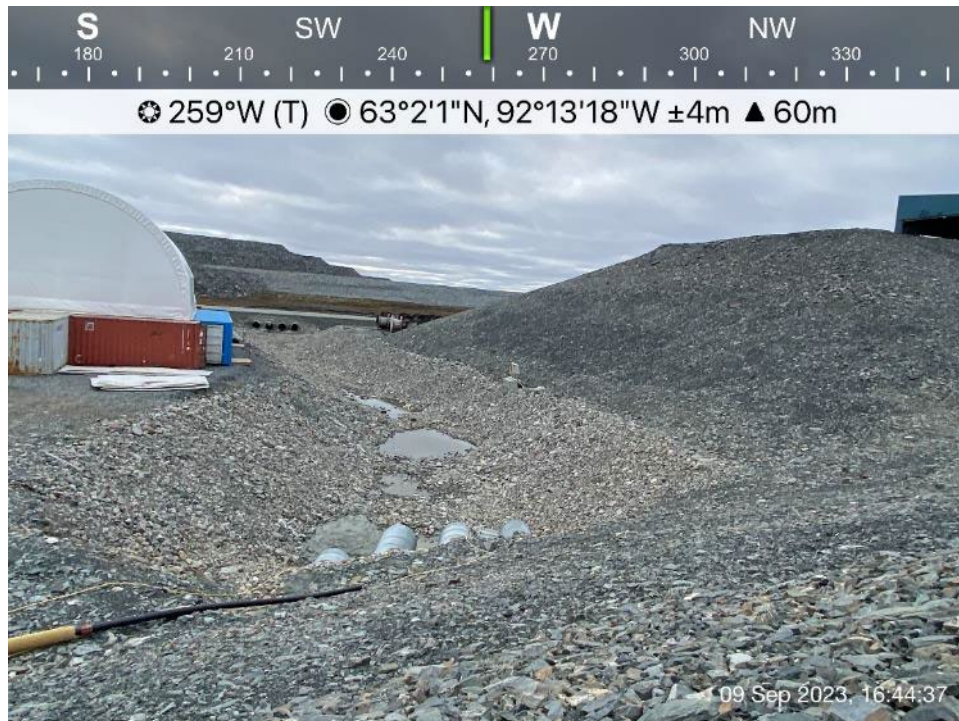
Channel 1 - Photo 2: Channel 1 - Crusher ramp embankment to the right, looking west.

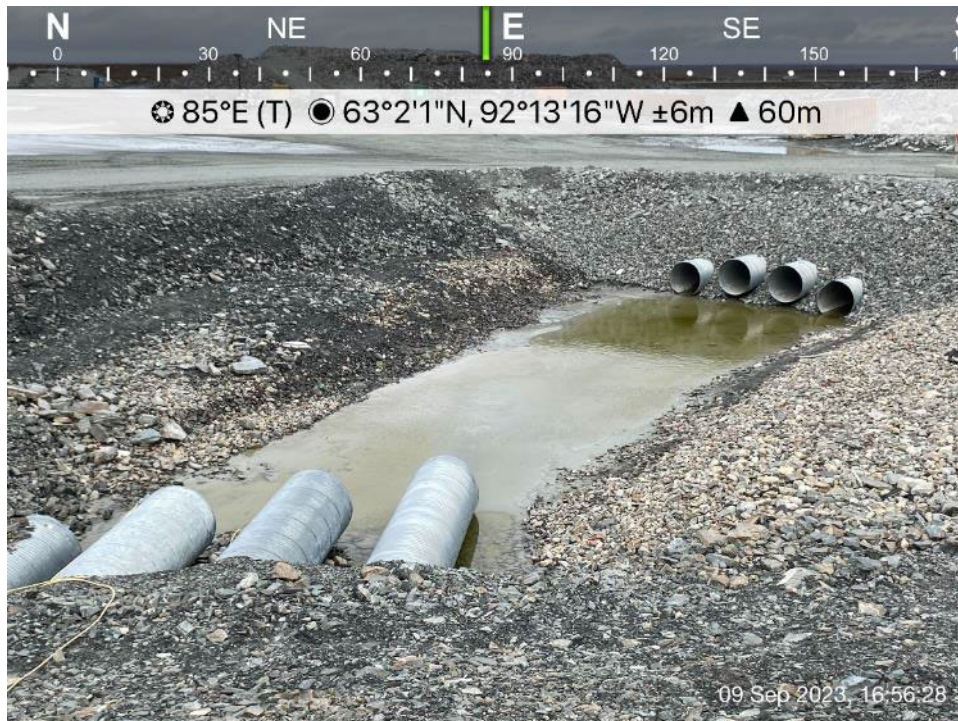
Channel 1 - Photo 3: Channel 1 - Channel length between crusher ramp and ore pad access, looking east.

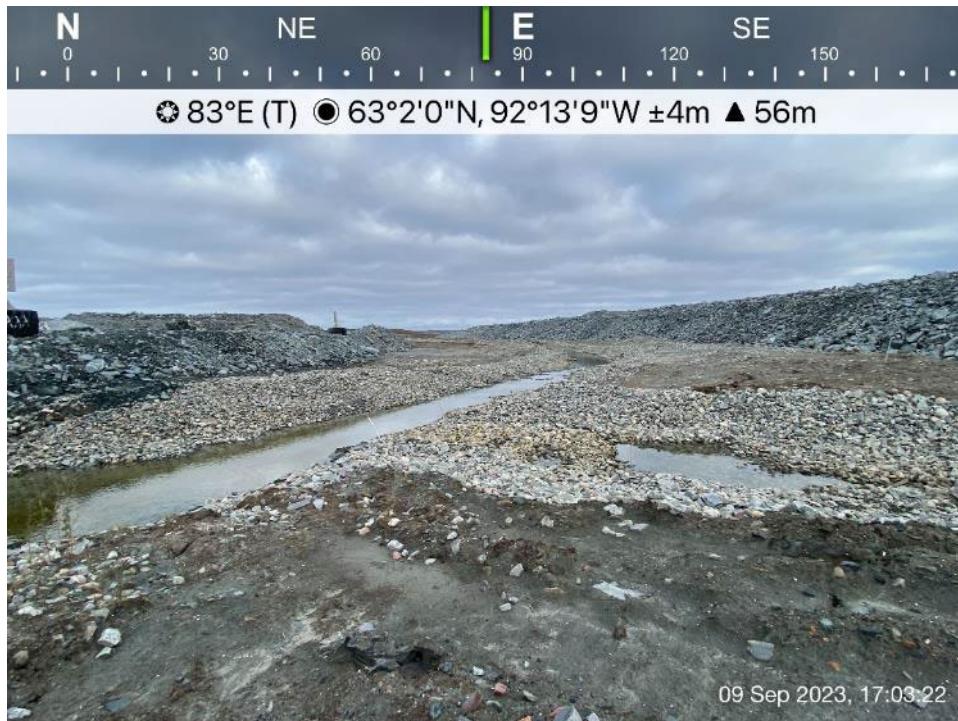
Channel 1 - Photo 4: Channel 1 - Lower reach to Lake H9, adjacent to ore stockpiles on left, looking east.

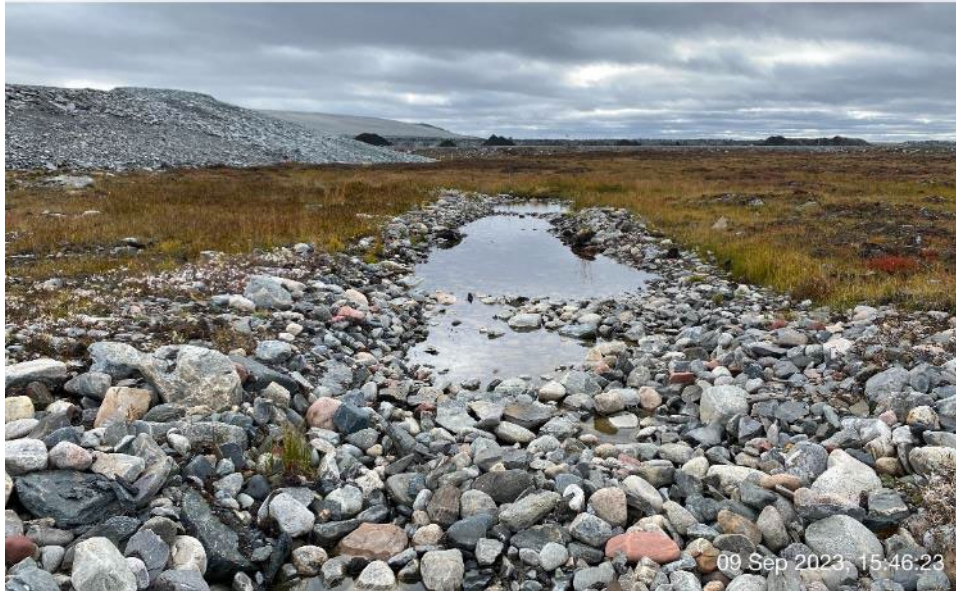
Channel 2 - Photo 5: Channel 2 - lower reach, water ponding at the end of the channel.

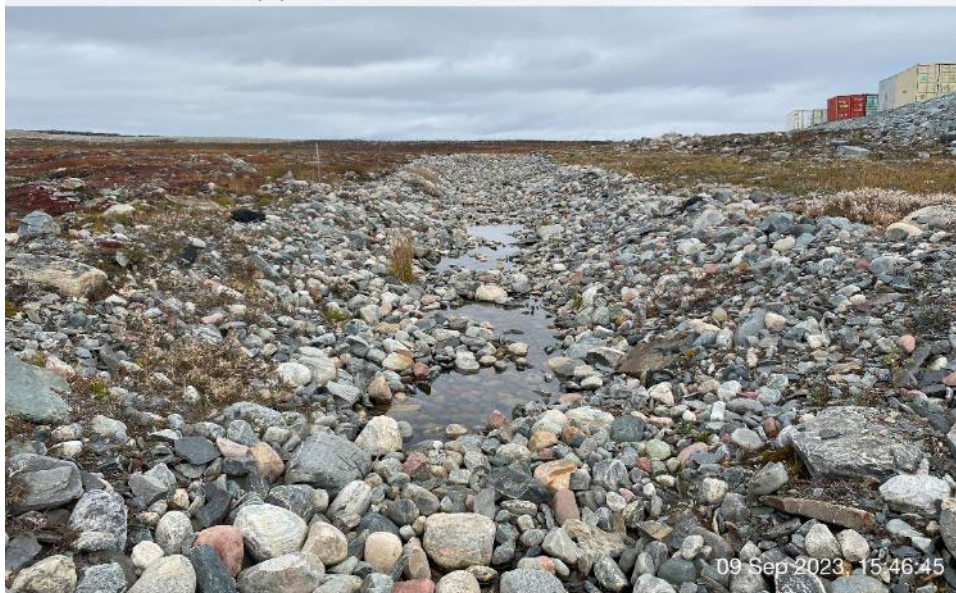
Channel 2 - Photo 6: Channel 2 -Middle section, minor water ponding observed at the base of channel due to thaw subsidence.

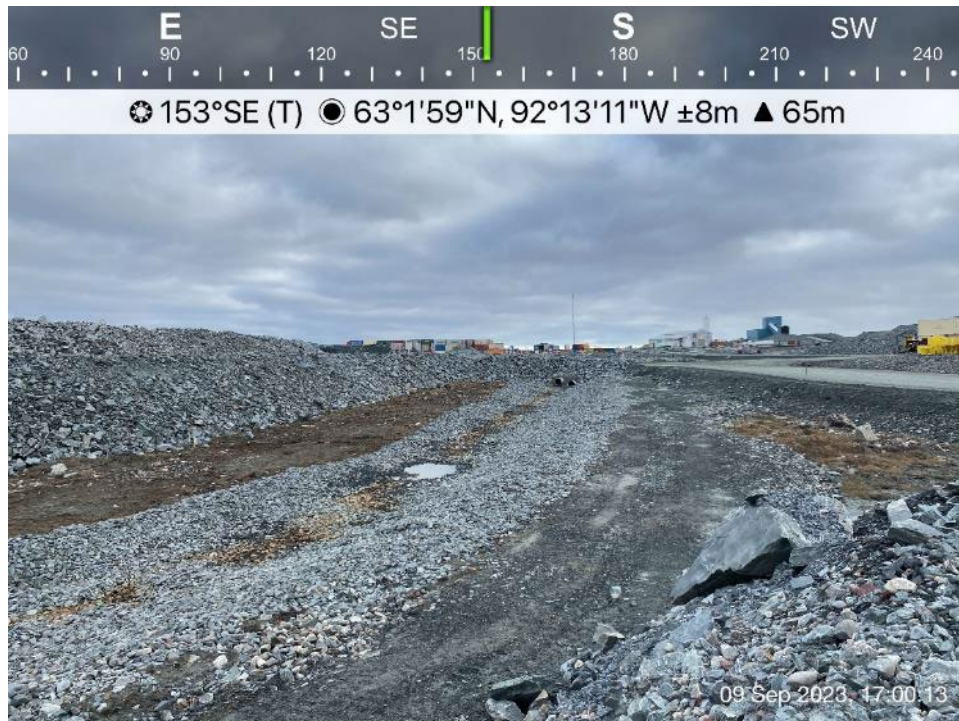
Channel 7 - Photo 15: Channel 7 - Upper reach and middle section of Channel 7, minor water ponding and thaw subsidence.

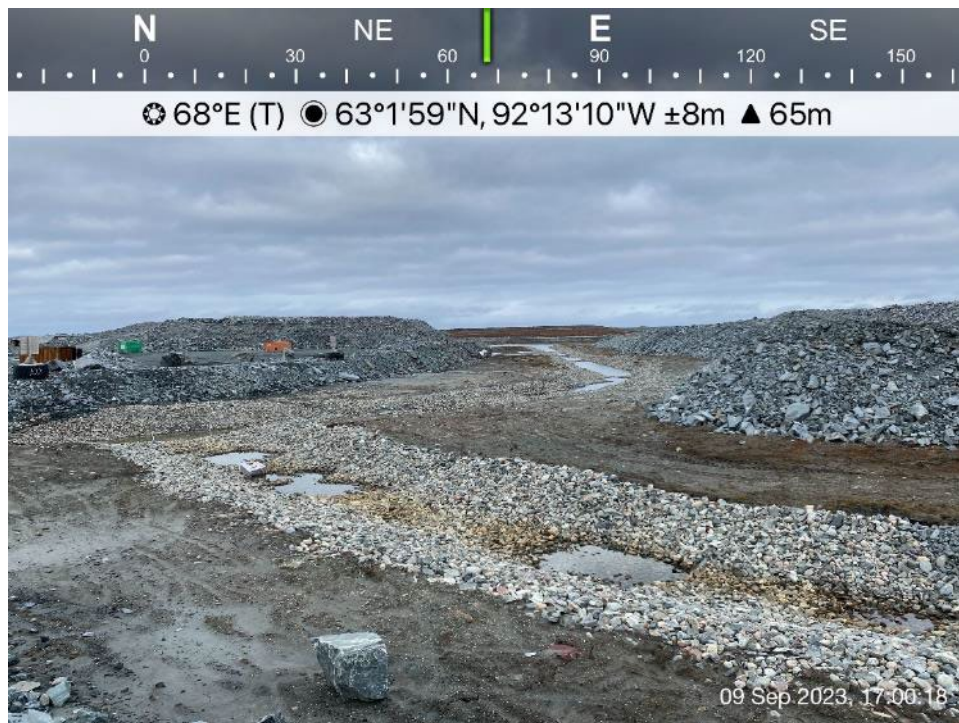
Channel 7 - Photo 16: Channel 7 -Outlet into Channel 1, minor water ponding and thaw subsidence, ore stockpiles in the background.

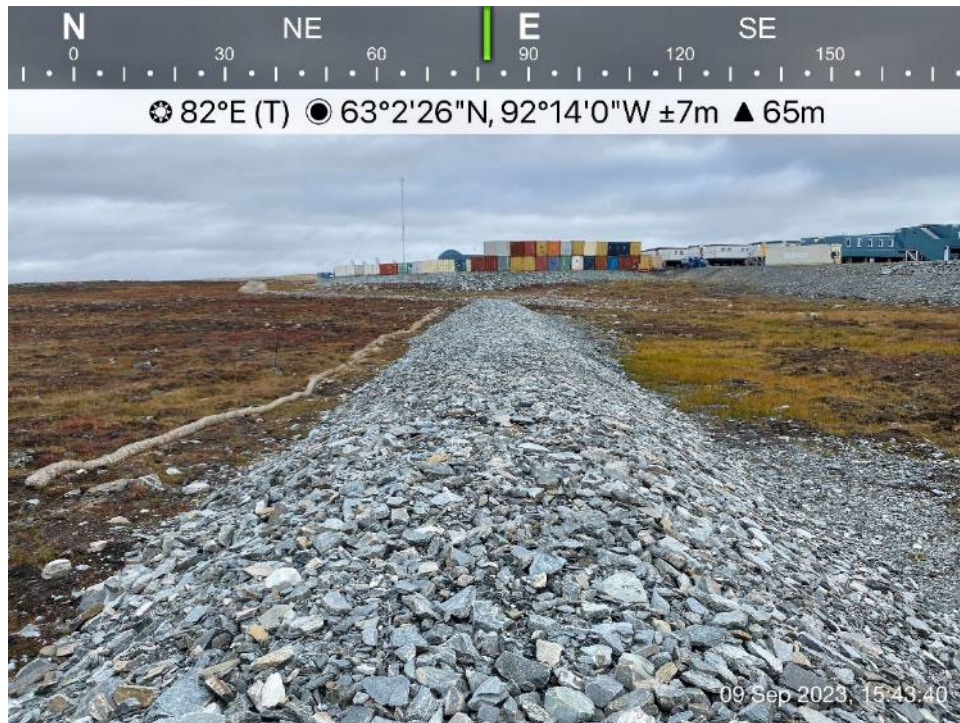
The recently constructed Channel 2 Berm was inspected by walking along the crest and slopes and examining the conditions of the berm for visual signs of deformation and instability, cracking, or uneven surfaces. No geotechnical concerns were identified along the berm (Photo 20, Appendix I).

Channel 2 Berm - Photo 20: Channel 2 Berm - Overview of the new constructed Channel 2 Berm.

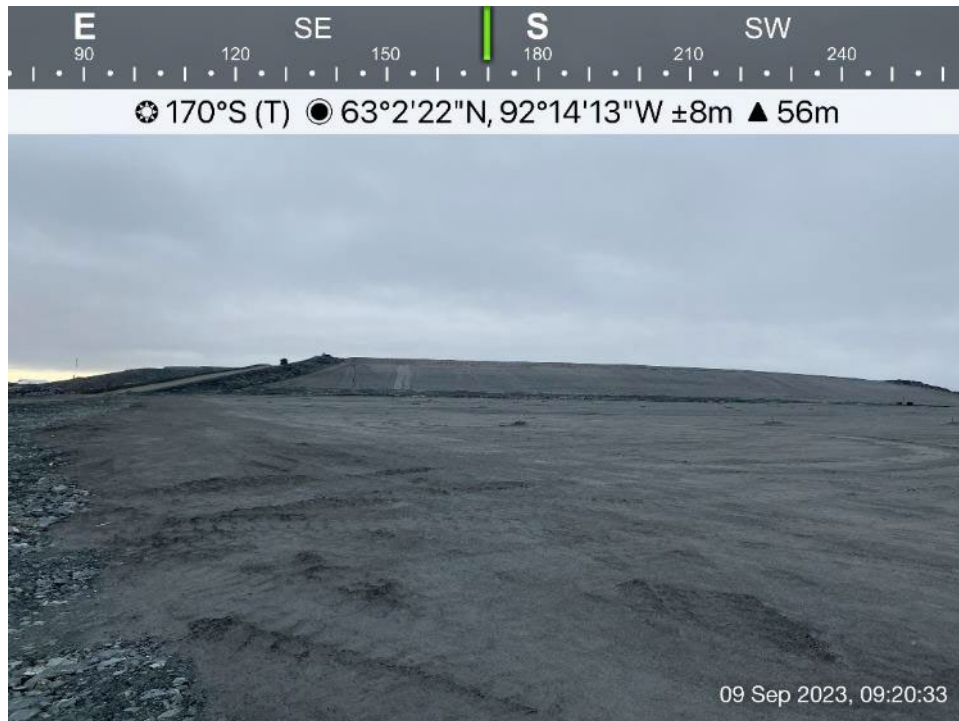
TSF - Photo 1: TSF - Overview of TSF Cell 2 and north slope of Cell 1.

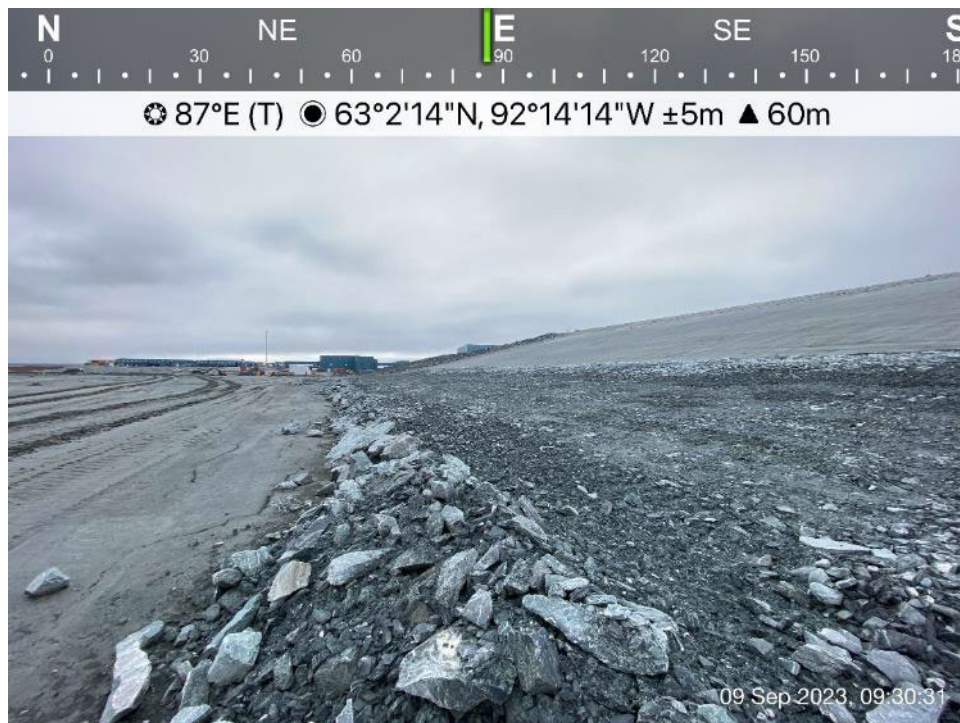
TSF - Photo 2: TSF - Rockfill berm constructed between Cell 1 and Cell 2 tie-in to reduce the surface erosion of north slope of Cell 1.

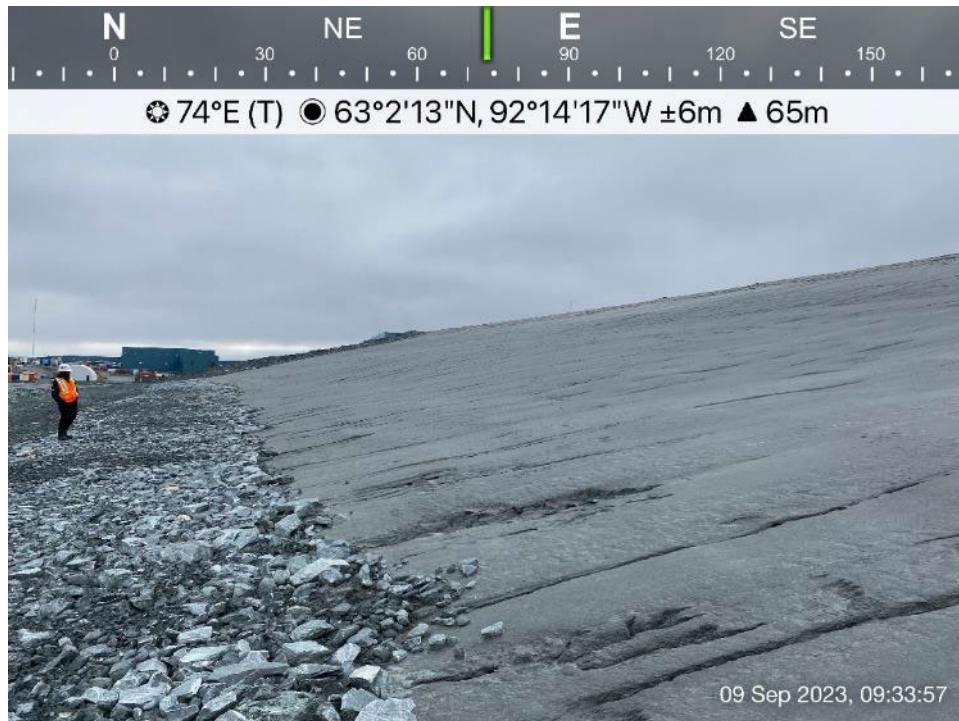
TSF - Photo 3: TSF - Cell 1 north slope surface erosion.

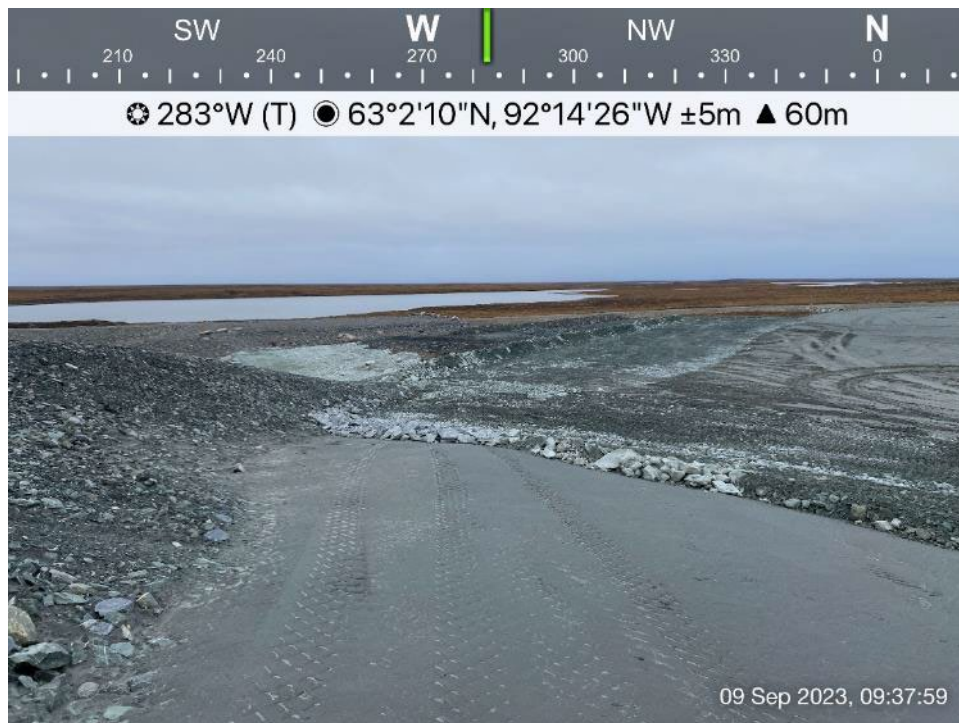
TSF - Photo 4: TSF - Rockfill cover of tailings along west side of Cell 2, looking west.

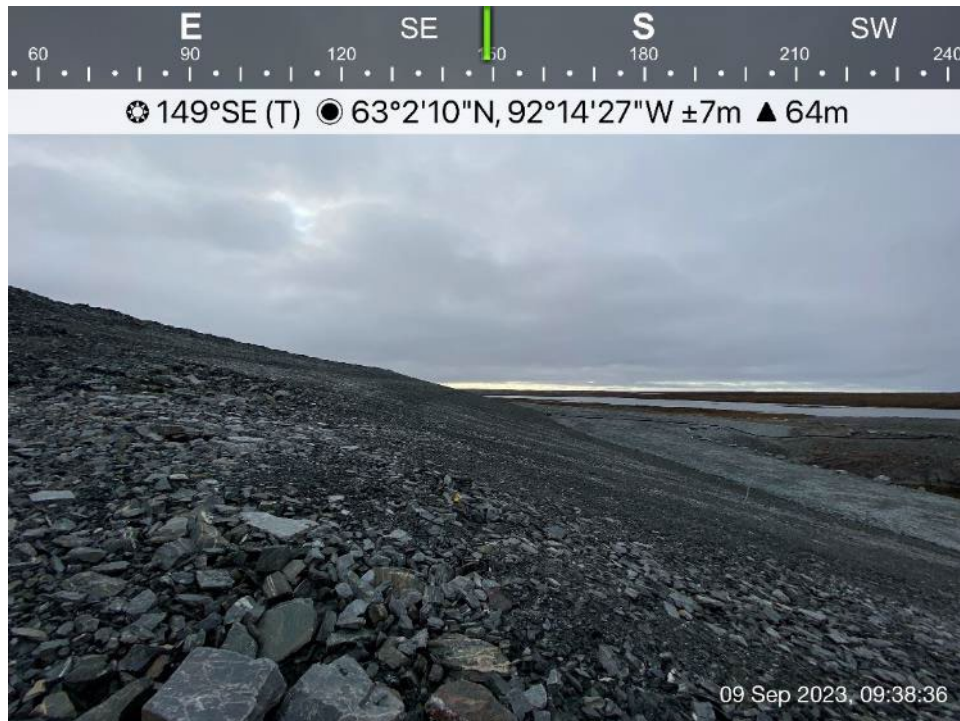
TFS - Photo 5: TFS - Rockfill cover slope along west side of Cell 1, looking southeast.

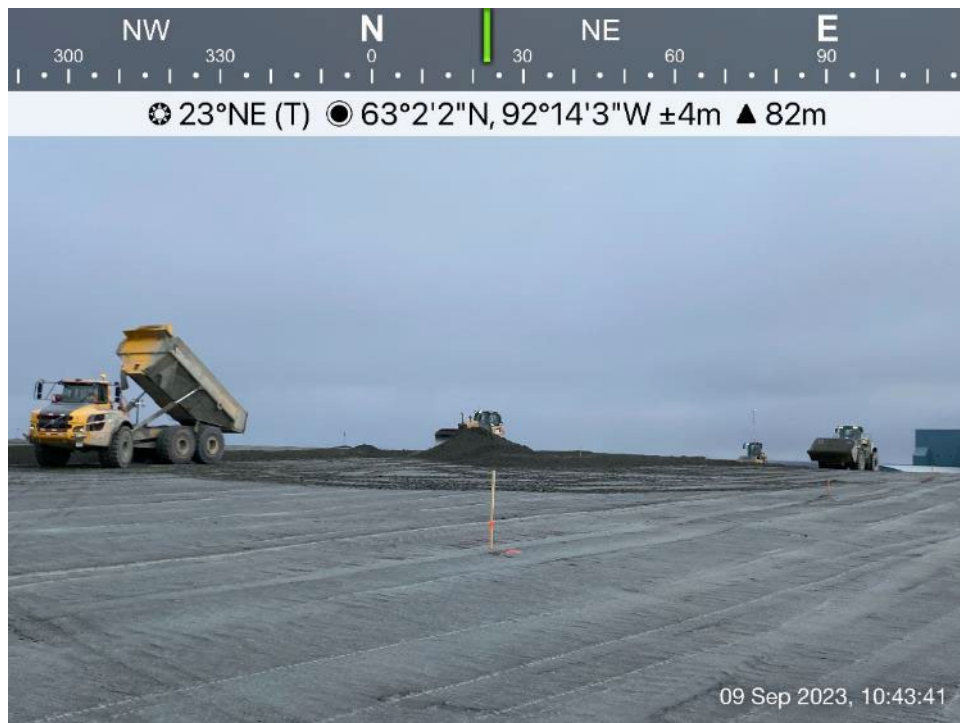
TFS - Photo 6: TFS - dumping, spreading and compacting of the tailings in Cell 1.

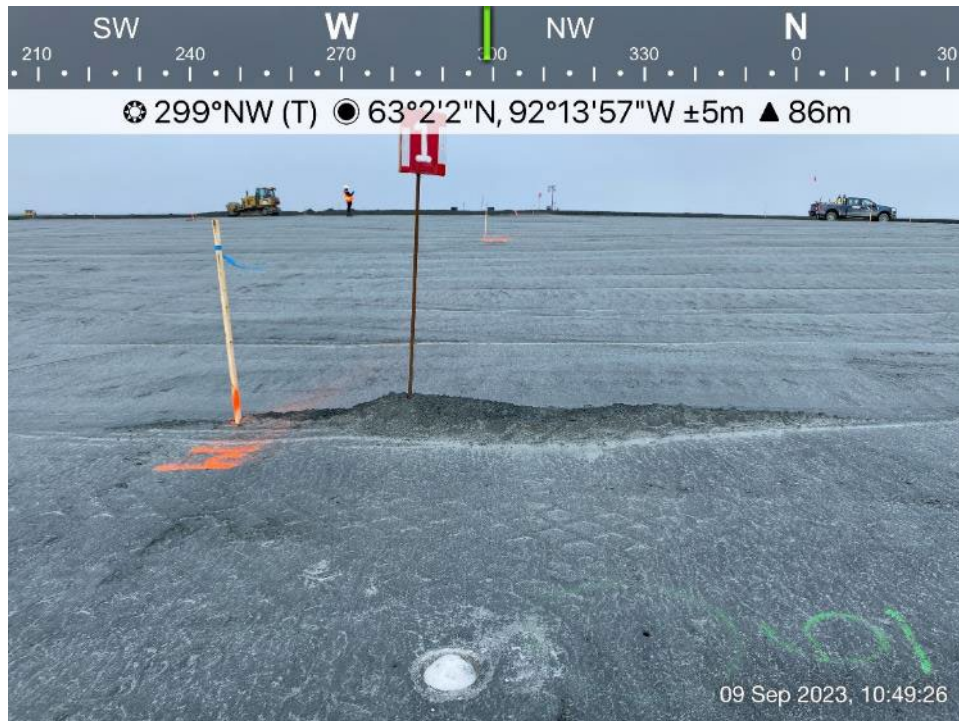
TSF - Photo 7: TSF - Sand cone and nuclear density testing locations.

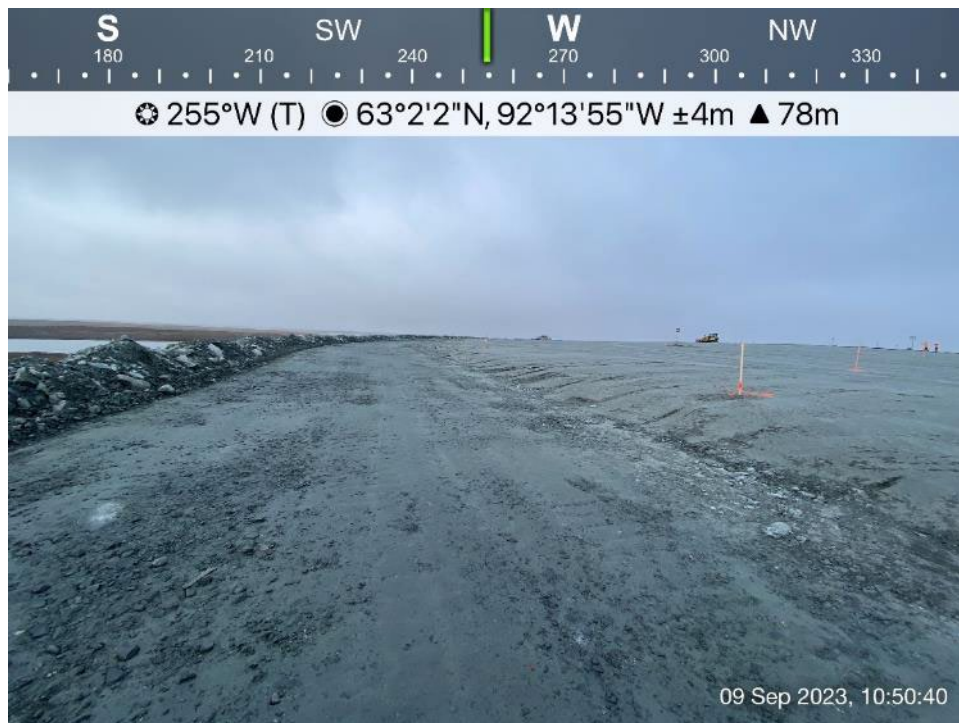
TSF - Photo 8: TSF - Crest of rockfill covered slope, and stack used for lift thickness control.

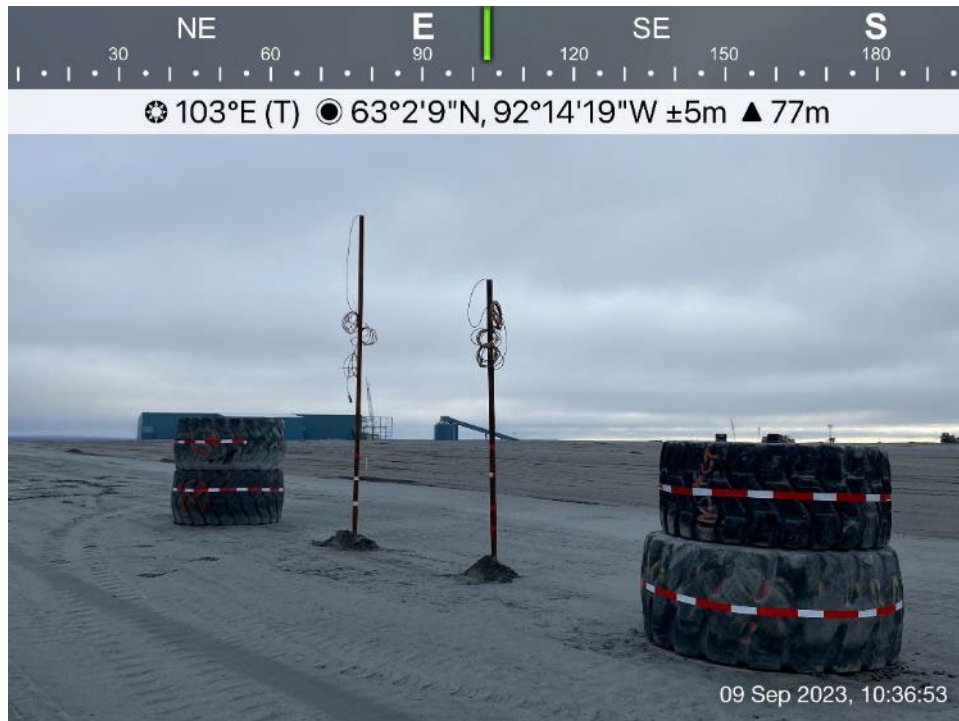
TSF - Photo 11: TSF - GTCs installed in the TSF.

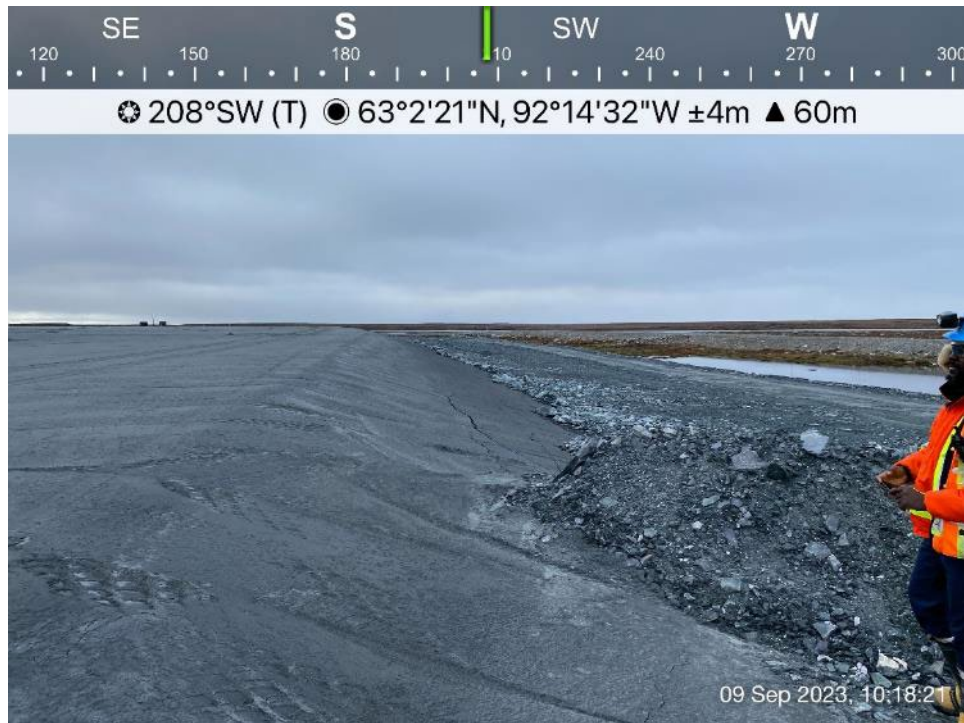
TSF - Photo 12: TSF - Rockfill cover and north slope of TSF Cell 2.

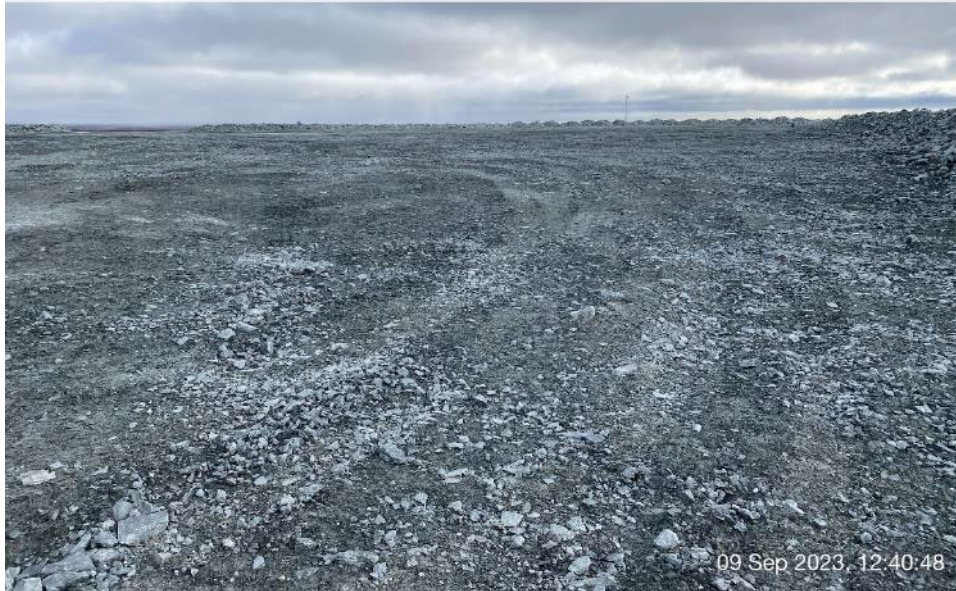
WRSF1 - Photo 1: WRSF 1 - dumping waste rock from bench 97 m, looking east.
