APPENDIX 6 2023 ANNUAL GEOTECHNICAL INSPECTION REPORT

2023 Annual Geotechnical Inspection Meliadine Gold Mine, Nunavut, Canada

PRESENTED TO
Agnico Eagle Mines Limited

JANUARY 31, 2024
ISSUED FOR USE
FILE: 704-ENG.EARC03140-33
AGNICO EAGLE DOCUMENT NUMBER: 65-600-230-TCR-001

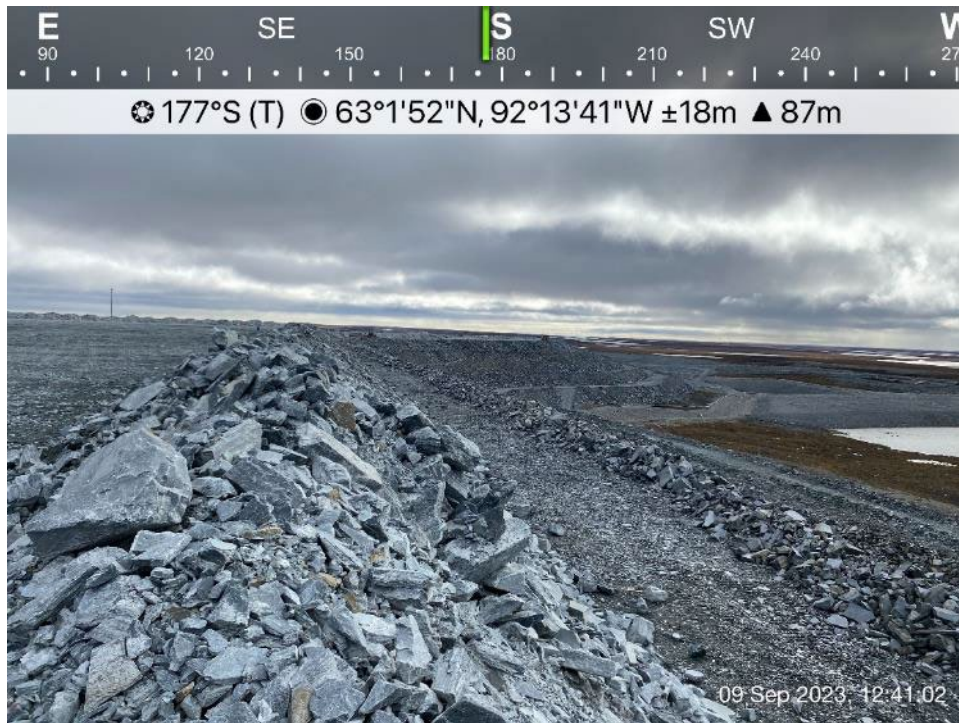
WRSF1 - Photo 3: WRSF 1 - WRSF1 west side benches and slopes, CP4 and CP4 berm in the background, looking south.

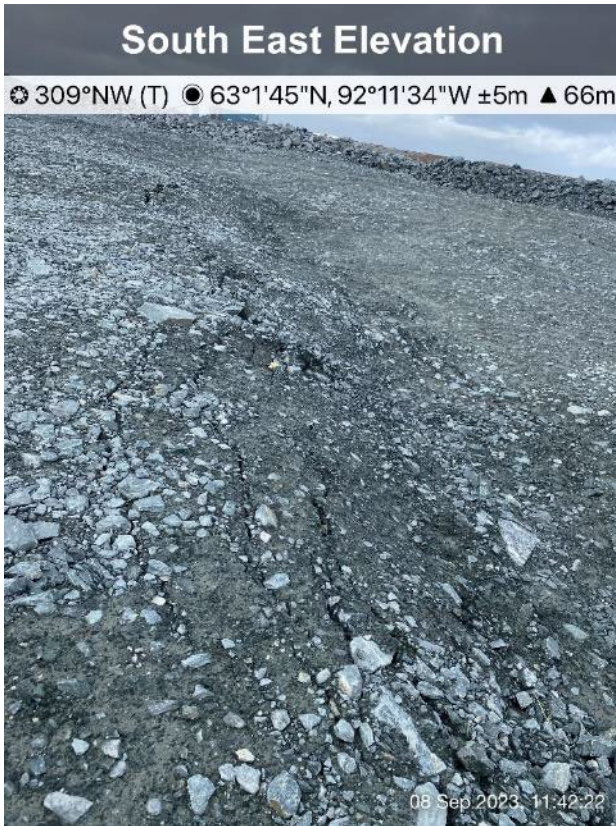
WRSF3- Photo 3: WRSF 3 - settlement and cracking observed on Bench 72 m.

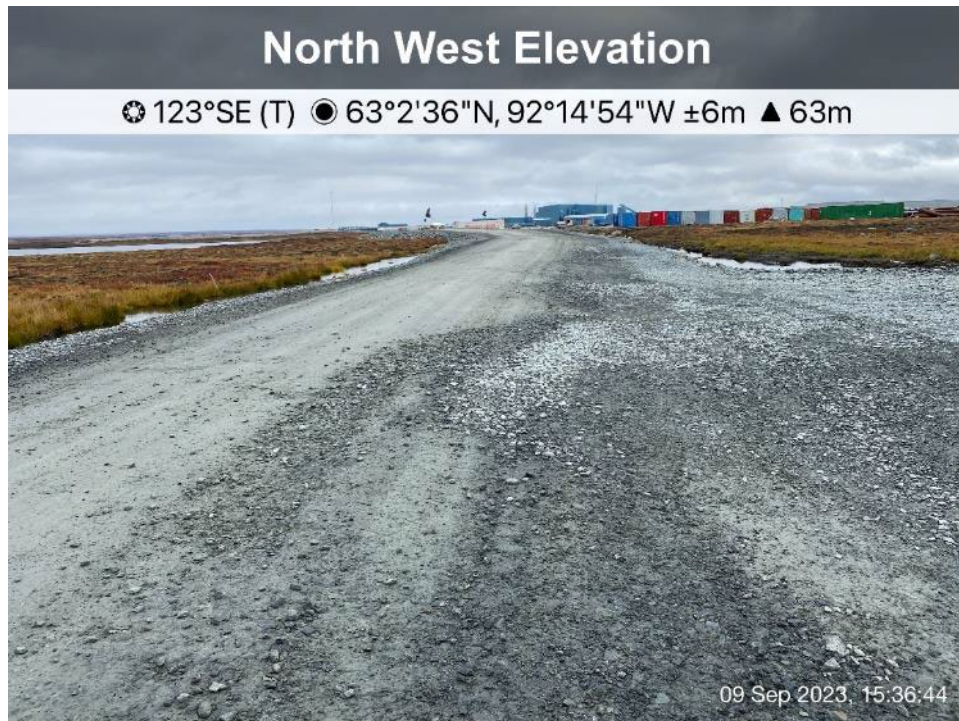
Site Road - Photo 1: Site Road - Road to Emulsion AN Pad and storage area.

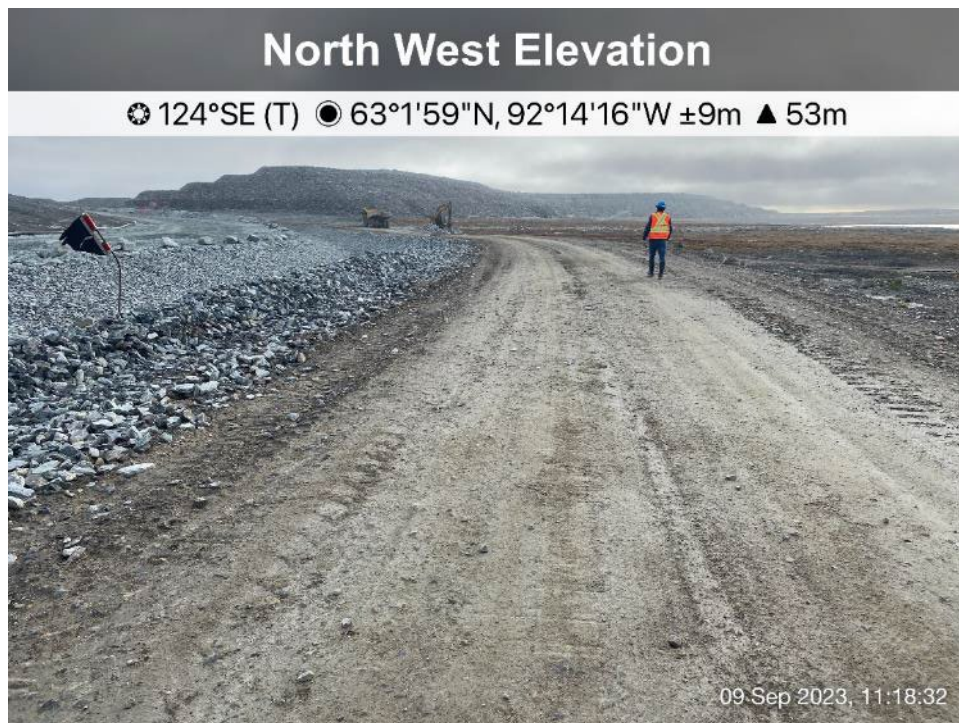
Site Road - Photo 2: Site Road - CP3 access road.

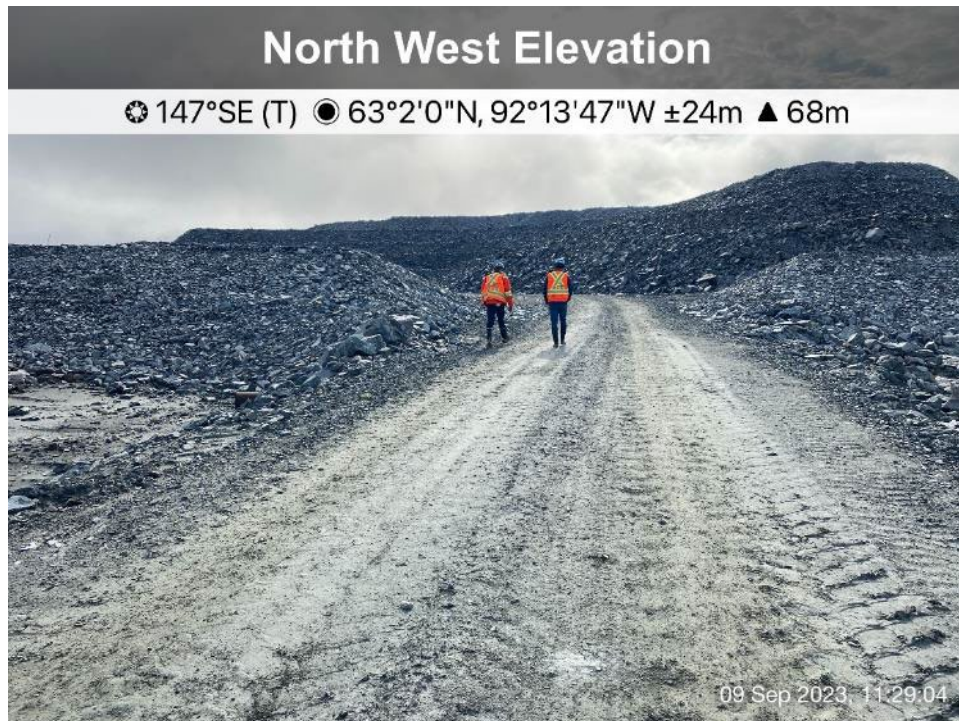
Site Road - Photo 3: Site Road - Landfill access road.

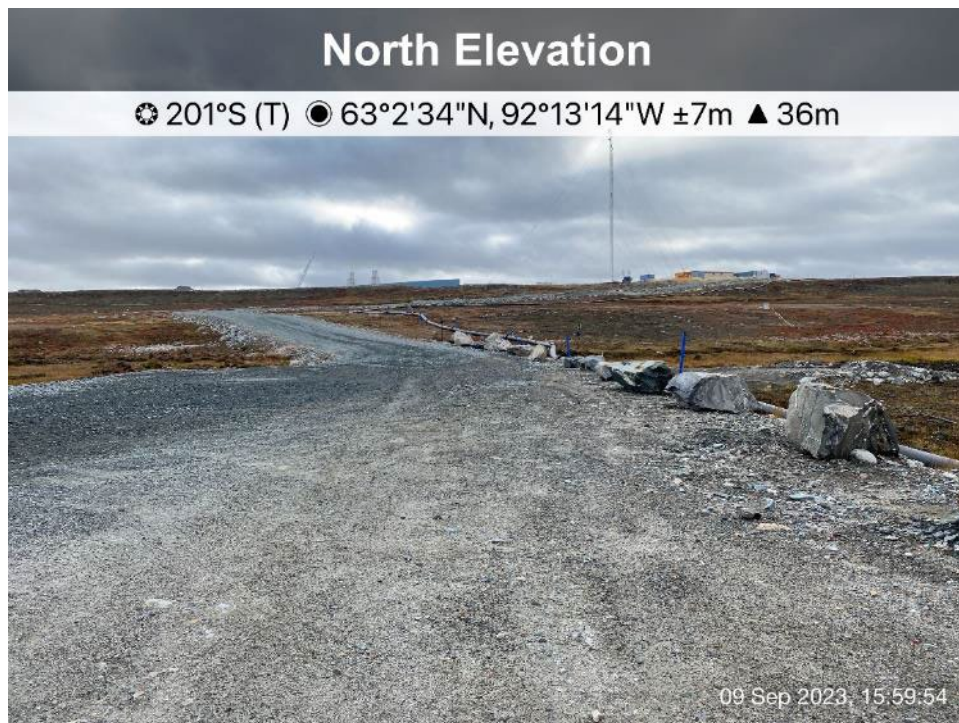
Site Road - Photo 4: Site Road - Fresh water intake access road.

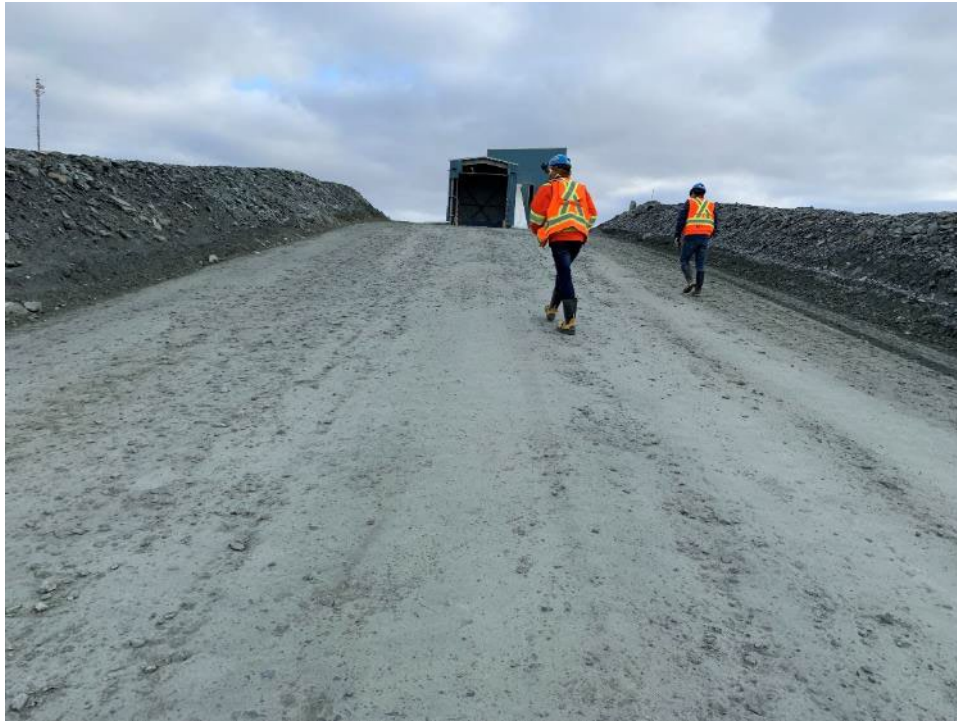
Site Road - Photo 5: Site Road - Paste plant access road.

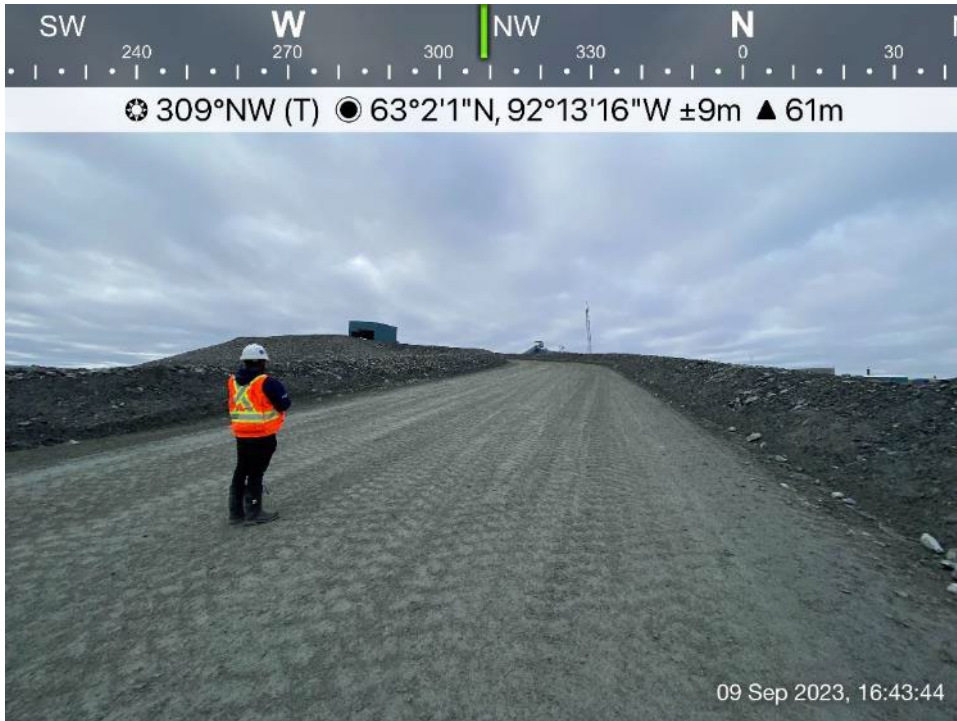
Site Road - Photo 6: Site Road - Crusher access ramp road.

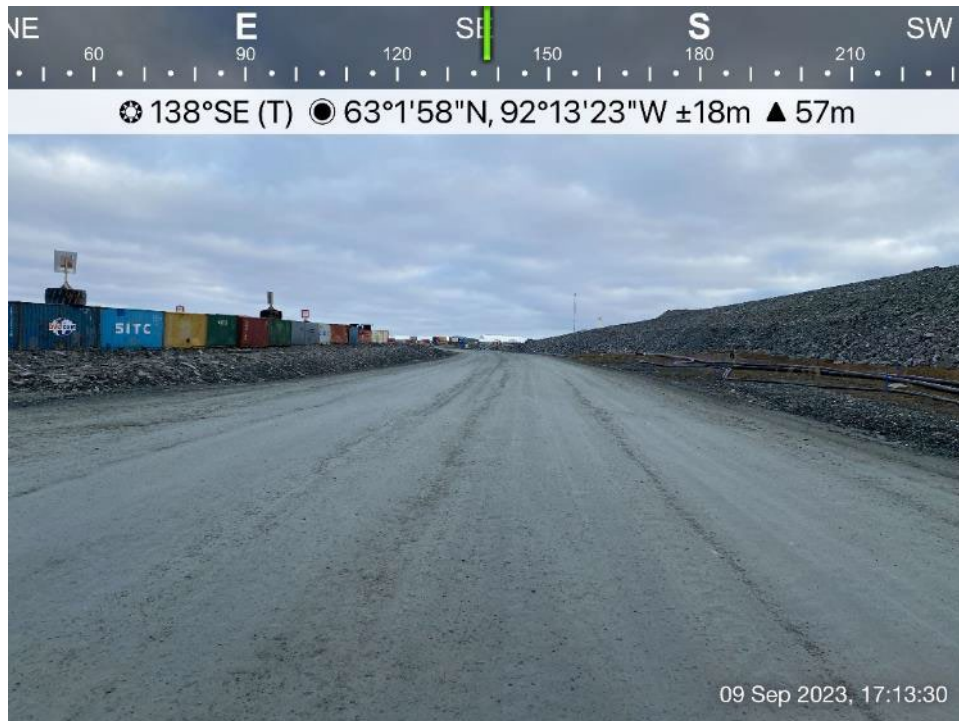
Site Road - Photo 7: Site Road - service road between WRSF1 and storage pad area.

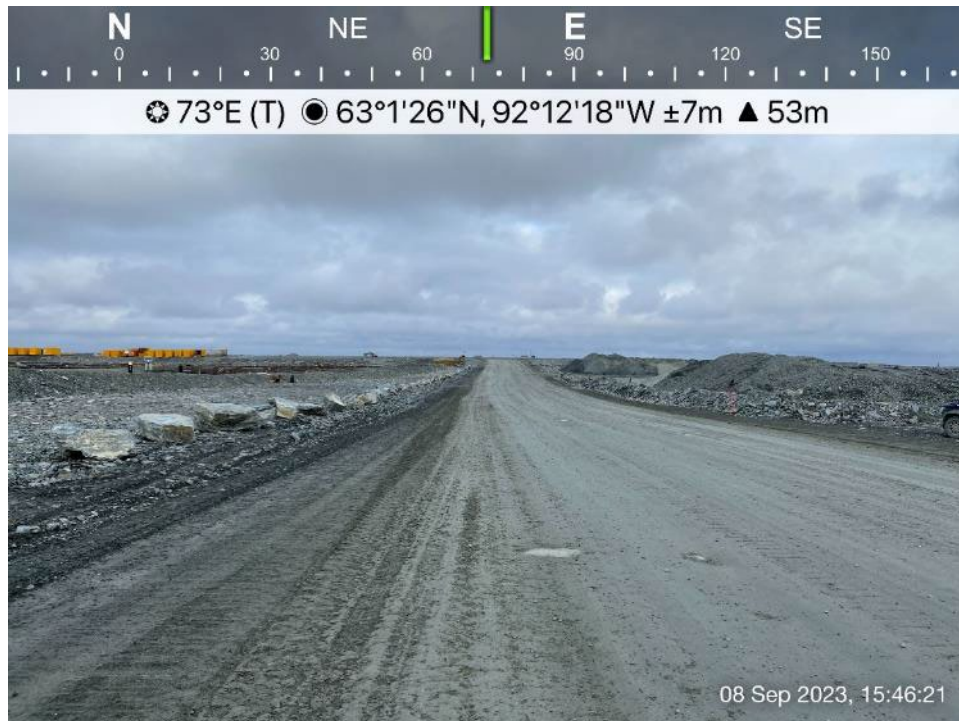
Site Road - Photo 8: Site Road - Haul Road between CP5 and Tiri Open Pit 02.

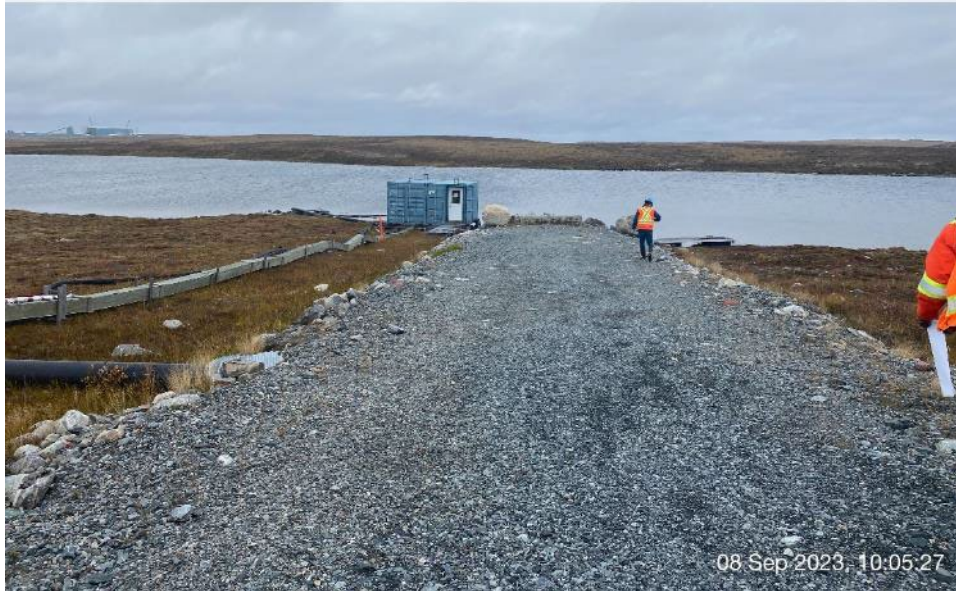
Site Road - Photo 9: Site Road - Exploration camp water intake access road.

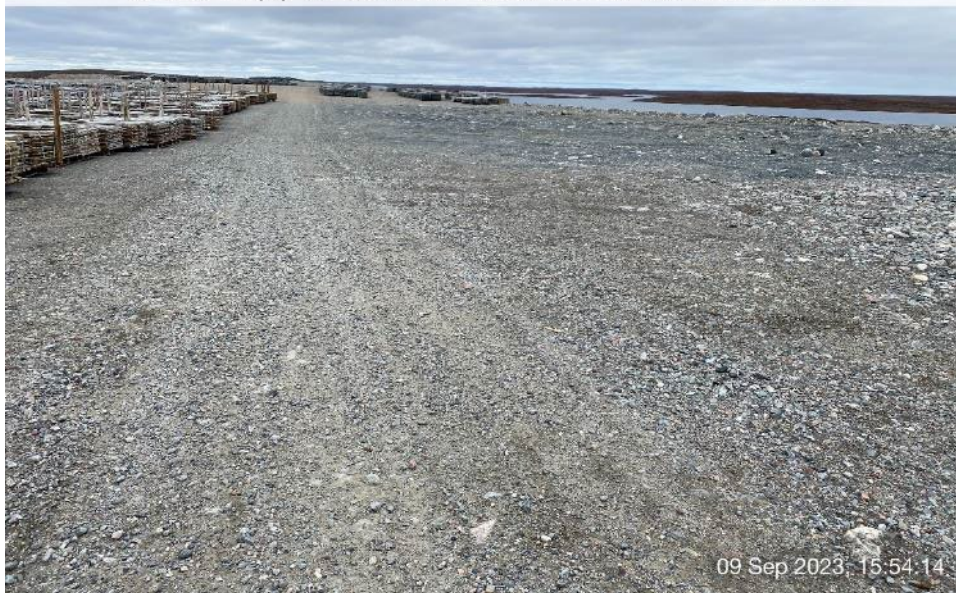
Site Road - Photo 10: Site Road - Meliadine North Esker access road.

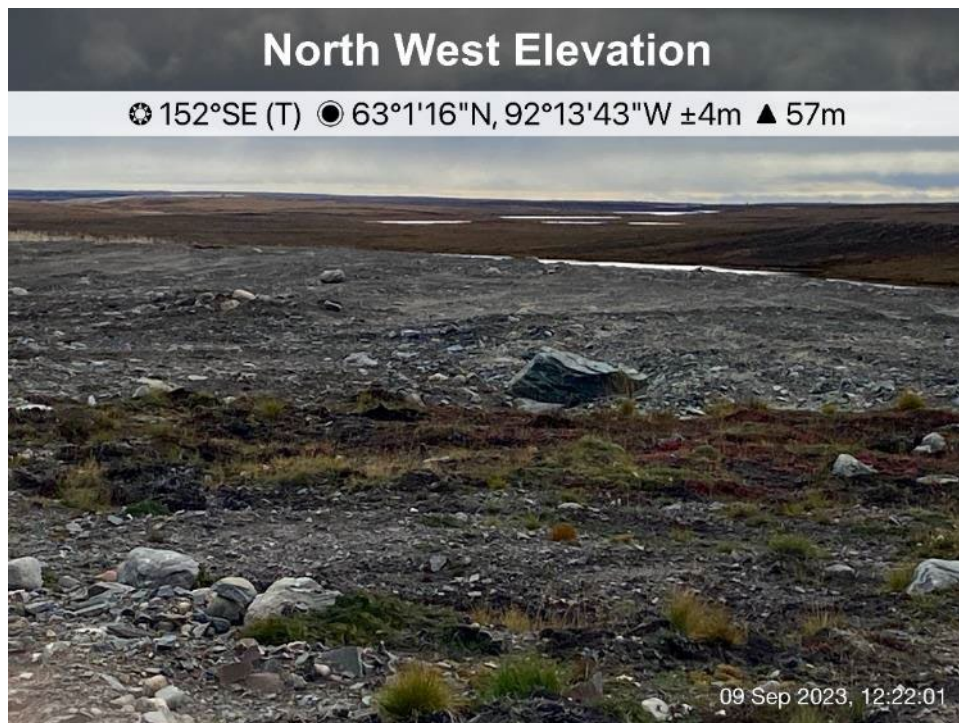
West Meg Esker - Photo 2: Borrow Source - West Meg esker borrow source, looking southeast.

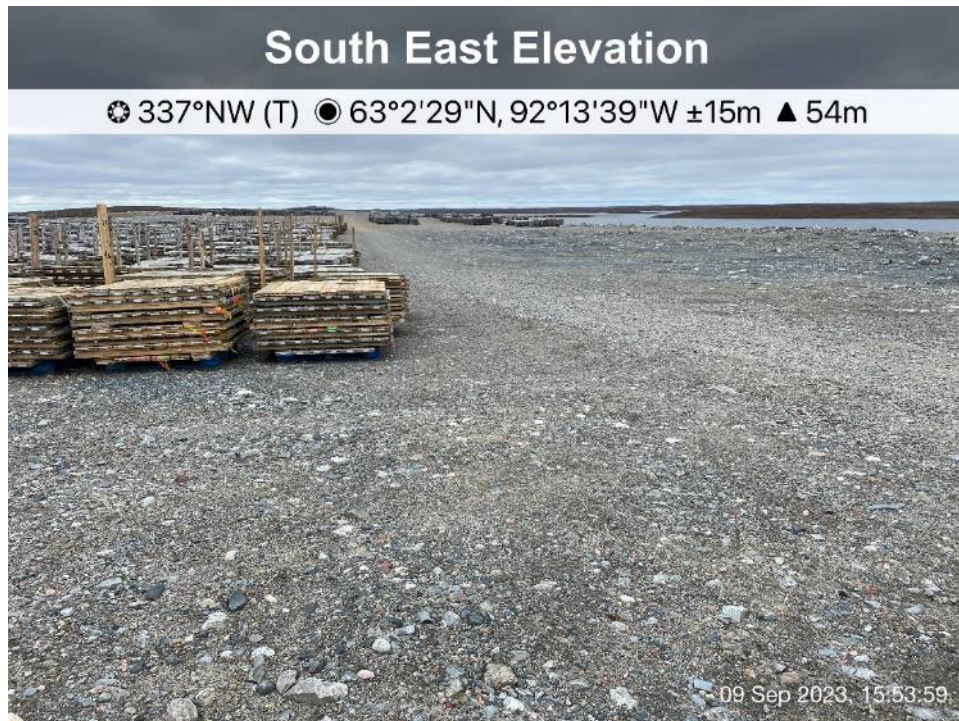
Mel North Esker - Photo 3: Borrow Source - Meliadine north esker borrow source, looking northwest.

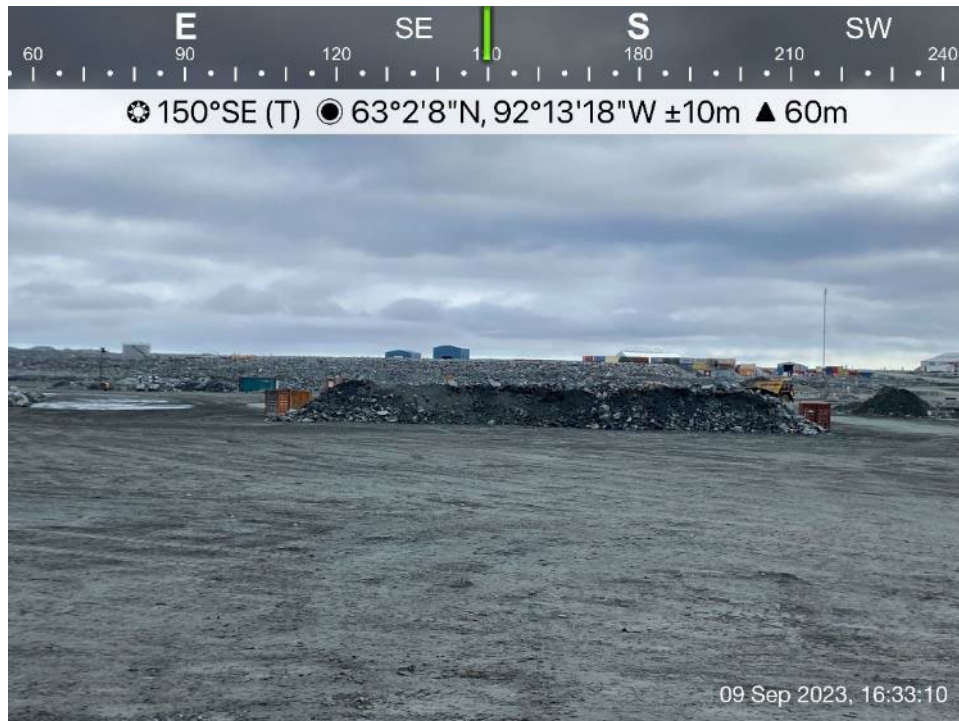
Ore Stockpile - Photo 1: Ore Stockpile - View from landfarm, looking southeast.

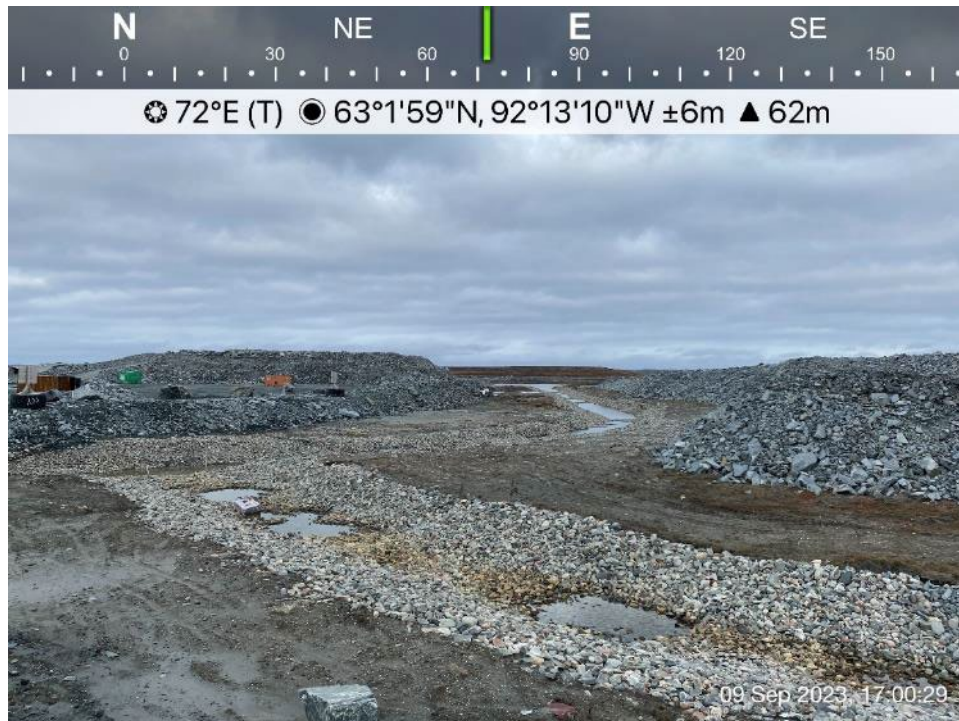
Ore Stockpile - Photo 3: Ore Stockpile - View from Channel 7, looking east.

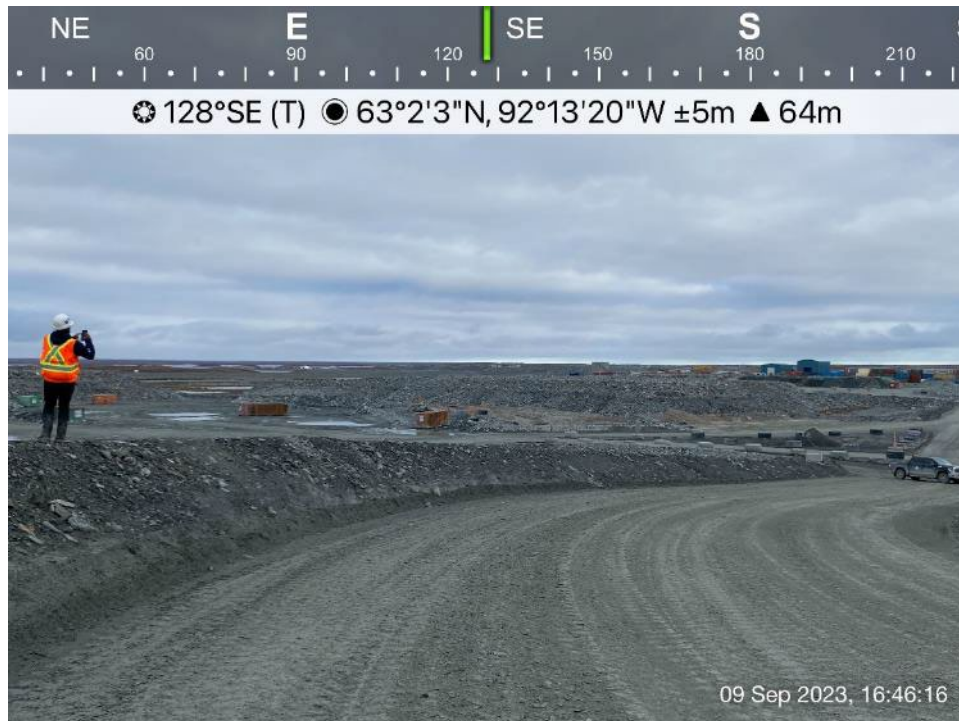
Ore Stockpile - Photo 4: Ore Stockpile - View from Crusher ramp, looking southeast.

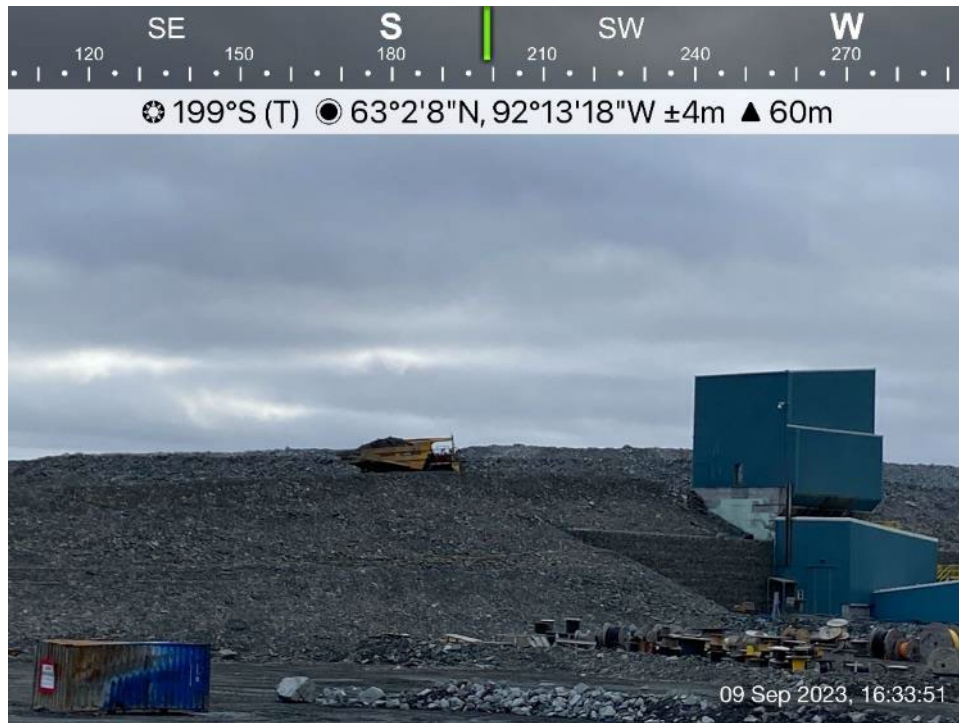
Crusher Pad - Photo 1: Crusher pad and ramp - Overview, looking south.

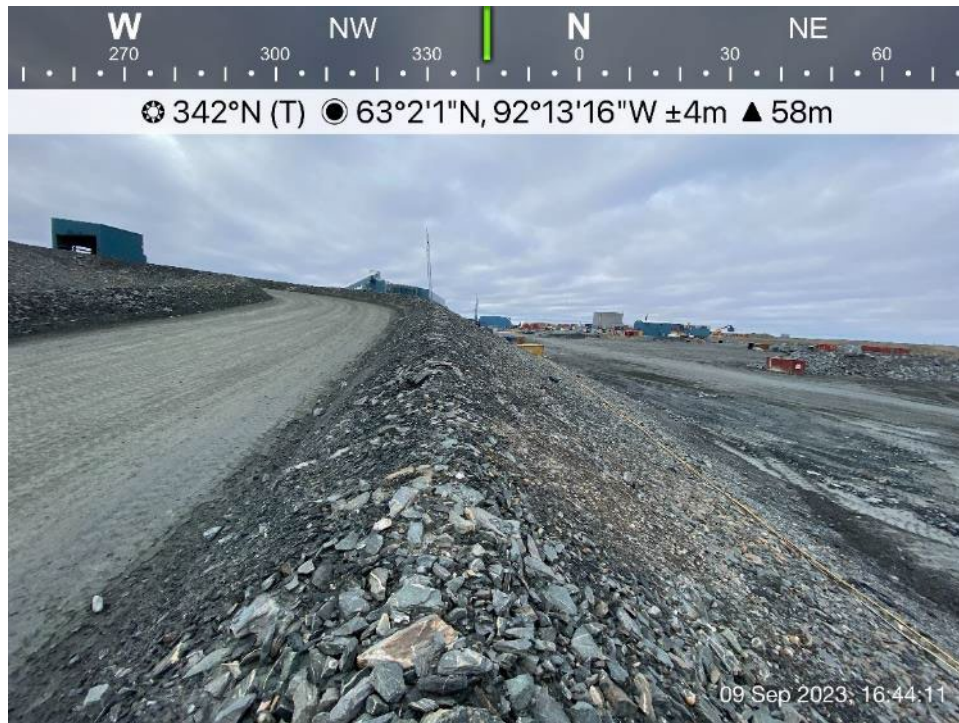
Crusher Pad - Photo 2: Crusher pad ramp and side slope - Overview, looking north.

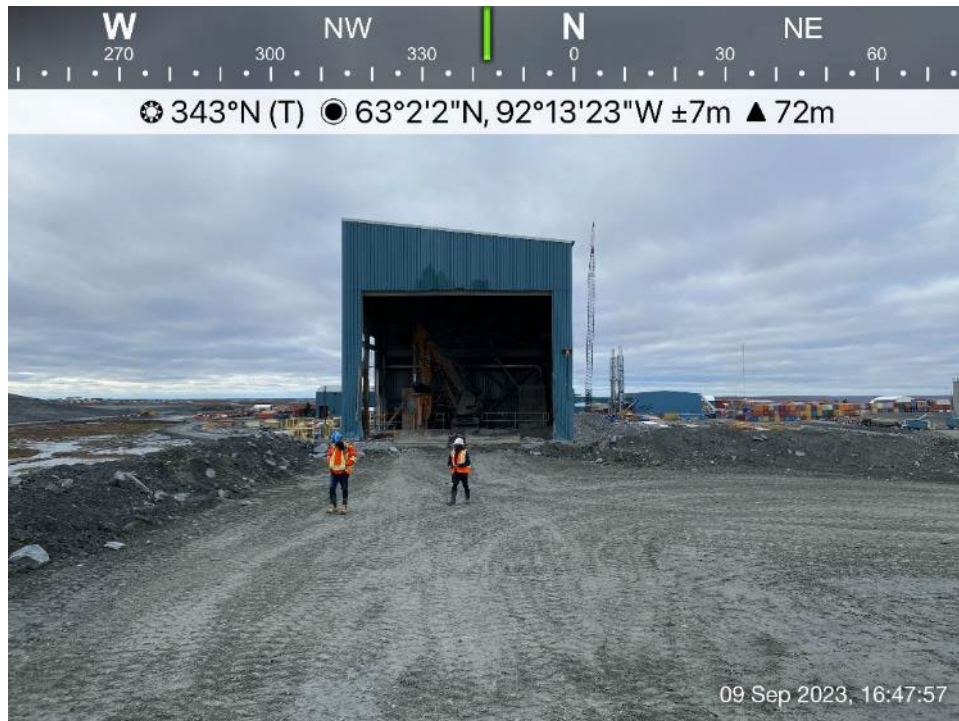
Crusher Pad - Photo 3: Crusher pad top view - looking north.

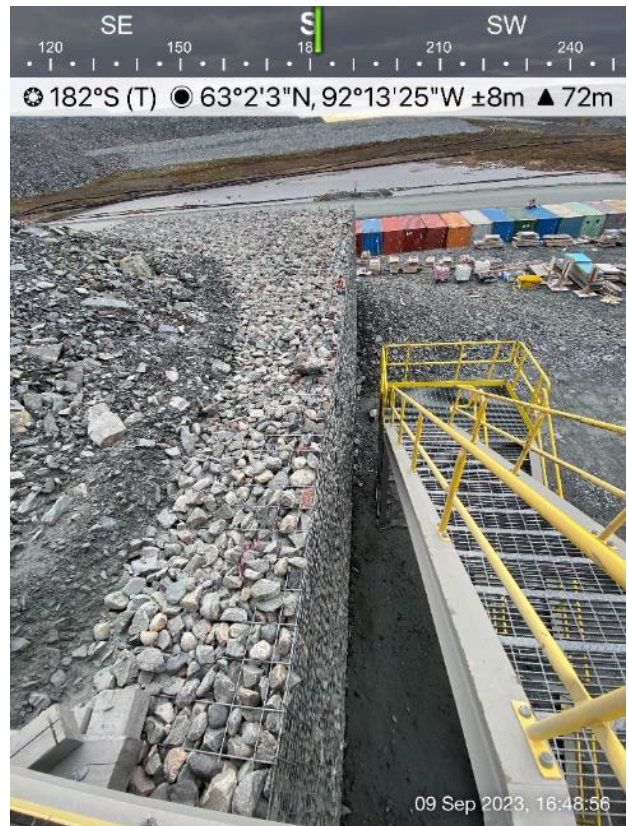
Crusher Pad - Photo 4: Crusher Pad - MSE retaining wall on the northwest corner, looking south.

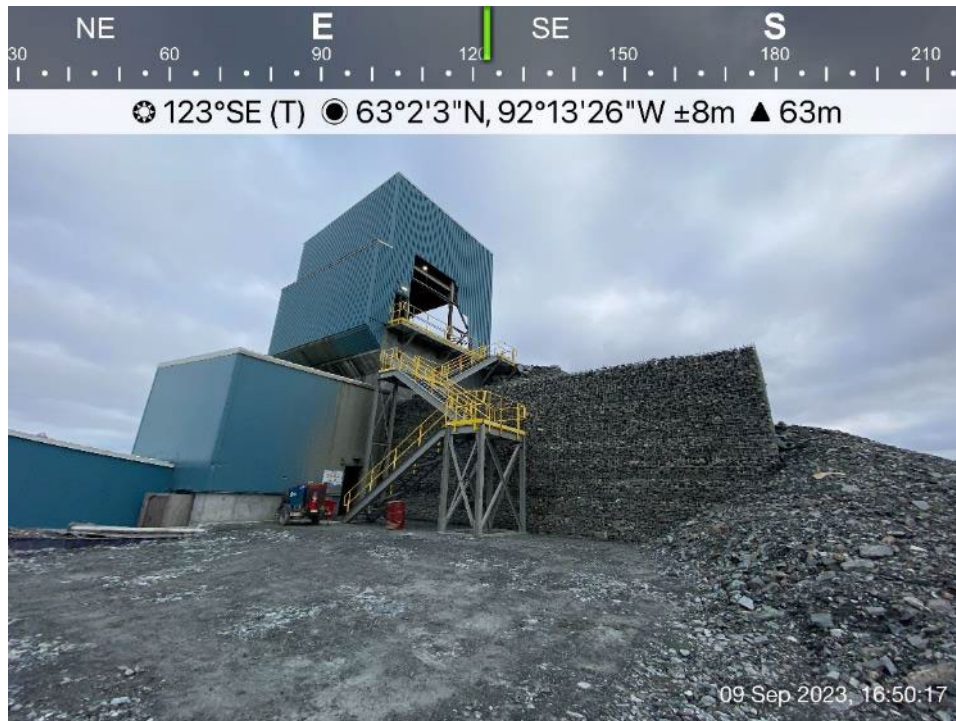
Crusher Pad - Photo 6: Crusher Pad - Overview of MSE retaining wall and crusher building - northwest side, looking southeast.

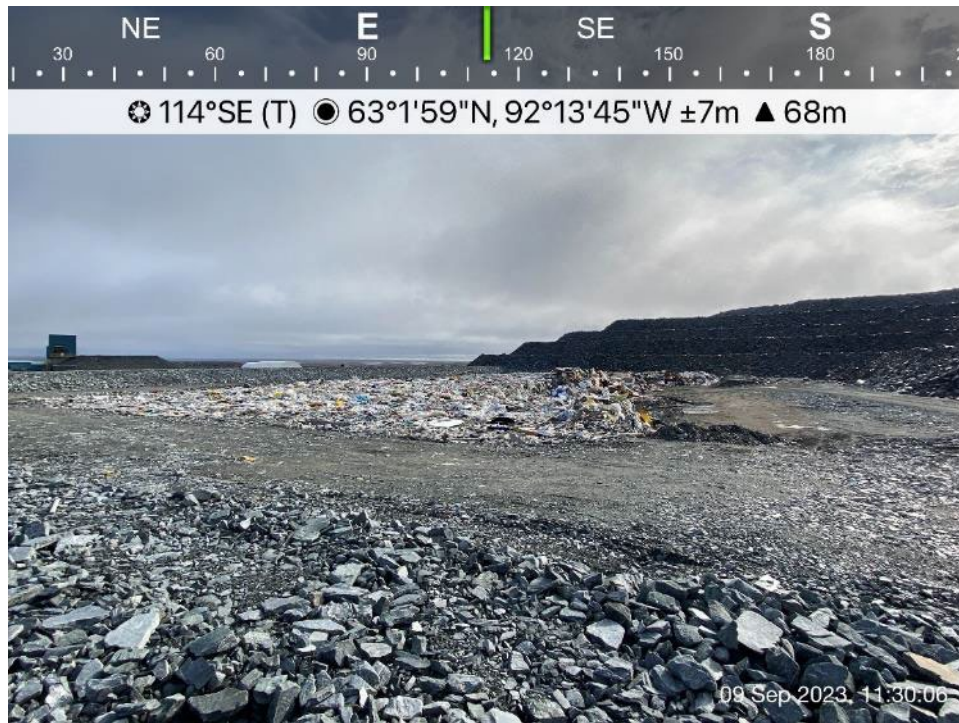
Landfill - Photo 8: WRSF1 Landfill - Overview of landfill, looking southeast.

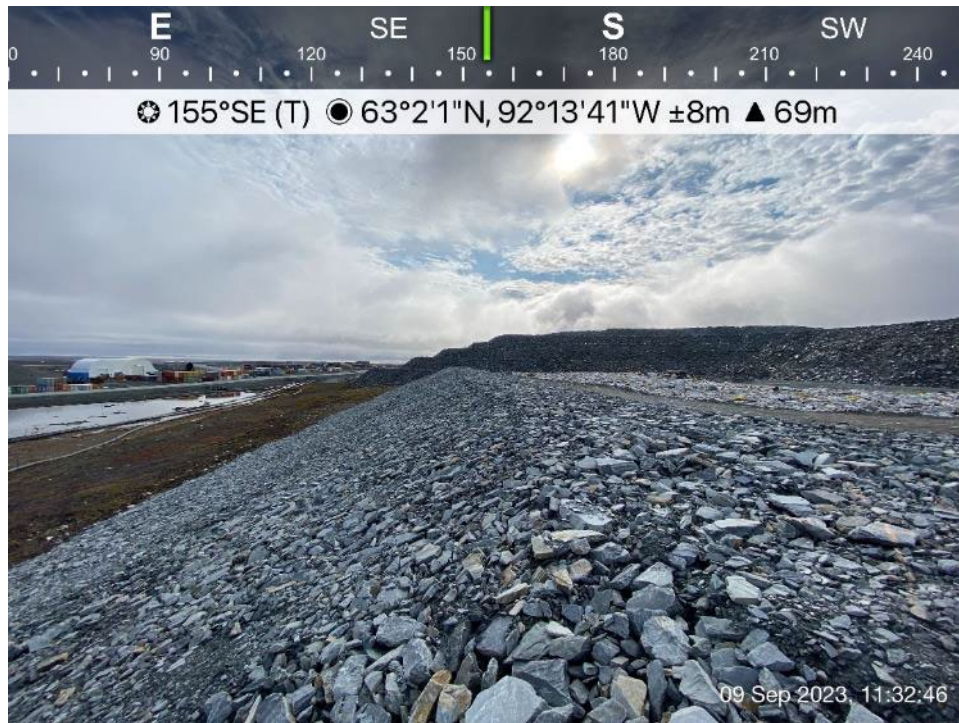
Landfill - Photo 10: WRSF1 Landfill- landfill west side slope, looking southeast.

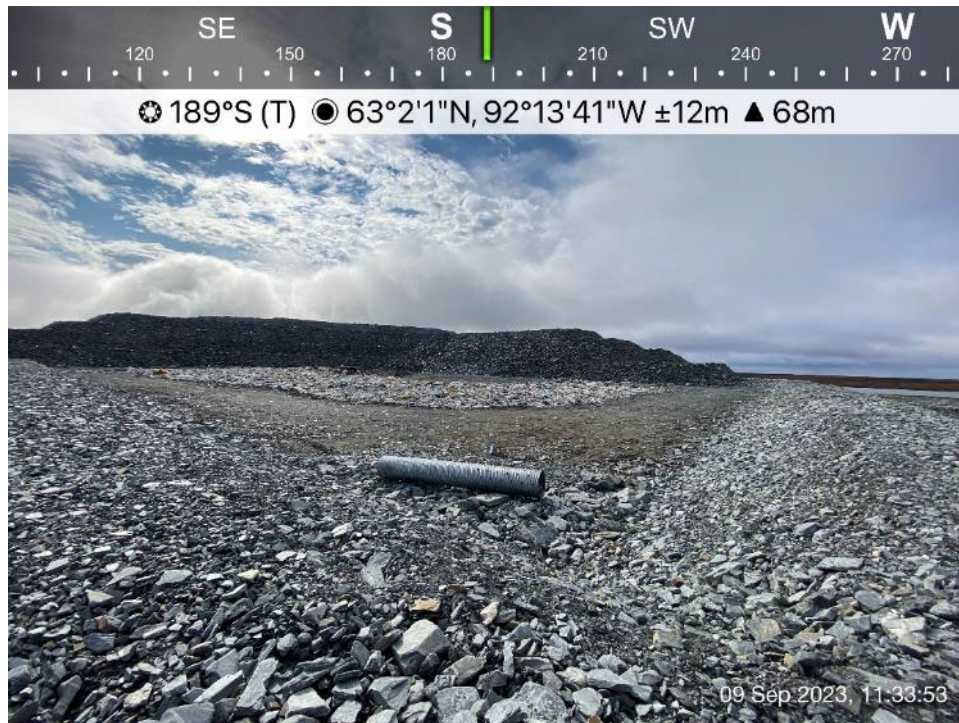
Landfill - Photo 12: WRSF1 Landfill - drainage well (to be installed for water management).

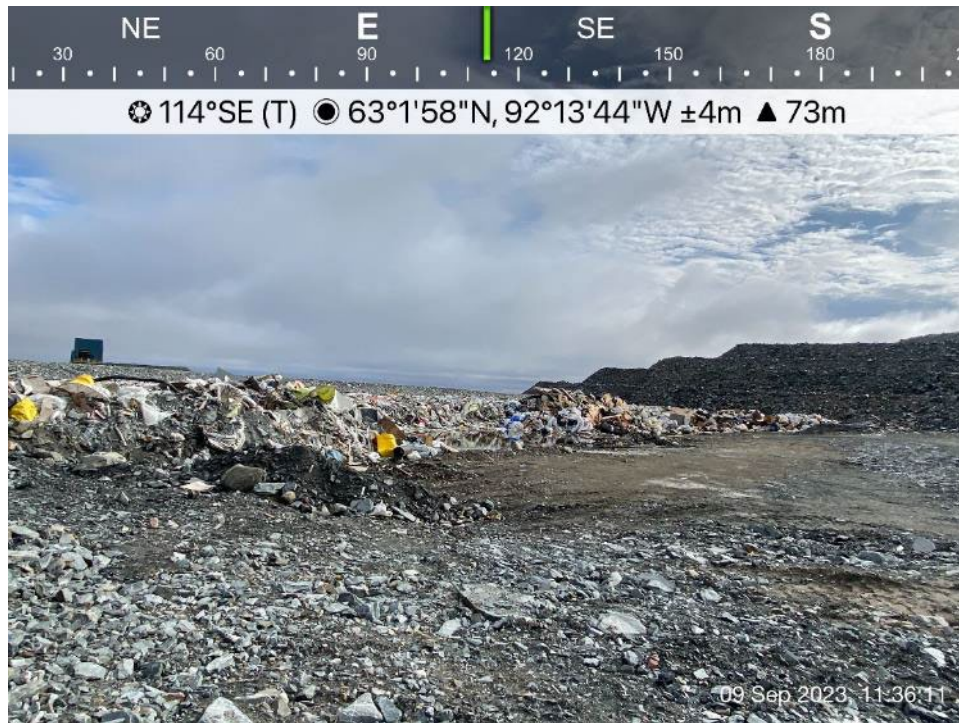
Landfill - Photo 13: WRSF1 Landfill - landfill waste and deris.

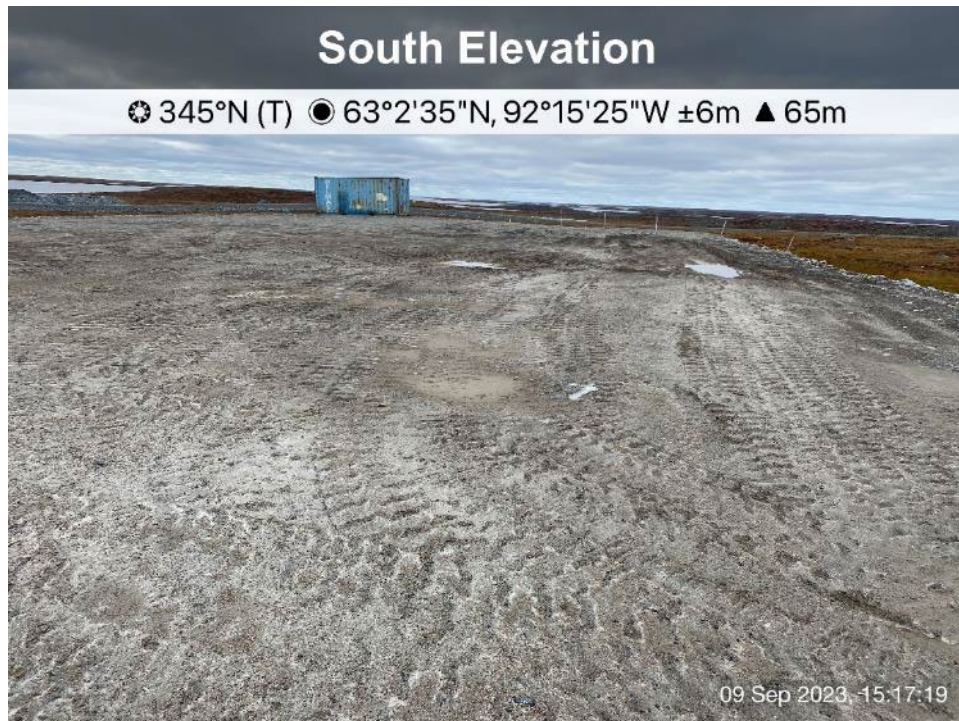
Emulsion Plant Pad - Photo 14: Emulsion Plant Pad - Overview, looking north.

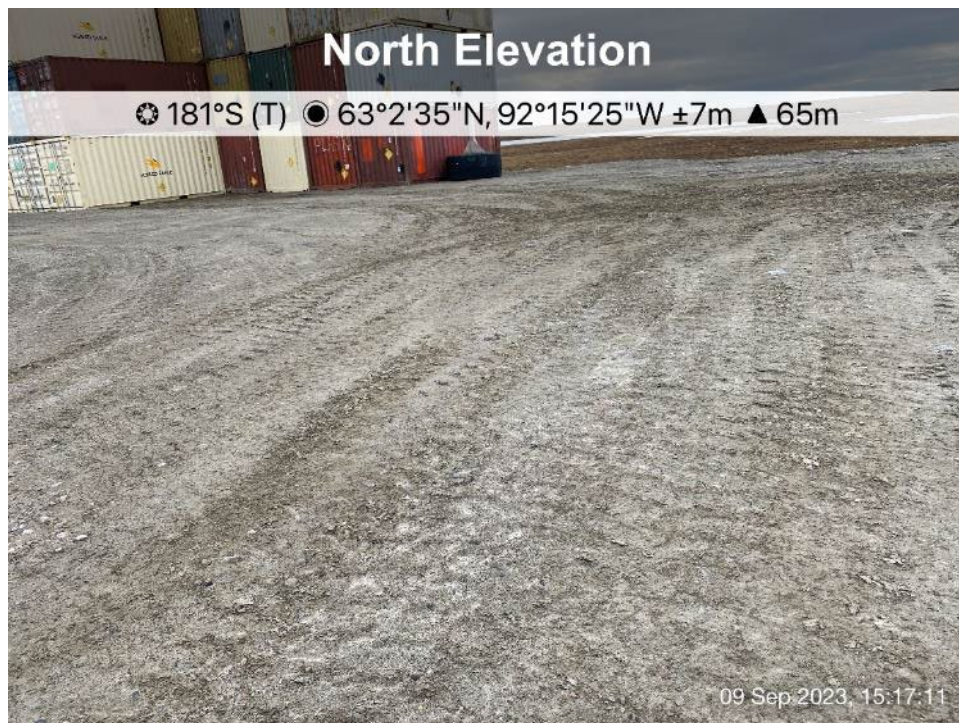
Emulsion Plant Pad - Photo 15: Emulsion Plant Pad - Overview, looking south.

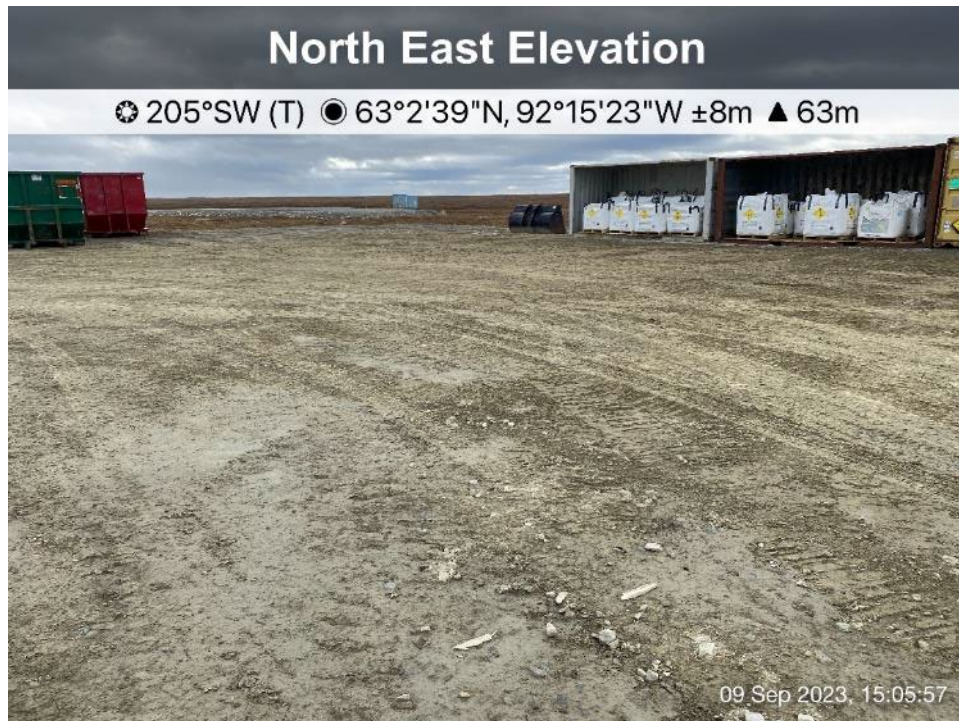
Emulsion Plant Pad - Photo 16: Emulsion Plant Pad - Overview, looking southwest.

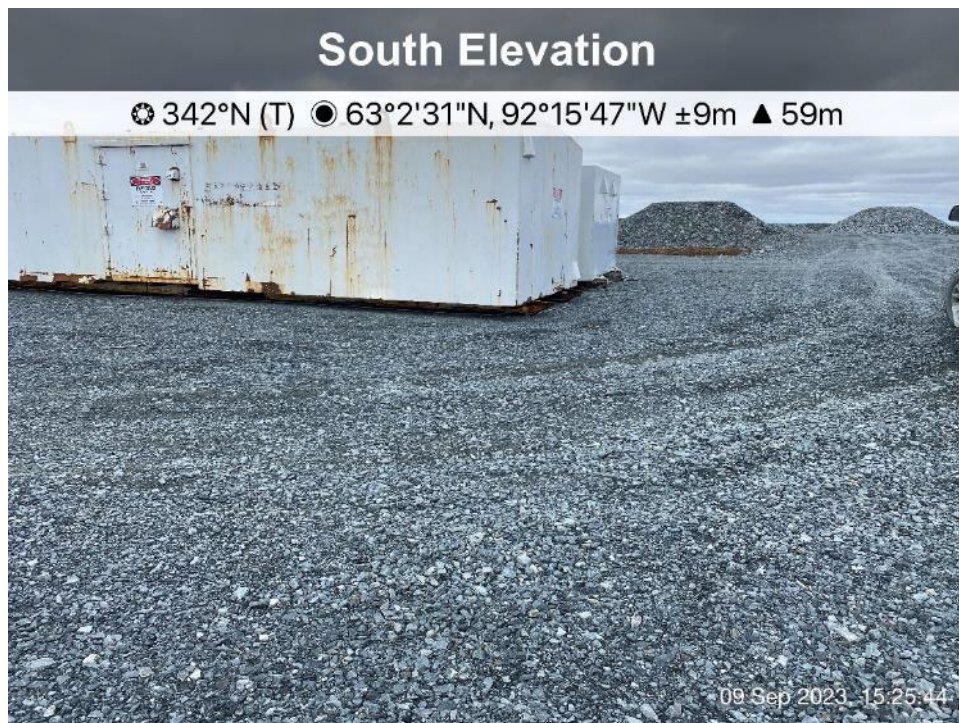
Emulsion Plant Pad - Photo 17: Emulsion Storage Pad- Overview, looking north.

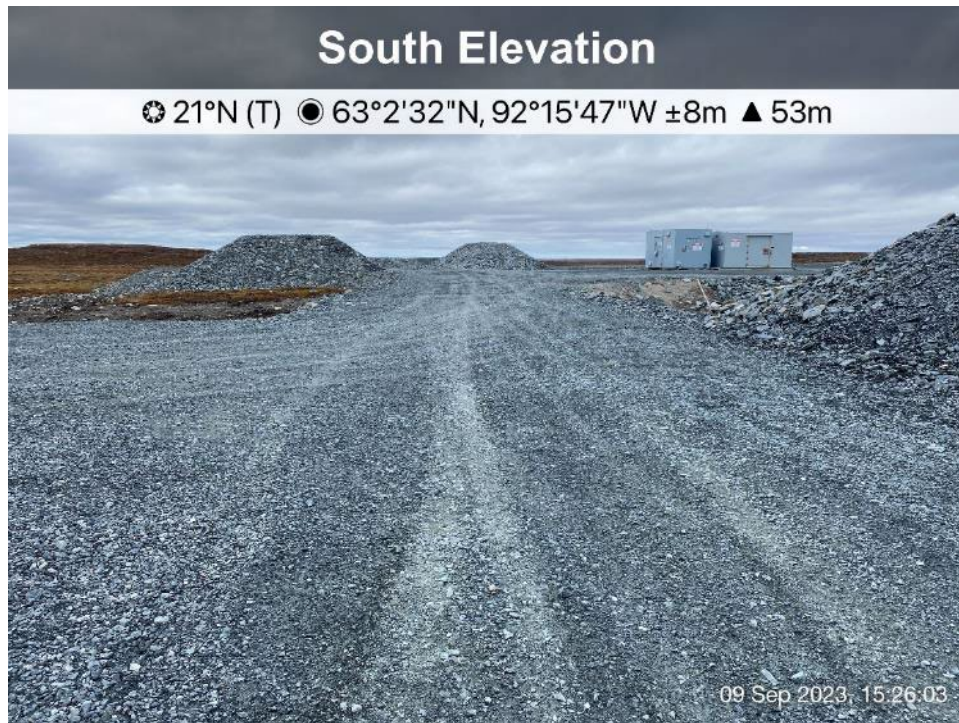
Emulsion Plant Pad - Photo 18: Emulsion Storage Pad - Overview, looking north.

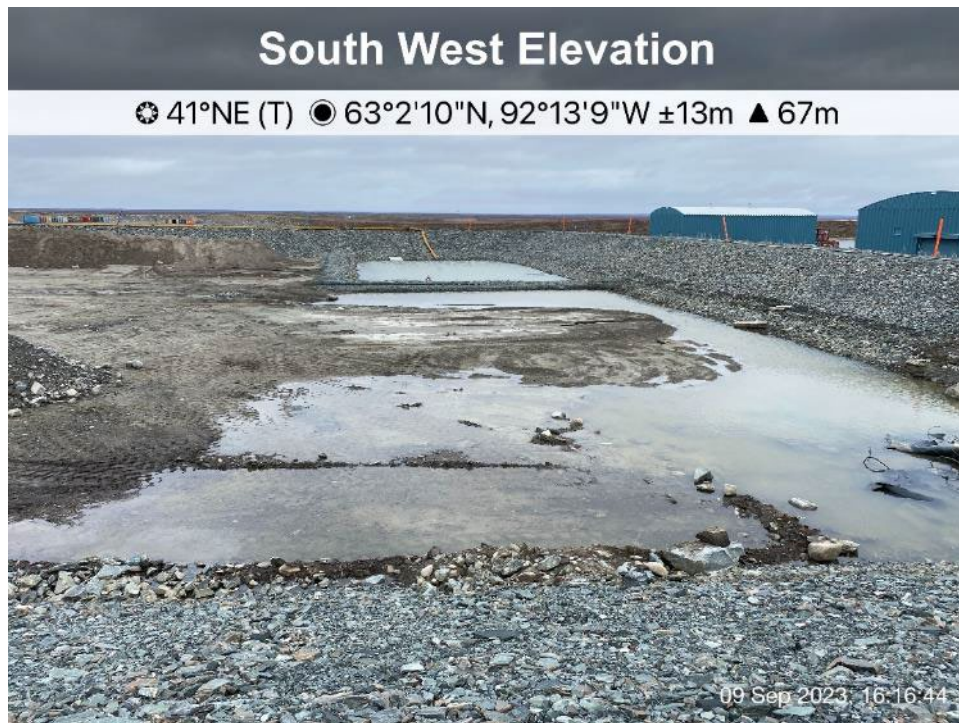
Landfarm - Photo 22: Landfarm - water collection pond and water ponding

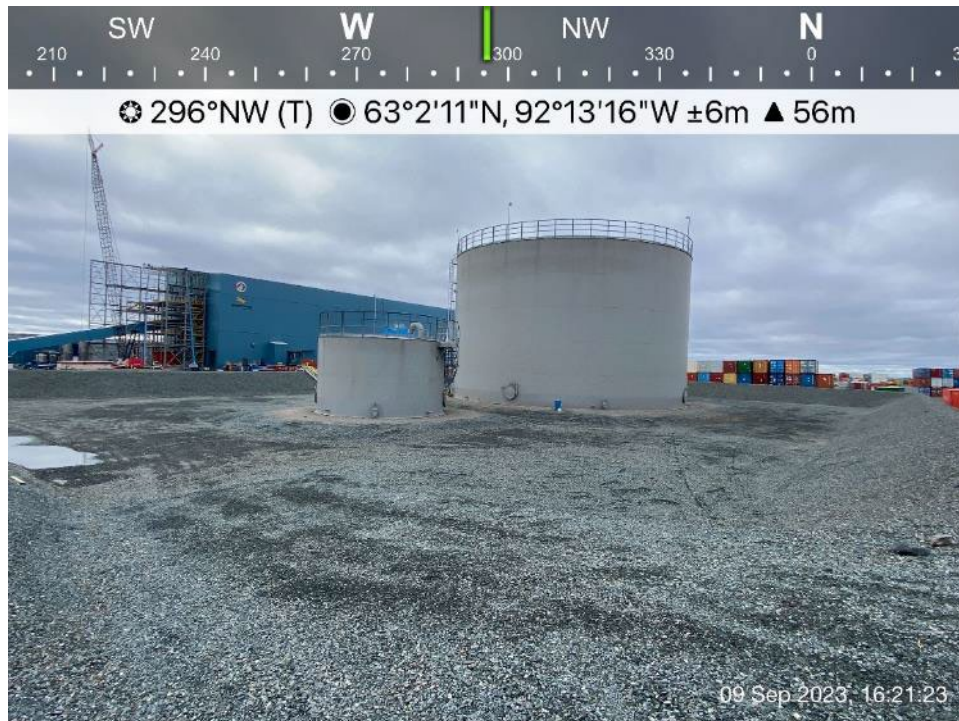
Industrial Fuel Tanks -Photo 23: Industrial Fuel Tanks - Overview, looking northwest.
