APPENDIX 6 2023 ANNUAL GEOTECHNICAL INSPECTION REPORT

2023 Annual Geotechnical Inspection Meliadine Gold Mine, Nunavut, Canada

PRESENTED TO
Agnico Eagle Mines Limited

JANUARY 31, 2024
ISSUED FOR USE
FILE: 704-ENG.EARC03140-33
AGNICO EAGLE DOCUMENT NUMBER: 65-600-230-TCR-001

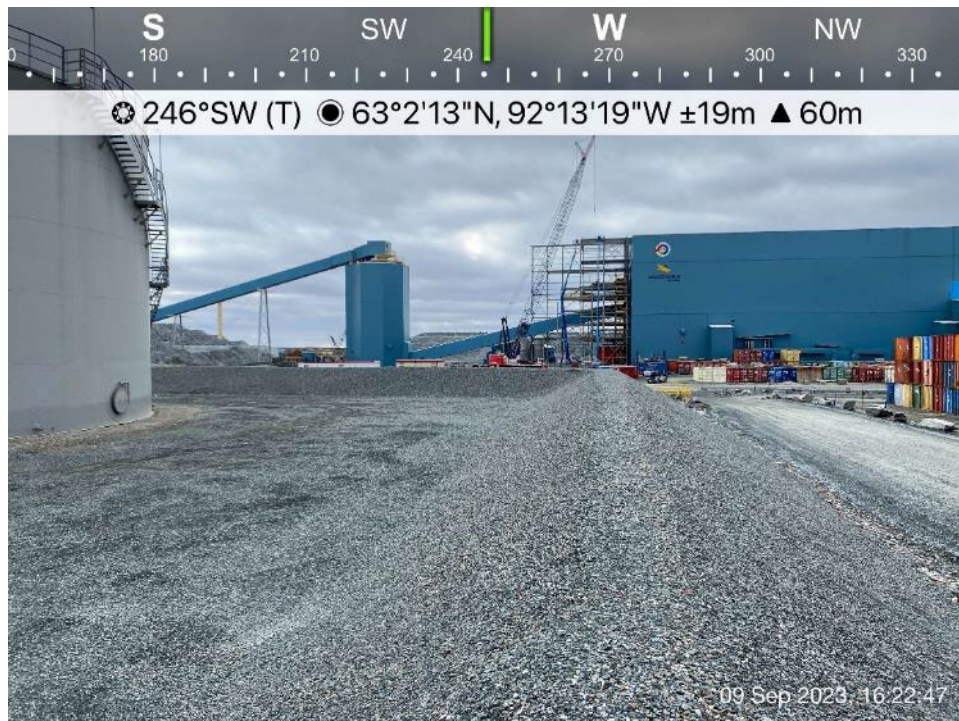
Industrial Fuel Tanks -Photo 24: Industrial Fuel Tanks - north side berm, looking southwest.

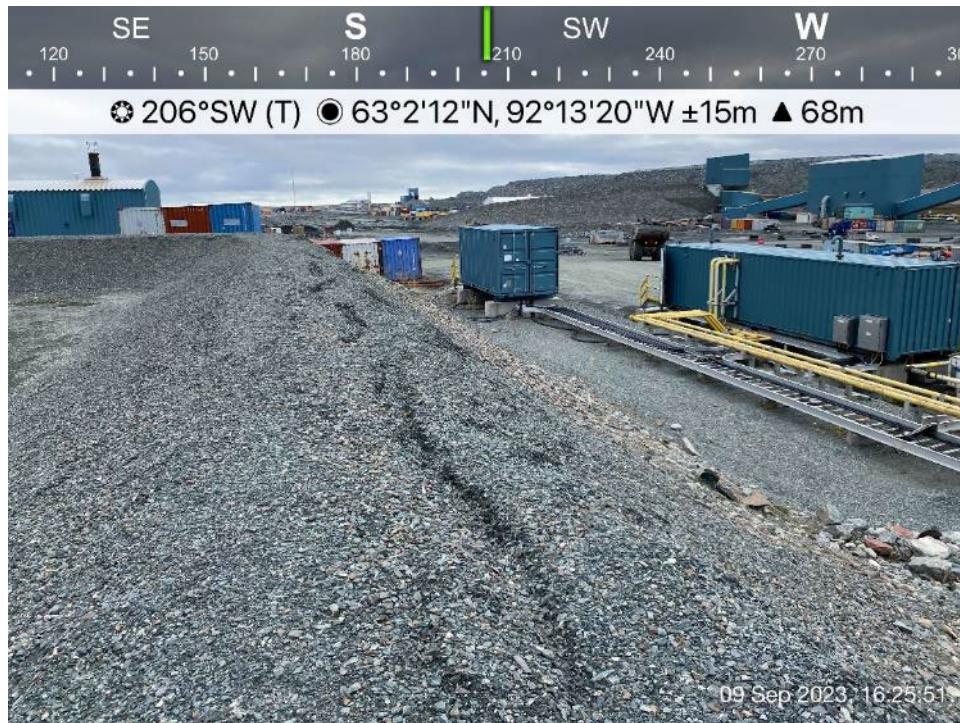
Industrial Fuel Tanks -Photo 25: Industrial Fuel Tanks - west side berm, looking southwest.

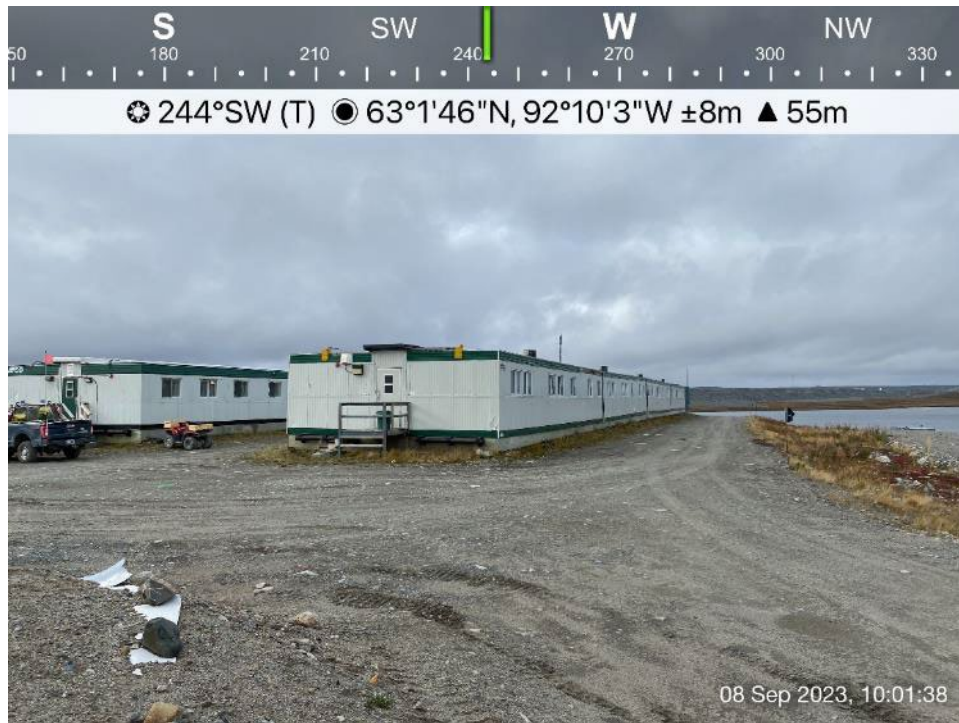
Exploration Camp - Photo 1: Exploration Camp - Overview, looking southwest.

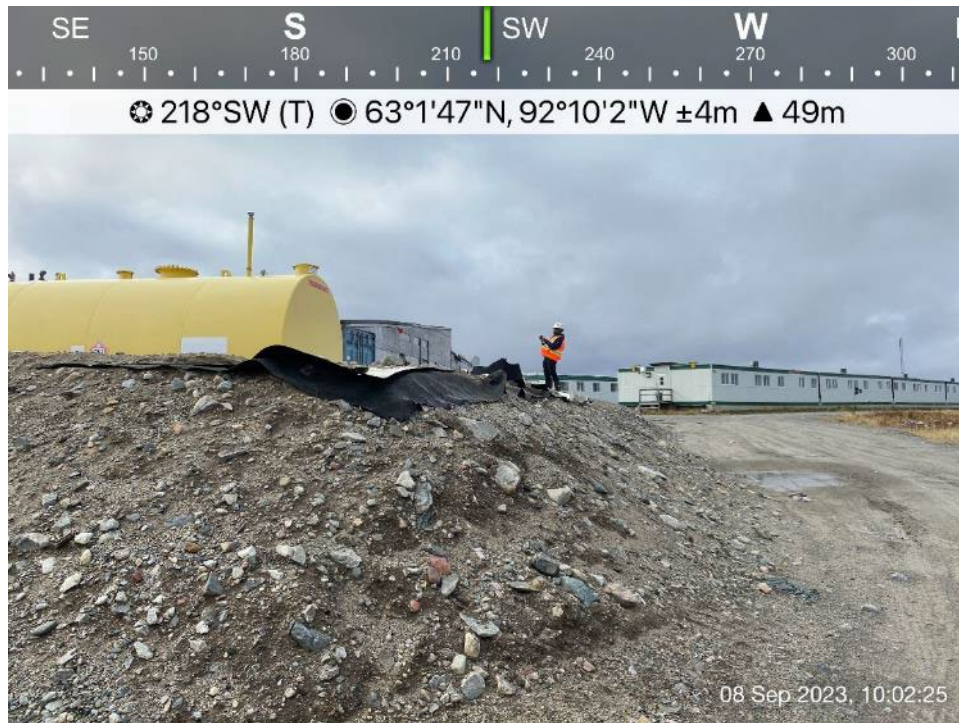
Exploration Camp - Photo 2: Exploration Camp - Fuel storage, looking southwest.

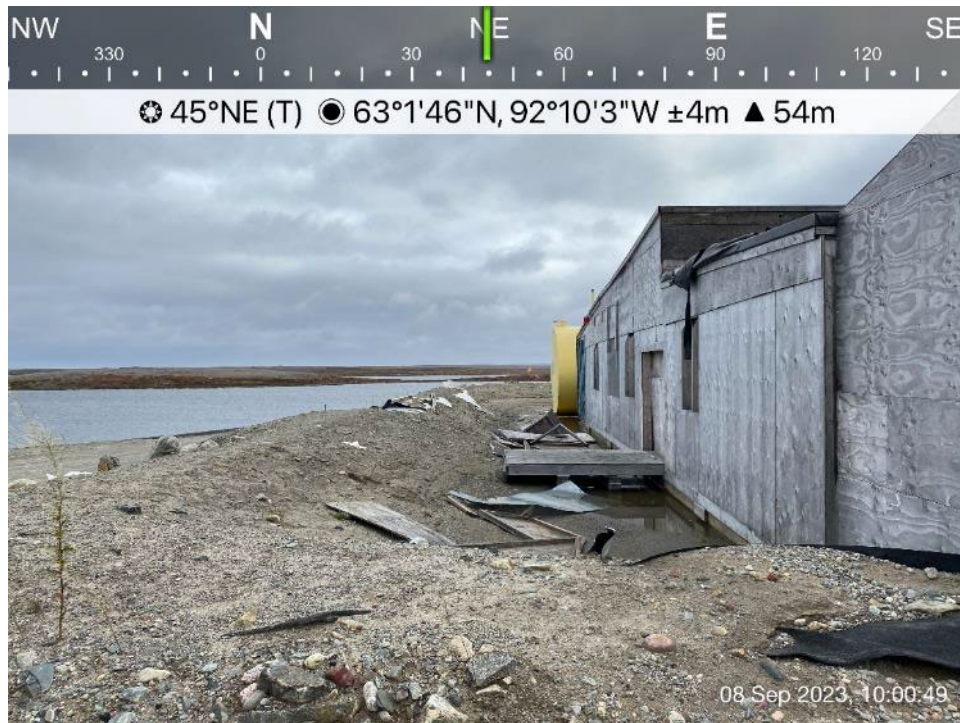
Exploration Camp - Photo 3: Exploration Camp - Fuel storage, looking northeast.

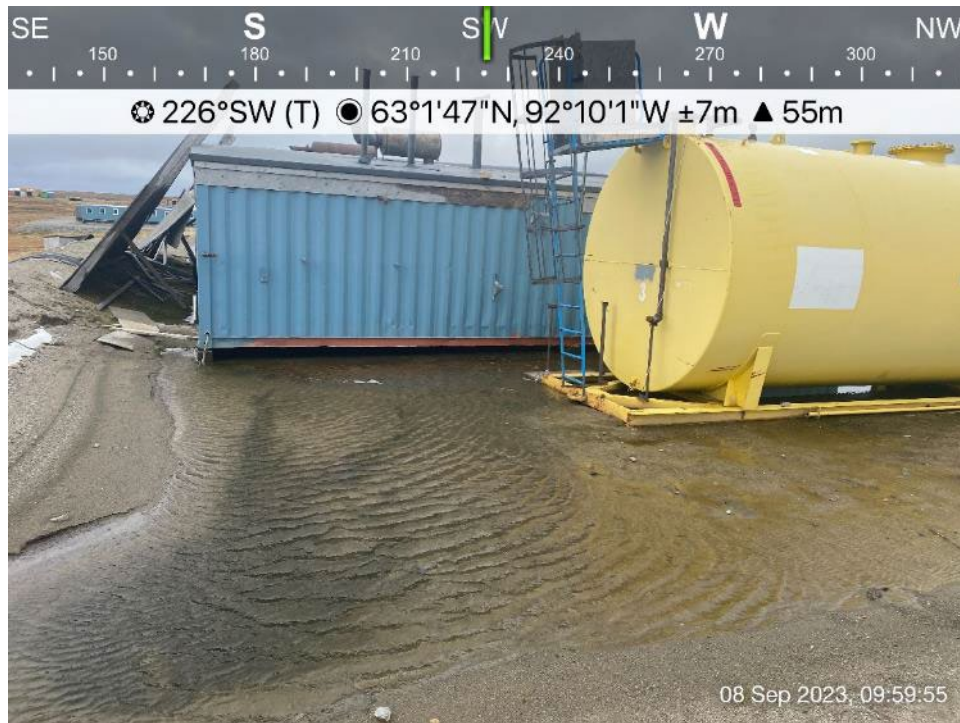
Exploration Camp - Photo 4: Exploration Camp - Fuel storage, looking southwest.

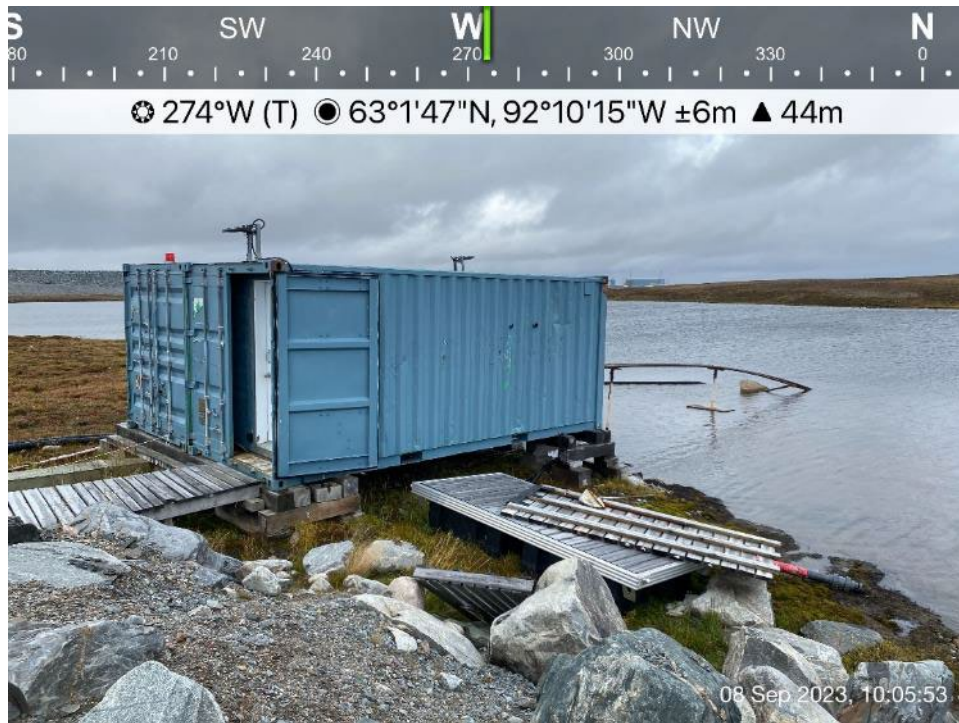
Exploration Camp - Photo 6: Exploration Camp - freshwater intake pump house, looking west.

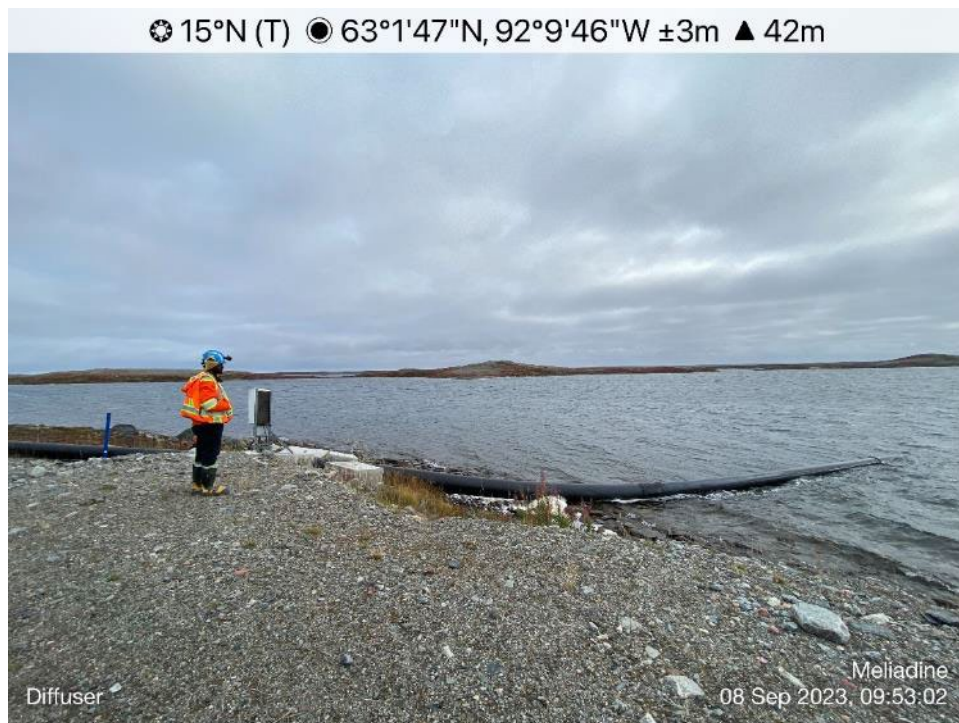
Exploration Camp - Photo 8: Exploration Camp - diffuer pipeline, looking north.

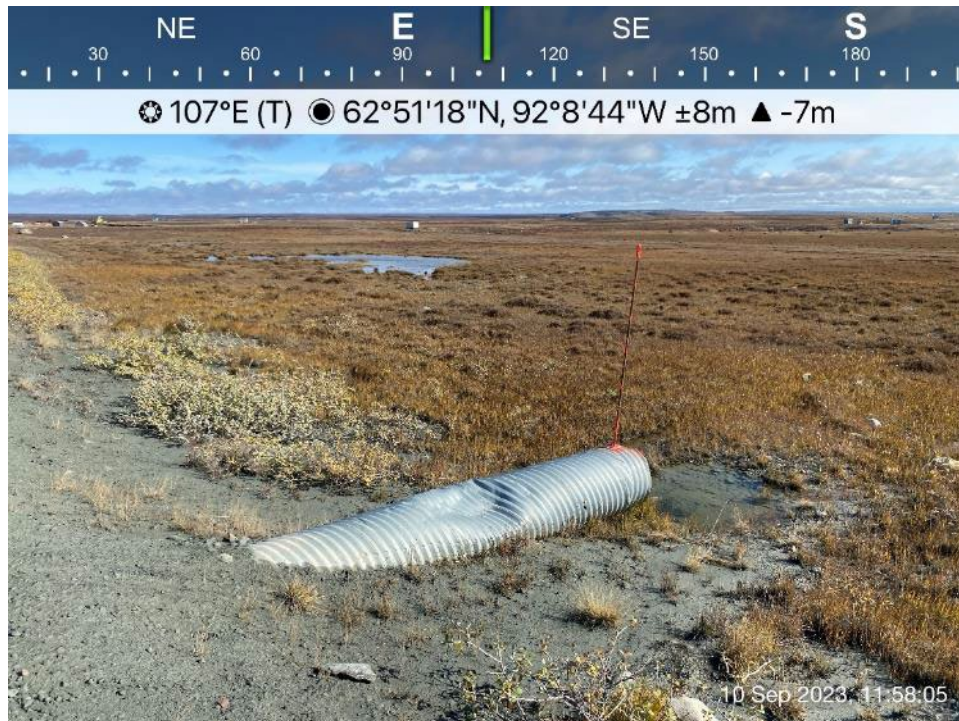
AWAR Road/Culvert - Photo 1: Culvert KM 5.5 - inlet.

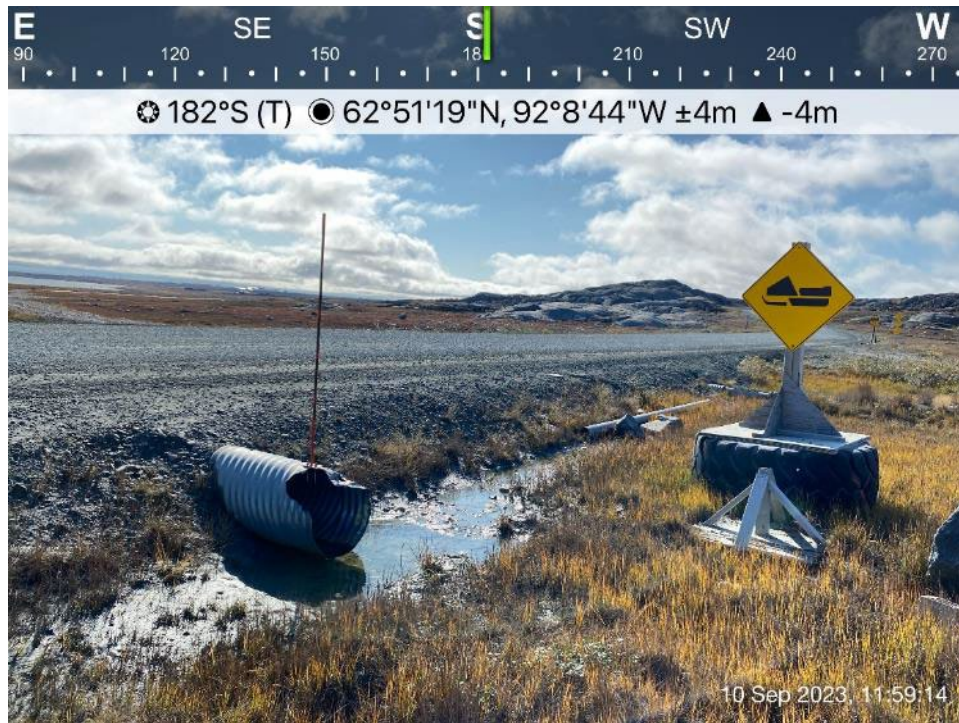
AWAR Road/Culvert - Photo 2: Culvert KM 5.5 - outlet.

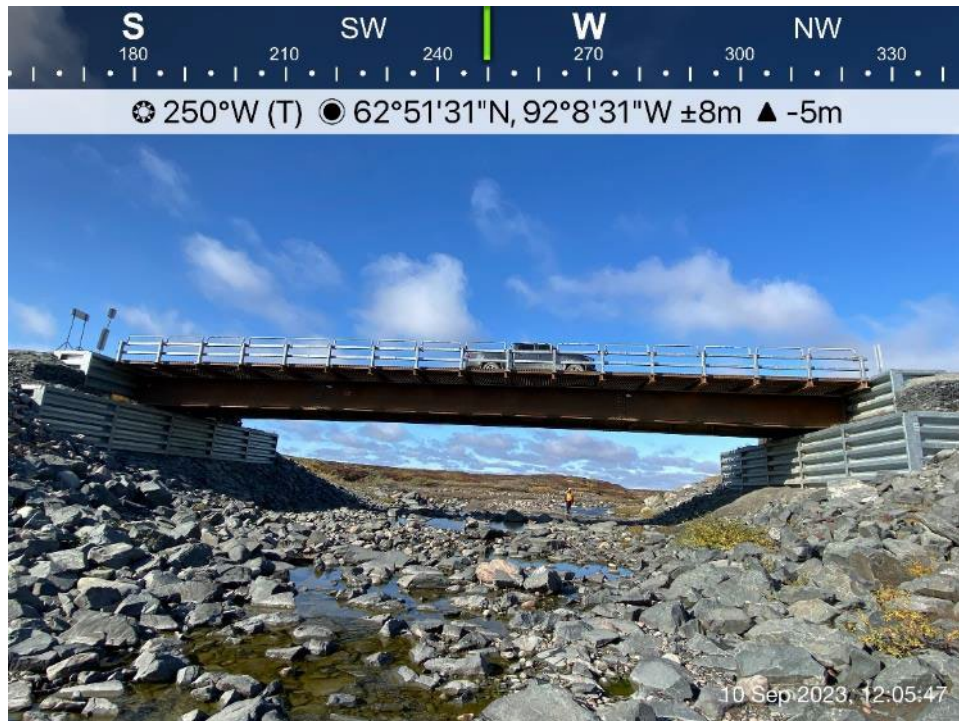
AWAR Road/Culvert - Photo 3: Char River Bridge KM 6.0.

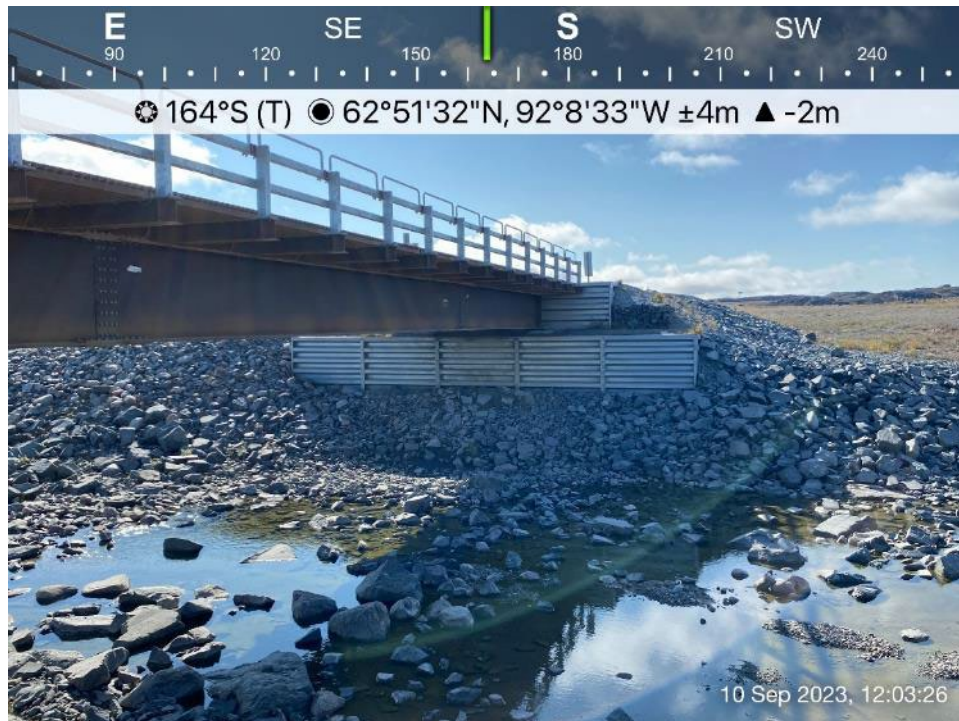
AWAR Road/Culvert - Photo 4: Char River Bridge KM 6.1 - north abutment.

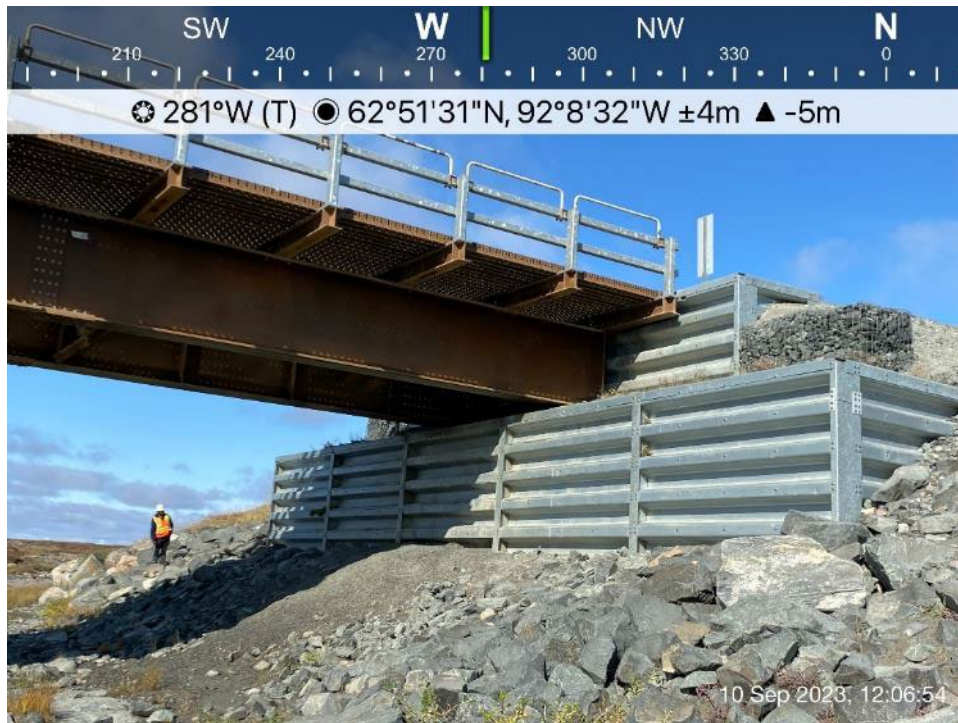
AWAR Road/Culvert - Photo 5: Char River Bridge KM 6.1 - south abutment.

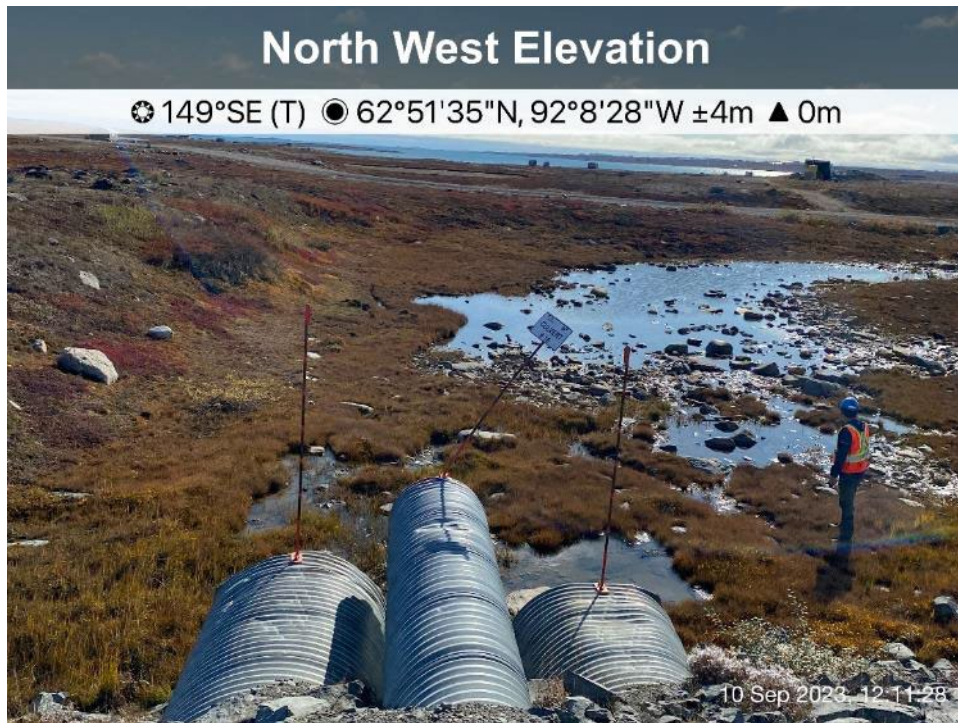
AWAR Road/Culvert - Photo 6: Culvert KM 6.2 - inlet.

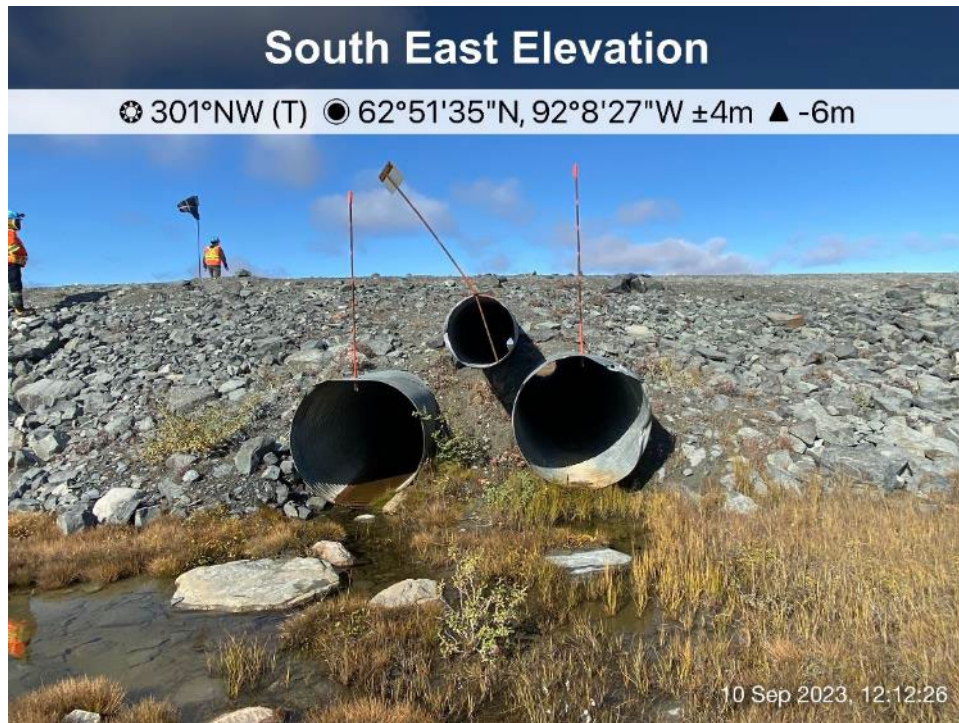
AWAR Road/Culvert - Photo 7: Culvert KM 6.2 - inlet.

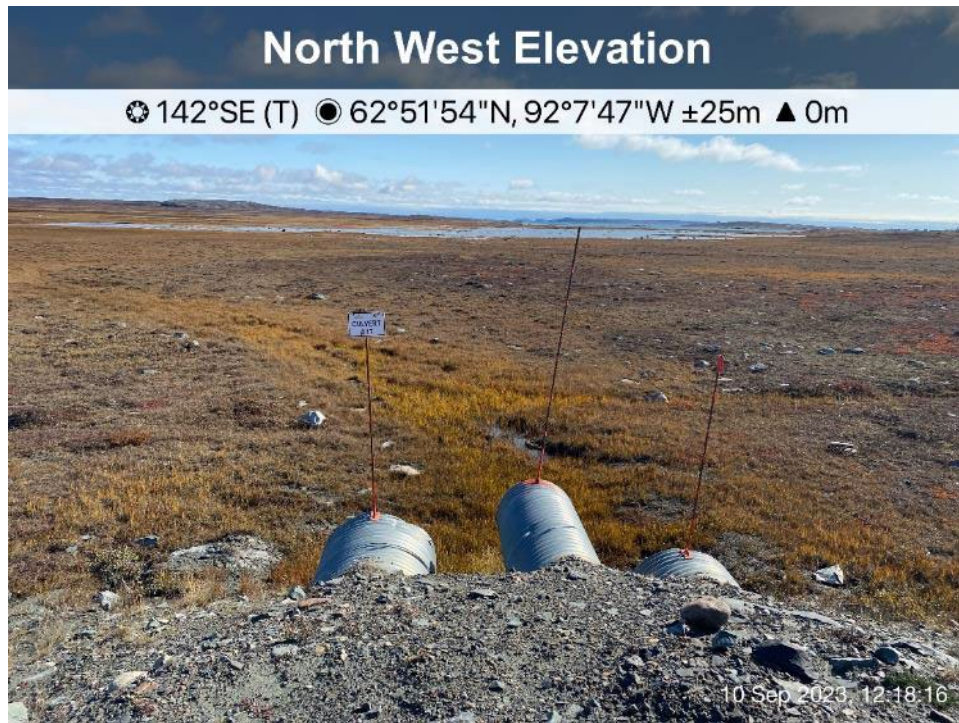
AWAR Road/Culvert - Photo 9: Culvert KM 7.0 - inlet.

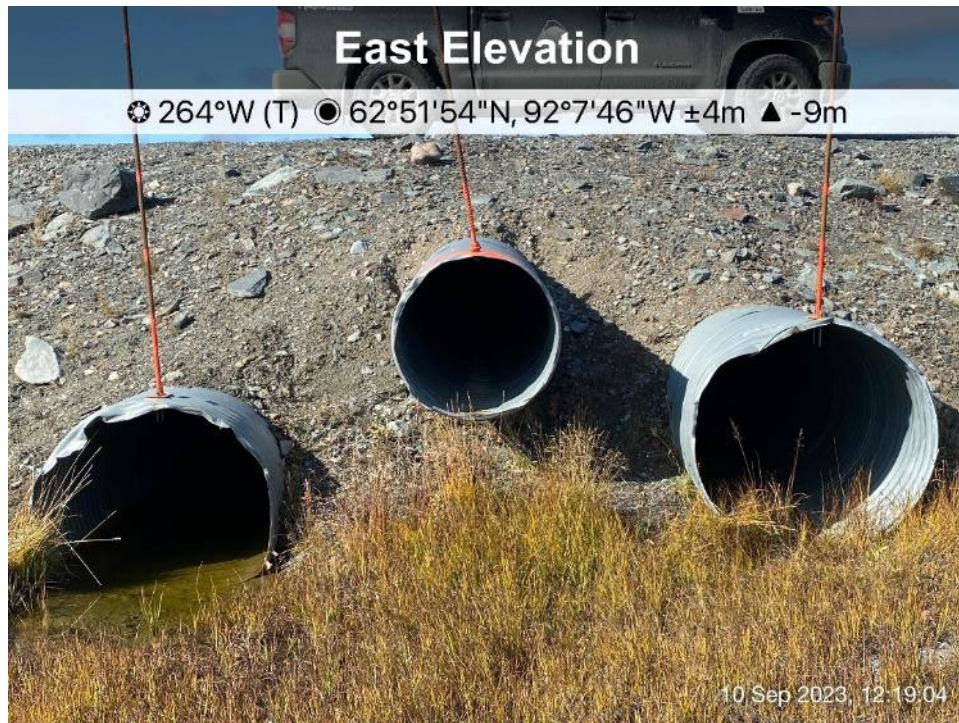
AWAR Road/Culvert - Photo 10: Culvert KM 7.0 - inlet.

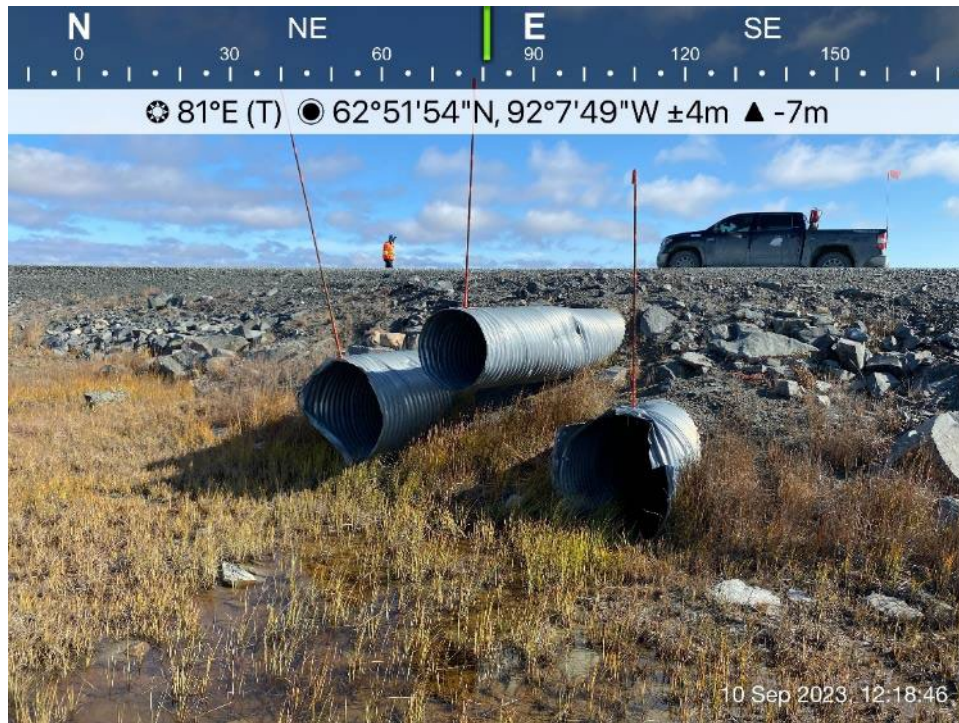
AWAR Road/Culvert - Photo 11: Culvert KM 7.0 - outlet.

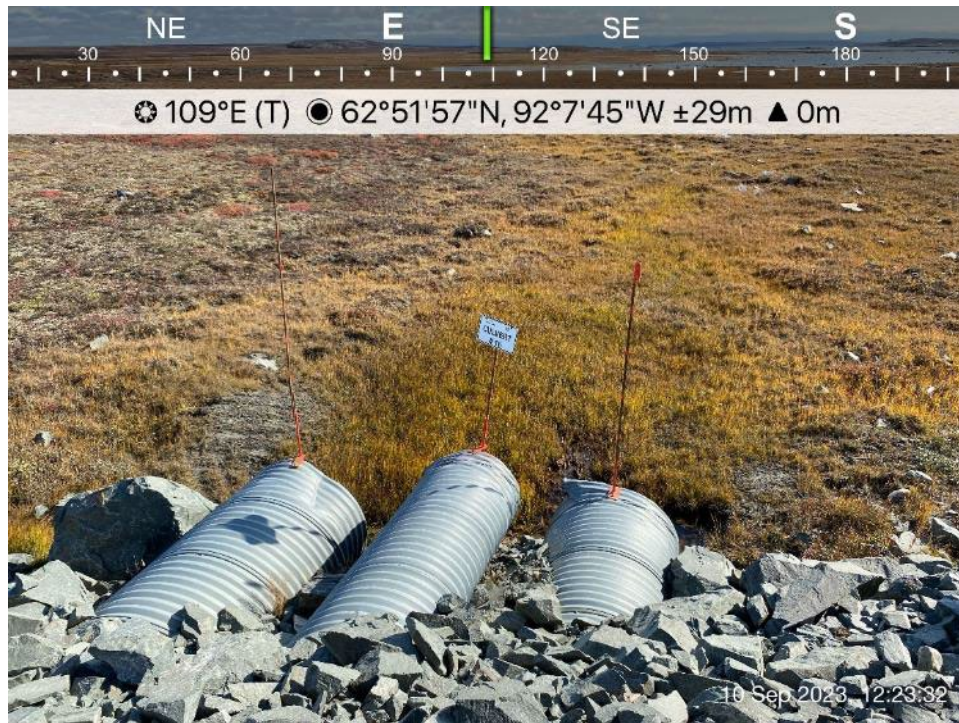
AWAR Road/Culvert - Photo 12: Culvert KM 7.1 - inlet.

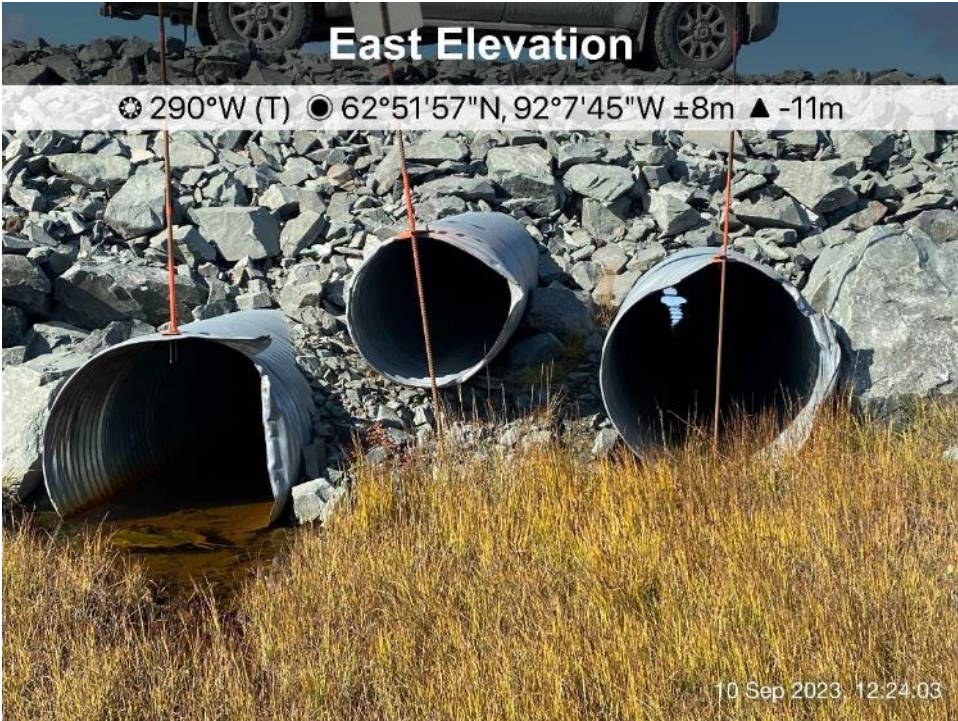
AWAR Road/Culvert - Photo 13: Culvert KM 7.1 – inlet.

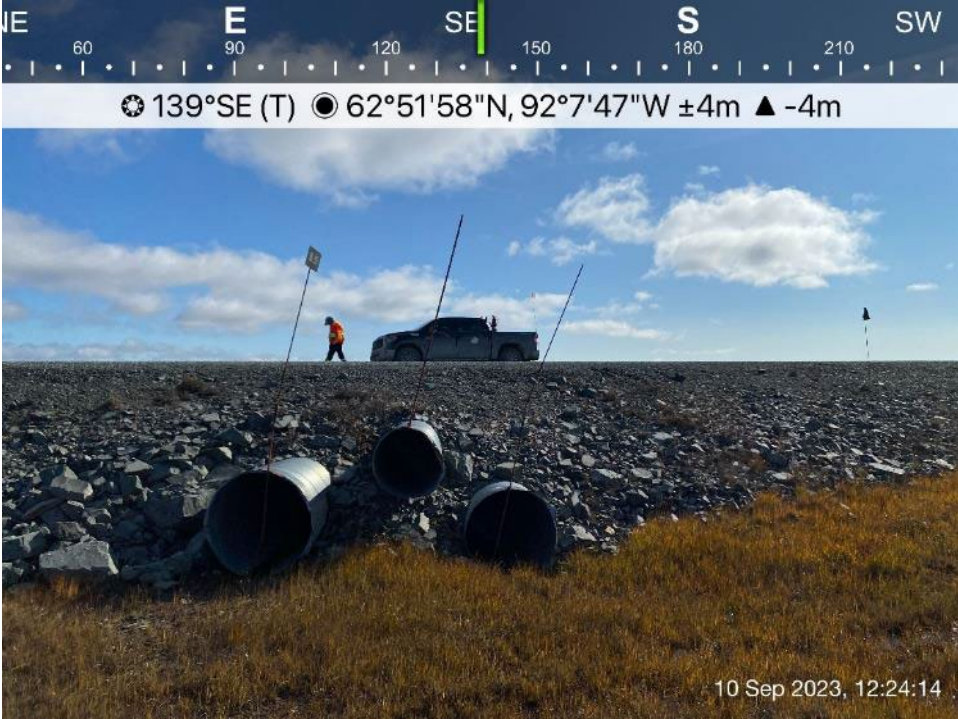
AWAR Road/Culvert - Photo 14: Culvert KM 7.1 – outlet.

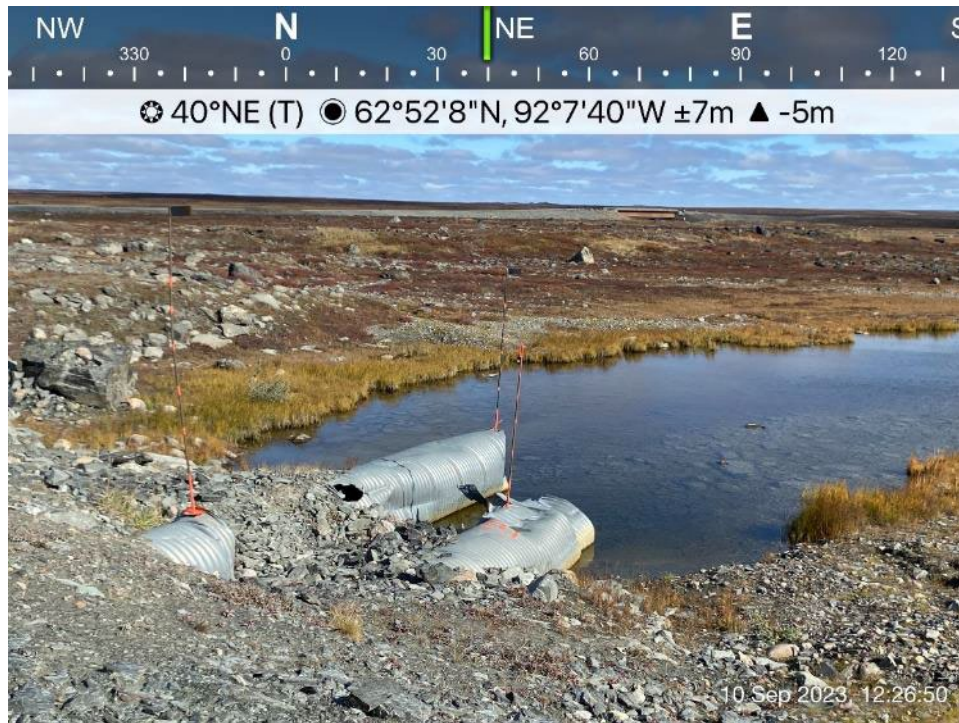
AWAR Road/Culvert - Photo 15: Culvert KM 7.4 – inlet.

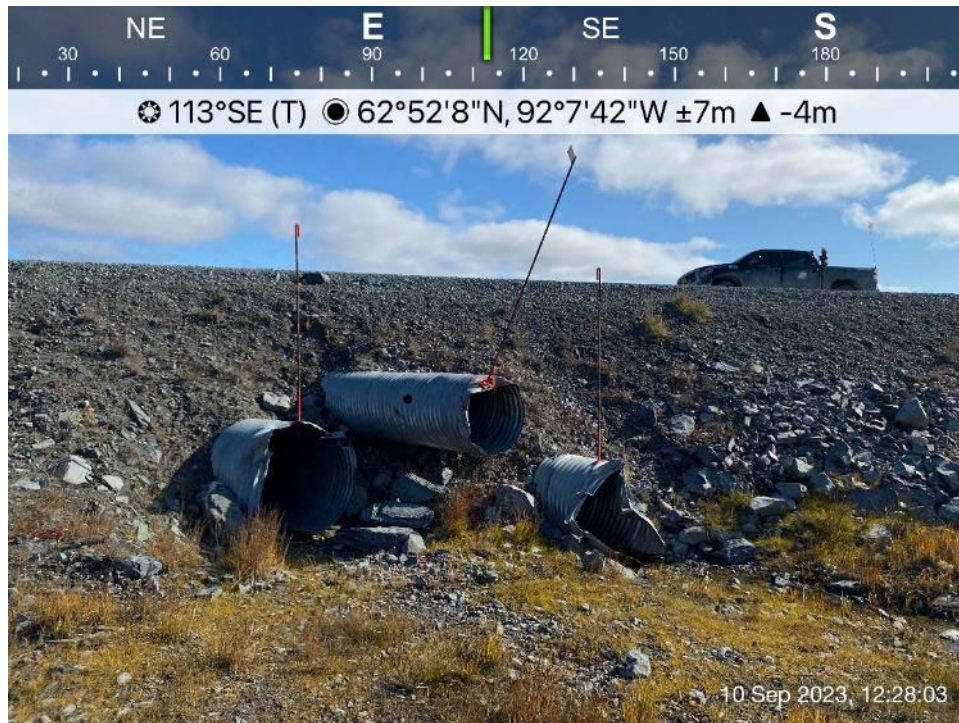
AWAR Road/Culvert - Photo 16: Culvert KM 7.4 – outlet.

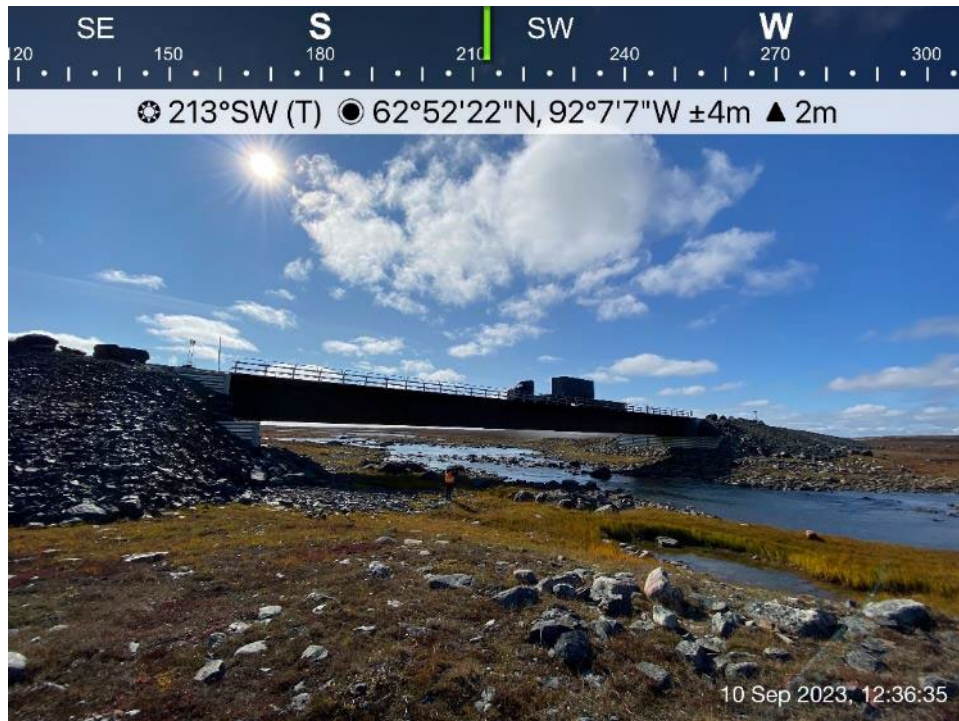
AWAR Road/Culvert - Photo 17: Meliadine River Bridge KM 8.0.

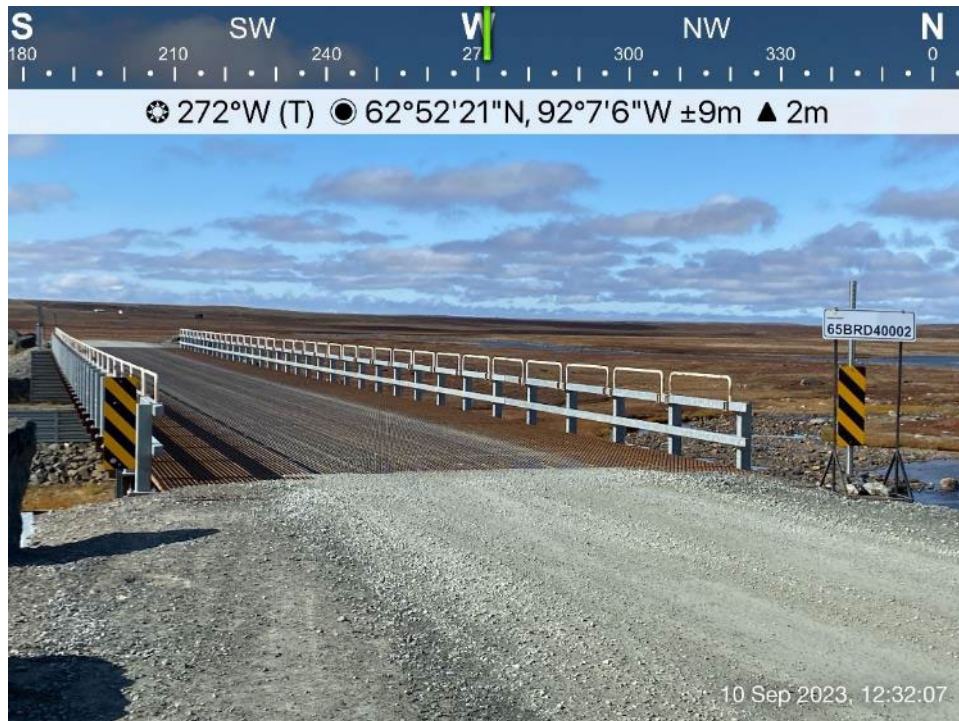
AWAR Road/Culvert - Photo 18: Meliadine River Bridge KM 8.0.

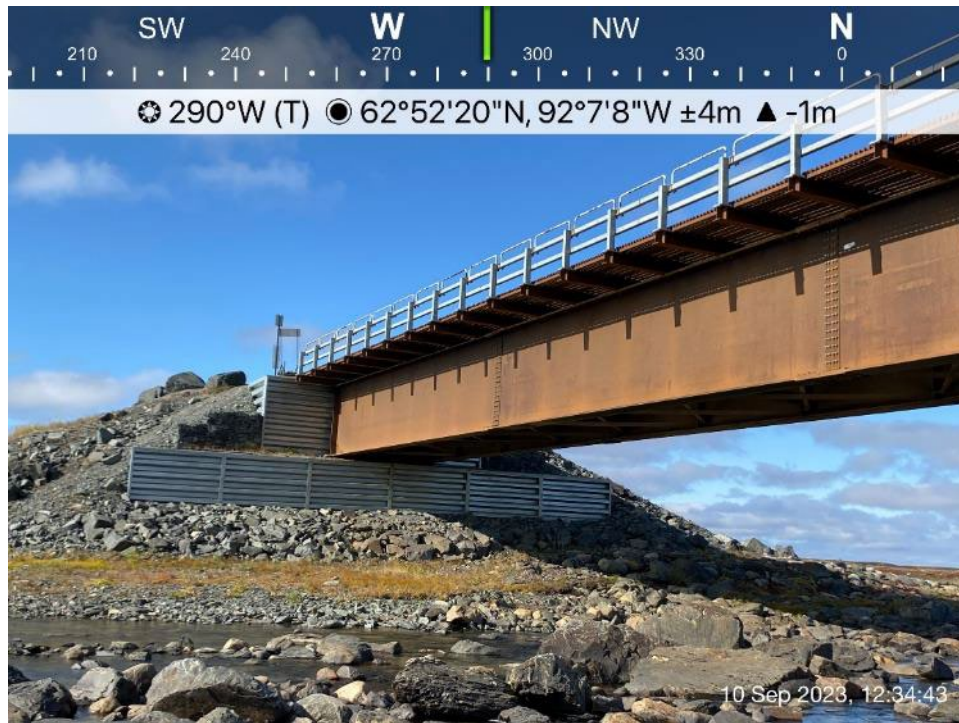
AWAR Road/Culvert - Photo 19: Meliadine River Bridge KM 8.0- east abutment.

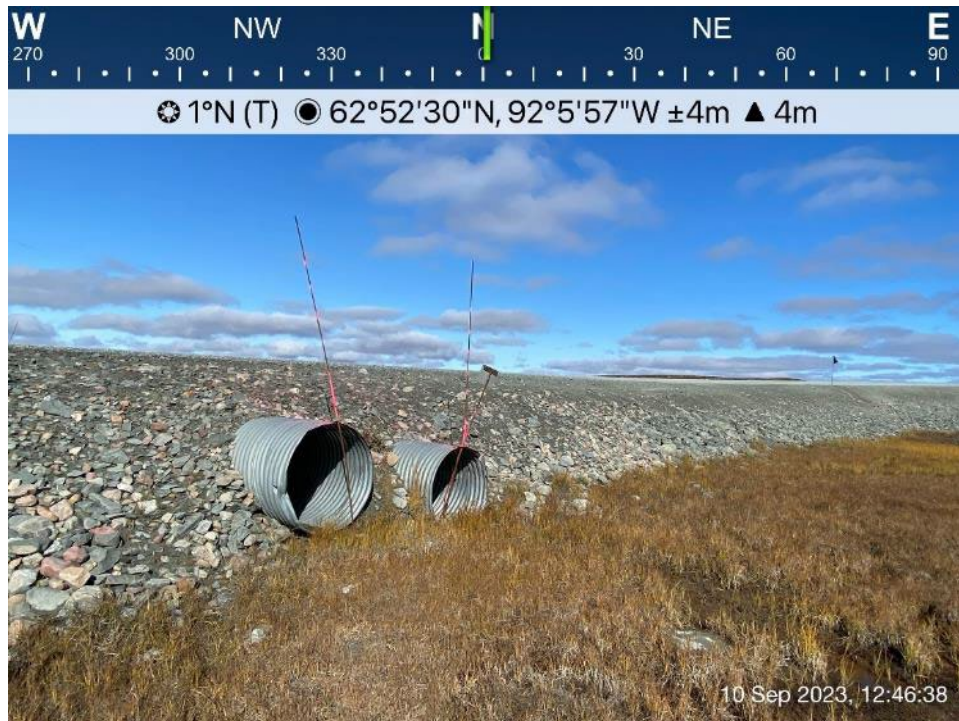
AWAR Road/Culvert - Photo 22: Culvert KM 9.1 – inlet.

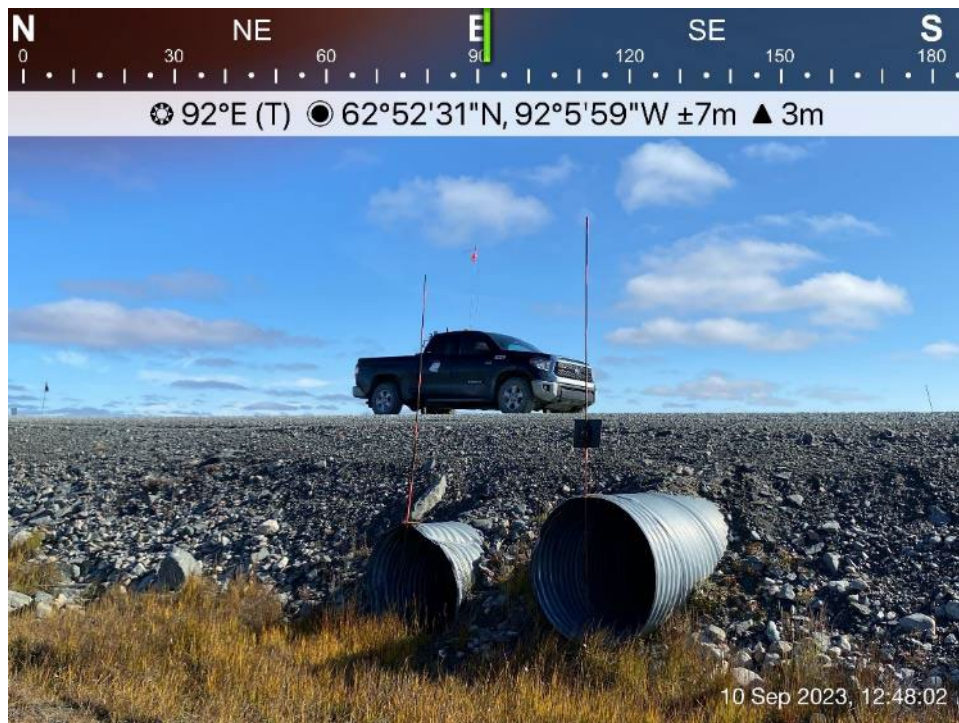
AWAR Road/Culvert - Photo 23: Culvert KM 9.1 – inlet.

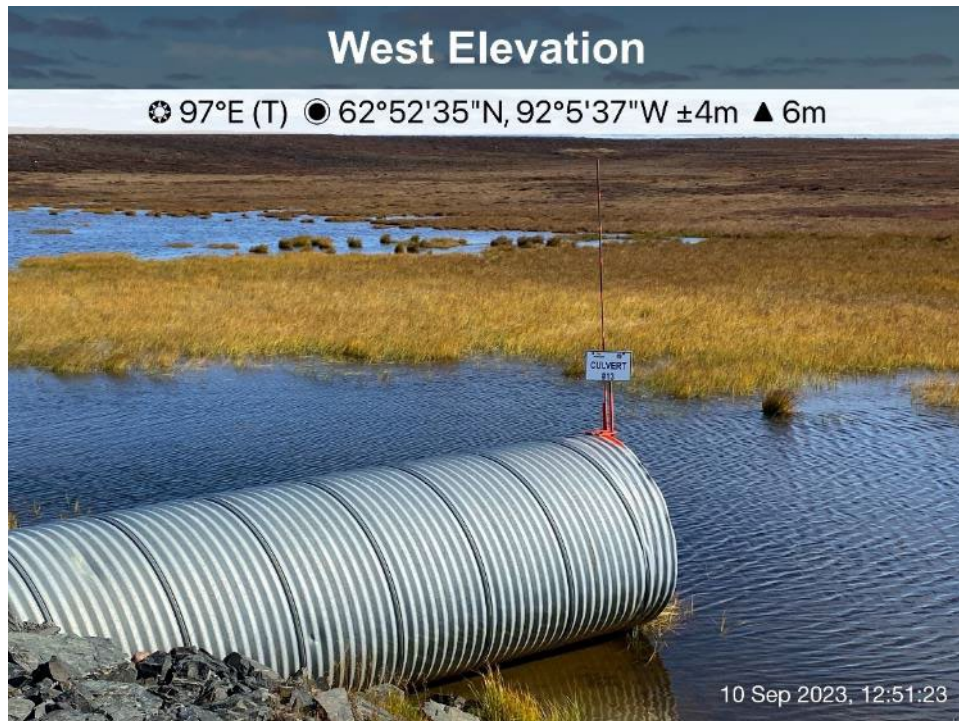
AWAR Road/Culvert - Photo 24: Culvert KM 9.1 – outlet.

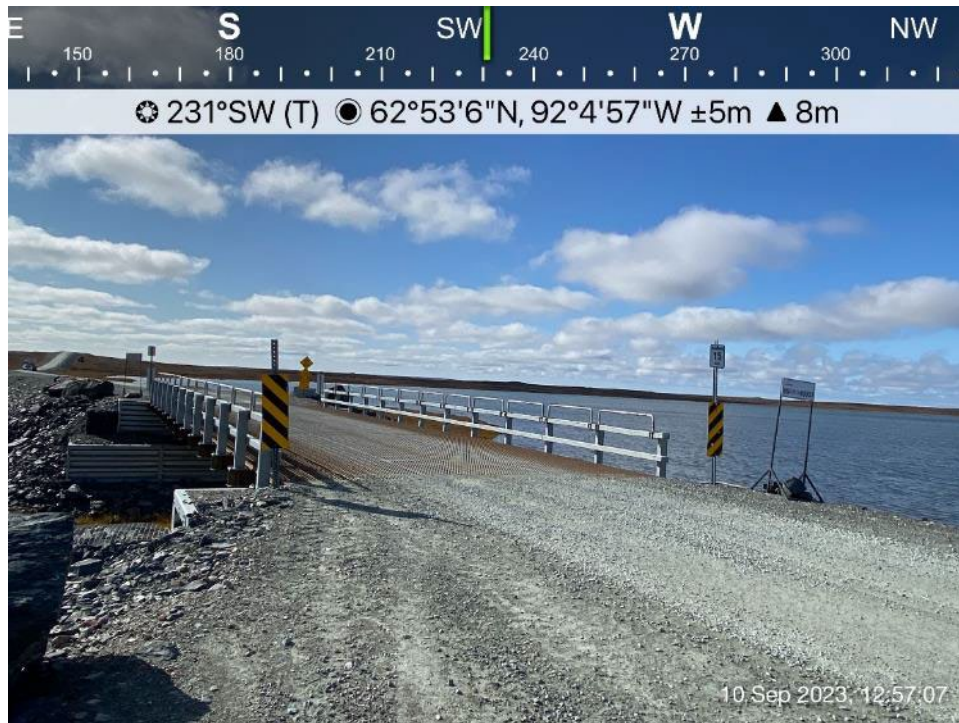
AWAR Road/Culvert - Photo 27: M-5 Bridge KM 10.5.

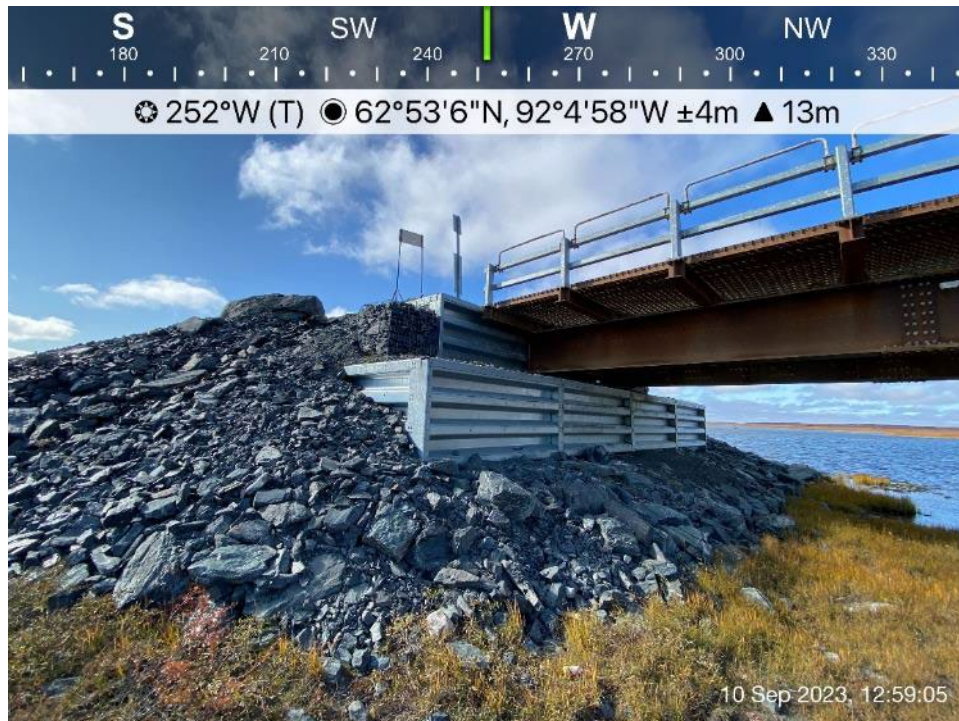
AWAR Road/Culvert - Photo 28: M-5 Bridge KM 10.5.

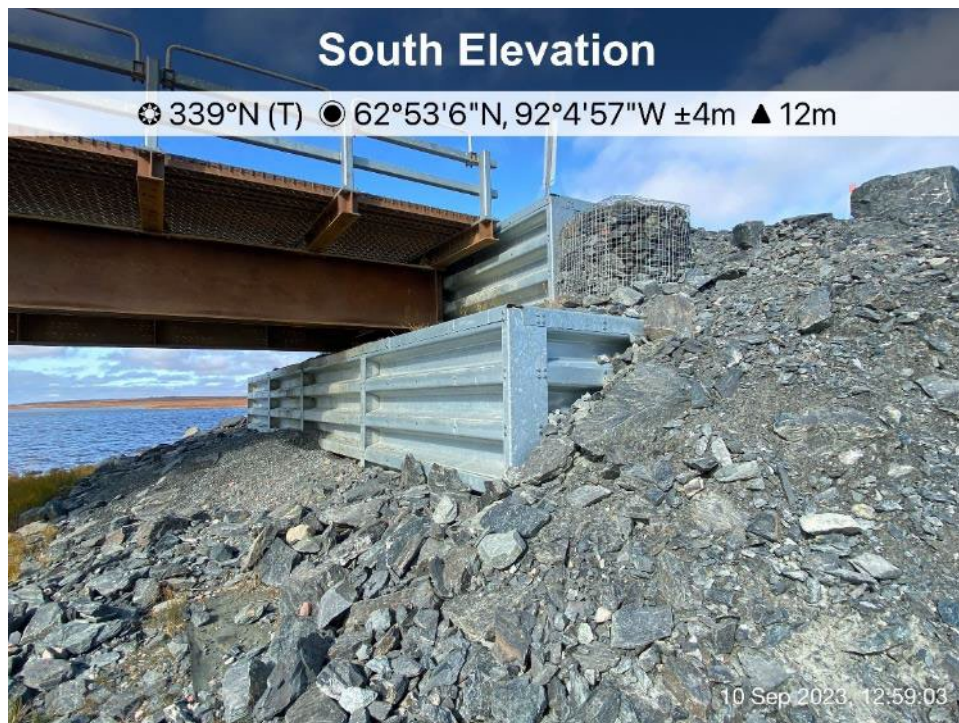
AWAR Road/Culvert - Photo 29: M-5 Bridge KM 10.5- south abutment.
