APPENDIX 6 2023 ANNUAL GEOTECHNICAL INSPECTION REPORT

2023 Annual Geotechnical Inspection Meliadine Gold Mine, Nunavut, Canada

PRESENTED TO
Agnico Eagle Mines Limited

JANUARY 31, 2024
ISSUED FOR USE
FILE: 704-ENG.EARC03140-33
AGNICO EAGLE DOCUMENT NUMBER: 65-600-230-TCR-001

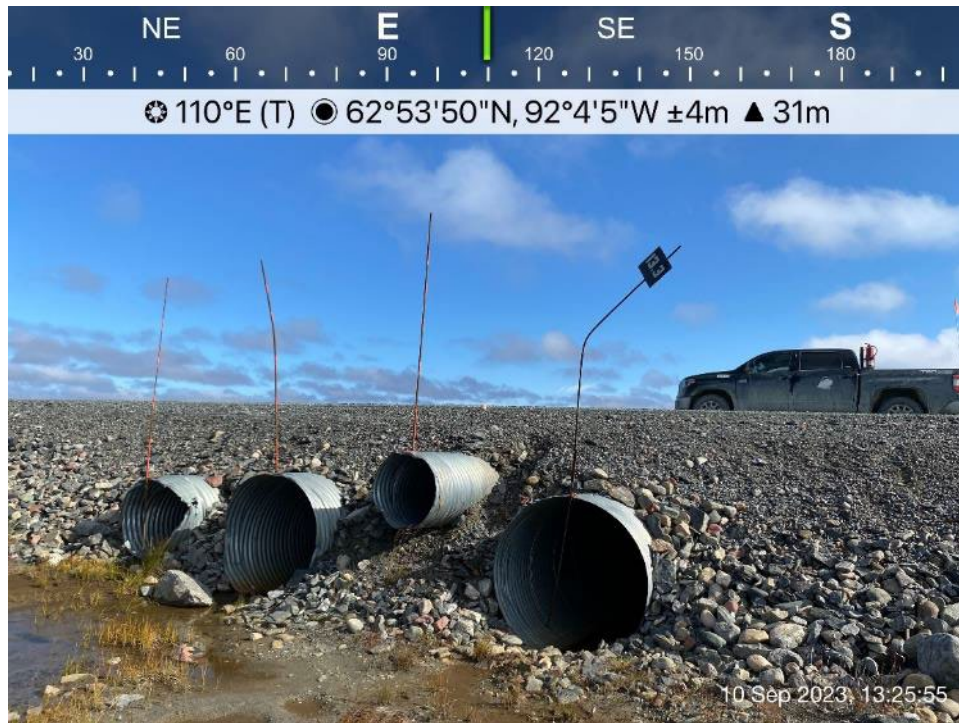
AWAR Road/Culvert - Photo 31: Culvert KM 12.1 – inlet.

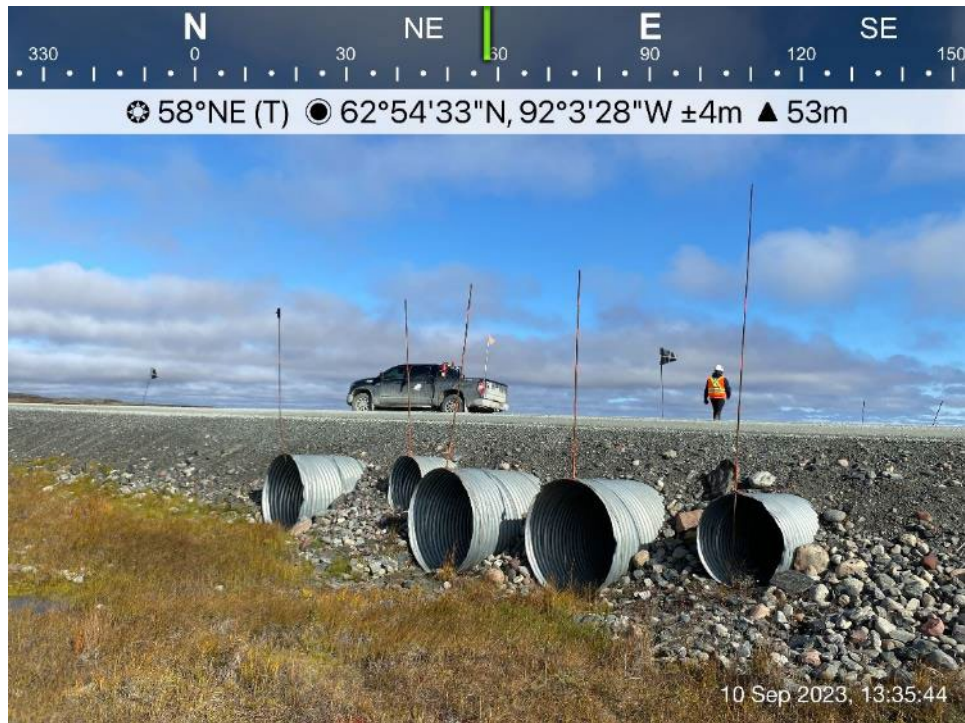
AWAR Road/Culvert - Photo 36: Culvert KM 13.5 – inlet.

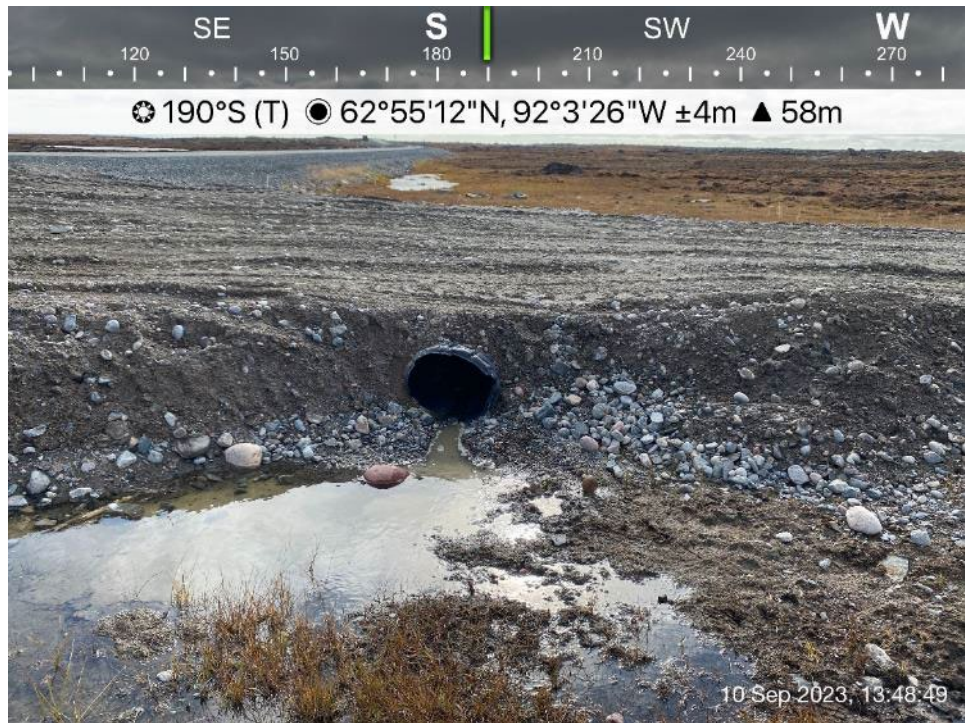
AWAR Road/Culvert - Photo 37: Culvert KM 13.5 – outlet.

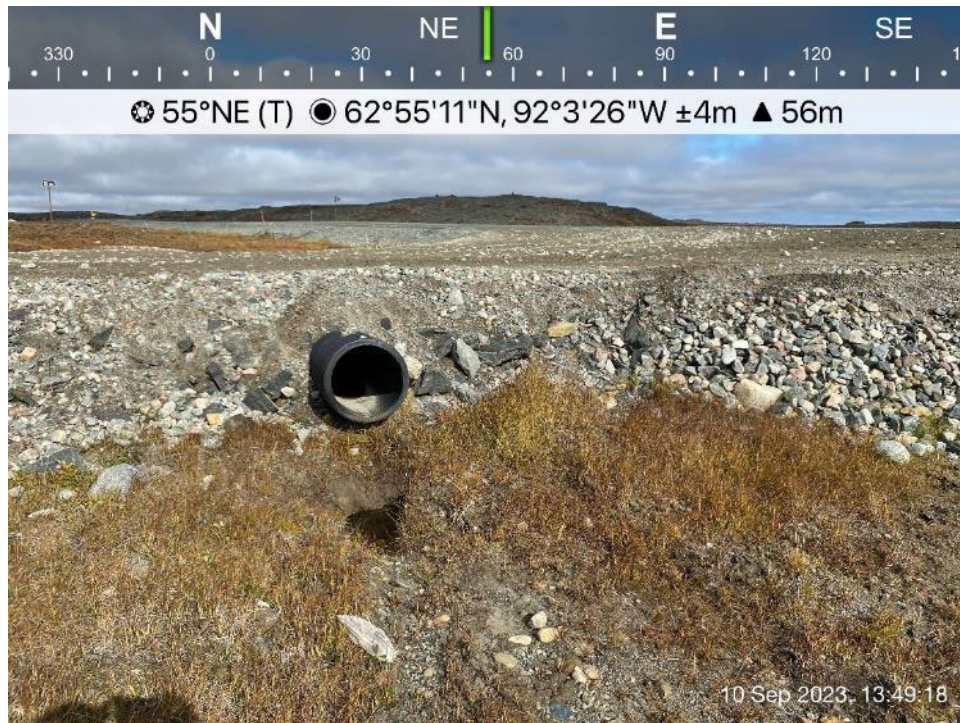
AWAR Road/Culvert - Photo 38: Culvert KM 14.7 - inlet - HDPE corrugated culvert.

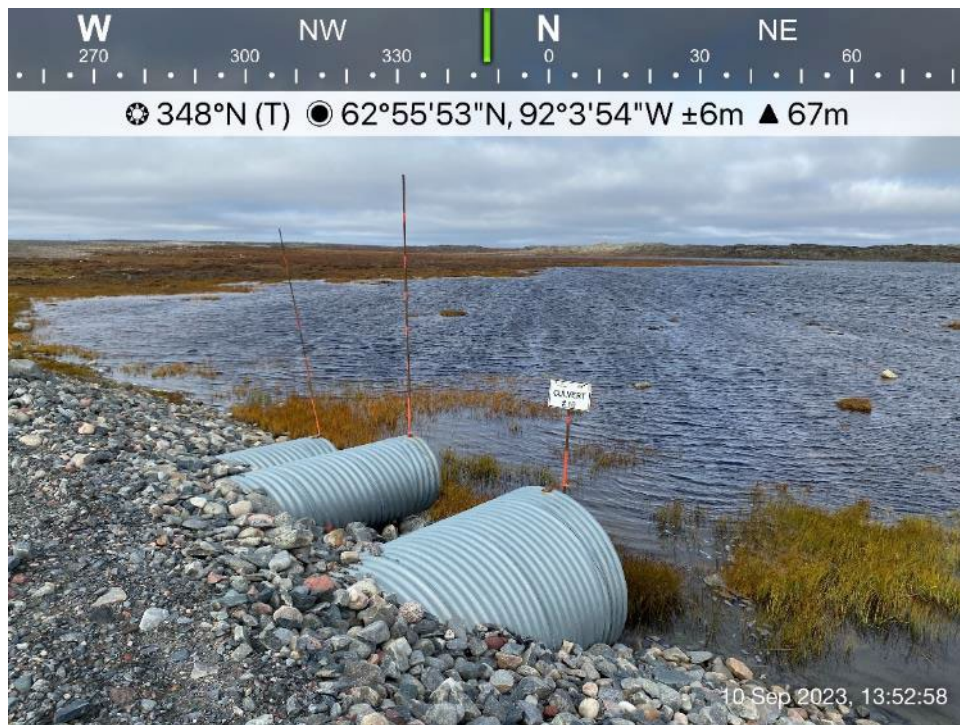
AWAR Road/Culvert - Photo 39: Culvert KM 14.7 - outlet- HDPE corrugated culvert.

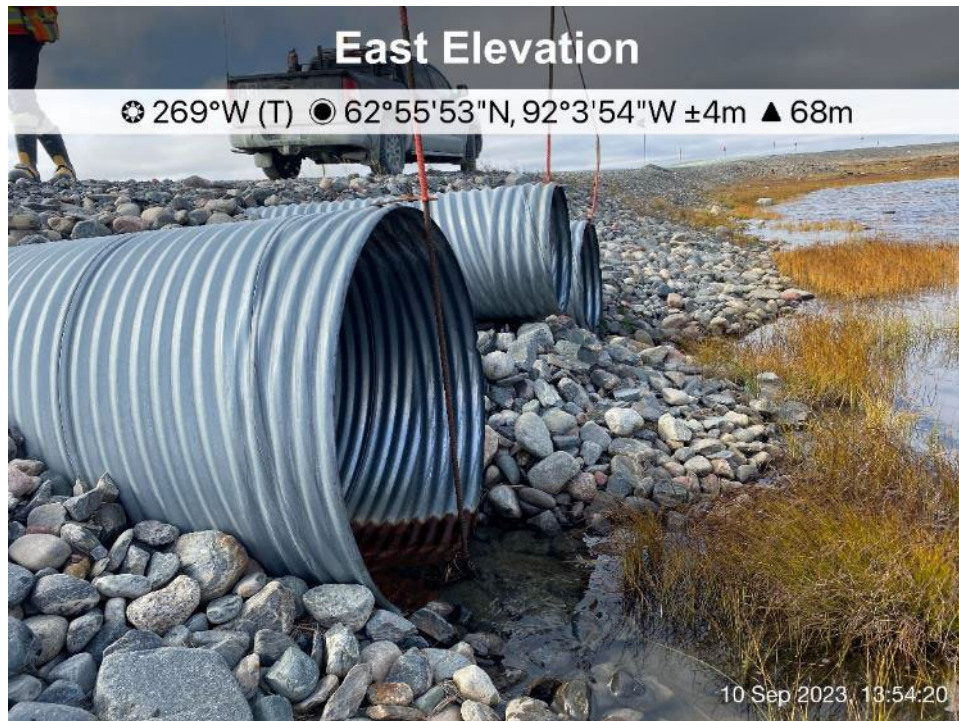
AWAR Road/Culvert - Photo 40: Culvert KM 16.3 – inlet.

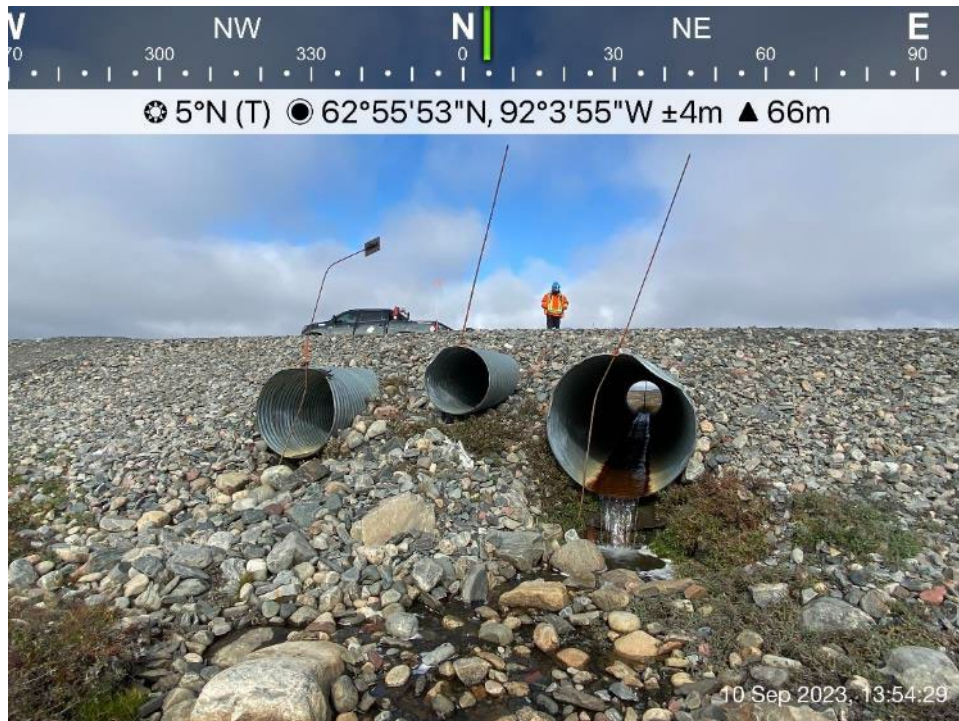
AWAR Road/Culvert - Photo 41: Culvert KM 16.3 – inlet.

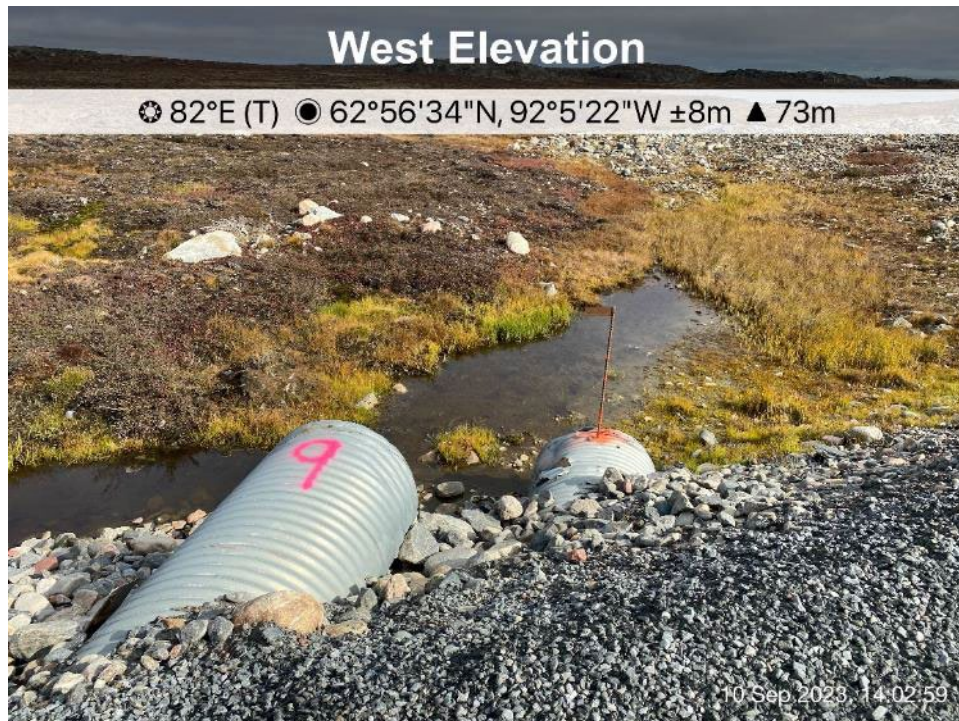
AWAR Road/Culvert - Photo 42: Culvert KM 16.3 – outlet.

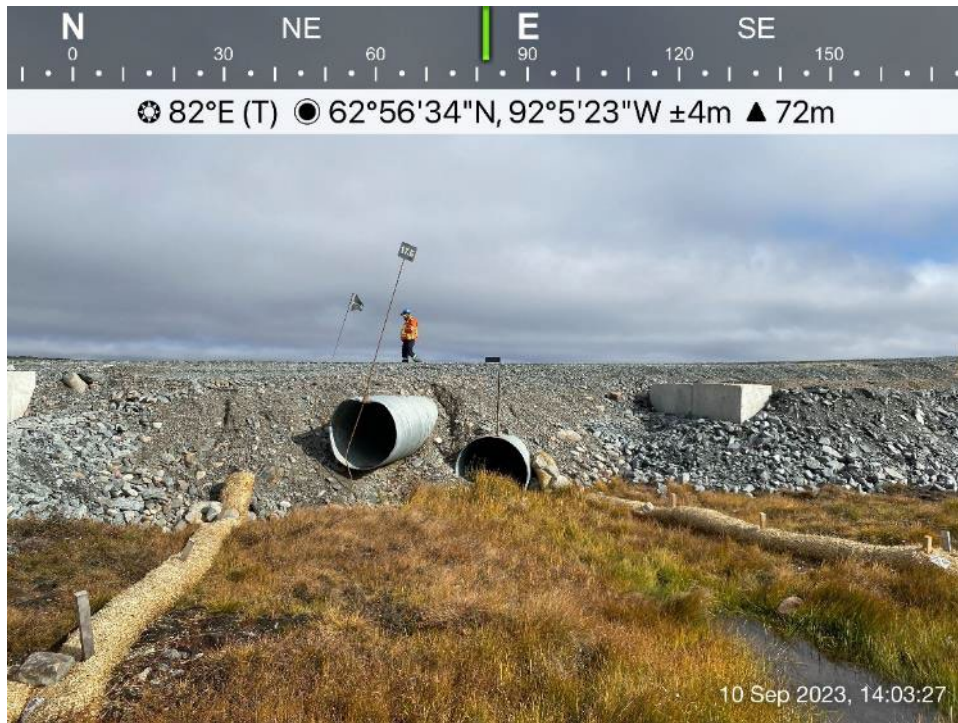
AWAR Road/Culvert - Photo 44: Culvert KM 18.1 – inlet.

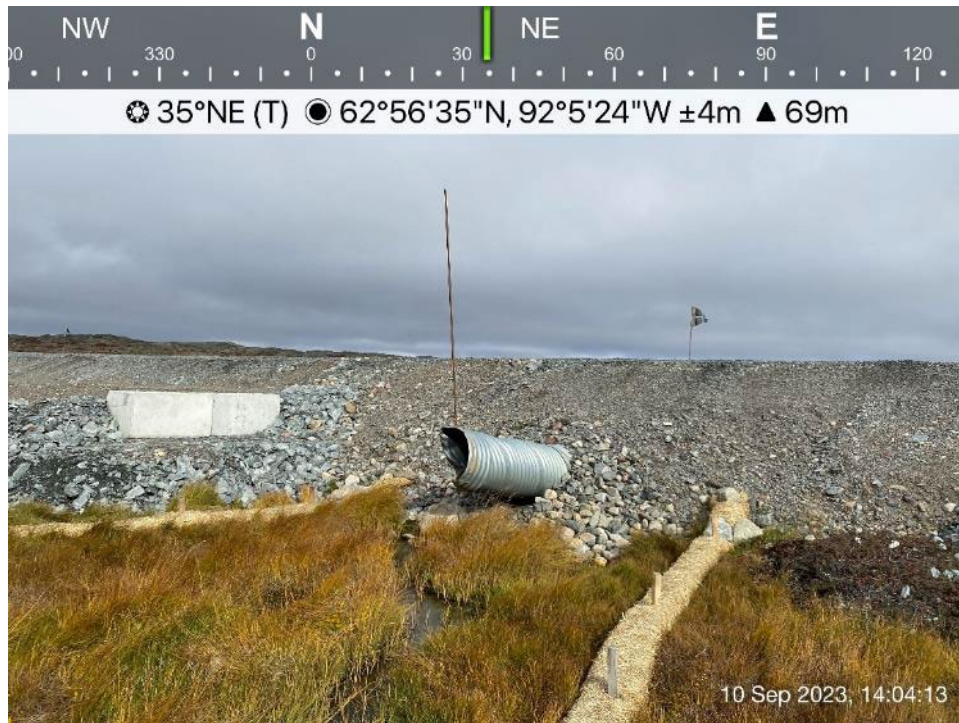
AWAR Road/Culvert - Photo 46: Culvert KM 18.15 – inlet.

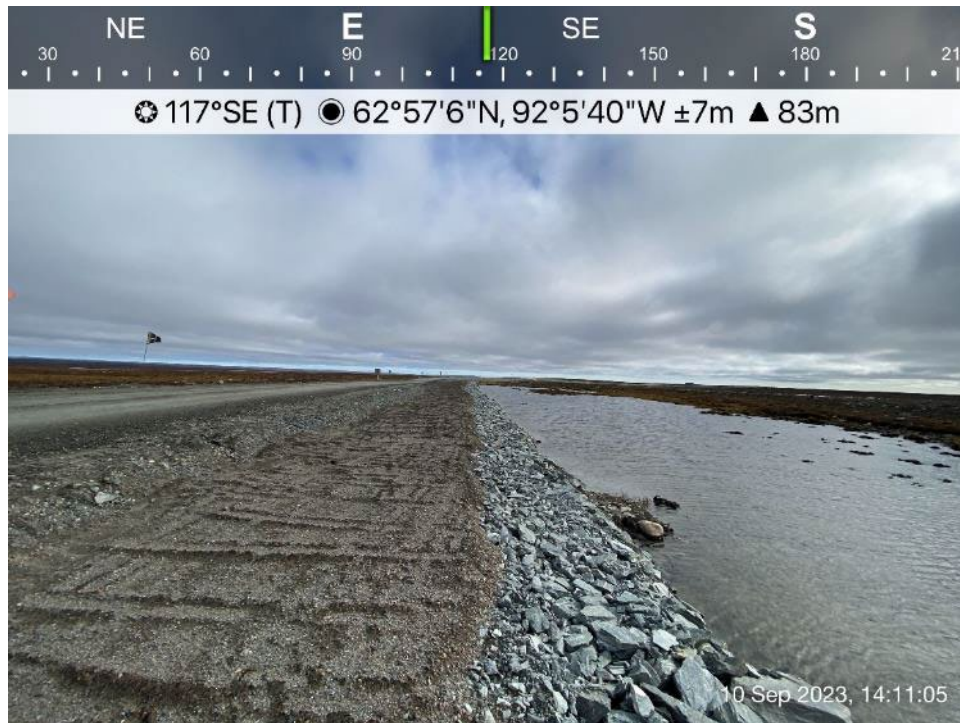
AWAR Road/Culvert - Photo 47: Culvert KM 18.15 – outlet.

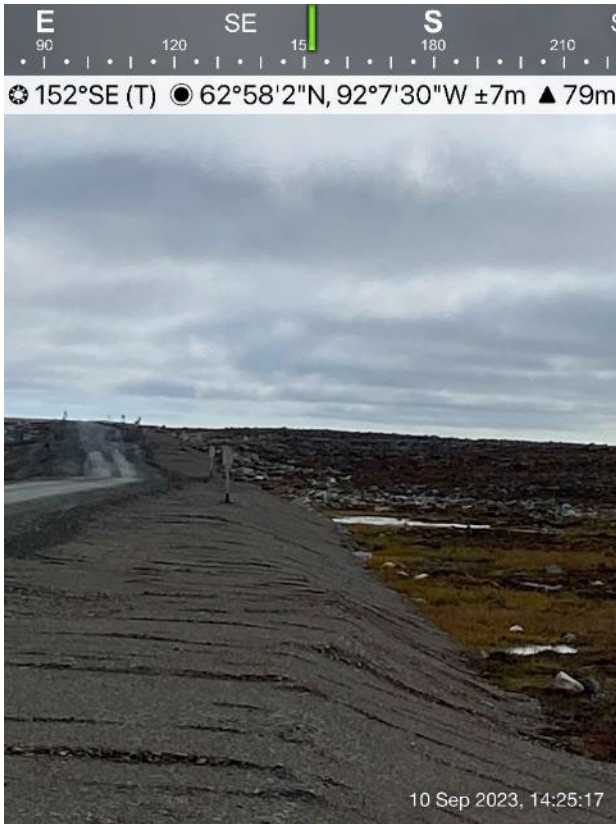
AWAR Road/Culvert
- Photo 52:

Culvert KM 22.3 - steel pipe as culvert, inlet is above water level.

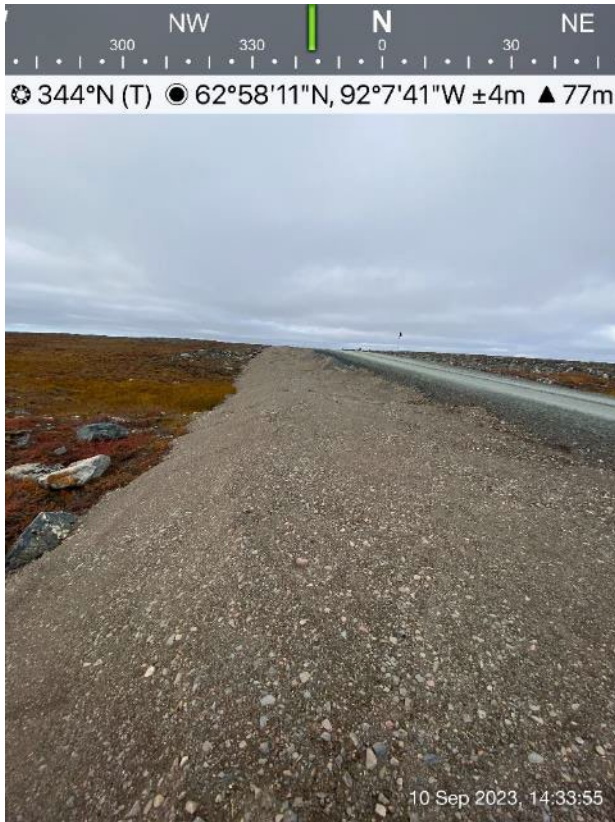
AWAR Road/Culvert - Photo 54:

KM 22.7 to 23.0 - No culvert installed, ponded water upstream.

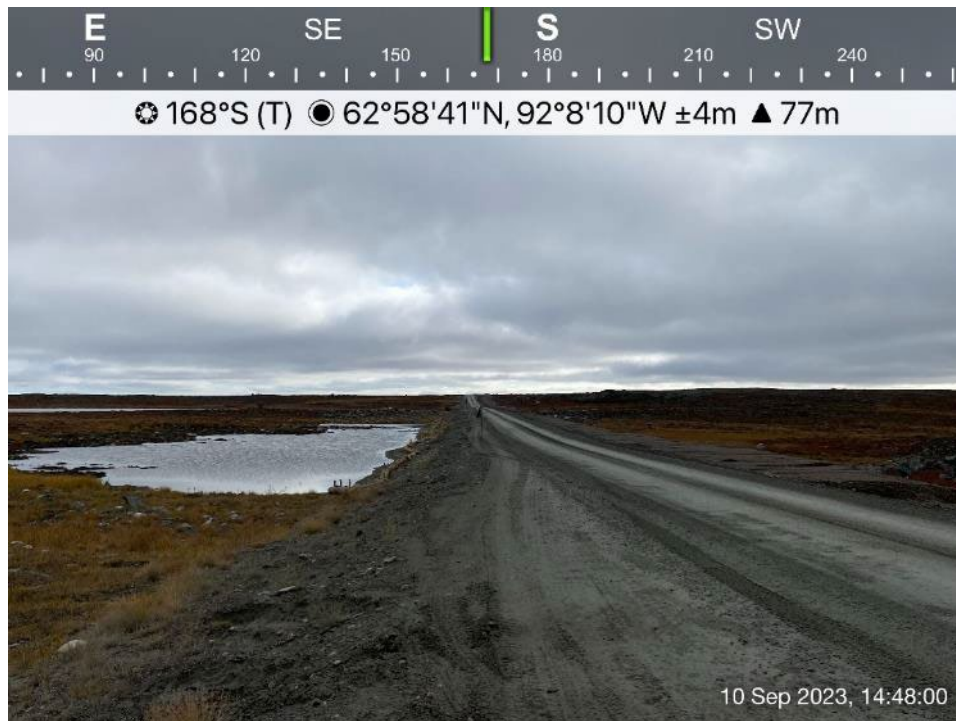
AWAR Road/Culvert - Photo 55: Culvert KM 25.8 - HDPE corrugated culvert – inlet.

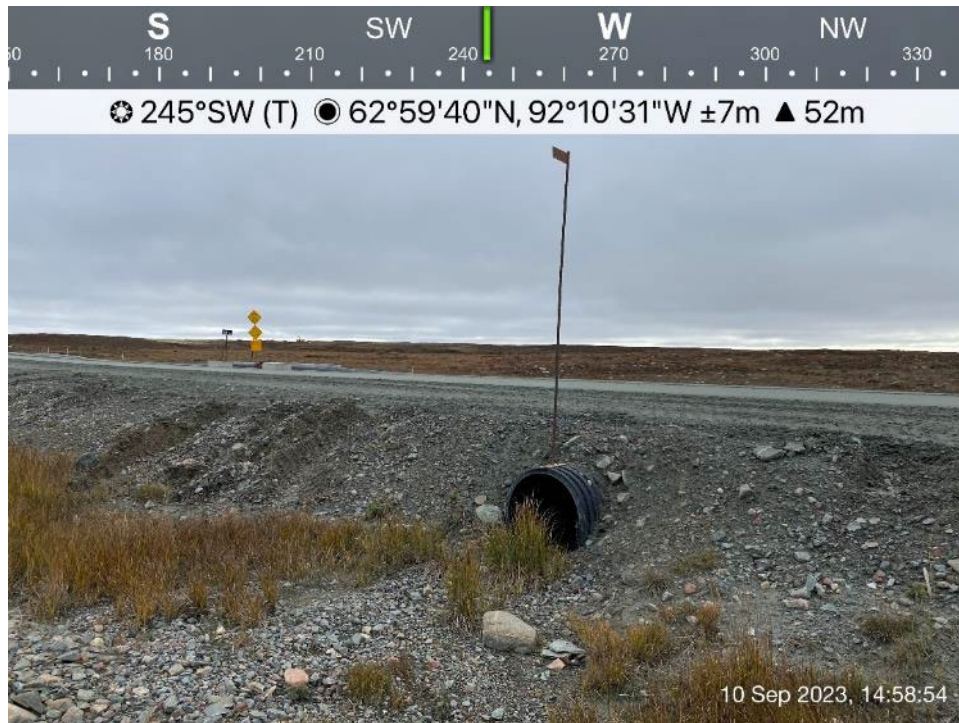
AWAR Road/Culvert - Photo 56: Culvert KM 25.8 - HDPE corrugated culvert – outlet.

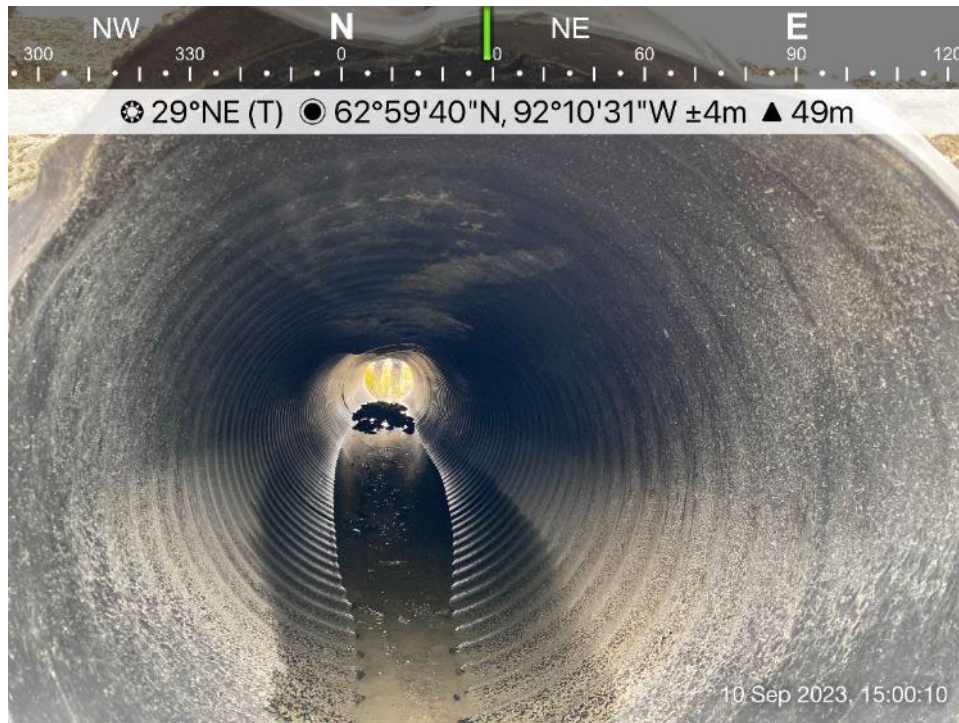
AWAR Road/Culvert - Photo 57: Culvert KM 25.8 - HDPE corrugated culvert - sign of deformation observed.

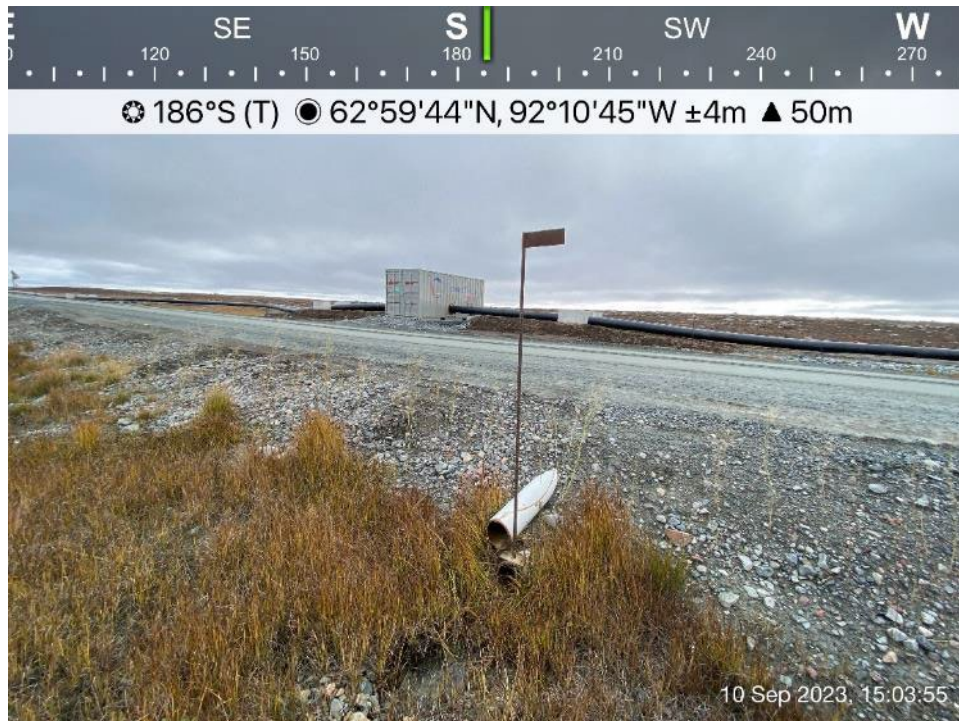
AWAR Road/Culvert - Photo 59: Culvert KM 26.2 - steel pipe as culvert, outlet.

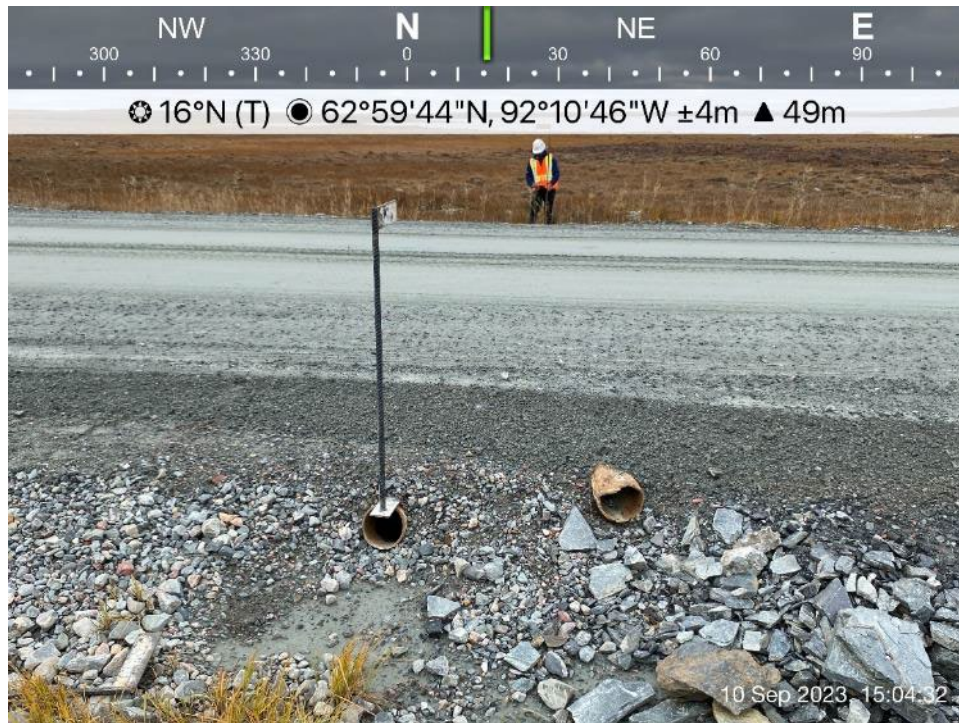
AWAR Road/Culvert - Photo 60: Culvert KM 26.5 – inlet.

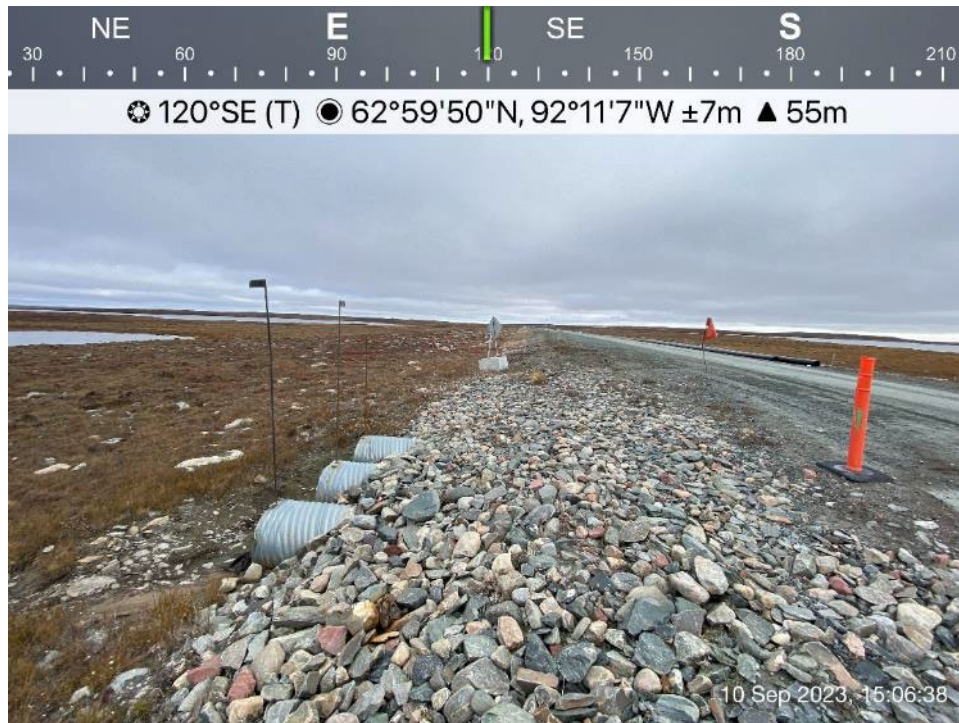
AWAR Road/Culvert - Photo 61: Culvert KM 26.5 – inlet.

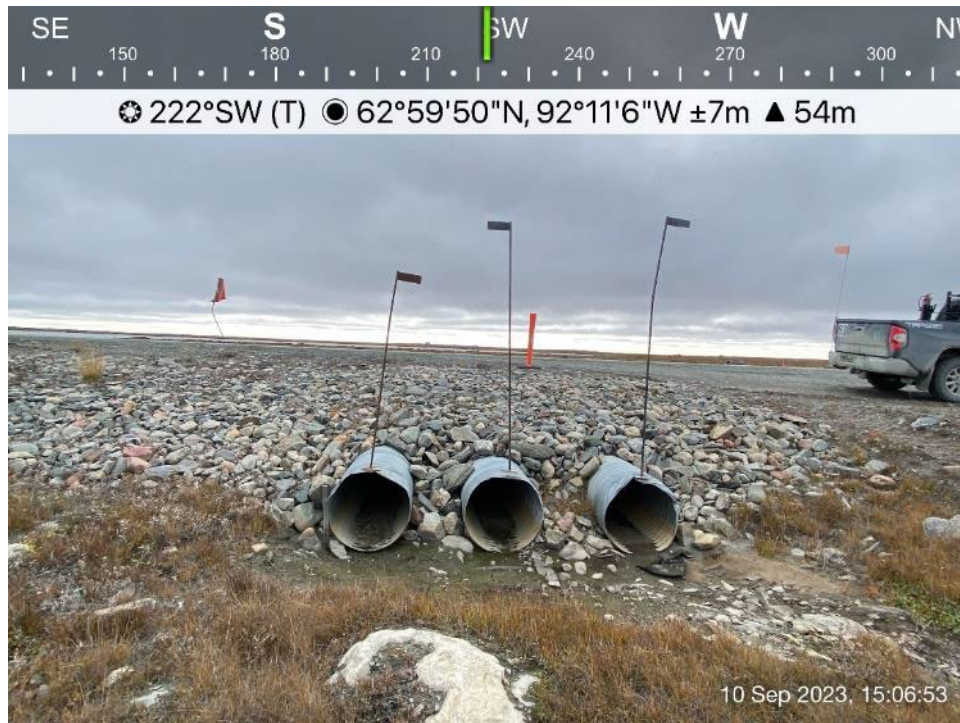
AWAR Road/Culvert - Photo 62: Culvert KM 26.5 – outlet.

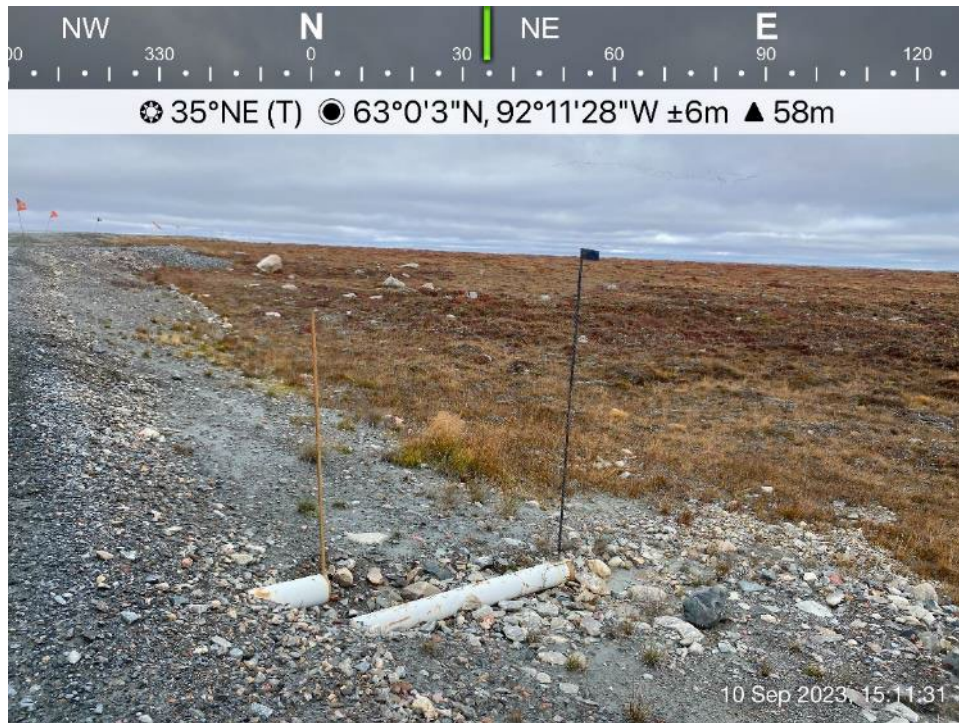
AWAR Road/Culvert - Photo 63: Culvert KM 26.8 - steel pipe as culvert, inlet is above water level.

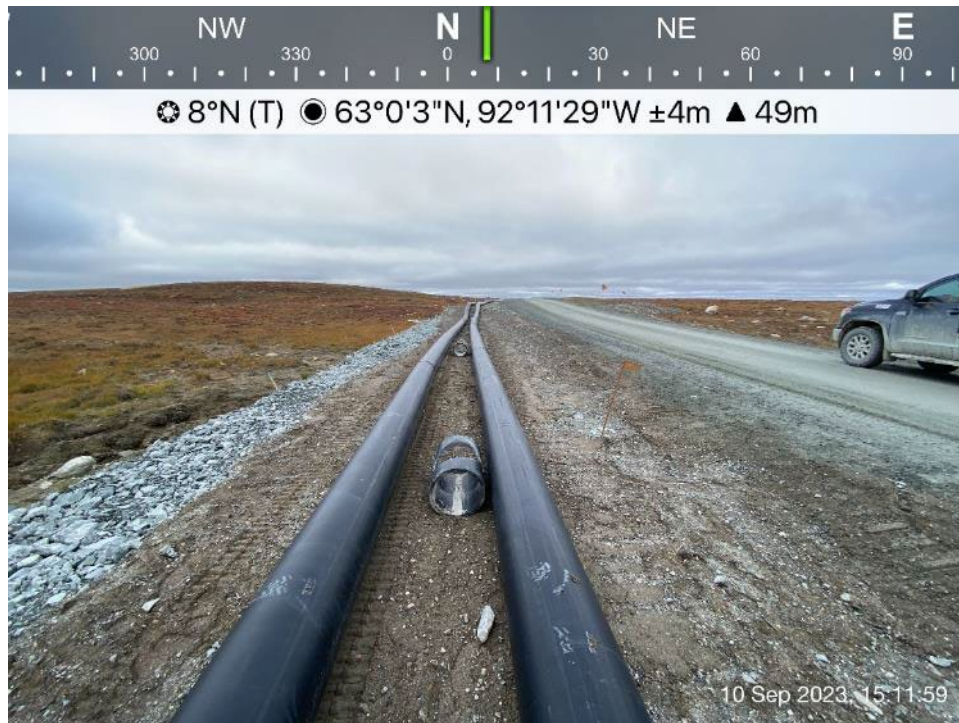
AWAR Road/Culvert - Photo 64: Culvert KM 26.8 - steel pipe as culvert, outlet was buried during the waterline project construction.

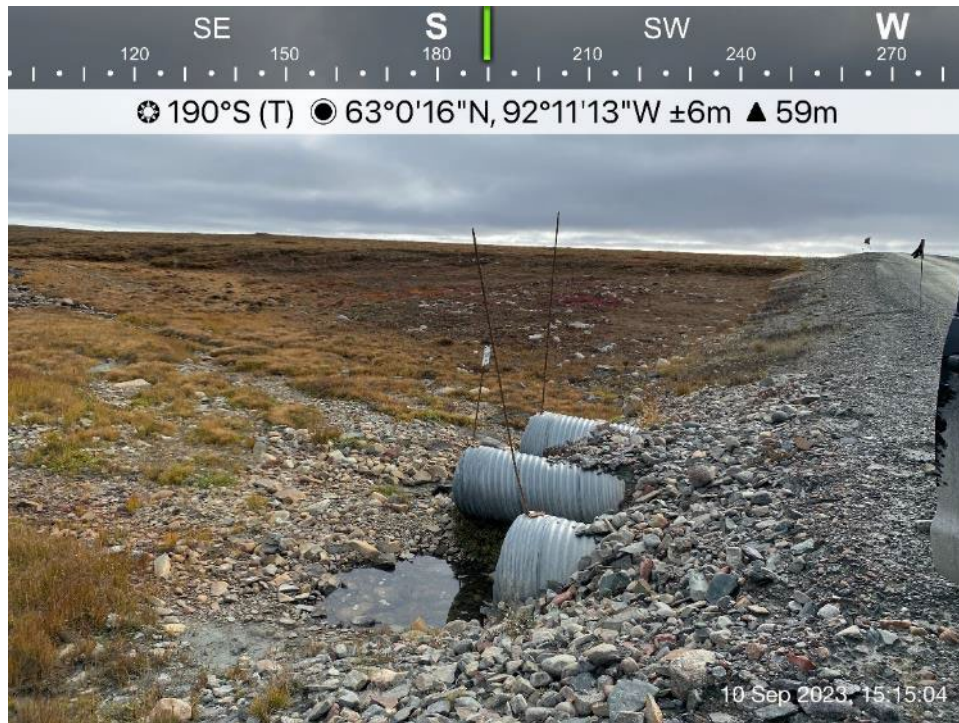
AWAR Road/Culvert - Photo 65: Culvert KM 27.1 – inlet.

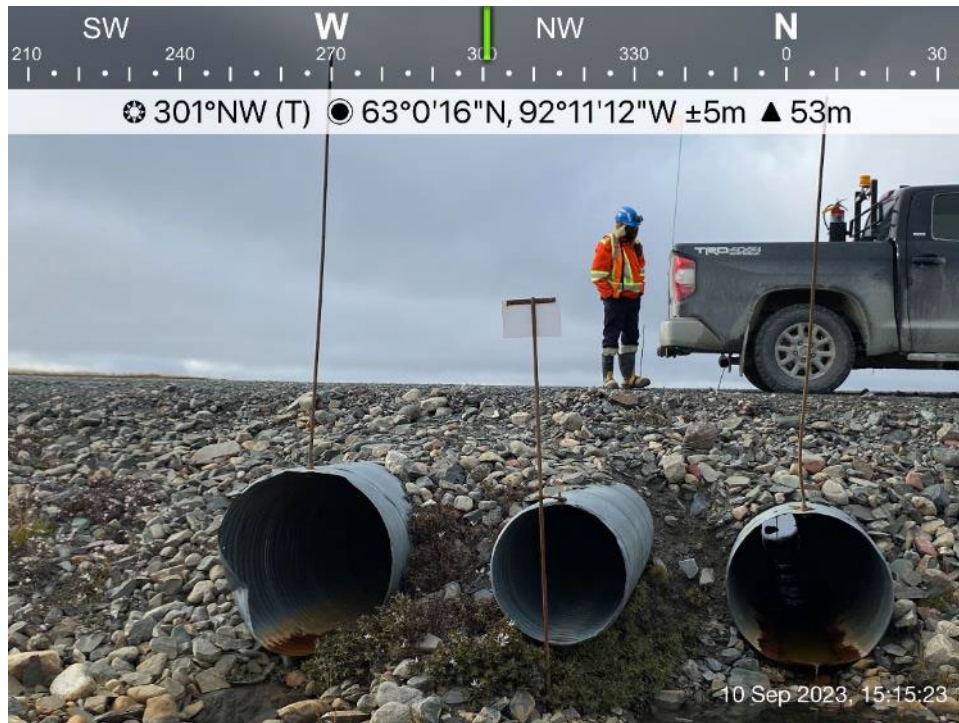
AWAR Road/Culvert - Photo 66: Culvert KM 27.1 – inlet.

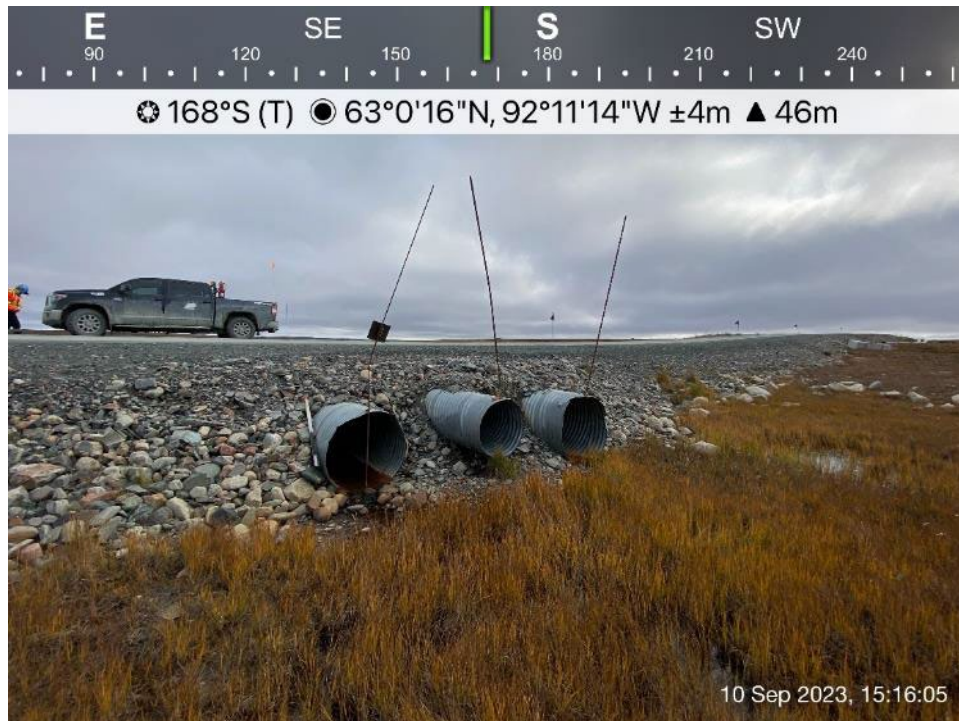
AWAR Road/Culvert - Photo 67: Culvert KM 27.1 – outlet.

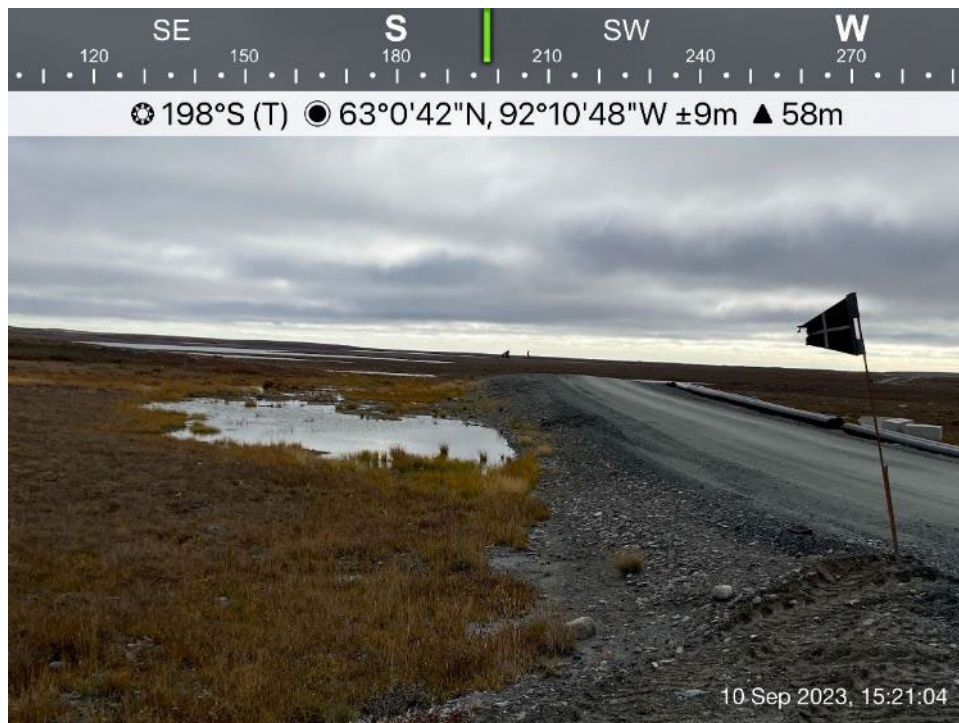
AWAR Road/Culvert - Photo 68: KM 28.7 - No culvert installed, ponded water upstream.

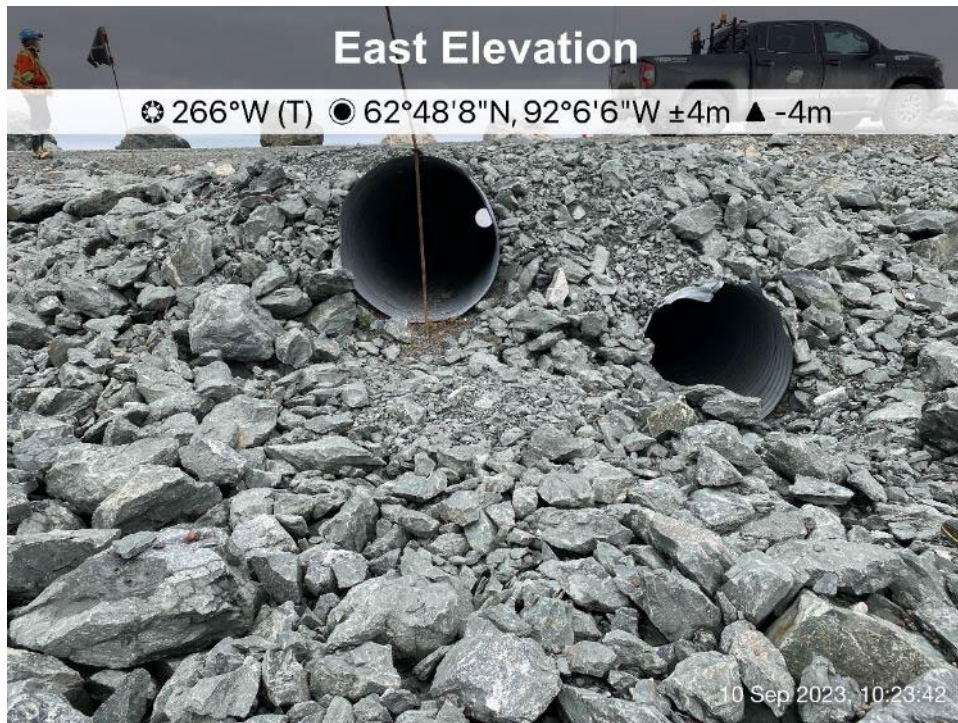
Itivia Bypass Road/Culvert - Photo 1: Culvert C01 Inlet.

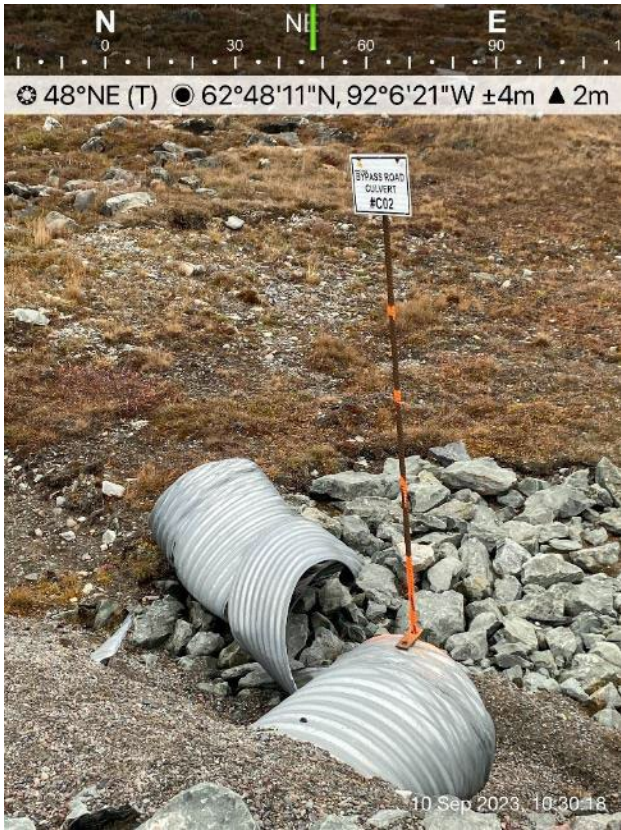
Itivia Bypass Road/Culvert Culvert C02 Inlet.
- Photo 3:

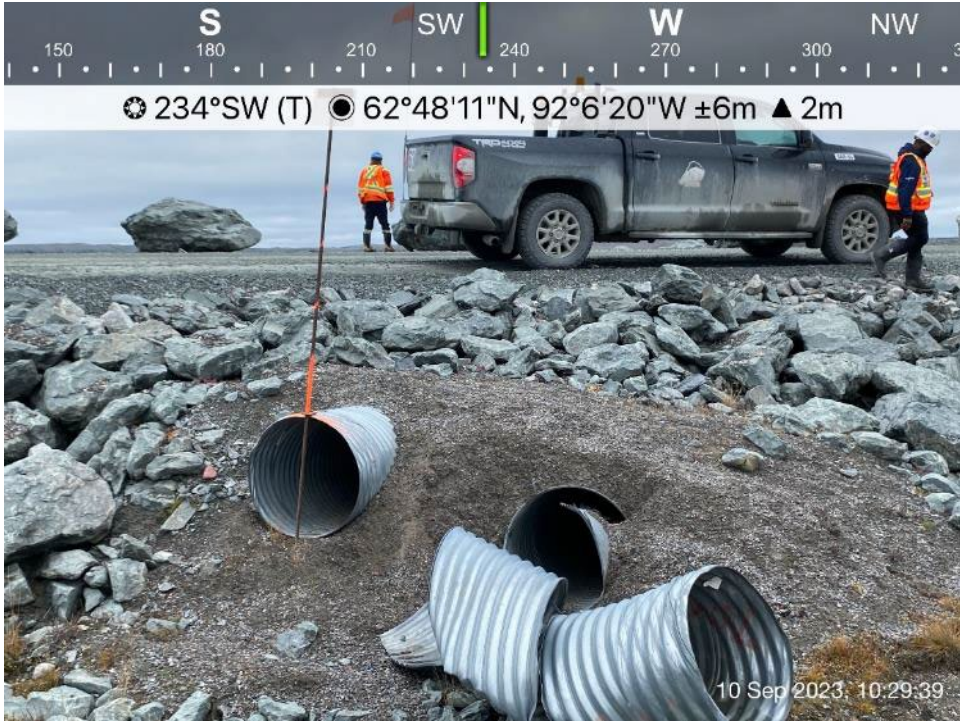
Itivia Bypass Road/Culvert - Photo 4: Culvert C02 Inlet.

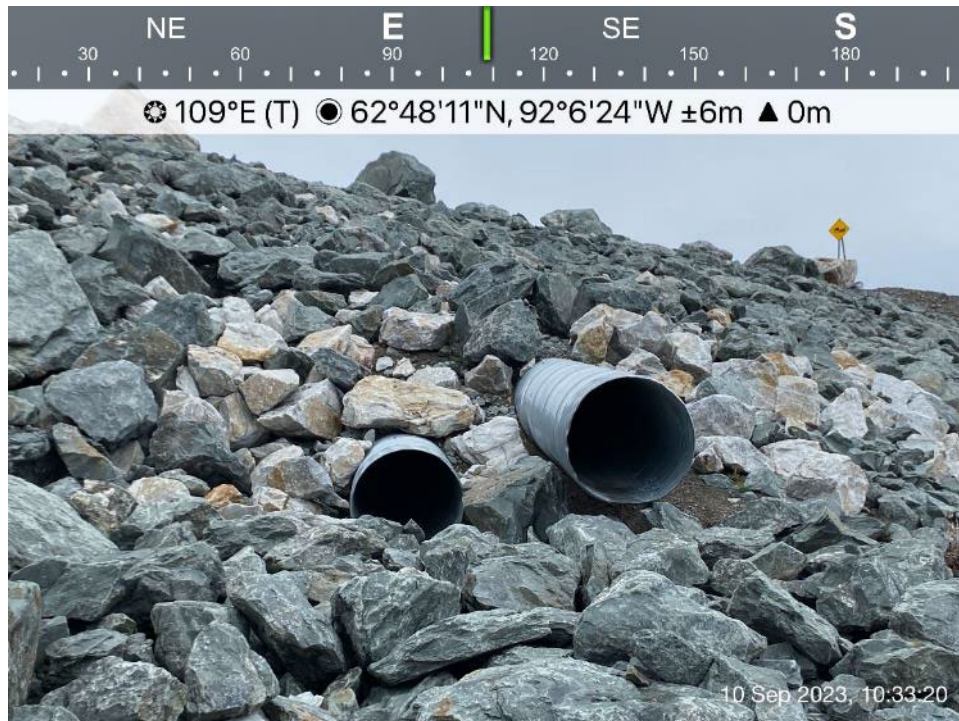
Itivia Bypass Road/Culvert - Photo 5: Culvert C02 outlet.

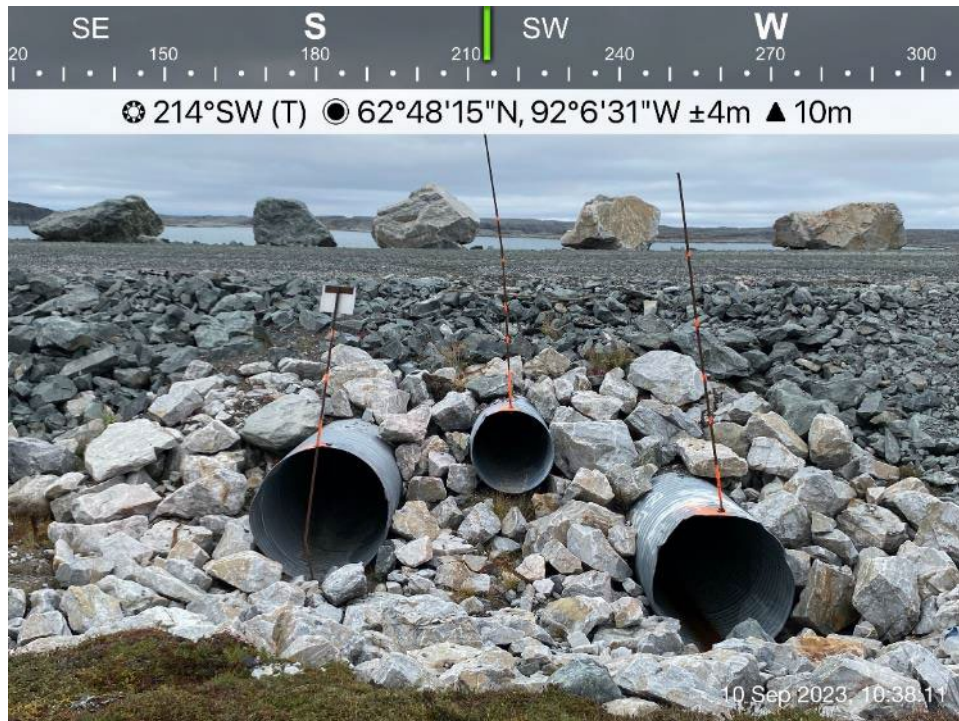
Itivia Bypass Road/Culvert - Photo 7: Culvert C03 inlet.

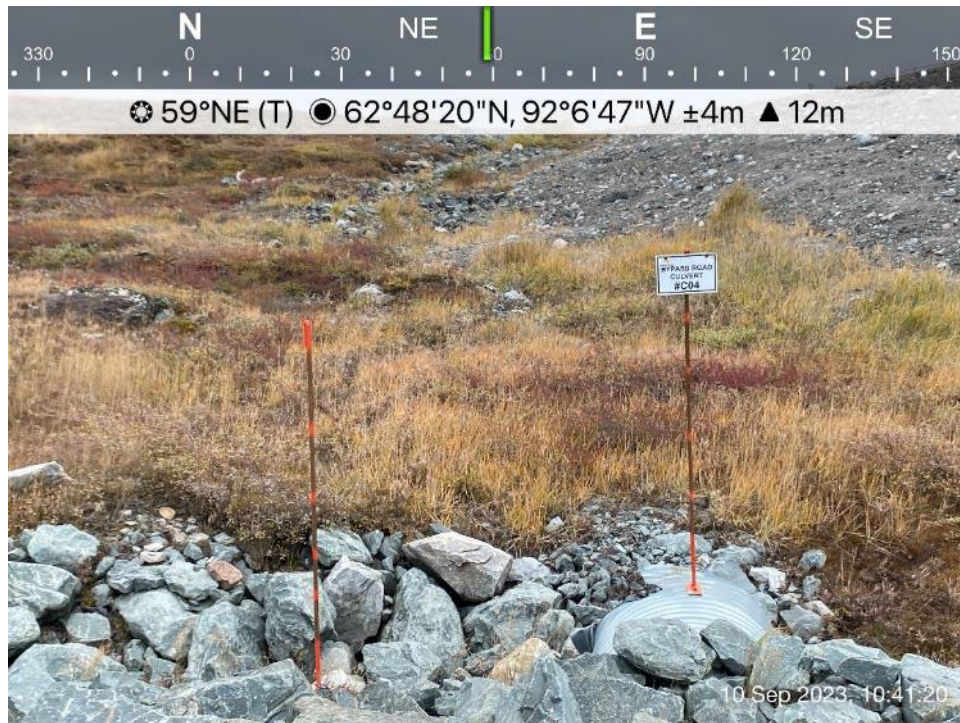
Itivia Bypass Road/Culvert - Photo 9: Culvert C04 inlet.

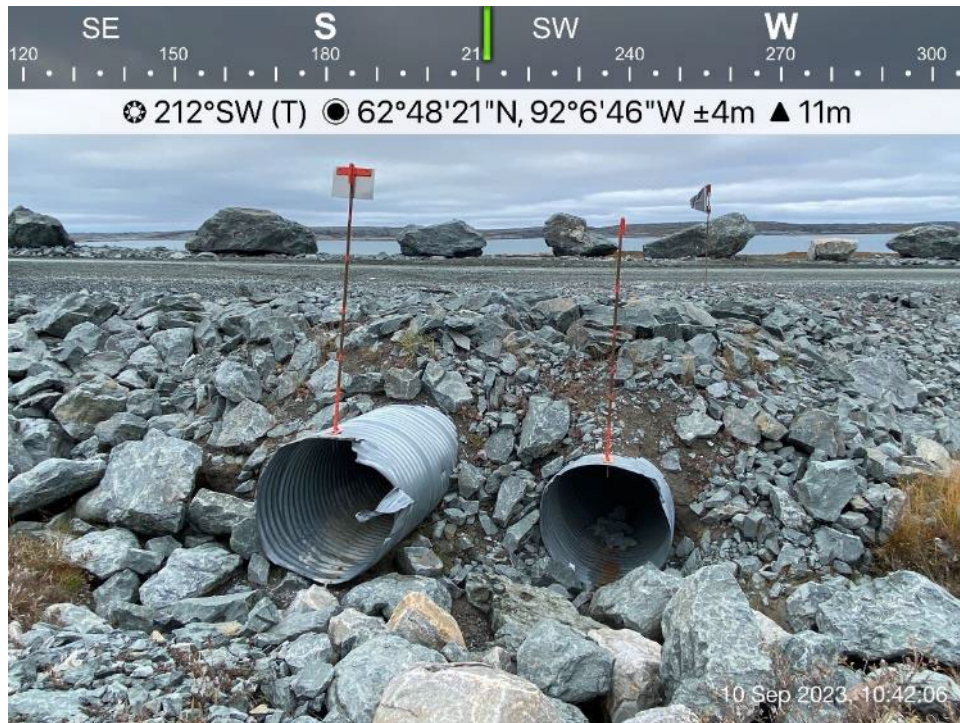
Itivia Bypass Road/Culvert - Photo 10: Culvert C04 inlet.
