APPENDIX 6 2023 ANNUAL GEOTECHNICAL INSPECTION REPORT

2023 Annual Geotechnical Inspection Meliadine Gold Mine, Nunavut, Canada

PRESENTED TO
Agnico Eagle Mines Limited

JANUARY 31, 2024
ISSUED FOR USE
FILE: 704-ENG.EARC03140-33
AGNICO EAGLE DOCUMENT NUMBER: 65-600-230-TCR-001

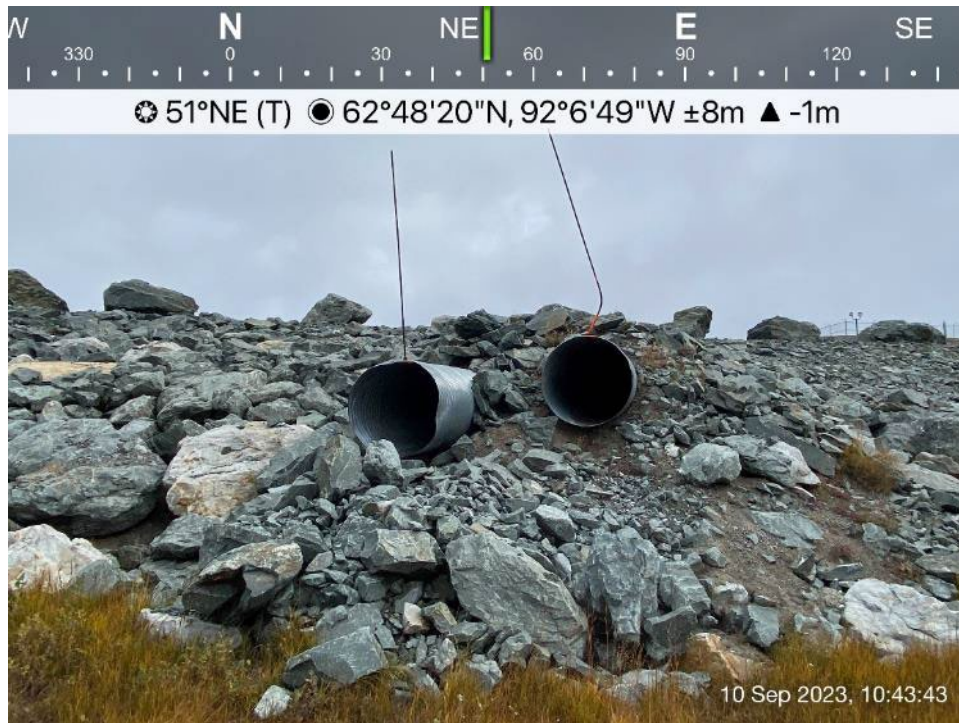
Itivia Bypass Road/Culvert - Photo 11: Culvert C04 outlet.

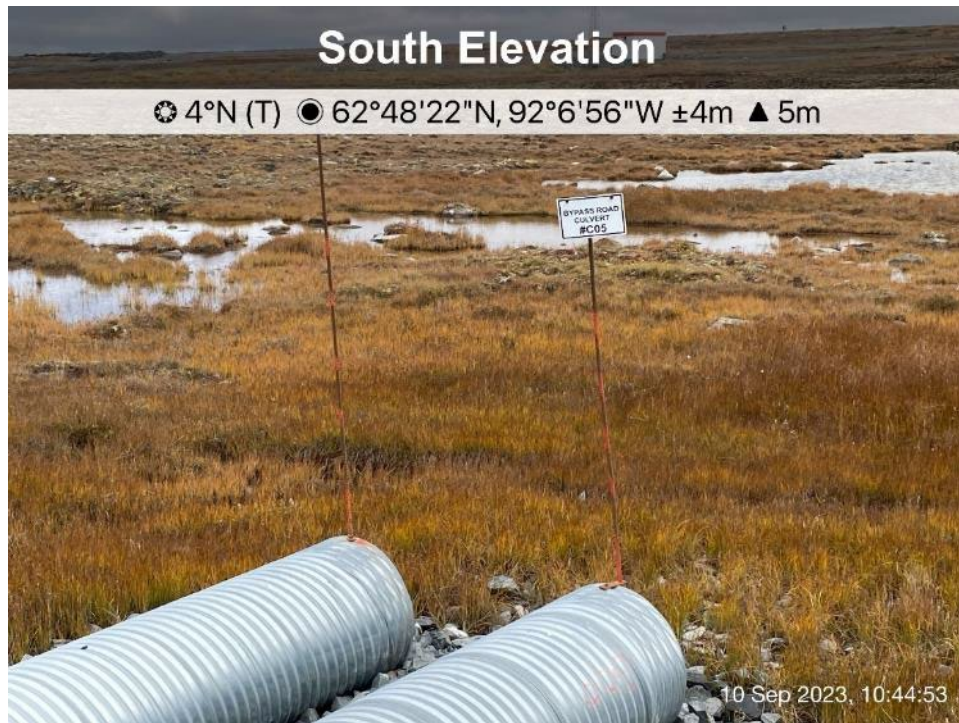
Itivia Bypass Road/Culvert - Photo 12: Culvert C05 inlet.

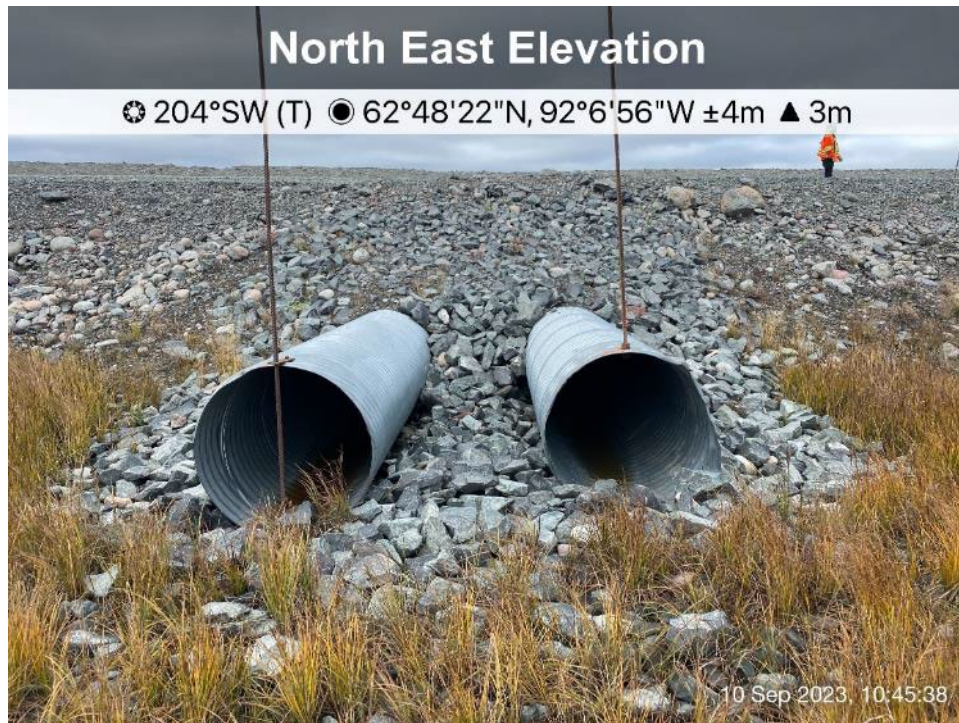
Itivia Bypass Road/Culvert - Photo 13: Culvert C05 inlet.

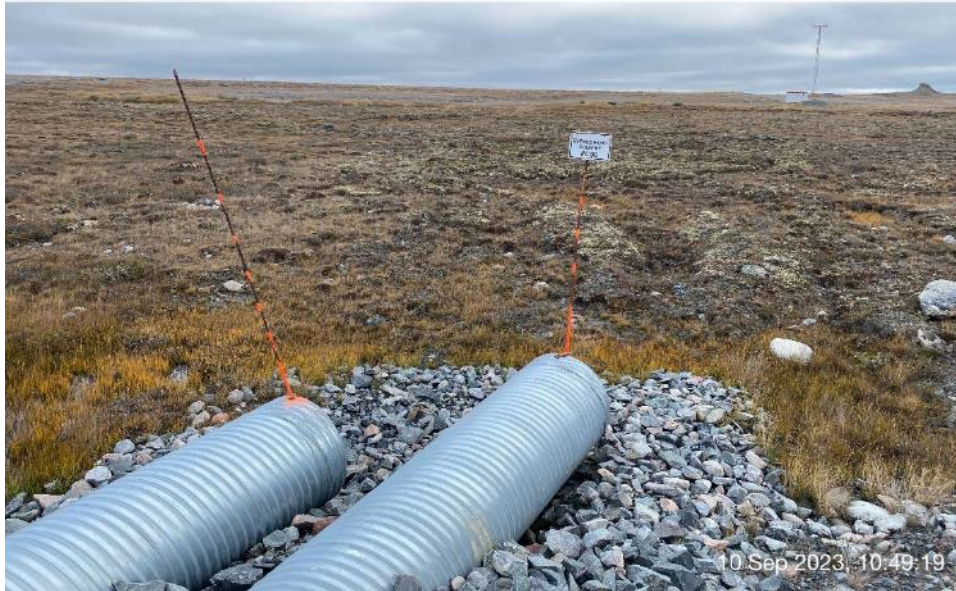
Itivia Bypass Road/Culvert - Photo 15: Culvert C06 inlet.

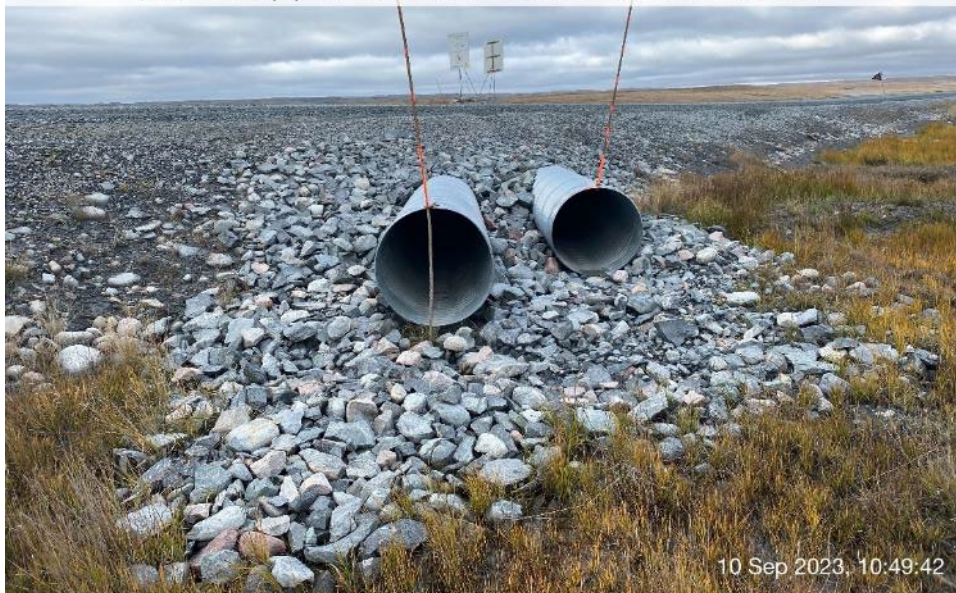
Itivia Bypass Road/Culvert - Photo 16: Culvert C06 inlet.

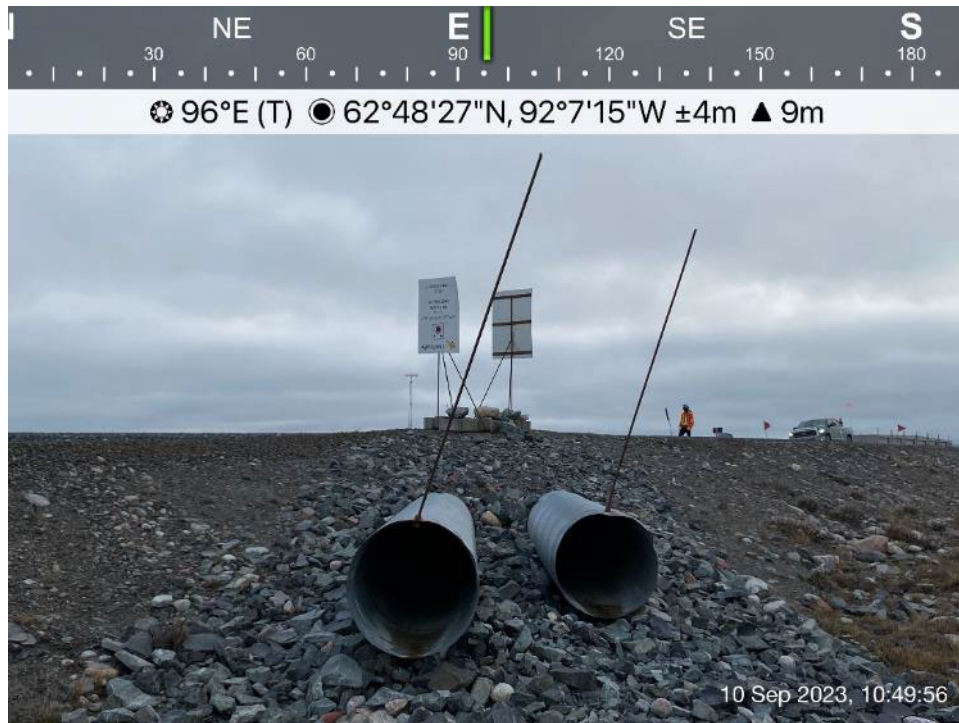
Itivia Bypass Road/Culvert - Photo 17: Culvert C06 outlet.

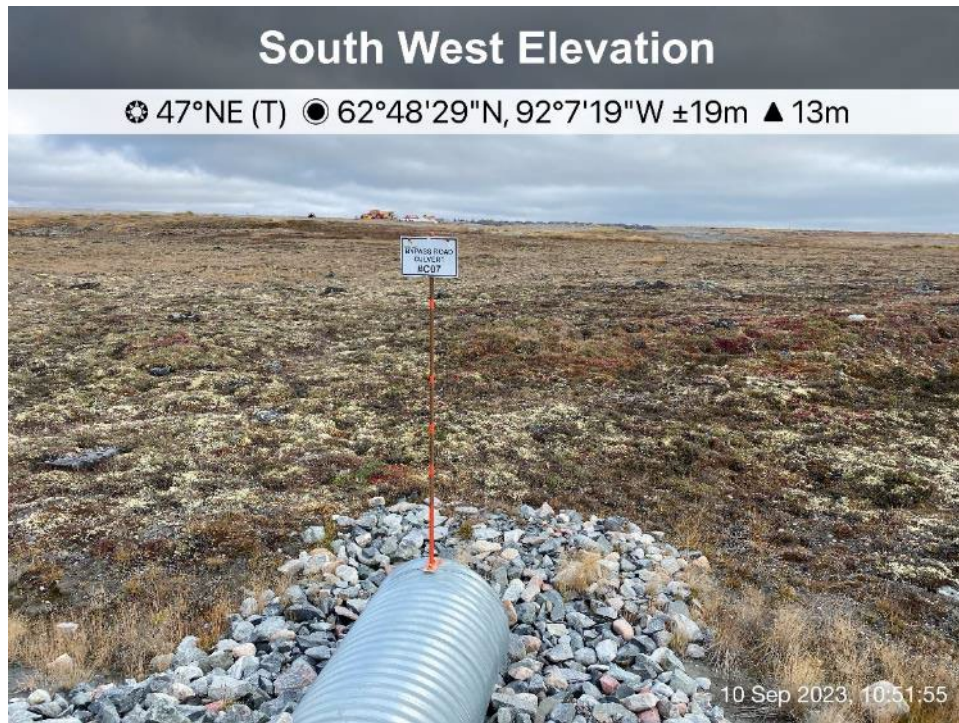
Itivia Bypass Road/Culvert - Photo 18: Culvert C07 inlet.

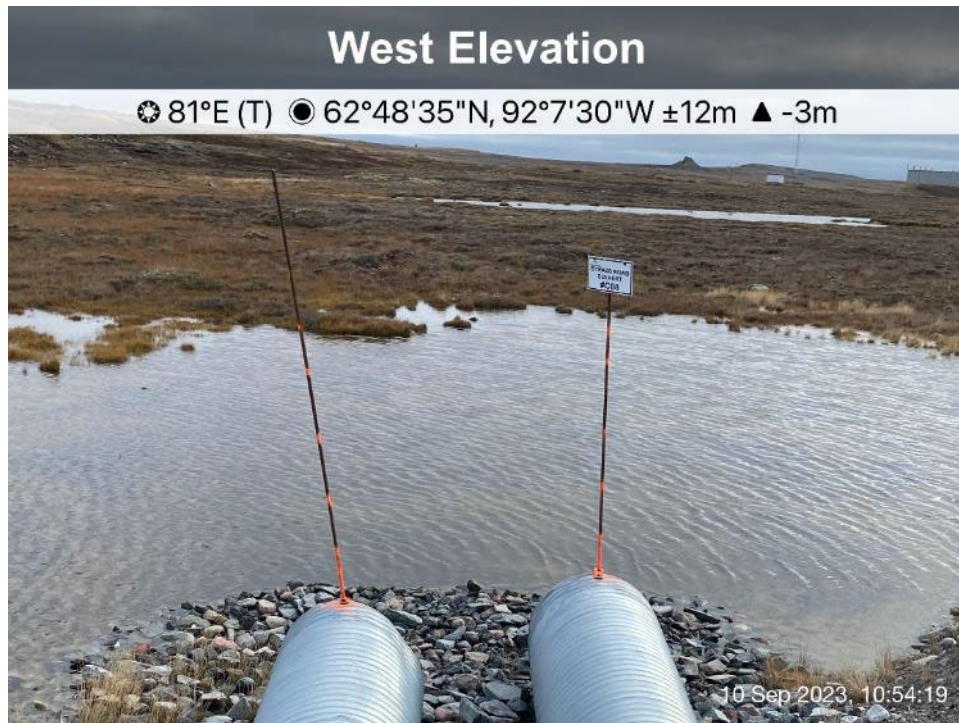
Itivia Bypass Road/Culvert - Photo 21: Culvert C08 inlet.

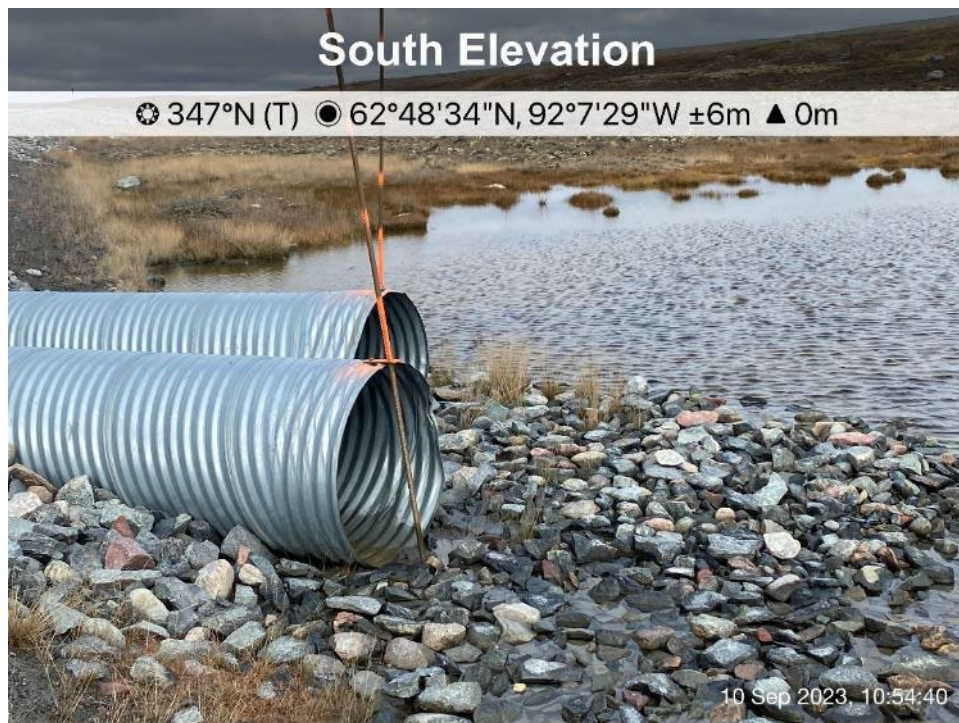
Itivia Bypass Road/Culvert - Photo 22: Culvert C08 inlet.

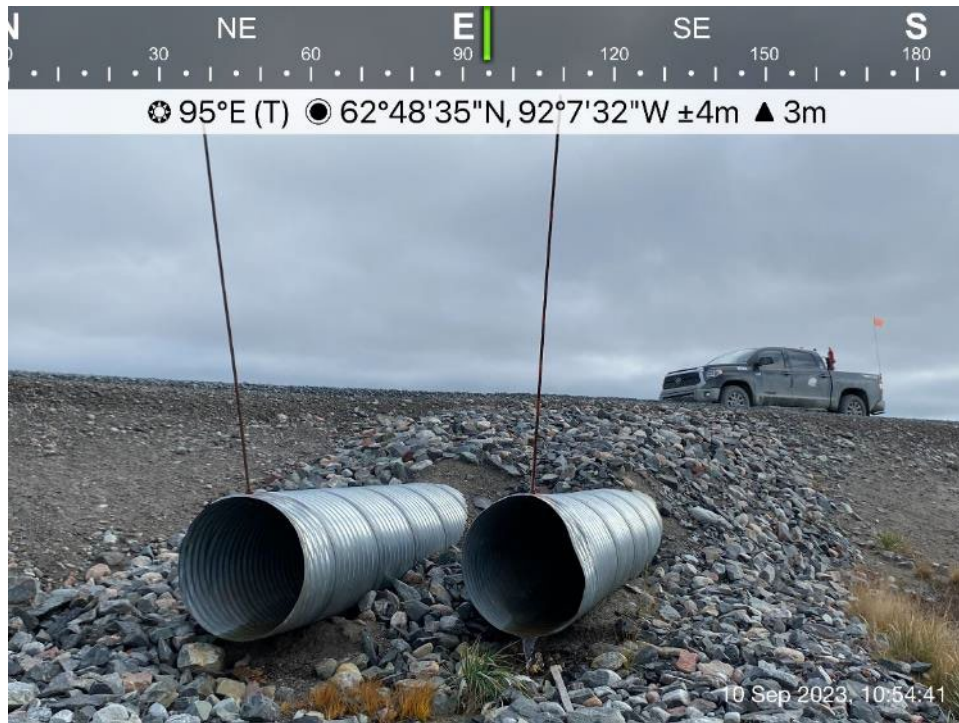
Itivia Bypass Road/Culvert - Photo 23: Culvert C08 outlet.

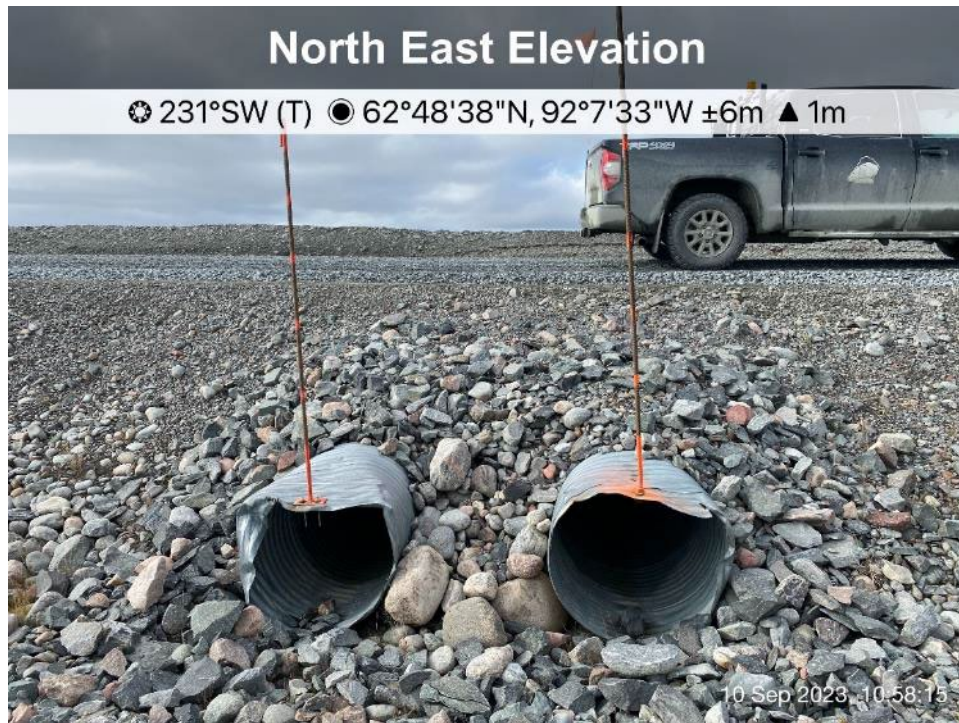
Itivia Bypass Road/Culvert - Photo 25: Culvert C09 inlet.

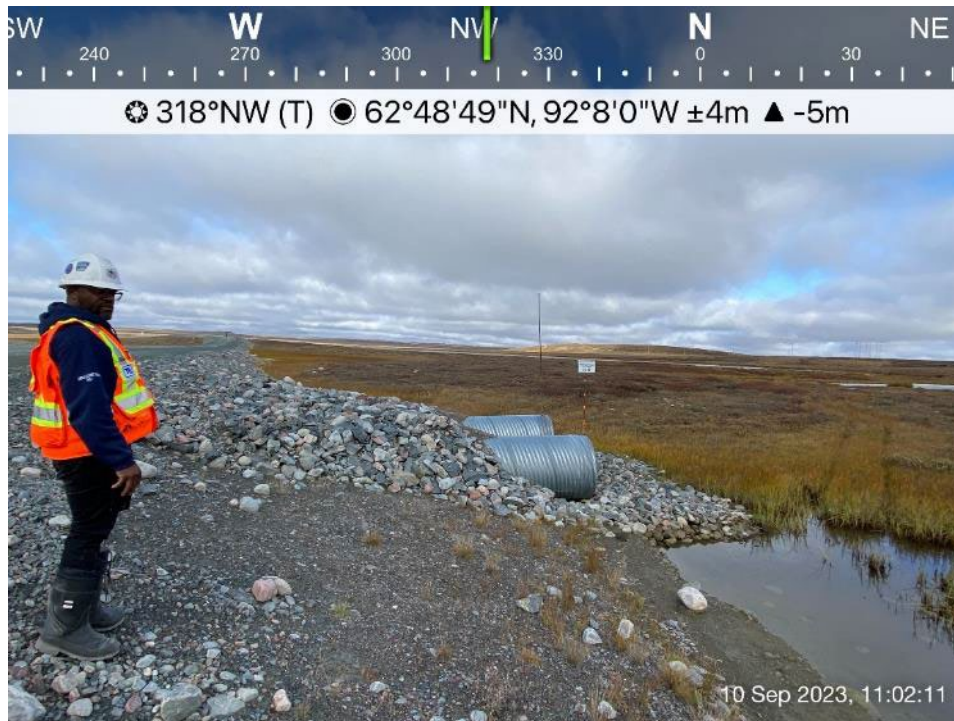
Itivia Bypass Road/Culvert - Photo 27: Culvert C10 inlet.

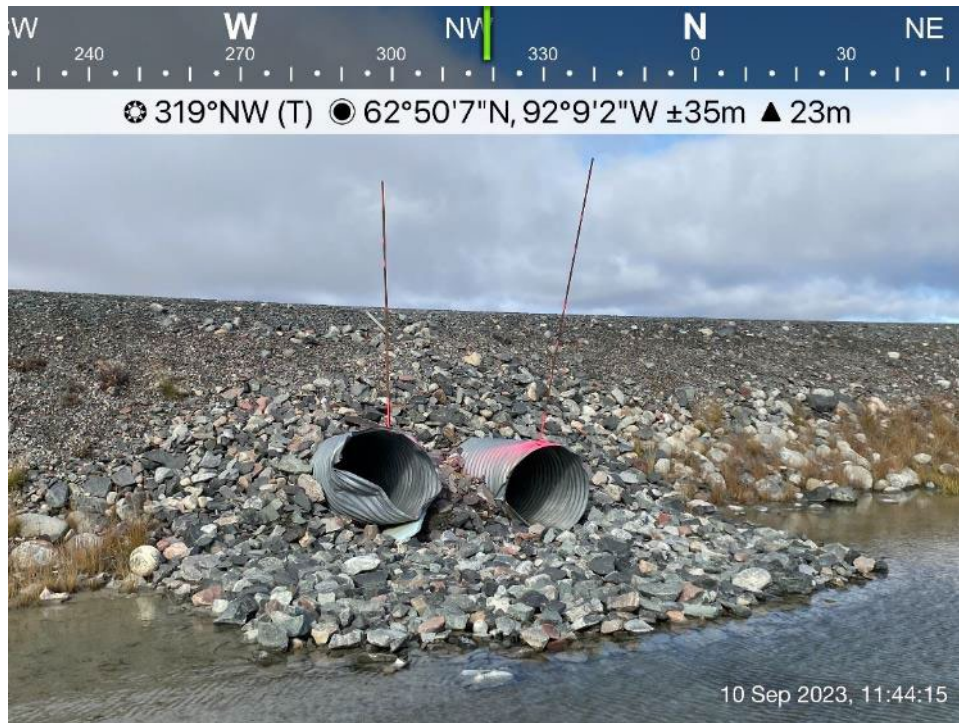
Itivia Bypass Road/Culvert - Photo 51: Culvert C18 inlet.

6.2 km	C18 (Design identification C13)	2 x 800 mm	Culverts are constructed over riprap and inverts are raised above surrounding tundra. Relatively large pond of water upstream and downstream of the culverts; road constructed through natural pond. Road constructed out of esker materials. Minor dents at east outlet. West inlet is damaged. The Culvert is bent with ¼ of the area. Low water flow at time of inspection.	Itivia Bypass Road Culvert – Photos 50 to 52
