APPENDIX 14 2023 REPORTABLE SPILLS

Re: Follow-up Report Spill #2023-009 – Release of 5 L of Sewage at the Meliadine Gold Project

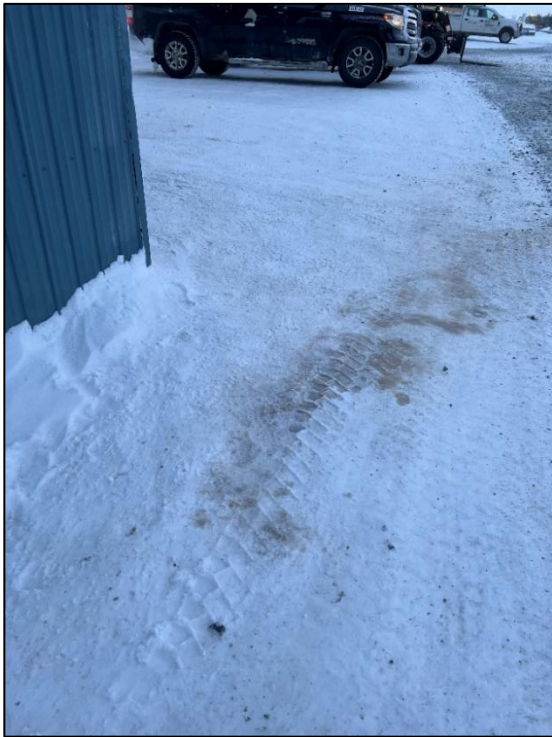
On January 10th, 2023, at approximately 1:00 pm, an estimated 5 L of sewage was spilled on the industrial pad at the multiple service building (MSB) lift station due to the vacuum truck operator deviating from an established procedure. The contents of the vacuum truck were emptied into the MSB lift station and the operator attempted to clear the hose. The operator deviated from the procedure when disconnecting the hose from the lift station and attempted to vacuum out the residual sewage from the hose. Due to the hose being disconnected from the lift station the remaining sewage in the line spilled to the industrial pad. The spilled sewage collected directly on the road behind the vacuum truck and was contained to the local area. No water bodies were impacted by this spill. The closest water body (G2) is approximately 300 meters north, as seen in Figure 1.

Photo 1: Sewage spill location.

Upon observing the spill, the operator shutdown the pump to prevent further spillage. The impacted surface area was hand excavated and an estimated 5 kg of contaminated snow was brought to Landfarm A as per the Spill Contingency Plan.

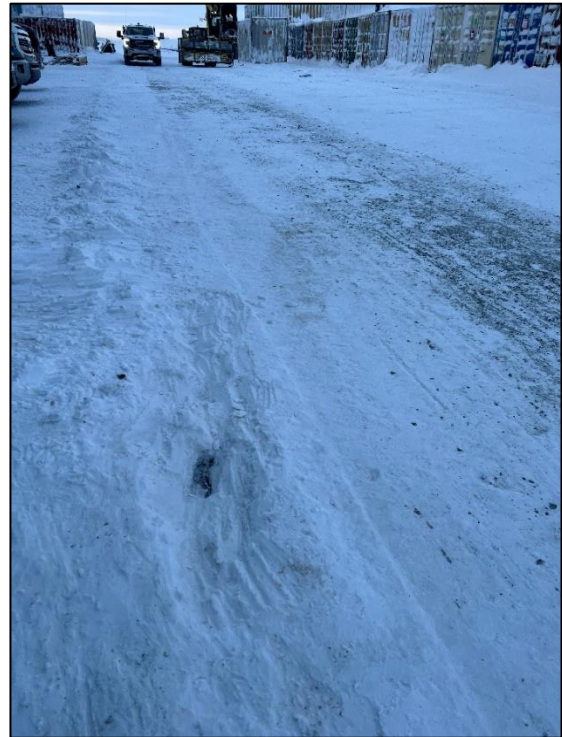
Photo 2: Sewage spill post remediation.

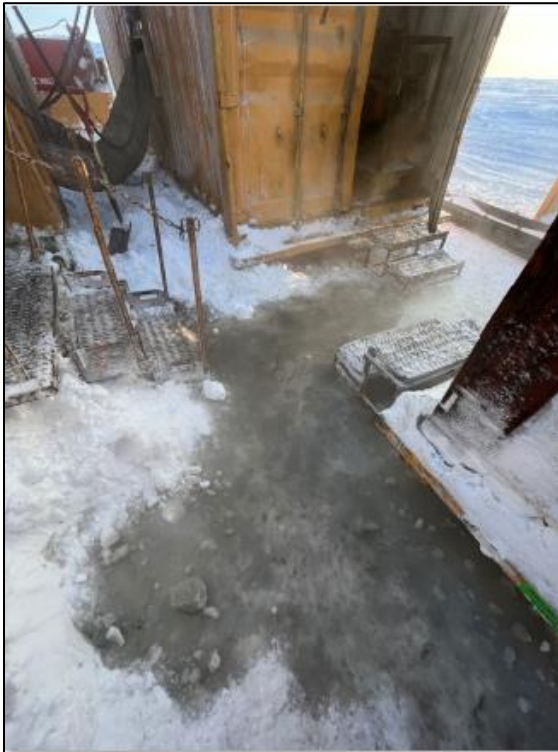
On February 26th, 2023, at approximately 8:00 am, an estimated 50 L of drill cuttings water was spilled onto the ice surface on lake A19. The generator powering the water recovery pan pump failed allowing the water recovery pan to overflow. The spill was located on Lake A19, as seen in Figure 1.

- The failure of the drill site generator resulted in a power loss to the water recovery pan pump allowing it to continue to fill from the water pressure pump.
- Water contaminated fuel was identified in the fuel filter sight glass resulting in a generator failure.

Photo 1: Drill cutting water spill.

- A signal light has been installed in the drills to notify the driller of a generator failure.
- Operating instructions to shut down the water pressure pump during a generator failure has been provided to all drilling employees.
- Direction has been provided to all drilling employees to inspect fuel nozzle to ensure there is no snow inside prior to refueling equipment, therefore preventing equipment failure.

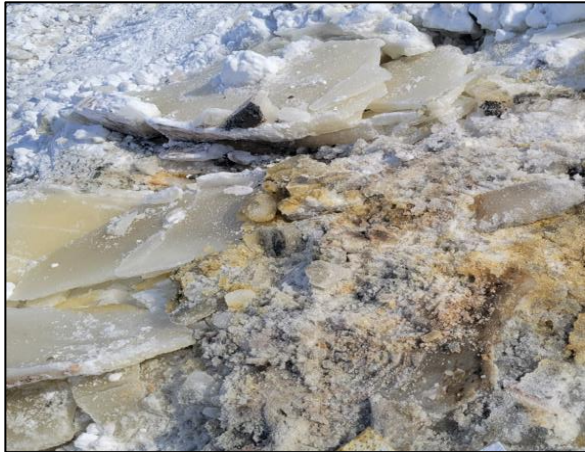
On March 17th, 2023, at approximately 14:00, an estimated 1 L of hydraulic oil was spilled onto the ice surface on Lake A8 as seen in Figure 1. While lowering the drill tower to relocate the drill a hydraulic line was pinched spilling hydraulic oil within the drill and into the water recovery pan. After the water recovery pan was removed and the drill relocated, remnant oil from under the drill floor was observed on the snow.

Photo 1: 1 L hydraulic oil spill location.

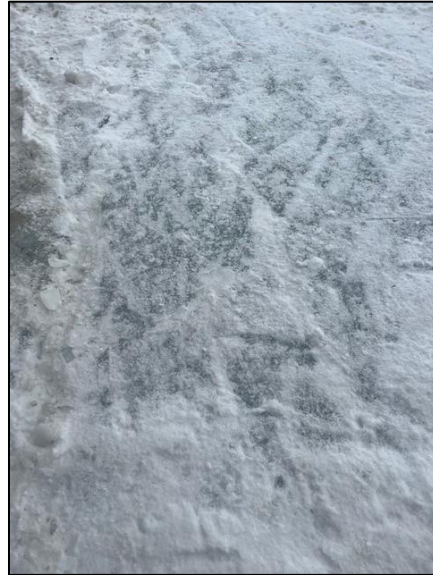
Photo 2: 1 L hydraulic oil spill post remediation.

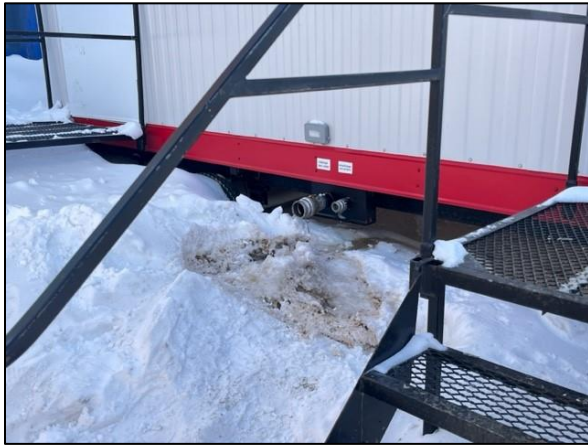
On April 7th, 2023, at approximately 13:30pm, an estimated 20 L of sewage was spilled onto the industrial pad by the powerplant wash car due to a miscommunication between the vacuum truck operators. During normal operations, both vacuum truck operators failed to confirm if hose was connected to the truck prior to transferring material from the lift station. No water bodies were impacted by this spill. The closest water body (G2) is approximately 595 meters northwest, as seen in Figure 1.

Photo 1: 20 L Sewage spill at powerplant washcar.

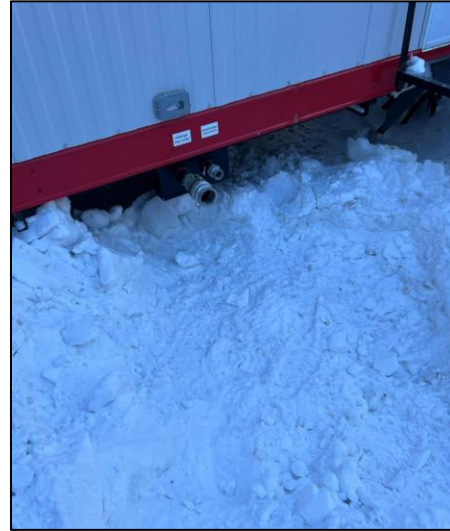
Photo 2: 20 L Sewage spill post remediation.

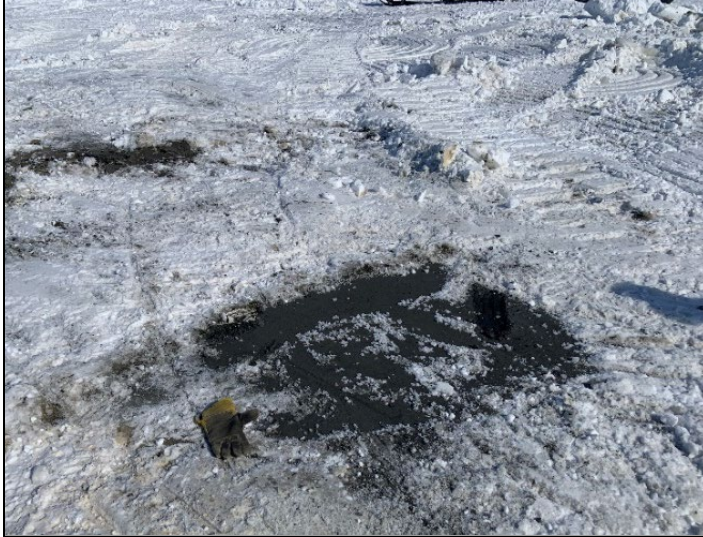
On April 16th and 17th, 2023, Orbit Garant Drilling was removing their drilling equipment from the ice surface of an unnamed waterbody approximately 7.5 kilometers east of the Meliadine Gold Mine industrial pad. At approximately 3:30 am on April 17th, the drill crew prepared to drag two skid-mounted units of drilling equipment, chained in series, behind a tractor. The last unit in the train was the cuttings recirculation unit. Due to the lack of daylight and the cuttings recirculation unit being at the back of the train, the drilling crew did not notice the spill of 40 L of drill cuttings to the ice surface as the equipment left the site. The spill was discovered during the post-drilling inspection on April 17th, 2023, at approximately 15:30. The location of the spill is shown in Figure 1.

Photos 1: 40 L Drill cuttings water spill.

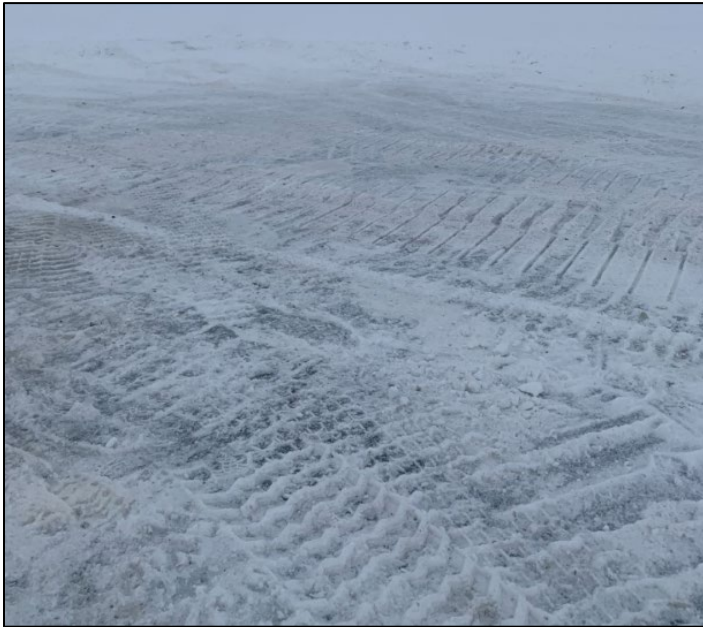
Photos 2: 40 L drill cuttings water spill post remediation.

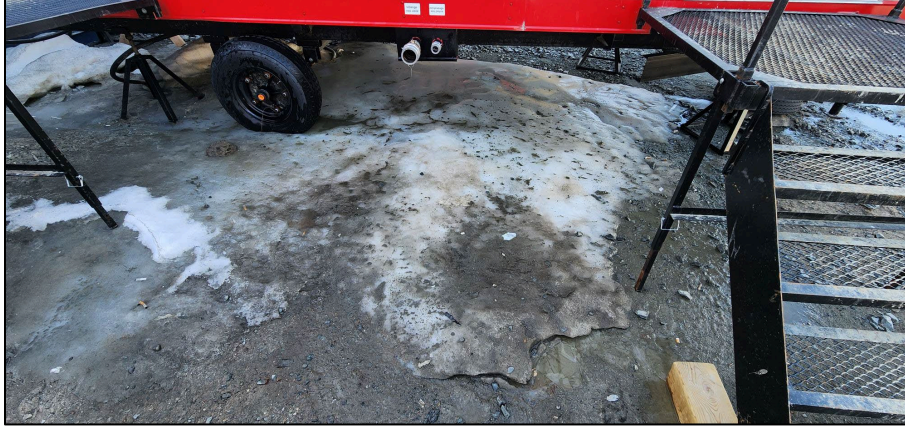
On May 22nd, 2023, at approximately 07:30, an estimated 15 L of sewage was spilled onto the industrial pad by the temporary power plant wash car due to a connection failure. No water bodies were impacted by this spill. The closest water body (G2) is approximately 565 meters west, as seen in Figure 1.

- Missing gasket on the camlock which connects the vacuum truck to the wash car.
- The vacuum truck hose was not properly inspected prior to use.

Photos 1: Sewage spill location.

- A new gasket was installed within the camlock to prevent future leaks.
- The supervisor met with employees to review the importance of performing complete checks on their equipment/tools before proceeding with their jobs.

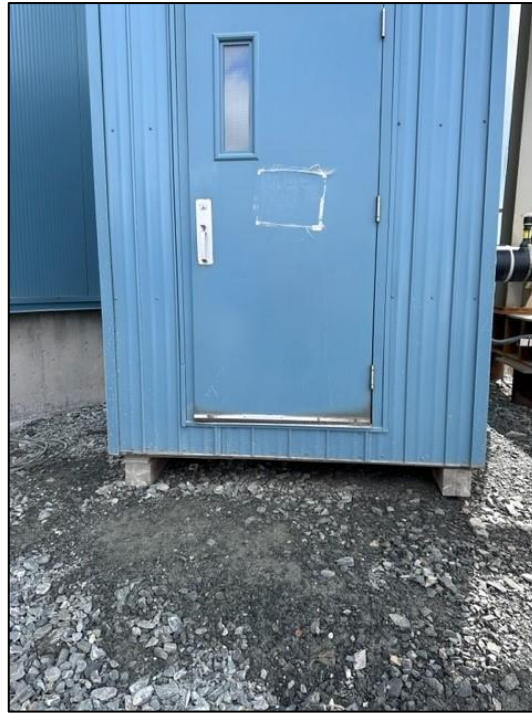
Photo 2: Sewage spill post remediation.

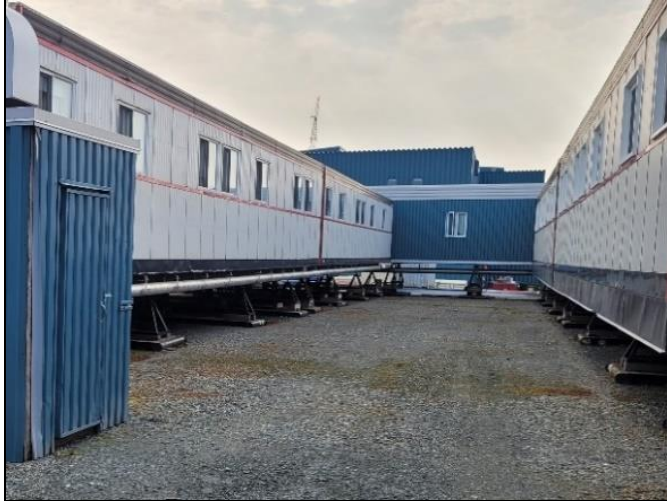
Photo 1: Sewage spill location.

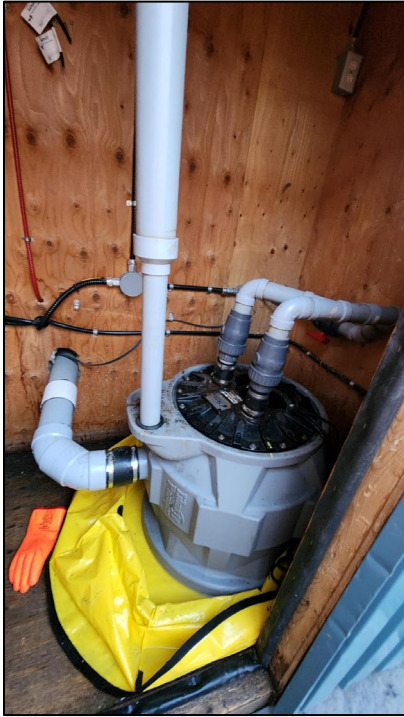
On August 30th, 2023, at approximately 05:00, an estimated 25 L of sewage was spilled onto the industrial pad by wing 4 lift station. A power failure at wing 4 de-energized the lift station and caused the spill. No water bodies were impacted by this spill. The closest water body (Lake G2) is approximately 225 meters northwest, as seen in Figure 1.

Photo 1: Sewage spill location.

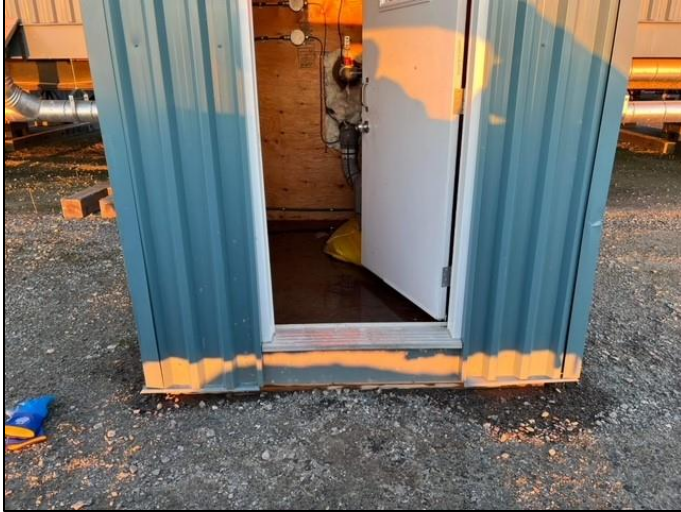
On October 16th, 2023, at approximately 17:00, an estimated 10 L of sewage was spilled onto the industrial pad by wing 14 lift station. A transfer pump failed due to blockage at the intake of the pumps, resulting in the sewage spill. No water bodies were impacted by this spill. The closest water body (Lake G2) is approximately 195 m northwest, as seen in Figure 1.

Photos 1: Sewage spill location.

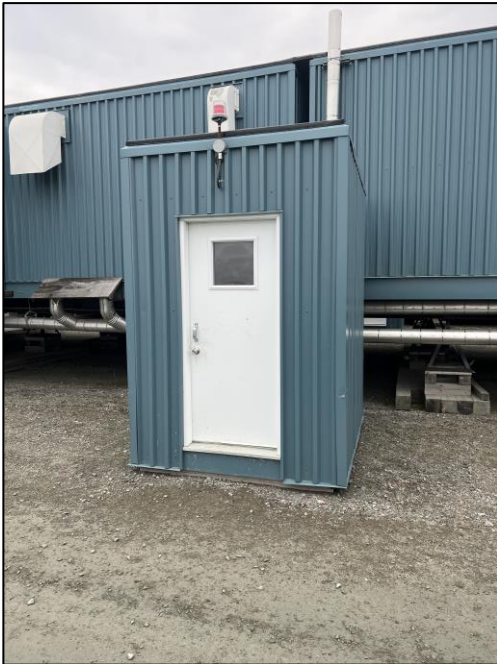
Photos 2: Spill location post remediation.

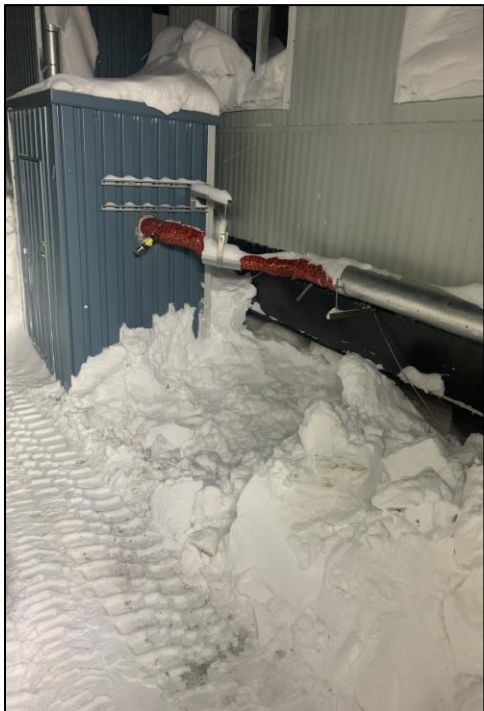
Photo 3: Spill location post remediation.

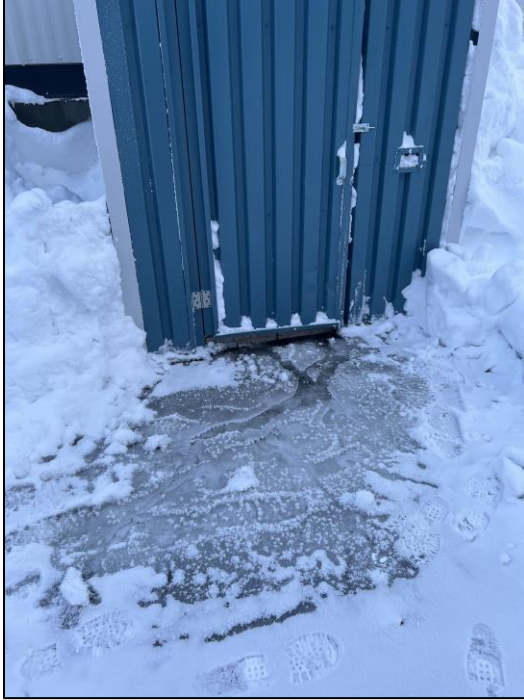
On December 11th, 2023, at approximately 11:30, an estimated 10 L of sewage was spilled onto the industrial pad at the wing 4 lift station. Due to a site power outage, the transfer pump did not engage allowing the lift station holding tank to overflow. No water bodies were impacted by the spill. The closest water body (Lake G2) is approximately 220 m northwest, as seen in Figure 1.

Photo 1: Sewage spill location.

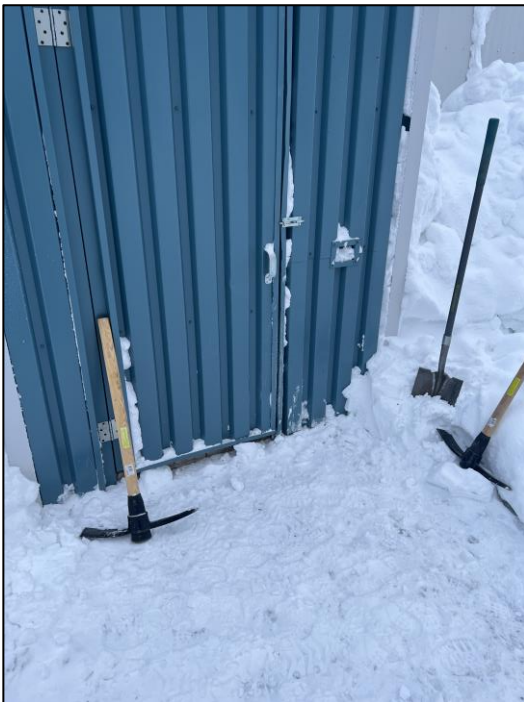
Photo 2: Spill location post remediation.
