Appendix 23

Meadowbank 2023 GN Spill Reports

GN reference #: 2023-004

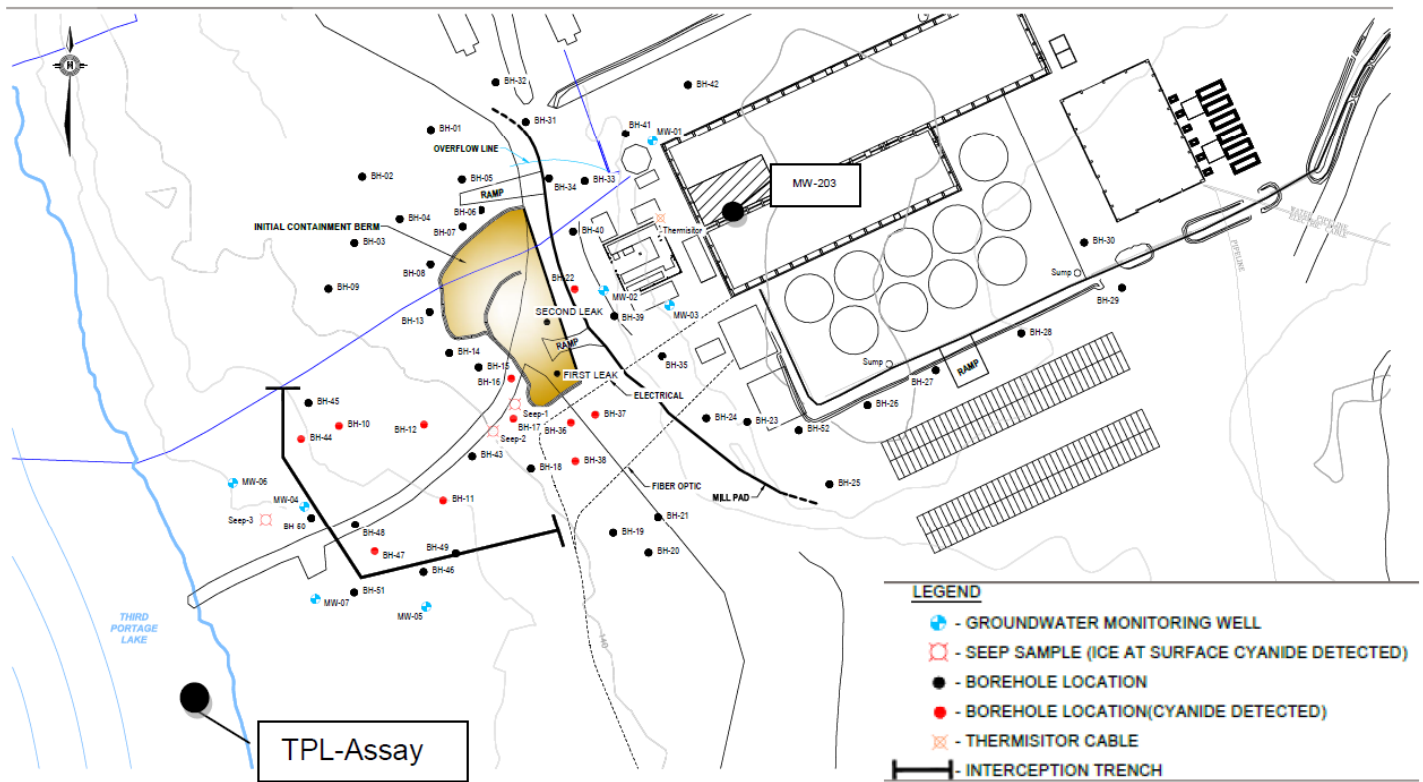
During a site assessment, evidence of water flow was observed on the west side of the assay lab road. Upon further investigation an inflow of water was found to be contained within existing water management infrastructure previously constructed.

The exact source of the spill is still currently under investigation and dye testing has been utilized to eliminate areas of potential release. There has been no visual water inflow observed since December 26th, 2023.

Figure 10. General Layout of the Assay Road Seepage monitoring wells as presented in the Meadowbank Complex’s 2022 Annual Report

Continued monitoring of the area will continue a routine basis throughout Freshet. Continued investigation work within the Mill utilizing dye within different sumps, tanks, and containments to identify the seepage origin, should water inflow resume. As a precaution Agnico will be bringing in an expert to inspect and repair, if needed, all foundation sealants, within the mill sumps.
