Meadowbank and Whale Tail 2023 Annual Geotechnical Inspection

2023 Annual Geotechnical Inspection

Meadowbank Complex, Nunavut

1623-2146800623-RA-Rev0

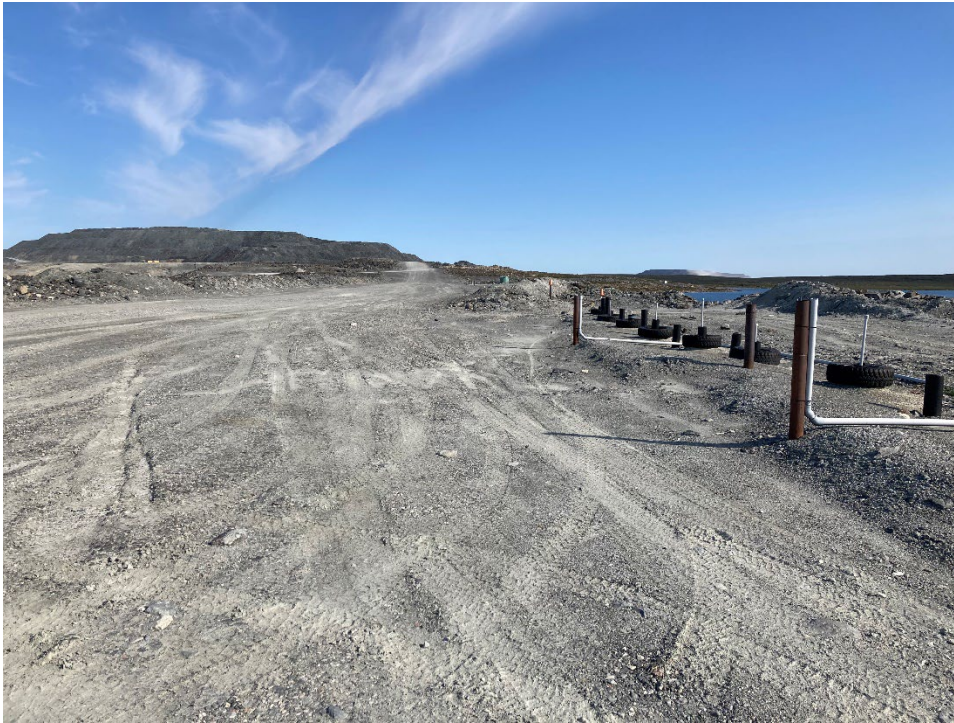
Photograph A1-1 East Dike

Description: From approximately Sta. 60+500, looking north at the crest.

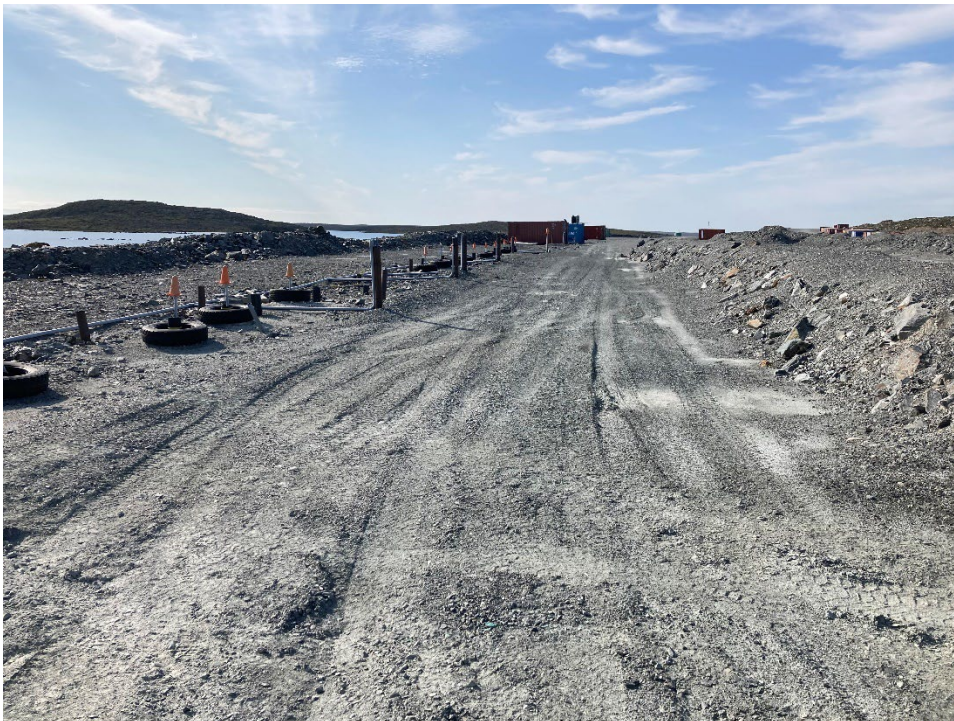
Photograph A1-2 East Dike

Description: From approximately Sta. 60+500, looking south at the crest.

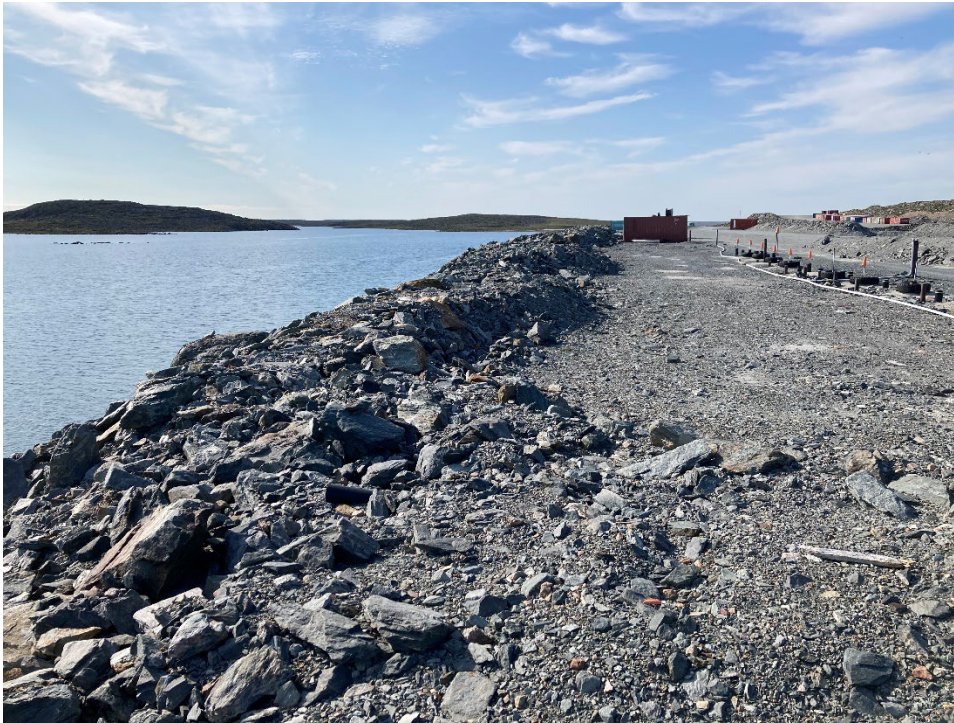
Photograph A1-3 East Dike

Description: From approximately Sta. 60+500 upstream, looking south at the crest.

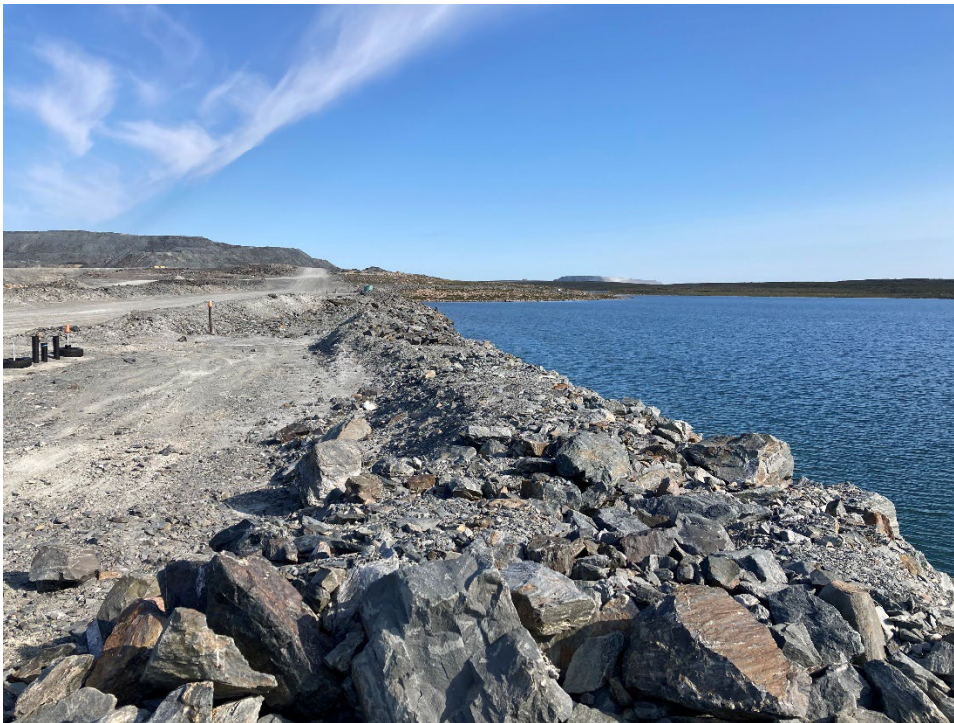
Photograph A1-4 East Dike

Description: From approximately Sta. 60+500 upstream, looking north at the crest.

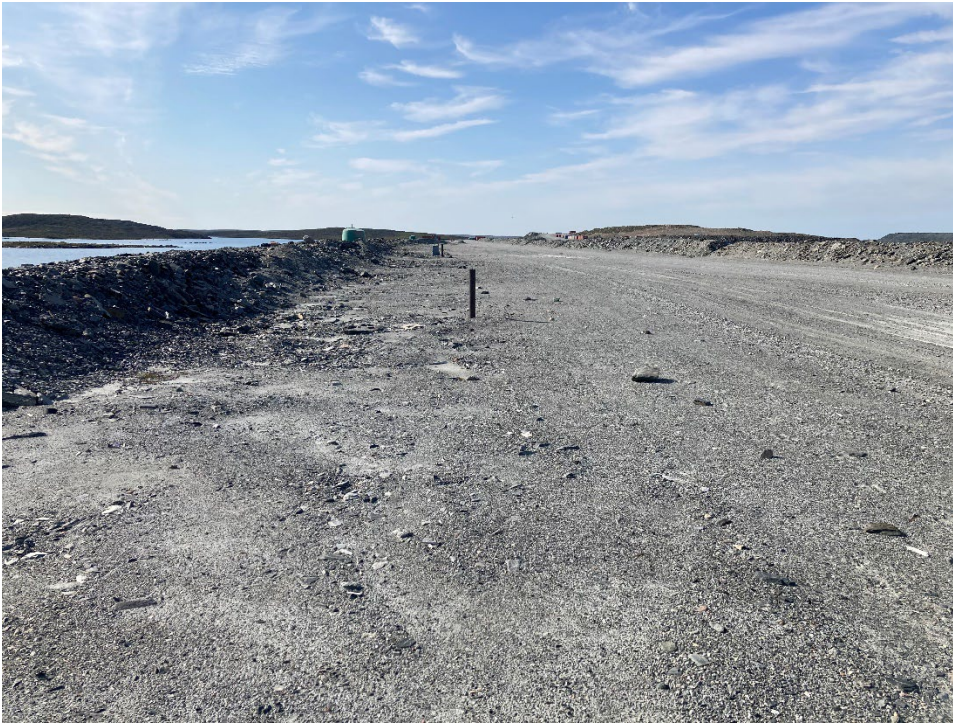
Photograph A1-5 East Dike

Description: From approximately Sta. 60+810, looking south at the crest and upstream slope.

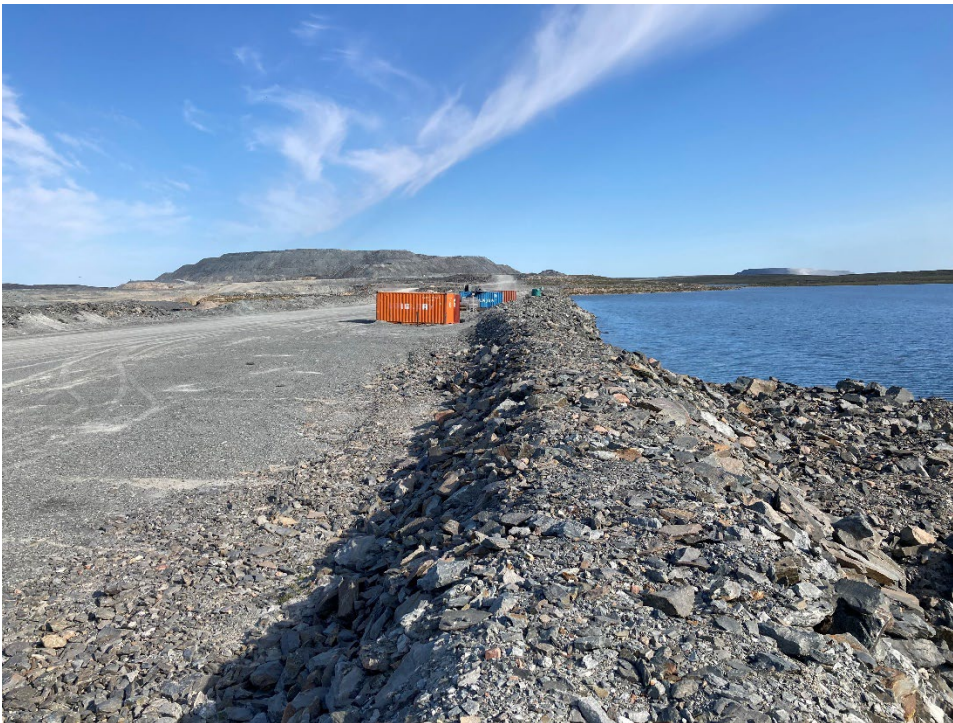
Photograph A1-6 East Dike

Description: From Sta. 60+300 upstream, looking north at the crest and upstream slope.

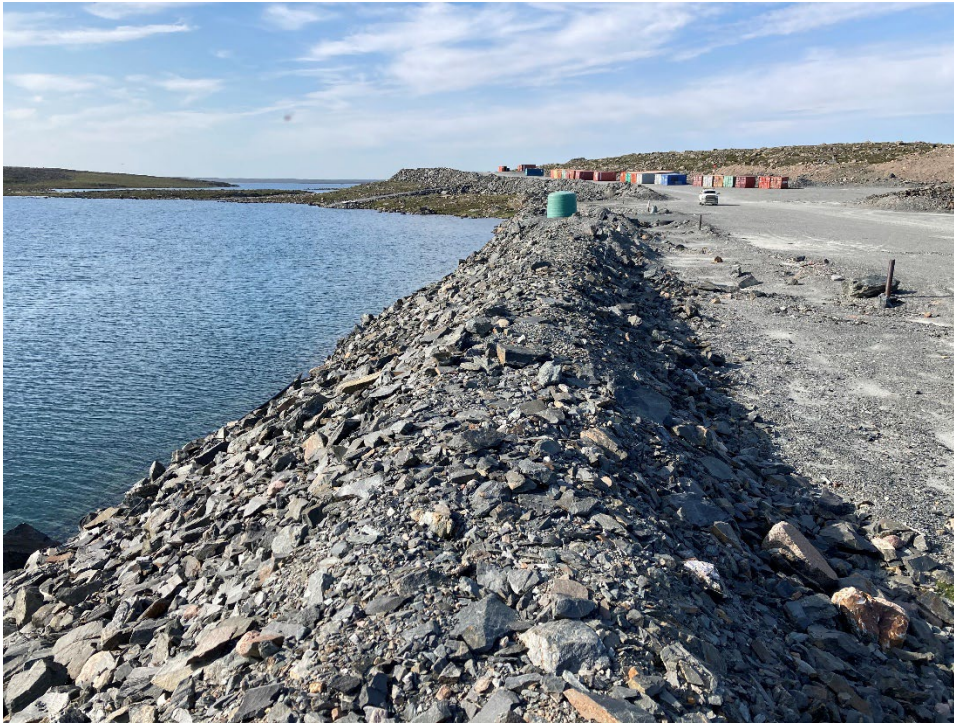
Photograph A1-7 East Dike

Description: From approximately Sta. 60+250 upstream, looking south at the upstream slope.

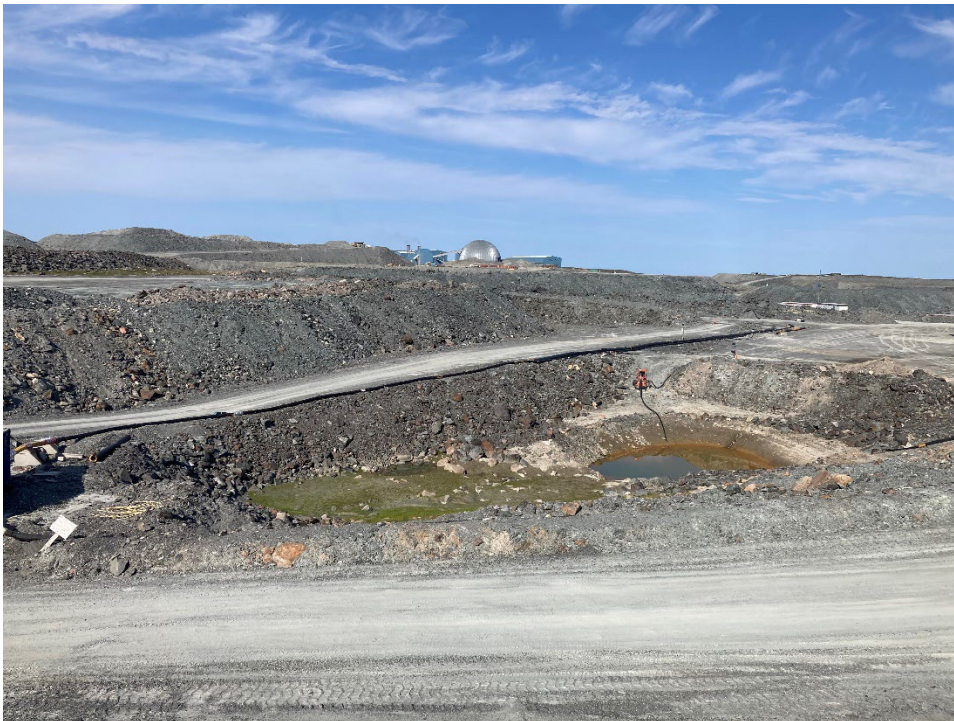
Photograph A1-8 East Dike

Description: From approximately Sta. 60+250, looking west at the downstream side and toe.

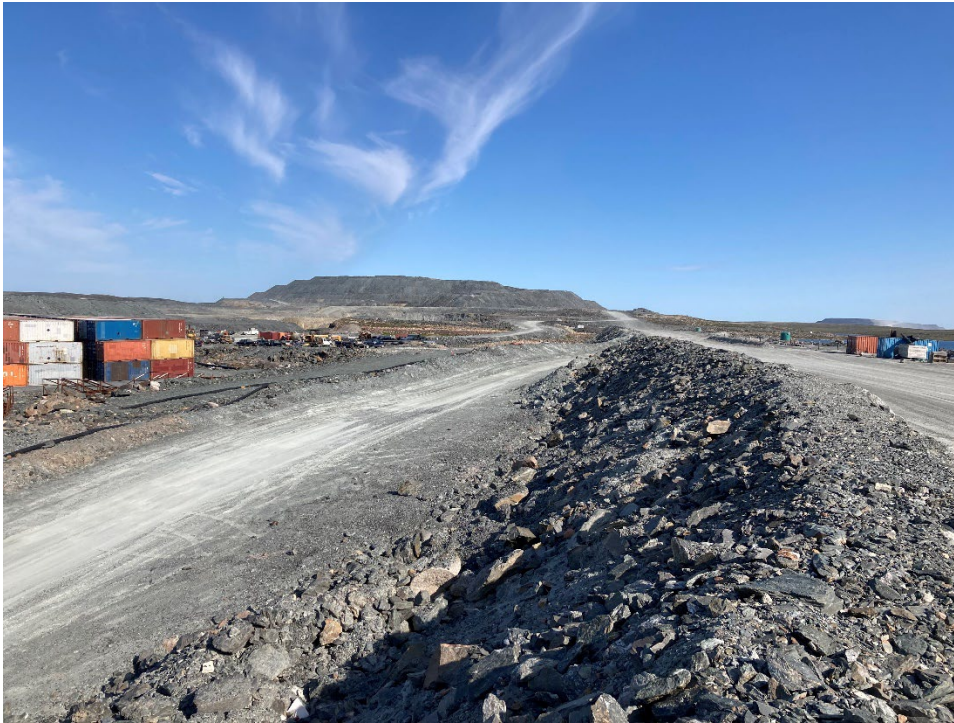
Photograph A1-9 East Dike

Description: From approximately Sta. 60+300, looking north at the downstream side and toe.

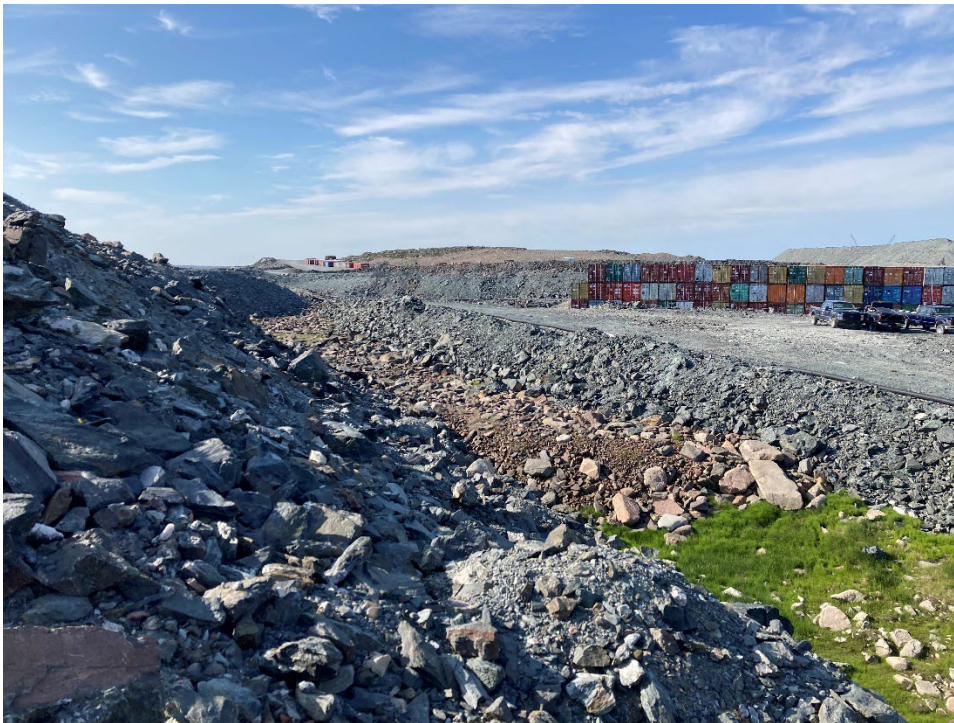
Photograph A1-10 East Dike

Description: From approximately Sta. 60+475, looking south at the downstream toe.

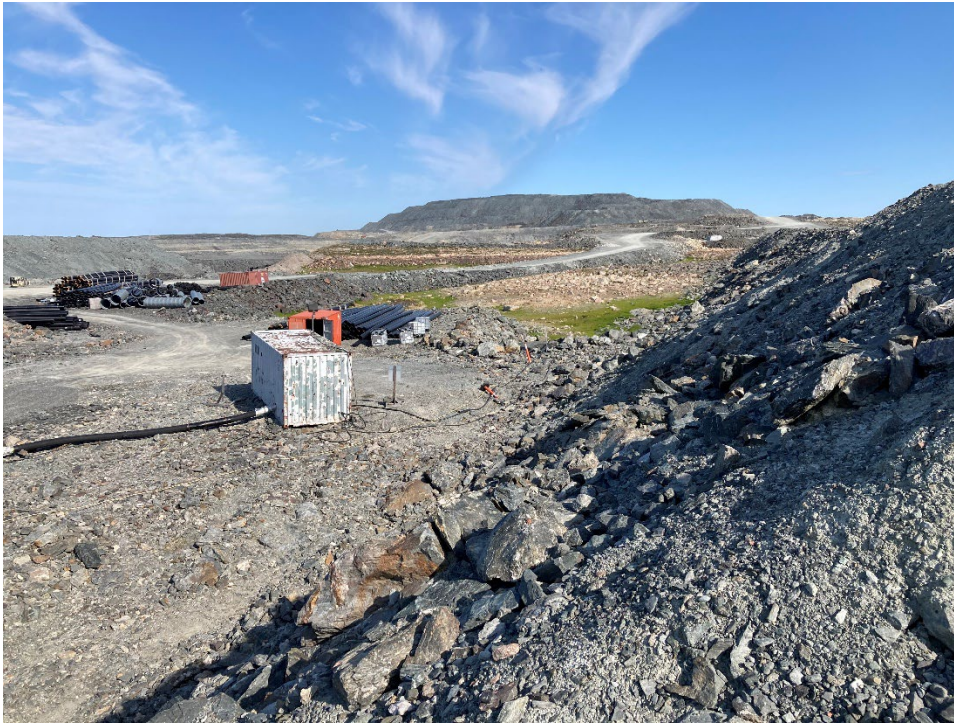
Photograph A1-11 East Dike

Description: From approximately Sta. 60+500, looking north at the downstream toe.

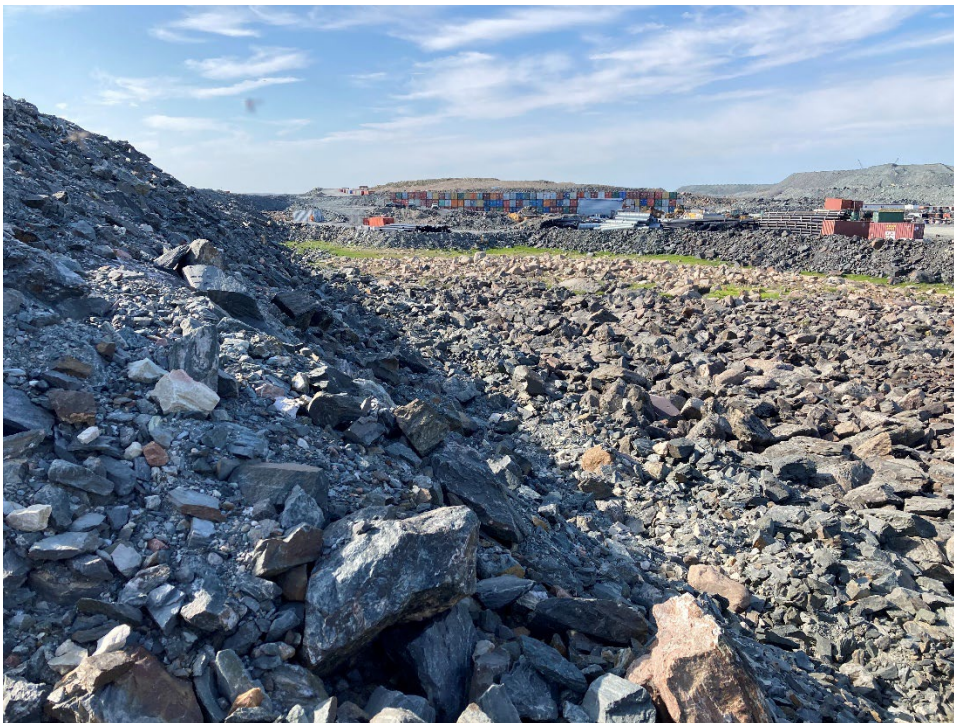
Photograph A1-12 East Dike

Description: From approximately Sta. 60+560, looking south at the downstream toe.

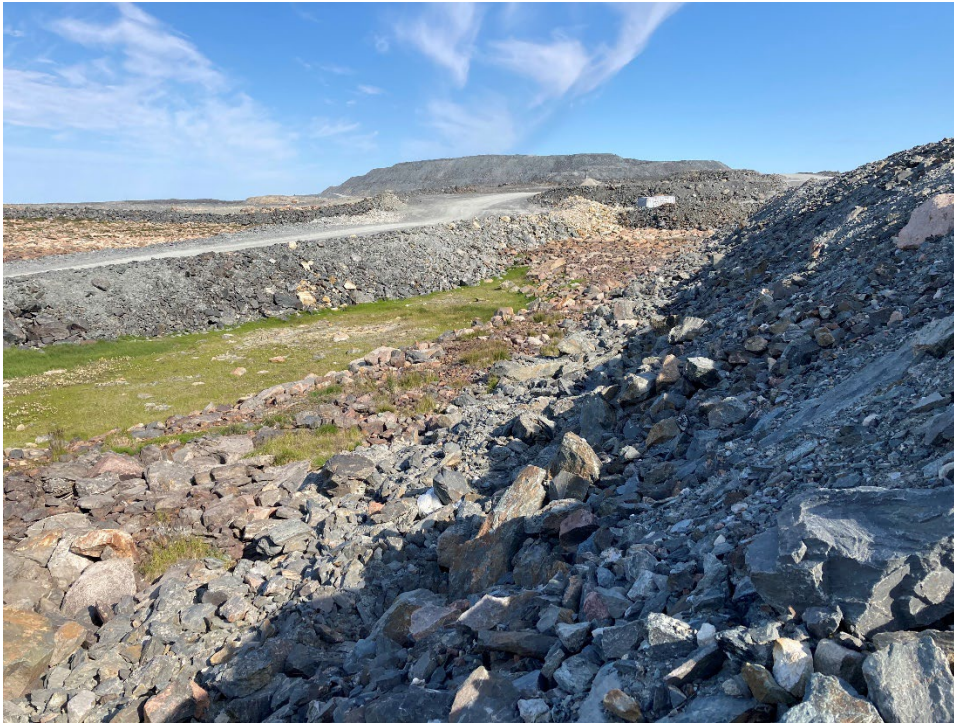
Photograph A1-13 East Dike

Description: From approximately Sta. 60+560, looking north at the downstream slope and toe.

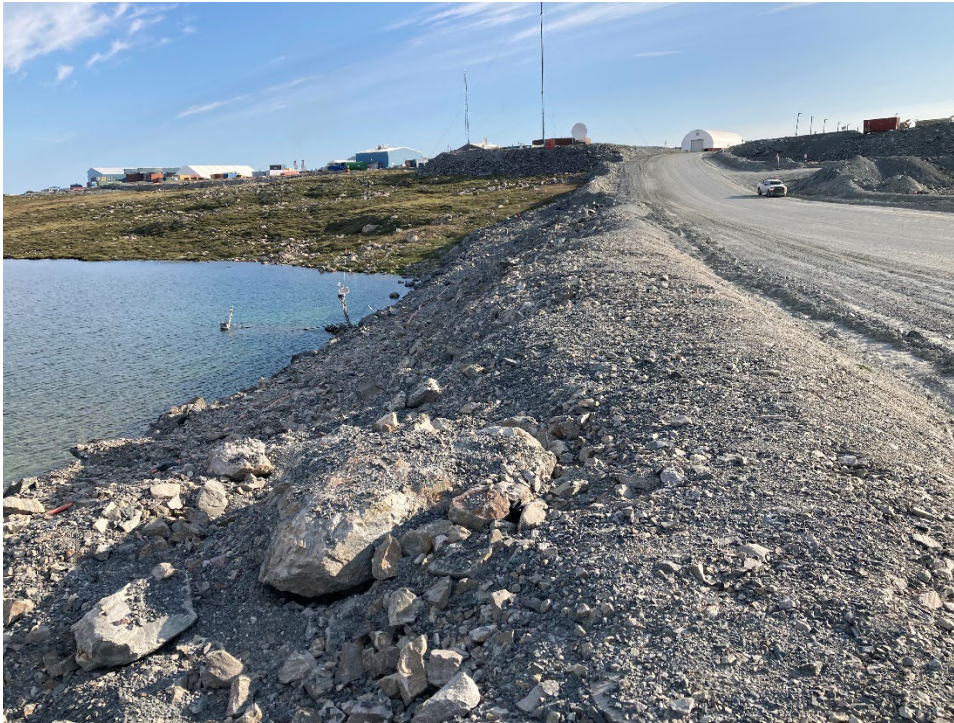
Photograph A2-1 South Camp Dike

Description: From the south abutment, looking north at the upstream slope and the thermistors instrumentation set-up.

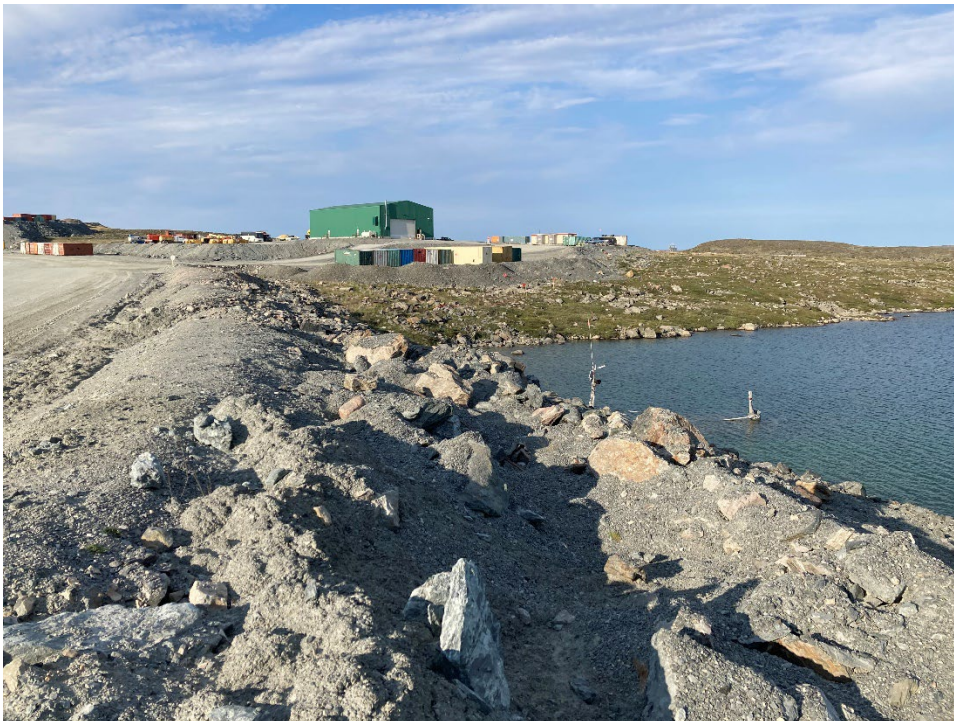
Photograph A2-2 South Camp Dike

Description: From the north abutment, looking south at the upstream slope and thermistors instrumentation set-up.

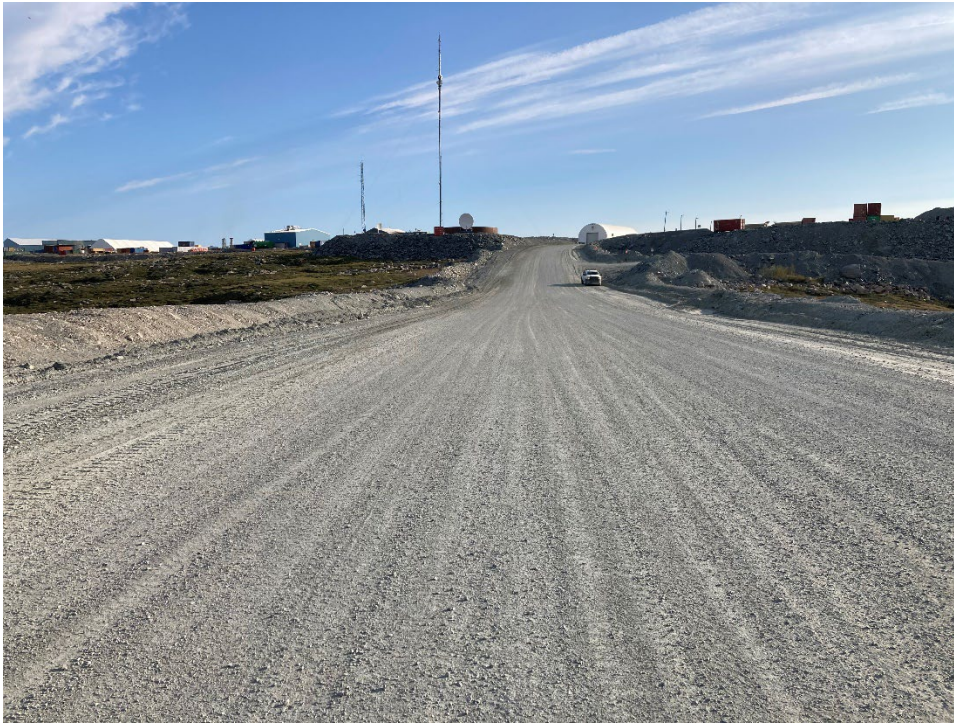
Photograph A2-3 South Camp Dike

Description: From the south abutment, looking north at the crest.

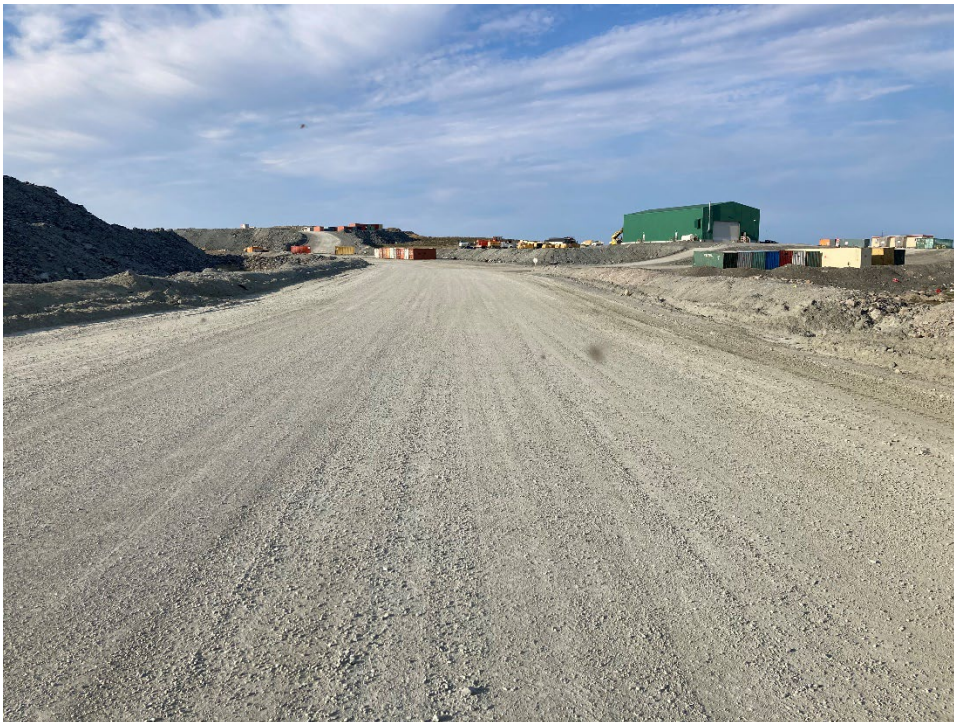
Photograph A2-4 South Camp Dike

Description: From the north abutment, looking south at the crest.

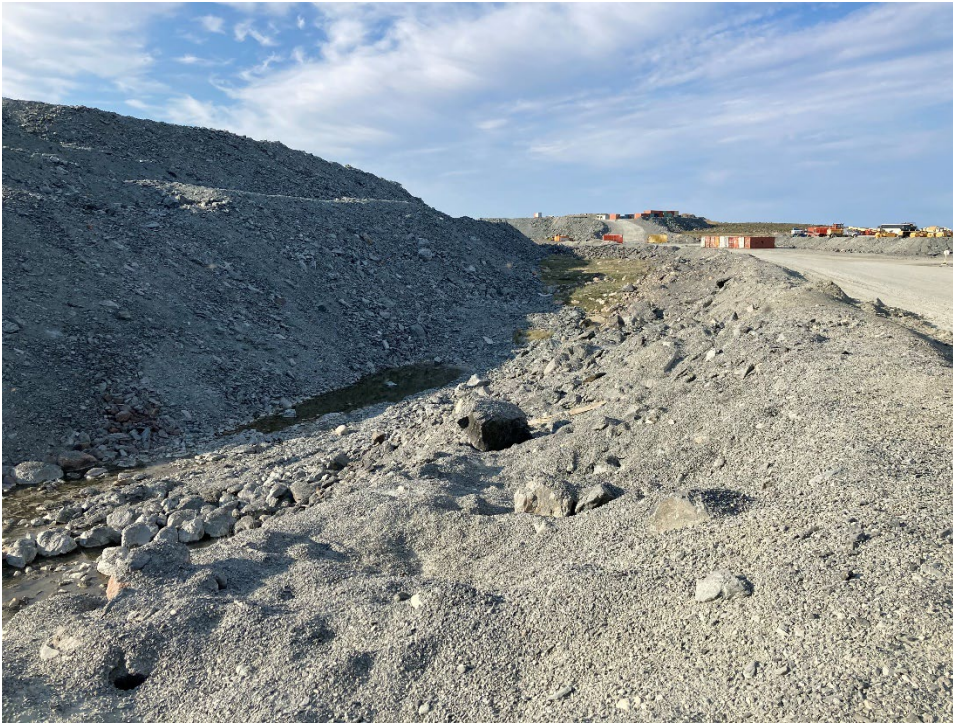
Photograph A2-5 South Camp Dike

Description: From the north abutment, looking south at the downstream slope. There is some water ponding, from run-off.

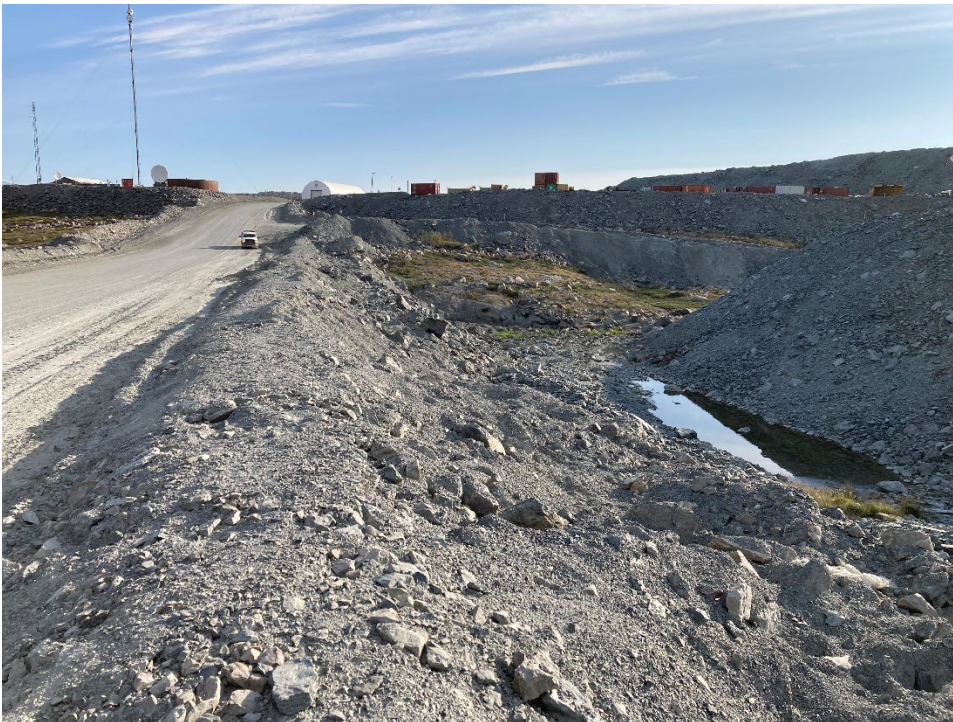
Photograph A2-6 South Camp Dike

Description: From the south abutment, looking north at the downstream slope. There is some water ponding, from run-off.

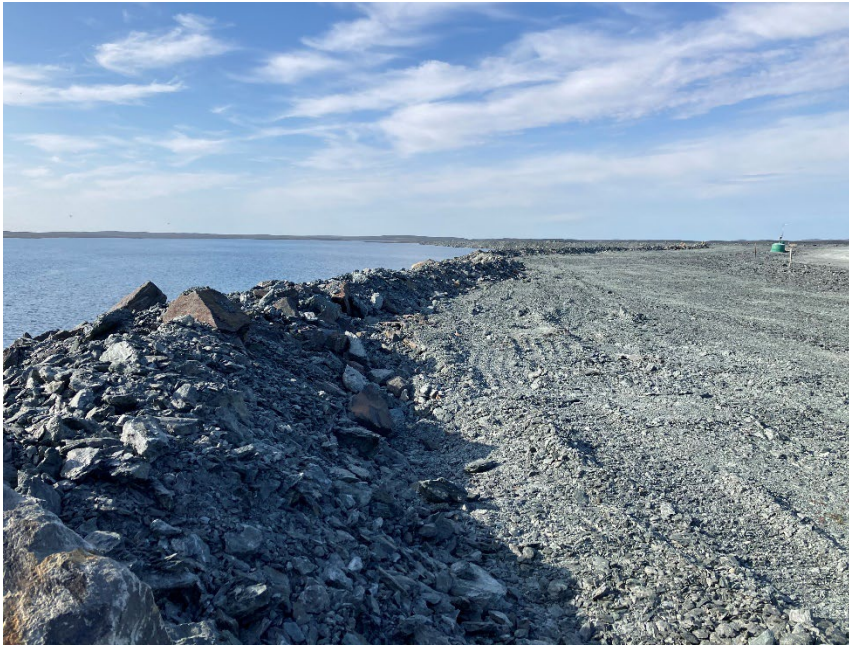
Photograph A3-1 Bay Goose Dike

Description: From approximately Sta. 30+142 (north abutment) looking southwest at the crest and upstream slope.

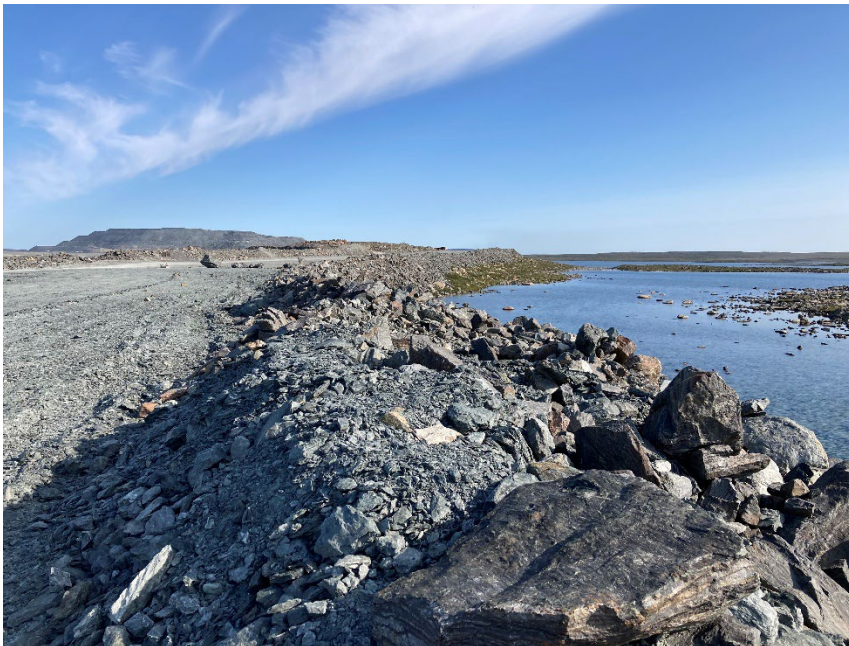
Photograph A3-2 Bay Goose Dike

Description: From approximately Sta. 30+130 (north abutment), looking north at the crest and upstream slope.

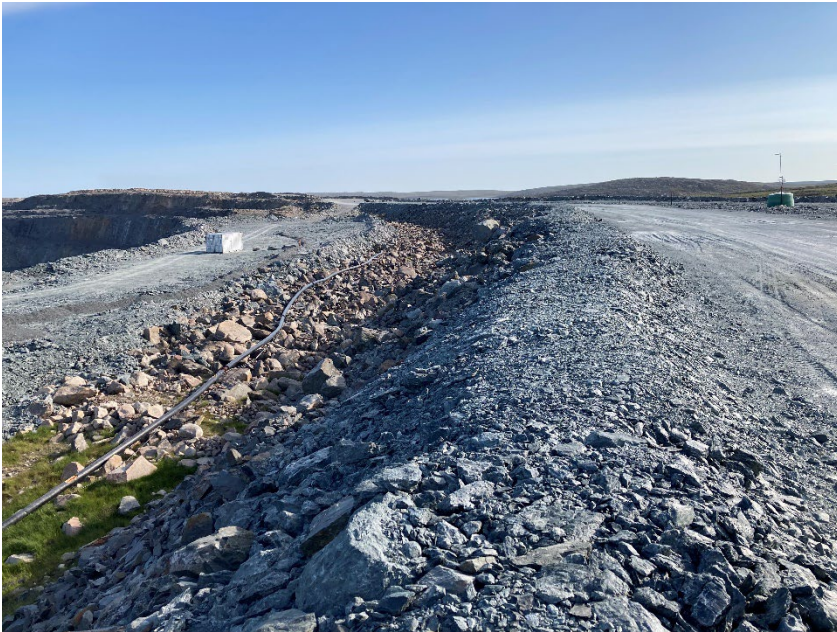
Photograph A3-3 Bay Goose Dike

Description: From approximately Sta. 30+340 on the crest, looking northeast at the dam crest and downstream slope

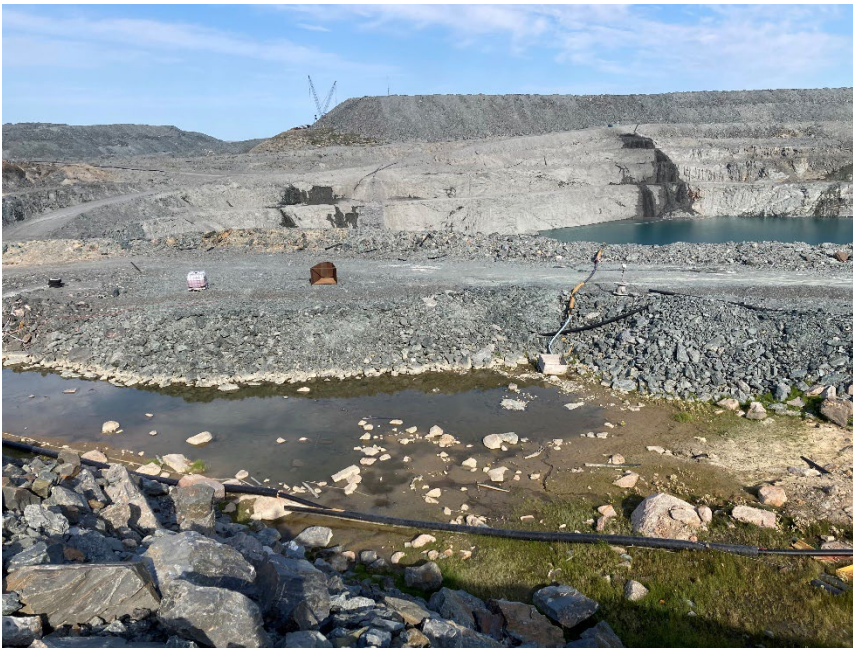
Photograph A3-4 Bay Goose Dike

Description: From approximately Sta. 30+340, looking northwest at the north seepage channel.

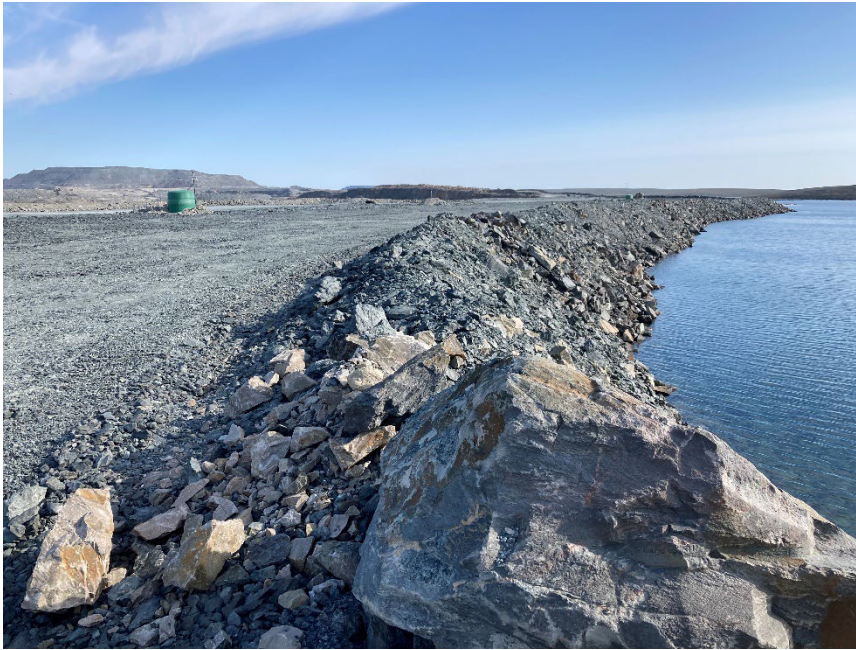
Photograph A3-5 Bay Goose Dike

Description: From Sta. 30+500, looking northeast at the crest and the upstream slope.

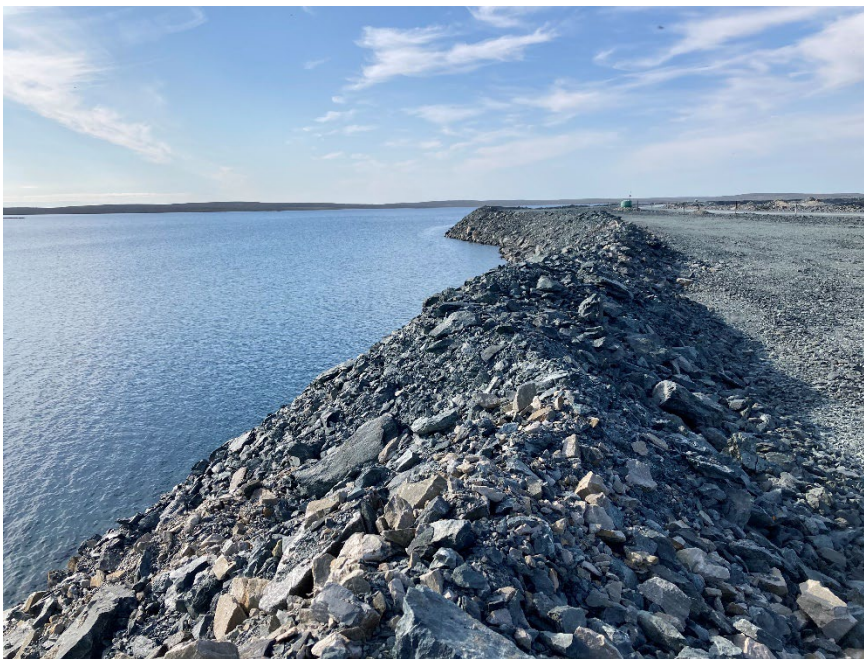
Photograph A3-6 Bay Goose Dike

Description: From Sta. 30+500, looking south at the crest and the upstream slope.

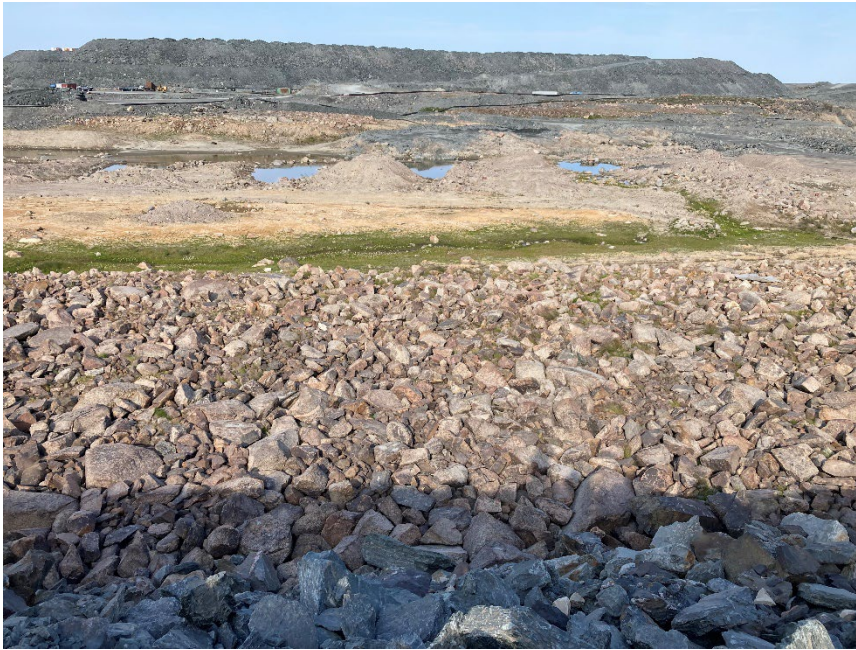
Photograph A3-7 Bay Goose Dike

Description: From Sta. 30+500, looking west at the downstream slope and toe.

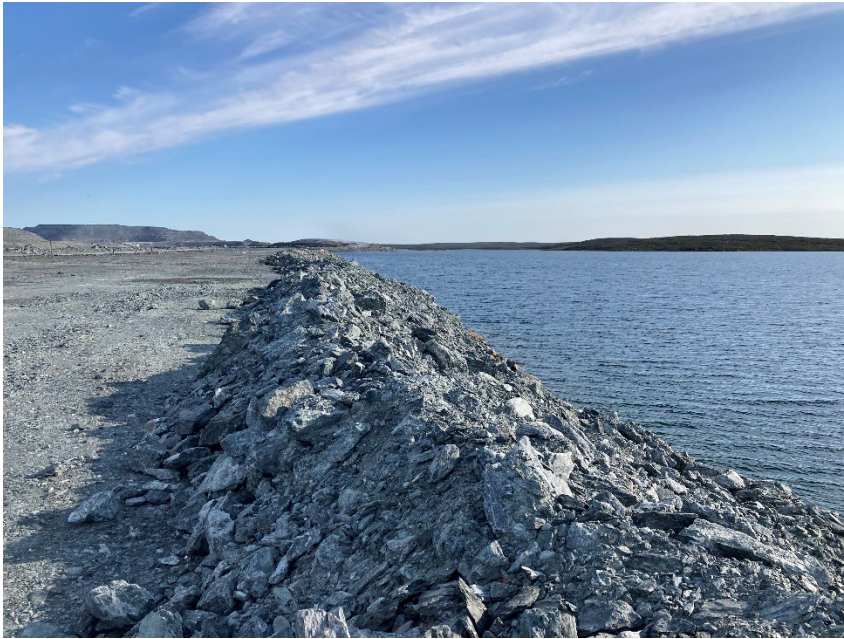
Photograph A3-9 Bay Goose Dike

Description: From approximately Sta. 31+130, looking north at the crest and upstream slope.

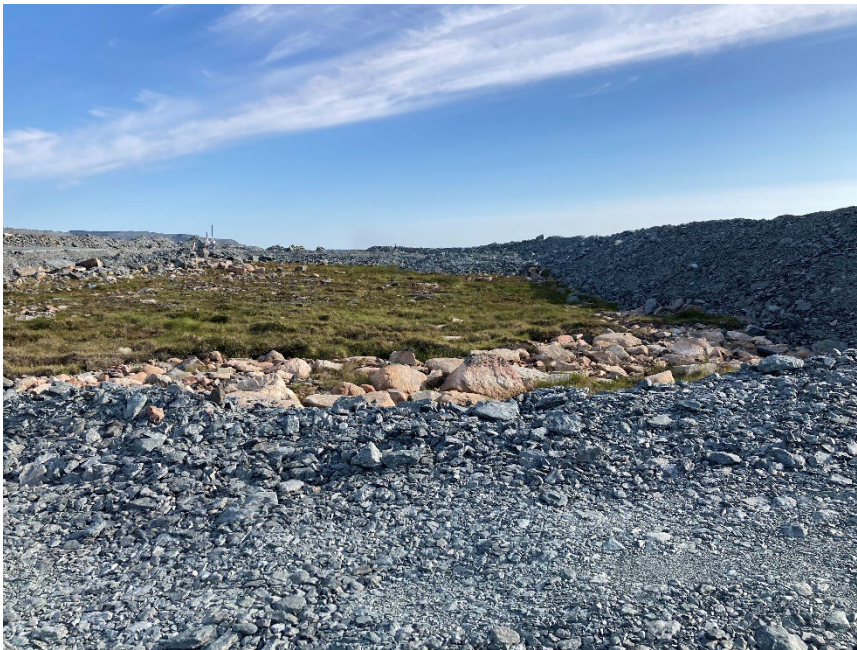
Photograph A3-10 Bay Goose Dike

Description: From approximately Sta. 31+080 on the crest, looking north at the downstream slope and toe.

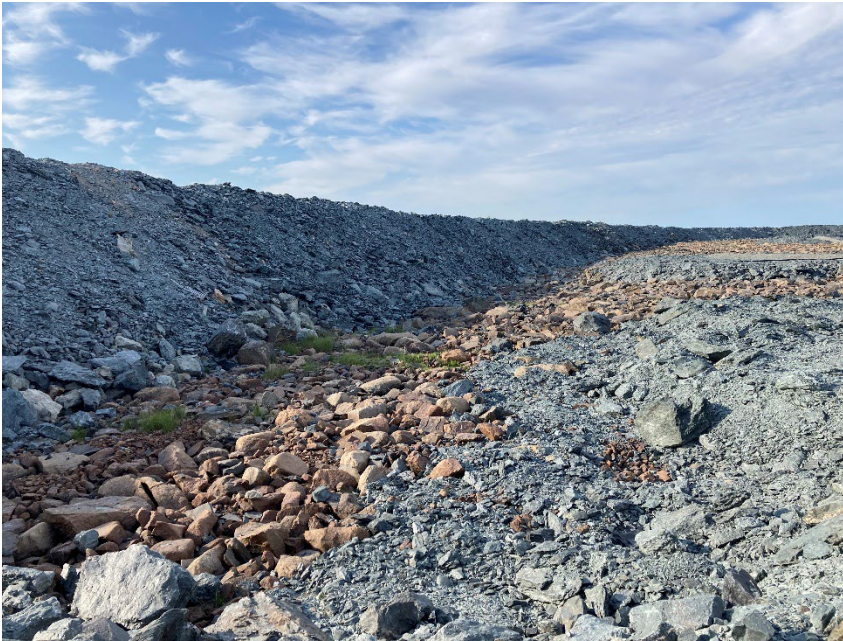
Photograph A3-11 Bay Goose Dike

Description: From approximately Sta. 31+080 on the crest, looking southwest at the Central Channel area.

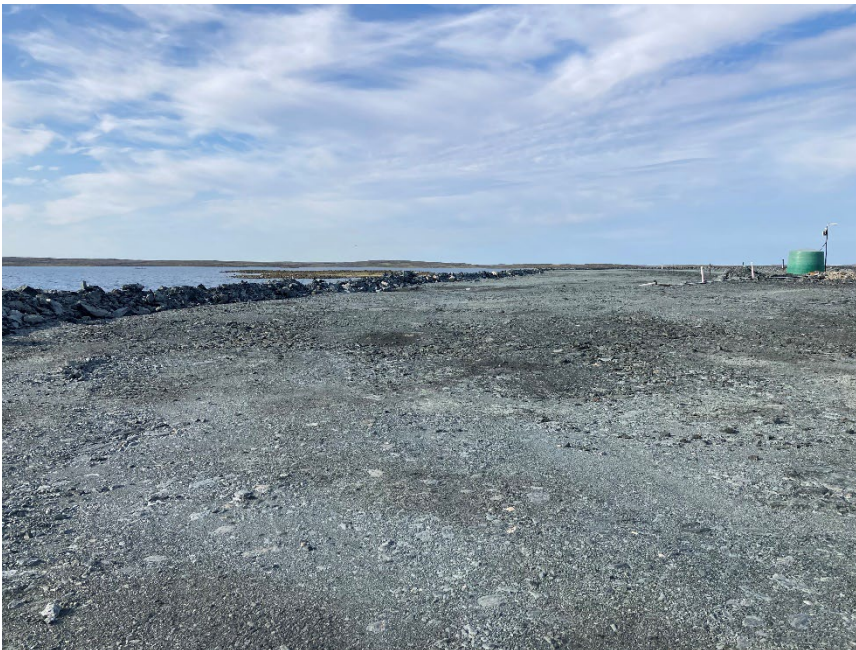
Photograph A3-12 Bay Goose Dike

Description: From approximately Sta. 31+130, looking southwest at the crest.

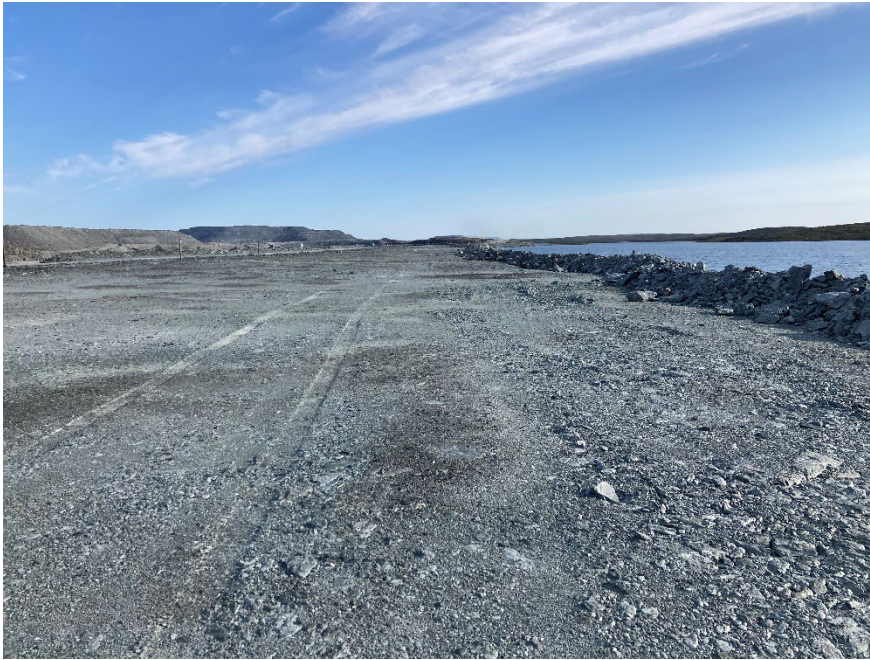
Photograph A3-13 Bay Goose Dike

Description: From approximately Sta. 31+130, looking north at the crest.

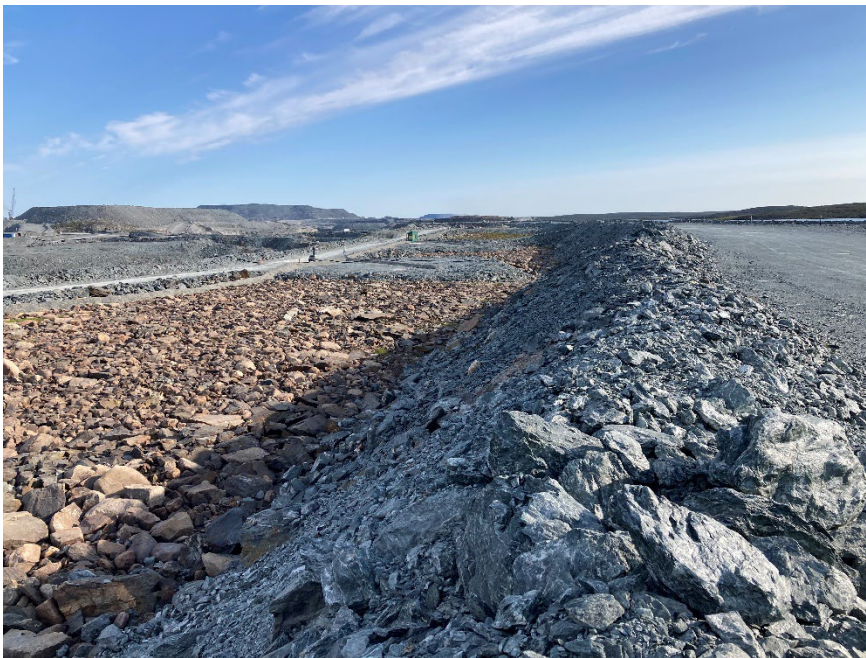
Photograph A3-14 Bay Goose Dike

Description: From approximately Sta. 31+280 on the crest, looking north at the downstream slope and toe area.

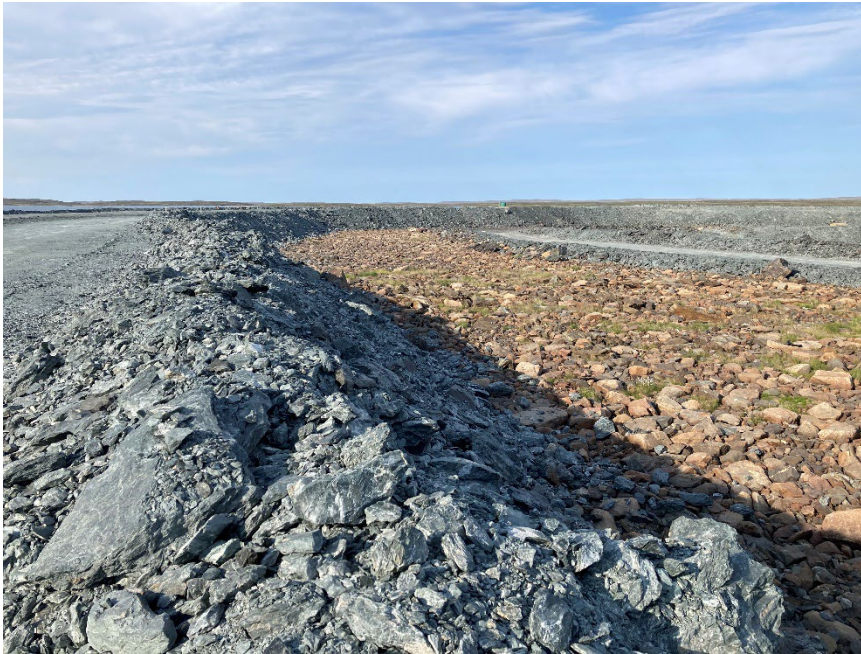
Photograph A3-15 Bay Goose Dike

Description: From approximately Sta. 31+280 on the crest, looking southwest at the downstream slope.

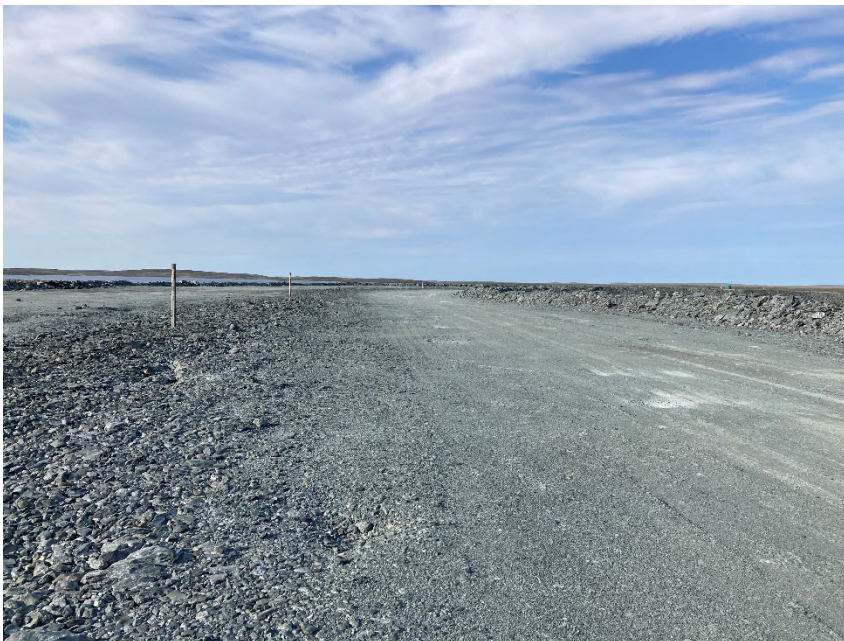
Photograph A3-16 Bay Goose Dike

Description: From approximately Sta. 31+280, looking south at the crest.

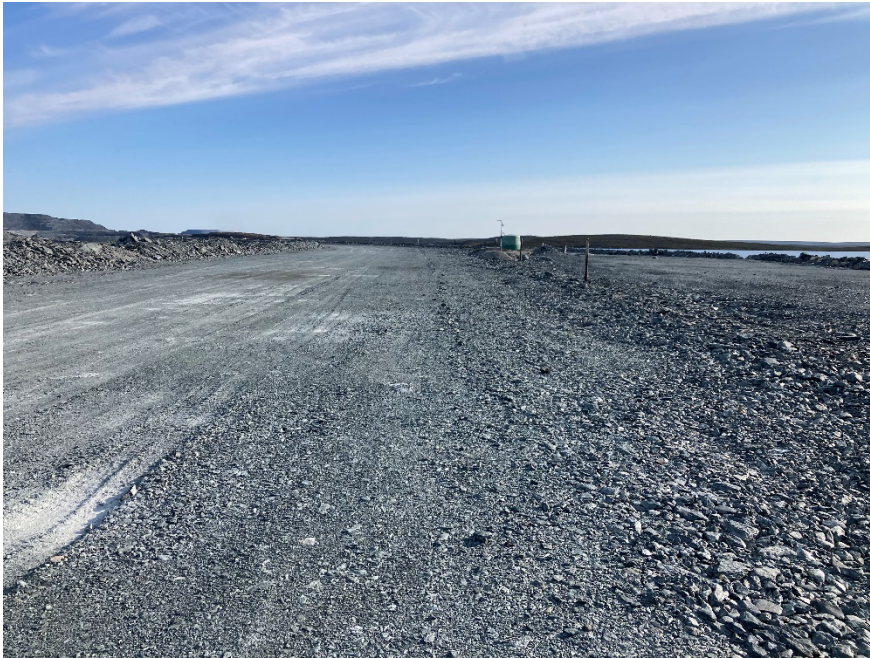
Photograph A3-17 Bay Goose Dike

Description: From approximately Sta. 31+280, looking northeast at the crest.
