Meadowbank and Whale Tail 2023 Annual Geotechnical Inspection

2023 Annual Geotechnical Inspection

Meadowbank Complex, Nunavut

1623-2146800623-RA-Rev0

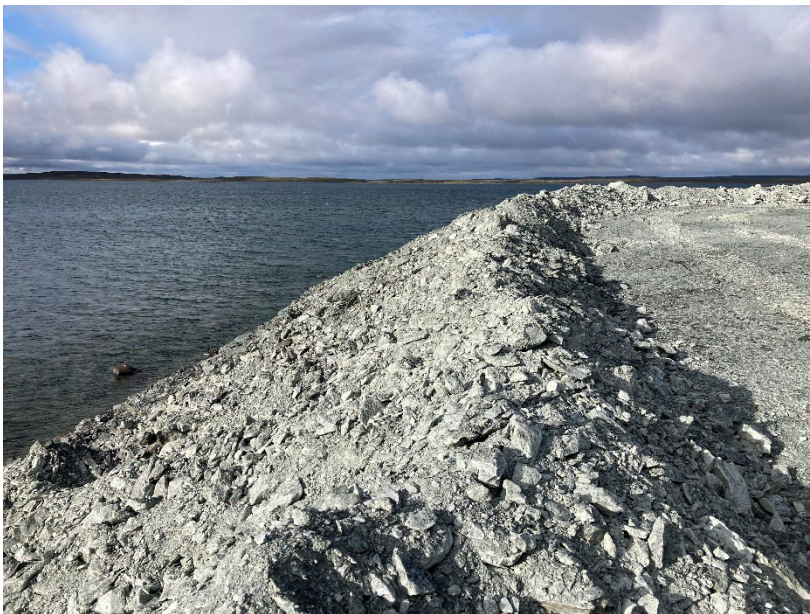
Photograph A3-18 Bay Goose Dike

Description: From approximately Sta. 31+475, looking west at the crest. Old cracks are disappearing.

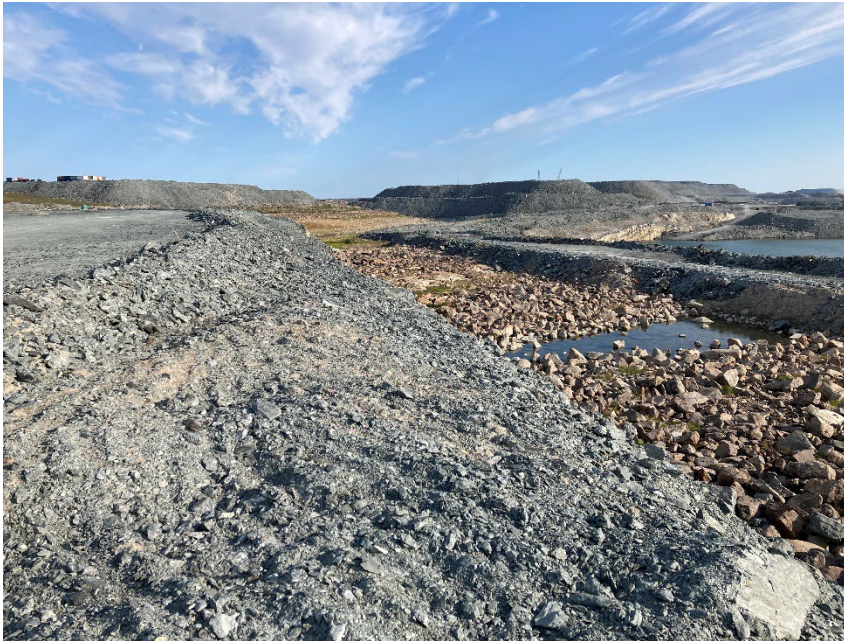
Photograph A3-27 Bay Goose Dike

Description: From the crest at approximately Sta. 31+740, looking north downstream at the water pond at Sta. 31+750.

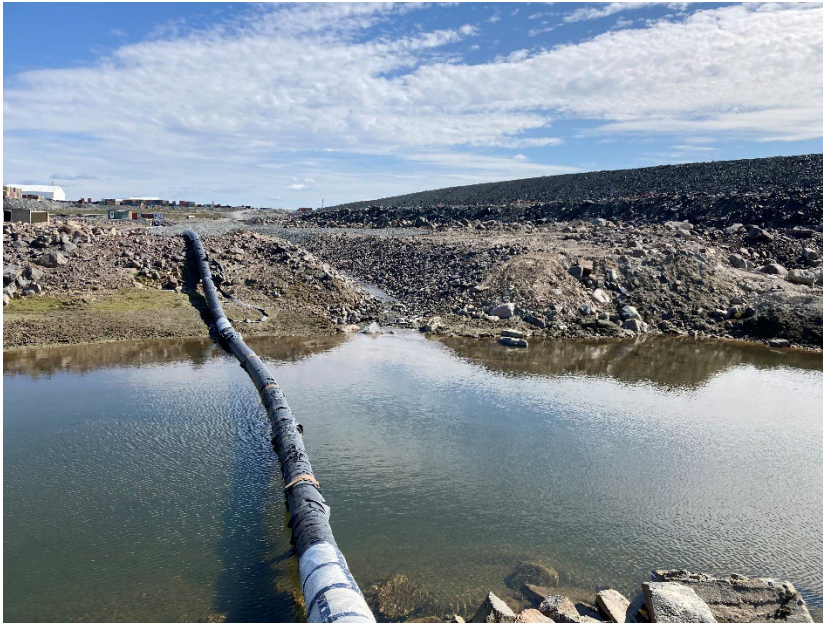
Photograph A5-1 Whale Tail Dike

Description: From approx. Sta. 0+250 downstream (P4 pumping station), looking southeast. A large amount of water is ponding.

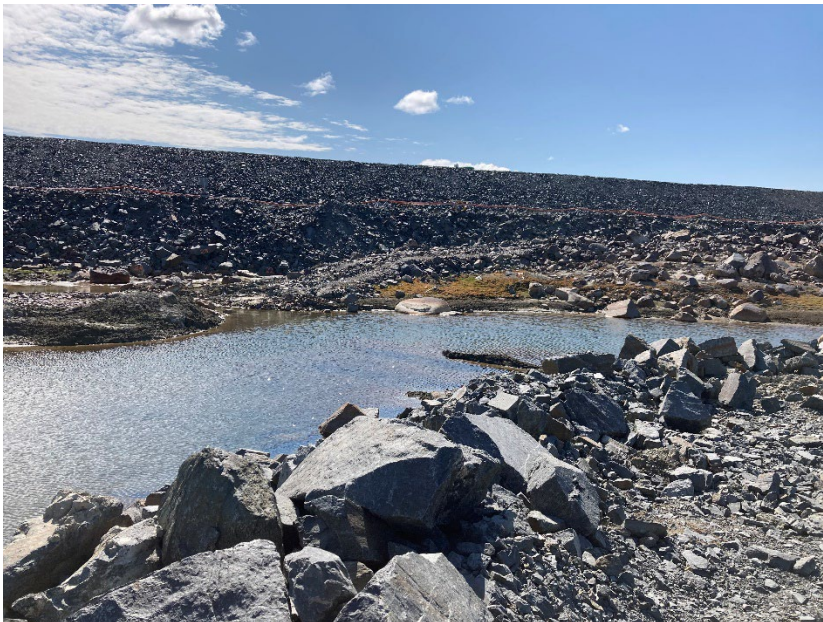
Photograph A5-2 Whale Tail Dike

Description: From approx. Sta. 0+250 downstream (P4 pumping station), looking southwest. A large amount of water is ponding.

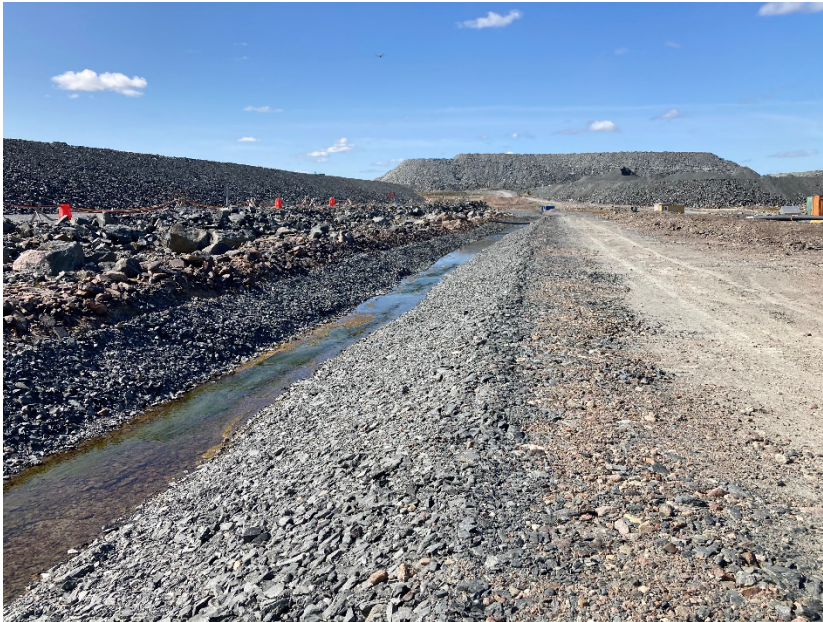
Photograph A5-3 Whale Tail Dike

Description: From approx. Sta. 0+600 downstream, looking southwest at the rebuilt seepage collection trench.

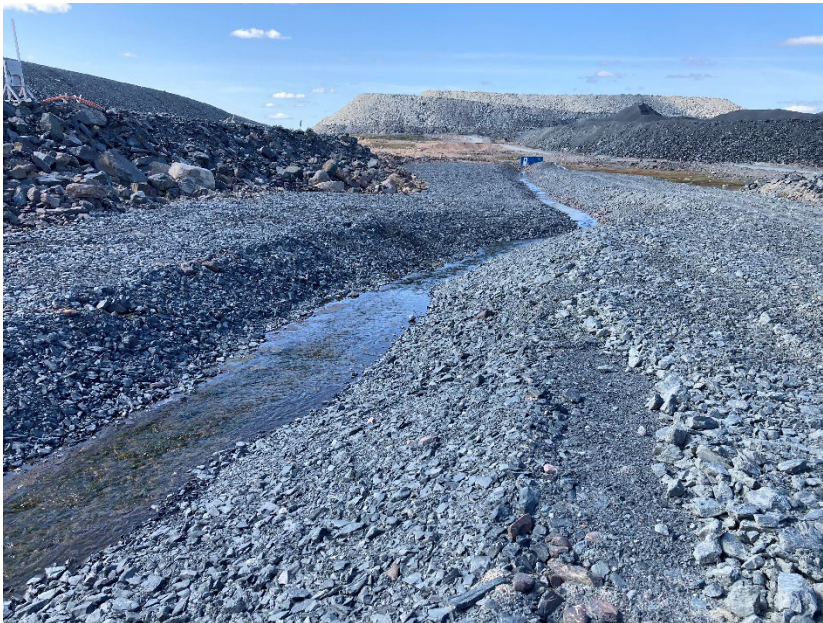
Photograph A5-4 Whale Tail Dike

Description: From approx. Sta. 0+430 downstream, looking west at the seepage collection trench which has been rebuilt. V-notch has been reinstalled further downstream of the trench.

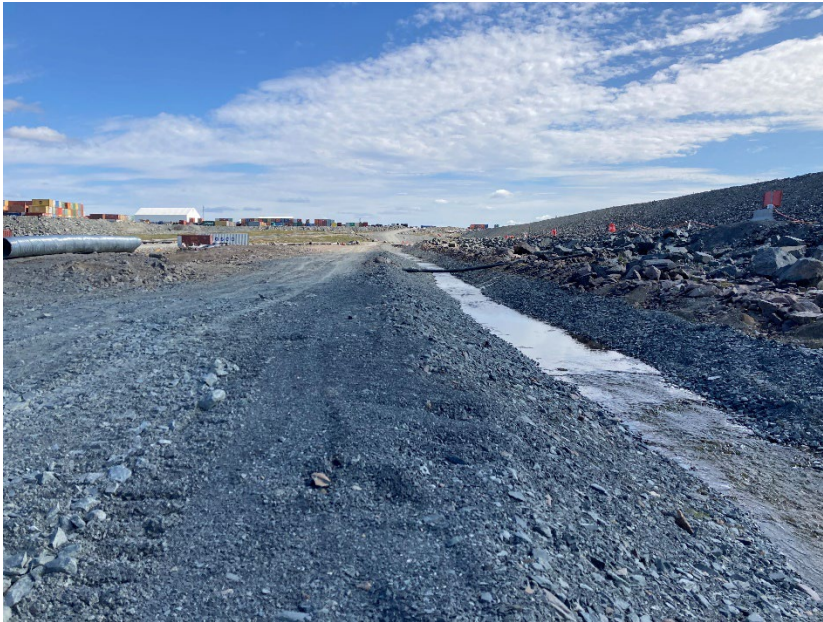
Photograph A5-5 Whale Tail Dike

Description: From approx. Sta. 0+450 downstream, looking east at the seepage collection trench and downstream toe.

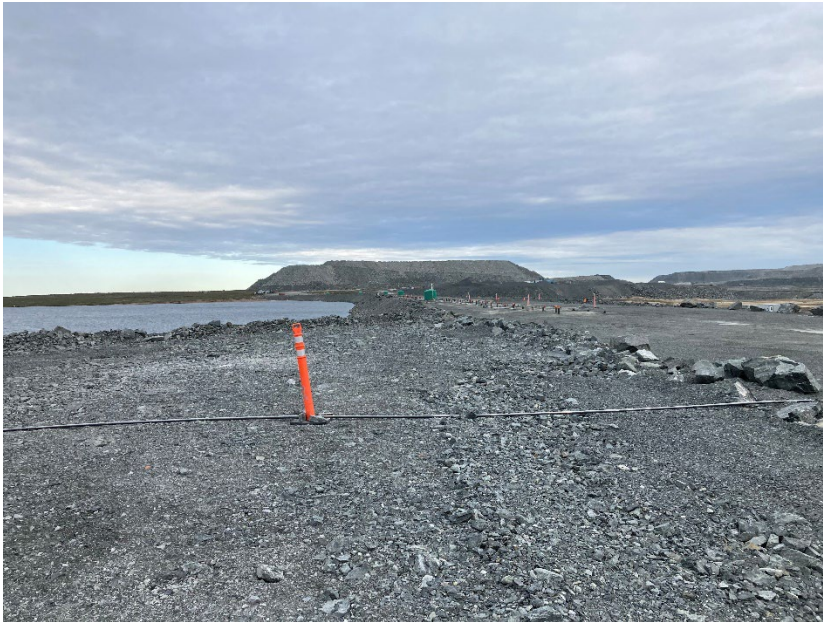
Photograph A5-25 Whale Tail Dike

Description: From approx. Sta. 0+725 looking downstream at the deformation in the rockfill slope.

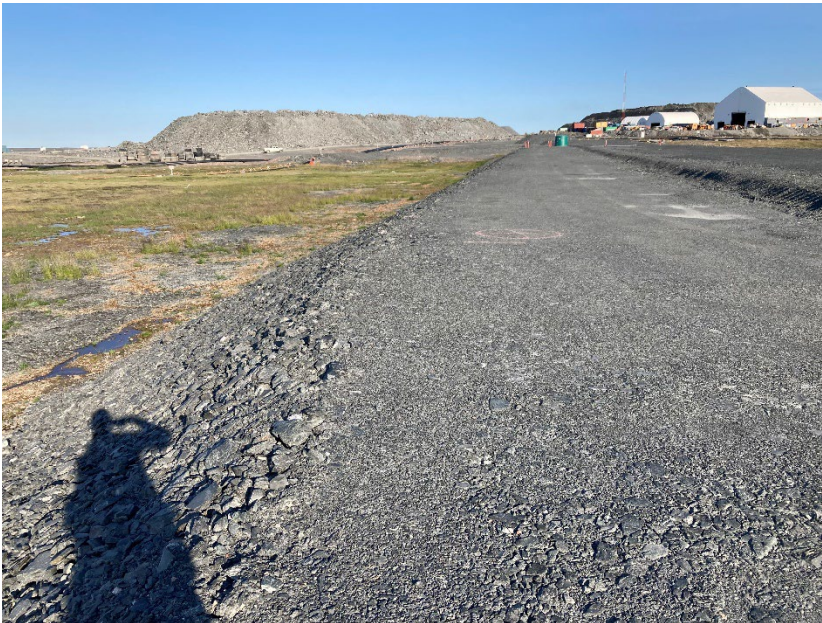
Photograph A6-8 IVR Dike D-1

Description: From approx. Sta. 0+300, looking northwest at the crest and downstream slope. Some water ponding at the toe.

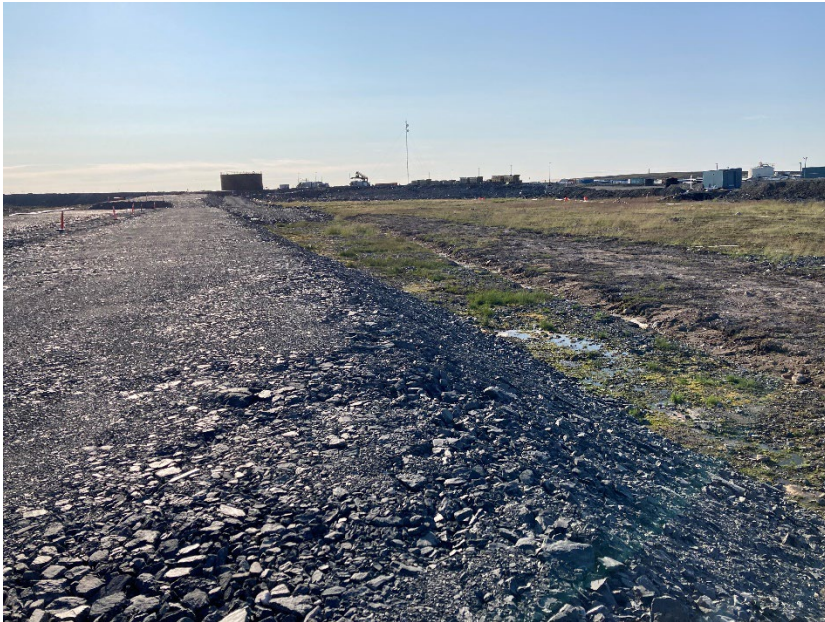
Photograph A6-9 IVR Dike D-1

Description: From approx. Sta. 0+300, looking east at the crest and downstream slope. Some water ponding at the toe.

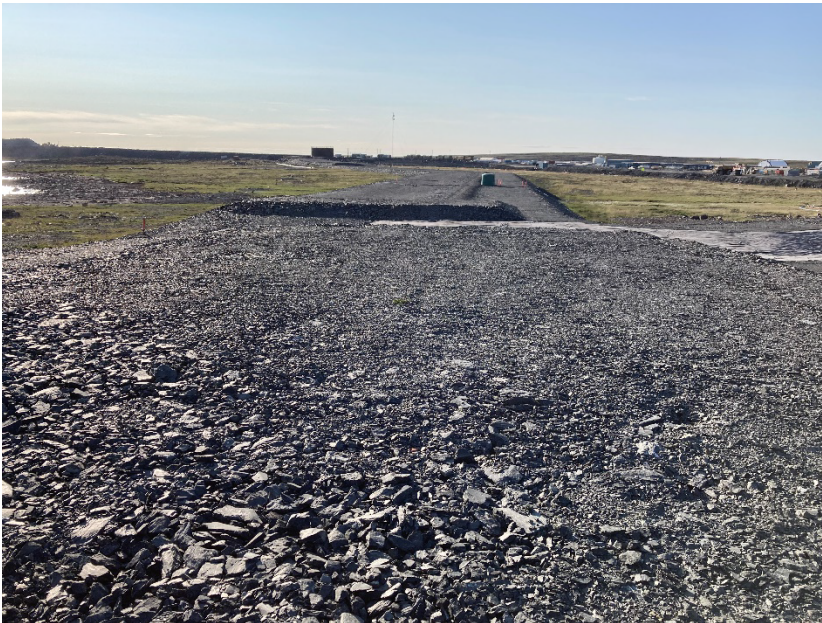
Photograph A6-14 IVR Dike D-1

Description: From approx. Sta. 0+030 (west abutment), looking southeast at the crest. Presence of settlement in the rockfill surface.

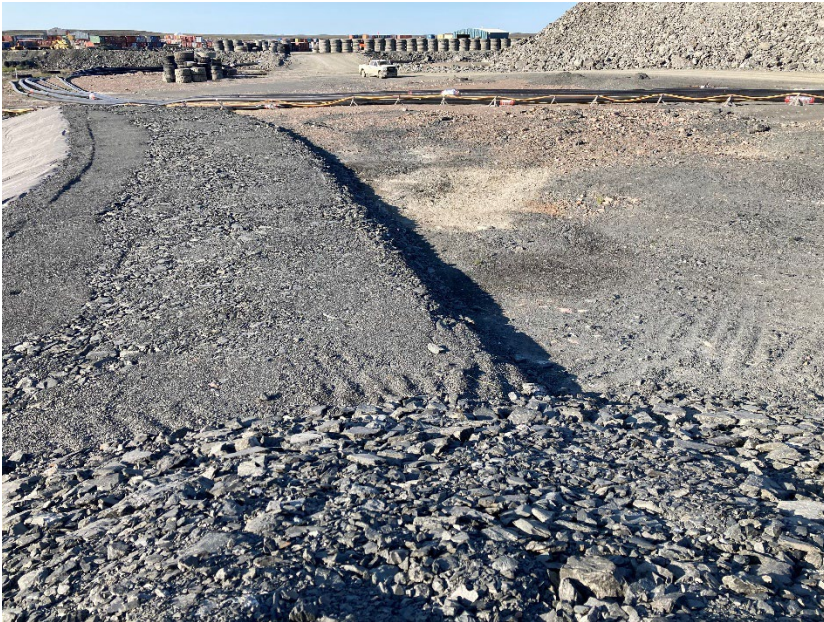
Photograph A6-15 IVR Dike D-1

Description: From approx. Sta. 0+050, looking south at the spillway. Presence of piping at the outlet of the spillway.

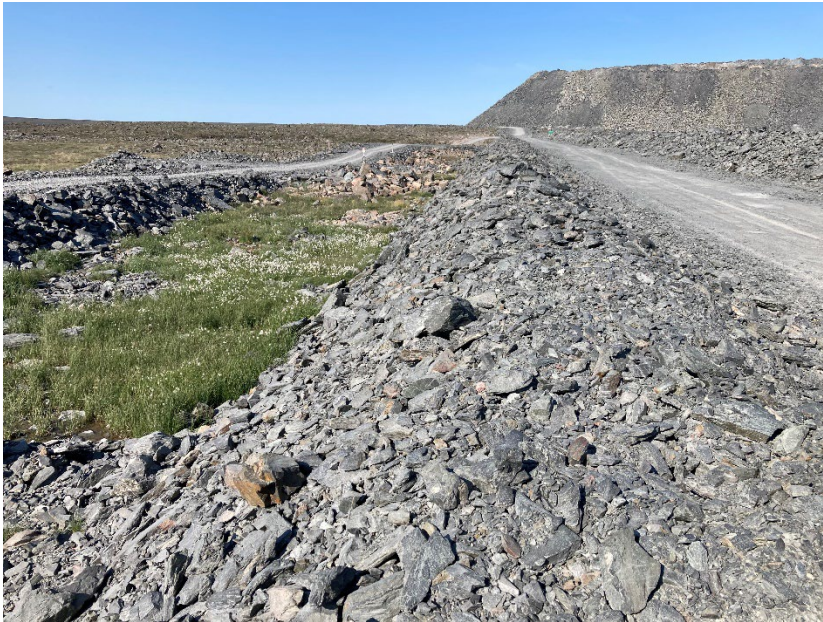
Photograph A7-1 WRSF Dike

Description: From approx. Sta. 0+350 (east abutment), looking west at the dike crest and downstream slope. Presence of water ponding at the toe.

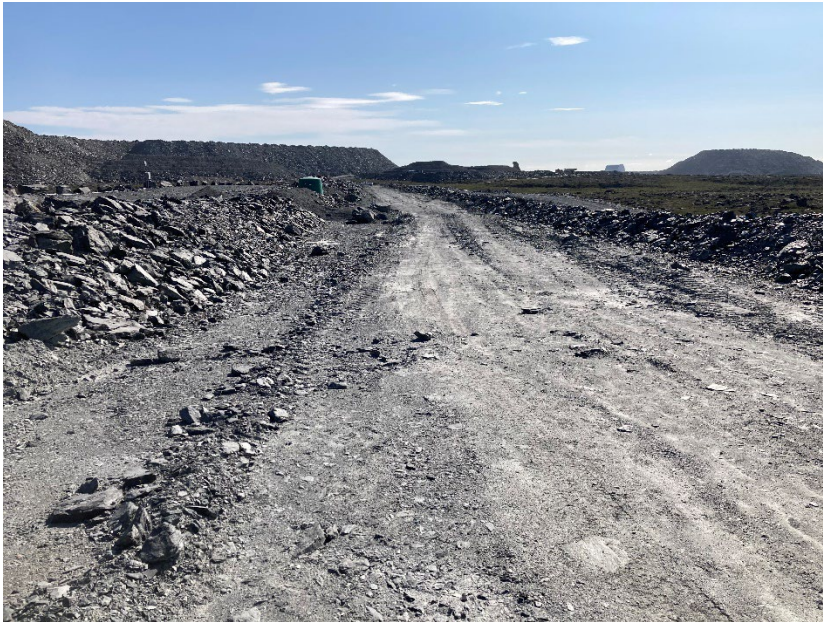
Photograph A7-9 WRSF Dike

Description: From approx. Sta. 0+080 (west abutment), looking east at the upstream thermal berm crest. Presence of holes (approx. 300mm)

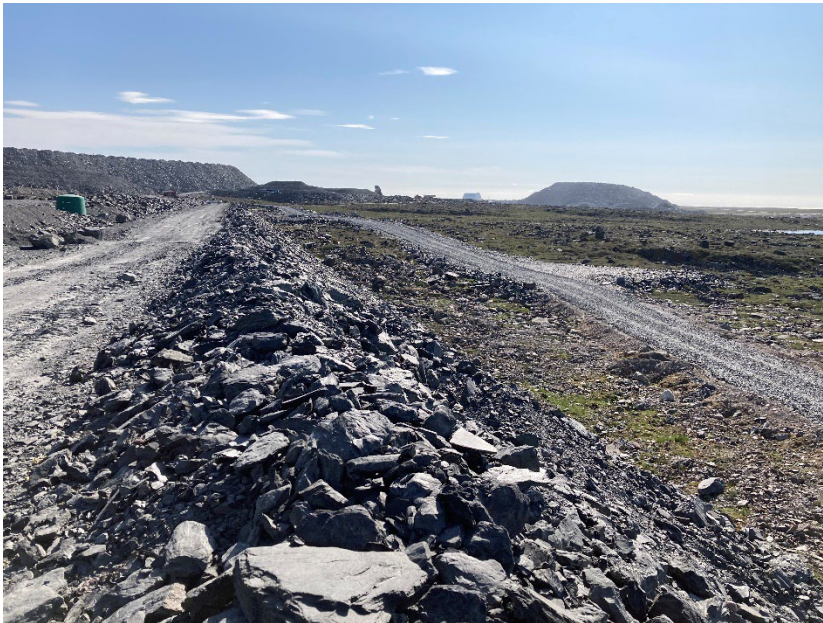
Photograph A7-10 WRSF Dike

Description: From approx. Sta. 0+080 (west abutment), looking east at the dike crest.

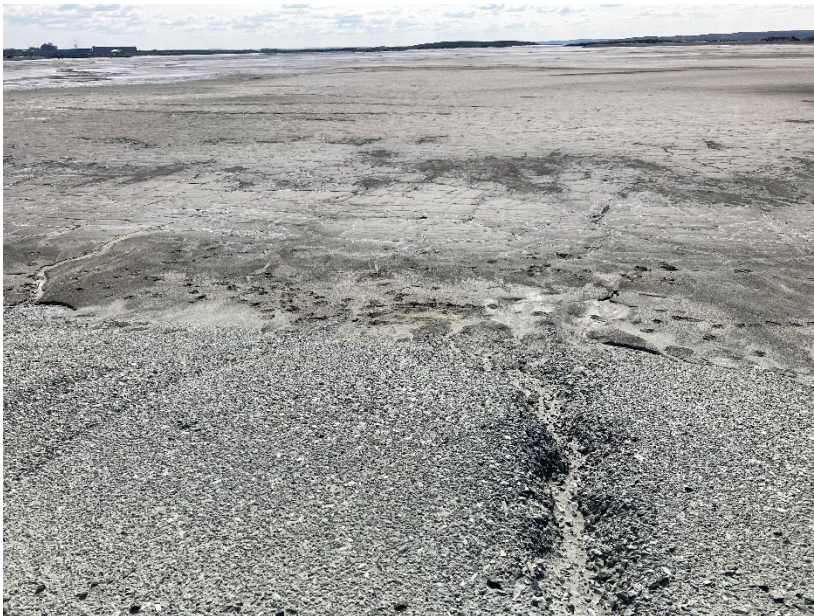
Photograph B1-6 Tailings Storage Facility

Description: From the North Cell Internal Structure, looking south at the North Cell and upstream slope. Presence of erosion on the upstream slope surface.

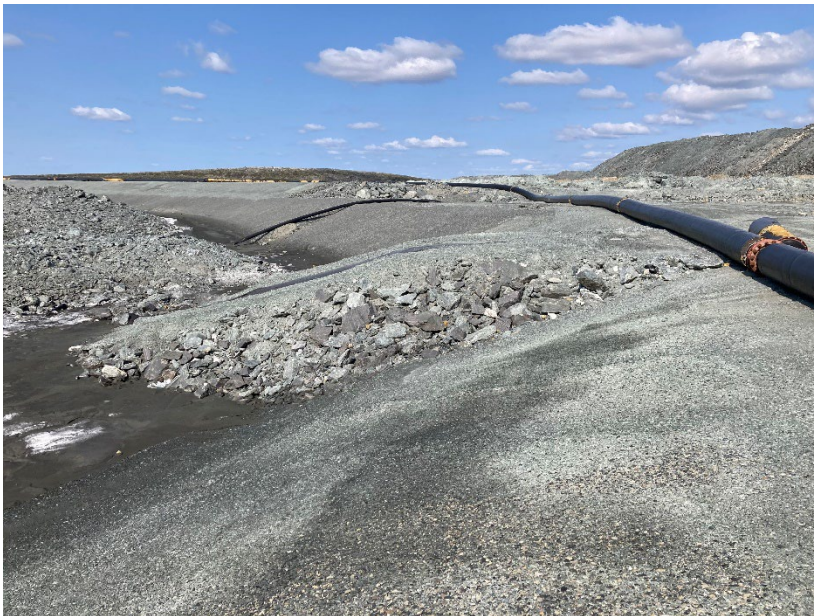
Photograph B1-10 Tailings Storage Facility

Description: From the North Cell Internal Structure at approx. Sta. 2+700, looking northwest at the upstream slope. Presence of tension crack on upstream slope (approx. 10-20 mm wide)

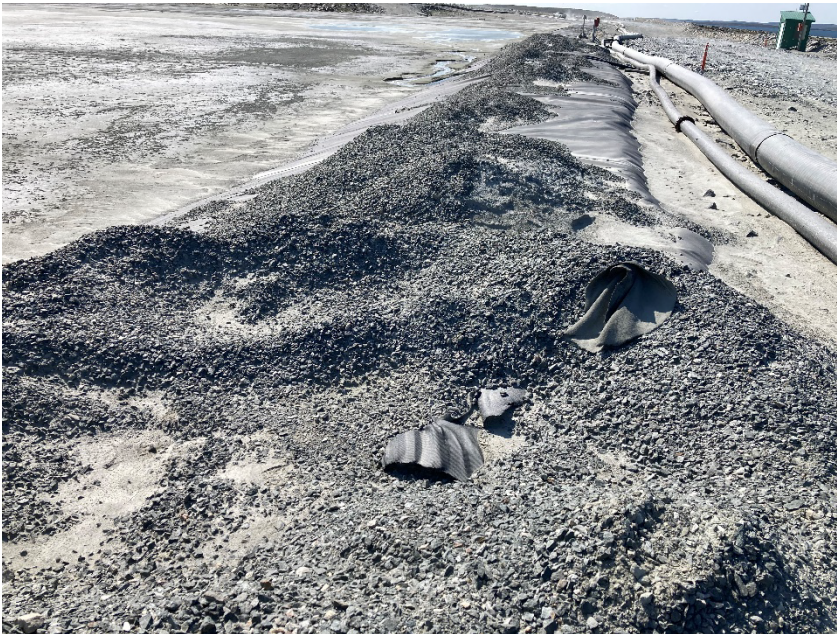
Photograph B2-4 Saddle Dam 1

Description: From approximately Sta. 0+120 upstream, looking south at the crest slope. The liner is ripped under piles of 0 – 20 mm gravel.

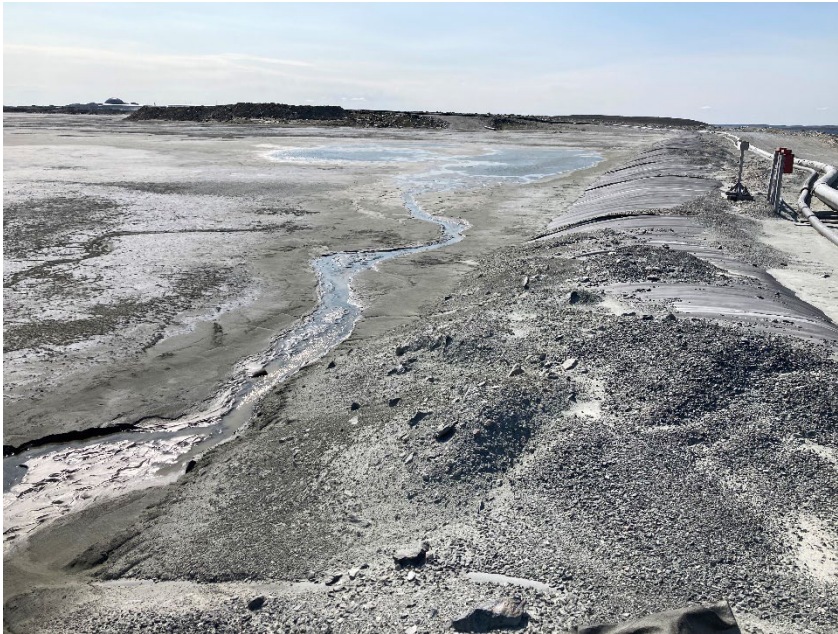
Photograph B2-5 Saddle Dam 1

Description: From approximately Sta. 0+195 upstream, looking south at the upstream slope. Adequate tailings beach against SD1. A small pond of water is present at the surface of the tailings and is not a concern.

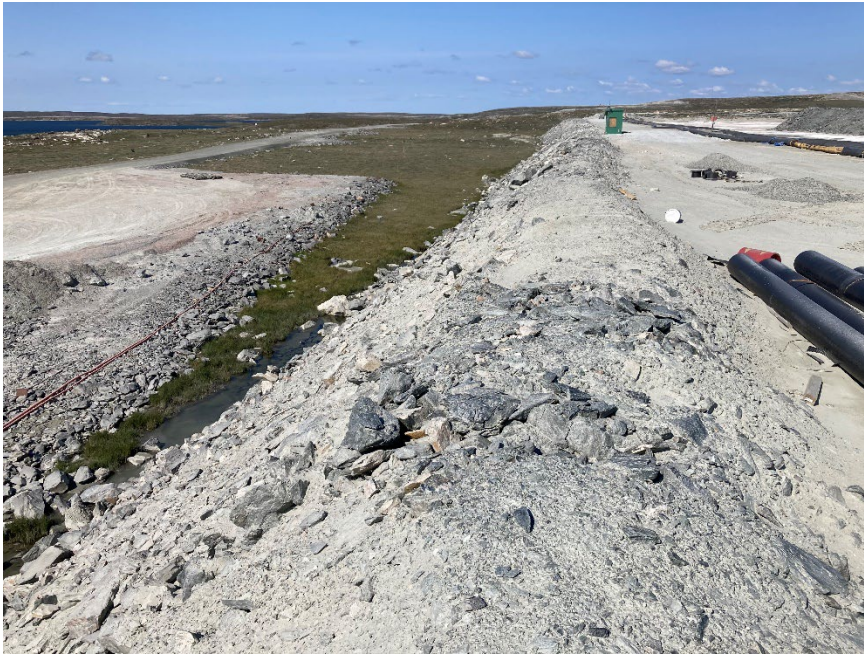
Photograph B3-7 Saddle Dam 2

INSPECTION ITEM	OBSERVATIONS DATA	PHOTO	COMMENTS & OTHER DATA
4.5 Outlet operating problem (if applicable)	Not applicable		
4.6 Other unusual conditions	Yes		Limited water is still ponding within the rockfill embankment between 20+275 to 20+475 approximately.

Description: From Saddle Dam 2 (approximately Sta. 20+500) downstream, looking northwest at the downstream toe and slope of Saddle Dam 2. Presence of water ponding at the toe.

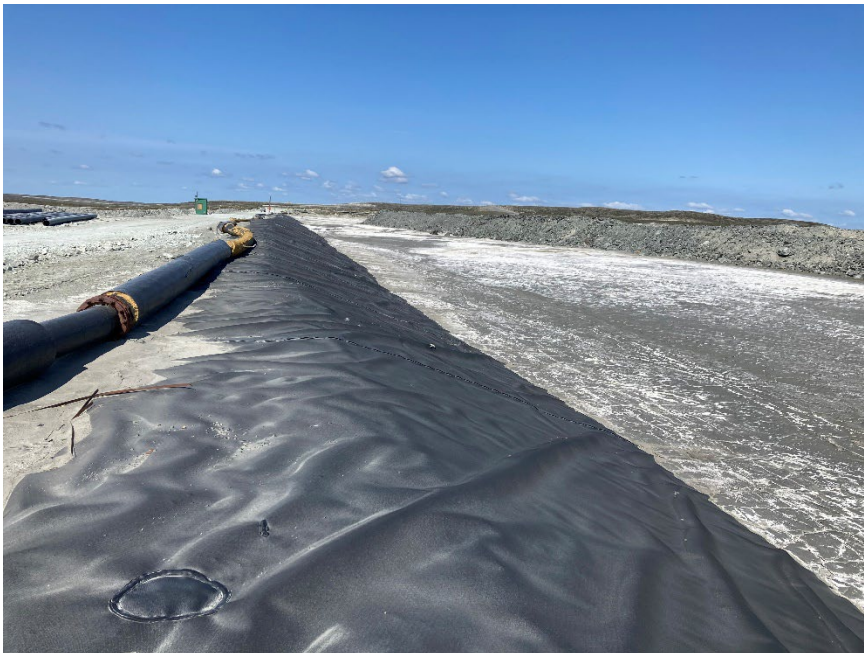
Photograph B3-8 Saddle Dam 2

Description: From Saddle Dam 2 (approximately Sta. 20+520) upstream, looking northwest at the upstream slope of Saddle Dam 2. Presence of drag marks on the liner, but no holes were observed.

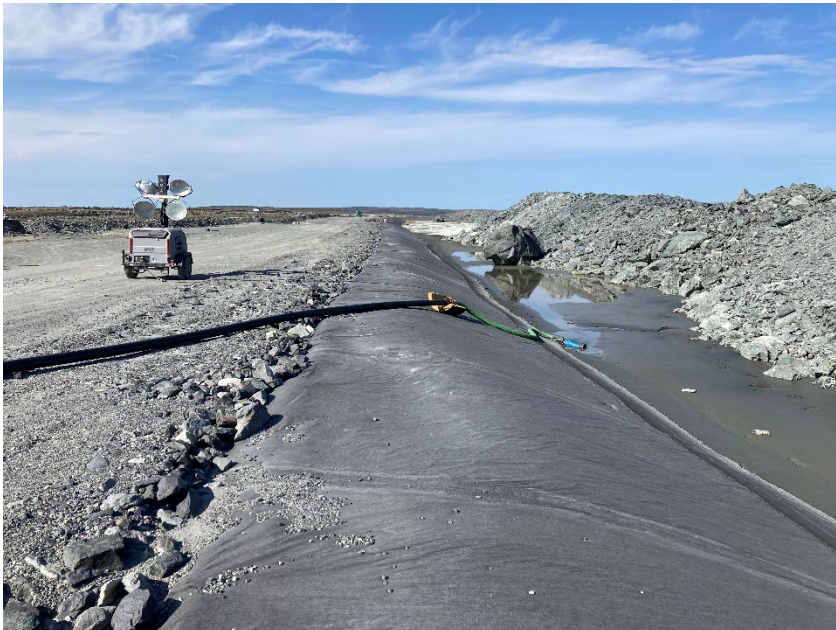
Photo Number: 363

Description: From the east abutment (11+100 approximately), looking west at the upstream face and the rockfill cover of the North Cell. Shallow water ponding against portion of the dike (less than 30 cm deep). Large rocks are present near the liner.

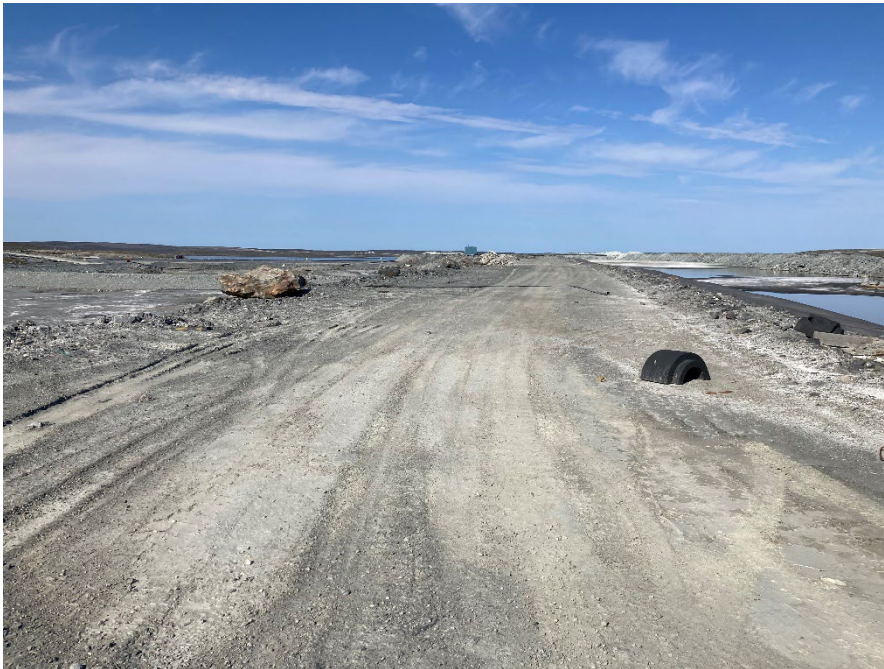
Photo Number: 366

Description: From Sta. 10+650 looking west at the crest and upstream slope. Shallow water against portion of Stormwater Dike.

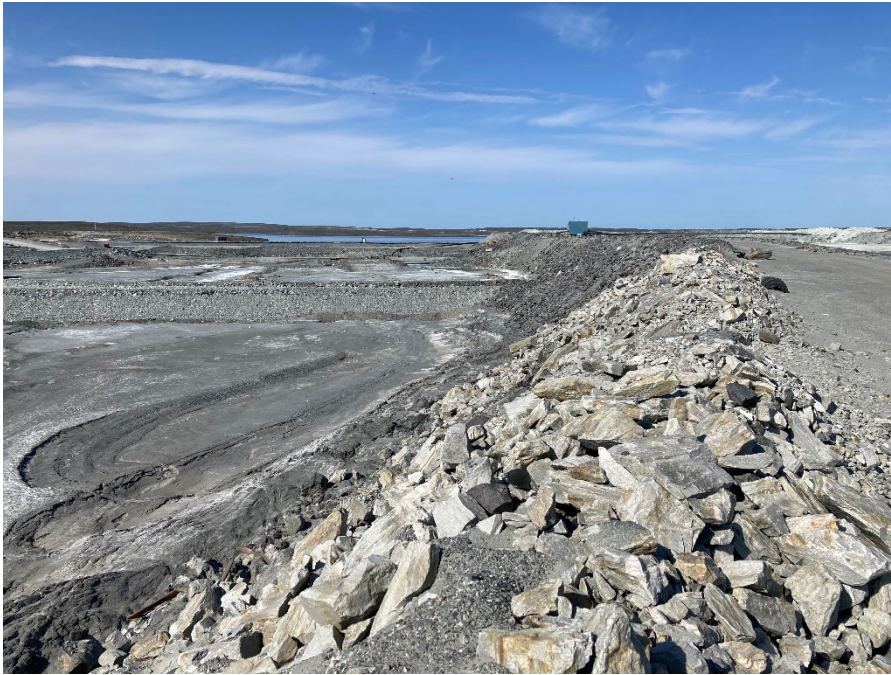
Photo Number: 369

Description: From approximately Sta. 10+575 looking northeast. A liner weld is open at the bottom of the exposed slope.

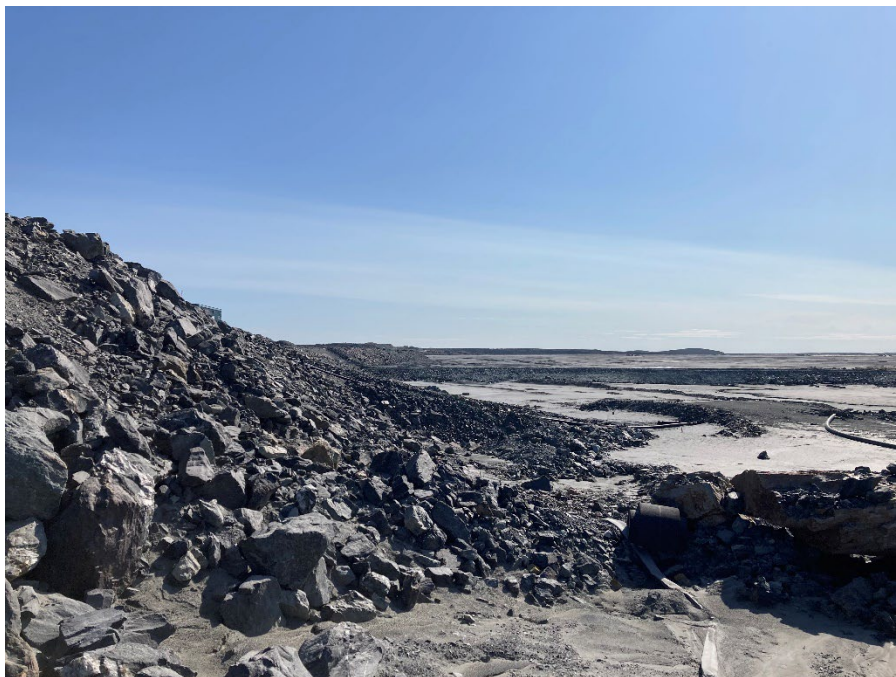
Photo Number: 370

Description: From Sta. 10+175, looking east at the upstream slope. The tailings beach is adequate.

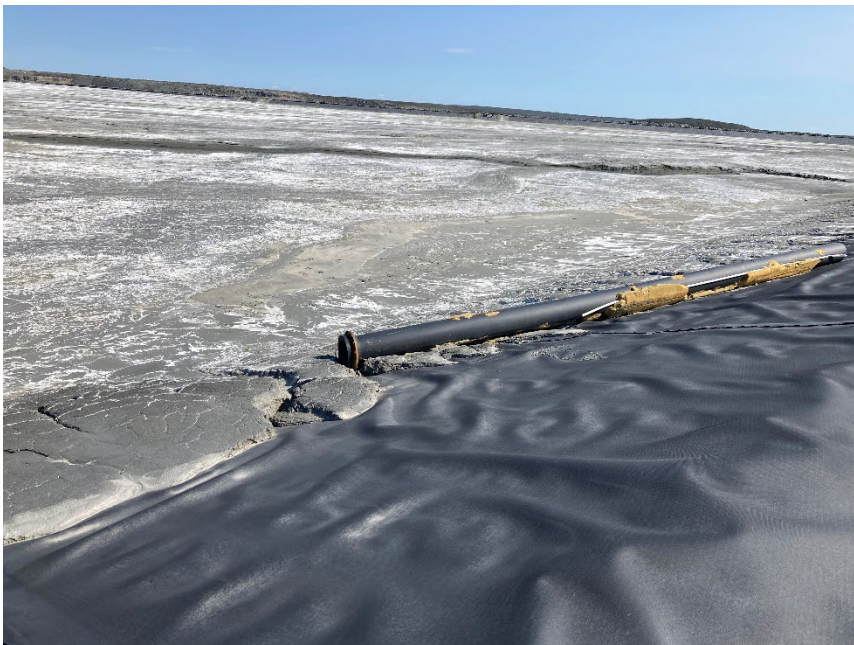
Photo Number: 205

Description: From 40+300 approximately, looking southeast at the upstream slope. Presence of a pipe on the liner.

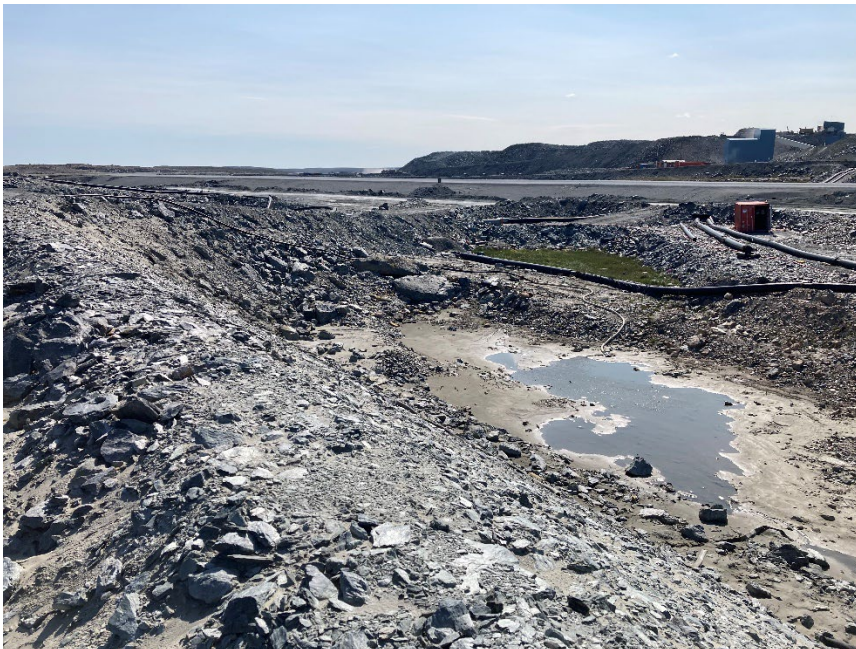
Photo Number: 198

Description: From 40+450 approximately, looking southeast at the crest and the downstream slope and toe. There is some water ponding at the toe.

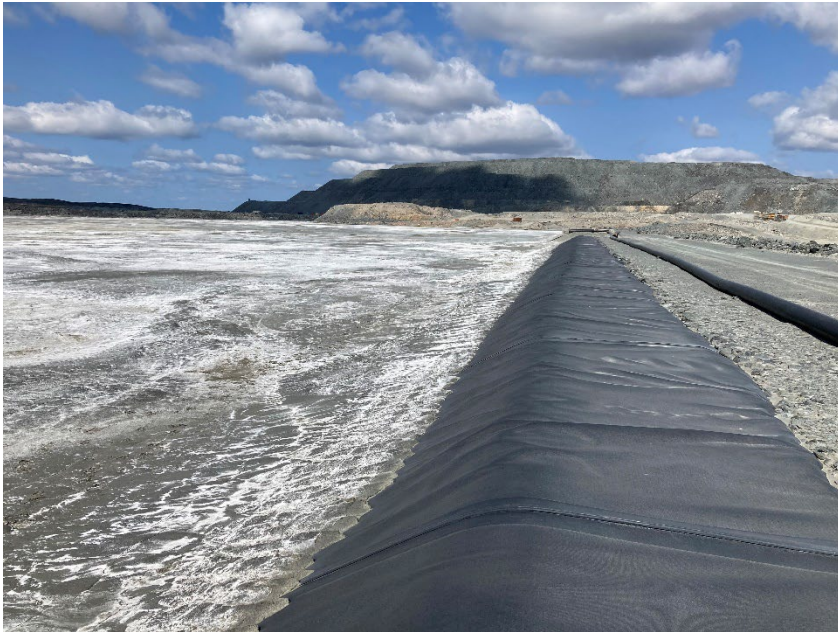
Photo Number: 219

Description: From approximately Sta. 0+400 (deposition point) looking west at the South Cell. Adequate tailings beach against the south section of the structure.

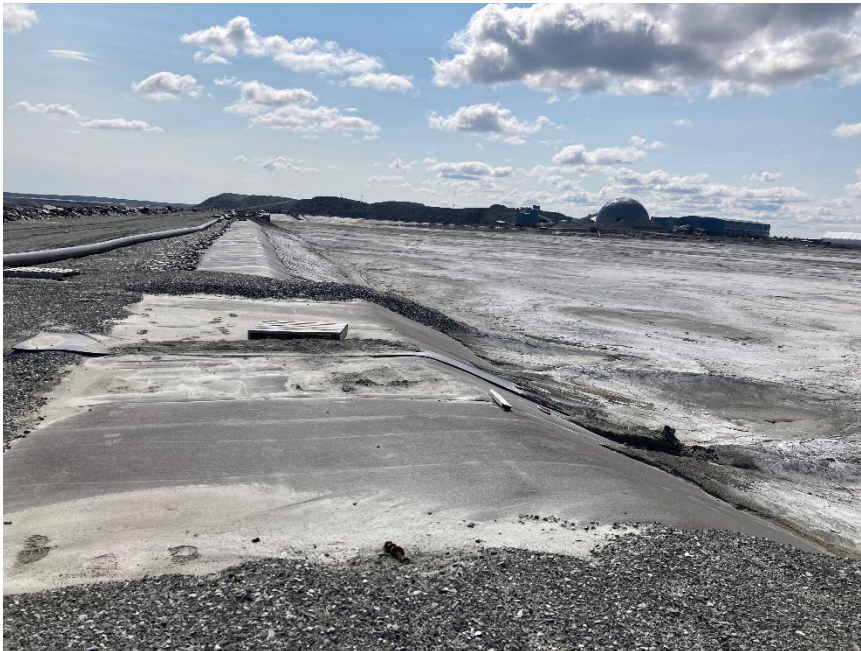
Photo Number: 218

Description: From approximately Sta. 0+400 (deposition point) looking south at the upstream slope. Adequate tailings beach against the south section of the structure.

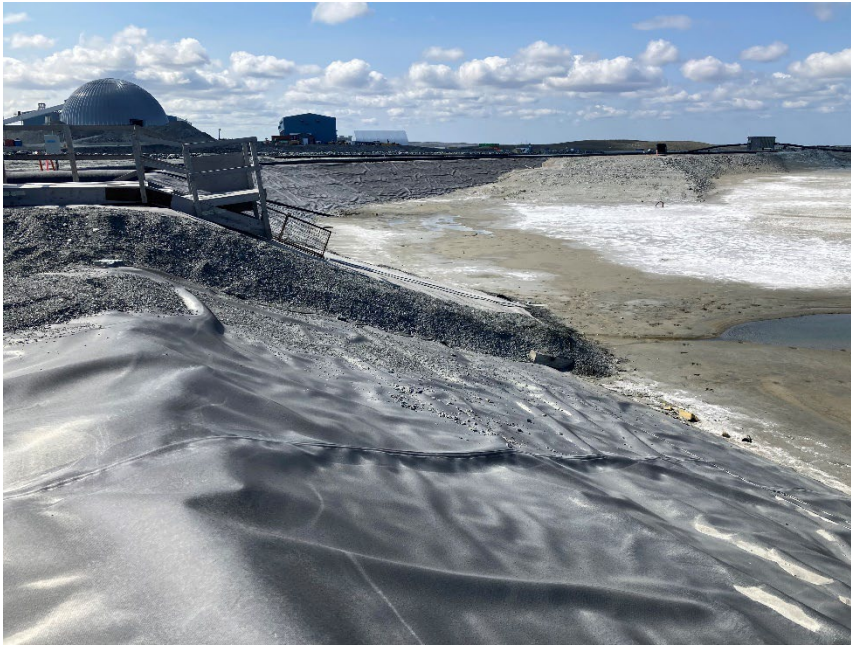
Photo Number: 210

Description: From approximately Sta. 0+950, looking south at the upstream slope. Presence of gravel on the liner.

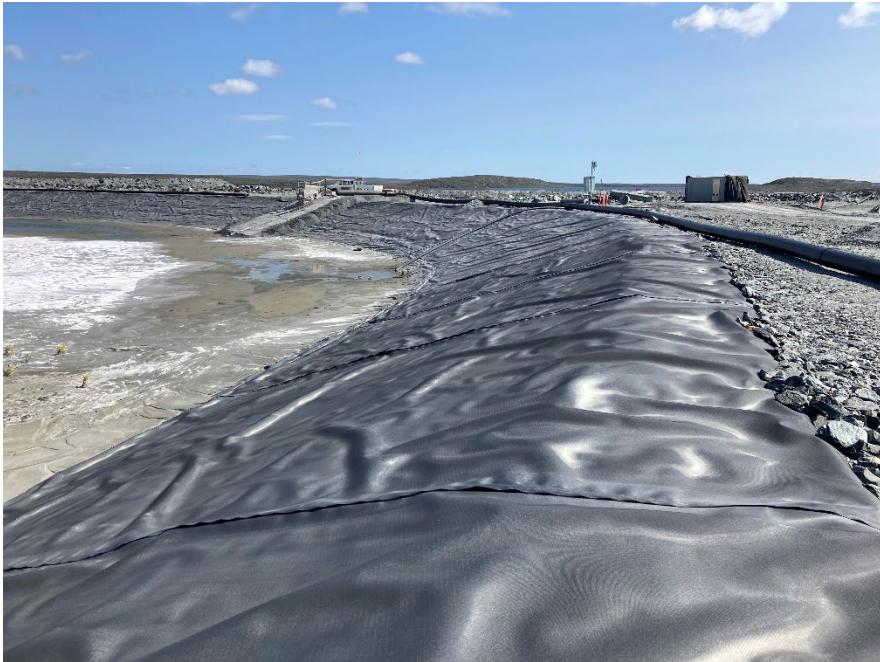
Photo Number: 209

Description: From approximately Sta. 1+000 looking east at the upstream slope of SD5 and Central Dike. Water is ponding against the liner.

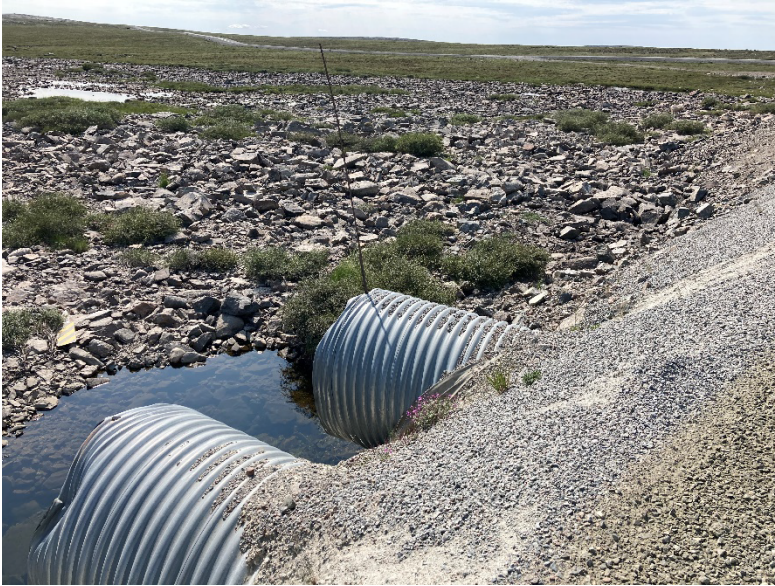
Photograph D2-1: PC-17A km 8+830

8+830	PC-17A	2x1800 mm CSP	Sign of erosion beneath the inlet and flow of water occurring beneath the culvert. The 1800 CSP were installed too high. While conditions are not perfect, they have proven stable over the past years. No sign of degradation from last year on both the inlet and outlet sides. Flow was observed beneath the culvert in the past, but in 2019 the flow moved further south (5-10 m from culvert). Stable, to keep monitoring for evolution.
8+850	PC-17	2x1200 mm CSP	The inlet is damaged but functional.

Description: View of the culvert outlets. No sign of degradation and the flow is stable south of the culverts (5-10 m away).

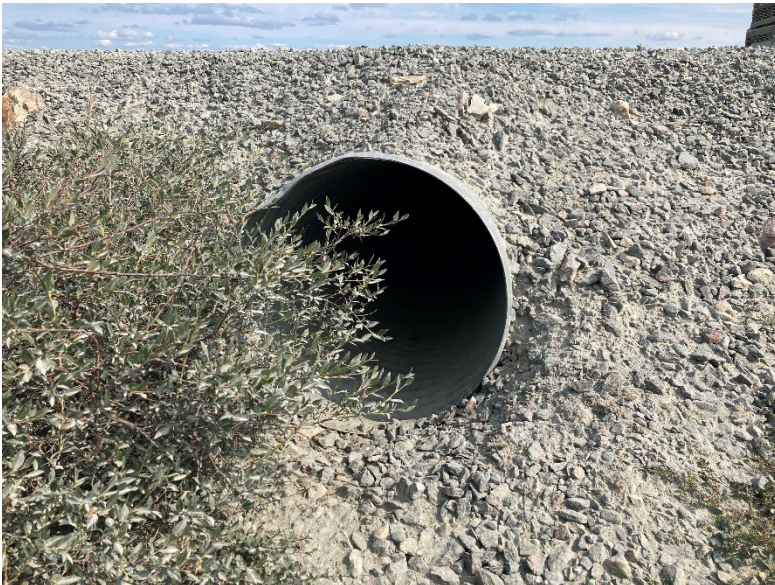
Photograph D2-2: PC-11 km 39+552

Description: View of the culvert inlet. Installed high but in good condition.

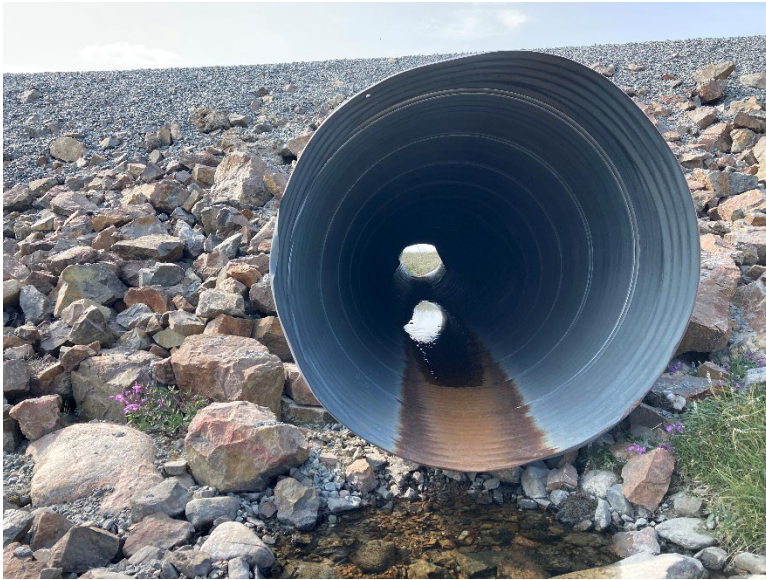
Photograph D2-3: R-14 km 67+840

Description: View of the culvert outlets. Water is flowing beneath the road between the culverts.

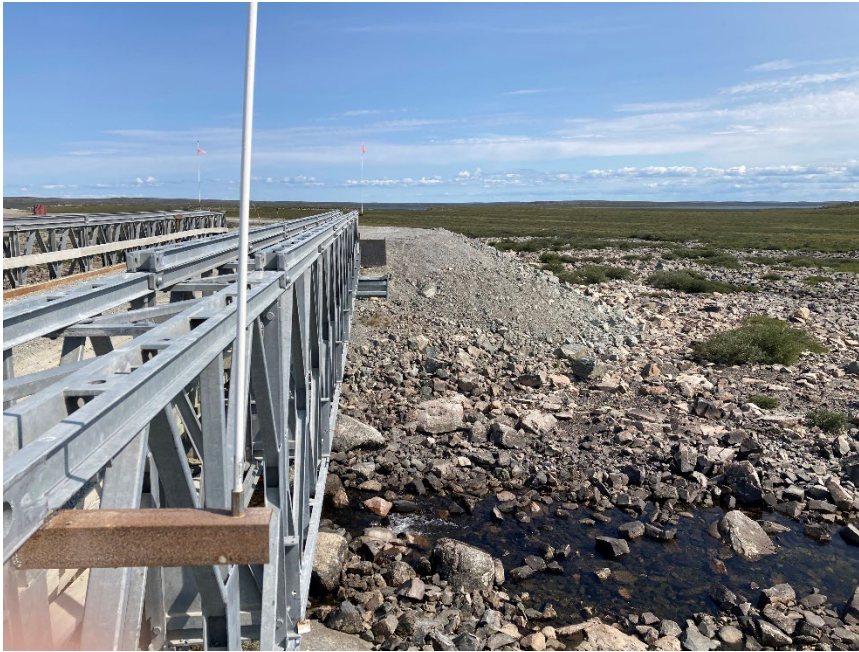
Photograph D3-1 Bridges 1 – R02 km 8+750

Description: Looking at the north abutment. The corrugated steel bin shows deformation under the weight of the bridge.

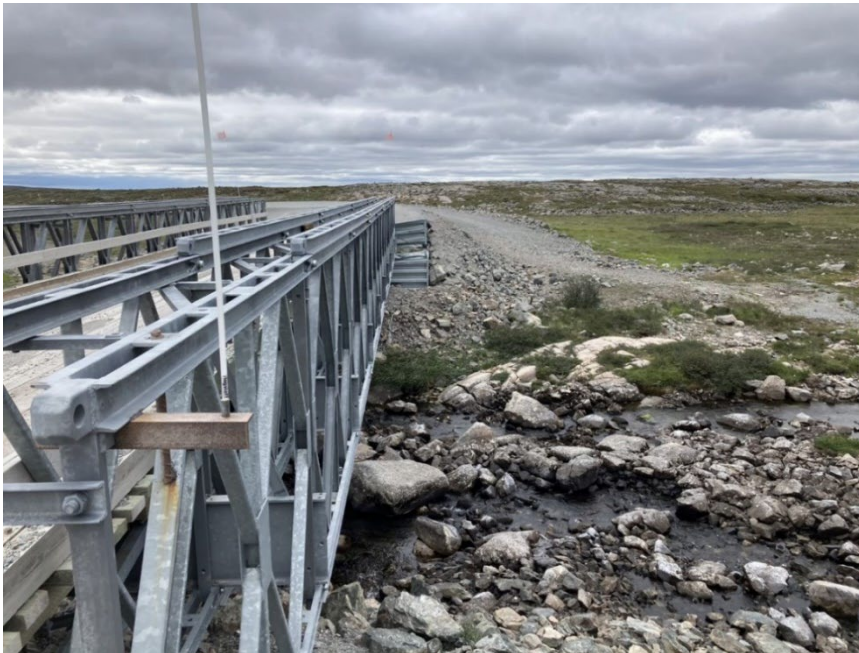
Photograph D3-2 Bridges 1 – R02 km 8+750

Description: Looking at the south abutment. The corrugated steel bin shows deformation under the weight of the bridge.

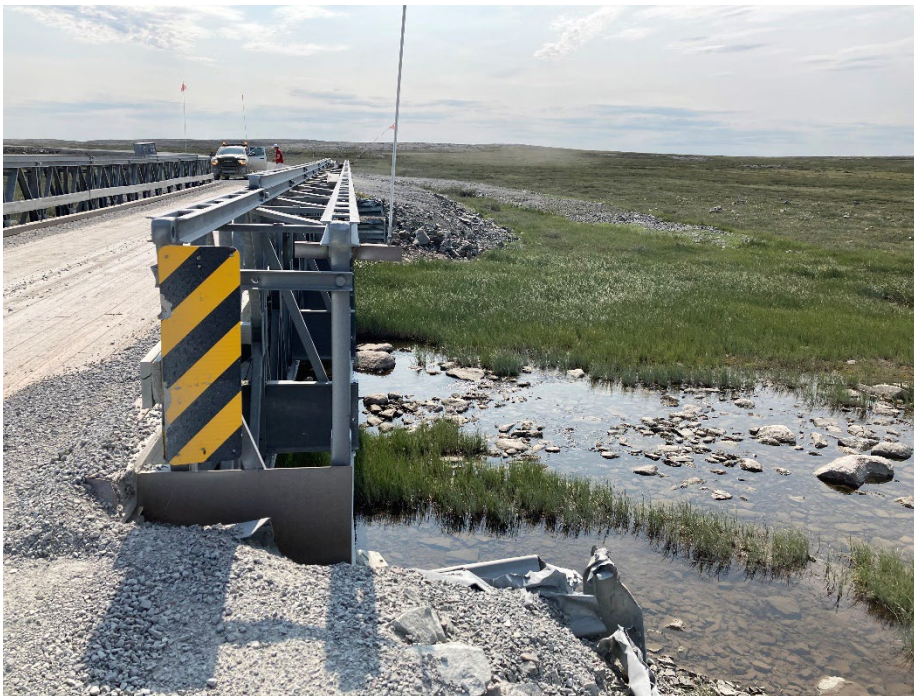
Photograph D3-4 Bridges 2 – R05 km 17+600

Description: Looking at the south abutment. Minor damage to the bin wall.

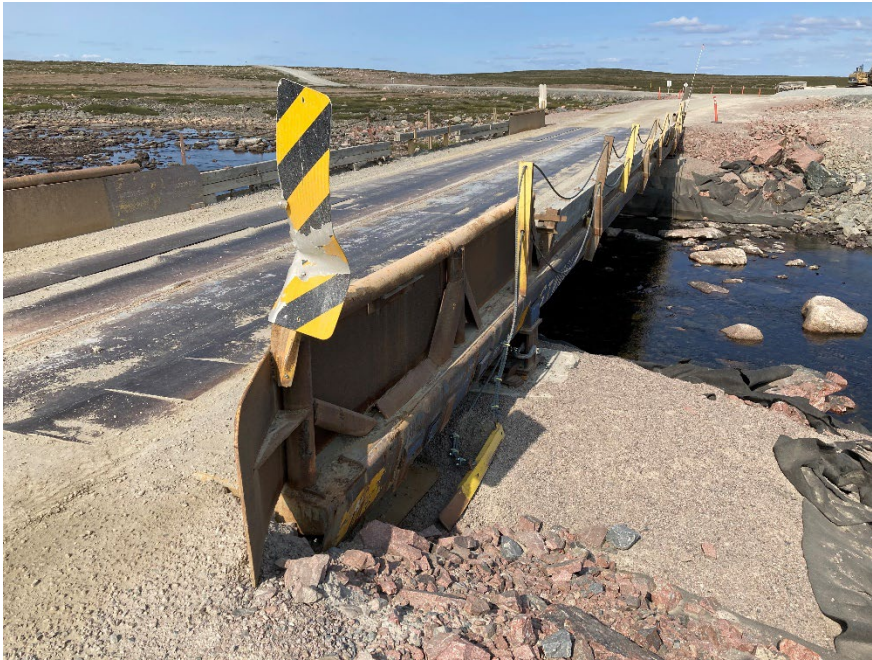
Photograph D3-11 Bridges 6 – R15 km 69+200

69+200	R15 Centre Bridge	30 m Acrow Panel Bridge	Bin wall of both abutments were observed to be damaged but they are still holding well. Limited surficial erosion of the granular material on the South abutment The bridge is dipping toward the west side on both north and south abutments. The foundation does not show signs of failure but is slowly settling. Its condition should be monitored.
70+400	Quarry 16		Presence of unstable loose rocks and boulders but in general good condition.
72+800	Quarry 17		Steep rock wall in stable conditions.
73+800	R16 Centre Bridge	12m Rapid Span Bridge	In good condition. Flow observed under the North abutment, but no sign of erosion.
77+440	R-17	1x1200 mm CSP	In good condition
79+500	R18 Centre Bridge	12 m Rapid Span Bridge	In good condition. Limited surficial erosion of granular material on the abutments.
80+200	Quarry 18		In general good condition, south wall is high (about 8 m) with some loose blocks.

Description: Looking at the north abutment. Damage to the bin wall likely caused during snow removal activities. Bridge is tipping toward the west side on the abutment.
