Meadowbank and Whale Tail 2023 Annual Geotechnical Inspection

2023 Annual Geotechnical Inspection

Meadowbank Complex, Nunavut

1623-2146800623-RA-Rev0

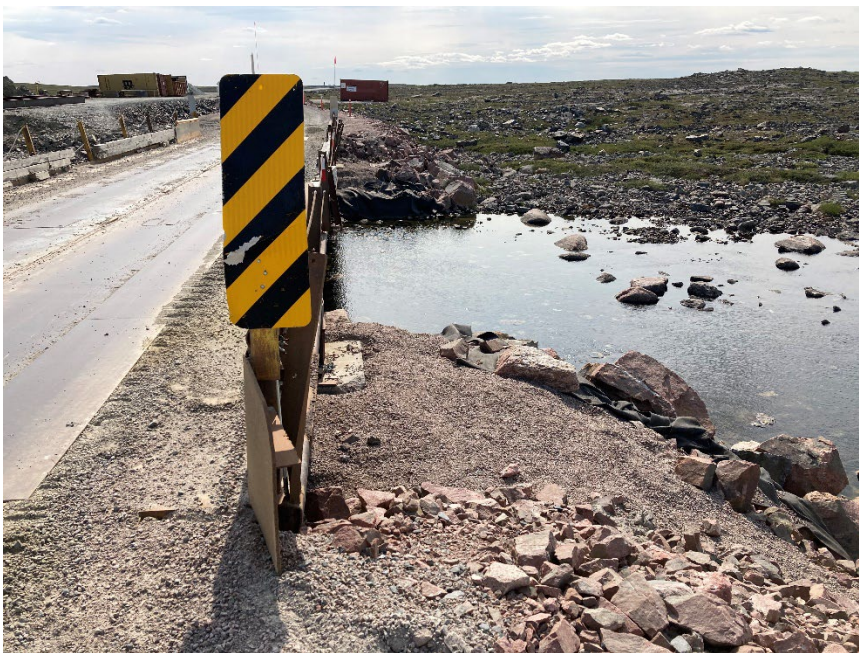
Photograph D3-12 Bridges 6 – R15 km 69+200

69+200	R15 Centre Bridge	30 m Acrow Panel Bridge	Bin wall of both abutments were observed to be damaged but they are still holding well. Limited surficial erosion of the granular material on the South abutment The bridge is dipping toward the west side on both north and south abutments. The foundation does not show signs of failure but is slowly settling. Its condition should be monitored.
70+400	Quarry 16		Presence of unstable loose rocks and boulders but in general good condition.
72+800	Quarry 17		Steep rock wall in stable conditions.
73+800	R16 Centre Bridge	12m Rapid Span Bridge	In good condition. Flow observed under the North abutment, but no sign of erosion.
77+440	R-17	1x1200 mm CSP	In good condition
79+500	R18 Centre Bridge	12 m Rapid Span Bridge	In good condition. Limited surficial erosion of granular material on the abutments.
80+200	Quarry 18		In general good condition, south wall is high (about 8 m) with some loose blocks.

Description: Looking at the south abutment. Damage to the bin wall likely caused during snow removal activities. Bridge is tipping toward the west side on the abutment.

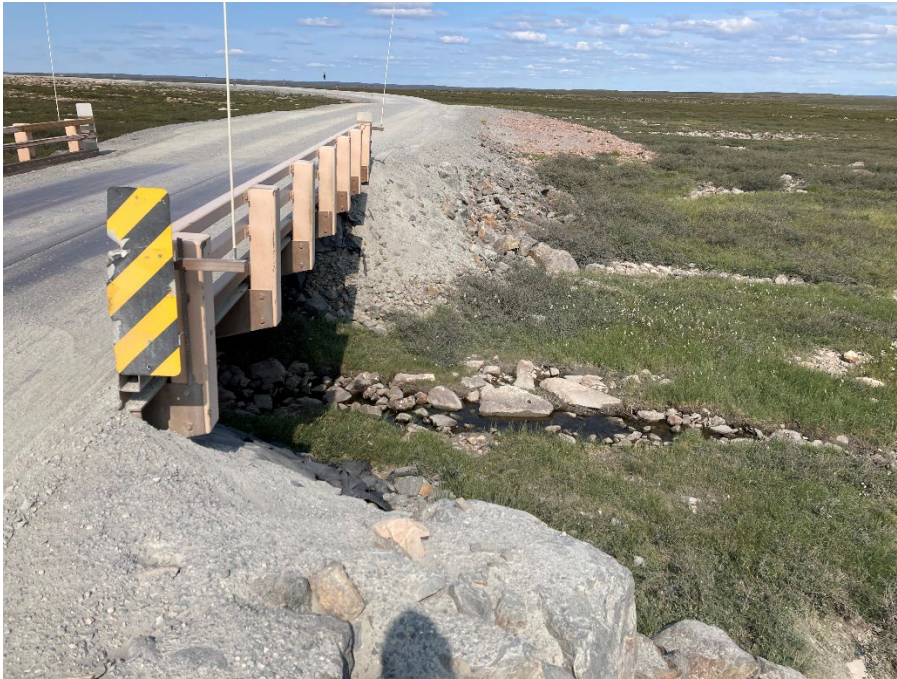
Photograph D3-13 Bridges 7 – R16 km 73+800

Description: Looking at the north abutment. In good condition.

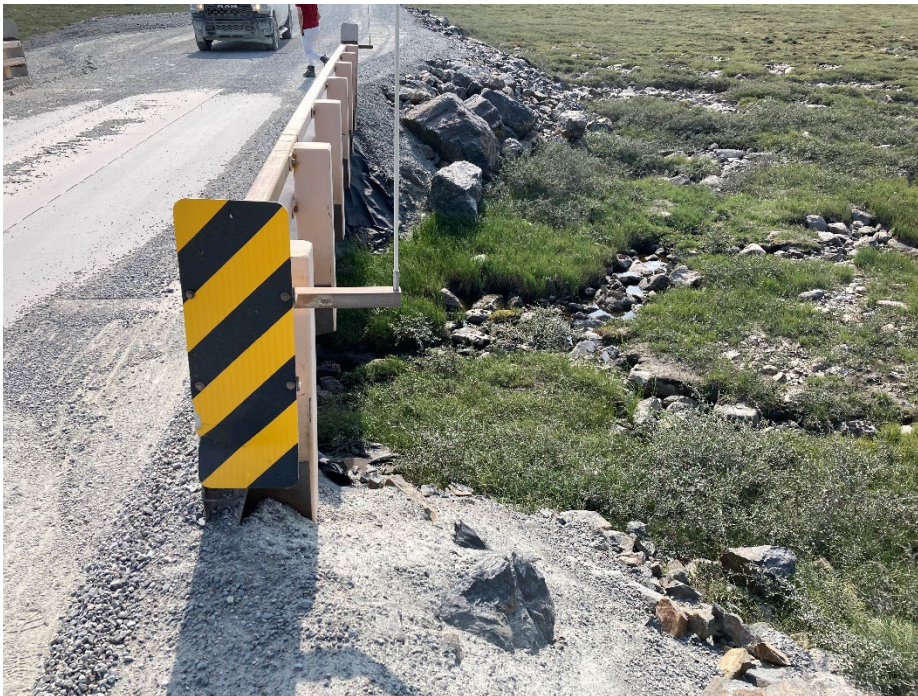
Photograph D3-14 Bridges 7 – R16 km 73+800

Description: Looking at the south abutment. In good condition.

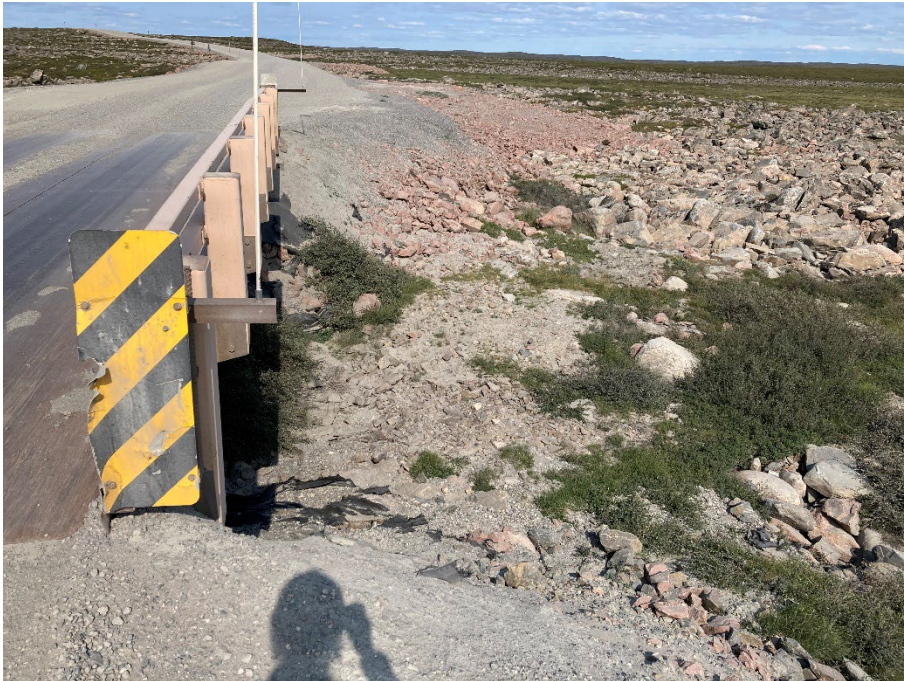
Photograph D3-15 Bridges 8 – R18 km 79+500

Description: Looking at the north abutment. In good condition.

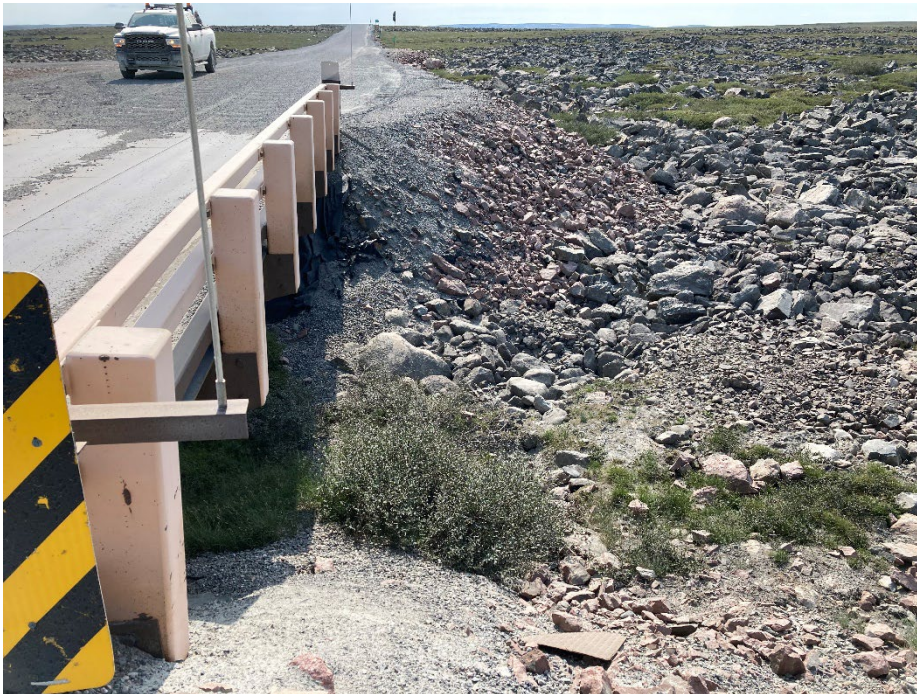
Photograph D3-16 Bridges 8 – R18 km 79+500

Description: Looking at the south abutment. In good condition.

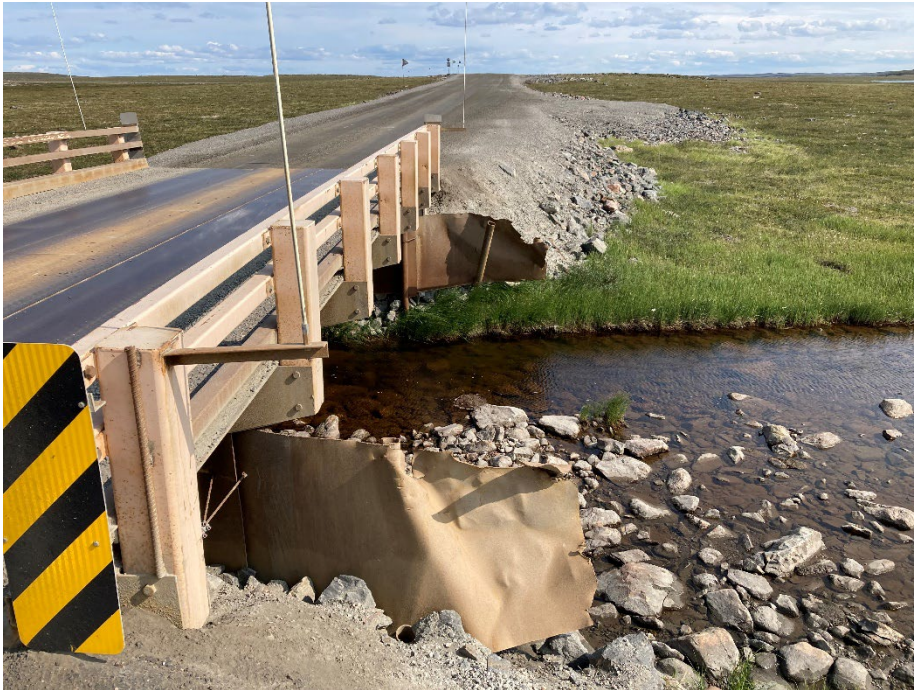
Photograph D3-17 Bridges 9 – R19 km 83+150

STATION	NAME	STRUCTURE DESCRIPTION	COMMENTS
80+950	R-18A	3x1200 mm CSP	In good condition.
	R-18B	1X600 mm CSP	In good condition, installed above ground surface (water can flow below culvert).
83-150	R19 Centre	12m Rapid Span Bridge	Some damage to the steel containment plates and to one pile was observed, which may be associated with snow removal activity. The damage is minor and does not affect the geotechnical integrity of the bridge. Old tension cracks in the top surface on the North abutment have disappeared. Northwest railing is bent.
84+300	Quarry 19		Rock walls are in good condition.
85+490	R-20	1x1200 mm CSP	Outlet of the culvert is slightly twisted. The middle of the culvert is slightly collapsed. The inlet is installed above the ground surface and water is able to flow beneath the culvert. No follow-up required, in stable conditions.
87+300	R-21	2x1200 mm CSP	Both culverts are slightly collapsed in the middle. Should have been installed lower to avoid erosion issue. In stable condition.

Description: Looking at the north abutment. Minor damage to steel plate due to snow removal activity.

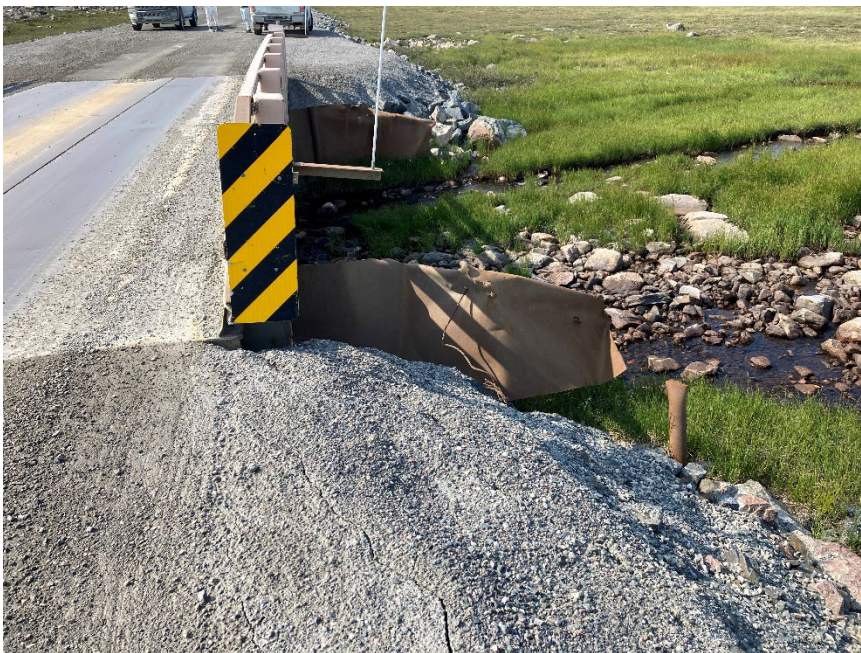
Photograph D3-18 Bridges 9 – R19 km 83+150

Description: Looking at the southwest abutment. Minor damage to steel plate due to snow removal activity. Minor tension cracks, seem inactive.

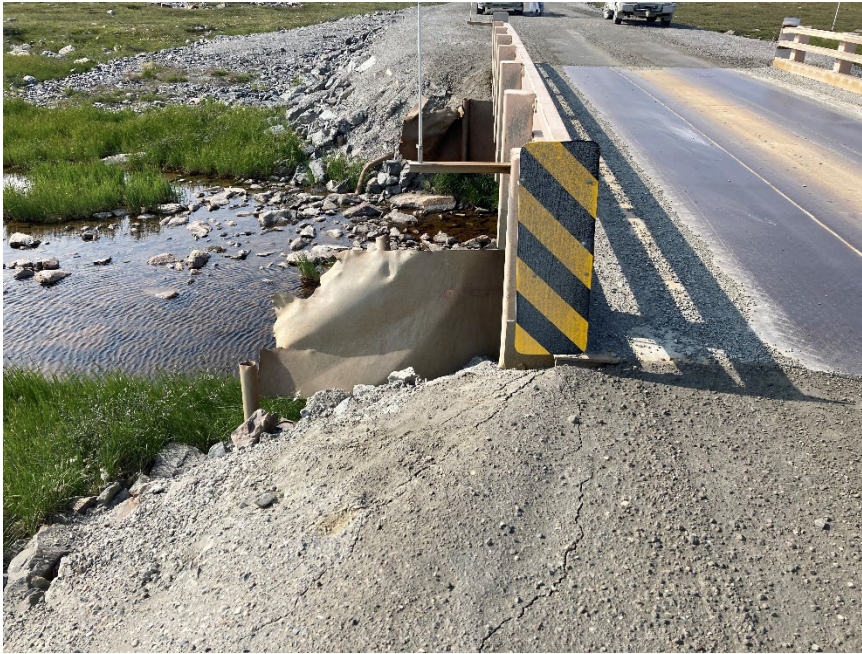
Photograph D3-19 Bridges 9 – R19 km 83+150

Description: Looking at the southeast abutment. Minor damage to steel plate due to snow removal activity. Minor tension cracks, seem inactive.

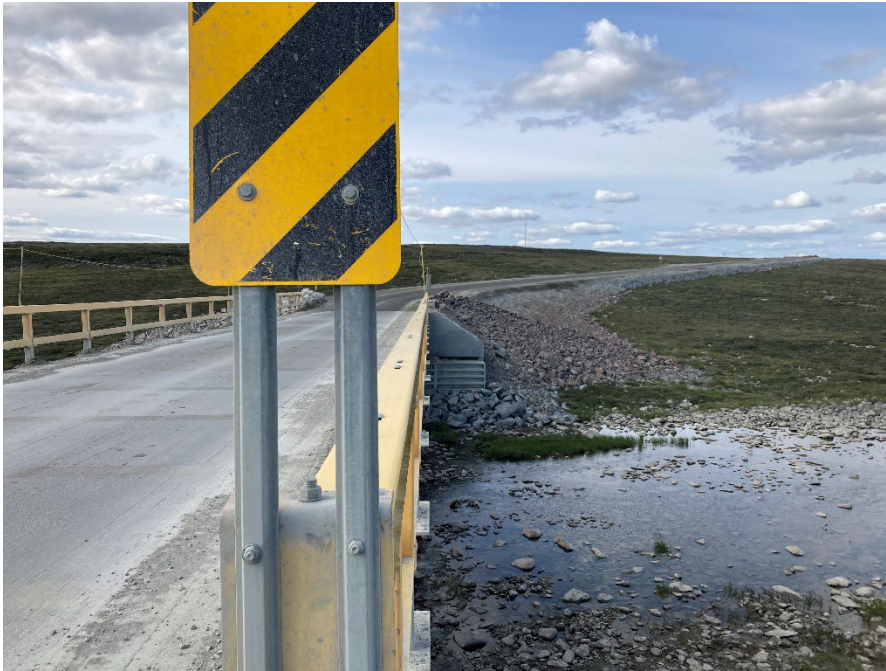
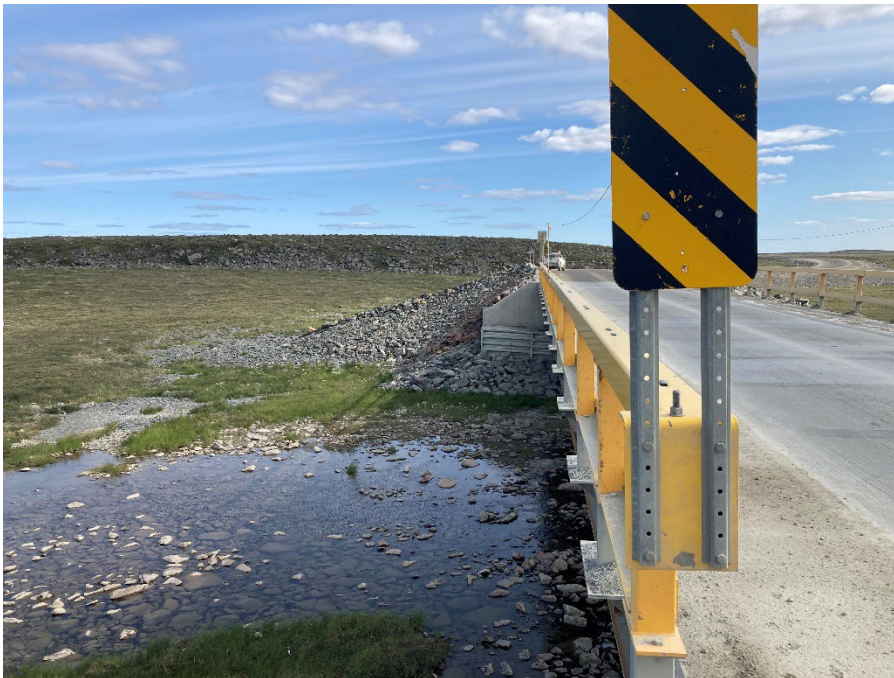
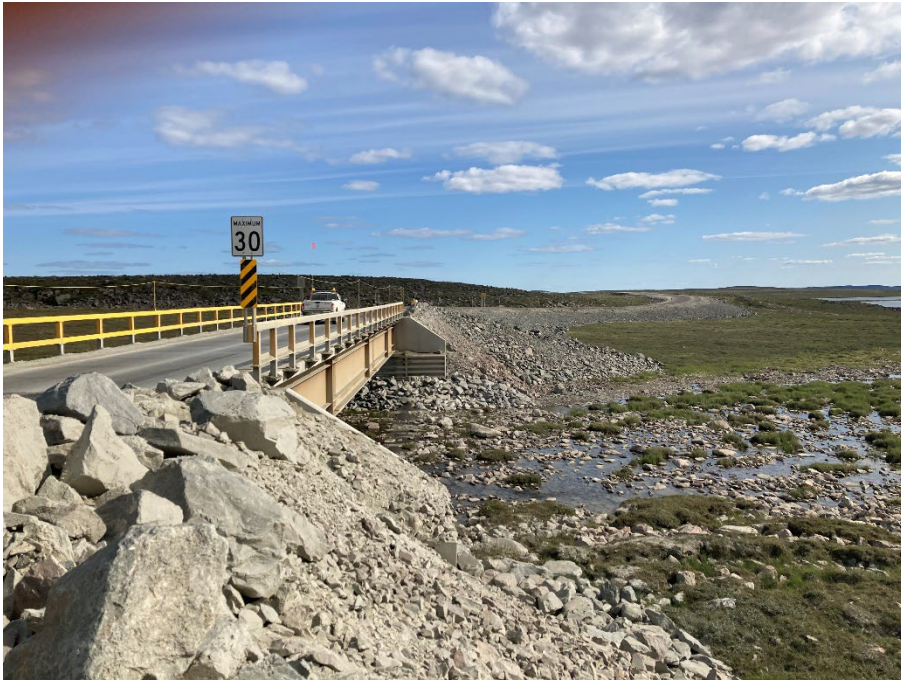
STATION	NAME	STRUCTURE DESCRIPTION	COMMENTS	Photo
127+905	#51	300 mm	Not observed.	-
128+195	#52	700 mm	Inlet in good condition, outlet buried.	-
128+240	#53	700 mm	In good condition.	-
128+388	#54	600 mm	Inlet is buried.	-
128+440	#55	600 mm	Inlet is buried.	-
128+485	#56	600 mm	In good condition.	-
128+635	#57	450 mm	In good condition.	-
128+740	#58	900 mm	In good condition.	-
128+760	#59	900 mm	In good condition.	-
128+775	#60	900 mm	In good condition.	-
129+050	#61	600 mm	Inlet in good condition, outlet buried.	-
129+265	#62	600 mm	In good condition.	-
129+390	#63	300 mm	Inlet in good condition, outlet buried.	-
129+920	#64	600 mm	Not observed.	-
130+924	#65	800 mm	In good condition but inlet is buried.	-
132+000	Bridge 16		The southwest abutment bin seems to be deforming under the weight of the bridge, but the bridge is still horizontal. No sign of instability, likely settling foundation.	135: southwest 136: southeast 134: north

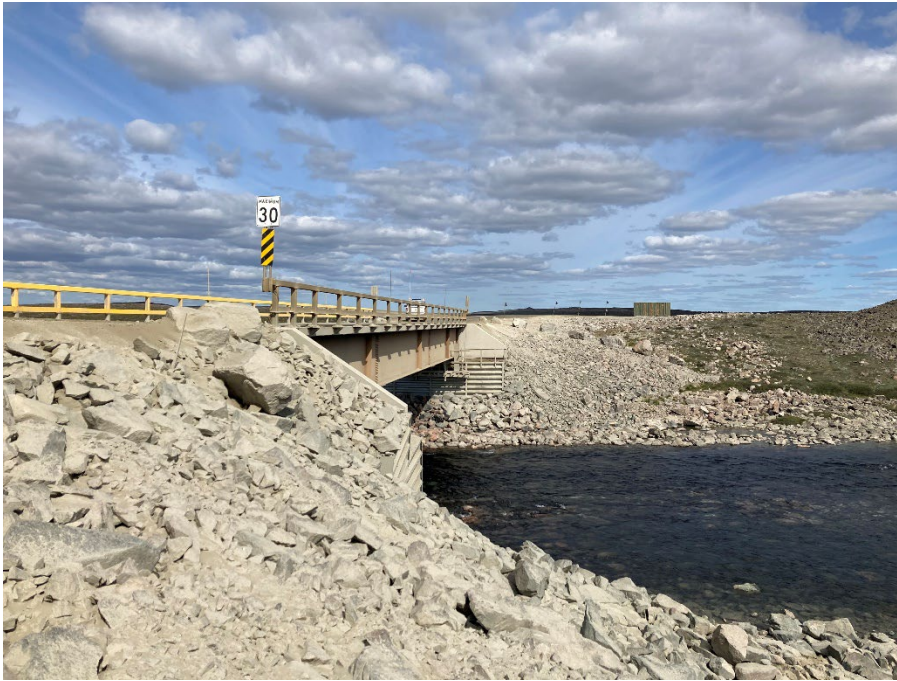
Photograph E2-15 Bridges 7 – km 148+300

Description: Looking at the south abutment.

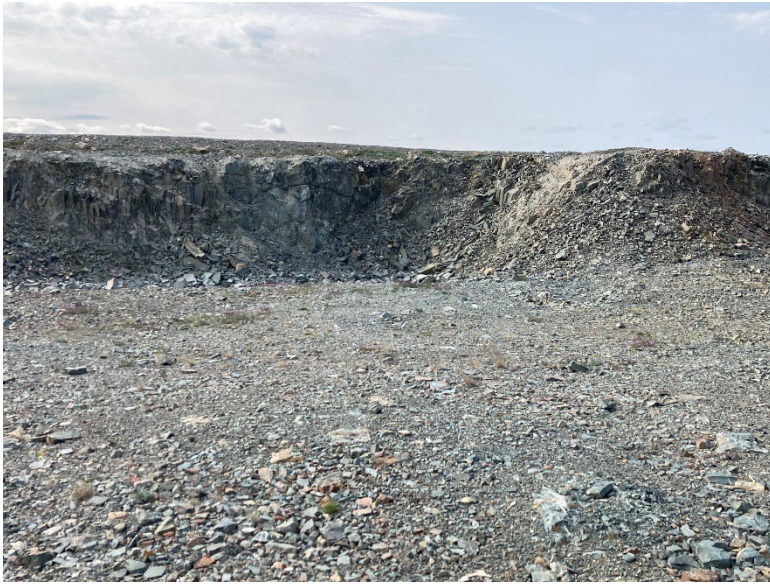
Photograph F-1: Quarry 12 – km 58+300

Description: View of north wall. Presence of loose blocks at the base of the wall.

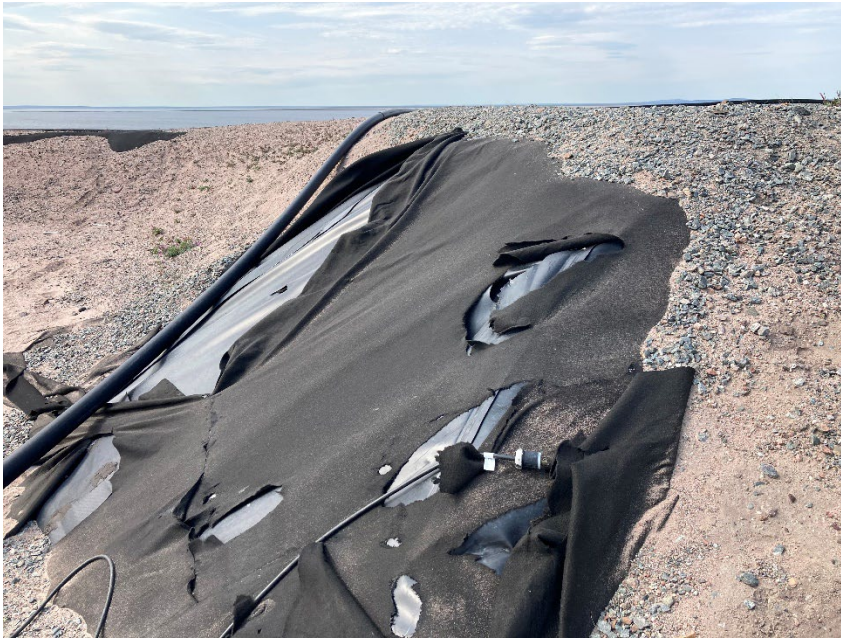
Photograph G1-5 Baker Lake Tank Farm

Description: Looking west. Presence of exposed and damaged geosynthetics in the slope.

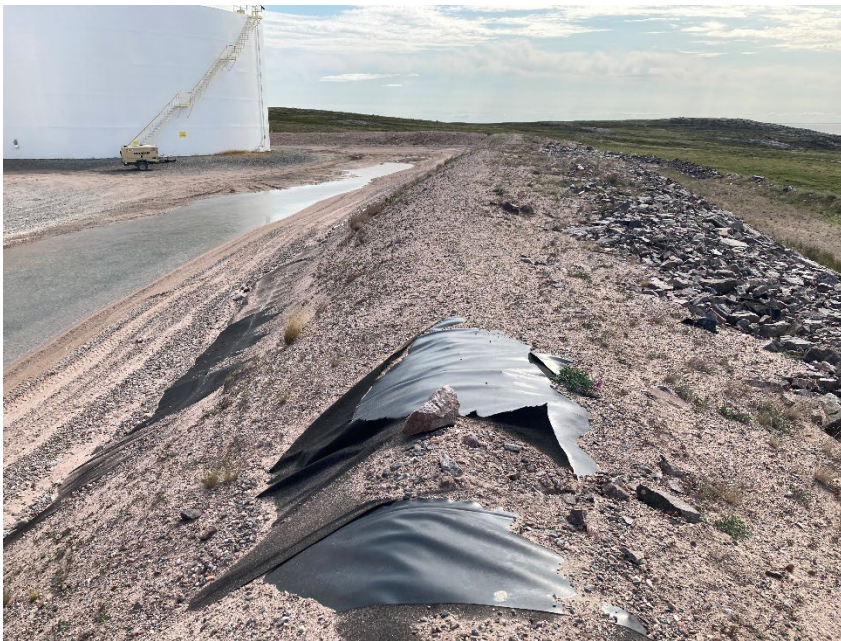
Photograph G1-6 Baker Lake Tank Farm

Description: From the southwestern corner of Tank 3 looking southeast. View of exposed geosynthetics.

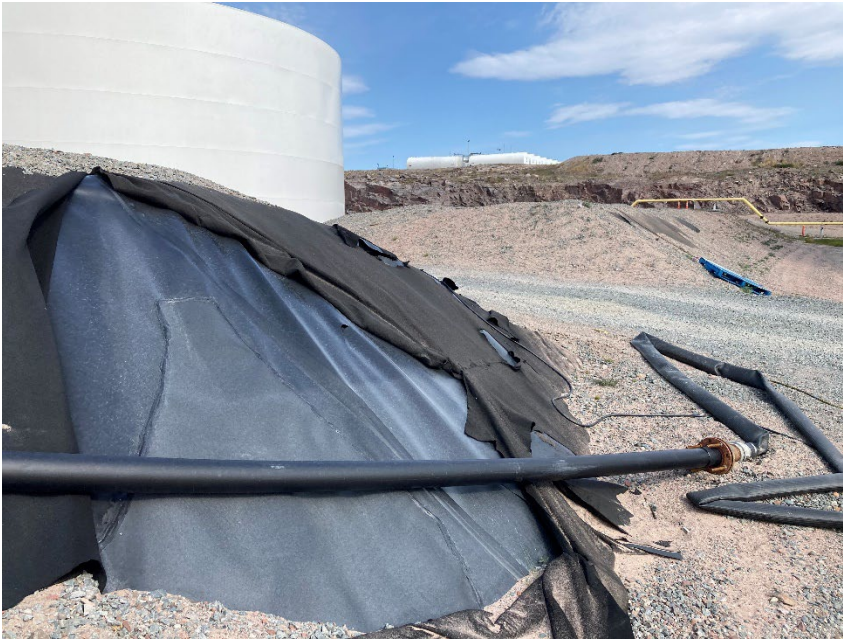
Photograph G1-7 Baker Lake Tank Farm

Description: From the southwestern corner of Tank 3 looking northeast. View of exposed geosynthetics.

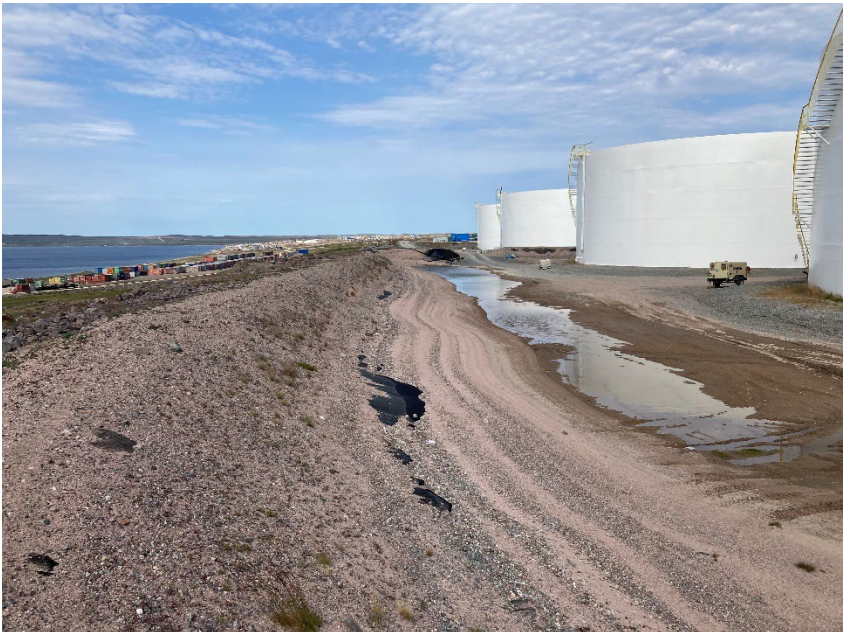
Photograph G1-8 Baker Lake Tank Farm

Description: From the south portion of the site looking northwest at the south side of Tank 3 and 4. View of exposed geosynthetics.

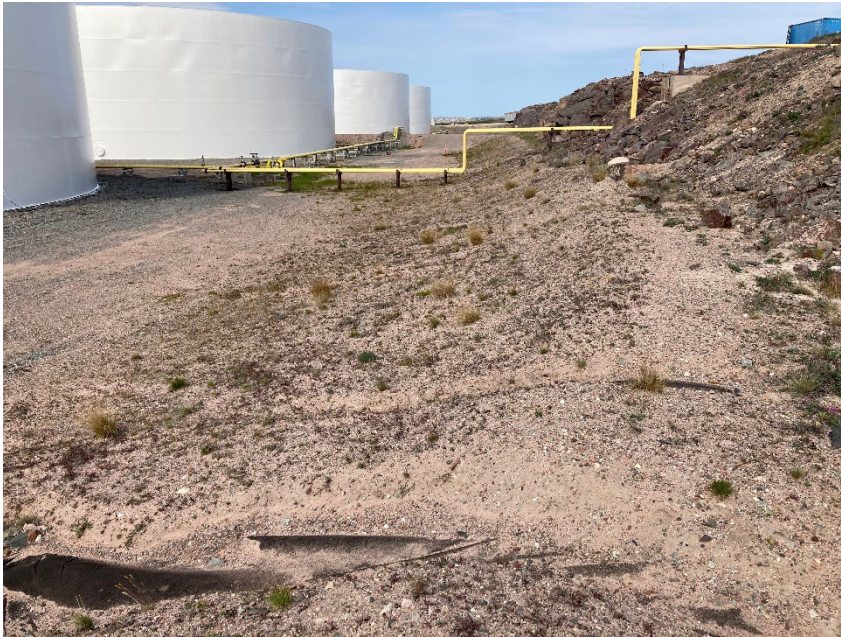
Photograph G1-11 Baker Lake Tank Farm

Description: From the northern side of Tank 4, looking northwest toward Tanks 4, 3, 2, and 1. Presence of exposed liner due to erosion of the granular cover.

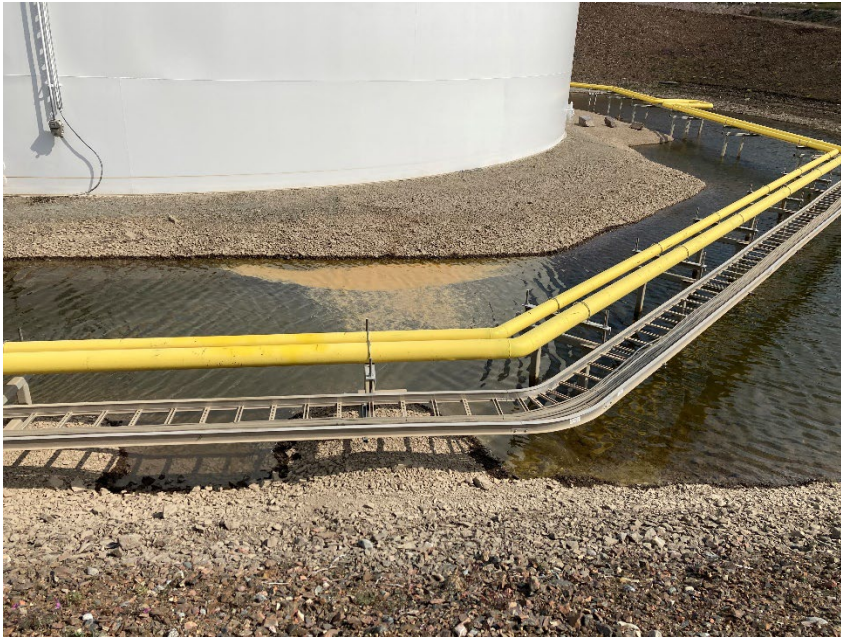
Photograph G1-15 Baker Lake Tank Farm

Description: Apparent fuel leak from temporary diesel containers.

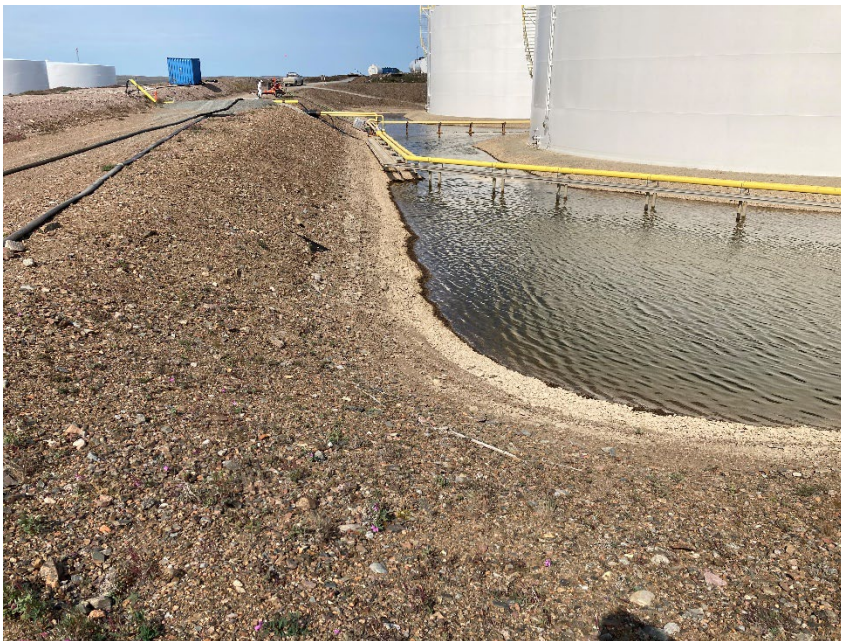
Photograph G1-16 Baker Lake Tank Farm

Description: From the southern corner of Tank 6, looking northeast at the southern side of Tanks 5 and 6. Presence of water ponding.

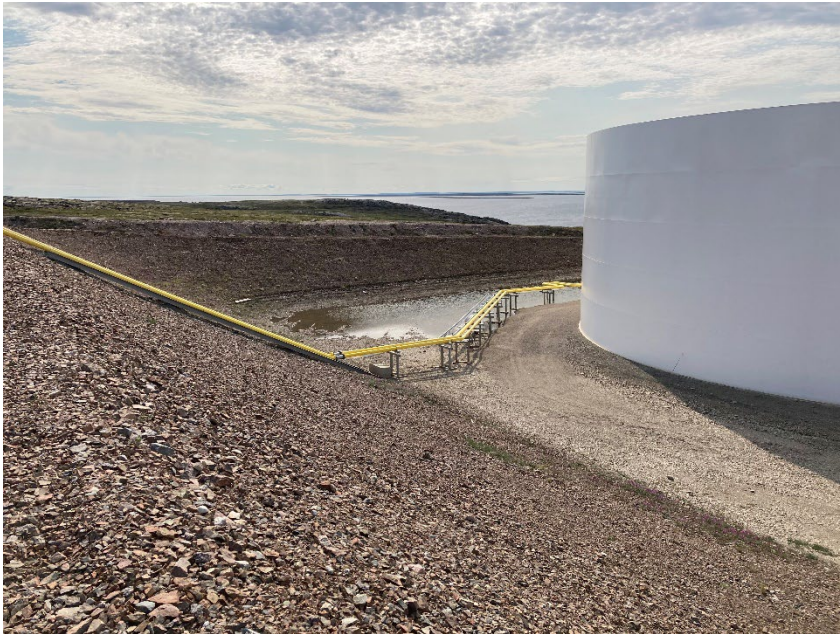
Photograph G1-17 Baker Lake Tank Farm

Description: Looking southeast at the northeastern side of Tank 6. Presence of old tension cracks.

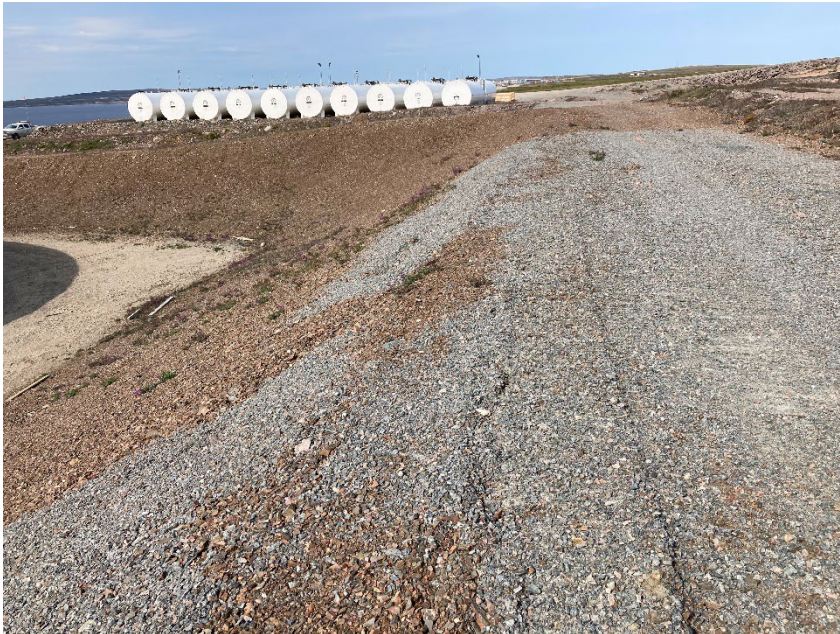
Photograph G1-18 Baker Lake Tank Farm

Description: Looking west at the crest on the northeastern side of Tank 5. Presence of old tension cracks.

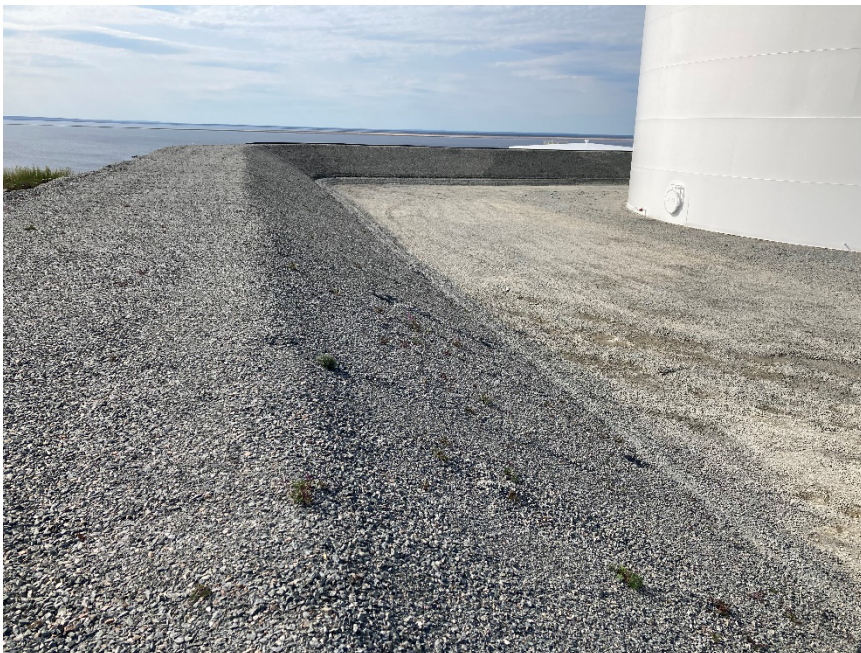
Photograph G1-20 Baker Lake Tank Farm

Description: Looking southwest at the crest on the southeast corner of Tank 7. Presence of animal burrows.

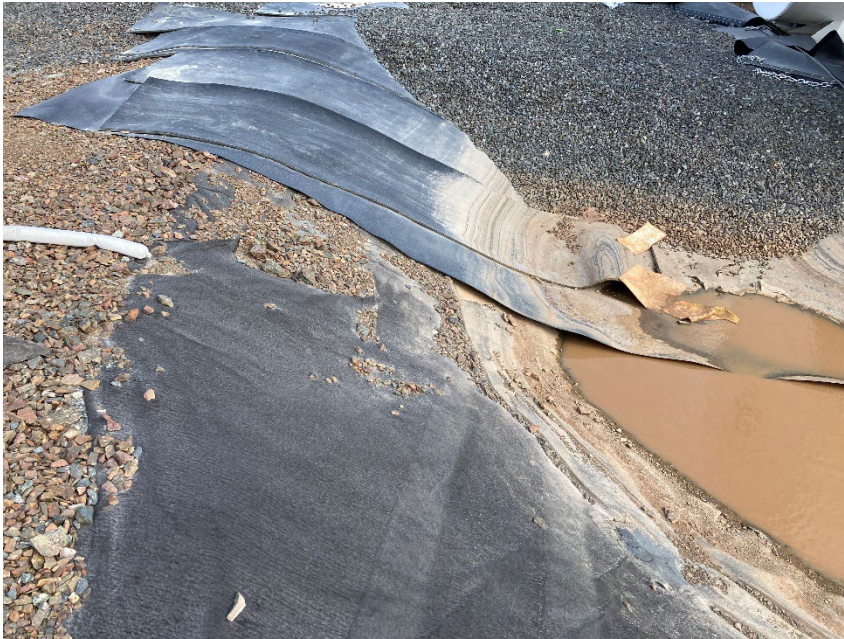
Photograph G1-21 Baker Lake Tank Farm

Description: From the southwestern corner of the Jet A fuel tanks looking northeast. Presence of exposed geomembrane with holes and water ponding.

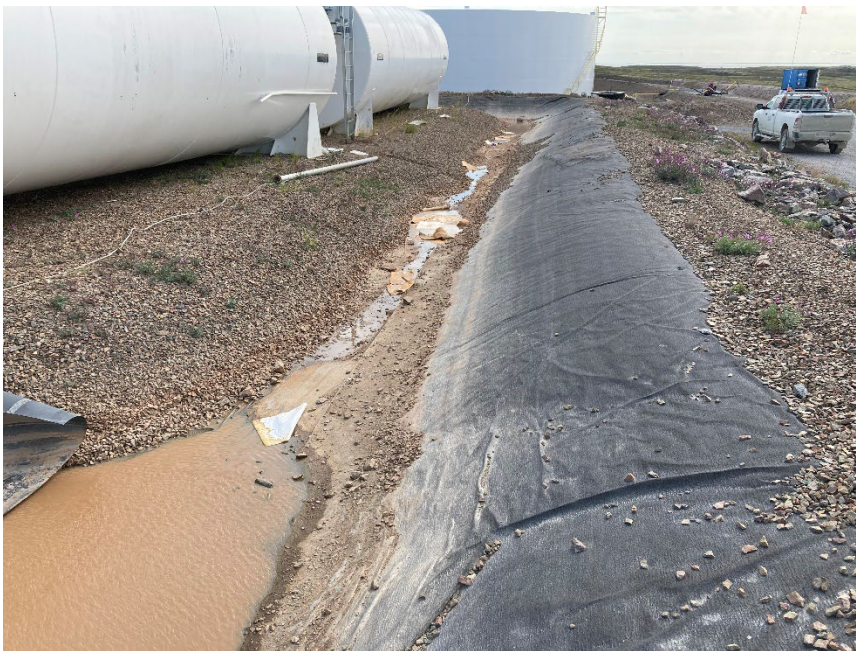
Photograph G1-22 Baker Lake Tank Farm

Description: From the southwestern corner of the Jet A fuel tanks looking east. Presence of exposed geomembrane and water ponding.

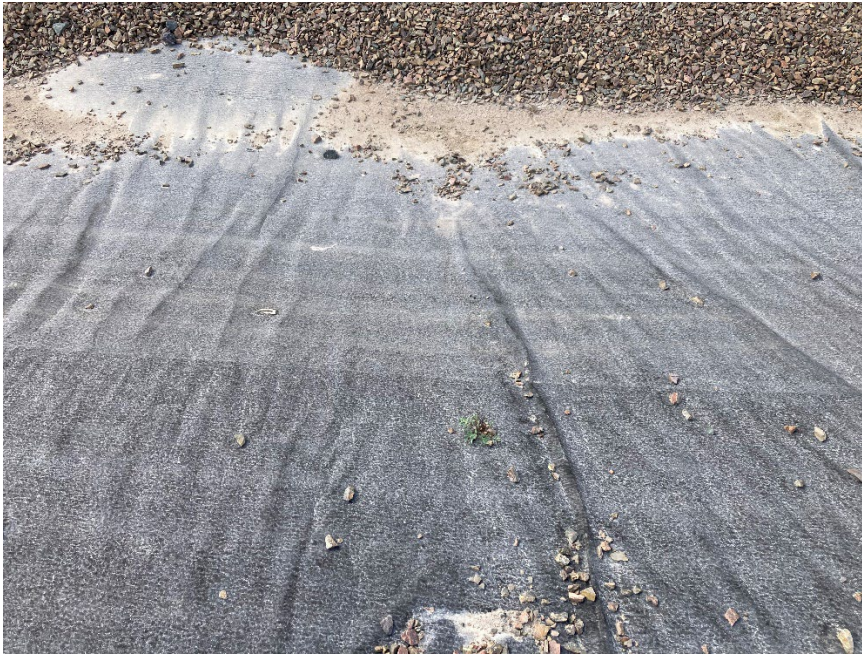
Photograph G1-23 Baker Lake Tank Farm

Description: From the northeastern corner of the Jet A fuel tanks looking southwest. There is a small hole in the liner.

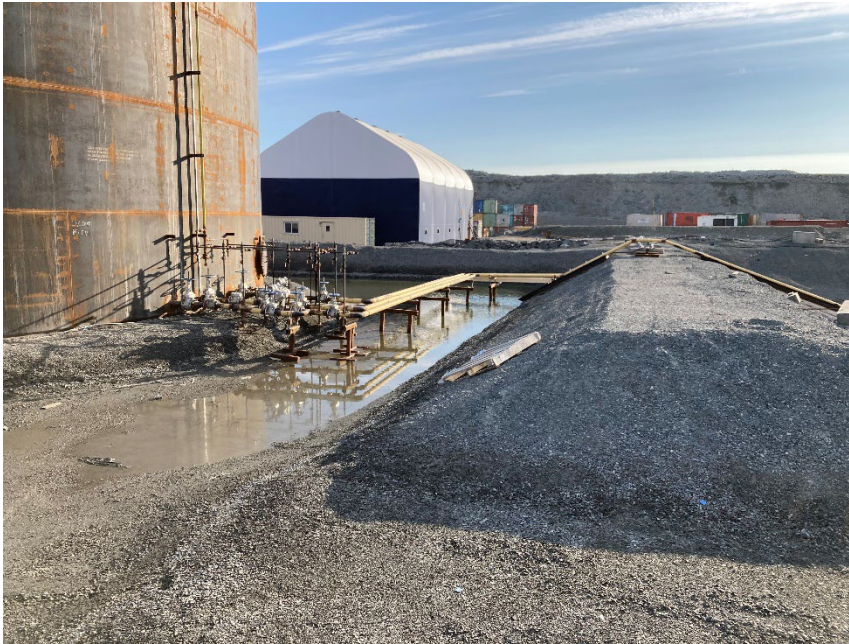
Photo Number: 289

Description: Looking northwest from the southern side of the new tank.

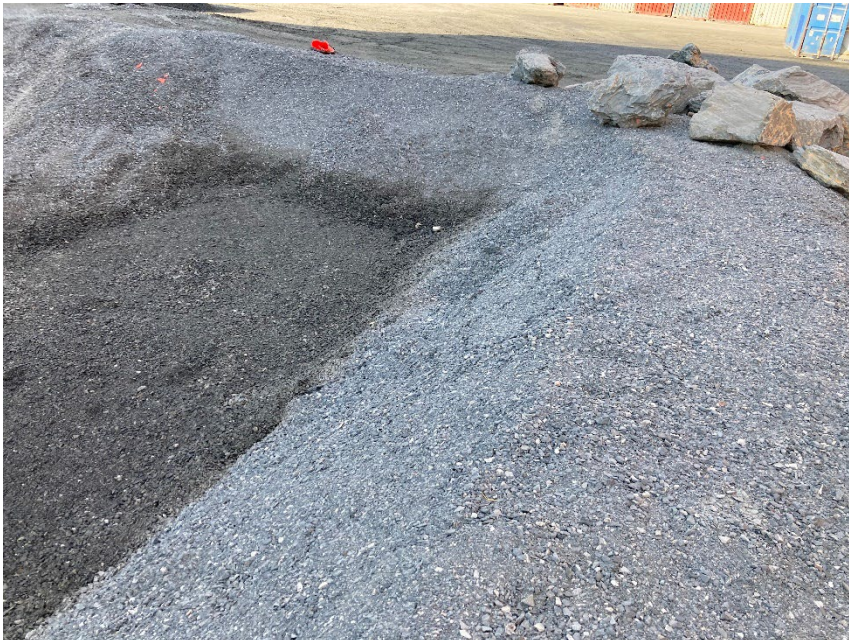
Photo Number: 289b

Description: Looking northeast from the southern side of the new tank.

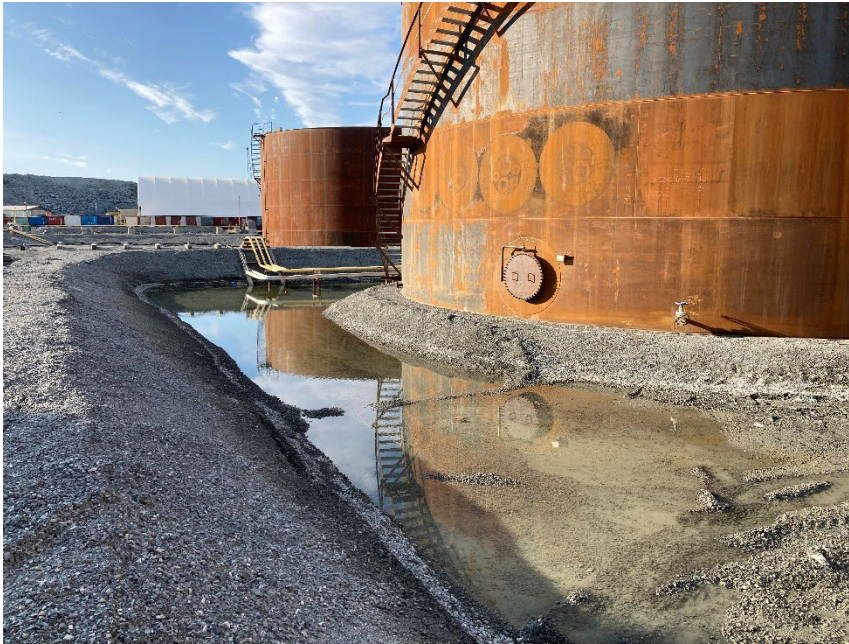
Photo Number: 290

Description: Looking south from the western side of the new tank. Presence of minor tension cracks in the berm.

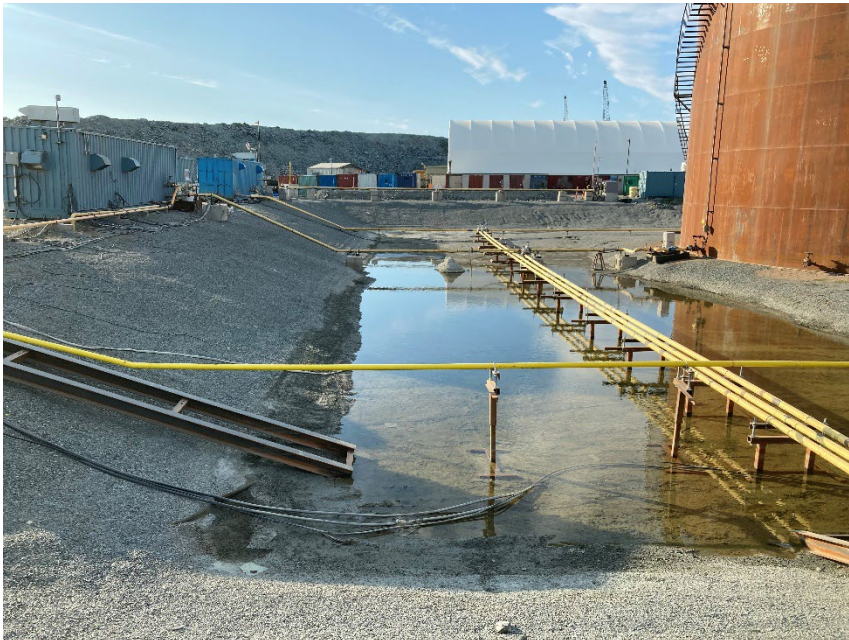
Photo Number: 291

Description: Looking southeast from the northern side of the new tank.

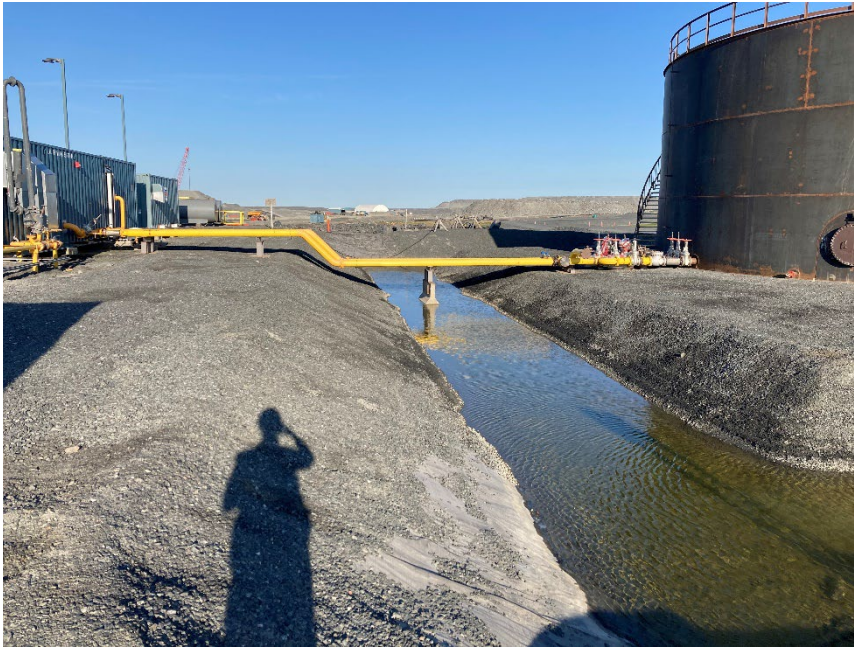
Photograph G3-1 Whale Tail Project Site Tank Farm

Description: From the fuelling pad, looking west at the Tank Farm. Presence of water ponding.

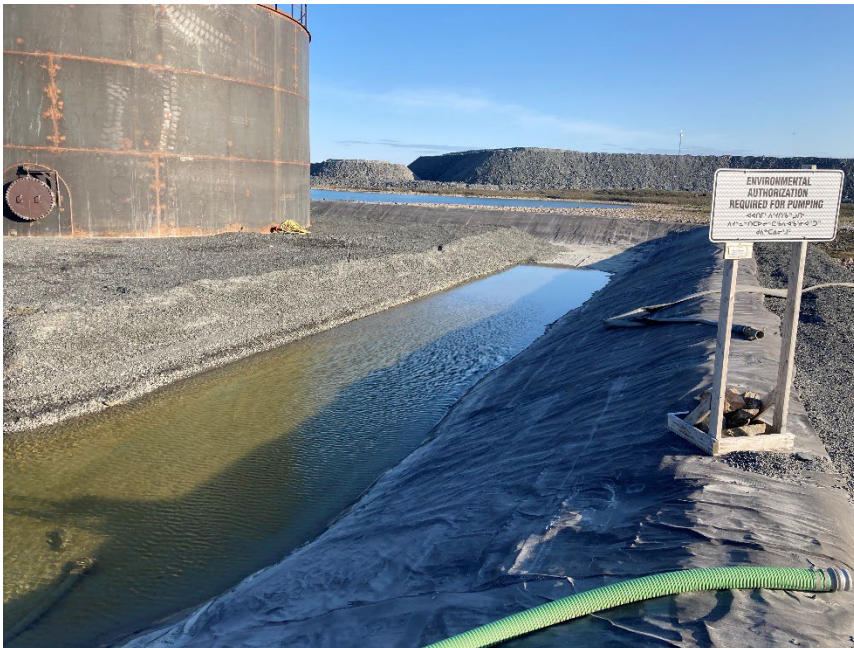
Photograph G3-2 Whale Tail Project Site Tank Farm

Description: From the fuelling pad, looking north at the Tank Farm. Presence of water ponding.

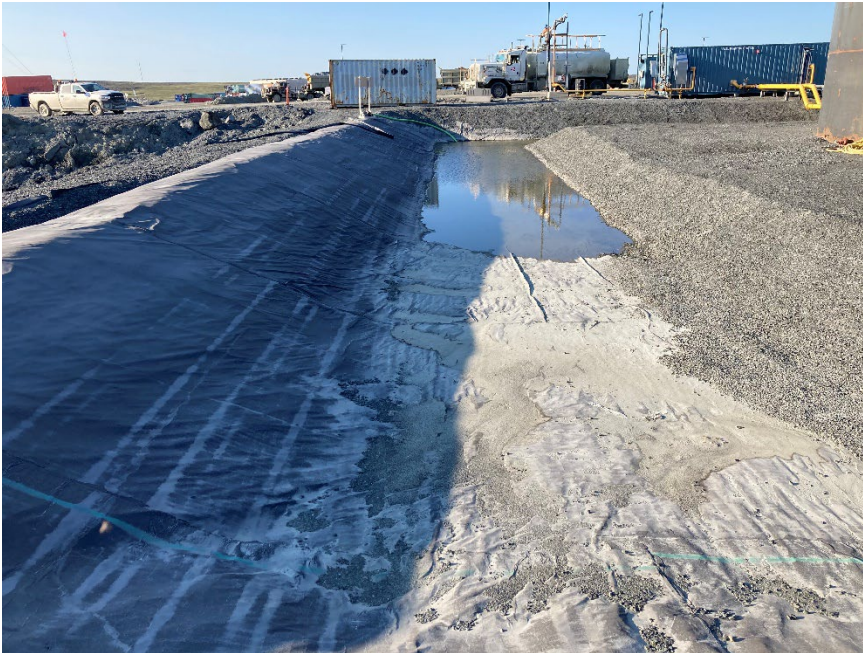
Photograph G3-6 Whale Tail Project Site Tank Farm

Description: From the northeast corner of the tank, looking south. Presence of 150-200 mm of water ponding.

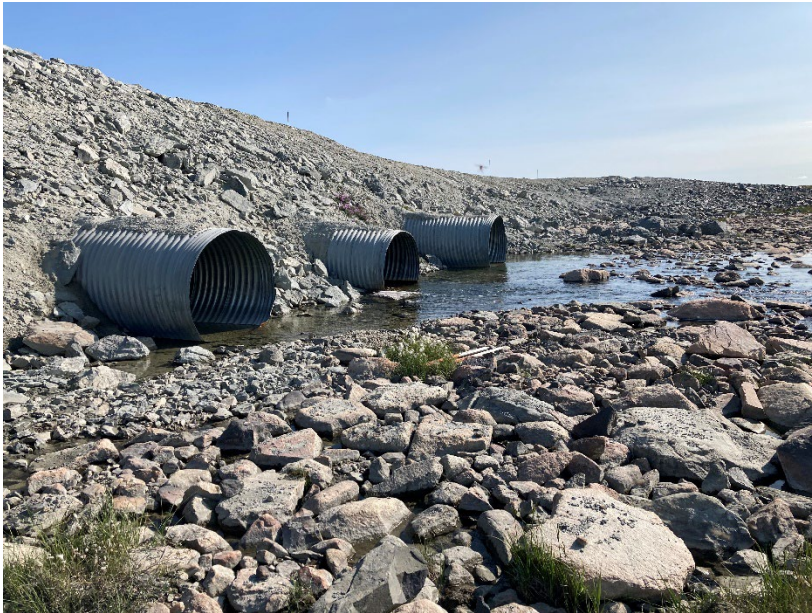
Photograph H1-1 Vault Road Culverts

Description: Looking at the outlet of the three culverts located on Vault Road at 640964E/7217466N. All of them are deformed in the middle.

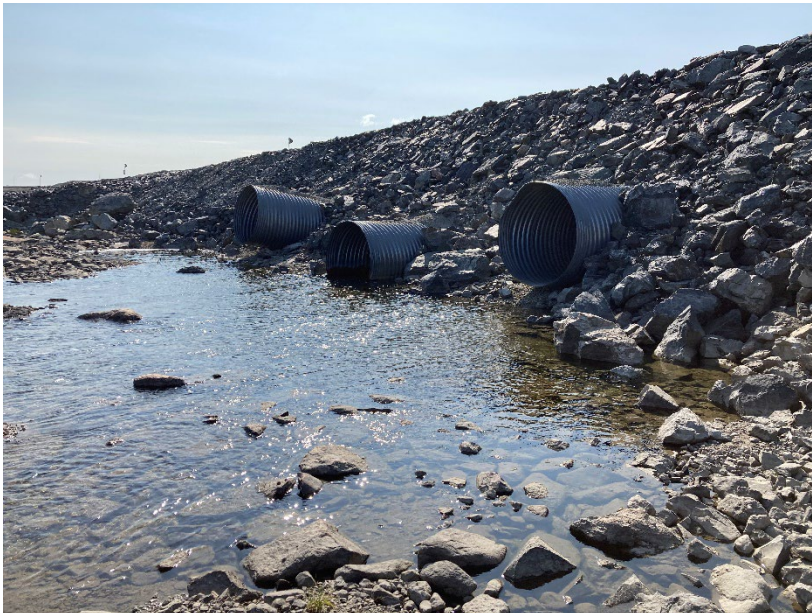
Photograph H1-2 Vault Road Culverts

Description: From the inlet side of the three culverts located on Vault Road at 640964E/7217466N. The culverts are slightly deformed on top in the middle.

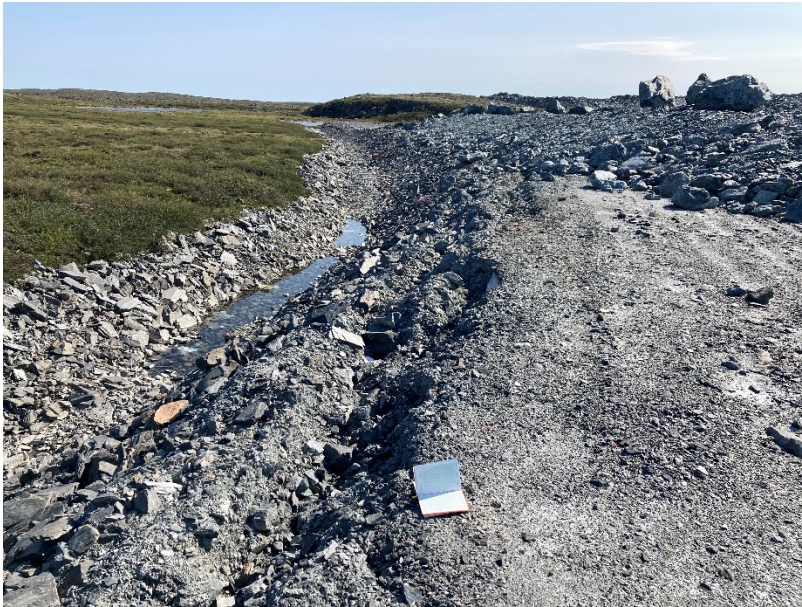
Photograph H2-9 Diversion Ditch and its Sediment and Erosion Protection Structure

Description: From the northern diversion ditch looking east. Presence of tension cracks in the rockfill slope.

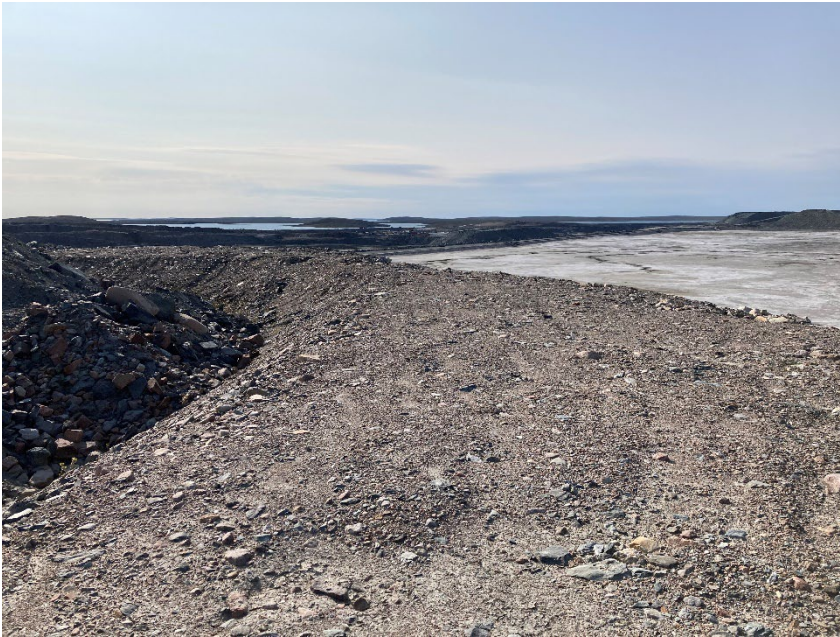
Photograph H5-1 Meadowbank Contaminated Soil Storage and Bioremedial Landfarm Facility

Description: From the eastern side of the Contaminated Soil Storage and Bioremedial Landfarm Facility, looking east at the containment berm. In good condition.
