Meadowbank and Whale Tail 2023 Annual Geotechnical Inspection

2023 Annual Geotechnical Inspection

Meadowbank Complex, Nunavut

1623-2146800623-RA-Rev0

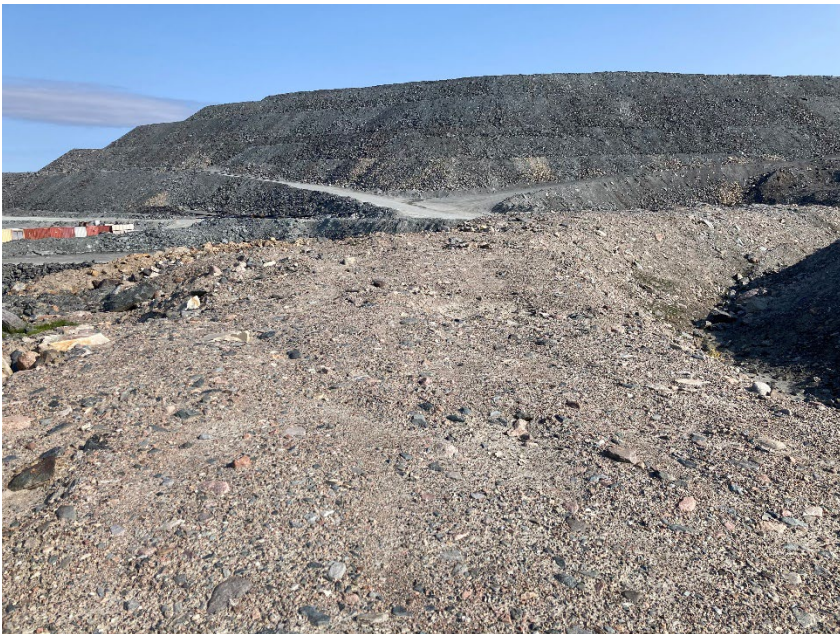
Photograph H5-2 Meadowbank Contaminated Soil Storage and Bioremedial Landfarm Facility

Description: From the northeast extremity of the South Cell, looking northeast at the Contaminated Soil Storage and Bioremedial Landfarm Facility. In good condition.

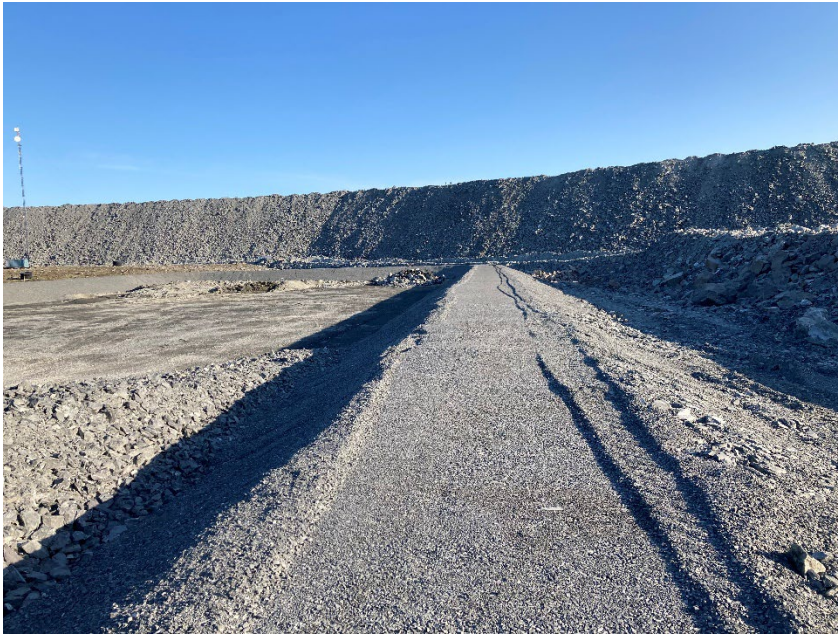
Photograph H5-3 Whale tail Project Contaminated Soil Storage and Bioremedial Landfarm Facility

Description: From the south extremity of the Whale Tail Project facility, looking north. In good condition.

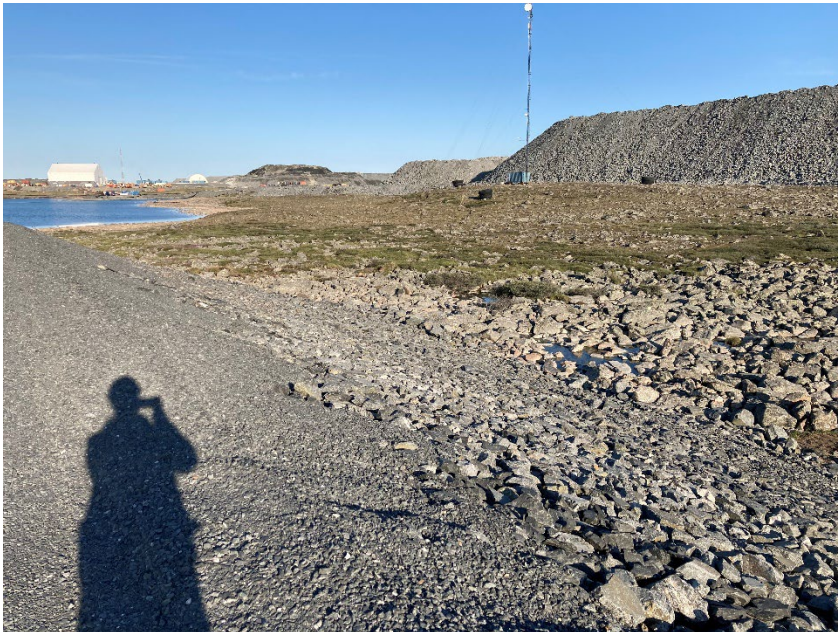
Photograph H5-4 Whale tail Project Contaminated Soil Storage and Bioremedial Landfarm Facility

Description: From the north extremity of the Whale Tail Project facility, looking west. In good condition.

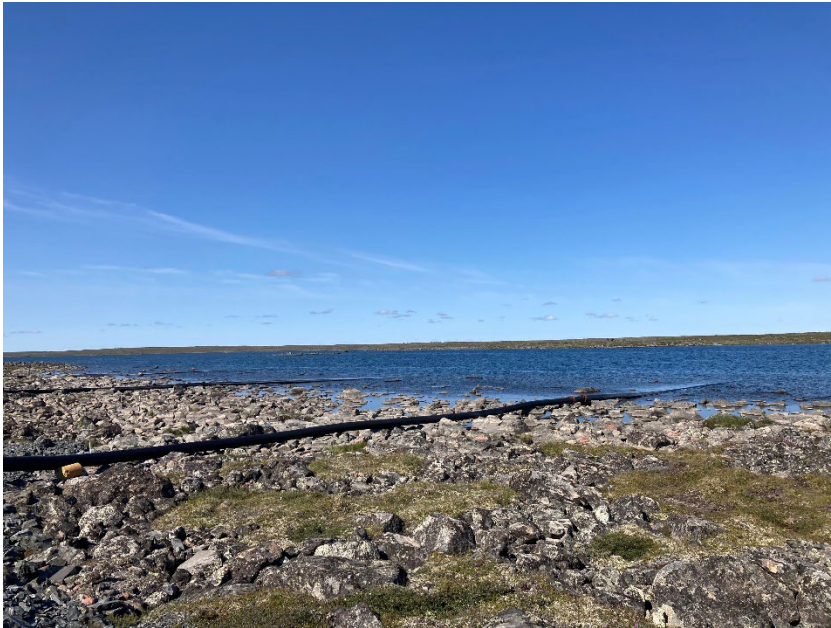
Photograph H9-1 Mammoth Lake Diffuser

Description: From the access road, looking west. Three diffusers are present and working normally.

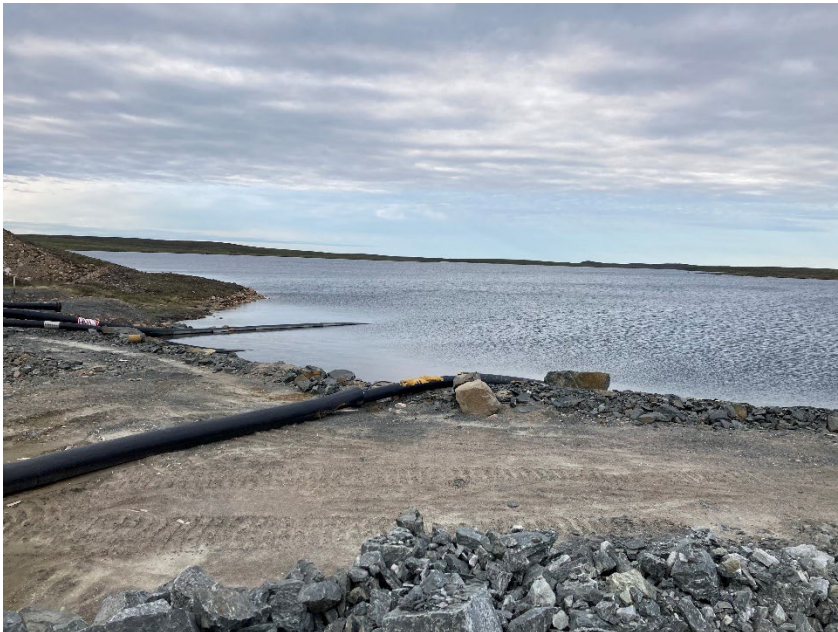
Photograph H9-2 Whale Tail South Diffuser

Description: From the east abutment of Whale Tail Dike, looking south. The diffuser is present and working normally.

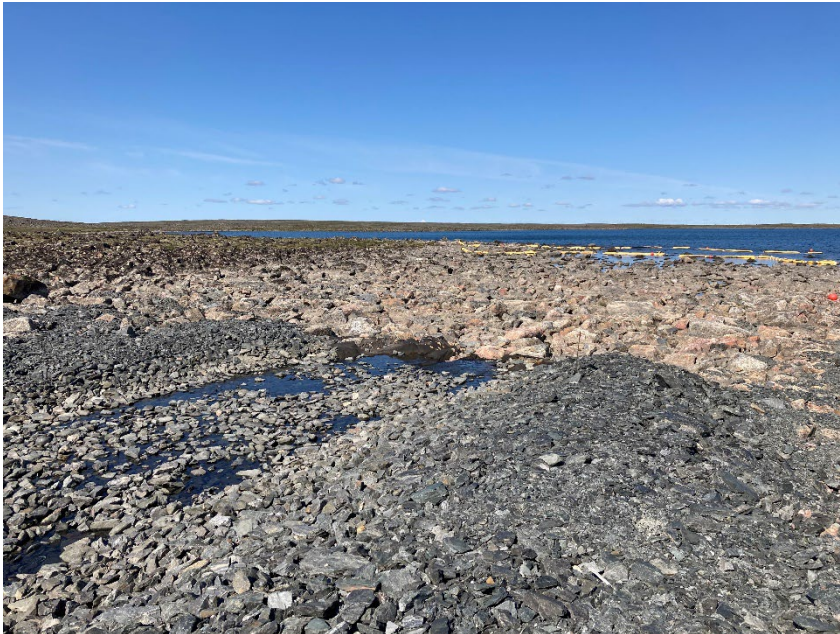
Photograph H10-1 South Whale Tail Channel

Description: From the outlet into Mammoth Lake, looking northwest. Two turbidity barriers are deployed in the lake.

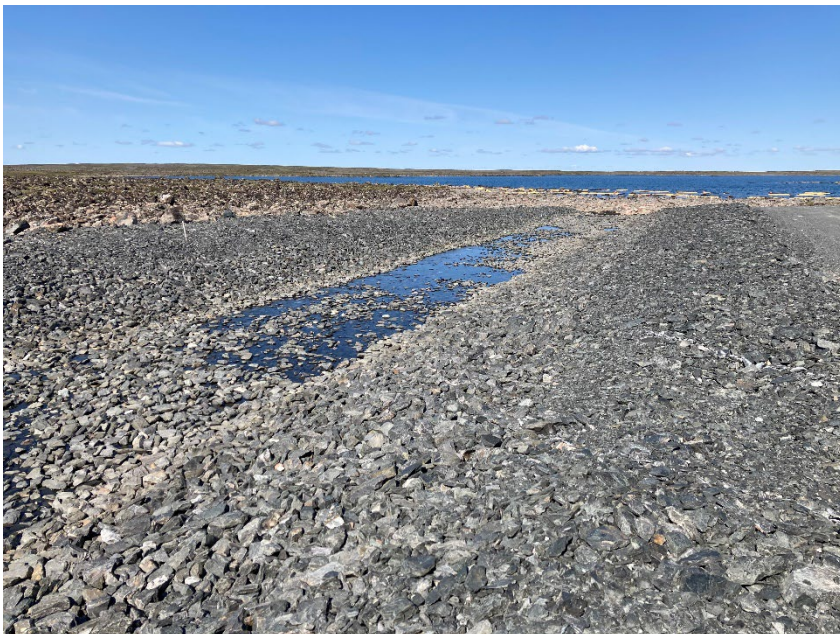
Photograph H10-2 South Whale Tail Channel

Description: From approx. Sta. 0+850, looking west. Settlement in the rockfill slope.

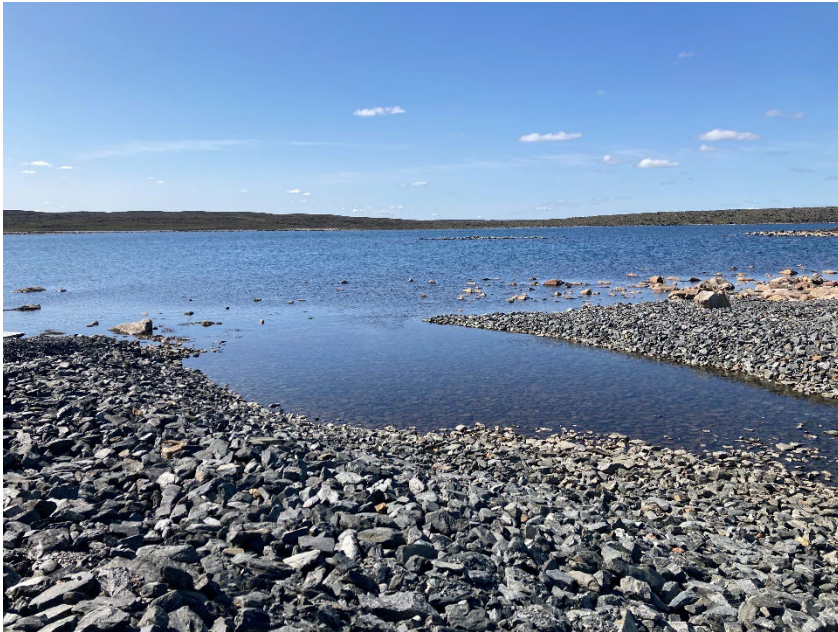
Photograph H10-7 South Whale Tail Channel

Description: From the Whale Tail South Lake inlet, looking southwest. Slight apparent sloughing in riprap.

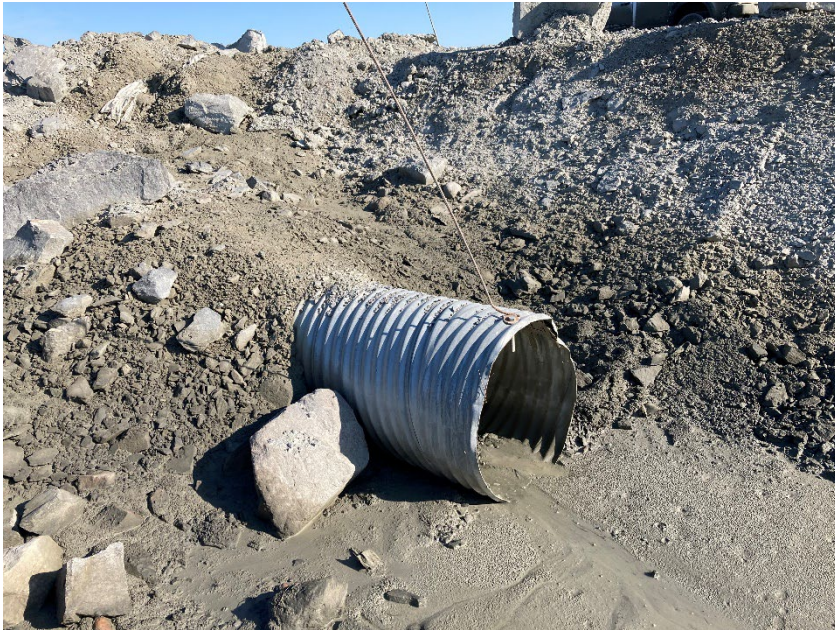
Photograph H11-1 Saline Ditch

Description: From the northern extremity of the Saline Ditch, looking west. The culvert is in good condition. Mud is accumulating in front of the inlet.

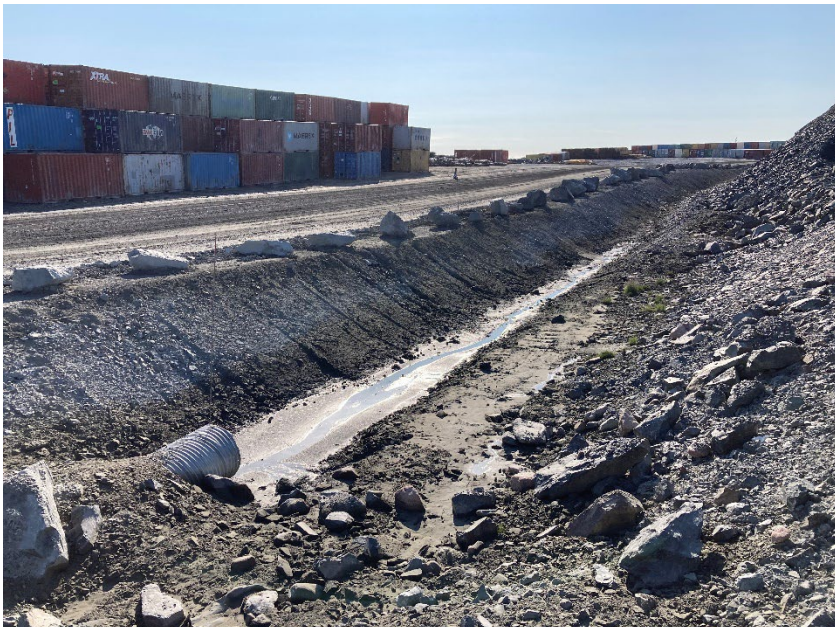
Photograph H11-2 Saline Ditch

Description: From the northern extremity of the Saline Ditch, looking east. Mud and gravel are present in the ditch.

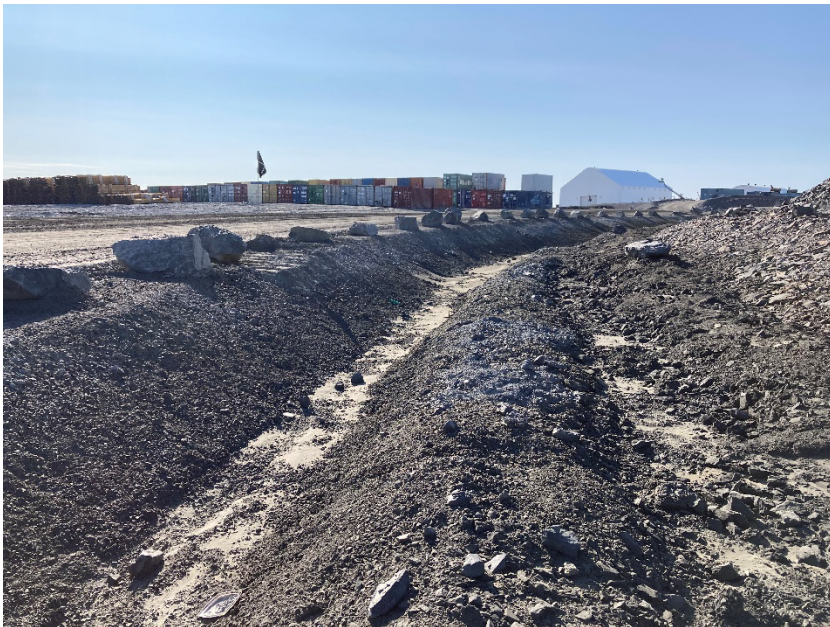
Photograph H11-4 Saline Ditch

Description: From approx. Sta. 0+180, looking southeast. Presence of mud and gravel in the ditch.

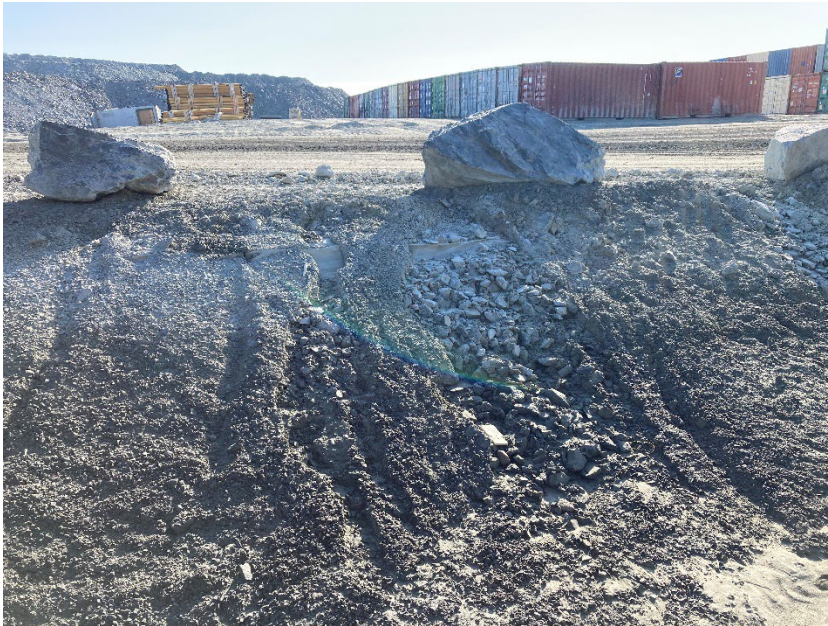
Photograph H11-5 Saline Ditch

Description: From approx. Sta. 0+250, looking west. Erosion of fine material, exposing liner underneath. Limited sloughing of fine material.

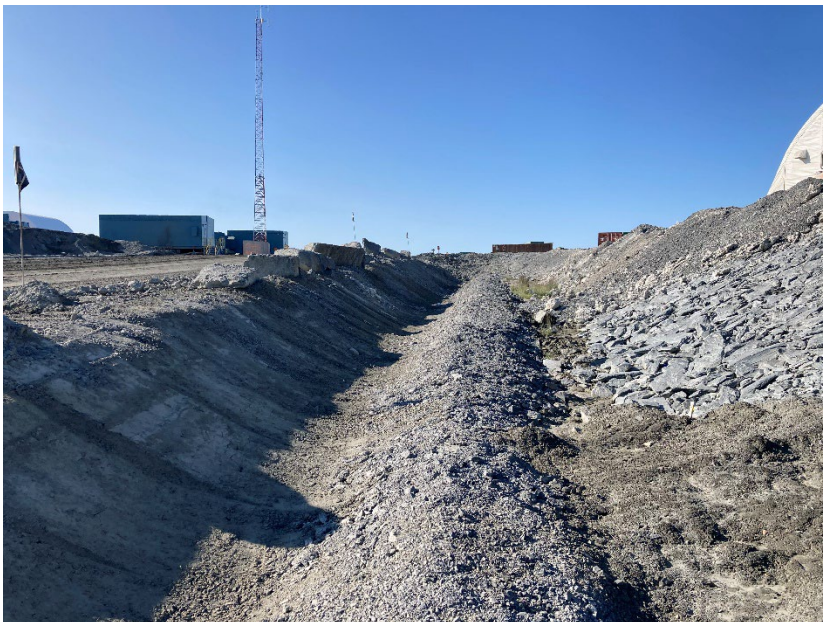
Photograph H11-6 Saline Ditch

Description: From approx. Sta. 0+300, looking south. Presence of gravel in the ditch.

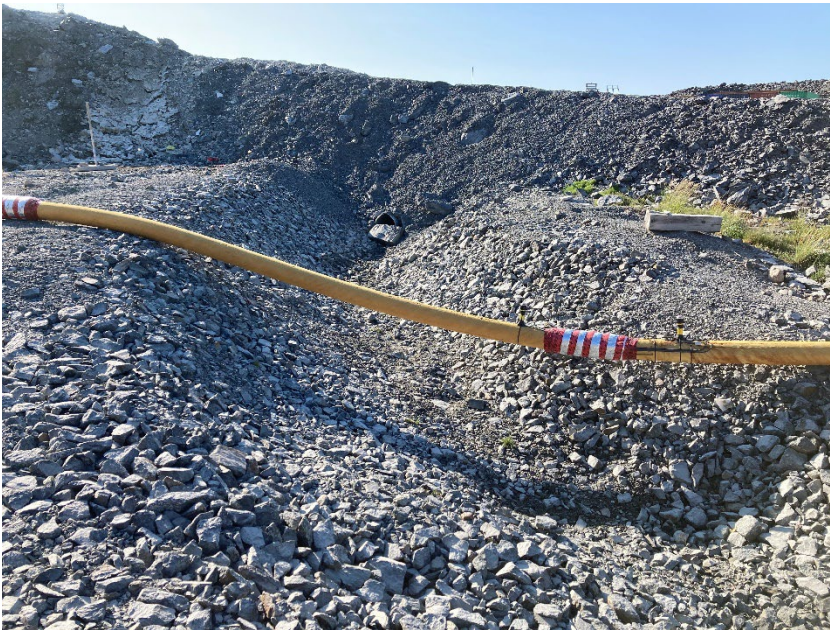
Photograph H11-10 Saline Ditch

Description: From approx. Sta. 0+560. Culvert obstructed by blocks and debris.

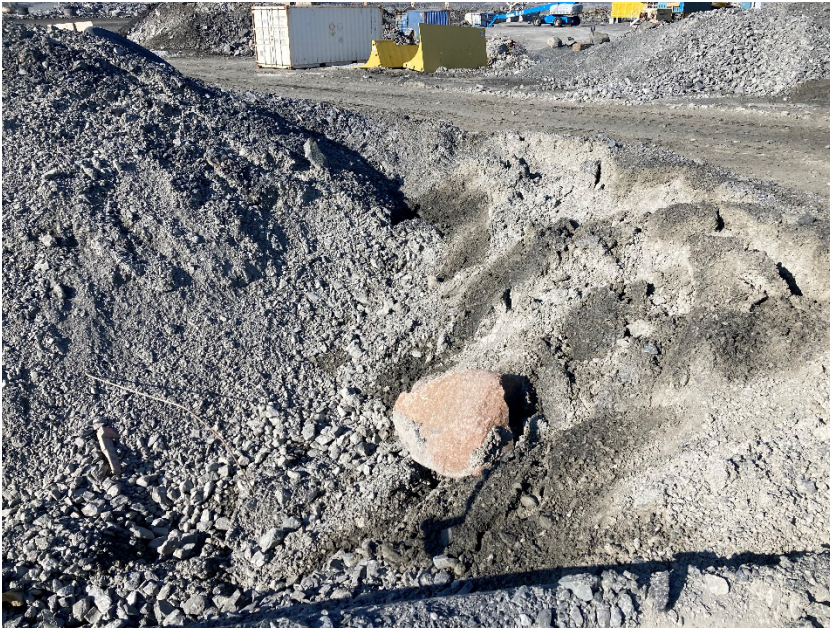
Photograph H11-13 Saline Ditch

Description: From the southwestern extremity of the Saline Ditch, looking northwest. Culvert blocked by boulder.

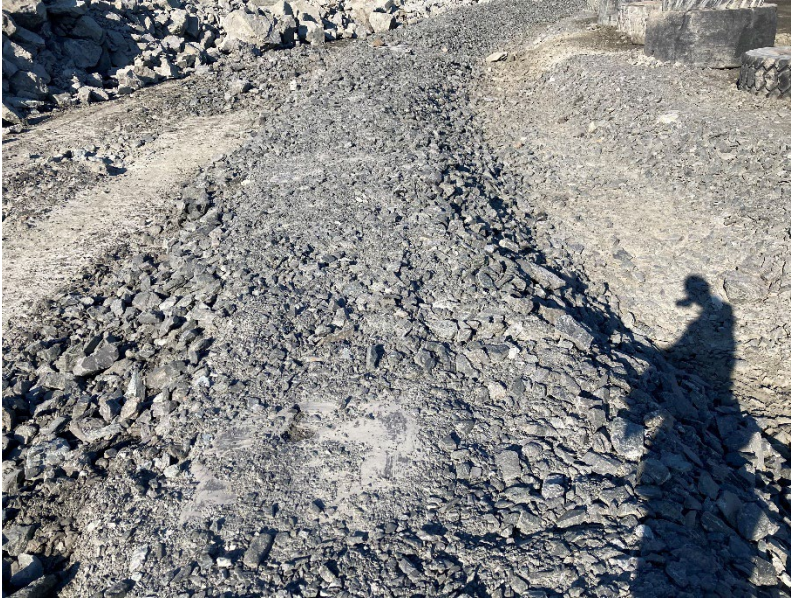
Photograph H12-3 UG Ore Stockpile Saline Ditch

Description: From approx. Sta. 0+050, looking southwest. Presence of debris in the ditch.

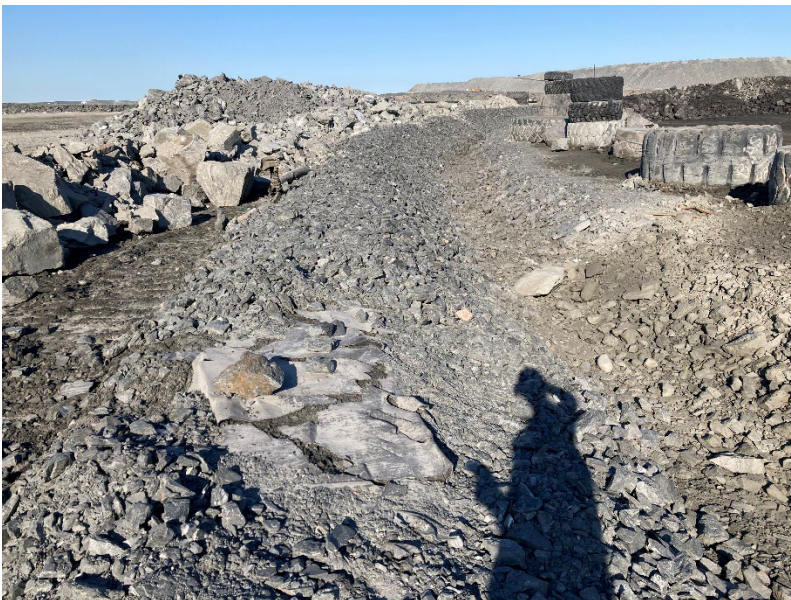
Photograph H12-4 UG Ore Stockpile Saline Ditch

Description: From approx. Sta. 0+070, looking southwest. Exposed and ripped liner at the top of the ditch.

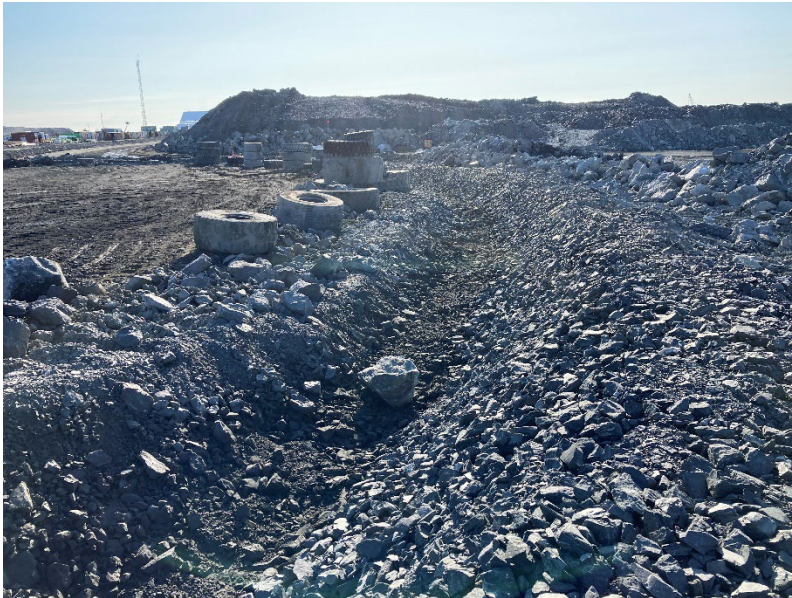
Photograph H12-5 UG Ore Stockpile Saline Ditch

Description: From approx. Sta. 0+150, looking southeast. Presence of a boulder in the ditch

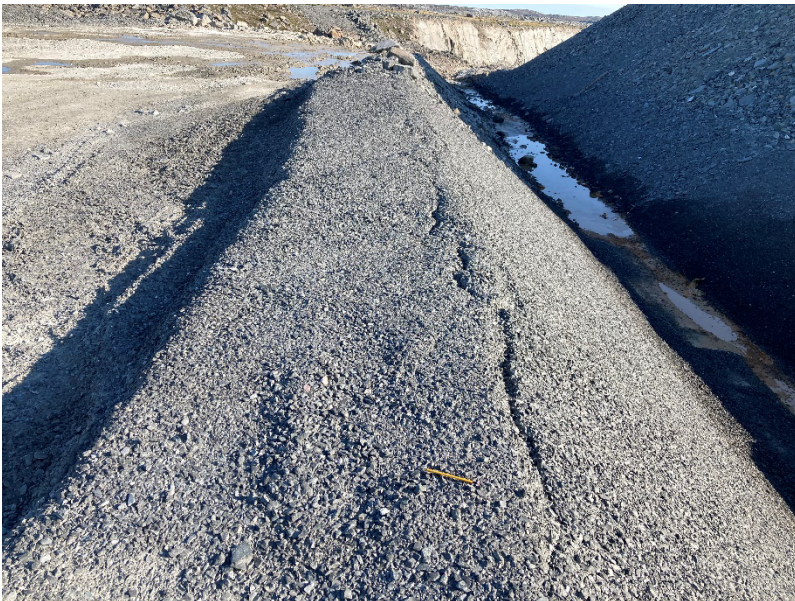
Photograph H12-8 UG Ore Stockpile Saline Ditch

Description: From approx. Sta. 0+300, looking north.

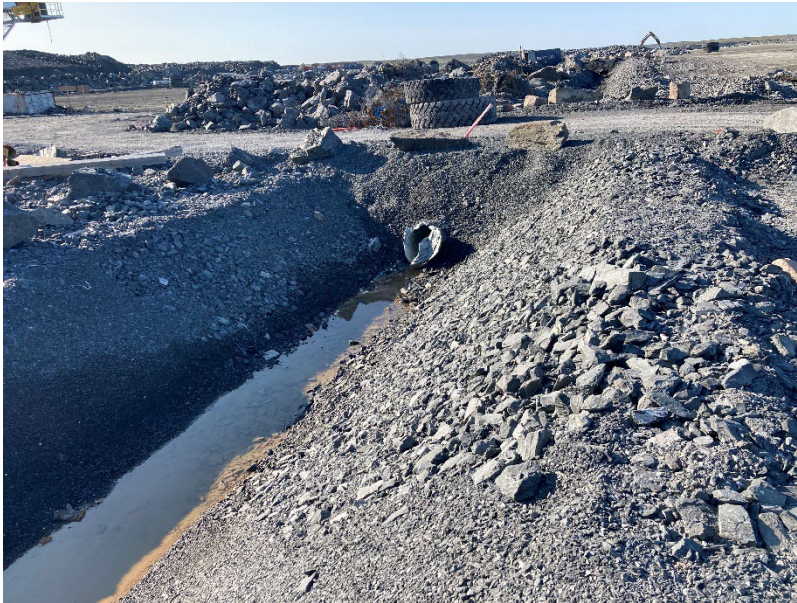
Photograph H12-9 UG Ore Stockpile Saline Ditch

Description: From approx. Sta. 0+300, looking south.

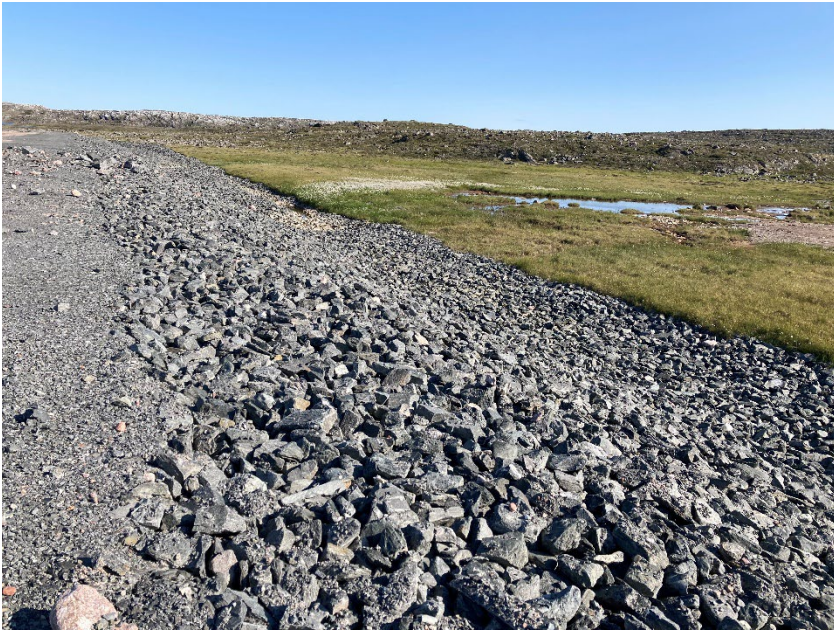
Photograph H13-1 IVR Diversion Channel

Description: From the south extremity of the IVR Diversion Channel, looking northwest.

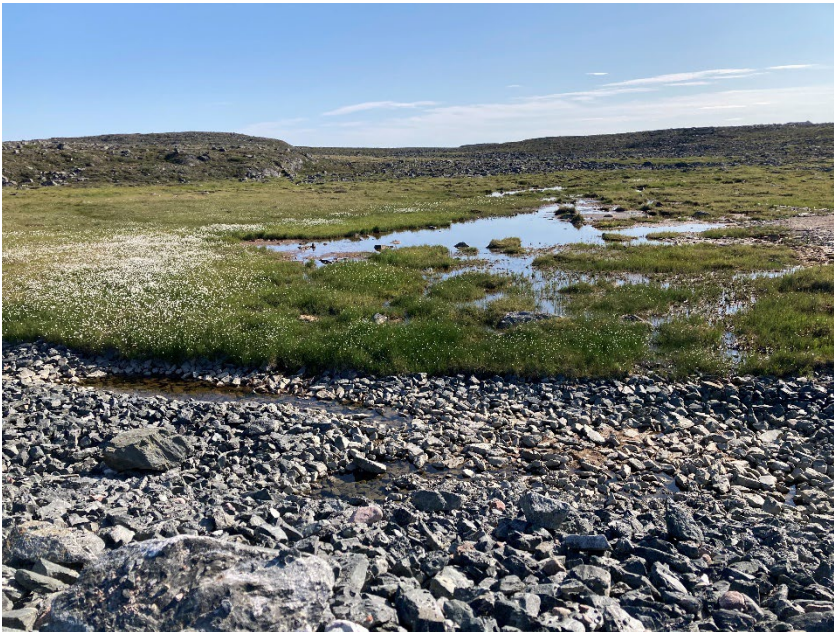
Photograph H13-2 IVR Diversion Channel

Description: From around Sta. 0+280, looking northeast. Water is entering the channel from the natural topography.

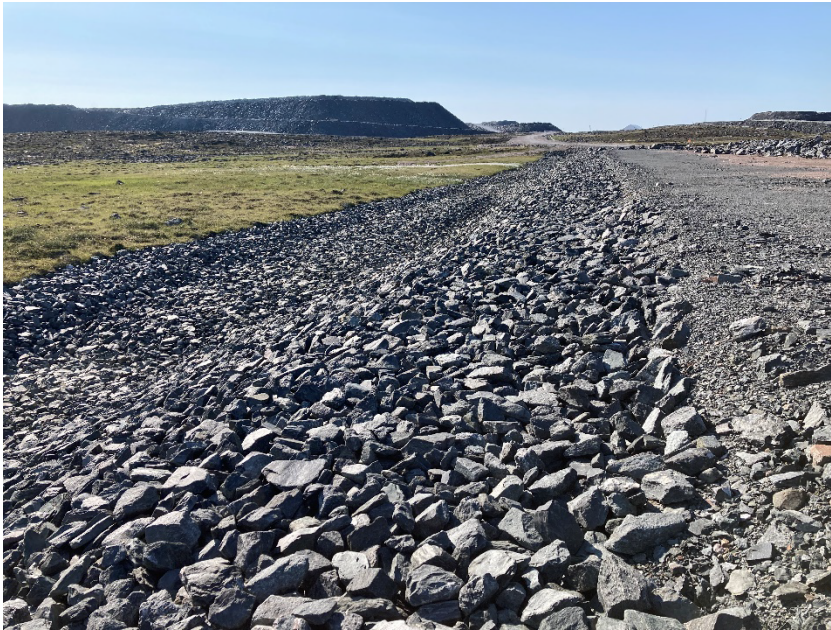
Photograph H13-3 IVR Diversion Channel

Description: From around Sta. 0+130, looking southeast.

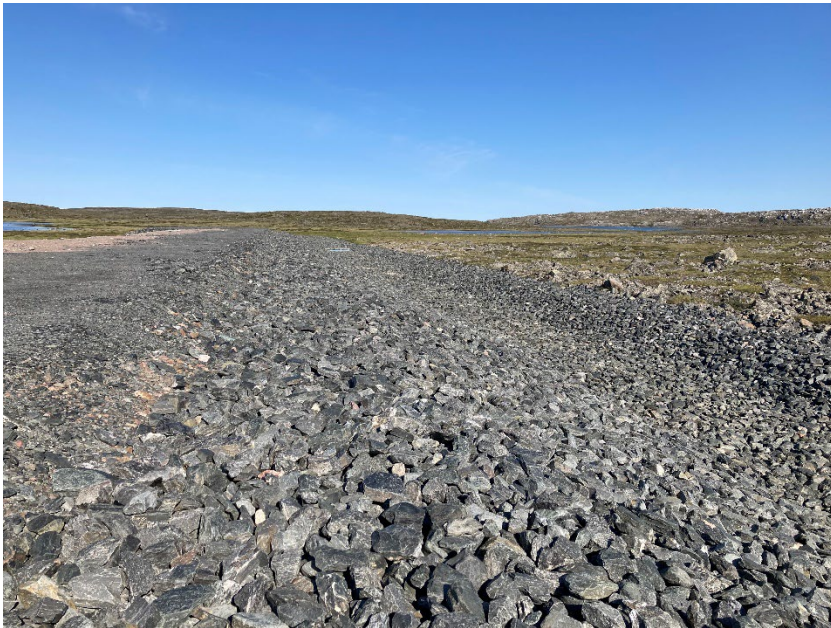
Photograph H13-4 IVR Diversion Channel

Description: From around Sta. 0+130, looking northwest.

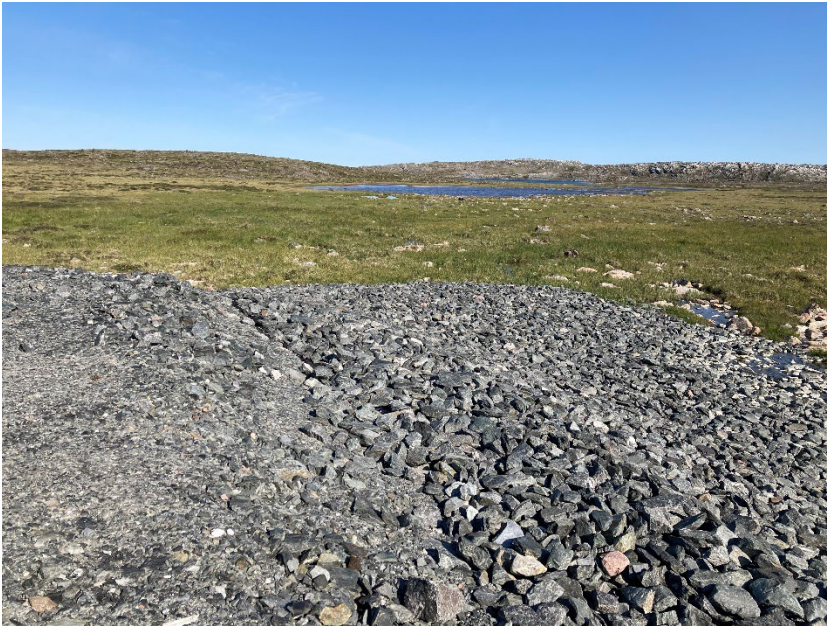
Photograph H13-5 IVR Diversion Channel

Description: From around Sta. 0+000, looking north at the outlet. Water is flowing well towards the lake.

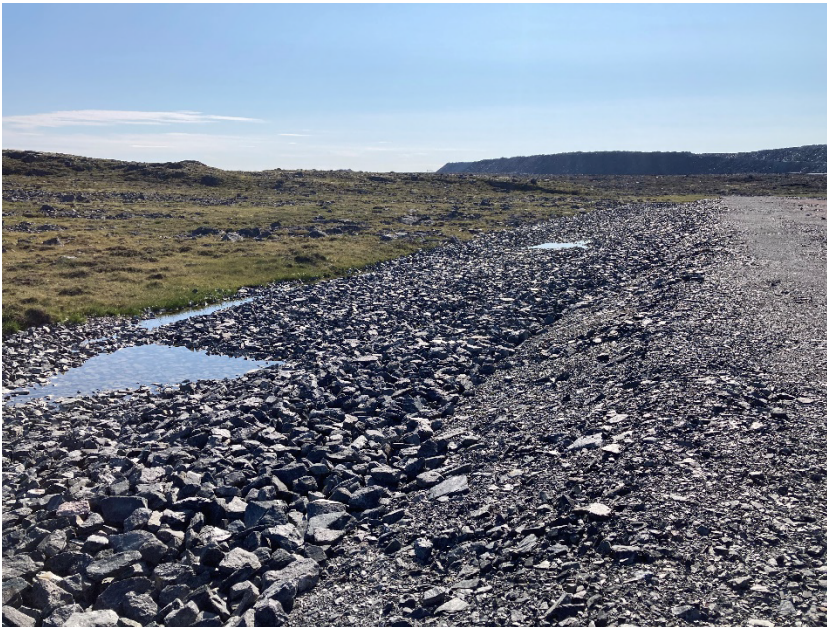
Photograph H13-6 IVR Diversion Channel

Description: From around Sta. 0+020, looking southeast.

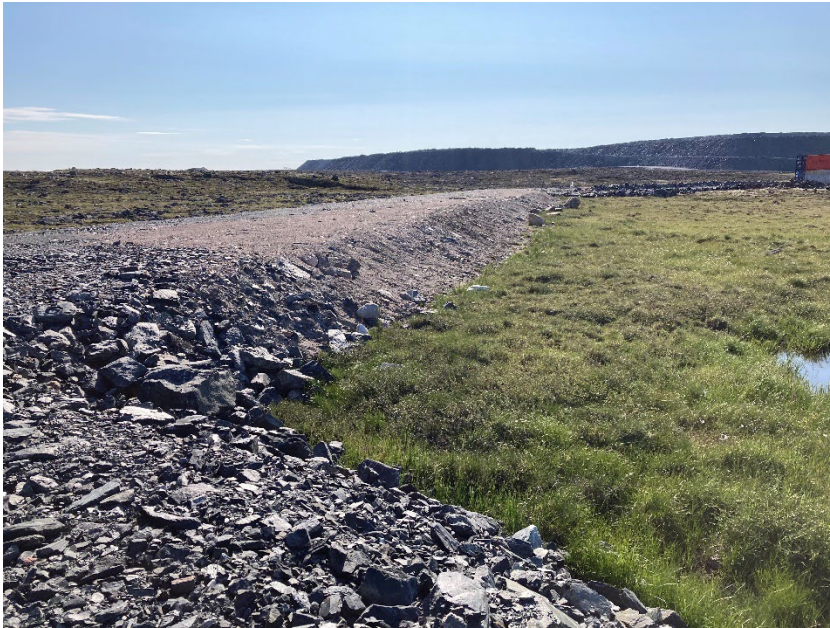
Photograph H13-7 IVR Diversion Channel

Description: From around the access road Sta. 0+020, looking southeast. Tension cracks in the side slope of the road.

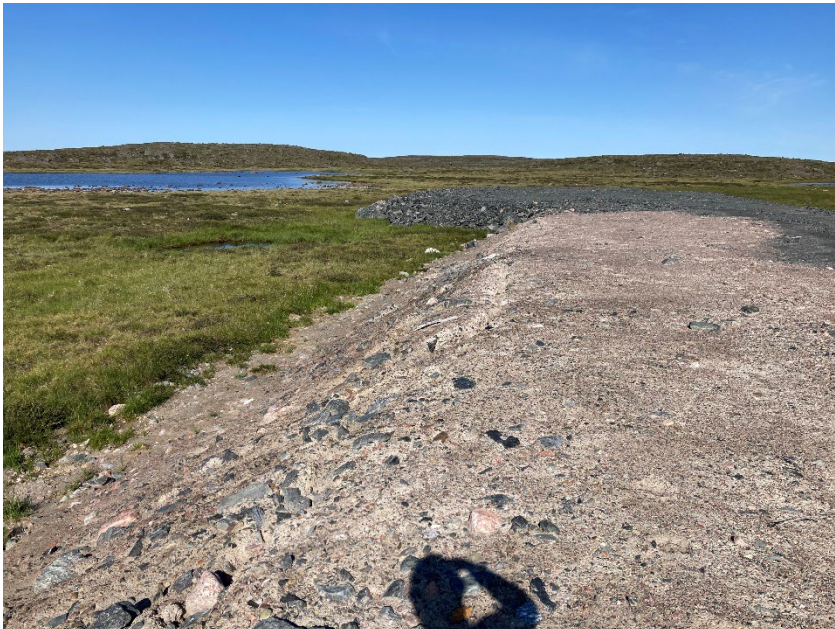
Photograph H13-8 IVR Diversion Channel

Description: From around the access road Sta. 0+080, looking northwest. Tension cracks in the side slope of the road.
