# **Meadowbank 2023 Annual Open Pit Geomechanical Inspection**

**RE: Meadowbank Complex - Meadowbank Site - 2023 Annual Open Pit  
Geomechanical Inspection**

# Meadowbank Complex - Meadowbank Site

## 2023 Annual Open Pit Geomechanical Inspection

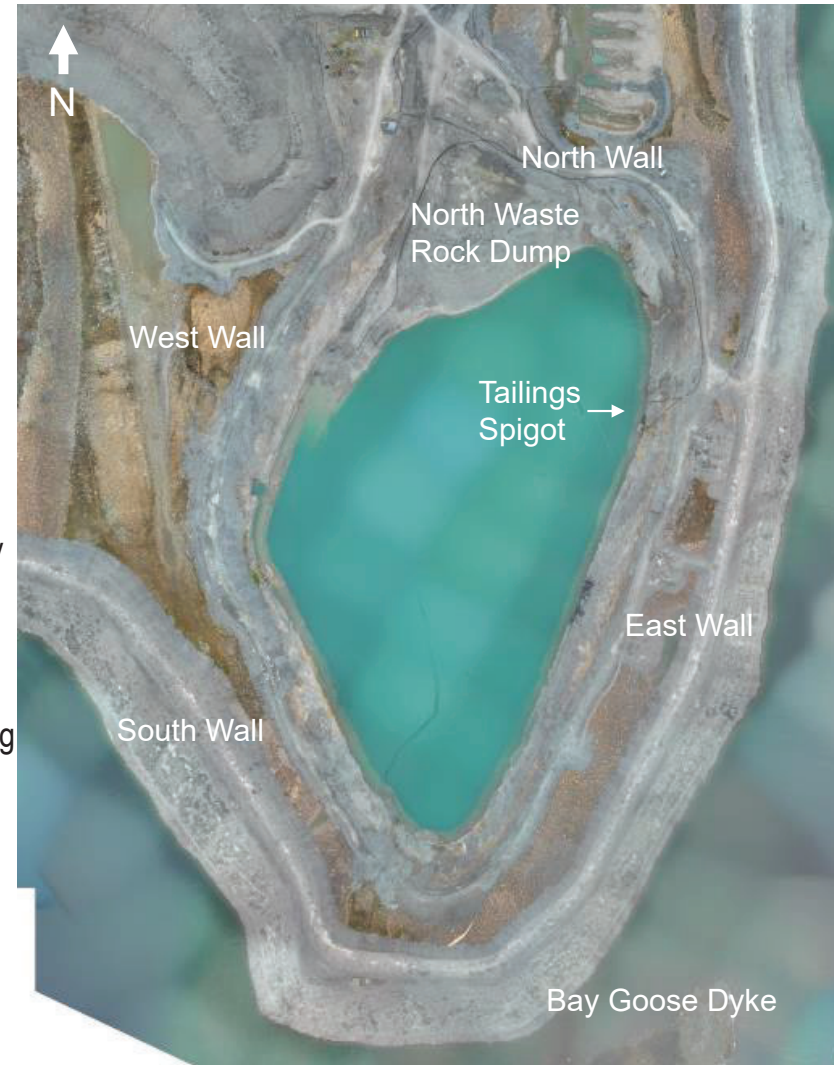
- A portion of a single bench is exposed above the current pit lake.
- The walls are performing well and no particular geomechanical concerns were noted.
- The exposed bench faces along the ramp at the northern end of the pit are relatively low and there is ample room to transit and work away from the wall. As a result, the rockfall risk is considered to be low.
- At the time of the inspection, the barricade at the top of the ramp had been knocked over. The barricade was moved back into place during the inspection.

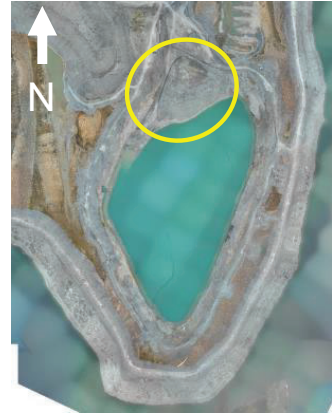
- The dump is inactive and access is prevented by both a rockfill berm and the presence of water pipes across the access point.
- The dump has been subsiding since 2015. The settlement is attributed to the deposition of water in the open pit, through a combination of thawing and increasing porewater pressure. The concern is that a sudden failure of the dump would create a wave that poses a hazard to personnel conducting water quality or tailings sampling in the pit lake.

- The settlement is monitored as part of monthly inspections by the Geotechnical Group. Four survey pins were installed in August 2022 and measurements made in September 2022, May 2023 and June 2023. The cumulative displacement is between 20 and 100 mm. The rate is less than 0.5 mm/day.

Looking North, with Settlement and Scarps Visible

- The visual monitoring and the survey pin measurements should continue on a monthly basis while access is still required to the open pit. There is a need to better quantify the extents and total deformation. Recommend using drone photogrammetry to assess this on an annual basis.

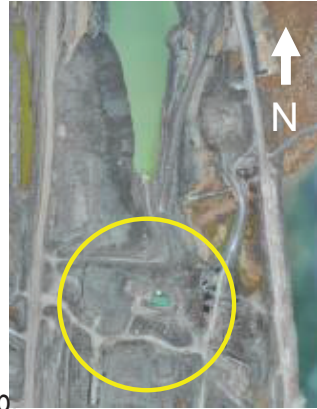
- A seacan used to provide power to the Pit A pumps was located inside the berm constructed along the crest. Since the 2022 inspection, the seacan has been moved outside of the berm. However, an electrical control panel remains inside the berm. Recommend relocating the control panel before the water elevation in Pit E reaches the base of the upper dam platform.

Electrical Seacan Outside Berm

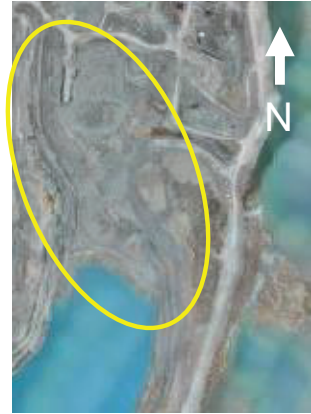
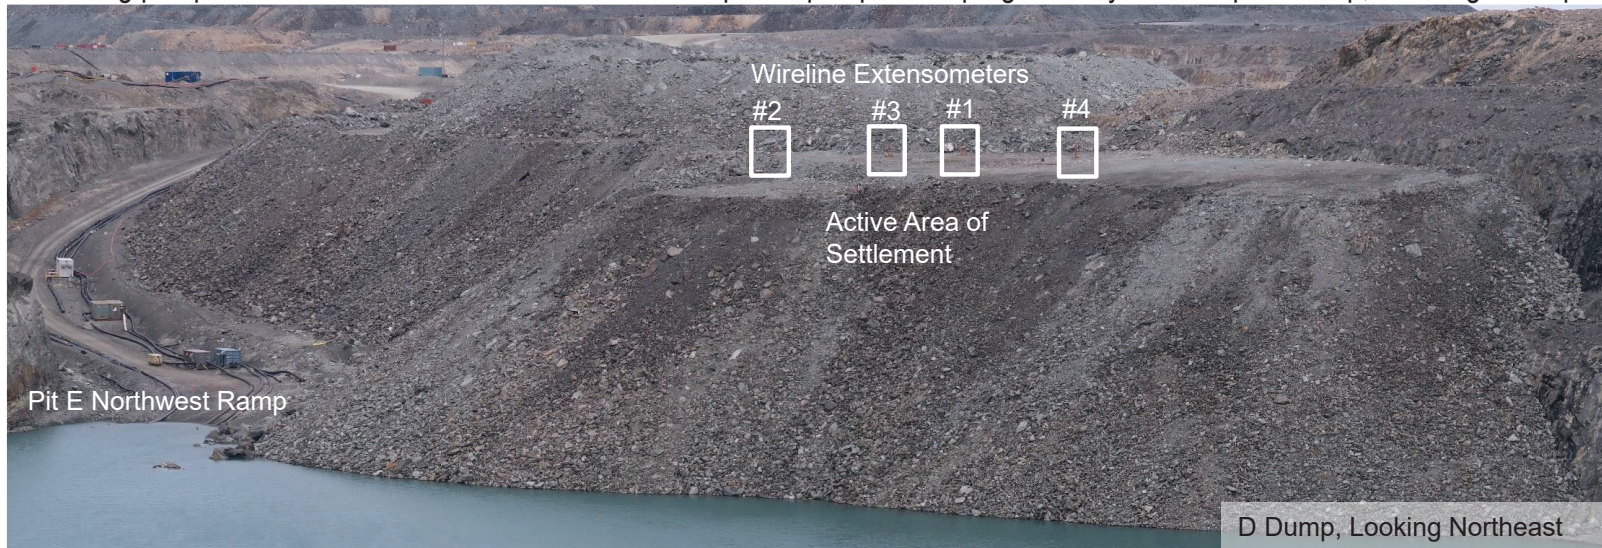
## D Dump

- The D Dump backfilled Pit D and forms the north wall of Pit E. The Pit E Northwest ramp runs along the western toe of the dump.
- Access to the top of the dump is restricted by a berm.
- The southwestern end of the dump started to settle in 2017. Tension cracks are visible in this area as well as along the crest immediately to the north. The current conditions are described on the following slides.
- Four wirelines extensometers have been installed at the crest of the dump in the area of settlement and tensions cracks and are discussed on a following slide.
- The dewatering pumps for Pit E are located at the toe of the dump. The pumps have progressively moved up the ramp, reducing the exposure of personnel.

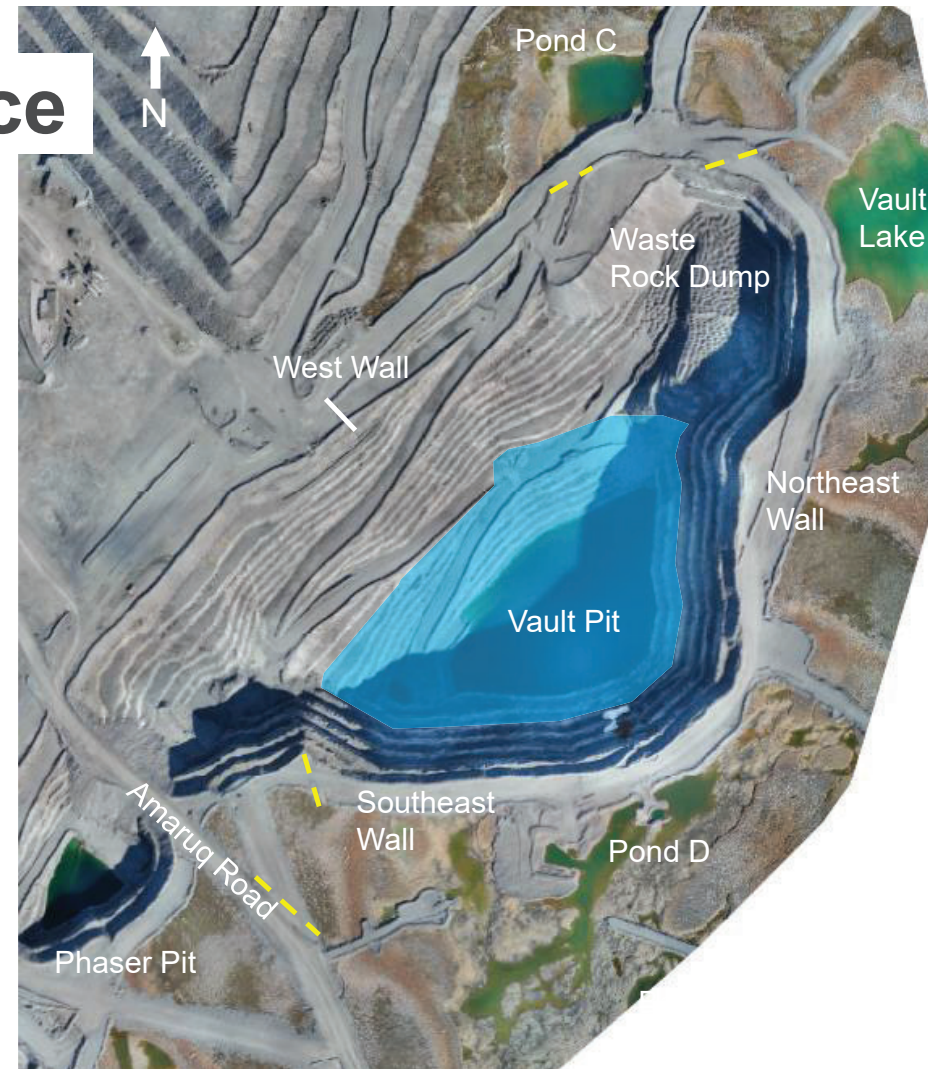
- The open pit is partially flooded. The elevation of the pit lake was last measured in June 2022 when it was approximately 5039 mRL. It has since risen to flood the area approximately shaded in blue in the image at right.

- The Amaruq All Weather Road (AWR) crosses between the Vault and Phaser Pits on a rockfill embankment.

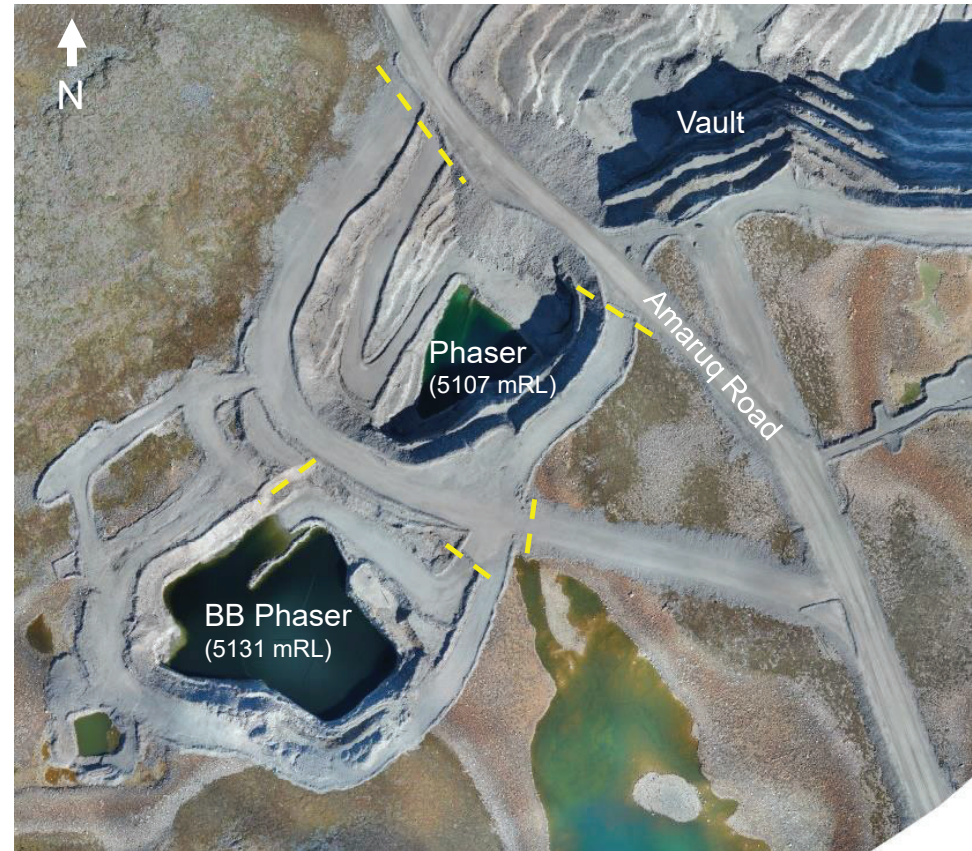
- At the time of the inspection, the accesses to the open pits were barricaded by berms (shown as dashed lines at right).
- Note that the Amaruq All Weather Road (AWR) crosses between the Vault and Phaser Pits on a rockfill embankment.

- AEM continues to complete monthly geomechanical inspections of the open pits. The AWR is also included in the inspections. These inspections should continue, though the open pit inspections could be discontinued during periods when water quality sampling is not occurring.
