# **Whale Tail 2023 Annual Open Pit Geomechanical Inspection**

## **RE: Meadowbank Complex - Amaruq Site - 2023 Annual Open Pit Geomechanical Inspection**

## 2023 Annual Open Pit Geomechanical Inspection

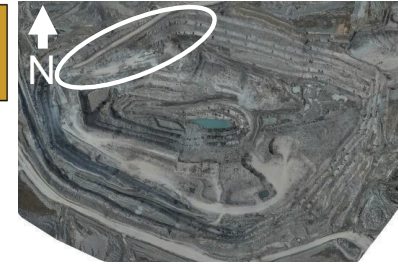
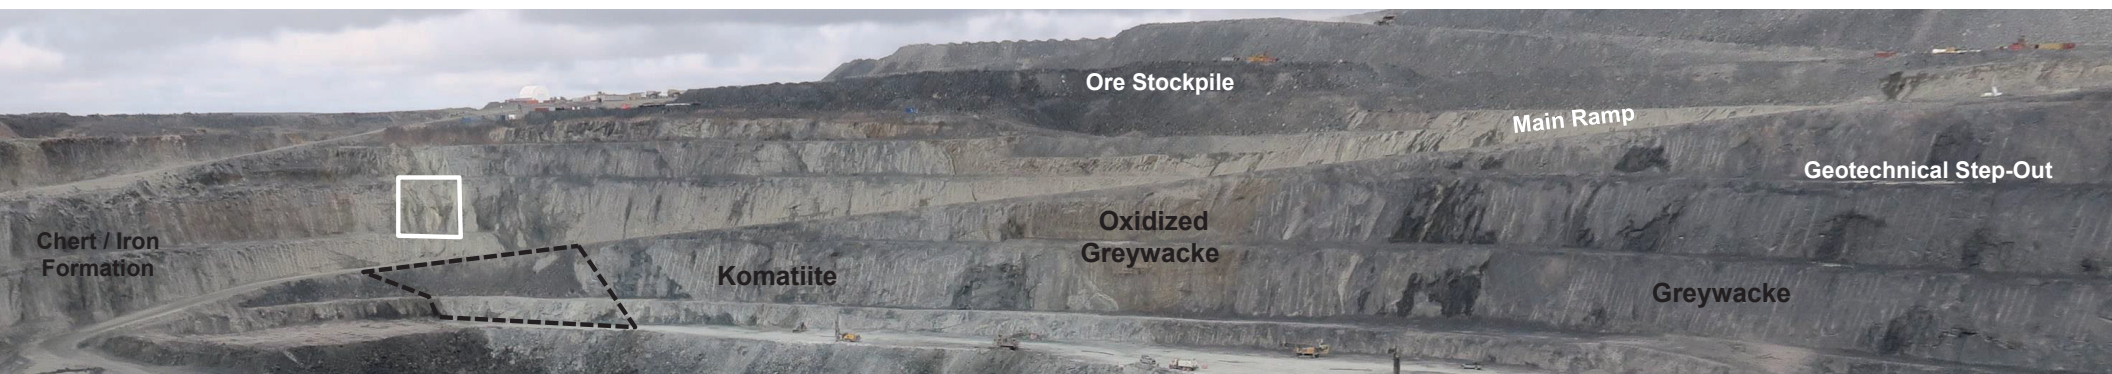
## Observations - Northwest Wall

- Final wall in Design Sector A1/A1K.
- Mining in this area resumed in 2023.
- The benches established prior to 2023 are generally performing well. The benches established in the Komatiite below the ramp in 2023 have experienced significant backbreak (outlined below in black). These benches are discussed further on the next slide.
- A potential wedge is present above the ramp (outlined below in white). The wedge is discussed further on a subsequent slide.
- The Oxidized Greywacke has performed well and no rockfalls have been reported since the last annual inspection. Observations made during this visit suggest that the western boundary of the zone could be partially defined by a large-scale structure.

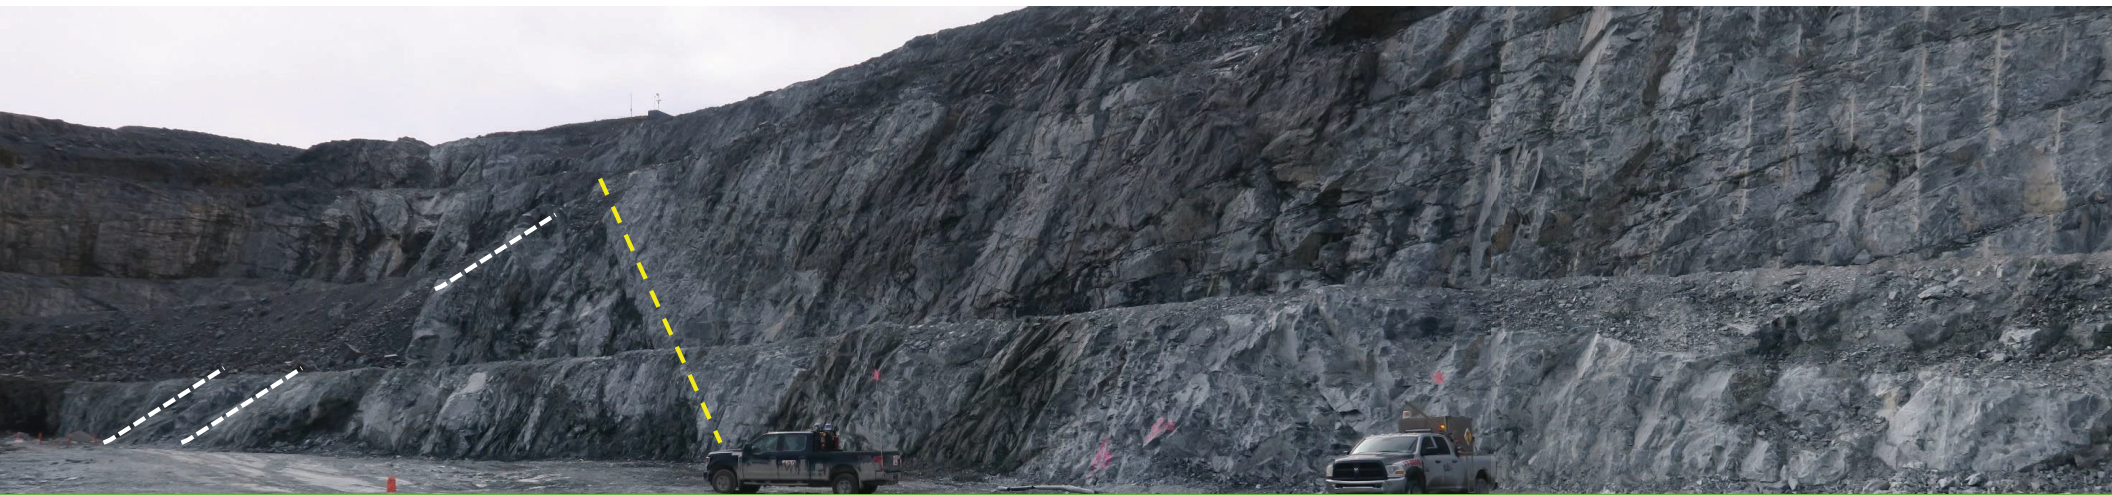
## Observations - Northwest Wall - Backbreak

- There are intervals with poor bench performance (example at far right in the image below). These areas appear to be associated with Brittle / High Strain Structures, persistent discontinuities dipping at a shallow angle to the south (S3 foliation?), and wedges formed by these structures and Joint Set D.

- The western end of the wall, near the ramp, is of notably lower rock mass quality. A prominent structure defines the eastern limit of this zone (yellow dashed line below). The reduction in rock mass quality is believed to be due to the presence of multiple Brittle / High Strain Structures (see next slide). The foliation in this area is distorted and at least locally has a much shallower dip (white dashed lines below, possibly the S3 foliation).

- The Brittle / High Strain Structures should be mapped to validate/refine the structural model.
- Structural mapping should be completed to better understand the variation in the foliation.

- If there are significant changes in the understanding of the rock mass structure, the potential impact on the slope performance and design should be reviewed.

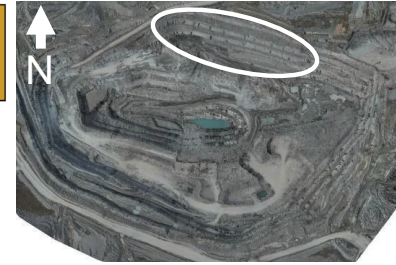
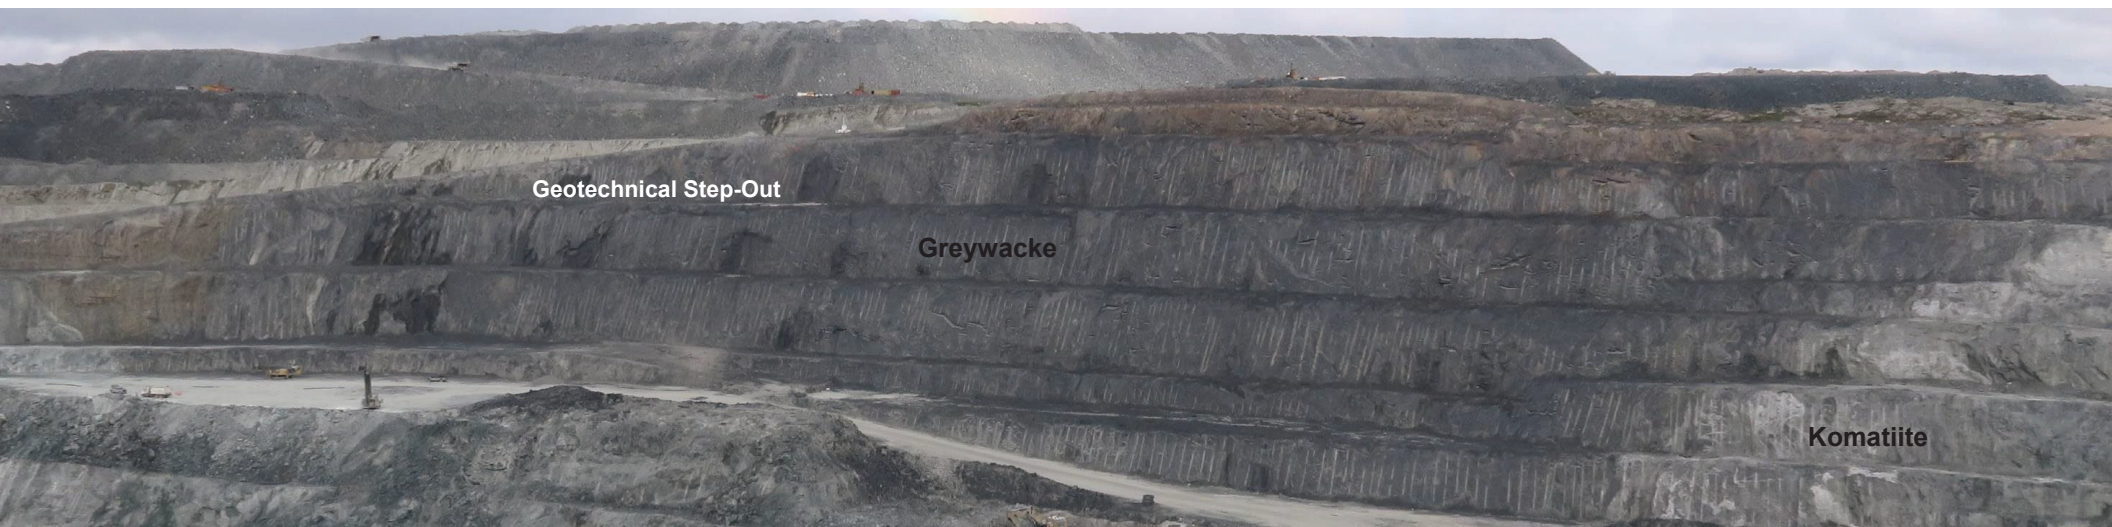
- Final wall in Design Sector B1.
- Limited mining has occurred in this area and there have been no slope failures since the last annual inspection.
- The benches are performing better than expected, with the bench face often standing steeper than the foliation.

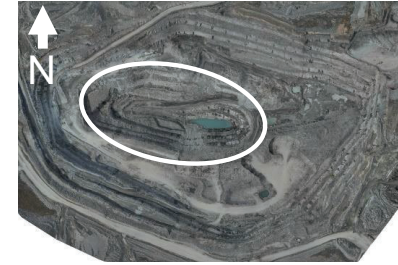
## Observations - Phase 1

- Mining of Phase 1 was completed in the first half of 2023. The ramp to Phase 1 is currently bermed off.
- The North Wall wall was established in the Komatiite, parallel to the foliation and experienced a series of bench-scale planar failures. Mining along the North Wall was successfully prioritized during winter to minimize the rockfall risk to personnel. A berm was installed at the toe of the slope prior to freshet to retain the expected rockfall. This approach was successful.

- A multi-bench instability occurred on the North Wall on May 14, 2022. As the first multi-bench failure to occur at Amaruq, it is important that this failure be back-analyzed to understand the failure mechanism. This has not yet been done.

Review the failure in the Phase 1 North Wall of the Whale Tail open pit in greater detail to better understand the failure mechanism, likely contributing factors, and the potential for the failure to continue below the ramp. A Maptek scan is recommended to better define the failure geometry.		A detailed review and back-analysis of the failure had not been completed at the time of the audit. A Maptek scan has been completed for the failure.	Complete the original recommendation.	P3	
Document the lithology, rock mass structure, and bench performance at regular intervals along the Northeast Wall of the IVR V2 pit in order to better understand the controls on the wall performance. While few benches remain in the pit, the results are relevant to the footwall of the IVR V1 pit.		This recommendation has been grouped with the one below.	None	N/A	
Document the bench performance and key rock mass characteristics in the IVR V2 open pit and compare them to the design. In particular, it is important to verify that the rock wall is being established in the Mafic Volcanics and below the Brittle Structure exposed along the contact between the Mafic Volcanics and the Komatiite as the slope geometry recommendations for the V2A and V2E design sectors are based on this premise.		The bench performance of the IVR V2 open pit was reviewed as part of the Open Pit Ground Control Quarterly Reports in Q3 2022 and Q1 2023. The lithologies and high-strain/brittle structures exposed in the open pit slopes have not been reviewed relative to the design.  The rock mass quality and structure encountered in the pit had not been quantitatively documented at the time of the audit.	Document the lithology, rock mass quality, and rock mass structure at regular intervals in the IVR V2 pit and compare them to the design. Continue to document and review the bench performance.  KP is in the process of completing a detailed review of the design of the IVR V2 open pit, including the bench performance and rock mass characteristics.	P3

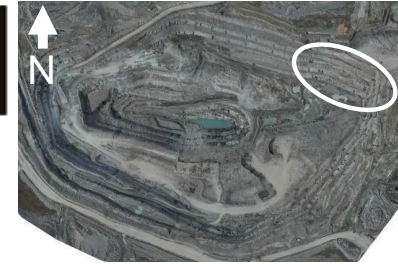
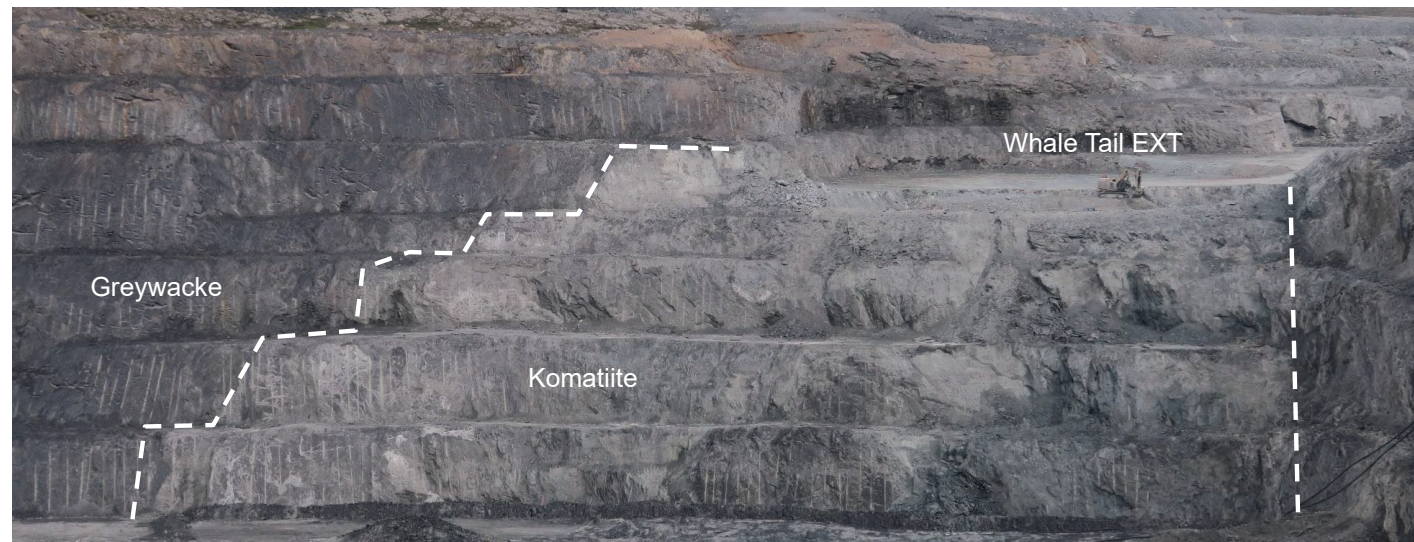
## Observations - Northeast Wall

- Final wall in Design Sector D4K.
- This sector is within the Komatiite and has been characterized by a series of bench scale failures. The failures are currently understood to be a hybrid of failure on the foliation and failure of the weak rock mass, influenced by water (i.e., a combination of seepage within the talik and surface runoff), and the High-Strain / Brittle Structures.

- The performance of the benches has improved since the slope design was revised in December 2021. While, bench-scale failures have and will continue to occur, no failures have occurred in this sector since the last annual inspection.

- The wall continues to be a focus for the Rock Mechanics team.
- The rock mass characteristics of the Komatiite vary significantly along the wall, at least in part due to the High-Strain / Brittle Structures. This is discussed further on the next slide.

- The design of the lower wall northeast wall, below the future ramp positions, was revised in 2023 based on the results of kinematic and numerical analyses.

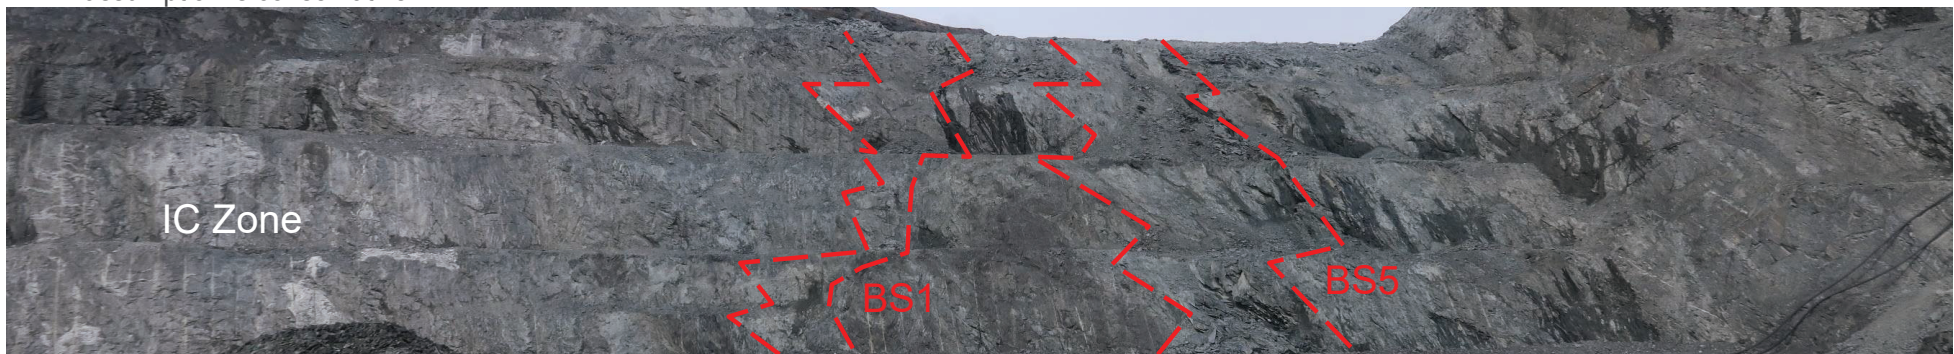
## Observations - Northeast Wall (Cont'd)

- A notable exception is the Komatiite along the western contact with the Greywacke. The Komatiite in this area is quartz-rich and numerous veins and veinlets are present. The bench faces locally stand steeper than the foliation after thawing. Matt Dewar (Geologist) of AEM noted that this quartz-rich zone is the IC Zone (Mineralized Zones #51 and 52). This zone pinches out towards the west and is not expected to be present in the Northwest Wall of the open pit.

- Assessments of the overall stability of this wall have assumed a weak structure along the western contact. The presence of the IC Zone suggests that this assumption is conservative.

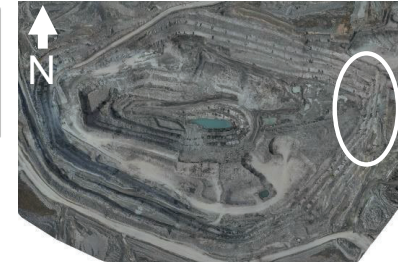
## Observations - East Wall

- Final wall in Design Sector E4.
- Mining of the Phase 3 pushback allowed limited scaling of an area that has been identified as a rockfall hazard for several years (outlined in black).
- Significant variation was observed in the rock mass quality exposed in the lowermost bench of the wall. This is discussed further on the next slide.
- The benches have generally performed well. Increased crest loss was observed where either a north dipping structure (Joint Set B?) or a sub-horizontal structure (Joint Set C) is present.
- The foliation strikes roughly perpendicular to the wall, which is favourable for bench stability. Half barrels are observed in some instances in the Komatiite.

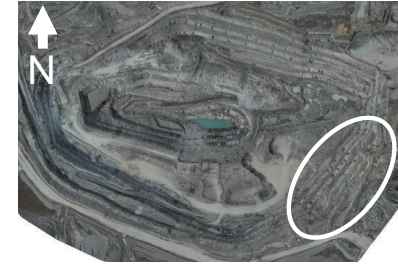
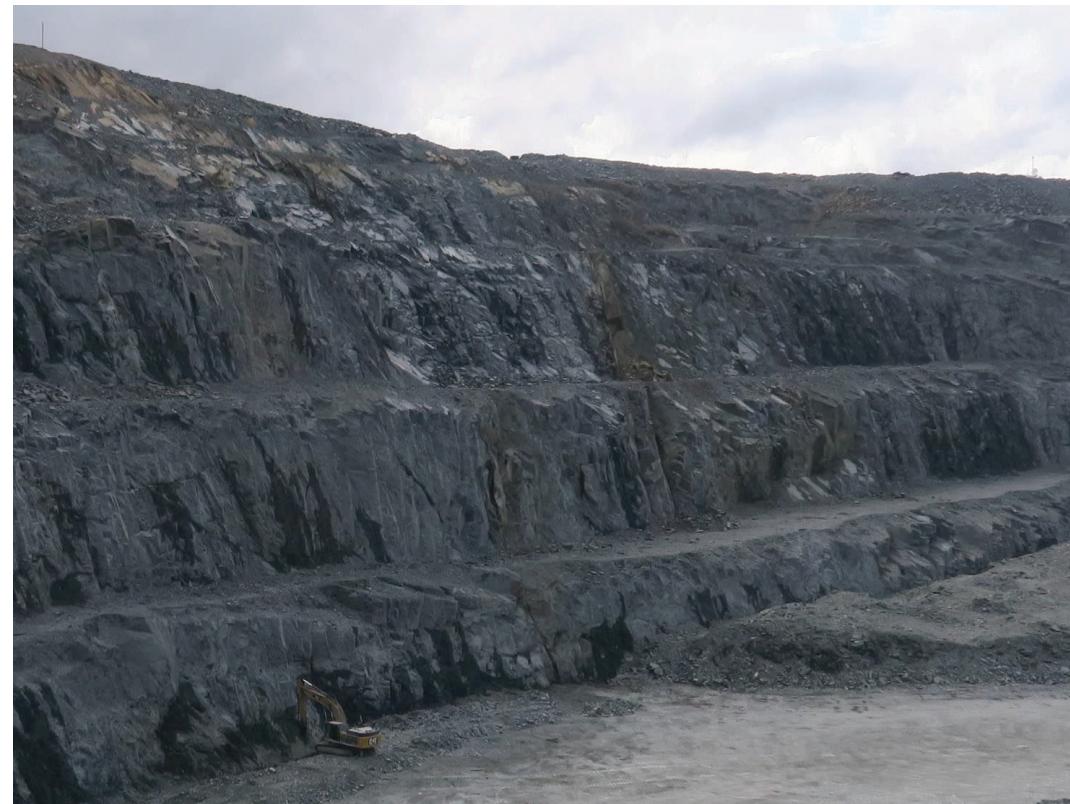
- Final wall in Design Sector F6.
- The slope geometry recommendations for this sector were adjusted in late 2021. Analyses demonstrated that the slope performance was sensitive to the persistence of Joint Set C. With careful blasting and scaling, a BFA of  $75^\circ$ , catch bench width of 16 m, and IRA of  $44^\circ$  was thought to be achievable. Backbreak in the order of 8 m was expected.
- The benches have performed better than expected. While backbreak has approached 8 m in some areas, the average ranges from approximately 2.75 to 4.25 m.
- Based on a statistical assessment of the observed backbreak, AEM reduced the catch bench width to 13 m in March 2023. This is reasonable.
- The tie-in between Phase 3 and Phase 2 on this wall was well executed, with only a very limited nose left.

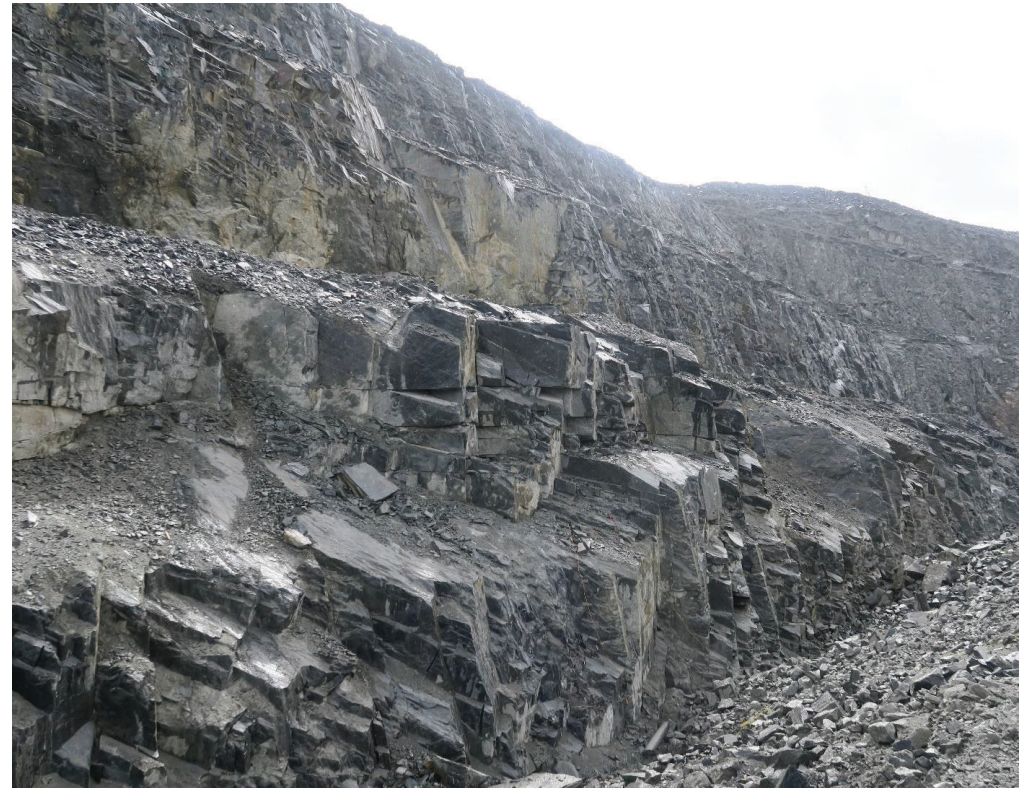
## Observations - Southeast Wall (Cont'd)

- The bench performance is generally consistent with the revised design. Joint Set C strongly influences the bench geometry and extensive scaling of the crest is required.
- Localized rockfall has occurred since the start of freshet. It is understood that it has been retained on the benches. Where possible, this should be documented as it can be used to validate/refine the design of the catch benches.
- The toe of the bench face often breaks to Joint Set C, forming a hard toe that requires hammering. The practice of hammering or trim blasting to remove the hard toes is important for maintaining the catch bench width / capacity and eliminating “ski jumps”.

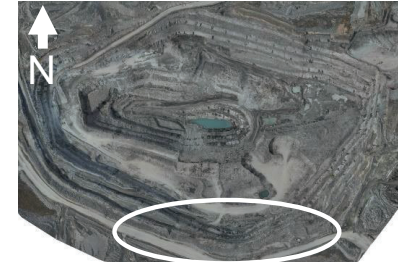
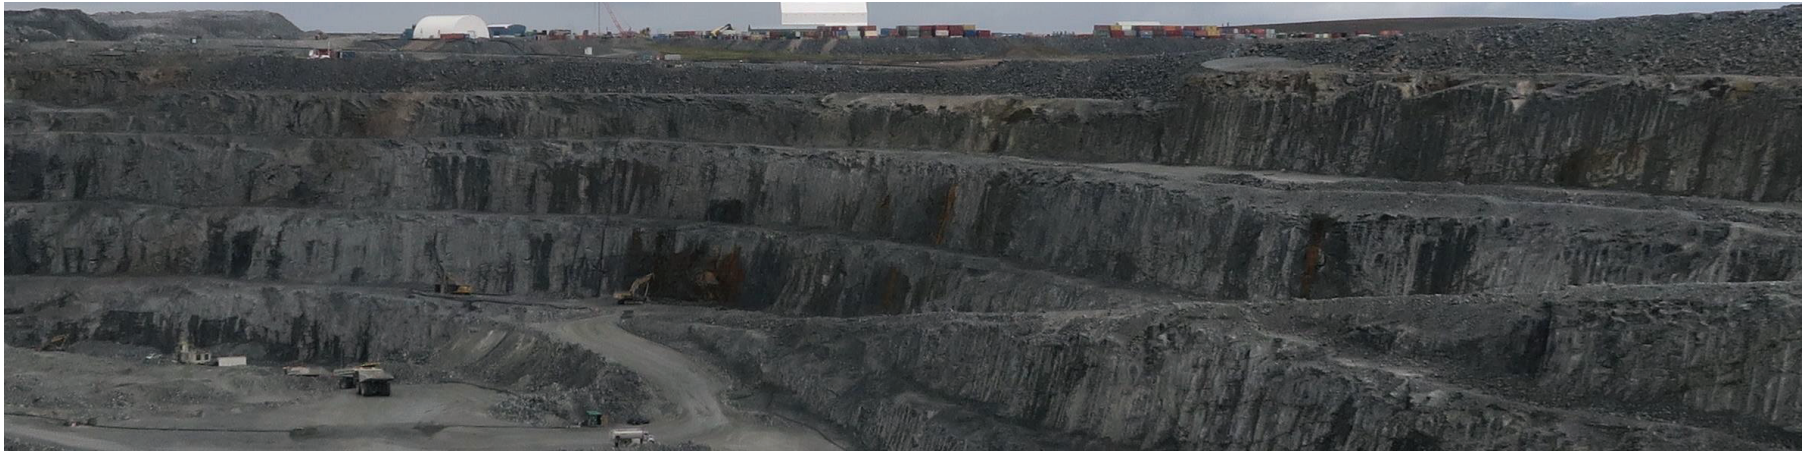
## Observations - South Wall

- Final wall in Design Sectors H6 (Diorite) and potentially H5.
- In 2022, the mine switched to double-benching using 10.5 m flitches in the waste (Diorite) instead of triple-benching using 7 m flitches. This does not appear to have adversely impacted wall performance and has reduced the exposure of personnel.

- The Phase 3 pushback has extended below the water management infrastructure (position of excavator in image below). A soft ramp is currently in place to allow the Phase 3 ramp to be used for pit operations but this will eventually be discontinued.

- Phase 3 is reaching an elevation where Structural Domain 5 is expected to be exposed in the South Wall. North dipping structures within this domain are expected to control the achievable bench face angle and the slope geometry recommendations reflect this. Periodic mapping is recommended to confirm the extents of this domain (and thus where the H5 slope geometry recommendations should be implemented).

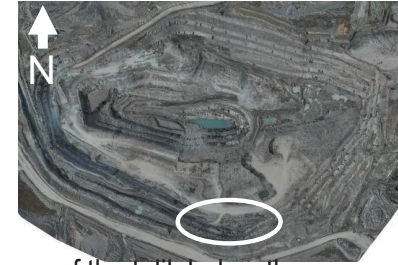
## Observations - South Wall (Cont'd)

- A sump and horizontal drains were established on the 5081 bench in the South Wall. The goal was to intercept seepage from the base of the talik below the former Whale Tail Lake and prevent the formation of an ice wall directly above the ramp.

- The drains (right photo) were installed in the location of the most prominent seep as a trial. There is sufficient flow from the horizontal drains that they do not freeze in the winter. Other seeps are present along the wall.

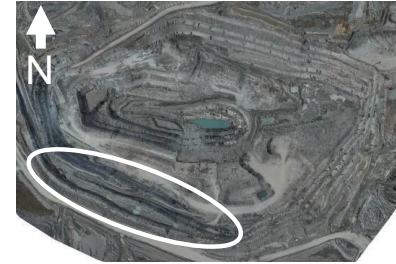
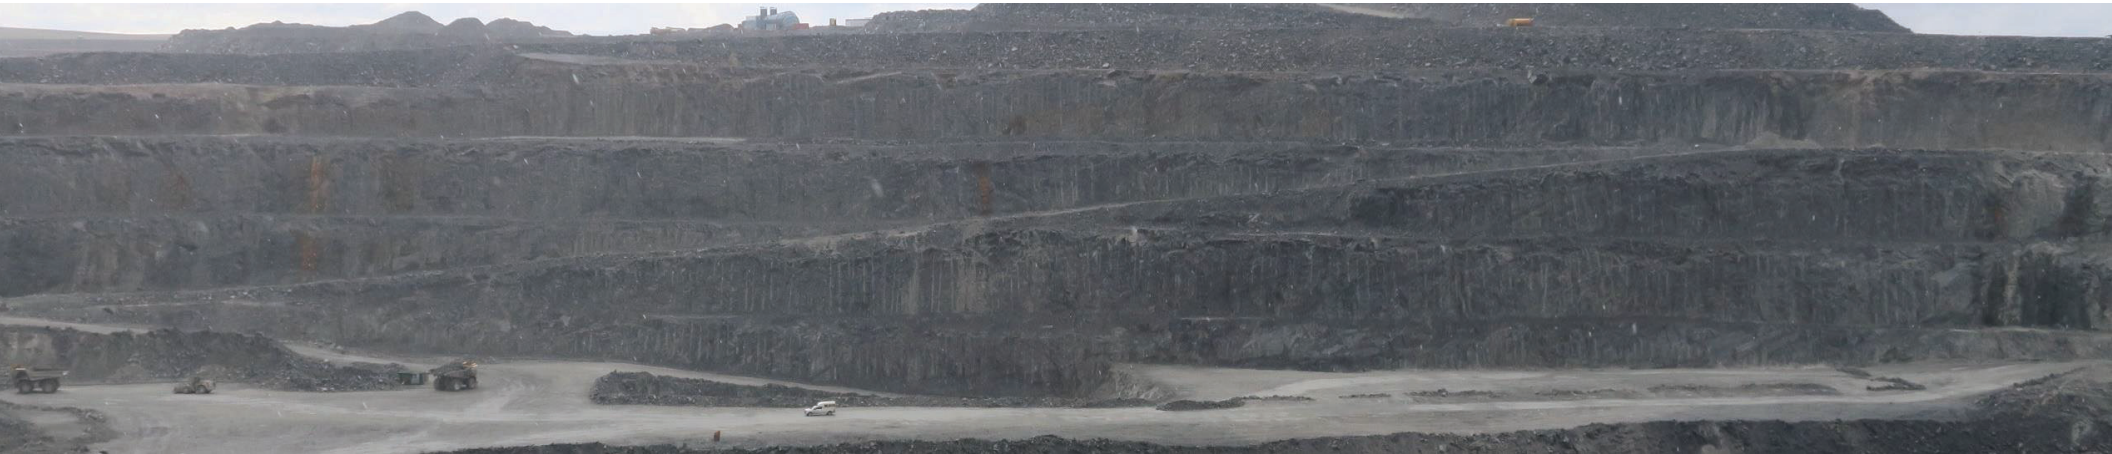
- Final wall in Design Sectors I6 (Diorite) and I1 (predominantly Greywacke).
- The wall is generally performing well. Two main items were discussed:
  - There continue to be challenges with drill and blasting practices resulting in crest loss or hard toes on the benches. Some of the blastholes directly above the future catch benches were sub-drilled, resulting in increased crest loss. It is understood that this has been corrected. However, there is a continued need to review and improve drill and blast practices.
  - Limited evidence of block toppling was observed at the crest of several benches. It is understood that this has not resulted in rockfall to date and that these areas continue to be monitored. The potential for toppling was identified during the original design studies but was not expected to control slope performance.

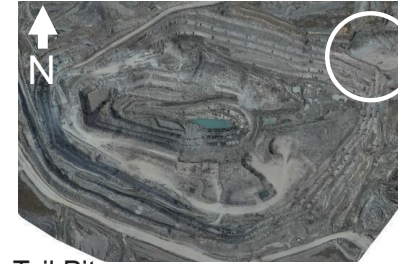
## Observations - Whale Tail EXT (North Wall)

- The southwestern end of the WHL EXT has reached its final elevation and no further mining of the northeast wall of the Whale Tail Pit is planned. The central portion of the EXT is planned to be mined a further 14 m down.

- The northwest wall is primarily within Greywacke. The foliation dips to the southeast and the wall performance is sensitive to the relative orientation of the wall and the foliation.

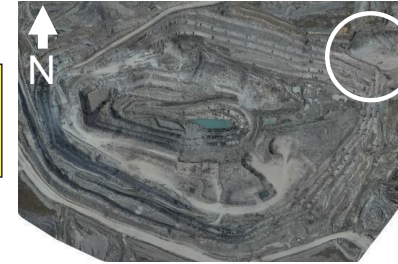
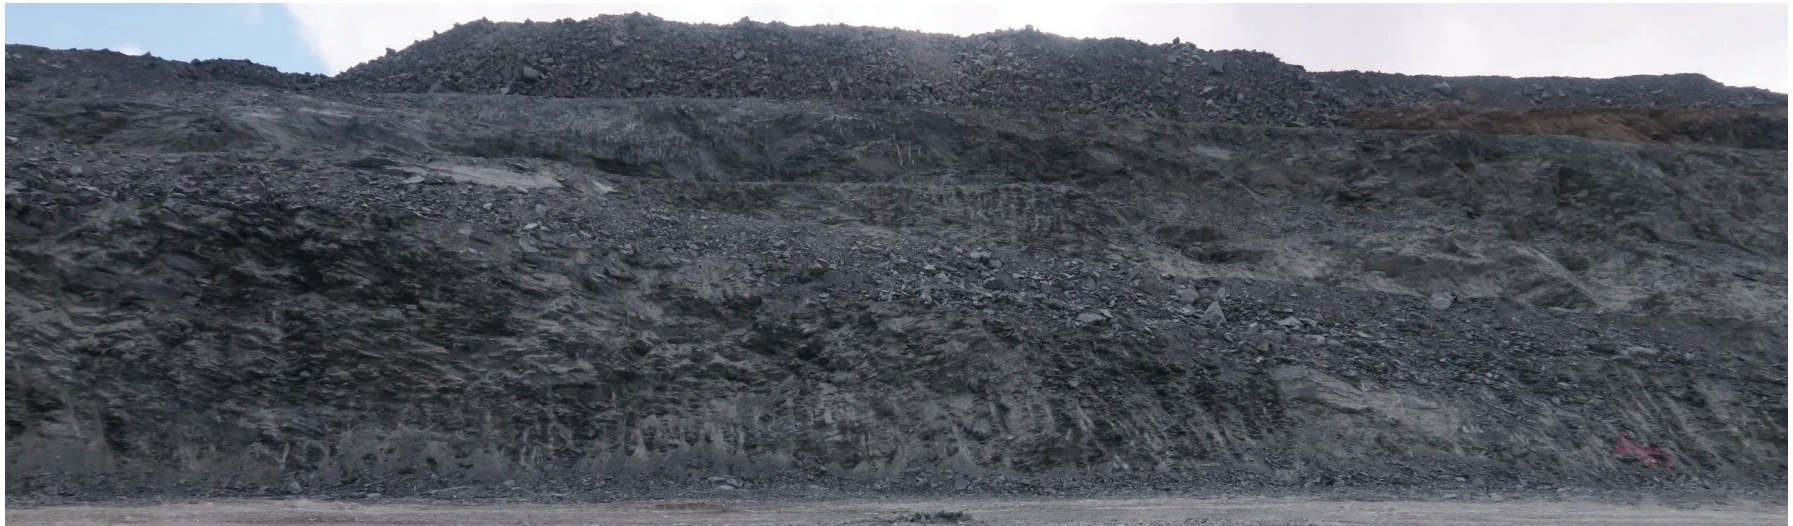
- The south wall is within the Komatiite. The wall was mined in single 7 m high benches without pre-shear.
- The Komatiite is of poor quality and ravelling and small-scale rockfalls are likely. The ramp is located along this wall, increasing exposure. However, it is expected that the risk can be adequately managed through inspections and scaling.
- On-going dewatering activities are planned in this area once mining of the EXT is complete. A rockfall berm should be installed along the inside of the ramp once mining of the EXT is complete to mitigate the risks associated with the rockfall hazard in the Komatiite.

(New Recommendation in 2023)	The Whale Tail Extension is planned to be used for water management purposes in the future. This will require periodic access along the ramp. The ramp is located within poor quality Komatiite and ravelling and small-scale rockfall is likely to occur over time.	Review the risks associated with future access along the ramp in the Whale Tail Extension for water management purposes. Implement mitigation measures as appropriate.	P3
		(New Recommendation in 2023)	The IVR V1 open pit is currently inactive and barricaded but is planned to be used for water management purposes in the future. This will require periodic access along the ramp and rockfall hazards are present above and below the ramp. An existing multi-bench failure on the North Wall could break back further into the ramp.	Review the risks associated with future access along the ramp in the IVR V1 open pit for water management purposes. Implement mitigation measures as appropriate.	P3

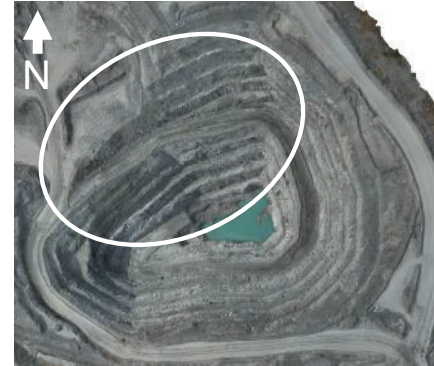
- This is the footwall of the deposit and is primarily within the Komatiite.
- The original design called for the use of staggered blastholes to establish the BFA at 45° in order to limit the potential for bench and inter-ramp scale failures on the foliation. This approach was unsuccessful due to a combination of poor blasting quality control and variability in the orientation of the foliation.

- As a result, the mine trialled a 55° pre-shear and then a 65° pre-shear to define the bench face. The 55° pre-shear trial was successful, but a series of bench scale planar and wedge failures have occurred in areas where the 65° pre-shear was trialled, including four in September 2022. The areas are outlined below.

- The failures outlined in yellow occurred on September 3 and 8, 2022 and were not anticipated. They were investigated as near misses. As a result of these failures, the mine implemented radar monitoring of this wall, reverted to a 55° pre-shear, and prioritized the completion of the V1 pit before the 2023 freshet.

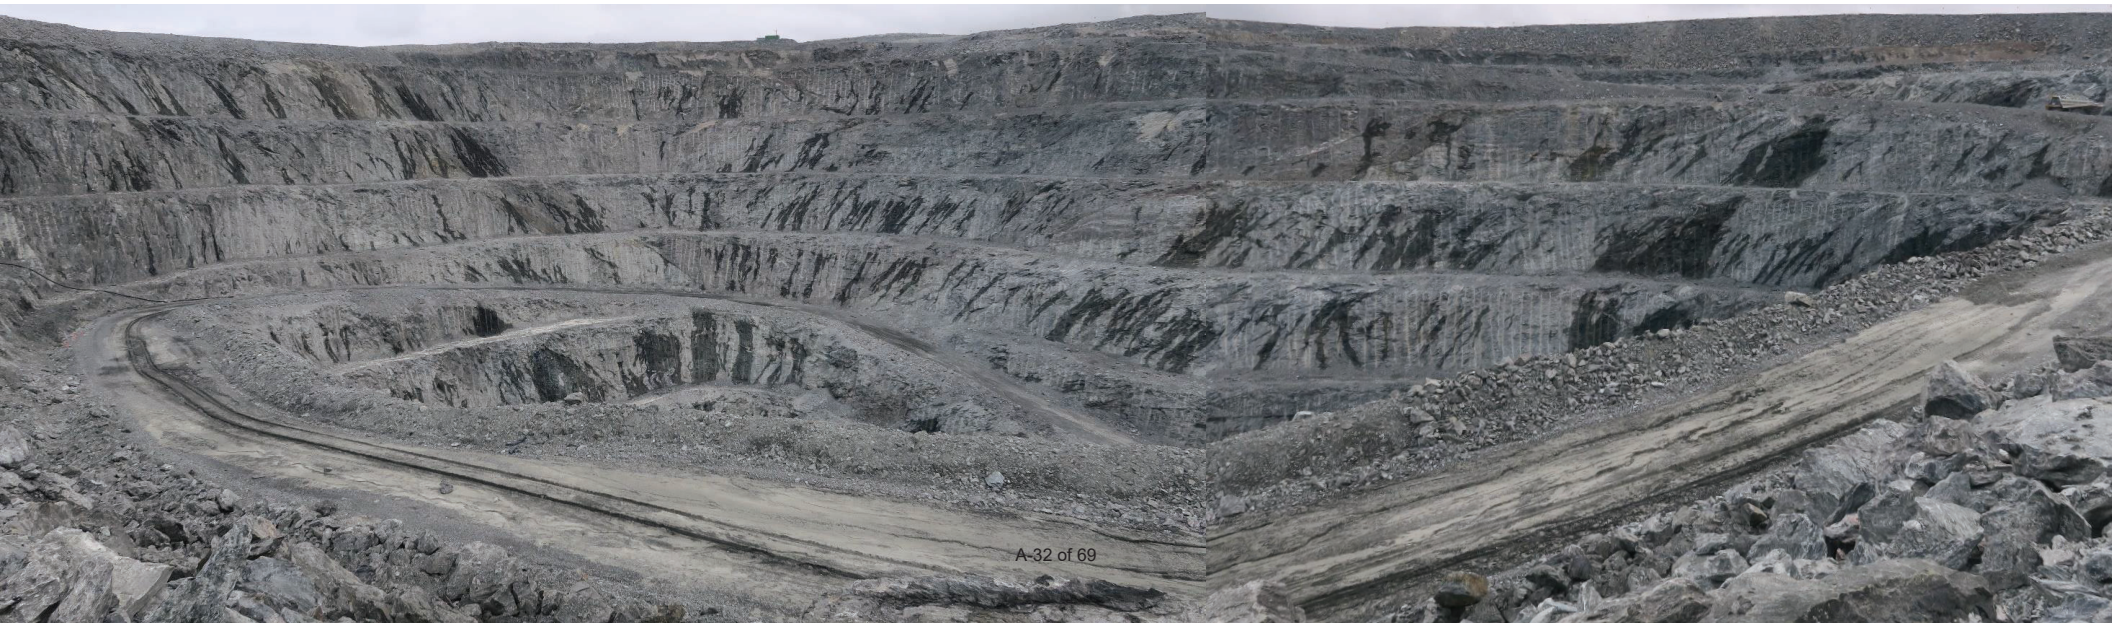
- These walls performed well, with half-barrels visible. The foliation is oriented perpendicular to the Northeast wall and dips into the South Wall.
- Cross-cutting structures resulted in numerous small wedges in the upper benches of the East Wall, and significant scaling was required when the benches were established. There was a concern that the benches would ravel over time. However, to date, very little material has accumulated on the catch benches.
- No particular geomechanical concerns.

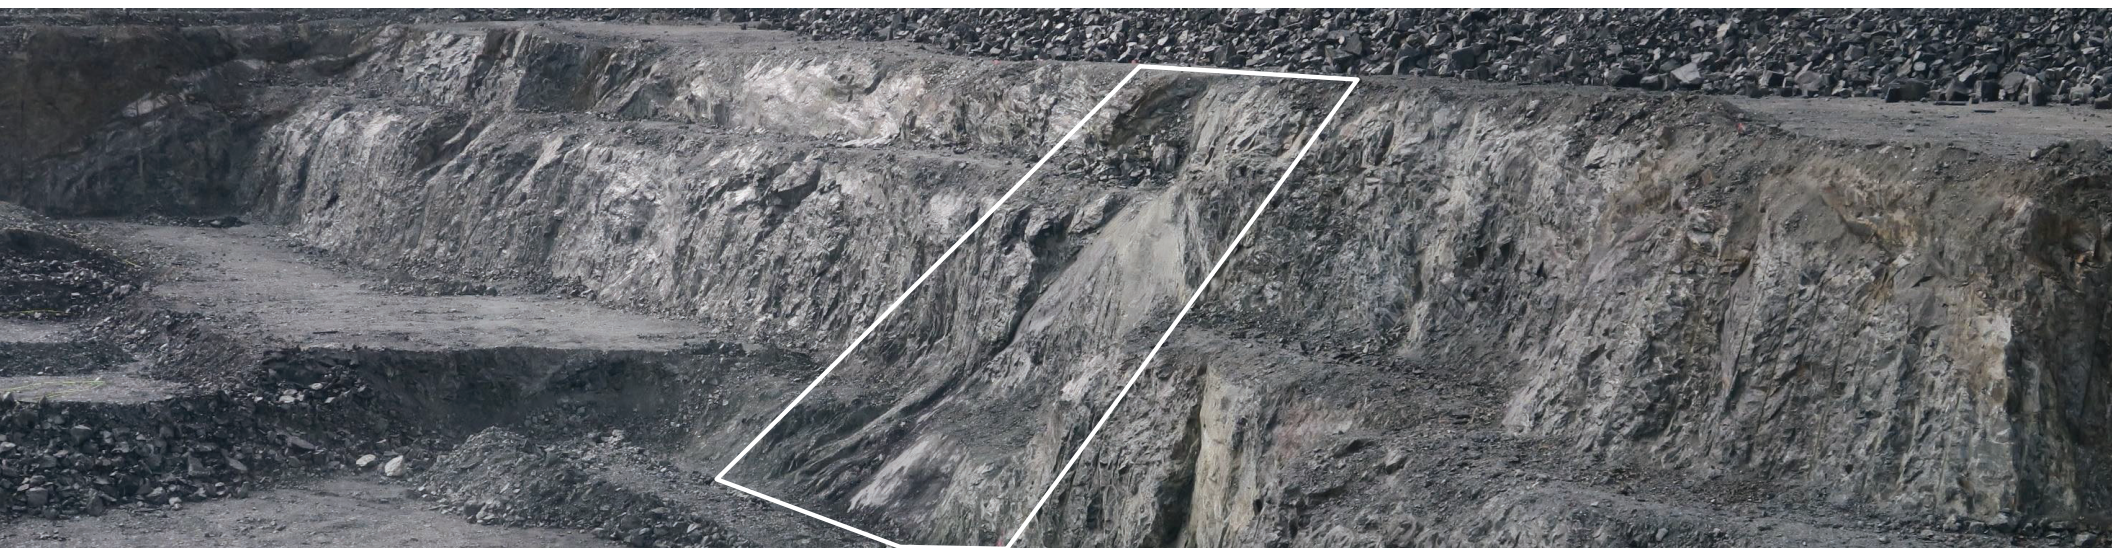
- Final wall established in the footwall of the deposit, primarily within the Mafic Volcanics.
- The initial two benches have generally performed well. Crest loss along the foliation has occurred, as expected. The bench faces in the Mafic Volcanics have often been held at a steeper angle than the dip of the foliation.
- A prominent structure with graphite infill has resulted in a local loss of the catch benches across multiple benches (outlined below). No tension cracks were observed on the crest above the failure. This may be High-Strain/Brittle Structure 18. The rock mass immediately to the east of the failure may be Komatiite, as it is of lower quality and more variable structure. This is not reflected in the lithology model.

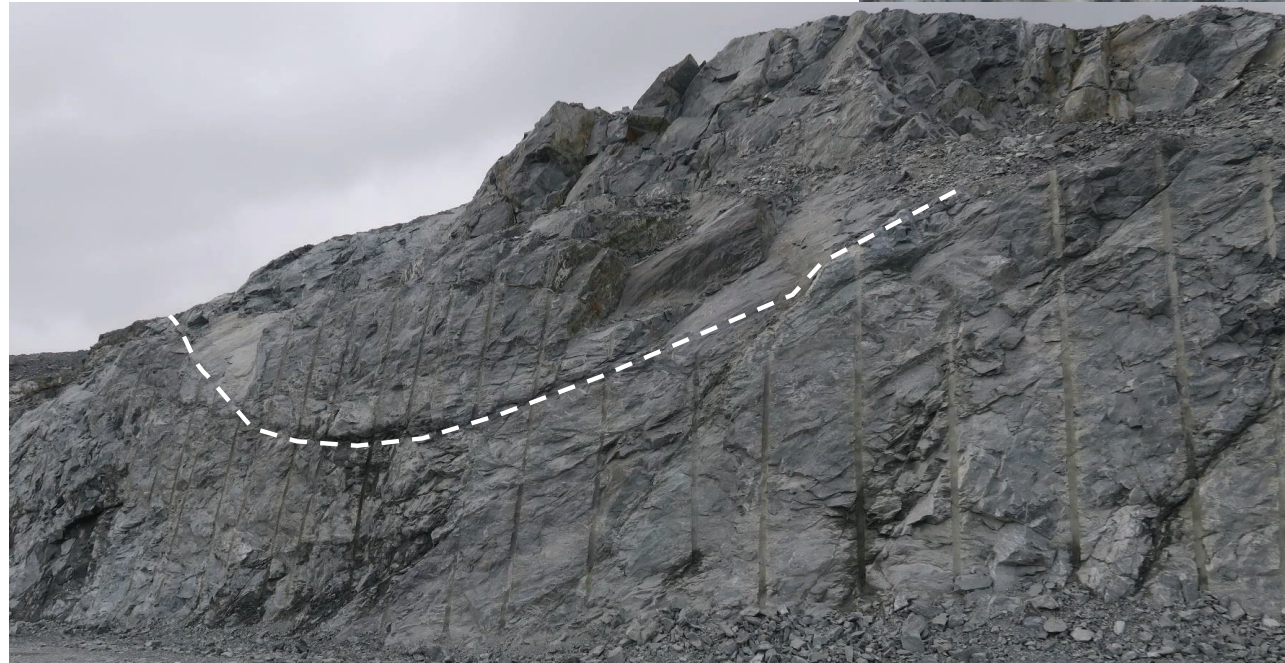
- A possible wedge formed by an undulation in the foliation was identified near the western end of the wall, within the Mafic Volcanics.
- It is understood that a significant effort was made to scale the wedge and that it has not shown evidence of movement or deterioration.
- The wedge should continue to be a focus of the visual monitoring program.
- This is an example of the folding in the foliation that results in considerable local variation in both the dip and strike of these discontinuities.

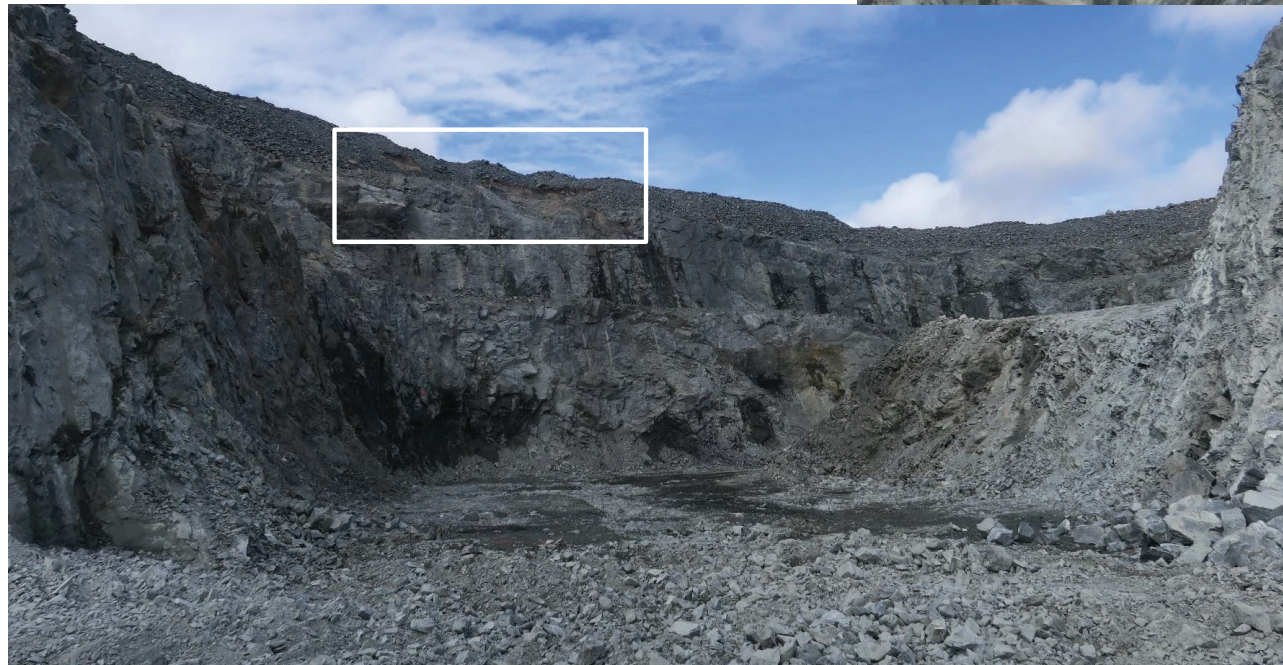
- Mining of this area is now complete, and access is prevented with a berm.
- Rockfall hazards were observed in several areas. If access is ever required in the future a visual inspection should be completed and scaling undertaken as required.
- The gaps in the thermal cap and exposed overburden identified in 2022 (example outlined below in white) continue to be present along the crest of the upper bench. Section 1.135 of the Nunavut Mine Health and Safety Act requires unconsolidated material to be excavated back a minimum of 2 m from the crest. Given the lack of exposure, the requirement for remediation should be confirmed with the WSCC.

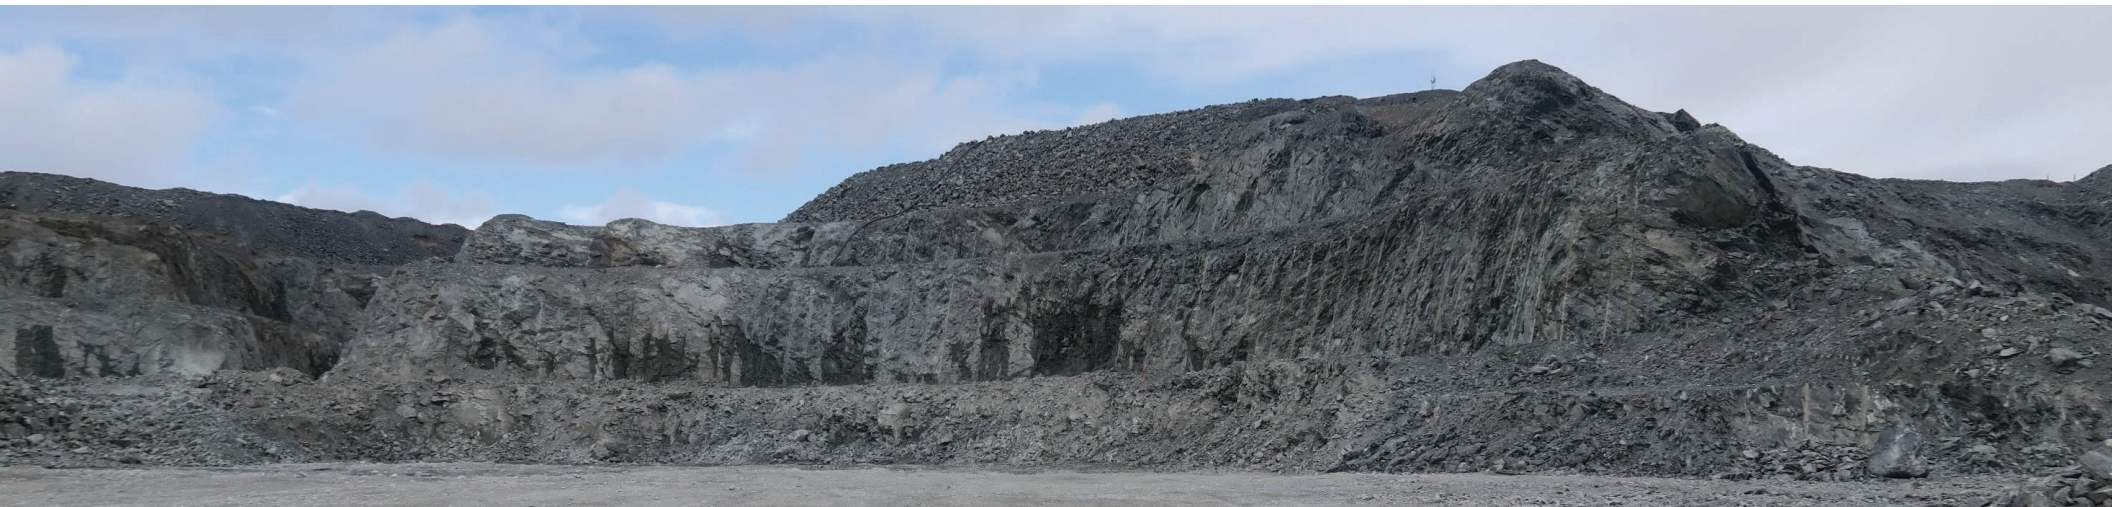
- The East Wall is performing well.
- The lowermost bench was recently established and still needs to be scaled.
- The noses formed with the Turtlehead and with the IVR V1 open pit represent potential rockfall hazards and should continue to be a focus of the visual inspections.

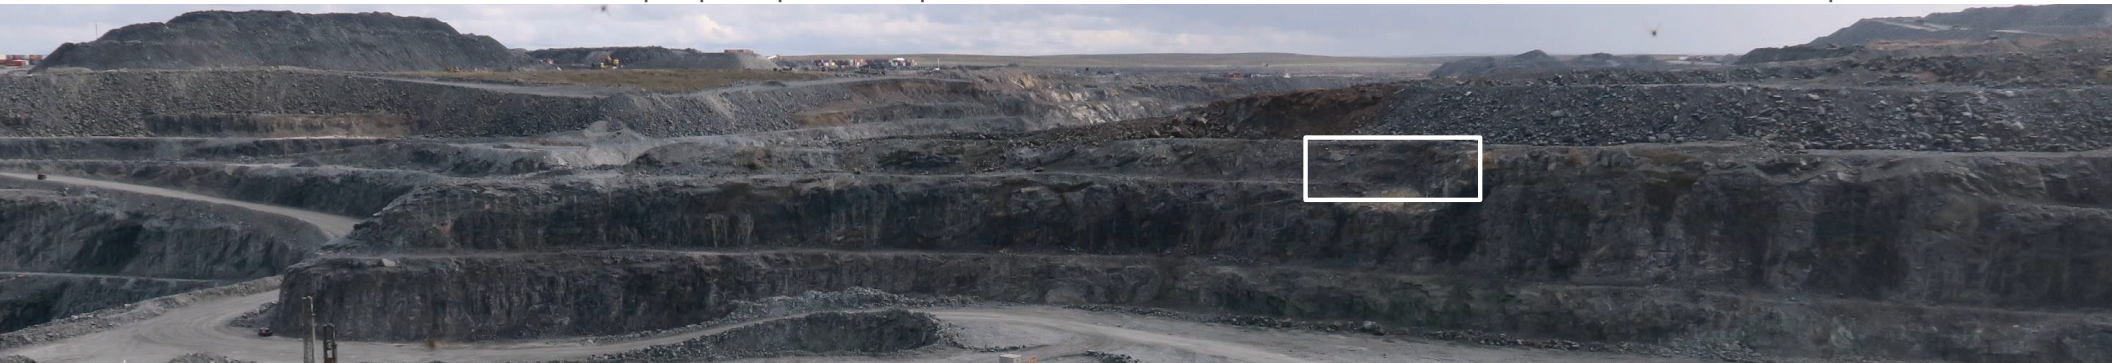
- The rock mass structure and quality is favourable in this sector and have not limited the achievable bench geometry.
- However, Drilling and Blasting practices are having a strong influence on bench performance, with hard toes, crest loss, and frozen rock on the face observed regularly along this wall. Irregularly spaced half-barrels were observed in some areas. It is likely that the design catch bench width is not being consistently achieved. These practices are discussed in greater detail later in this presentation (Slide 60).

- A series of discontinuities dipping to the east have locally resulted in crest loss of one of the benches (outlined in white below). These discontinuities approximately correspond to Joint Set E observed in the underground development.

- The nose between the V1 and V2 open pits represents a potential rockfall hazard and should continue to a focus of the visual inspections.

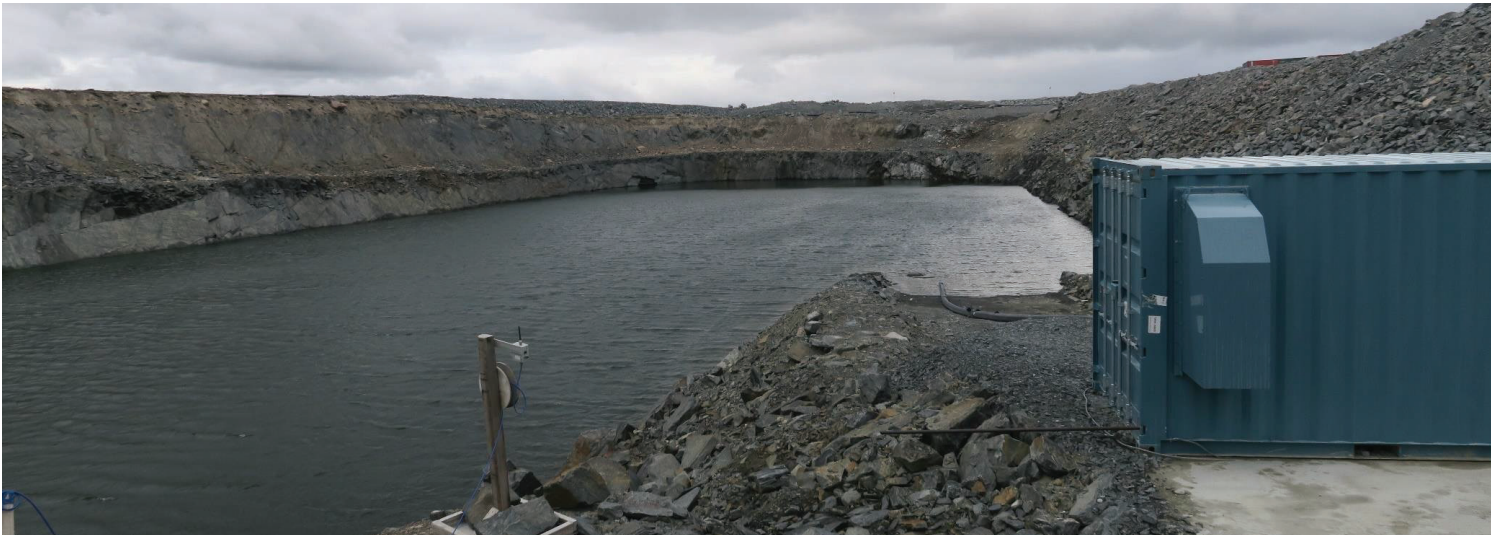
- Attenuation Pond 5 is a former quarry located to the east of the WHL open pit that is now used for water management. The pond was inspected on July 8, 2023.
- The pond is partially flooded, with one to two benches exposed above the pond water level. As a result, a detailed inspection could not be completed.
- No stability concerns were identified in the exposed slopes.
- Pumps were present at the time of the inspection.
