# **Whale Tail 2023 Annual Open Pit Geomechanical Inspection**

## **RE: Meadowbank Complex - Amaruq Site - 2023 Annual Open Pit Geomechanical Inspection**

## 2023 Annual Open Pit Geomechanical Inspection

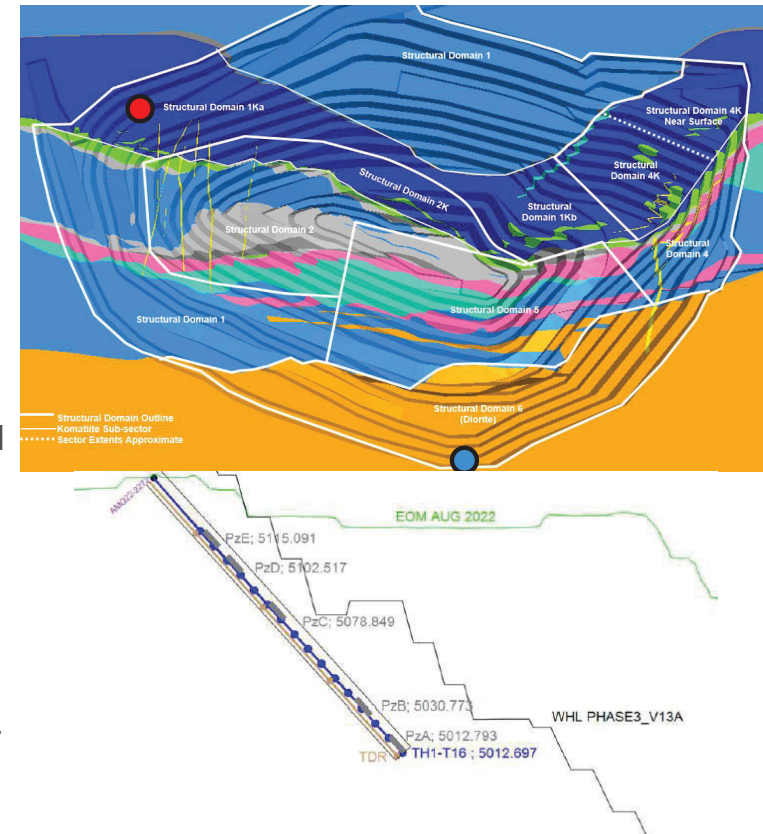
Cross Section of TDR/WVP/Thermistor String in South Wall

- Vibrating wire piezometers and a thermistor string were installed in the same hole as the TDR in order to monitor the hydrogeological conditions within the talik exposed in the south wall. The mine has done a nice job summarizing and reviewing the data. The data show a clear response to mining and are consistent with a gradual drawdown of the piezometric surface as mining extends to depth.
