Project: CAPR003066
March 26, 2025

Subject Hope Bay Site-Wide – 2024 Annual Geotechnical Inspections

2024 Annual Geotechnical Inspection

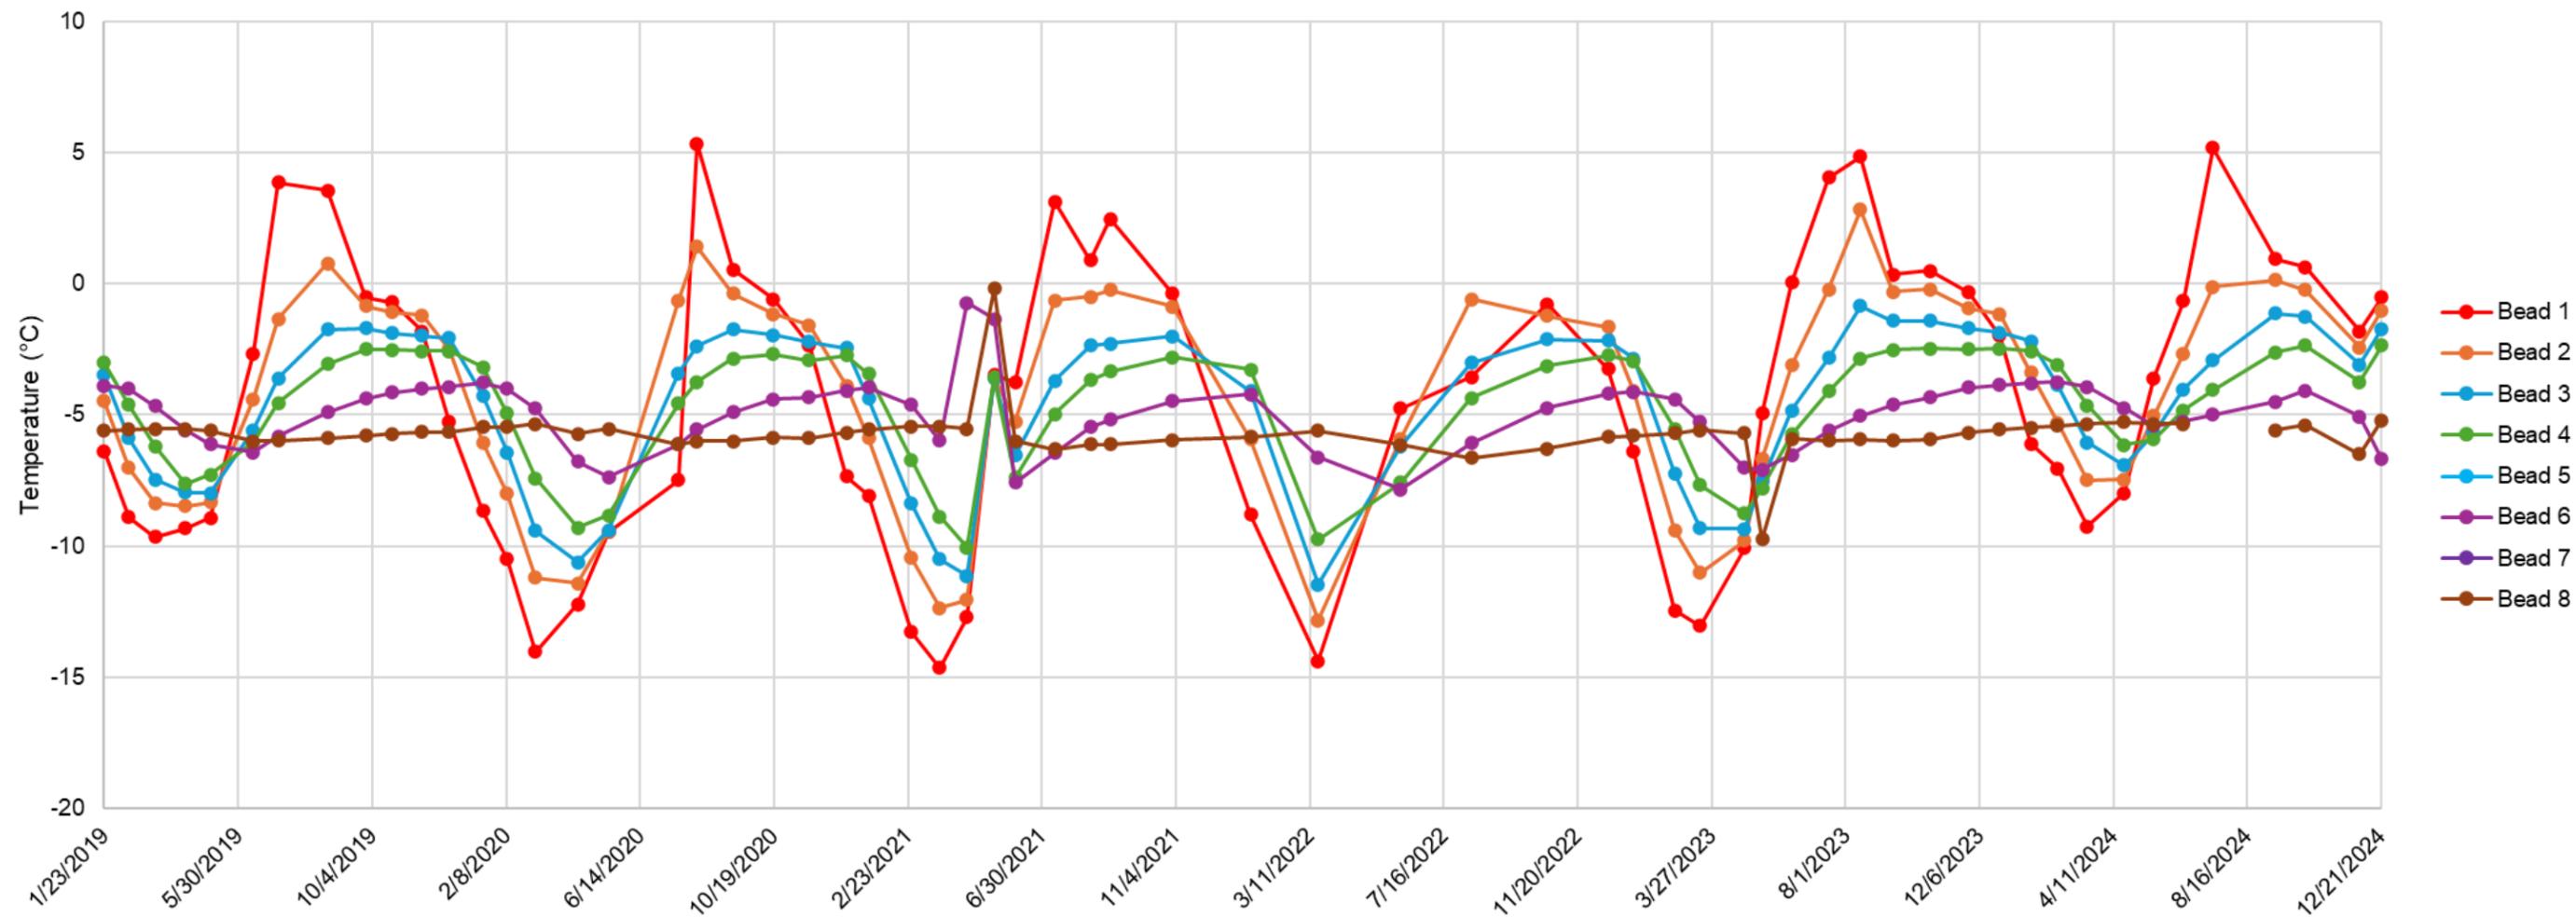
Infrastructure	Observations	Recommendations and Comments	Recommendation ID
	<ul style="list-style-type: none"> ■ SRK-12-GTC-DH02 and SRK-12-GTC-DH03 ground temperature measurements indicate slightly warmer minimum ground temperatures in 2024, which have been seen across site, but are also indicative of potential warming along the CWP berm and liner-in. 	<ul style="list-style-type: none"> ■ Although minimum monitoring frequency stated in the water license has been met for active cables, consider increasing frequency of readings to maintain resolution of data. Consider installation of a datalogger at SRK-12-GTC-DH02 and SRK-12-GTC-DH03 to increase the resolution of the thermal data collected in this location. 	<ul style="list-style-type: none"> ■ 2024-AGI-11
Doris Sediment Pond	<ul style="list-style-type: none"> ■ Several holes and cuts noted in liner, on slope near crest of berm. These are patterned cuts (parallel and perpendicular to the direction of the HDPE roll and appear to be located above the overflow culverts installed in the downstream berm of the pond. ■ Wrinkles in the liner are present in the north corner. 	<ul style="list-style-type: none"> ■ <i>Overall, the pond is in satisfactory condition, though repairs are needed to prevent the observed defects from getting worse, and to prevent water from leaking through the cuts when the pond is full.</i> ■ Inspect the liner for additional defects and confirm elevation of any observed defect is above the overflow culvert elevation. ■ Consider getting the holes and cuts observed in the liner repaired by a specialty liner contractor to prevent the cuts from getting larger. 	<ul style="list-style-type: none"> ■ <i>Comment</i> ■ 2023-AGI-32
