Meadowbank and Whale Tail IRB Report No 32

January 30th, 2025

Reference: Report No 32
Meadowbank Independent Review Board (MBK IRB)
Site visit August 21st to 23rd, 2024 and meeting, Montréal, December 10th and 11th, 2024.

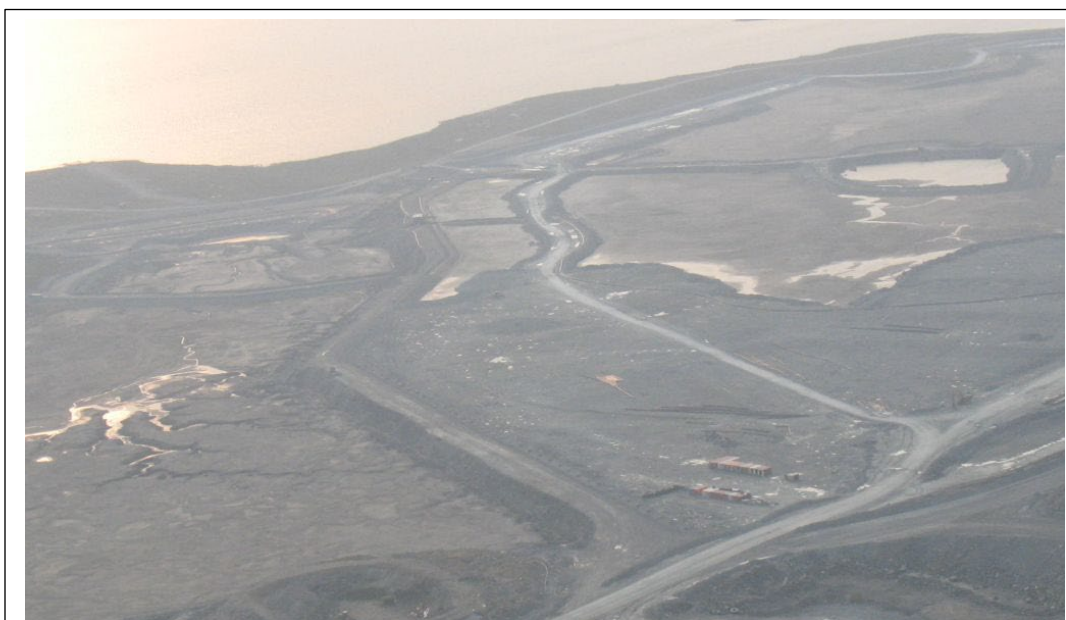
- At the TSF Saddle Dams, rockfill placement for protection of the liner at SD-1 was underway as a precursor to capping of the tailings (Photos #15 and 16). A similar operation will be carried out at the other containment structures of the TSF.
- At the TSF Stormwater Dike, additional capping has been accomplished in the vicinity of this dike but no tailings deposition for landscaping has been carried out this year (Photos #18 and 19).
- The TSF Central Dike is performing well, and the downstream pond (photos #20 and 21) is still being maintained at elevation 115 masl.

Photo #18 Stormwater Dike and capping of TSF North Cell

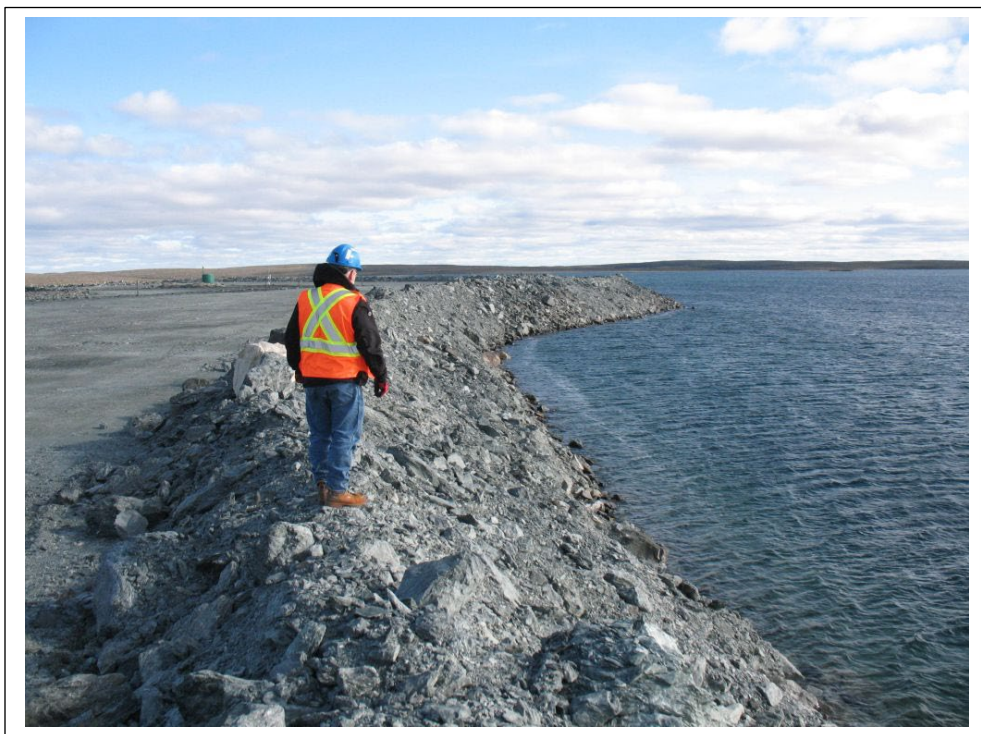
- At Bay-Goose dike (photo #24), extra fill has been placed and regrading carried out to facilitate more efficient visual observation of the condition of the dike crest (photo #25). It was observed that the material comprising the upstream face of the dike contains a significant proportion of finer material (photo #26) that could be either recently placed or due to progressive breakdown of the soapstone rock. However, little wave damage was noted, and the wide crest (80 m) would provide a large volume of sacrificial material in such an event.

Photo #26 Bay-Goose Dike. Upstream face in SW segment.

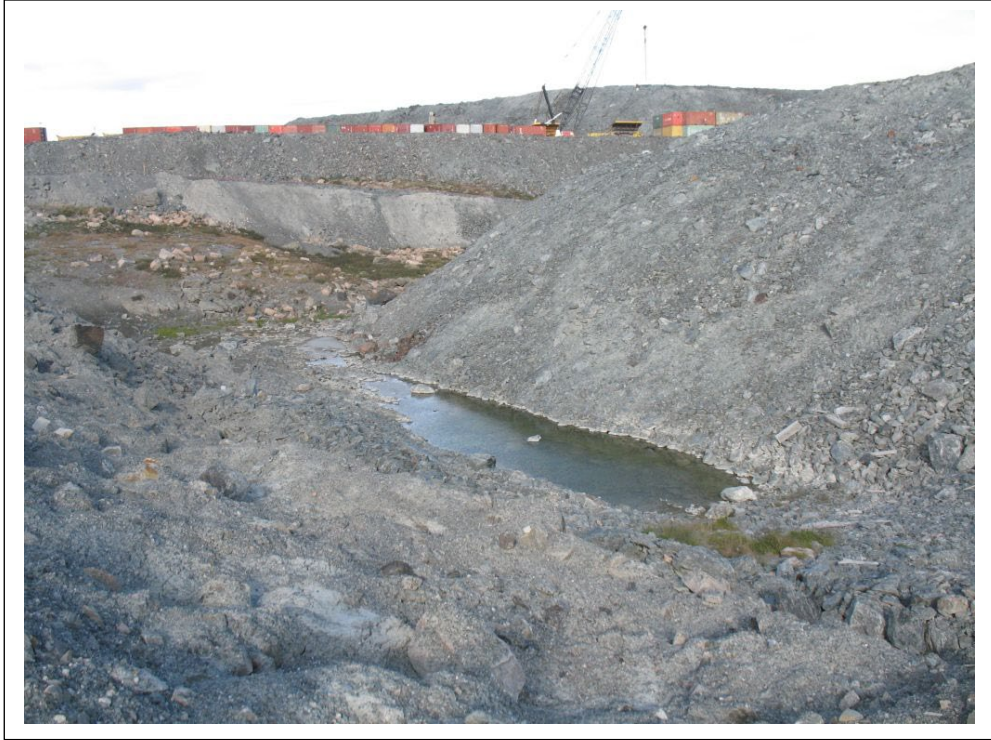
Photo#27 South Camp Dike. Downstream pool retained by waste rock pile
