Appendix 23

Meadowbank 2024 GN Spill Reports

2024-01-10 MBK 500L Waste Oil

GN reference #: 2024-011

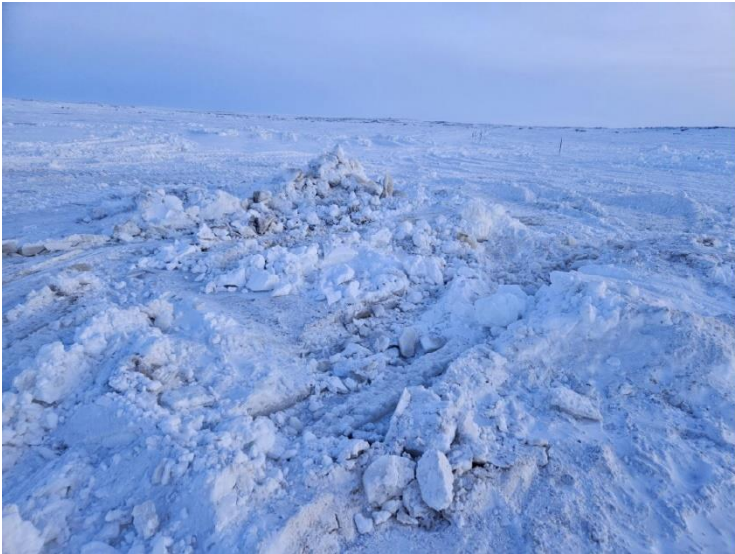
During a follow up drill inspection at unnamed lake, approximately 680m N of Wally Lake, a spill of oil was discovered. Upon further investigation a spill of ~5L of hydraulic oil was found. A prior post drilling inspection of this area was completed on February 3rd, 2024.

Figure 1 – Post Drill Inspection on Feb. 3, 2024

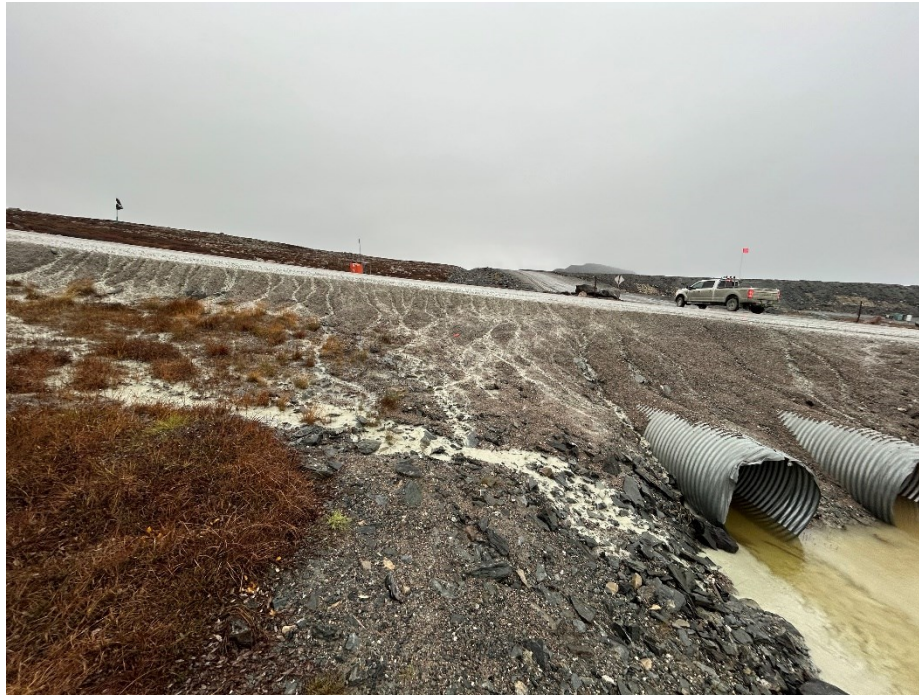
Figure 2. Upstream ST-6 (2024/09/22)
