Meadowbank 2024 Annual Open Pit Geomechanical Inspection

February 13, 2025

**RE: Meadowbank Complex - Meadowbank Site - 2024 Annual Open Pit
Geomechanical Inspection**

Meadowbank Complex - Meadowbank Site - 2024 Annual Open Pit Geomechanical Inspection

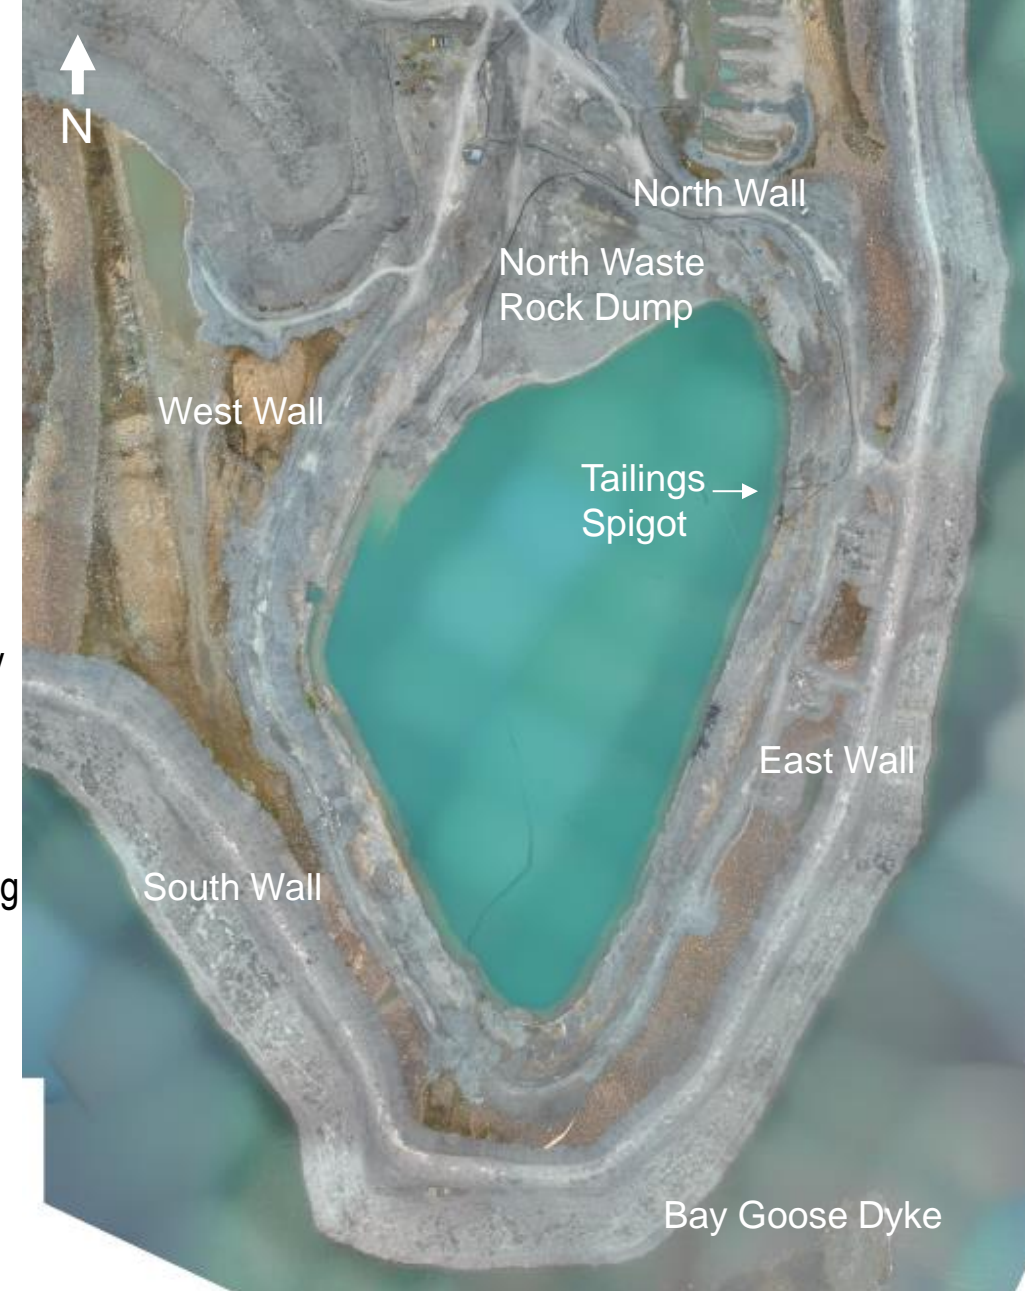
Goose Open Pit

- A portion of the upper bench is exposed above the current pit lake.
- The walls are performing well and no particular geomechanical concerns were noted.
- The exposed bench faces along the ramp at the northern end of the pit are relatively low and there is ample room to transit and work away from the wall. As a result, the rockfall risk is considered to be low.
- A barricade is no longer present at the top of the ramp. However, a restricted access sign has been installed.

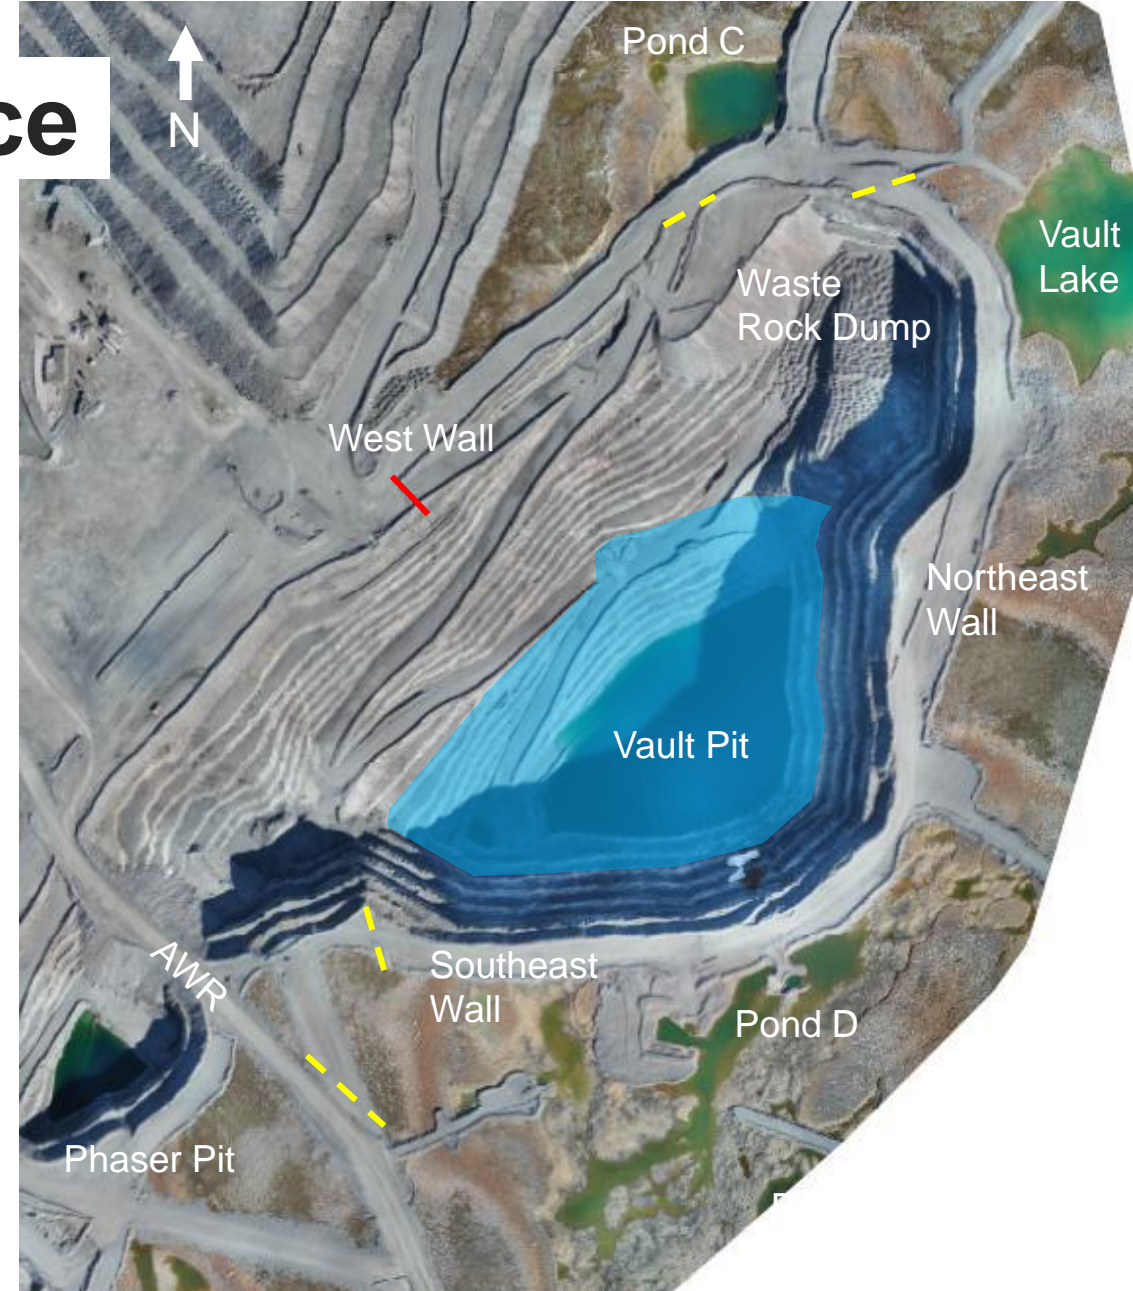
Vault Open Pit - Northeast and Southeast Walls

- The open pit is partially flooded. The elevation of the pit lake was last measured in June 2022. It has since risen to flood the area approximately shaded in blue in the image at right.

- The Amaruq All Weather Road (AWR) crosses between the Vault and Phaser Pits on a rockfill embankment.

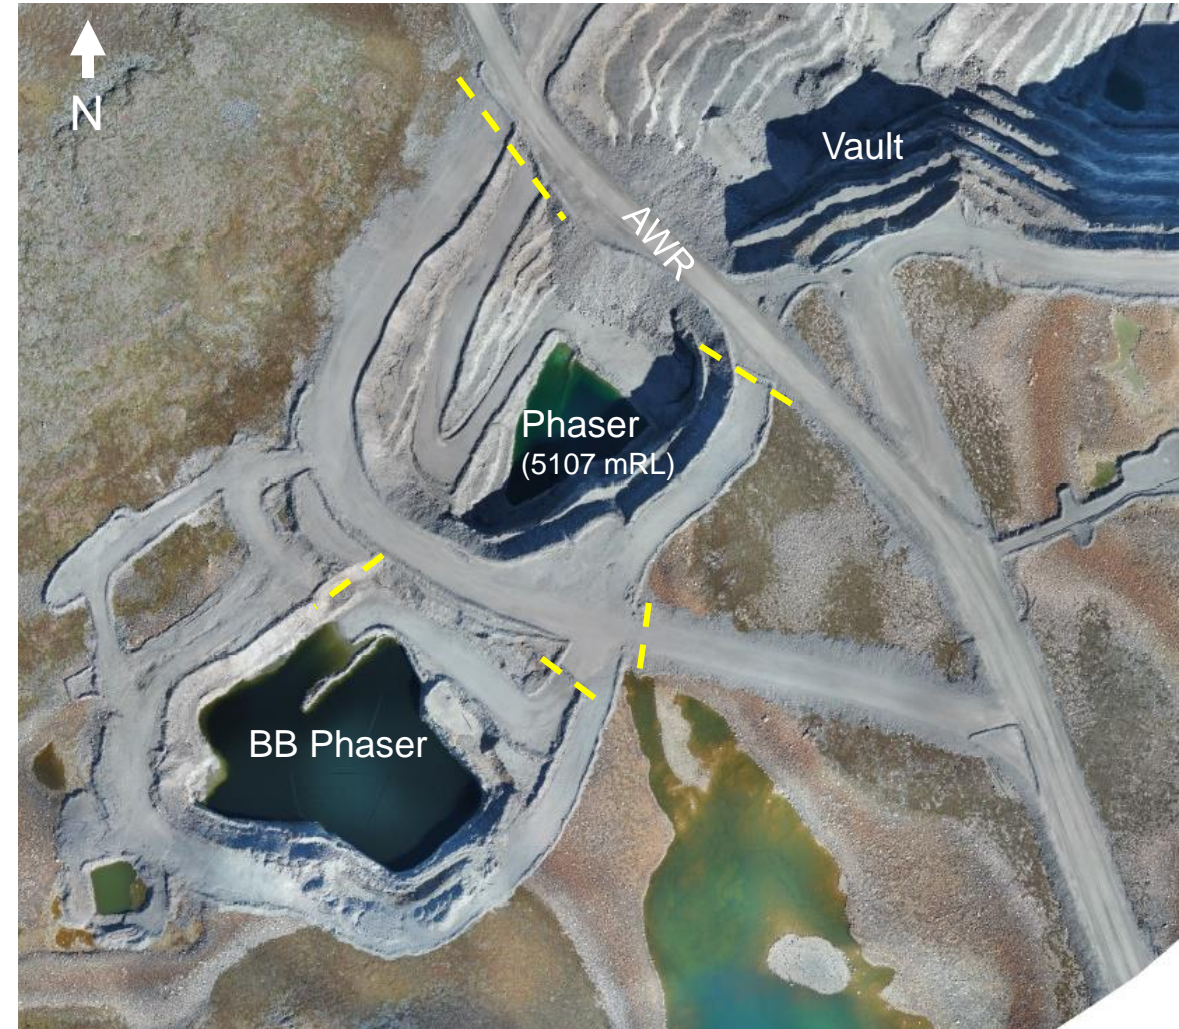
Phaser Open Pit - General

- At the time of the inspection, the accesses to the open pits were barricaded by berms (shown as dashed lines at right).
- Note that the Amaruq All Weather Road (AWR) crosses between the Vault and Phaser Pits on a rockfill embankment.

- AEM continues to complete monthly geomechanical inspections of the open pits. The AWR is also included in the inspections. These inspections should continue, though the open pit inspections could be discontinued during periods when water quality sampling is not occurring.
