Whale Tail 2024 Annual Open Pit Geomechanical Inspection

February 3, 2025

RE: Meadowbank Complex - Amaruq Site - 2024 Annual Open Pit Geomechanical Inspection

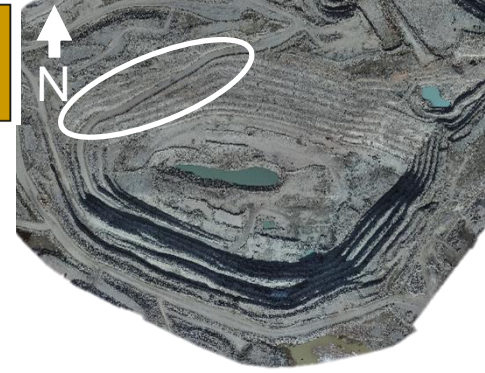
Observations - Northwest Wall

- Final wall in Design Sector A1/A1K.
- The benches in the Greywacke and Oxidized Greywacke are generally performing well.
- The benches in the Komatiite below the ramp have experienced significant backbreak in the northwest corner, as well as a sequence of bench-scale failures (outlined below in black). This is discussed further on the next slide. Elsewhere in the sector the Komatiite has performed well.
- A potential wedge is present above the ramp (white box below). The wedge is discussed further on a subsequent slide.

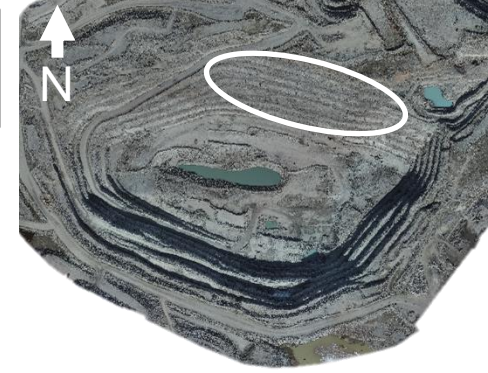
Observations - North Wall

- Final wall in Design Sector B1.
- Approximately two benches have been mined on this wall since the last annual inspection.
- There have been no slope failures since the last annual inspection.
- The benches are performing better than expected, with the bench face often standing steeper than the foliation.

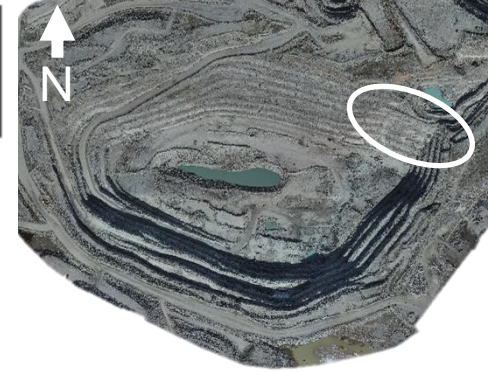
Observations - Northeast Wall

- Final wall in Design Sector D4K.
- This sector is within the Komatiite and has been characterized by a series of bench scale failures associated with the weak rock mass and the High-Strain / Brittle Structures (select structures are shown in red below). The slope design was revised in December 2021 and has been successful in managing the performance of the slope.

- Four rockfalls and bench-scale failures have occurred in this sector since the last annual inspection, ranging in size from 23 to 480 tonnes. All of the failures occurred behind berms between April and July 2024 and the failure mechanism is consistent with previous failures in this sector.

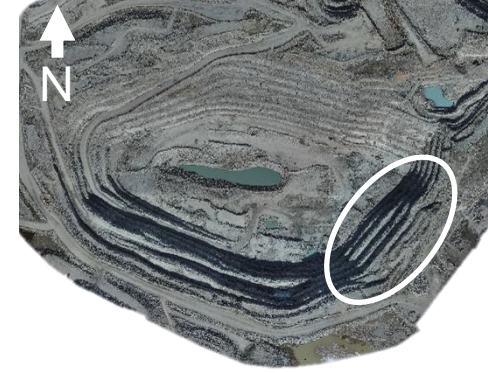
Observations - Southeast Wall

- Final wall in Design Sector F6
- The slope geometry recommendations for this sector were adjusted in late 2021. A catch bench width of 16 m, was thought to be achievable, with the expectation of backbreak in the order of 8 m along Joint Set C. The benches initially performed better than expected, with backbreak typically less than 4 m, and AEM reduced the design catch bench width to 13 m in March 2023.

- Subsequently, the 5046 bench experienced > 6 m of crest loss over significant intervals of the catch bench. While rockfalls have not been reported or observed in this sector to date, the potential for rockfall exists.

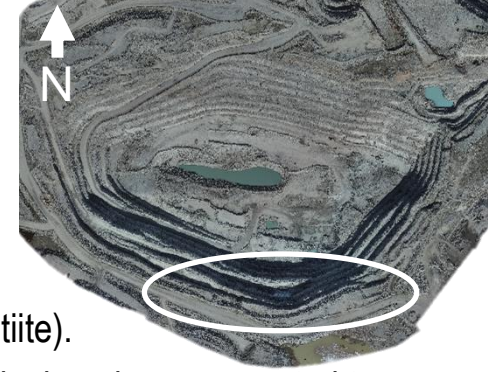
Observations - South Wall

- Final wall in Design Sectors H6 (Diorite) and potentially H5 (predominantly Greywacke and Mafic Volcanics with intervals of Komatiite).
- The wall has reached an elevation where Structural Domain 5 is expected to be exposed in the wall. North dipping structures in this domain are expected to limit the achievable bench face angle. Periodic mapping is recommended to confirm the extents of this domain.

- A sump and horizontal drains were established on the South Wall (circled in white) to intercept seepage from the base of the talik below the former Whale Tail Lake and prevent the formation of an ice wall directly above the ramp. Significant seepage has been observed on the wall below the sump and AEM is currently reviewing options for managing the seepage and ice in this area. This is endorsed.

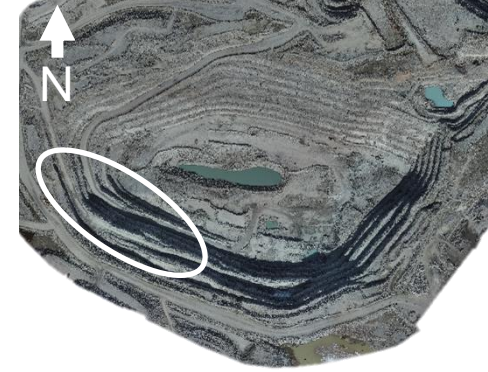
Observations - Southwest Wall

- Final wall in Design Sectors I6 (Diorite) and I1 (predominantly Greywacke).
- The wall is generally performing well. However, there continue to be challenges with drilling and blasting practices resulting in crest loss or hard toes on the benches.

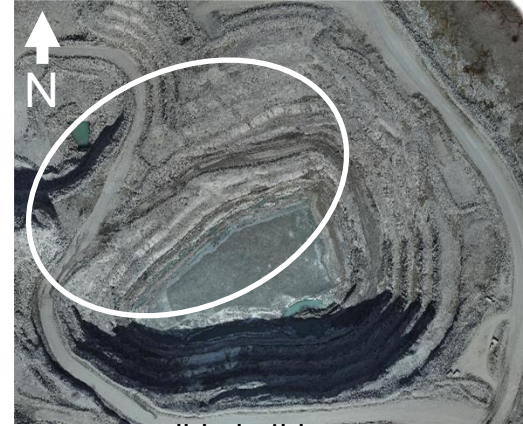
Observations - Northwest Wall

- The Northwest Wall is the footwall of the deposit and was established primarily within the Komatiite.
- Several bench scale failures and rockfalls have occurred over time on this wall, primarily associated with planar or wedge failures along the foliation. A progressive failure below the ramp (circled in black below) has impacted the ramp. Further failures are possible in this area.

- Two rockfalls and a bench-scale failure have occurred since the last annual inspection and are circled in white below. These failures occurred after mining in the open pit was completed and access to the pit was prevented. Two of the failures are associated with progressive ravelling of a high-strain / brittle structure in the western corner of the pit. The third failure was a 1,580 t wedge failure on the foliation.

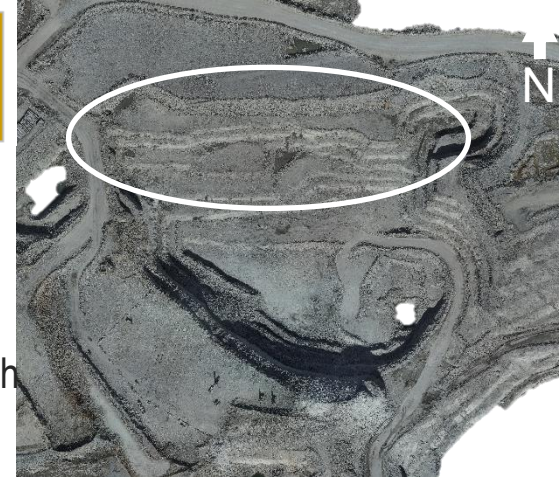
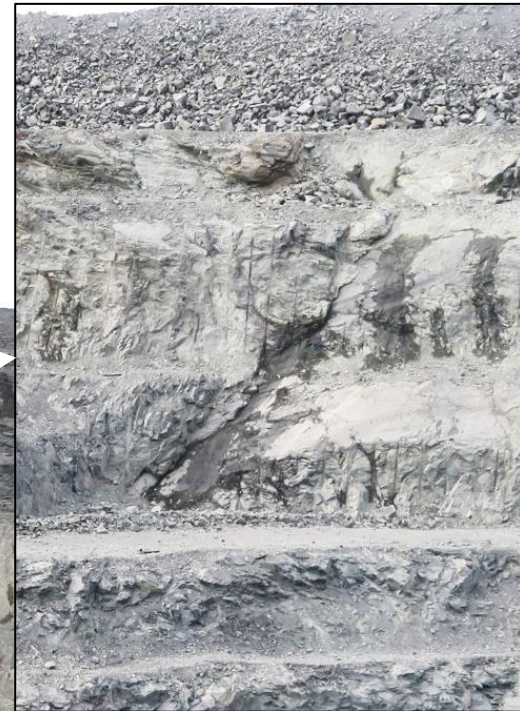
Observations - North Wall

- Final wall established in the footwall of the deposit, primarily within the Mafic Volcanics.
- The observed slope behaviour is consistent with expectations. While crest loss occurs along the foliation, the bench face is typically held at a steeper angle than the dip of the foliation. However, crest loss has been greater than planned. This is discussed further later in this presentation.
- A prominent structure with graphite infill has resulted in a local loss of the catch benches across multiple benches (outlined in white below). This may be High-Strain/Brittle Structure 18.
- A possible wedge formed by an undulation in the foliation was previously identified near the western end of the wall within the Mafic Volcanics (circled in black). The condition of the wedge has not obviously changed since the last annual inspection.

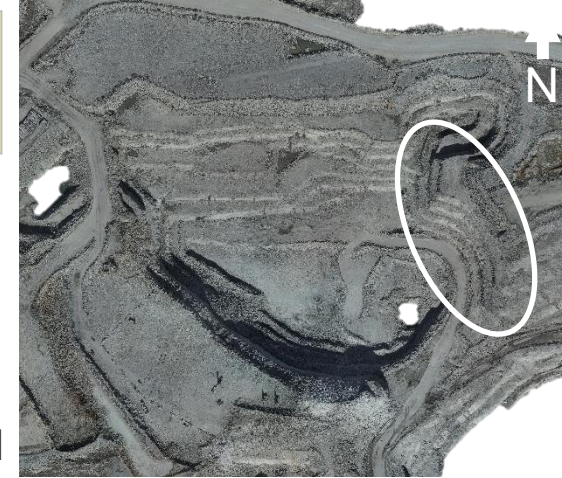
Observations - East Wall

- The East Wall is performing well. However, the crest loss has been greater than planned. This is attributed to the previous Drill and Blast practices.
- The noses formed with the Turtlehead and with the IVR V1 open pit represent potential rockfall hazards and should continue to be a focus of the visual inspections.
- Note that the lowermost bench was recently established and has not yet been scaled.

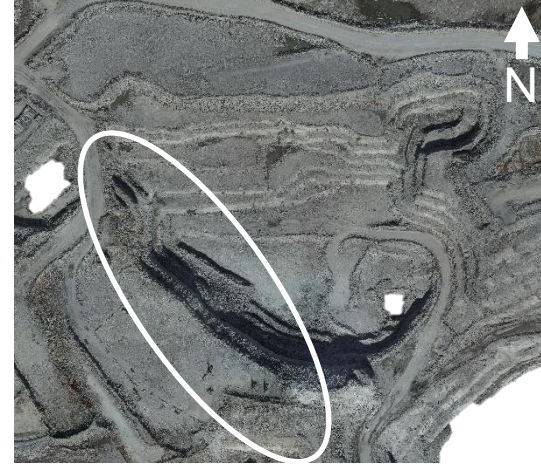
Observations - West Wall

- The pushback of the west wall is in progress. Only a single bench was exposed at the time of the annual inspection.
- The rock mass structure is favourable in this sector and the bench has performed well.

- The bench is expected to be established in a combination of Mafic Volcanics and Komatiite. An interval of Komatiite was observed towards the northern end of the wall (outlined below). It is important for the performance of the North Wall that the Komatiite not extend into that wall in significant quantities. Comments on the design of the open pit are provided on the next slide.

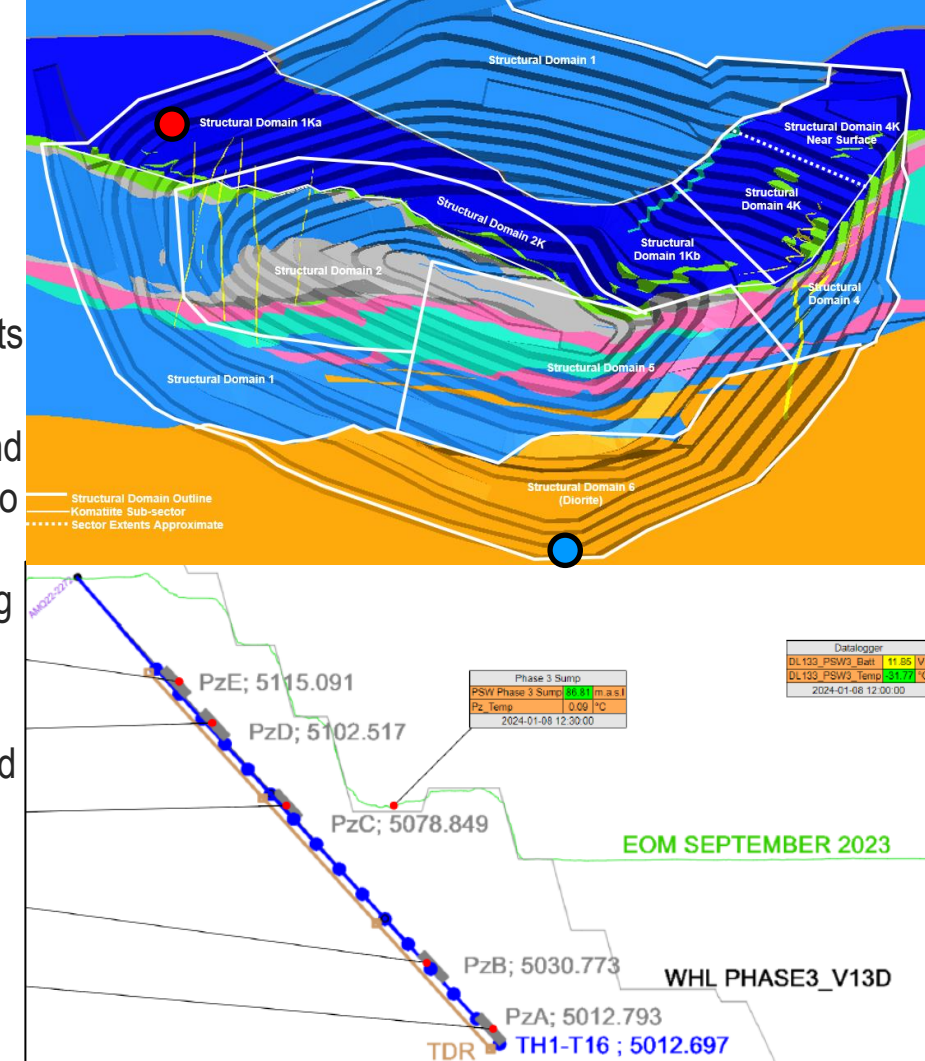
Northwest Wall Thermistor String Data

- The sub-surface geotechnical and hydrogeological instrumentation in the open pits consists of the following instruments in the Whale Tail pit:
 - A thermistor installed in the Northwest Wall (red dot at right) to a depth of 15 m behind the wall. The data indicate that the rock mass is fully frozen during winter but thaws to a depth of 6.5 m over approx. 4 months starting in May. Freeze back started in late October and took approx. 1 month. This information is useful for better understanding the timing and behaviour of rockfalls in the open pits.

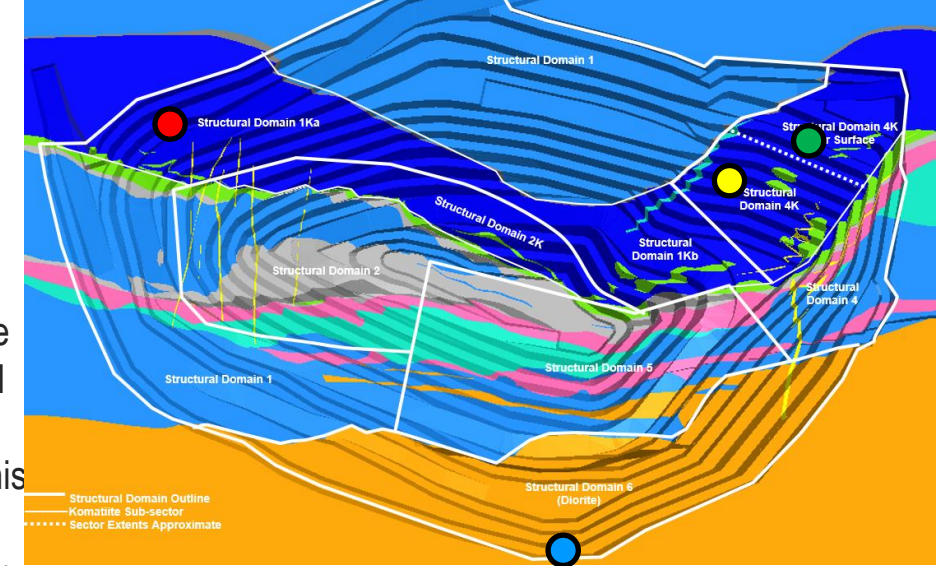
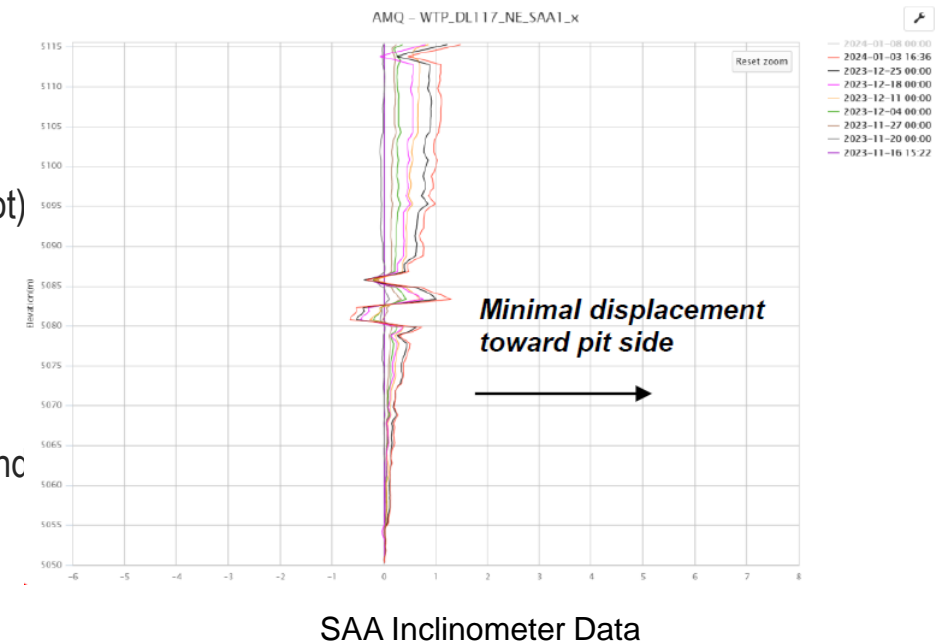
- A second SAA inclinometer and VWP were installed in the lower Northeast Wall (yellow dot) in Q1 2024. The SAA was damaged during installation and only the VWP is functional.

- The inclinometer is not yet fully integrated into the mine's monitoring system (e.g., MonitorIQ). Trigger thresholds, alarms, and a TARP need to be developed to govern the management and interpretation of the instrument data. The communication issue should be resolved.

- Additional instrumentation should be installed as mining progresses (e.g., Design Sector A1K and potentially IVR V2 Design Sector V2A).
- Ideally there would be additional inclinometers and/or TDRs in the Northeast wall that cross the northern contact of the Komatiite. However, this is likely not feasible due to access limitations.

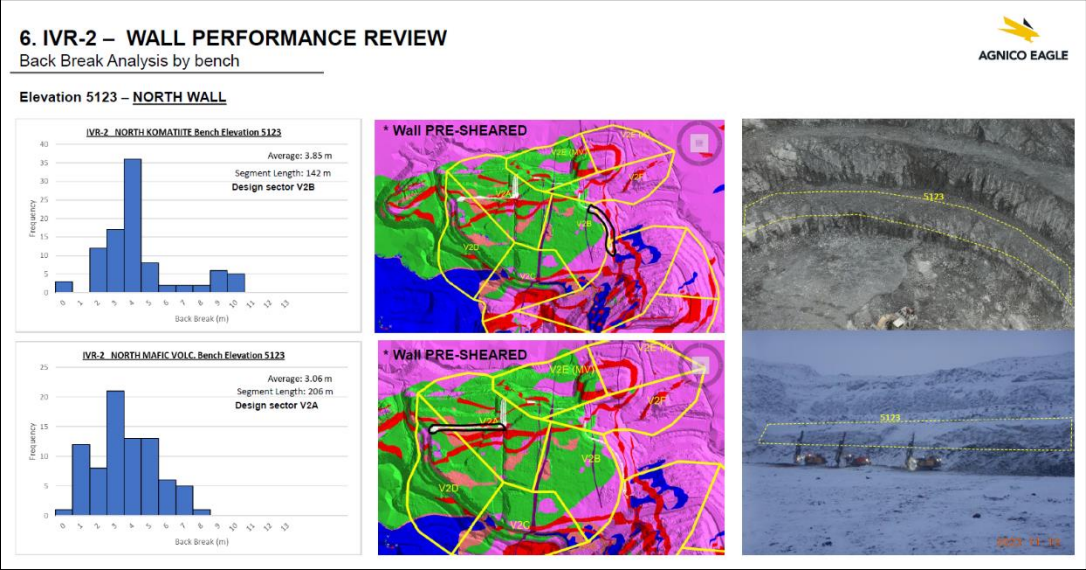
- The achieved slope geometry is documented through the Maptek scans completed for all final walls. The scans are used to measure backbreak of the catch benches and the results are summarized in the quarterly reports.
- The assessments of the catch bench performance are well done. However, the results are not consistently compared to the design basis. Recommend directly comparing the results of the bench performance reviews to the bench design (e.g., does the backbreak exceed the amount planned for?).
- The assessments of catch bench performance to date have focused on the IVR open pits, though an assessment of recent benches in the WHL open pit was completed in August 2024. In the future, the new benches in each of the open pits should be consistently evaluated.

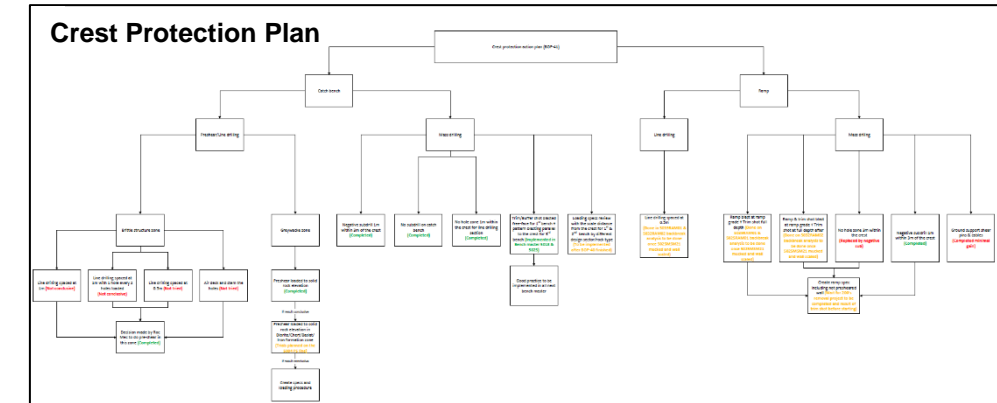
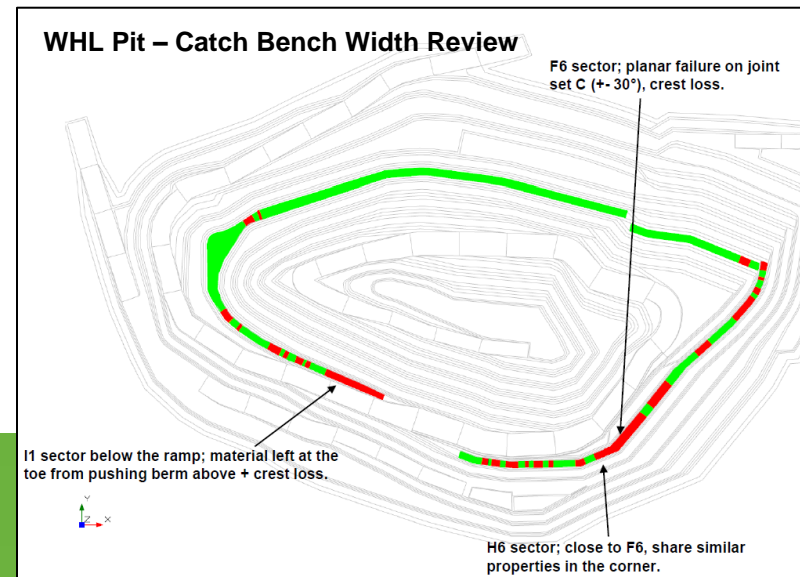
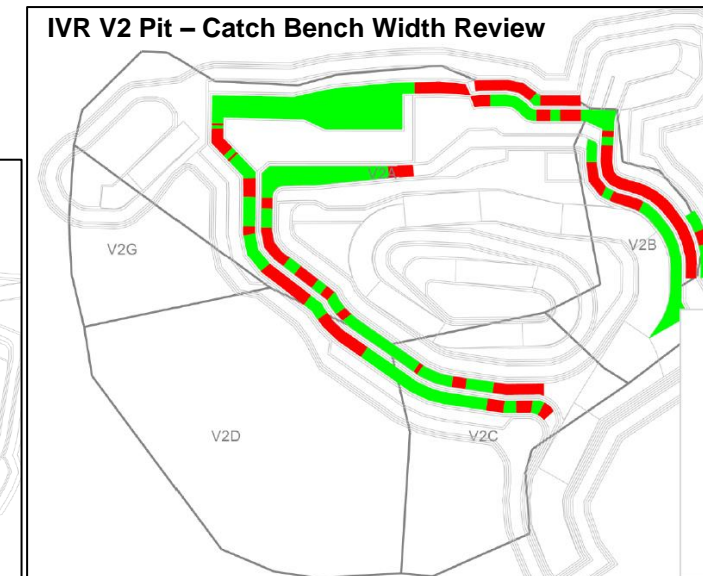
- During the site visit, no immediate rockfall hazards were observed in these areas.
- Observations made during this and previous reviews suggest that the dominant cause is poor drilling and blasting practices, though adverse rock mass structure (e.g., WHL Sector F6) and scaling to remove identified hazards can also be factors.

Note, green shading indicates a catch bench width of 8 m or more

- The mine implemented a Crest Protection Plan in 2024 and has progressively iterated through a series of trials to improve the catch bench performance. This includes line drilling, air-decking, negative sub-drill near the future crest position, etc. This is an important development and should be continued until the minimum catch bench width is reliably achieved.

- The status and effectiveness of the initiatives to reduce the catch bench loss needs to be compiled and quantified.
- Ultimately the mine needs to demonstrate that the minimum catch bench width can be reliably achieved. Otherwise the design catch bench width will need to be increased or a variance obtained from the WSCC.
