Project: CAPR003759
March 25, 2026

Subject Hope Bay – 2025 Annual Geotechnical Inspection – Site-Wide

Agnico Eagle Mines contracted SRK Consulting (Canada) Inc. to conduct the 2025 Annual Geotechnical Inspection for the Hope Bay site in Nunavut. Hope Bay is a gold mine, located in Nunavut Territory 705 km northeast of Yellowknife, NWT and 153 km southwest of Cambridge Bay, NT. The mine is currently in care and maintenance.

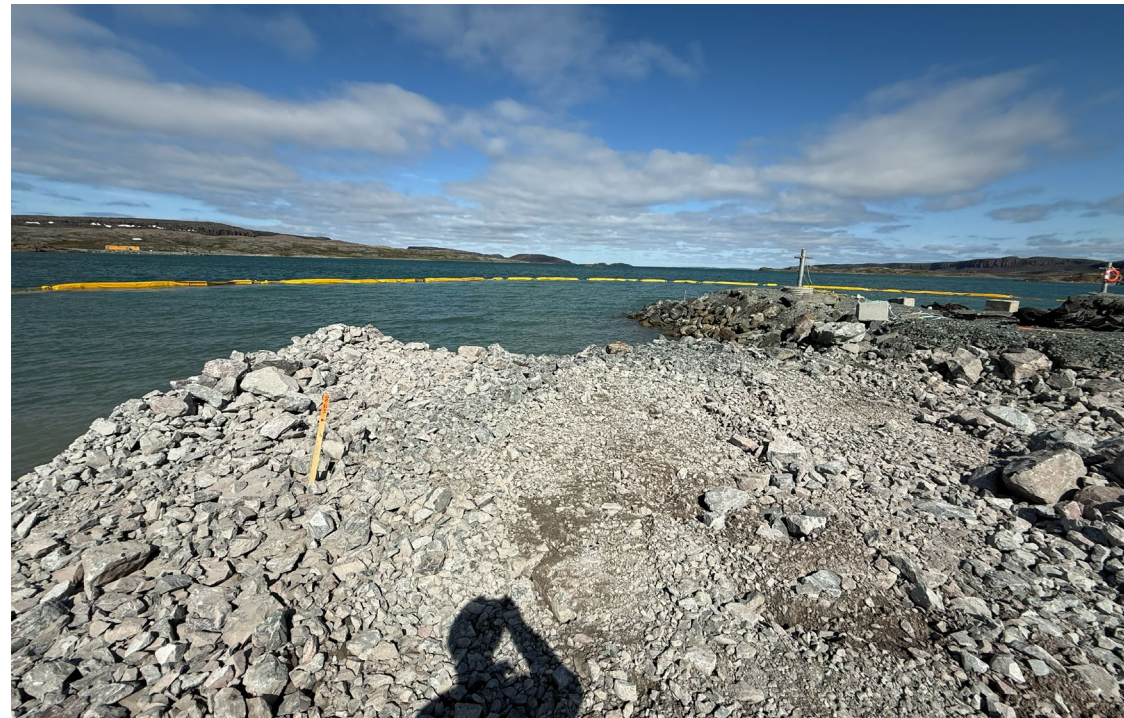
Photo 1: Roberts Bay Jetty overview

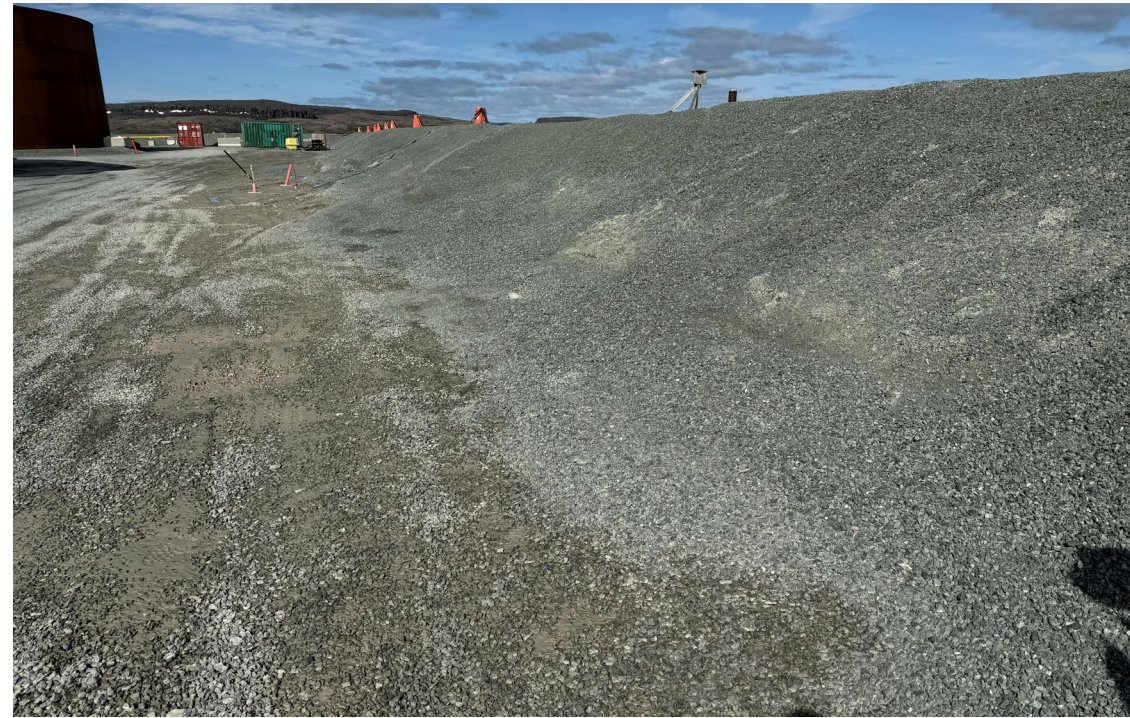
Photo 6: Multi-tank farm (20M liter) east berm

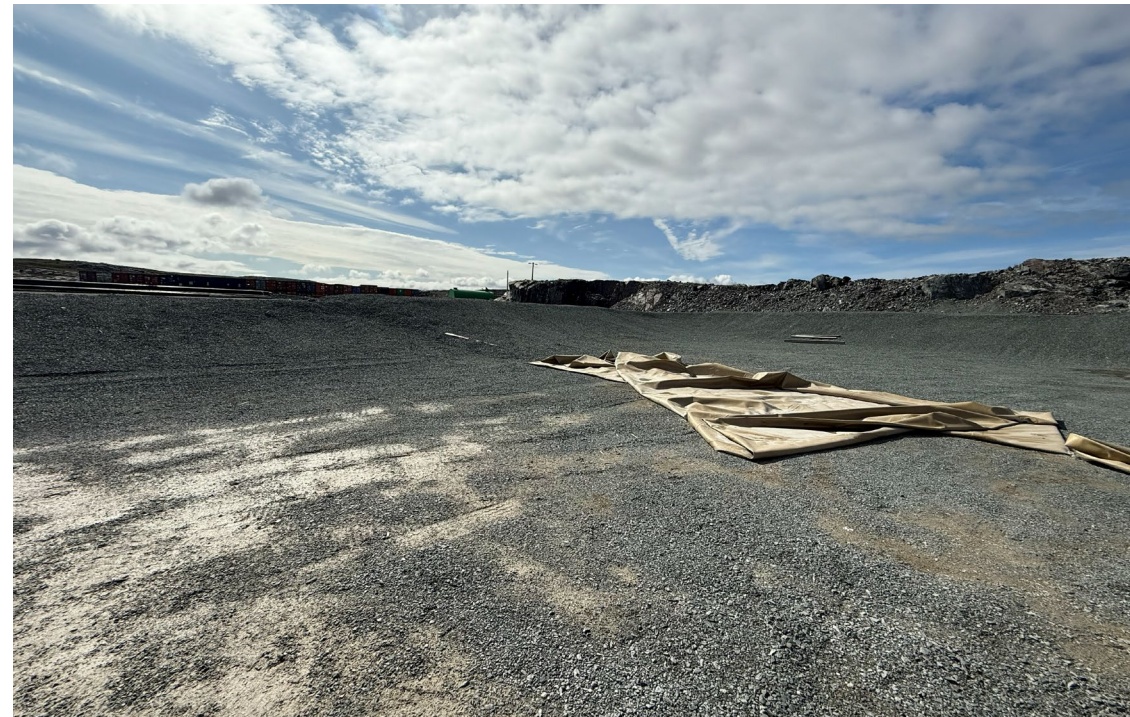
Photo 8: Quarry 1 (50M liter) tank farm

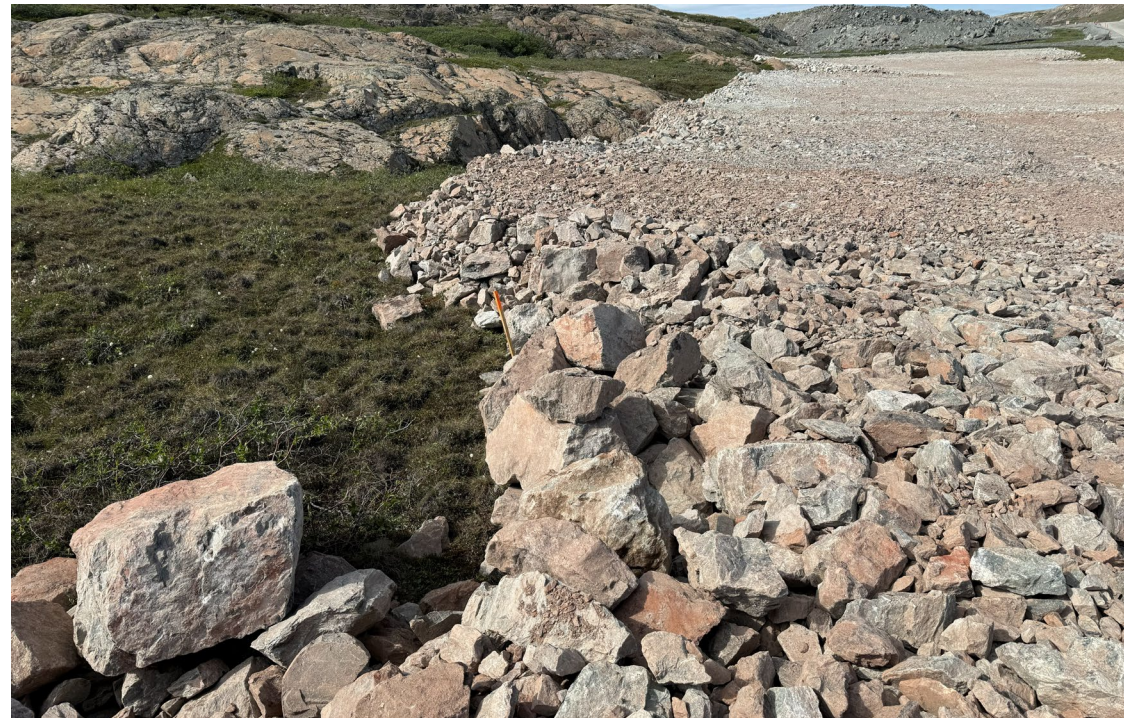
Photo 21: New laydown and Sewage Treatment Plant pad under construction

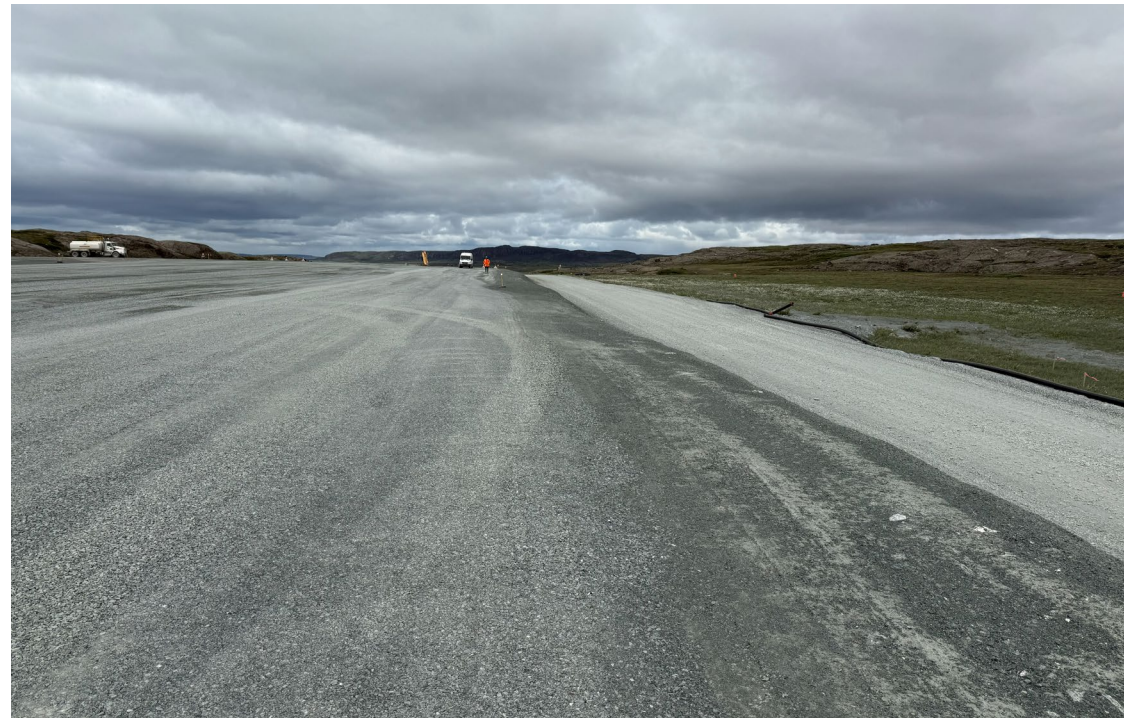
Photo 25: Airstrip east shoulder, looking north

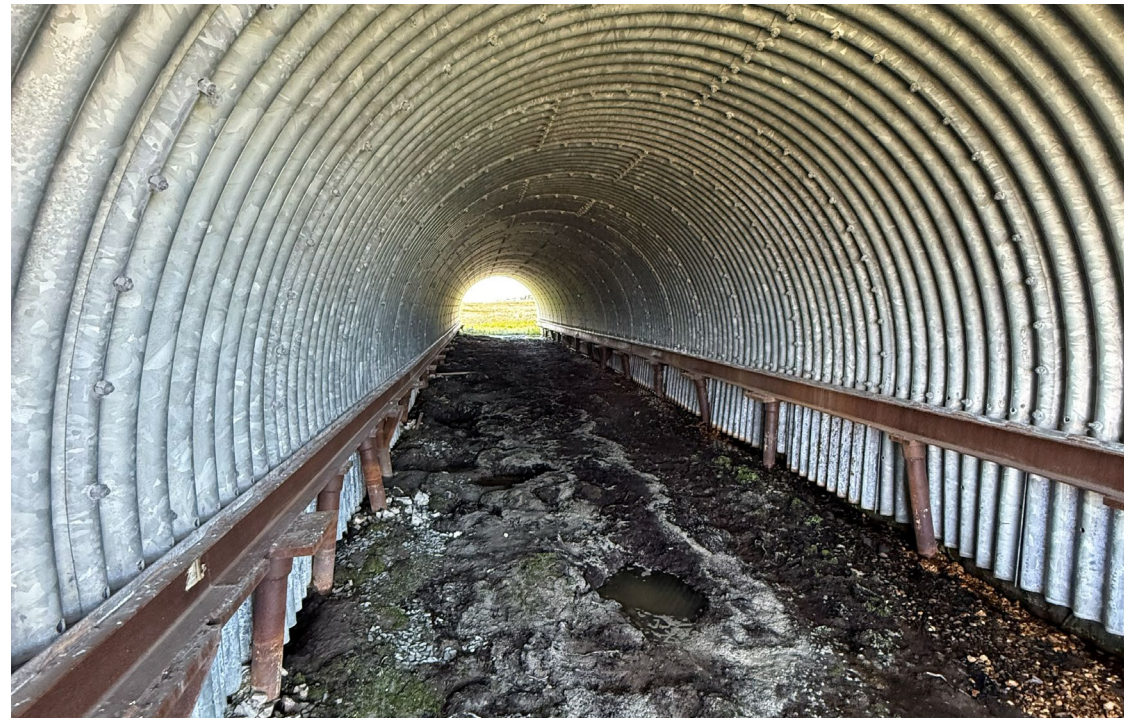
Photo 29: Doris-Madrid Road culvert inspection

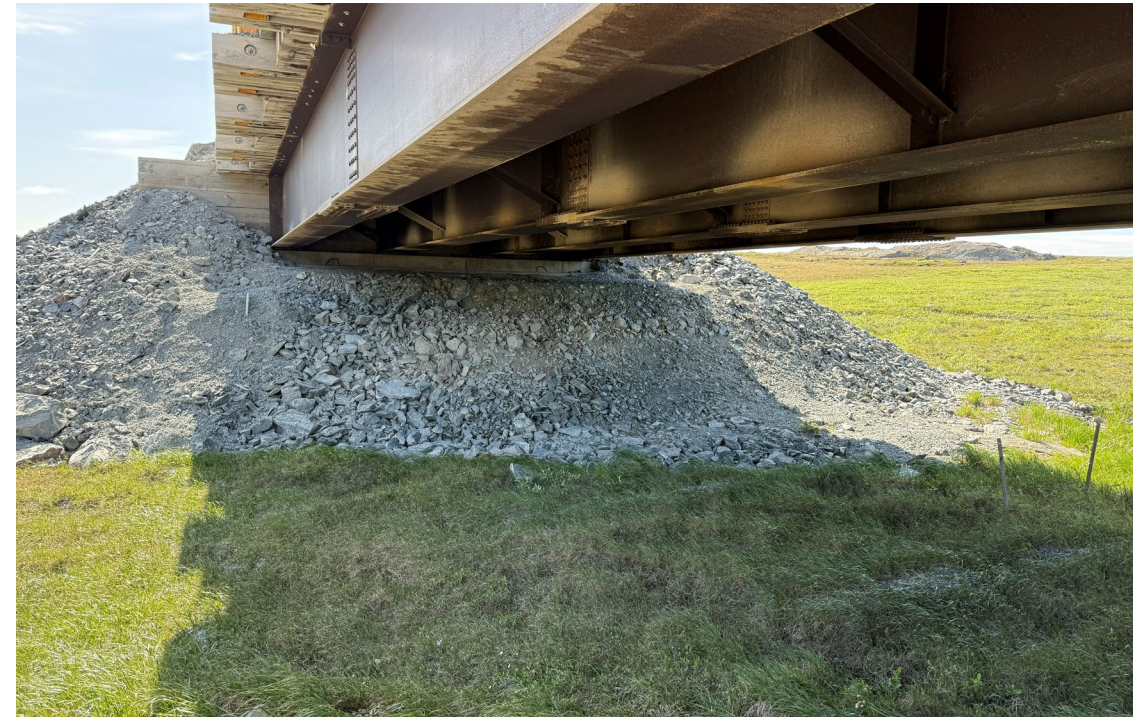
Photo 30: Doris-Madrid Road bridge 2/3 abutment inspection

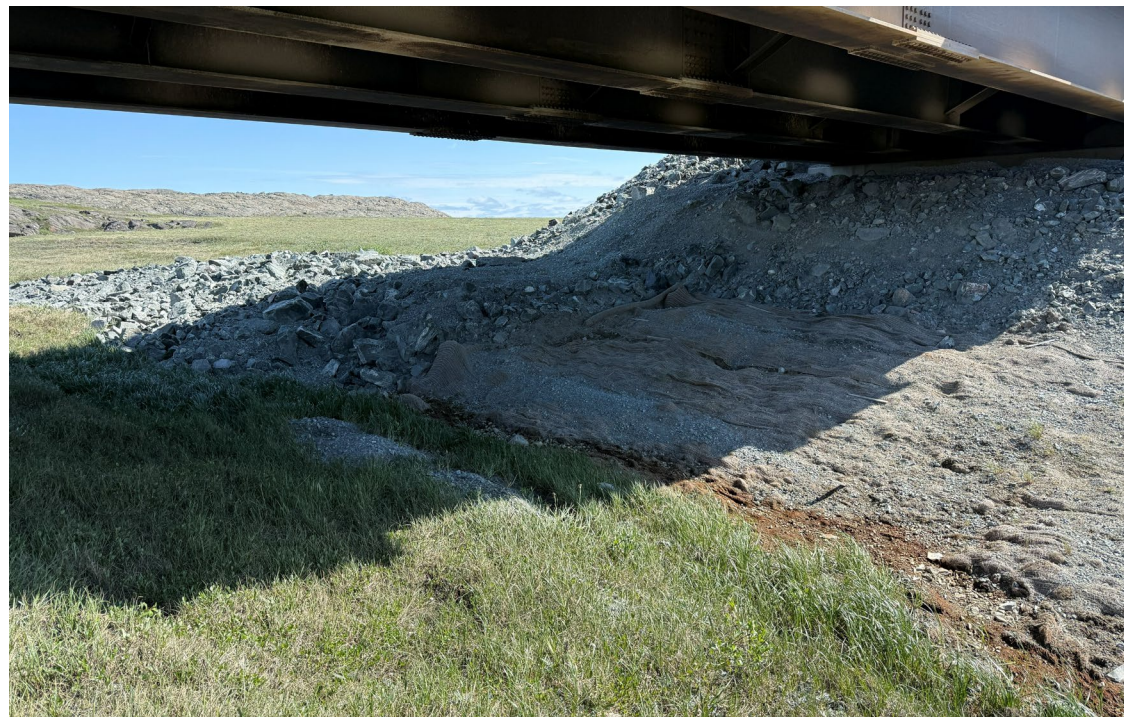
Photo 31: Doris-Madrid Road bridge 2/3 abutment inspection

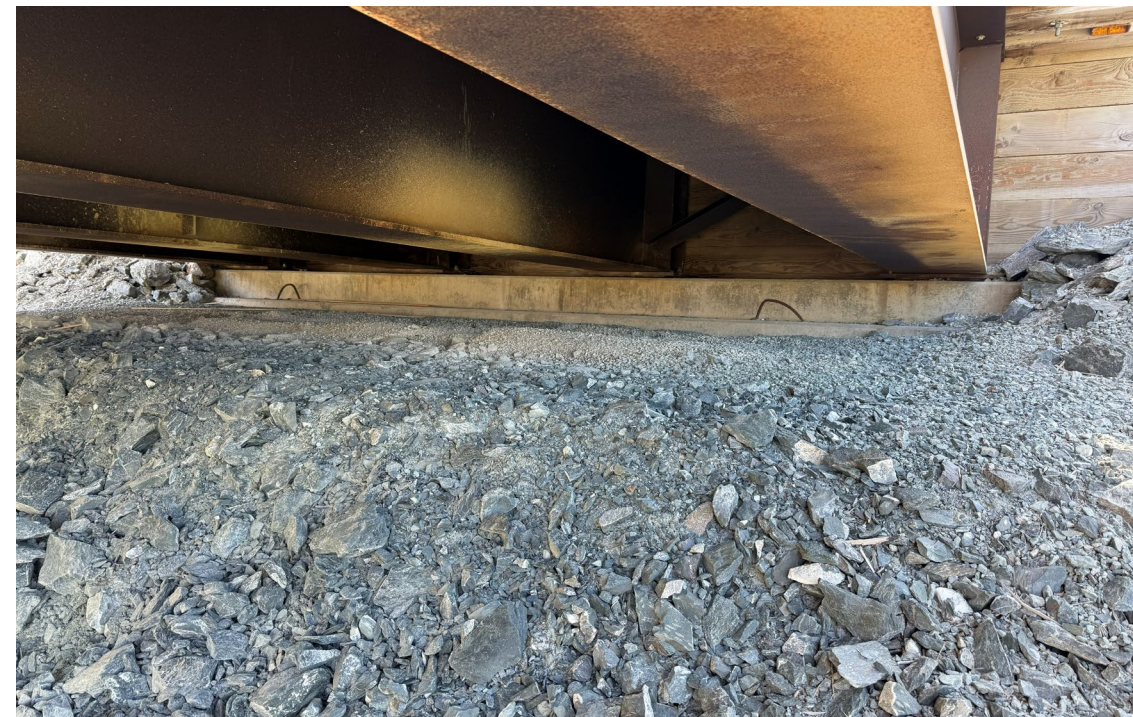
Photo 32: Doris-Madrid Road bridge 2/3 abutment inspection

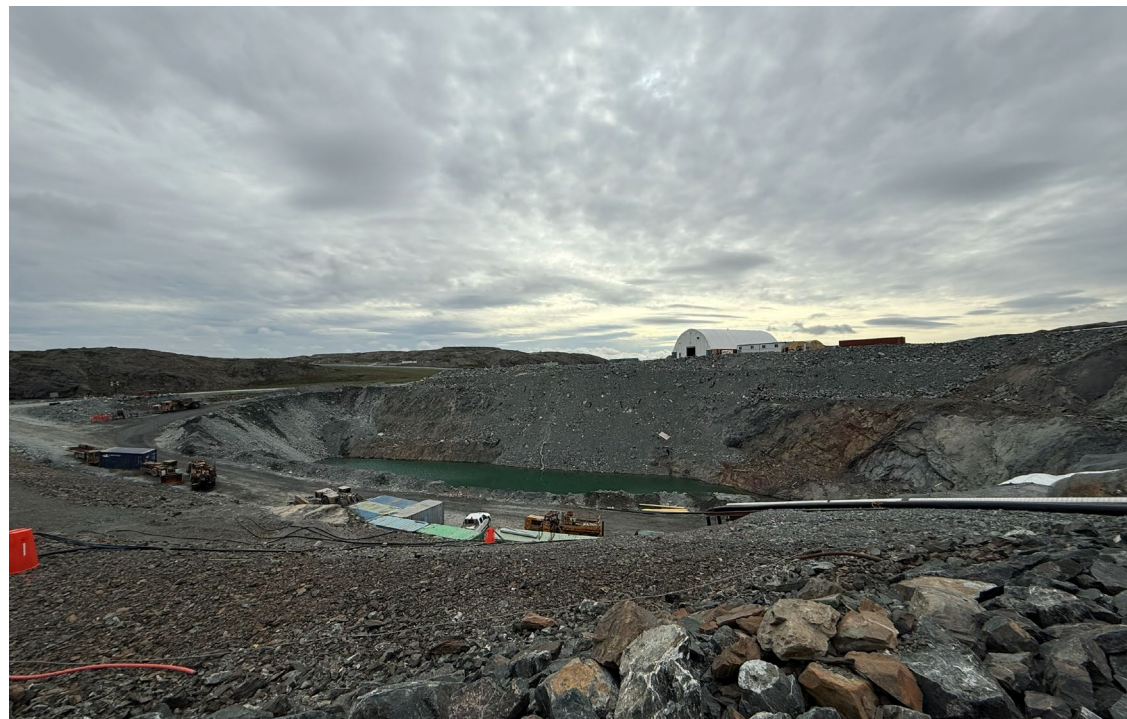
Photo 35: Naartok East pit inspection
