2025 Annual Geotechnical Inspection – Doris Tailings Impoundment Area

Hope Bay Mine, Nunavut, Canada
Agnico Eagle Mines Limited

SRK Consulting (Canada) Inc. ■ CAPR003759 ■ March 2026

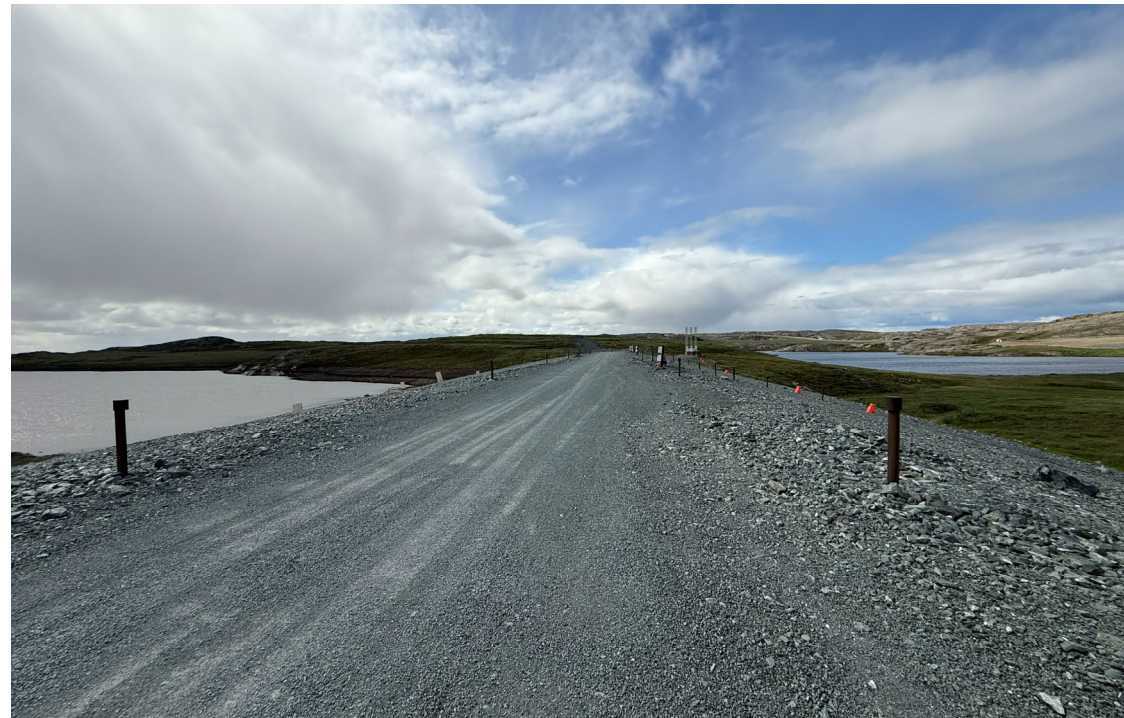
Photo 1: North Dam Crest Overview

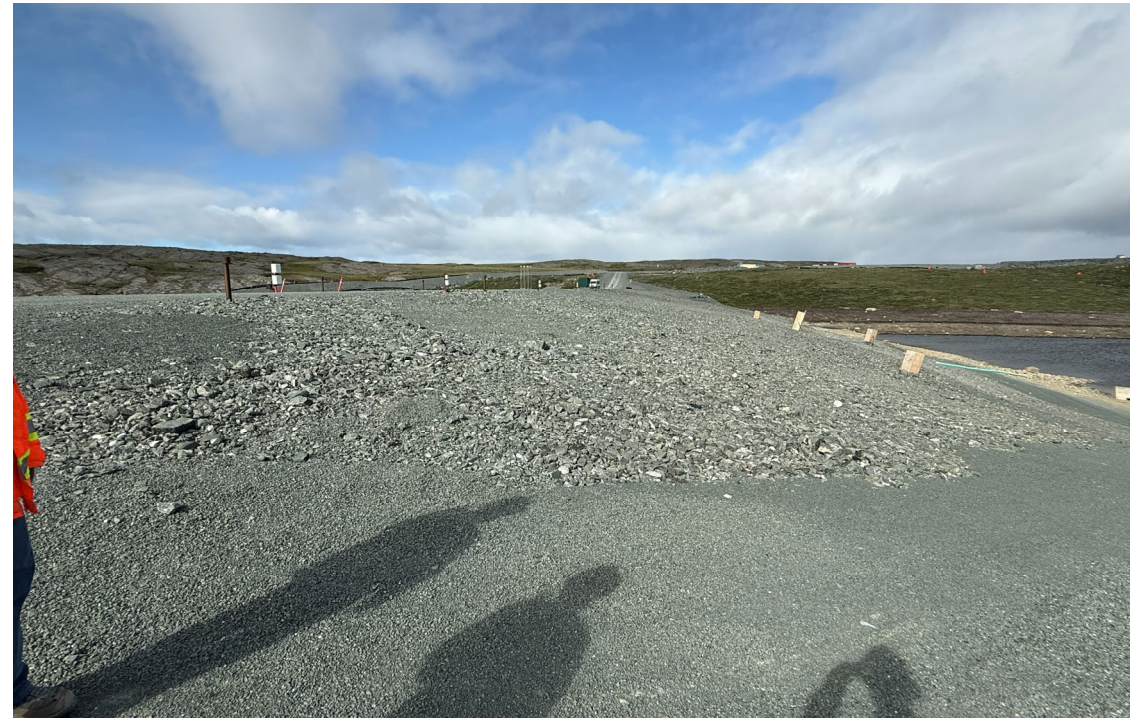
Photo 2: North Dam Upstream Face

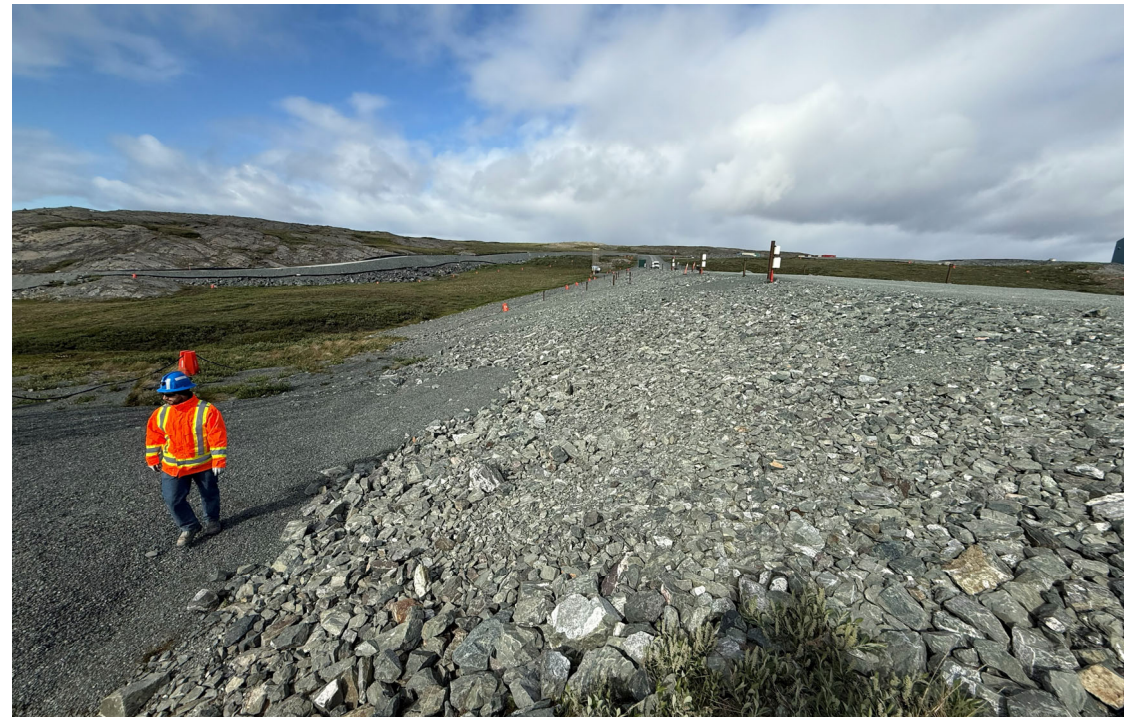
Photo 3: North Dam Downstream Face

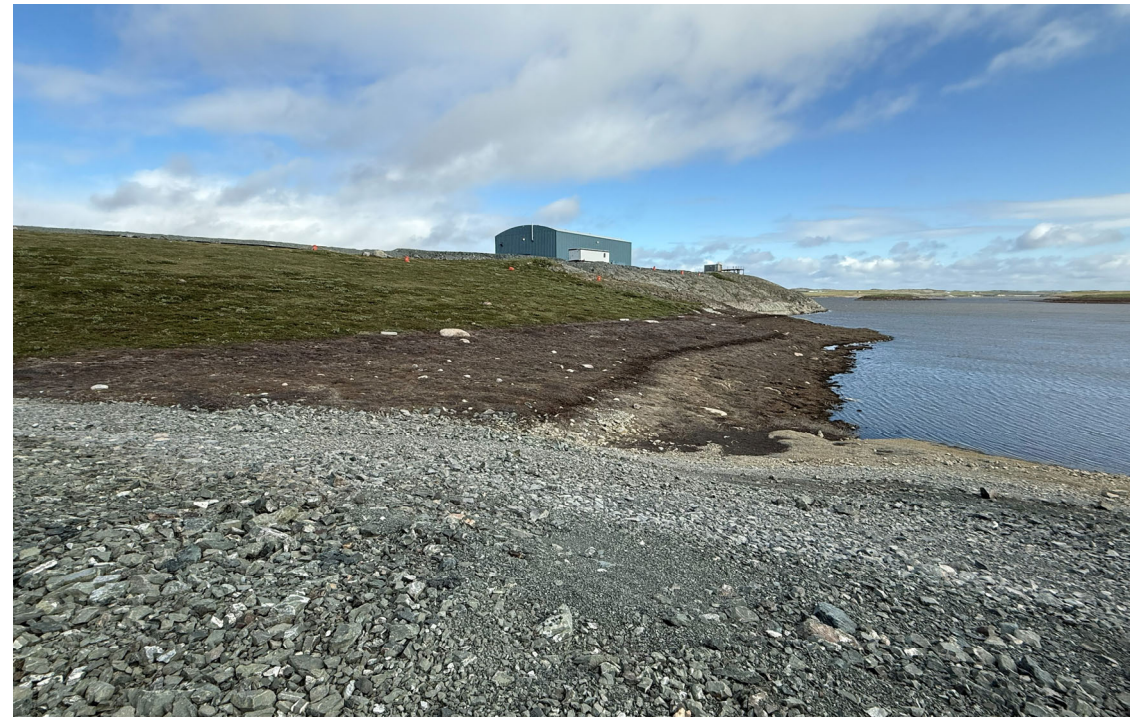
Photo 4: North Dam Upstream Toe Tundra Die-Back

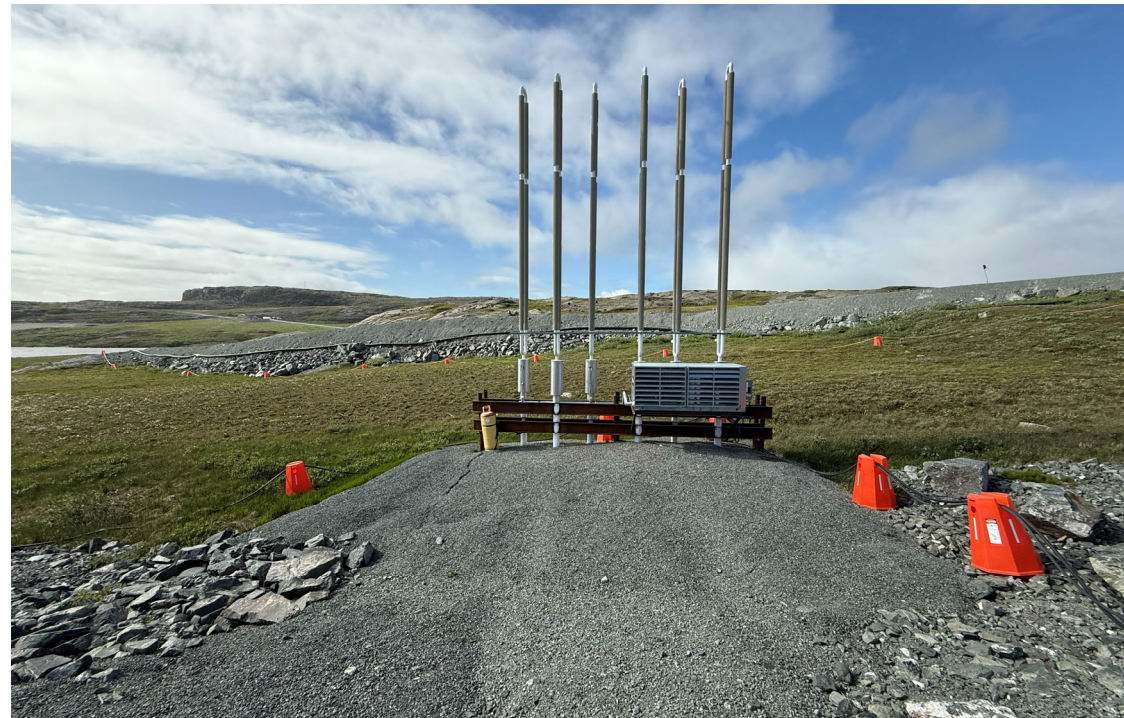
Photo 5: North Dam North Thermosyphon Bank

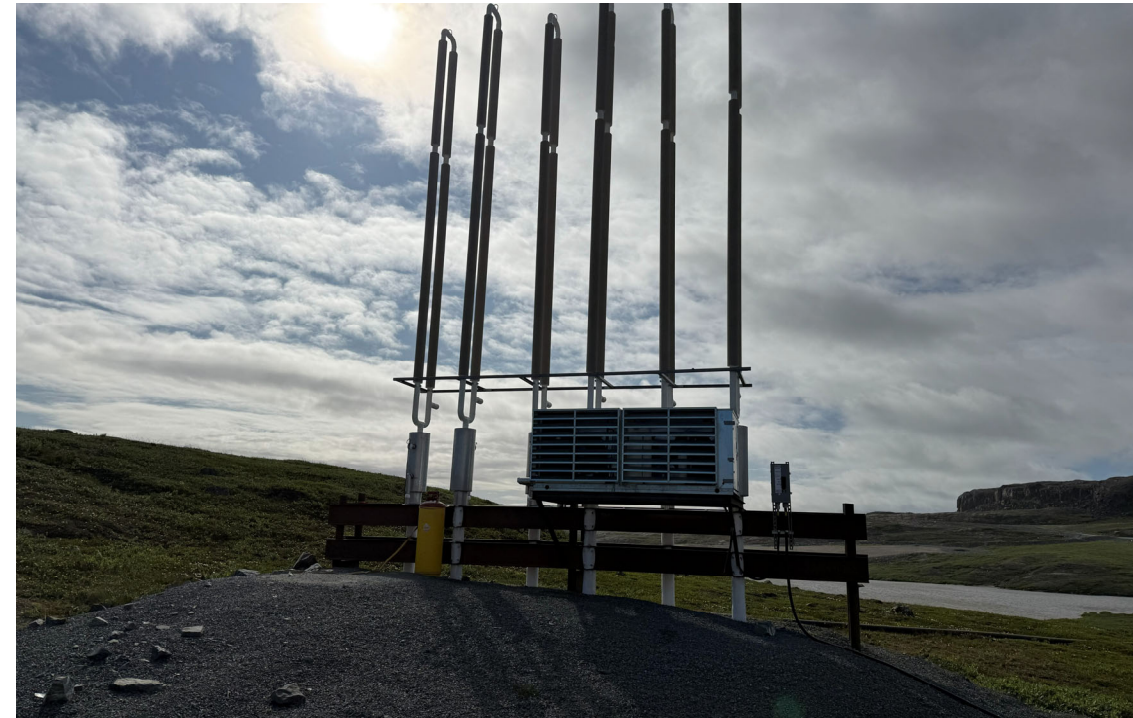
Photo 6: North Dam South Thermosyphon Bank

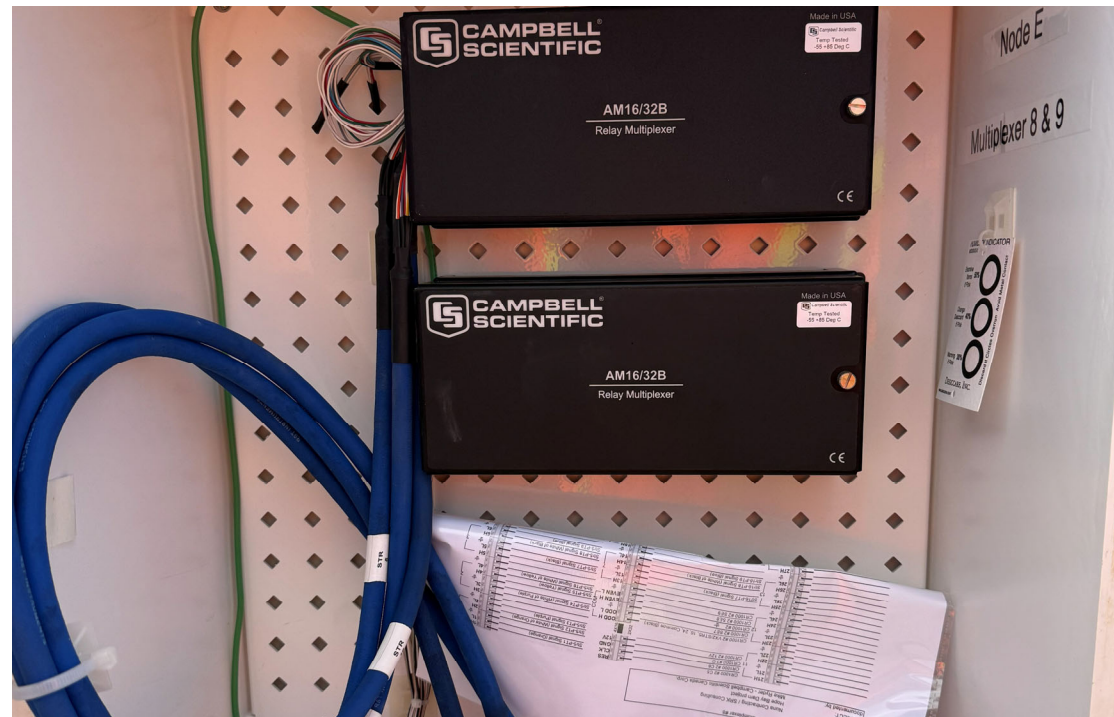
Photo 7: North Dam Instrumentation Inspection

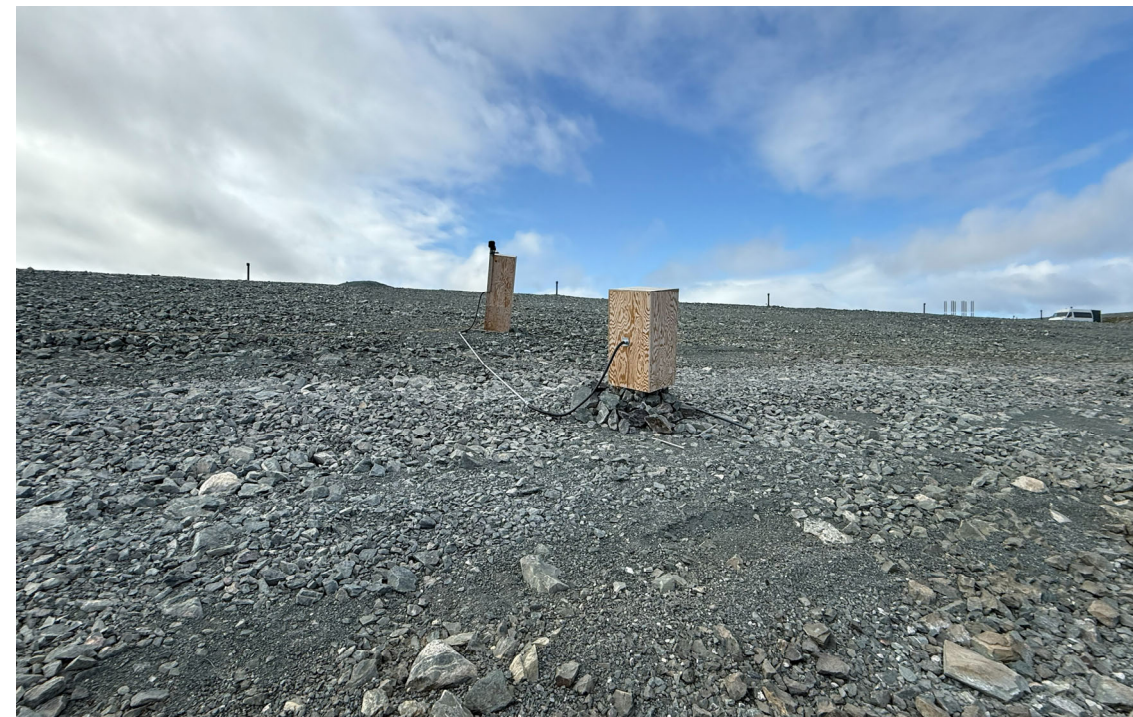
Photo 8: North Dam Instrumentation Inspection

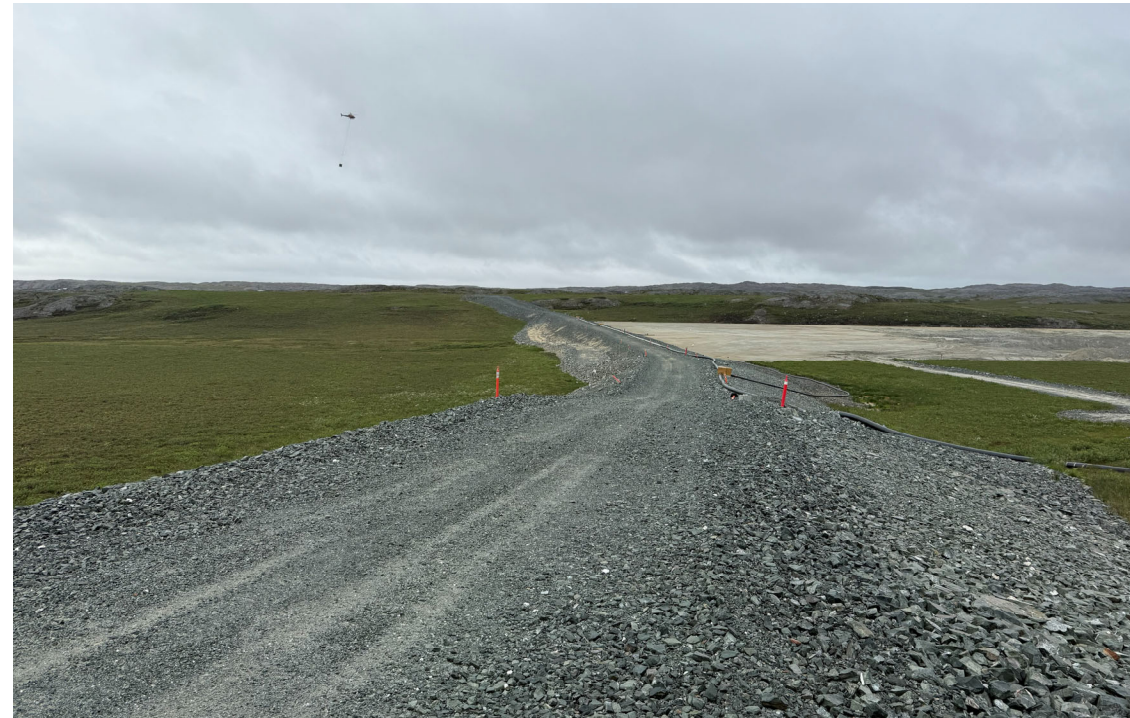
Photo 10: South Dam Crest Overview

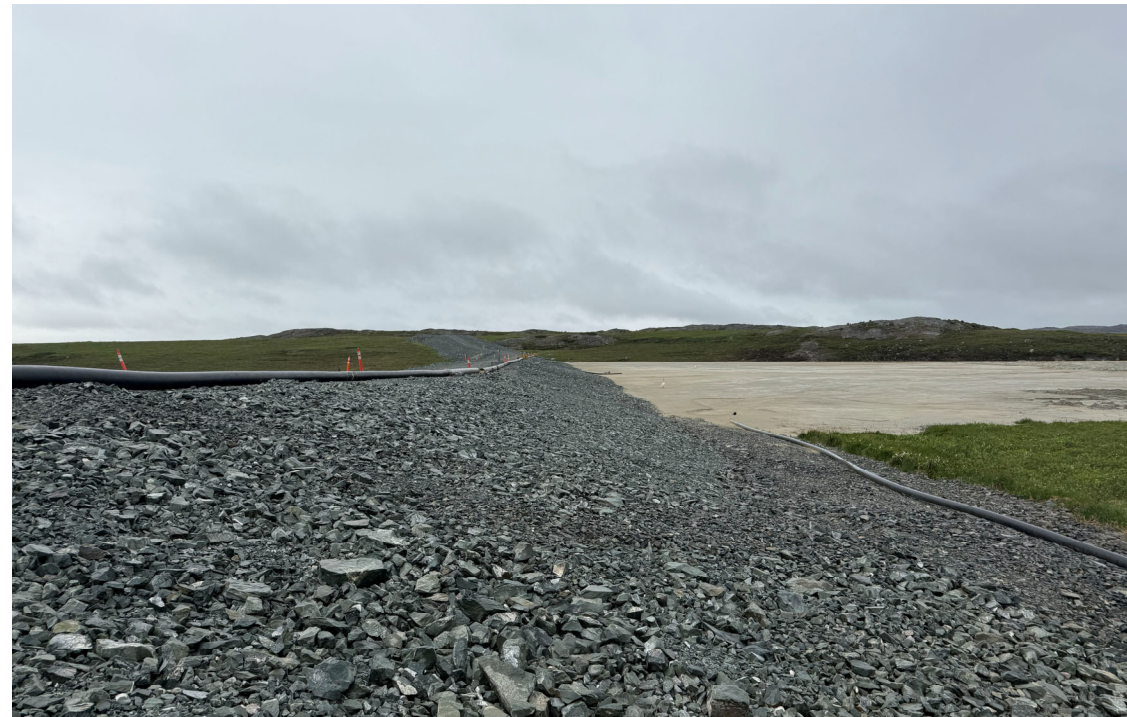
Photo 11: North Dam Upstream Face

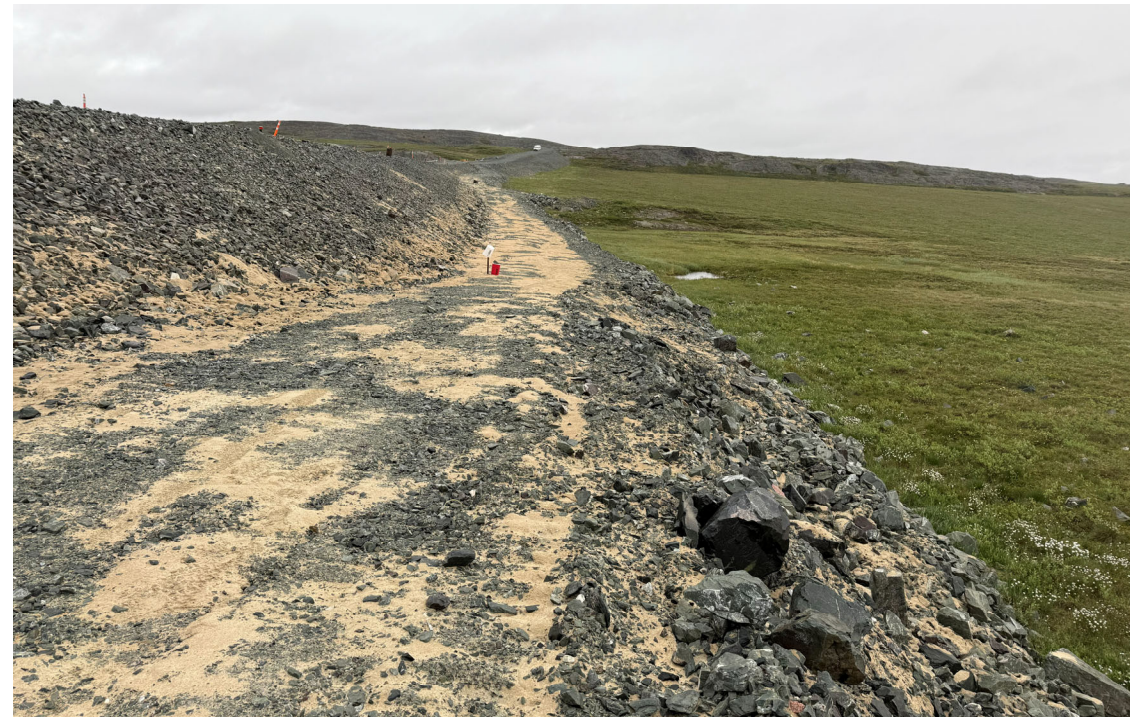
Photo 12: South Dam Downstream Toe Berm

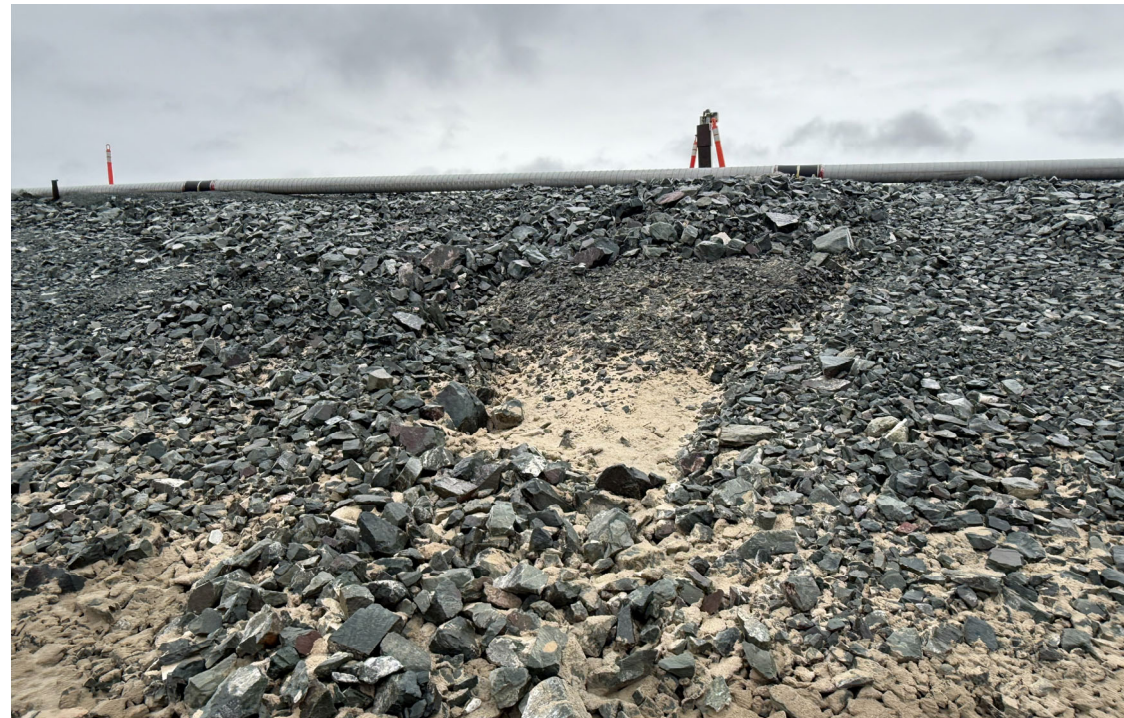
Photo 13: South Dam Downstream Face Excavator Mark

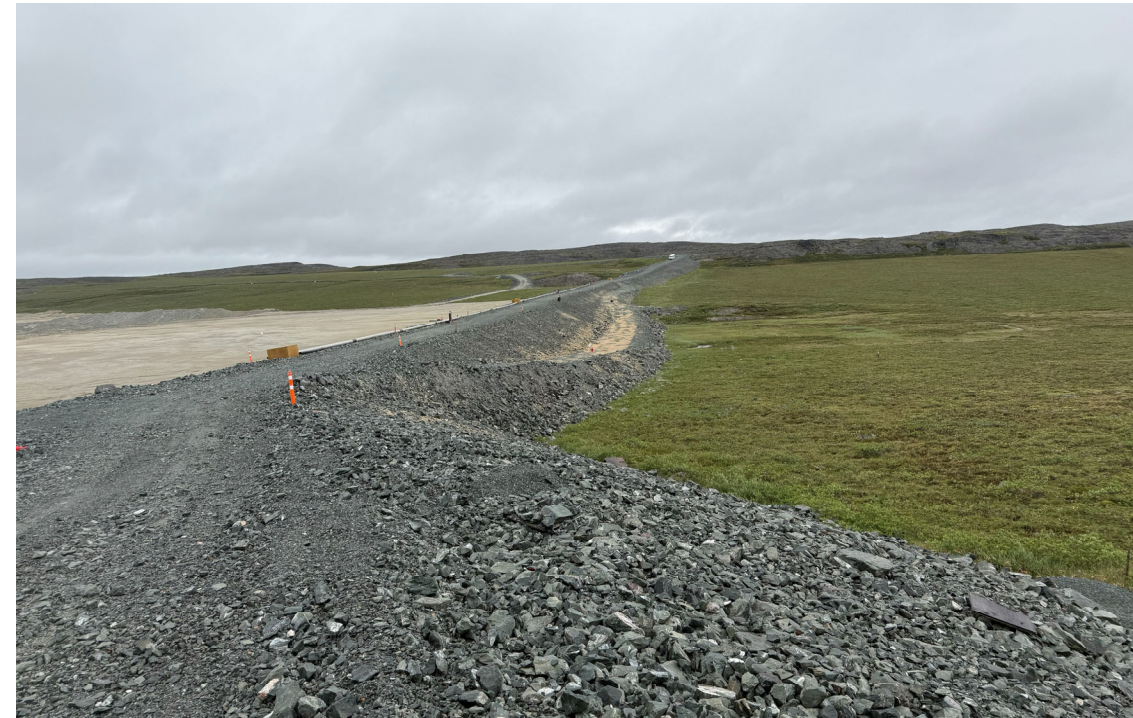
Photo 14: South Dam Downstream Toe Berm

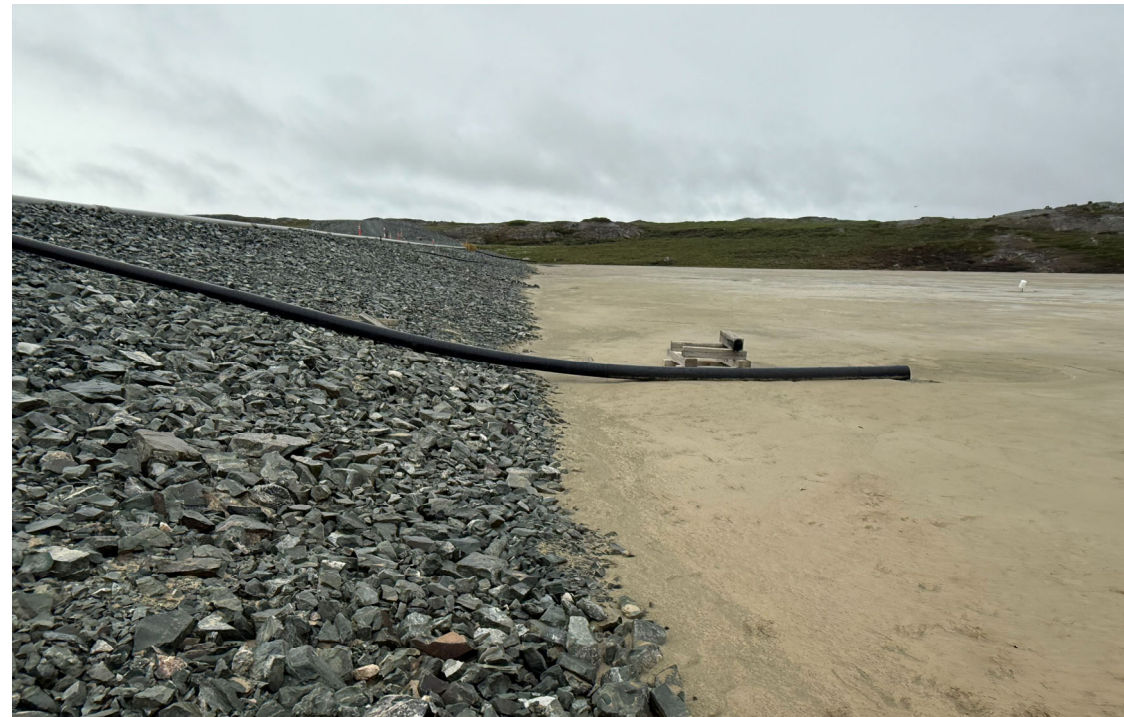
Photo 15: South Dam Upstream Face

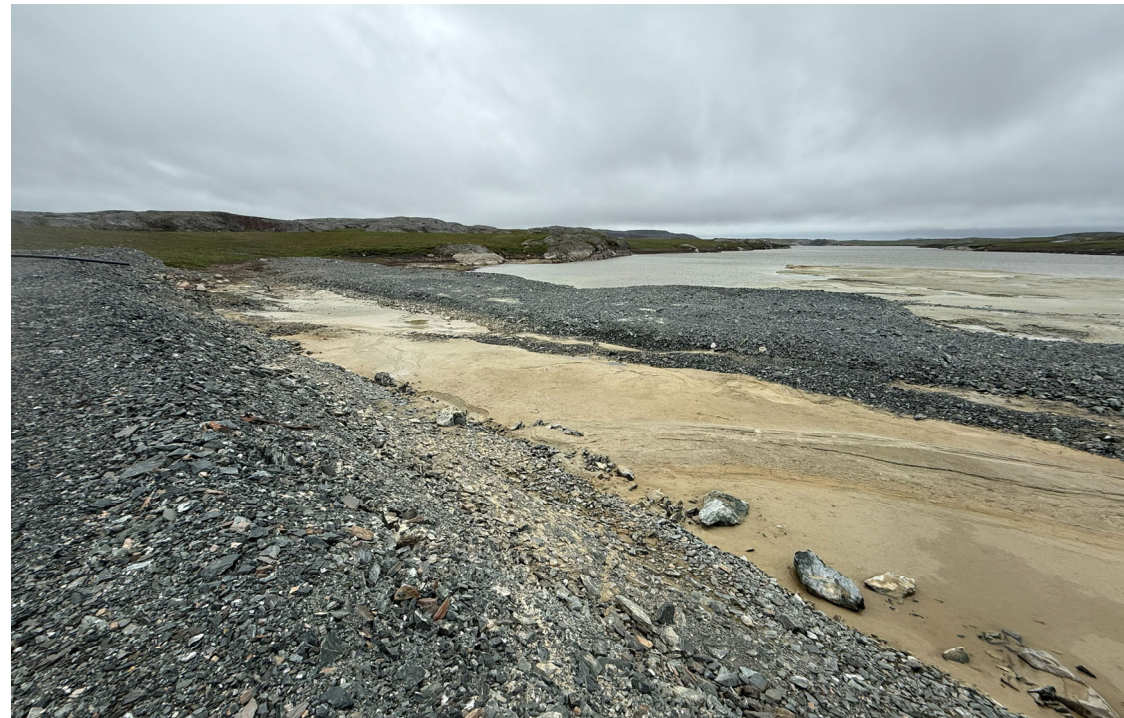
Photo 17: Interim Dike Downstream Slope Overview

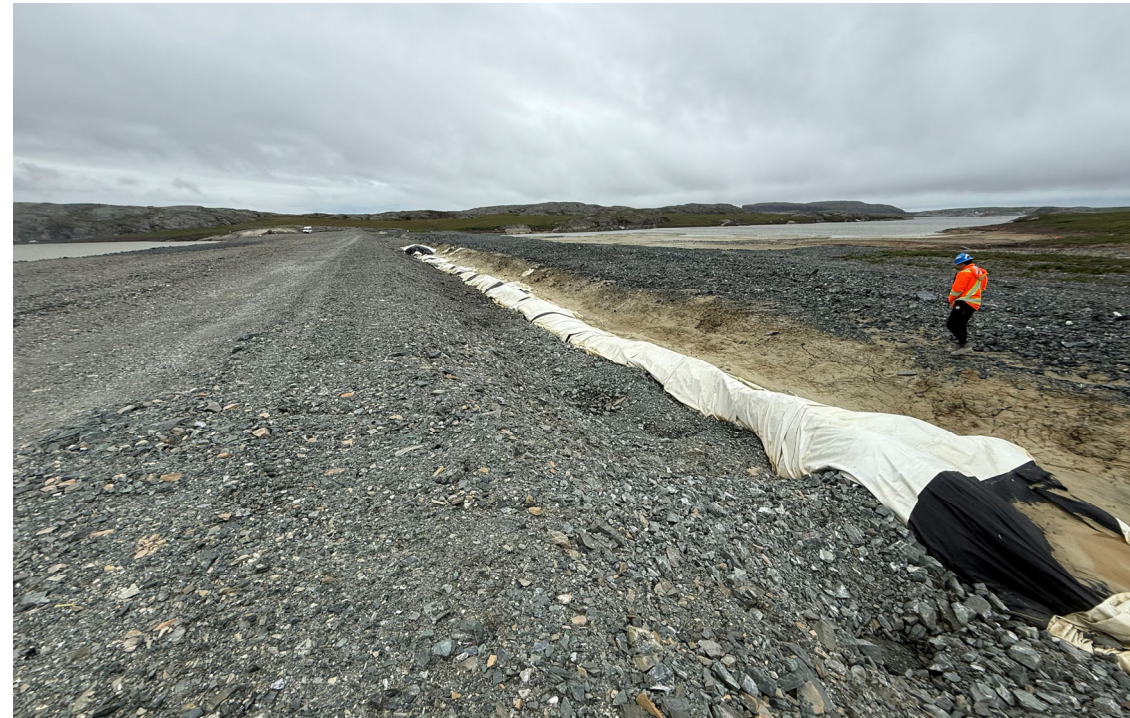
Photo 18: Interim Dike Overview and Former Aquadam Location (Looking West).

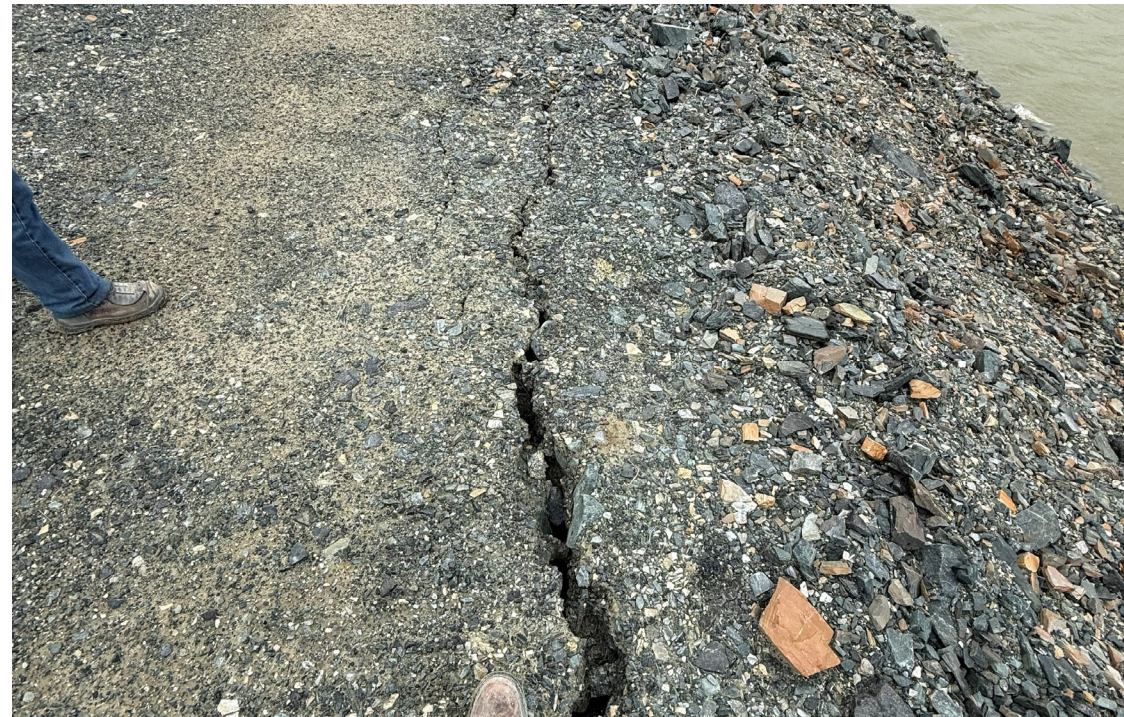
Photo 19: Interim Dike Upstream Crest Tension Cracking

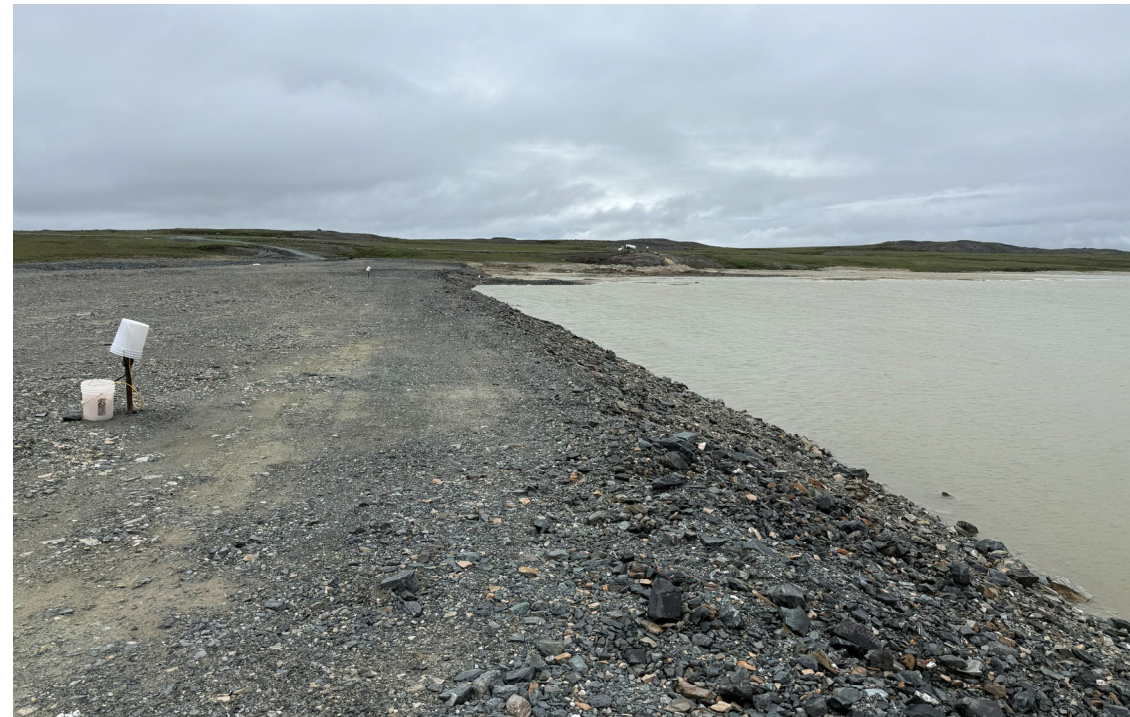
Photo 20: Interim Dike Upstream Face

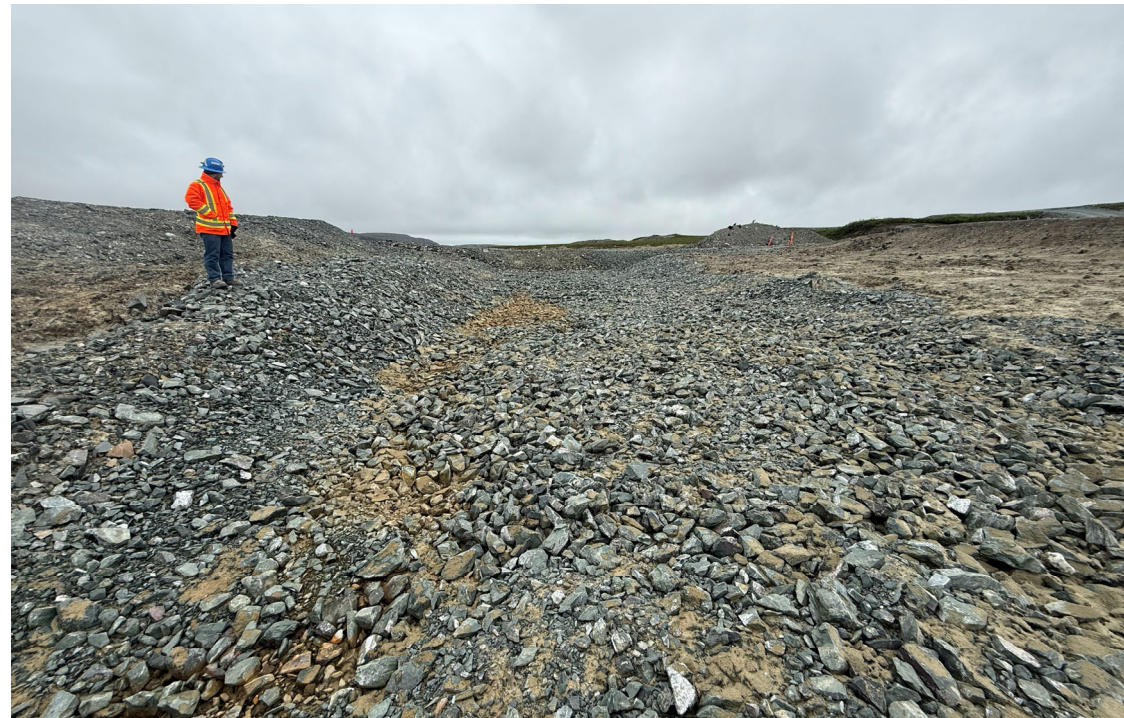
Photo 21: Interim Dike Water Elevation Control Channel

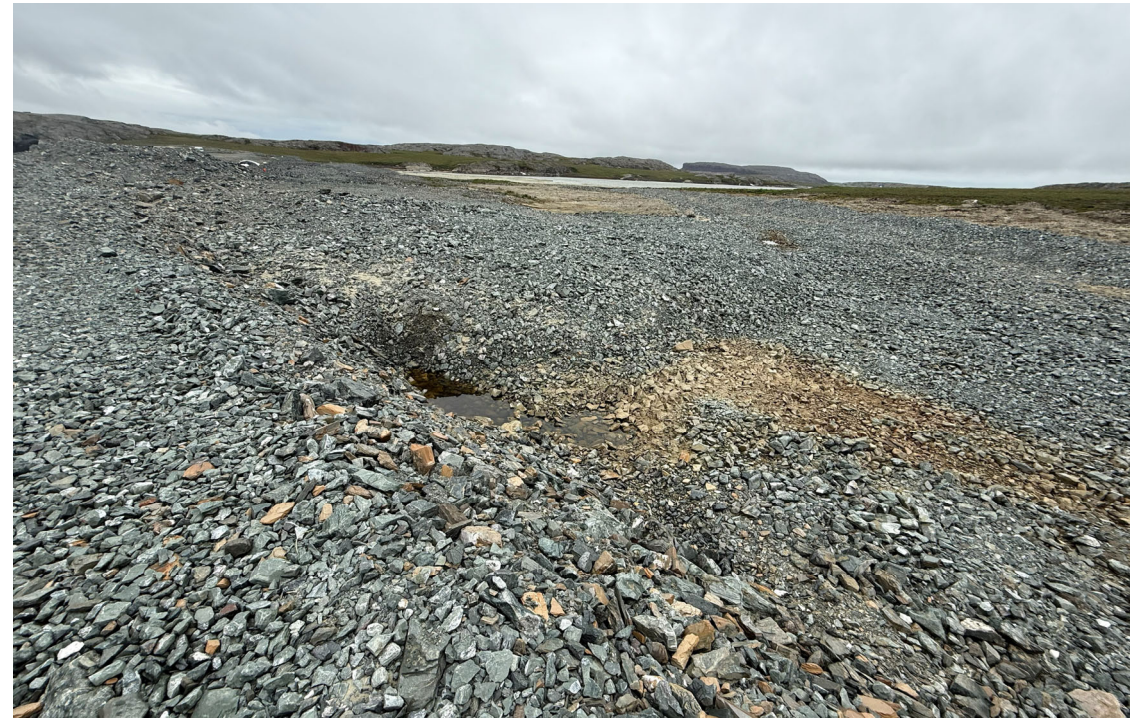
Photo 22: Interim Dike Interim Dike Water Elevation Control Channel

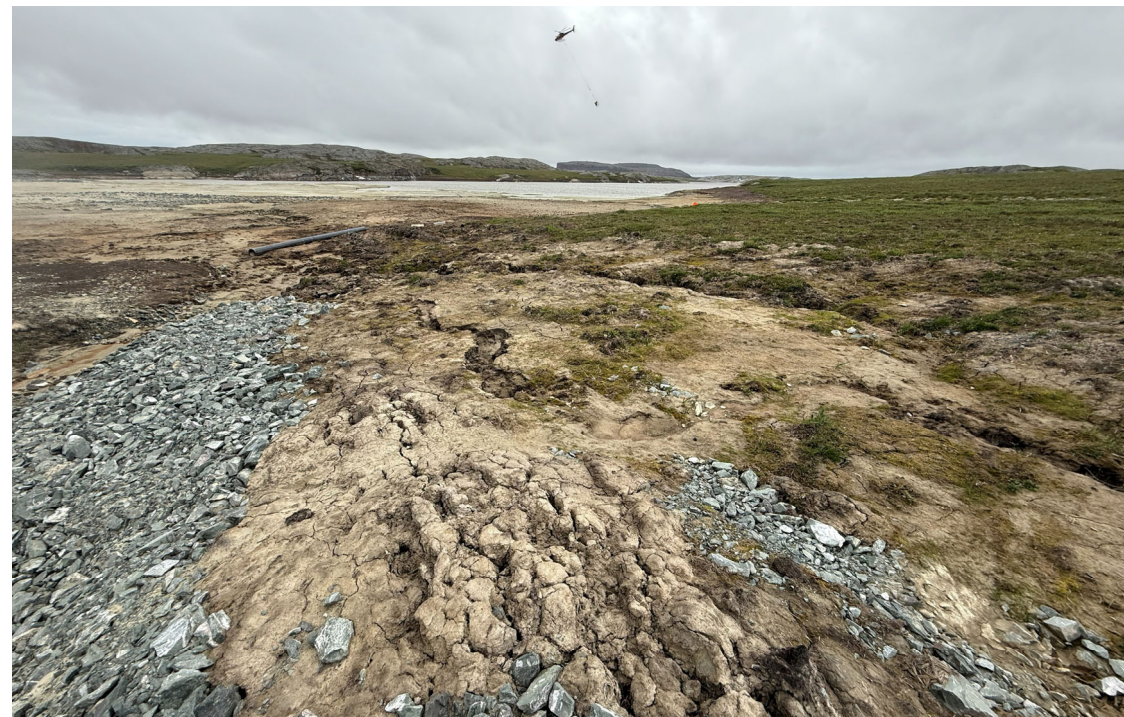
Photo 23: Interim Dike Water Elevation Control Channel shoulder, erosion near outlet

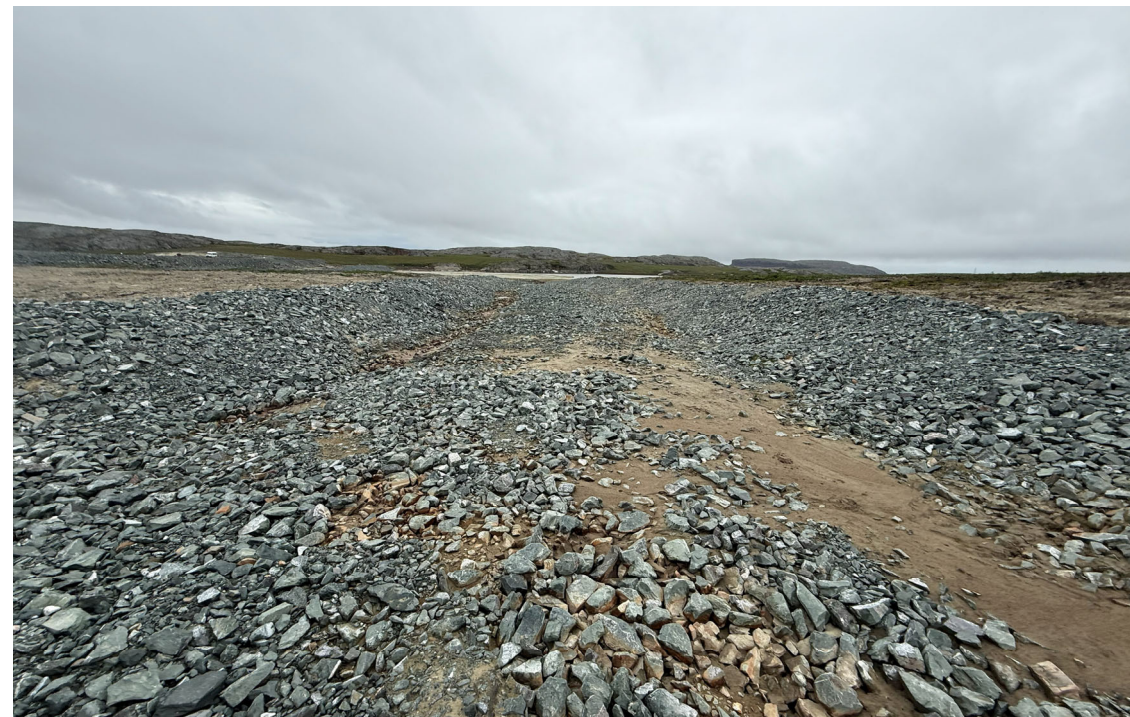
Photo 24: Interim Dike Water Elevation Control Channel Base Near Invert

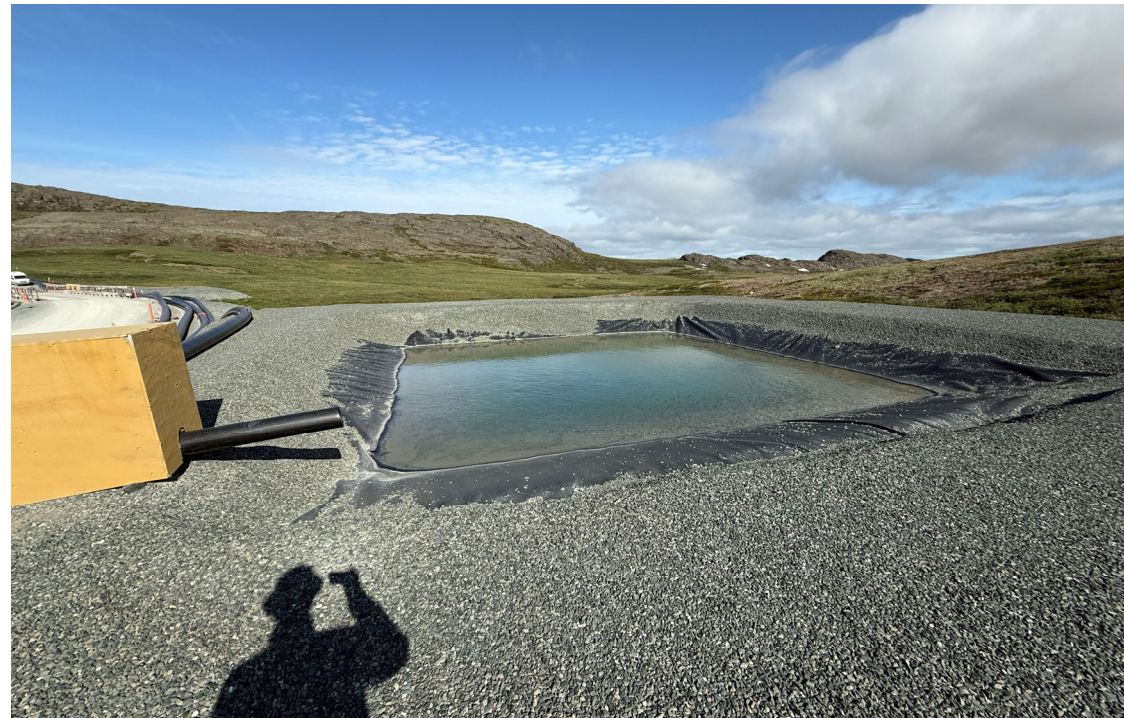
Photo 25: Eastern Emergency Dump Catch Basin

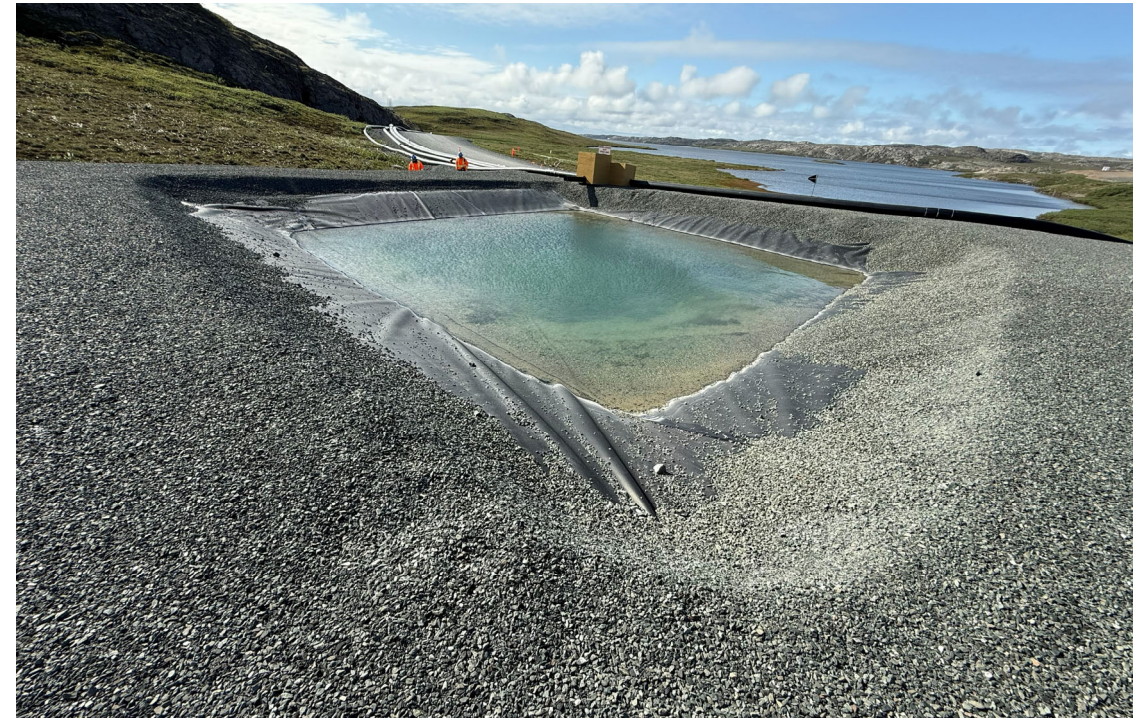
Photo 26: Eastern Emergency Dump Catch Basin

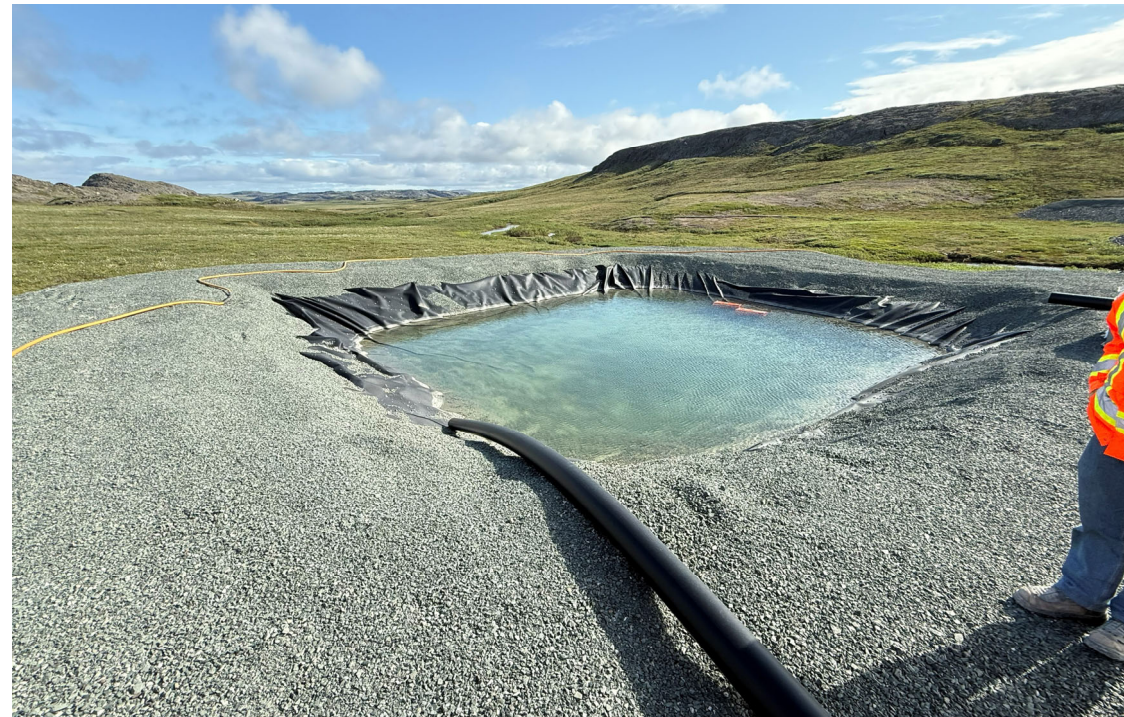
Photo 27: Western Emergency Dump Catch Basin

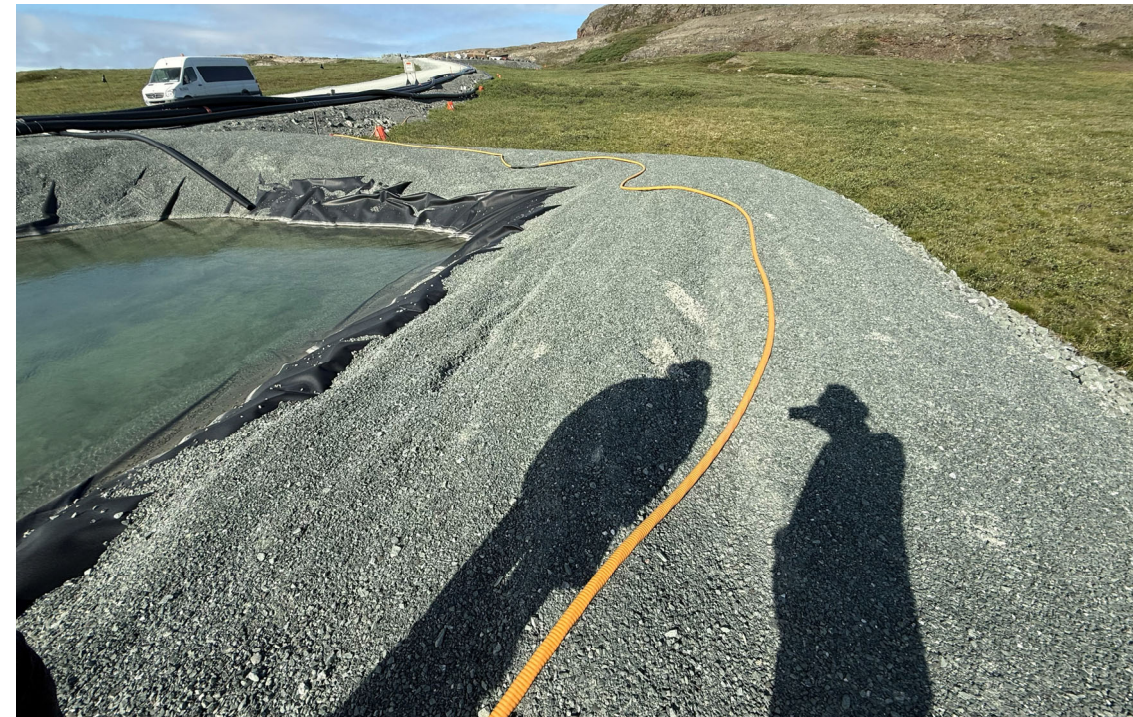
Photo 28: Western Emergency Dump Catch Basin Slope

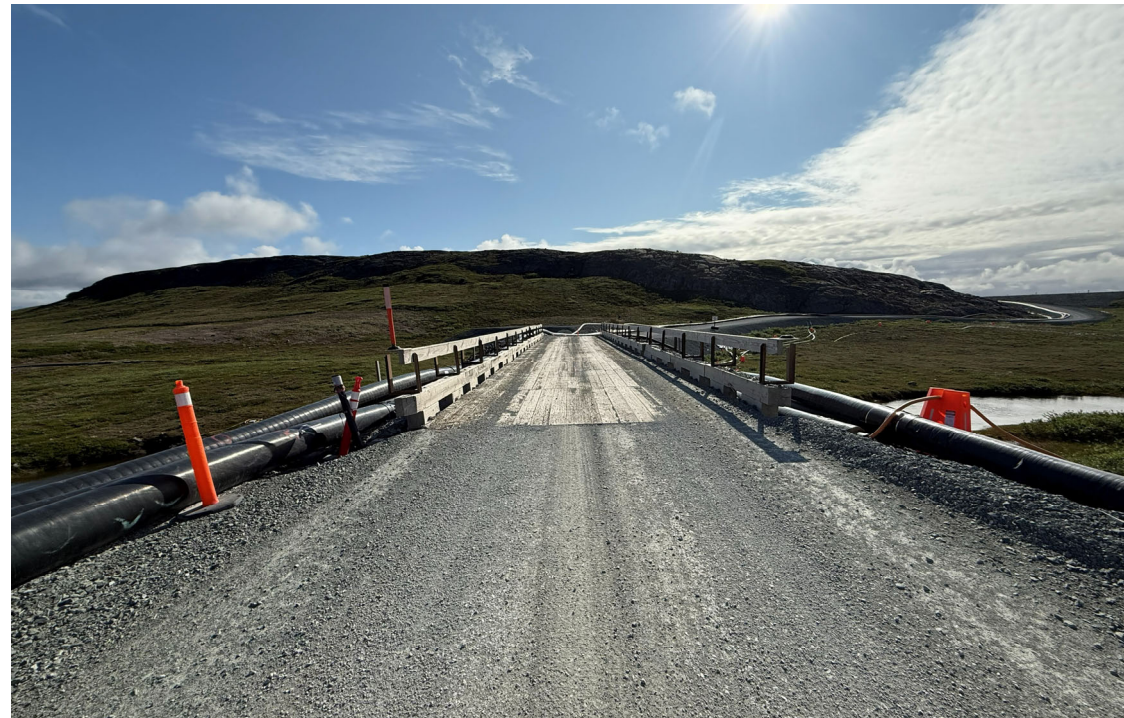
Photo 29: Doris Bridge Overview

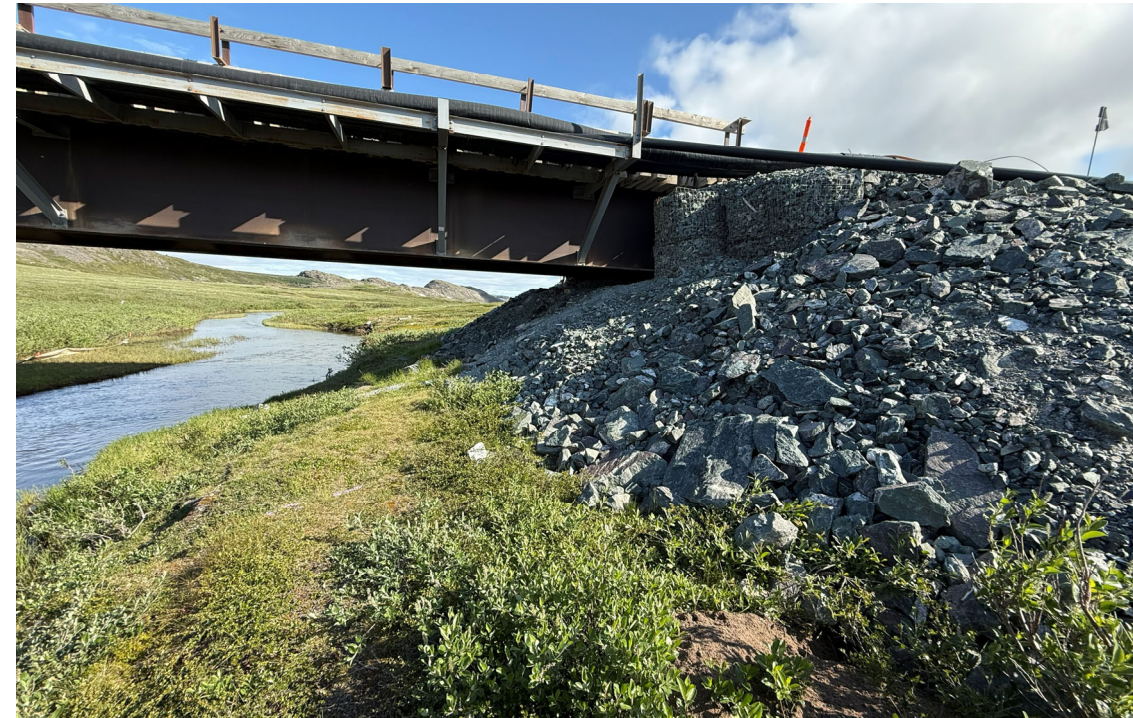
Photo 30: Doris Bridge Abutment and Gabion Inspection
