2025 Annual Geotechnical Inspection – Doris Tailings Impoundment Area

Hope Bay Mine, Nunavut, Canada
Agnico Eagle Mines Limited

SRK Consulting (Canada) Inc. ■ CAPR003759 ■ March 2026

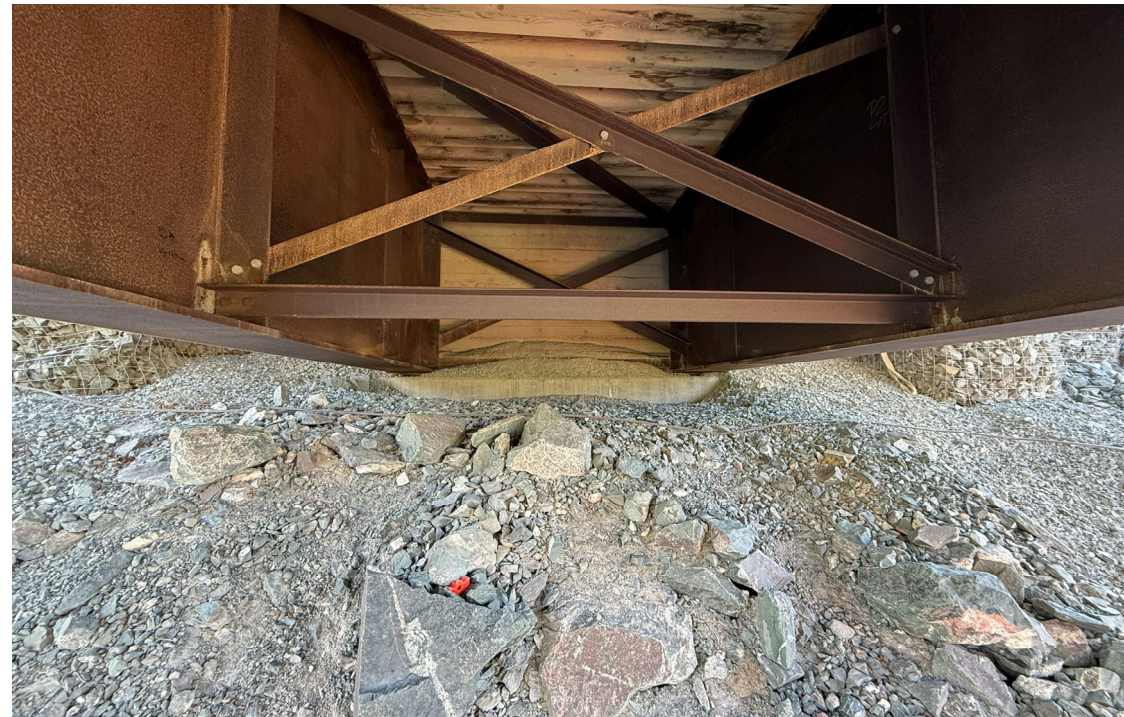
Photo 31: Doris Bridge Inspection

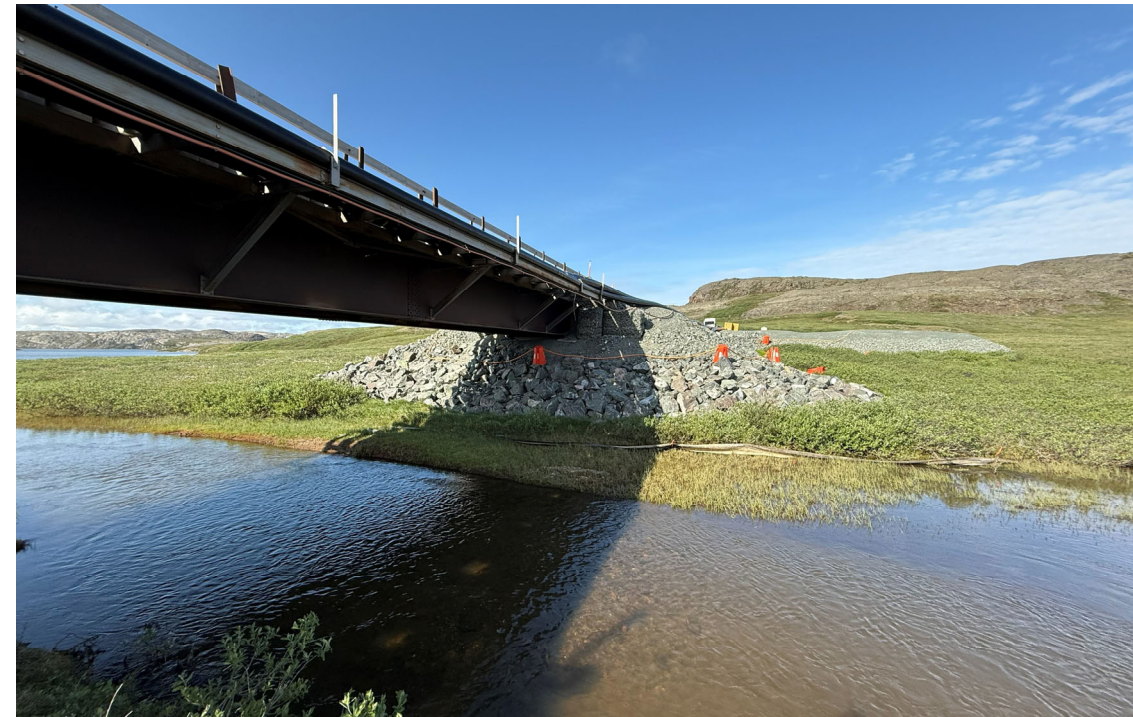
Photo 32: : Doris Bridge Overview Below the Deck

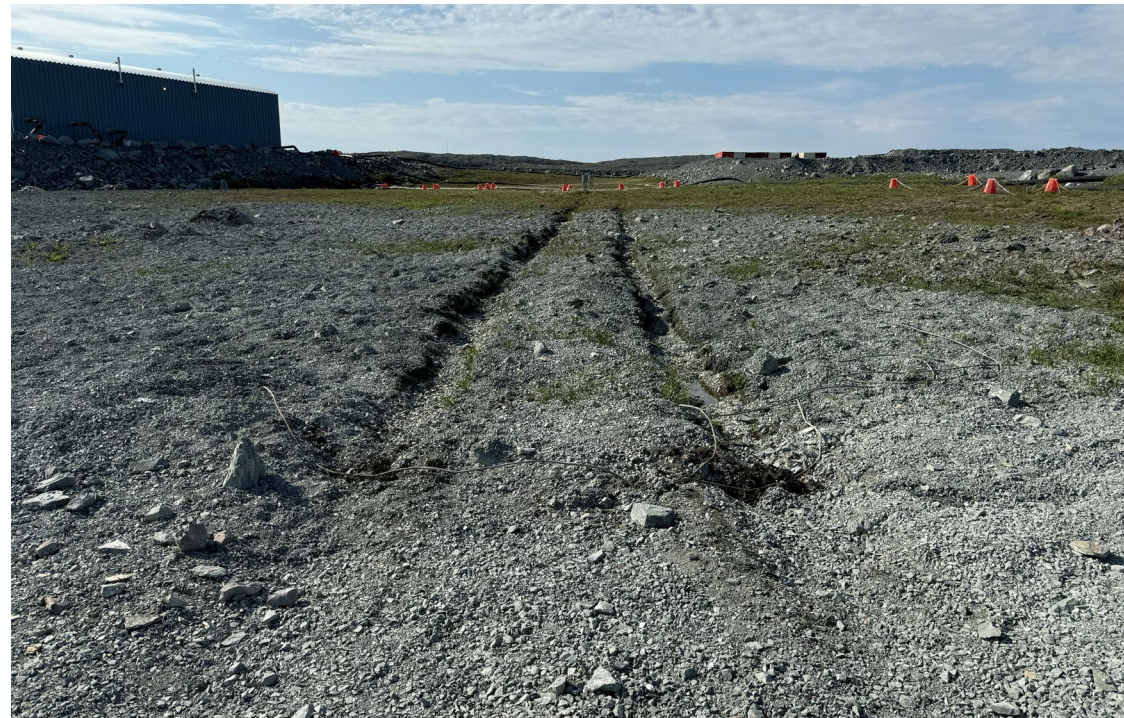
Photo 33: Disturbance in Tundra (Dozer Tracks)

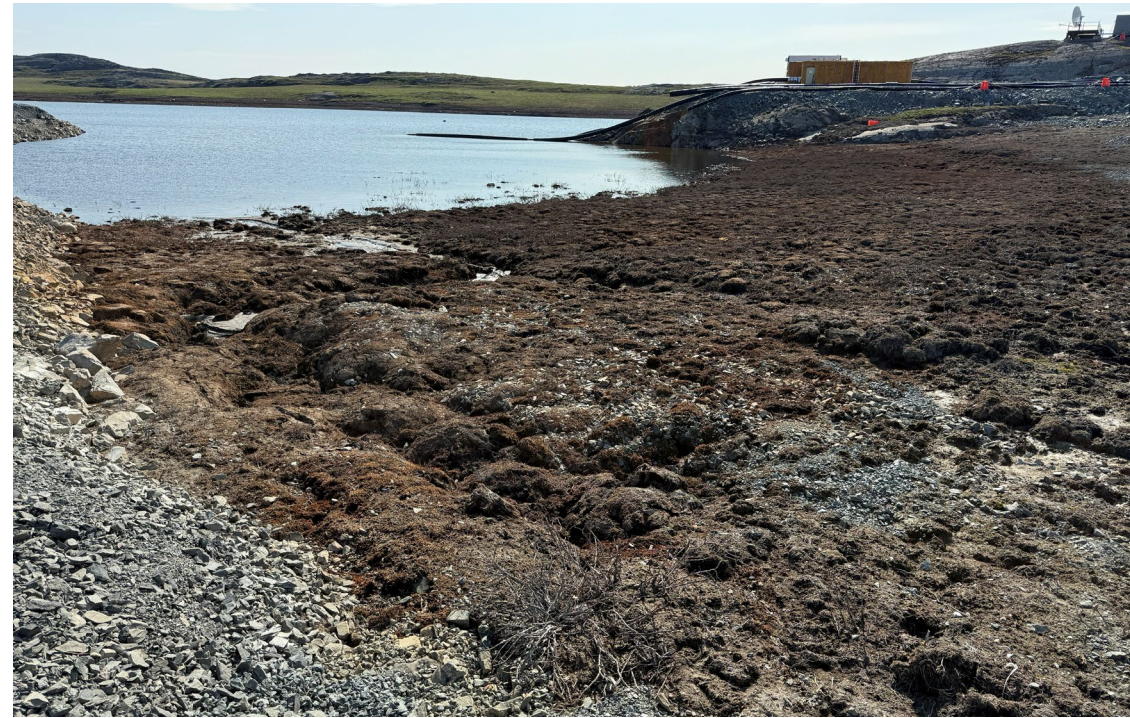
Photo 34: Shoreline Degradation near the previous Reclaim Jetty.

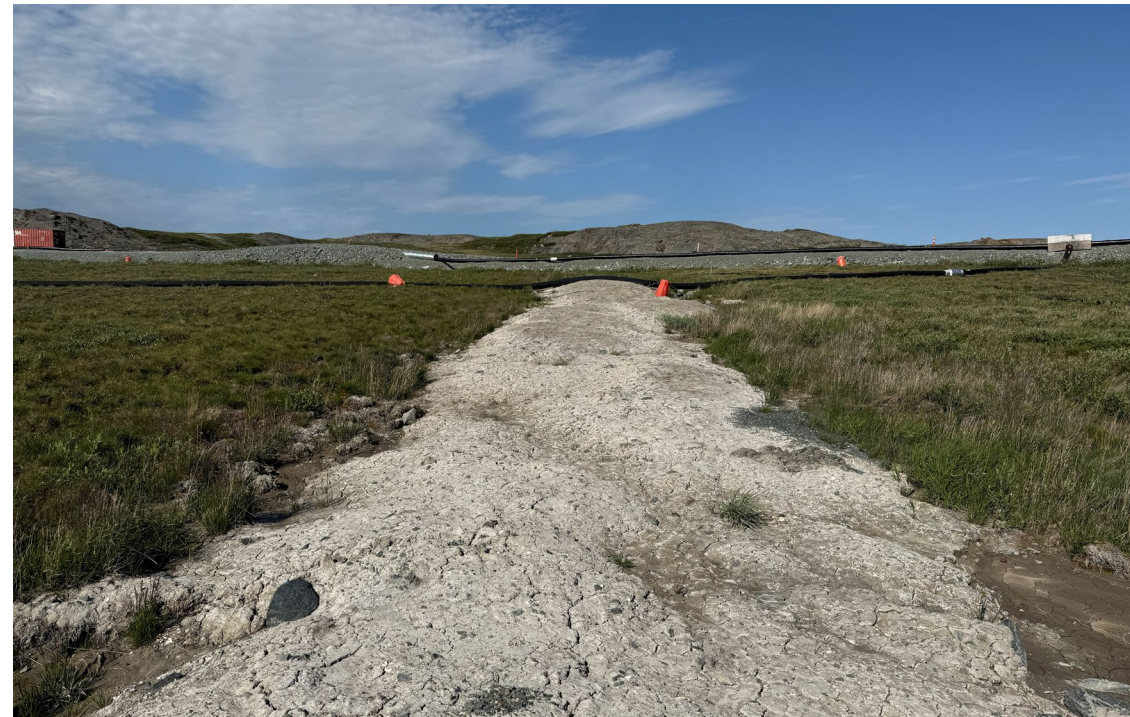
Photo 36: Presence of Waste Material
