APPENDIX 15 2025 REPORTABLE SPILLS

Re: Follow-up Report Spill #2025-007 – Release of 1,000 L of waste oil at the Meliadine Gold Project

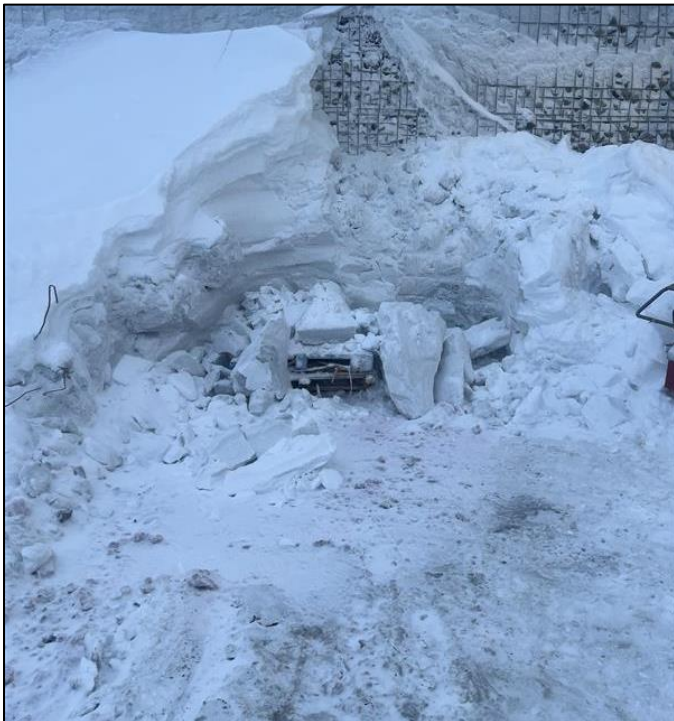
Photo 2: Spill location post remediation.

- A secondary containment will be installed at the primary crusher for storage of glycol and other hazardous materials.

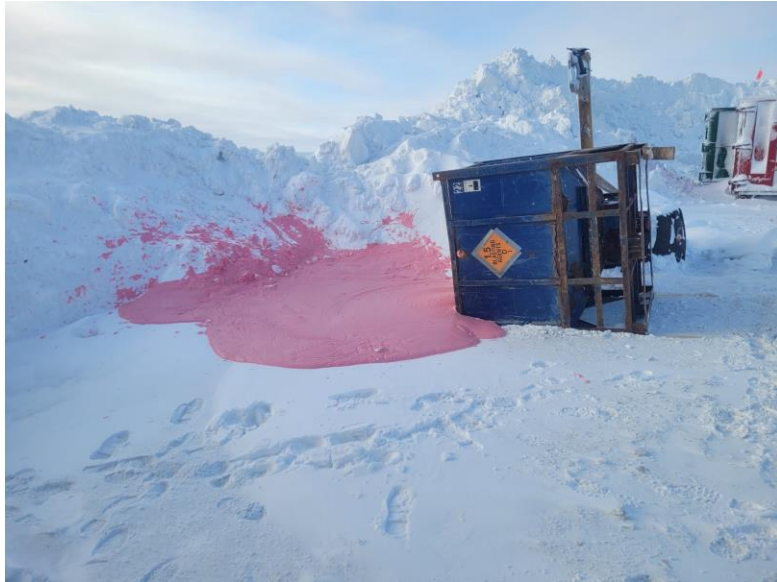
While loading the first bin on the rack, the operator initially thought it was placed too deep. To adjust its position, he attempted to re-lift the bin, causing the bin to move even deeper on the rack and making it impossible to insert the forks into the bin cradle. As he lifted the bin from the ends of the fork to gain more purchase, it began to pivot, causing the base plate to press against the bottom of the forks, which resulted in the base plate breaking and the bin tipping over.

Photo 1: Emulsion spill location, at the Dyno Nobel Laydown pad.

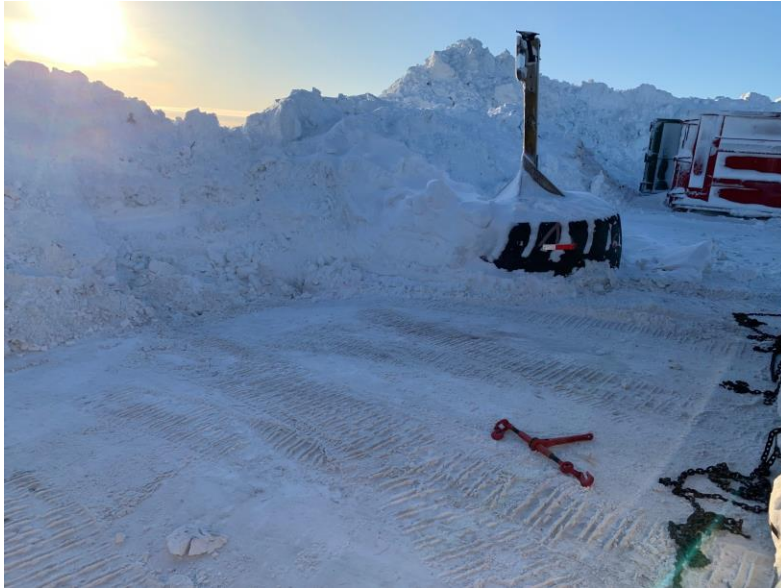
Photo 3: Emulsion spill location, post remediation.

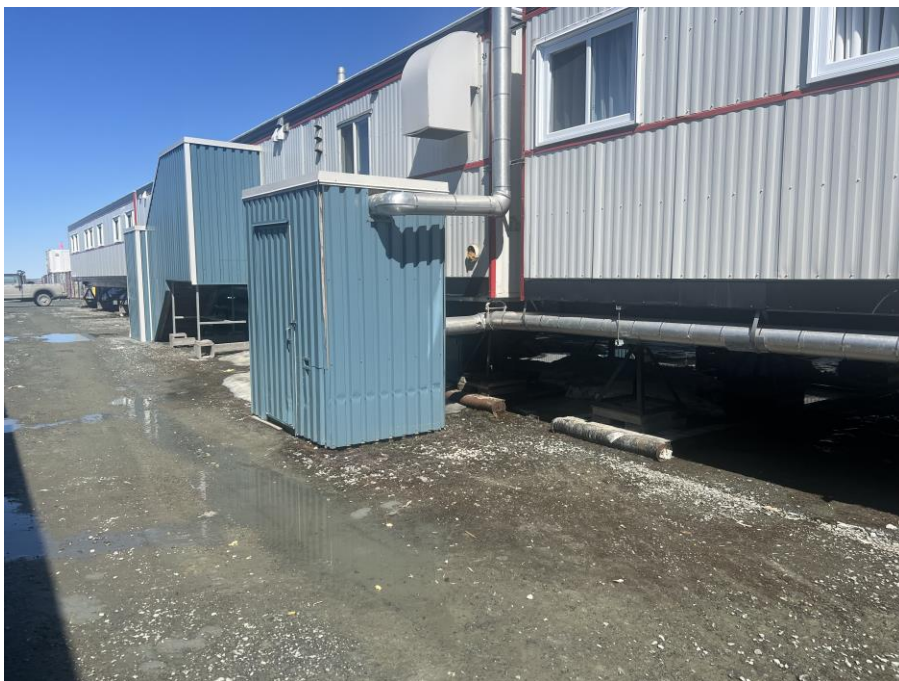
Photo 2: Spill location post remediation

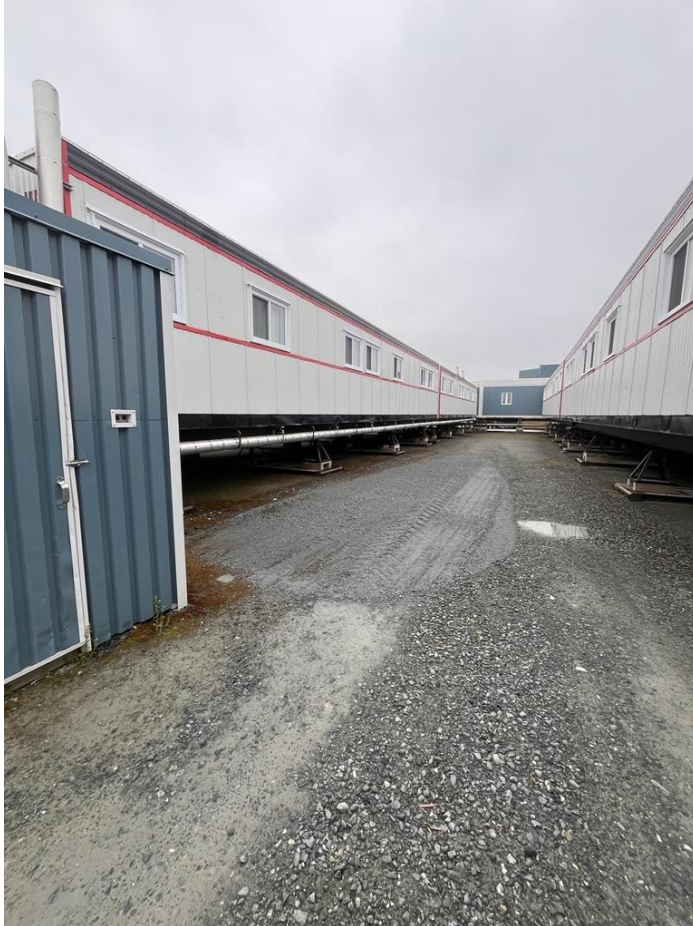
Photo 2: Spill location post remediation

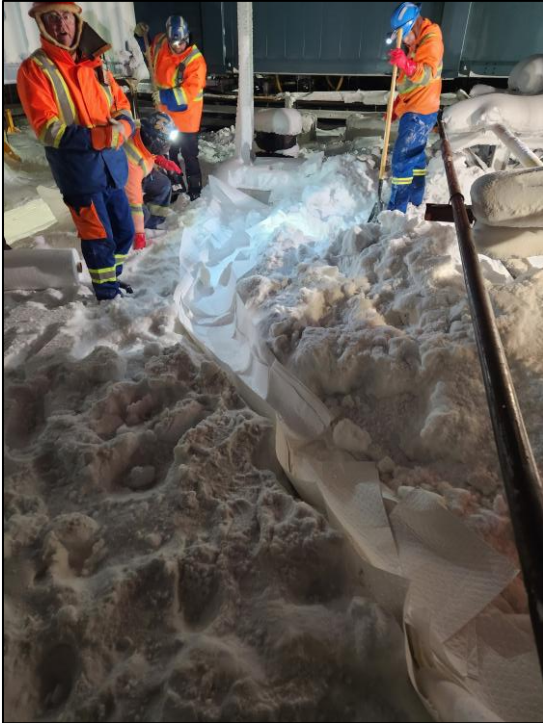
Photos 1: Spill location

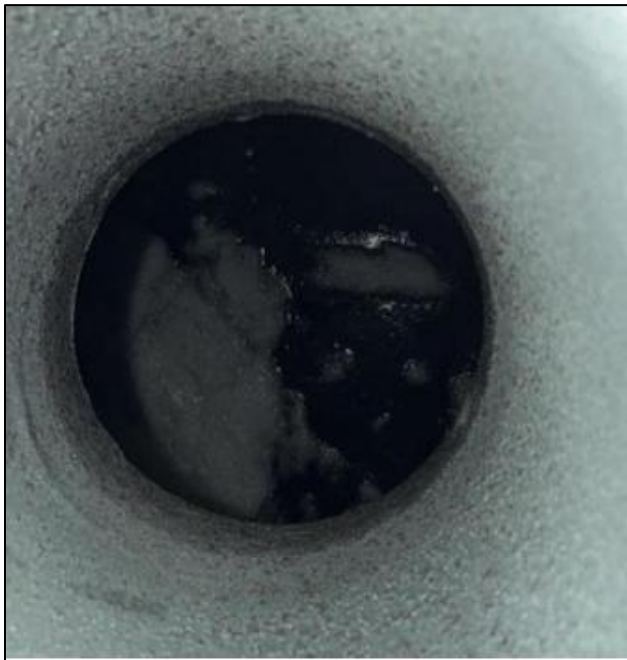
Photo 2: Paraffin in diesel tank from summer fuel being left in tank too late into winter.

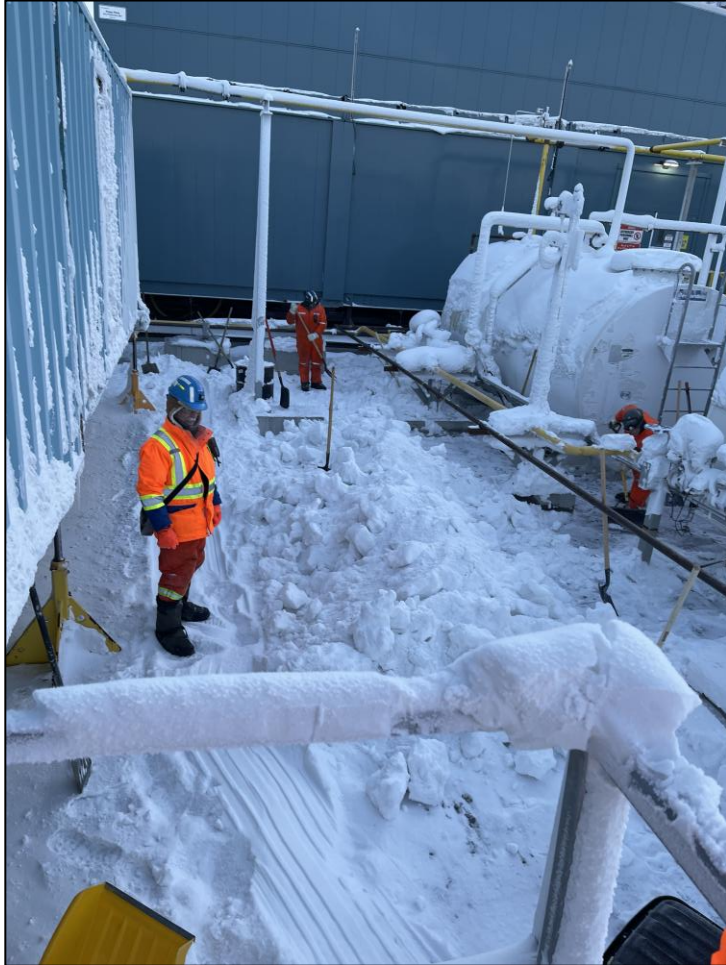
Photo 3: Spill location during remediation
