MEADOWBANK COMPLEX

2020 Landfarm Report

In Accordance with NIRB Project Certificates No.004 & No. 008
&
NWB Type A License 2AM-MEA1530 & 2AM-WTP1830

Prepared by:
Agnico-Eagle Mines Limited – Meadowbank Division

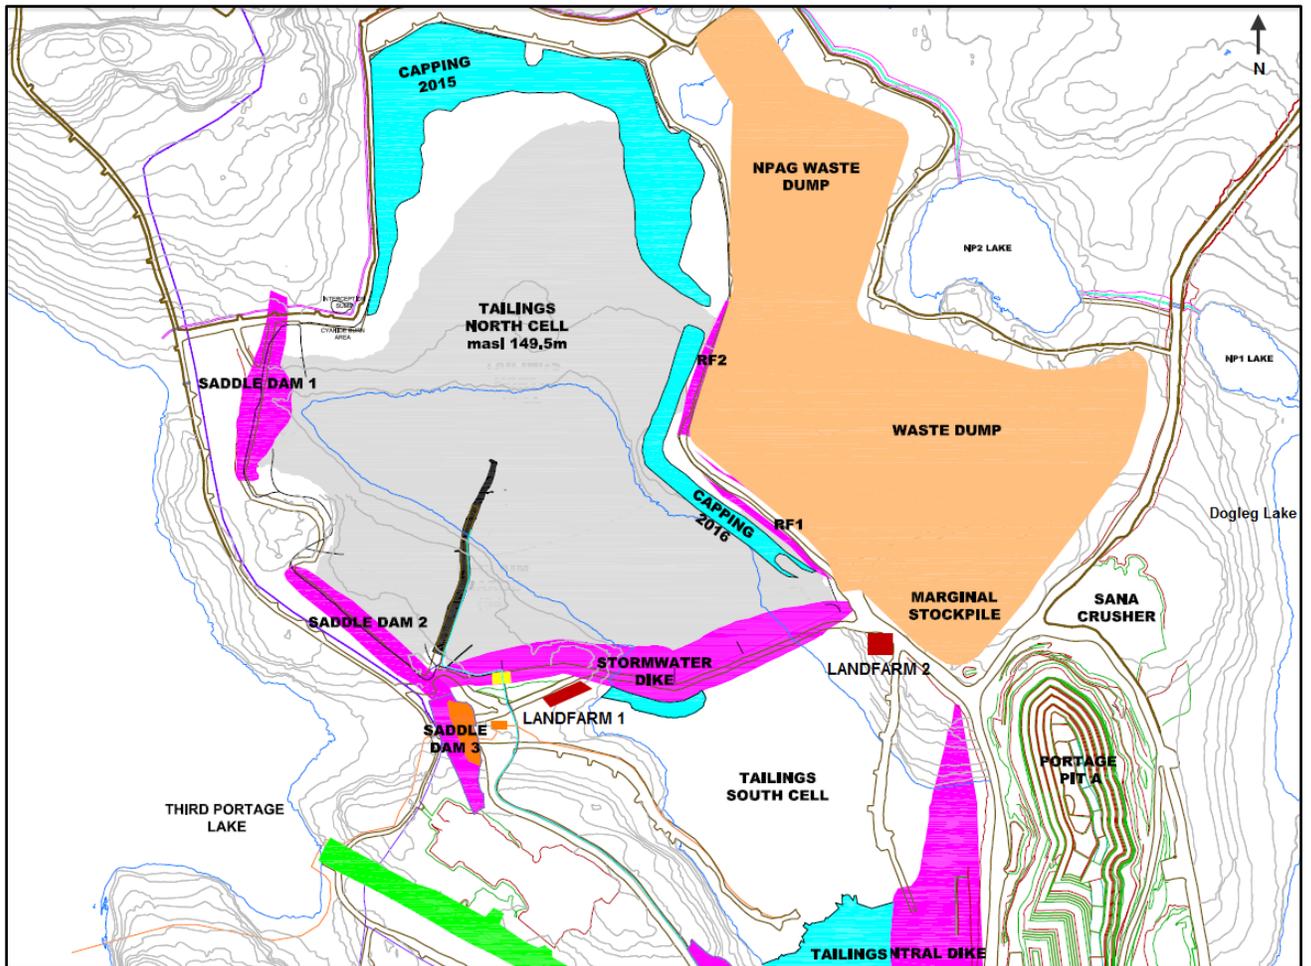
Figure 1. Landfarm 1 and Landfarm 2 locations.

The original landfarm design was submitted by Agnico to the Nunavut Water Board in October 2012 and was in use until 2016. As presented in Figure 1 below, the original landfarm (Landfarm 1) was located on the north-west side of the South Tailings Cell impoundment (within the Tailing Storage Facility – TSF).

As presented on Figure 1, Landfarm 2 is located on the north east side of the South Tailing Cell, north of the Central Dike. Locating this site within the tailings impoundment provides containment in case of runoff water from the contaminated material.
