AGNICO EAGLE

MEADOWBANK SITE

DEWATERING DIKES

**Operation, Maintenance and
Surveillance Manual**

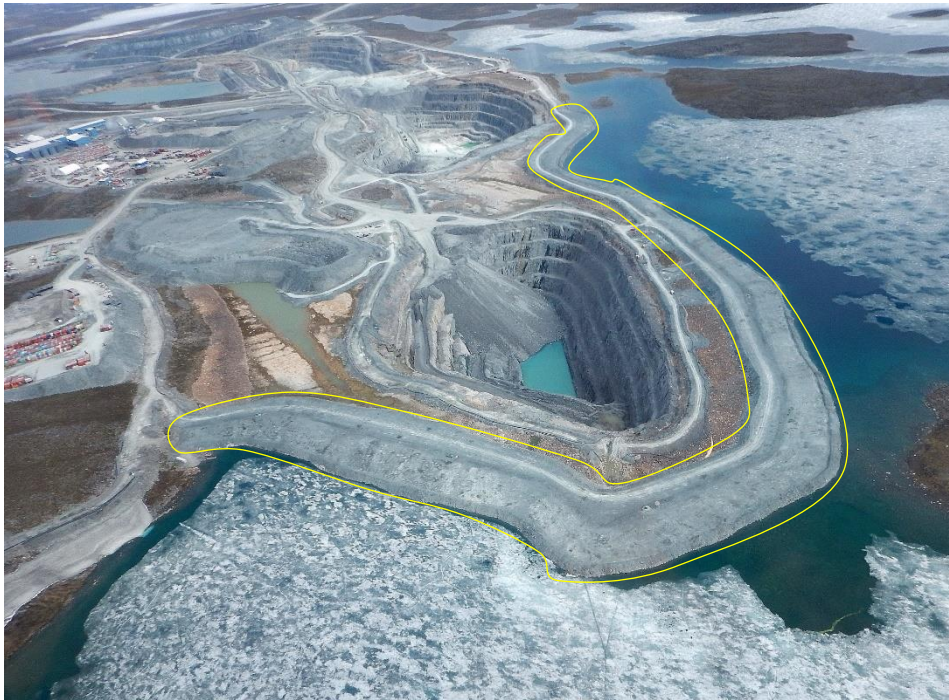
Figure 3-3 : Aerial View of Bay-Goose Dike

2.2 km long rockfill embankment with cement-soil-bentonite cutoff wall with filter system. To reach bedrock depths – used injection jet-grouting to create the full cutoff wall. After cutoff wall, a 5 m deep injection curtain into the bedrock						
Operation Highlight						
<ul style="list-style-type: none"> • Settlement and tension cracks observed in the thermal capping of the structure • Small seepage observed at the toe of the structure. Naturally report to Goose Pit 						
No risk assessment performed on this structure yet, planned for 2022. Annual Probability of Failure and design Factor of Safety in Appendix B.

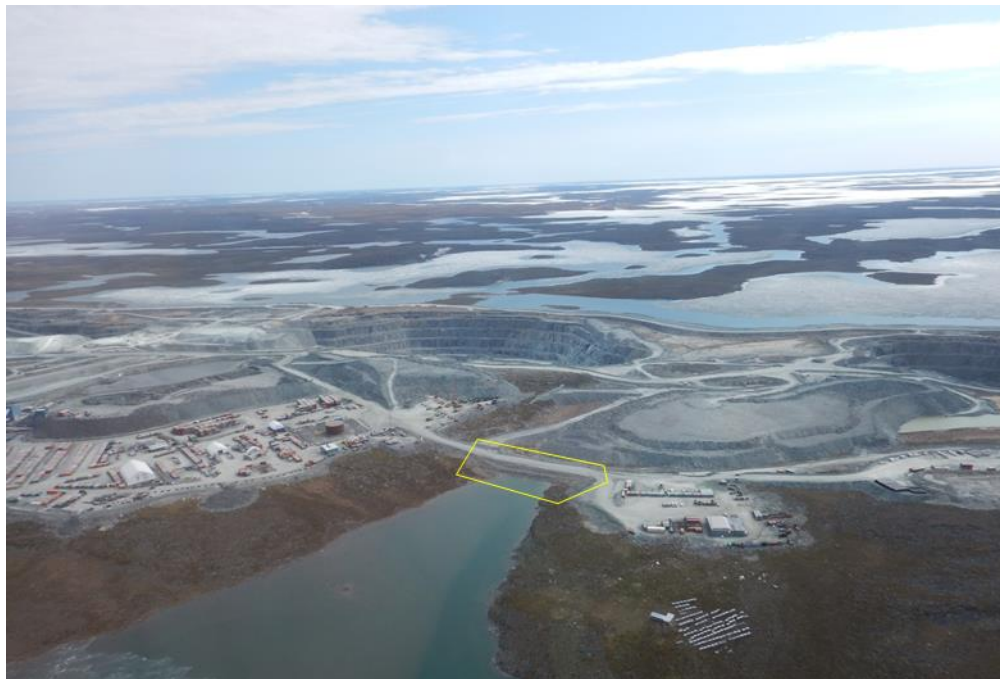
Figure 3-5 : Aerial View of South Camp Dike

The South Camp Dike was primarily constructed between April and June of 2009, prior to ice breakup. During the winter of 2009-2010 additional thermal capping material and rockfill for the haul road was added to the dike. The South Camp Dike has a broad rockfill shell with a bituminous geomembrane liner installed on the upstream side of the shell. The liner was founded on native frozen (permafrost) till material, in a trench approximately 3 to 5 m below the lakebed surface. Compacted granular material mixed with bentonite was placed above the toe of the liner. The haul road is located on the downstream side of the dike.

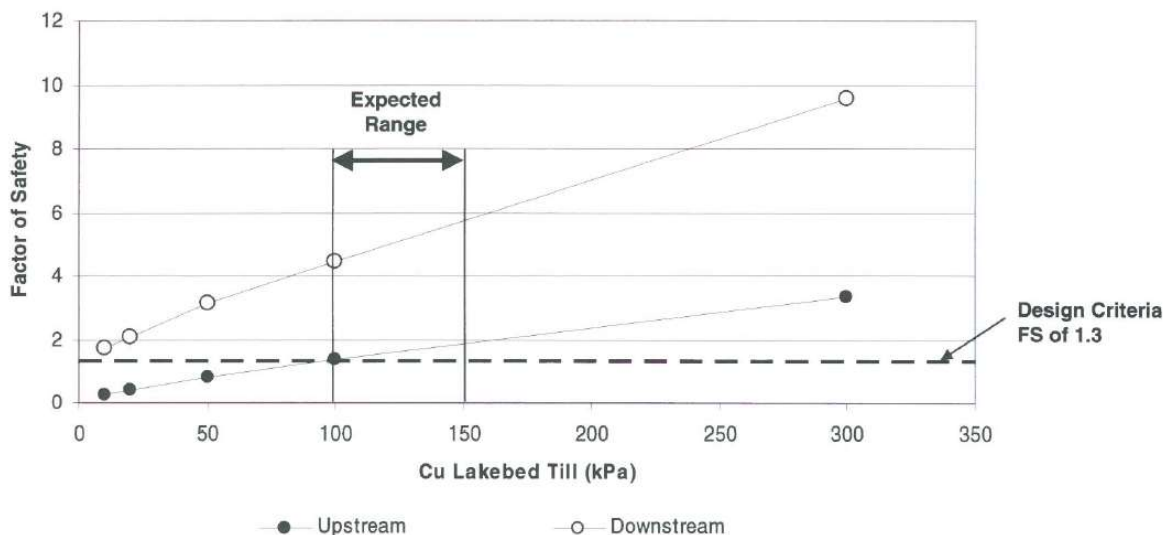
Figure B-1: Factor of safety VS foundation undrained strength (rapid drawdown condition with undrained foundation) (Golder, 2007)

The FoS obtained in the detailed design of the structures are illustrated in Figures B-1 and B-2 as well as Table B-2 below for different analyzed conditions. Detailed stability results are available in the detailed design report for the dewatering dikes (Golder, 2007, for Bay-Goose Dike, East Dike and South Camp Dike; SNC, 2013, for Vault Dike).

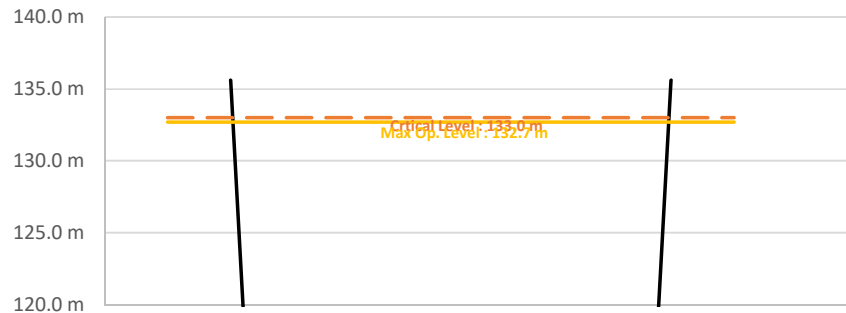
In-Pit Tailings Deposition - Operational Guidelines

Critical Level : 133.0m
Max Op. Level : 132.7m
Approx Bottom : -24.0m

East Dike Critical level (>134.8): Increased risk of East Dike overtopping. Immediately take action to stop increase. Inform stakeholder as per communication chart. Environment & Critical

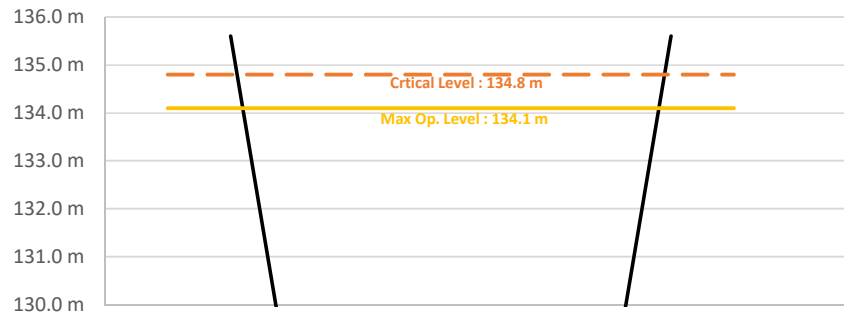
Second Portage Lake - Operational Guidelines

Critical Level : 134.8m
Max Op. Level : 134.1m
Approx Bottom : 120.0m

East Dike Core (135.6 m) : Overtopping of East Dike core. Uncontrolled inflow into site. Deploy measure to ensure structure integrity and protect worker

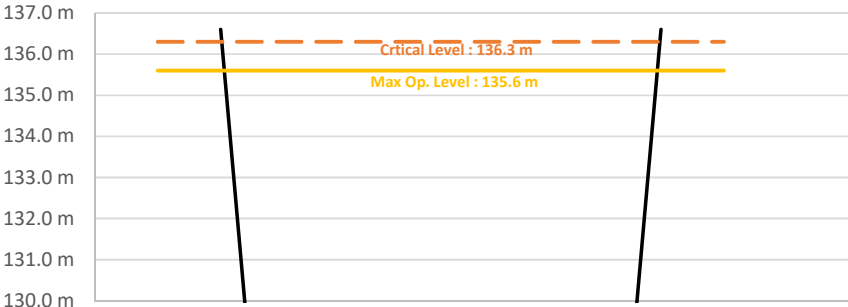
Third Portage Lake - Operational Guidelines

Critical Level : 136.3m
 Max Op. Level : 135.6m

Approx Bottom : 102.0m

South Camp Dike Thermal Cap (136.6 m) : Overtopping of thermal cap of South Camp Dike. Uncontrolled inflow into site. Deploy measures to ensure structure integrity and protect workers.
