WHALE TAIL PROJECT

WATER MANAGEMENT INFRASTRUCTURE

Operation, Maintenance and Surveillance Manual

Version 2
November 2021

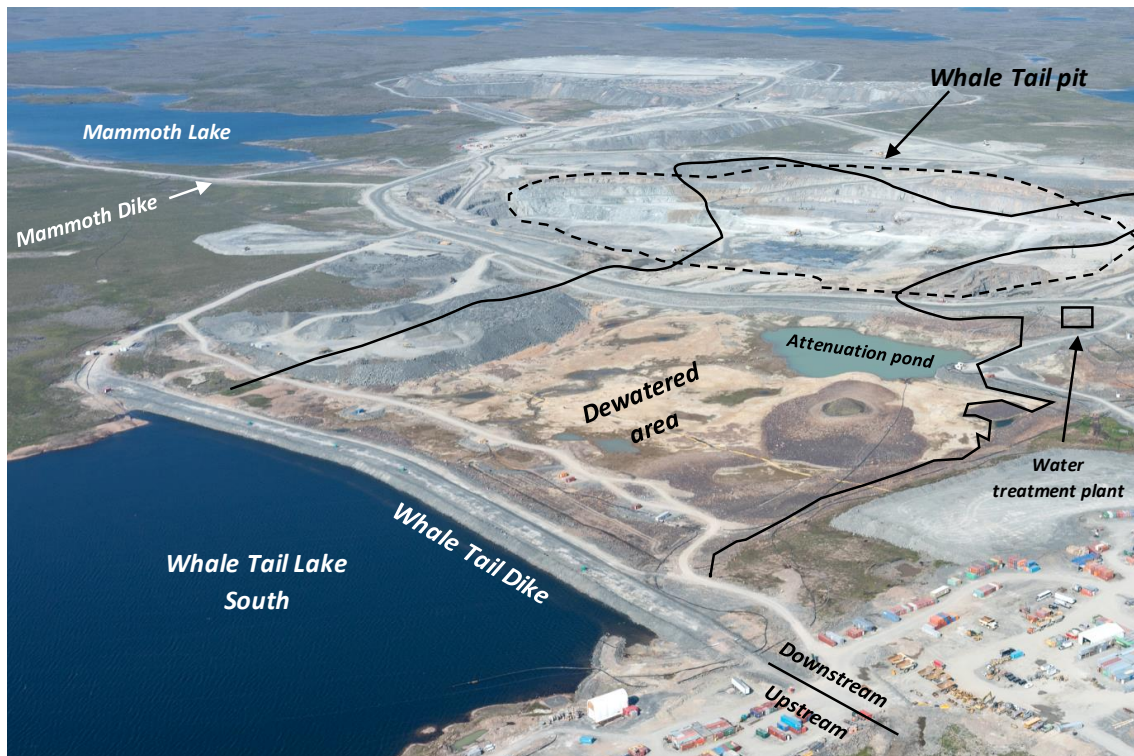
Figure 3-1 : Aerial View of Whale Tail Dike

WTD is approximately 835 m in length and was constructed within Whale Tail Lake on a shallow plateau of the lake floor. It consists of a wide rockfill shell, with downstream filters and a cement-bentonite cutoff wall build with secant pile that extends into the bedrock. The cutoff wall extends up to 12 m below lake level and is socketed 1.37 m in the bedrock in average. The dike has a 5 m grout blanket on the upstream side and a 10 m grout curtain on the downstream side from 0+180 to 0+516. The top of the secant pile is at El. 157 which is 1 m higher than the design IDF water level. Thermal cover rockfill of 2.0 m thick was placed between secant pile top elevation and the final crest elevation of the dike at 159 masl.

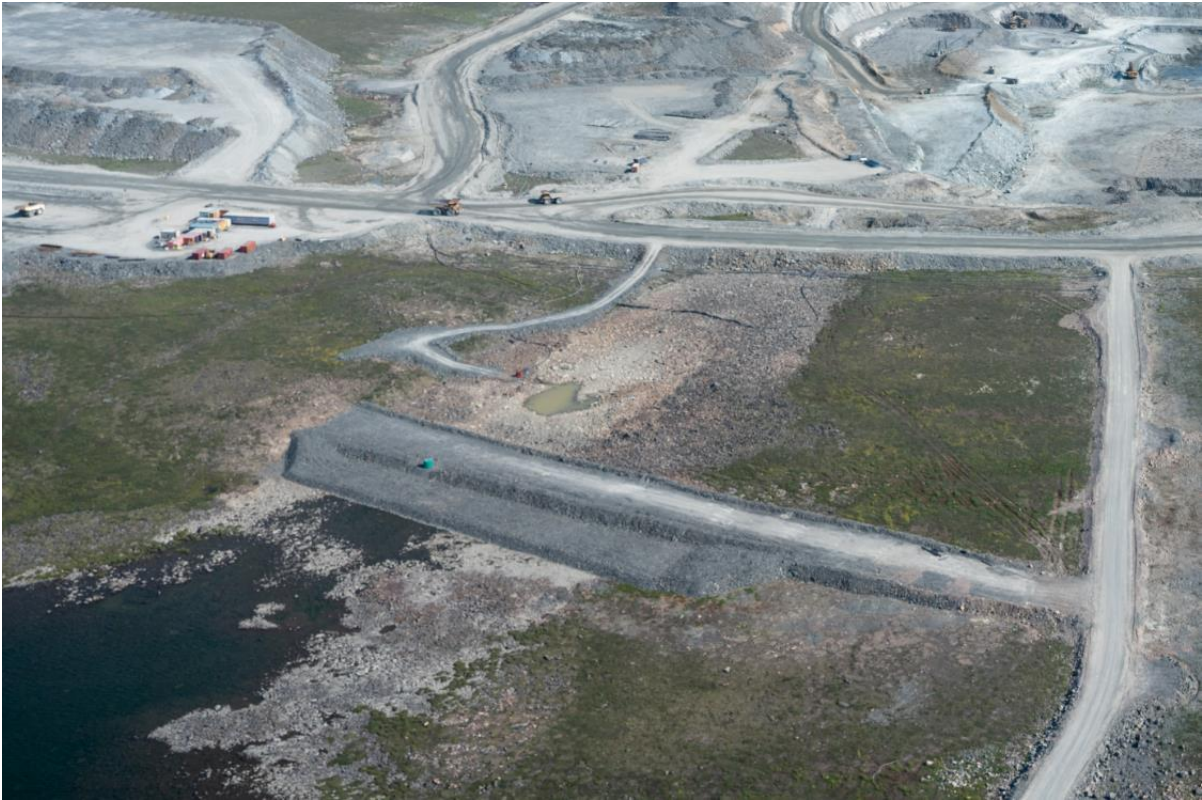
Figure 3-2 : Aerial View of Mammoth Dike

The construction of Mammoth Dike occurred from February 2019 to March 2019 to maintain the frozen condition of the foundation. This structure is a zoned rockfill dike with a filter system. The low permeability element of the dike consists of a bituminous geomembrane (BGM) installed on the upstream face anchored in a key trench with fine filter amended with bentonite (FFAB). The key trench is approximately 3 m deep and is founded on bedrock. Blasting was required during the construction of this infrastructure.

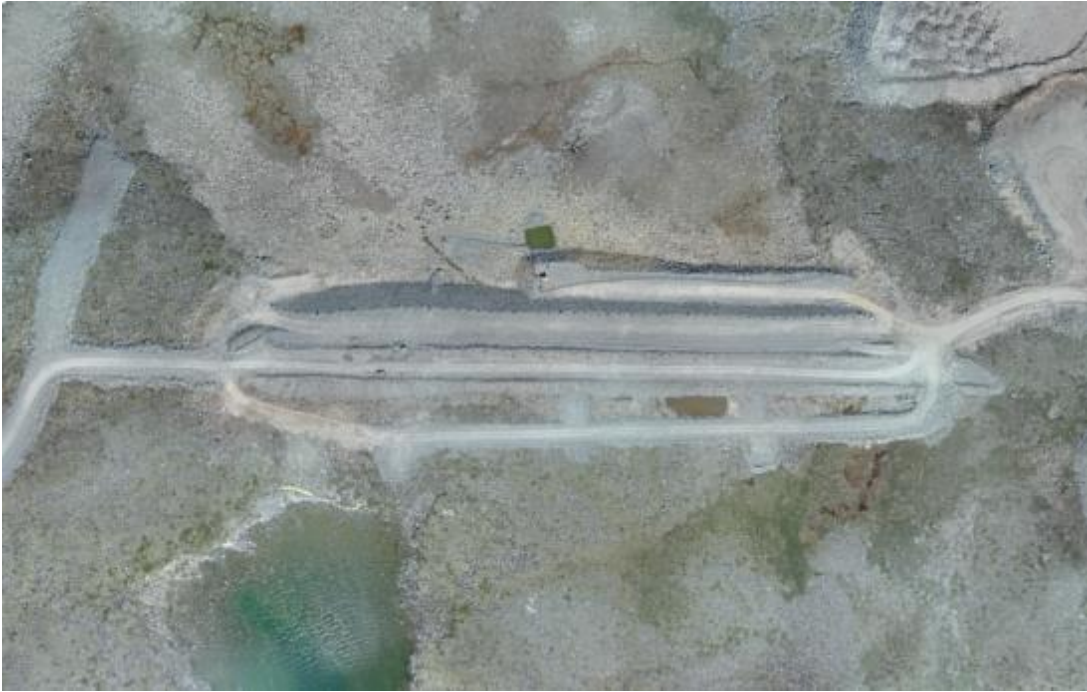
Figure 3-4 : Aerial View of WRSF Dike

In August 2019, the TARP level of the WRSF Dike was increased to yellow due to seepage observed toward Mammoth Lake. The situation was remediated by building a thermal berm in the winter of 2020 and by lowering the operating level of the pond. These strategies were successful in preventing seepage in 2020 and the TARP level of the structure is now Green.

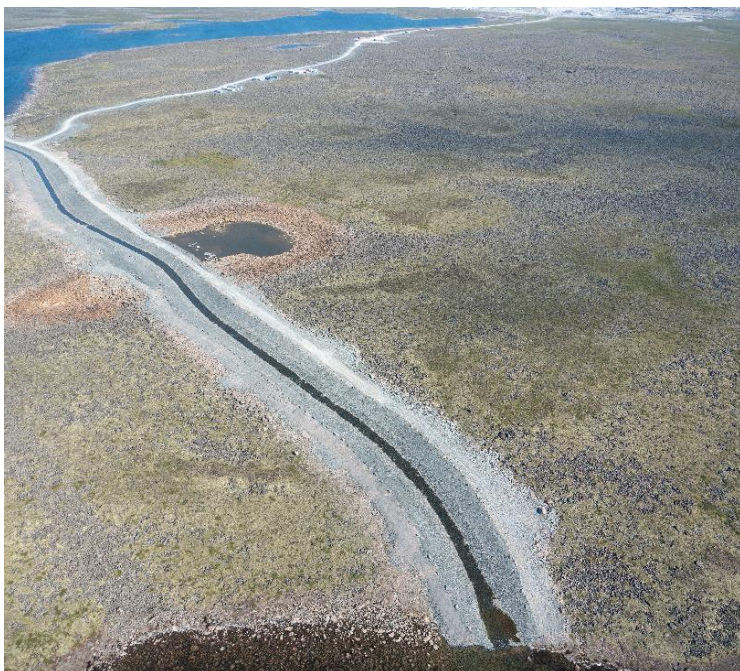
Figure 3-9 : Plan View of SWTDC

The South Whale Tail Diversion Channel (SWTDC) is a blasted channel in the south-western part of the Whale Tail Lake watershed. It allows non-contact water to be discharged by gravity from Whale Tail Lake to Mammoth Lake.

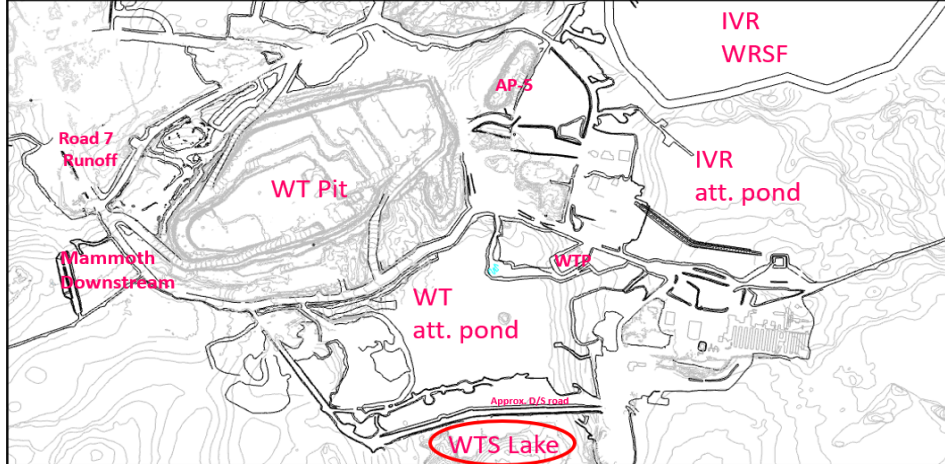
WTS Lake - Operational Guidelines

Within Op. level (152.5m to 155.8m) : Resume or maintain standard operations. SWTC inlet at El. 155.3 m

Above Critical Level (>156.3m) : Increased risk of WTD core overtopping. Immediately lower water to operational level. Could include work at SWTC. Inform stakeholder as per communication chart. Environment & Critical Infrastructure Superintendent in charge of action plan.

WTD Secant Wall Elevation (157 m) : WTD secant wall overtopping and uncontrolled release to WT Attenuation Pond. Deploy measures to ensure structure integrity and ensure worker safety.

Critical Level : 156.3m
Max Op. Level : 155.8m
Min Op. Level : 152.5m
Approx Bottom : 136.0m
