## MEADOWBANK GOLD PROJECT

# 2017 Annual Report

Agnico Eagle Mines Limited – Meadowbank Division

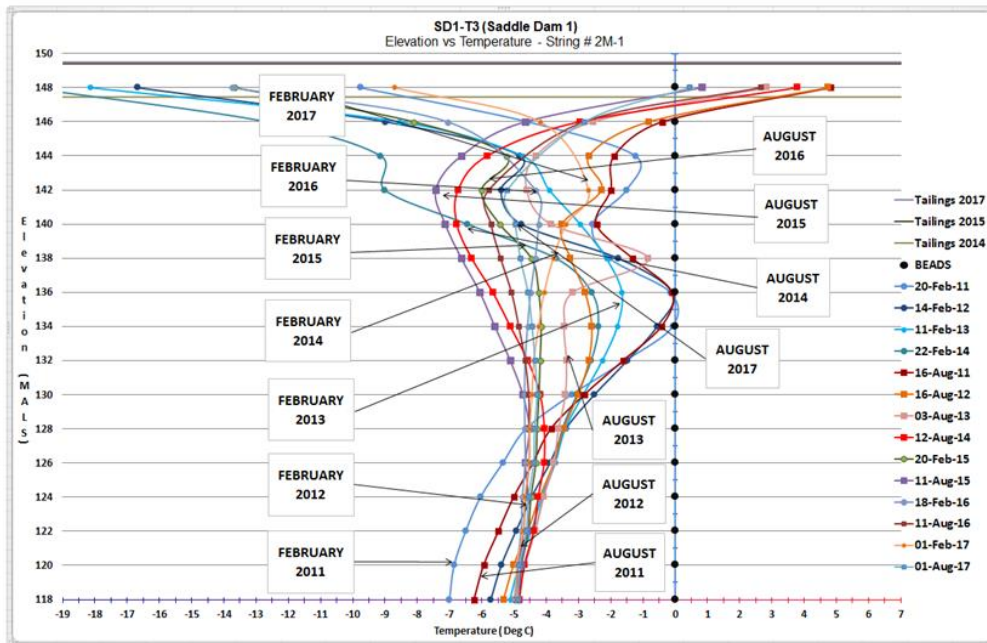
Figure 7. Thermistor Results SD1-T3

**SADDLE DAM 1 - T3**

Agnico started to determine capping thickness in 2009 by installing thermistor SD1-T2, SD1-T3 and SD1-T4 on Saddle Dam 1 to monitor the thermal conditions within the structure and its foundation. The results are illustrated on Figures 5 to 8. The four thermistors are automatically read every 3 hours following the installation of the dataloggers in 2017. Temperature data from thermistor beads located within the structure indicate that the dike foundation remained frozen since the installation of the instrumentation. The foundation remained in a frozen state with temperatures ranging from about  $-1.3\text{ }^{\circ}\text{C}$  to  $-5.4\text{ }^{\circ}\text{C}$ . No seepage has been observed since the beginning of service of the structure, which is performing as expected.

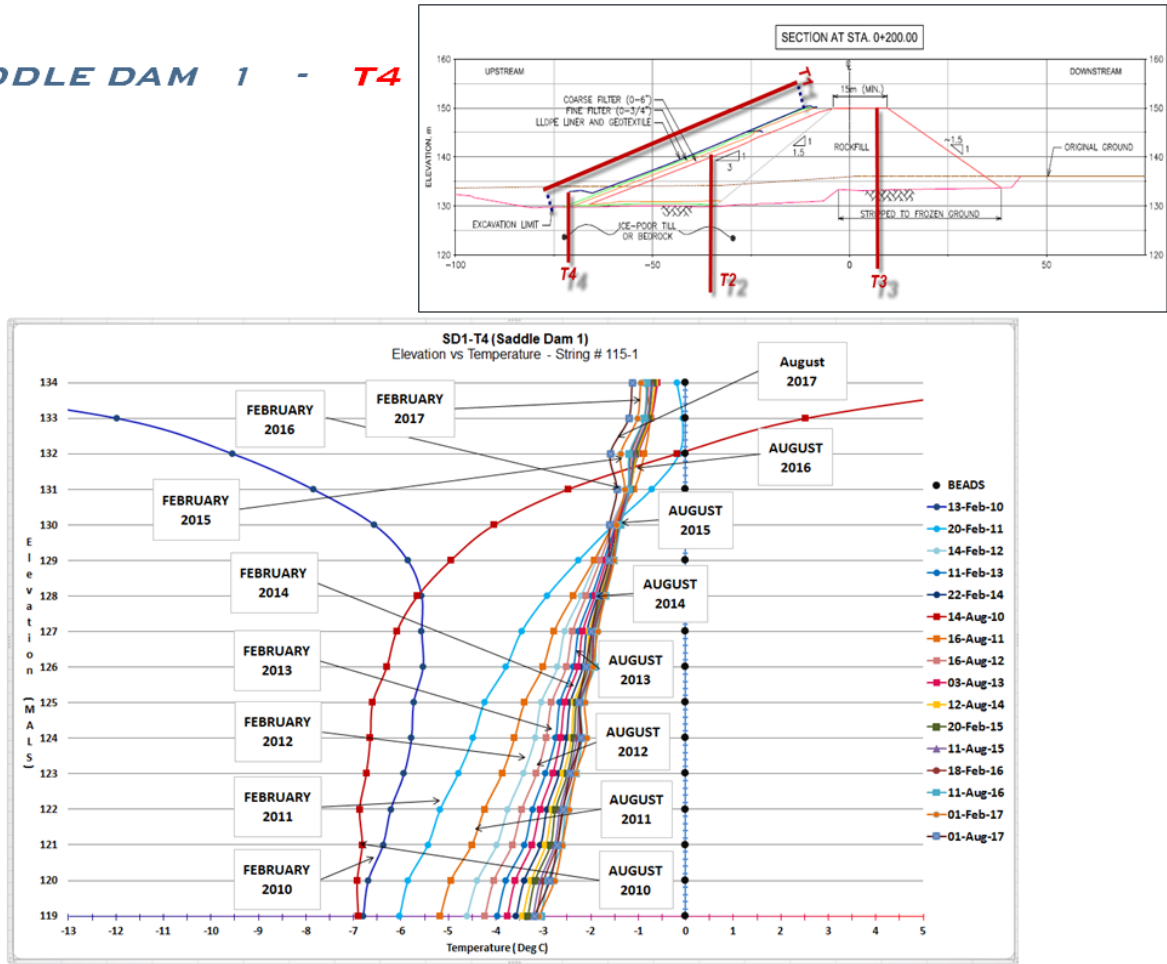
Figure 8. Thermistor Results SD1-T4

**SADDLE DAM 1 - T4**

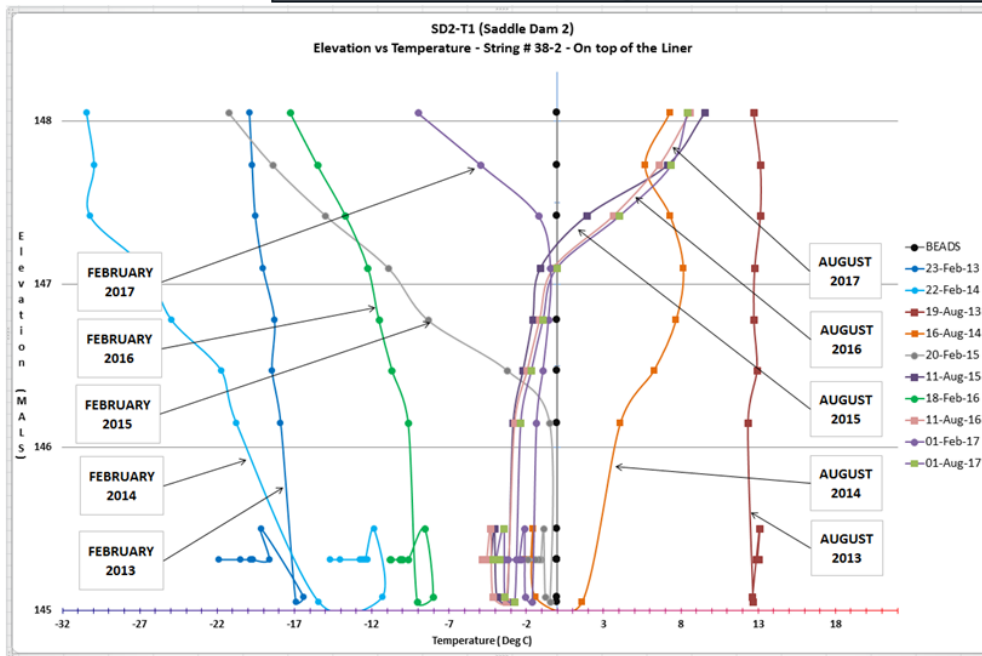
Figure 9. Thermistor Results SD2-T1

**SADDLE DAM 2**  
- T1

Agnico also installed thermistor strings SD2-T1, SD2-T2, SD2-T3 and SD2-T4 on Saddle Dam 2. The results are illustrated on Figure 9 to 12. Temperature data from thermistor beads within the structure indicate that the dike foundation remained frozen all year long in 2017 with temperatures ranging from about -3.5°C to -8°C. The SD2 dike shows similar or lower temperature values compared with surrounding permafrost conditions for both the foundation and the embankment. No signs of seepage or thawing of the foundation soil were observed. The structure is performing as expected.

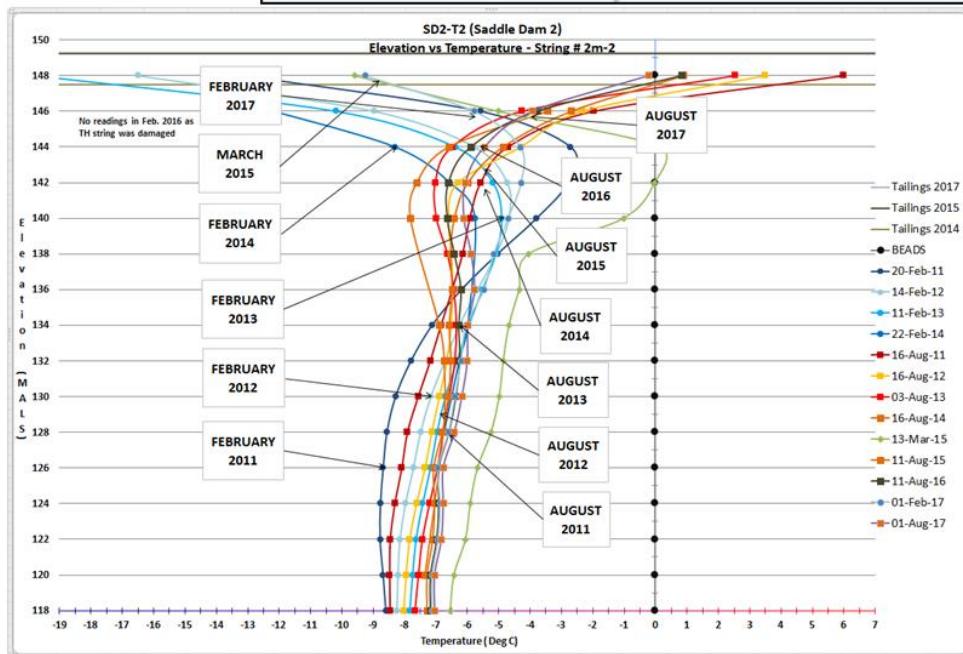
Figure 10. Thermistor Results SD2-T2

**SADDLE DAM 2**  
- T2

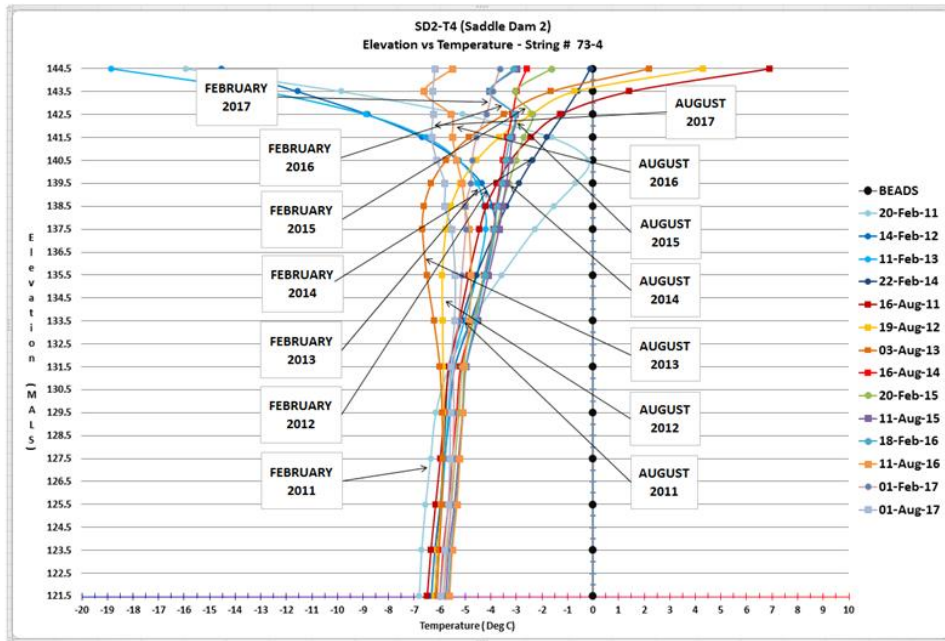
Figure 12. Thermistor Results SD2-T4

**SADDLE DAM 2**  
- T4

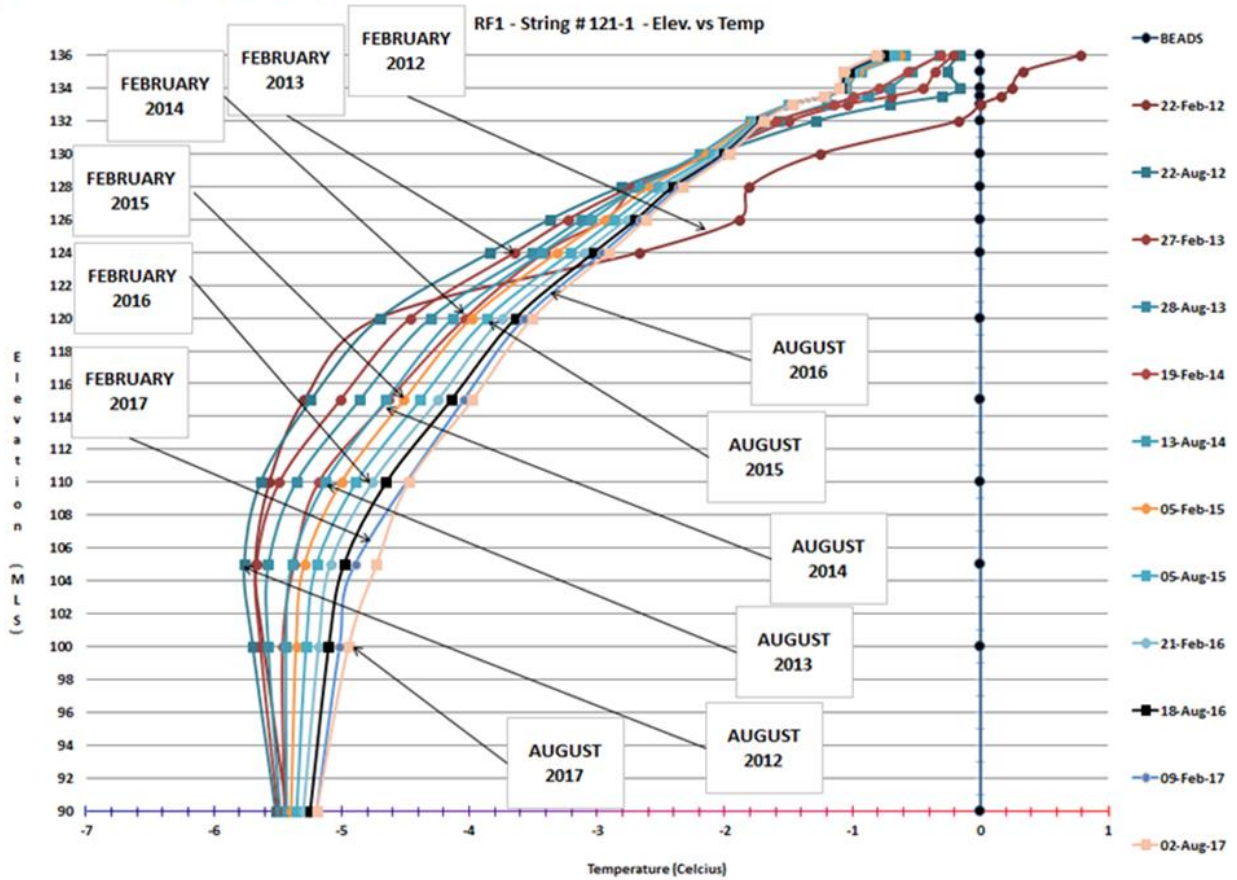
Figure 13. Thermistor Results RF1-T121-1

**RF1 - T121-1**

Other thermistors were installed in 2012 in the TSF to monitor the temperature of the tailings as well as the temperature of RF1 and RF2 (which delineate the eastern side of the North Cell TSF). Plots of these thermistors data are presented in Figure 13 to 16. Three thermistors are installed on RF1 (T121-1, T73-6, and RF1-3).

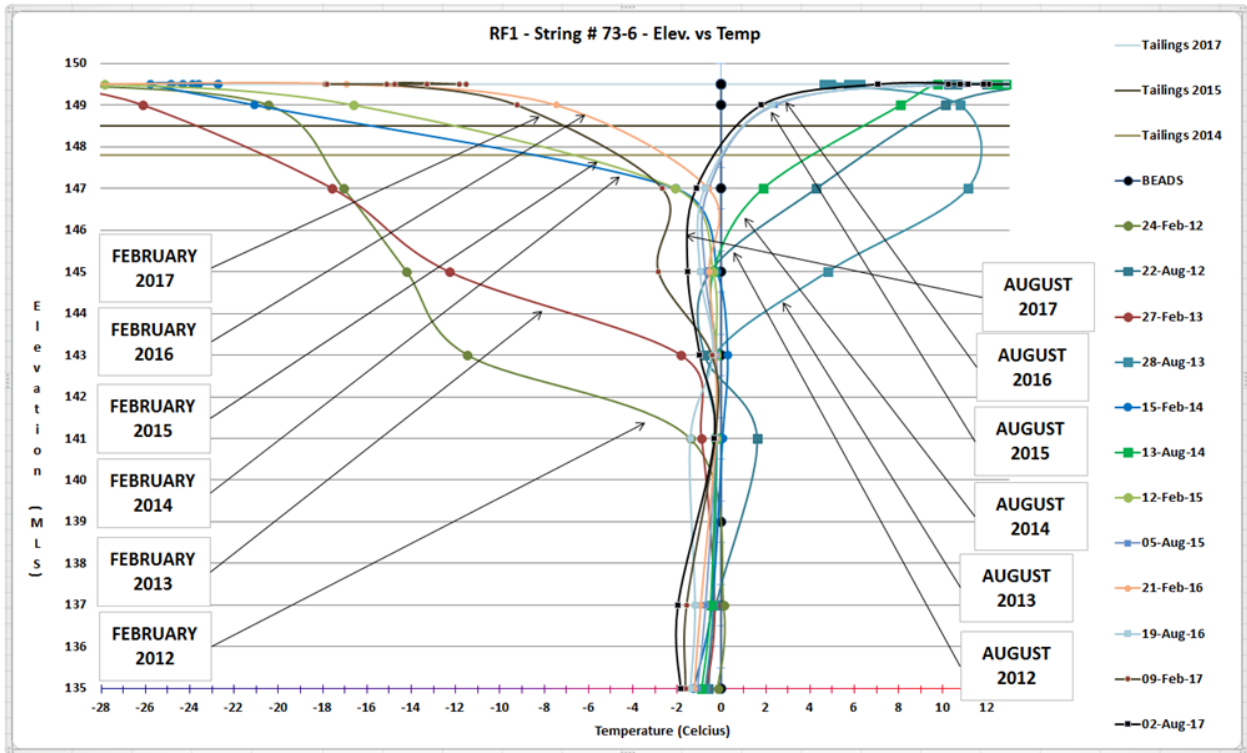
Figure 14. Thermistor Results RF1-T73-6

**RF1 - T73-6**

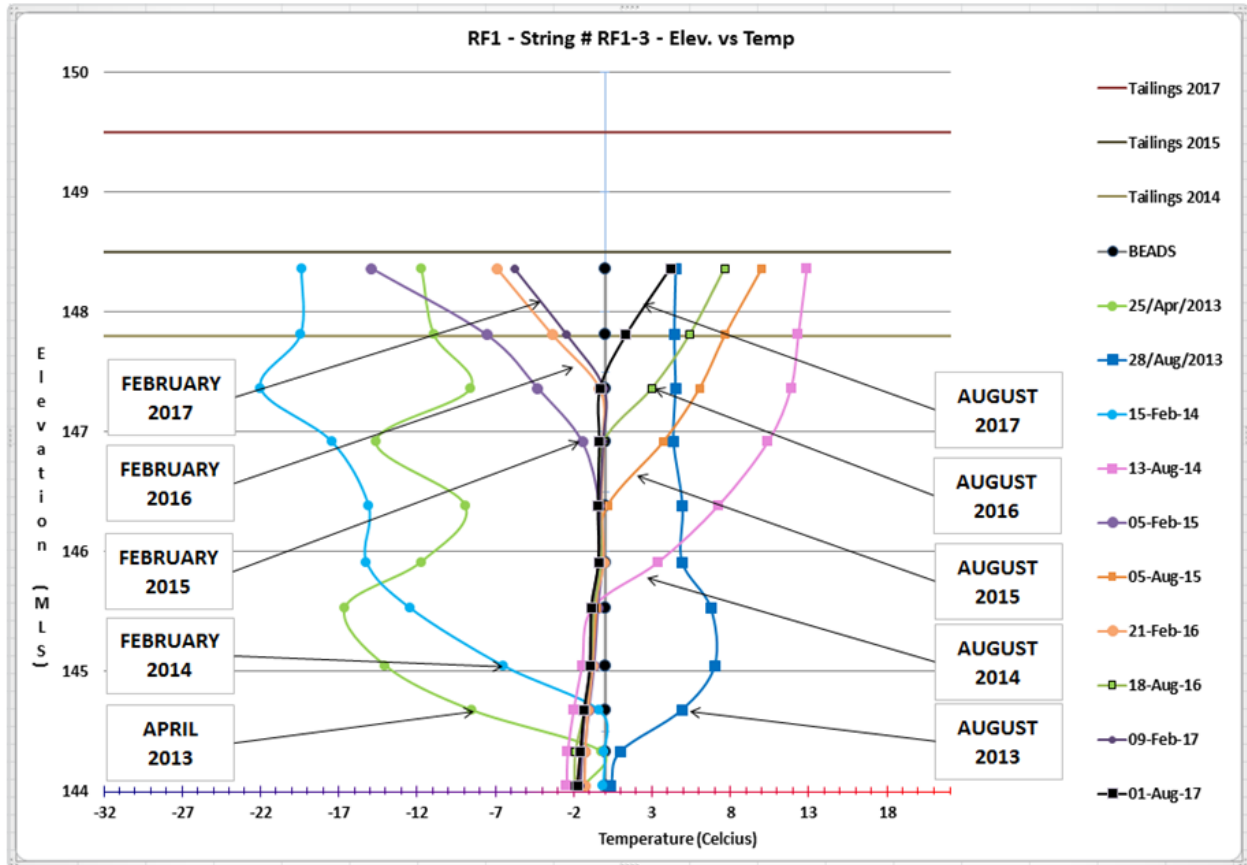
Figure 15. Thermistor Results RF1-RF1-3

**RF1 - RF1-3 (ALONG SLOPE)**

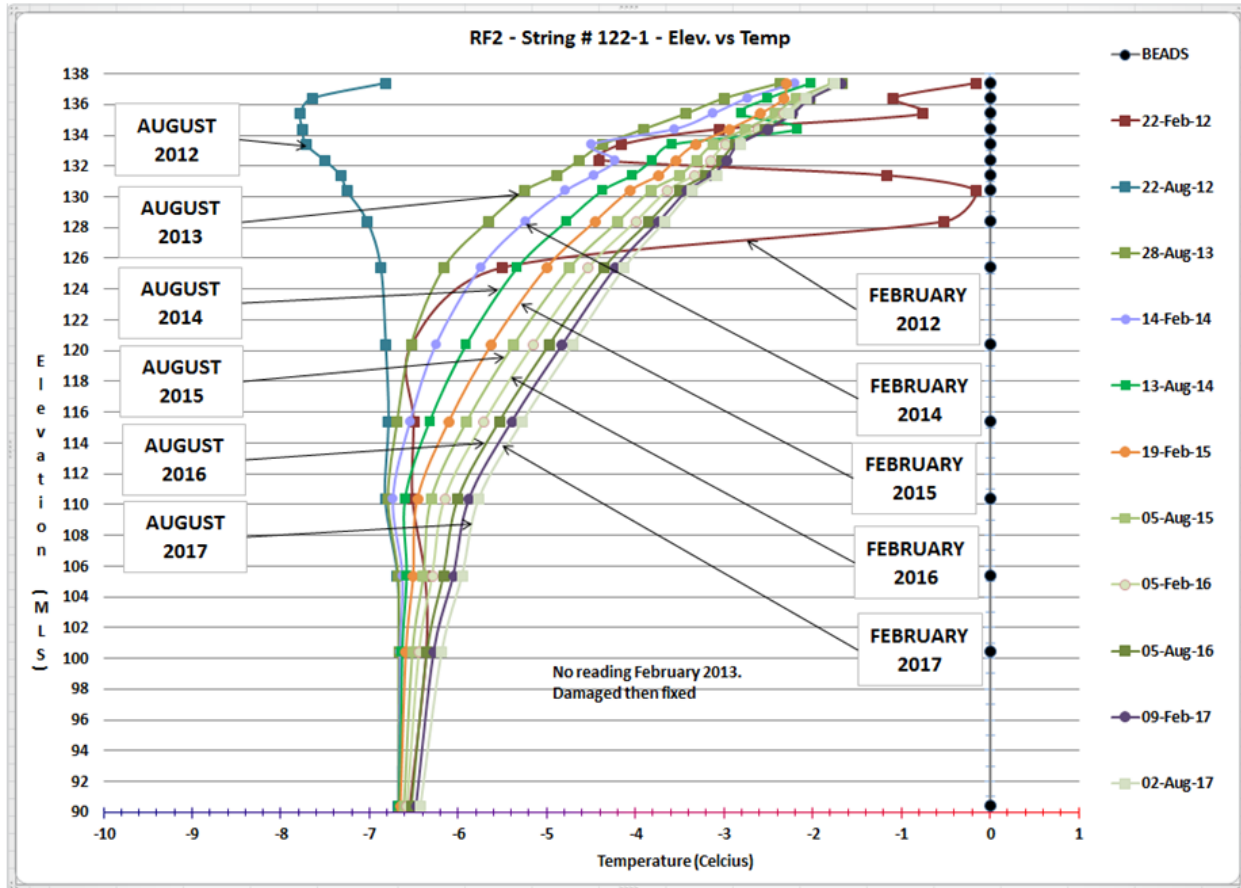
Figure 16. Thermistor Results RF2-T122-1

**RF2 - T122-1**
