MEADOWBANK GOLD PROJECT

2018 Annual Report

Agnico Eagle Mines Limited – Meadowbank Division

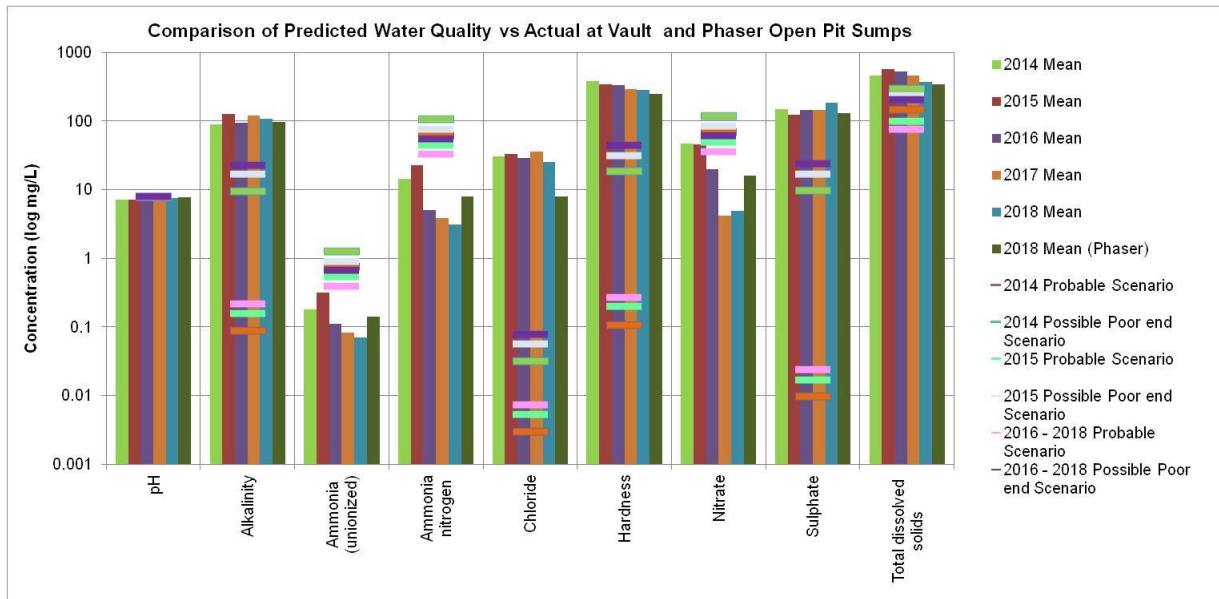
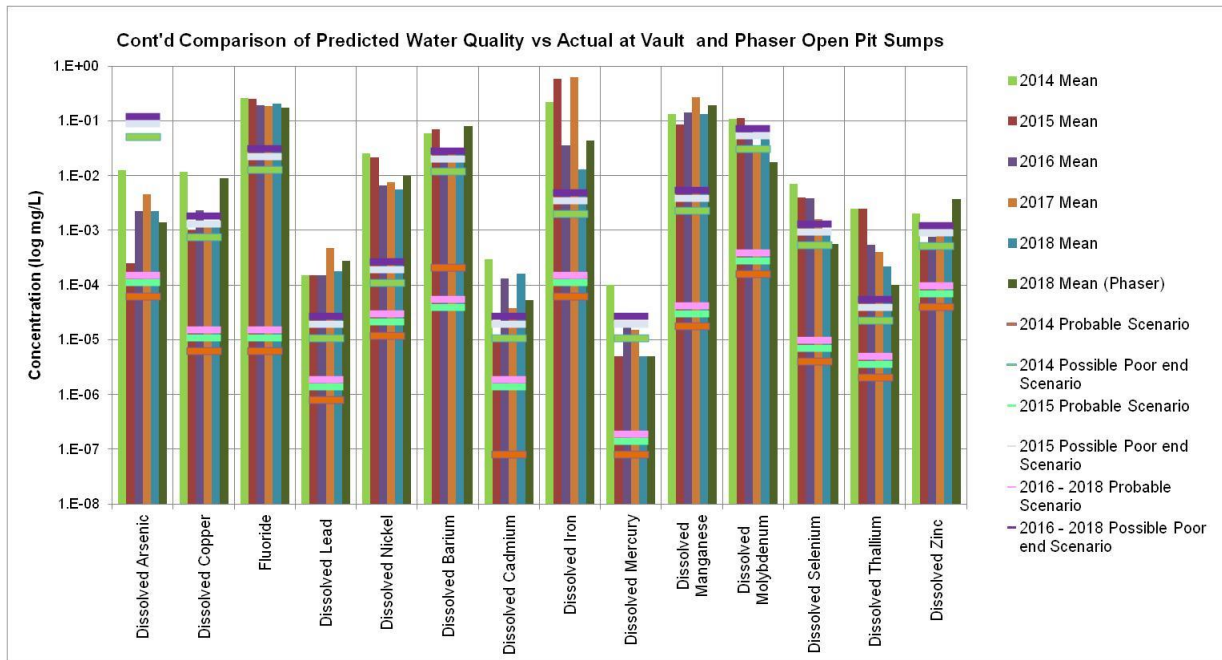
Figures 9 to 12 on the following pages illustrate the measured annual mean concentrations (represented by the vertical bars) and the probable and possible poor scenario (represented by horizontal lines). It is possible to observe that some parameters fall in between the probable and possible poor limits, such as dissolved iron in the Third Portage Pit, Goose Pit and North Portage Pit. Third Portage Pit is the pit where the majority of the parameters have measured concentrations that are within or below the forecasted limits. Graphics for the 25th percentile data were not plotted since there are years where not enough samples were taken to statistically evaluate this value.

Figure 9. Meadowbank Mean Annual Water Quality - Vault and Phaser Open Pit Sumps

Based on this analysis, many of the predicted values for the Probable and Probable Poor End scenarios have differences greater than +/- 20% when compared to the measured values. There are several potential causes that could contribute to these differences:

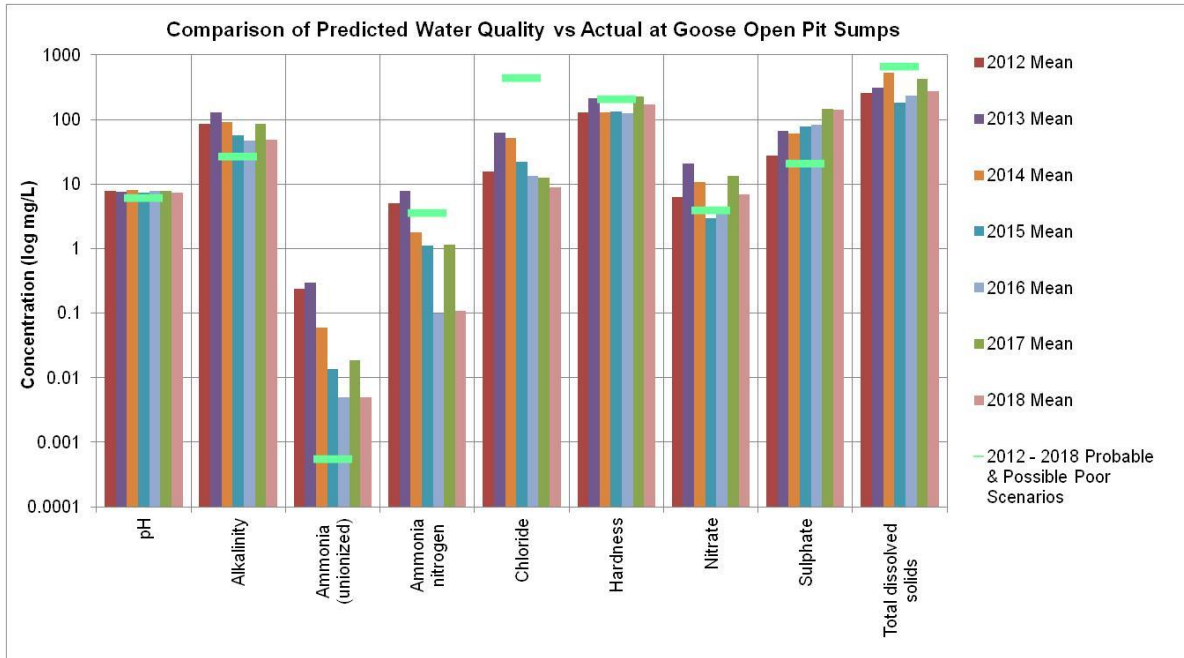
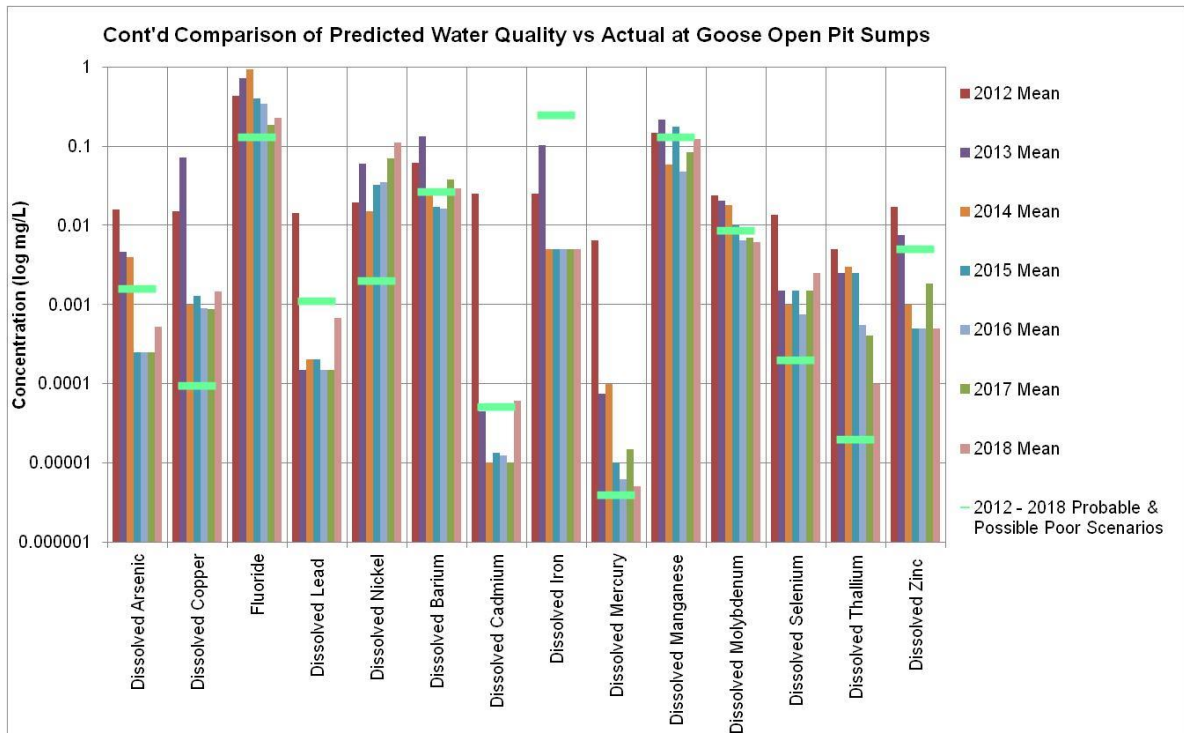
Figure 10. Meadowbank Mean Annual Water Quality – Goose Open Pit Sumps

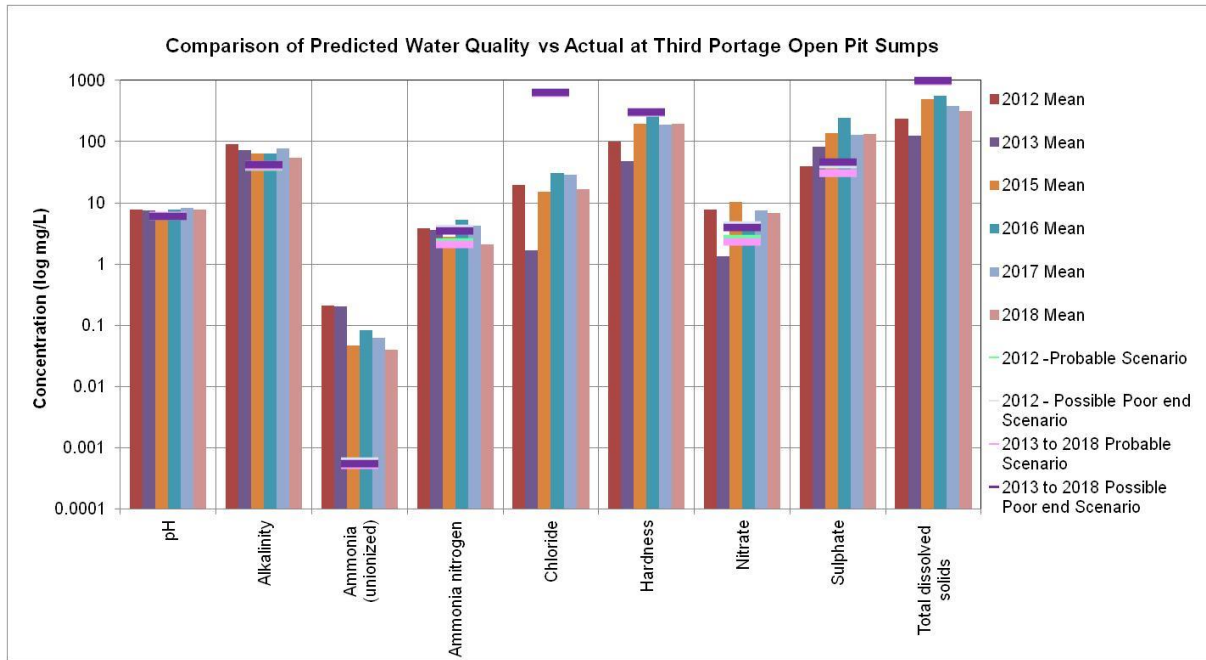
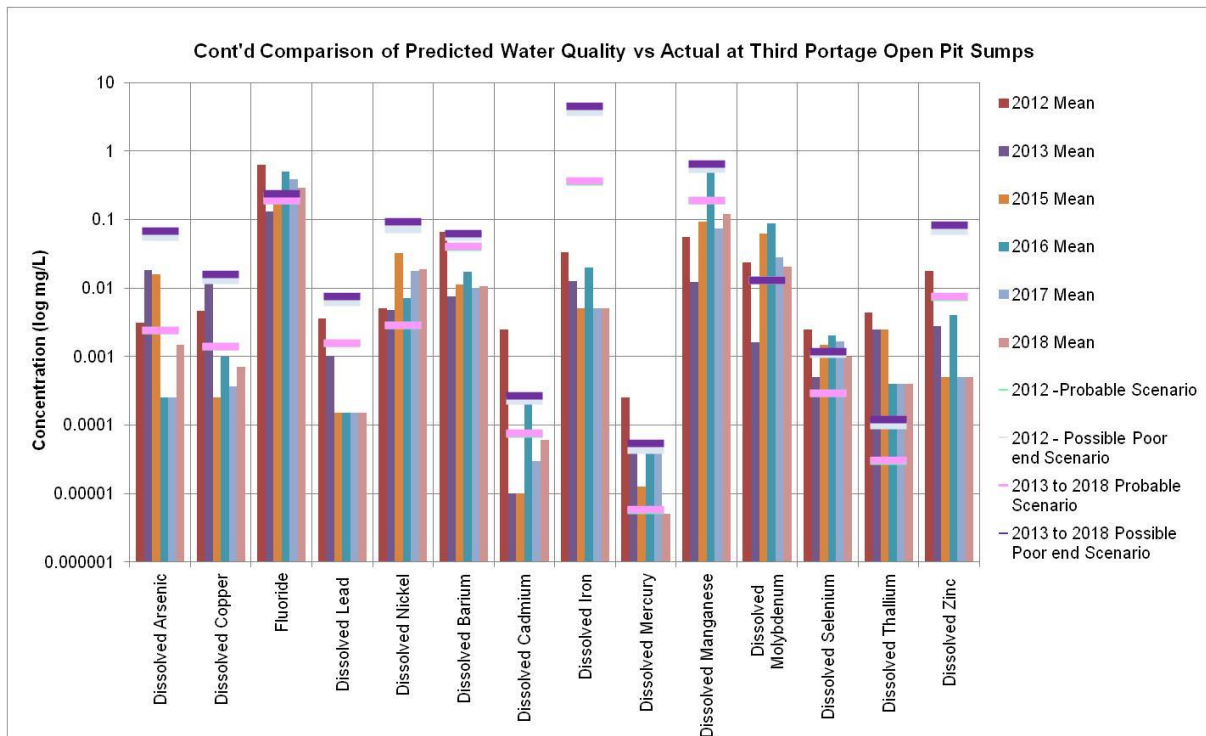
Figure 11. Meadowbank Mean Annual Water Quality – Third Portage Pit Sumps

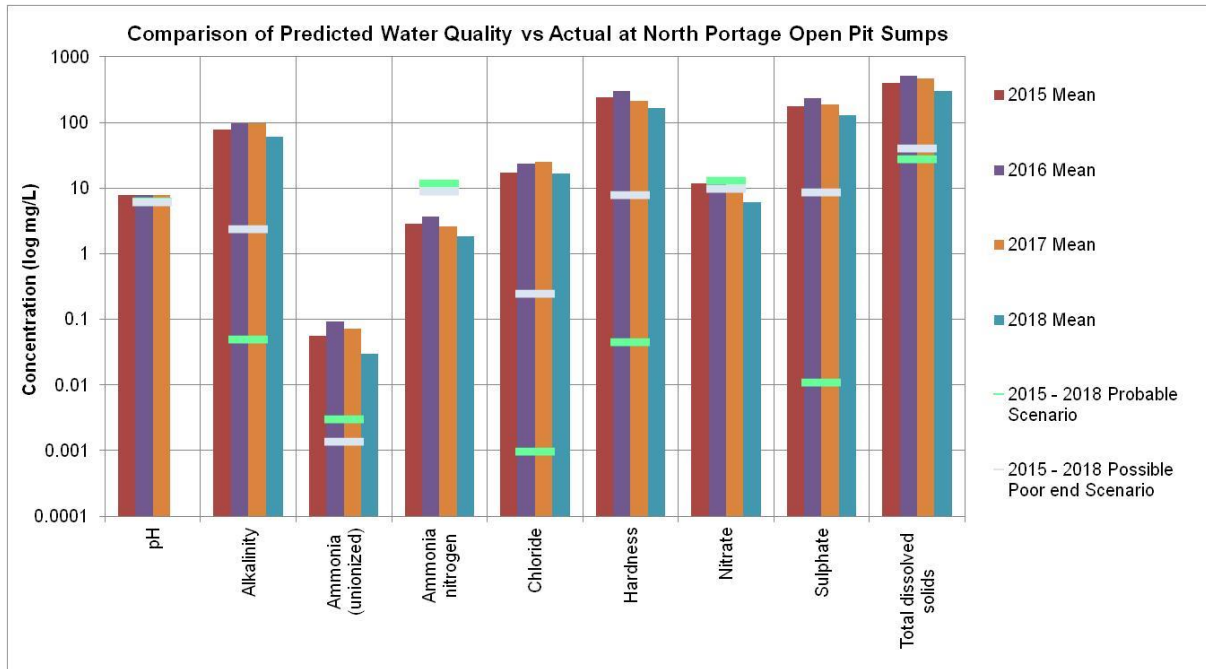
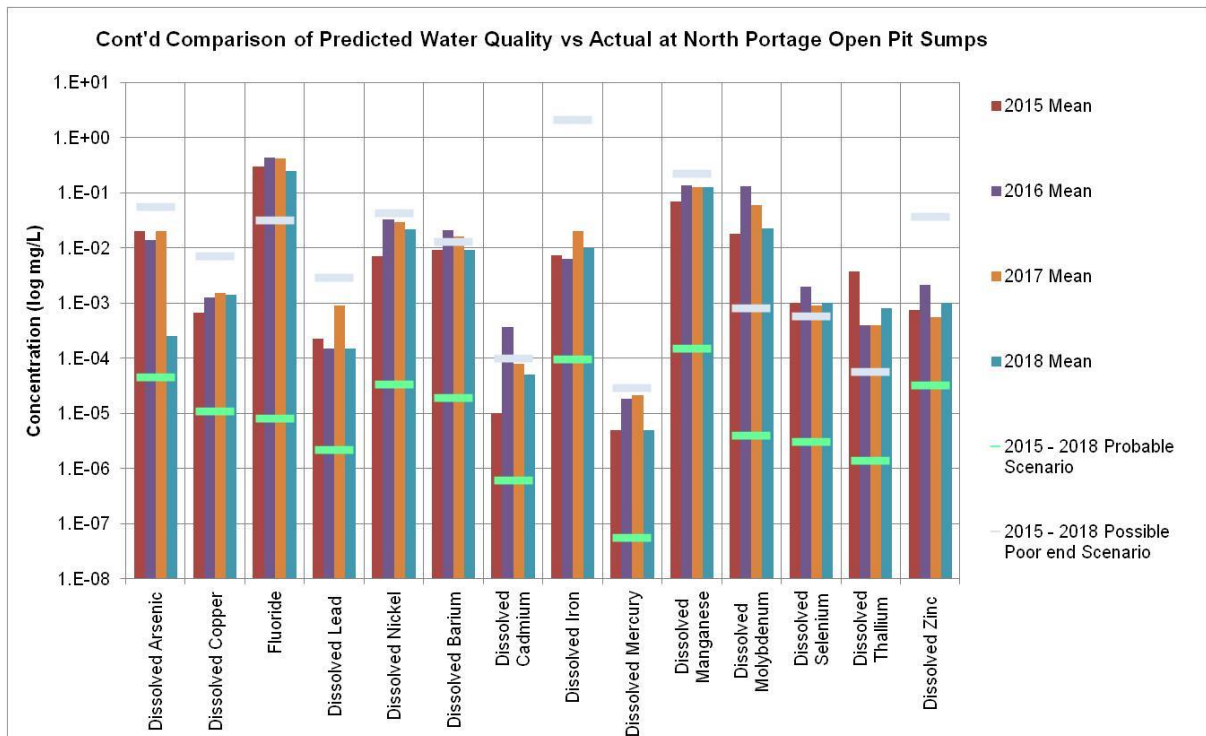
Figure 12. Meadowbank Mean Annual Water Quality – North Portage Pit Sumps

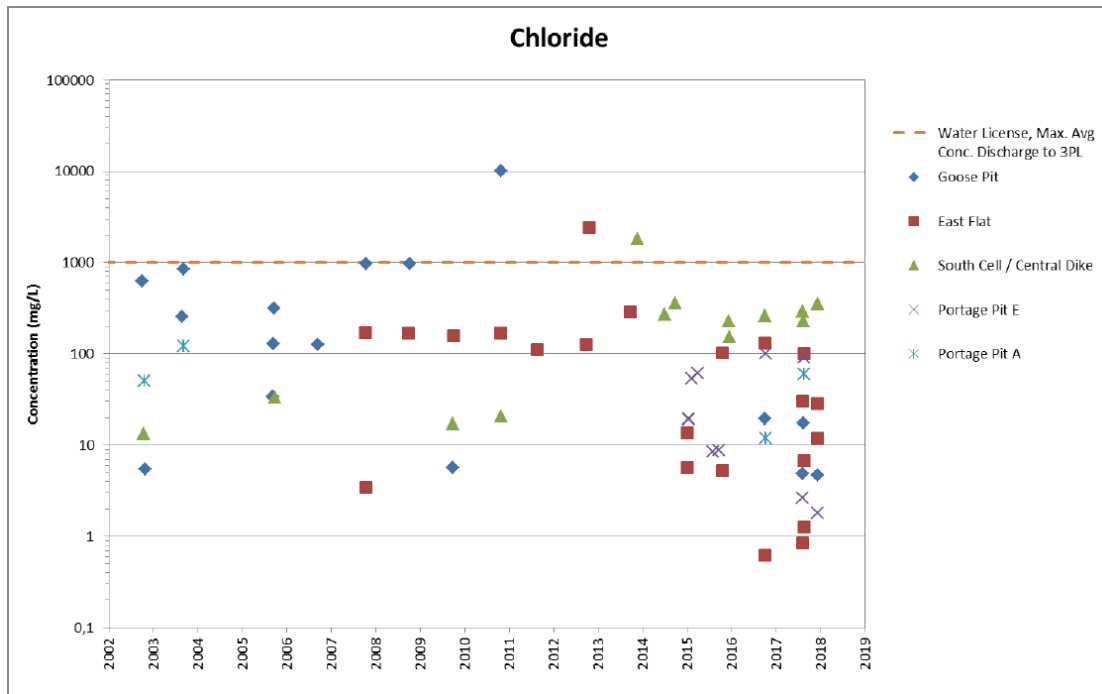
High chloride concentrations were found in several monitoring wells before 2014, especially in the Goose Pit area. The cause of these elevated level of chloride could related to the used of de-icing salt and calcium chloride brine solution used to prevent the boreholes of the monitoring well from freezing after drilling operation and remains present in the groundwater for years despite intensive purging of the wells after installation. Chloride concentrations at South Cell and Central Dike area show higher values than the other monitoring wells and could be directly related to the reclaim water stored in the South Cell Tailings Storage Facility (TSF).

Figure 17. Meadowbank Groundwater quality results chloride

Water analytical results were compared to the criteria listed in Agnico Groundwater Reports 2016 to 2018. Parameters exceed the criteria when they are three times the concentrations of Third Portage Lake (TPL) fresh water. Analytical results are found in Appendix I of the 2018 Groundwater Monitoring Report (Appendix 37) and concentrations exceeding these criteria are highlighted in bold format. Table 3-3 (Appendix 37) also shows the sampling stations and parameters that are exceeding criteria. To avoid confusion in the data interpretation, Agnico will refer the reader to the 2018 Groundwater Monitoring Report. Figure 17 to 19 below show the historical water quality results for chloride, copper and sulphate.

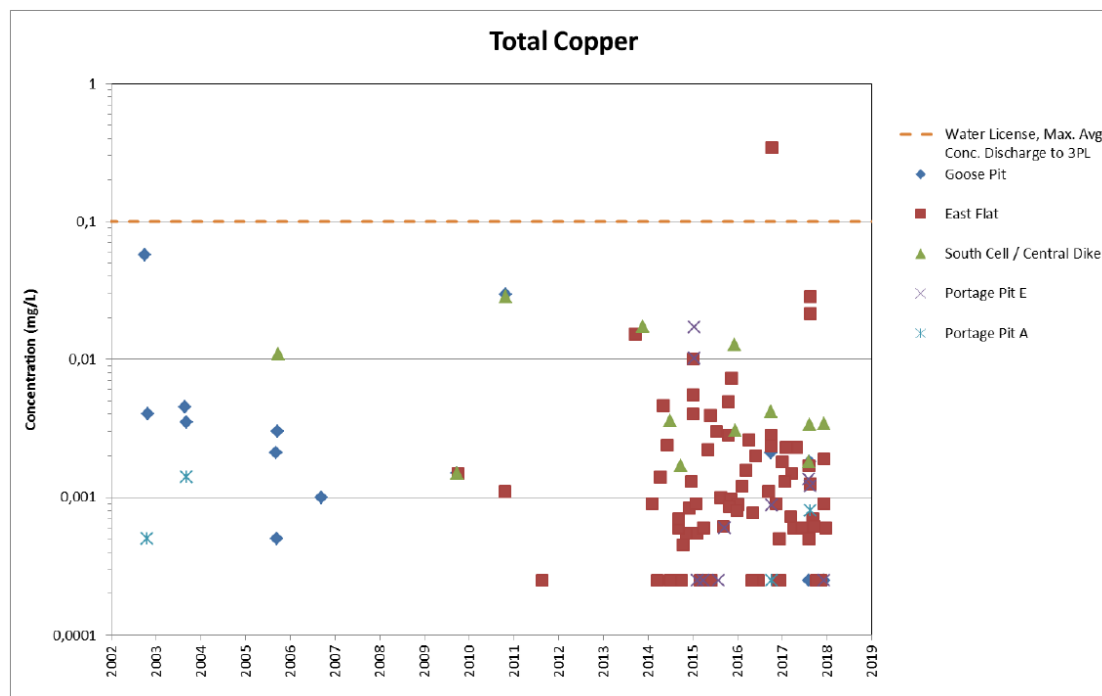
Total copper concentrations in most areas seems to decrease with time, which could be caused by adsorption of copper onto the surrounding rock body and/or its precipitation.

Figure 18. Meadowbank Groundwater quality results copper

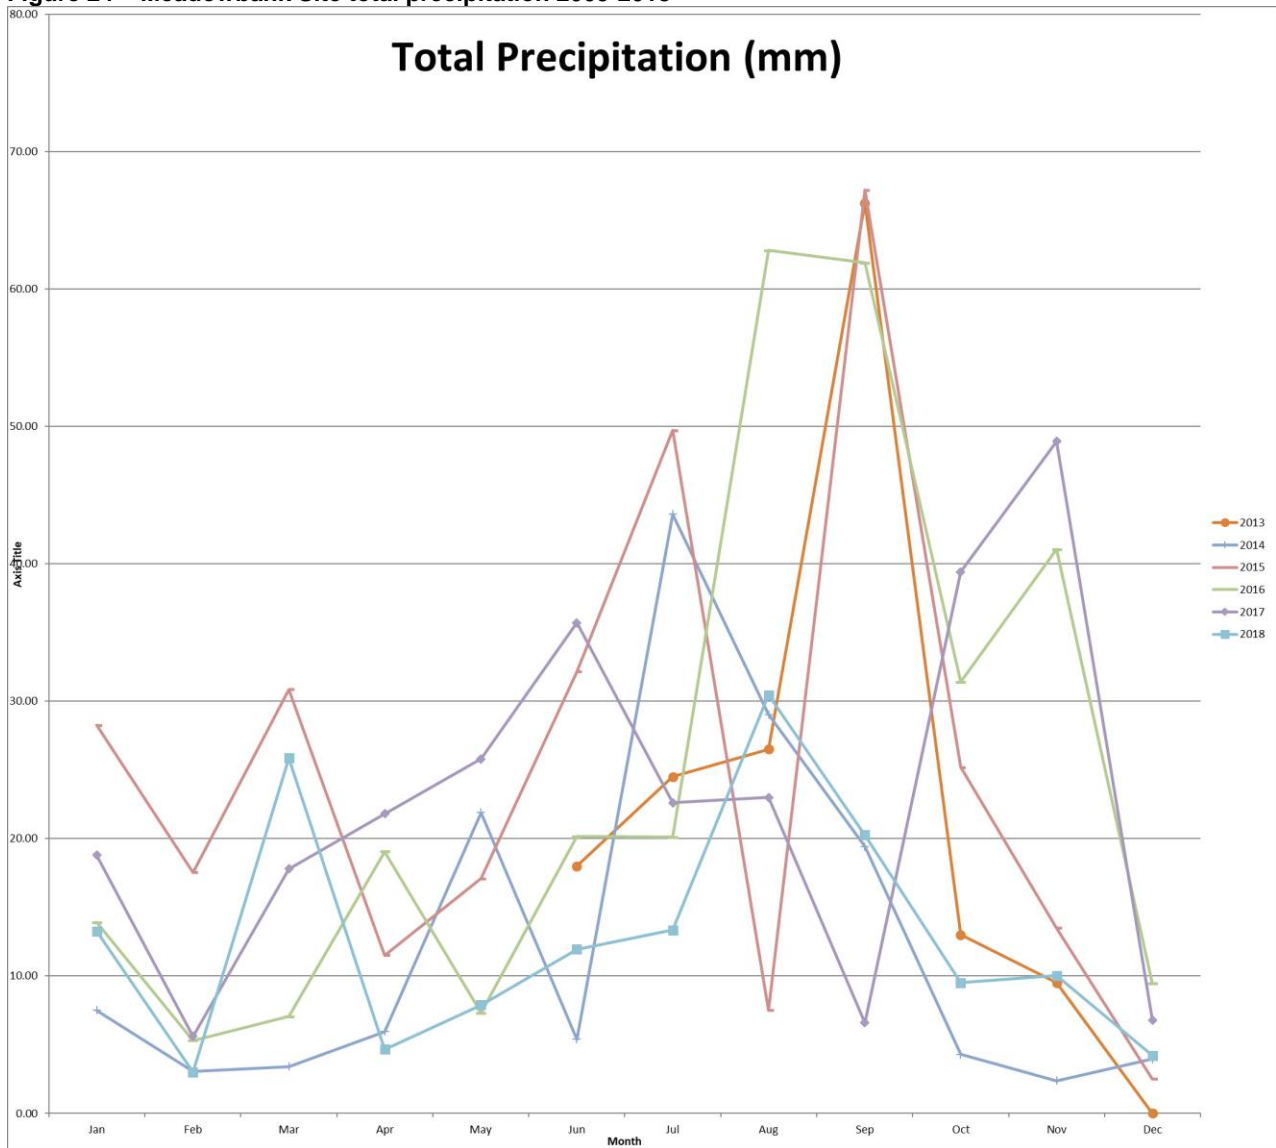
Figure 24 – Meadowbank Site total precipitation 2009-2018

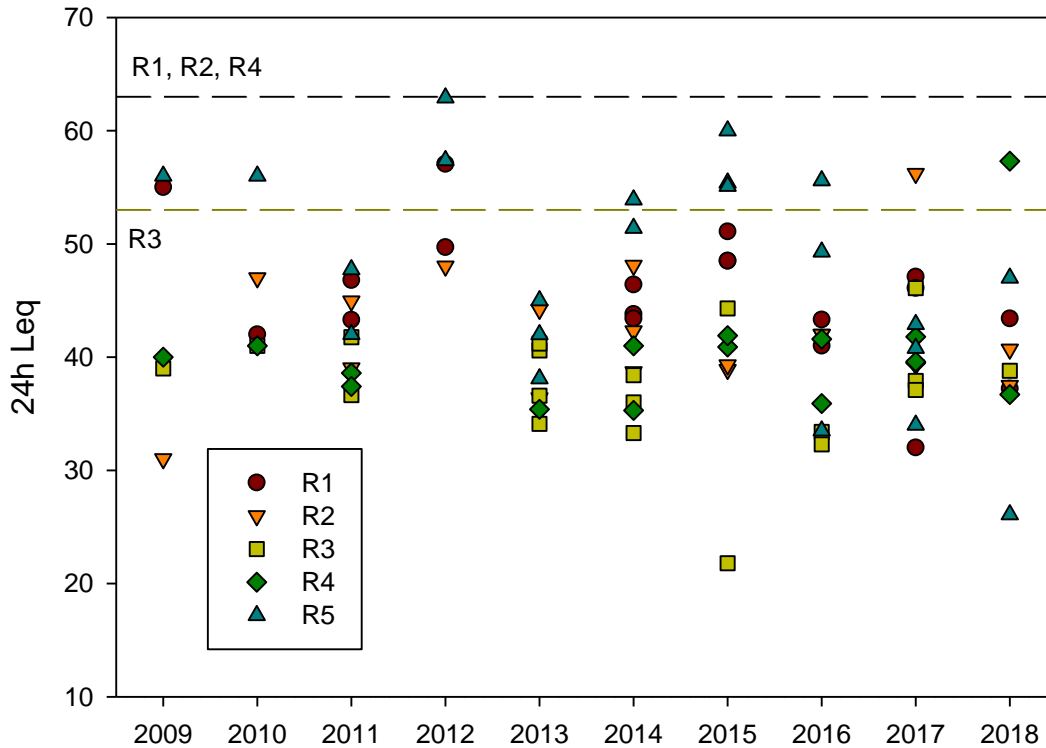
Figure 32. L_{eq} values calculated from filtered data for 24 h averaging times at locations R1 – R5 on the Meadowbank site in surveys from 2009 - 2018. Dashed lines indicate maximum predicted sound levels in the FEIS for each location (24-h L_{eq} prediction not available for R5).

However, 24-h Leq measurements since 2009 were reviewed for all monitoring stations to understand if any trends towards increasing noise levels above FEIS predictions are occurring for any location on site (Figure 32). The upper level of predicted values is shown for R1 – R4. No prediction with respect to a 24h Leq was made for R5. As shown in this figure, there is no clear trend towards increasing sound levels at any site, with the highest sound levels generally occurring in 2012. Although no predictions were made regarding the 24-h Leq for R5, a decreasing trend is seen for noise levels at this station since 2012. Further analysis of trends over time for different averaging times is presented in the 2018 Noise Monitoring Report (Appendix 44).
