### **Meadowbank and Whale Tail 2022 Landfarm Report**

**2022 Landfarm Report**

In Accordance with NIRB Project Certificates No.004 & No. 008  
&  
NWB Type A License 2AM-MEA1530 & 2AM-WTP1830

Prepared by:  
Agnico-Eagle Mines Limited – Meadowbank Complex

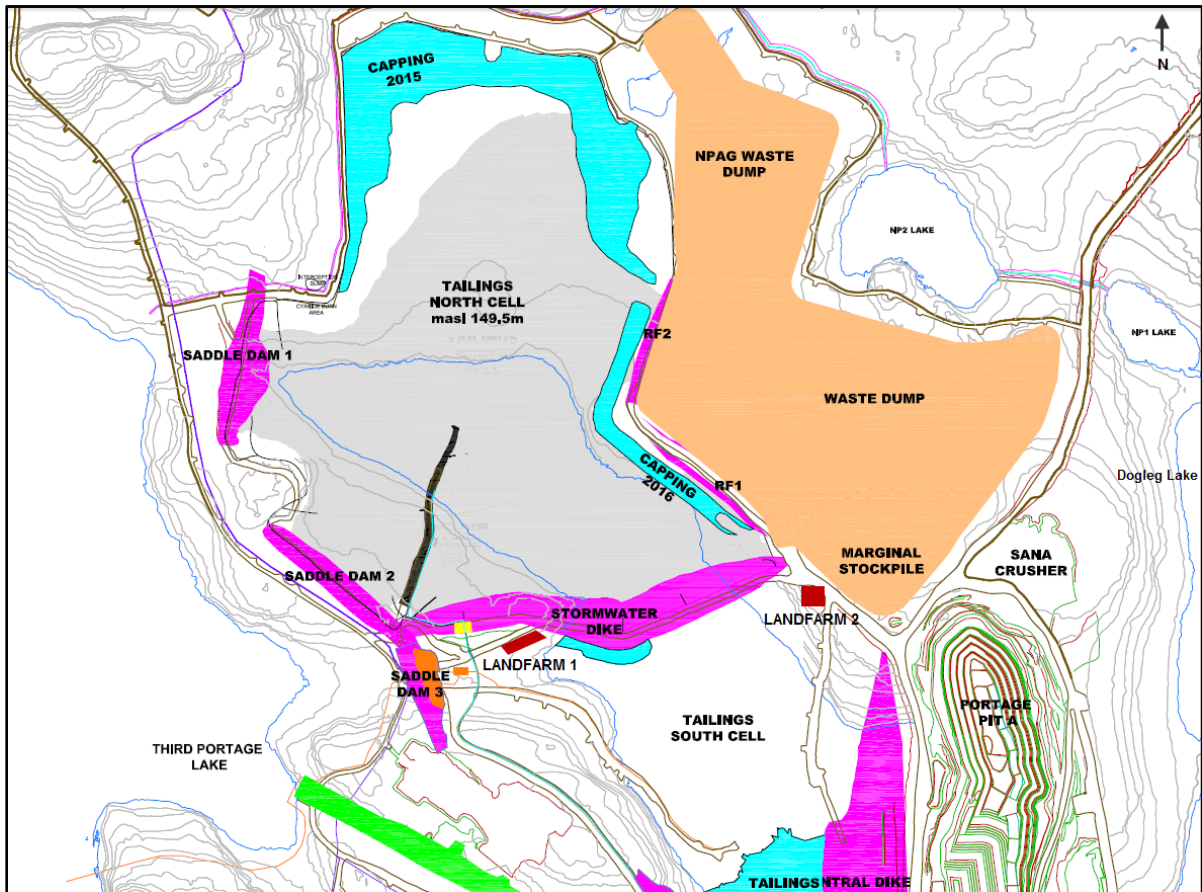
**Figure 2-1. Meadowbank Landfarm 1 and Landfarm 2 locations**

Meadowbank's first landfarm (Landfarm 1) was constructed in 2012 and located on the north-west side of the South Tailings Cell within the Tailings Storage Facility. Since this area was planned to eventually become flooded with reclaim water, Agnico Eagle constructed a new landfarm (Landfarm 2) in 2016, in order to continue the treatment of contaminated soil. In 2019, the Landfarm 1 area became flooded with reclaim water, and it is thus no longer in operation.

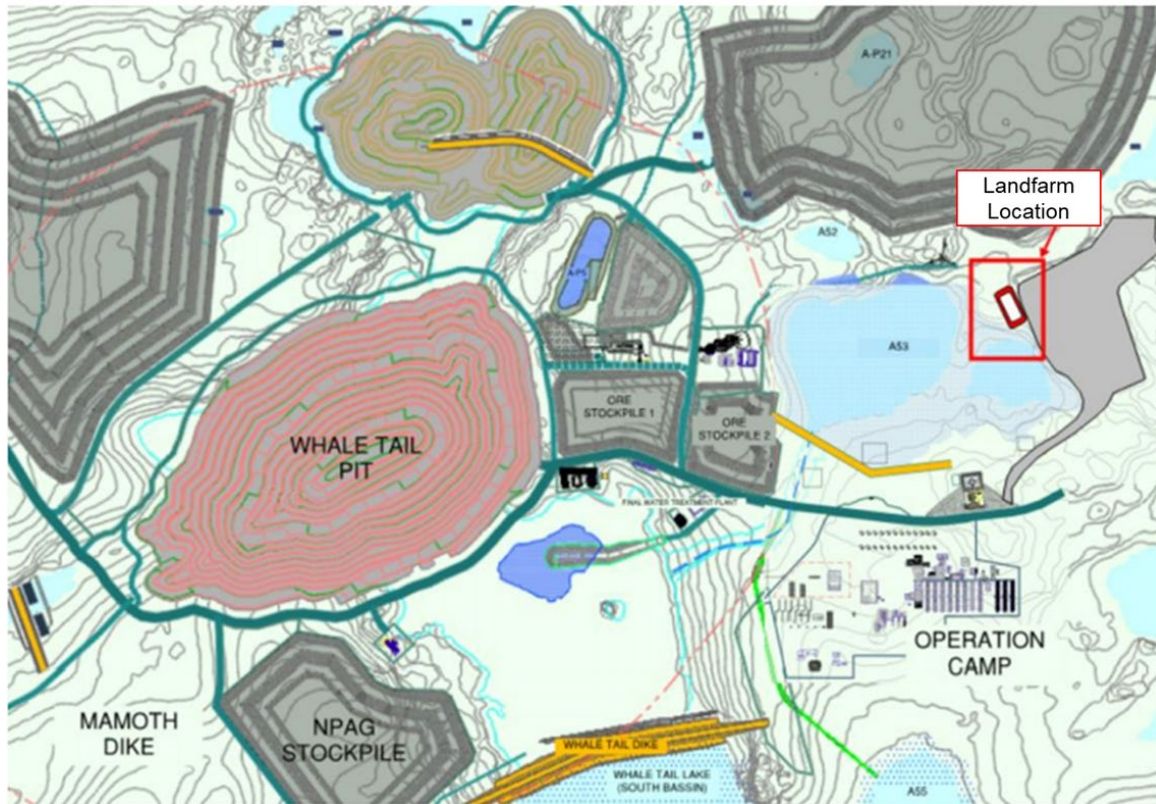
**Figure 3-1 Whale Tail Landfarm Location**

The construction of the landfarm at Whale Tail Mine was approved by the NWB on October 27, 2021. The landfarm was built in fall of 2022 and is located east of the IVR Attenuation Pond as presented in Figure 3-1. It is located away from any receiving environment waterbody. Since the landfarm was not operational the majority of 2022, no activities occurred. Only 15 m<sup>3</sup> of soil were brought to the landfarm in 2022.
