Meadowbank Dewatering Dike OMS Version 10

MEADOWBANK SITE

DEWATERING DIKES

**Operation, Maintenance and
Surveillance Manual**

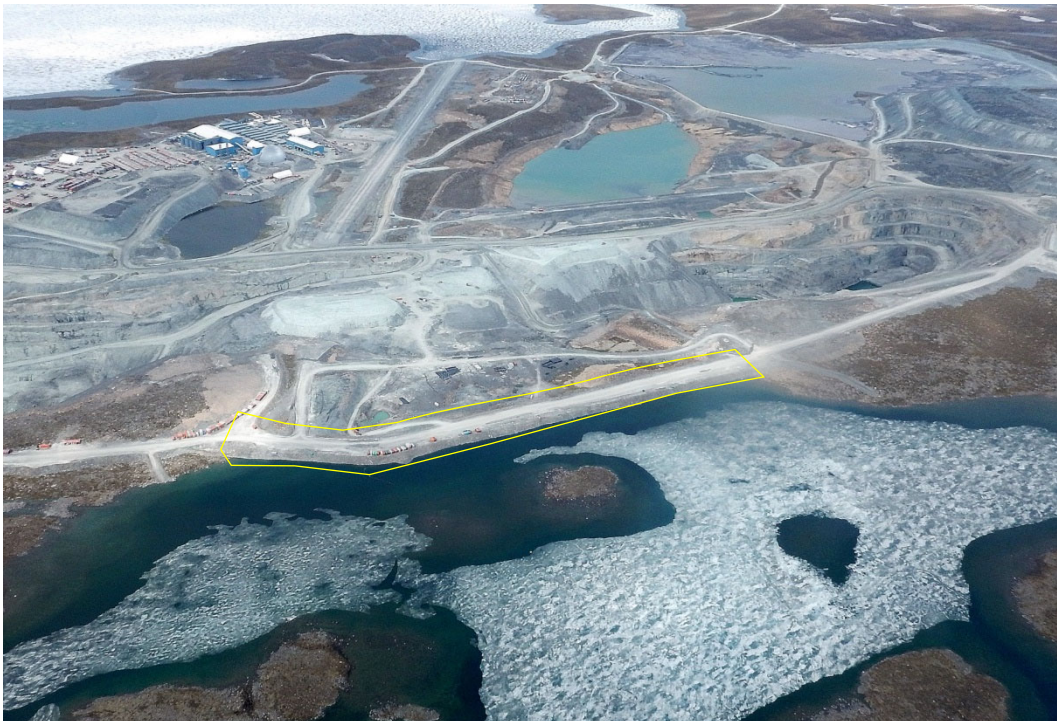
Figure 3-1 : Aerial View of East Dike

| Figure 3-1 : Aerial View of East Dike..... | 15 |

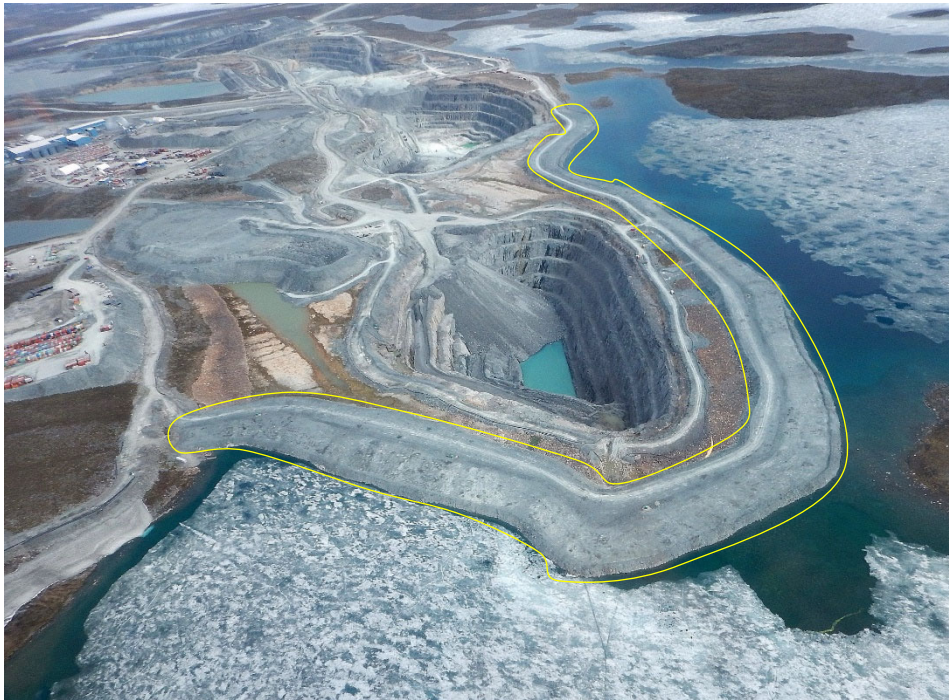
Figure 3-3 : Aerial View of Bay-Goose Dike

| Figure 3-3 : Aerial View of Bay-Goose Dike | 20 |

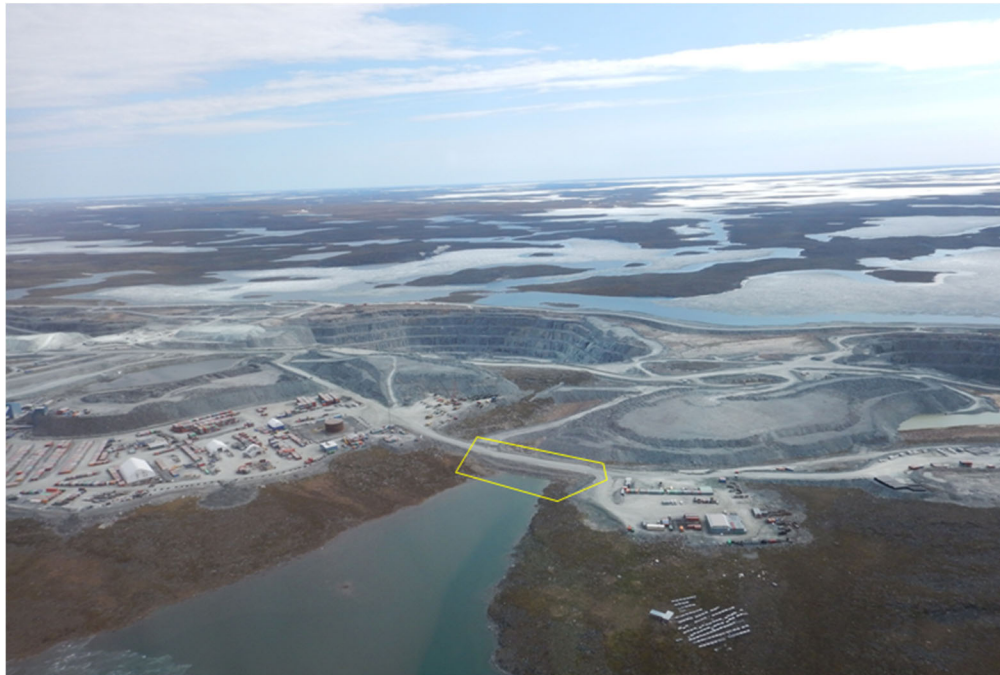
Figure 3-5 : Aerial View of South Camp Dike

| Figure 3-5 : Aerial View of South Camp Dike | 27 |

The South Camp Dike was primarily constructed between April and June of 2009, prior to ice breakup. During the winter of 2009-2010 additional thermal capping material and rockfill for the haul road was added to the dike. The South Camp Dike has a broad rockfill shell with a bituminous geomembrane liner installed on the upstream side of the shell. The liner was founded on native frozen (permafrost) till material, in a trench approximately 3 to 5 m below the lakebed surface. Compacted granular material mixed with bentonite was placed above the toe of the liner. The haul road is located on the downstream side of the dike.

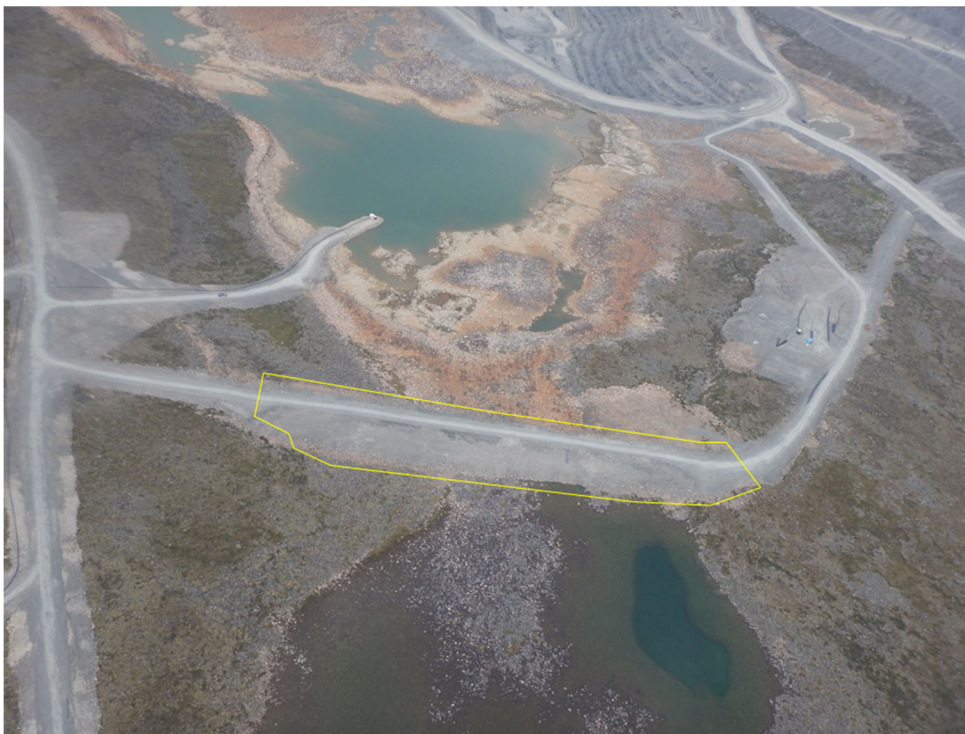
Figure 3-7 : Aerial View of Vault Dike

| Figure 3-7 : Aerial View of Vault Dike..... | 30 |
