Meadowbank Tailings Storage Facility OMS Version 11

TAILINGS MANAGEMENT

**Operation, Maintenance and
Surveillance Manual**

Version 11
Dec 2022

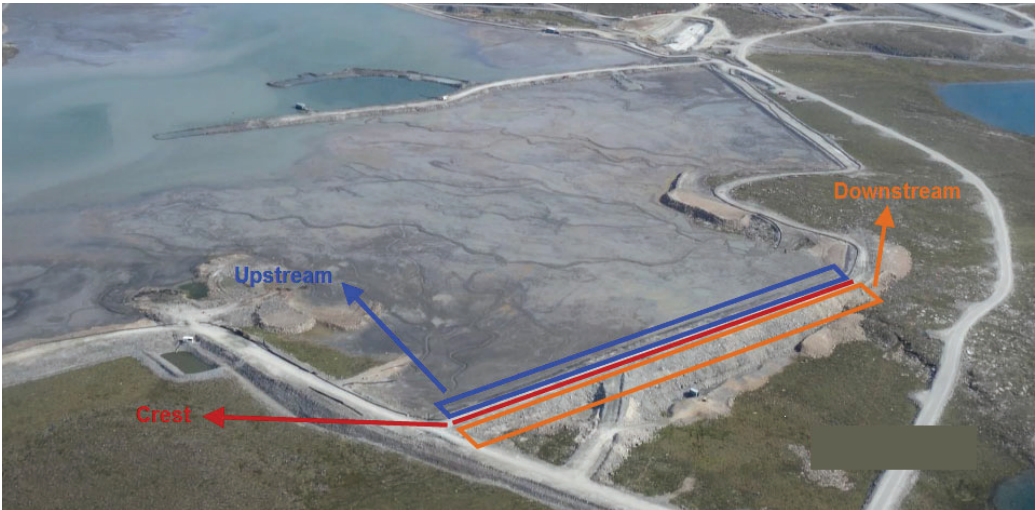
Figure 3-2: Aerial View of Saddle Dam 1

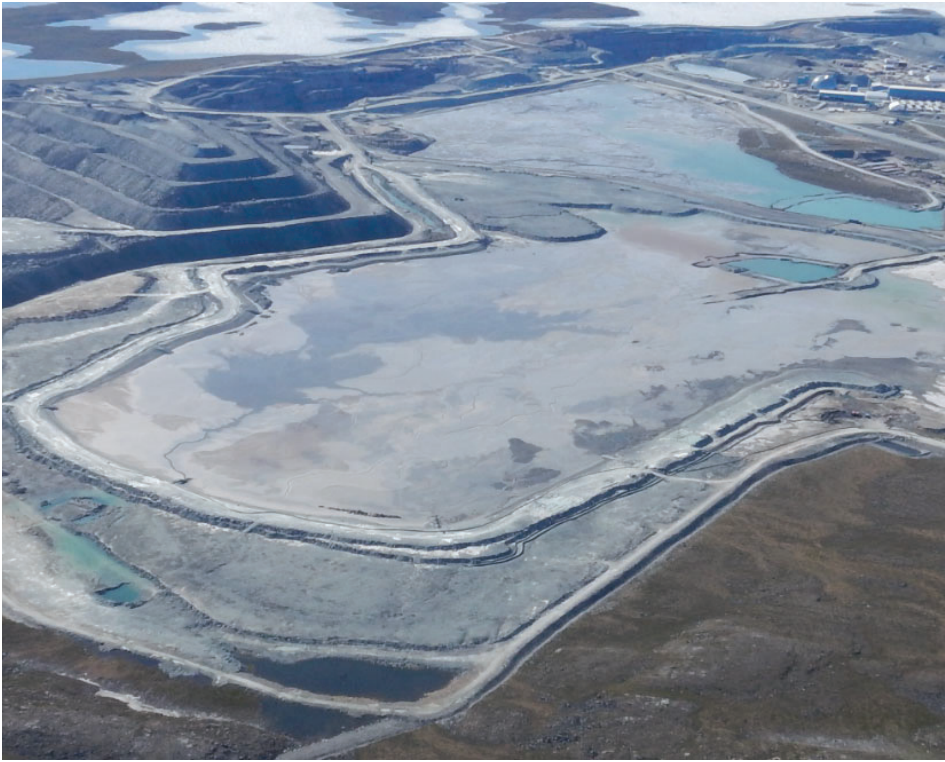
Figure 3-8: Aerial View of the North Cell Internal Structure

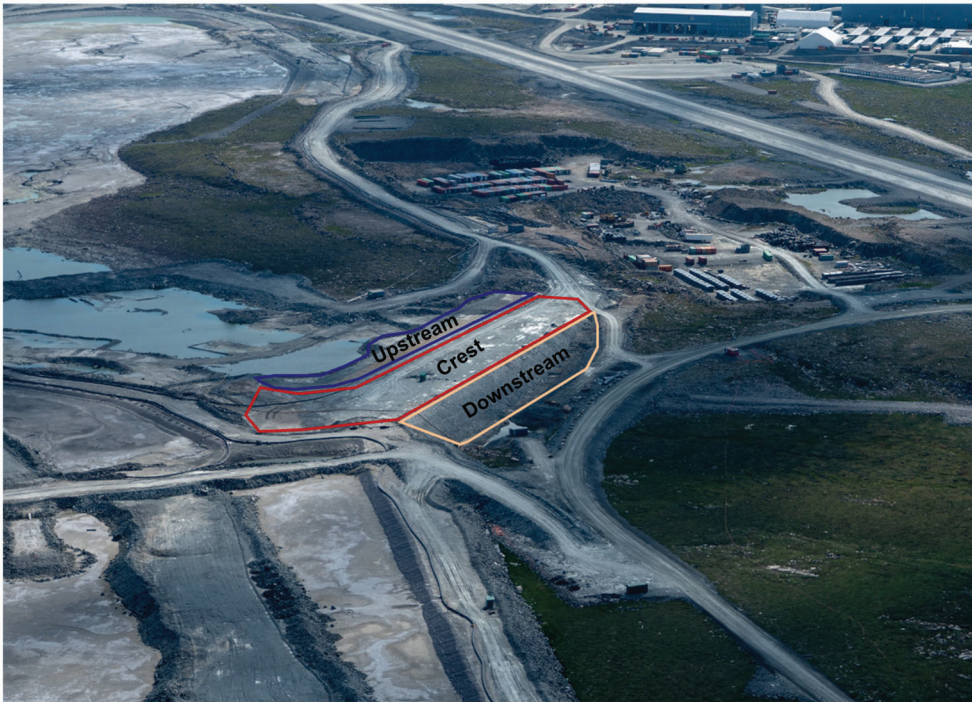
Figure 3-10: Aerial View of Saddle Dam 3

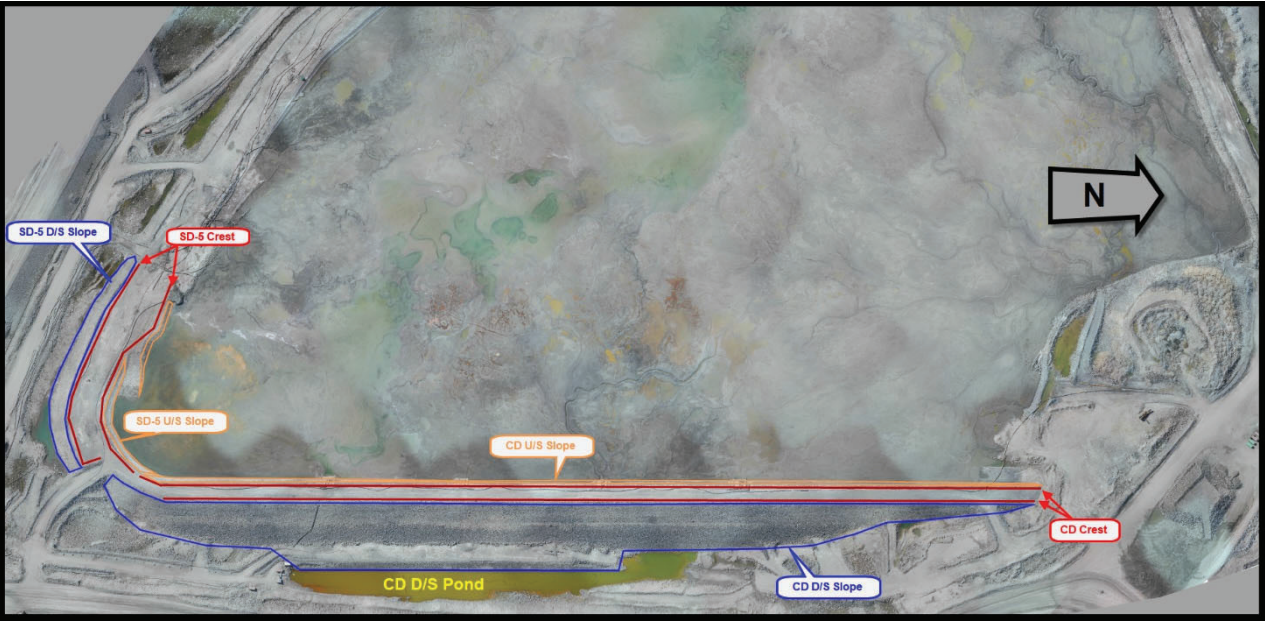
Figure 3-13: Aerial View of Central Dike and SD5

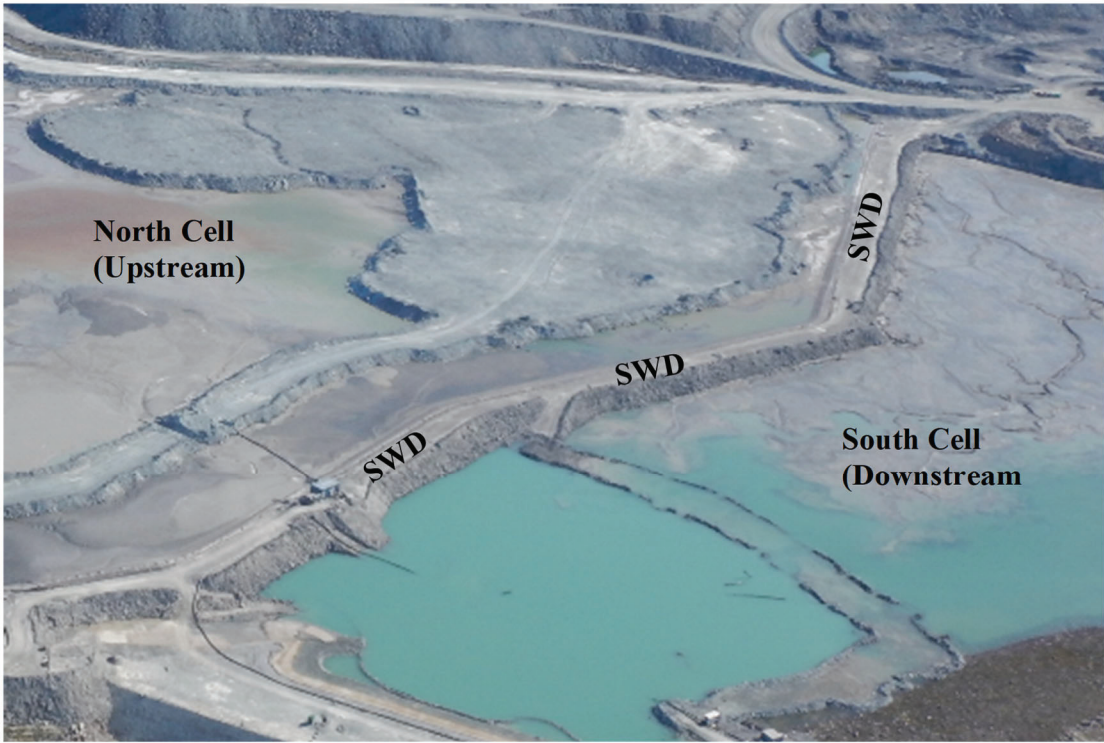
Figure 3-15: Aerial View of Stormwater Dike (2019)

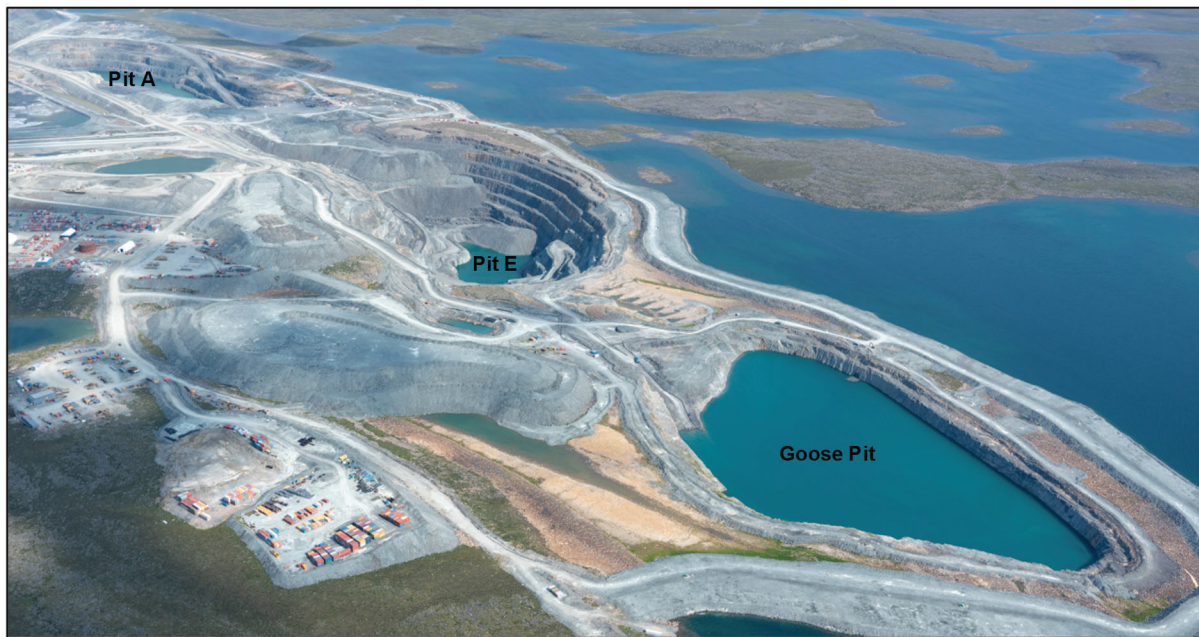
Figure 3-18: In-Pit Area for Tailings Management (Summer 2020)

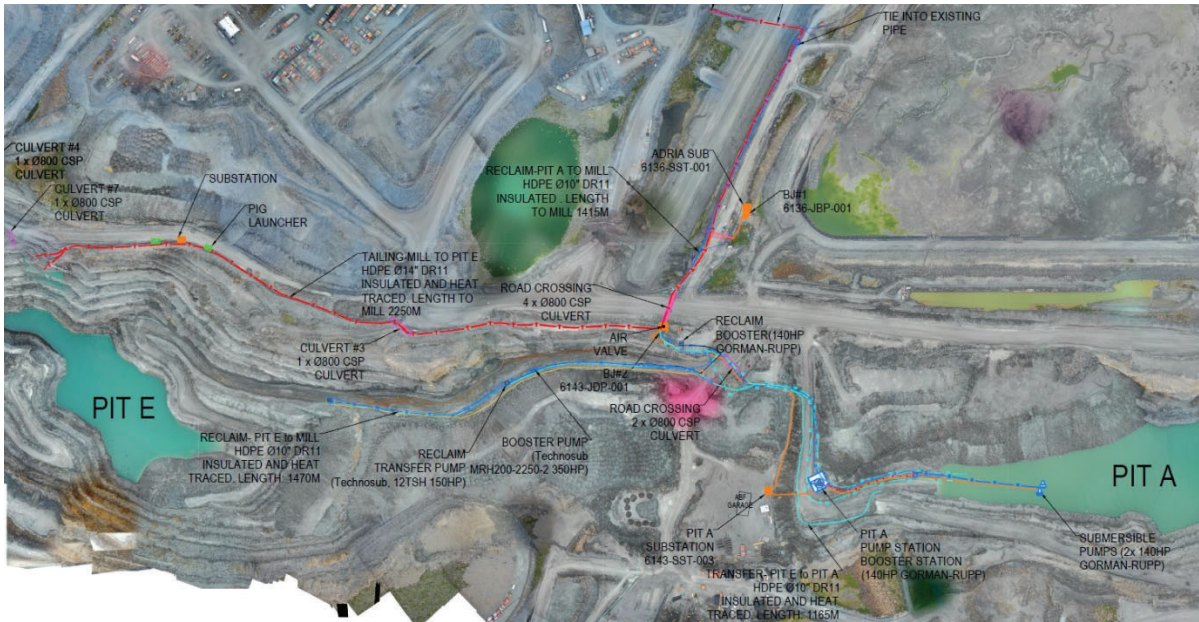
Figure 3-19: Plan view of In-Pit Area and Related Infrastructure (as of Fall 2022)

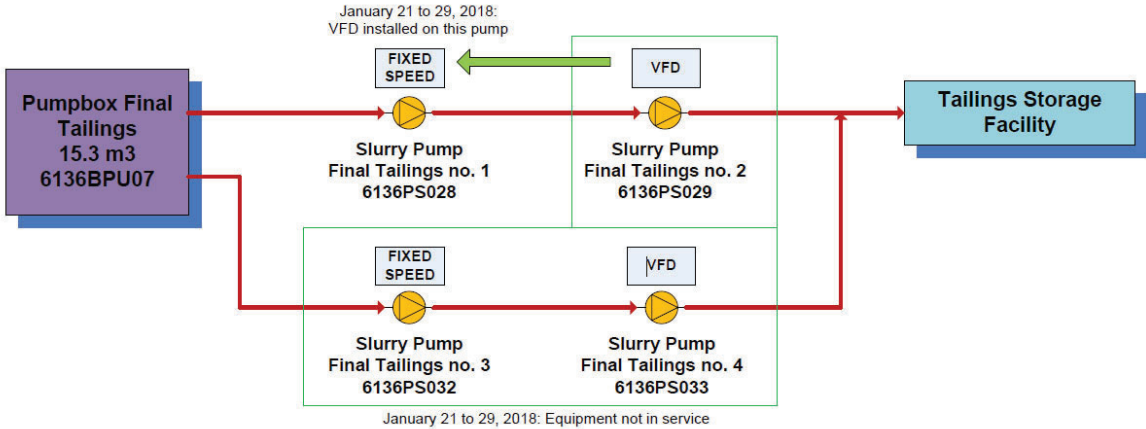
Figure 3-20: Schematic Diagram of the Final Tailings Installation System at the Process Plant

From the tailings pumpbox tailings are pumped to the designed tailings management area using the process plant tailings slurry pumps. A simplified flow sheet of the process plant flow diagram is included in Appendix C. A schematization of the tailings pumpbox system is included in Figure 3-20.
